(10) **Patent No.:** **US 7,401,570 B2**  
(45) **Date of Patent:** **Jul. 22, 2008**

(54) **AIRCRAFT EXTREMITY MARKER**

A marker for the wingtip or other extremity of an aircraft. The marker includes a fabric pouch having a flap containing hook and loop fasteners, to hold the pouch on the aircraft extremity. A fabric tube extends outwardly and substantially horizontally from the pouch and supports a marker flag at its tip. The fabric tube contains a breakable support rod, so that if the aircraft wingtip collides with an object, the support rod will break and the flag will droop, providing a visible indication that a collision has occurred. The broken rod can then be replaced.

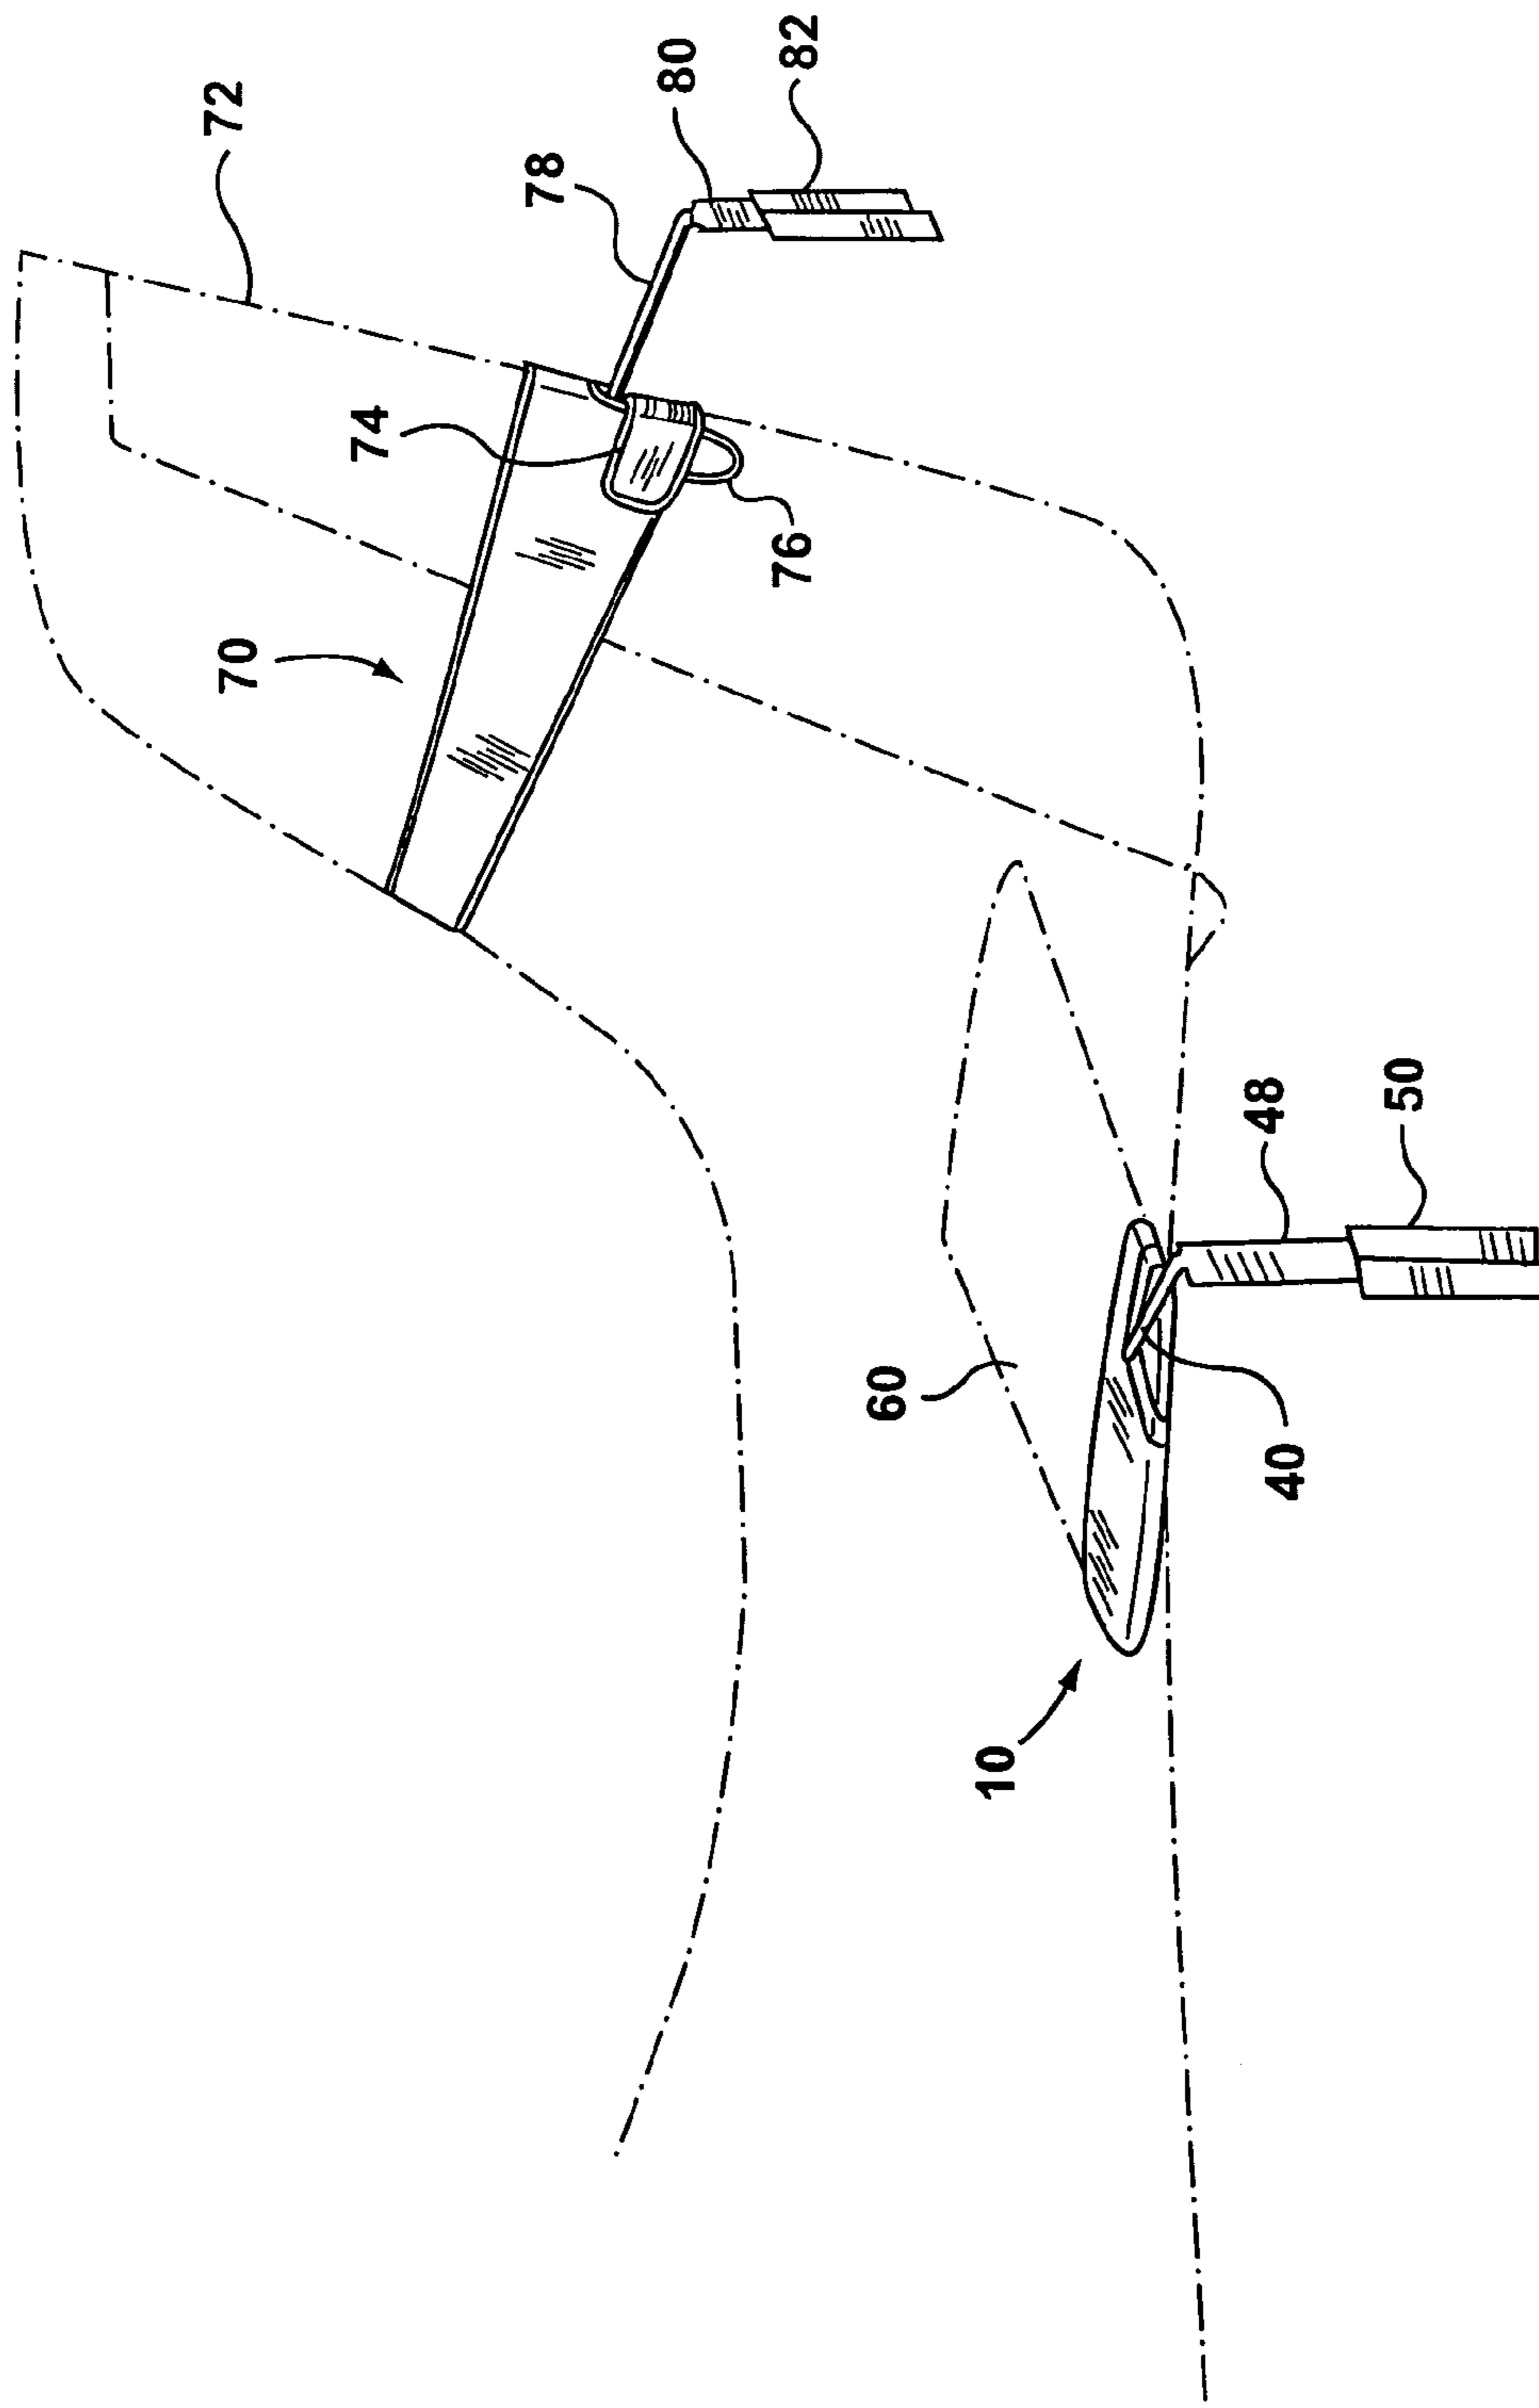
**FIG. 7**

FIG. 7 is a diagrammatic view showing the device of the invention as applied to an aircraft rudder and to an aircraft elevator;

While the marker **10** has been shown as applied to an aircraft wingtip, it can as shown in FIG. **7** be applied to the tip of an aircraft elevator (tail wing) **60**. The shape of the pouch formed by the marker **10** will of course be made to fit the end of the elevator, and as before, the fabric tube **40** extends substantially horizontally, preferably rearwardly and outwardly from the tip of the elevator **60**.

As also shown in FIG. **7**, a marker **70** similar to that described may be used to mark the rear edge of the rudder (tail) **72** of the aircraft. The rudder marker **70** is preferably formed as a strip of fabric which may be wrapped around the rudder, with a flap **74** (corresponding to the flap **28**) which has a patch of hook and loop fasteners on its inner surface. The flap **74** is located at one end of the strip of fabric forming the marker and may be pulled over a corresponding fastener patch (not shown) containing mating hook and loop fasteners, to hold the marker **70** on the aircraft rudder. A fabric loop or tab **76** may be attached to the flap **74** to serve as a grip to pull the flap **74** tightly over the hook and loop patch (not shown) beneath the flap **74**.

A fabric tube **78** is attached to the rudder marker **70** in any desired manner so that the tube **78** projects rearwardly and at least partially horizontally from the rear edge of the rudder **72**. The tube **78** includes a support rod (not shown in FIG. **7**) therein, exactly like rod **42**, and which may be inserted or removed through a hole in tube **78**. A fabric strip **80** and flag **82** which are exactly like strip **48** and flag **50**, are attached to the end of fabric tube **78**, to mark the rear end of the aircraft.

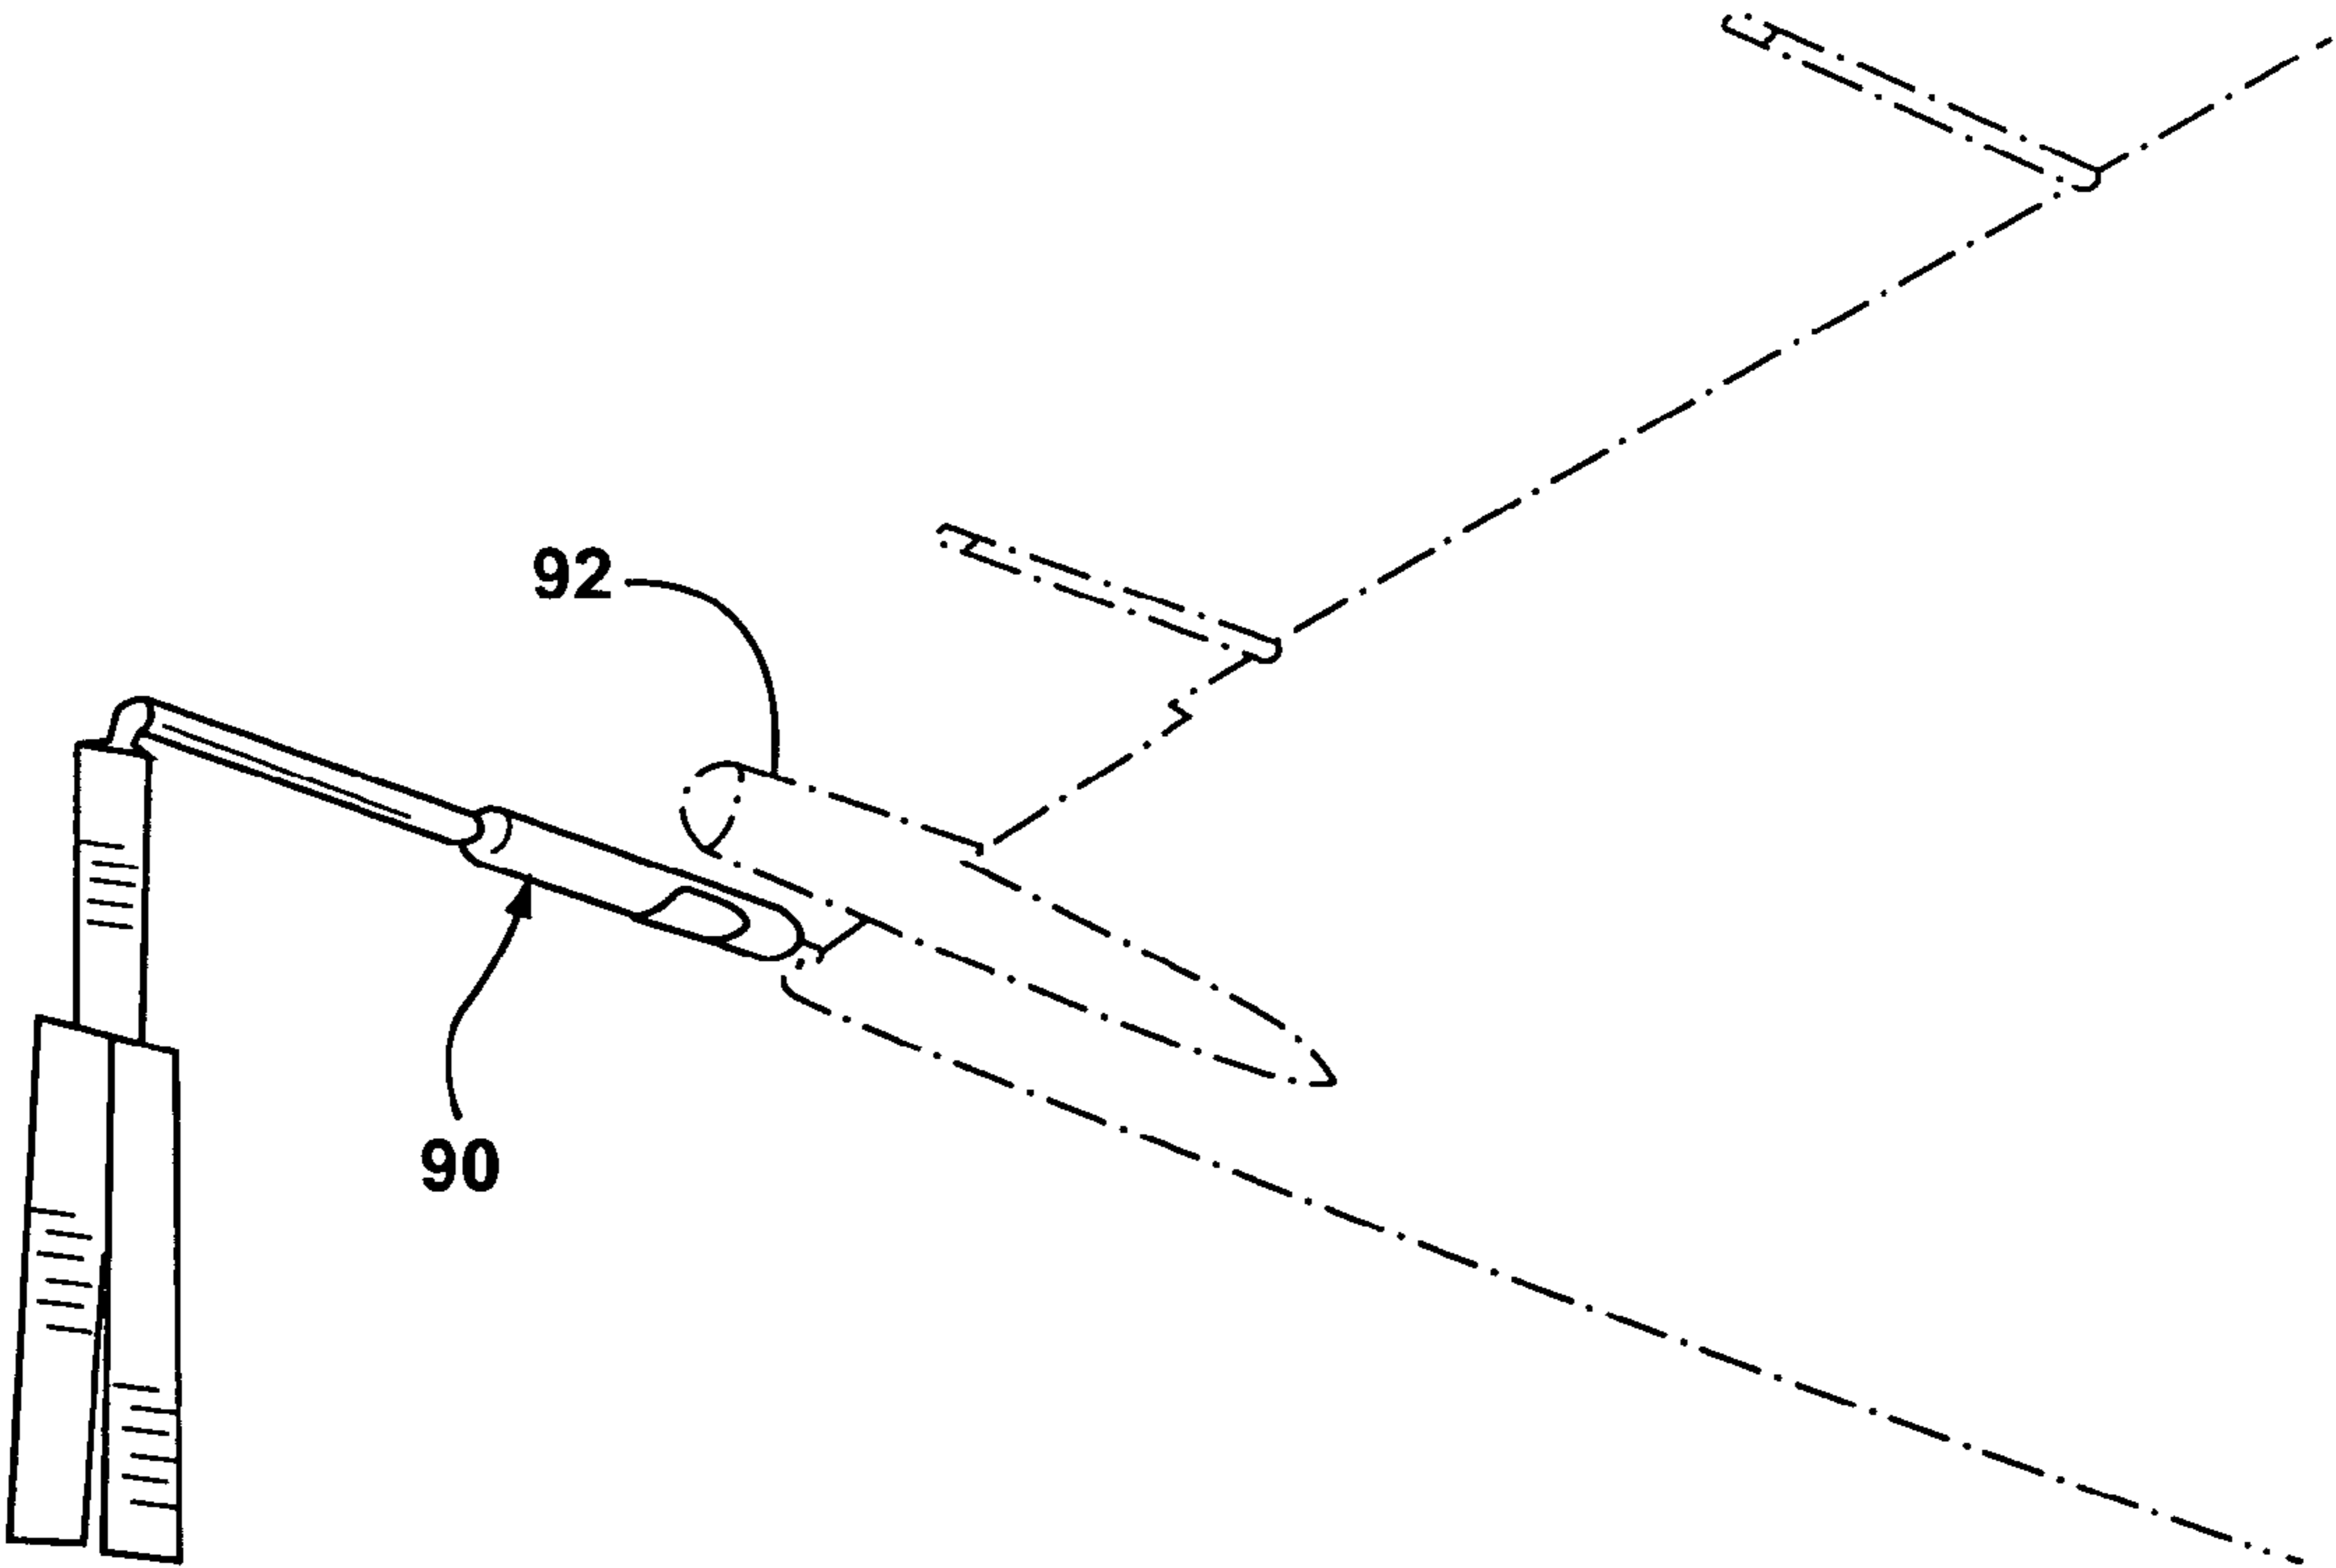
**FIG. 8**

FIG. 8 is a diagrammatic view showing a device according to the invention applied to an aircraft static wick;

FIGS. **8** to **10** show a marker **90** wrapped around a static wick **92** (also sometimes called a static discharger) on the rear edge of an aircraft wing near the wingtip. The marker **90** includes a fabric tube **94**, like tube **40** and containing a support rod having a weakened portion (not shown) like rod **42**, and having a hole (not shown) for insertion and removal of the support rods. The tube **94** is preferably of a high friction material. Two inner flaps **96**, **98**, joined by a fabric bridge **100**, are sewn to the tube **94** near one end thereof and can be wrapped around the static wick and held tightly thereon by an outer flap **101** sewn to the inner flaps **96**, **98**. The outer flap **101** has two cooperating patches **102**, **104** of hook and loop fasteners which can be pressed together as shown in FIG. **10** to hold the tube **94** on the static wick **92**.

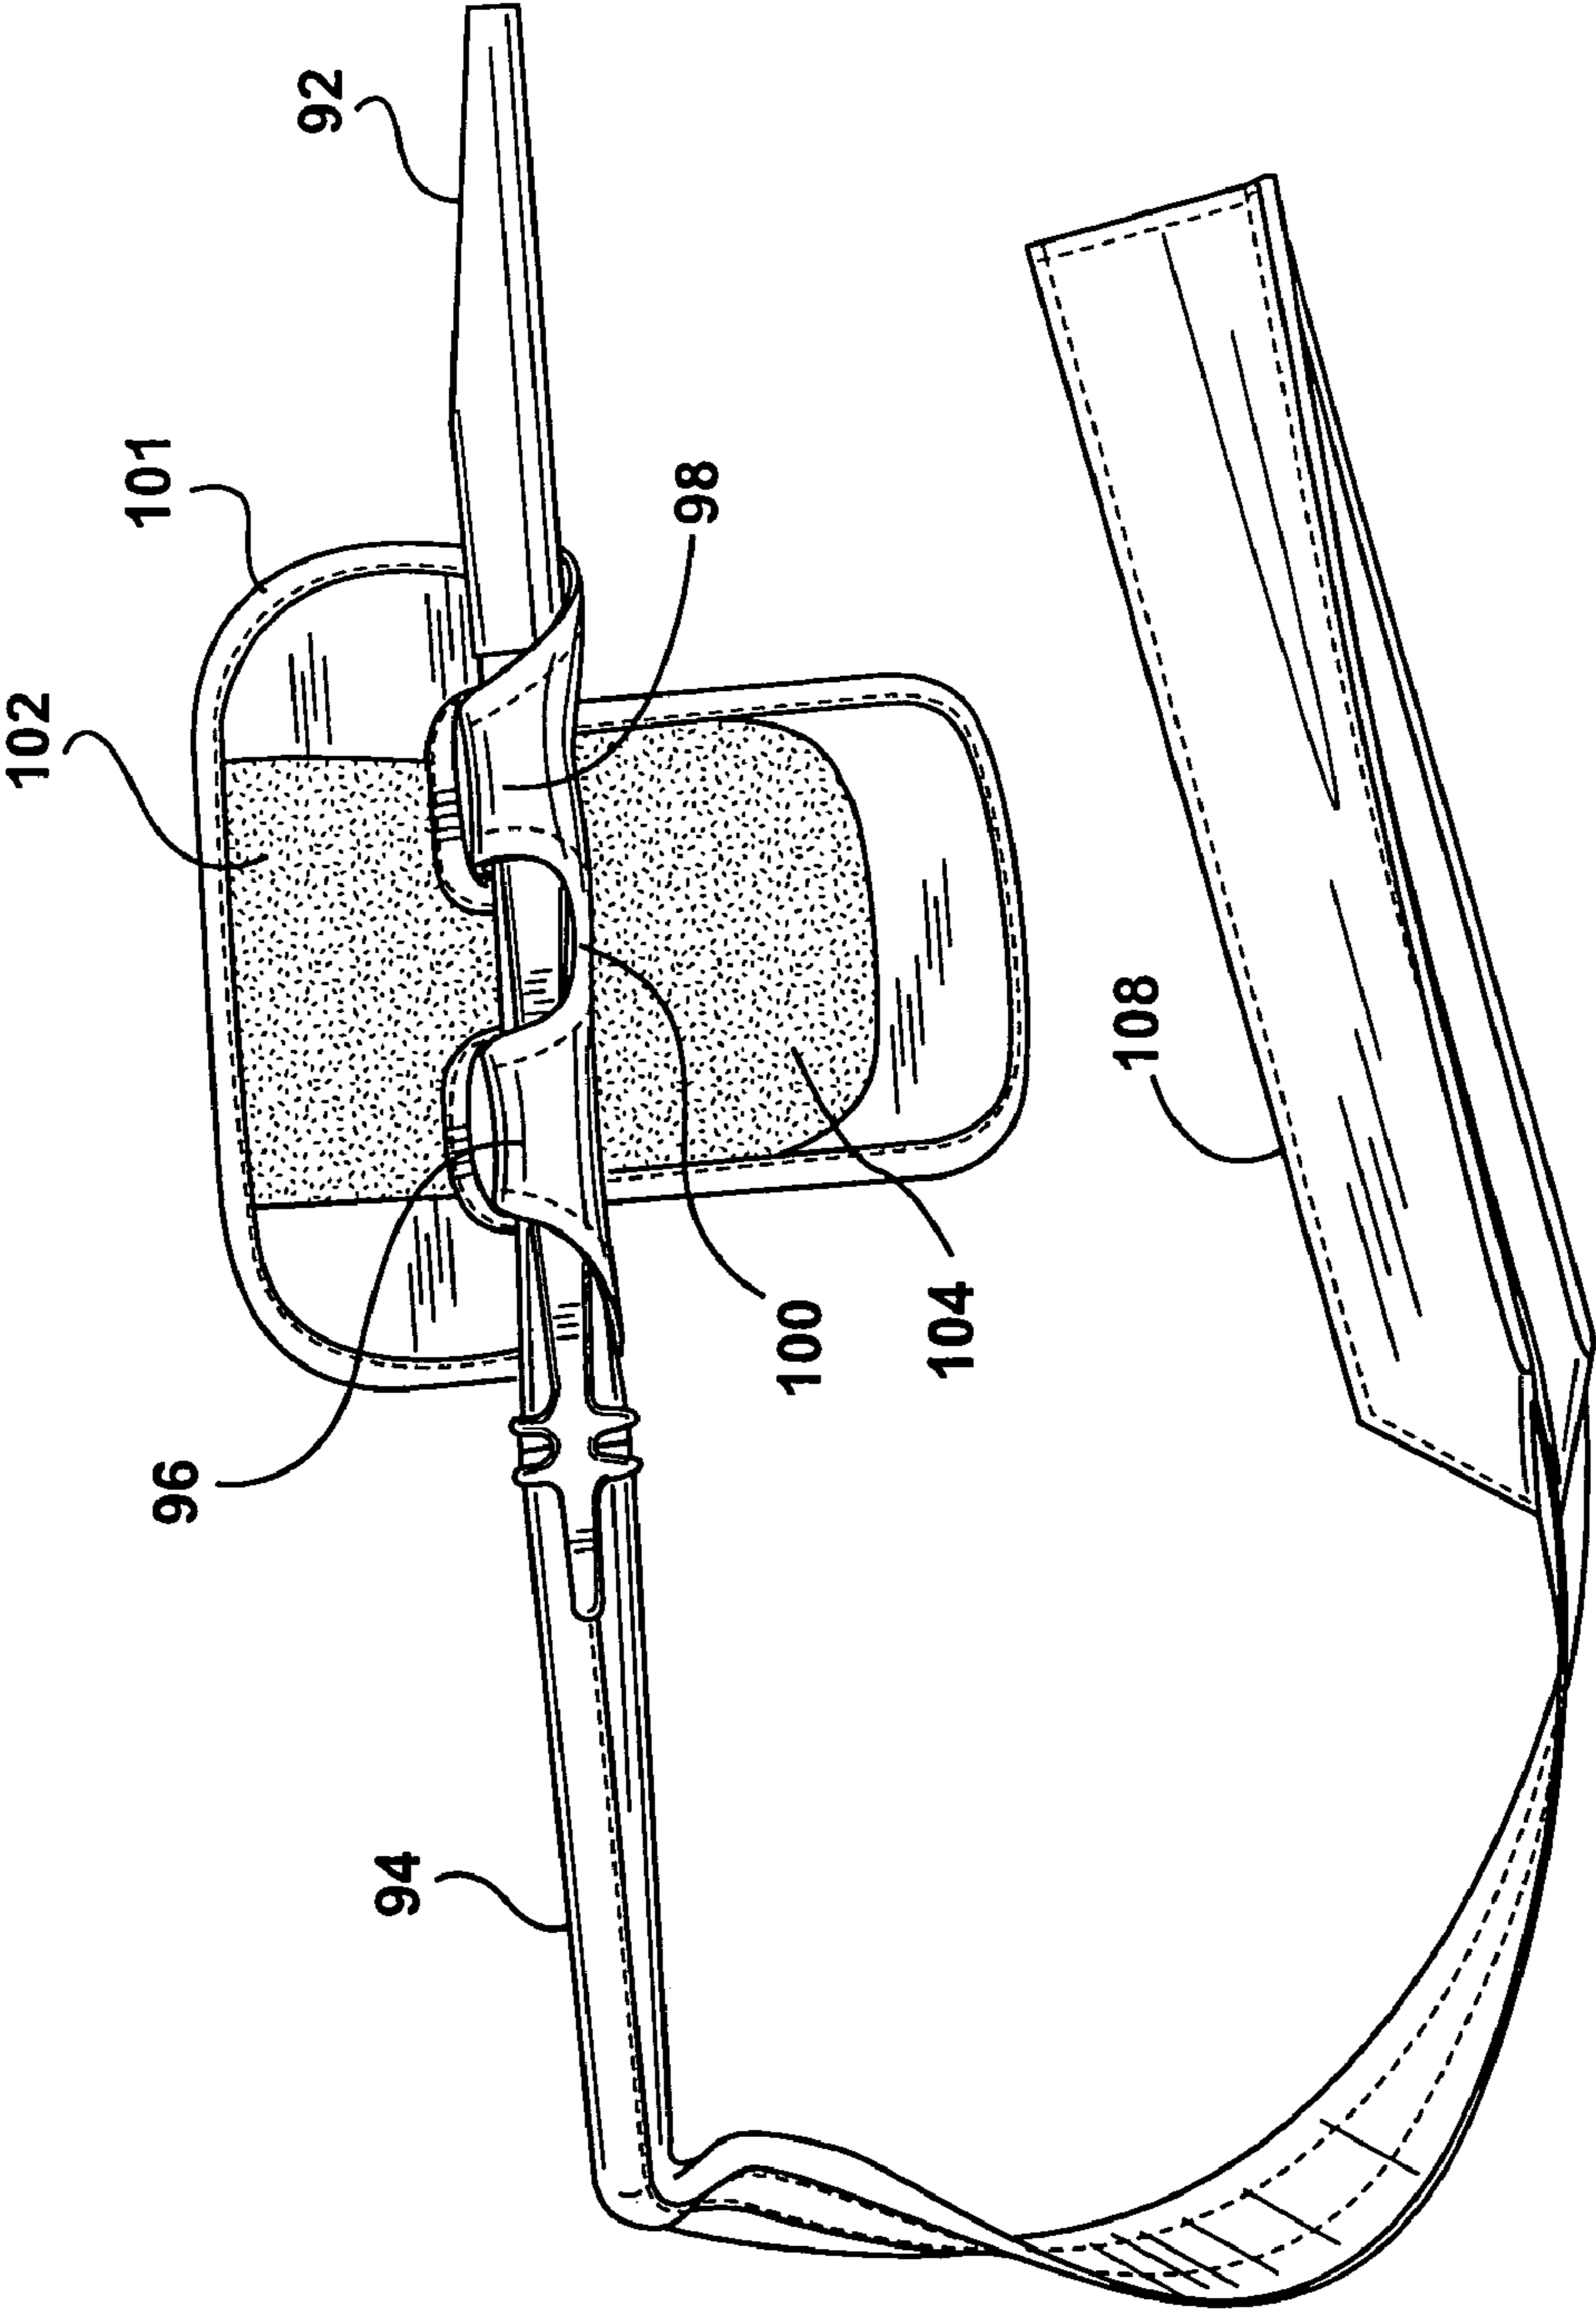
**FIG. 9**

FIG. 9 is a perspective view of the embodiment of FIG. 8, in open condition; and

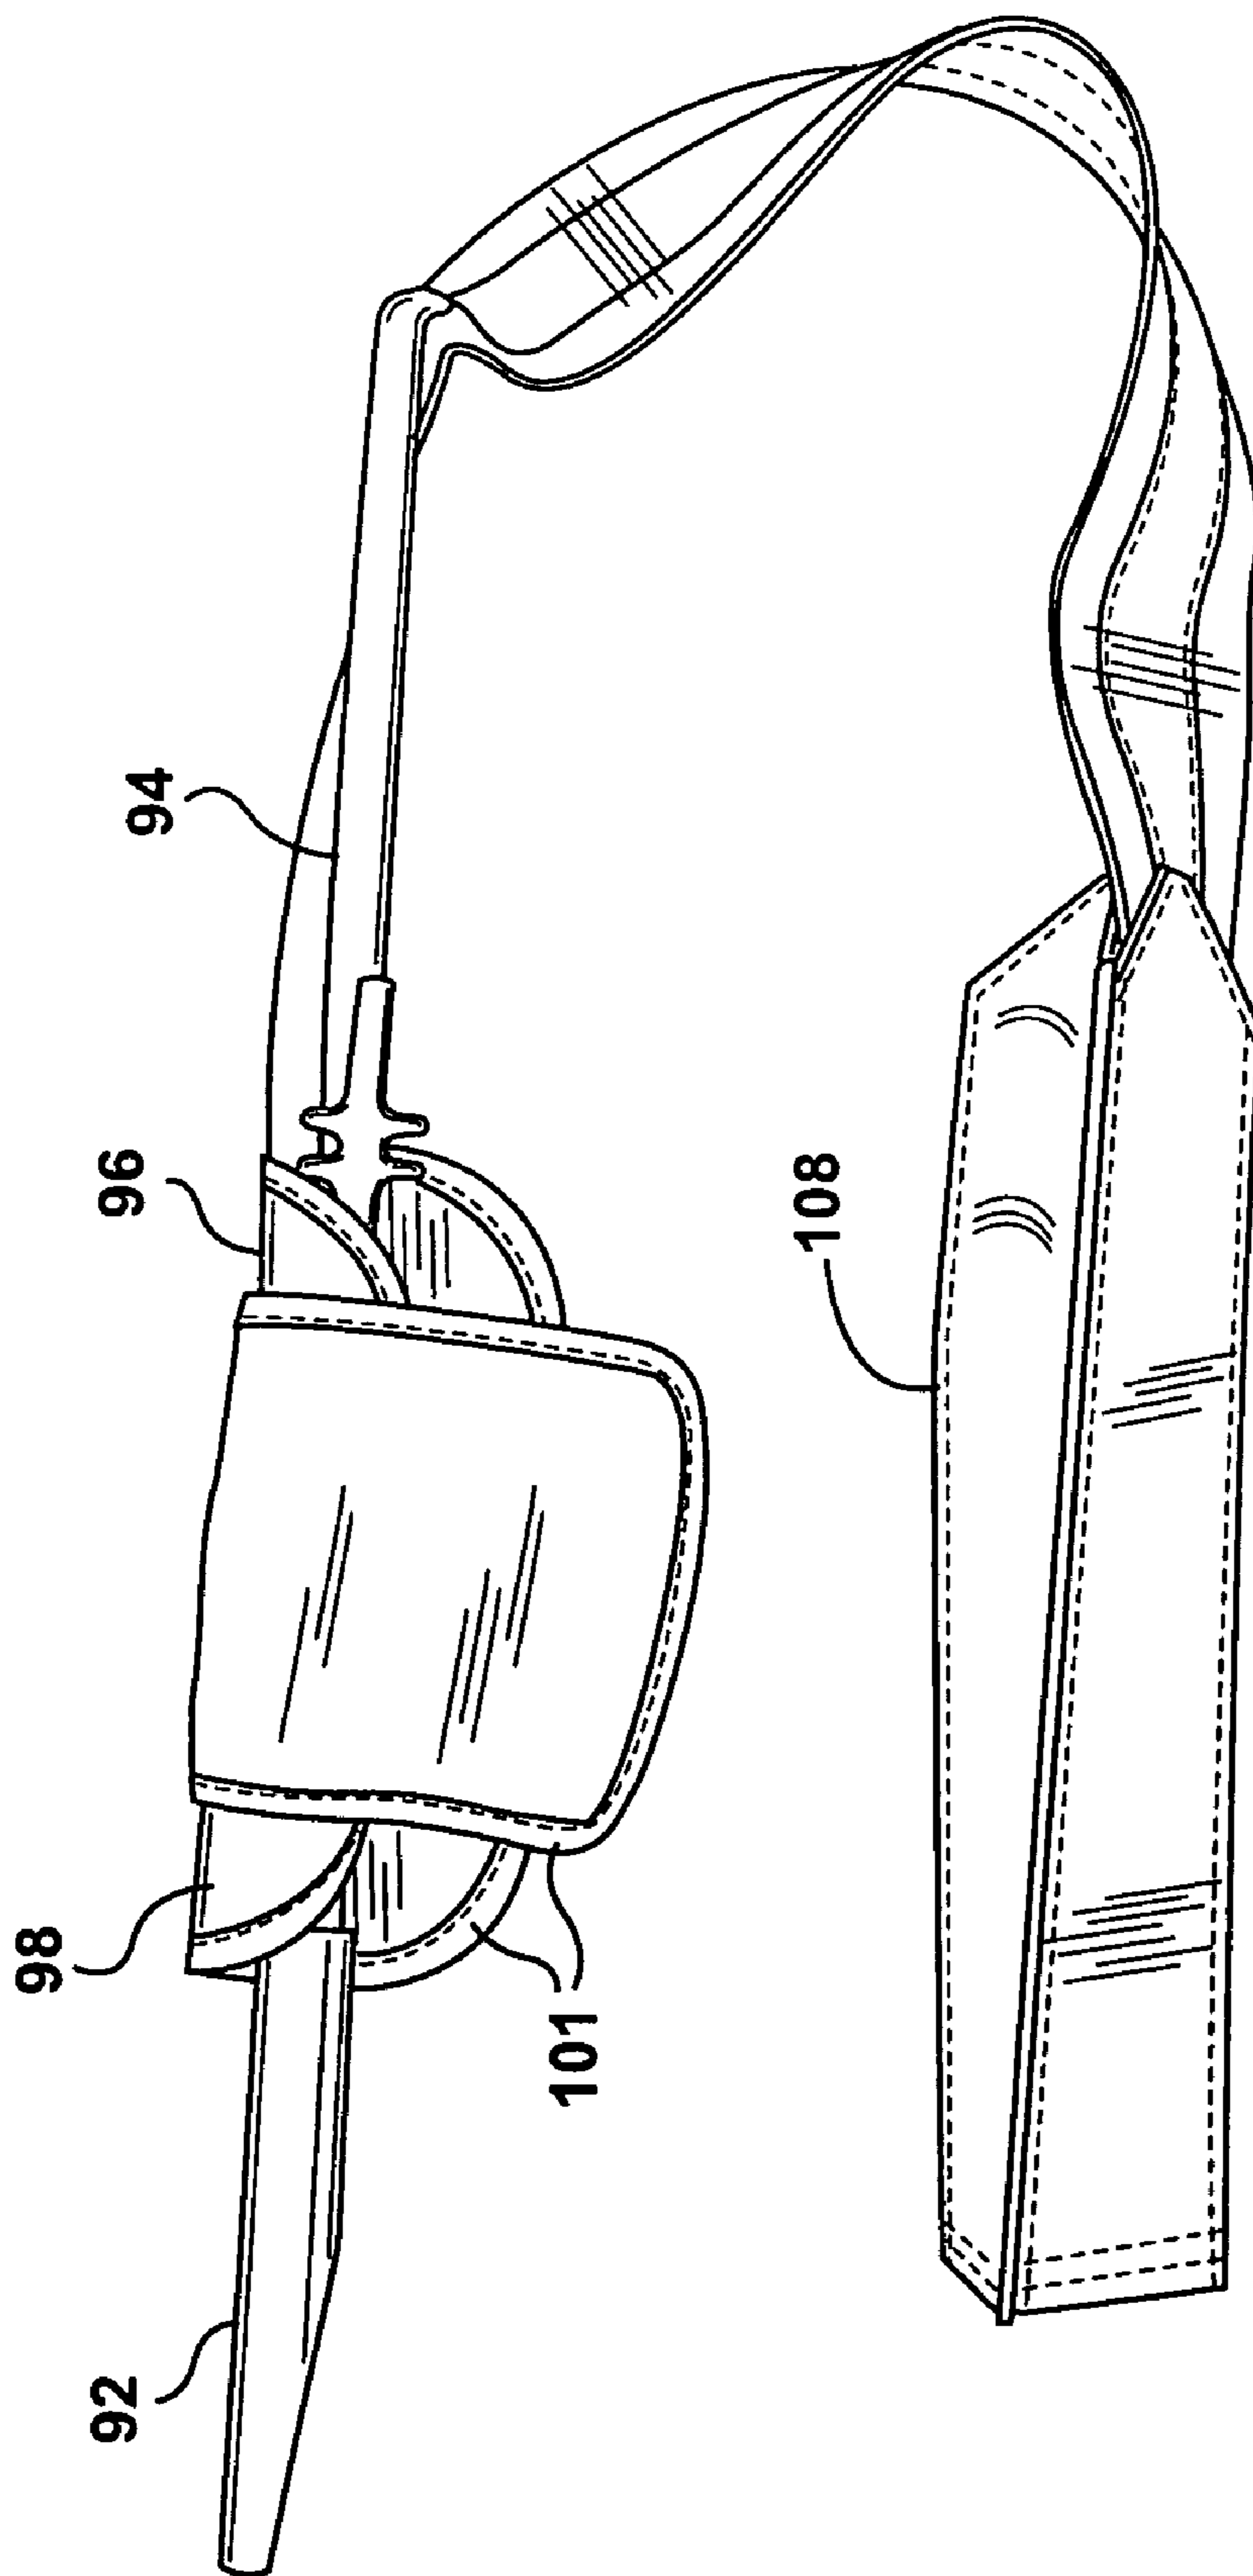
FIG. 10 is a perspective view of the embodiment of FIG. 8, in closed condition.
