(10) **Patent No.:** **US 7,434,990 B2**
(45) **Date of Patent:** **Oct. 14, 2008**

(54) **METHOD TO DETECT TERMITE INFESTATION IN A STRUCTURE**
(75) Inventor: **Peng Lee**, Oxford, MS (US)
(73) Assignee: **University of Mississippi**, University, MS (US)
(*) Notice: Subject to any disclaimer, the term of this patent is extended or adjusted under 35 U.S.C. 154(b) by 57 days.

A method for confirming the presence of termites in a structure, involving a preliminary infrared scan of a structure and confirmation of termite infestation with at least one detector in order to quickly locate potential areas of termite infestation.

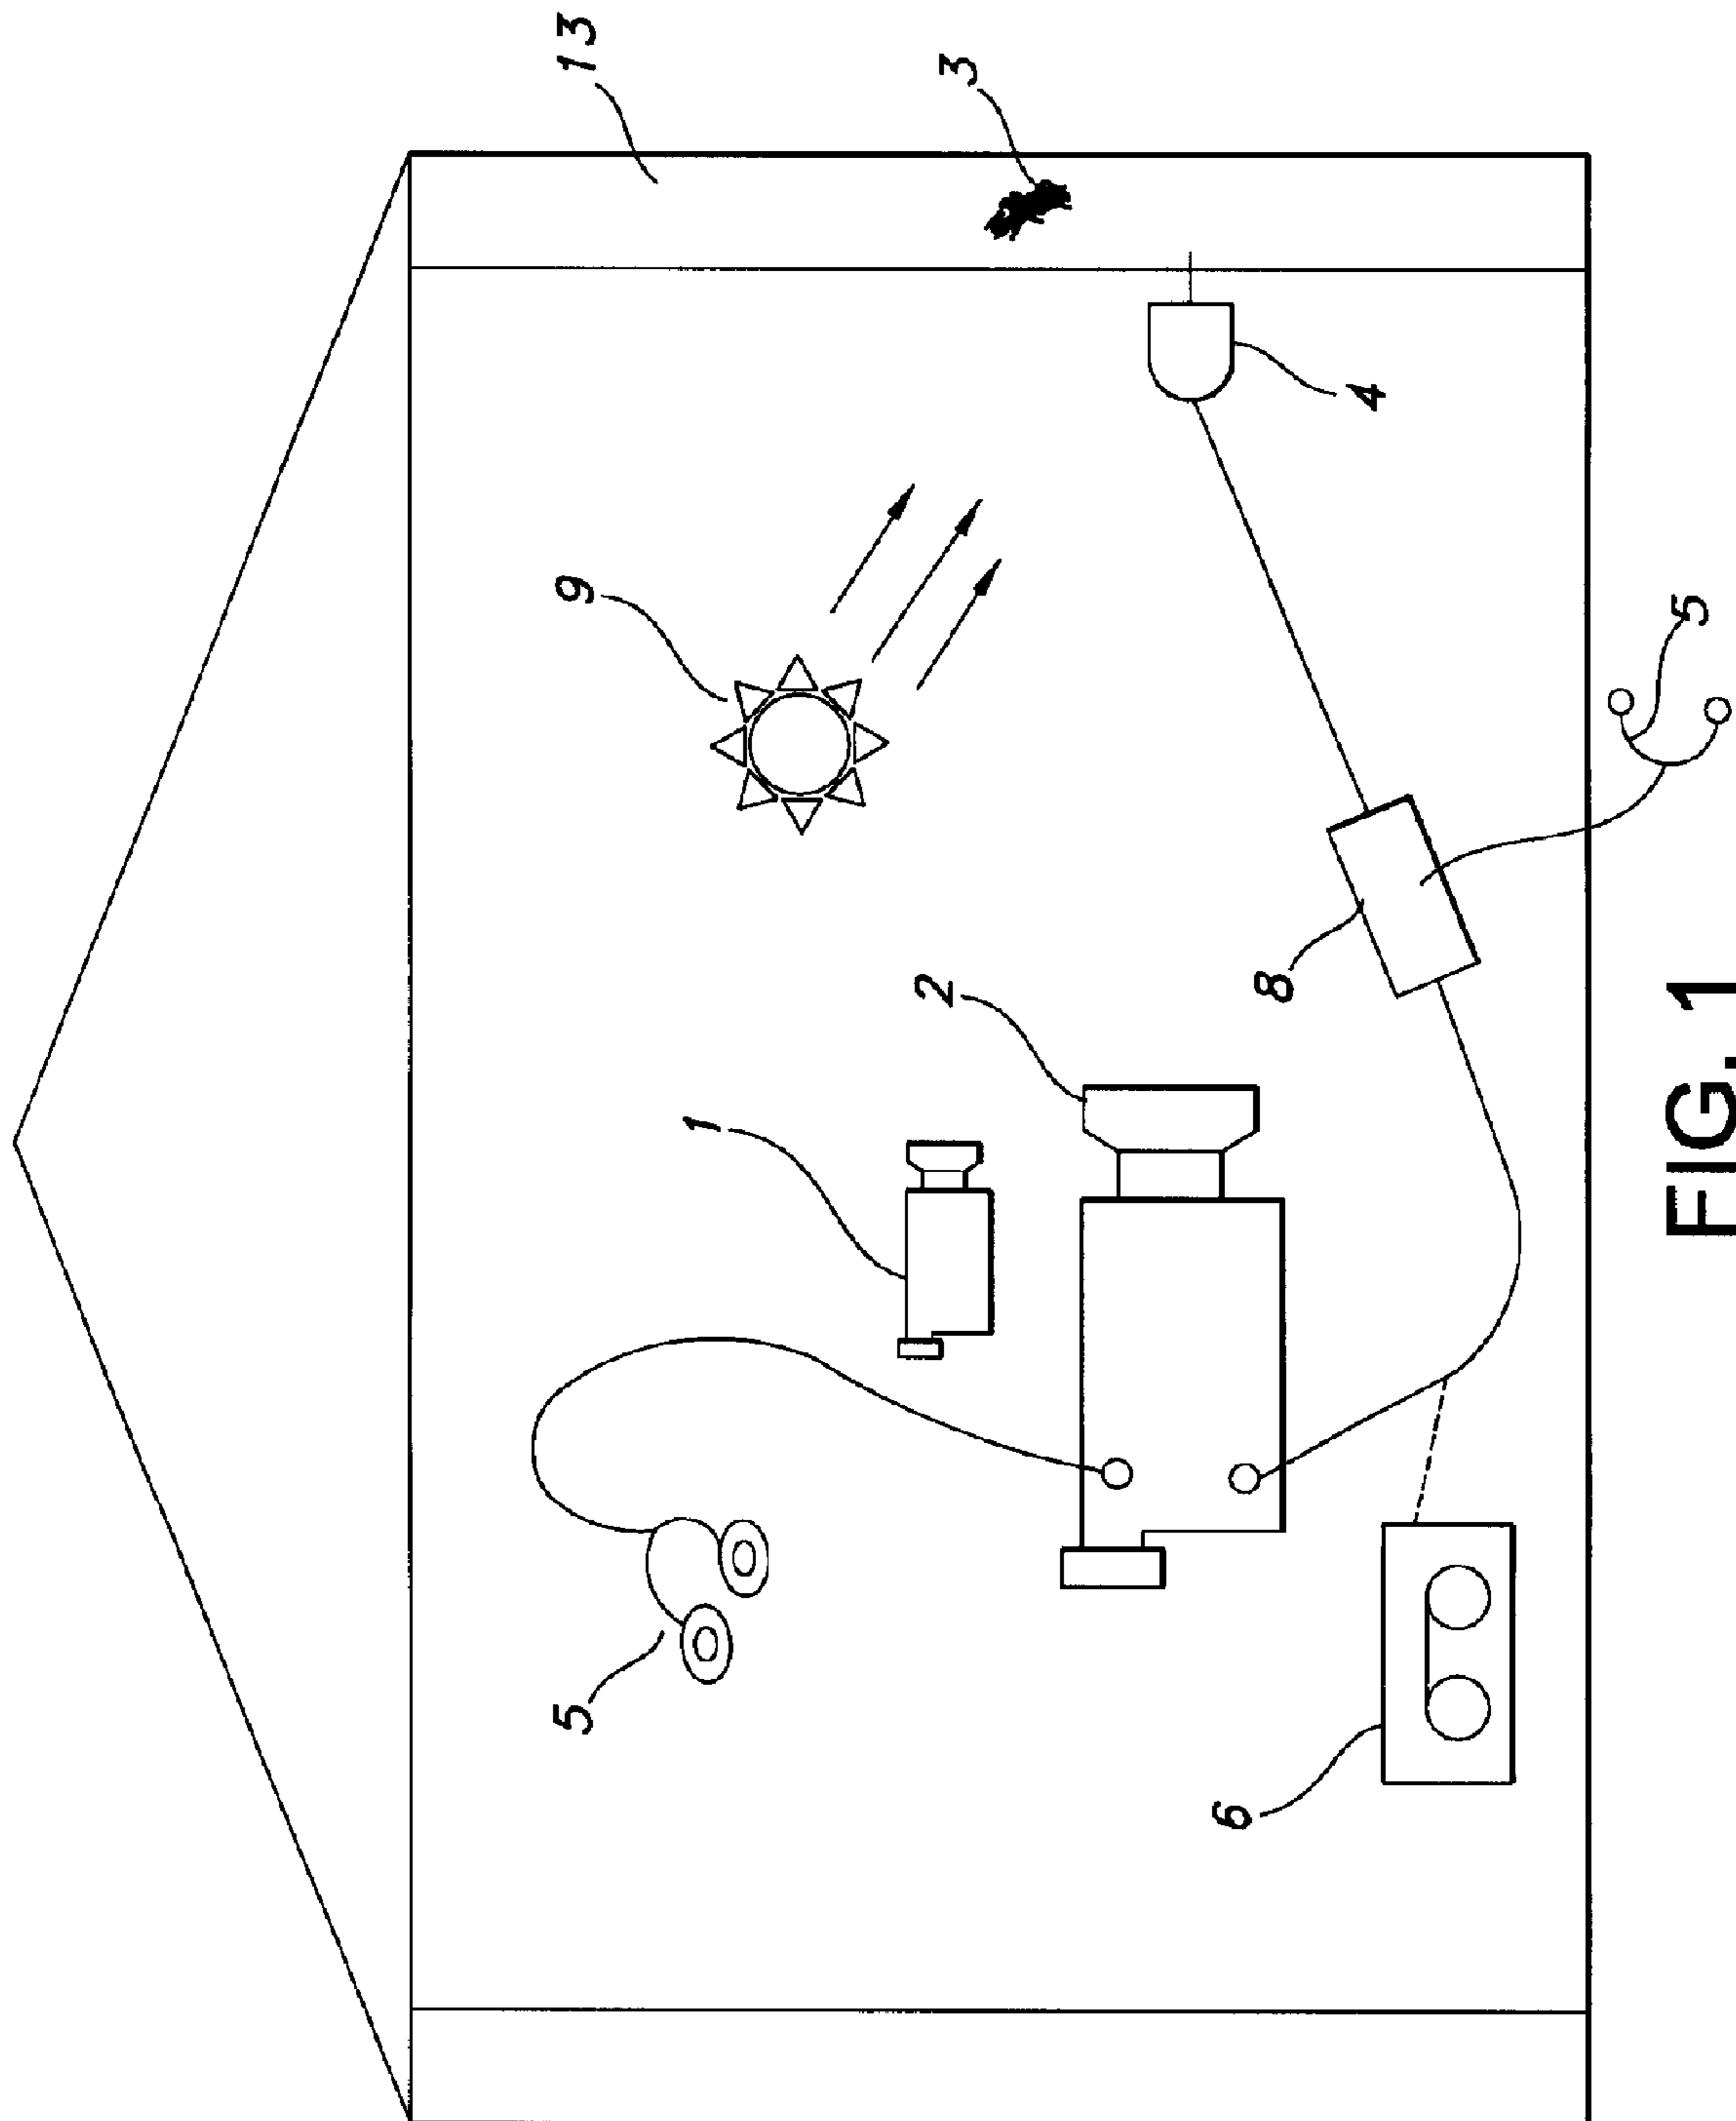
FIG. 1 is a schematic illustration of a termite detection system assembled in accordance with the principles of a preferred embodiment of the invention.

As schematically depicted in FIG. 1, a preferred embodiment of the apparatus and method of the present invention includes a thermal imaging camera 1 for performing a preliminary scan of a structure 13 in order to locate potential termite infestation sites 3. A thermal imaging camera 1 is used to perform an infrared scan. The structure 13 can be a wooden object, such as a wall stud, paneling or in one embodiment a live tree. Termite infestation sites 3 can be the result of subterranean termite or dry-wood termite activity. In the case of a subterranean termite infestation, the moisture brought in by the subterranean termites will show up as a "suspicious cold or hot spot" in a thermal imaging scan. In the case of a dry-wood termite infestation, a heat or cold source 9 is needed to increase or decrease the temperature of a targeted structure 13. This heat source 9 can be an electric, gas or oil heat source as well as an incandescent or infrared light source. The areas in the targeted structure 13 that contain a cavity created by dry-wood termites will show up as "suspicious warm or hot spots." The correspondent video images of the potential termite infestation are recorded by the camcorder 2 or by the thermal imaging camera if it is equipped with recording capability 6.

Thermal imaging camera 1 may be any of a number known, commercially available infrared cameras conventionally used by structural engineers, police and the military. In order to improve the accuracy by which the thermal imaging camera 1 detects potential areas of termite infestation, the thermal imaging camera may further include termite infestation recognition software, such as matched filtering software which compares the frequency spectrum of a thermal image with frequency spectra of a reference images known to indicate termite infestation, thereby reducing the level of skill required of the camera operator, reducing time required and increasing termite identification effectiveness. This database of infestation images of suspicious thermal images can be built by one skilled in the art.

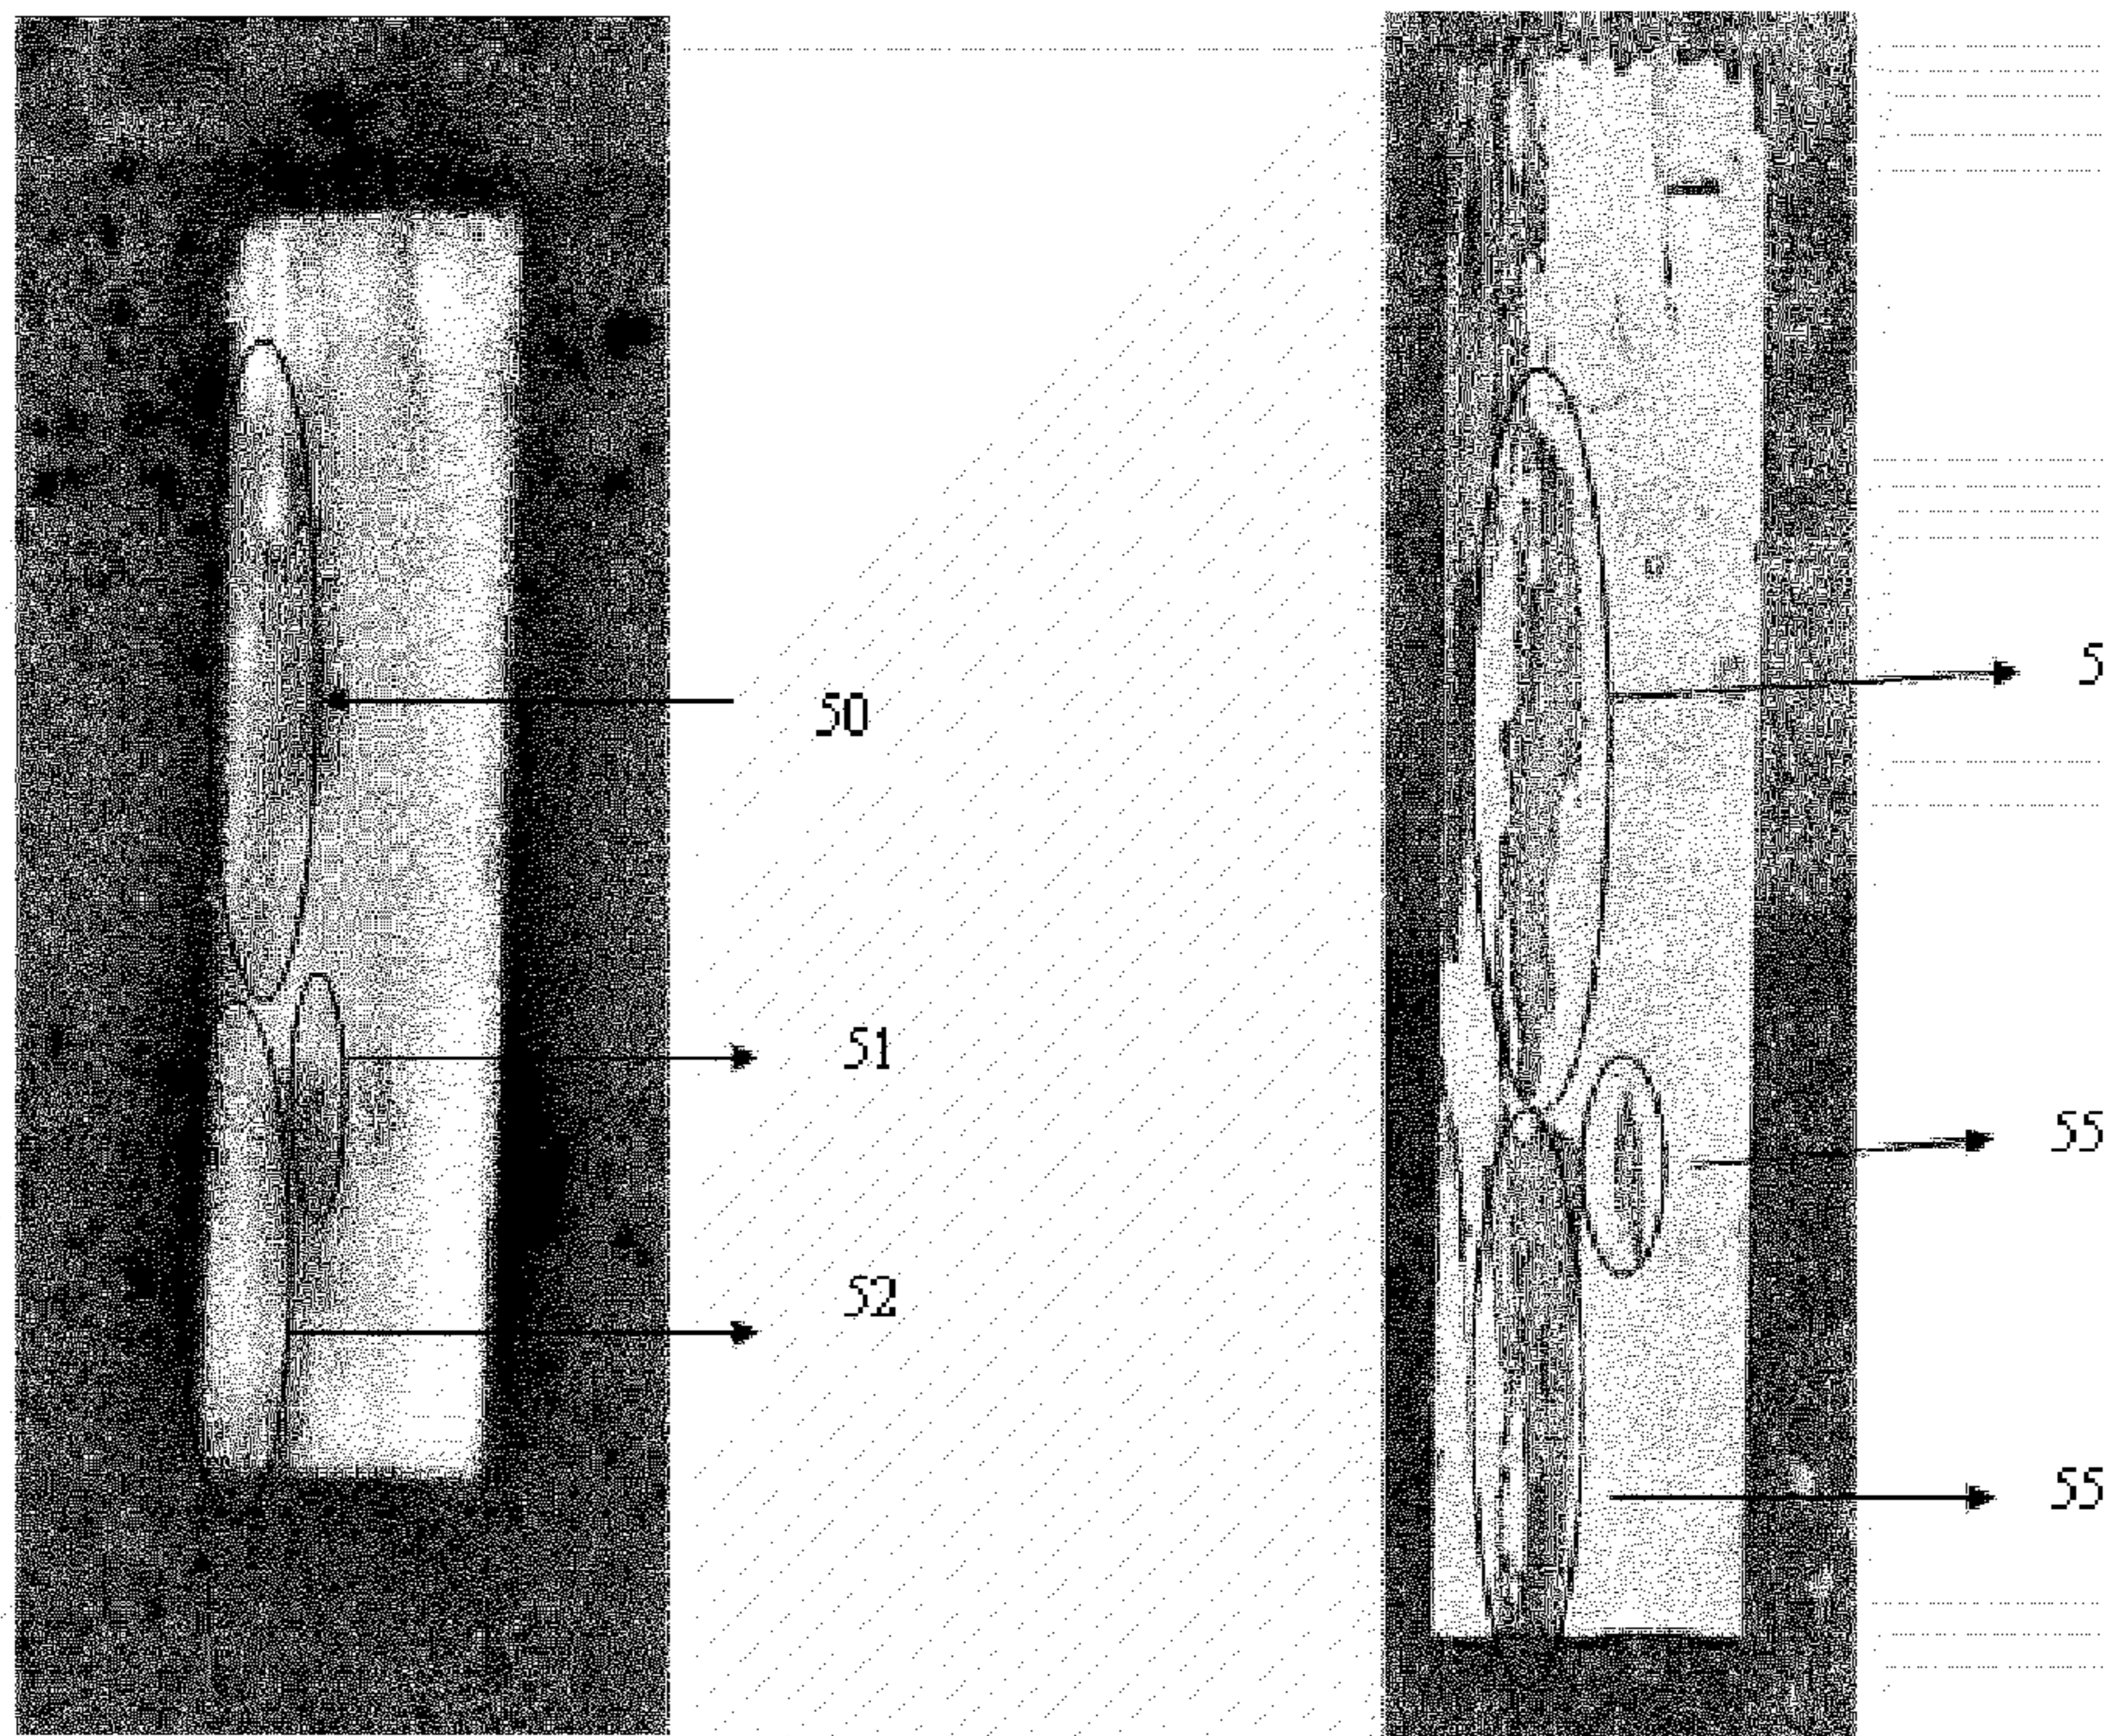
FIGURE 2A

FIG. 2A is an infrared scan of a structure showing drywood termite infestation.

FIG. 2B is a photo of a wood structure with the surface material removed.

Referring now to FIGS. 2A and 2B, an infrared scan of a wall shows potential termite damage at 50, 51 and 52. The surface material was removed in FIG. 2B to show termite damage at 53, 54 and 55.

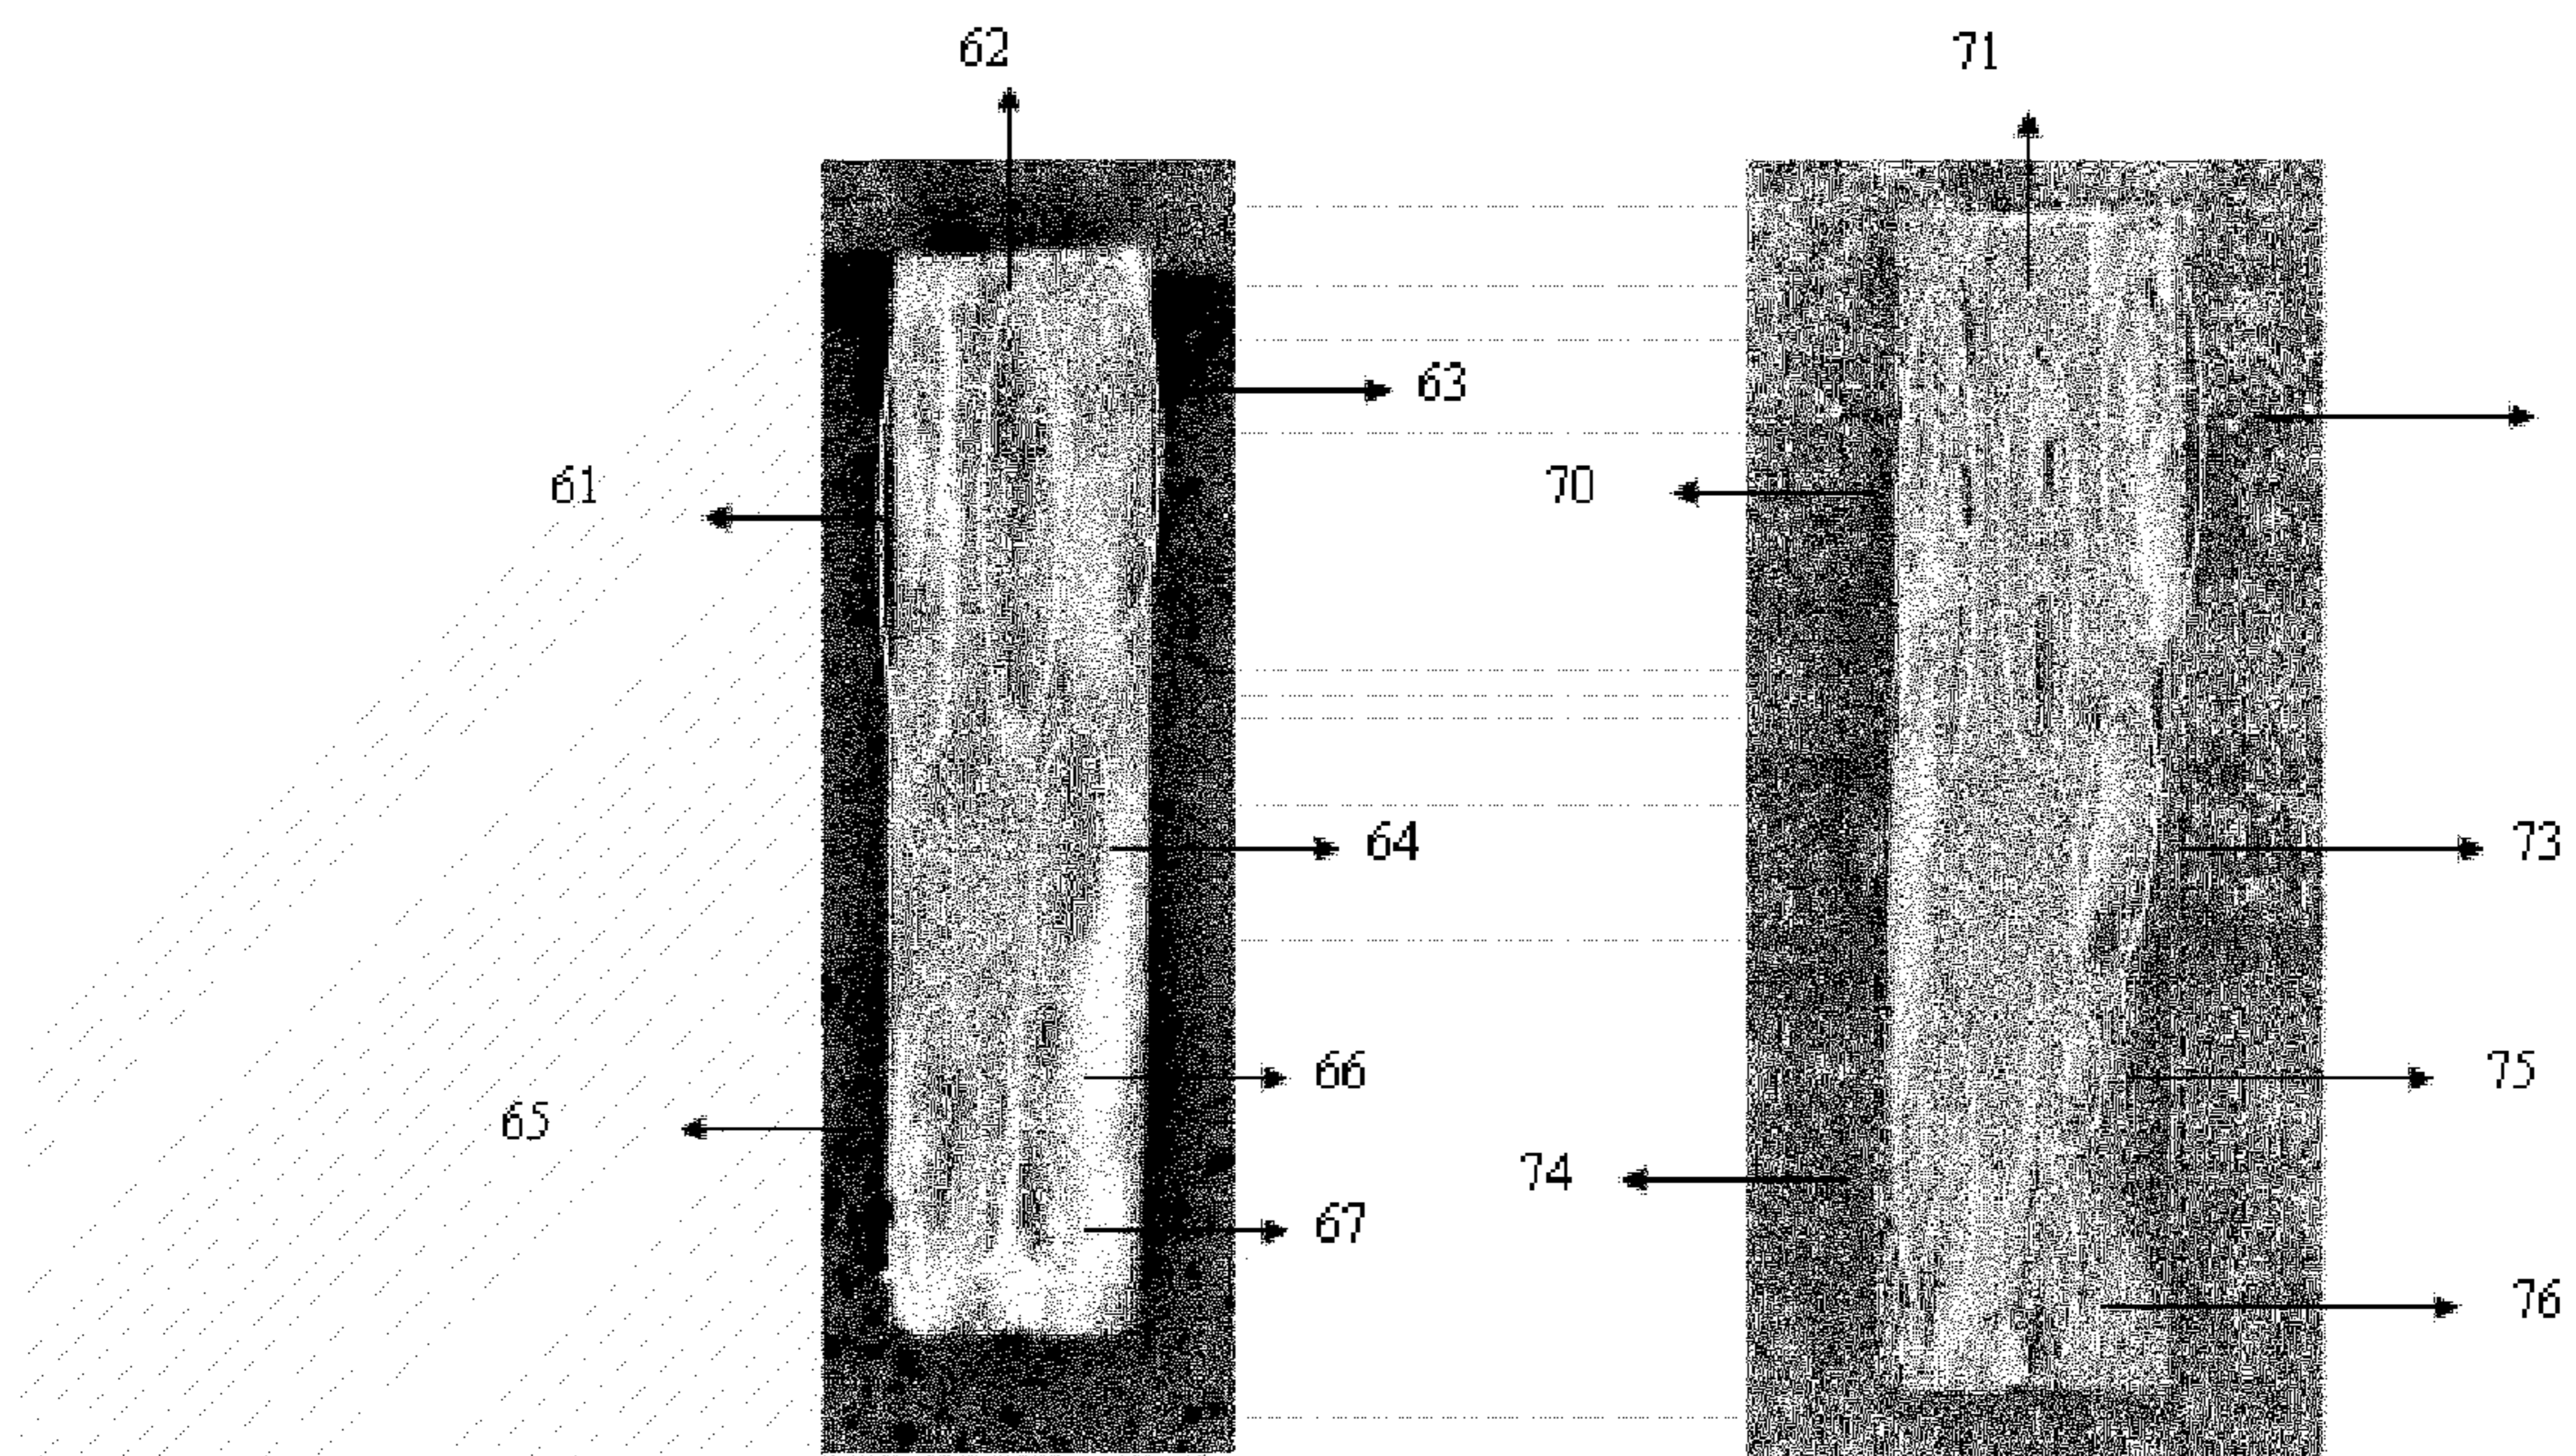
FIGURE 3A

FIG. 3A is an infrared scan of a structure showing drywood termite infestation.

FIG. 3B is a photo of a wood structure with the surface material removed.

Referring now to FIGS. 3A and 3B, an infrared scan of a wall shows potential drywood termite damage at 61-67. The surface material was removed in FIG. 2B to show termite damage at 70-76.

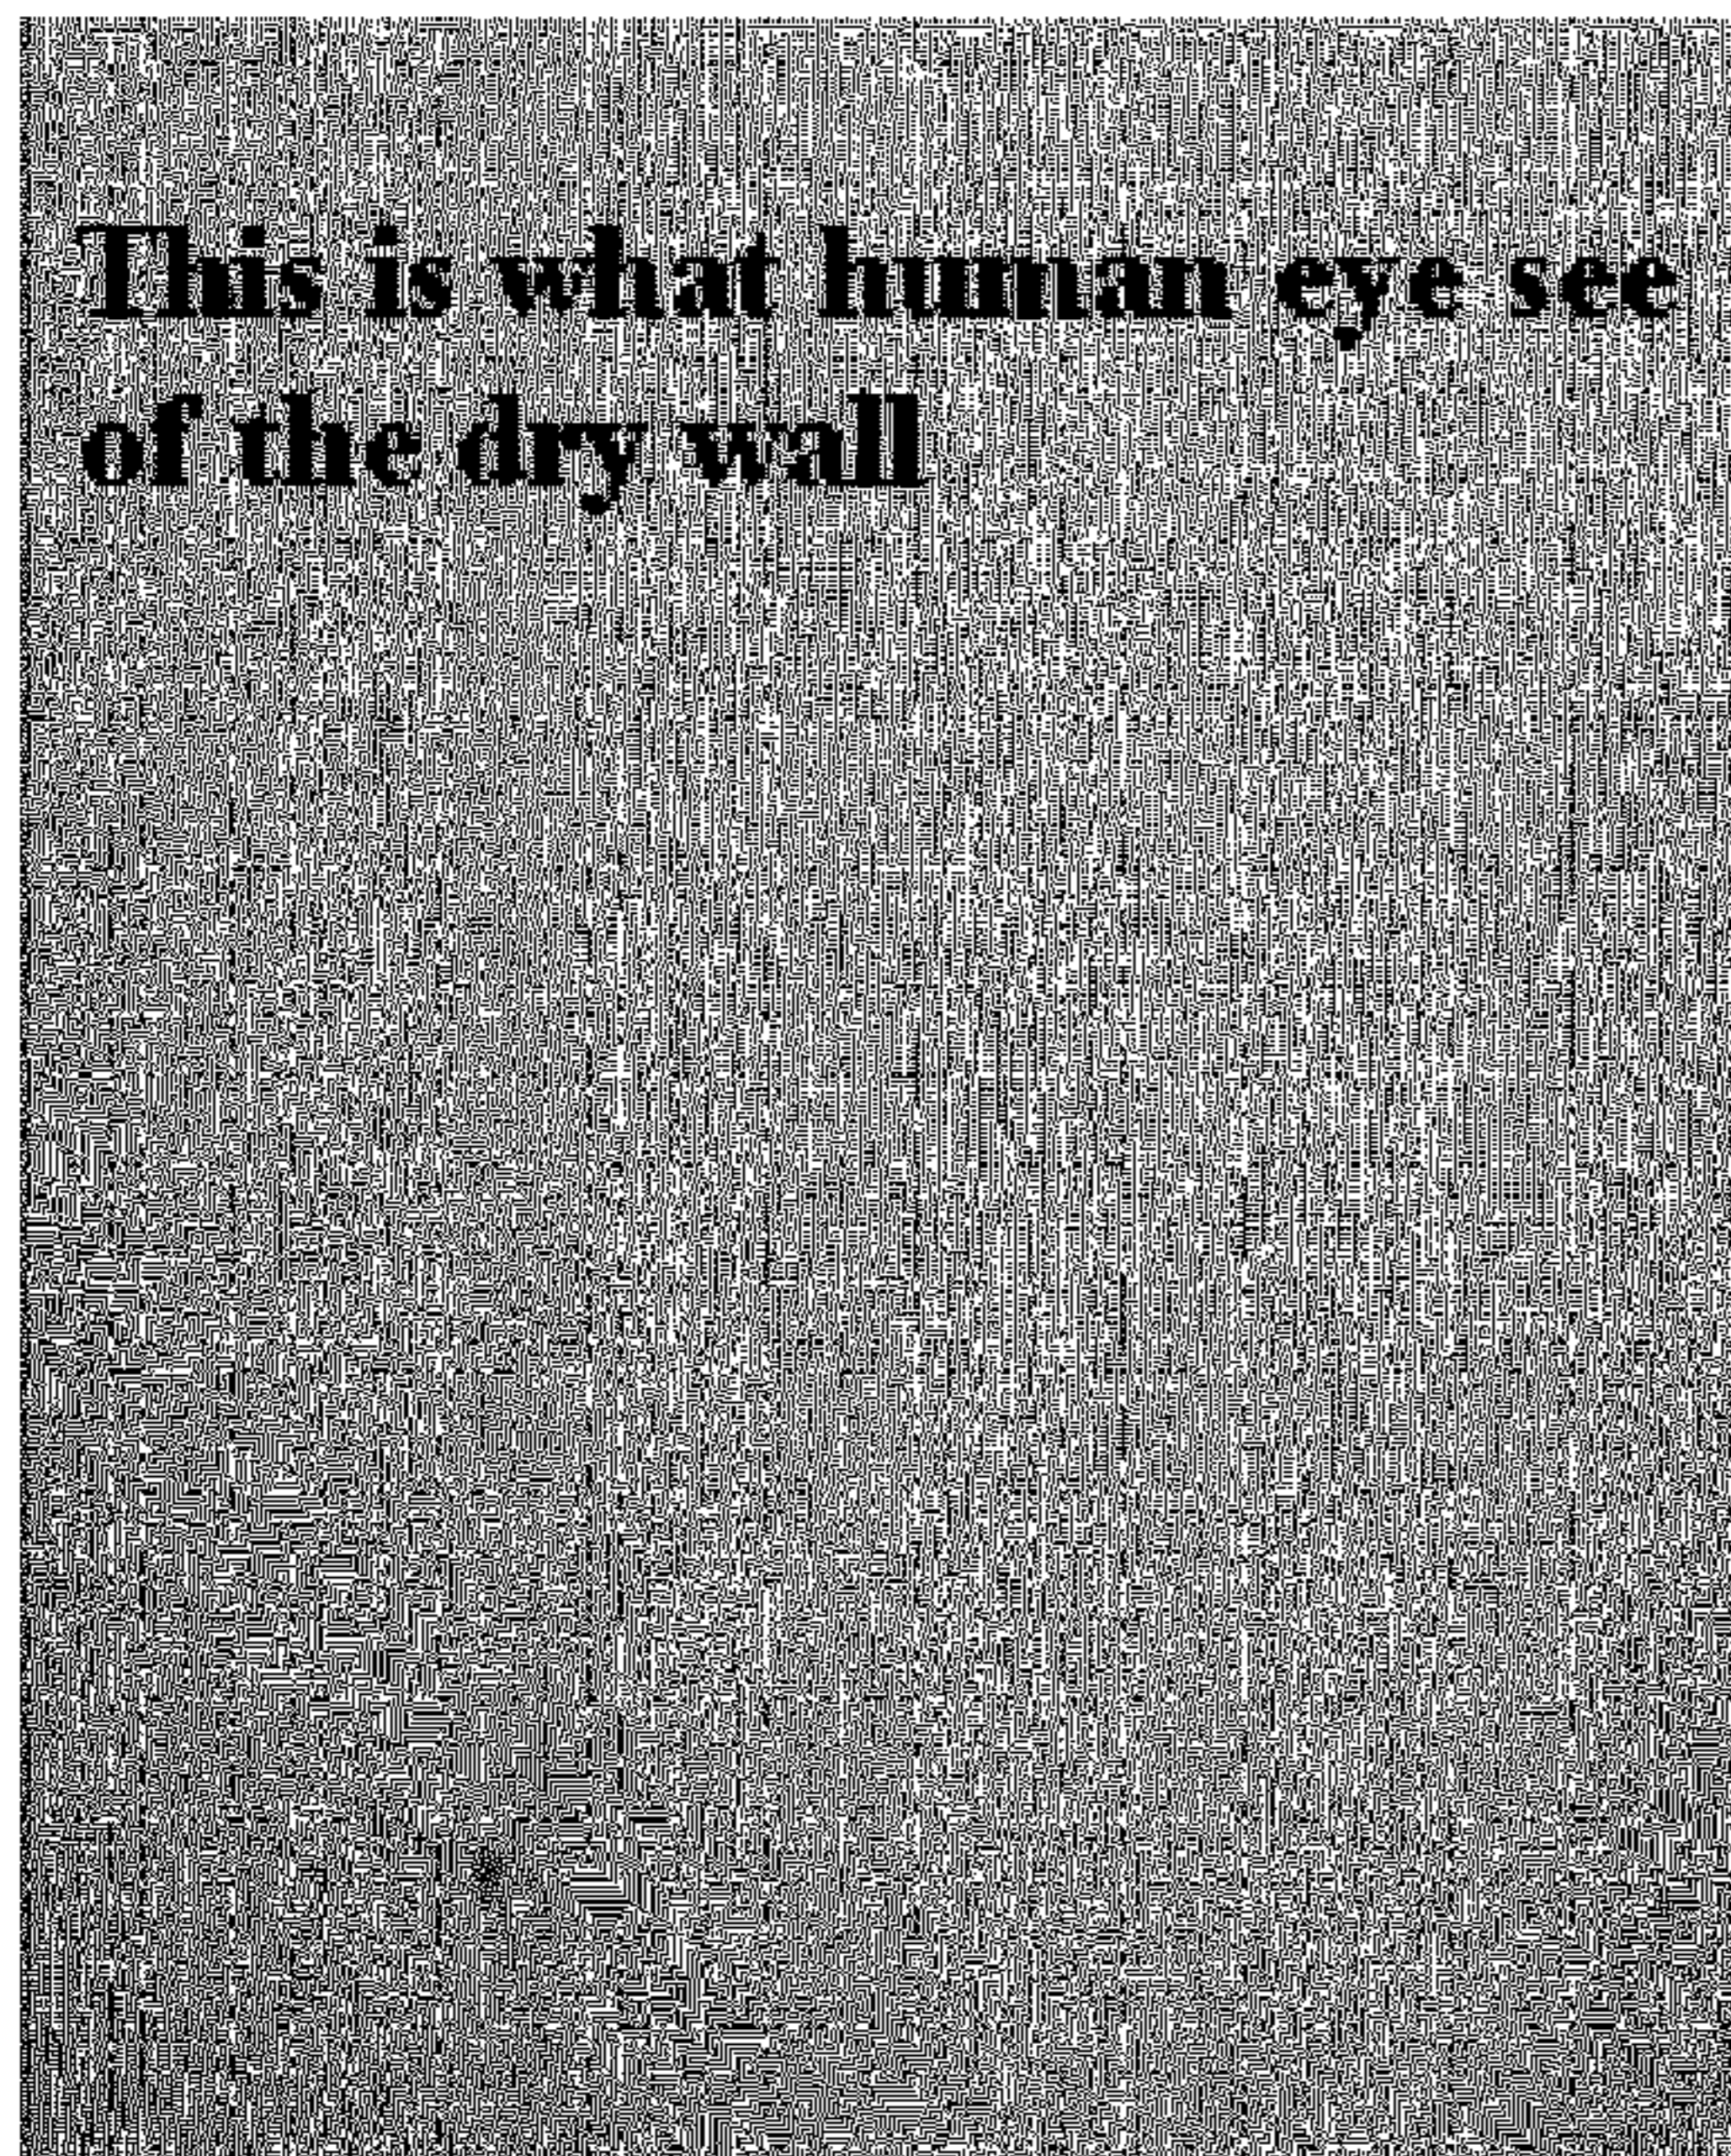
FIGURE 4A

FIG. 4A is a photograph of a wall.

FIG. 4A-4C show additional preliminary infrared detection. In FIG. 4A, a photograph of a wall is shown. This is what a human eye sees. In FIG. 4B, a preliminary infrared scan shows suspicious black spots which might be subterranean termite infestation. Subterranean termite infested areas contain very high moisture content, as the moisture evaporates infested areas appear as cold spots. In FIG. 4B, when the wall is removed, actual termite damage is shown at 60 and 61. However, it would be better to confirm wood damaging termite damage or infestation prior to destructive of the dry wall.

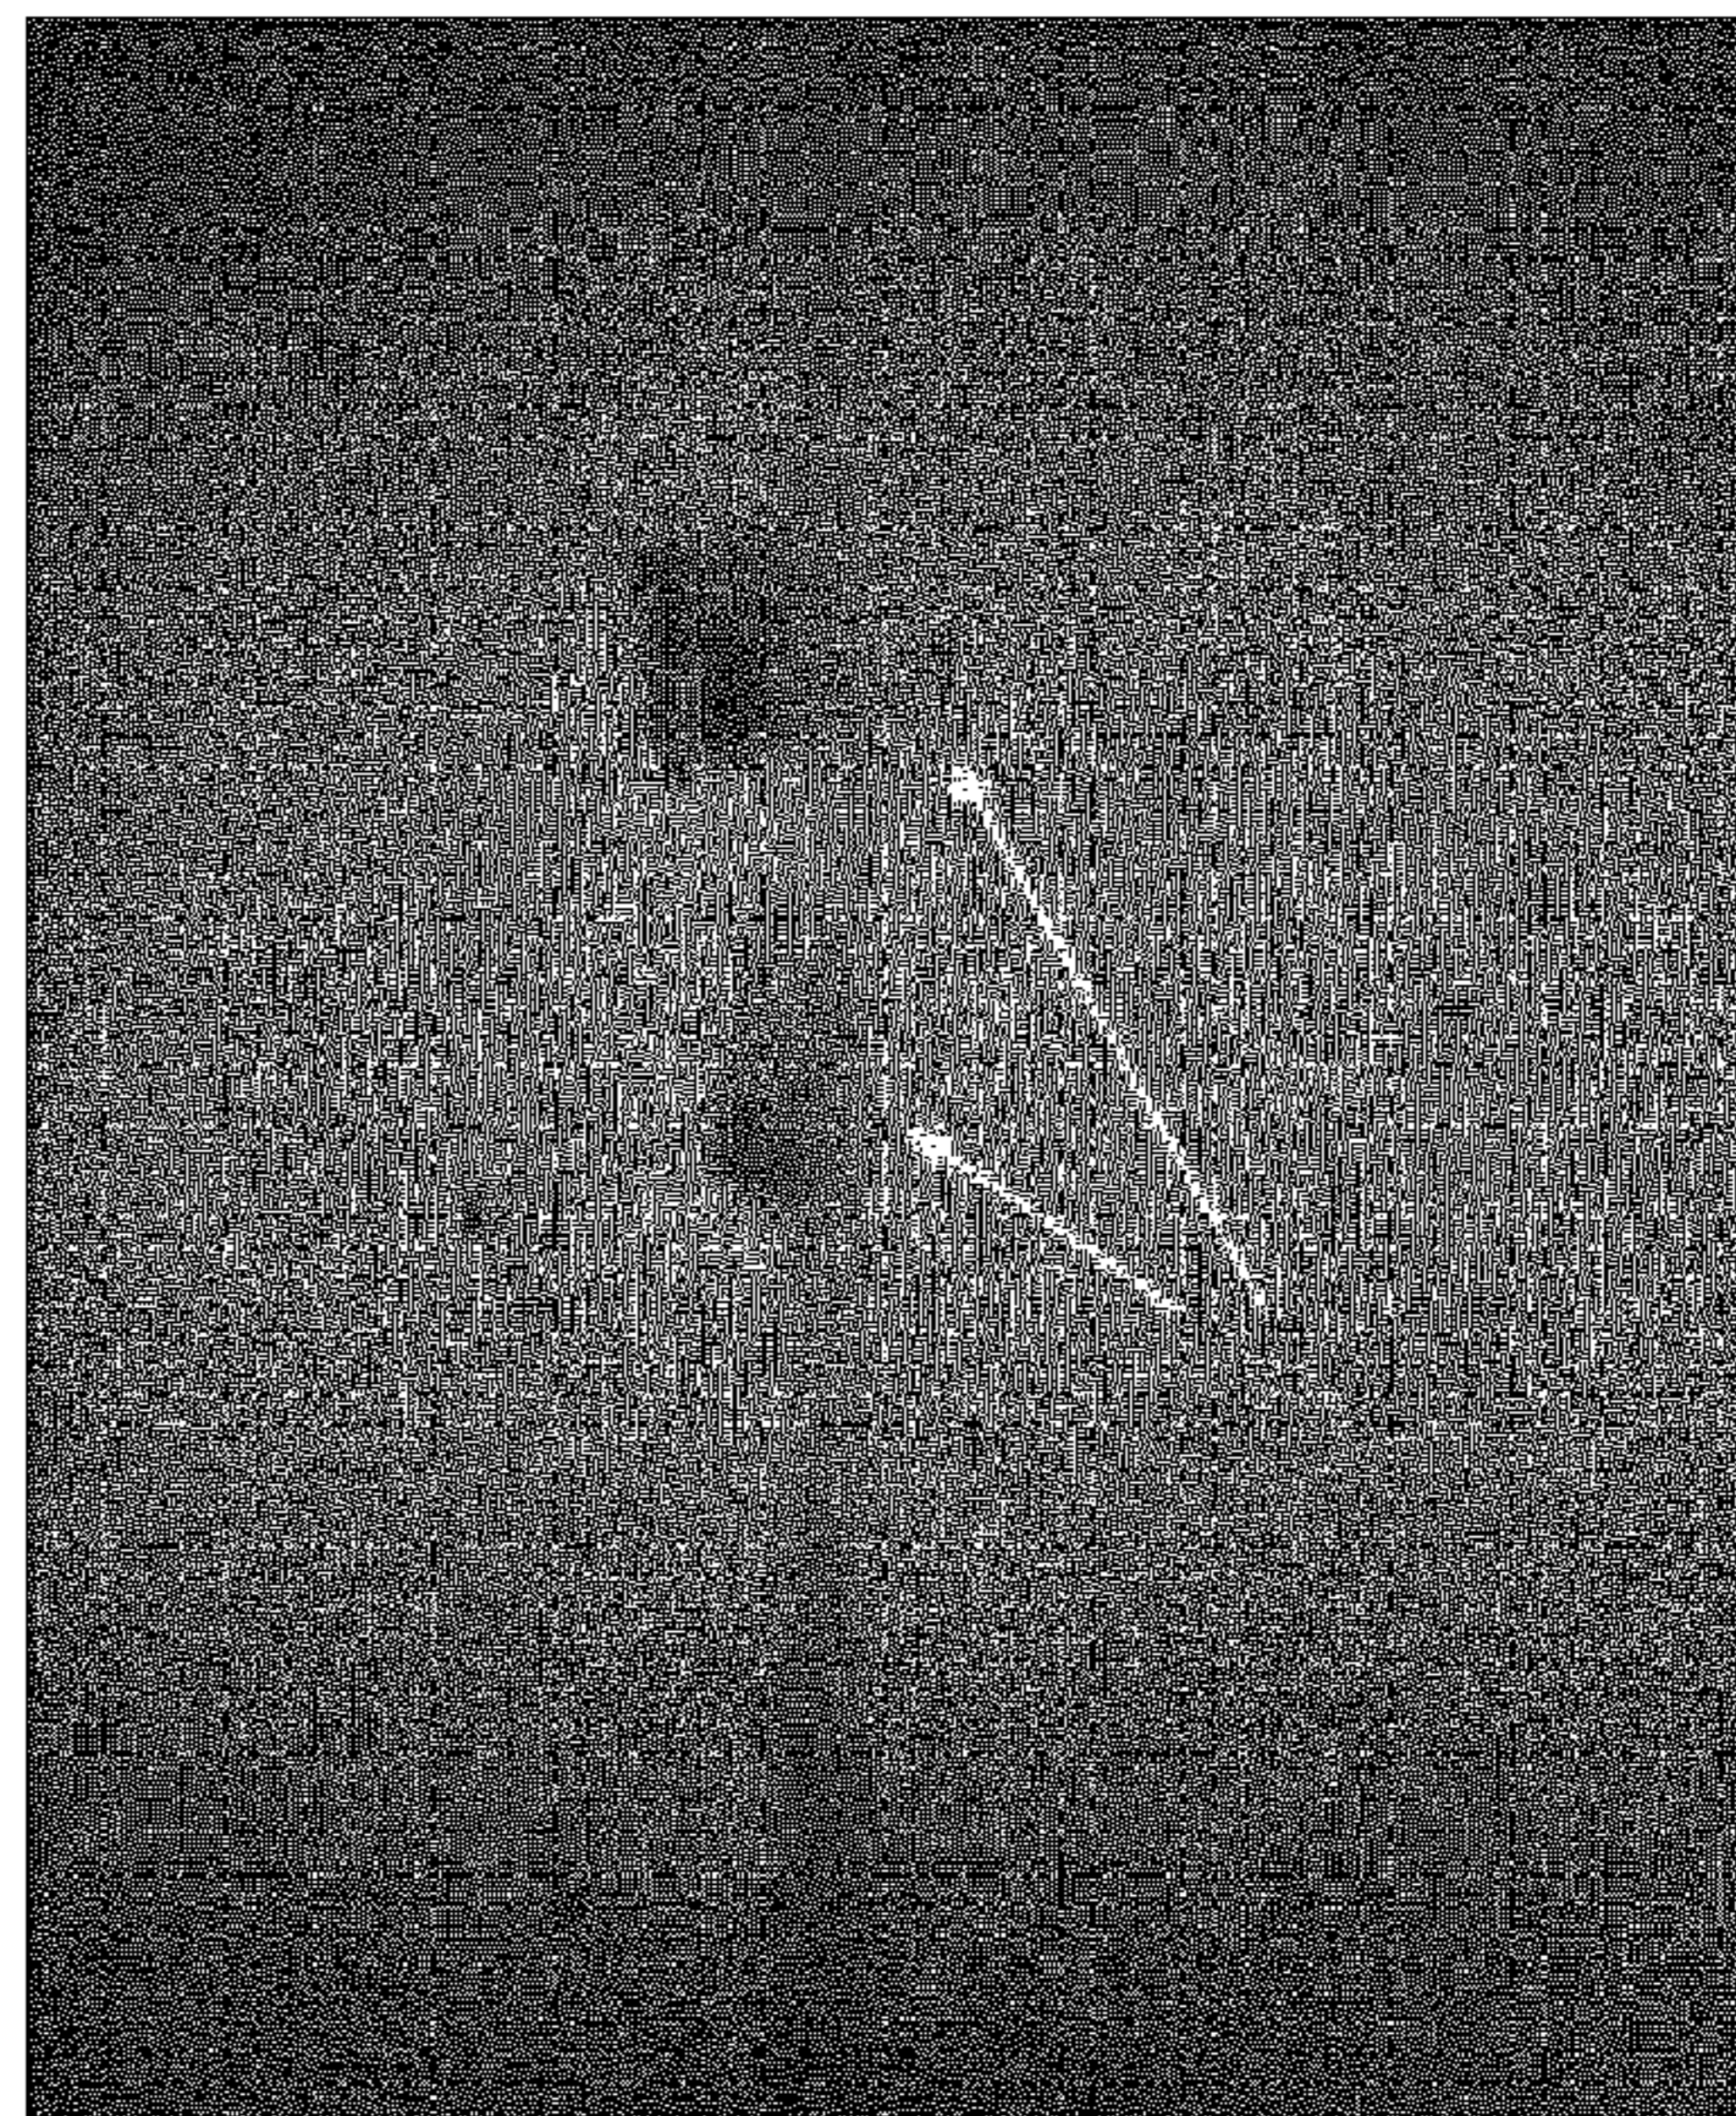
FIGURE 4B

FIG. 4B is an infrared scan of the wall.
