(10) **Patent No.:** **US 7,434,990 B2**
(45) **Date of Patent:** **Oct. 14, 2008**

(54) **METHOD TO DETECT TERMITE INFESTATION IN A STRUCTURE**
(75) Inventor: **Peng Lee**, Oxford, MS (US)
(73) Assignee: **University of Mississippi**, University, MS (US)
(*) Notice: Subject to any disclaimer, the term of this patent is extended or adjusted under 35 U.S.C. 154(b) by 57 days.

A method for confirming the presence of termites in a structure, involving a preliminary infrared scan of a structure and confirmation of termite infestation with at least one detector in order to quickly locate potential areas of termite infestation.

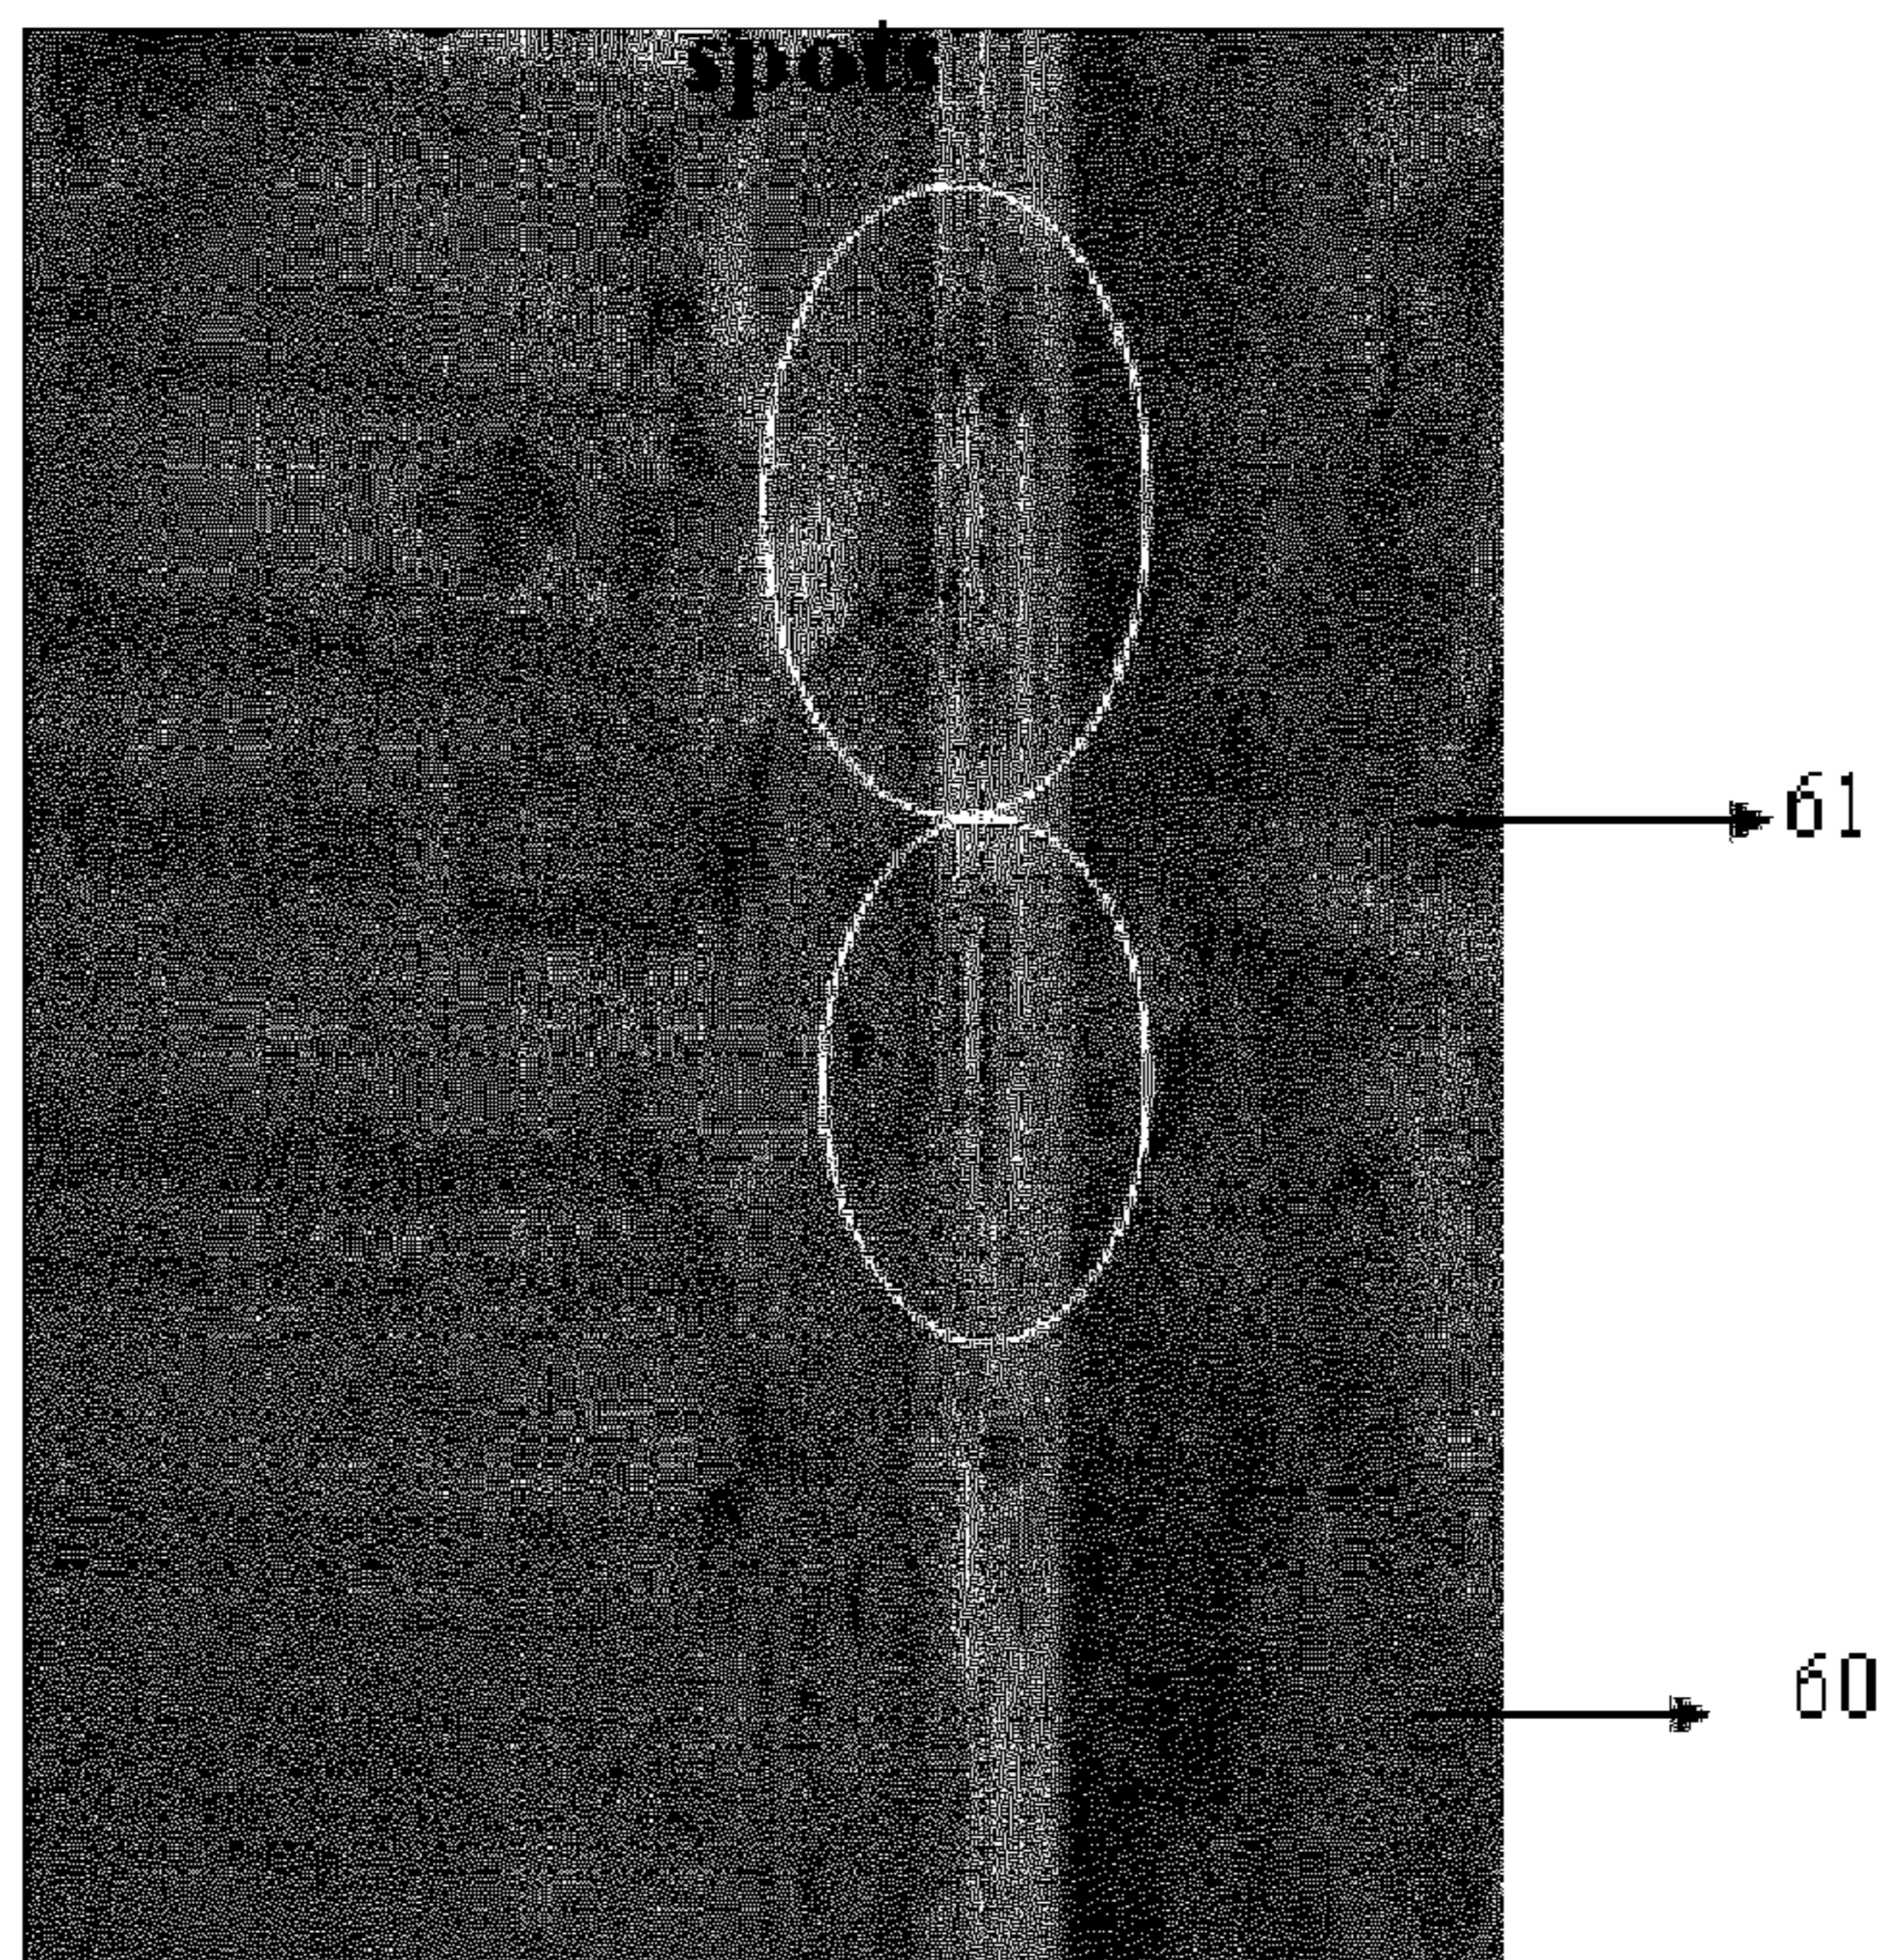
FIGURE 4C

When dry wall was removed

FIG. 4C is a photograph of the wall with the dry wall removed, it shows the 2x4 stud damaged by subterranean termite.

FIG. 4A-4C show additional preliminary infrared detection. In FIG. 4A, a photograph of a wall is shown. This is what a human eye sees. In FIG. 4B, a preliminary infrared scan shows suspicious black spots which might be subterranean termite infestation. Subterranean termite infested areas contain very high moisture content, as the moisture evaporates infested areas appear as cold spots. In FIG. 4B, when the wall is removed, actual termite damage is shown at 60 and 61. However, it would be better to confirm wood damaging termite damage or infestation prior to destructive of the dry wall.
