## (54) METHOD TO DETECT TERMITE INFESTATION IN A STRUCTURE

# (10) Patent No.: US 7,434,990 B2 (45) Date of Patent: Oct. 14, 2008

A method for confirming the presence of termites in a structure, involving a preliminary infrared scan of a structure and confirmation of termite infestation with at least one detector in order to quickly locate potential areas of termite infestation.

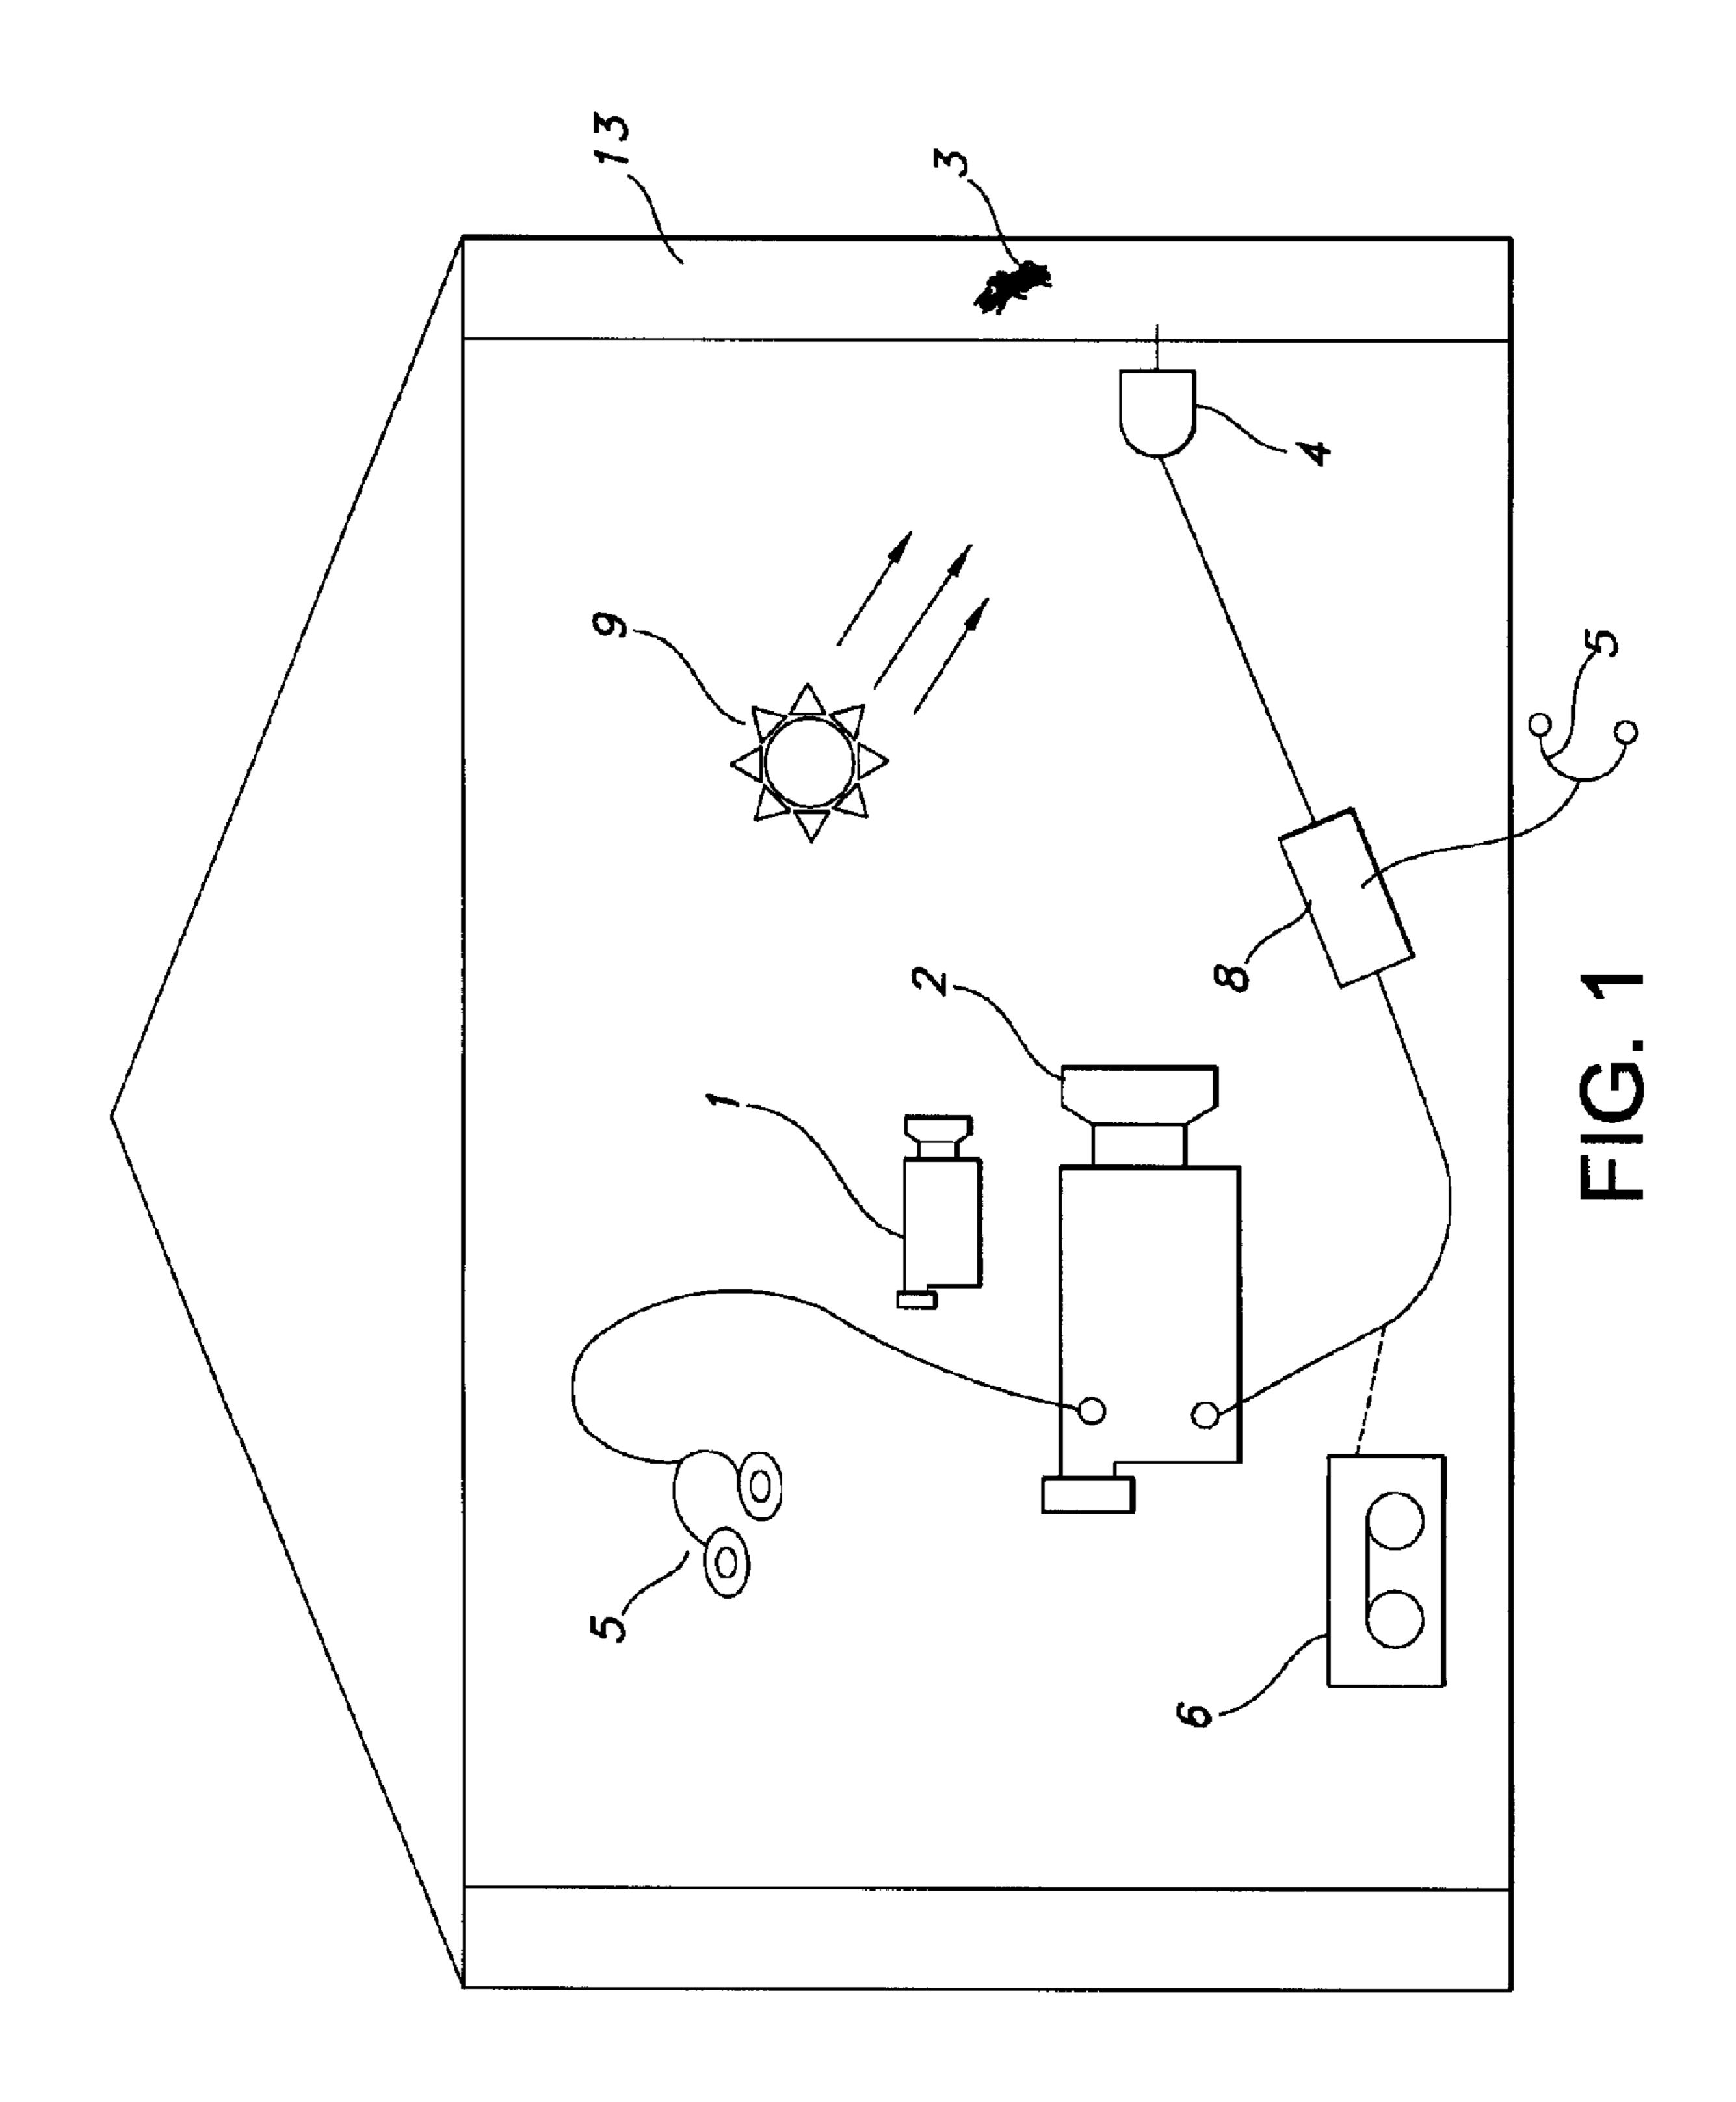
As schematically depicted in FIG. 1, a preferred embodiment of the apparatus and method of the present invention includes a thermal imaging camera 1 for performing a preliminary scan of a structure 13 in order to locate potential termite infestations sites 3. A thermal imaging camera 1 is used to perform an infrared scan. The structure 13 can be a wooden object, such as a wall stud, paneling or in one embodiment a live tree. Termite infestation sites 3 can be the result of subterranean termite or dry-wood termite activity. In the case of a subterranean termite infestation, the moisture brought in by the subterranean termites will show up as a "suspicious cold or hot spot" in a thermal imaging scan. In the case of a dry-wood termite infestation, a heat or cold source 9 is needed to increase or decrease the temperature of a targeted structure 13. This heat source 9 can be an electric, gas or oil heat source as well as an incandescent or infrared light source. The areas in the targeted structure 13 that contain a cavity created by dry-wood termites will show up as "suspicious warm or hot spots." The correspondent video images of the potential termite infestation are recorded by the camcorder 2 or by the thermal imaging camera if it is equipped with recording capability 6.

- FIG. 1 is a schematic illustration of a termite detection system assembled in accordance with the principles of a preferred embodiment of the invention.
- FIG. 2A is an infrared scan of a structure showing drywood 60 termite infestation.
- FIG. 2B is a photo of a wood structure with the surface material removed.
- FIG. 3A is an infrared scan of a structure showing drywood termite infestation.
- FIG. 3B is a photo of a wood structure with the surface material removed.

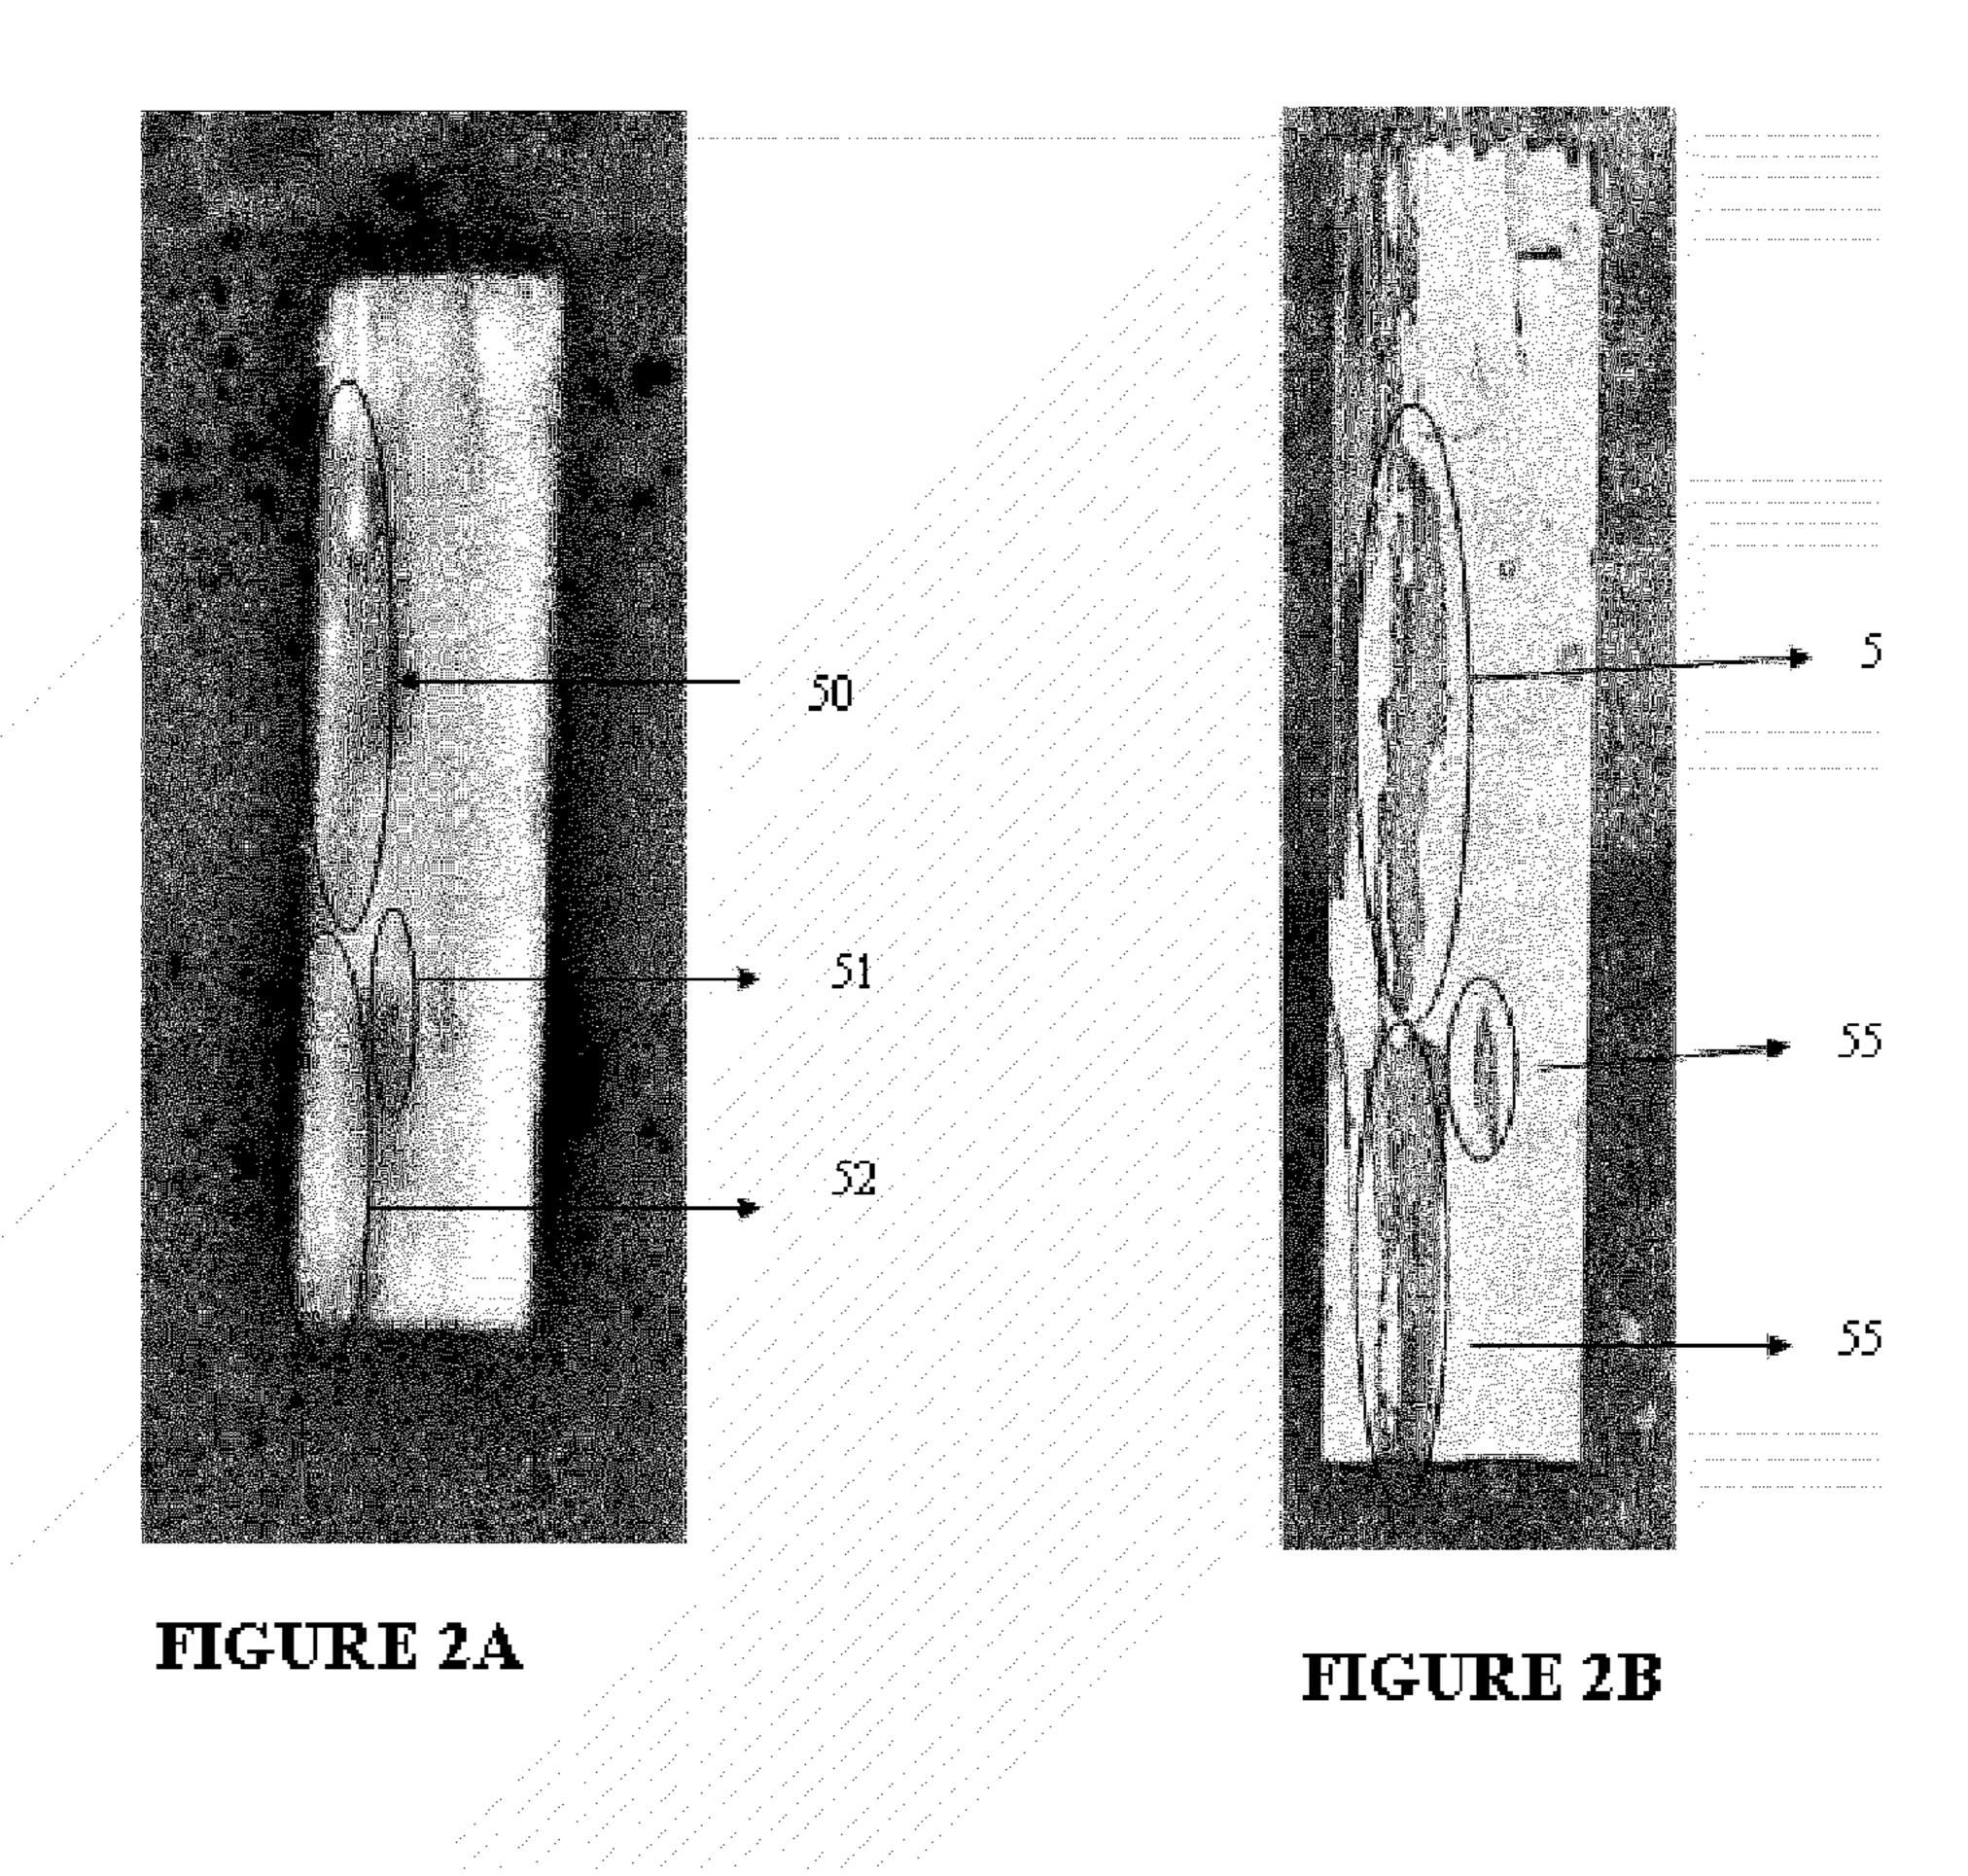
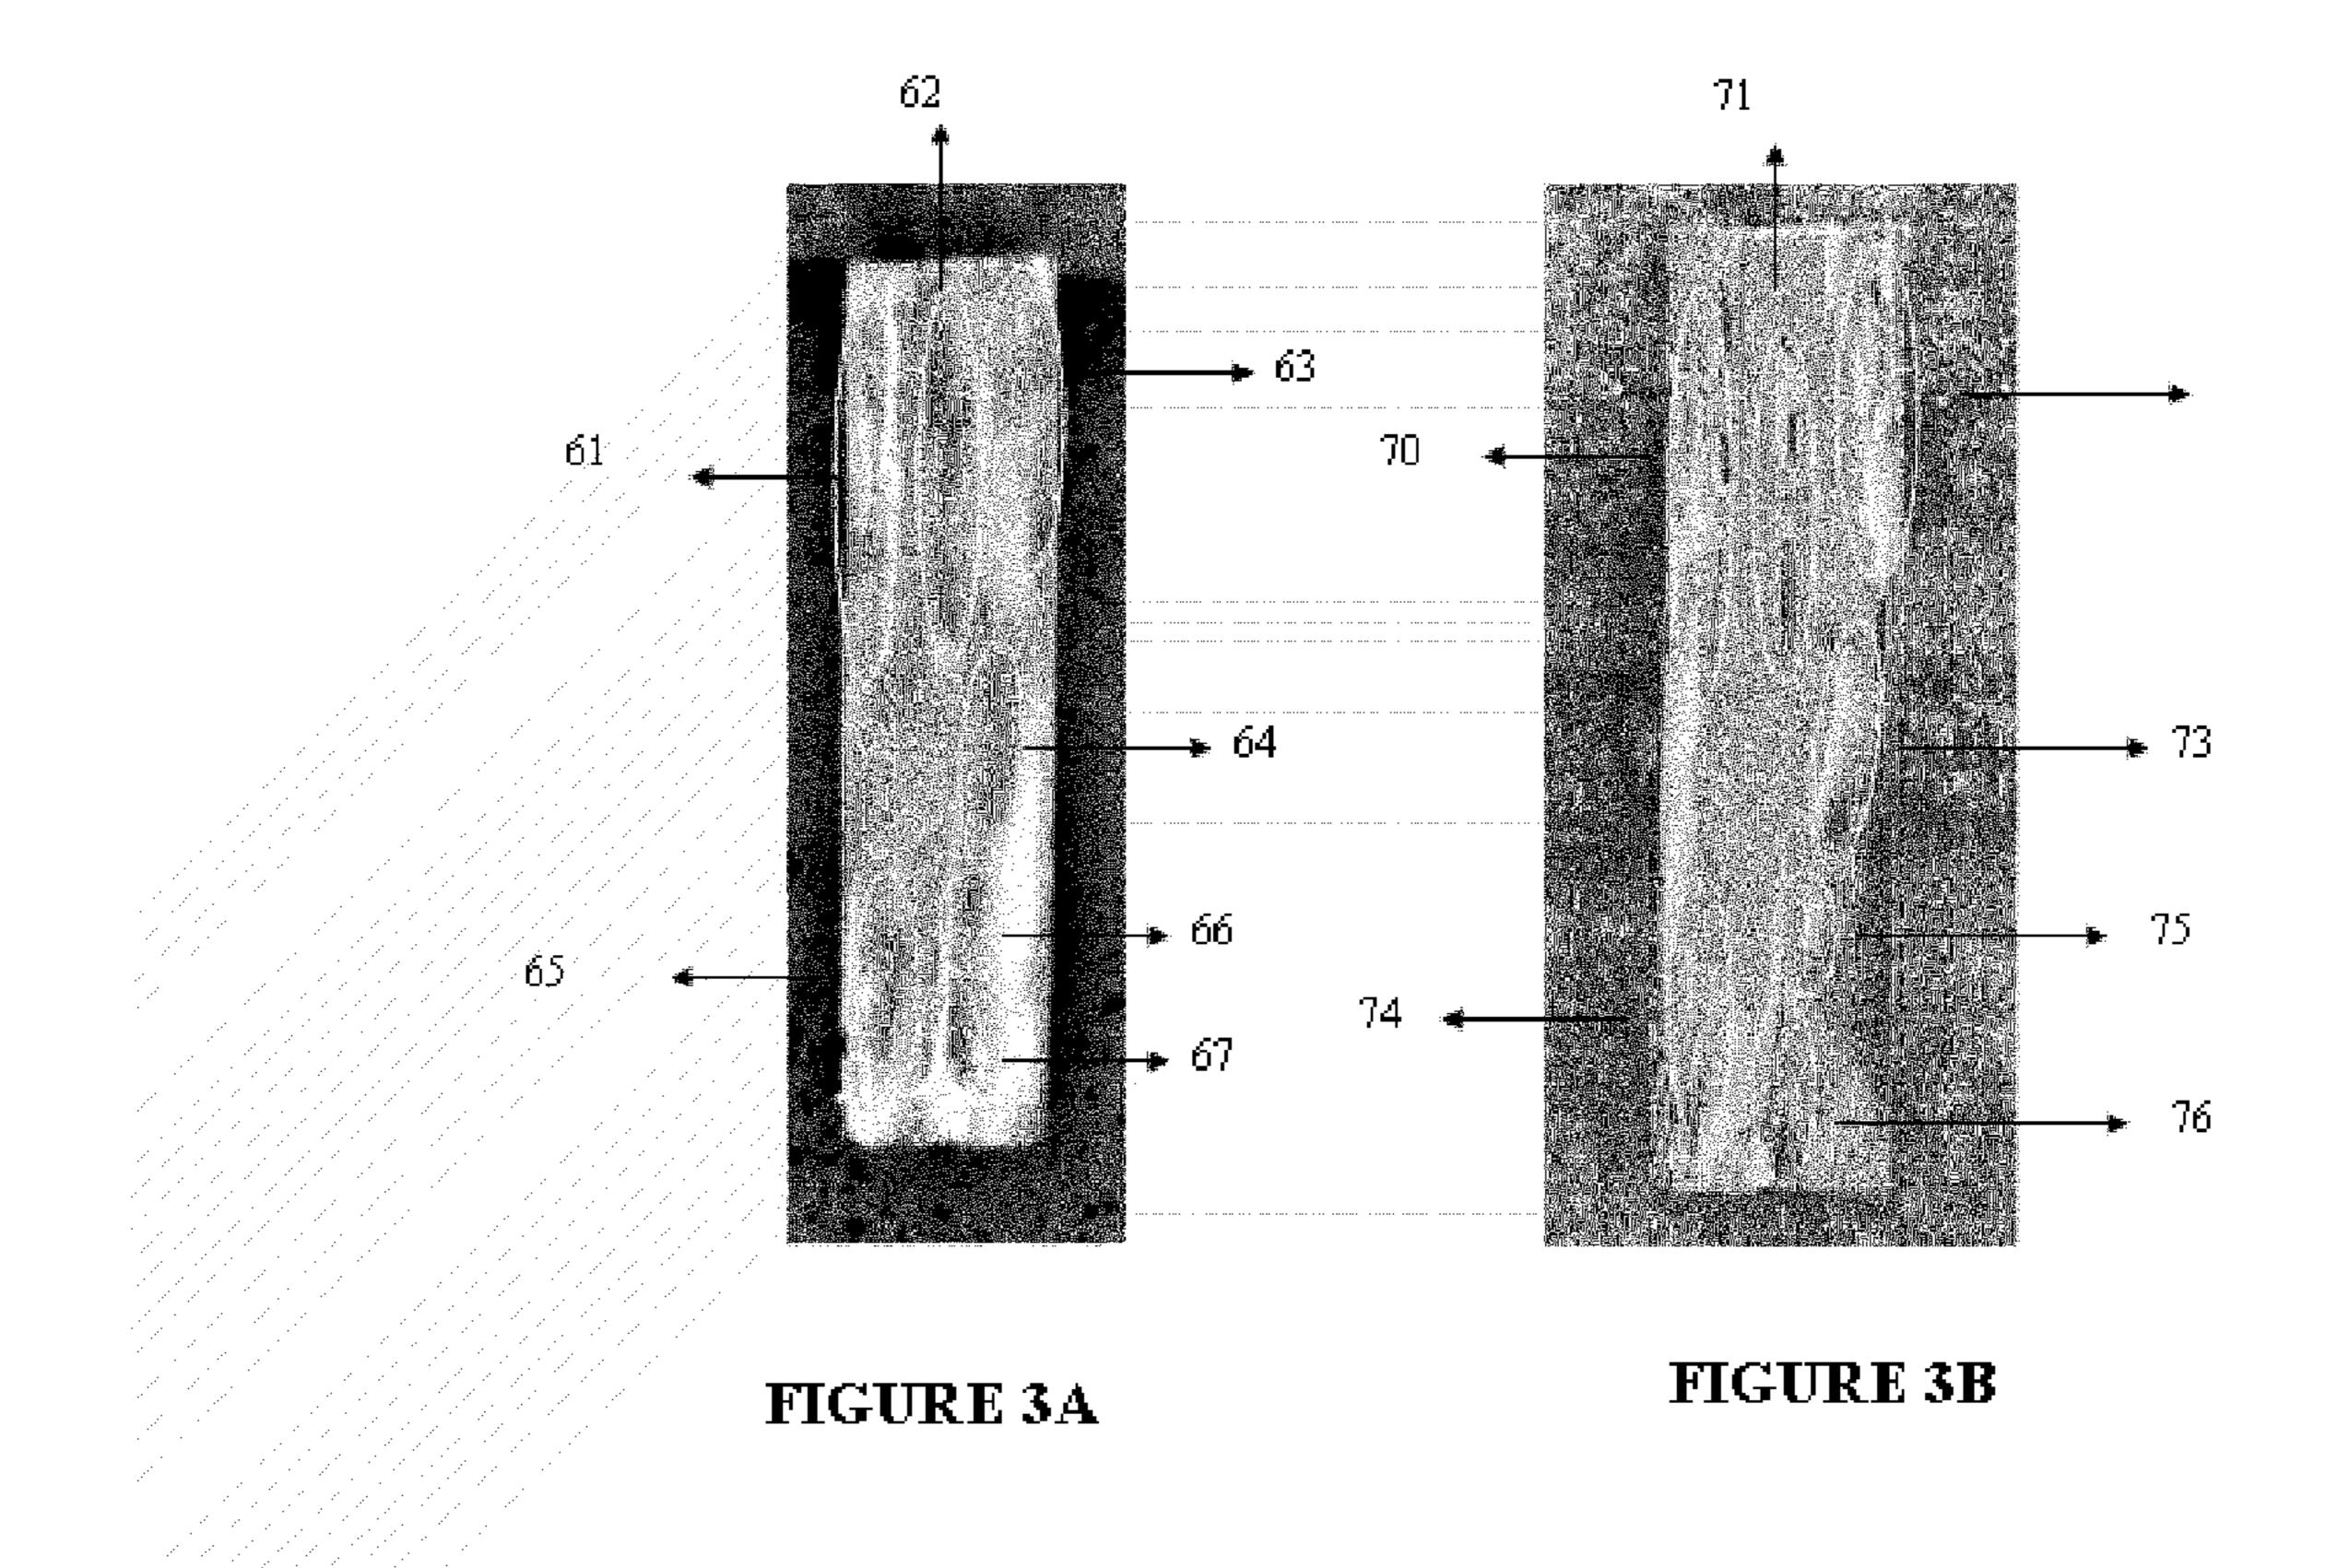
> Referring now to FIGS. 2A and 2B, an infrared scan of a wall shows potential termite damage at 50, 51 and 52. The surface material was removed in FIG. 2B to show termite damage at **53**, **54** and **55**.

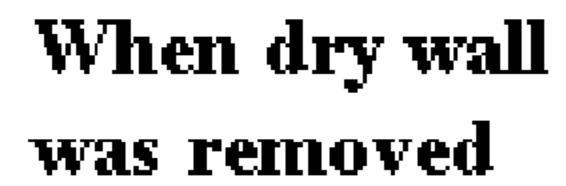
IR scan of
Suspicious
FIGURE 4B
wet
termite

FIG. 4B is an infrared scan of the wall.

FIG. 4A-4C show additional preliminary infrared detection. In FIG. 4A, a photograph of a wall is shown. This is what a human eye sees. In FIG. 4B, a preliminary infrared scan shows suspicious black spots which might be subterranean termite infestation. Subterranean termite infested areas contain very high moisture content, as the moisture evaporates infested areas appear as cold spots. In FIG. 4B, when the wall is removed, actual termite damage is shown at 60 and 61. However, it would be better to confirm wood damaging ter-65 mite damage or infestation prior to destructive of the dry wall.

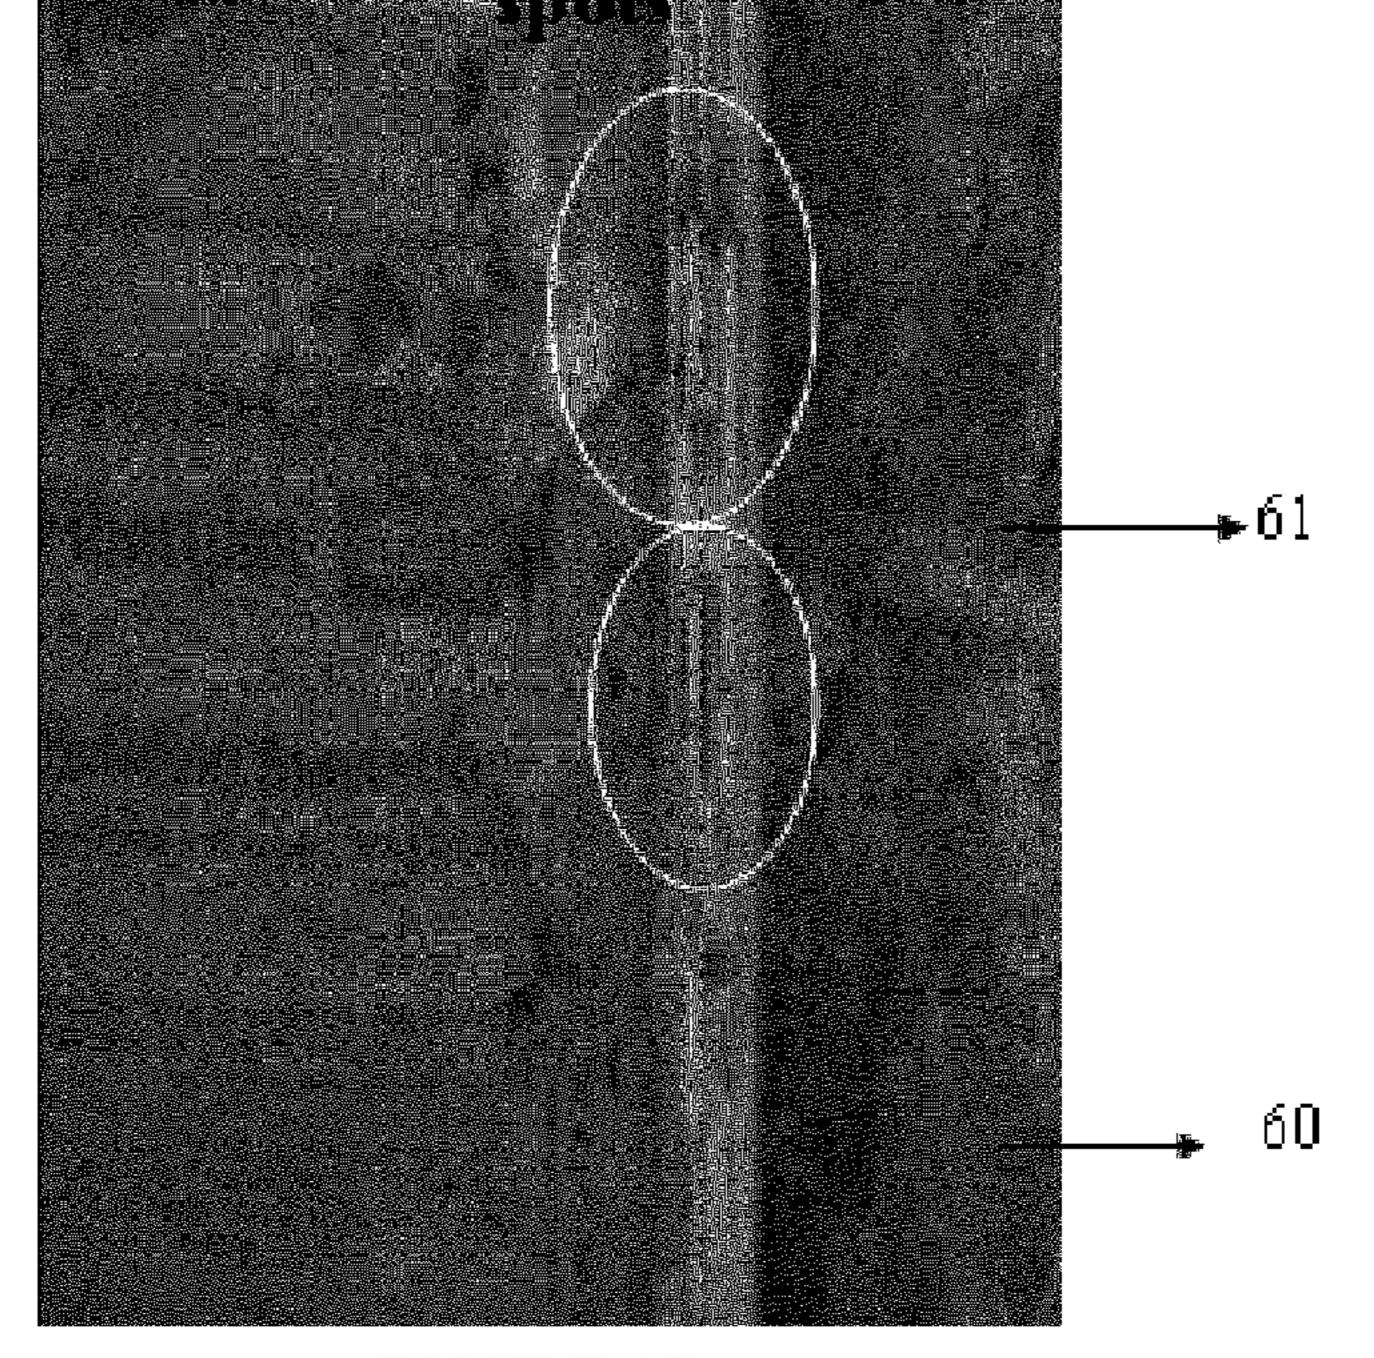
FIGURE 4C

FIG. 4C is a photograph of the wall with the dry wall removed, it shows the  $2\times4$  stud damaged by subterrarean termite.
