(12) **United States Patent**
Lai

(10) **Patent No.:** **US 7,436,466 B2**
(45) **Date of Patent:** **Oct. 14, 2008**

(54) **REPAIRING METHOD OF A THIN FILM TRANSISTOR ARRAY SUBSTRATE**

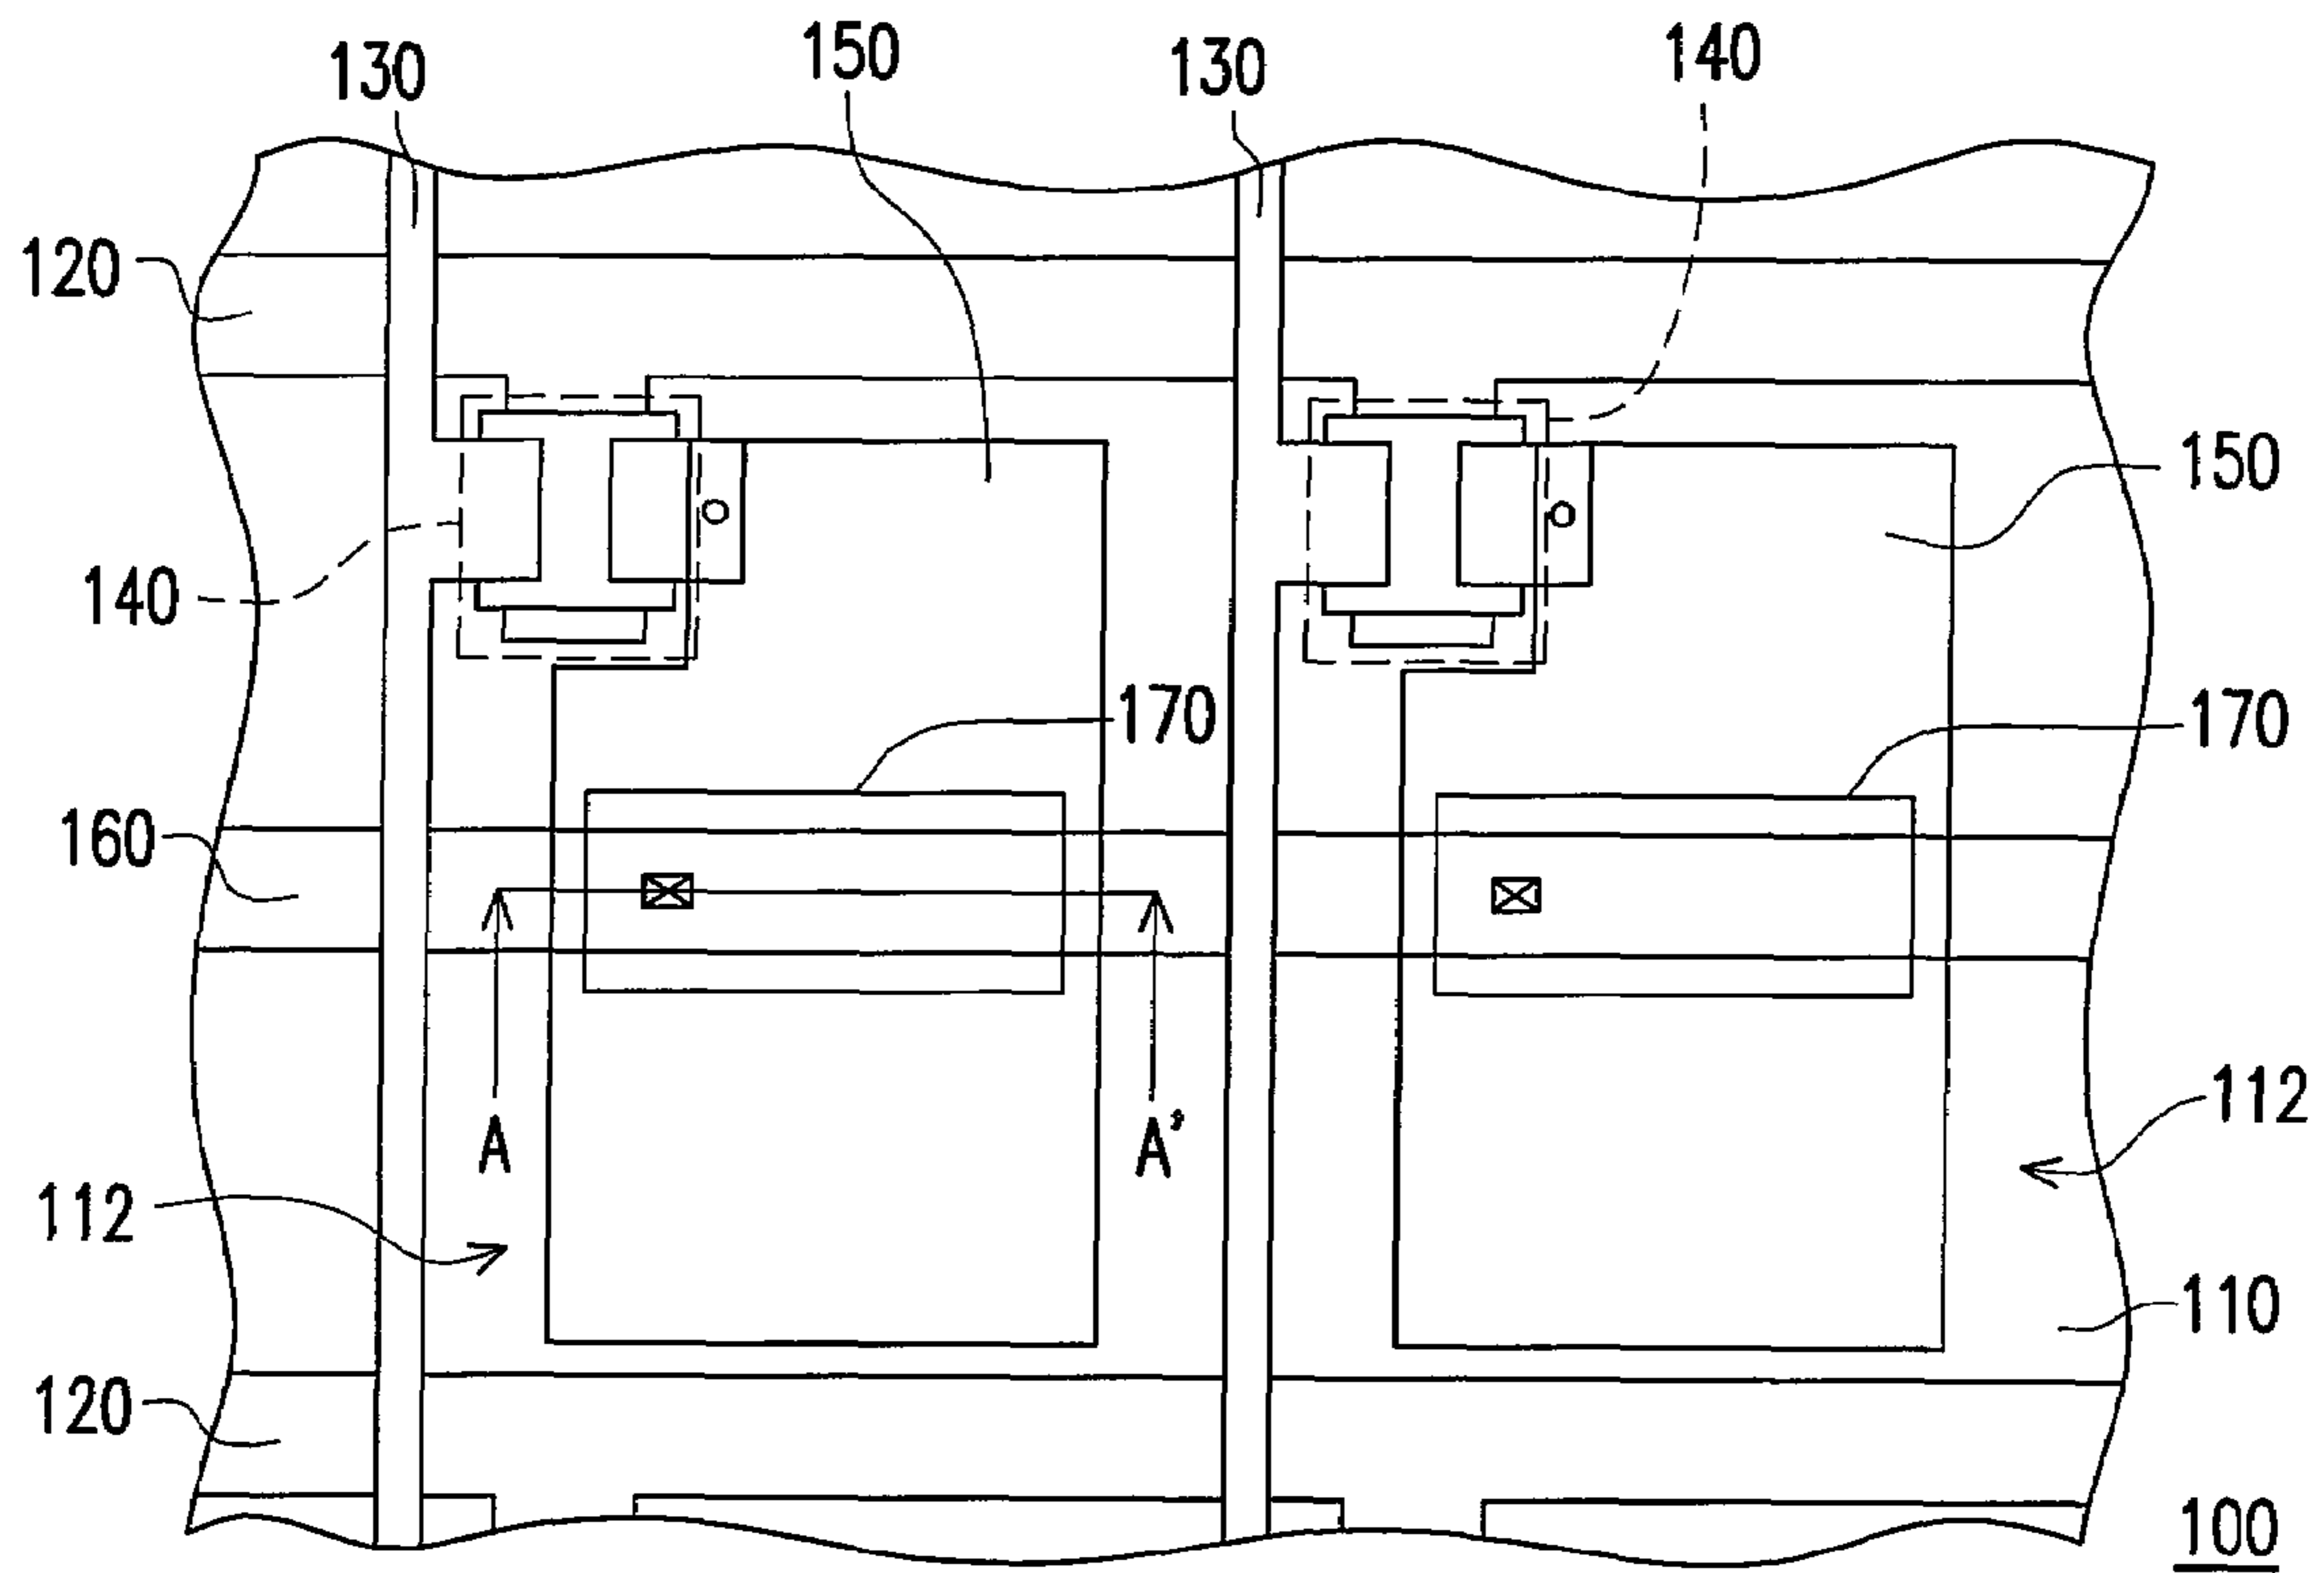
FIG. 1 is a top view of a portion of a conventional thin film transistor array substrate.

FIG. 1 is a top view of a portion of a conventional thin film transistor array substrate. FIG. 2 is a schematic cross-sectional view along line A-A' of the thin film transistor array substrate in FIG. 1. As shown in FIGS. 1 and 2, a conventional thin film transistor array substrate 100 mainly comprises a

substrate 110, a plurality of scan lines 120, a plurality of data lines 130, a plurality of thin film transistors 140, a plurality of pixel electrodes 150, a plurality of common lines 160 (only one is shown) and a plurality of upper electrode 170.

The scan lines 120 and the data lines 130 are disposed over the substrate 110 to define a plurality of pixel areas 112. Each thin film transistor 140 is disposed inside one of the pixel areas 112 and is driven by one of the scan lines 120 and data lines 130. Each pixel electrode 150 is also disposed inside one of the pixel areas 112 and is electrically connected to one of the thin film transistors 140. The common line 160 is disposed over the substrate 110 such that a portion area of the pixel electrode 150 is above one of the common lines 160.

In addition, an upper electrode 170 is disposed between each pixel electrode 150 and one of the common lines 160. Furthermore, a dielectric layer 180 is disposed between the upper electrode 170 and the corresponding common line 160 for isolating the upper electrode 170 and the common line 160. Another dielectric layer 190 is also disposed between the upper electrode 170 and one of the pixel electrodes 150. The dielectric layer 190 has a contact 192 for connecting the upper electrode 170 and the corresponding pixel electrode 150 electrically together.

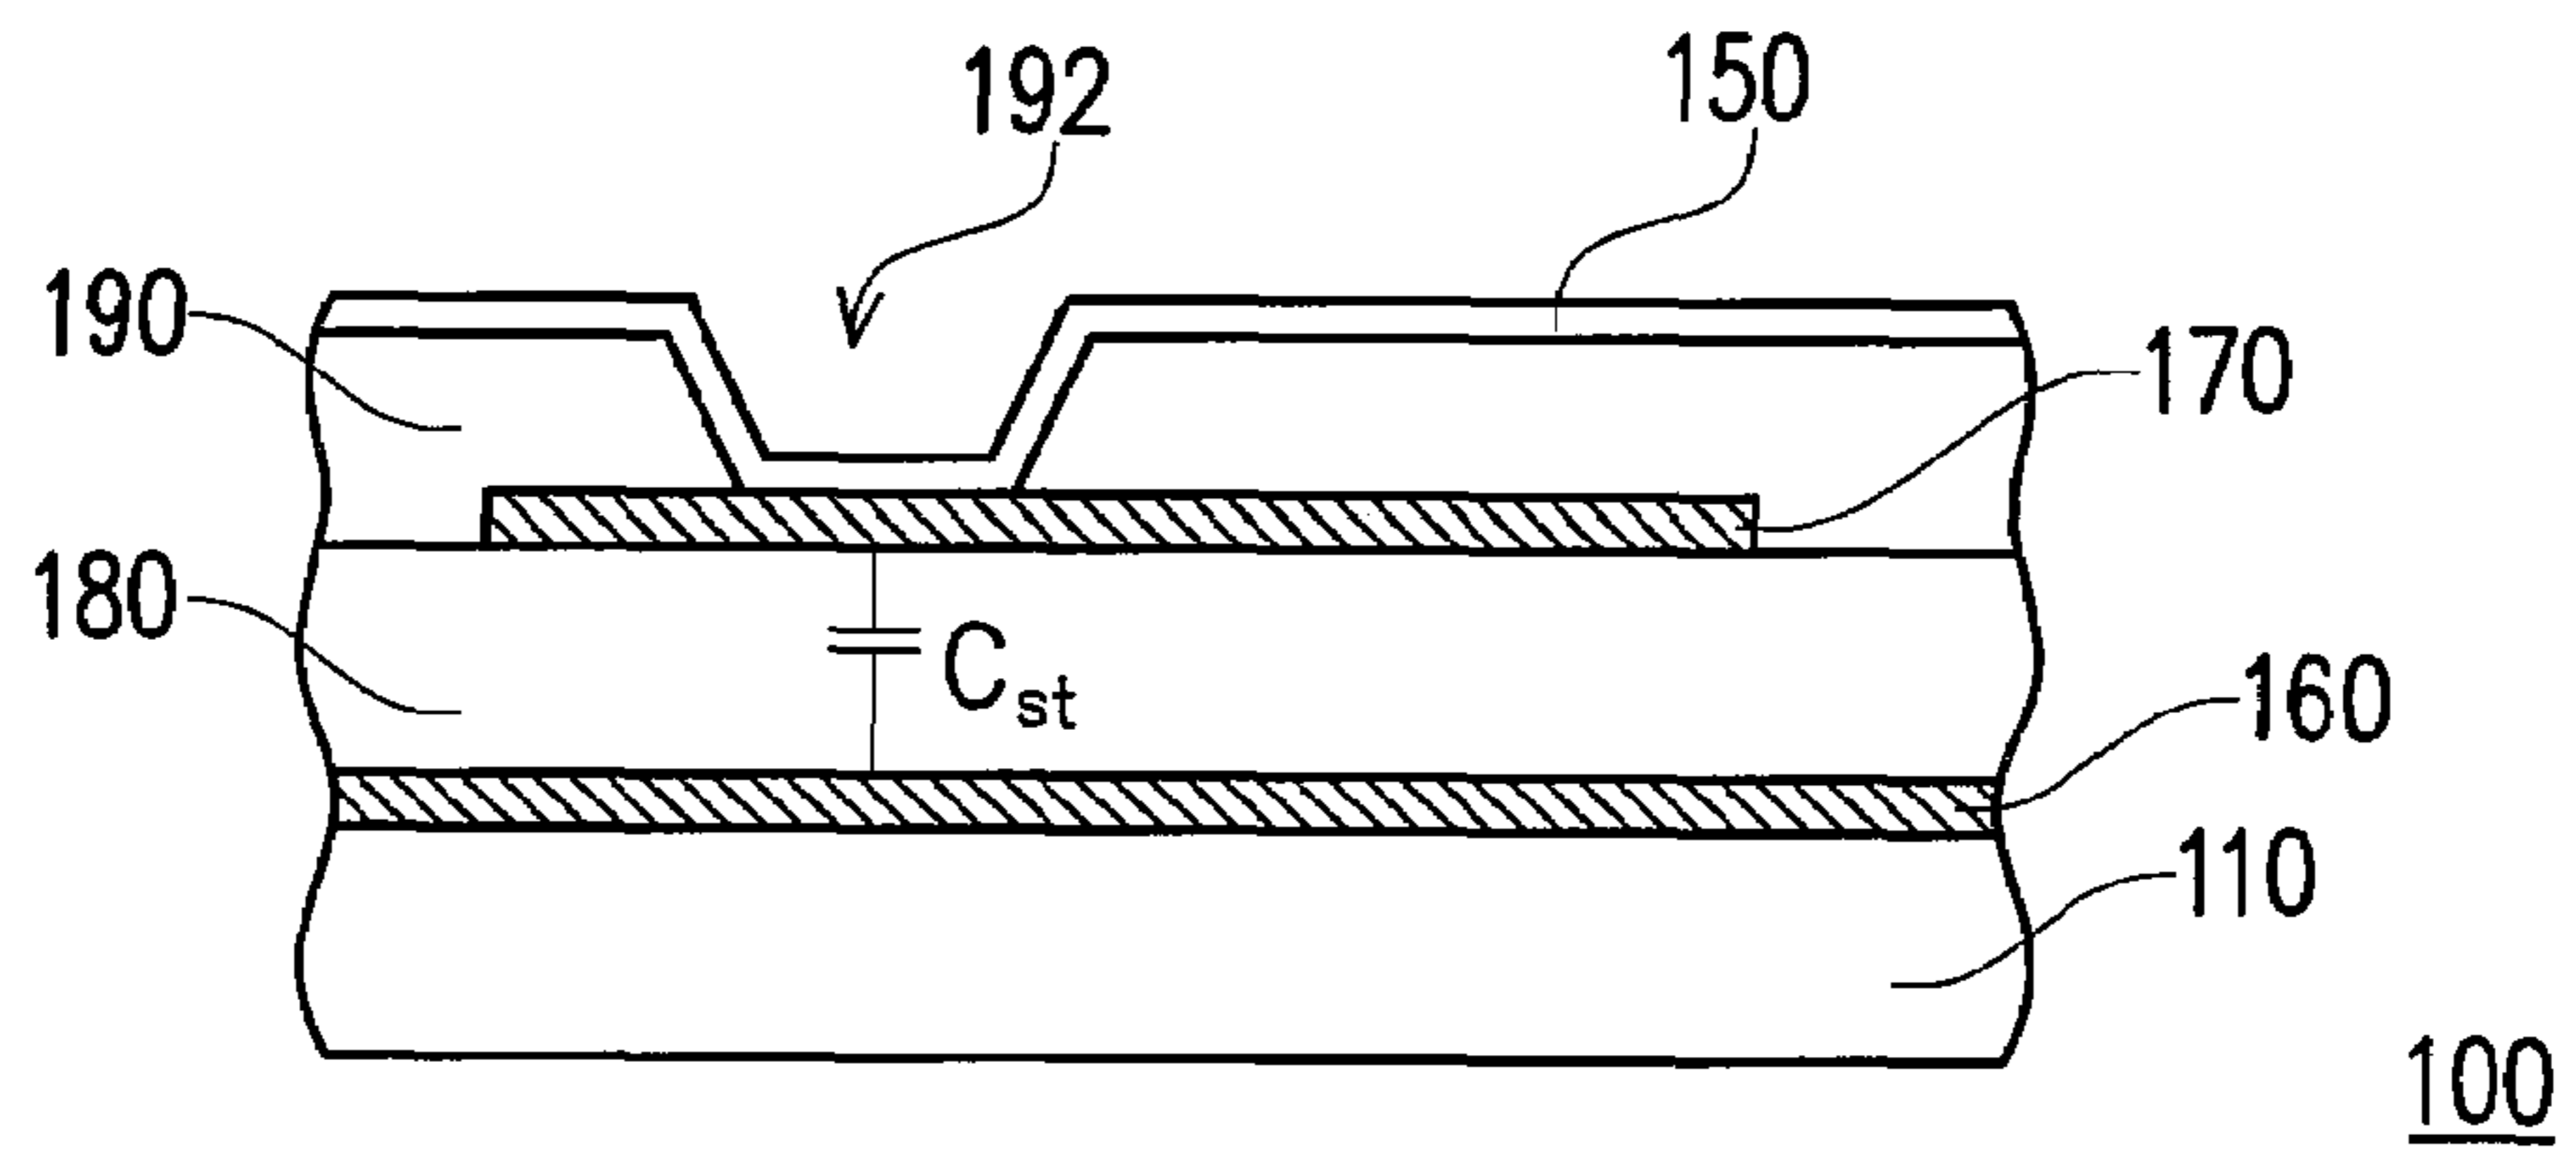
FIG. 2 is a schematic cross-sectional view along line A-A' of the thin film transistor array substrate in FIG. 1.

As shown in FIG. 2, the upper electrode 170 and the corresponding common line 160 together form a storage capacitor (Cst) that smooth out the normal operation of various pixels within the thin film transistor liquid crystal display. However, any processing defect or other factors may lead to some particles falling into the dielectric layer 180 or trapped in the defects within the dielectric layer 180 and produce a leaky capacitor. Ultimately, the display quality of the pixel will be compromised.

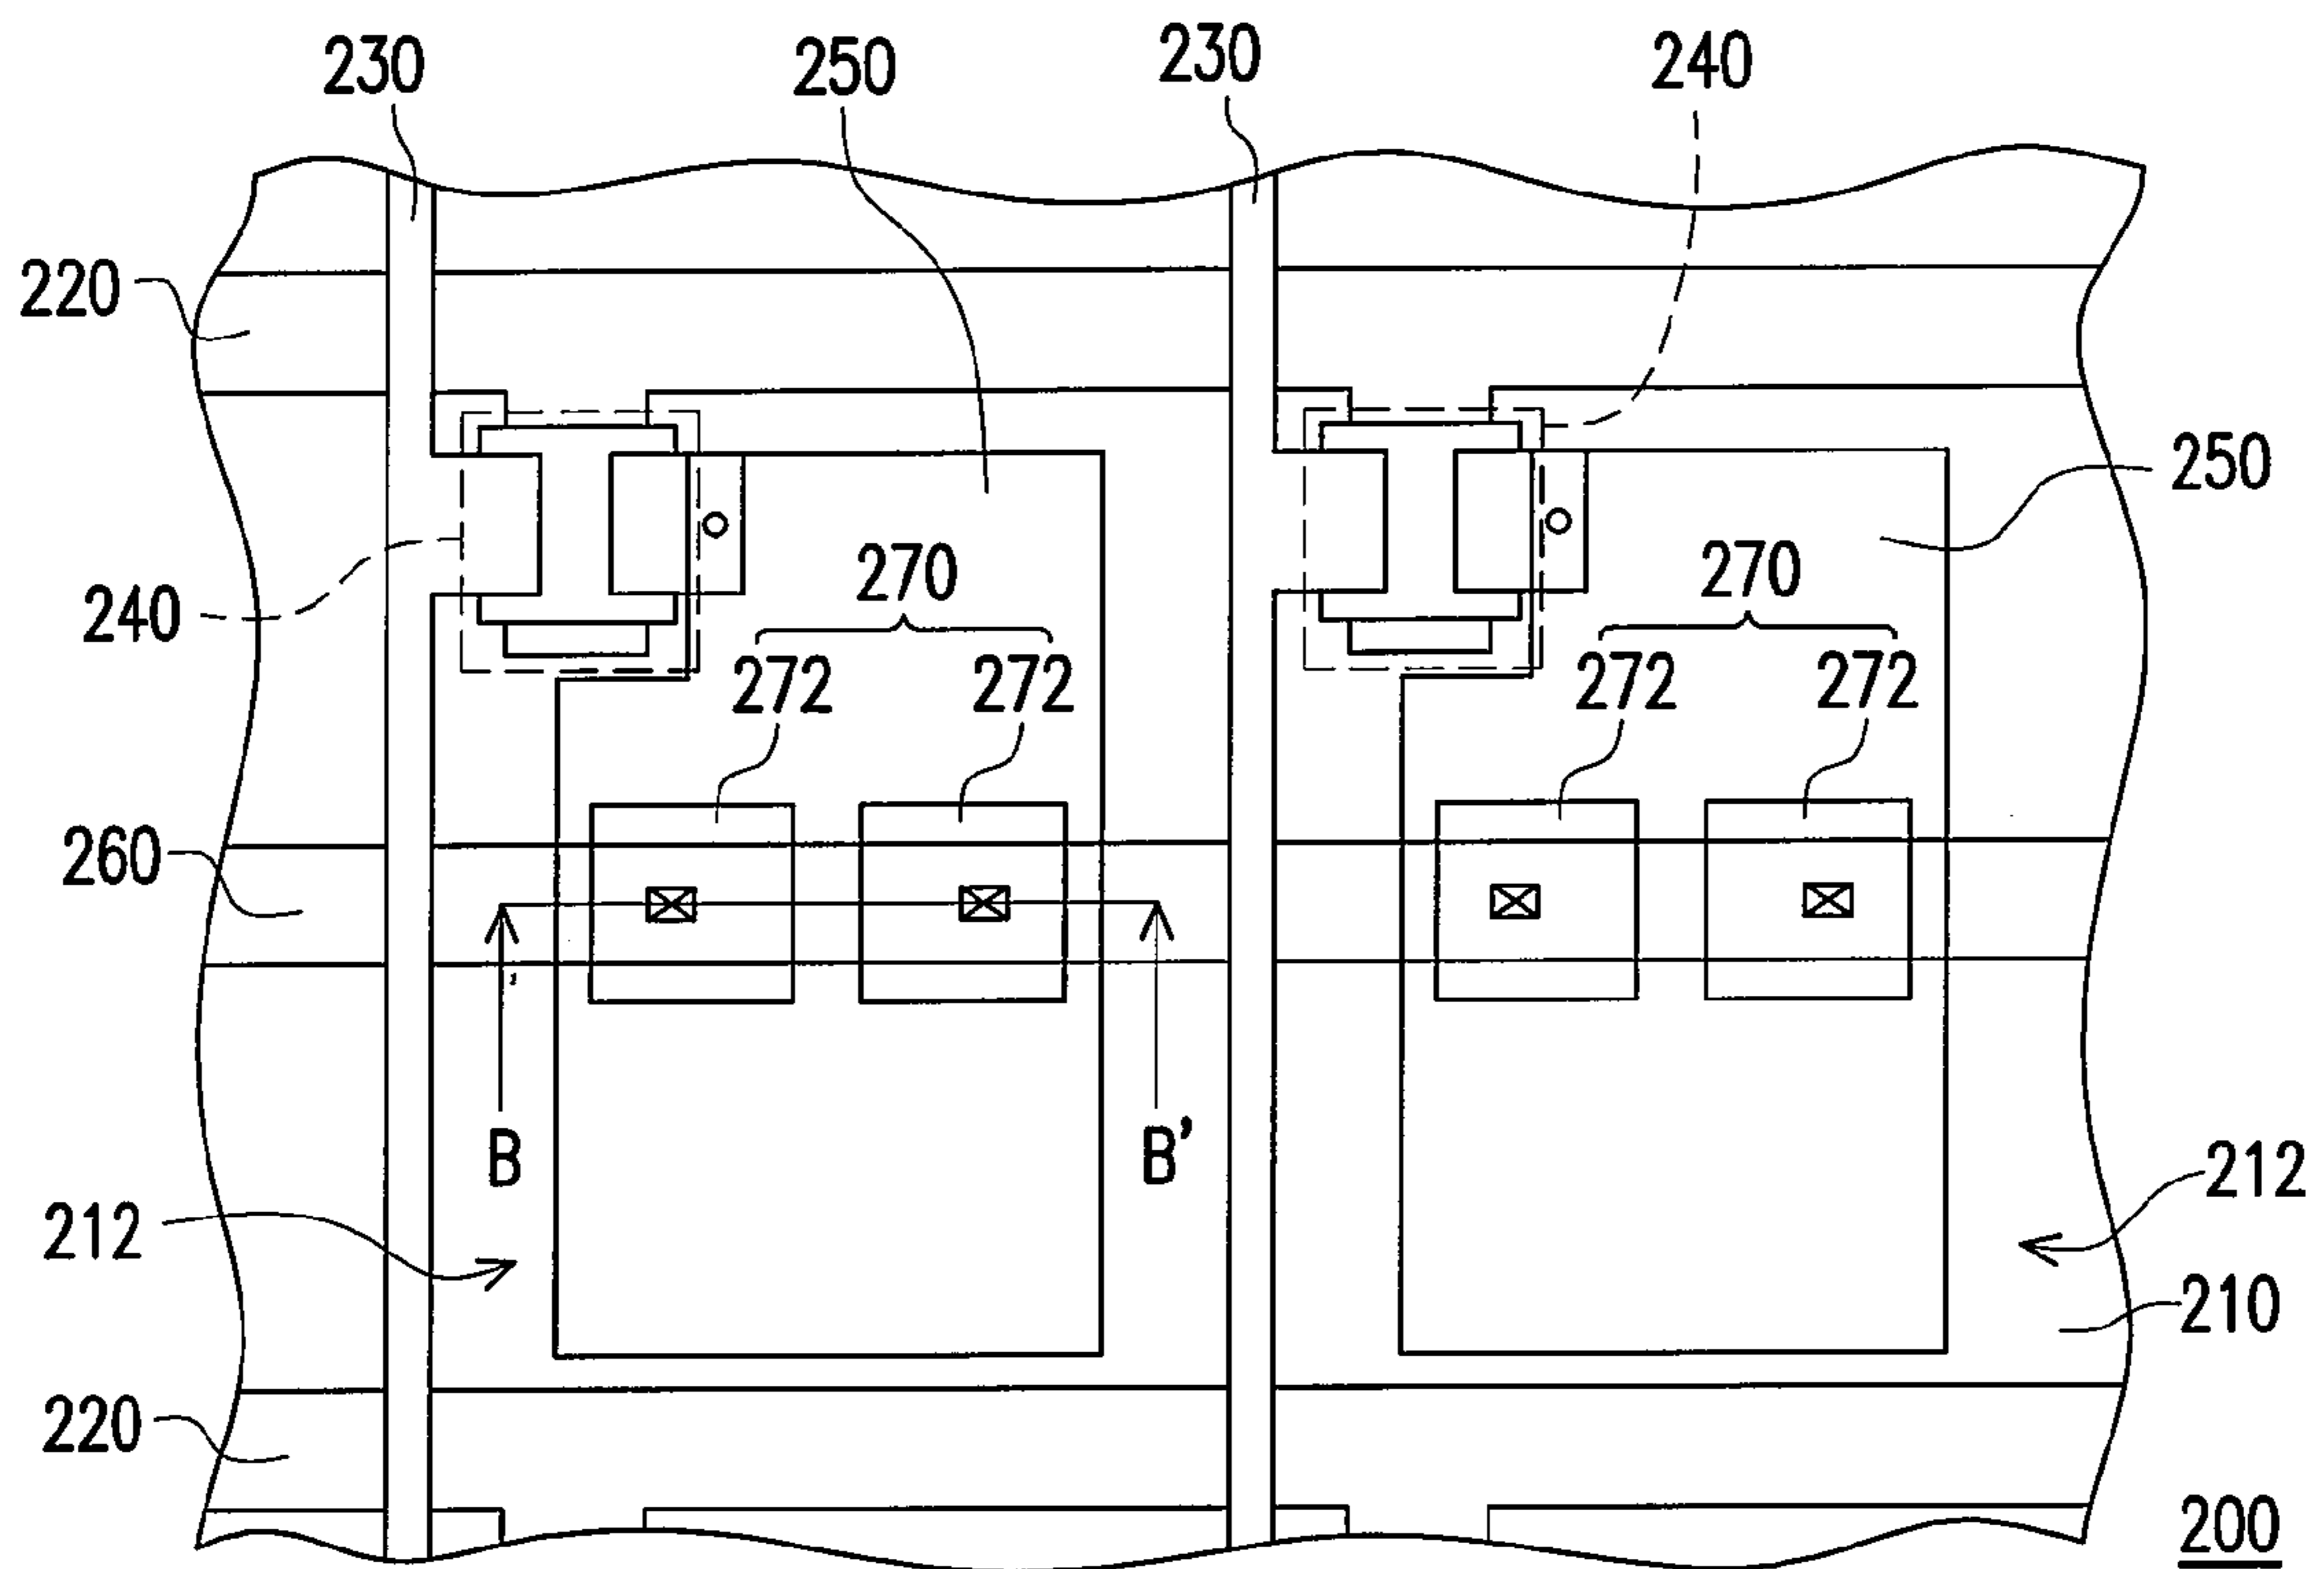
FIG. 3 is a top view of a thin film transistor array substrate according to one preferred embodiment of the present invention.

FIG. 3 is a top view of a thin film transistor array substrate according to one preferred embodiment of the present invention. FIG. 4 is a schematic cross-sectional view along line B-B' of the thin film transistor array substrate in FIG. 3. As shown in FIGS. 3 and 4, the thin film transistor array substrate 200 mainly comprises a substrate 210, a plurality of scan lines 220, a plurality of data lines 230, a plurality of thin film transistor 240, a plurality of pixel electrodes 250, a plurality of common lines 260 (only one is shown) and a patterned upper electrode 270.

The scan lines 220 and the data lines 230 are disposed over the substrate 210 to define a plurality of pixel areas 212. Each thin film transistor 240 is disposed inside one of the pixel areas 212 and driven by one of the scan lines 220 and one of the data lines 230. Each pixel electrode 250 is disposed inside one of the pixel areas 212 and electrically connected to one of the thin film transistors 240. The common line 260 is disposed over the substrate 210 such that a portion area of each pixel electrode 250 is above one of the common lines 260.

The patterned upper electrode 270 is disposed between each pixel electrode 250 and the corresponding common line 260. A dielectric layer 280 is disposed between the patterned upper electrode 270 and the common line 260. Another dielectric layer 290 is disposed between the patterned upper electrode 270 and the pixel electrode 250. It should be noted that the patterned upper electrode 270 comprises a plurality of sub-upper electrodes 272 (only two of them are shown). A portion area of each sub-upper electrode 272 is electrically connected to one of the pixel electrodes 250. For example, a contact 292 is formed in the dielectric layer 290 above each sub-upper electrode 272 so that each sub-upper electrode 272 is electrically connected to one of the pixel electrodes 250. Hence, the sub-upper electrode 272 and one of the common lines 260 together form a storage capacitor (Cst).

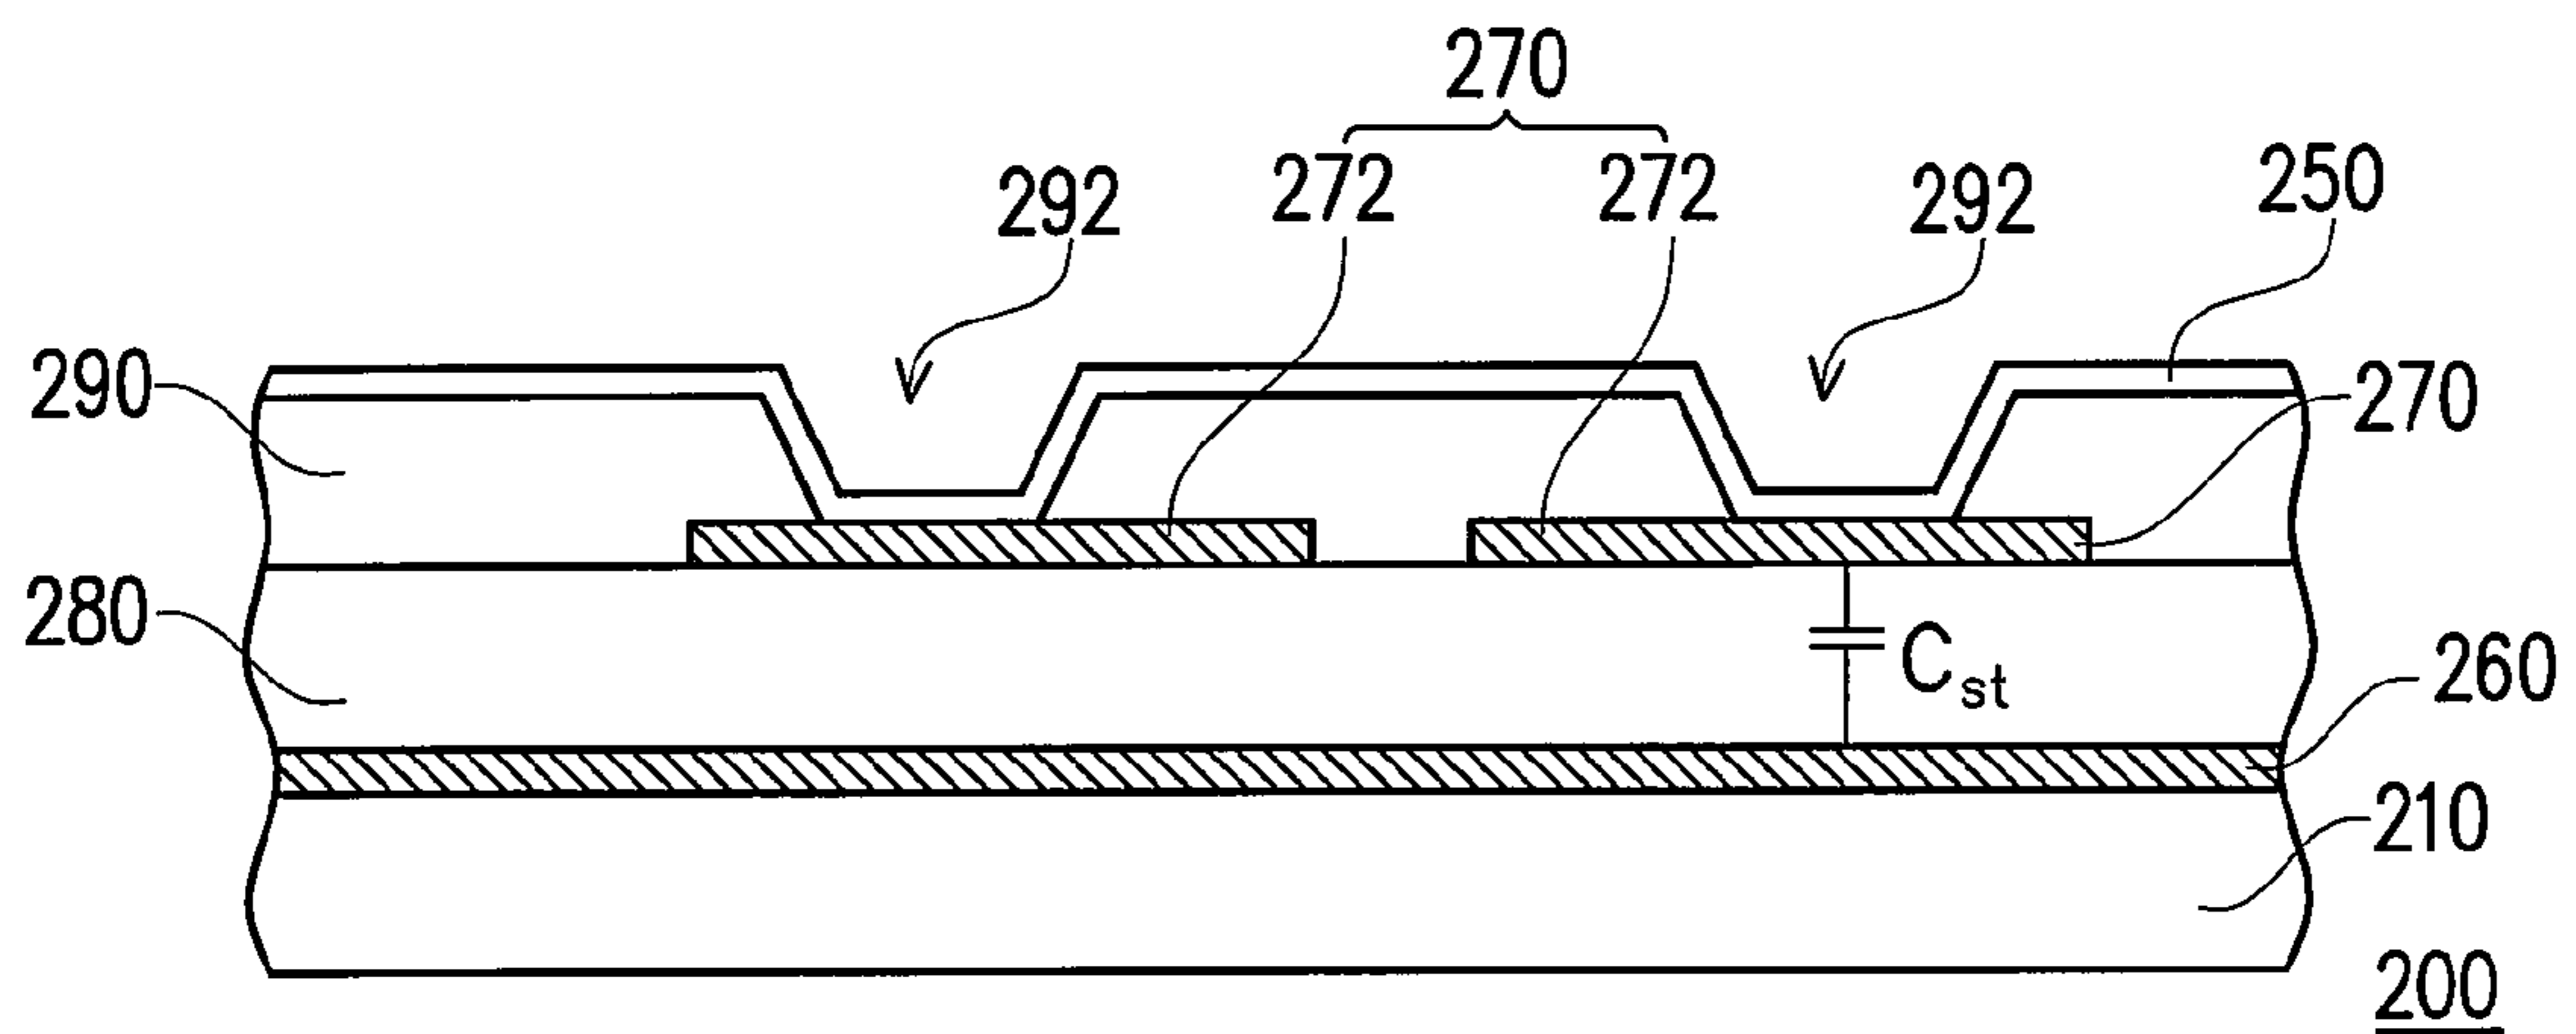
FIG. 4 is a schematic cross-sectional view along line B-B' of the thin film transistor array substrate in FIG. 3.

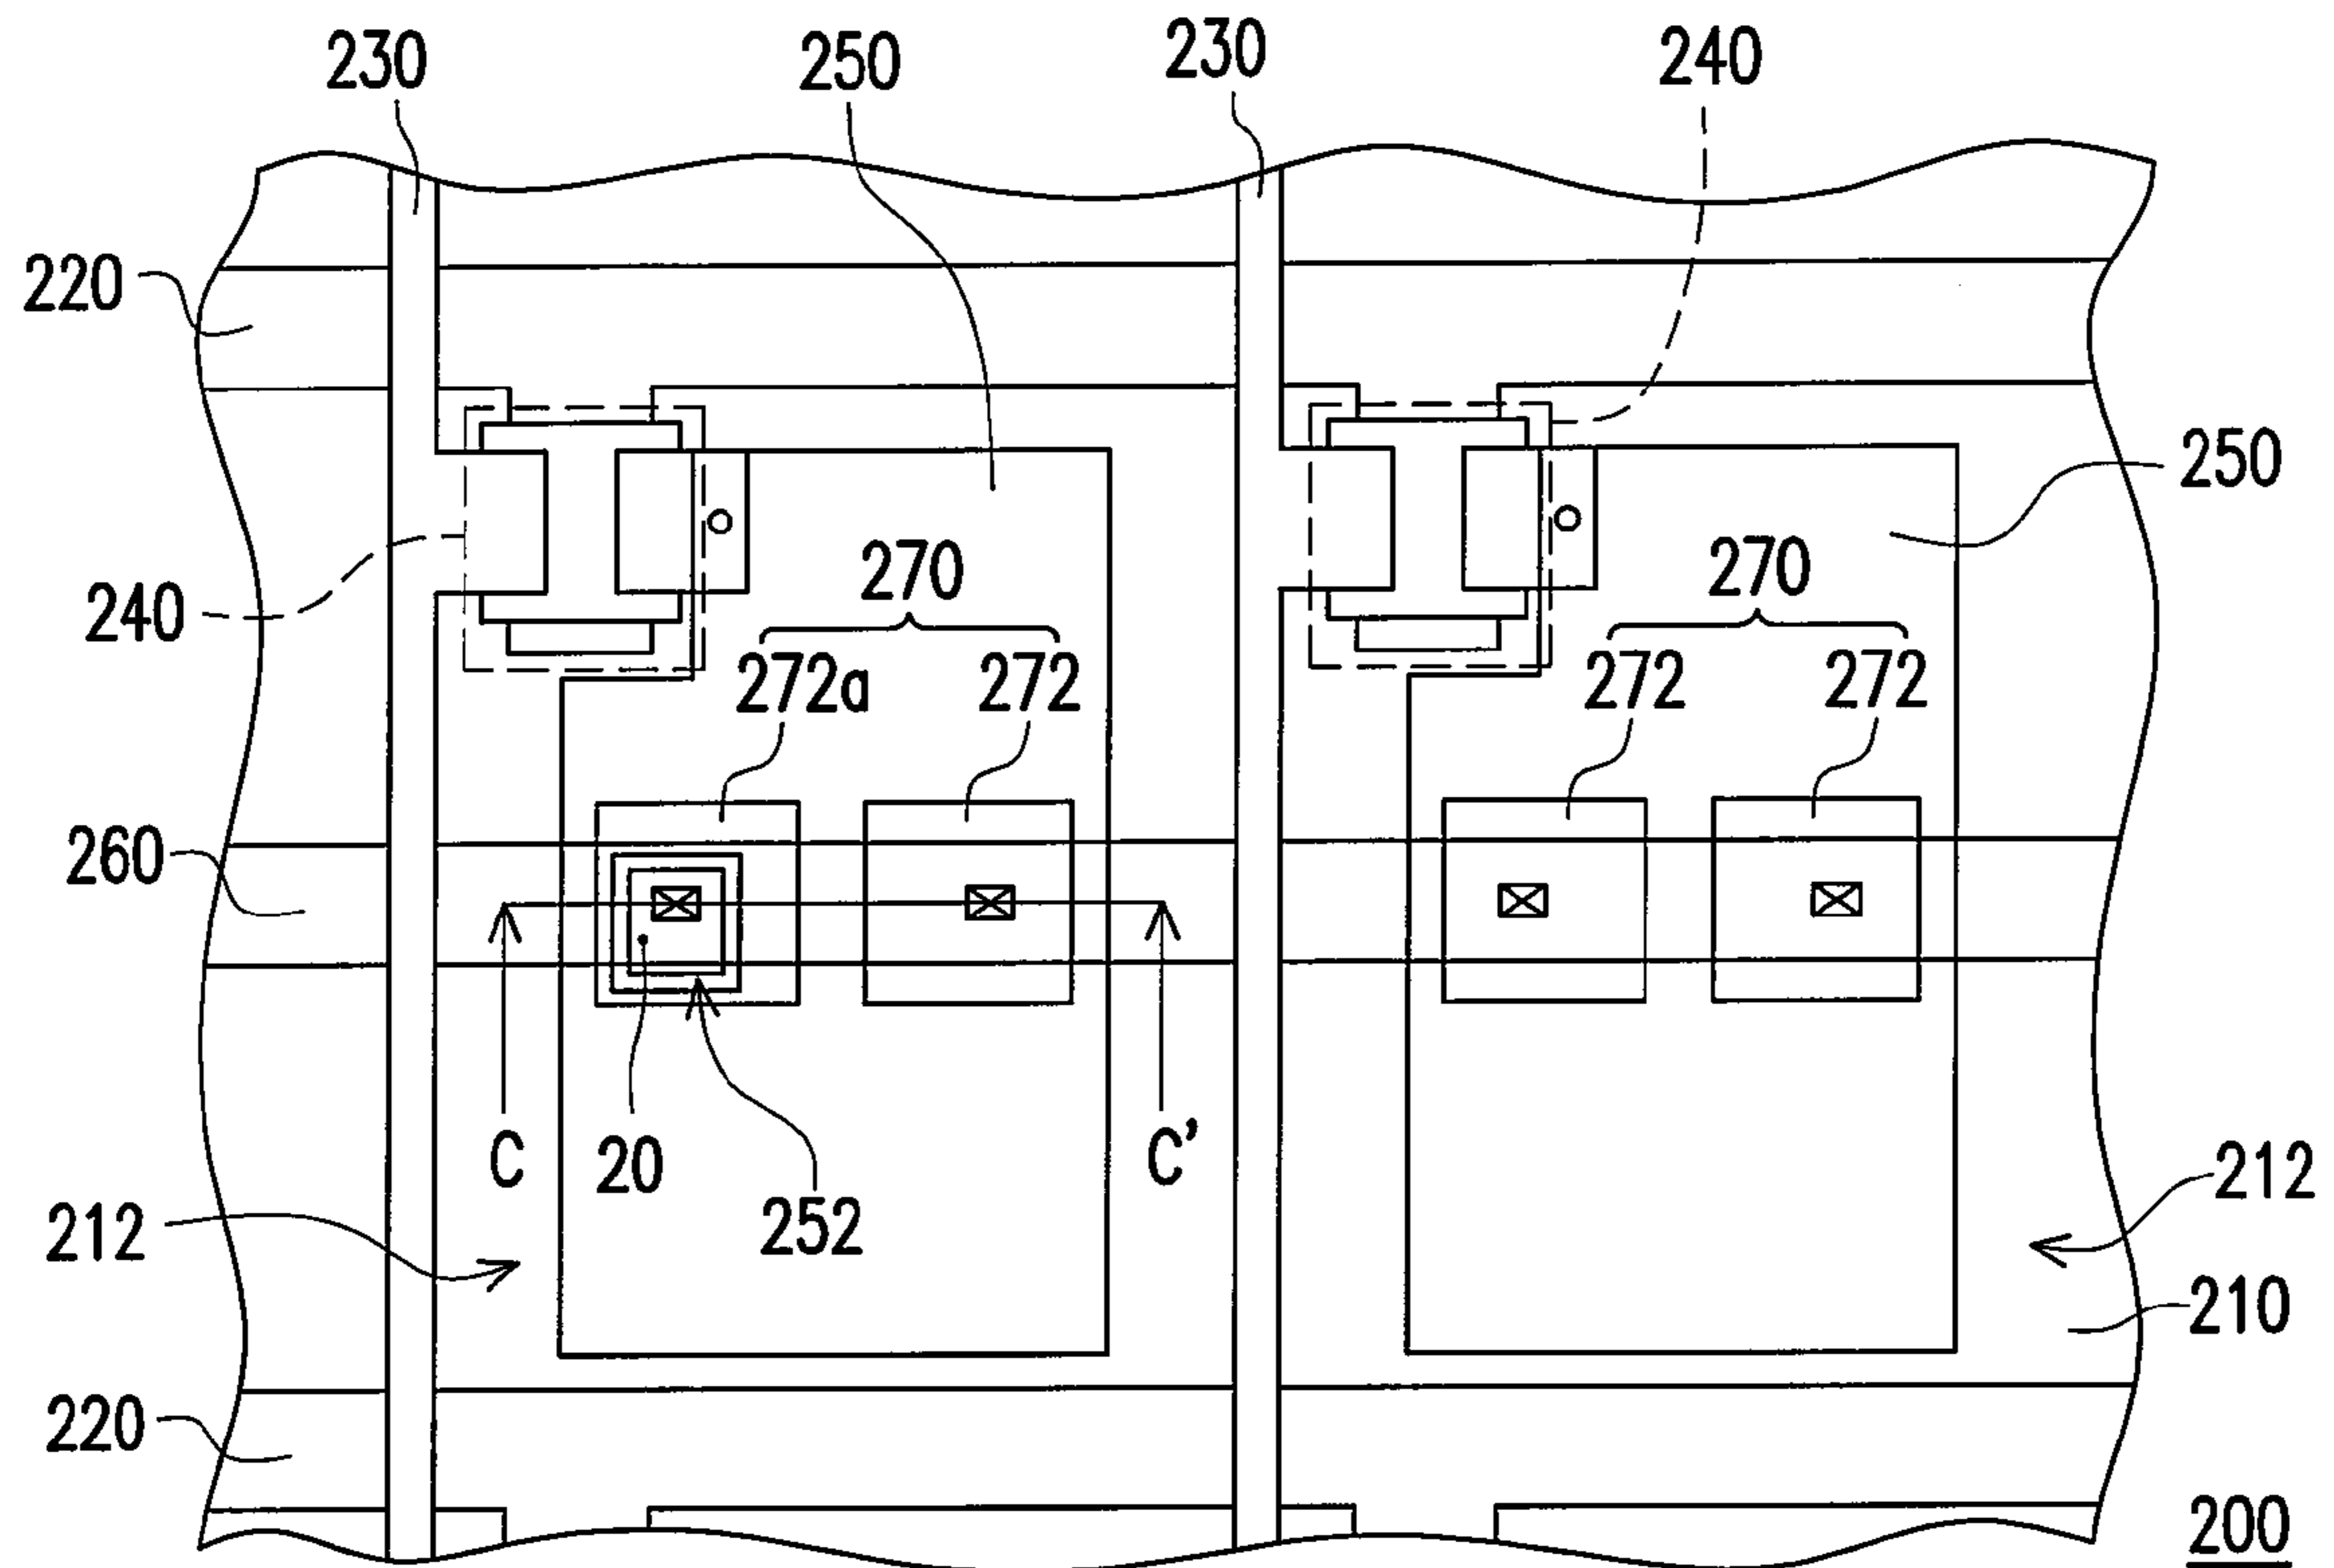
FIG. 5 is a top view of the thin film transistor array substrate in FIG. 3 after performing a laser repairing operation.

FIG. 5 is a top view of the thin film transistor array substrate in FIG. 3 after performing a laser repairing operation. FIG. 6 is a schematic cross-sectional view along C-C' of the thin film transistor array substrate shown in FIG. 5. As shown in FIGS. 5 and 6, if there is a particle (or defect) in the material between one of the sub-upper electrodes 272 and one of the common lines 260, leakage between the sub-upper electrode 272a and the common line 260 may occur. Thus, the pixel may display abnormally and need a repair. The method of repairing the pixel includes removing a portion area of the pixel electrode 250 corresponding to the sub-upper electrode 272a of the defective capacitor so that the sub-upper electrode 272a and the corresponding pixel electrode 250 of the defective capacitor are electrically isolated.

In the present embodiment, a portion area of the pixel electrode 250 above the sub-upper electrode 272a of the corresponding defective capacitor is removed to form an opening 252. The method of removing a portion area of the pixel electrode 250 includes laser ablation, for example. The opening 252 is located around the contact area between the sub-upper electrode 272a and the corresponding pixel electrode 250 of the defective capacitor (that is, around the contact 292). By forming the opening 252, the sub-upper electrode 272a and the corresponding pixel electrode 250 of the defective capacitor are electrically isolated. Since the repair

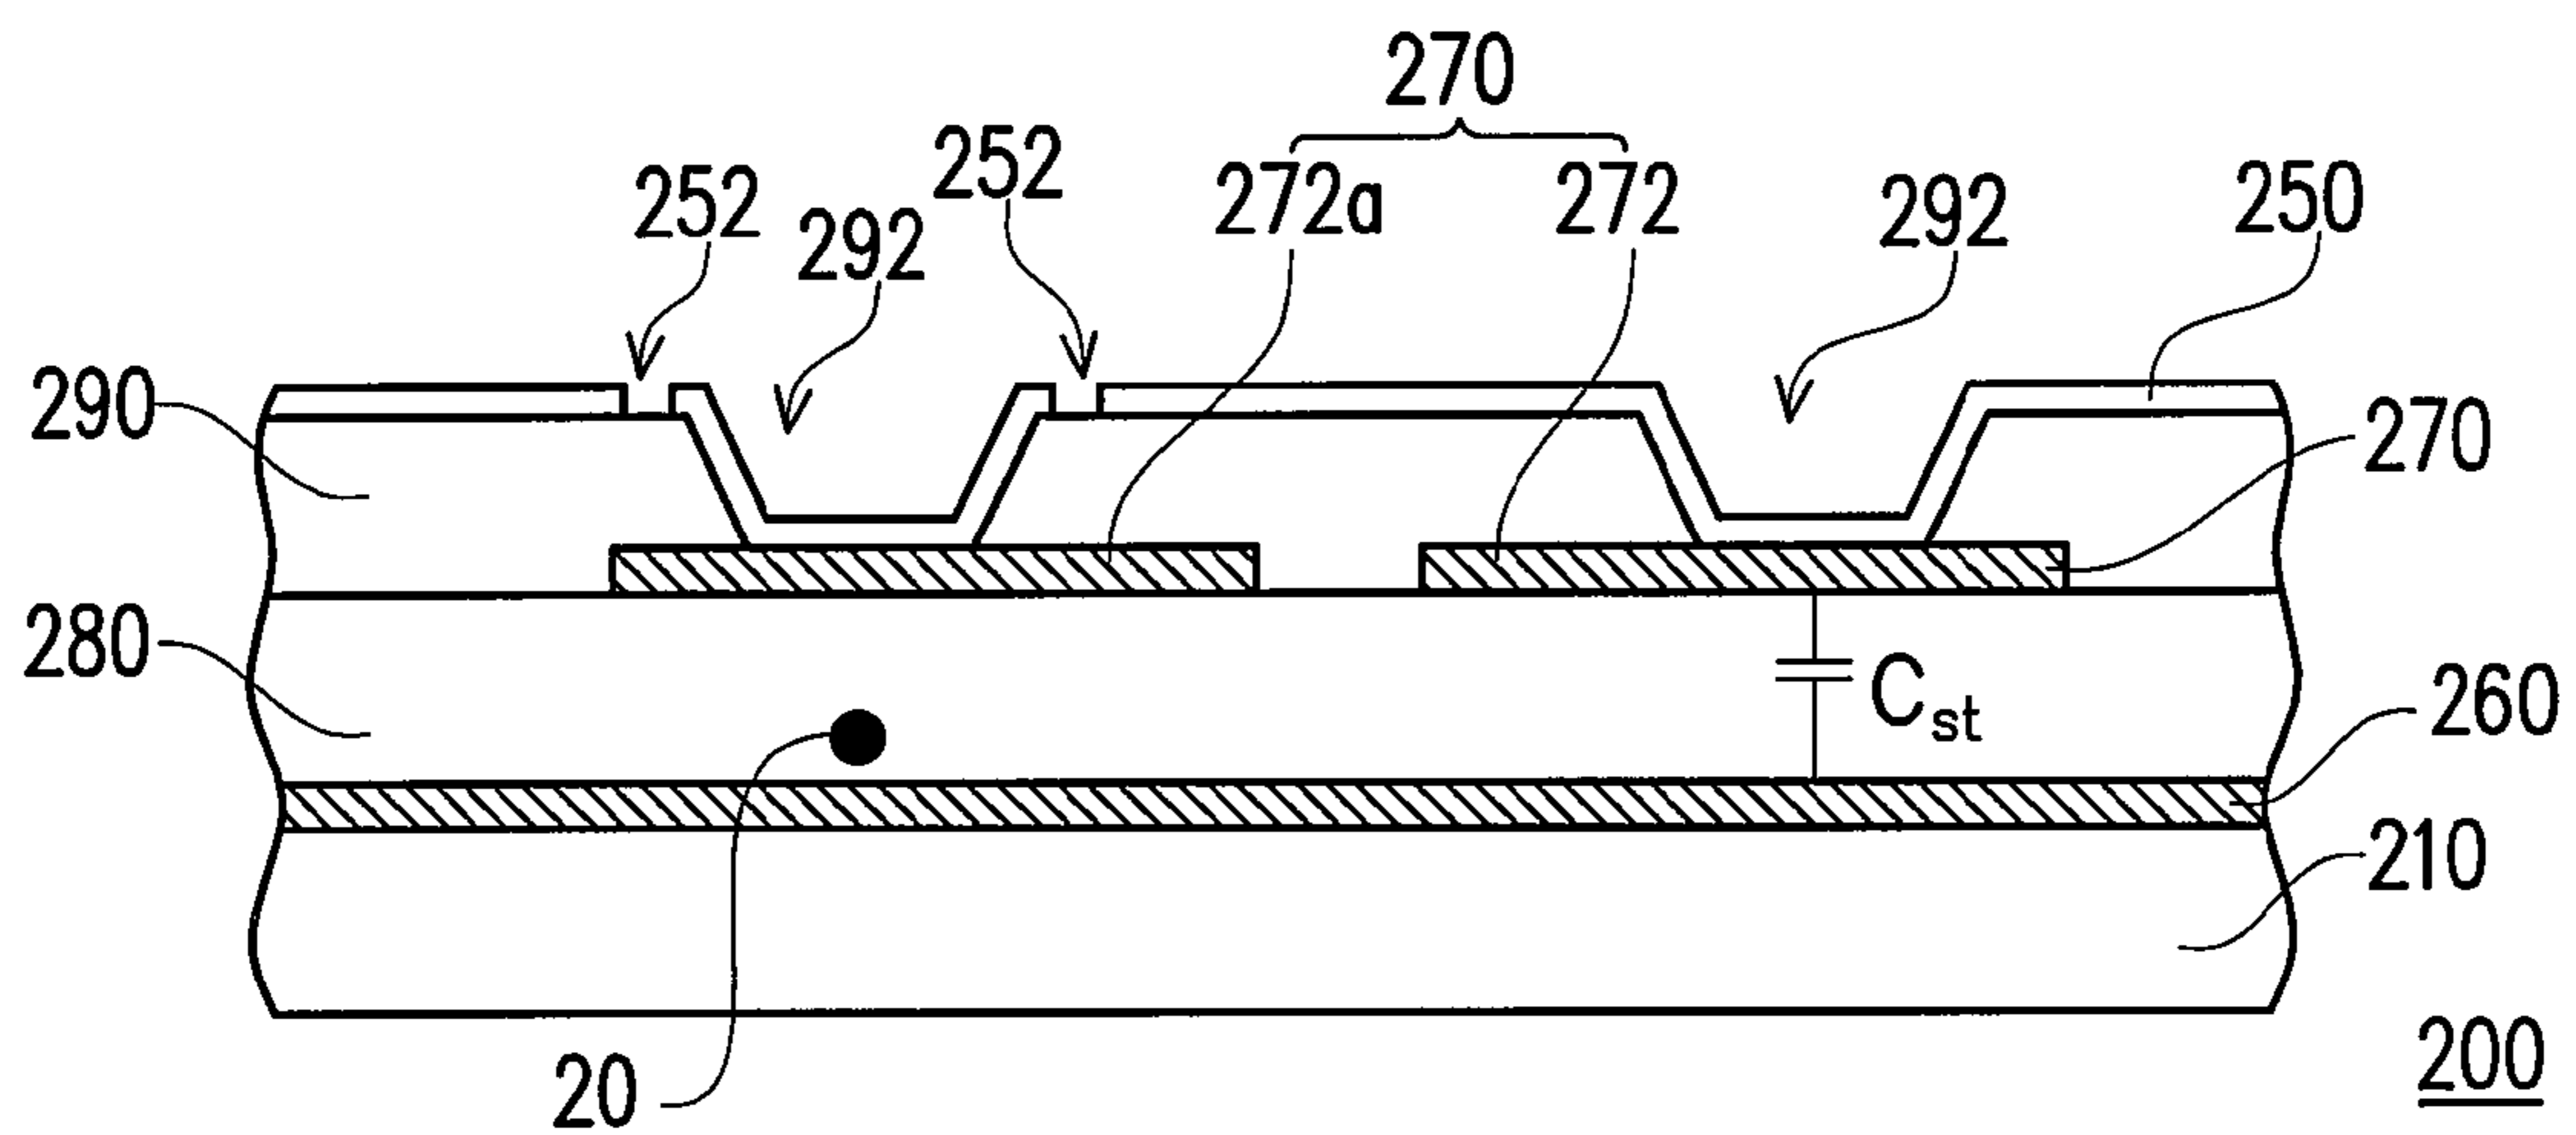
FIG. 6 is a schematic cross-sectional view along C-C' of the thin film transistor array substrate shown in FIG. 5.
