(12) **United States Patent**
Lai

(10) **Patent No.:** **US 7,436,466 B2**
(45) **Date of Patent:** **Oct. 14, 2008**

(54) **REPAIRING METHOD OF A THIN FILM TRANSISTOR ARRAY SUBSTRATE**

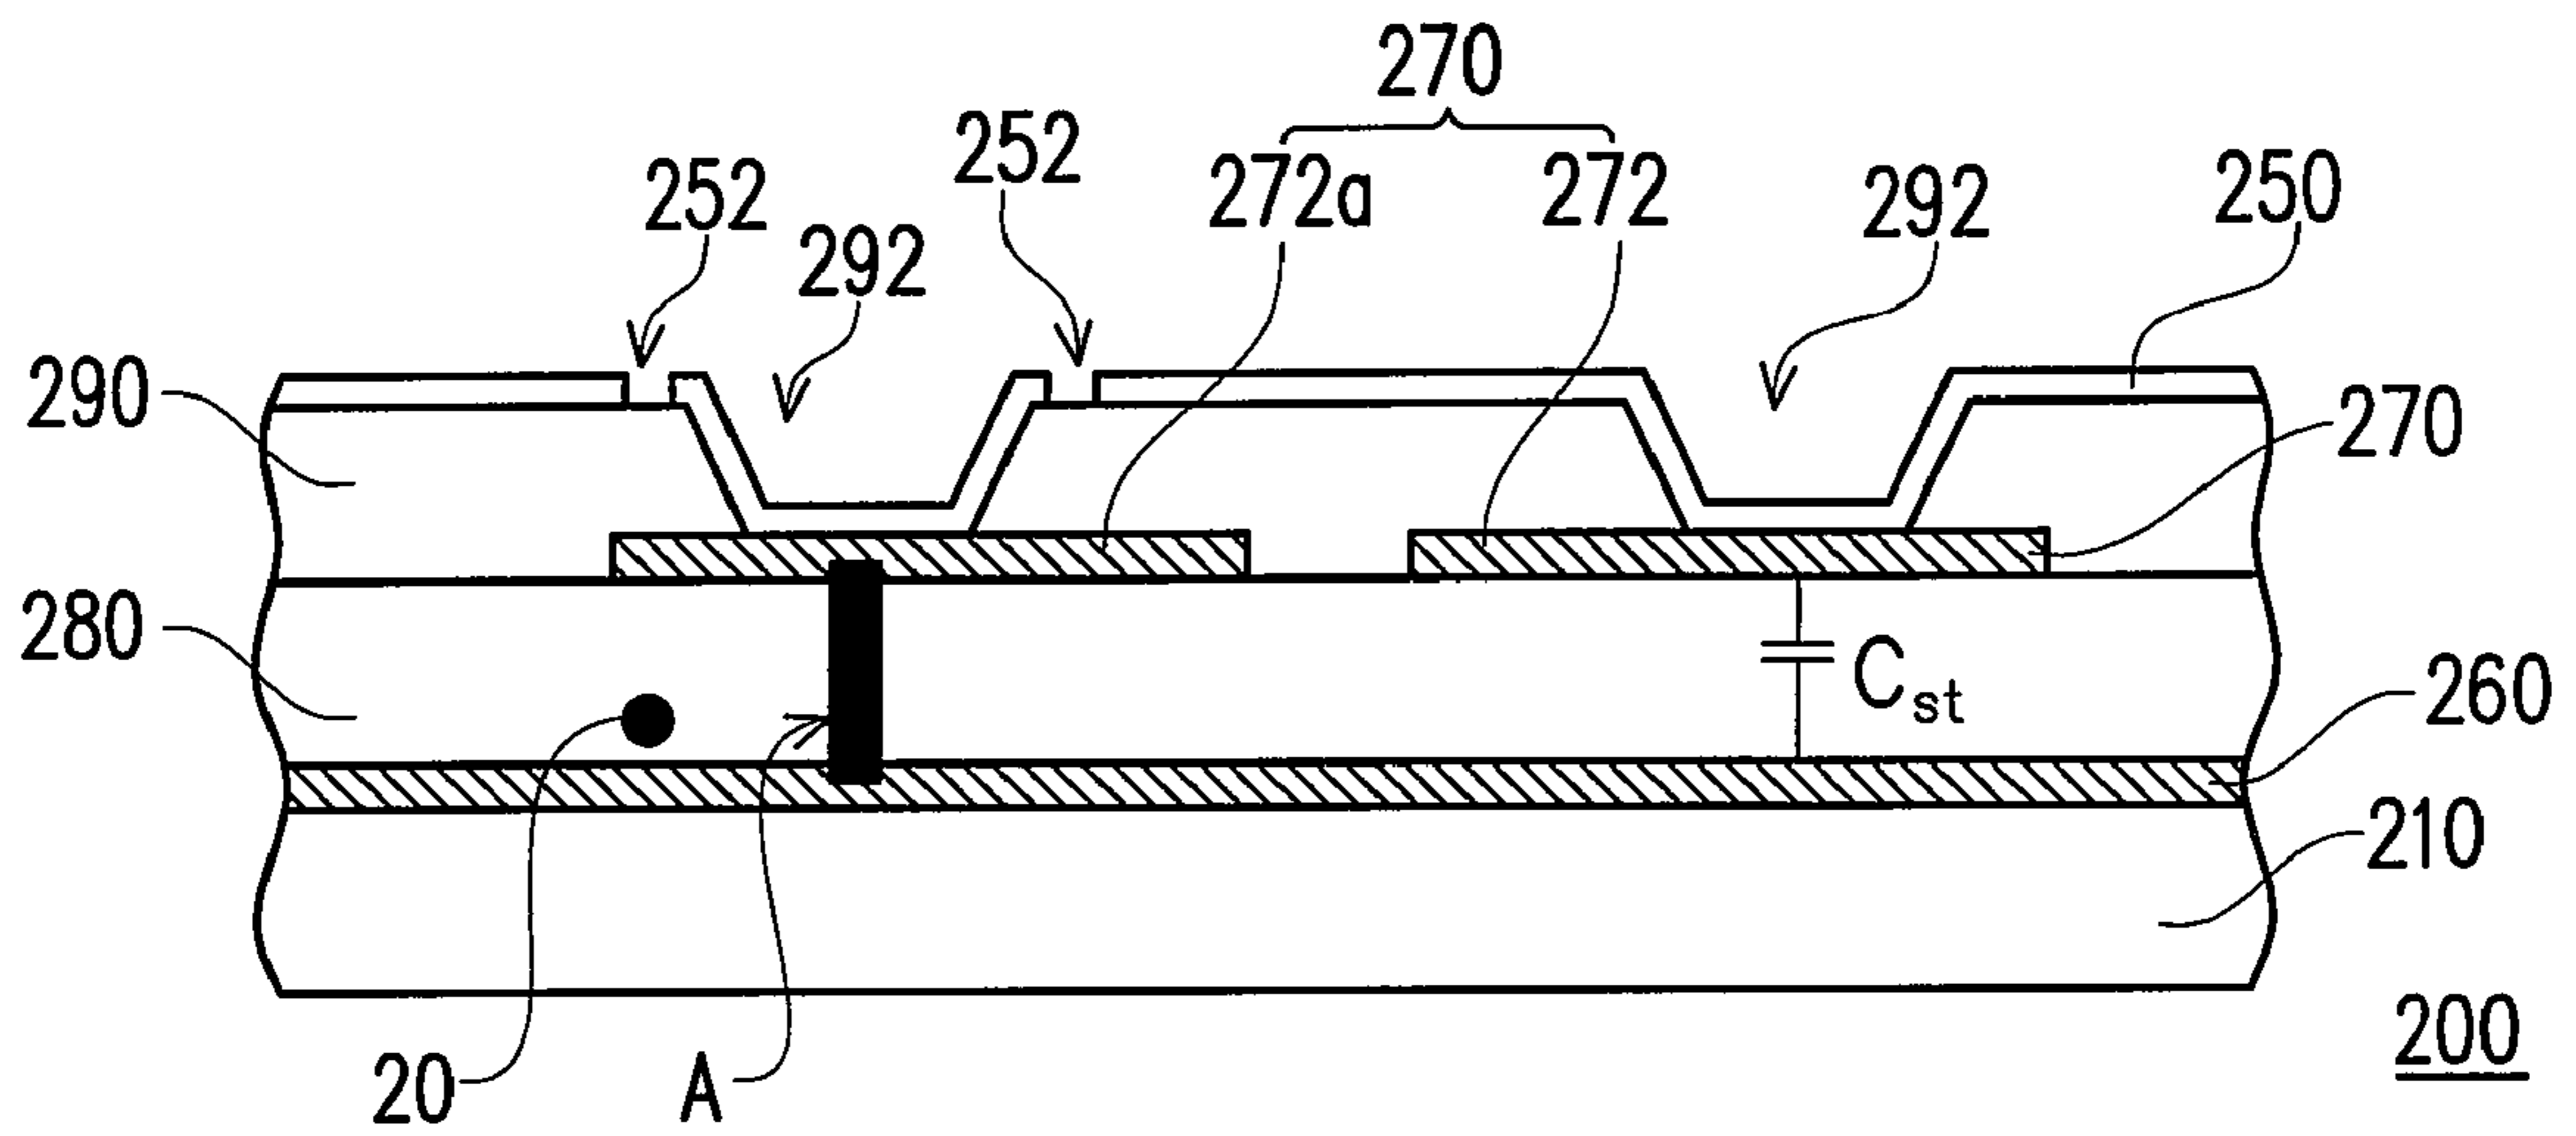
FIG. 7 is a schematic cross-sectional view showing the electrical connection between the common line and the sub-upper electrode in a defective capacitor for repairing a thin film transistor array substrate according to one preferred embodiment of the present invention.

FIG. **7** is a schematic cross-sectional view showing the electrical connection between the common line and the sub-upper electrode in a defective capacitor for repairing a thin film transistor array substrate according to one preferred embodiment of the present invention. After removing a portion area of the pixel electrode **250** corresponding to the sub-upper electrode **272a** of the defective capacitor to isolate the sub-upper electrode **272a** and the pixel electrode **250** electrically, the sub-upper electrode **272a** and the corresponding common line **260** are welded together (labeled A). Hence, the sub-upper electrode **272a** and the common line **260** of the defective capacitor are configured at the same potential to prevent any leakage via the particles (or defects). The sub-upper electrode **272a** and the corresponding common line **260** are welded together by performing a laser welding process, for example.

In the present invention, the location at which the sub-upper electrode **272a** and the corresponding common line **260** of the defective capacitor weld together is underneath the contact **292**. However, anyone familiar with the technologies may choose other suitable locations convenient for welding the sub-upper electrode **272a** and the corresponding common line **260** of the defective capacitor together.

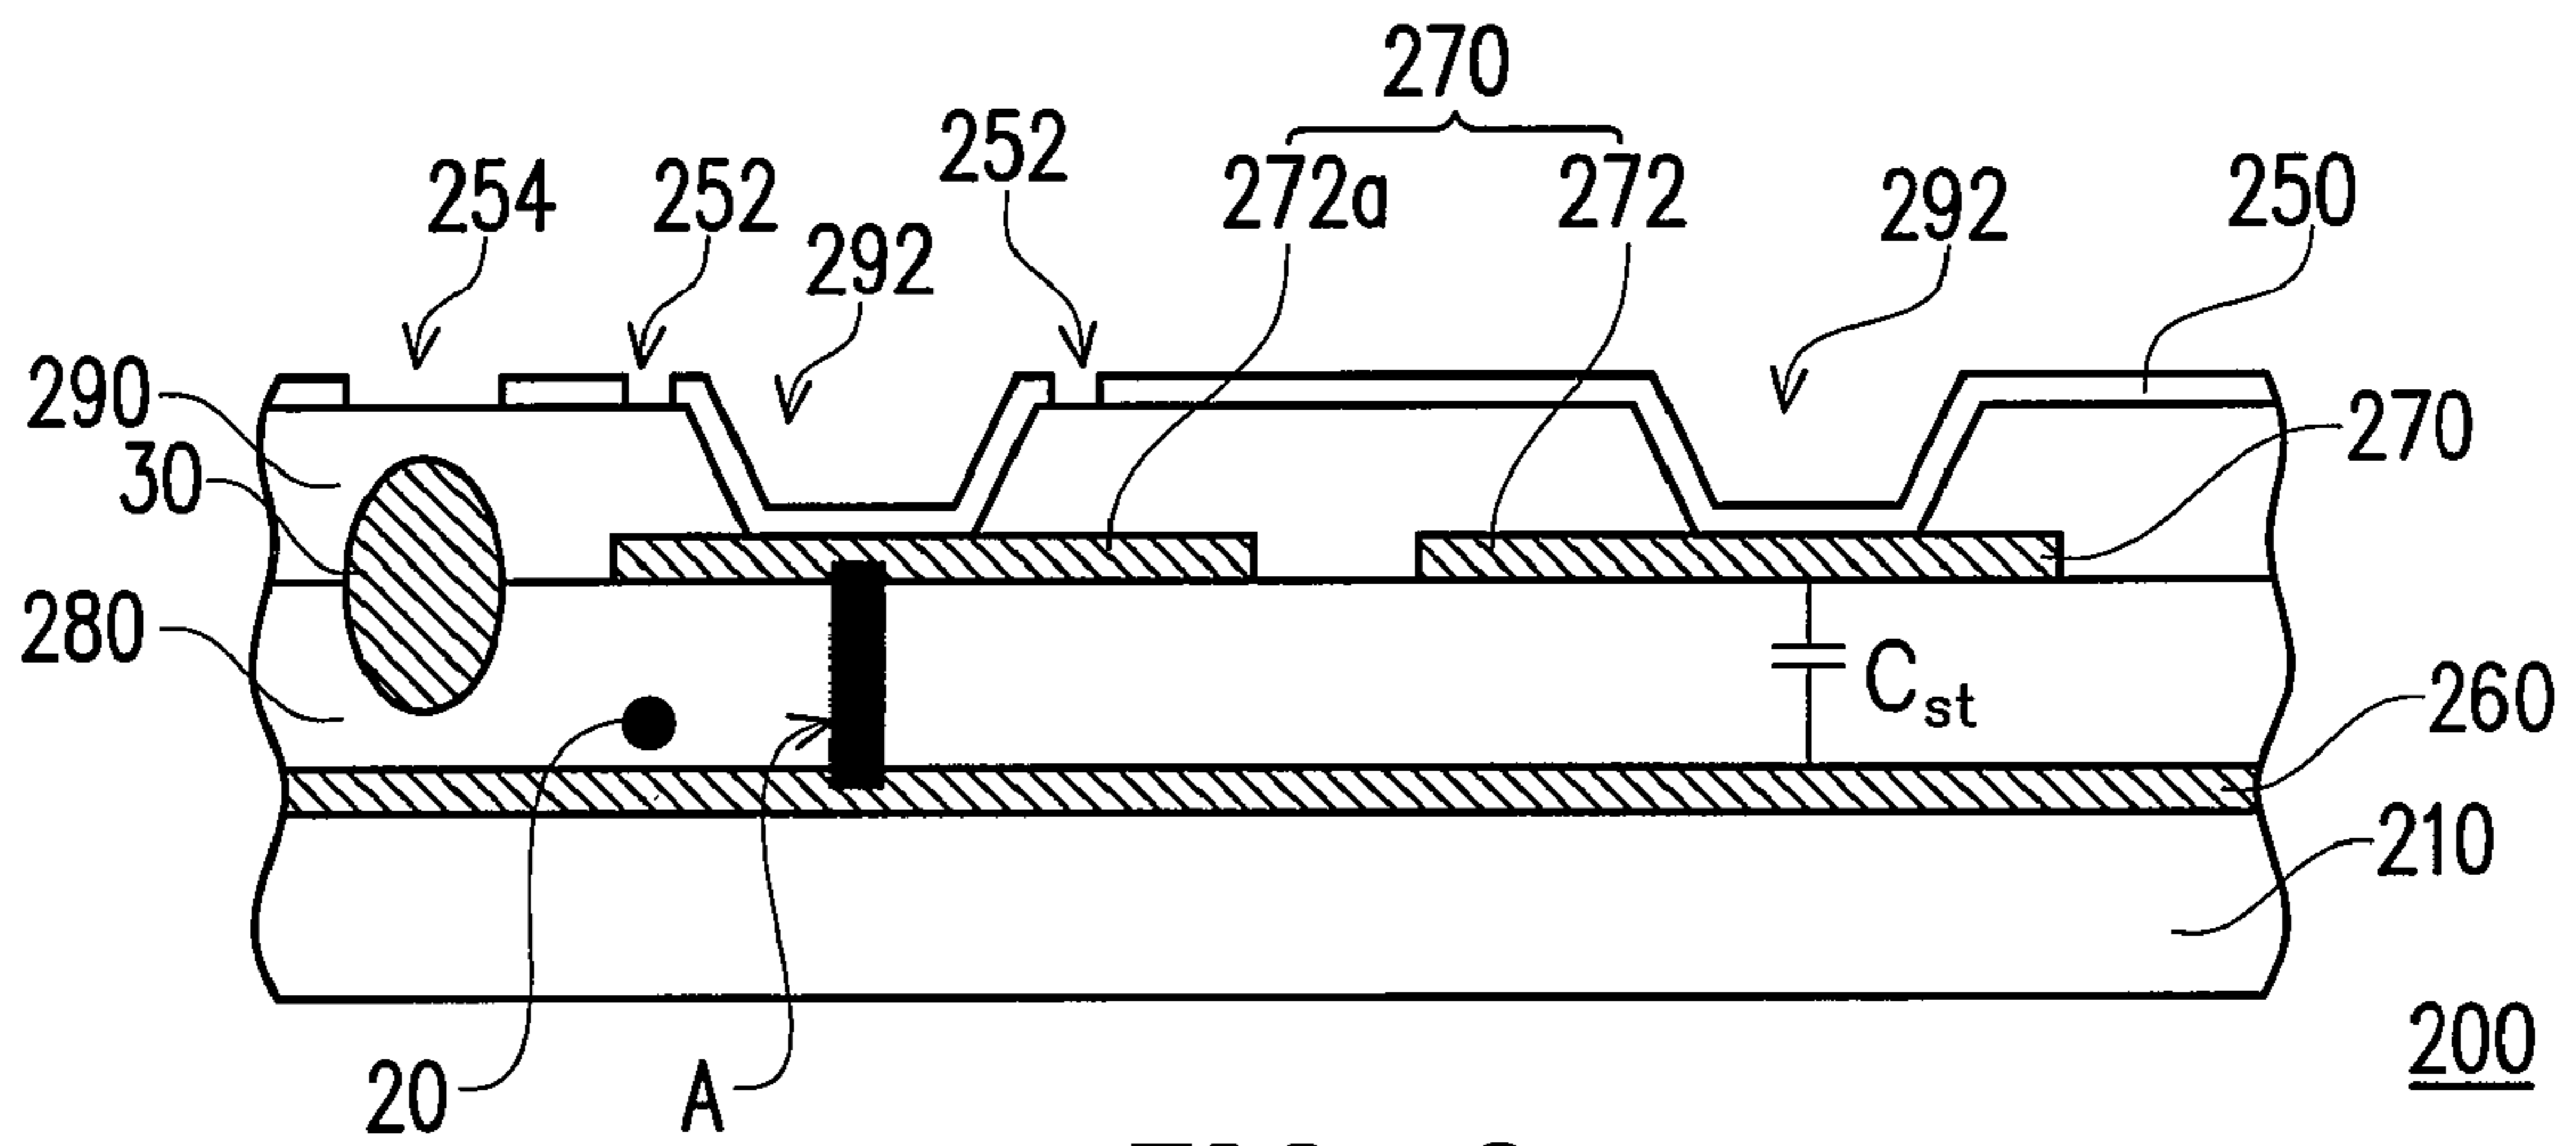
FIG. 8 is a schematic cross-sectional view showing the reparation of a thin film transistor array substrate when a particle is disposed between a pixel electrode and a common line.

FIG. **8** is a schematic cross-sectional view showing the reparation of a thin film transistor array substrate when a particle is disposed between a pixel electrode and a common line. When a particle **30** (or a defect) is formed inside the layers between the pixel electrode and one of the common lines, the repairing method of the present invention also permits the removal of a portion area of the pixel electrode **250** above the particle **30** (or defect). For example, a portion area of the pixel electrode **250** is removed to form an opening **254** that exposes the particle **30** (or defect) using a laser beam.

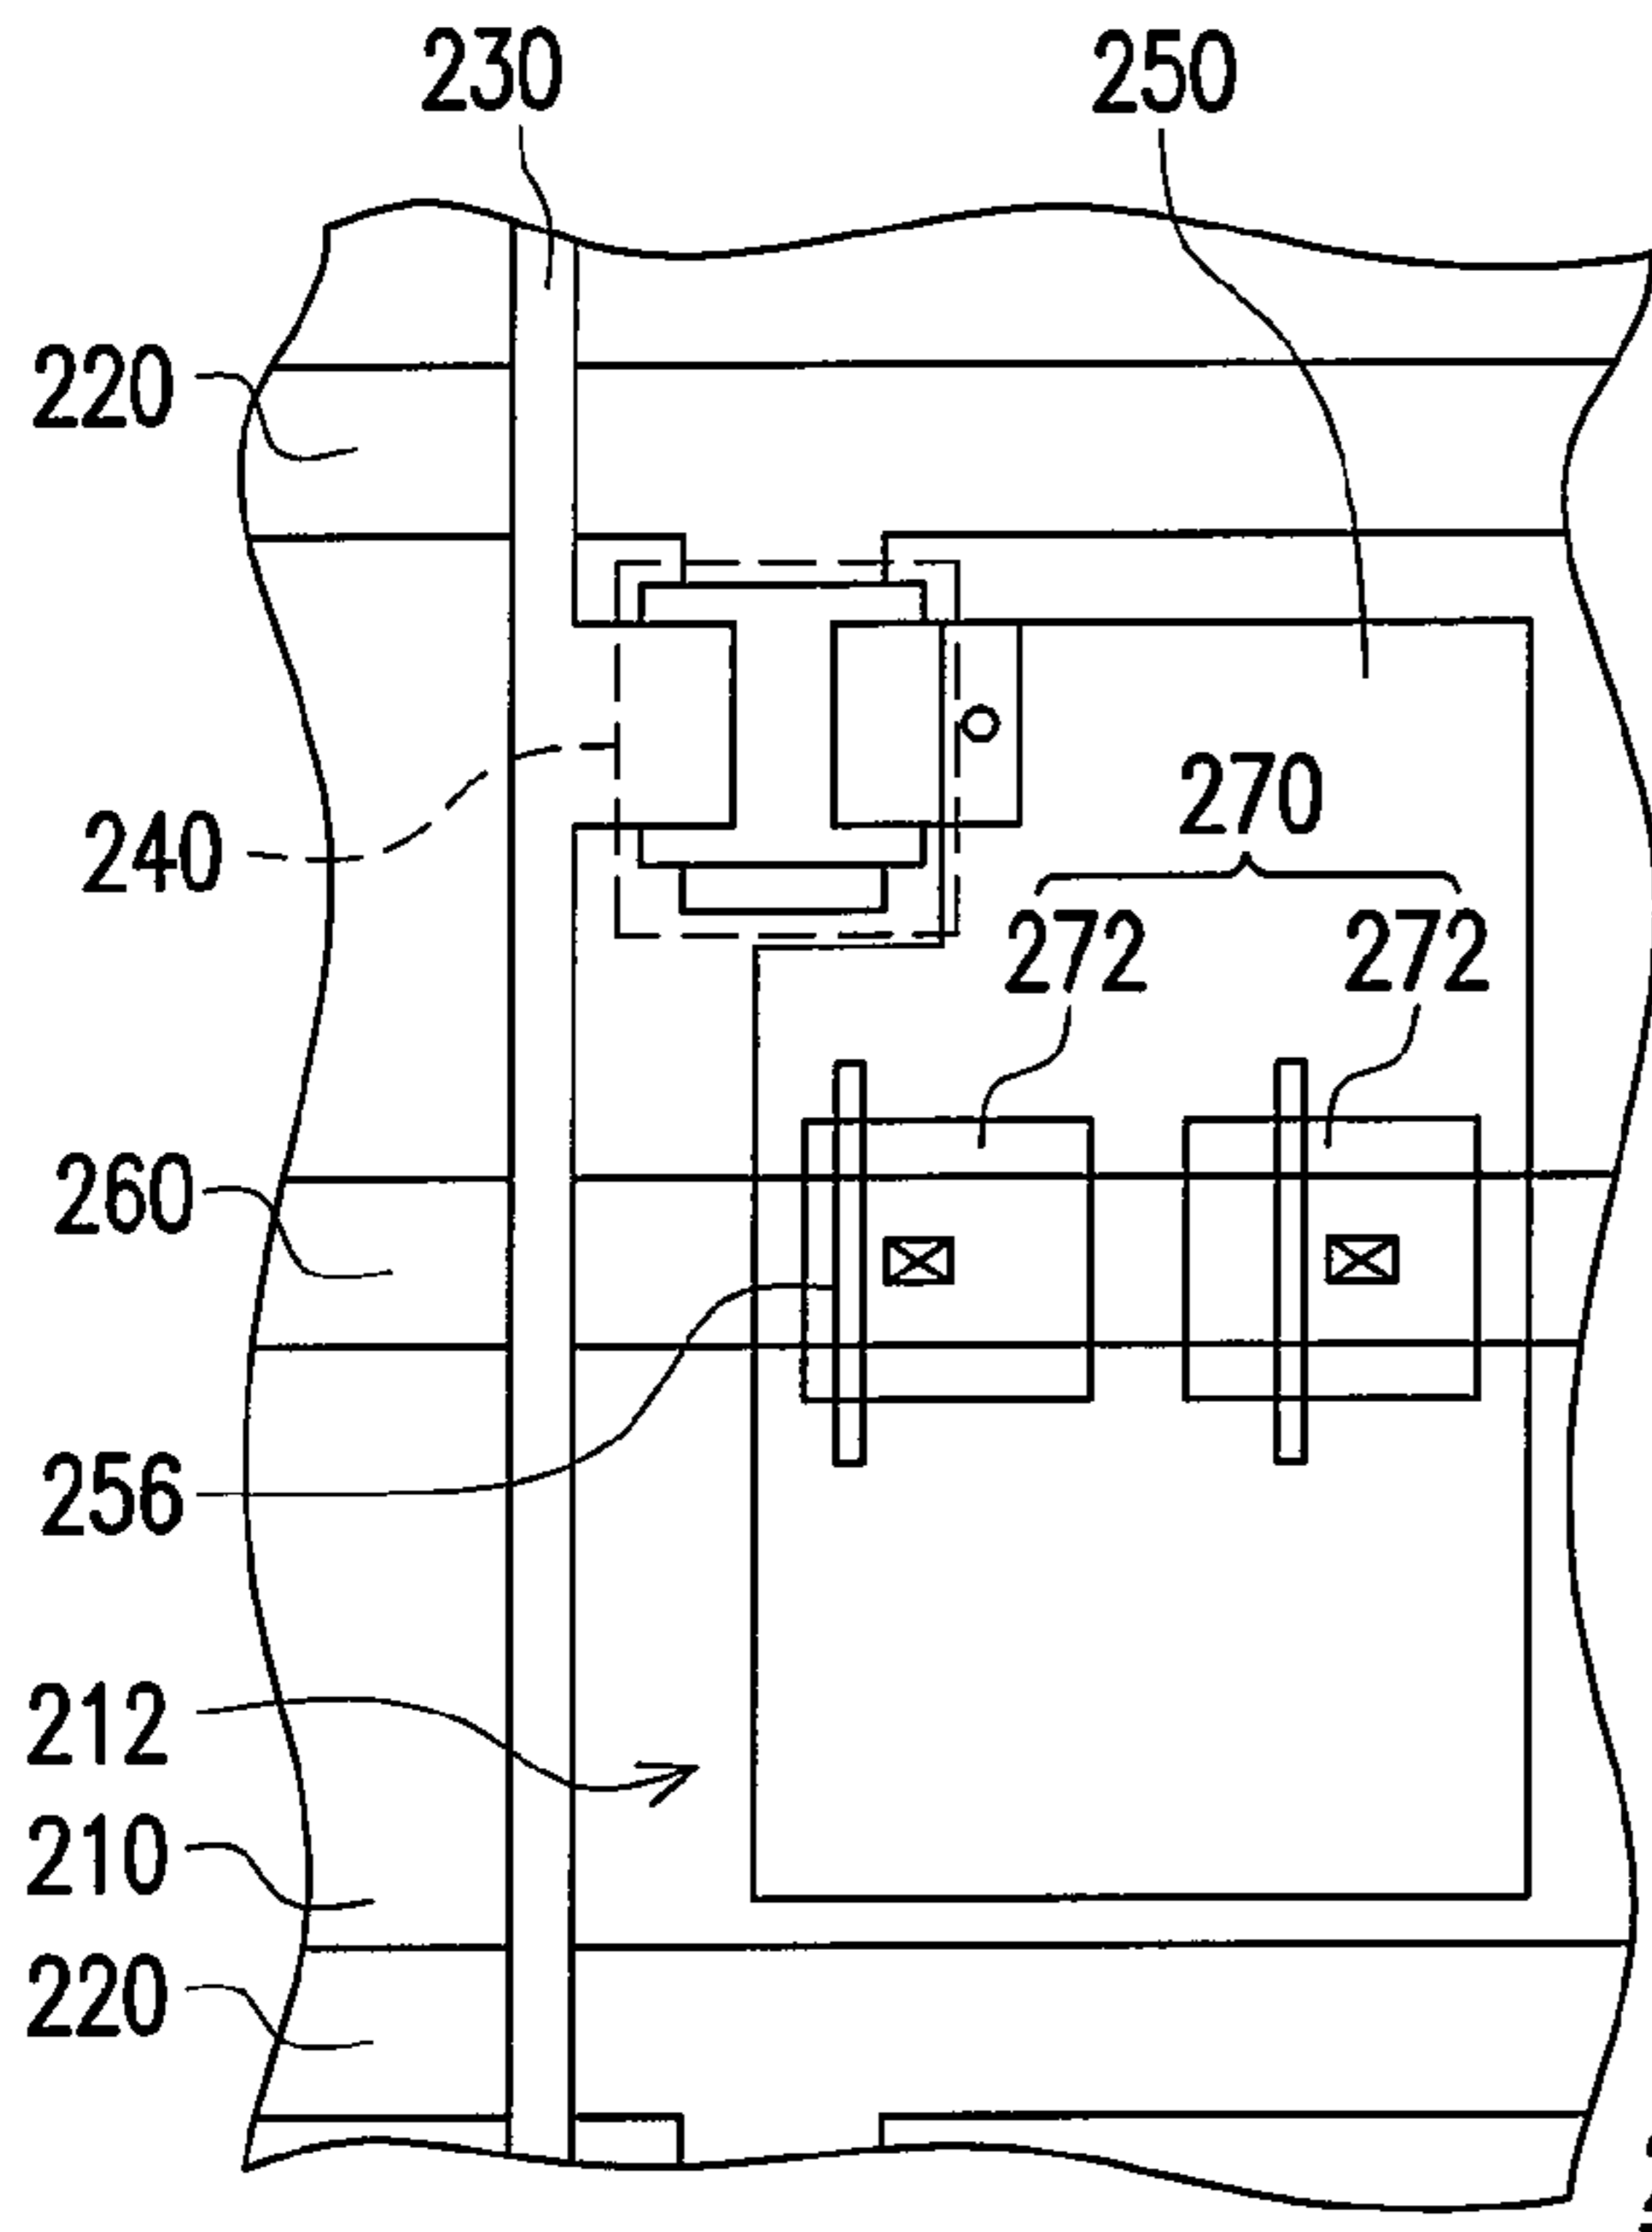
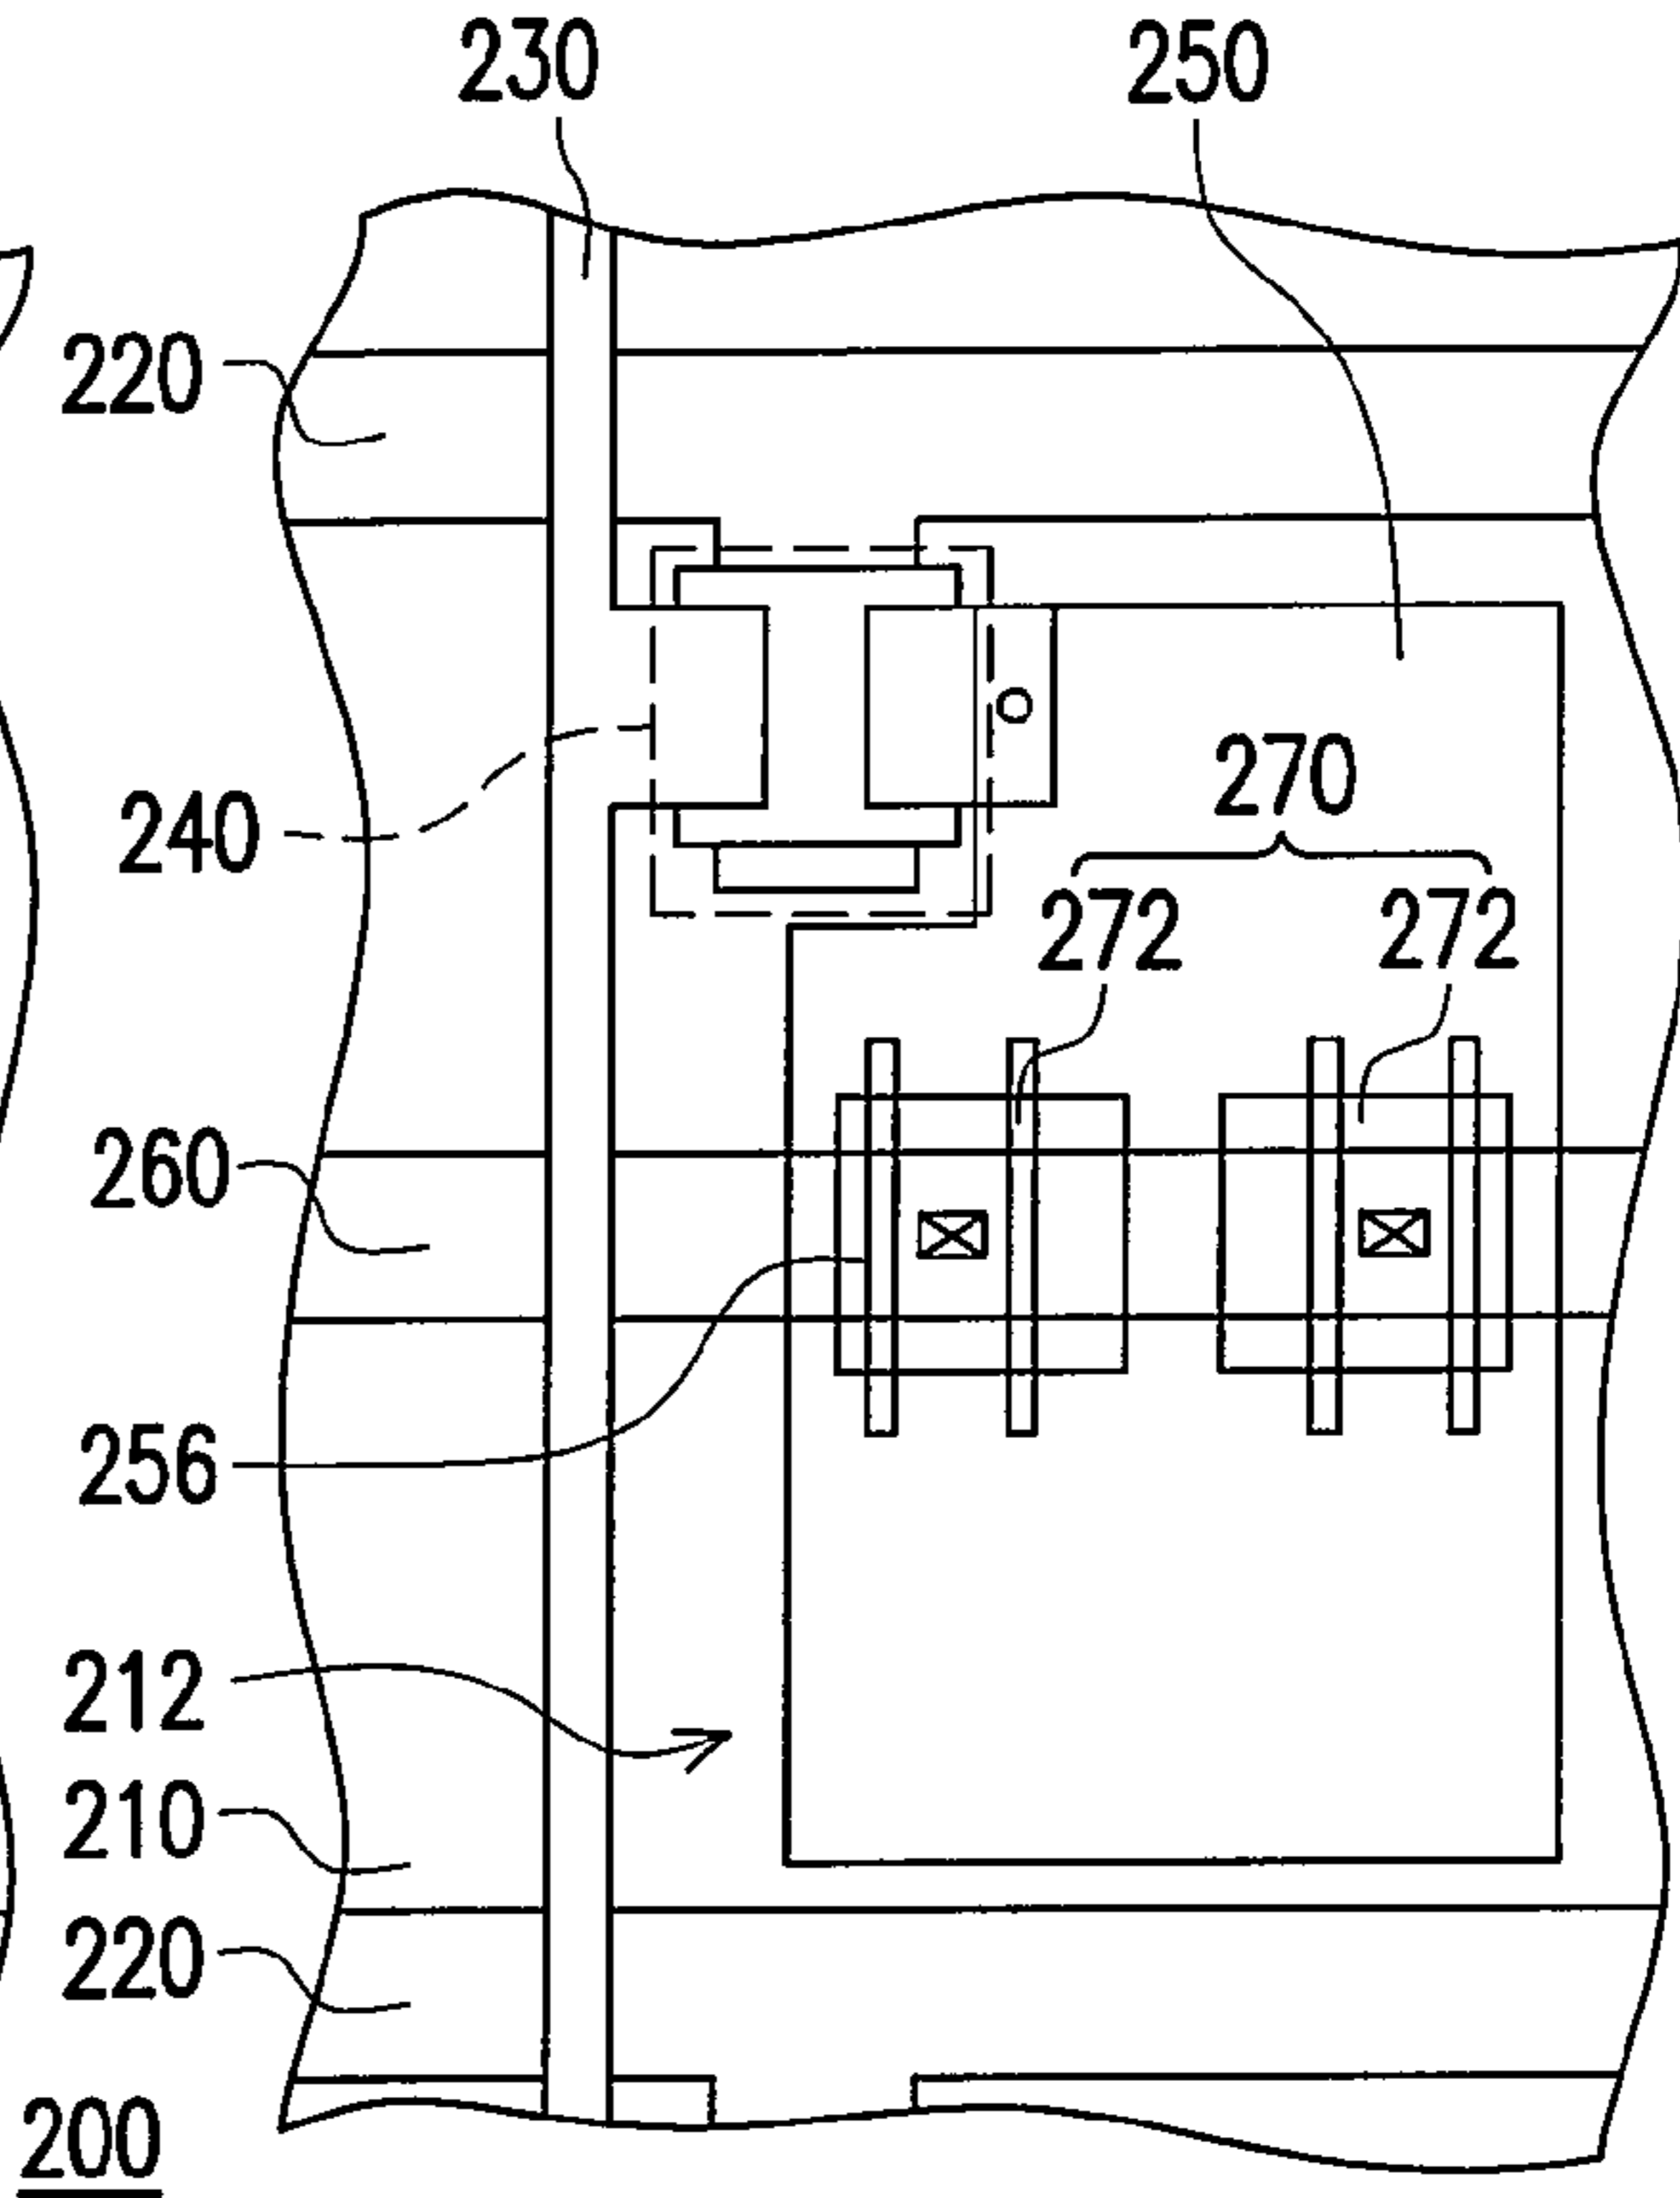
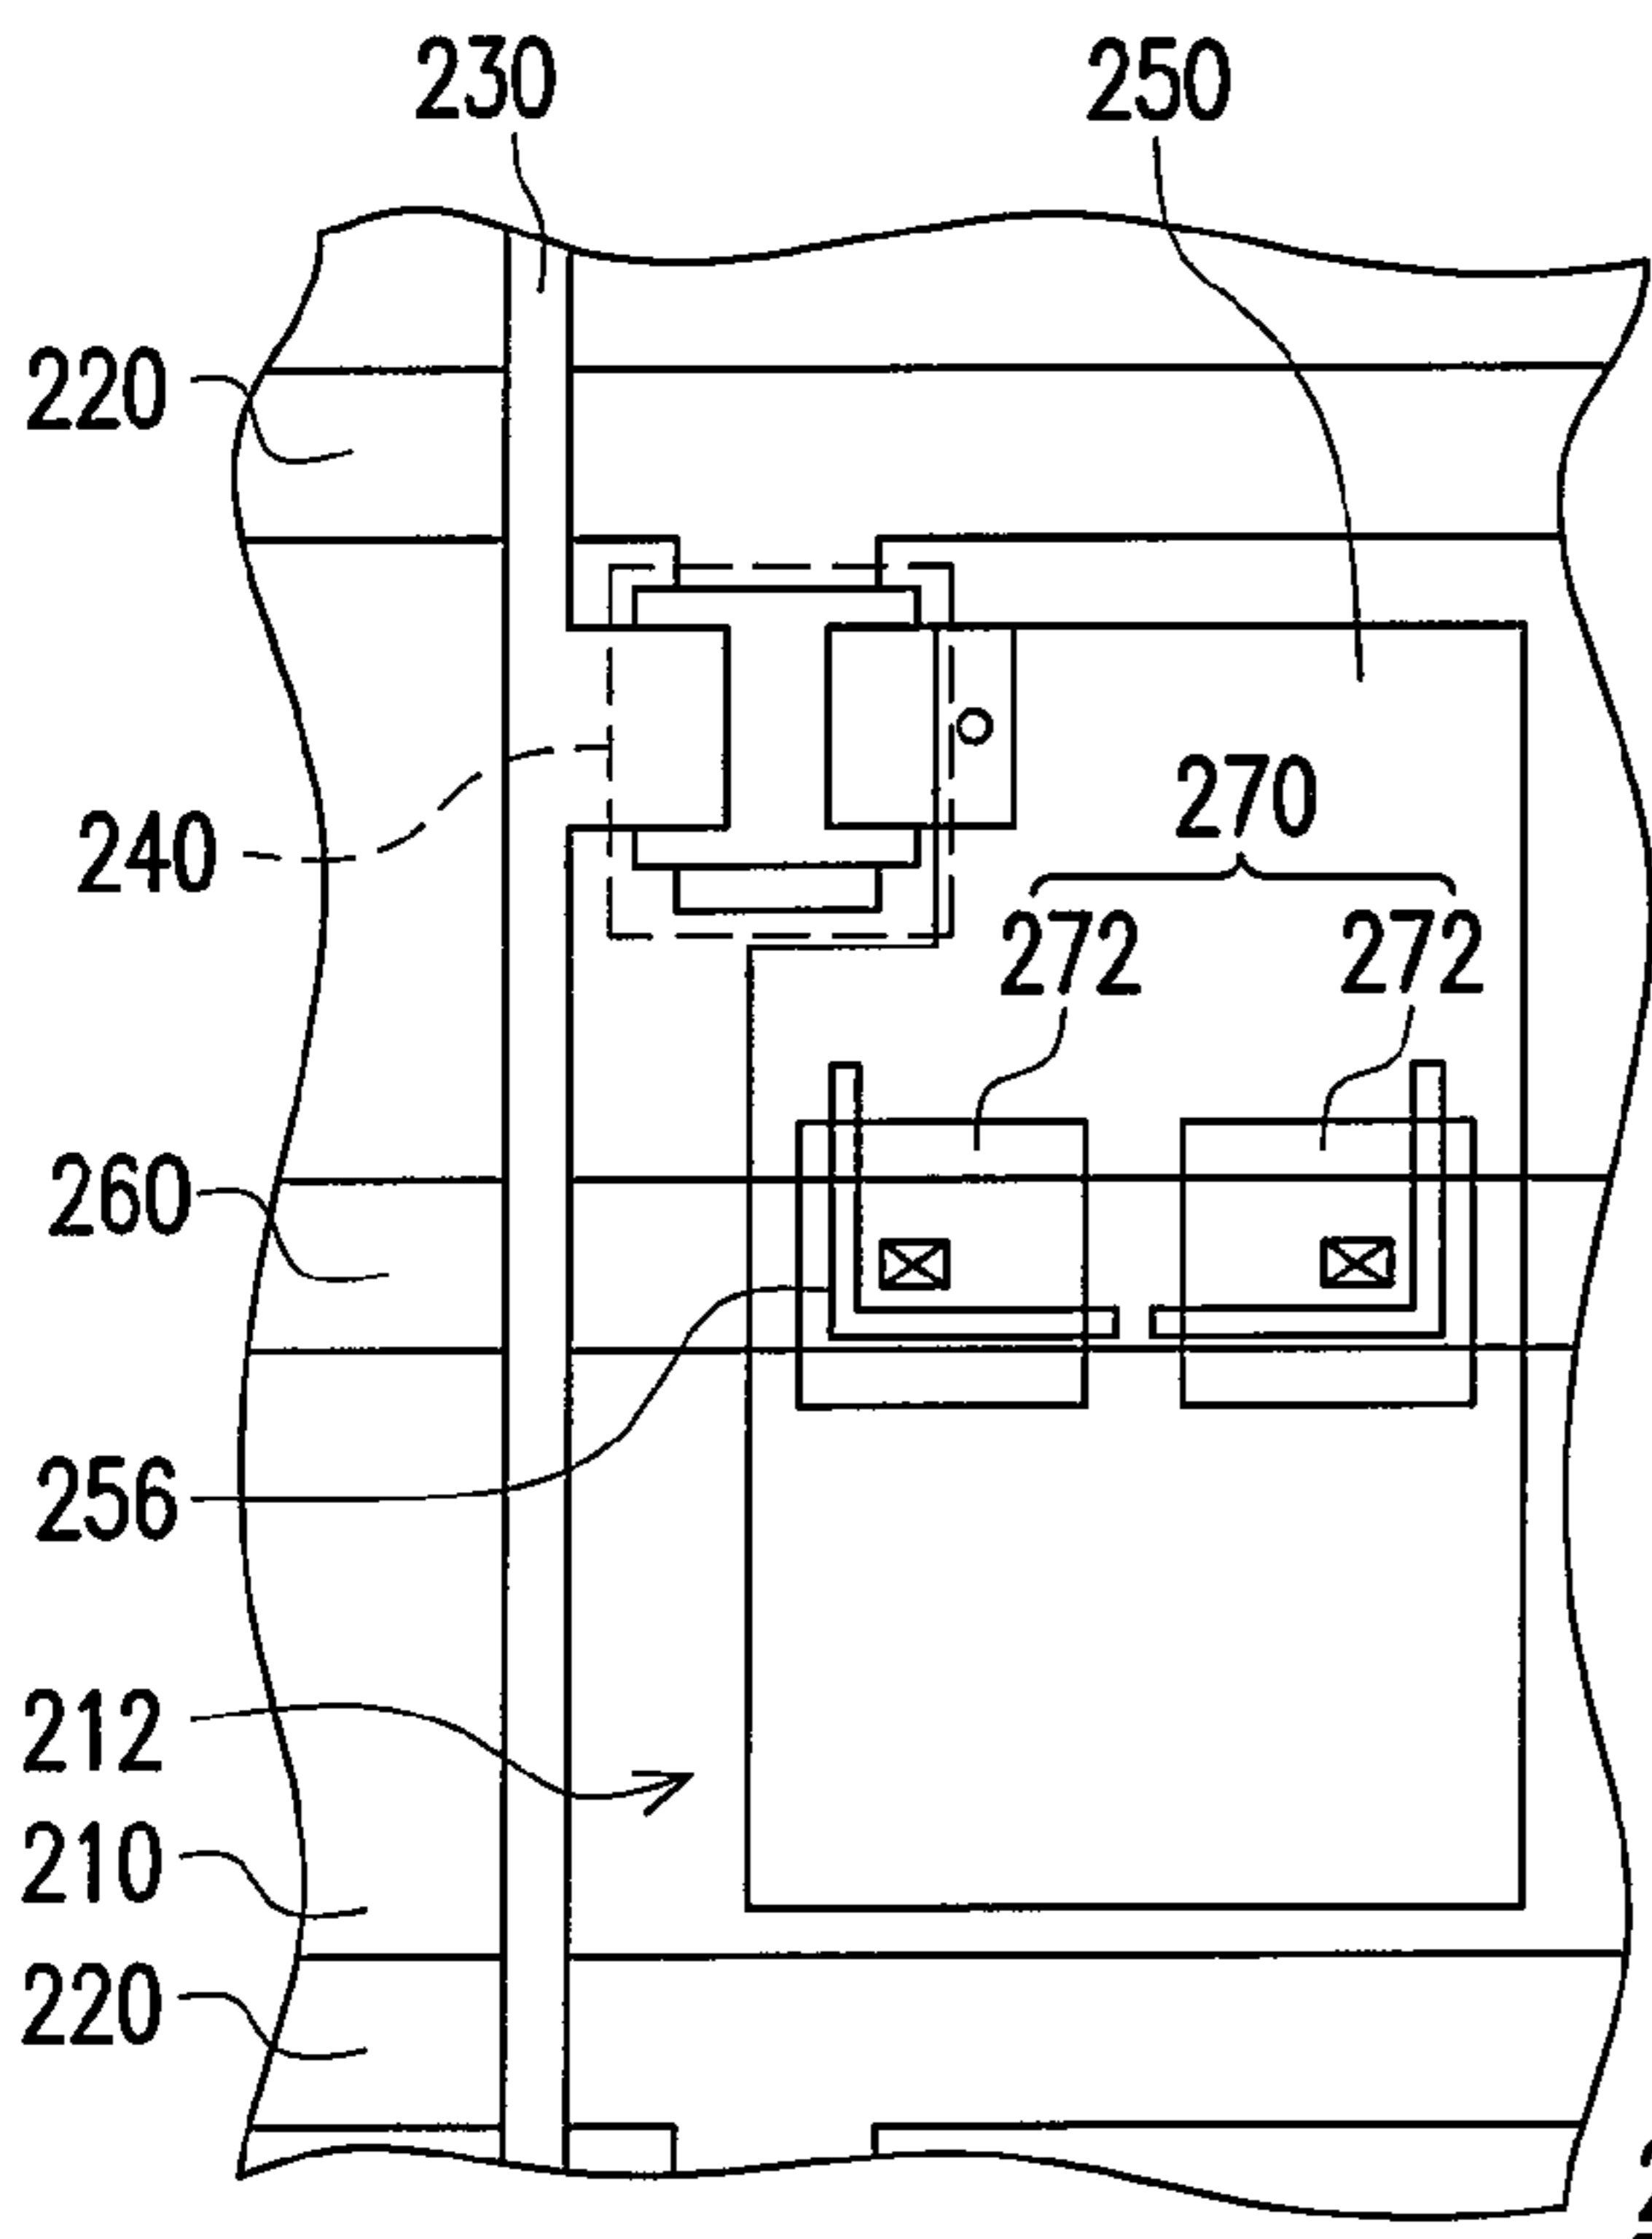
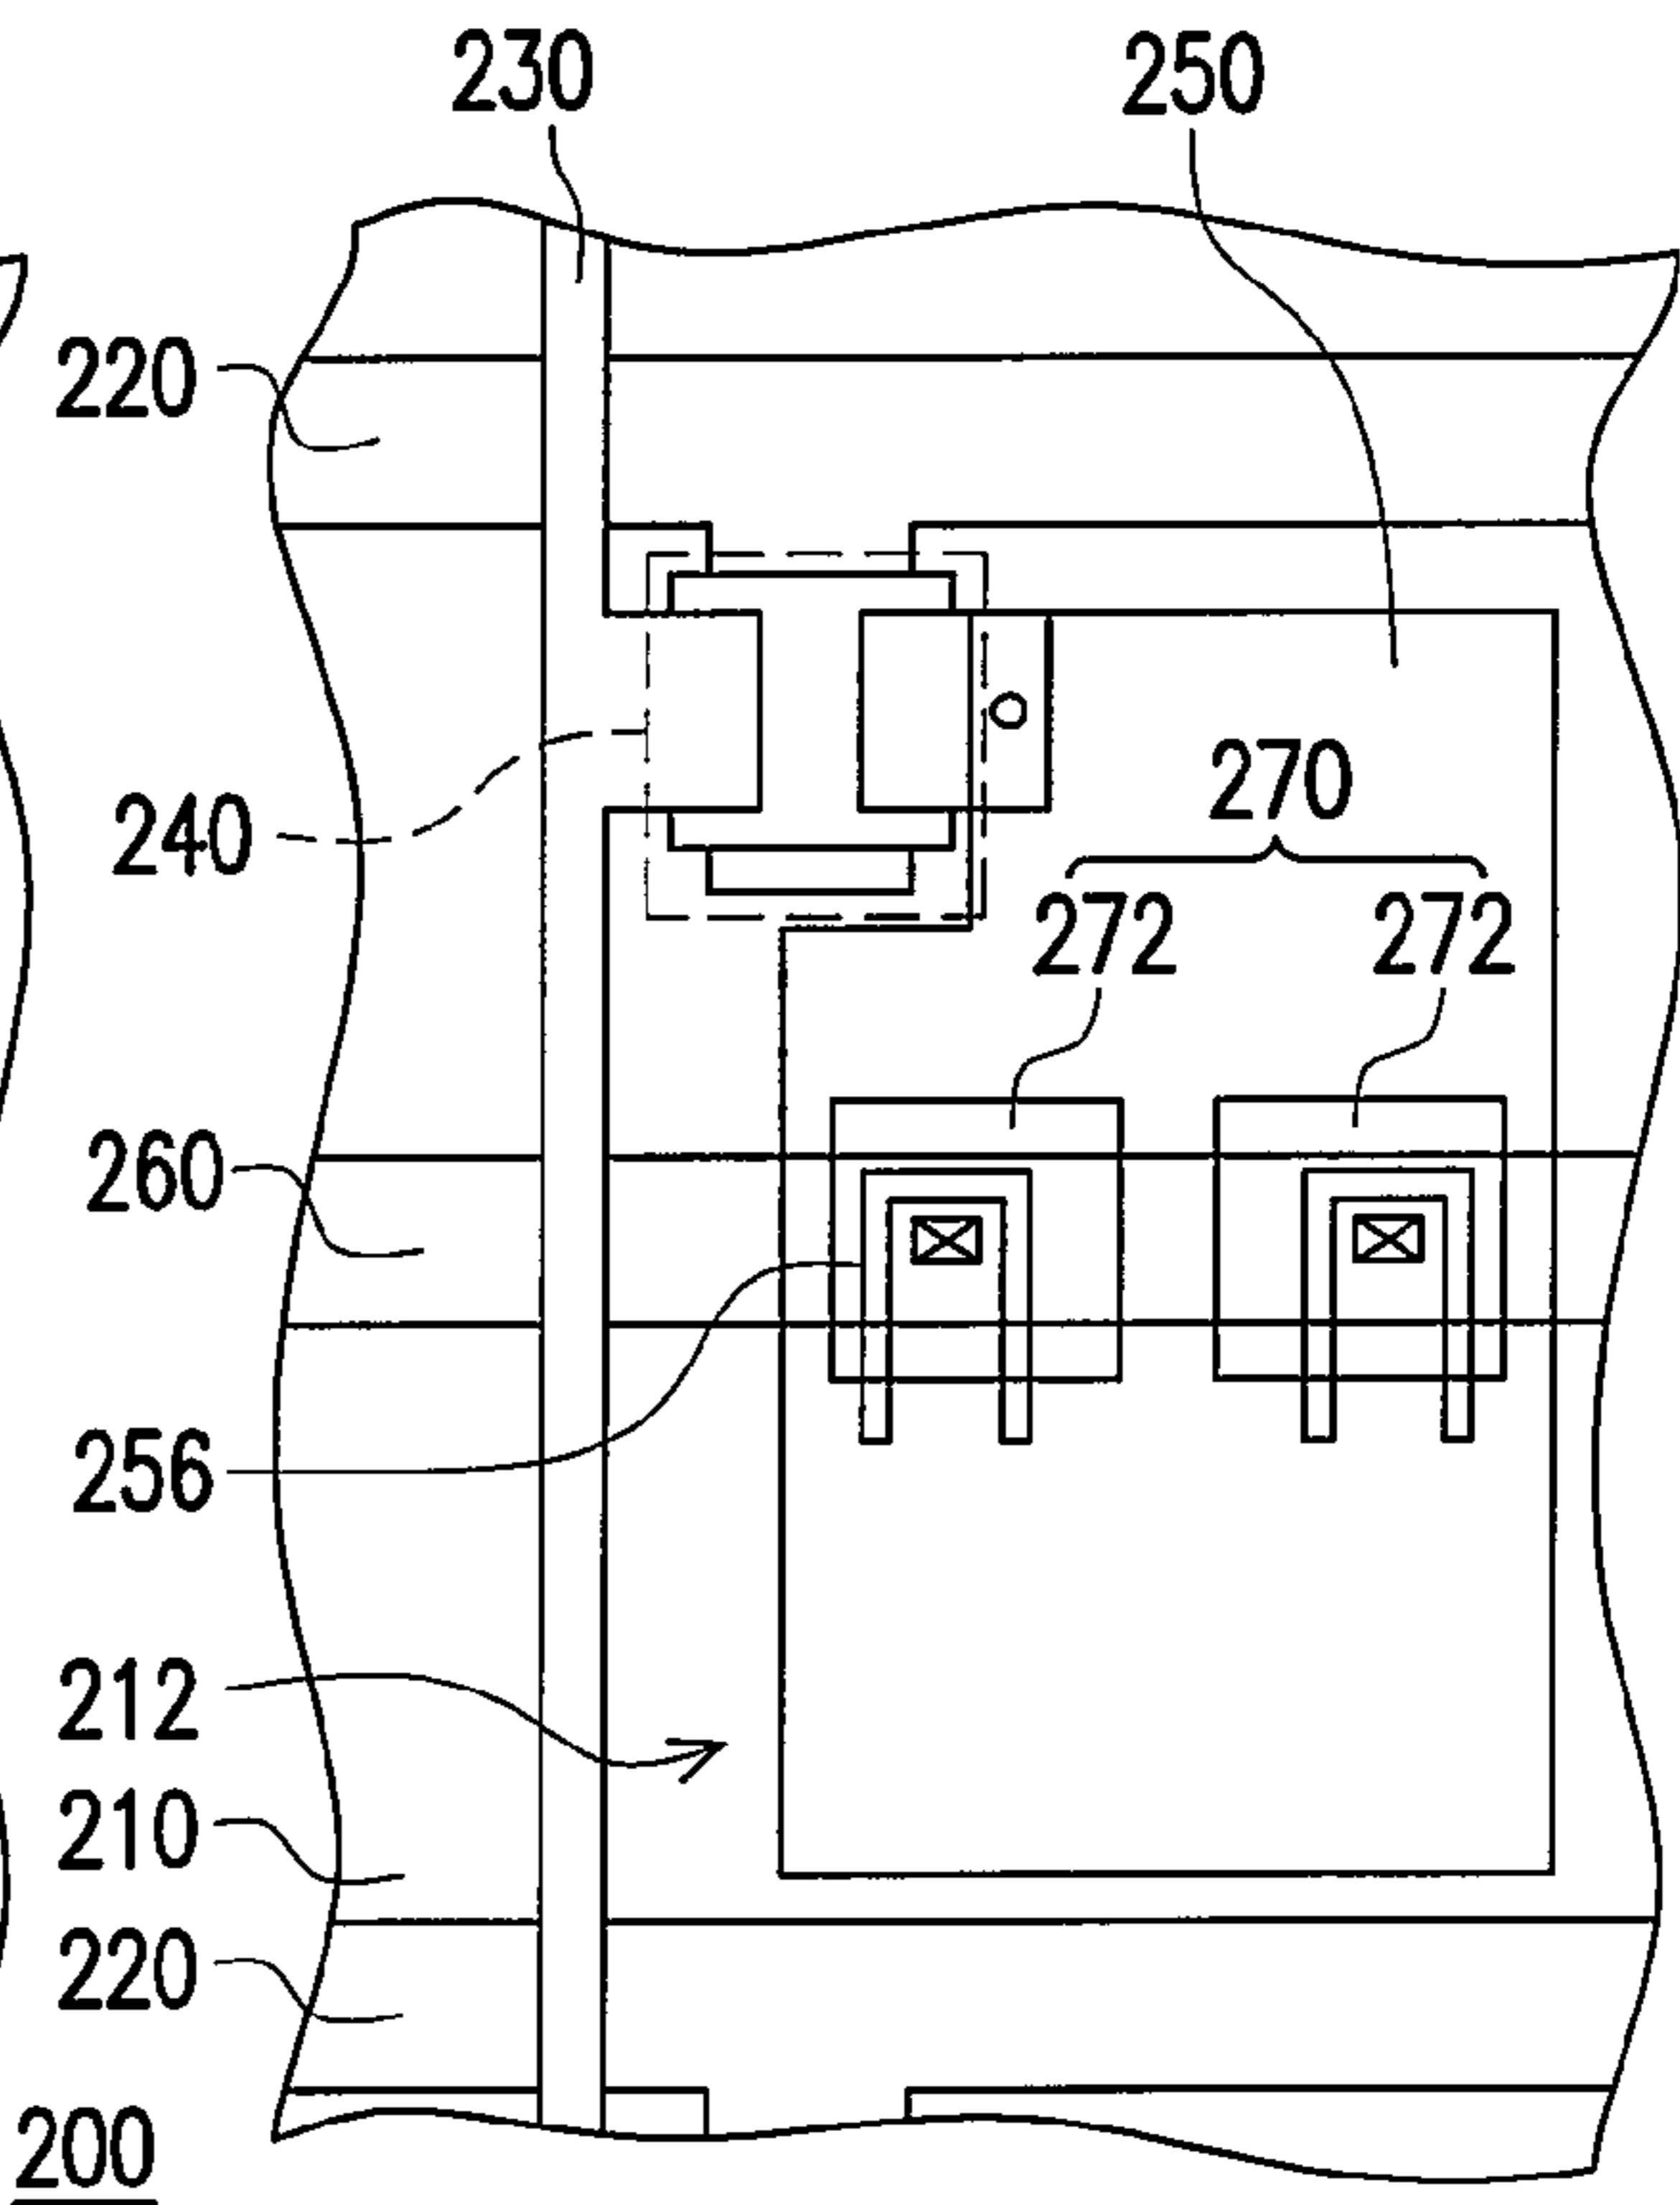
FIGS. 9A through 9D are top views showing different types of thin film transistor array substrates according to another preferred embodiment of the present invention.

FIGS. **9A** through **9D** are top views showing different types of thin film transistor array substrates according to another preferred embodiment of the present invention. The thin film transistor array substrate of the present embodiment is mostly identical to the one shown in FIG. **3**. One major difference is that one or more openings **256** are formed in each pixel electrode **250** when the pixel electrodes **250** are formed. The openings **256** are disposed around the contact region between each sub contact pad **272** and one of the pixel electrodes **250**. For example, a straight line opening **256** (shown in FIG. **9A**), two straight line openings **256** (shown in FIG. **9B**), an L-shaped opening (shown in FIG. **9C**) or a U-shaped opening **256** (shown in FIG. **9D**) is formed over the pixel electrode **250** corresponding to each sub contact pad **272**. With an opening **256** formed over the every pixel electrode **250**, a portion area of any one pixel electrode **250** can be readily removed to connect the ends of the opening **256**. Hence, an opening similar to the opening **252** that encircles the contact **292** as shown in FIG. **5** can be produced when there is a particle (or defect) between a sub-upper electrode **272** and one of the common lines **260**. In the present embodiment, the method of removing a portion area of the pixel electrode **250** includes performing a laser ablation process.

As shown in FIGS. **9A** through **9D**, a portion area of the opening **256** is disposed above the area occupied by the sub-upper electrode **272** while the remaining portion area of the opening **256** is disposed outside the area occupied by the sub-upper electrode **272**. In other words, the openings **256** also cover a region outside the upper electrode **272** to simplify and speed the repairing operation. In addition, anyone familiar with the technology may notice that there is no particular restriction on the dimension of each opening **256**.
