(12) **United States Patent**
Lai

(10) **Patent No.:** **US 7,436,466 B2**
(45) **Date of Patent:** **Oct. 14, 2008**

(54) **REPAIRING METHOD OF A THIN FILM TRANSISTOR ARRAY SUBSTRATE**

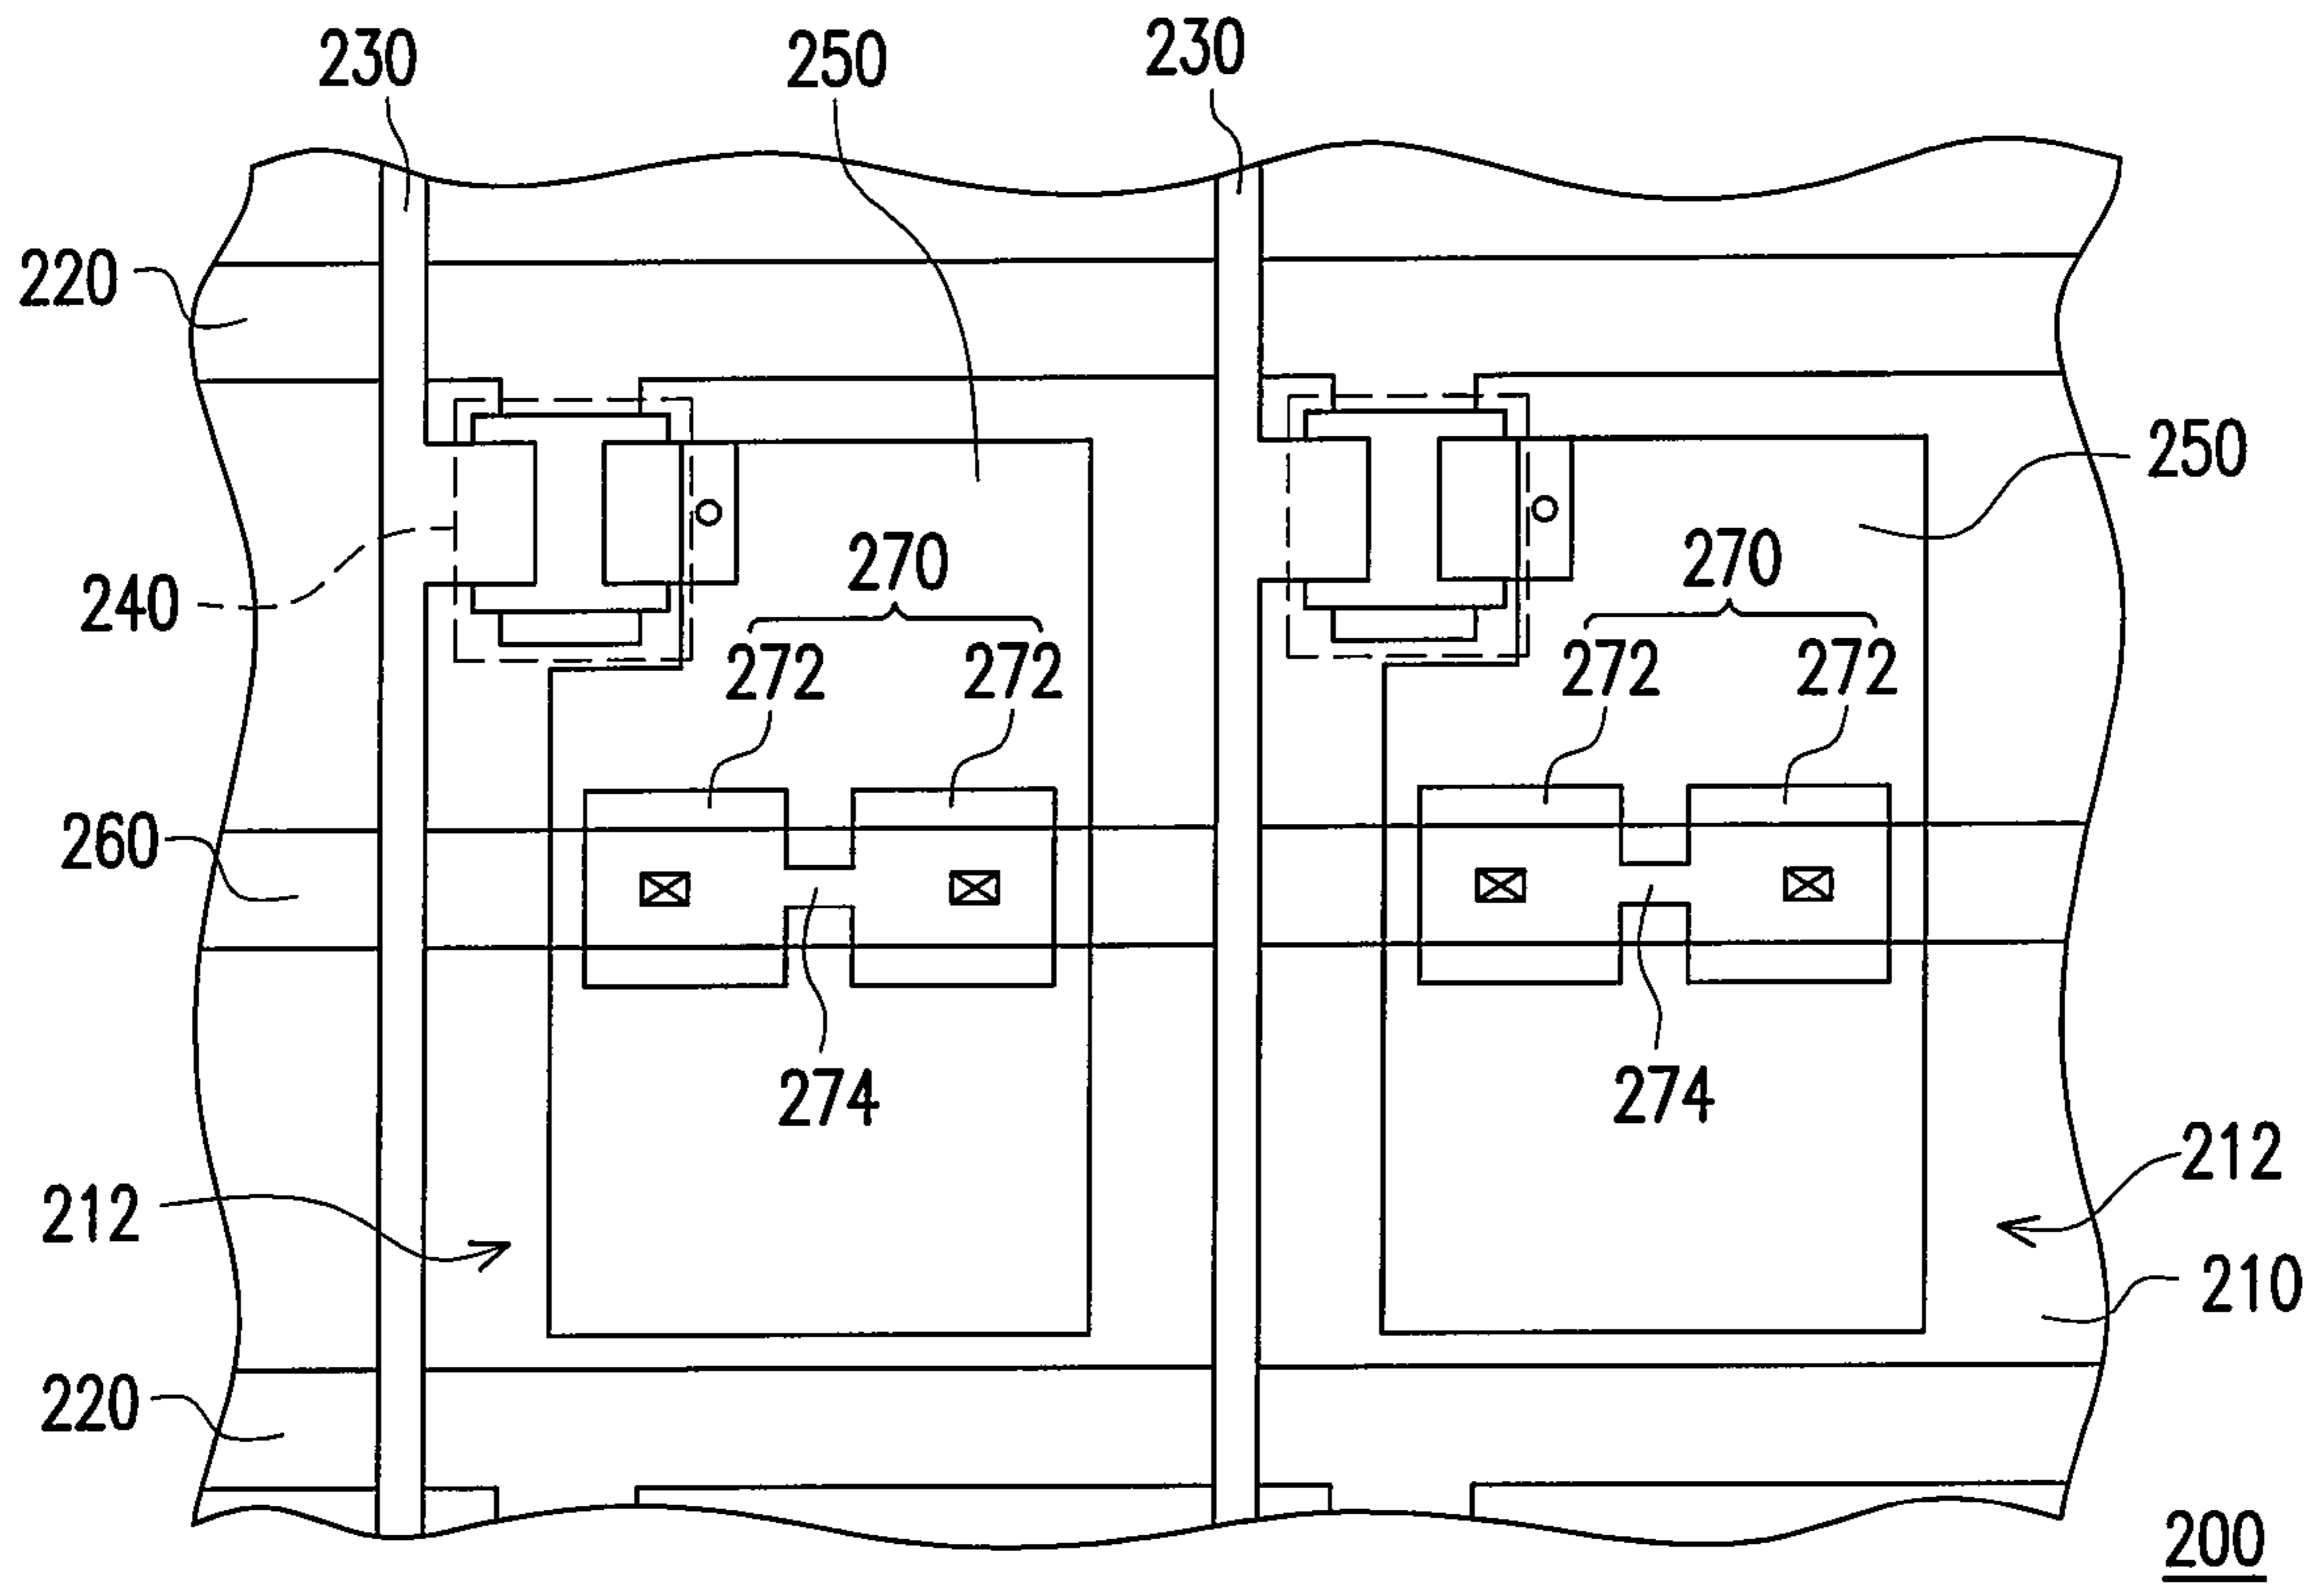
FIG. 10 is a top view of a thin film transistor array substrate according to another preferred embodiment of the present invention.

FIG. **10** is a top view of a thin film transistor array substrate according to another preferred embodiment of the present invention. FIG. **11** is a top view of the thin film transistor array substrate in FIG. **10** after a laser repairing operation. In the present embodiment, the thin film transistor array substrate has a structure mostly similar to the one shown in FIG. **3**. One major difference of the present embodiment is that the sub-upper electrodes **272** underneath each pixel electrode **250** are mutually connected through a neck portion **274** that can be severed in a repair operation.

In the presence of a particle **20** (or defect) between one of the sub-upper electrode **270** and one of the common lines **260**, a leakage between the sub-upper electrode **272a** and the common line **260** may occur. To repair such defect, a portion area of the pixel electrode **250** corresponding to the sub-upper electrode **272a** of the defective capacitor is removed. Thereafter, the neck portion **274** connecting with the sub-upper electrode **272a** of the defective capacitor **272a** is cut so that the sub-upper electrode **272a** and the corresponding pixel electrode **250** of the defective capacitor are electrically isolated. In the present embodiment, a portion area of the pixel electrode **250** is removed to form an opening **252**. The opening **252** is located around the contact area between the sub-upper electrode **272a** and the corresponding pixel electrode of the defective capacitor. Furthermore, the method of removing a portion area of the pixel electrode **250** includes performing a laser ablation and the method of cutting the neck portion **274** includes performing a laser cutting operation. After cutting the neck portion **274** connecting the sub-upper electrode **272a** of the defective capacitor, the sub-upper electrode **272a** and the corresponding pixel electrode **250** are electrically isolated to achieve the goal of repairing a thin film transistor array substrate.

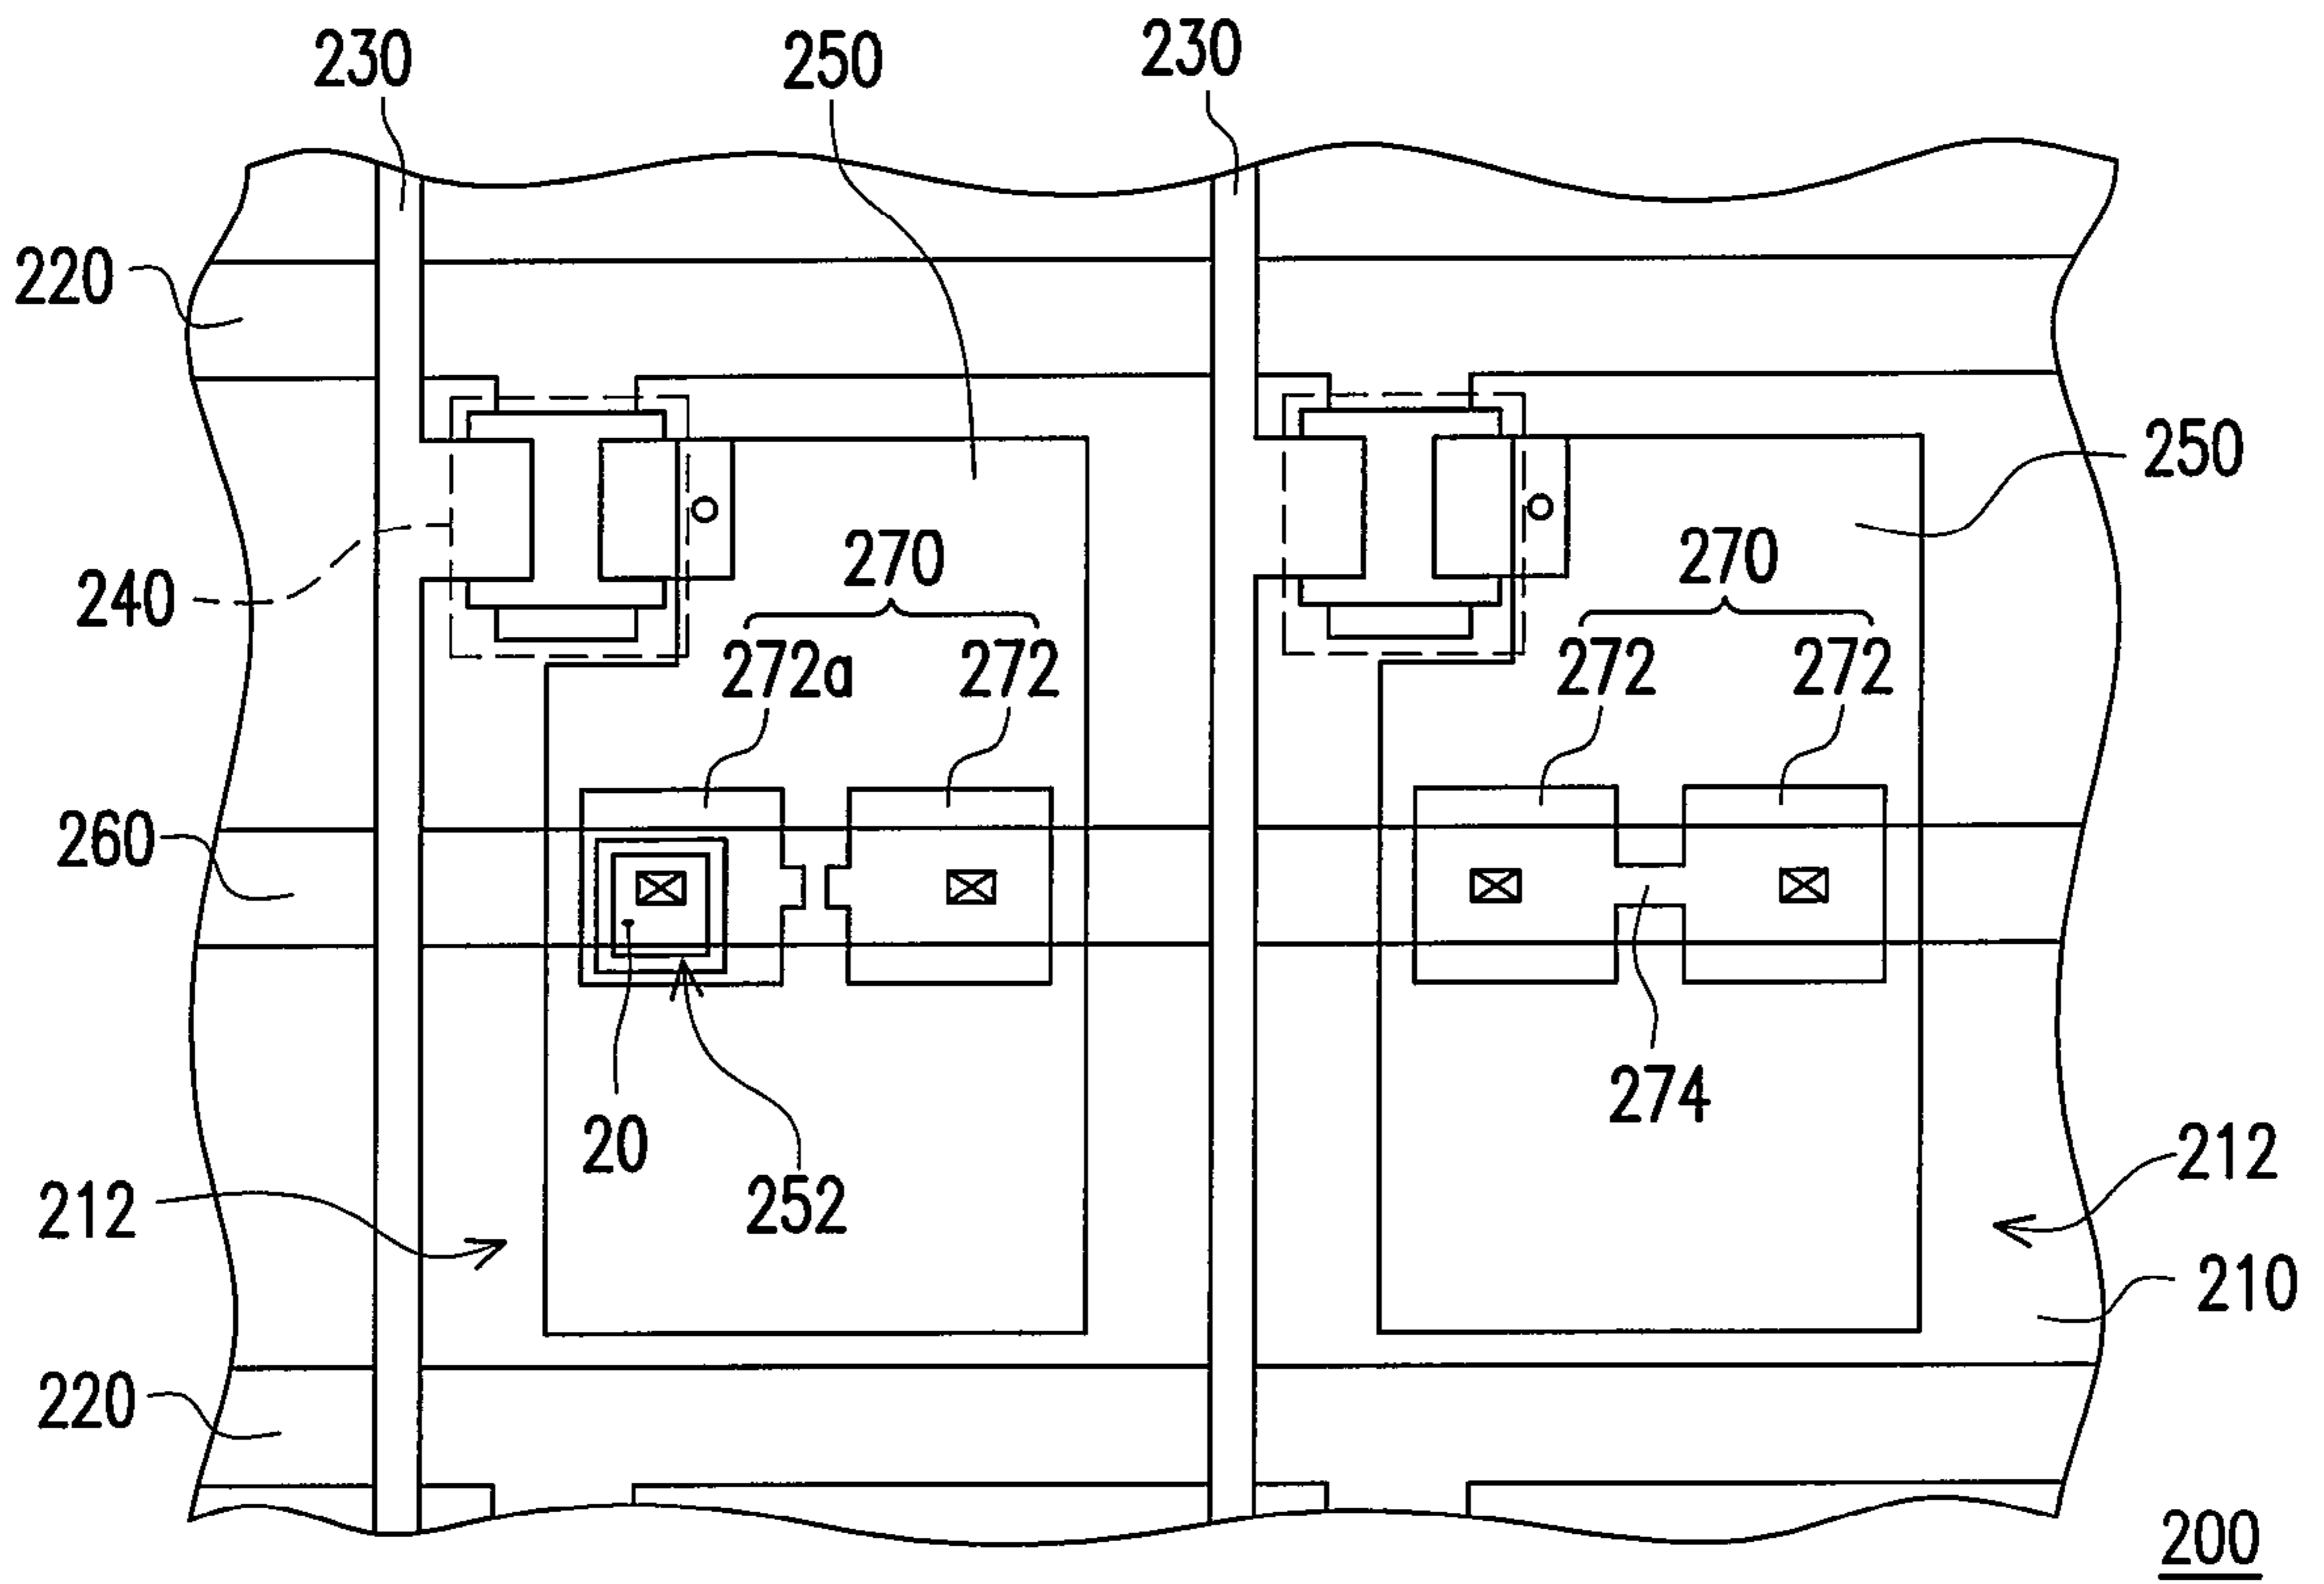
FIG. 11 is a top view of the thin film transistor array substrate in FIG. 10 after a laser repairing operation.

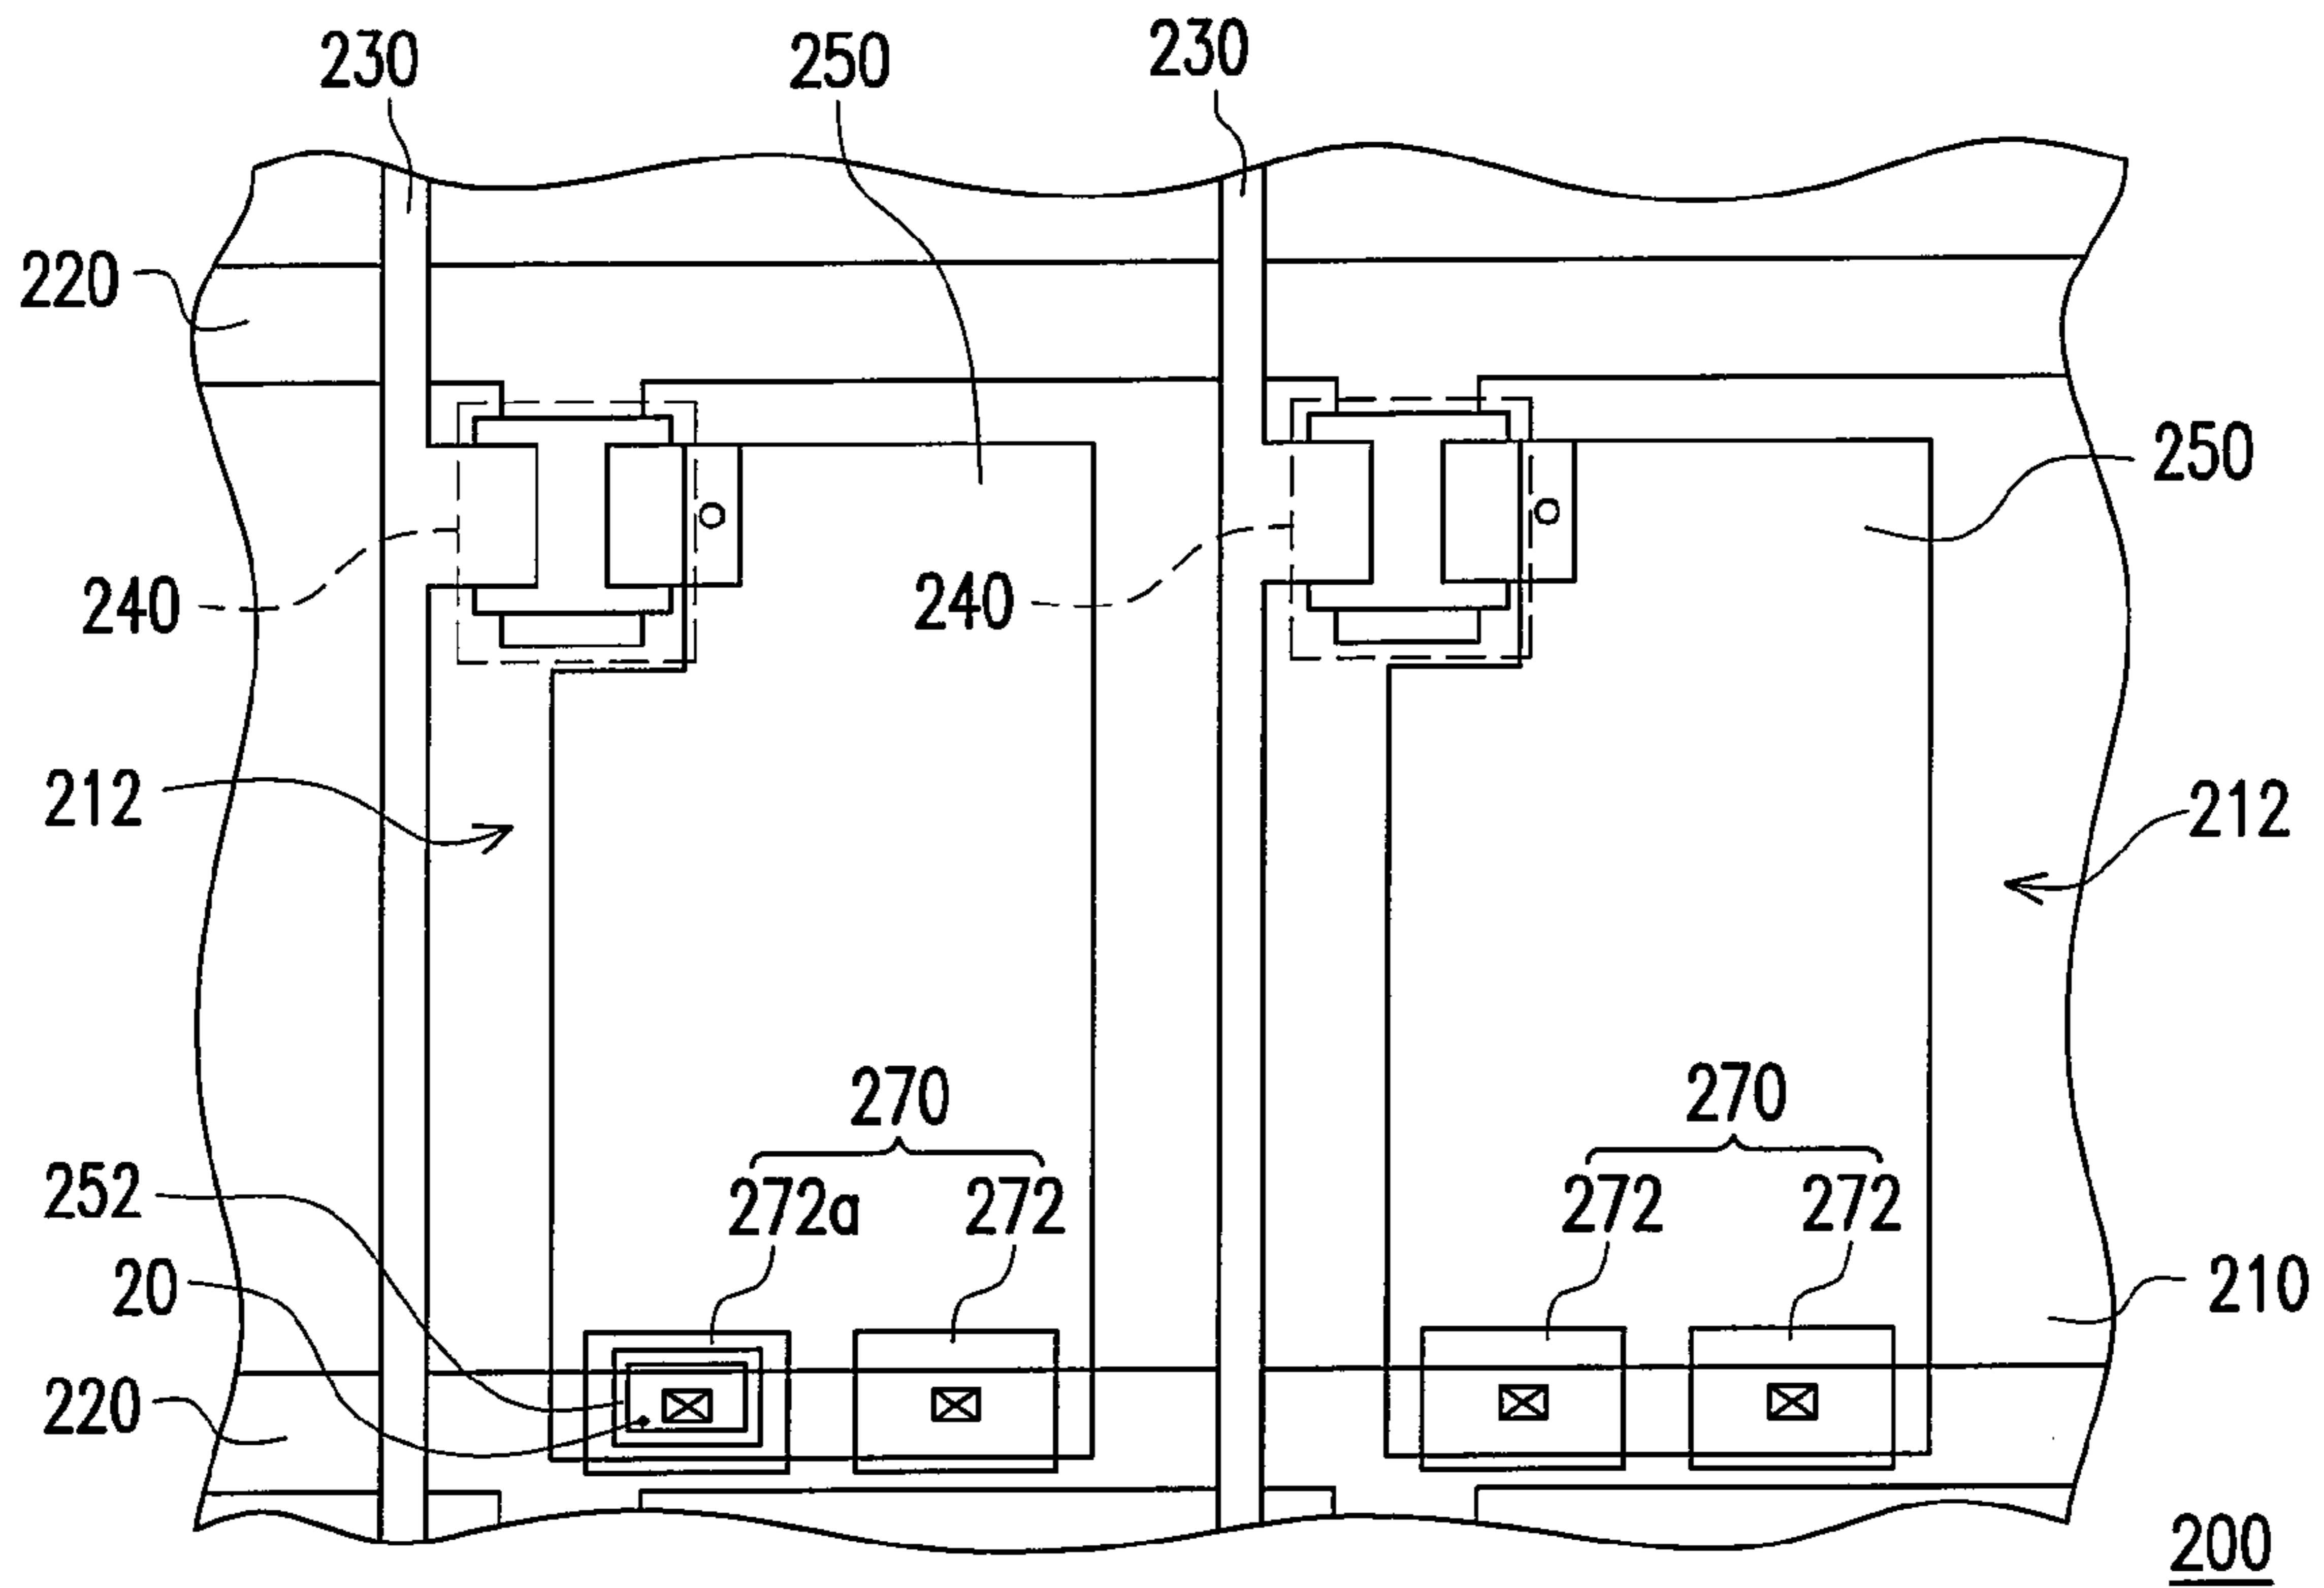
FIG. 12

FIGS. 12 and 13 are top views showing the method of repairing the scan line structure of the storage capacitor inside a thin film transistor array substrate according to the present invention.

FIGS. **12** and **13** are top views showing the method of repairing the scan line structure of the storage capacitor inside a thin film transistor array substrate according to the present invention. As shown in FIGS. **12** and **13**, the thin film transistor array substrate has a capacitor on scan line structure (Cst on gate) similar to one shown in FIG. **5**.

As shown in FIG. **12**, a portion area of each pixel electrode **250** extends into the area above one of the scan lines **220**. The patterned upper electrode **270** is disposed between the pixel electrode **250** and the corresponding scan line **220**. The patterned upper electrode **270** comprises a plurality of sub-upper electrodes **272**. The sub-upper electrode **272** and its underlying scan line **220** together form a storage capacitor inside each pixel.

As shown in FIG. 12, a portion area of the pixel electrode **250** above the sub-upper electrode **272a** of the corresponding defective capacitor is removed to form an opening **252**. By forming the opening **252** in the pixel electrode **250**, the sub-upper electrode **272a** and the corresponding pixel electrode **250** of the defective capacitor are electrically isolated. The method of removing a portion area of the pixel electrode **250** includes laser ablation, for example.

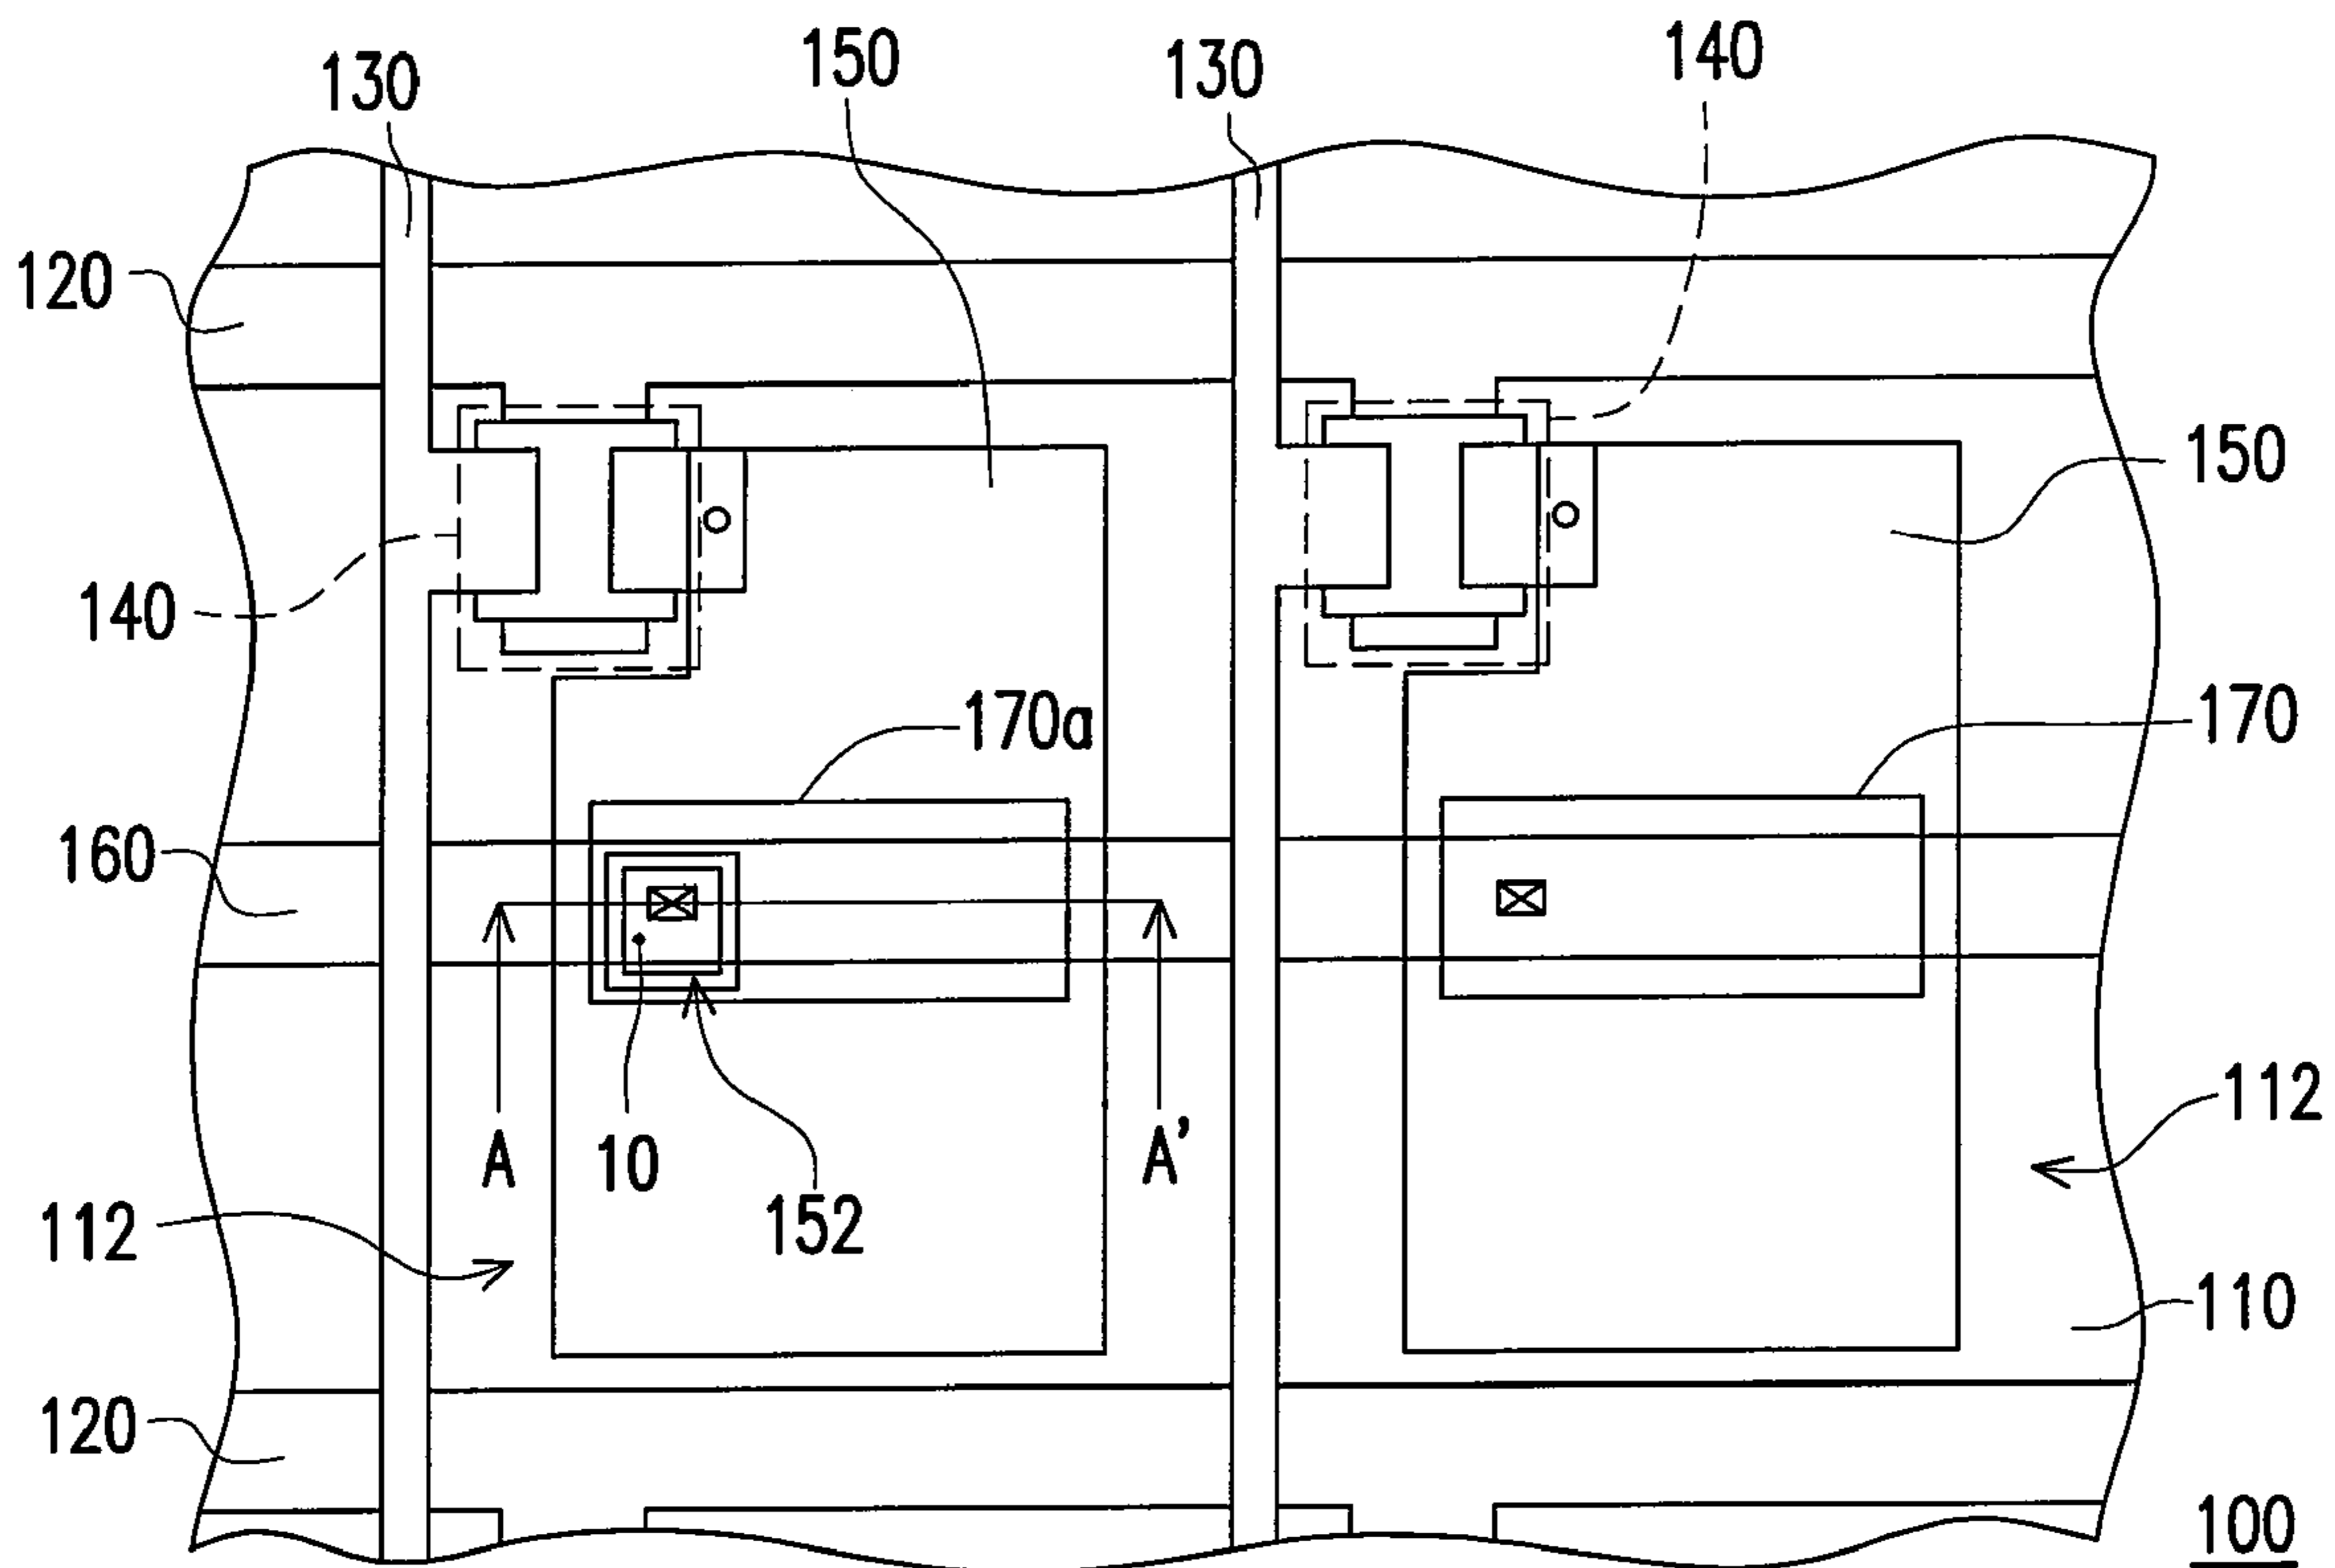
FIG. 14

FIGS. 14 and 15 are top view and cross-sectional view showing the configuration after applying the method of the present invention to repair a conventional thin film transistor array substrate.

FIGS. 14 and 15 are top view and cross-sectional view showing the configuration after applying the method of the present invention to repair a conventional thin film transistor array substrate. As shown in FIGS. 14 and 15, a conventional thin film transistor array substrate **100** has an upper electrode **170** between every pixel electrode **150** and corresponding common line **160**. In the presence of a particle (or defect) **10** between any upper electrode **170** and the corresponding common line **160**, the repairing method of the present invention can be used to rectify the problem. The repairing method of the present embodiment includes removing a portion area of the pixel electrode **150** corresponding to the upper electrode **170a** of the defective capacitor so that the upper electrode **170a** and the pixel electrode **150** of the defective capacitor is electrically isolated. Thereafter, the upper electrode **170a** and the corresponding common line **160** are welded together. Obviously, whether to weld the upper electrode **170a** and the common line **160** of the defective capacitor together can be determined by the amount of leakage in the defective capacitor.

In the present embodiment, a portion area of the pixel electrode **150** above the upper electrode **170a** of the corresponding defective capacitor is removed to form an opening **152**. The method of removing a portion area of the pixel electrode **150** includes laser ablation, for example. The opening **152** is located around the contact area between the upper electrode **170a** and the corresponding pixel electrode **150** of the defective capacitor (that is, around the contact **192**). By forming the opening **152**, the upper electrode **170a** and the

corresponding pixel electrode **150** of the defective capacitor are electrically isolated. Thereafter, the upper electrode **170a** and the corresponding common line **160** are welded together (as shown in label B), for example, by performing a laser welding process, so that the upper electrode **170a** and the common line **160** of the defective capacitor are configured at the same potential.
