(12) **United States Patent**
Lai

(10) **Patent No.:** **US 7,436,466 B2**
(45) **Date of Patent:** **Oct. 14, 2008**

(54) **REPAIRING METHOD OF A THIN FILM TRANSISTOR ARRAY SUBSTRATE**

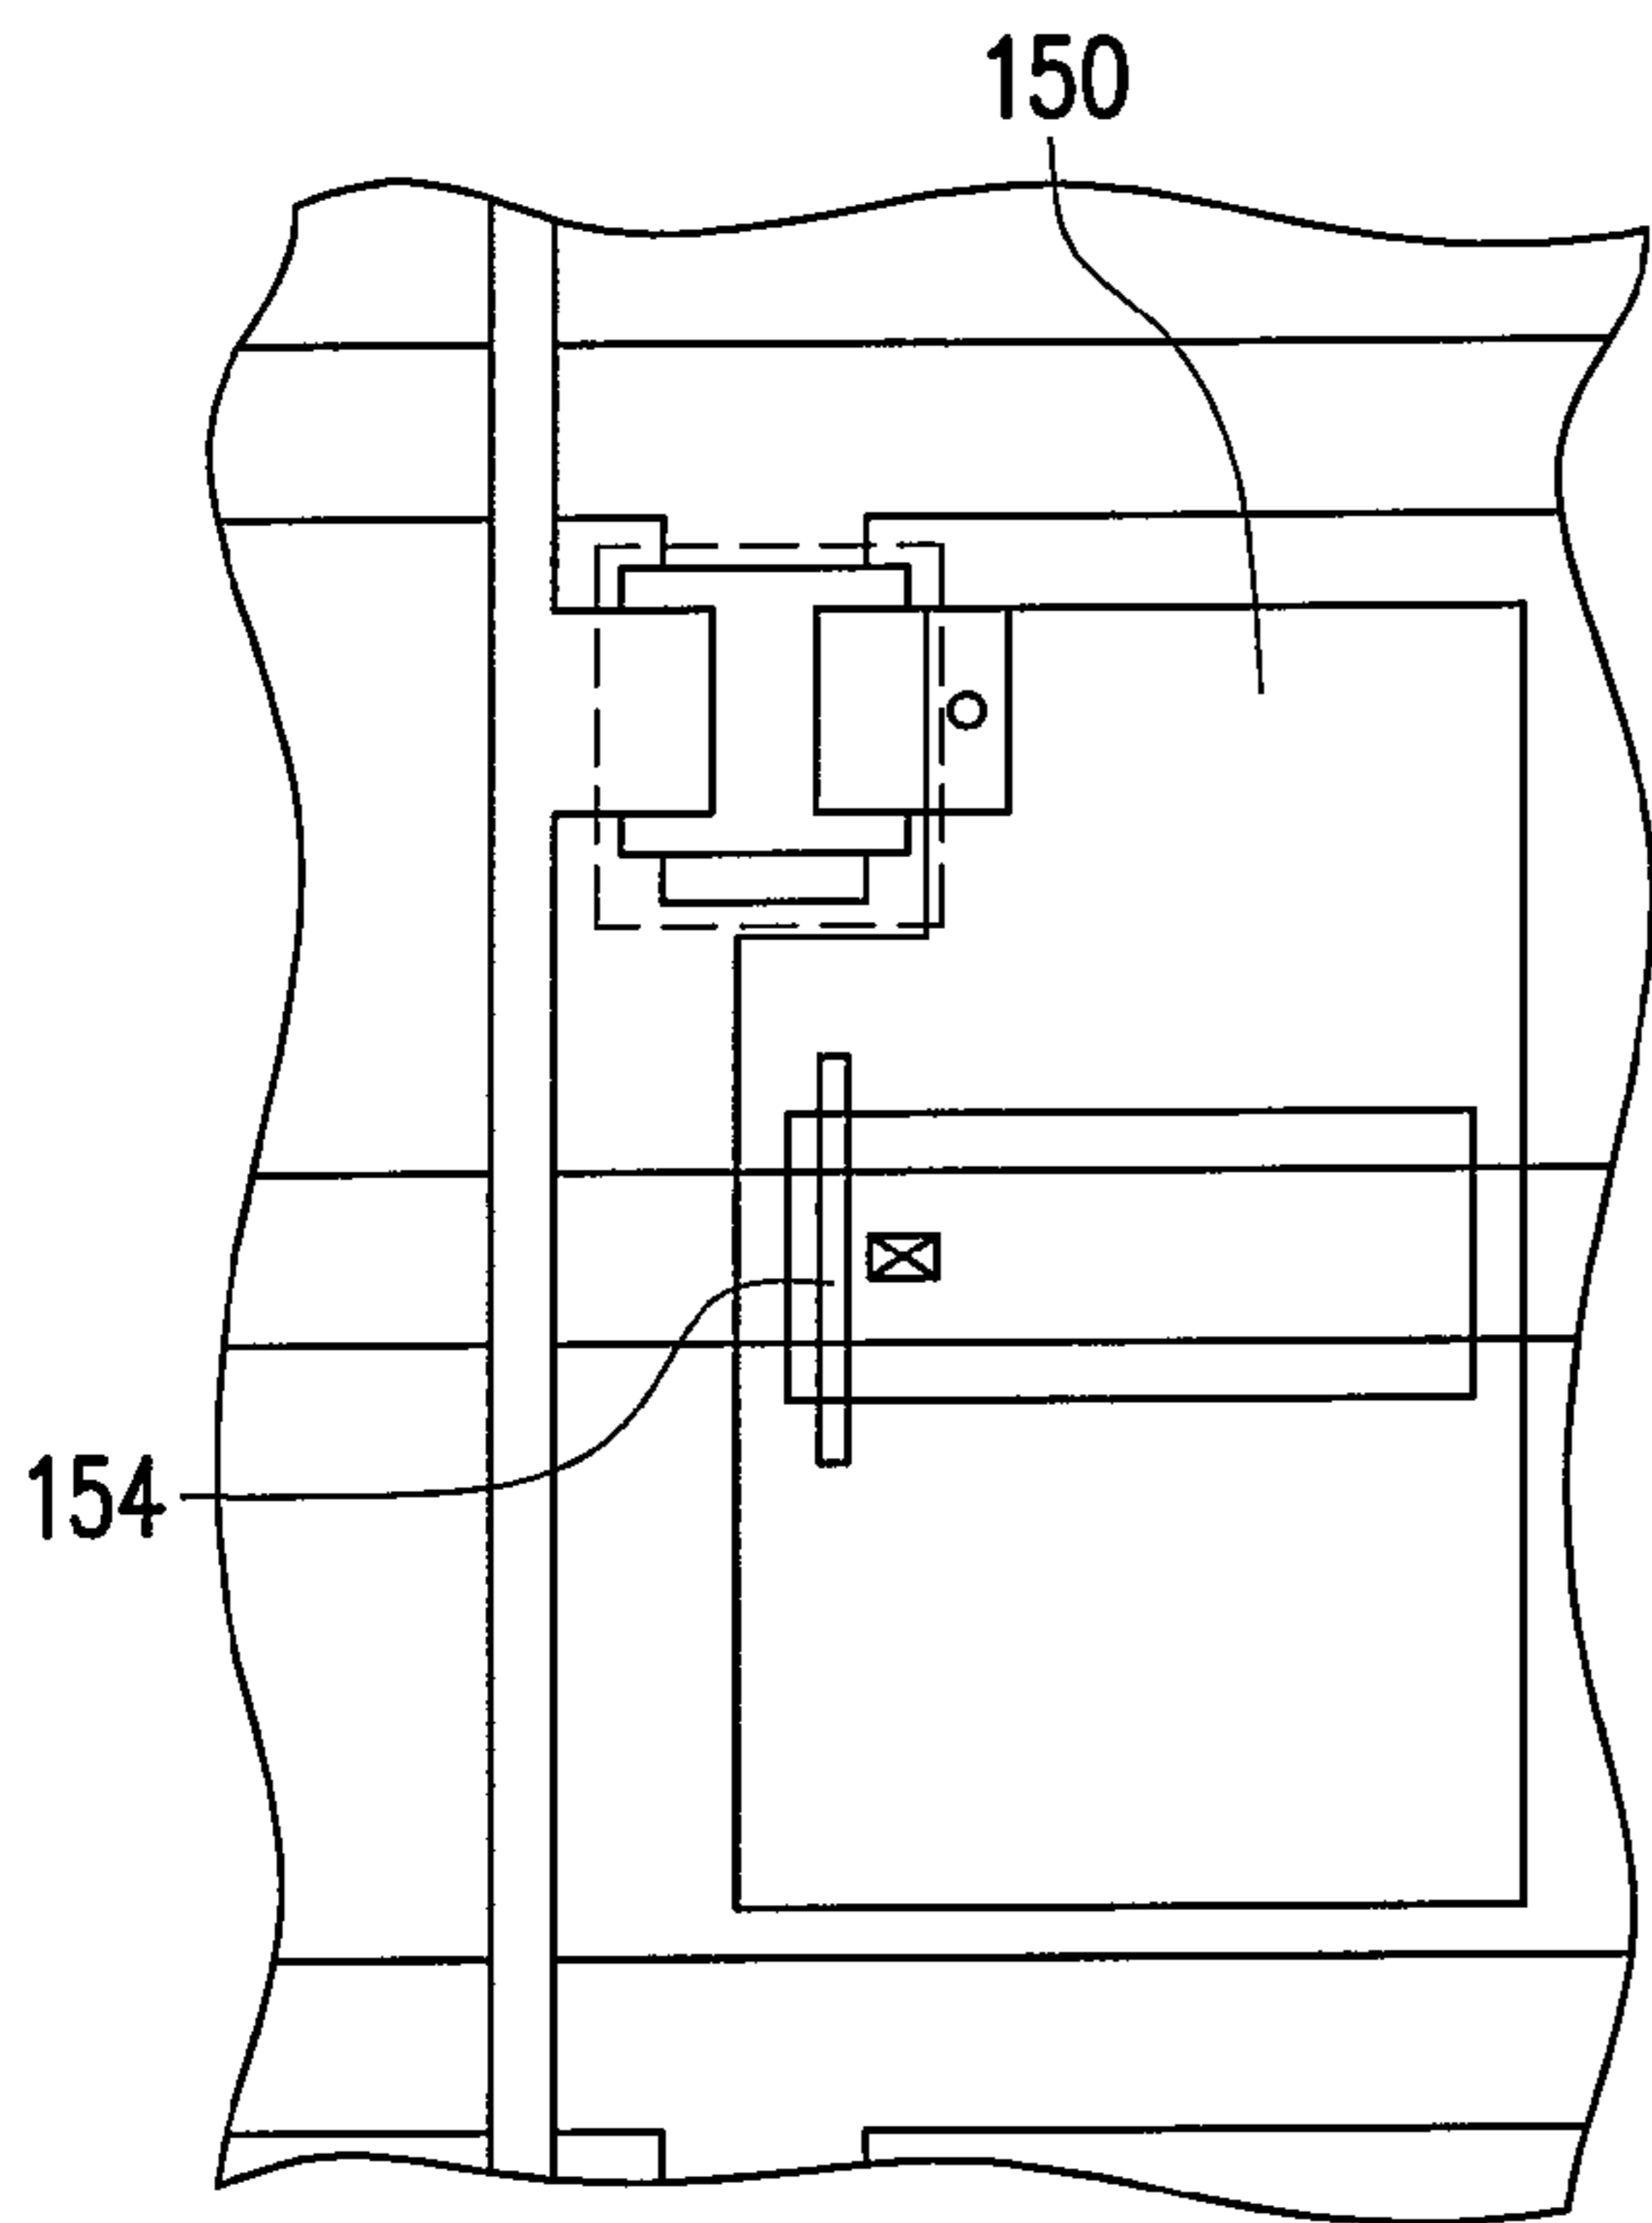
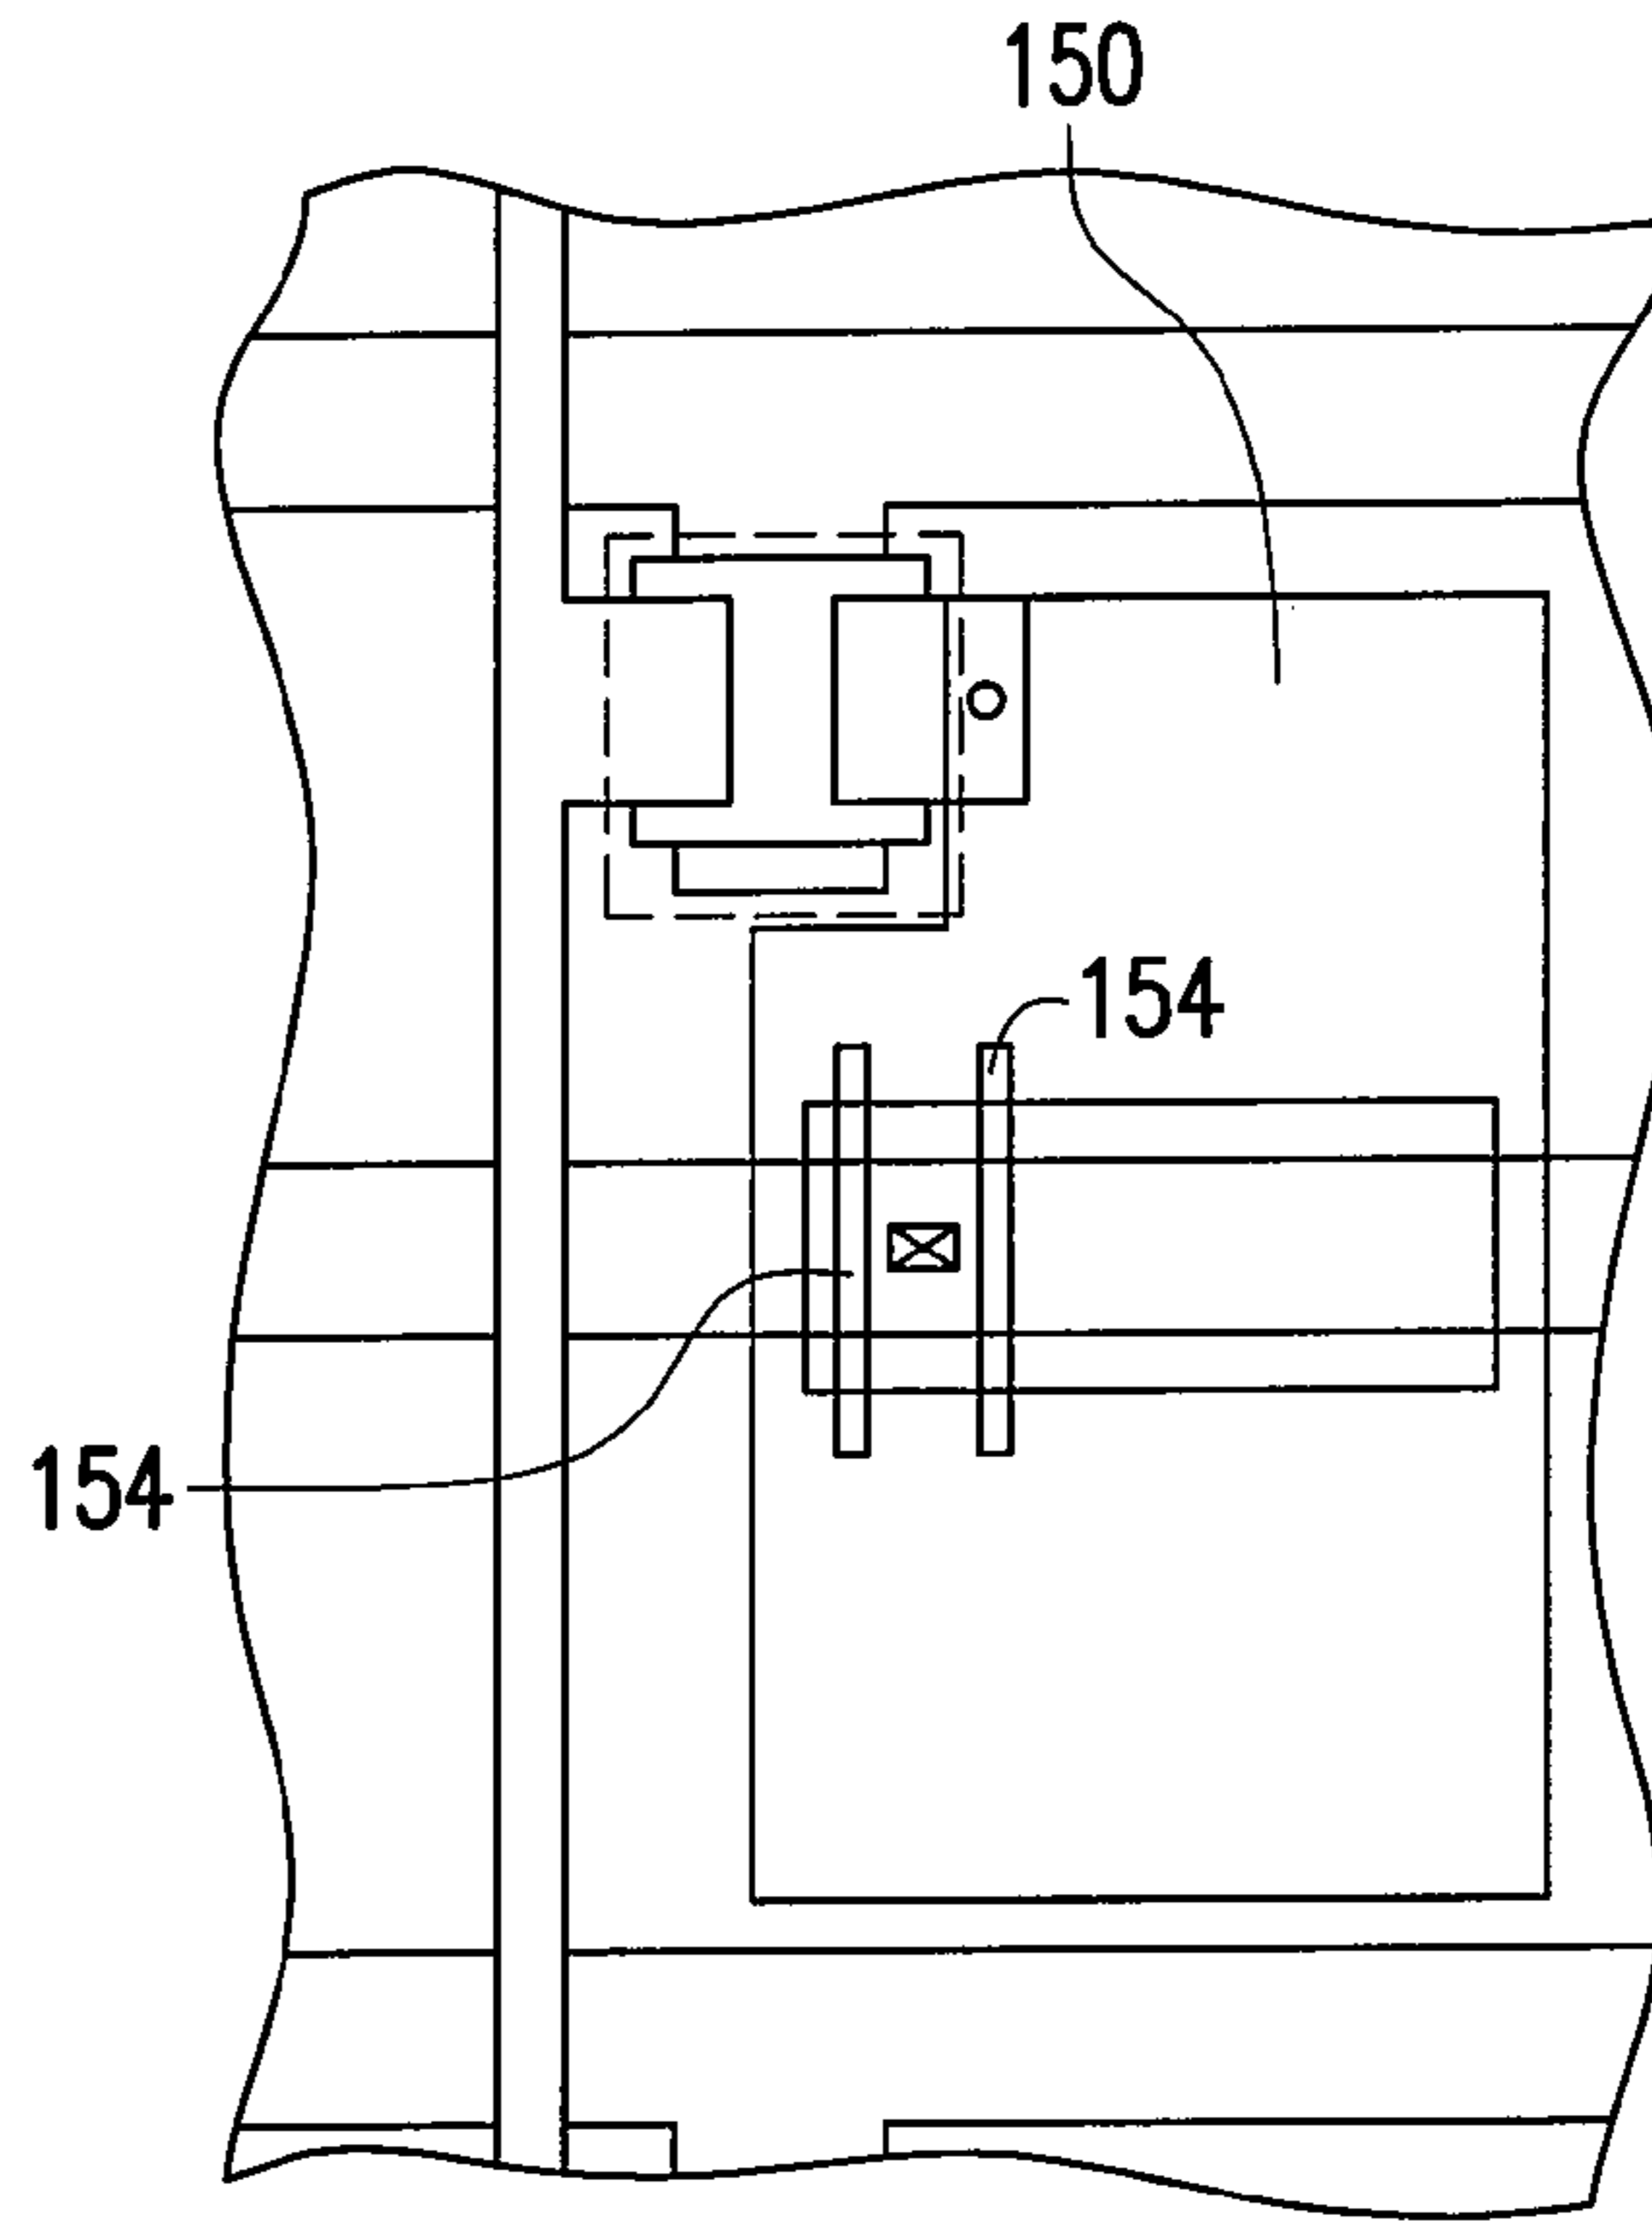
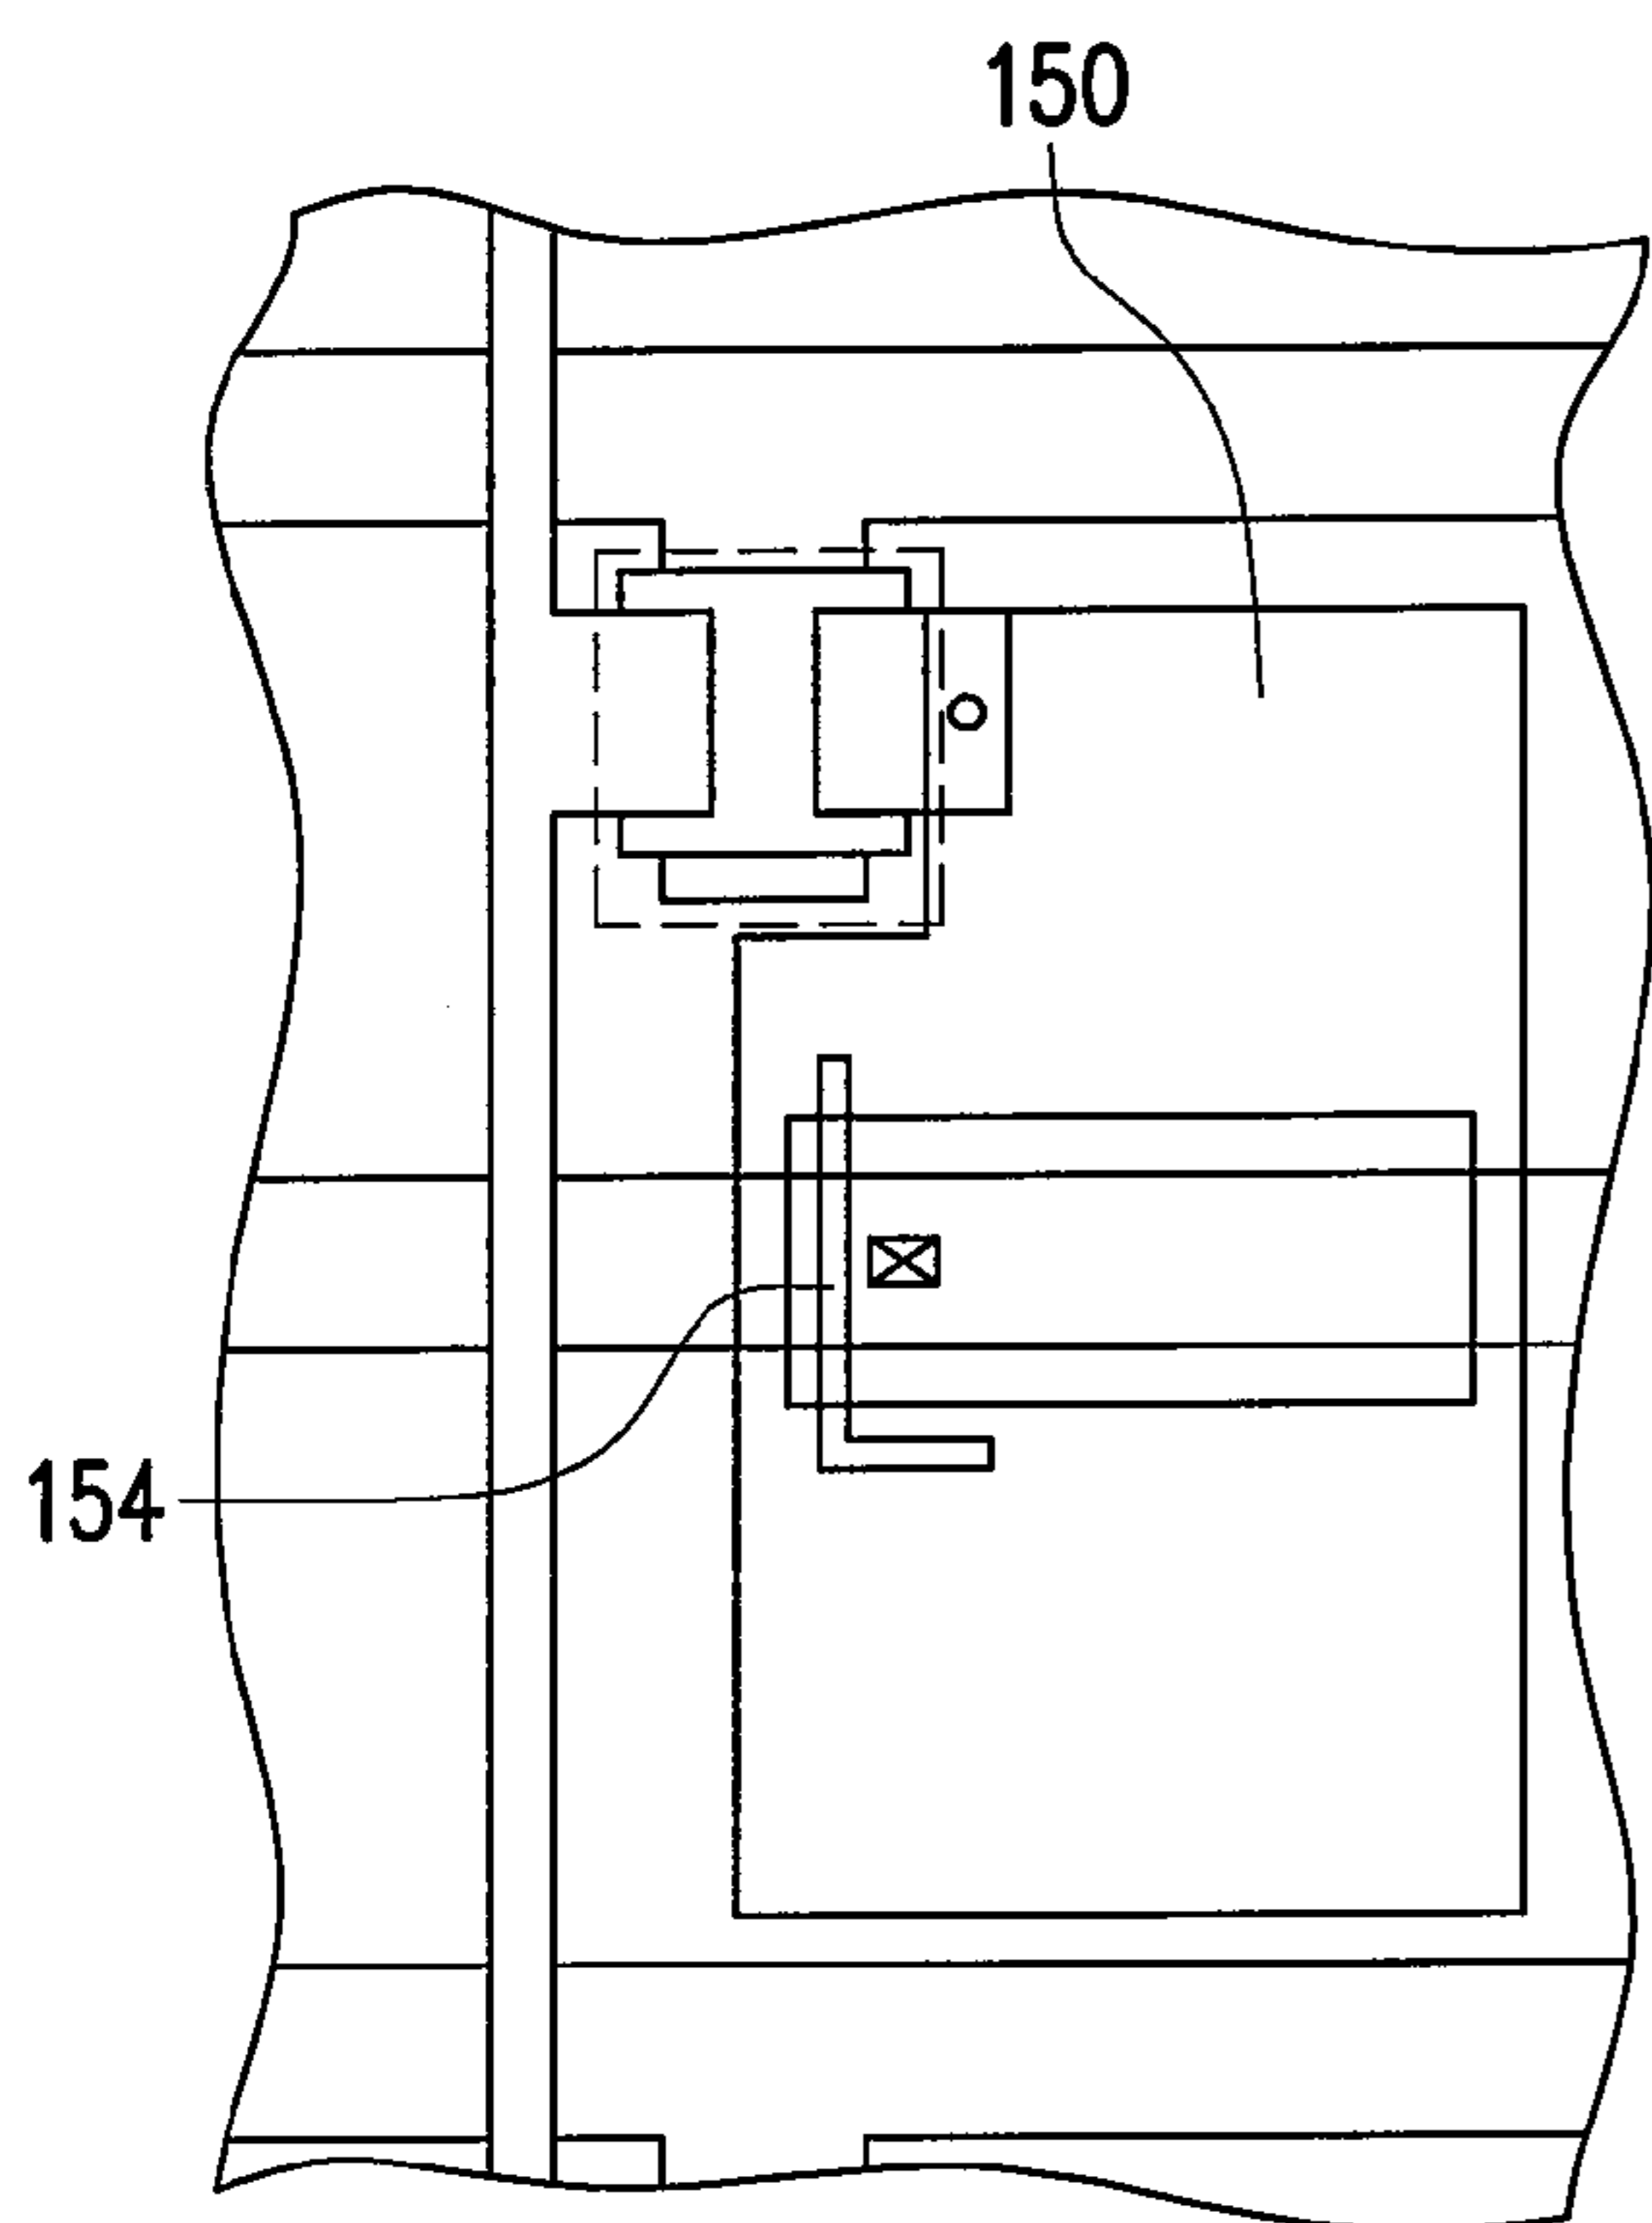
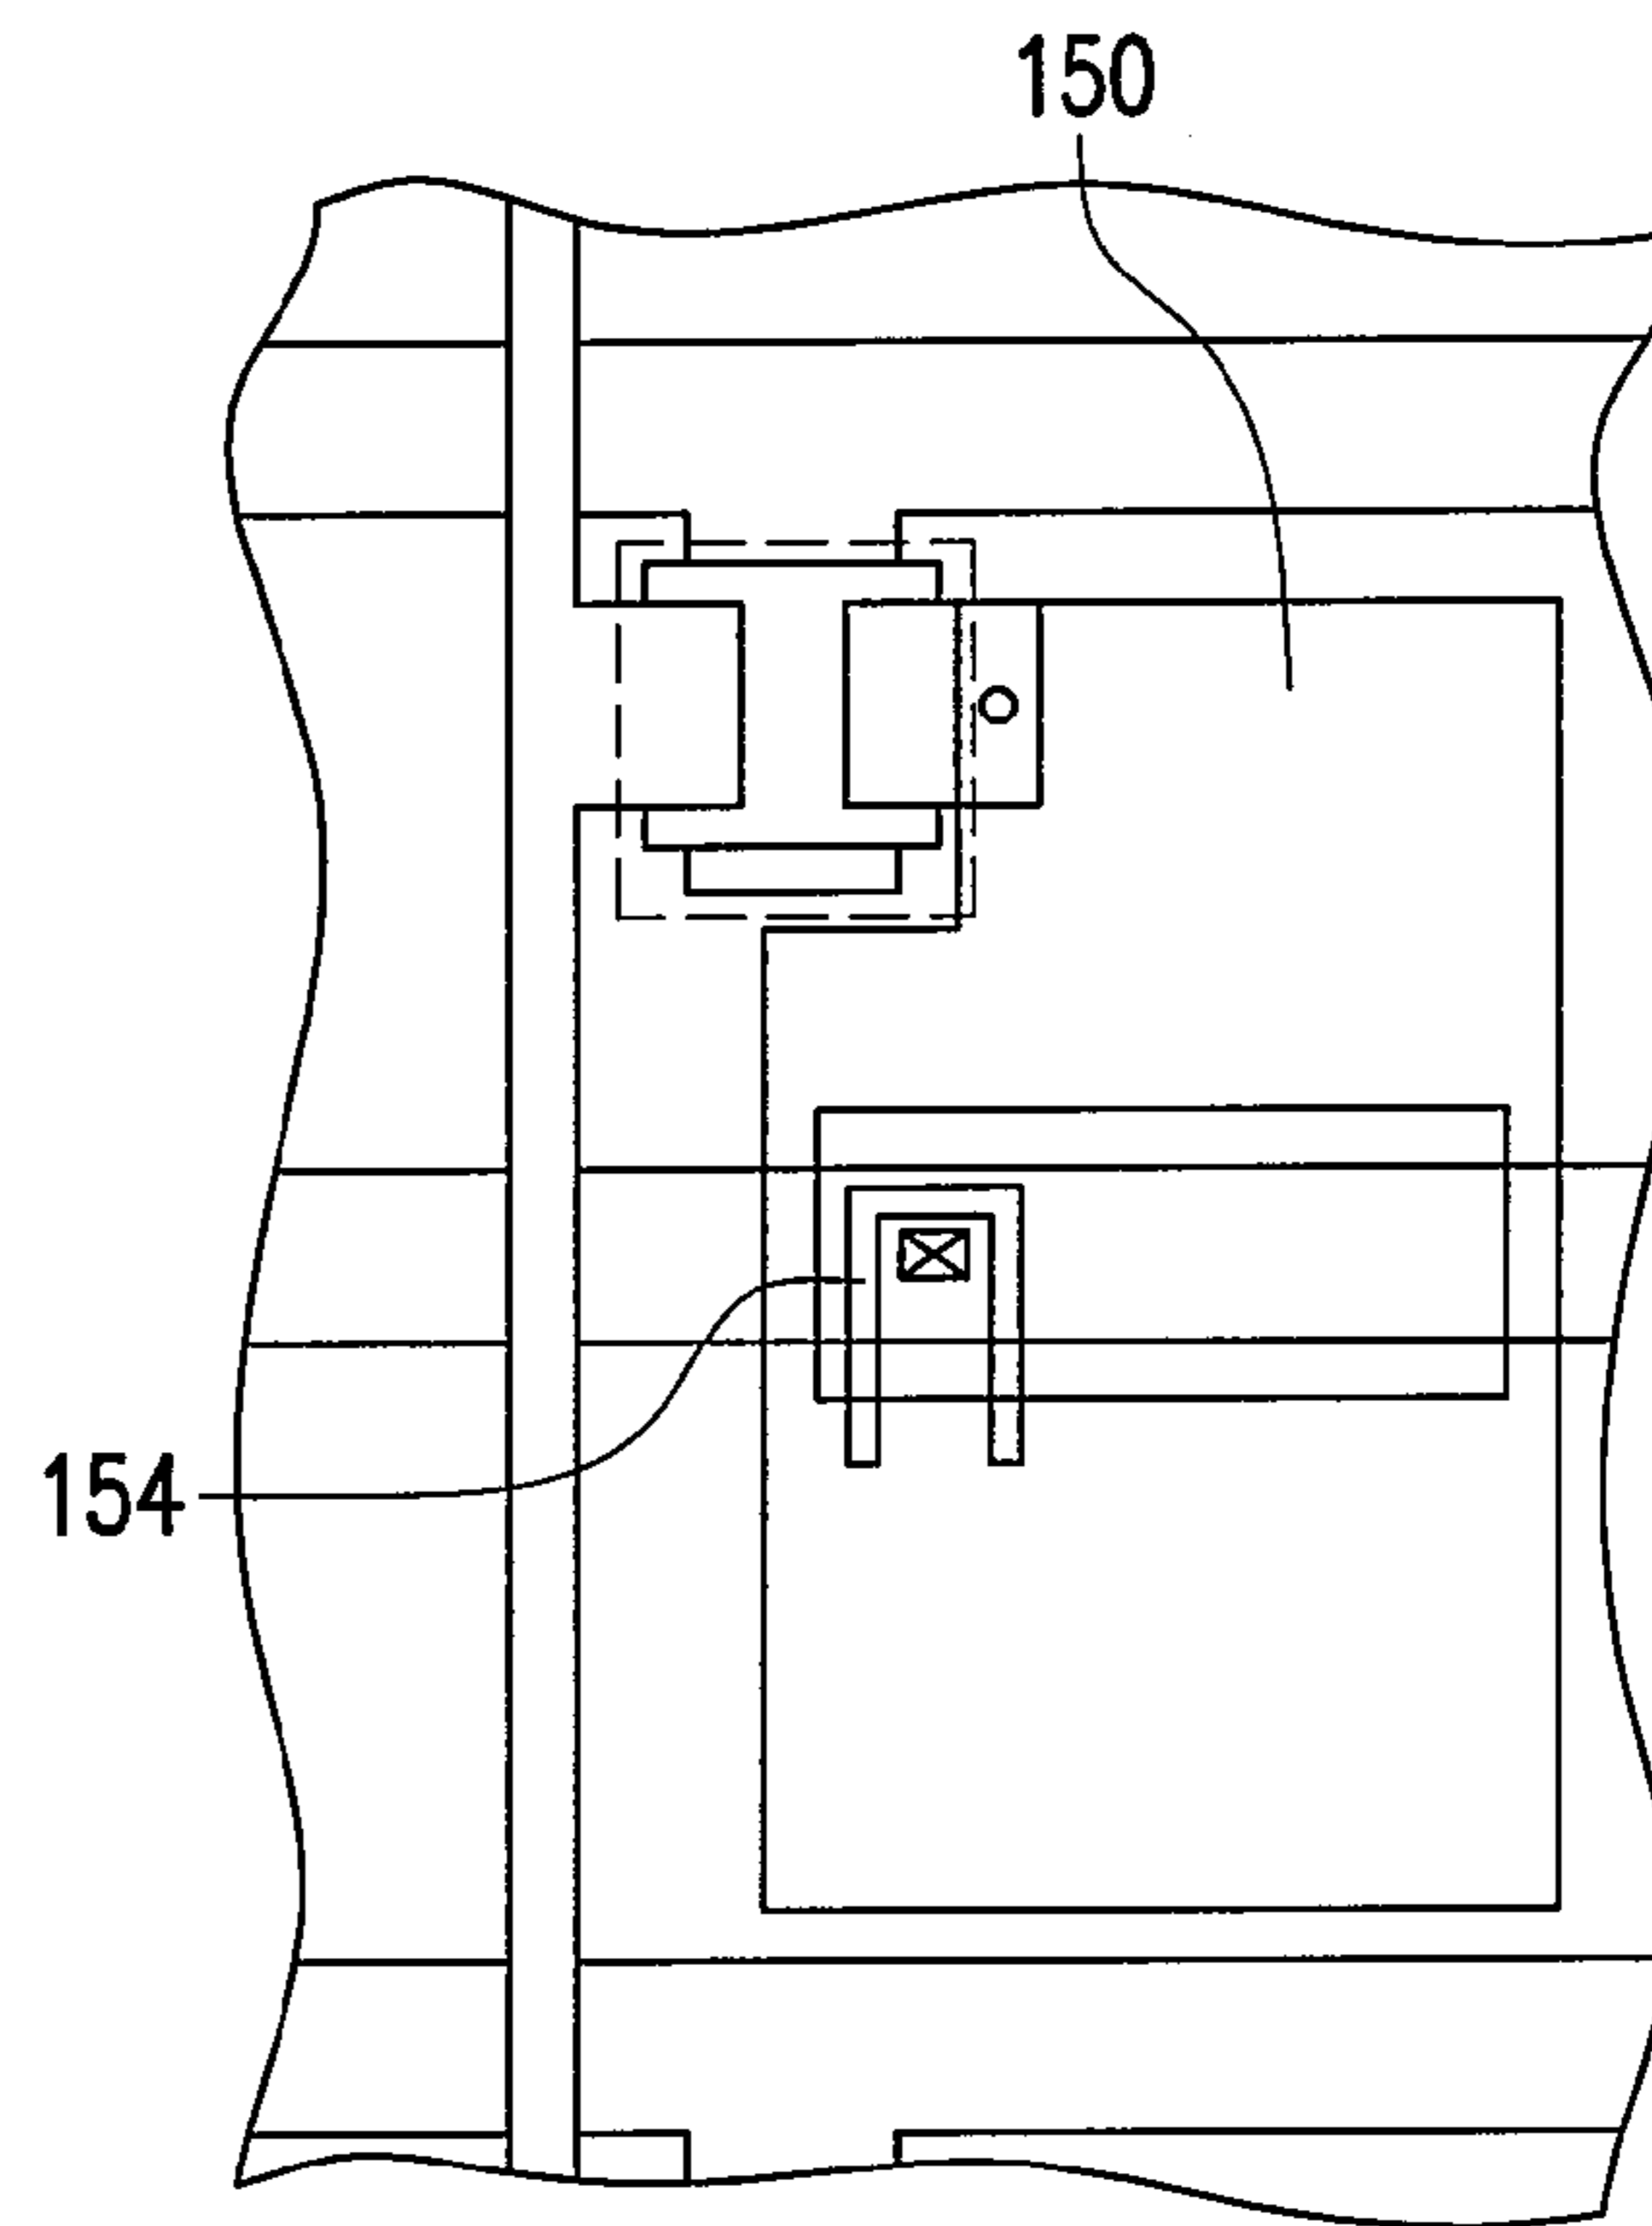
FIGS. 16A through 16D show the types of openings formed on the pixel electrode of a conventional thin film transistor array substrate.

FIGS. 16A through 16D show the types of openings formed on the pixel electrode of a conventional thin film transistor array substrate. To simplify and speed up the repairing process, one or more openings **154** are also formed over the thin film transistor array substrate in the process of fabricating the pixel electrode **150**. For example, a straight line opening **154** (as shown in FIG. 16A), a pair of straight line openings **154** (as shown in FIG. 16B), an L-shaped opening **154** (as shown in FIG. 16C) or a U-shaped opening **154** (as shown in FIG. 16D) are formed over the pixel electrode **150**. Since the openings **154** are similar to the openings disclosed in FIGS. 9A through 9D, detailed description is omitted.

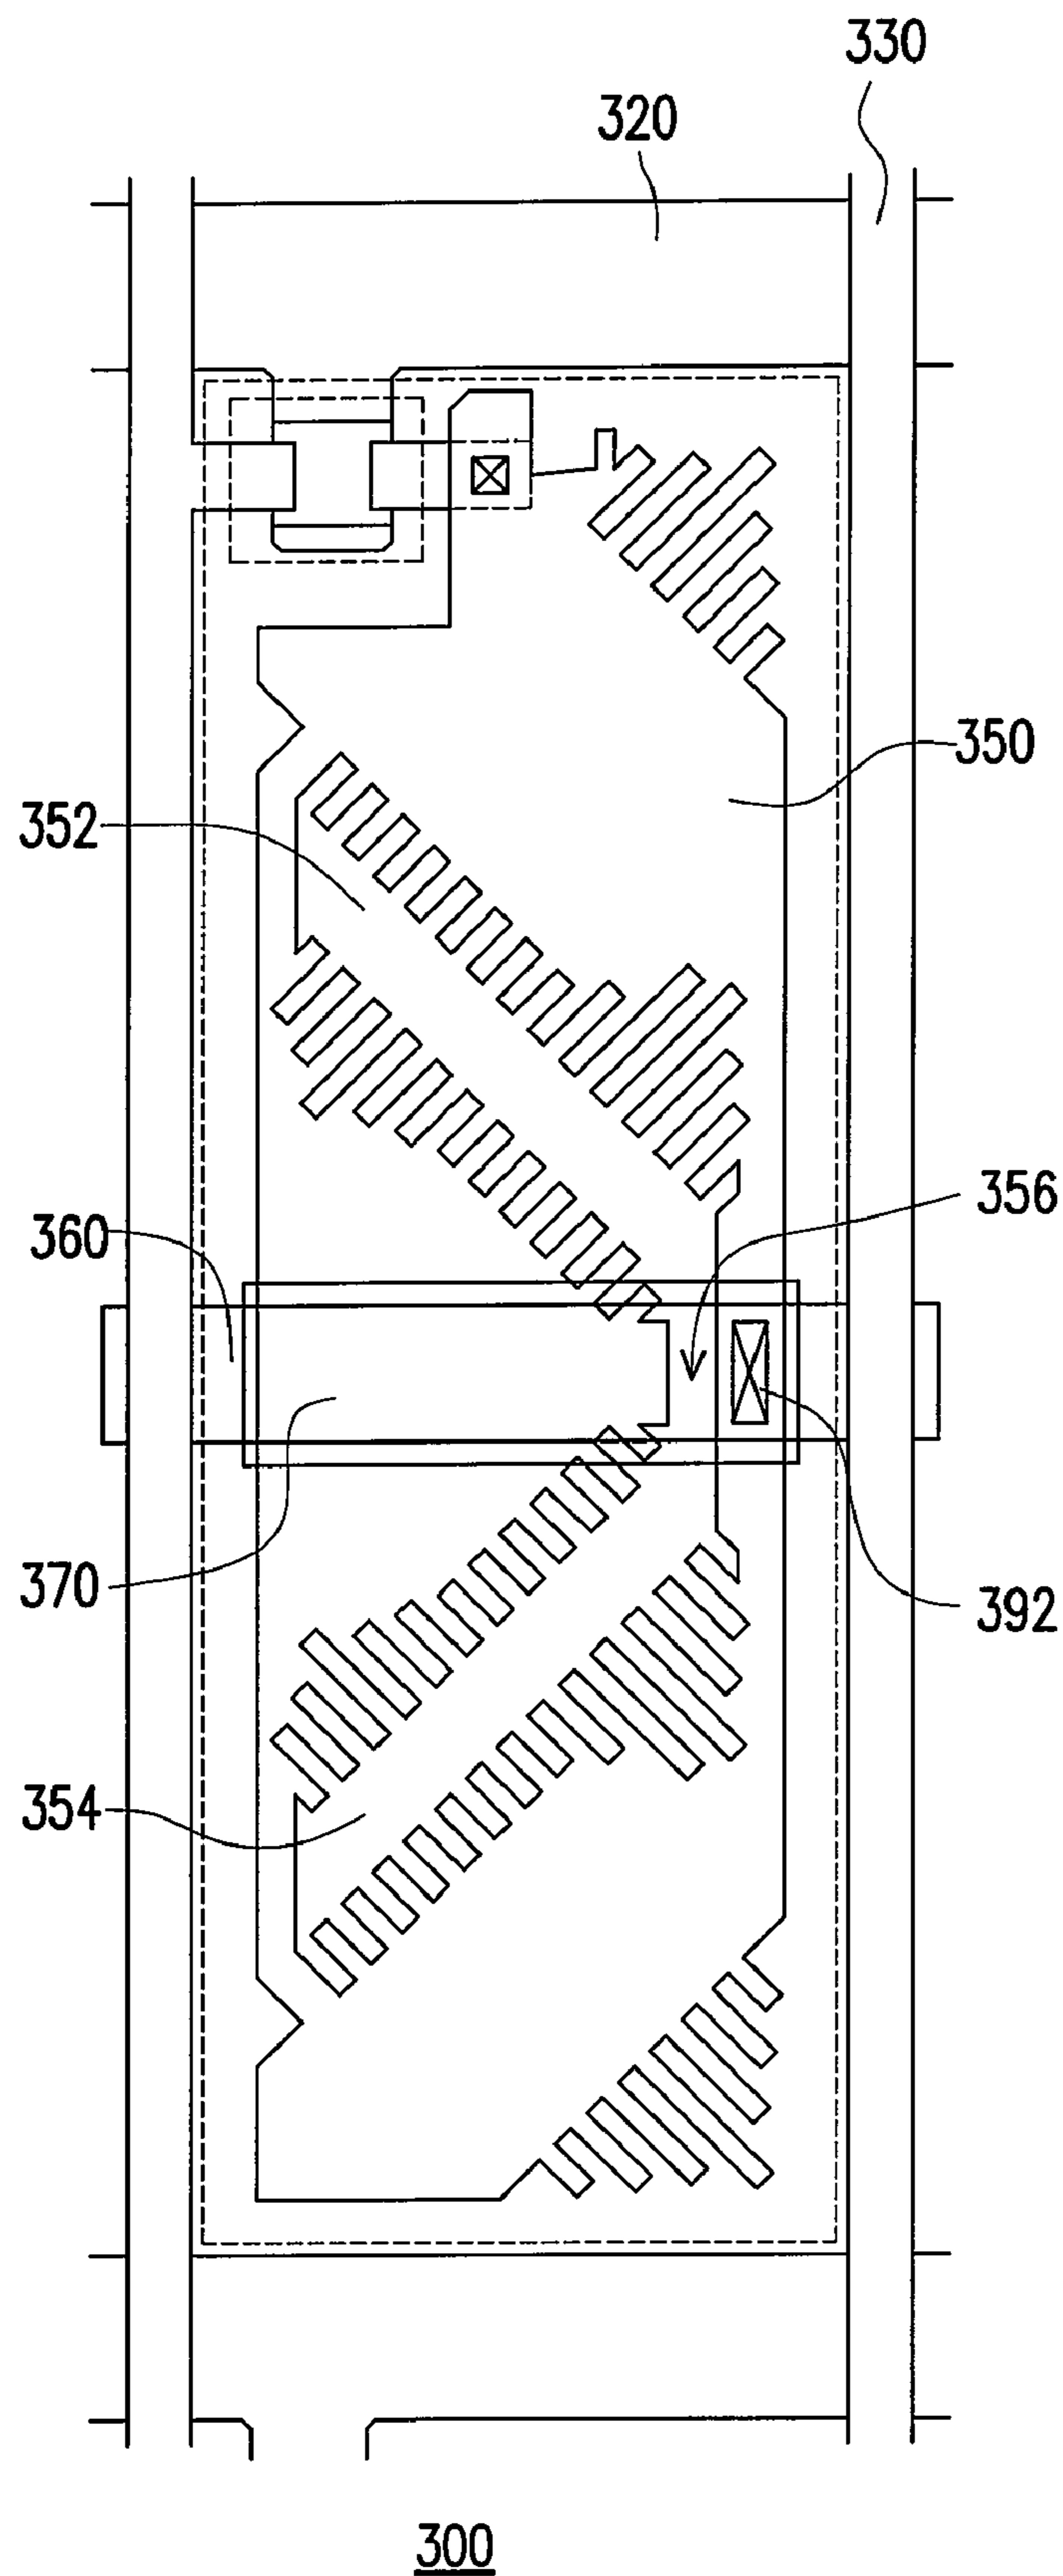
300
FIG. 17

FIG. 17 is a top view showing a thin film transistor array substrate applied to a multi-domain vertical alignment liquid crystal display (MVA-LCD) according to yet another preferred embodiment of the present invention.

FIG. 17 is a top view showing a thin film transistor array substrate applied to a multi-domain vertical alignment liquid crystal display (MVA-LCD) according to yet another preferred embodiment of the present invention. The thin film transistor array substrate **300** in the present embodiment has a structure very similar to the thin film transistor array substrate disclosed in FIG. 1. Hence, only the dissimilar portions are described in the following.

The thin film transistor array substrate **300** has at least a first slit **352** and at last a second slit **354** disposed over each pixel electrode **350**. The first slit **352** extends in a direction different from the second slit **354** and the direction of exten-

sion of the first and the second slit **352**, **354** are different from the scan line **320**, the data line **330** or the common line **360**. In addition, a first slit **352** and one of the second slits **354** are connected together through a connecting area **356** when the first slits **352** and the second slits **354** are formed. The electrical contact area (the contact **392**) between the upper electrode **370** and the corresponding pixel electrode **350** are adjacent to the connecting area **356** between the first and the second slit. Furthermore, the upper electrode **370** and the corresponding common line **360** are coupled to form a capacitor.

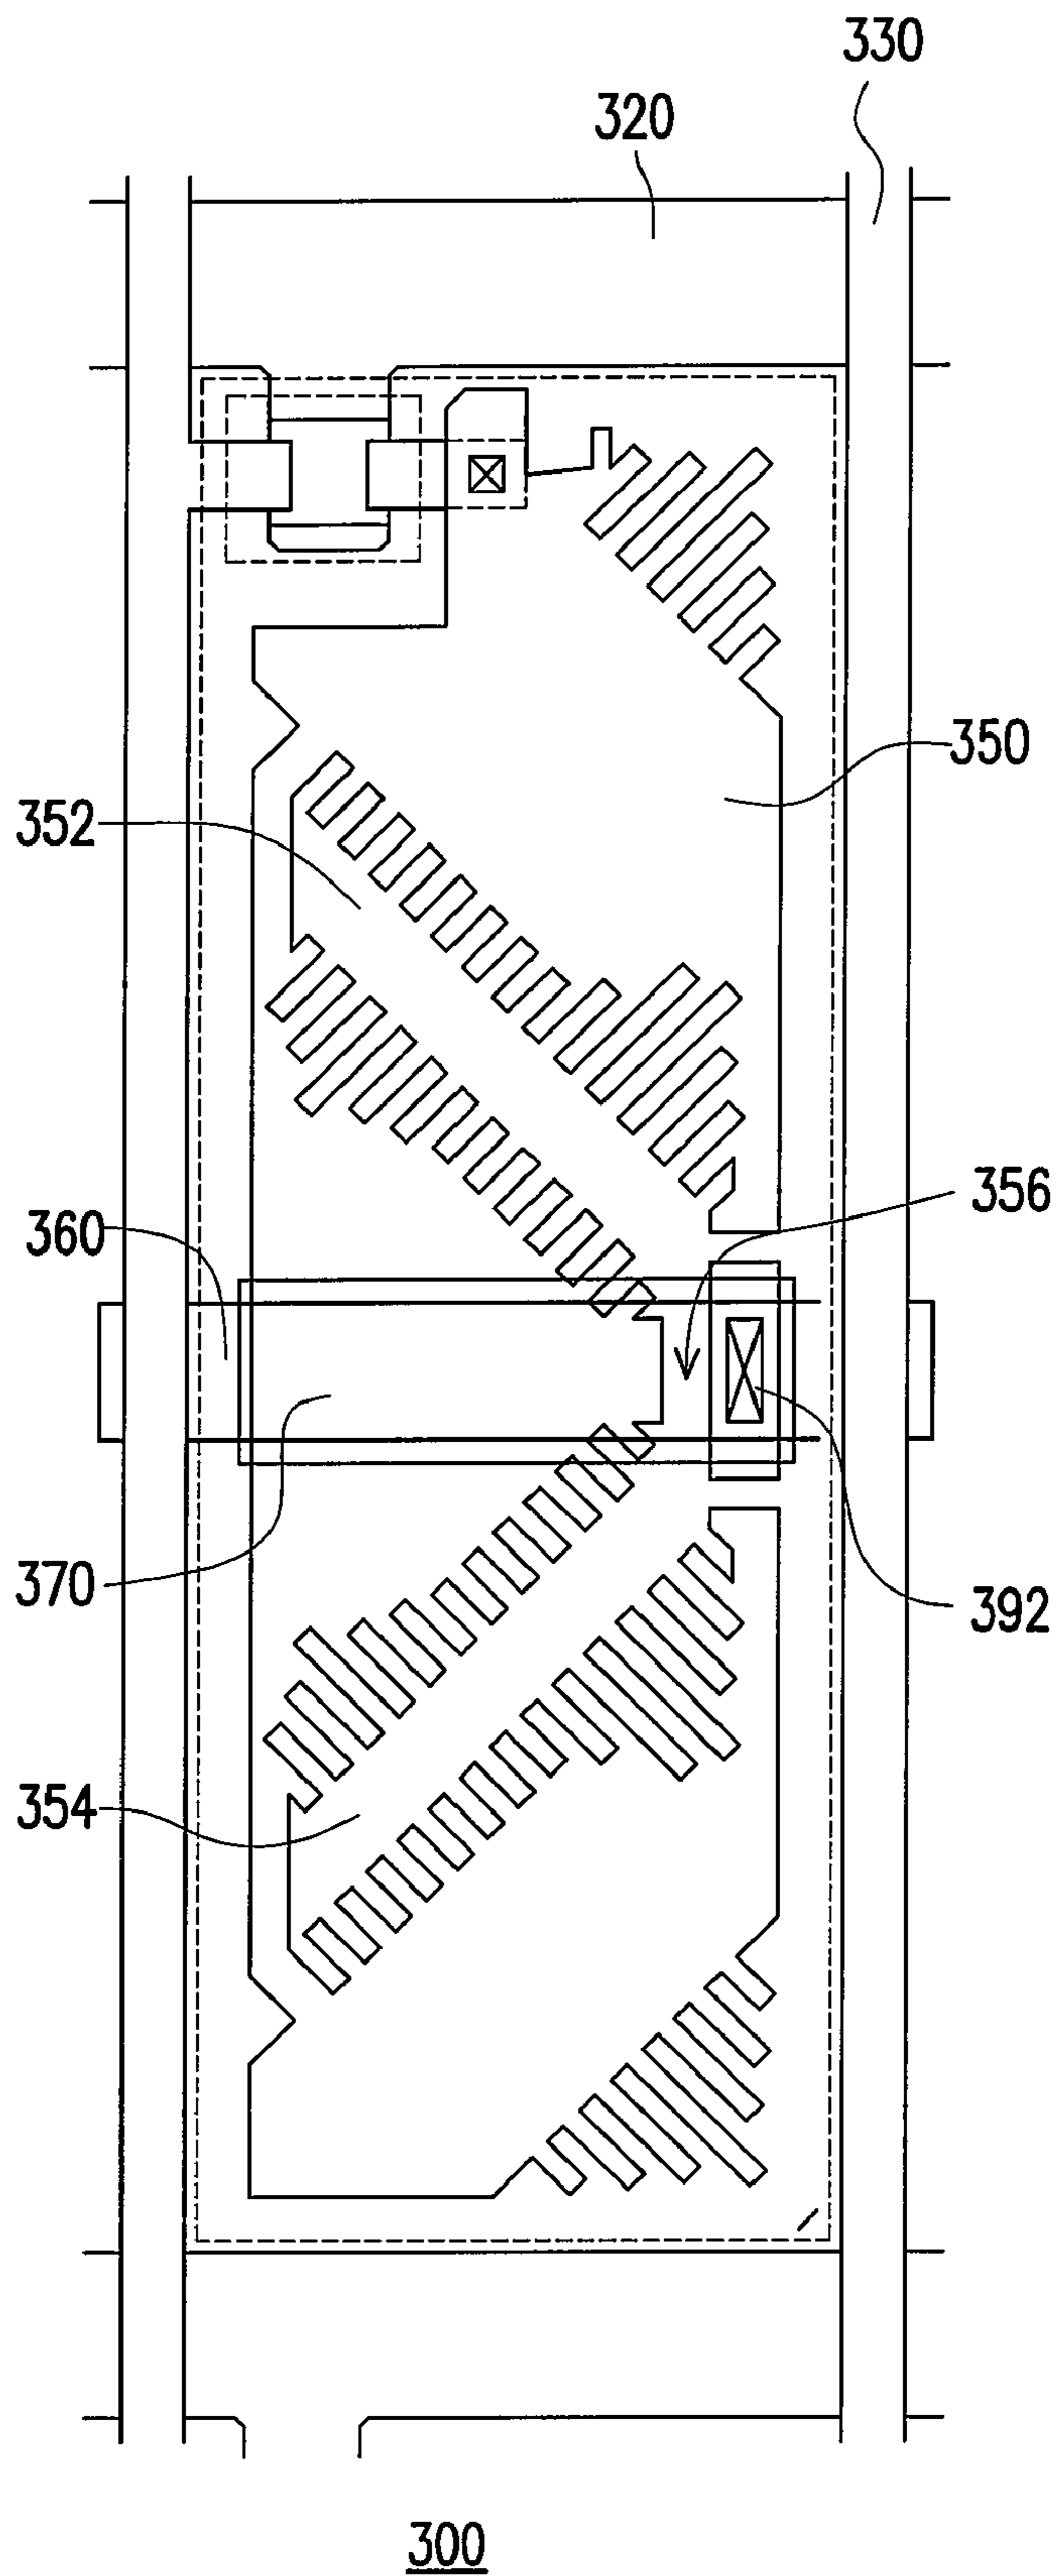
FIG. 18 is a top view of the thin film transistor array substrate of the MVA-LCD in FIG. 17 repaired according to the method of the present invention.

It should be noted a repair is required when a particle or defect is formed between the upper electrode **370** and one of the common lines **360** so that the upper electrode **370** and the common line **360** together form a defective capacitor. FIG. **18** is a top view of the thin film transistor array substrate of the MVA-LCD in FIG. **17** repaired according to the method of the present invention. The repairing method includes removing a portion area of the pixel electrode **350** corresponding to the upper electrode of the defective capacitor. In the present embodiment, the portion area of the pixel electrode **350** to be removed is the area around the electrical contact (the contact **392**) between the upper electrode **370** and the corresponding pixel electrode **350**. Thus, the upper electrode **370** of the defective capacitor and the corresponding pixel electrode **350** are electrically isolated. In other words, by removing a small portion of the pixel electrode **350** (a small area around contact **392**) covering the upper electrode **370**, the upper electrode **370** and the corresponding pixel electrode **350** of the defective capacitor are electrically isolated. Since only a small portion of the pixel electrode **350** covering the upper electrode **370** is removed in the present embodiment, a large capacitance can be maintained after the repair operation.

Thereafter, the upper electrode **370** and the corresponding common line **360** of the defective capacitor are welded together so that the upper electrode **370** and the corresponding common line **360** of the defective capacitor are at the same potential. Obviously, whether to weld the upper electrode **370** and the common line **360** of the defective capacitor together can be determined by the amount of leakage in the defective capacitor.
