(10) **Patent No.:** **US 7,444,892 B2**
(45) **Date of Patent:** **Nov. 4, 2008**

(54) **CONTINUOUSLY VARIABLE TRANSMISSION BELT INSPECTION METHOD AND INSPECTION DEVICE THEREOF**

(73) Assignee: **Jatco Ltd.** (JP)

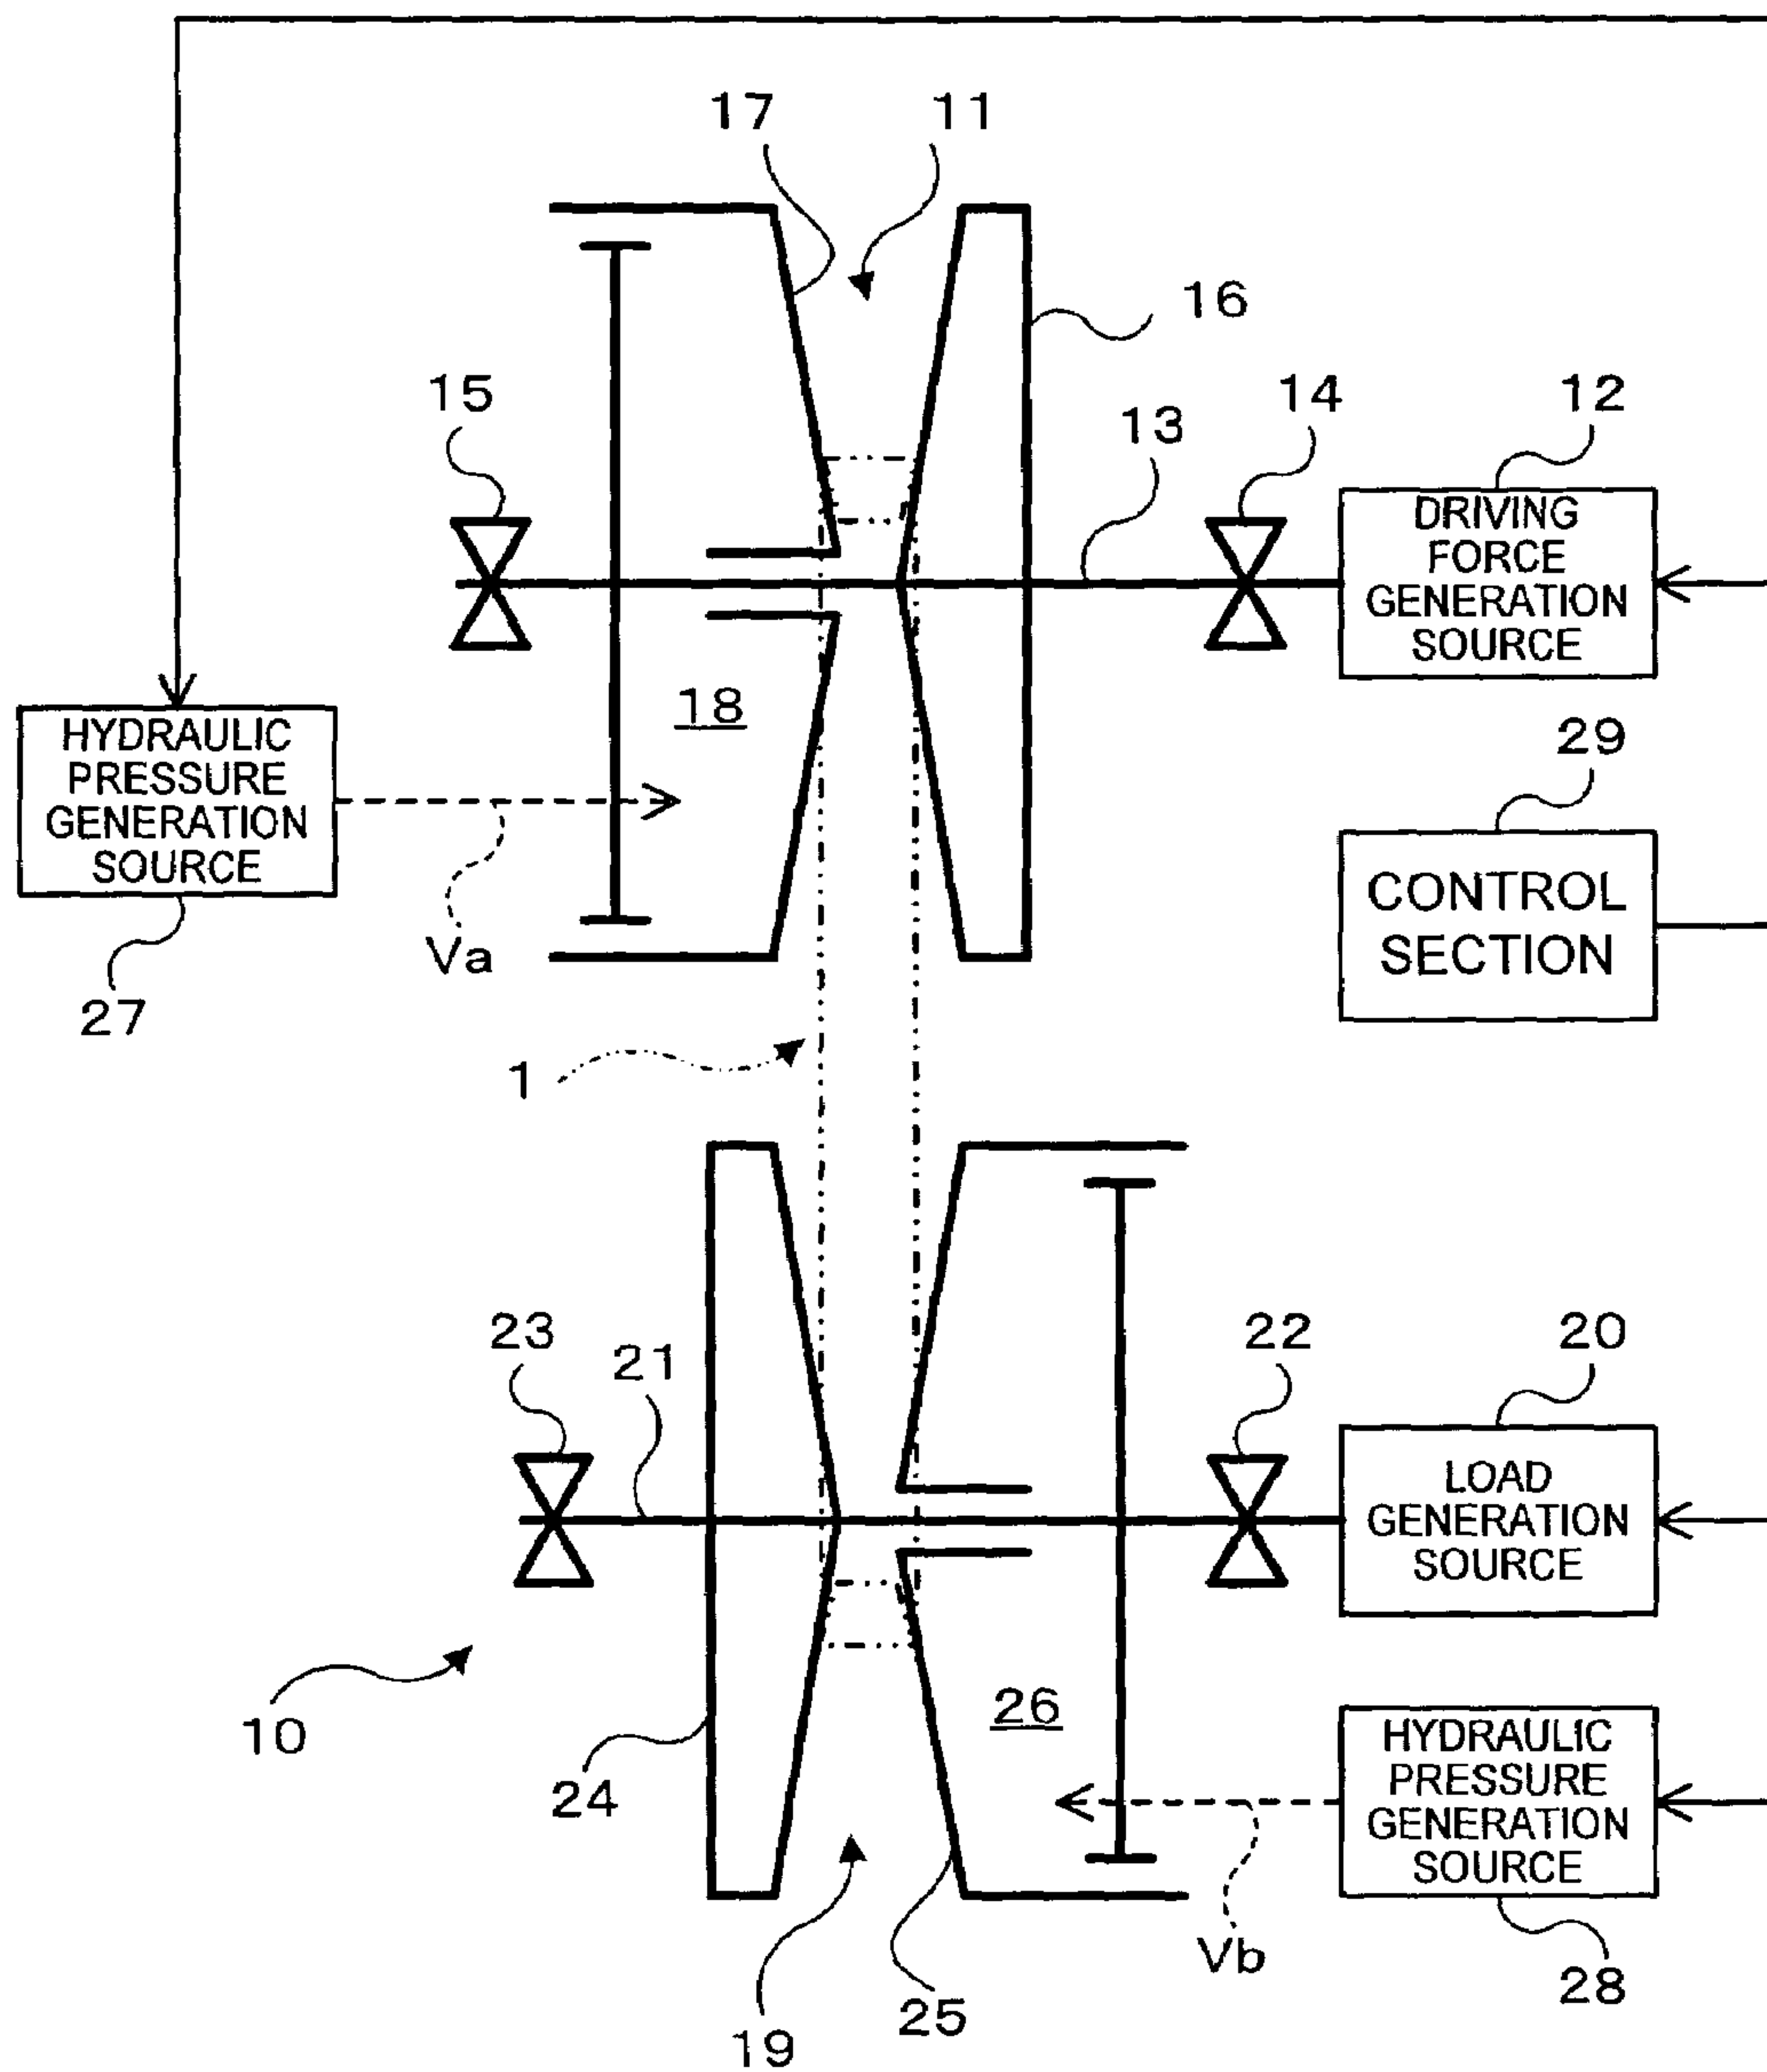
FIG. 1 is a diagram showing the outline structure of a testing device 10;

FIG. **1** is a diagram showing the outline structure of a testing device **10**. As seen in FIG. **1**, a drive pulley **11** comprises a drive shaft **13** coupled to the rotational axis of a driving force generation source **12** (for example, an electric motor); bearing **14**, **15** retain both ends of the drive shaft **13** enabling free rotation; a fixed side pulley half-body **16** is secured to the drive shaft **13**; and a movable side pulley half-body **17** is positioned on the drive shaft **13** in relation to the fixed side pulley half-body **16**. The movable side pulley half-body **17** applies force toward the fixed side pulley half-body **16** responsive to the oil pressure V_a interaction in an oil chamber **18**. The movable side pulley half-body **17** is also referred to as a moveable sheave.

In addition, a driven pulley **19** comprises a drive shaft **21** positioned in parallel with the drive shaft **13** and coupled to the rotational axis of a load generation source **20** (for example, regenerative brake equipment using an electric motor); a bearing **22**, **23** retain both ends of the drive shaft **21** enabling free rotation; a fixed side pulley half-body **24** is secured to the drive shaft **21**; a movable side pulley half-body **25** is positioned on the drive shaft **21** in relation to the fixed side pulley half-body **24**. The movable side pulley half-body **25** applies force toward the fixed side pulley half-body **24** responsive to the oil pressure V_b interaction in oil chamber **26**. The movable side pulley half-body **25** is also referred to as a moveable sheave.

Furthermore, the testing device **10** comprises the hydraulic pressure generation sources **27**, **28** for generating oil pressures V_a , V_b ; and comprises a control section **29** for controlling operation of a load generation source **20** and the hydraulic pressure generation sources **27**, **28**.

Based on the testing device **10** having such a configuration, initially, a CVT belt **1** is wrapped around the drive pulley **11** and the driven pulley **19**. By controlling the respective oil pressures V_a , V_b , tensile and compressive forces are applied to either or both sides of the movable side pulley half-body **17**, **25** of the drive pulley **11** and the driven pulley **19** toward the fixed side pulley half-body **16**, **24**, as well as can be freely set to the desired effective radius of the drive pulley **11** and the

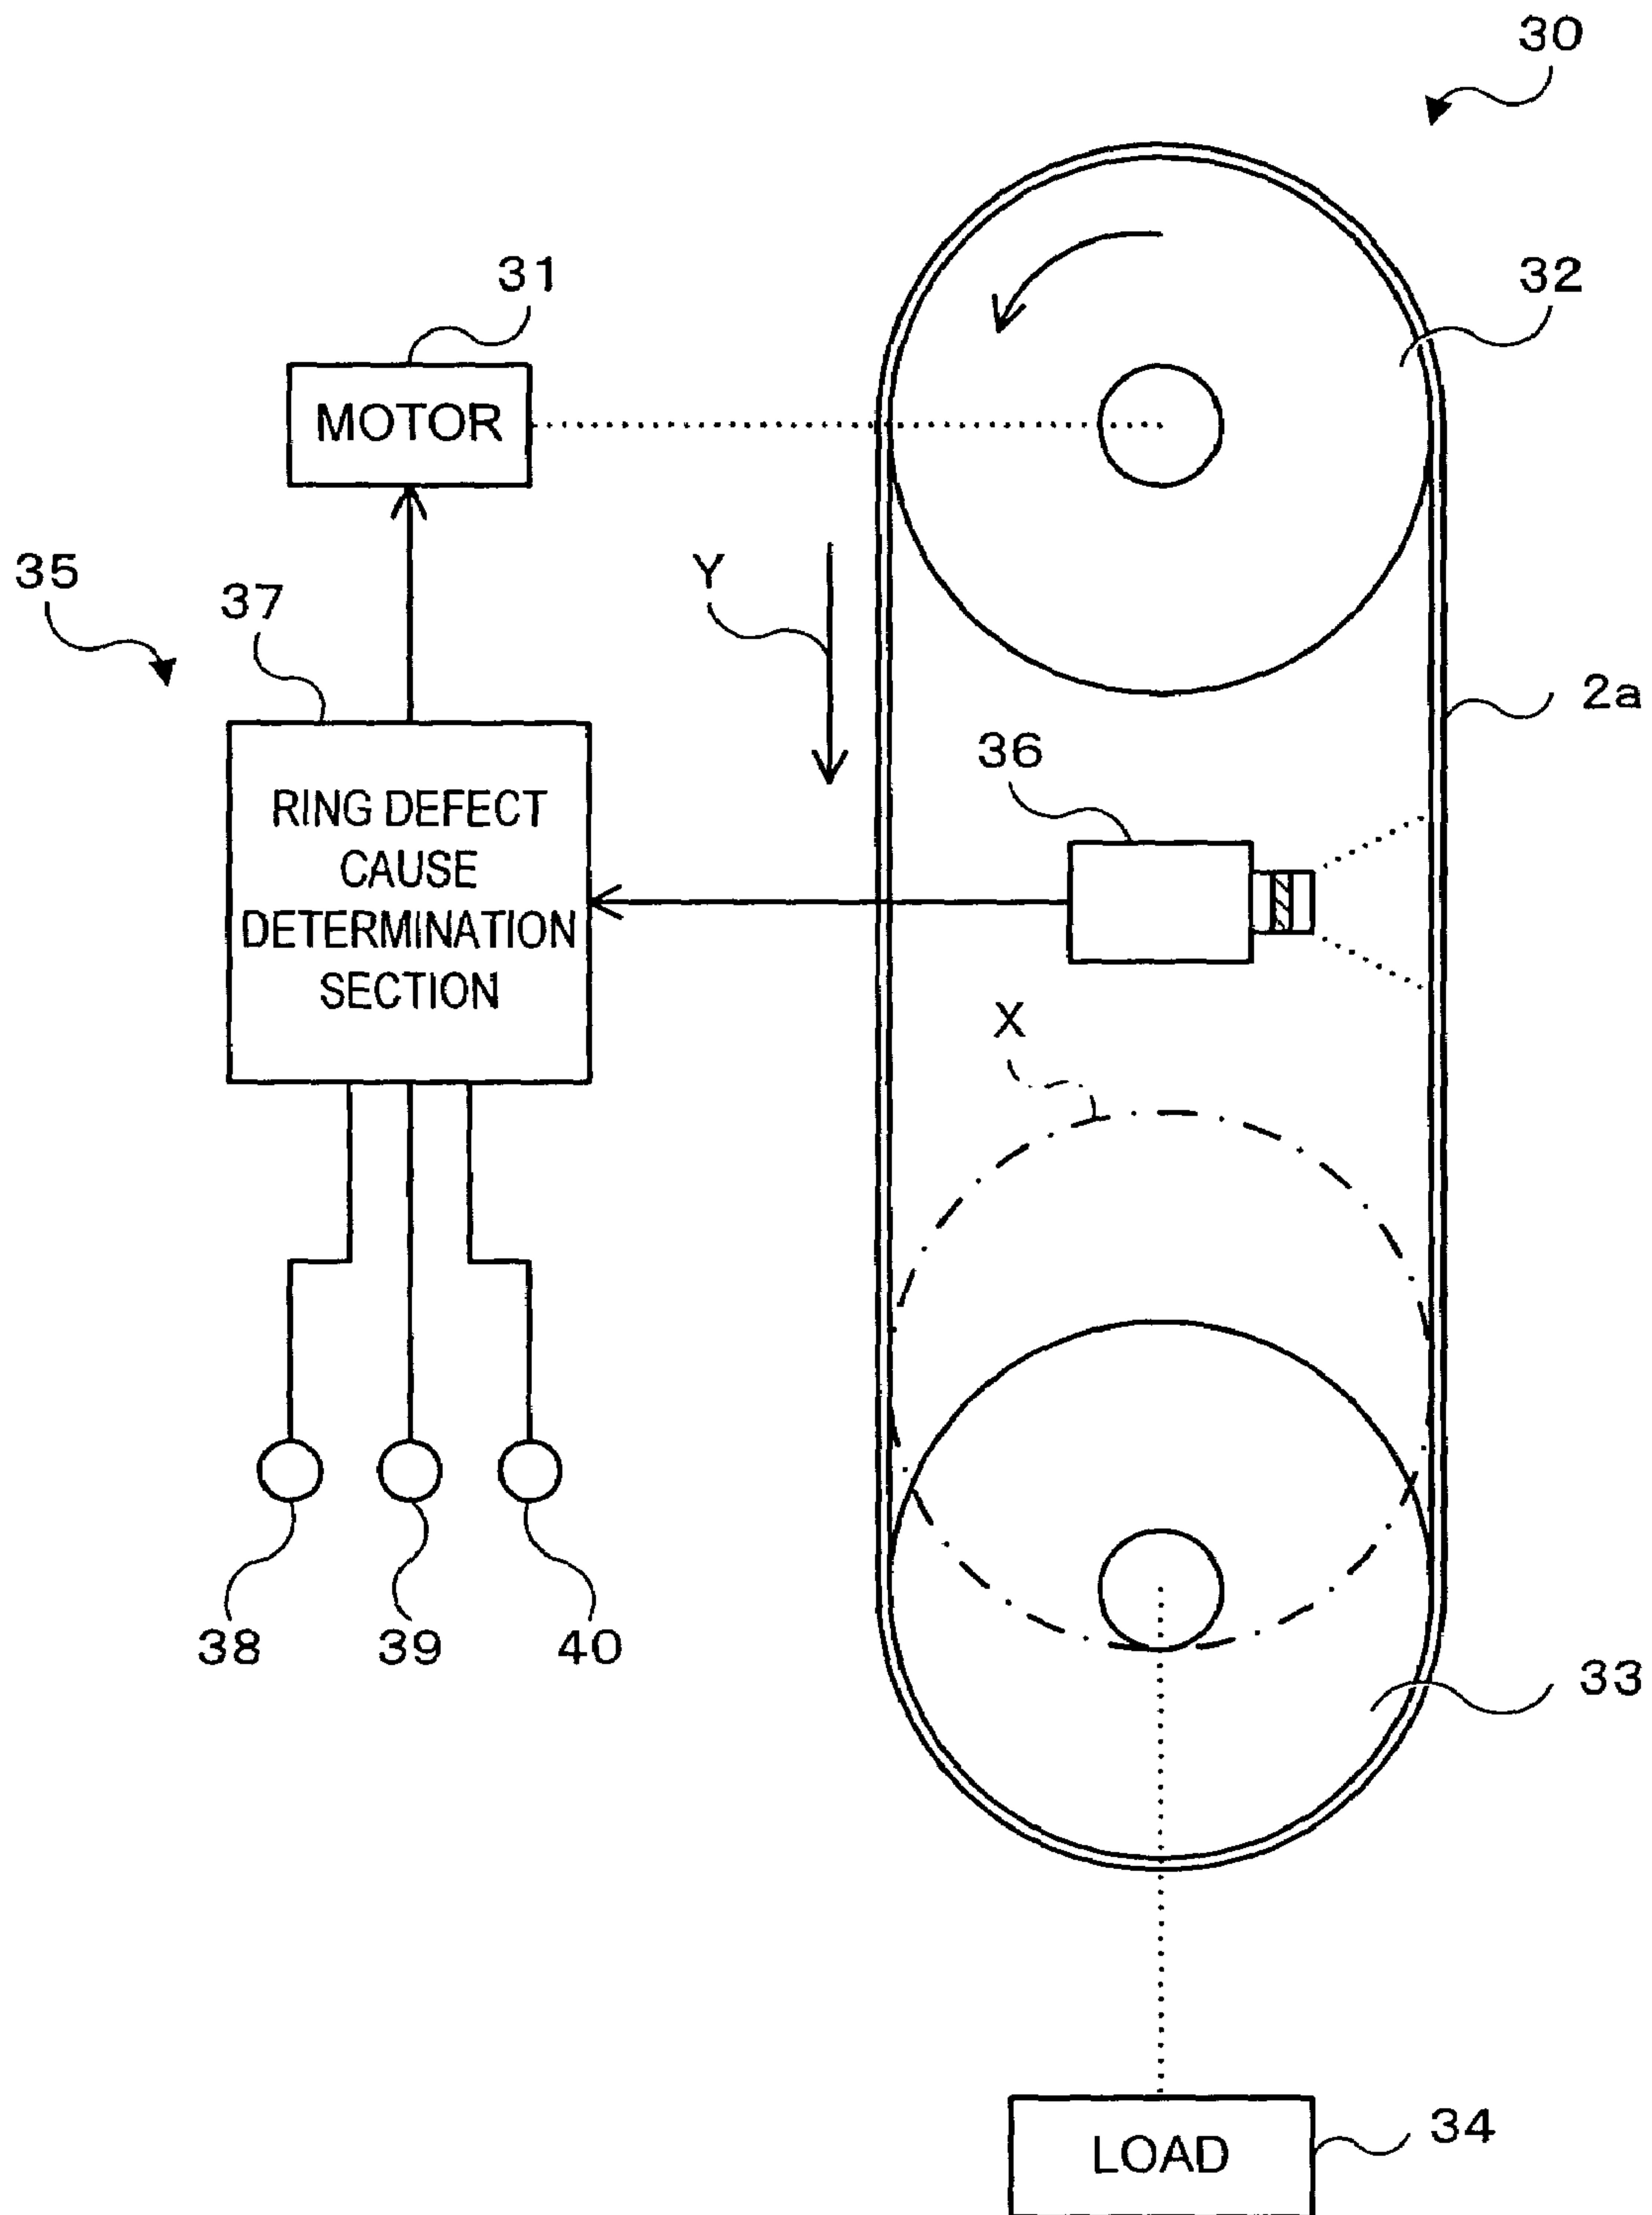
FIG. 2 is a conceptual configuration diagram of a CVT belt inspection device 30;

FIG. **2** is a conceptual configuration diagram of a CVT belt inspection device **30**. The Continuously Variable Transmission (CVT) belt inspection device **30** (hereinafter, only denoted as “belt inspection device”) configuration comprises a fixed position drive pulley **32** rotated by a motor **31**; a variable position driven pulley **33** in which spacing arrangement is performed on the same rotation plane as the drive pulley **32**; a load **34** with predetermined mass (example: 80 kg (176 lbs.)); and a ring defect inspection part **35**. Besides, in addition to the drive pulley **32** and the driven pulley **33**, the belt inspection device **30** may further have one or a plurality of guidance belt pulleys, but the requisite minimum of belt pulleys is two: the drive pulley **32** and the driven pulley **33**.

When identifying the existence of a CVT belt “running track” and that generation cause, a CVT belt **1** which completed a test drive is disassembled and the metal belts **2a** situated in the innermost circumference layer of that laminated belt **2** are placed in the inspection device **30**.

Specifically, the driven pulley **33** is placed in an initial position (position of the dashed and dotted line X in FIG. 2). The metal belts **2a** (metal belts **2a** situated in the innermost circumference layer of a laminated belt **2**) are wrapped around between the two belt pulleys (drive pulley **32** and driven pulley **33**). Subsequently, the required tension is supplied to the metal belts **2a** by furnishing the load **34** to the driven pulley **33** which performs downward movement of the driven pulley **33**. Then, while in the same state and with the motor **31** started, the metal belts **2a** perform circumferential movement in a constant direction (direction of arrow “Y” in FIG. 2). At this stage, the rear face of the metal belts **2a** (the surface which is the ring (metal band) innermost circumference surface and actually comes in contact with the element saddle part **3g** of a metal element **3a**) is inspected with the ring defect inspection part **35**.

The ring defect inspection part **35** comprises a detection section **36** (detection means) for continuously observing the rear face of the metal belts **2a** and for detecting gloss marks possibly scarred to the same surface in the duration of at least one revolution of the ring circumference direction; a ring defect cause determination section **37** (determination means) for performing cause identification in cases where there is existence of a running track and with a running track; and several cause display lamps **38–40**.

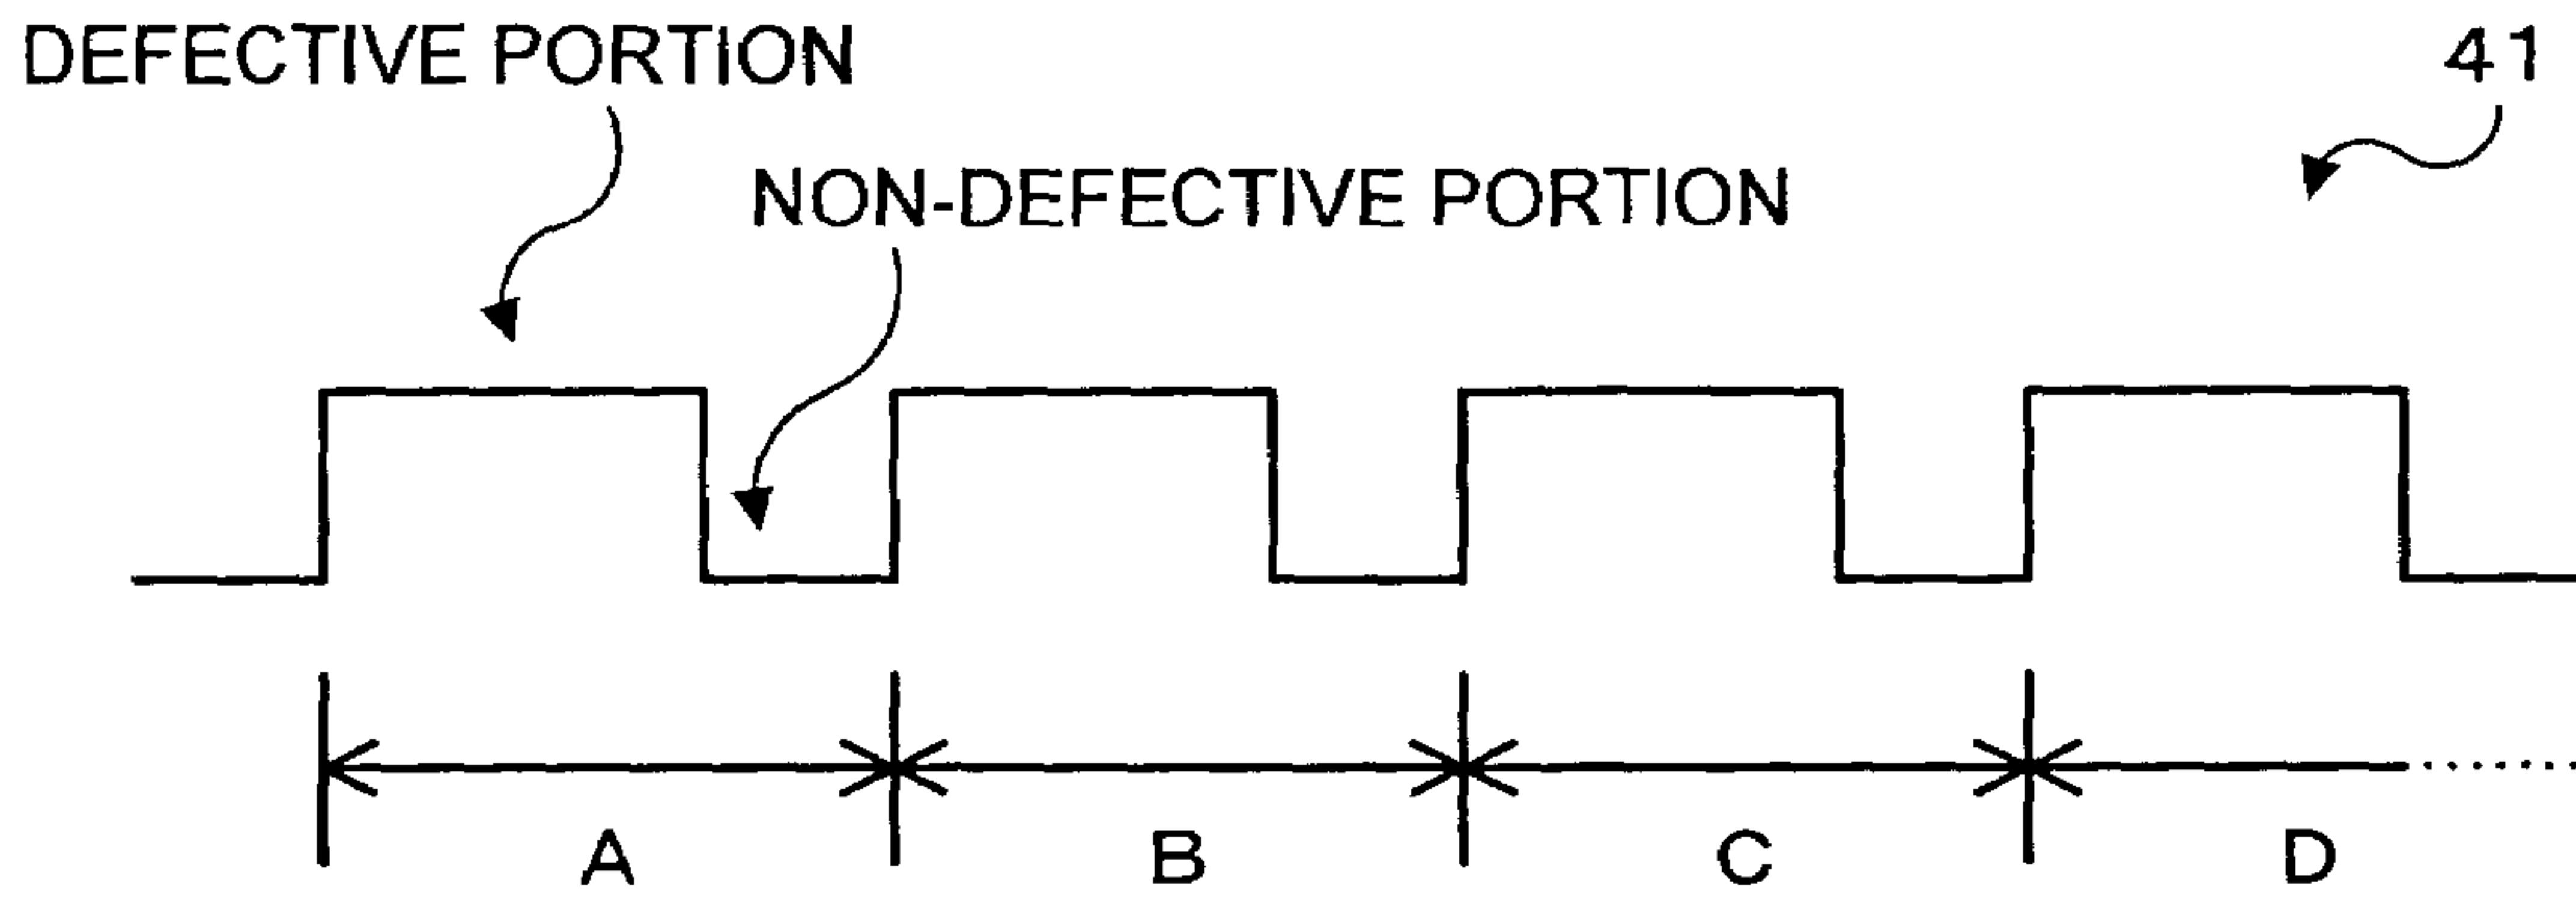
FIG. 3A is a diagram showing the binary signal **41**. The binary signal **41** low logic level segments indicate non-glossy segments within the metal belts **2a** rear face, namely, non-defective portions without flaws. The high logic level segments indicate glossy segments within the same rear face, namely, gloss mark portions (defective portions).

The binary signal **41** length of a high logic level segment is equivalent to L_a and the interval of a low logic level segment is equivalent to L_b . Further, one cycle length of a high logic level segment and a low logic level segment is equivalent to L_c .

At this stage, each cycle length of the binary signal **41** inputted into the ring defect cause determination section **37** is designated as “A”, “B”, “C”, “D”, . . . for convenience. Then, such cycle lengths are sequentially saved to a predetermined table in the ring defect cause determination section **37**. In addition, the “A”, “B”, “C”, “D” seen in FIG. 3A are simply only substitutes and do not illustrate actual values. Therefore,

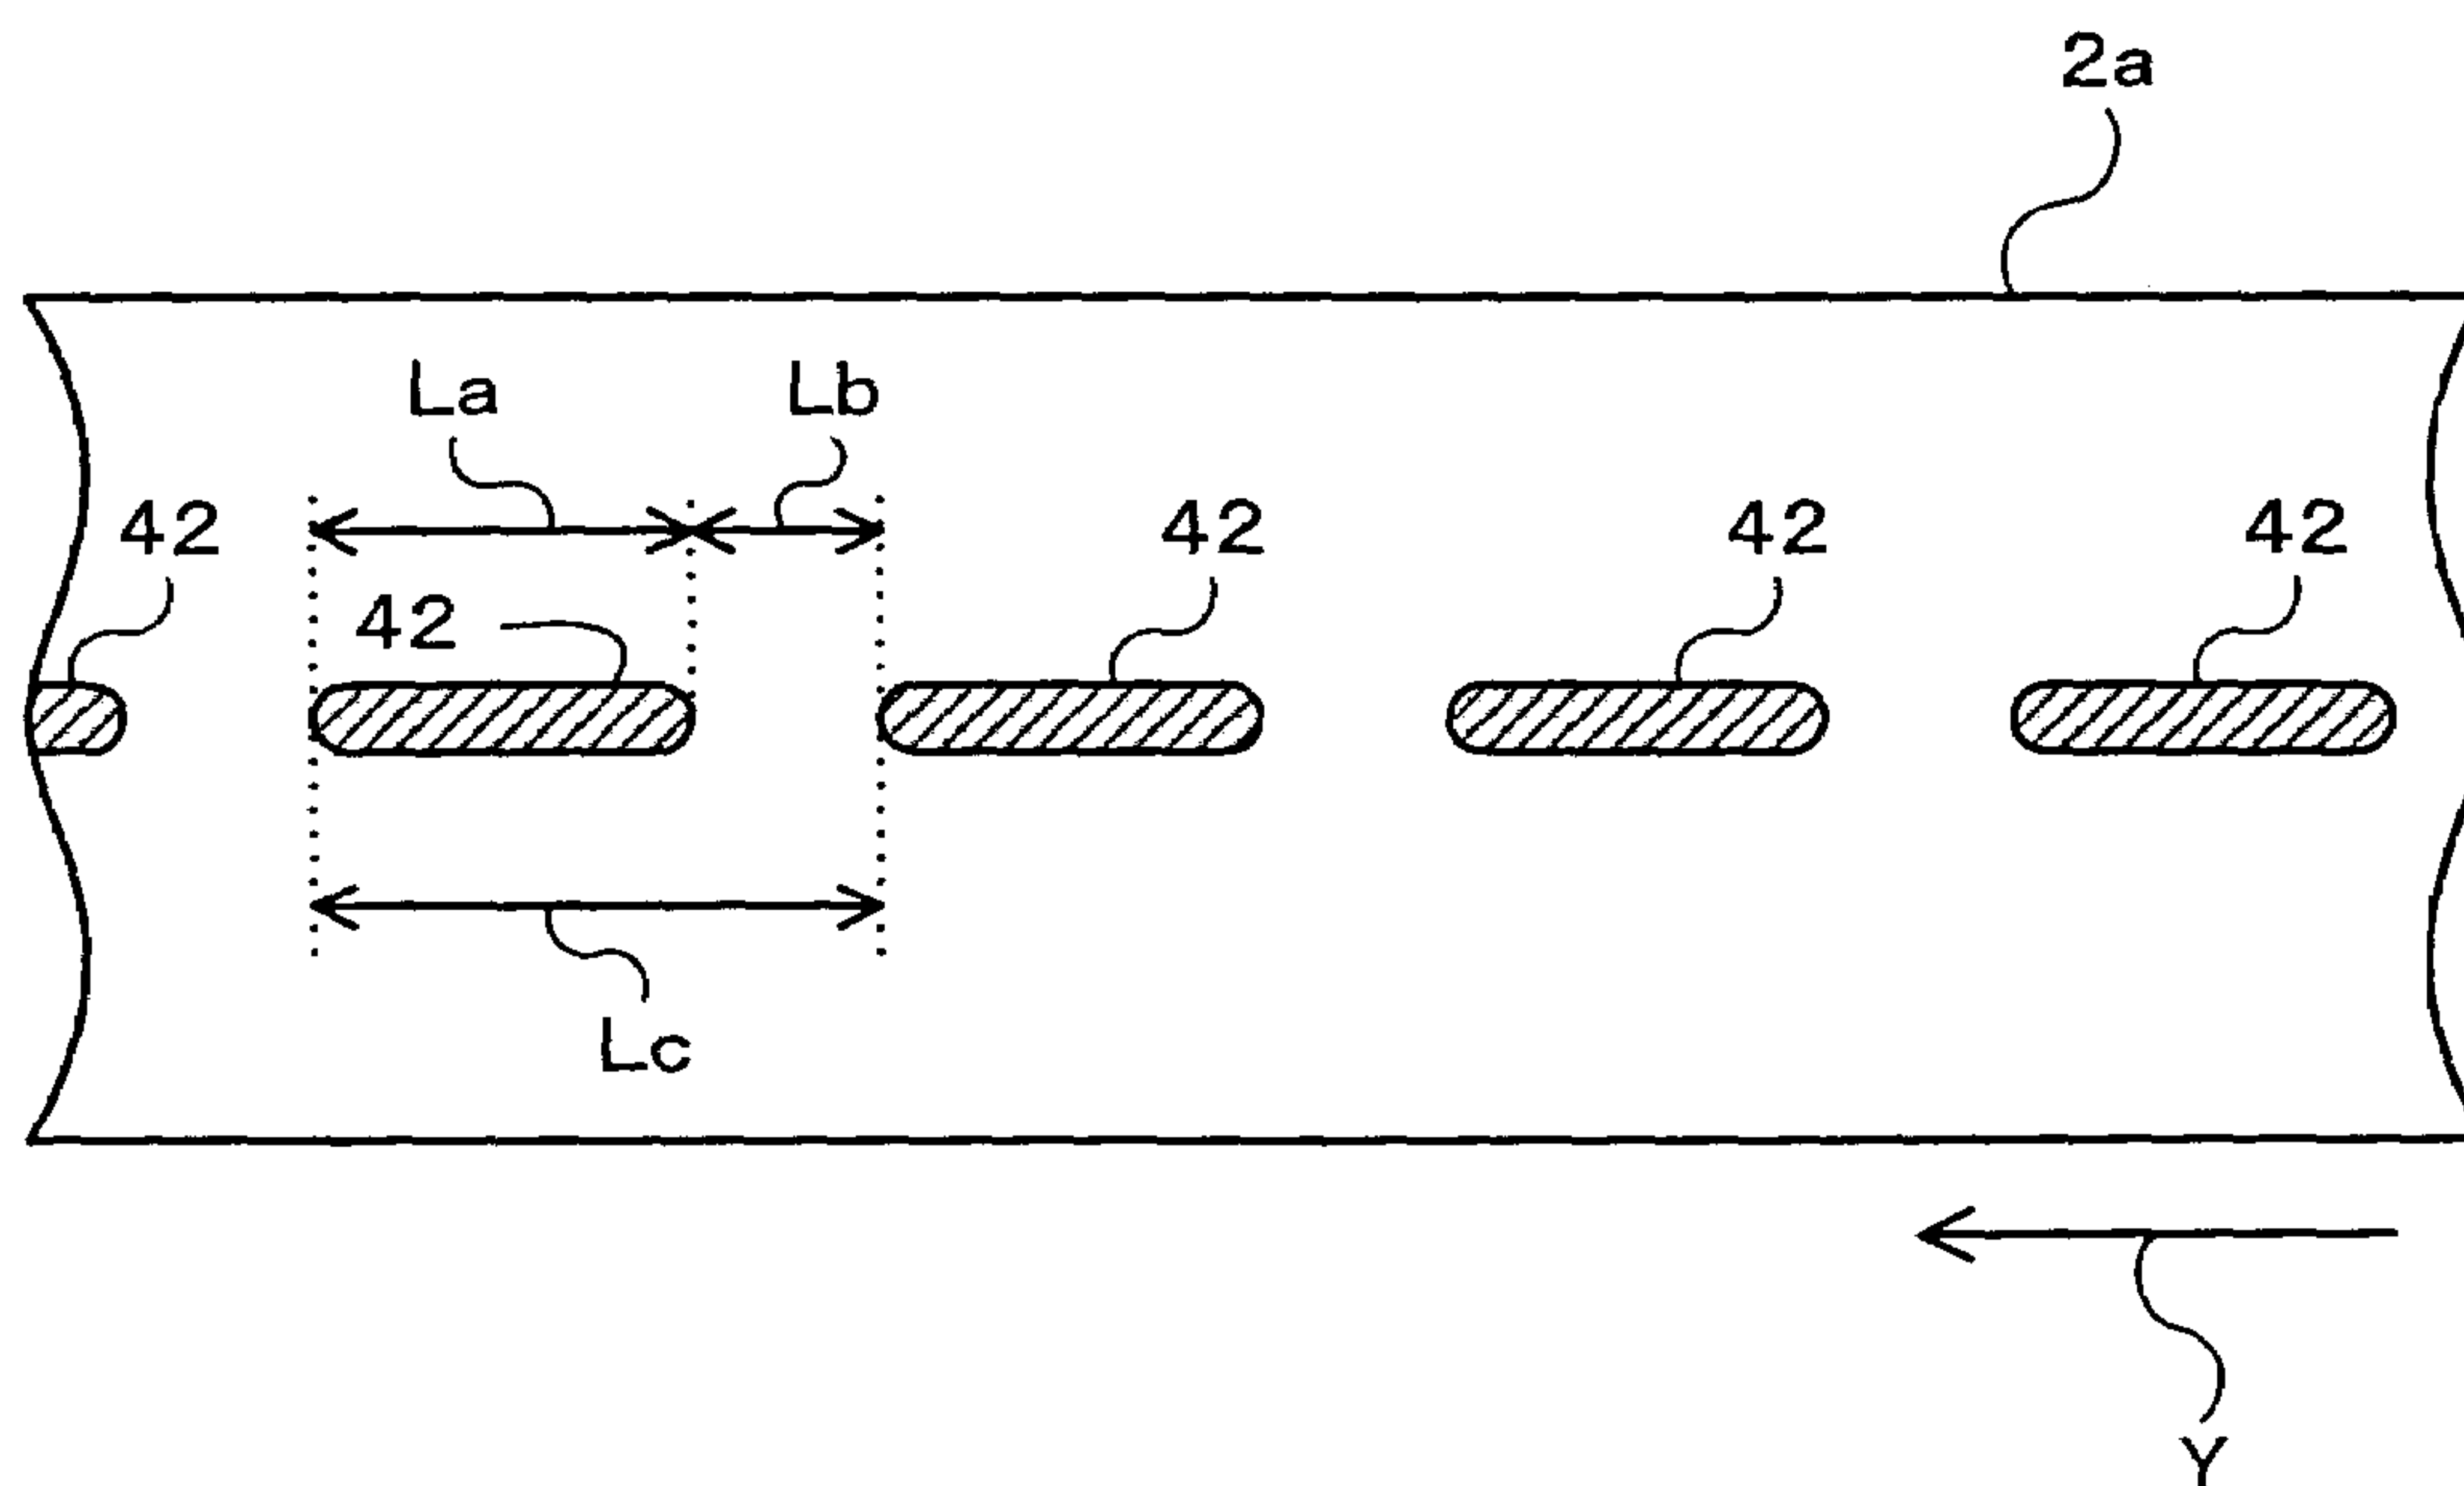
FIG. 3B is a mimetic diagram showing a running track. The rear face of the metal belts **2a** as seen in FIG. 3B, the gloss marks **42** (intermittent flaws) are scarred intermittently in the circumferential direction. When L_a denoting length of a gloss mark **42** in the circumferential direction is performed to L_b denoting interval (spacing) of a gloss mark **42** in the circumferential direction, the pitch of that gloss mark **42** constitutes L_c ($L_c=L_a+L_b$). These measurements of L_a , L_b and L_c are determined in proportion to the “difference” between the circumferential traveling speed of the layered elements **3** and the circumferential traveling speed of the two laminated belts **2**.

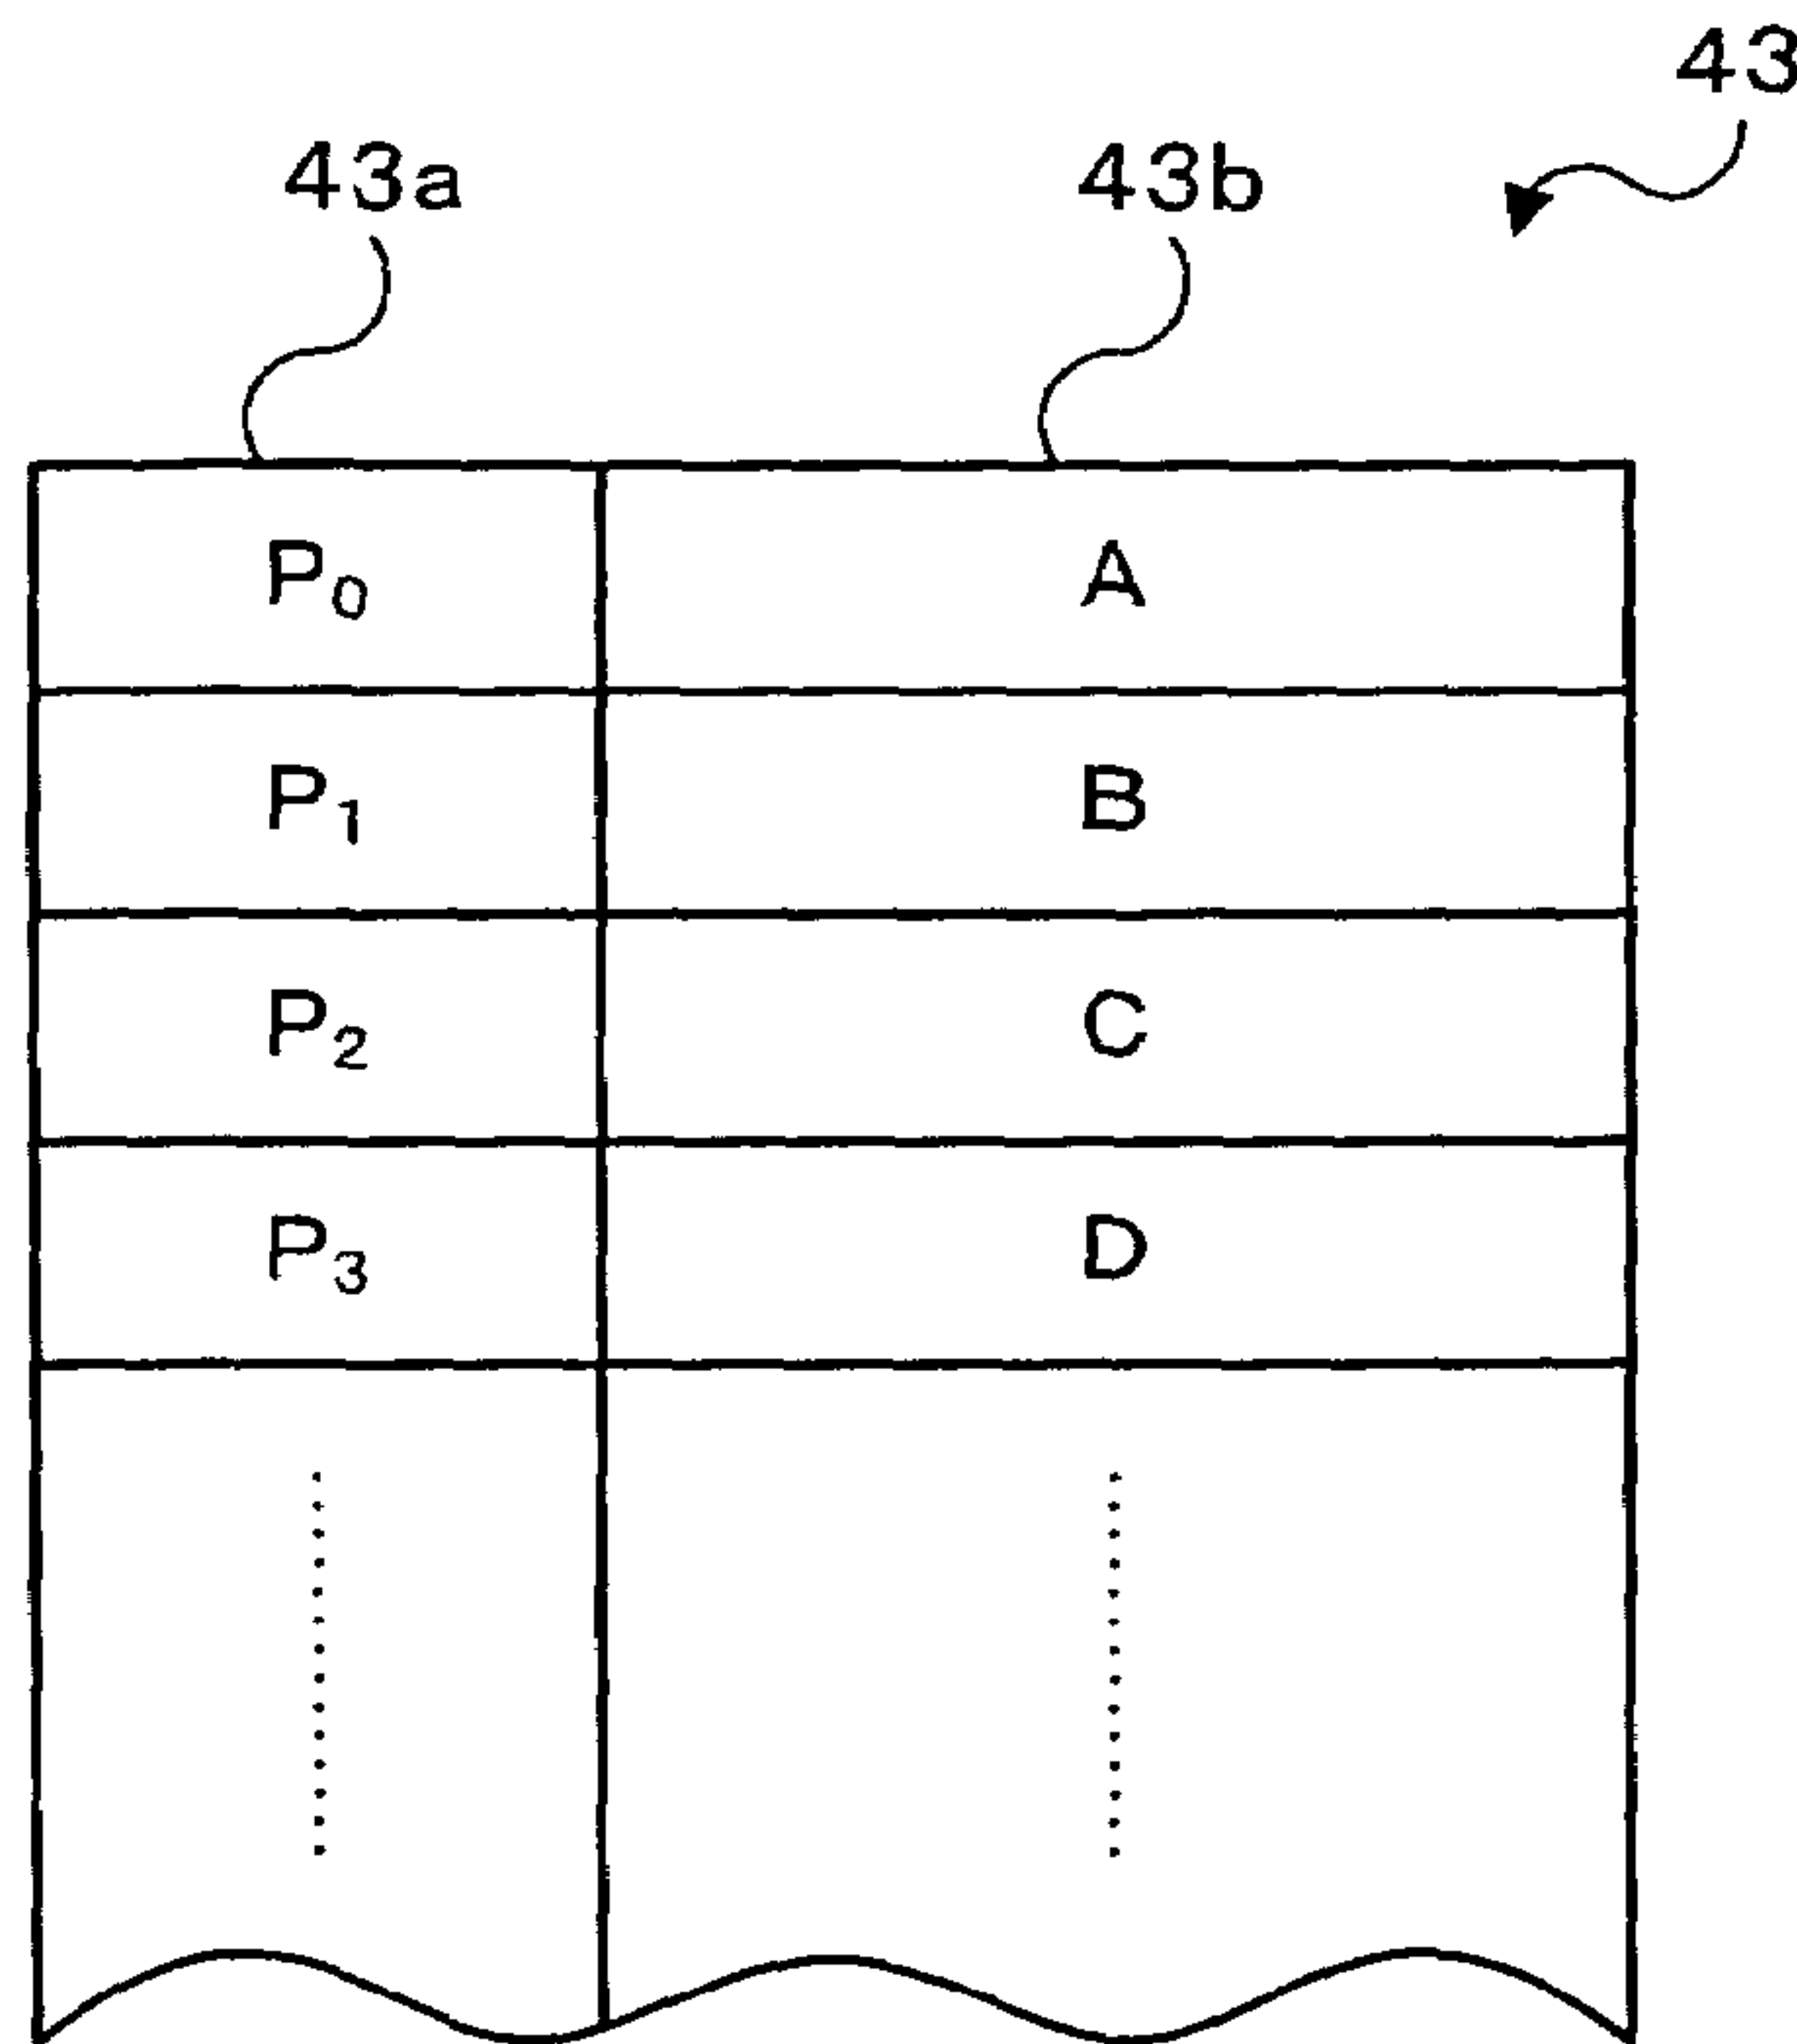
FIG. 4A is a conceptual diagram showing a predetermined table. The table **43** contains a cycle number field **43a** for storing the cycle numbers $P_0, P_1, P_2, P_3, \dots$ and a cycle length field **43b** for storing each cycle length (“A”, “B”, “C”, “D”, . . .).

Essentially, the ring defect cause determination section **37** stores an entire cycle length equivalent to at least one revolution of a metal belt **2a** in the table **43**. In cases where the cycle length distribution stored in the table **43** is examined and falls within a predetermined distribution tendency, the object is judged as the generation cause of a “running track” and attributed to an irregular-shaped area formed on the element saddle part **3g** on one of the metal elements **3a**. This results in one of the predetermined lamps lighting up (for convenience, the ring defect detection lamp **38** for an element saddle part irregular-shaped area).
