(10) **Patent No.:** **US 7,444,892 B2**
(45) **Date of Patent:** **Nov. 4, 2008**

(54) **CONTINUOUSLY VARIABLE TRANSMISSION BELT INSPECTION METHOD AND INSPECTION DEVICE THEREOF**

(73) Assignee: **Jatco Ltd.** (JP)

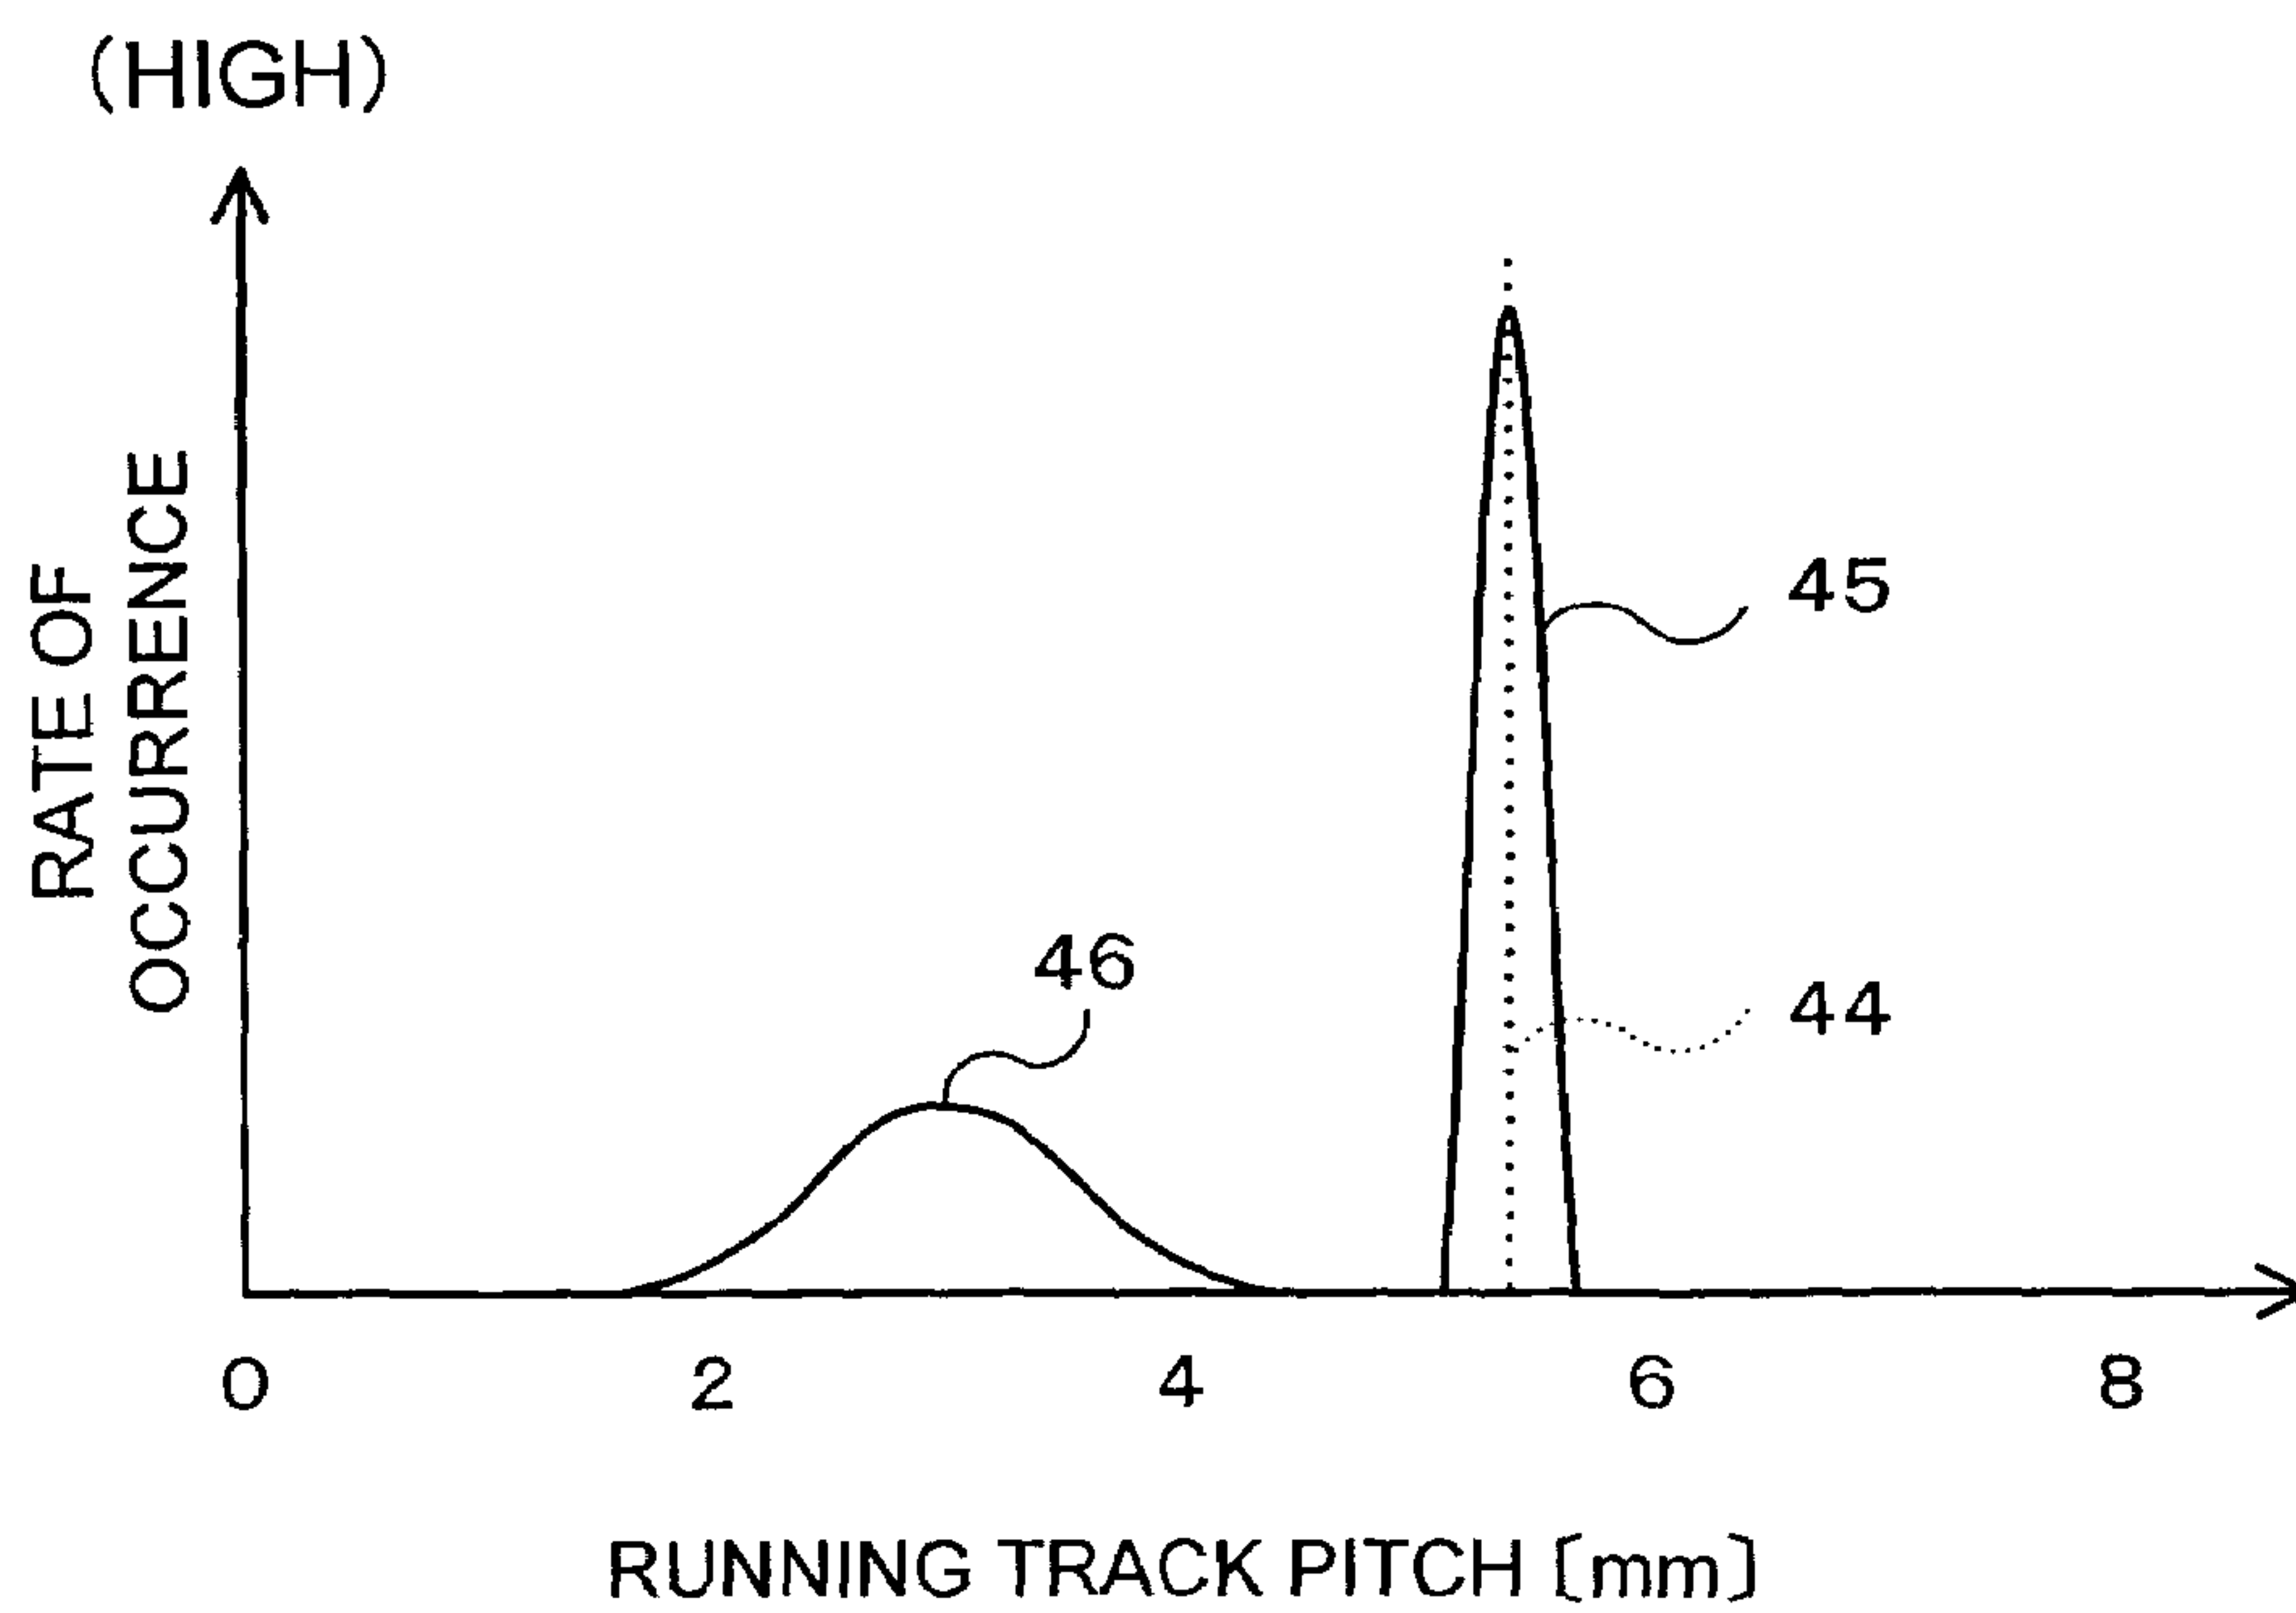
FIG. 4B is a conceptual diagram showing a rate of occurrence graph of a running track pitch (L_c). In this diagram, the vertical axis denotes the “rate of occurrence” and the horizontal axis denotes the “running track pitch.” Within the graph, a dotted line **44** (reference period) denotes the theoretical value of the running track pitch based on the relative speed difference of the metal elements **3a** and the metal belts **2a**. For example, this theoretical value is placed between 5 mm to 6 mm (0.19 in. to 0.23 in.). Meanwhile, the solid lines illustrate two characteristic lines **45**, **46** of test results performed by the inventors. The right side characteristic line **45** which is distributed narrowly (accordingly, constant periodicity was observed) using the substantially theoretical value as the center represents an object of an irregular-shaped area formed on the element saddle part **3g** on one of the metal elements **3a**. The left side characteristic line **46** which is distributed widely (accordingly, constant periodicity was not observed) and discriminated distinctly below the theoretical value represents a substance of an innocuous impurity, for example, metal powder, etc., which penetrated into the CVT belt **1**.

In this manner, even though termed simply as a “running track,” there are definite differences in the pitch periodicity proportionate to each of these two causes (an object attributable to an irregular-shaped area and a substance attributable to an impurity, for example metal powder, etc.). Thus, the generation causes (an object attributable to an irregular-shaped area and a substance attributable to an impurity, for example metal powder, etc.) of a running track can be accurately identified using these differences. In addition, constant periodicity observed in a running track is an indication of an irregular-shaped area as the cause because the position of an irregular-shaped area is unchangeable. On the other hand,

constant periodicity not observed in a running track is an indication of an impurity as the cause because the position of a substance impurity dissimilarly changes.

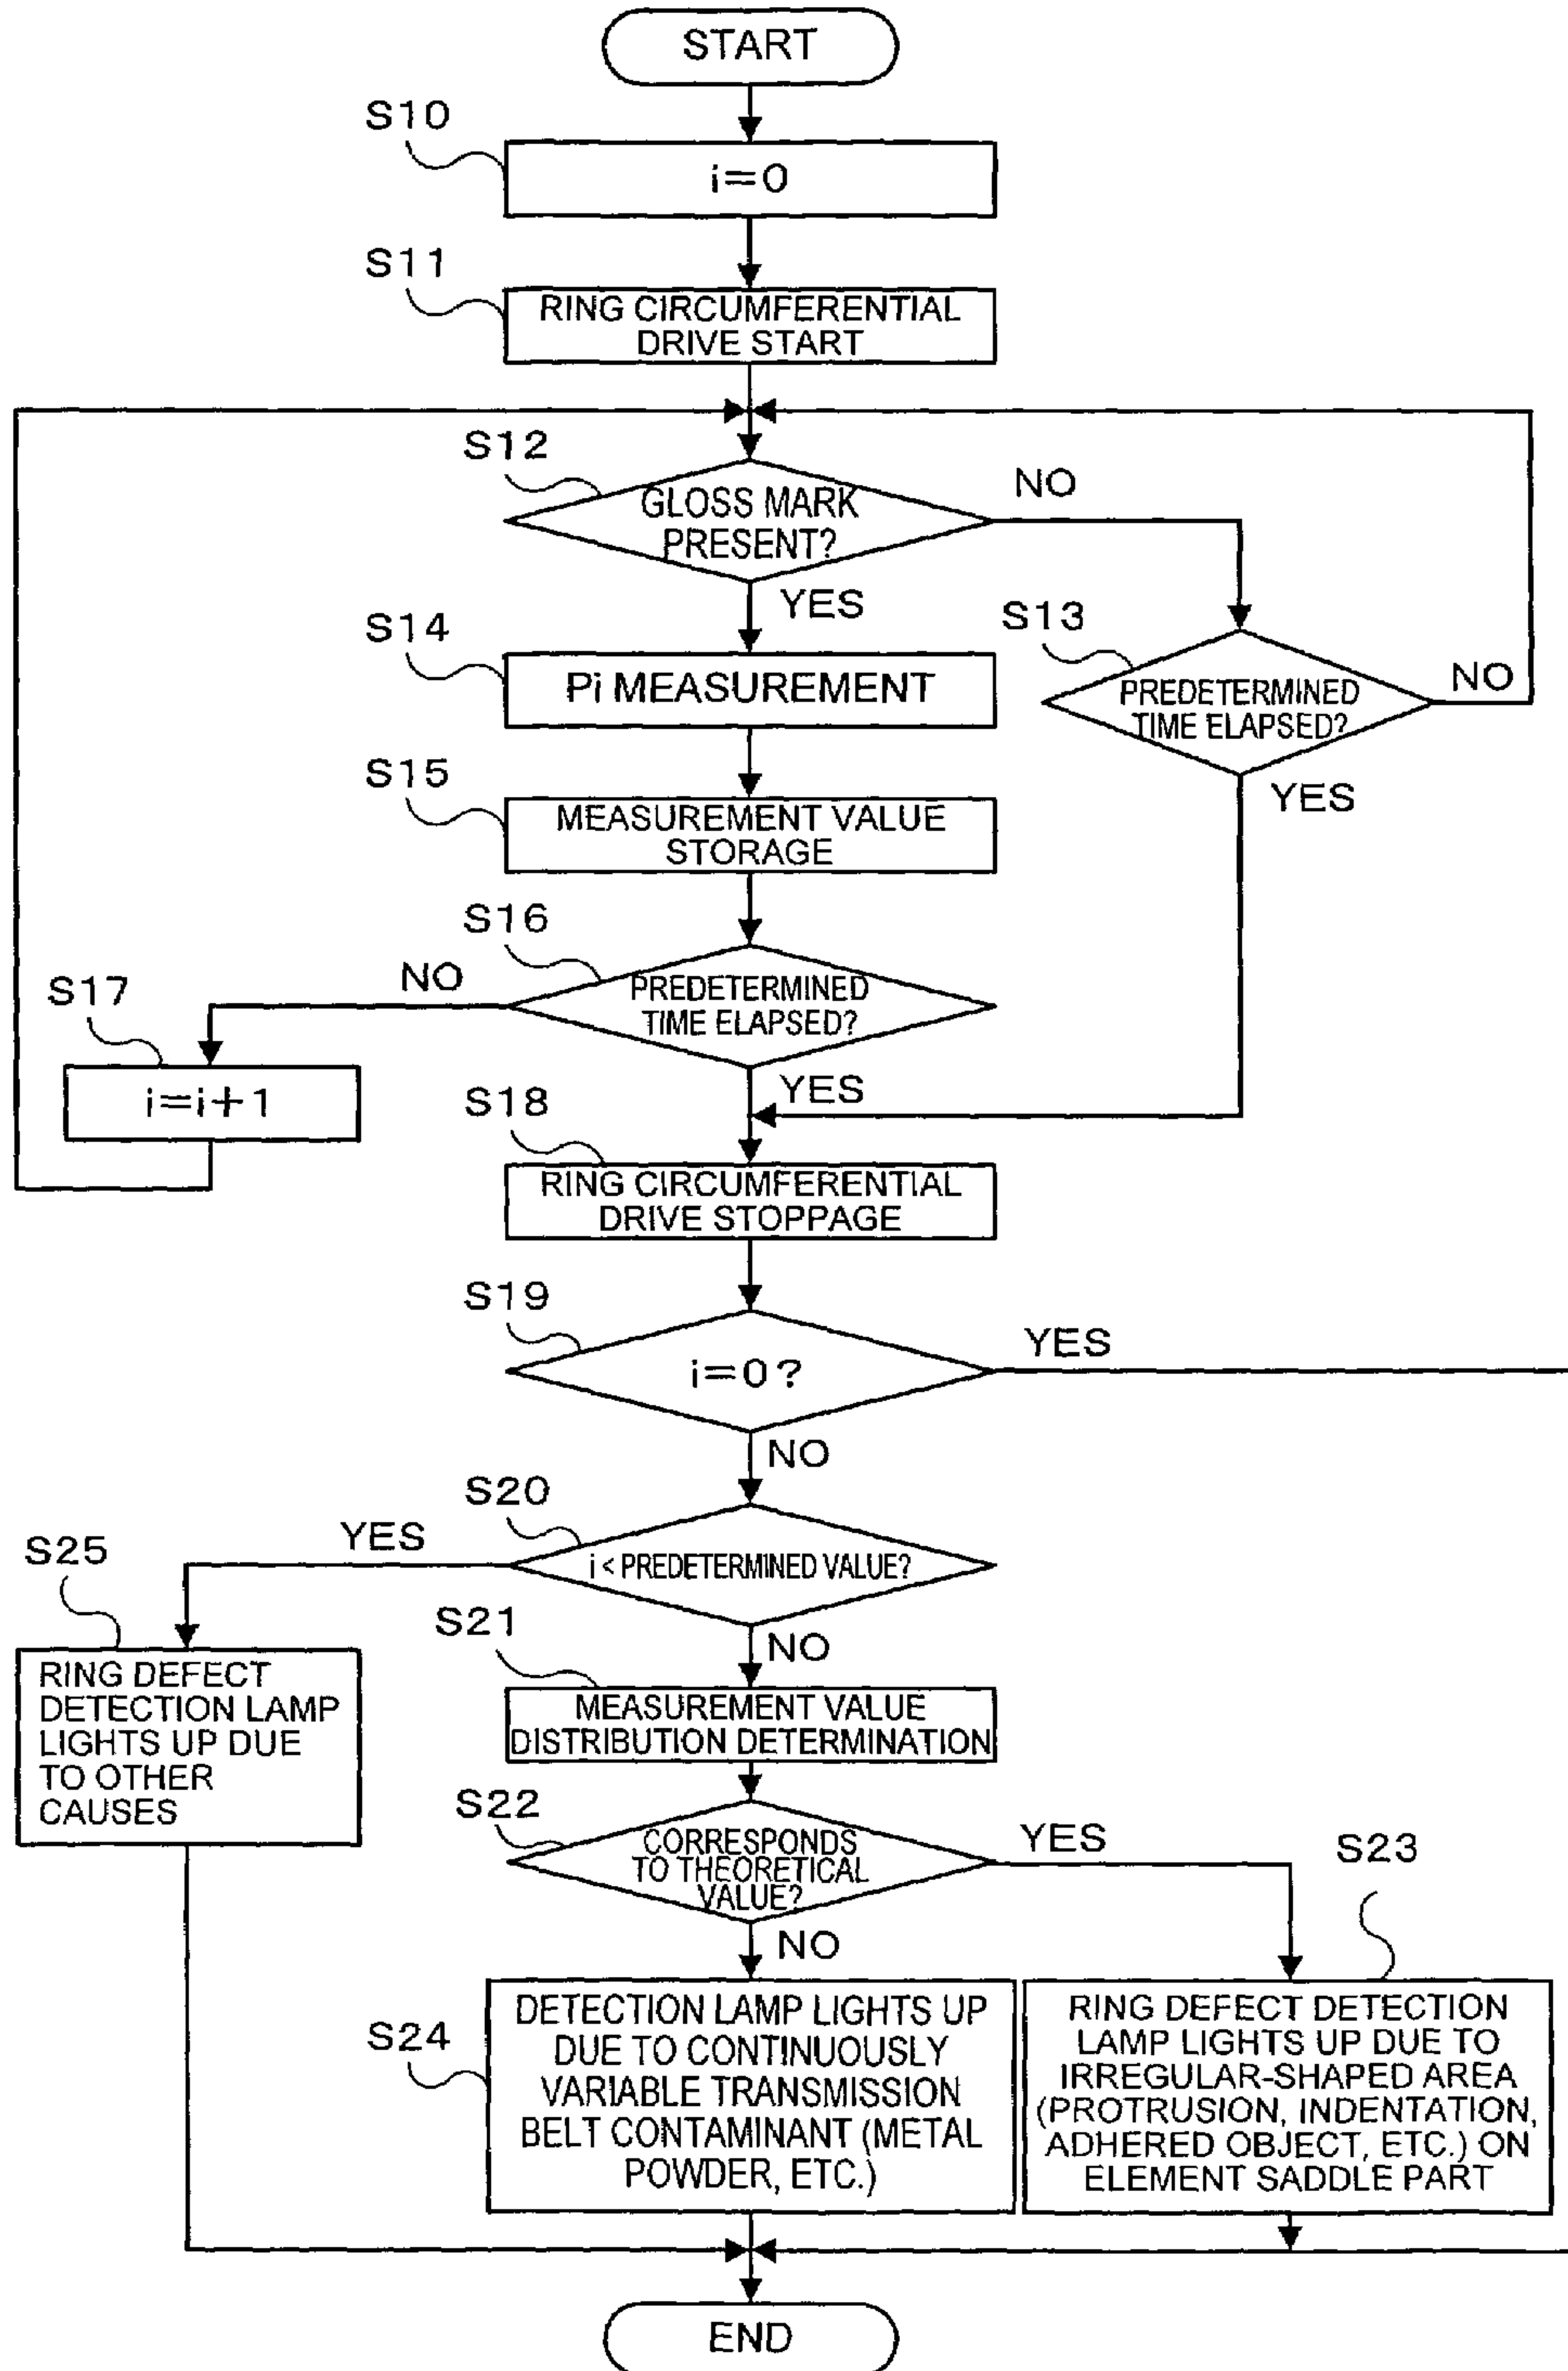
FIG. 5 is a diagram showing an operation flow chart of a ring defect cause determination section 37;

FIG. 5 is a diagram showing an operation flow chart of the ring defect cause determination section 37 which adapts the above principle. As seen in this flow chart, first, an initial value (0) is set to a loop variable *i* (Step S10), and ring circumferential drive (drive of the motor 31) is started (Step S11).

Then, ring circumferential drive is stopped (Step S18). Next, the operation judges whether or not the loop variable *i* remains as the initial value (0) (Step S19). When the loop variable *i* remains as the initial value (0), the above-mentioned loop is also not executed once. Namely, this signifies that during one rotation of the metal belts 2a, gloss marks are also not detected one time. Accordingly, in this case, because the metal belts 2a are non-defective, the program is terminated in that condition.

Meanwhile, when the loop variable *i* is not the initial value (0), subsequently the operation judges whether or not the loop variable *i* is less than a predetermined value (Step S20). Here, a predetermined value is a reference value for judging the extent of a gloss mark in one or several places other than a running track. When the loop variable *i* is less than a predetermined value, the cause of any gloss marks is neither an object attributable to an irregular-shaped area on an element saddle part 3g nor an impurity which penetrated into the CVT belt 1. As this indicates an "other" cause, a lamp for specifying that result lights up (for example, the ring defect detection lamp 40 due to "other" causes) (Step S25) and the program is terminated.

When corresponding to the theoretical value (dotted line 44), for example, if "A"="B"="C"="D" . . . =5.5 mm (0.21 in.), the operation judges the cause of those gloss marks as an object attributable to an irregular-shaped area on an element saddle part 3g. A lamp for specifying that result lights up (for example, the ring defect detection lamp 38 due to an element saddle part irregular-shaped area) (Step S23) and the program is terminated.

When not corresponding to the theoretical value (dotted line 44), for example, if "A"="B"="C"="D" . . . =2~4 mm (0.07~0.15 in.), the operation judges the cause of those gloss marks as a substance attributable to an impurity, such as metal powder, etc., which penetrated into the CVT belt 1. A lamp for specifying that result lights up (for example, the ring defect detection lamp 39 due to an impurity on the CVT belt 1) (Step S24) and the program is terminated.

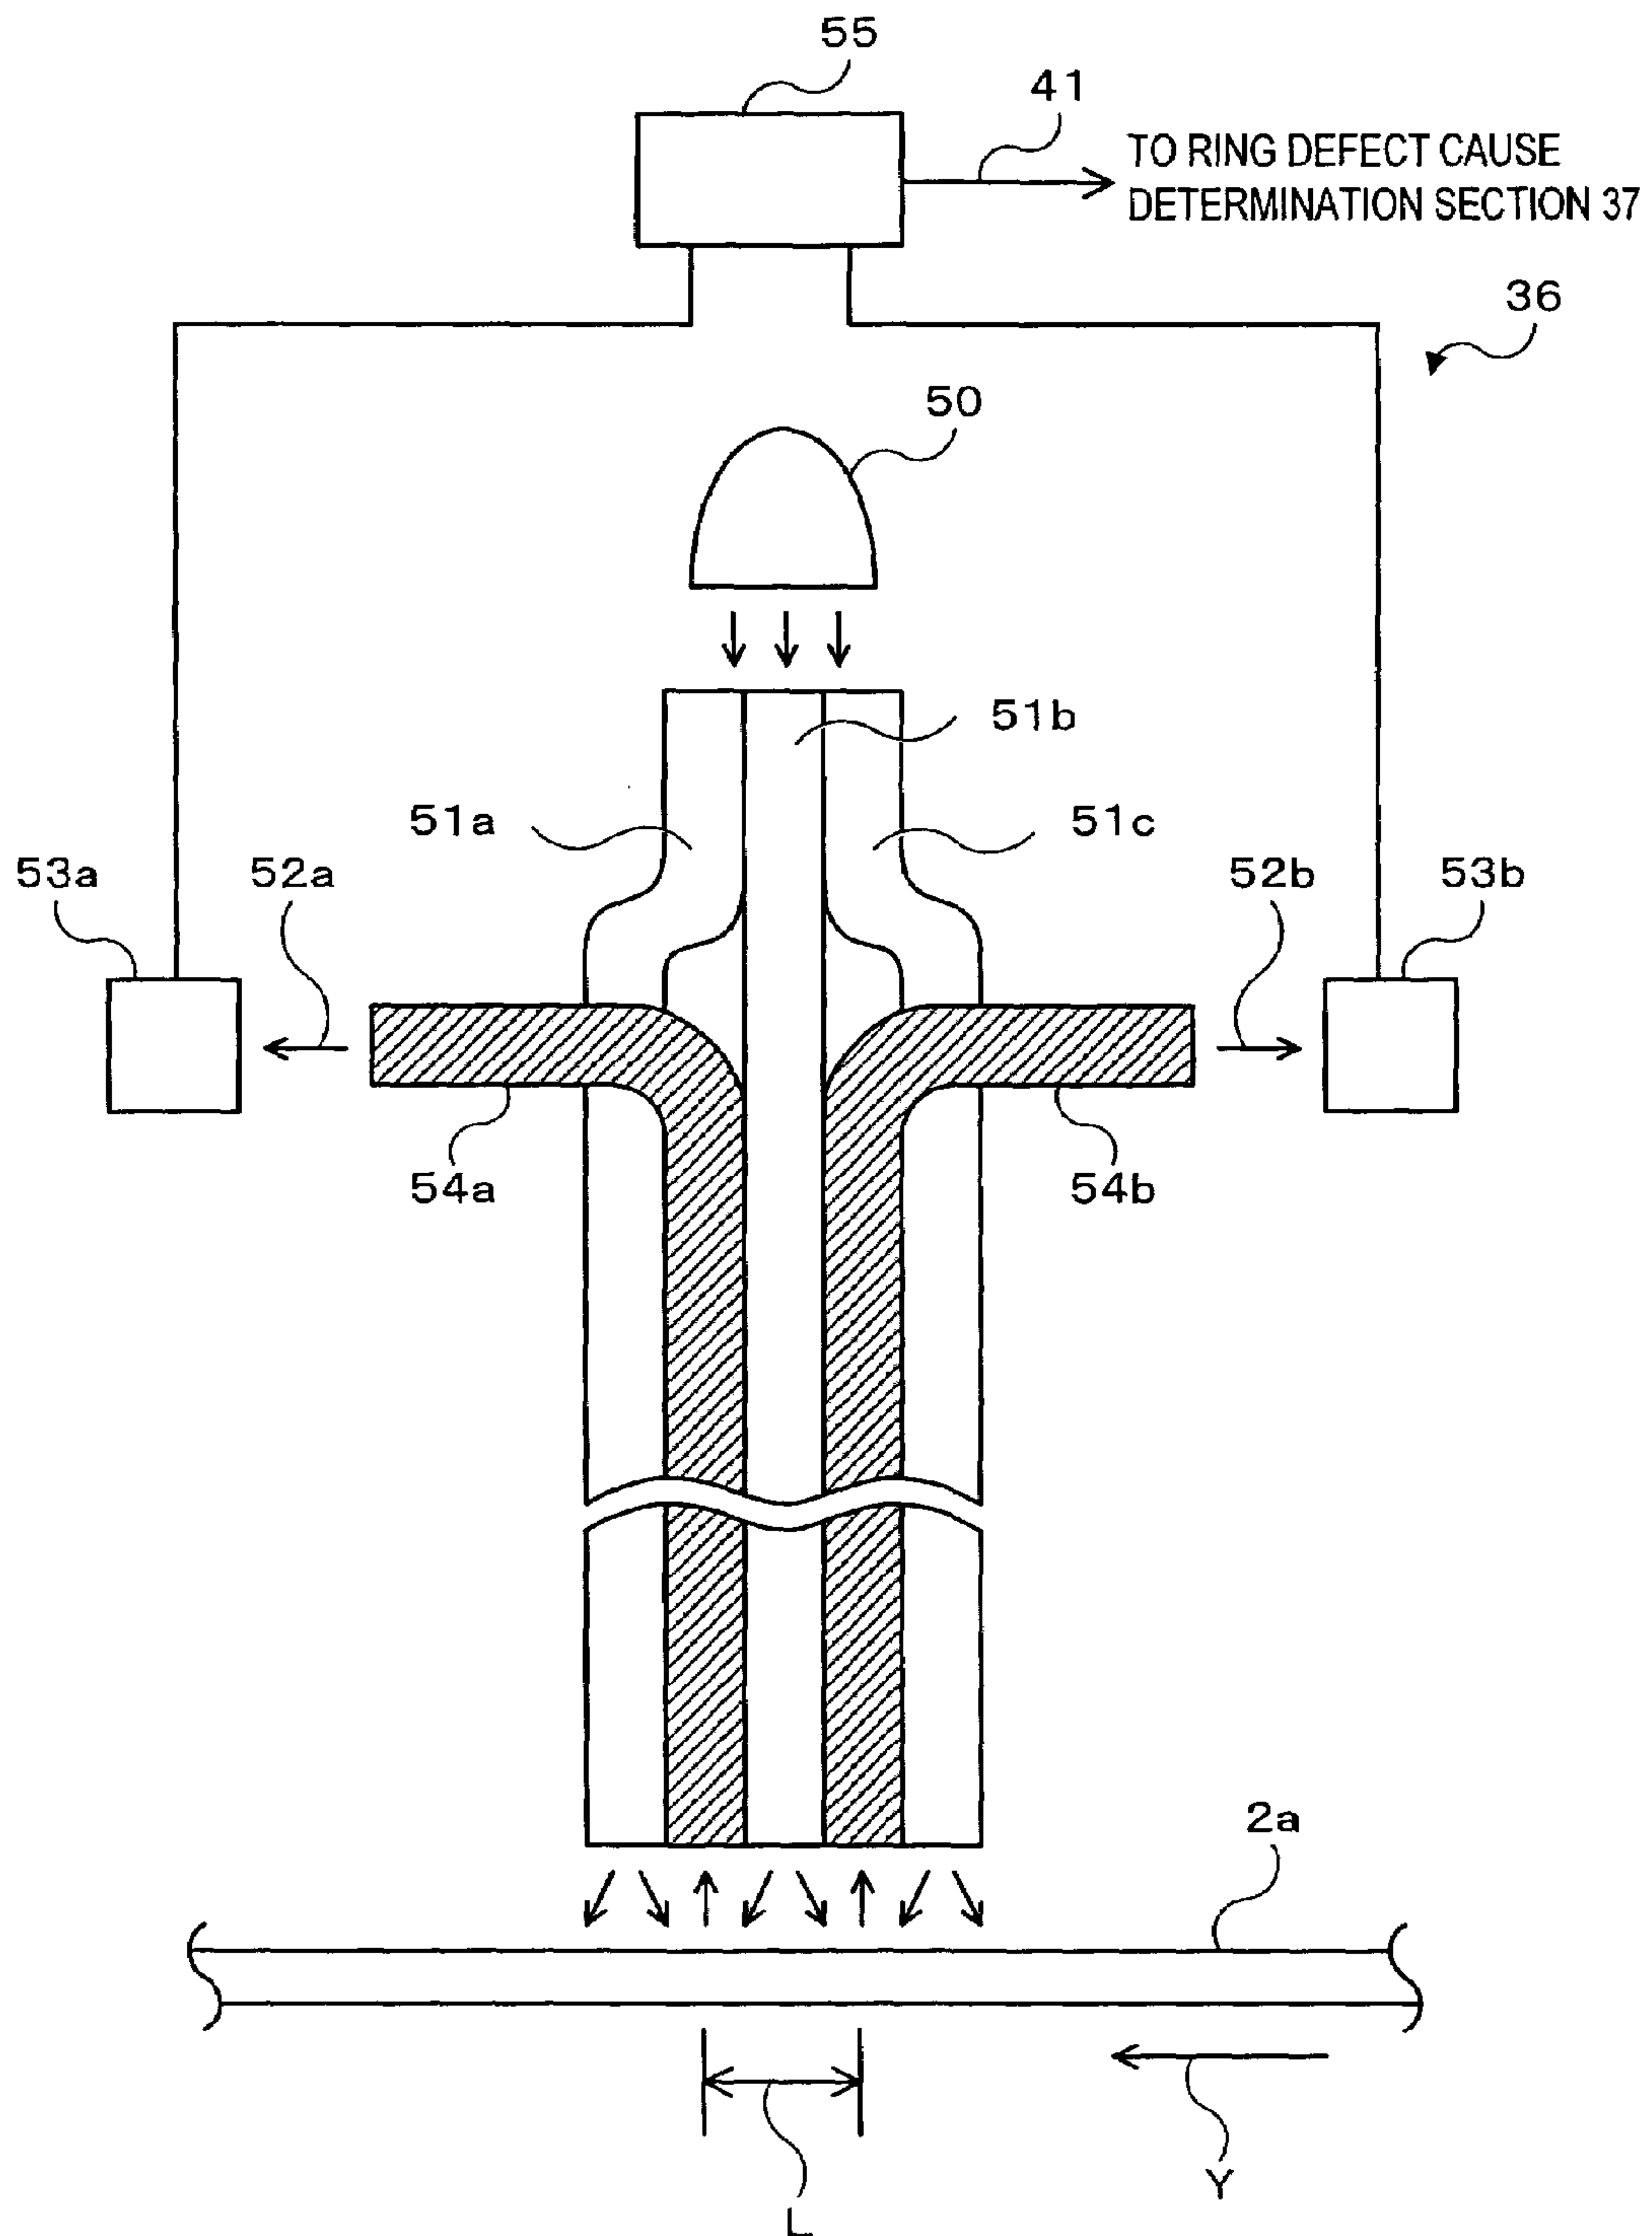
FIG. 6 is another configuration diagram of a detection section 36;

Additionally, in the above embodiment, although an imaging unit, for example, a CCD, etc., is utilized for the detection section 36, the present invention is not restricted to this. Briefly, this function can be performed as follows. For example, the imaging unit needs only to be capable of outputting the binary signal 41 for indicating the non-glossy segments (non-defective portions without flaws) and the glossy segments (gloss mark portions with flaws) within the rear face of the metal belts 2a.

In the non-defective portions (non-glossy segments) of the inner circumference surface of the metal belts 2a, the reflected light 52a, 52b guided by the two light guiding paths 54a, 54b for light reception is supplied to the light reception portions 53a, 53b at substantially equivalent intensity. Meanwhile, in the defective portions (glossy segments) of the inner circumference surface of the metal belts 2a, the reflected light of a glossy segment increases. When the magnitude of a gloss mark exceeds the interval L of the two light guiding paths 54a, 54b for light reception, a difference is generated in the reflected light 52a, 52b guided by the two light guiding paths 54a, 54b for light reception. For this reason, in the binary signal generation circuit 55, the binary signal 41 generated

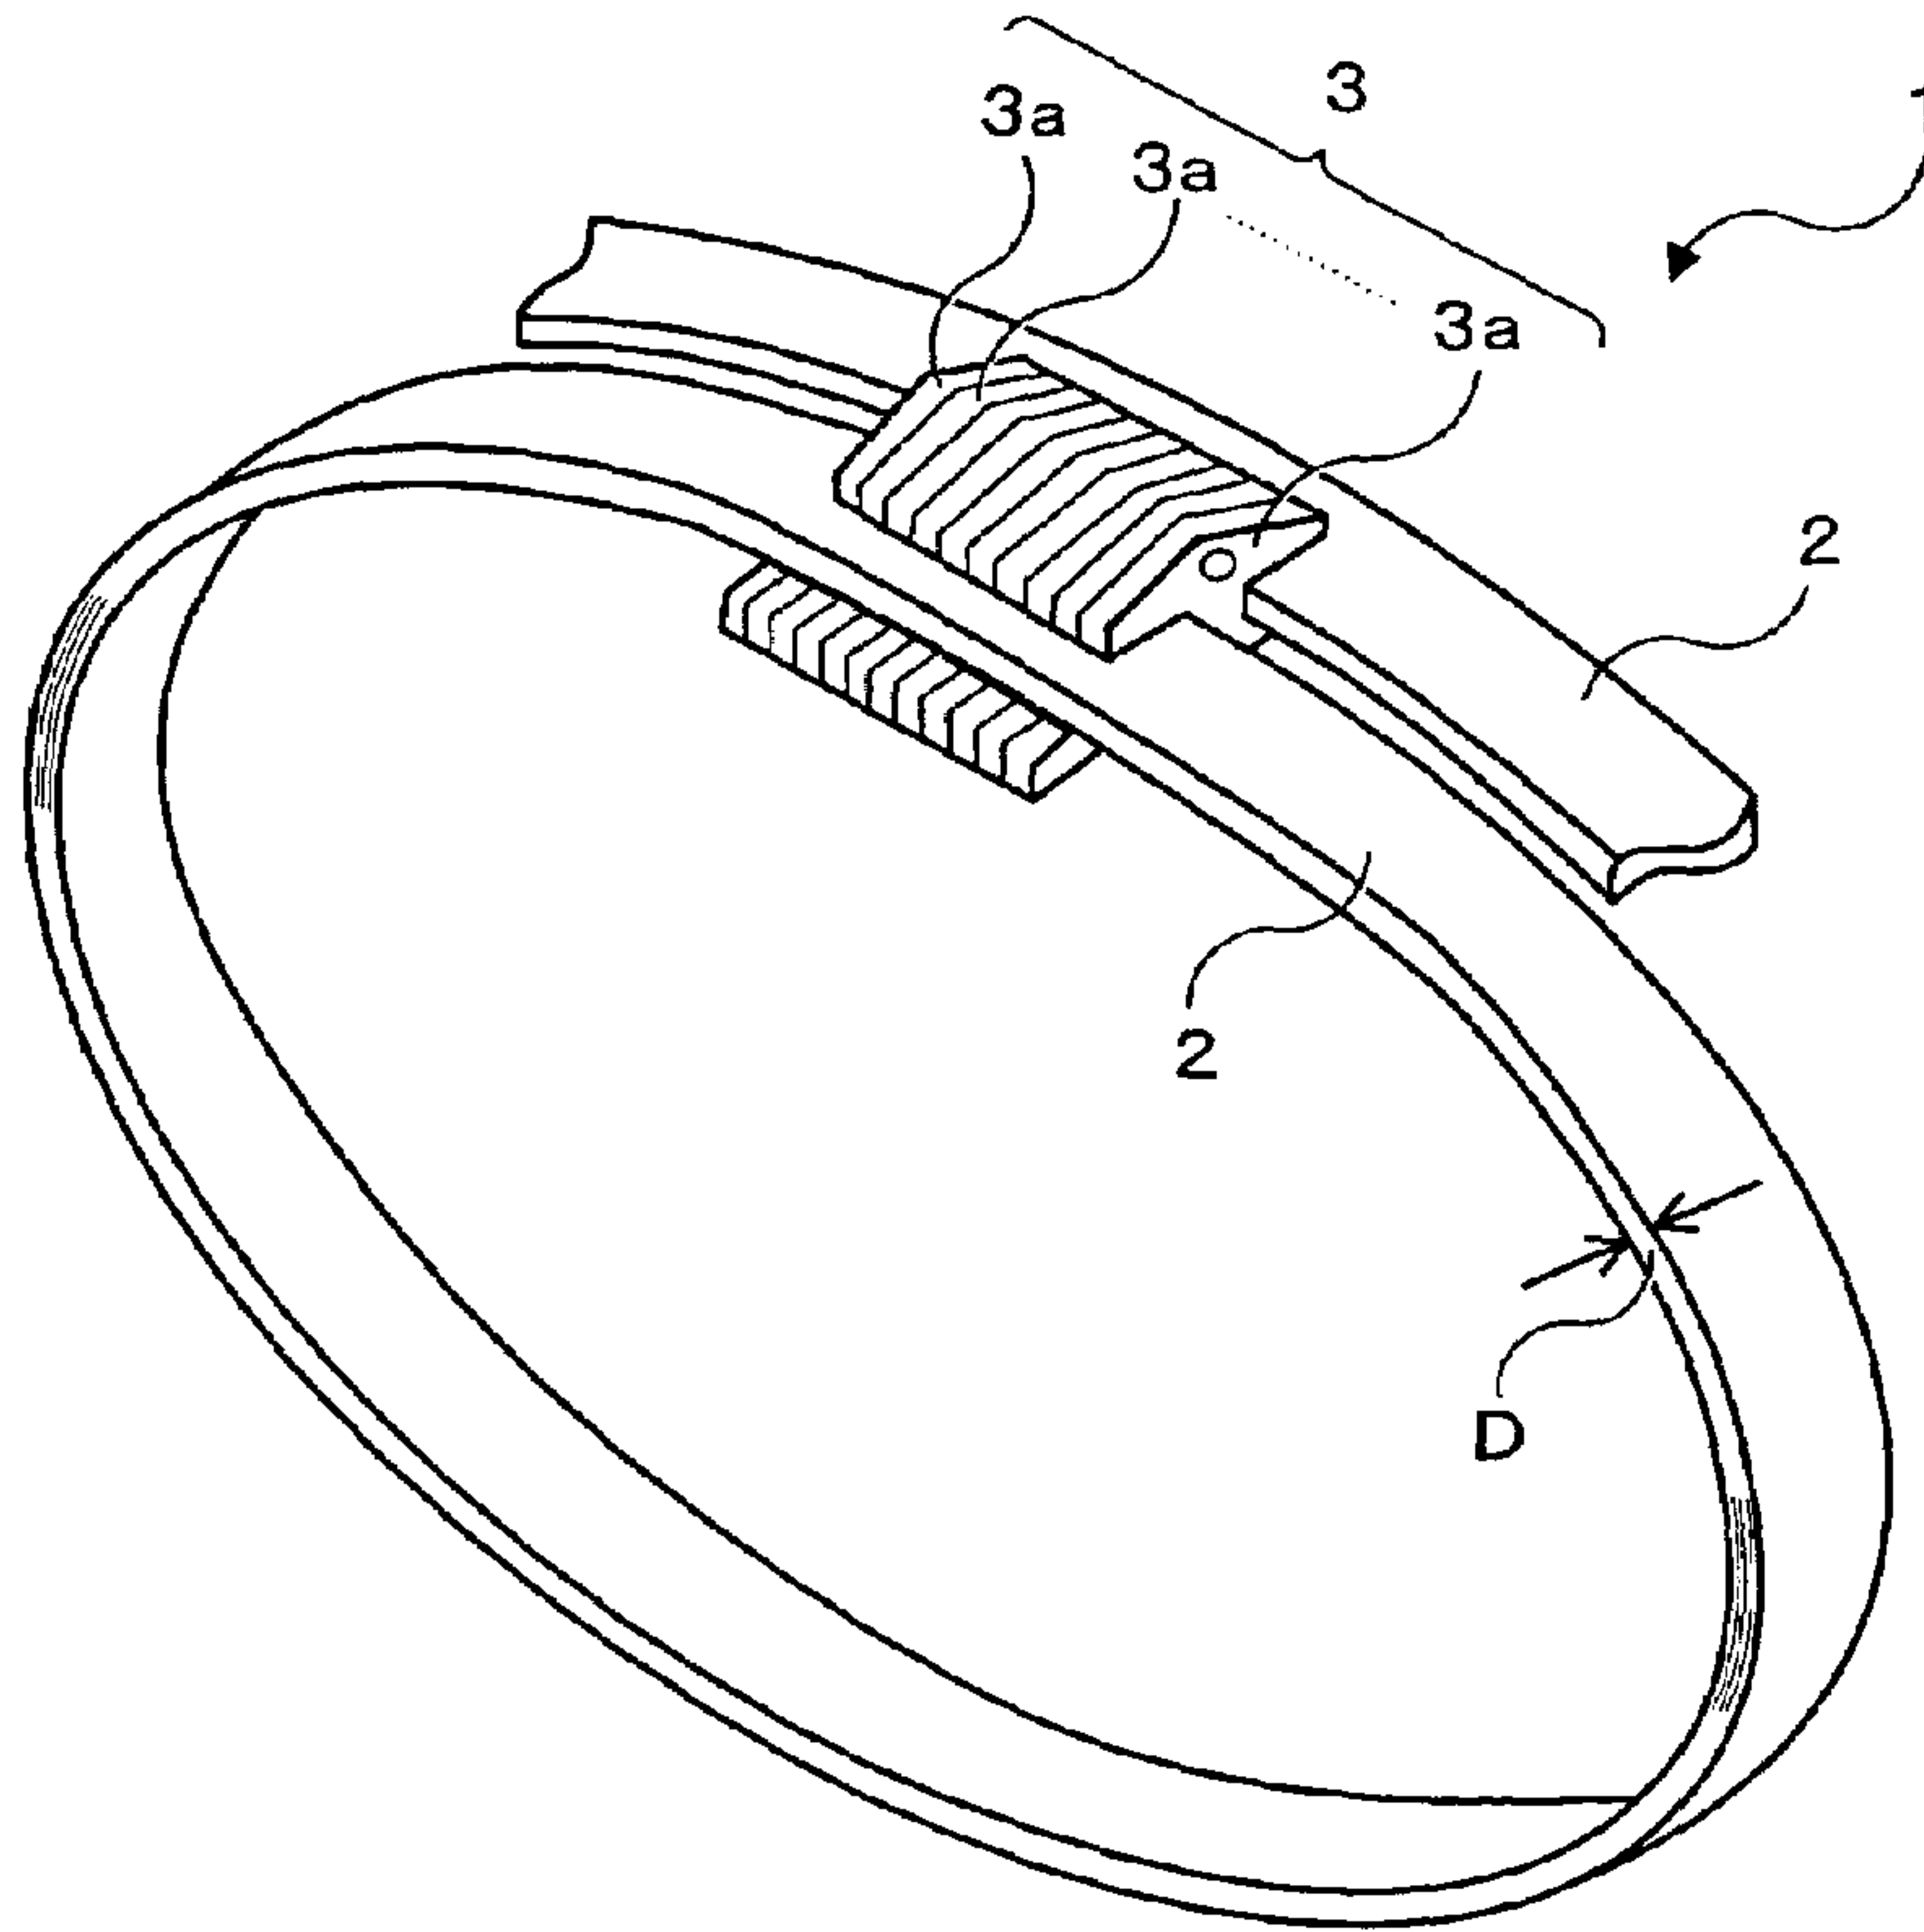
FIG. 7A

FIGS. 7A~7B are outline views of a CVT belt disclosed in Japanese Laid-Open (Kokai) Patent Application No. 2001-21007 titled "BELT FOR CONTINUOUSLY VARIABLE TRANSMISSION", etc. In this diagram, a CVT belt **1** is constructed by assembling two laminated belts **2** containing a plurality of metal belts **2a** (for example, a stack of about 12 endless layers) which are supported by thin trapezoidal layered elements **3** composed of a large number of metal elements **3a** (for example, about 400 consecutive elements).

FIG. 7A~7B are outline views of a CVT belt in conventional prior art; and

Each of the metal elements **3a** consists of a steel block (small piece of metal) punched and processed from a metal plate and molded into a specified shape, for example, the physical form resembling the upper-half image of a human body. Specifically, a metal element **3a** resembles a molded shape having a head portion **3b** and a chest portion **3c**, along with a neck portion **3d** which connects between the head portion **3b** and the chest portion **3c**.

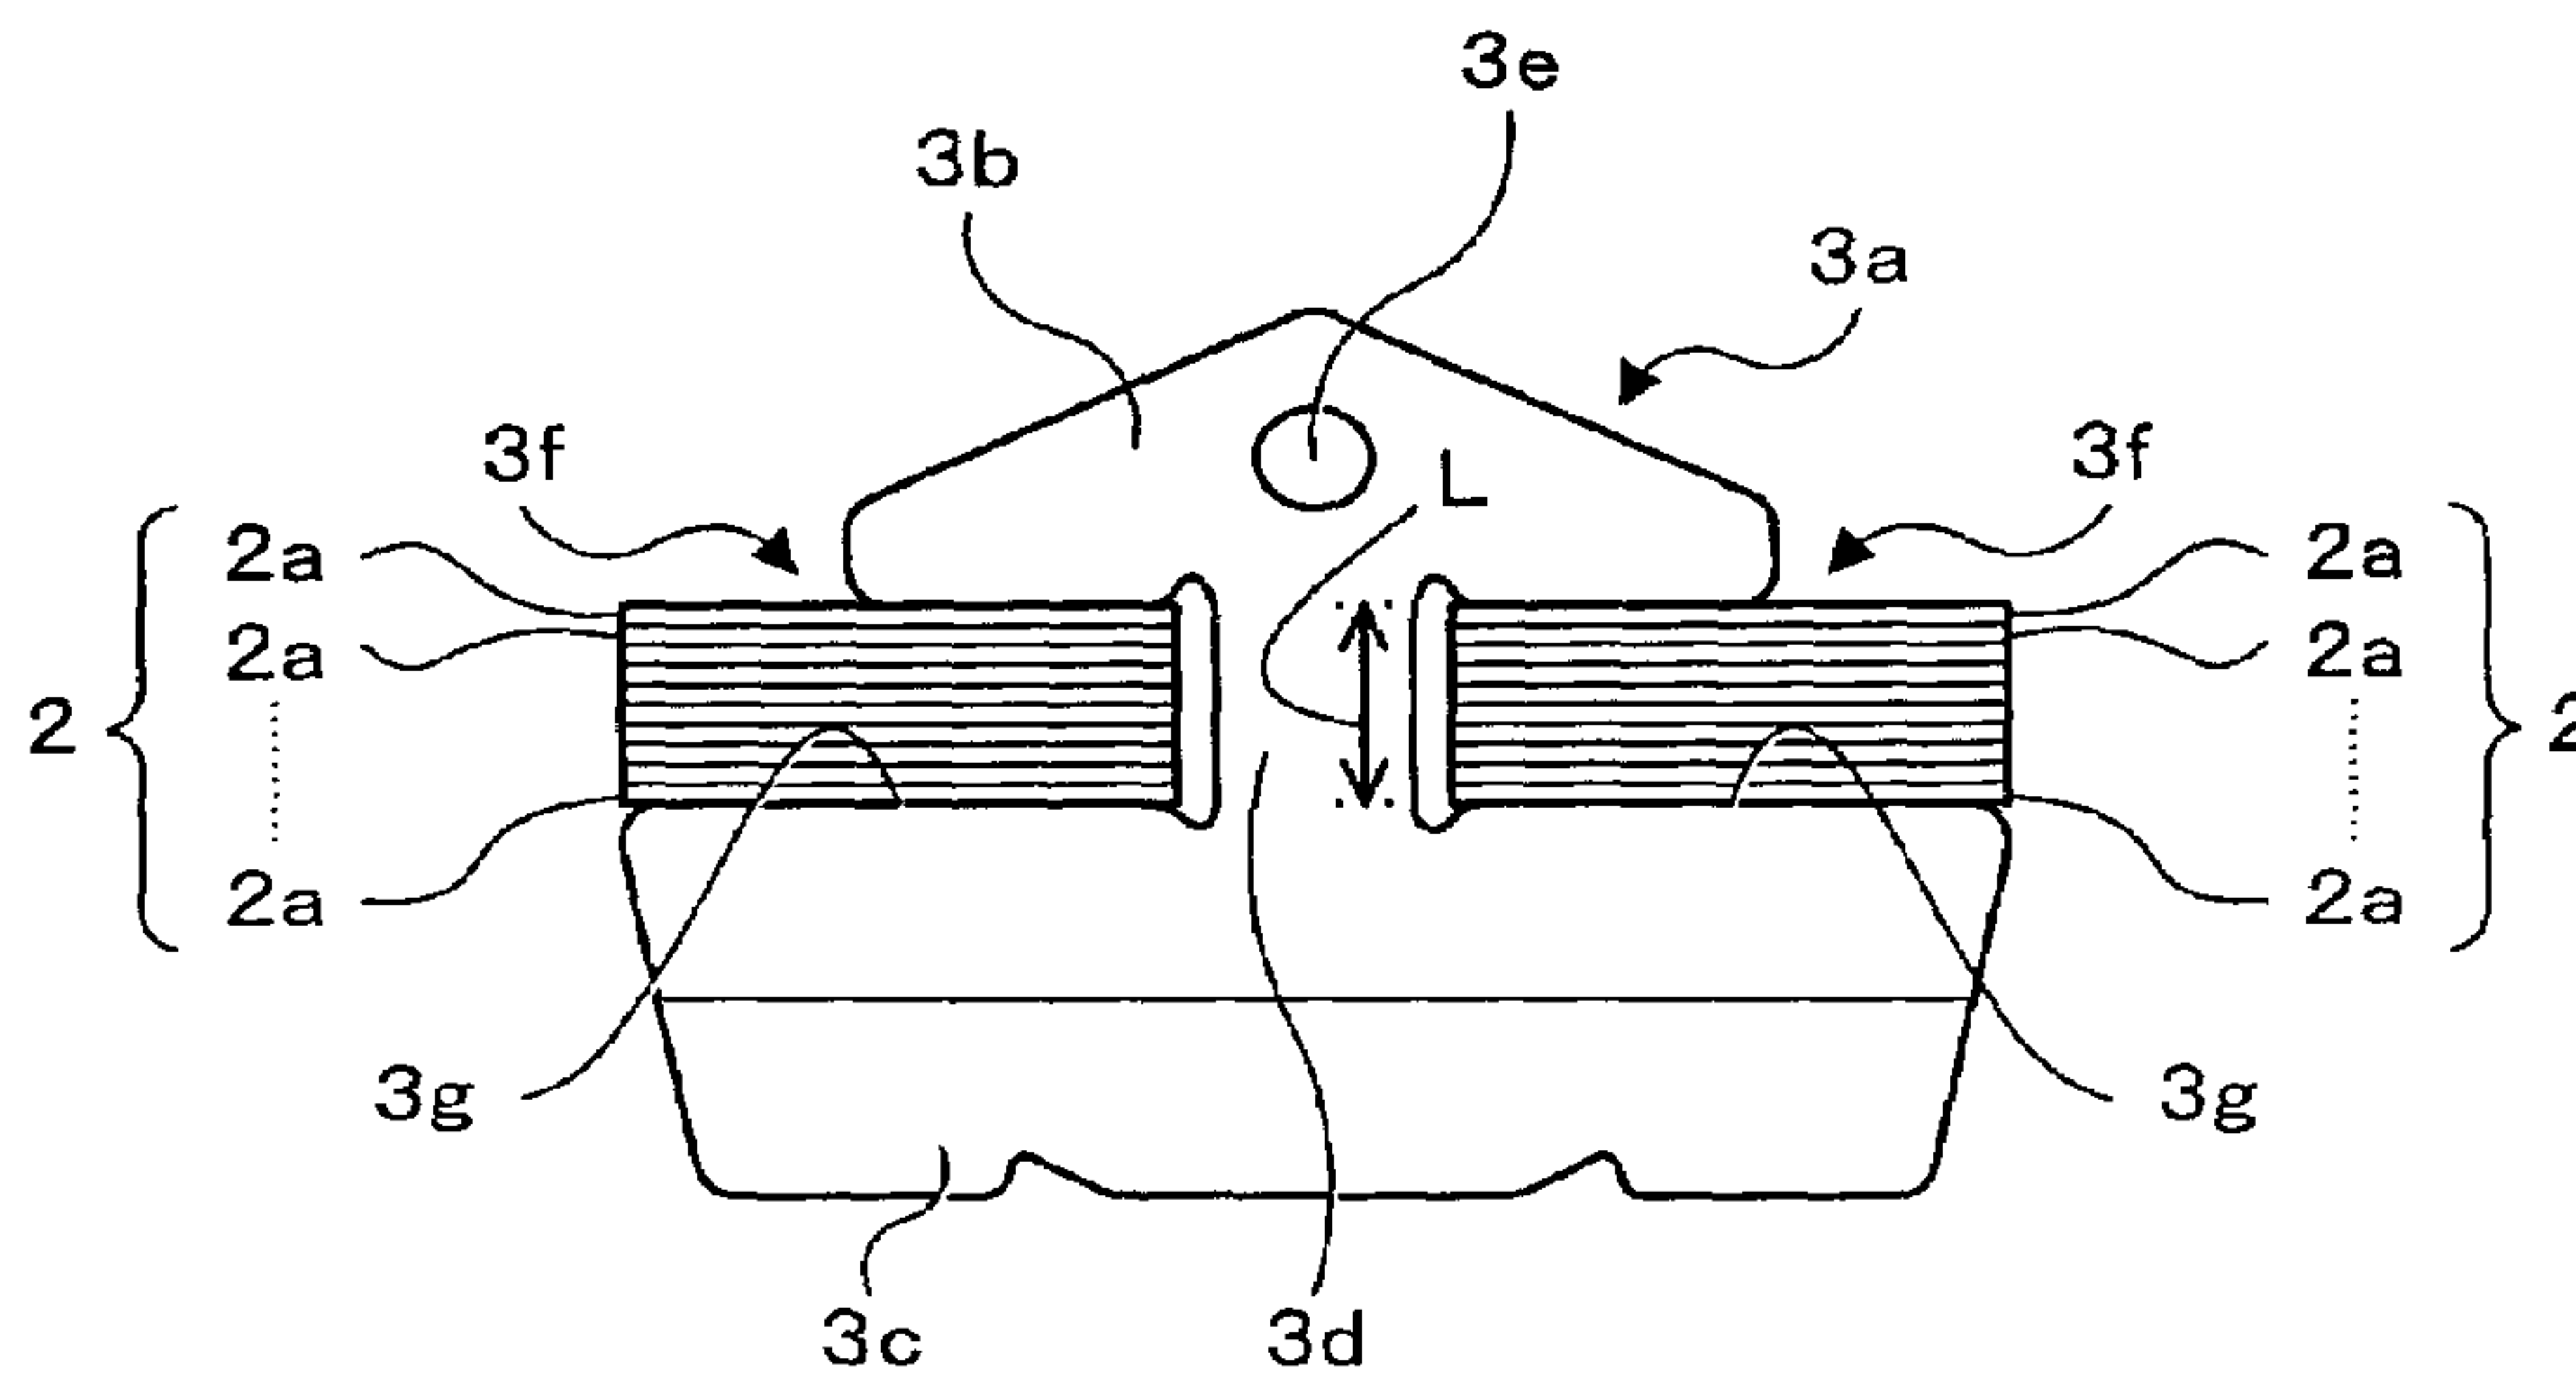
FIG. 7B

The head portion **3b** has a protrusion **3e** (raised circular knurl) (front surface as seen in FIG. 7B) formed in one direction of the surface side and a cavity (circular indent) (rear surface not shown) formed in the same location on the opposite direction surface side. Alignment of the metal elements **3a** is accomplished by consecutively inserting the protrusion **3e** into the cavity of adjoining metal elements **3a**.

Two laminated belts **2** are inserted into the recessed parts **3f** (belt grooves) formed between the head portion **3b** and the chest portion **3c** of the metal elements **3a**, respectively. Here, when the gap (the space clearance width of the recessed parts **3f**) between the head portion **3b** and the chest portion **3c** is defined as "L" (refer to FIG. 7B), the number of stacked layers for the laminated belts **2** is set so that the lamination thickness "D" for each of the laminated belts **2** (refer to FIG. 7A) becomes substantially "L" of an equivalent or slightly smaller value.
