(10) **Patent No.:** **US 7,444,892 B2**
(45) **Date of Patent:** **Nov. 4, 2008**

(54) **CONTINUOUSLY VARIABLE TRANSMISSION BELT INSPECTION METHOD AND INSPECTION DEVICE THEREOF**

(73) Assignee: **Jatco Ltd.** (JP)

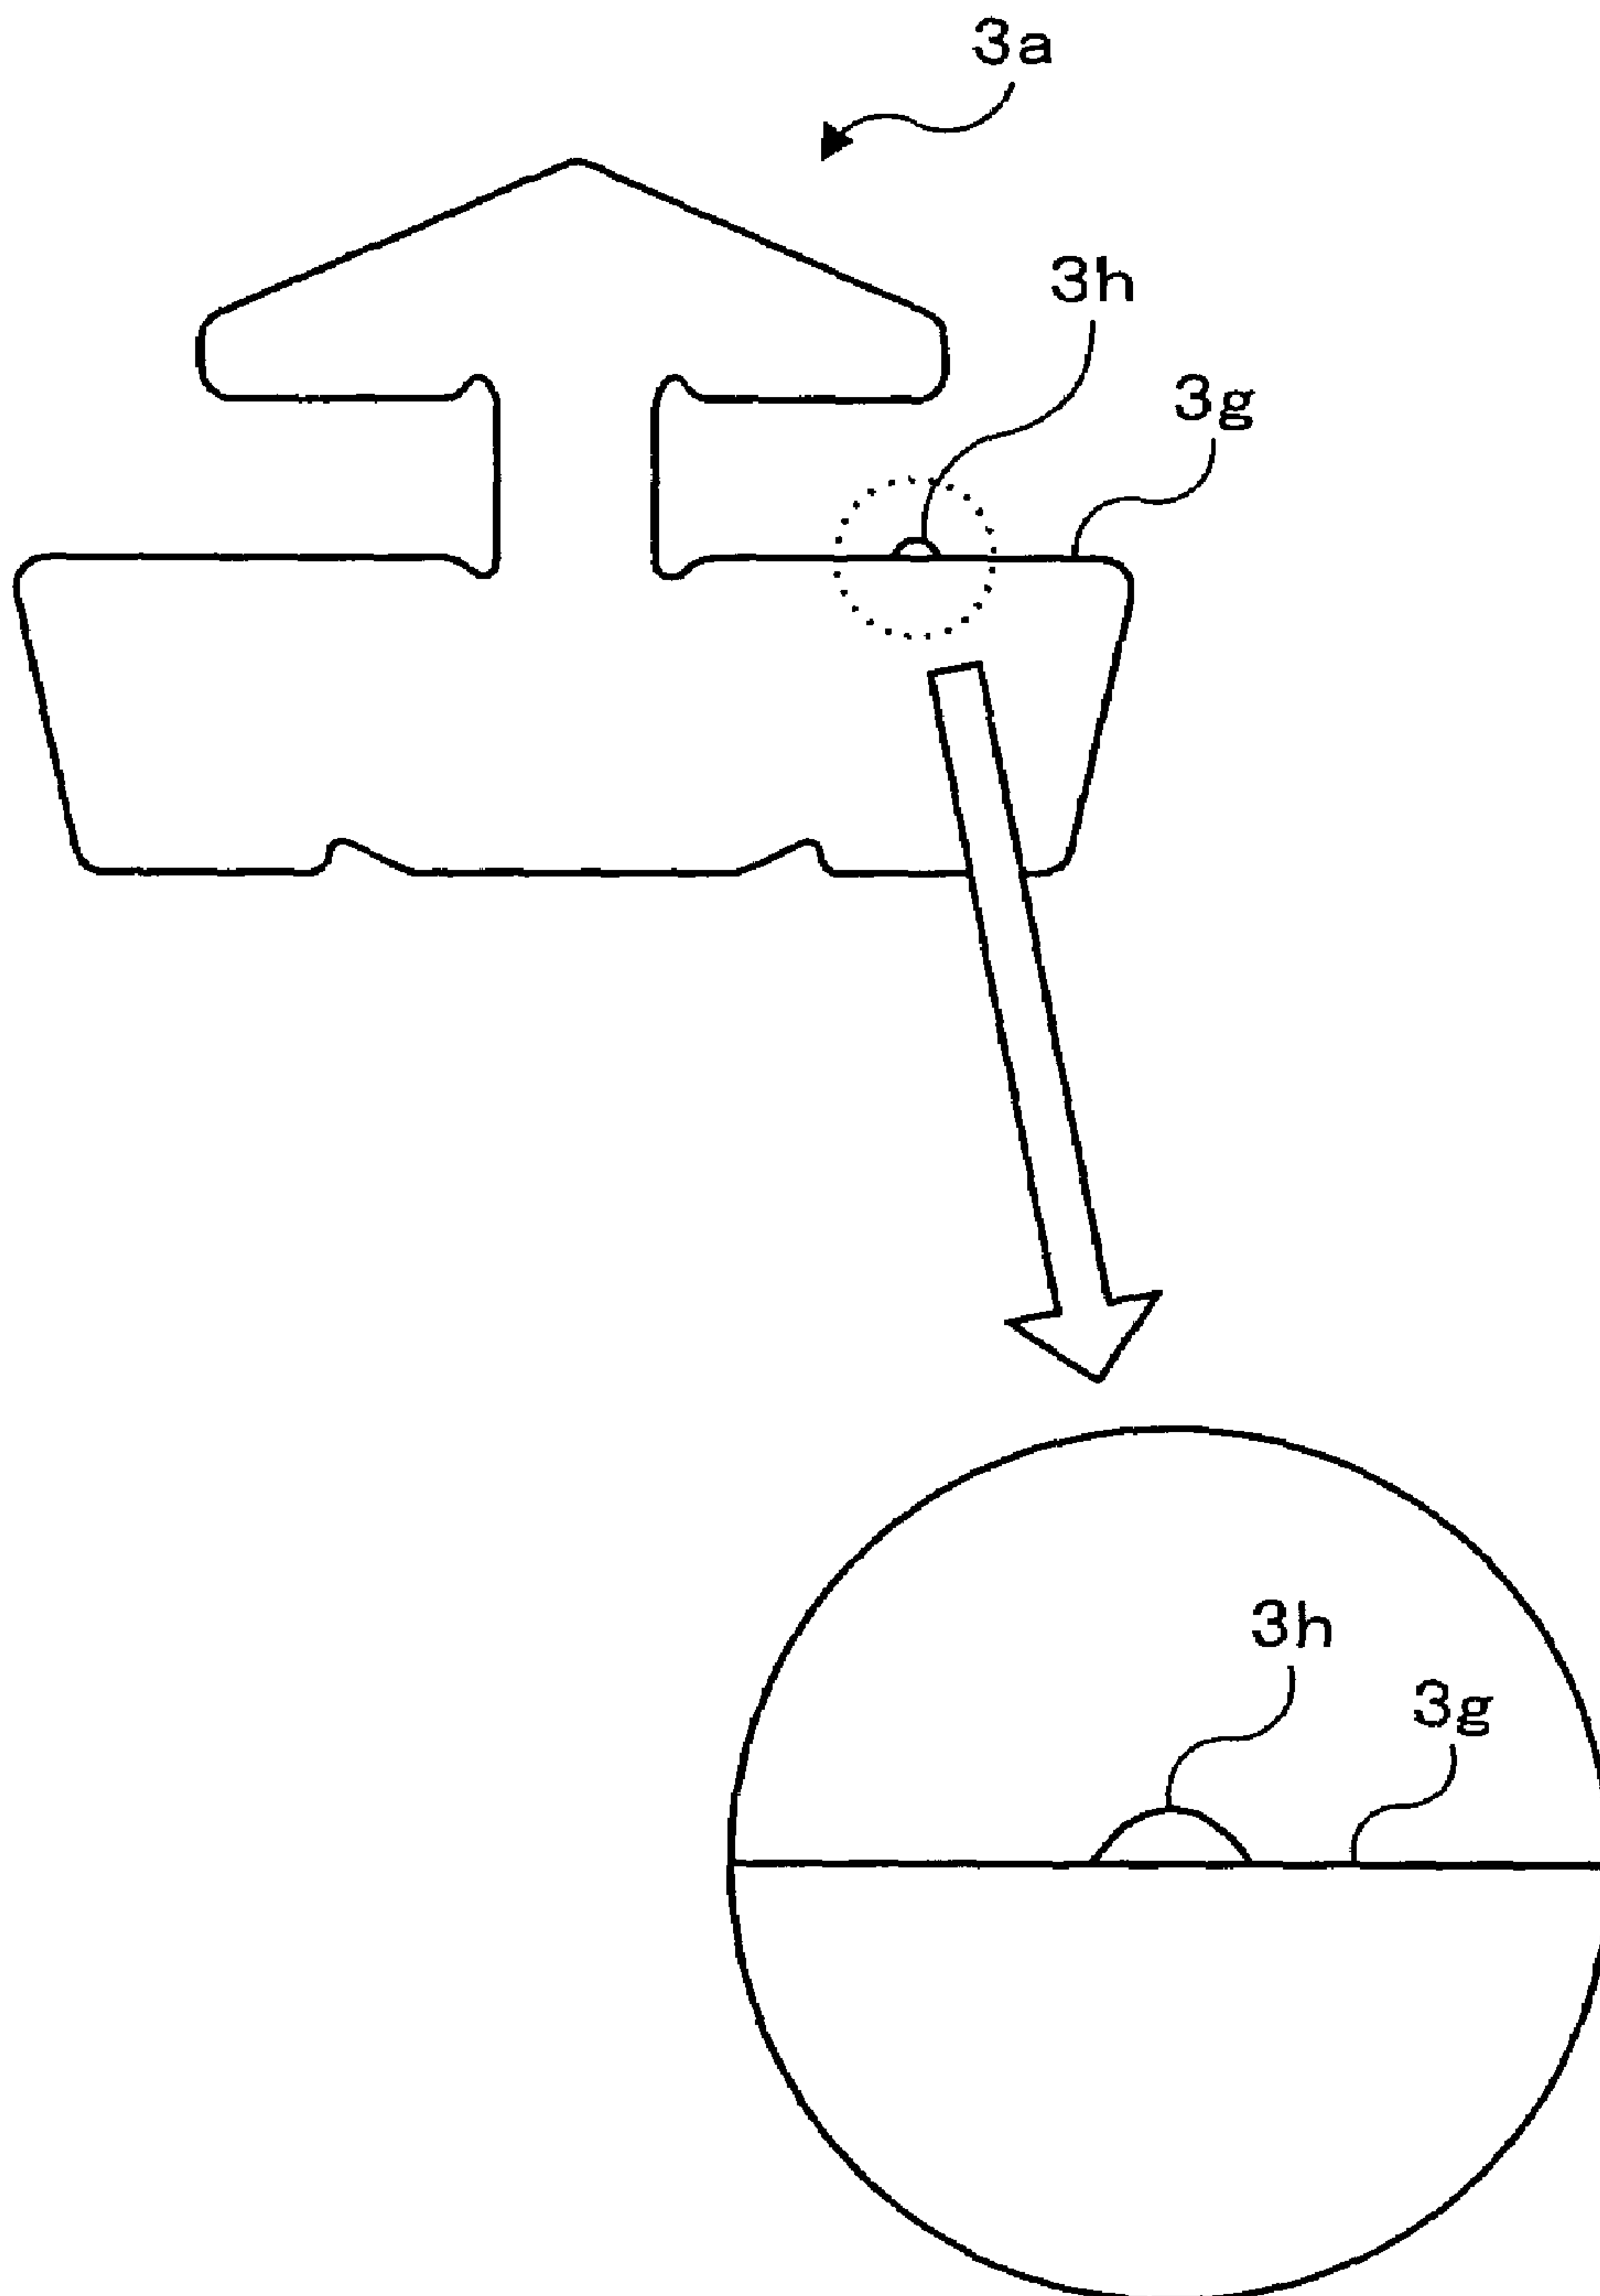
FIG. 8 is a diagram showing an irregular-shaped area example on a metal element **3a**. In this drawing, a small protrusion **3h** formed on the element saddle part **3g** represents an irregular-shaped area. As also explained earlier, since this element saddle part **3g** is the part pushed < > pulled by a strong force against the metal belts **2a** situated in the innermost circumference layer of the laminated belts **2** when transmitting driving force, by the existence of this protrusion **3h**, a flaw will be scarred on the surface of a metal belt **2a** situated in the innermost circumference layer of the laminated belt **2**. In addition, this flaw is observed as a glossy flaw, namely, a gloss mark. In this regard, the metal belt **2a** surface constitutes a matted hardened coating (non-glossy lusterless finish) and the hardened coating is partly exfoliated by the protrusion **3h**. As a result, the underlying base layer is exposed as being glossy. Also, an irregular-shaped area is not restricted to only the protrusion **3h** in the diagram. Other abnormalities which can scrape away some of the metal belt **2a** surface hardened layer such as an indentation, an adhered object, etc. are included.

FIG. 8 is a diagram showing an irregular-shaped area example on a metal element 3a.
