(10) **Patent No.:** **US 7,499,122 B2**
(45) **Date of Patent:** **Mar. 3, 2009**

(54) **THIN FILM TRANSISTOR ARRAY
SUBSTRATE AND REPAIRING METHOD OF
THE SAME**

(73) Assignee: **Au Optronics Corporation**, Hsinchu
(TW)

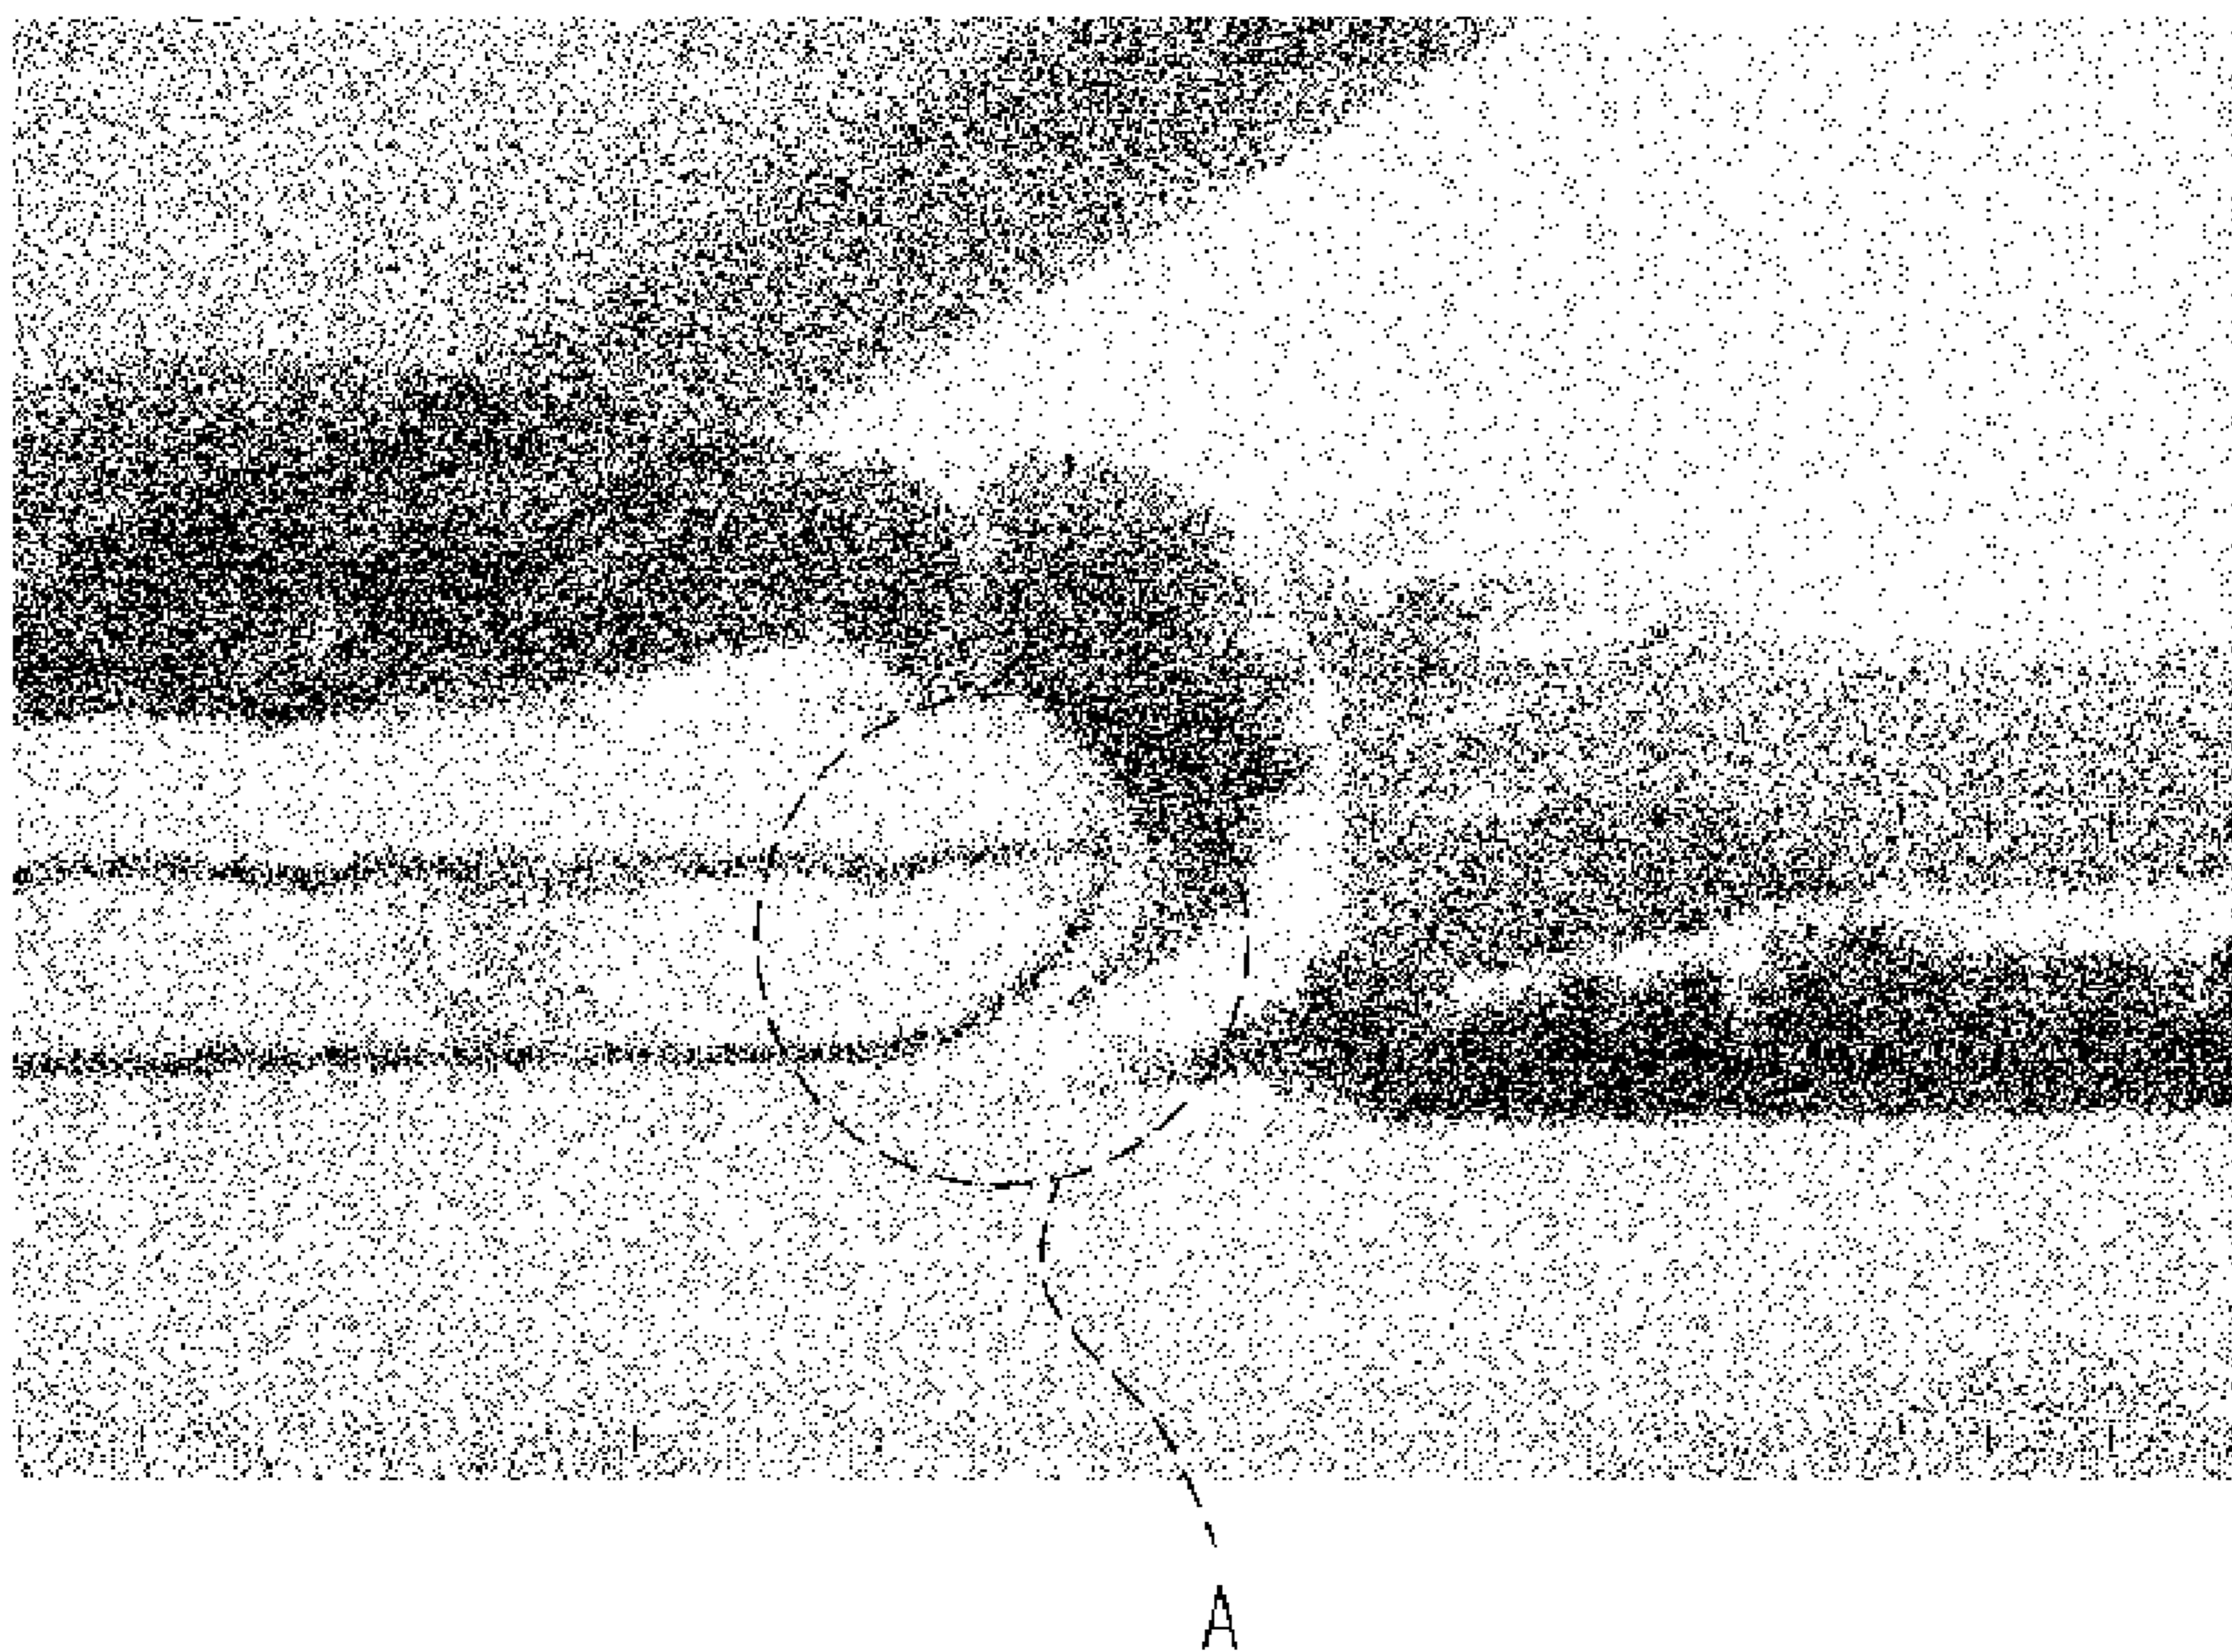
FIG. 2 (PRIOR ART)

FIG. 2 is a cross-sectional view of the intersection repaired by a conventional laser repairing method. Referring to FIG. 2, it is noted that the data line **104** may get damaged by laser beam when repairing in the openings **110**. Since a conventional data line **104** is usually comprised of molybdenum, aluminum and molybdenum multilayer metal structure, and the melting point of aluminum is less than that of the molybdenum. Therefore, after the data line **104** laser is irradiated by the laser beam to form the opening **110**, the aluminum metal layer will get vaporized resulting in a formation of a data line with bent profile A as shown in FIG. 2. It is to be noted that, the repair line **112** formed by laser chemical vapor deposition (CVD) process may be susceptible to breakage near the bent section at the bent profile A, and thus the repairing technique using laser CVD process is accordingly not desirable.

FIG. 2 is a cross-sectional view illustrating an intersection repaired by a conventional laser repairing method.

Thereafter, referring to FIG. **5**, in one embodiment, the data line **230** comprised of, for example but not limited to, a multilayer metal structure such as a first metal layer **232**, a second metal layer **234** and third metal layer **236**. In addition, the melting point of the first metal layer **232** is higher than that of the second metal layer **234**. The first metal layer **232** and the third metal layer **236** is comprised of, for example but not limited to, a molybdenum metal having a high melting point. The second metal layer **234** is comprised of, for example but not limited to, aluminum metal having a low melting point lower. For example, when the data line **230** is a multilayer metal structure comprised of molybdenum, aluminum and molybdenum, if a conventional design and repairing method is applied, the repairing process will fail. However, in the embodiment of the invention, the normal lines **234** and **236** are welded to the quasi-welding repair pads **260'** and electrically connected to each other by repair line **290**. Therefore, the forming and breaking of the bending profile A near the repair line **112** as shown in FIG. **2** will not occur in the present invention. Thus, the repairing yield can be effectively increased.

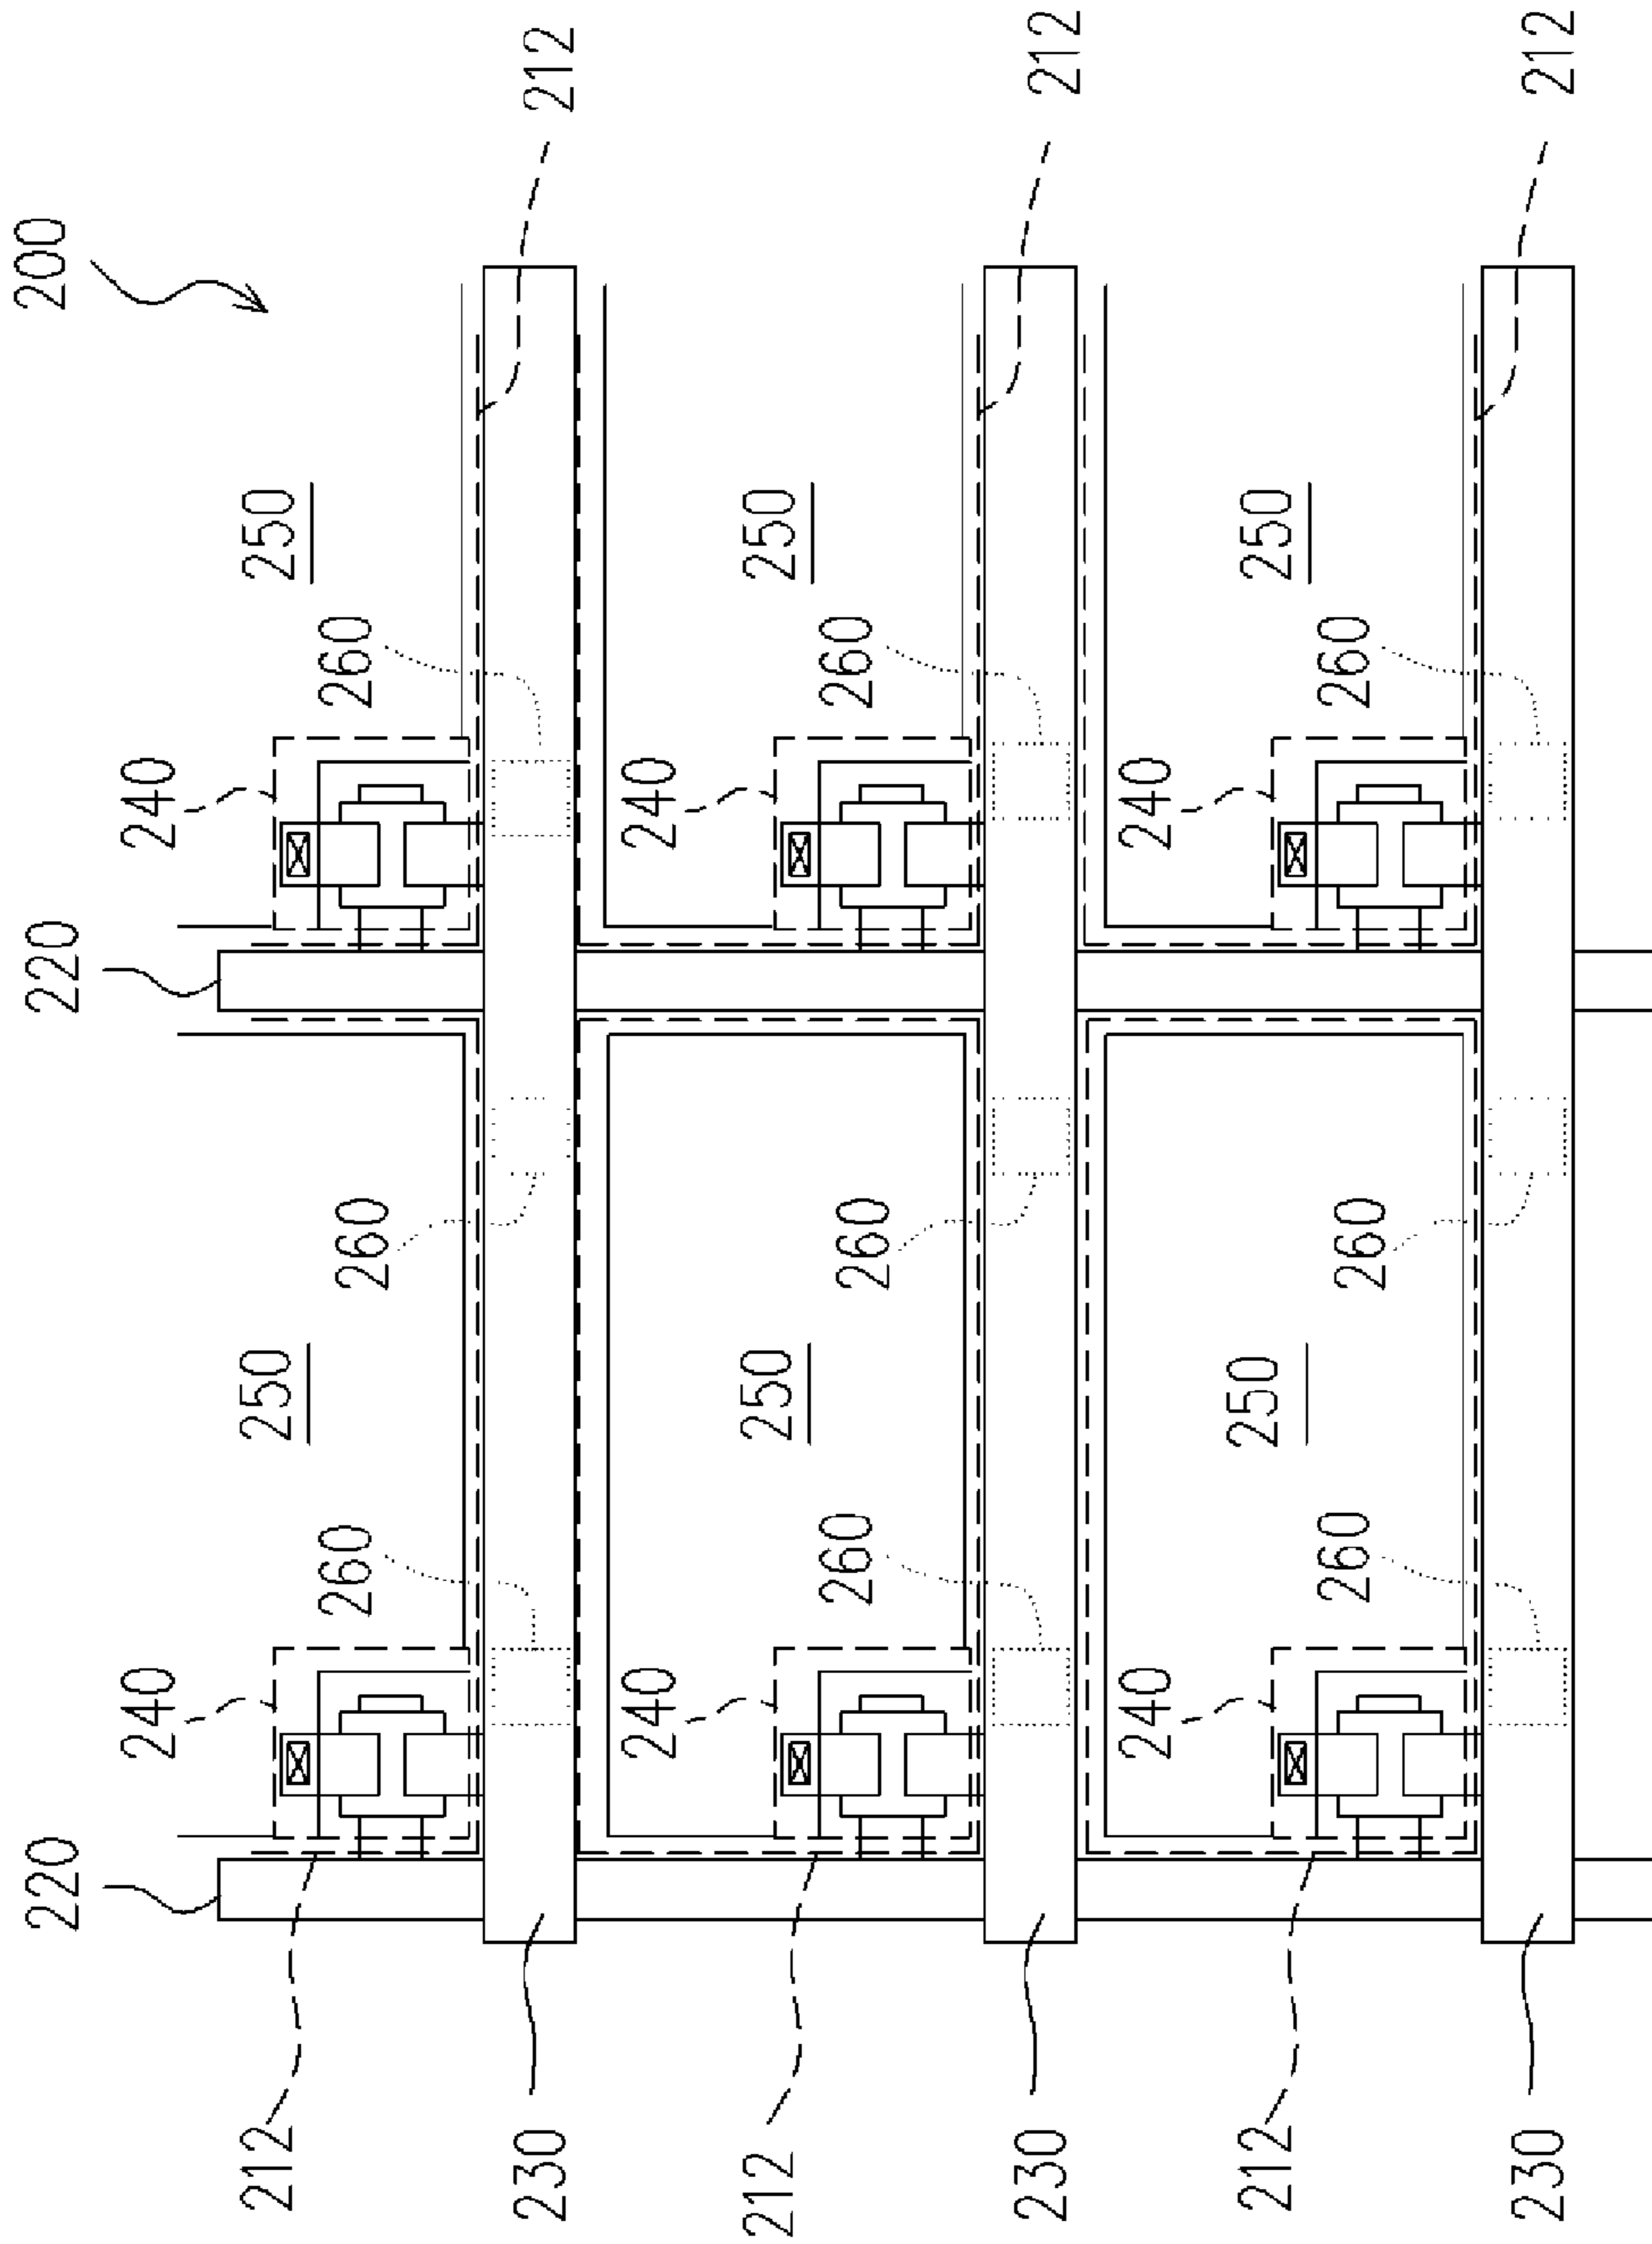
FIG. 3 is a drawing schematically illustrating a thin film transistor array substrate according to one embodiment of the present invention.

FIG. 3 is a drawing schematically illustrating a thin film transistor array substrate according to one embodiment of the present invention. Referring to FIG. 3, the thin film transistor (TFT) array substrate **200** comprises, for example but not limited to, a substrate **210** (shown in FIG. 5), a plurality of scan lines **220**, a plurality of data lines **230**, a plurality of thin film transistors **240**, a plurality of pixel electrodes **250**, and a plurality pairs of repair pads **260**. The scan lines **220** and data lines **230** are formed over the substrate **210** to define a plurality of pixel regions **212** over the substrate **210**. The thin film transistors **240** are disposed in each pixel region **212** respectively and driven by the corresponding scan line **220** and data line **230**. The pixel electrodes **250** are also disposed in each pixel region **212** respectively and electrically connected to the corresponding thin film transistor **240**. The repair pads of each pair of repair pads **260** are disposed at of the intersection of each scan line **220** and data line **230**. Each pair of repair pads **260** is disposed under the corresponding data line **230**. Furthermore, the repair pads **260** are formed together with the gate of the thin film transistor **240**, thus the material of the repair pads **260** is, for example but not limited to, the same as that of the scan line.

Referring to FIG. **3**, the pixel electrode **250** comprises, for example but not limited to, indium tin oxide (ITO), indium zinc oxide (IZO) or other conductive transparent materials, or other conductive material with light reflecting property such as metal. In other words, when the pixel electrode **250** is comprised of transparent material, a transparent liquid crystal panel may be constructed by combining the TFT array substrate **200** with the other opposite aligned substrate. On the other hand, when pixel electrode **250** is comprised of metal or other light reflecting material, a reflective liquid crystal panel may be constructed when the TFT array substrate **200** is combined the other opposite aligned substrate. Moreover, when one portion of the pixel electrode **250** is comprised of transparent material and the other portion thereof is comprised of metal or other light reflecting material, a semi-transparent semi-reflective liquid crystal panel may be formed after the TFT array substrate **200** and the other opposite aligned substrate are combined.

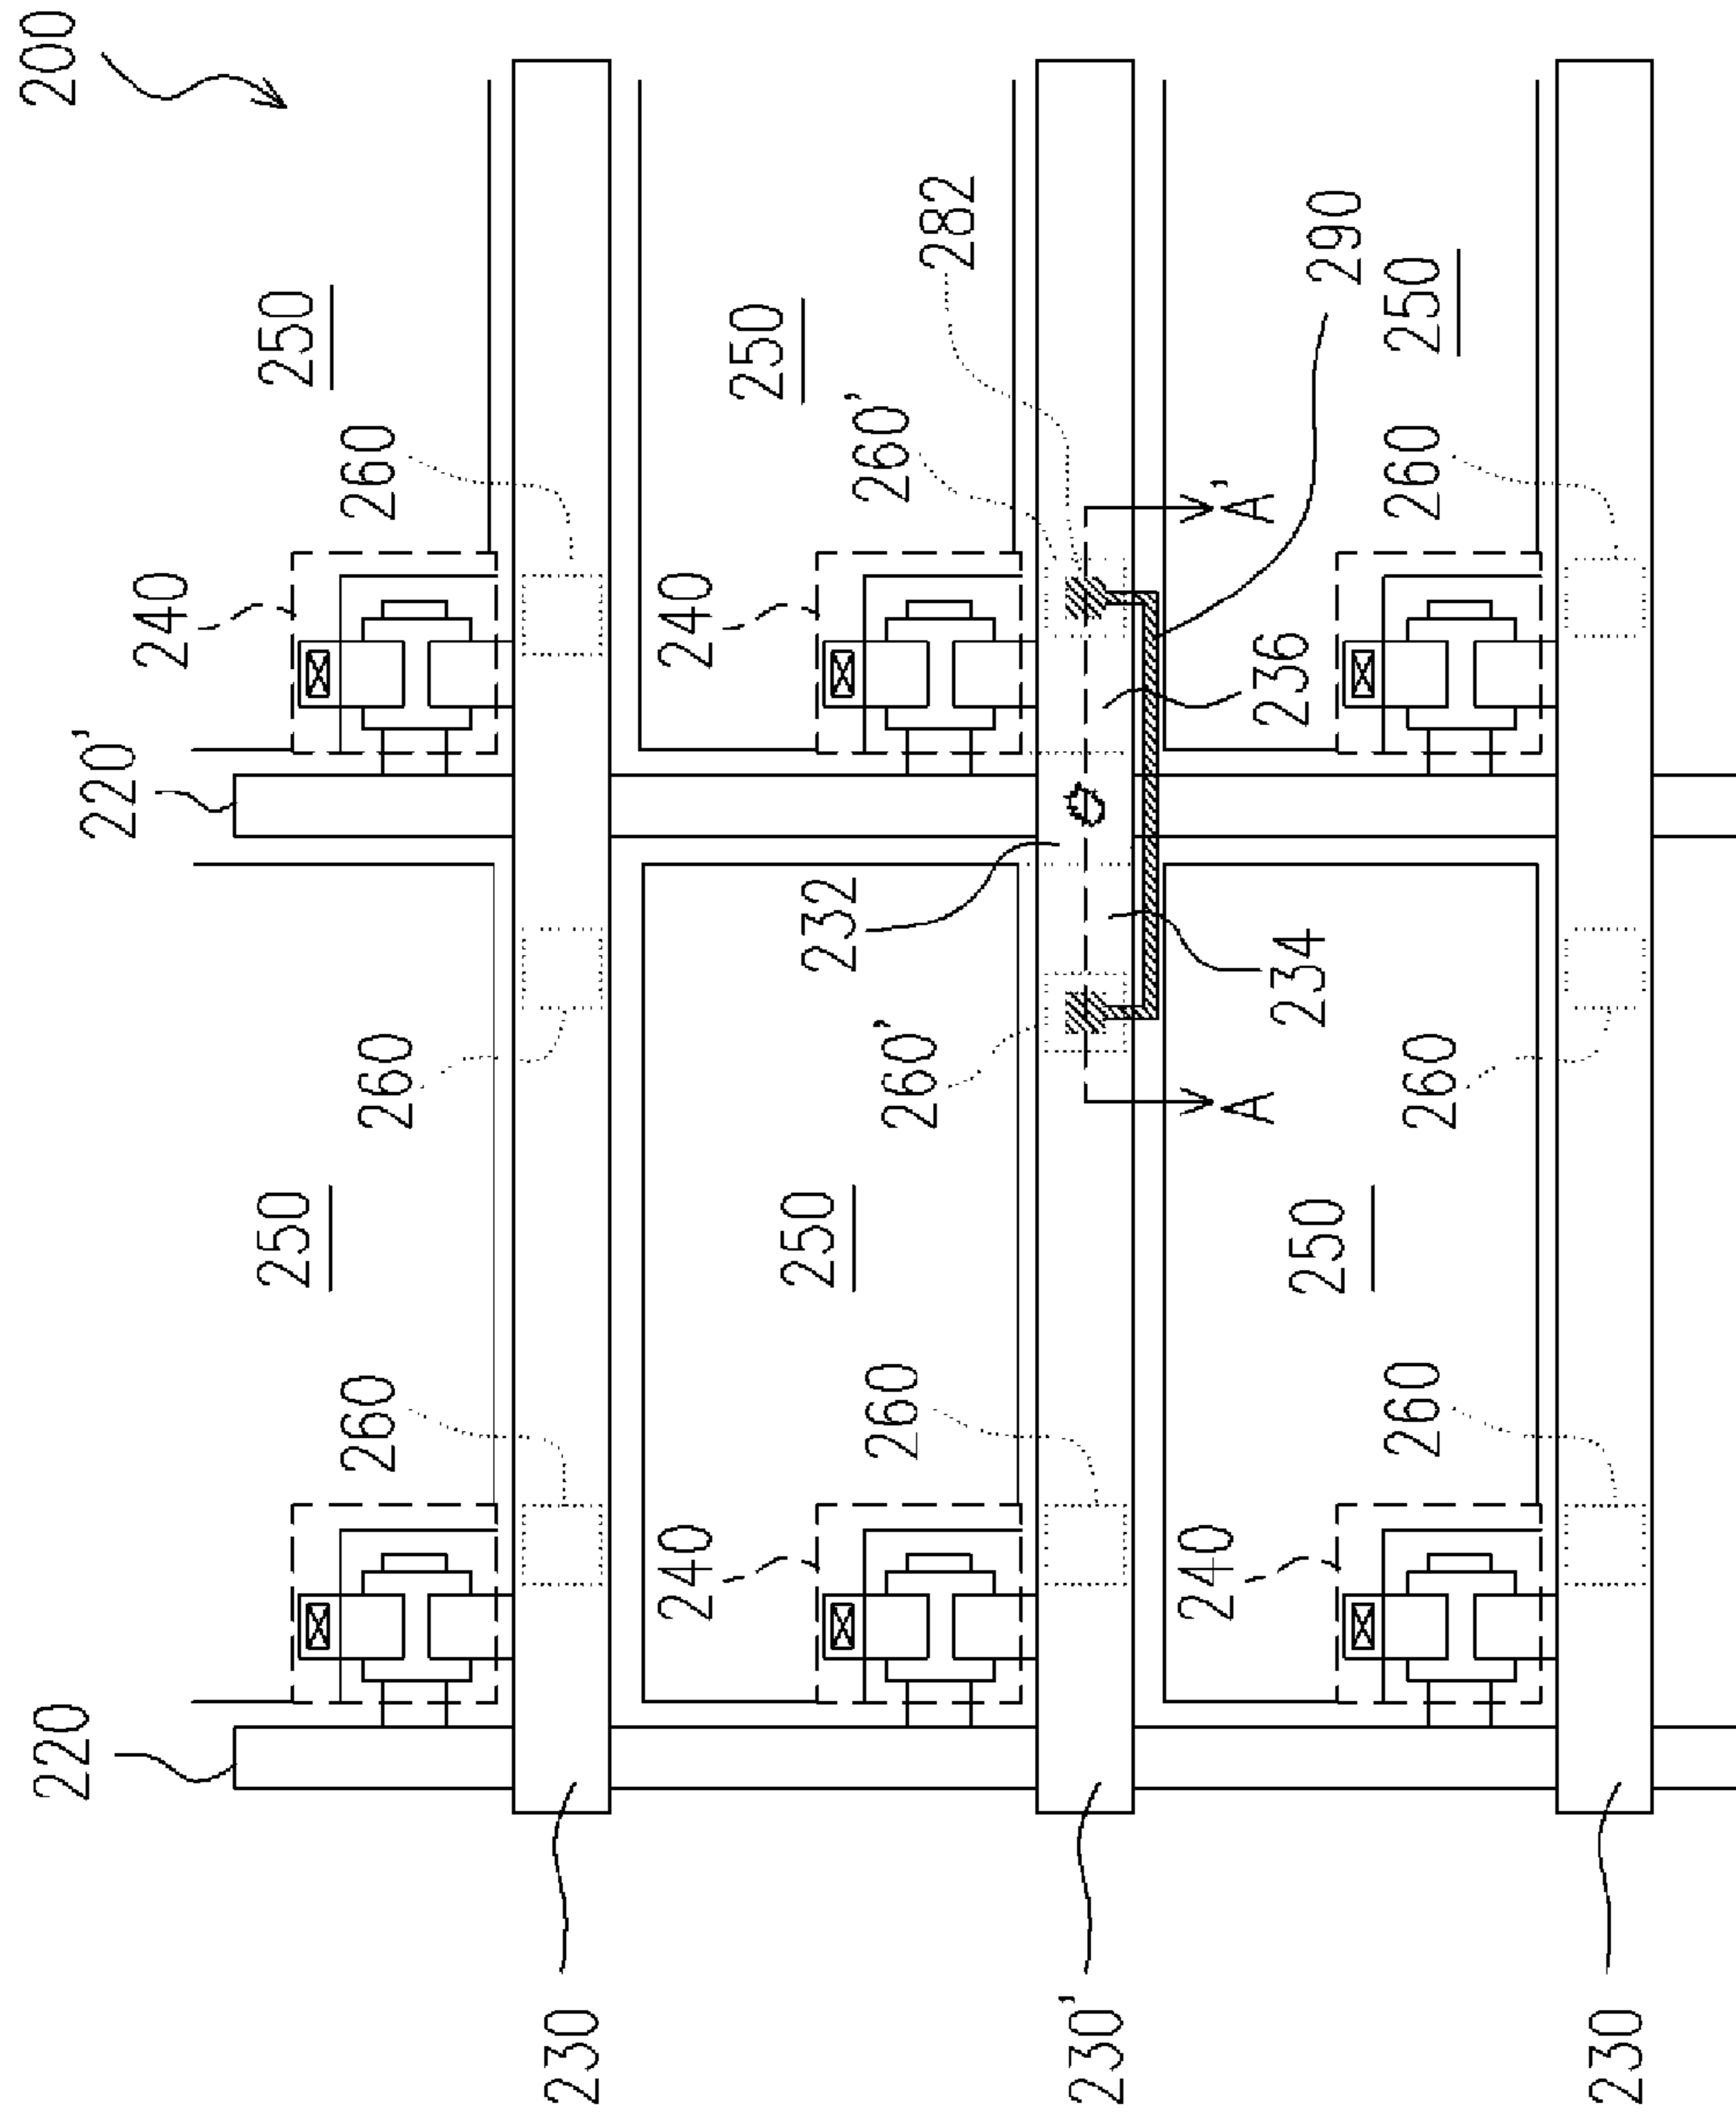
FIG. 4 is a drawing schematically illustrating the TFT array substrate of FIG. 3 after being repaired by a laser repairing method.

Referring to FIG. **4**, when a defective scan line **220'** and a defective data line **230'** are abnormally conductive at the intersection of both, the data signal can not be written into the pixel controlled by the defective scan line **220'** and the defective data line **230'**. Therefore, the pixel needs to be repaired. In one embodiment of the present invention, the defective data line **230'** is cut to form a defective line **232** and two normal lines **234**, **236** at both sides of the defective scan lines **220'**. The defective line **232** is above the defective scan line **220'**, and the normal lines **234** and **236** are at both sides of the defective scan line **220'** respectively. In addition, the defective data line **230'** is cut by using, for example but not limited to, a laser cutting method.

Thereafter, referring to FIG. **4** and FIG. **5**, after the defective data line **230'** is cut to form the defective line **232** and the normal lines **234** and **236**, a pair of quasi-welding repair pads **260'** corresponding to the defective data line **230** are welded to the normal line **234** and **236** respectively. It is noted that, the quasi-welding repair pads **260'** and the normal lines **234** and **236** are welded by using, for example but not limited to, a laser beam. The protection layer **280** above the normal lines **234** and **236** are irradiated by the laser beam to form an opening **282**. Thereafter, the normal lines **234** and **236**, the inter-gate dielectric layer **270** and the quasi-welding repair pad **260'** are irradiated by the laser beam, and then the inter-gate dielectric layer **270** will be burned through to weld the normal lines **234** and **236** with corresponding quasi-welding repair pads **260'** respectively. The normal lines **234** and **236** are electrically connected to the corresponding quasi-welding repair pads **260'** respectively by welding metal **285**. In the embodiment, the welding metal **285** is generated during the

Then, a repair line **290** crossing over the defective scan line **220'** is formed after the laser beam welding process to reconnect the normal lines **234** and **236** that correspond to the quasi-welding repair pad **260'**. In one embodiment, the repair line **290** is formed by performing, for example but not limited to, a laser chemical vapor deposition (CVD) process.

Thereafter, the normal lines **234** and **236** of the defective data line **230'** are welded to a portion of the quasi-welding repair pad **260'** after the TFT array substrate **200** is repaired and electrically connected to each other by the repair line **290**. Therefore, the defective line **232** of the defective data line **230'** that is conducted to the defective scan line **220'** will not adversely influence the driving of the pixel.

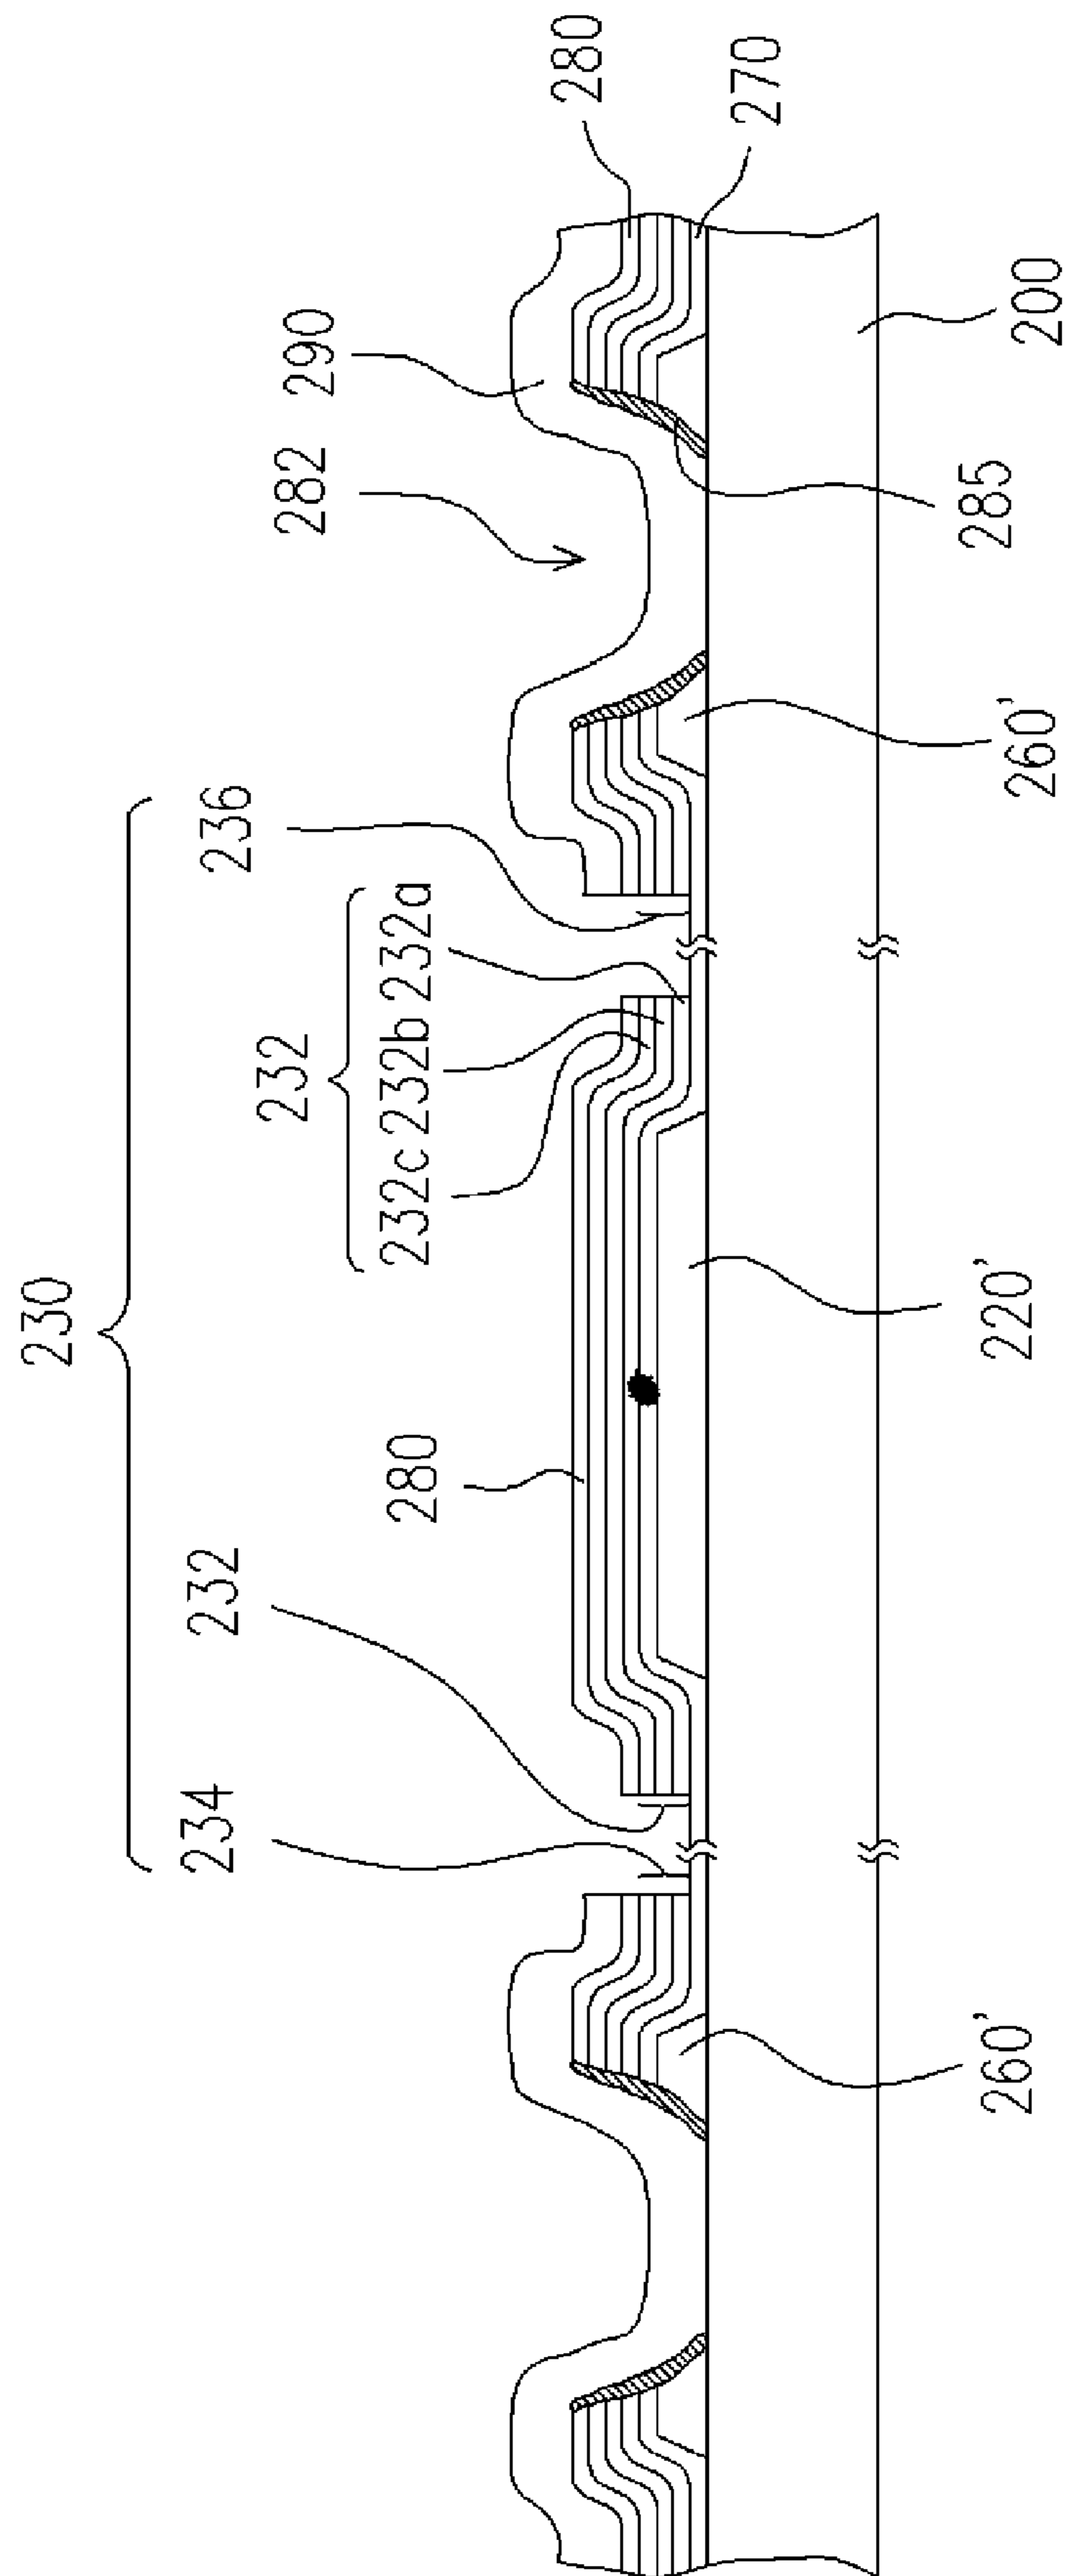
FIG. 5 is a cross-sectional view schematically illustrating the TFT array substrate of FIG. 4 taken along line A-A'.

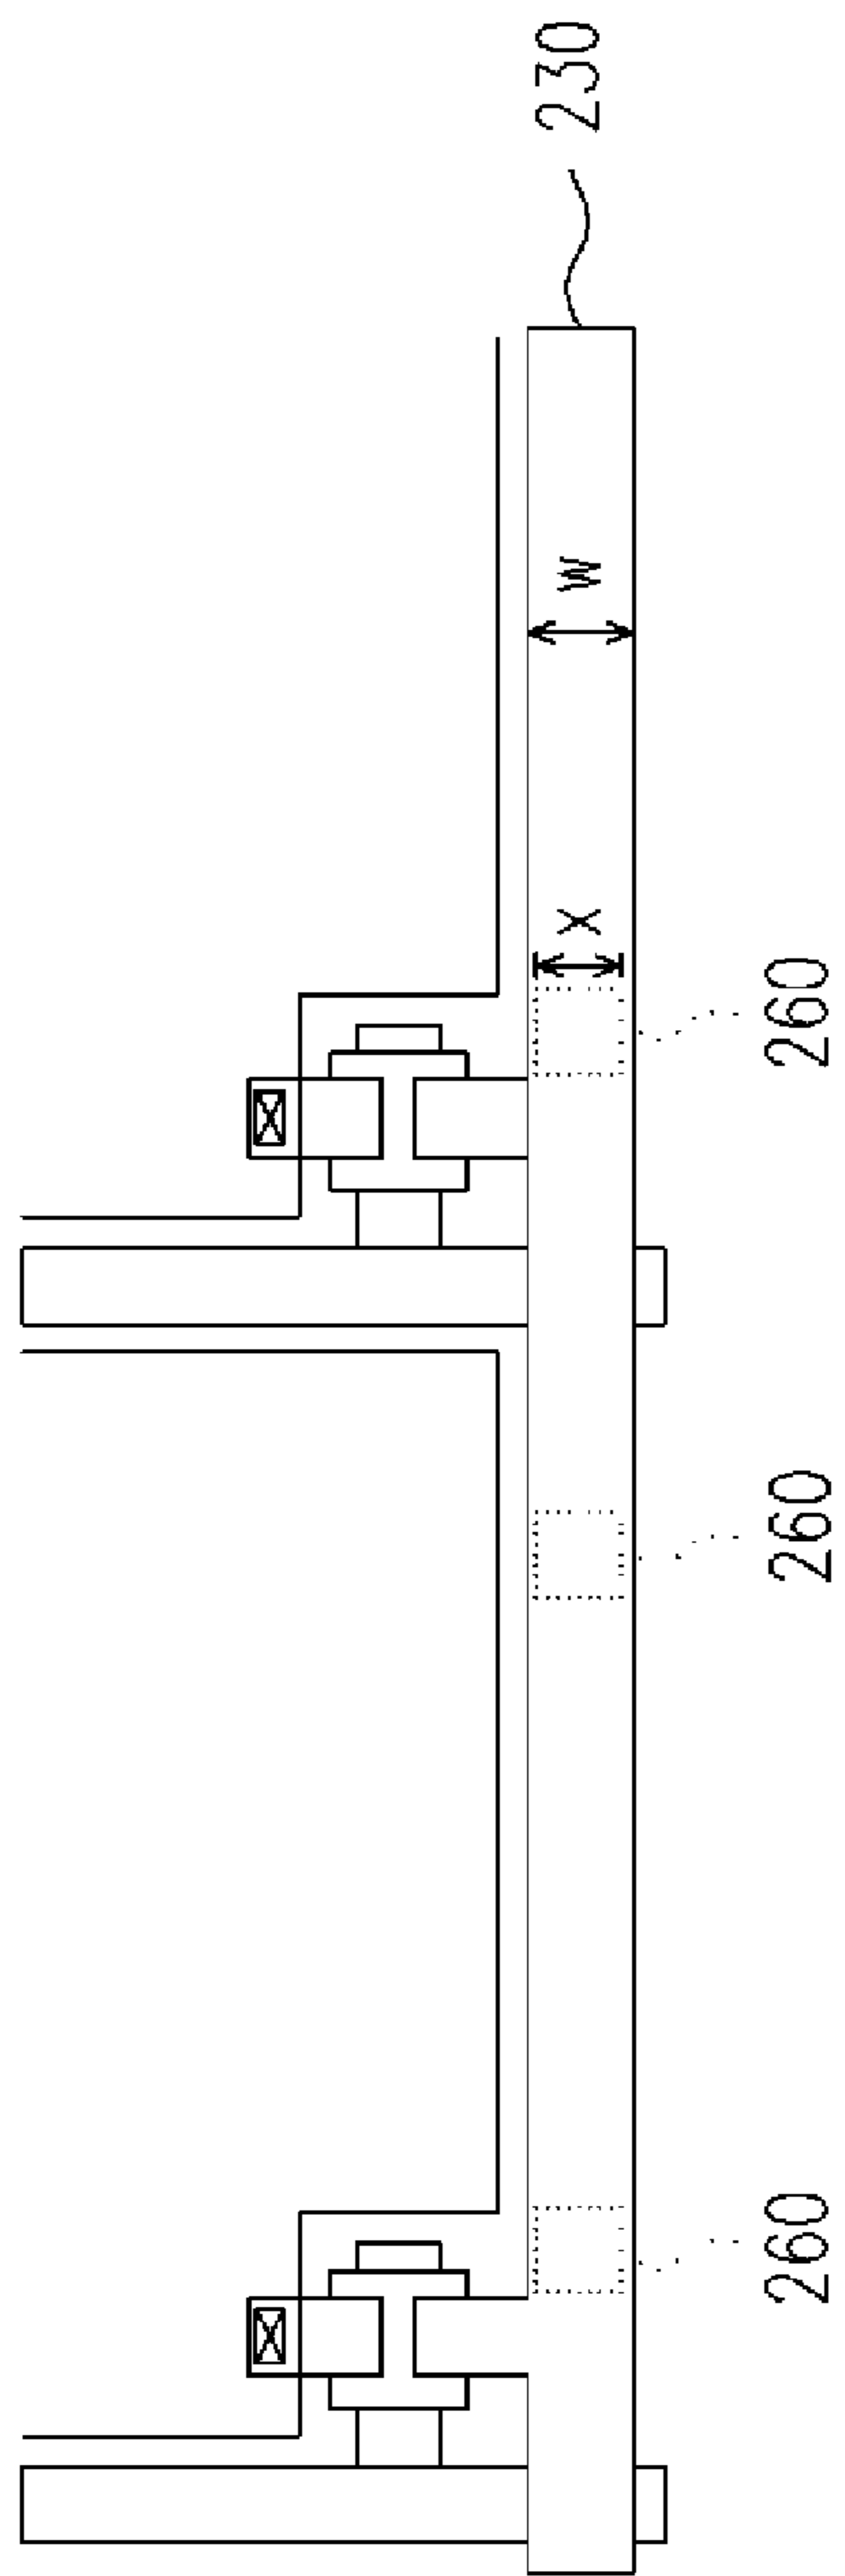
FIG. 6A

FIG. 6A, FIG. 6B and FIG. 6C are views schematically illustrating the distribution of repair pads and data lines with different sizes according to one embodiment of the present invention.

FIG. **6A**, FIG. **6B** and FIG. **6C** are views schematically illustrating the distribution of repair pads and data lines with different sizes according to one embodiment of the present invention. Referring to FIG. **6A** to FIG. **6C**, the size X of the repair pad **260** is, for example but not limited to, less than the width W of the data line **230** (as shown in FIG. **6A**), equal to the width W of the data line **230** (as shown in FIG. **6B**), or larger than the width W of the data line **230** (as shown in FIG. **6C**). Furthermore, the repair pad **260**, for example but not limited to, need not be totally disposed under the data line **230** (as shown in FIG. **6A**), or a portion of the repair pad **260** is disposed under the data line **230** (as shown in FIG. **6B** and FIG. **6C**). It is noted that, those skilled in the art may change the shape, distribution, position, size and so on, of the repair pads **260**, which is still within the scope and spirit of the present invention.

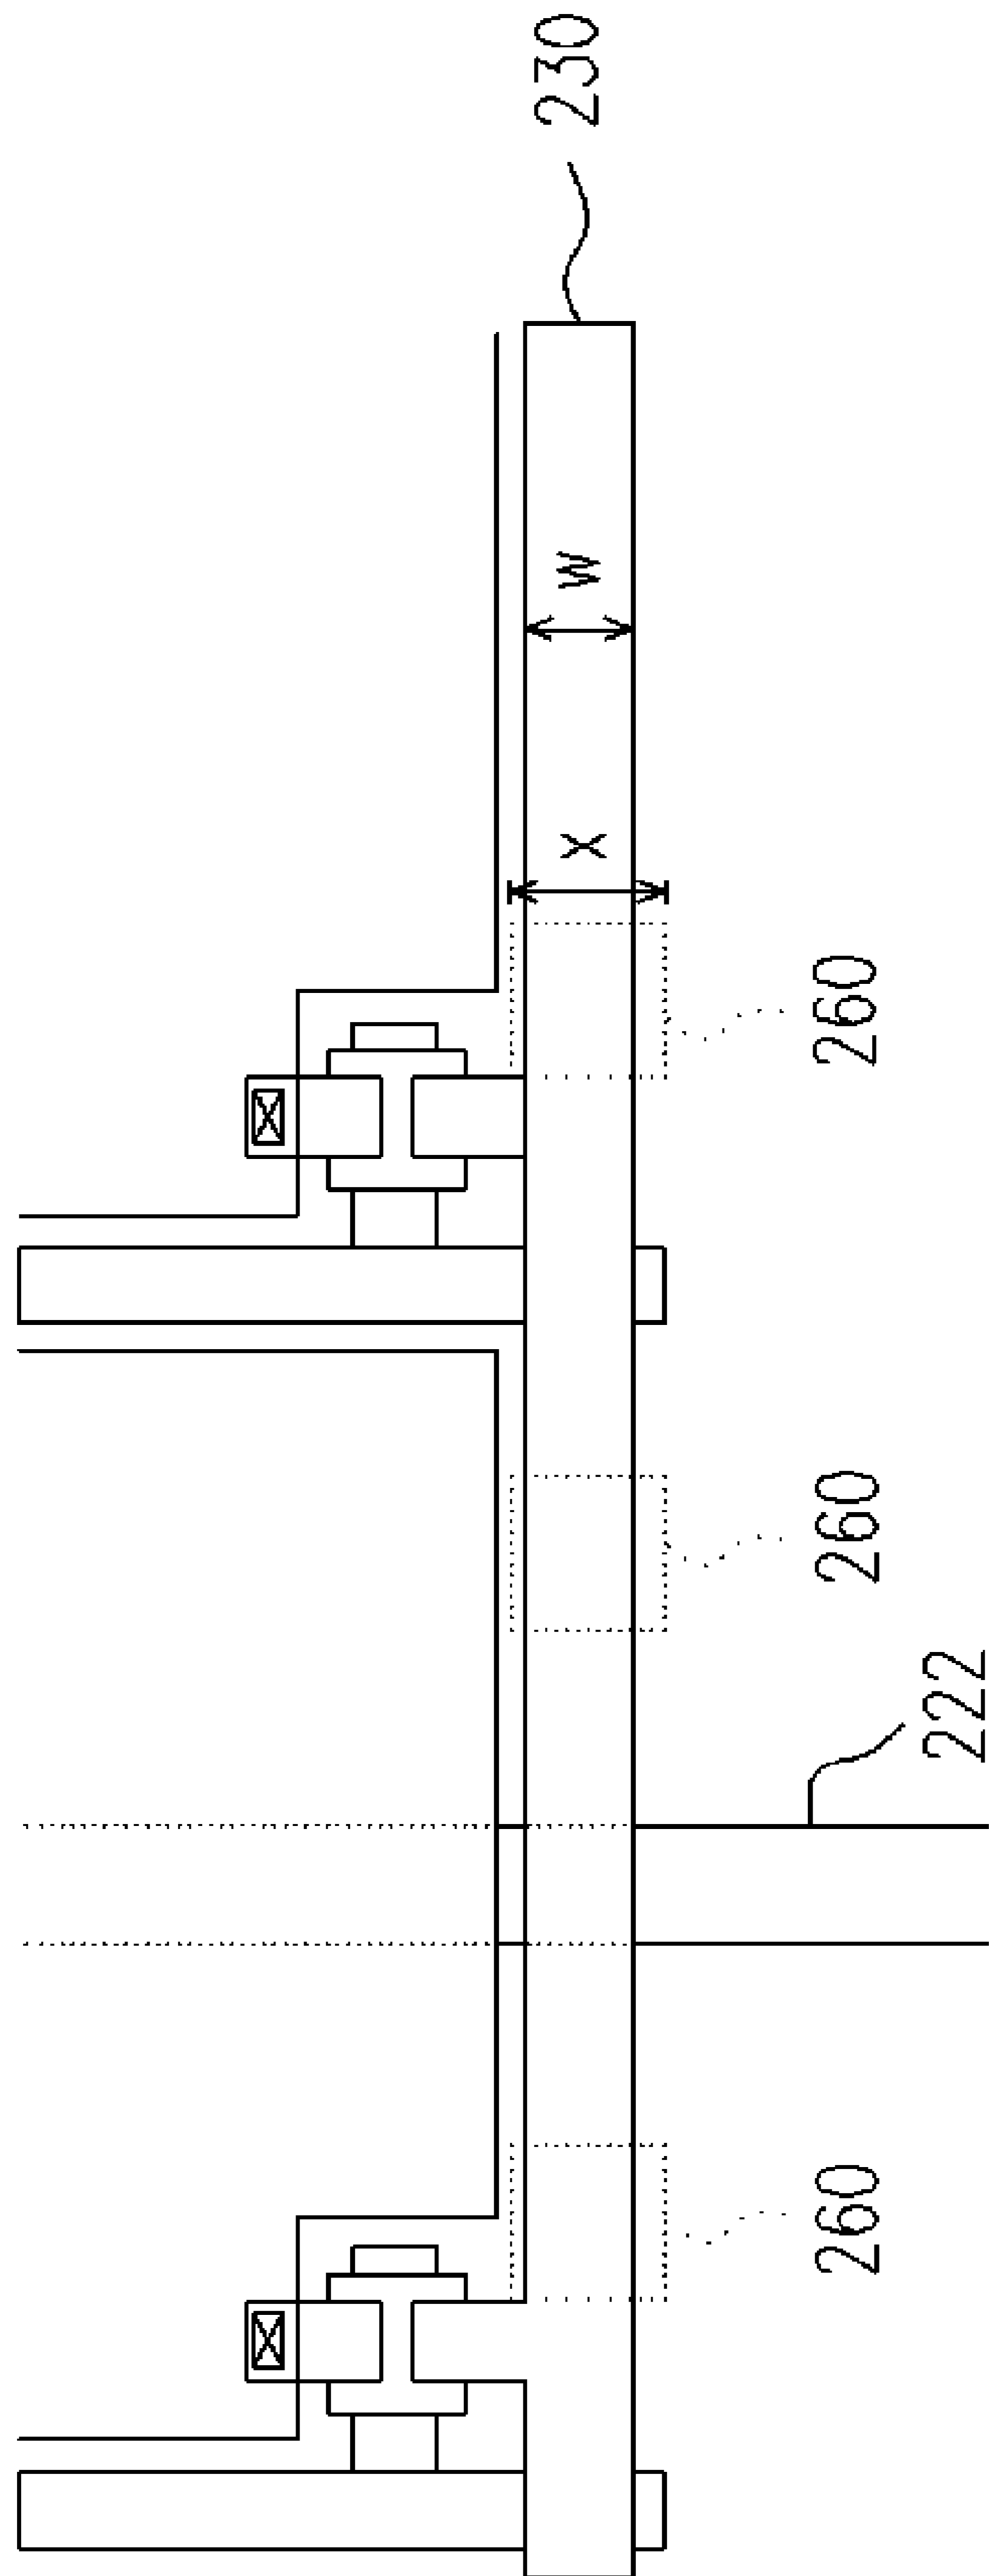
FIG. 6C

Referring to FIG. **6C**, it is noted that in one embodiment of the invention, the repair pads (or the quasi-welding repair pads) **260** are set in pairs and located on two sides of an intersection of the scan line and the data line **230** respectively.

In addition, referring to FIG. **6C**, it is noted that in one embodiment of the invention, the repair pads (or the quasi-welding repair pads) **260** are set in pairs and can also be located on two sides of an intersection of a common line **222** and the data line **230** respectively. The characteristic and function of the repair pad of the present embodiment is similar to the other embodiments described above and will not be described in detail.
