(10) **Patent No.:** **US 7,499,122 B2**
(45) **Date of Patent:** **Mar. 3, 2009**

(54) **THIN FILM TRANSISTOR ARRAY
SUBSTRATE AND REPAIRING METHOD OF
THE SAME**

(73) Assignee: **Au Optronics Corporation**, Hsinchu
(TW)

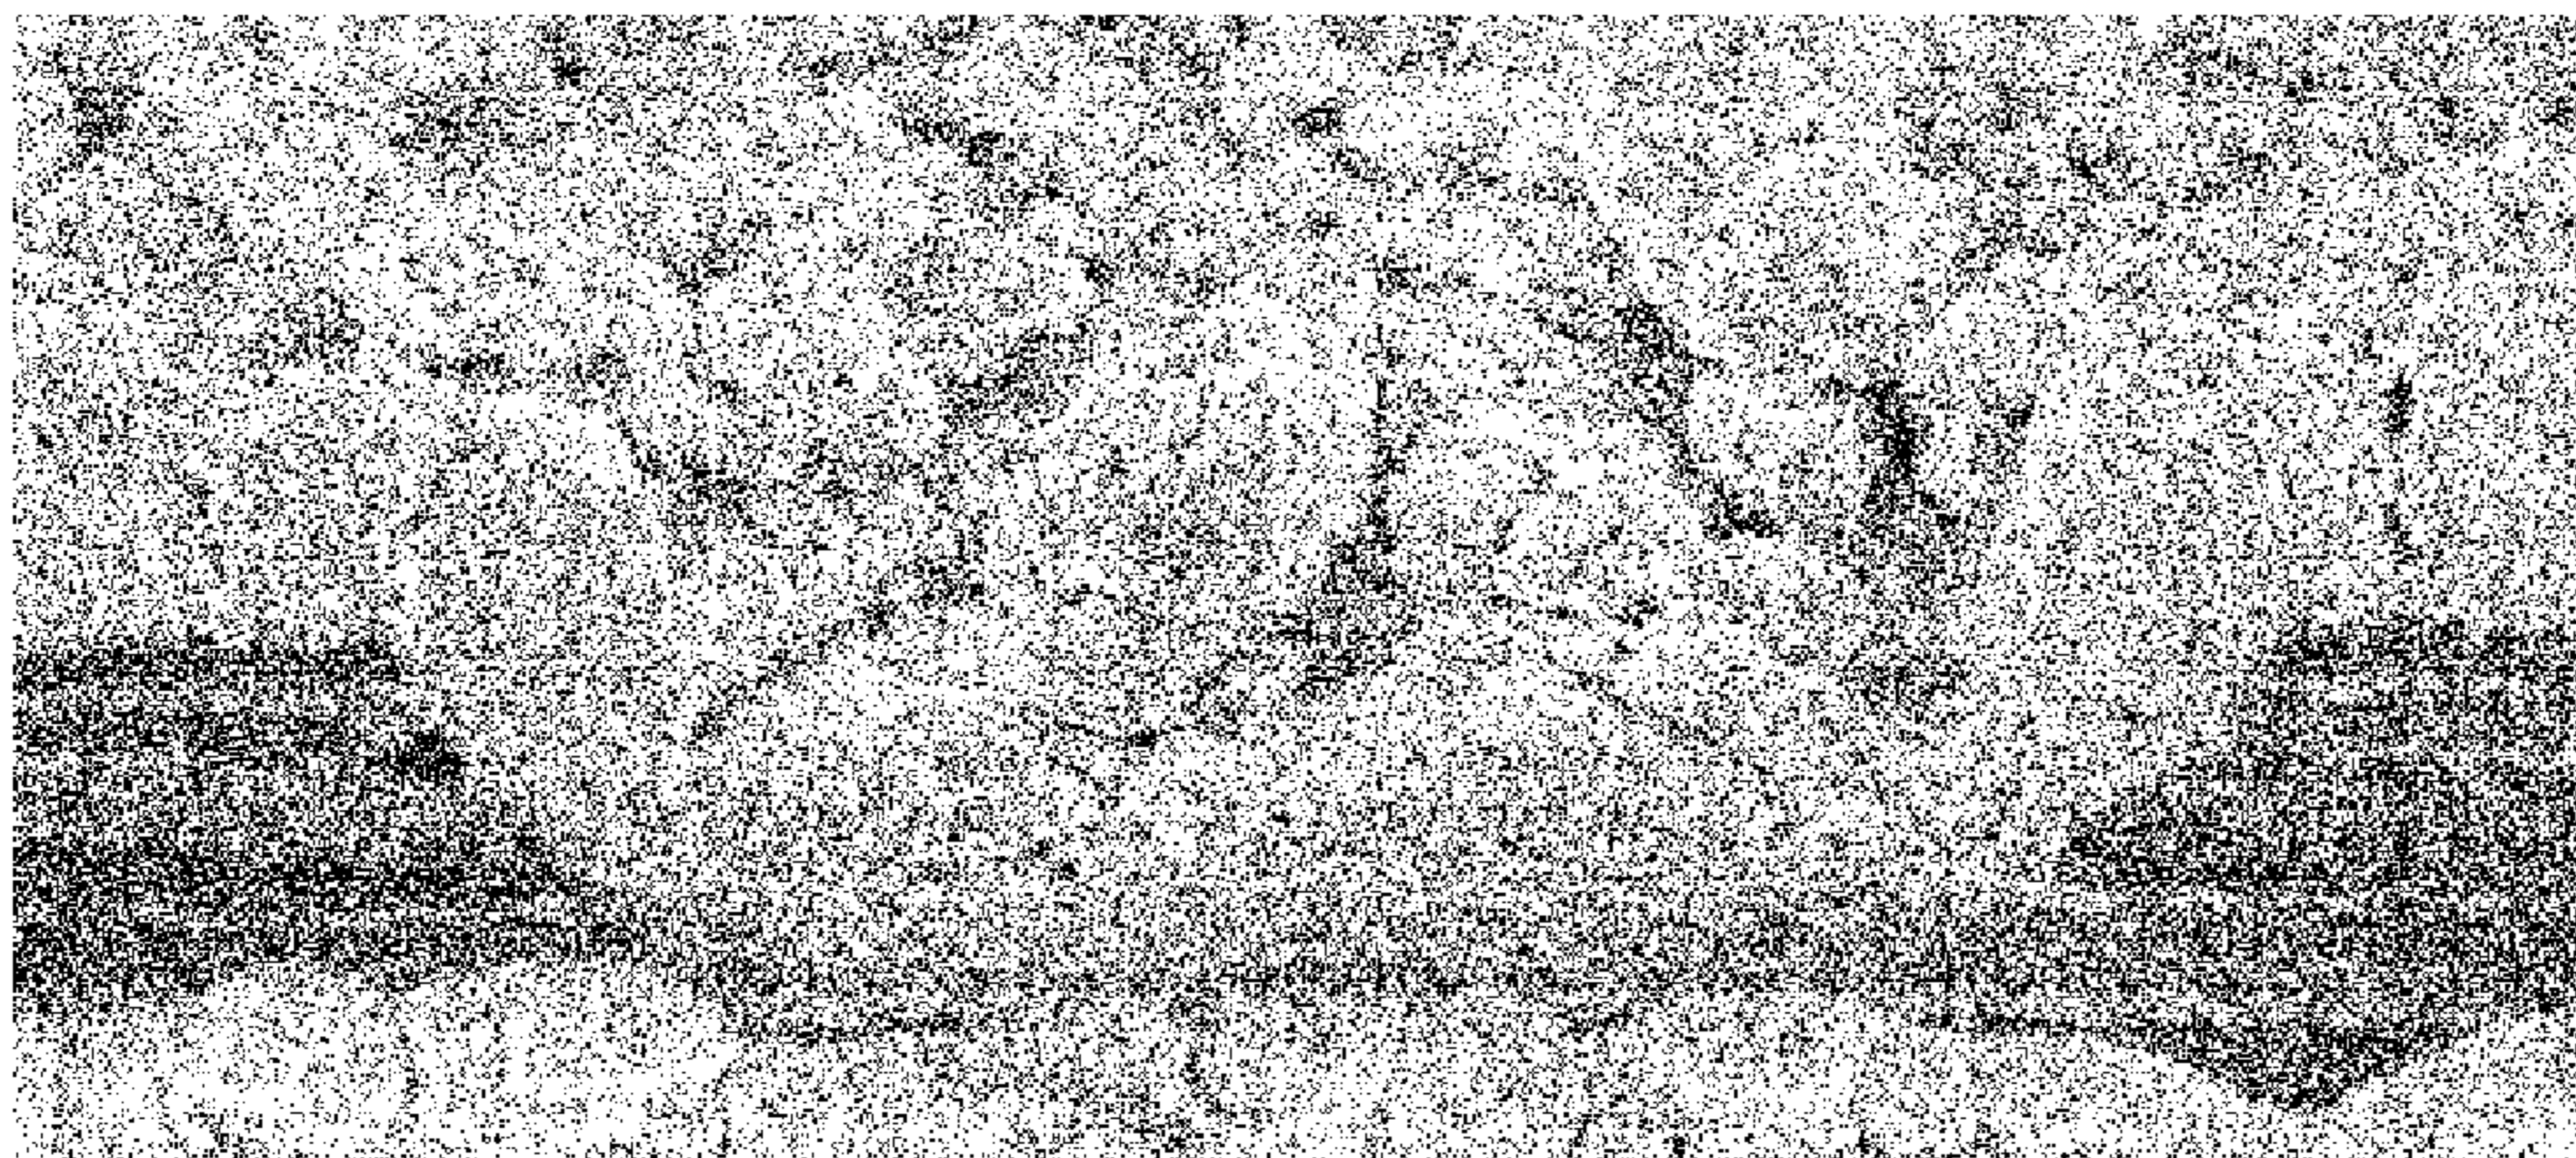
FIG. 8 is a cross-sectional view illustrating the repaired portion after the laser repairing method is applied according to one embodiment of the present invention.

are being welded according to one embodiment of the present invention. FIG. 8 is a cross-sectional view illustrating the repaired portion after the laser repairing method is applied according to one embodiment of the present invention. Referring to FIG. 7, after the normal line and the quasi-welding repair pads are welded, a repair line with a bent profile will not generated at the welded surface thereof. Therefore, the repair line formed by the laser chemical vapor deposition (CVD) process will not break easily.
