(12) **United States Patent**  
**Bublath et al.**

(10) **Patent No.:** **US 7,500,833 B2**  
(45) **Date of Patent:** **Mar. 10, 2009**

(54) **METHOD FOR REPAIRING A COMPONENT OF A TURBOMACHINE**

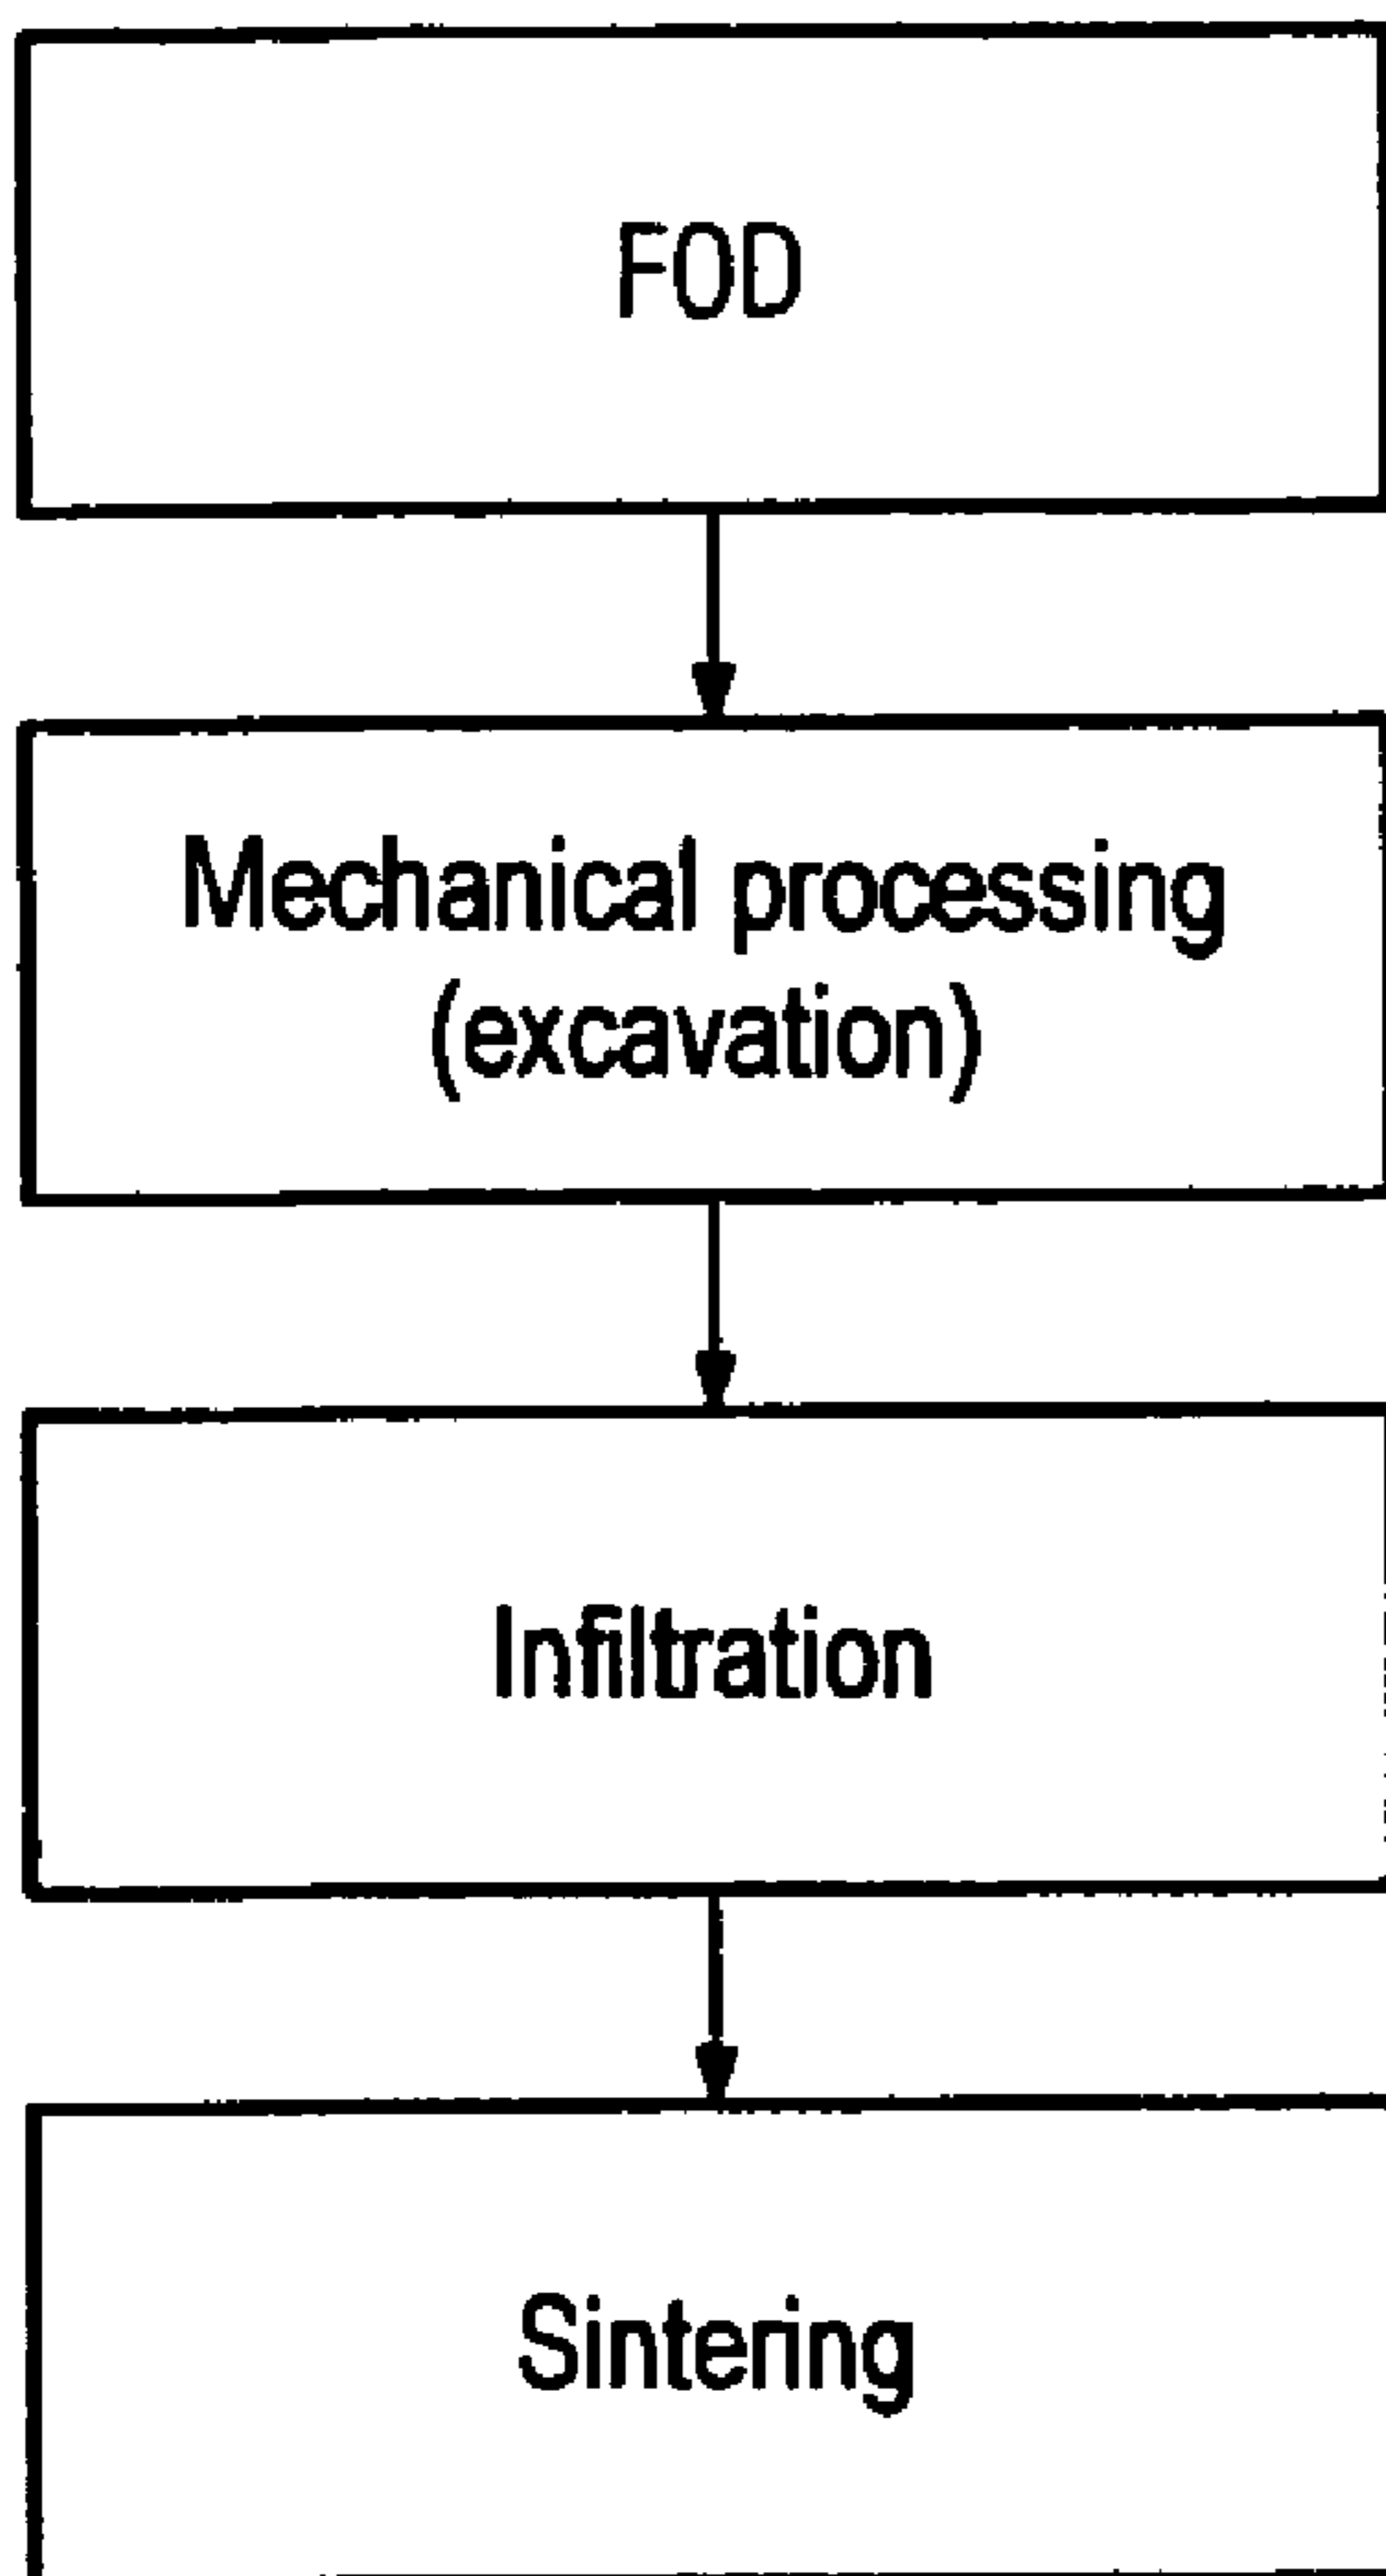
FIG 2

FIG. 2 shows a second method according to the invention for repairing a component installed in a gas turbine,

Another method is proposed according to FIG. 2, the matrix of the damaged component 1 being leached out locally in a first step (FIG. 8). The fibers are inserted in a further step, in which case it is possible to achieve improved mechanical properties compared to the ceramic matrix 5. The steps of infiltration and sintering are subsequently carried out as in the previous example of FIG. 1.

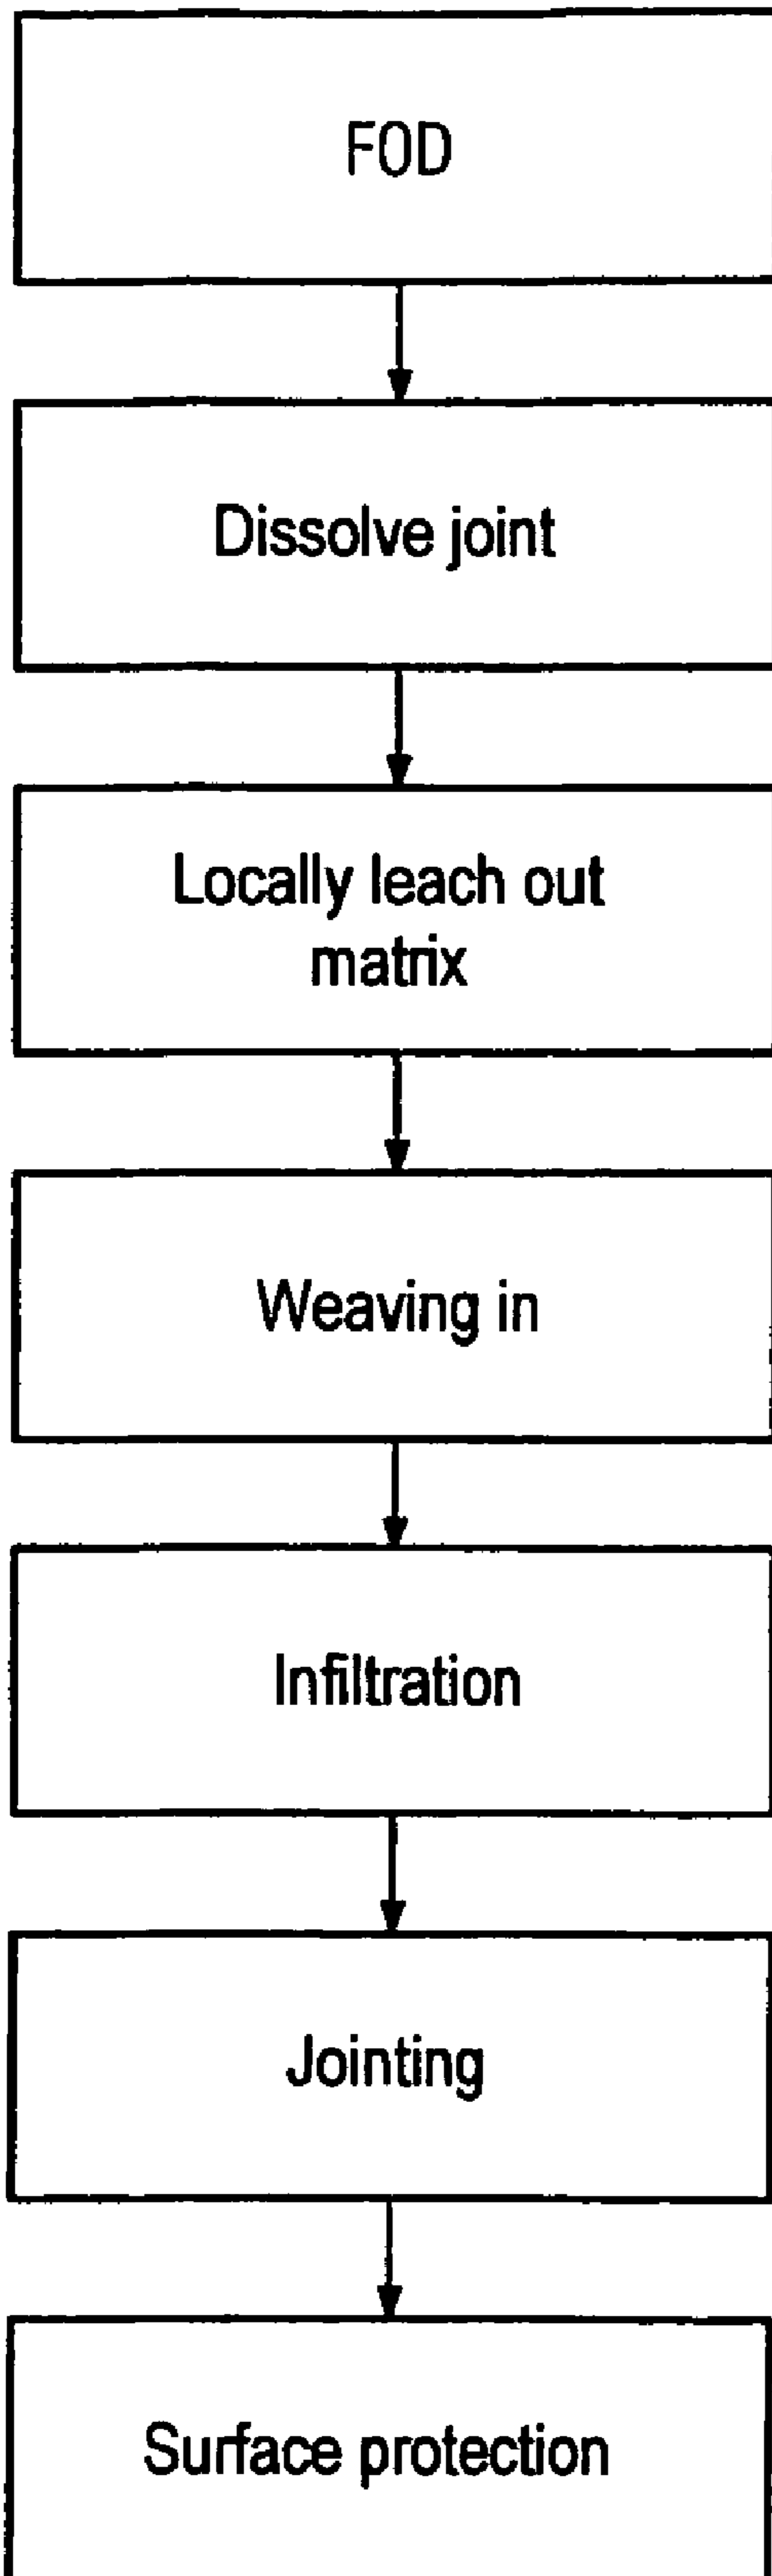
FIG 6

FIG. 6 shows a method for repairing a component with coating of the fibers and surface protection,

Another method sequence according to the invention is represented in FIG. 6, in which recoating of the fibers is provided in contrast to the method sequence represented in FIG. 5.
