US007515243B2

(54) **DISPLAY DEVICE AND METHOD FOR REPAIRING LINE DISCONNECTION THEREOF**

(73) Assignee: **Mitsubishi Electric Corporation**, Tokyo (JP)

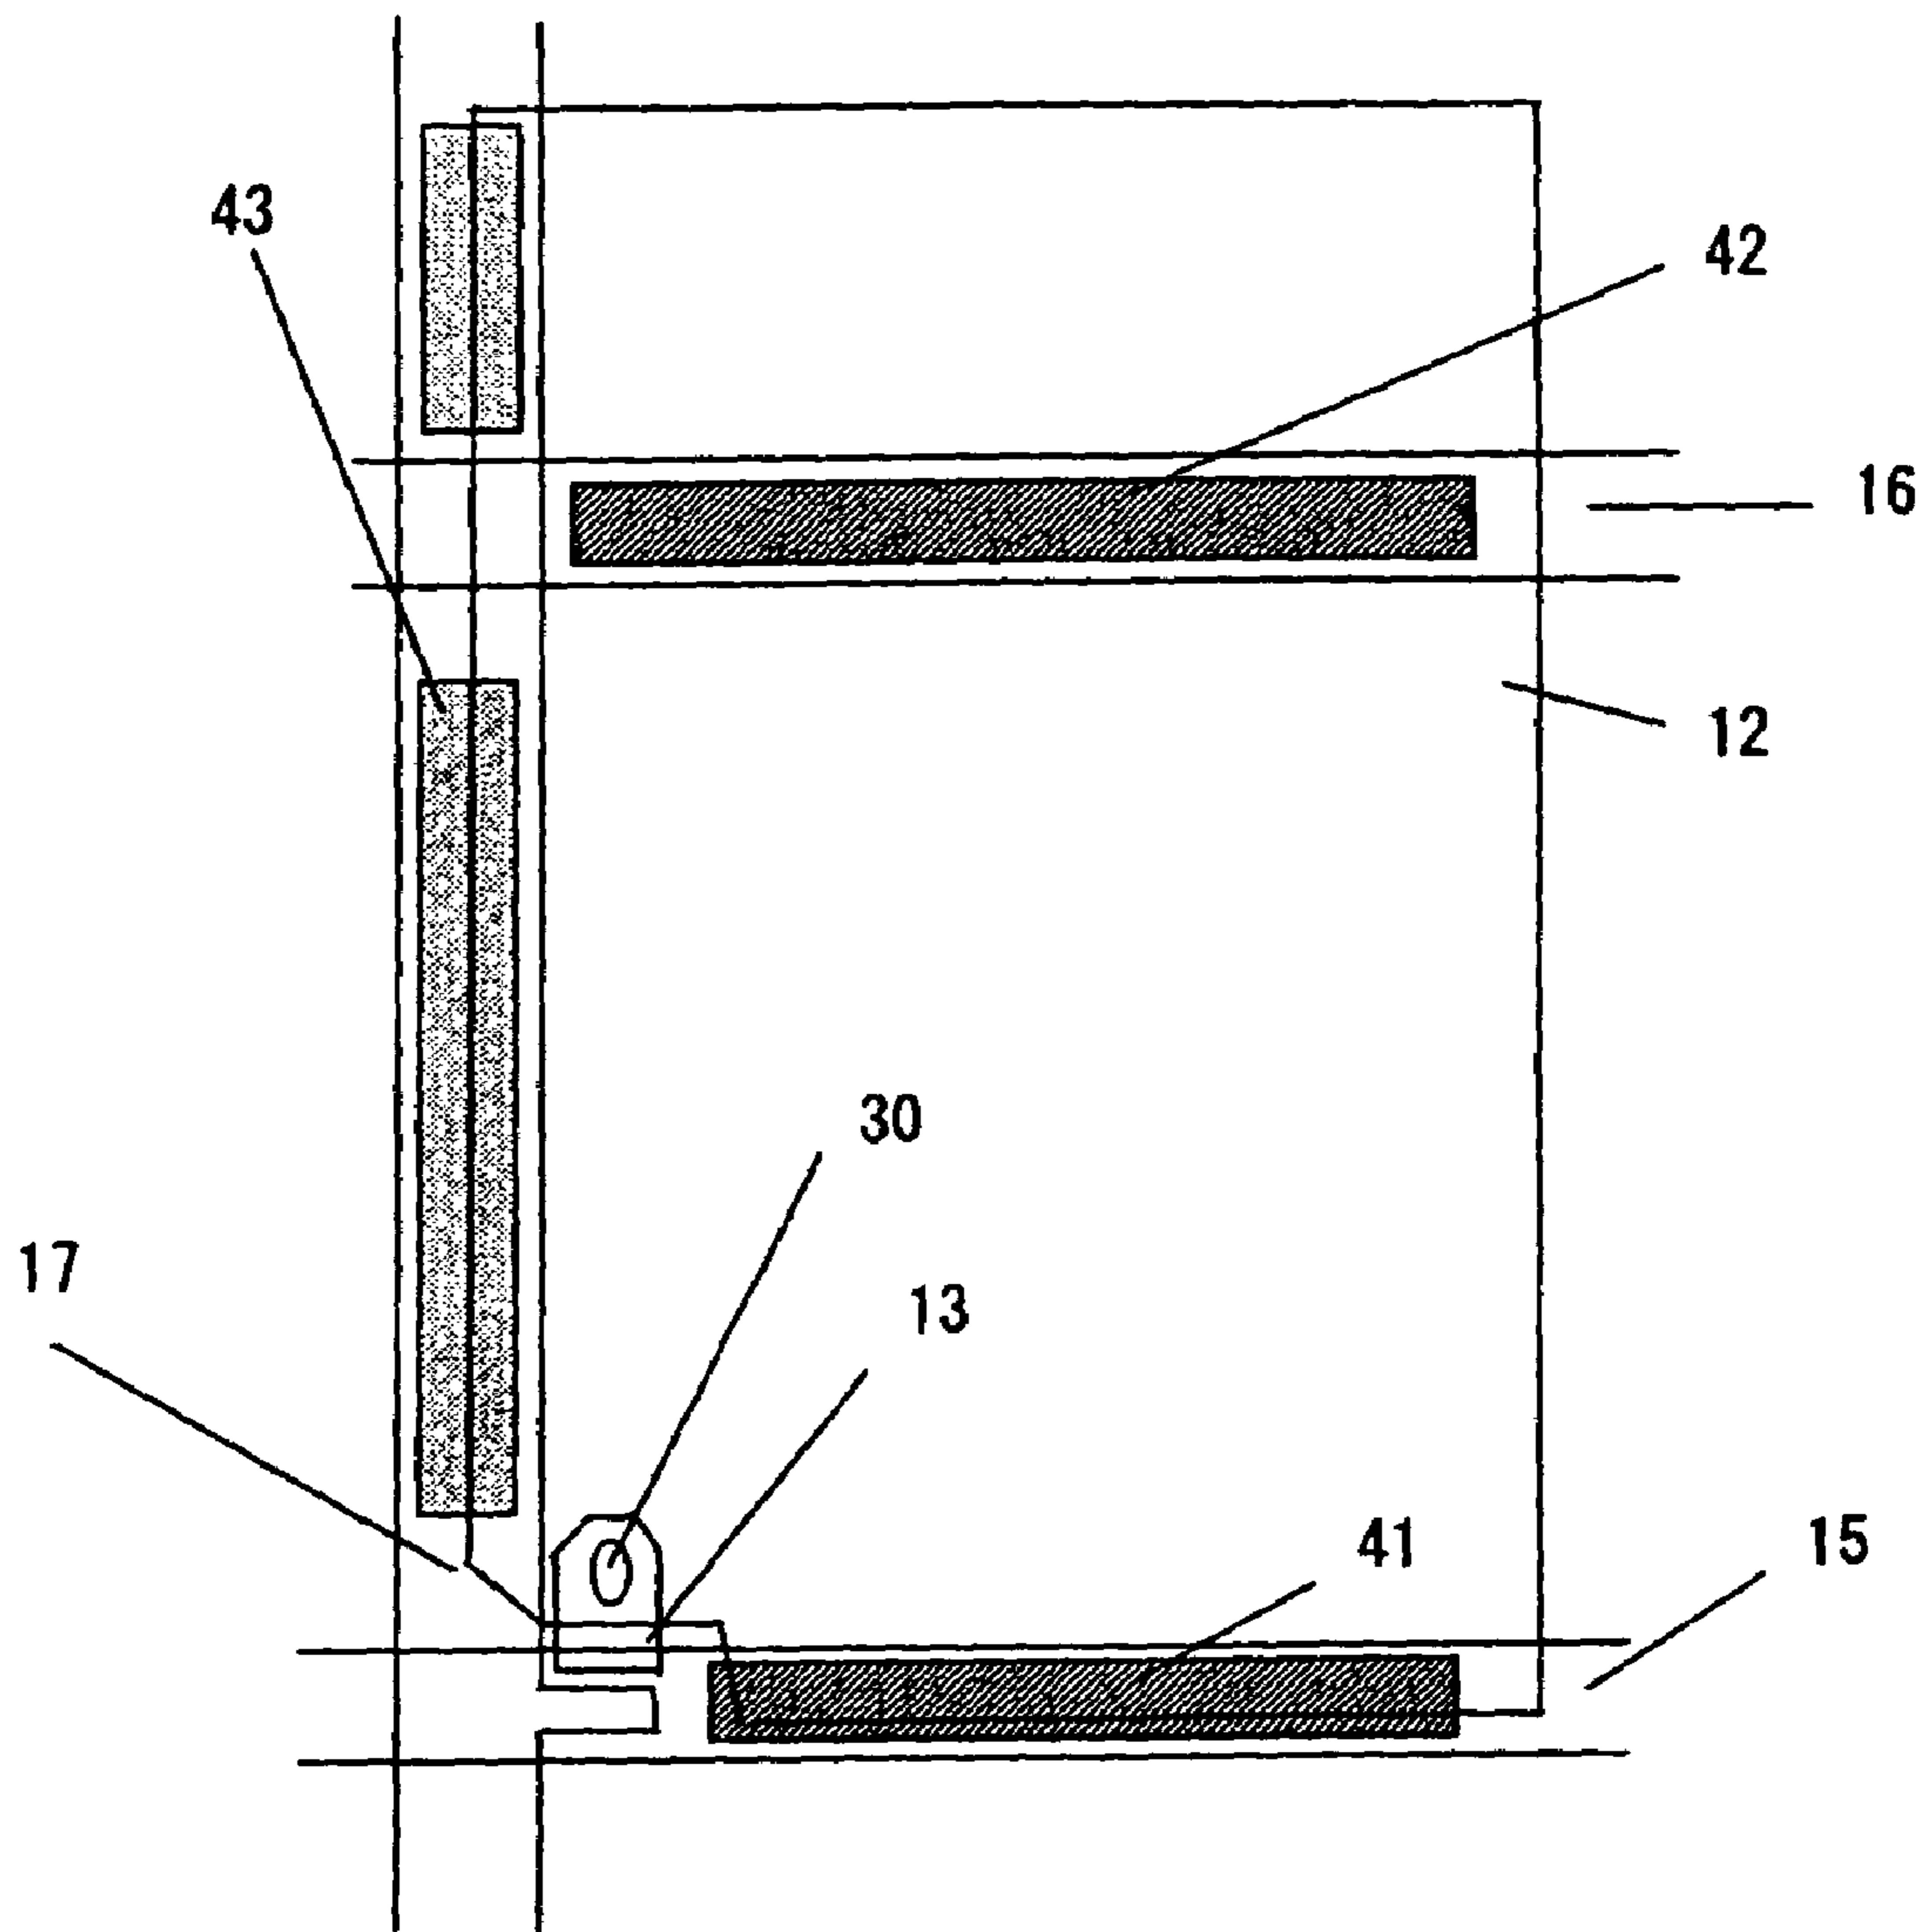
FIG. 1 is a plan view showing a structure of one pixel area of a liquid crystal display device according to the first embodiment of the present invention.

A method for repairing line disconnection according to the present invention will be explained hereinafter with reference to FIGS. 1 to 4. FIG. 1 is a plan view showing a structure of one pixel area of an active matrix liquid crystal display device according to the present invention. FIG. 2 is a plan view showing a structure of the pixel area where each of a gate line, source line, and storage capacitor line has a disconnected portion 28. FIG. 3A is a sectional view showing a structure of the disconnected portion of the gate line. FIG. 4 is a sectional view showing a structure of a TFT area of the active matrix liquid crystal display device. Reference numeral 11 designates a substrate, 12 a pixel electrode, 13 a thin film transistor (TFT), 14 a drain electrode, 15 a gate line, 16 a storage capacitor line, 17 a source line, 21 a gate electrode, 22 a gate insulating film, 23 a silicon semiconductor layer, 24 an etching stopper, 25 the first n⁺ silicon layer, 26 the second n⁺ silicon layer, 27 a source electrode, 28 a disconnected portion, 29 a molten metal, 30 a contact hole, 41 a conductive layer for repairing gate line disconnection, 42 a conductive layer for repairing storage capacitor line disconnection, and 43 a conductive layer for repairing source line disconnection.

As shown in FIG. 1, the pixel electrode 12 is connected with the TFT 13 that is a switching element. The gate electrode 21 of the TFT 13 is connected with the gate line 15, and gate signals input to the gate electrode 21 drives and controls the TFT 13. The source electrode 27 of the TFT 13 is connected with the source line 17, and data (display) signals are input to the drain electrode 14 shown in FIG. 4 through the TFT 13 when the TFT 13 is selected. From the drain electrode 14, the data signals are input to the pixel electrode 12 through the contact hole 30. The gate line 15 and the source line 17 cross each other at right angles, surrounding the pixel electrode 12. The drain electrode 14 of the TFT 13 is connected with the pixel electrode 12. The conductive layer 41, the conductive layer 43, and the conductive layer 42 are provided for the gate line 15, the source line 17, and the storage capacitor line 16, respectively. The conductive layers are island shaped or electrically floating.

If the storage capacitor line 16 is provided between the gate lines 15 as shown in FIG. 1, the conductive layer 43 has to avoid electrical contact with the line 16. The conductible layer 43 is preferably as large as possible to enlarge the area where line disconnection can be repaired. If the storage capacitor line 16 is not provided, on the other hand, the conductive layer 43 has to avoid electrical contact with the adjoining gate line 15, while being as large as possible to obtain a larger repairable area. The conductive layer 43 can be formed between the source line 17 and the pixel electrode 12 with an insulating film interposed therebetween.

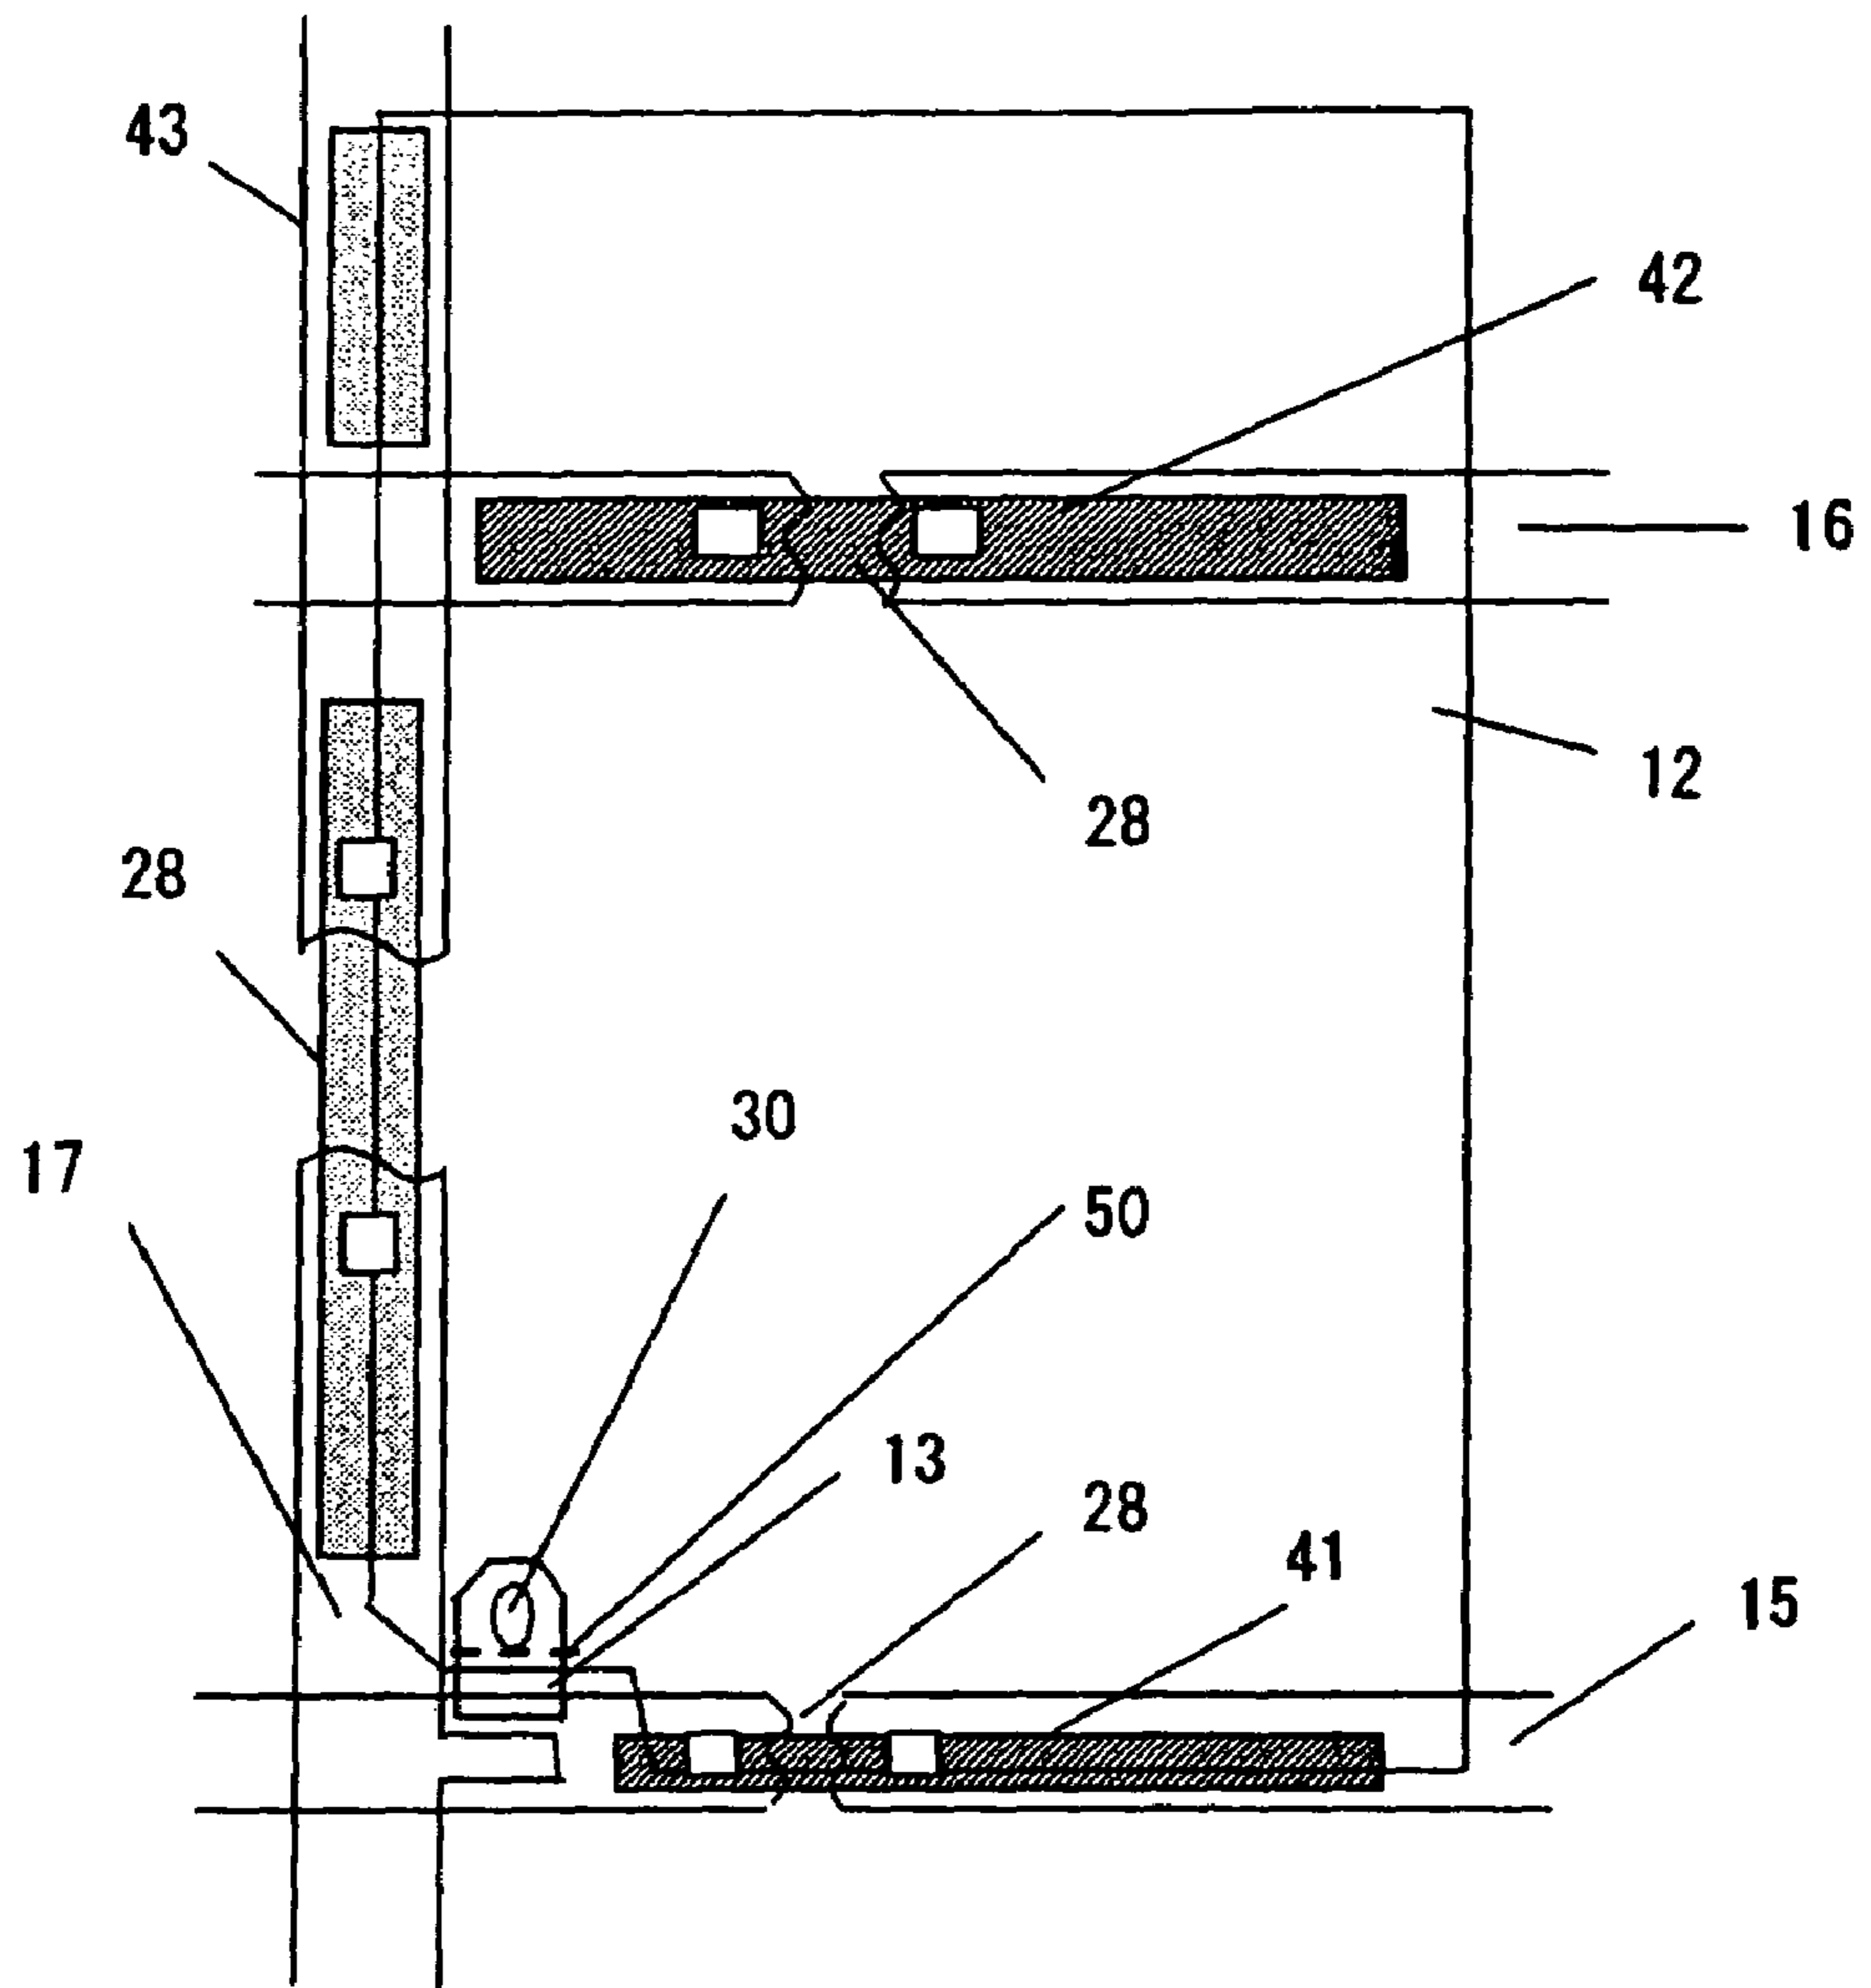
FIG. 2 is a plan view showing a structure of one pixel area of the liquid crystal display device according to the first embodiment of the present invention, where line disconnection occurs.

FIG. 2 shows the case where each of the three lines has the disconnected portion 28. Repair of the disconnection will be explained hereinafter with reference to FIG. 3. The explanation will be given on the repair of the gate line 15. FIG. 3A shows a structure of a cross-section of the disconnected portion of the gate line in one pixel area of an active matrix liquid crystal display device. On the substrate 11 as the bottom layer are provided the gate line 15, the gate insulating film 22, the conductive layer 41, the insulating film 45, and the pixel electrode 12 as the top layer. For example, on the insulating substrate 11 such as a glass substrate, aluminum of approximately 0.3 μm thick is formed as the gate line 15. Next, silicon nitride of approximately 0.3 to 0.5 μm thick is formed as the gate insulating film 22. Then, a conductive metal is provided as the conductive layer 41. The conductive layer 41 melts by laser application. A laser device is a YAG laser, for example. The conductive metal is formed by chromium, tantalum, titanium, aluminum, molybdenum, and the like. Its thickness is approximately 0.1 to 0.2 μm. Further, silicon nitride of approximately 0.1 μm is formed as the insulating film 45.

50 shown in FIG. **2** to separate the pixel from the TFT **13**. Though a point defect occurs at the subject pixel, the disconnection of the gate line **15** is repaired. No error voltage is thereby applied to the pixel electrode **12** to prevent deterioration of display quality.

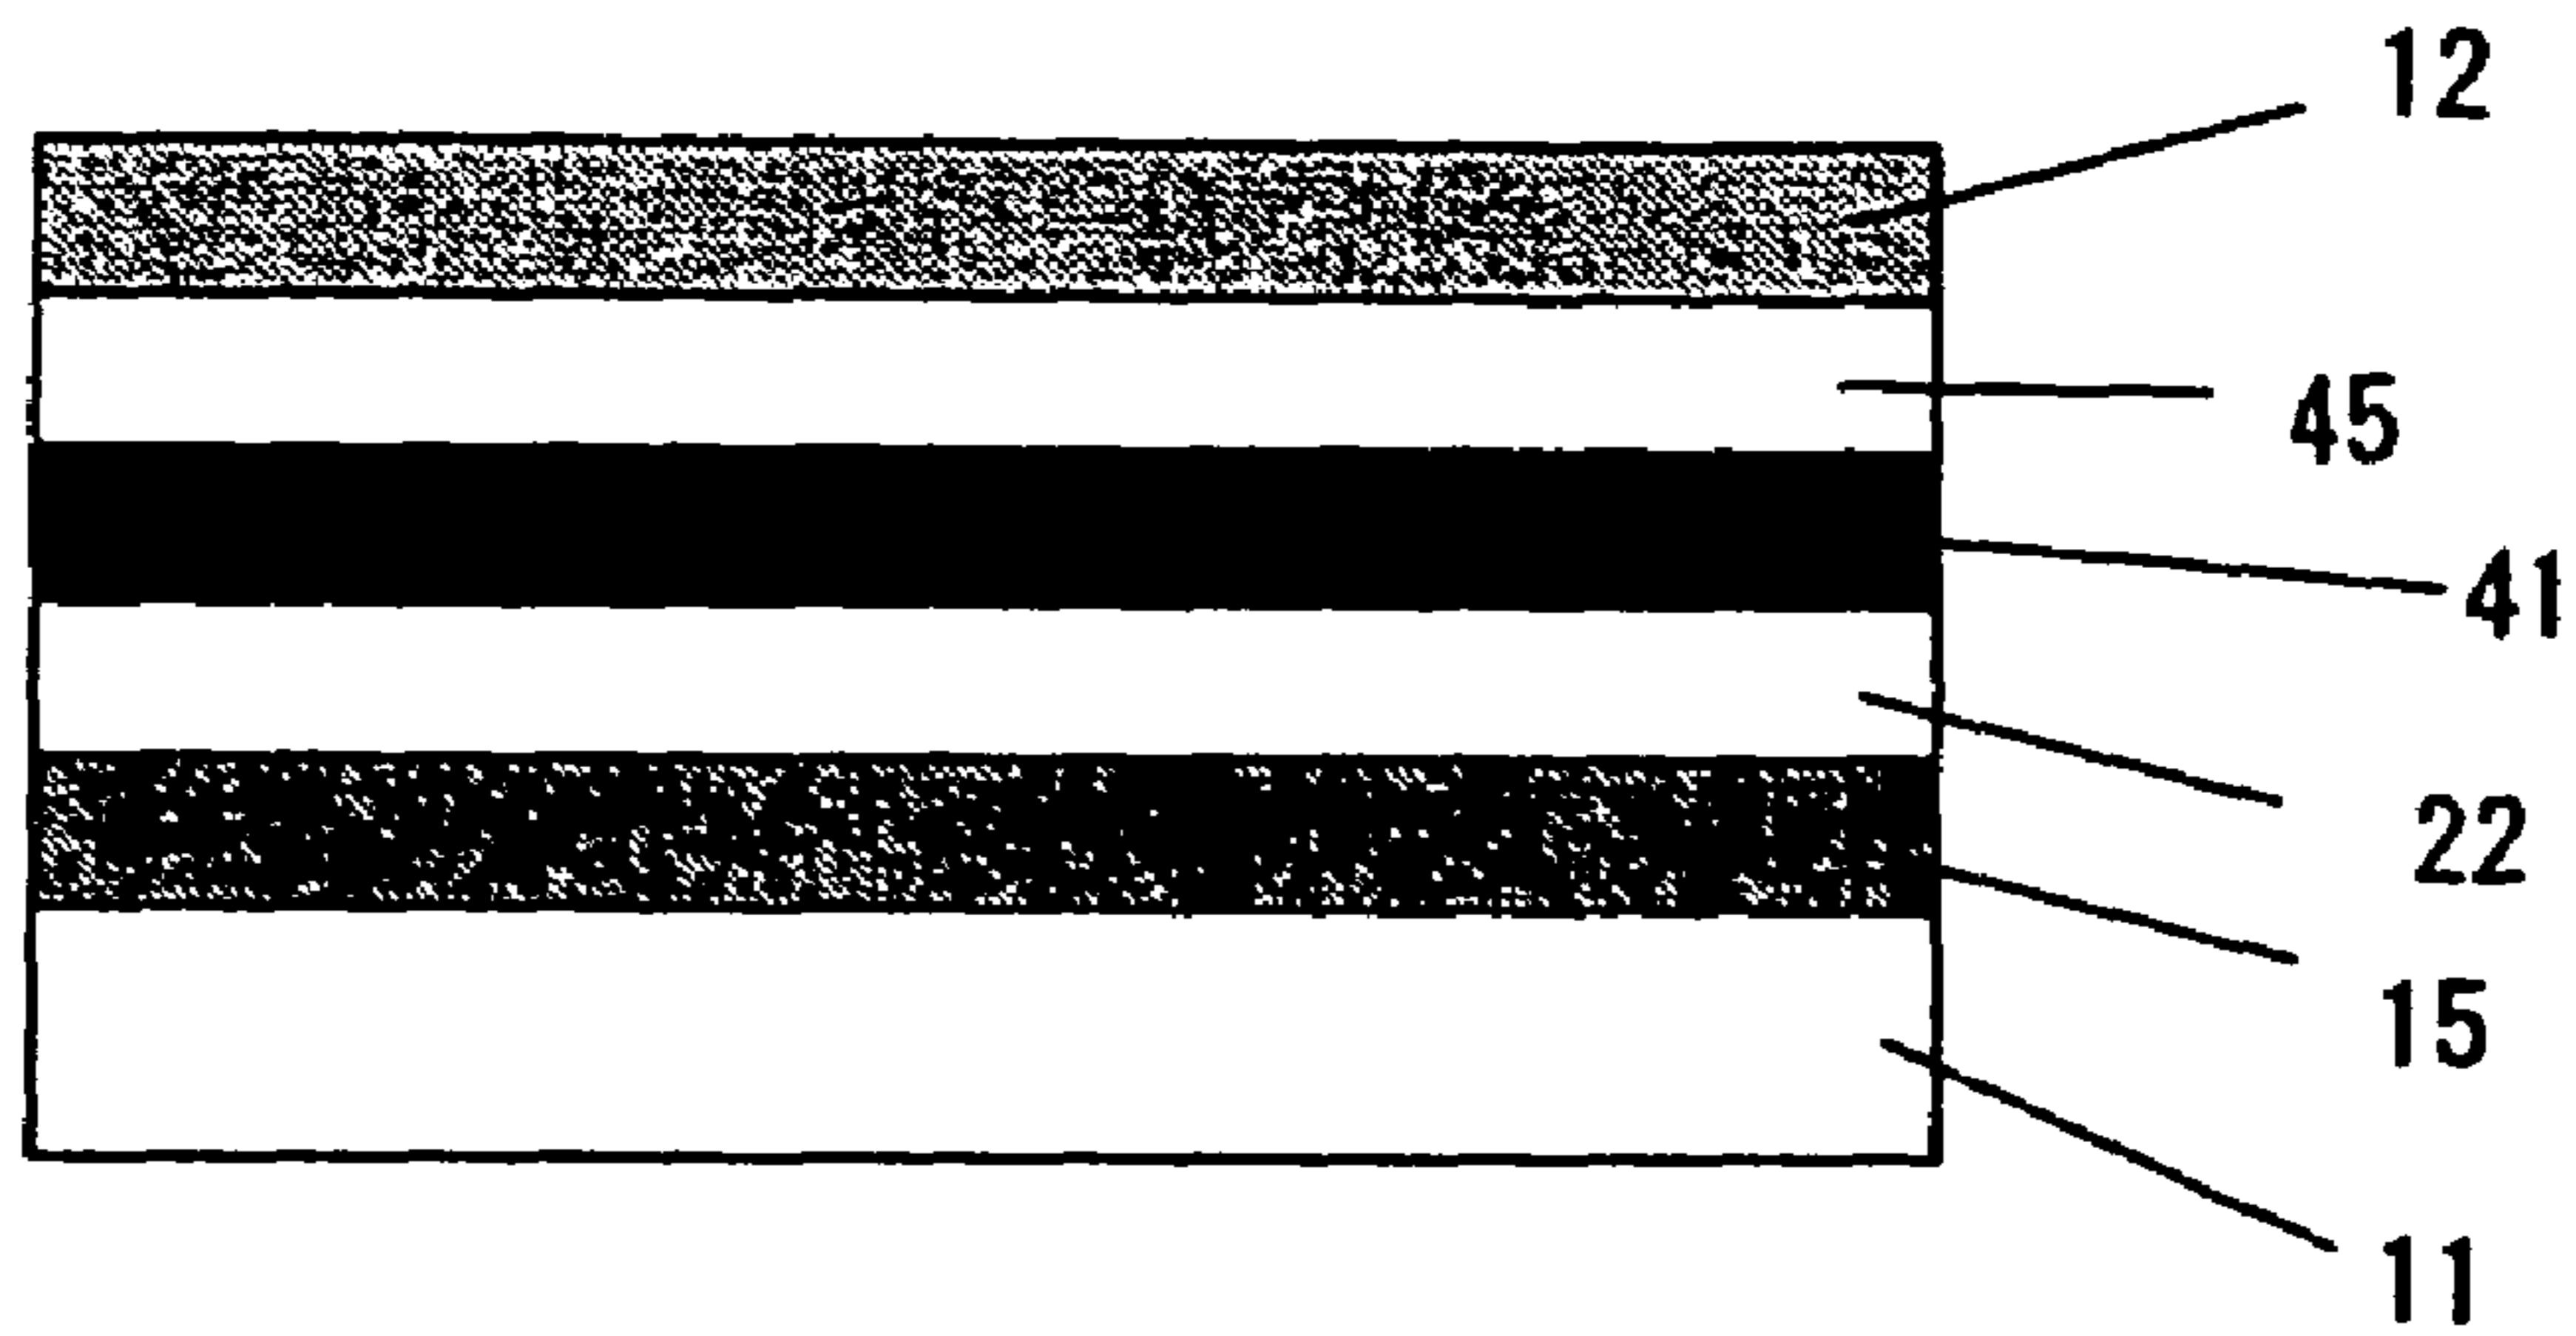
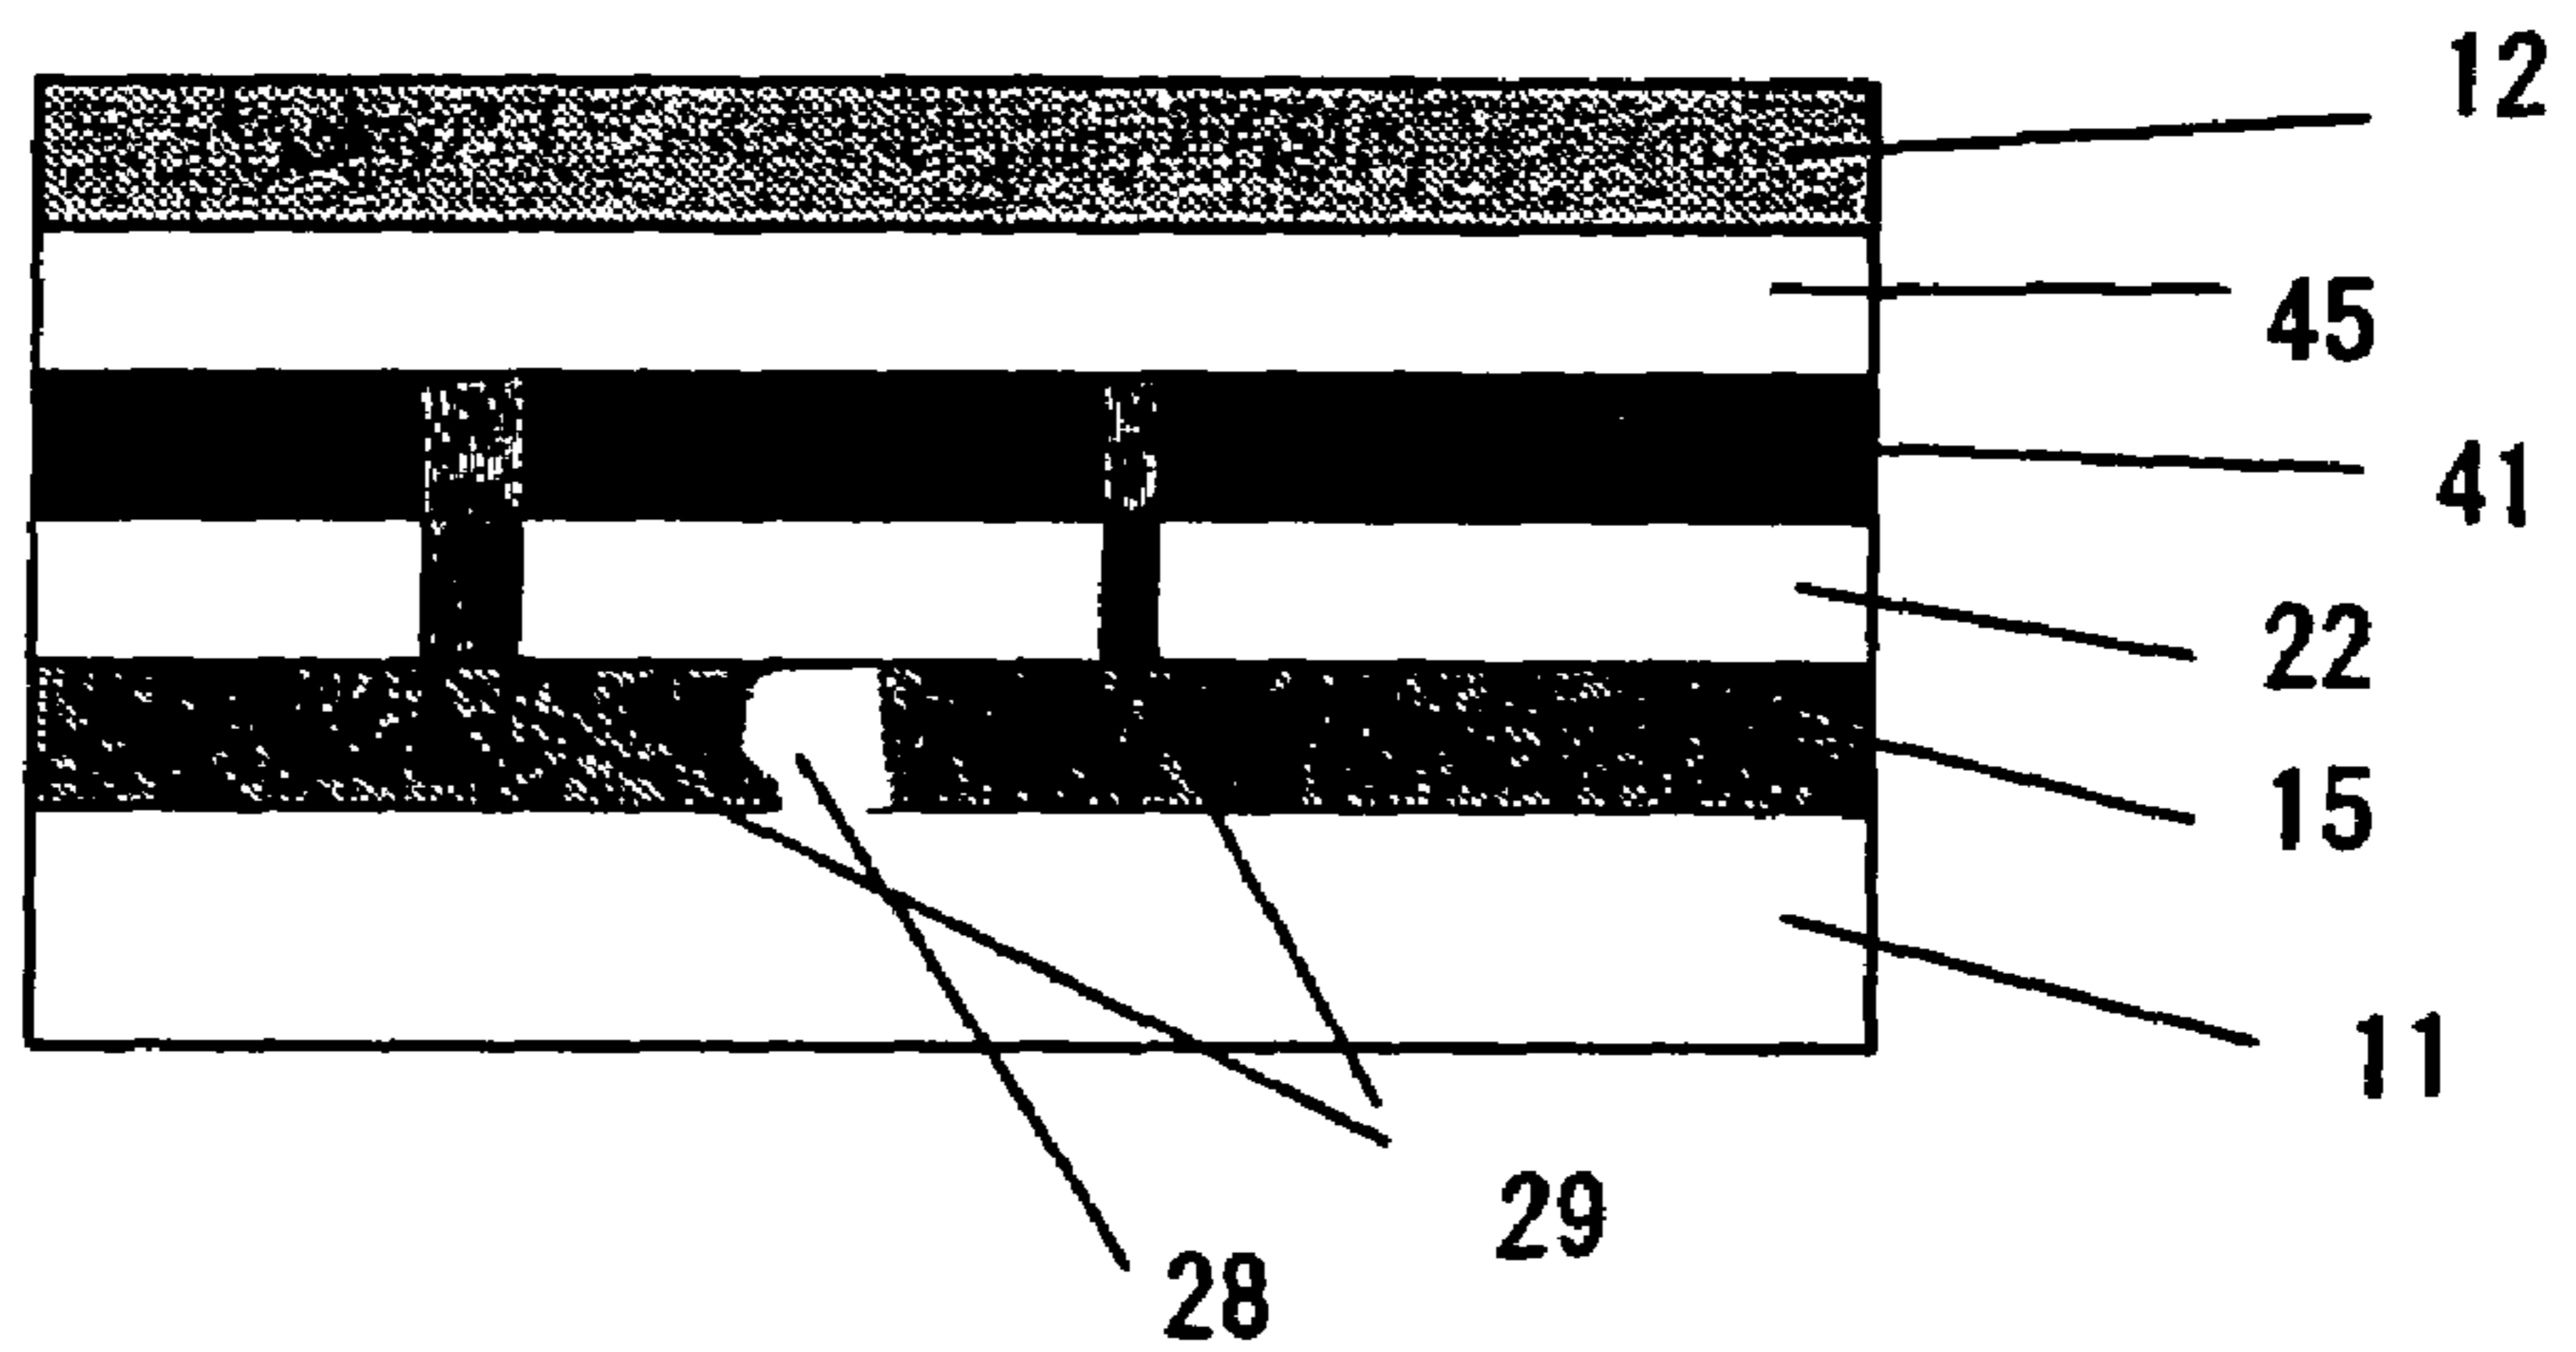
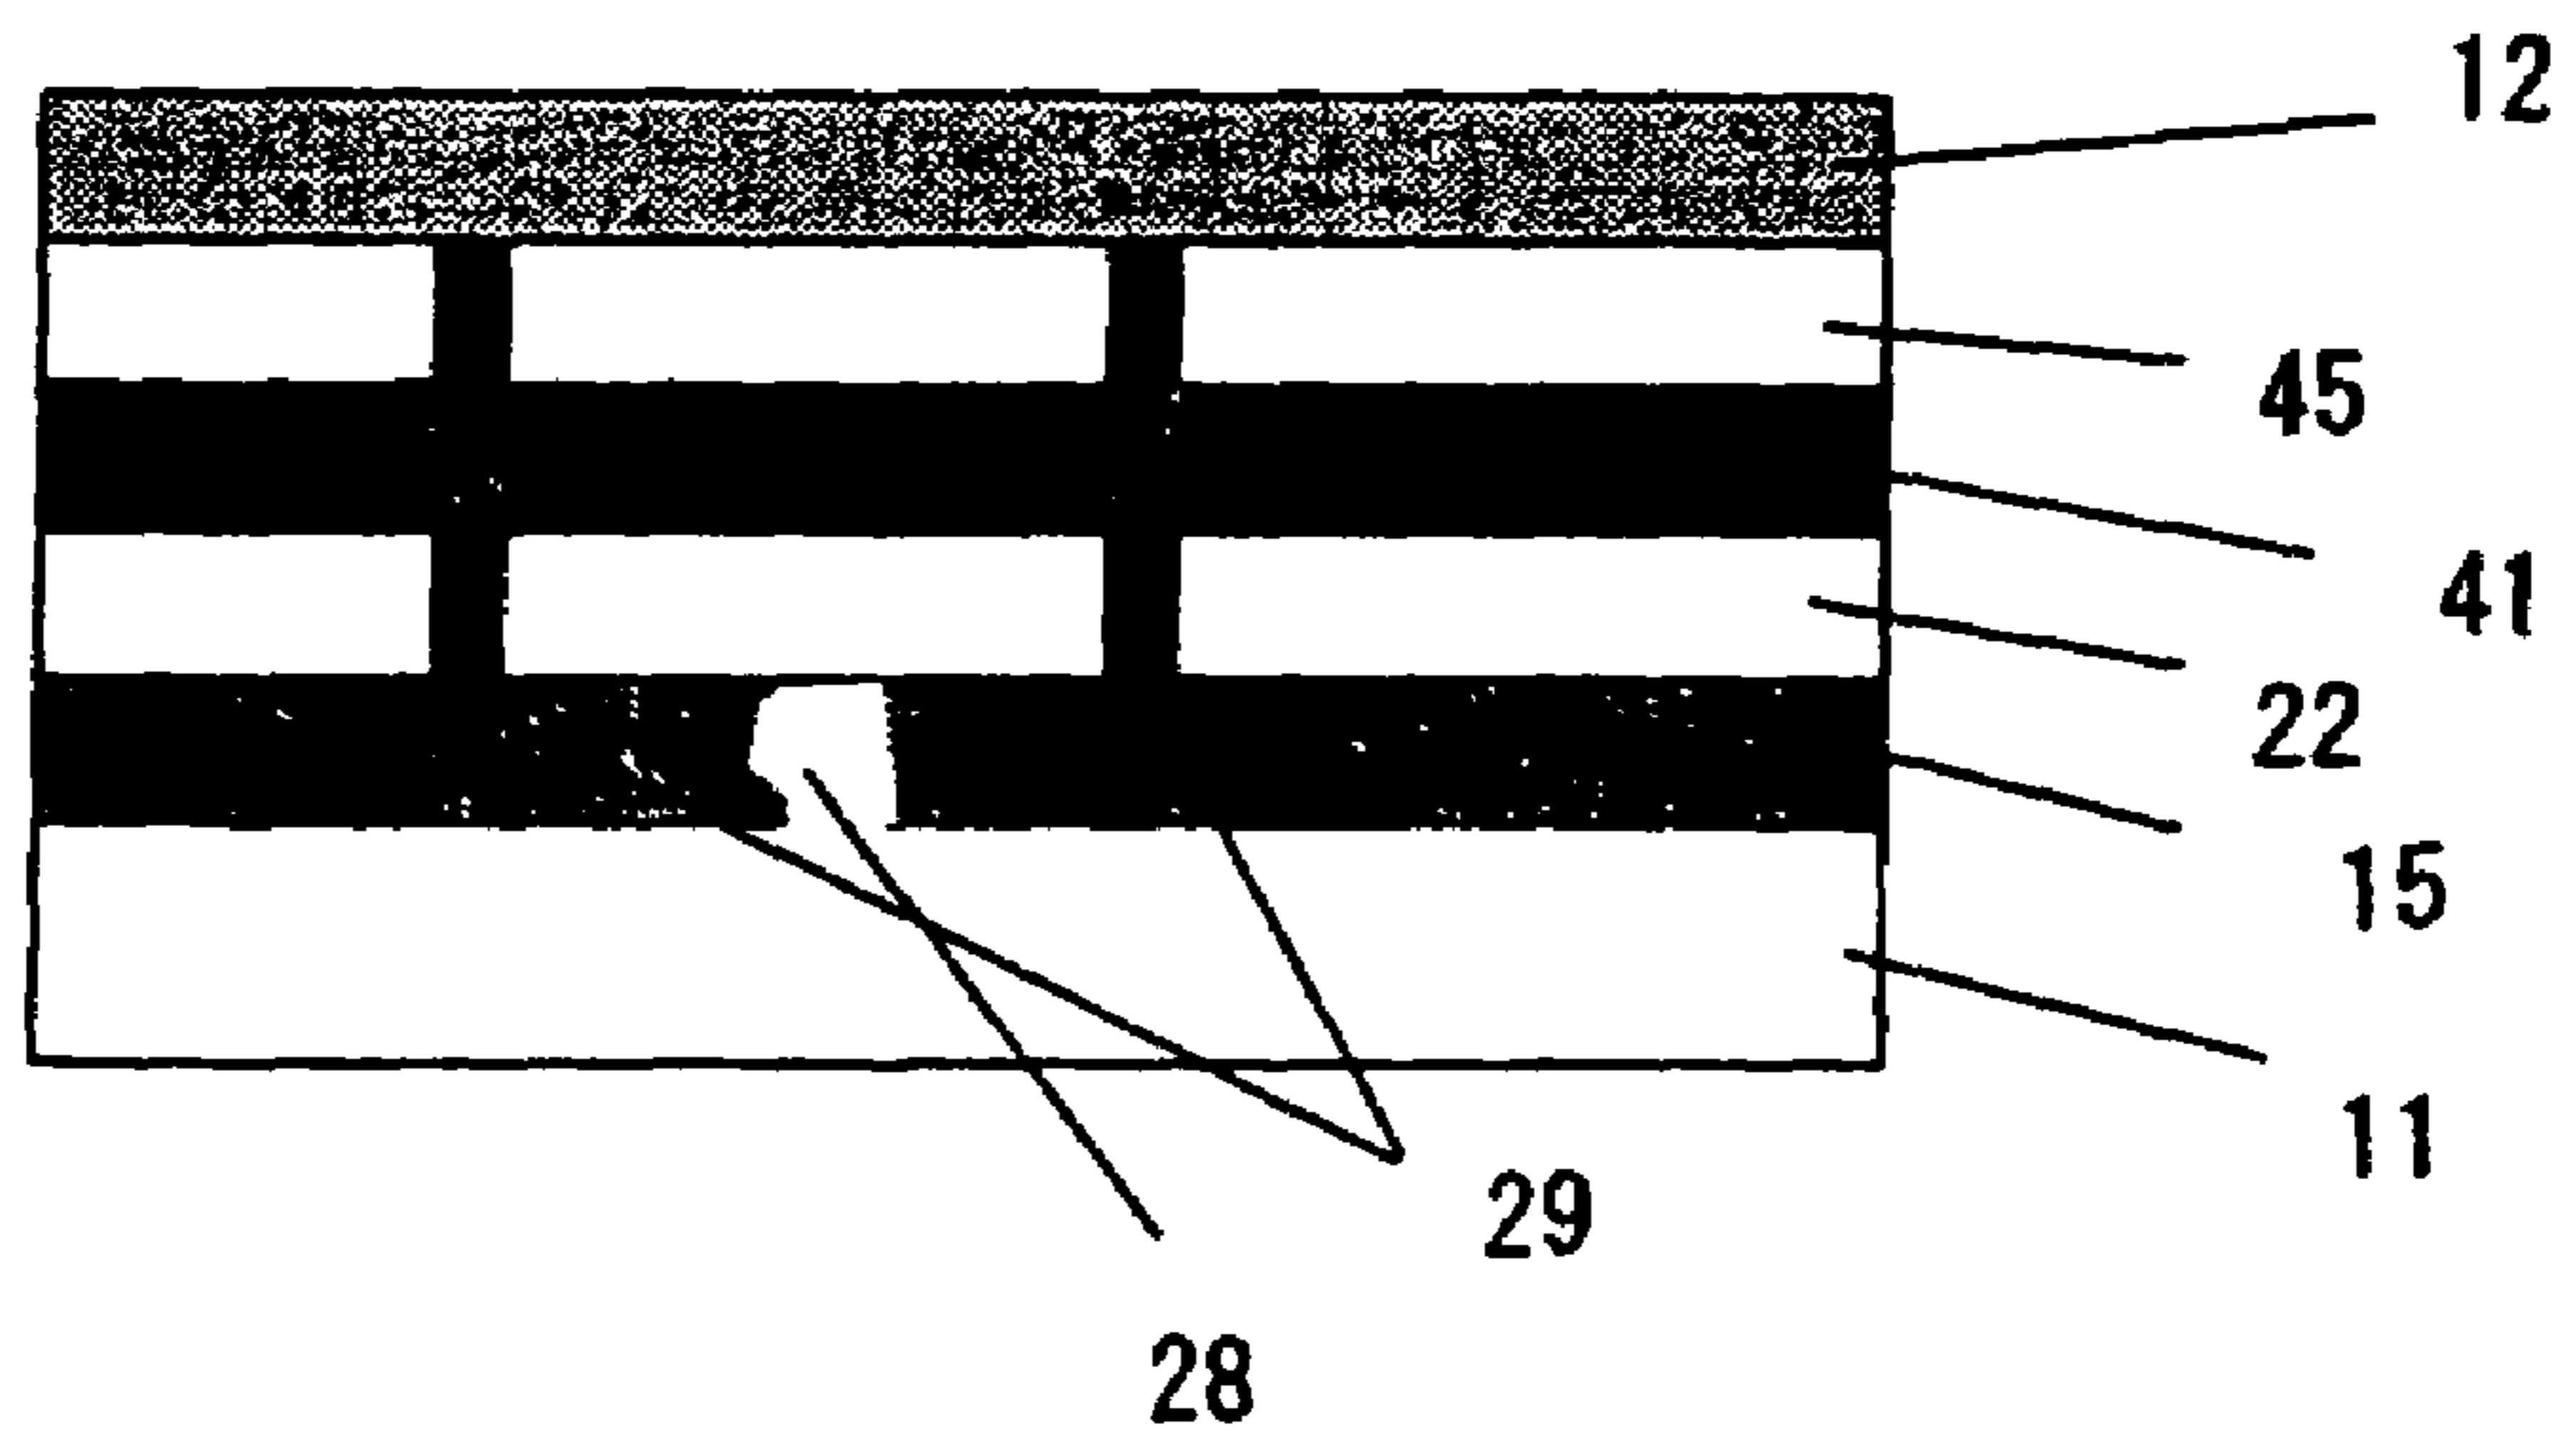
FIGS. 3A, 3B, and 3C are sectional views showing structures of a disconnected portion of a gate line in the liquid crystal display device according to the first embodiment of the present invention.

FIG. **3B** shows a cross-section of the gate line **15** when a laser is applied to the square marks on both outsides of the disconnected portion **28** of the gate line **15** shown in FIG. **2**. The laser is applied from the side of the gate line which is the side of the substrate **11** where the TFT **13** is not formed. The application of the laser to the marks melts the conductive layer **41** and the gate line **15** to produce the molten metal **29**. A bypass route through the gate line **15**, the molten metal **29**, the conductive layer **41**, the molten metal **29** and the gate line **15** is thereby created to let gate signals go through it, avoiding the disconnected portion **28**. The disconnection is thereby repaired. Since the bypass route has no contact with the pixel electrode **12**, the pixel electrode **12** serves as a shield so that gate signals going through the conductive layer **41** have no adverse effect on liquid crystals arranged on the pixel electrode **12**. No error voltage is thereby applied to the pixel electrode **12** to be free from deterioration of display quality.

If a laser is applied from the side of the pixel electrode **12**, on the other hand, electrical continuity is provided between the pixel electrode **12** and the gate line **15** as shown in FIG. **3C**. Gate signals go through a bypass route through the gate line **15**, the molten metal **29**, the conductive layer **41**, the molten metal **29**, and the gate line **15**, or through the gate line **15**, the molten metal **29**, the pixel electrode **12**, the molten metal **29**, and the gate line **15**. The laser is applied to a cut line
