US007515243B2

(54) **DISPLAY DEVICE AND METHOD FOR REPAIRING LINE DISCONNECTION THEREOF**

(73) Assignee: **Mitsubishi Electric Corporation**, Tokyo (JP)

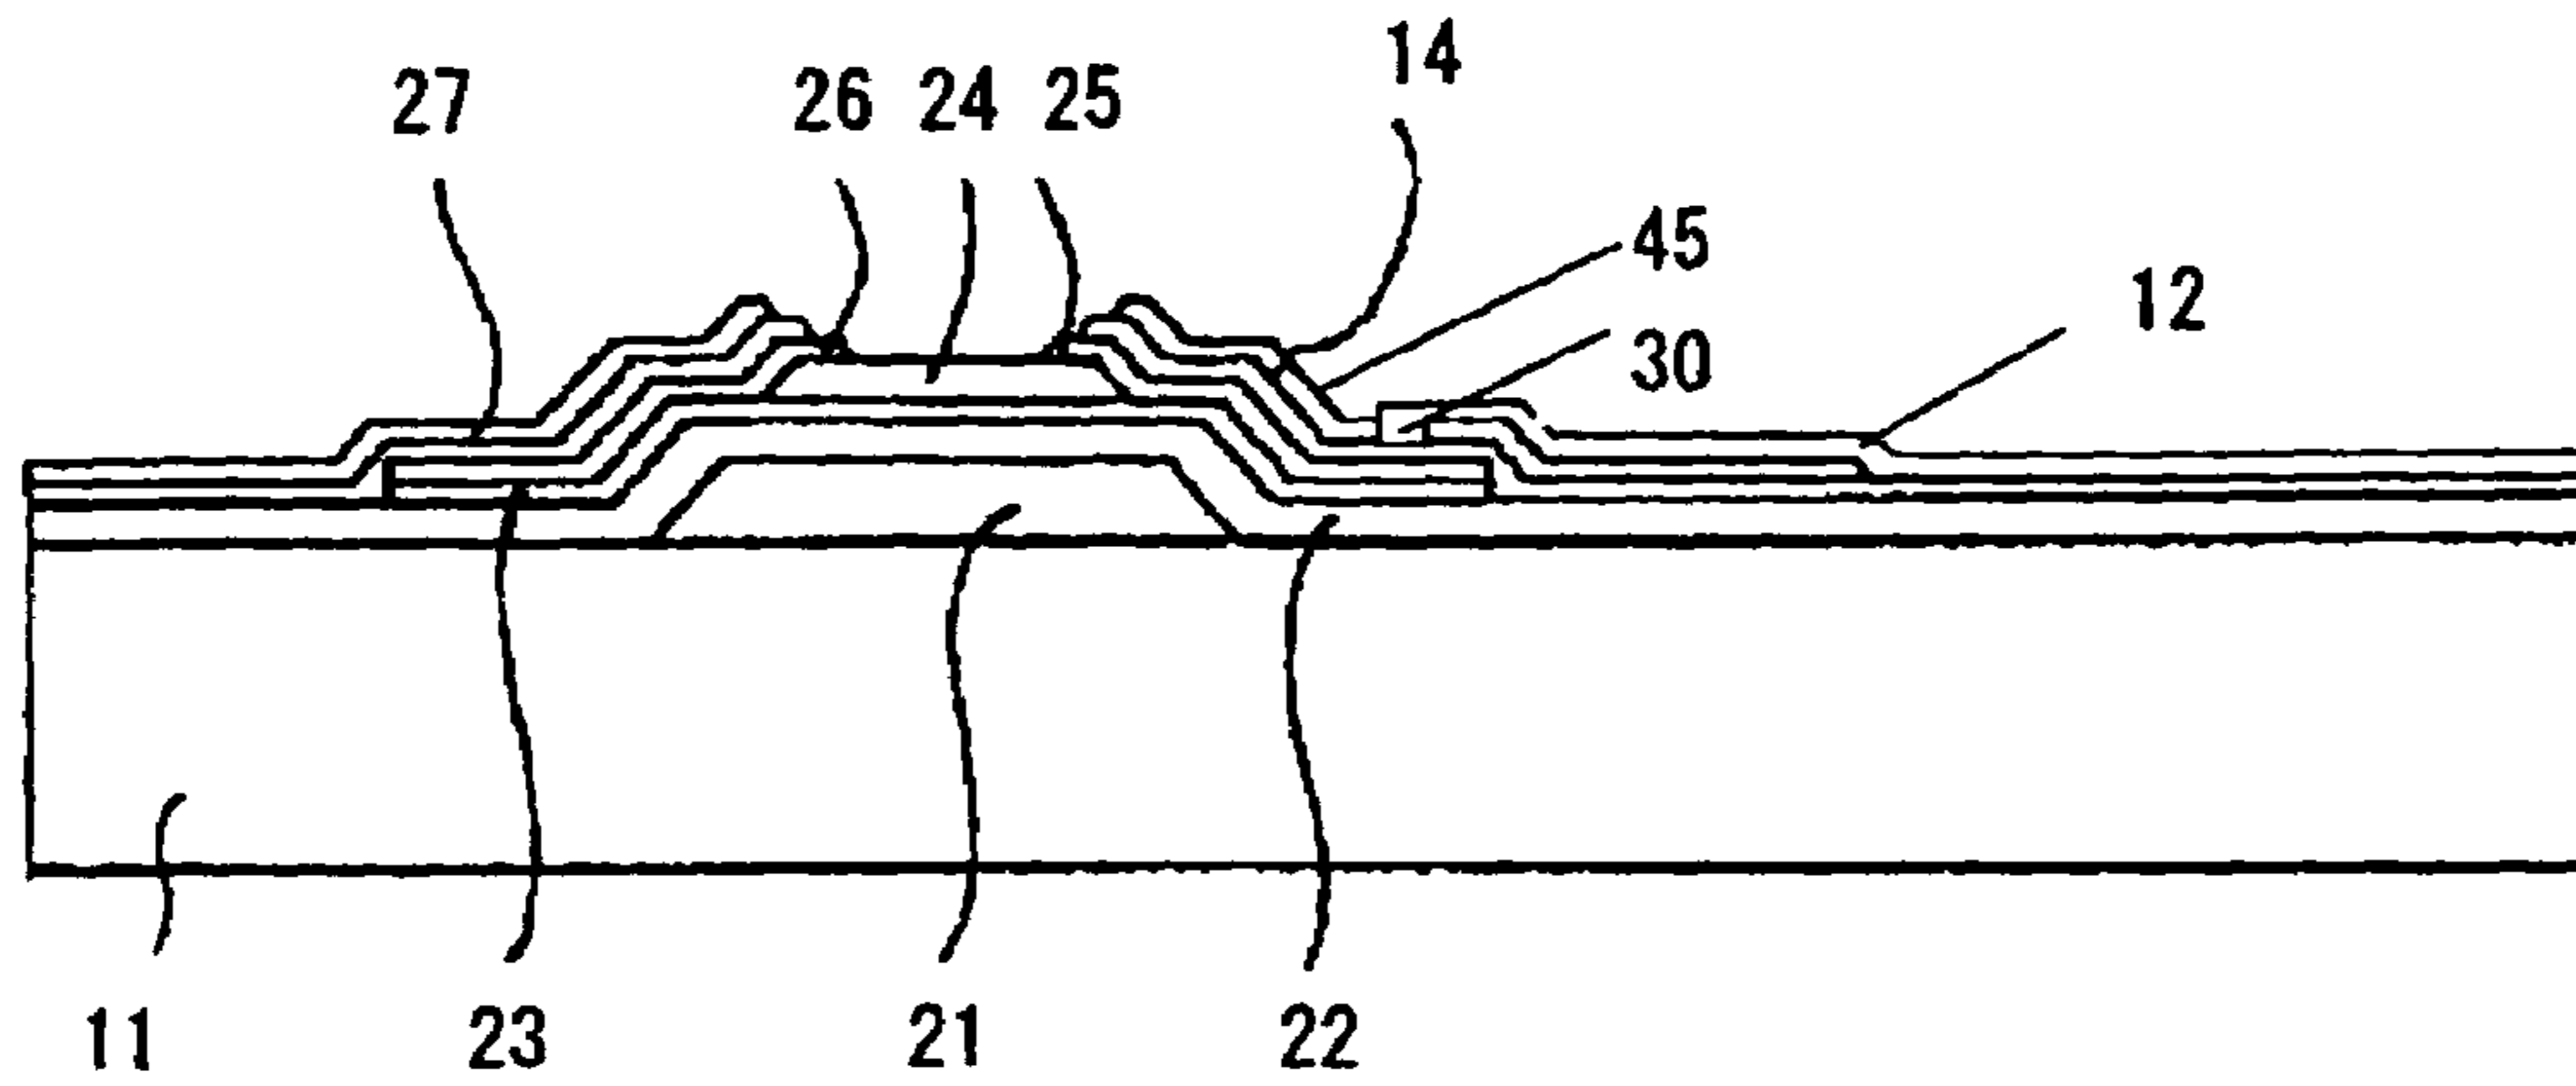
FIG. 4 is a sectional view showing a structure of a TFT area of the liquid crystal display device according to the first embodiment of the present invention.

FIG. **4** shows a sectional view of the TFT area of the active matrix liquid crystal display device. As shown in FIG. **4**, on the insulating substrate **11** such as a glass is formed the gate electrode **21**. Then, the gate insulating film **22** is formed to cover the gate electrode **21**. The silicon semiconductor layer **23** is formed thereon; then, on the middle thereof, the etching stopper **24** as a protective layer of a channel layer, and the insulating layer **45** are successively formed. The gate electrode **21** is formed by patterning a conductive film deposited by sputtering in a photolithography process. The gate insulating film **22**, the silicon semiconductor layer **23**, and the etching stopper **24** are successively deposited by chemical vapor deposition (CVD), and patterned by the photolithography process.

Next, the first n^+ silicon film **25** and the second n^+ silicon film **26** are formed in isolation from each other. On the second n^+ silicon film **26** is formed the source electrode **27**, the two electrically connected. On the first n^+ silicon film **25** is the drain electrode **14**, electrically connected. The first n^+ silicon film **25** and the second n^+ silicon film **26** are formed by doping the silicon semiconductor layer **23** with impurities such as P and As. It is therefore possible to form the first n^+ silicon film **25** and the second n^+ silicon film **26** in the same step. The drain electrode **14** and the source electrode **27** are deposited by sputtering, and patterned by the photolithography process.

Then, the contact hole **30** is formed on the insulating film **45** to electrically connect the pixel electrode **12** and the drain electrode **14**. The contact hole **30** is formed in the process of resist coating, exposure, development, etching, resist stripping, and so on. The pixel electrode **12** is formed thereon by depositing ITO by sputtering to have electrical connection with the drain electrode **14**. The conductive layer **41** according to the present embodiment can be formed in the same layer as the drain electrode shown in FIG. **4**. That is, in patterning the conductive layer to form the drain electrode **14** and the source electrode **27**, the conductive layer is also left on the gate line **15** as the conductive layer **41**. No additional step is therefore required to form the conductive layer **41**. Similarly, the insulating layer **45** can be formed at the same time as forming the TFT **13**.

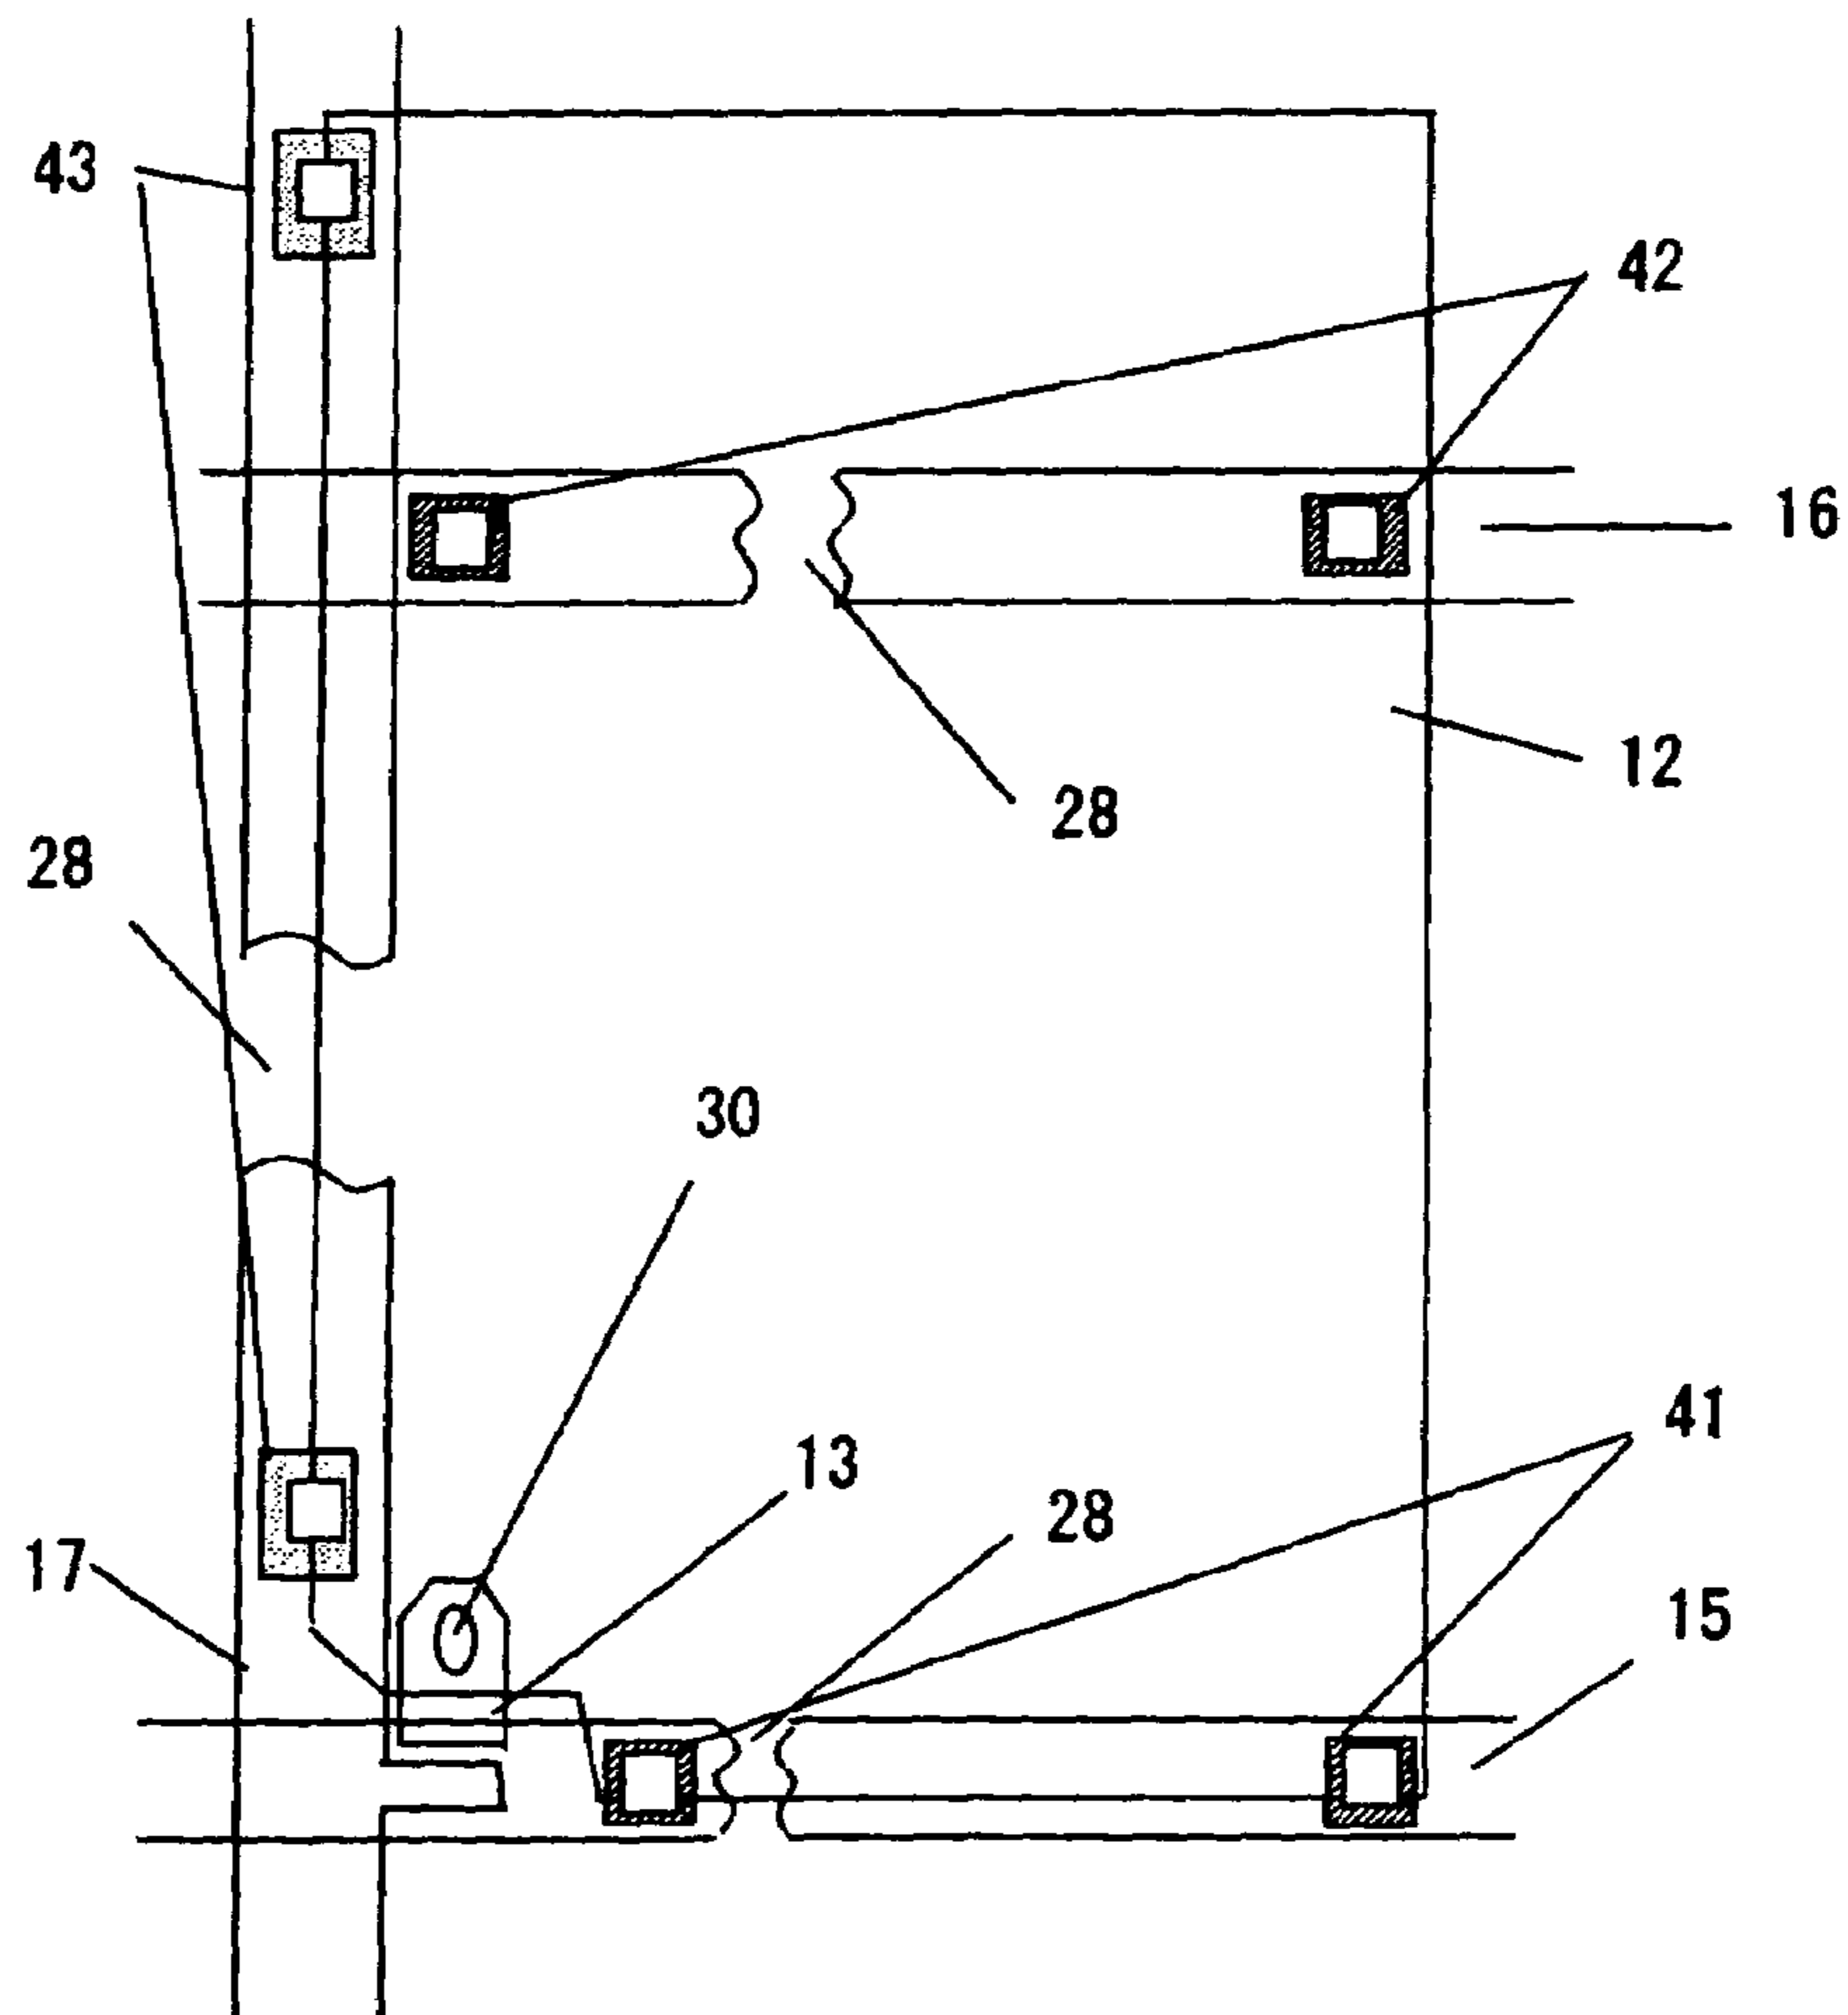
FIG. 5 is a plan view showing a structure of one pixel area of a liquid crystal display device according to the second embodiment of the present invention, where line disconnection occurs.

A method for repairing line disconnection according to the second embodiment of the present invention will be explained hereinbelow with reference to FIGS. **5** and **6**. Like FIG. **1**, FIG. **5** is a plan view showing a structure of one pixel area of an active matrix liquid crystal display device. FIG. **6** is a sectional view showing a structure of the portion where line disconnected is repaired. The same reference numerals as those in FIGS. **1** to **4** designate the same elements, and redundant description will be omitted. The description of the manufacturing process will be also omitted since it is the same as in the first embodiment.

Below the pixel electrode **12**, a pair of the conductive layers **41**, a pair of the conductive layers **42**, and a pair of the conductive layers **43** are formed in an island shape above the gate line **15**, the storage capacitor line **16**, and the source line **17**, respectively. The conductive layers are electrically floating. In the first embodiment, the conductive layer is provided in a possibly larger area on each of the three lines surrounding one pixel. In the second embodiment, on the other hand, each of the pair of the conductive layers is provided at each end of the three lines. The conductive layers above the gate line **15** and the storage capacitor line **16** can be formed in the same layer as the drain electrode **14** shown in FIG. **4** as with the case with the first embodiment. The conductive layers **41** and **42** have to avoid contact with the source line **17**. The conductive layers on one line are preferably separated as far as possible to obtain a larger repairable area.

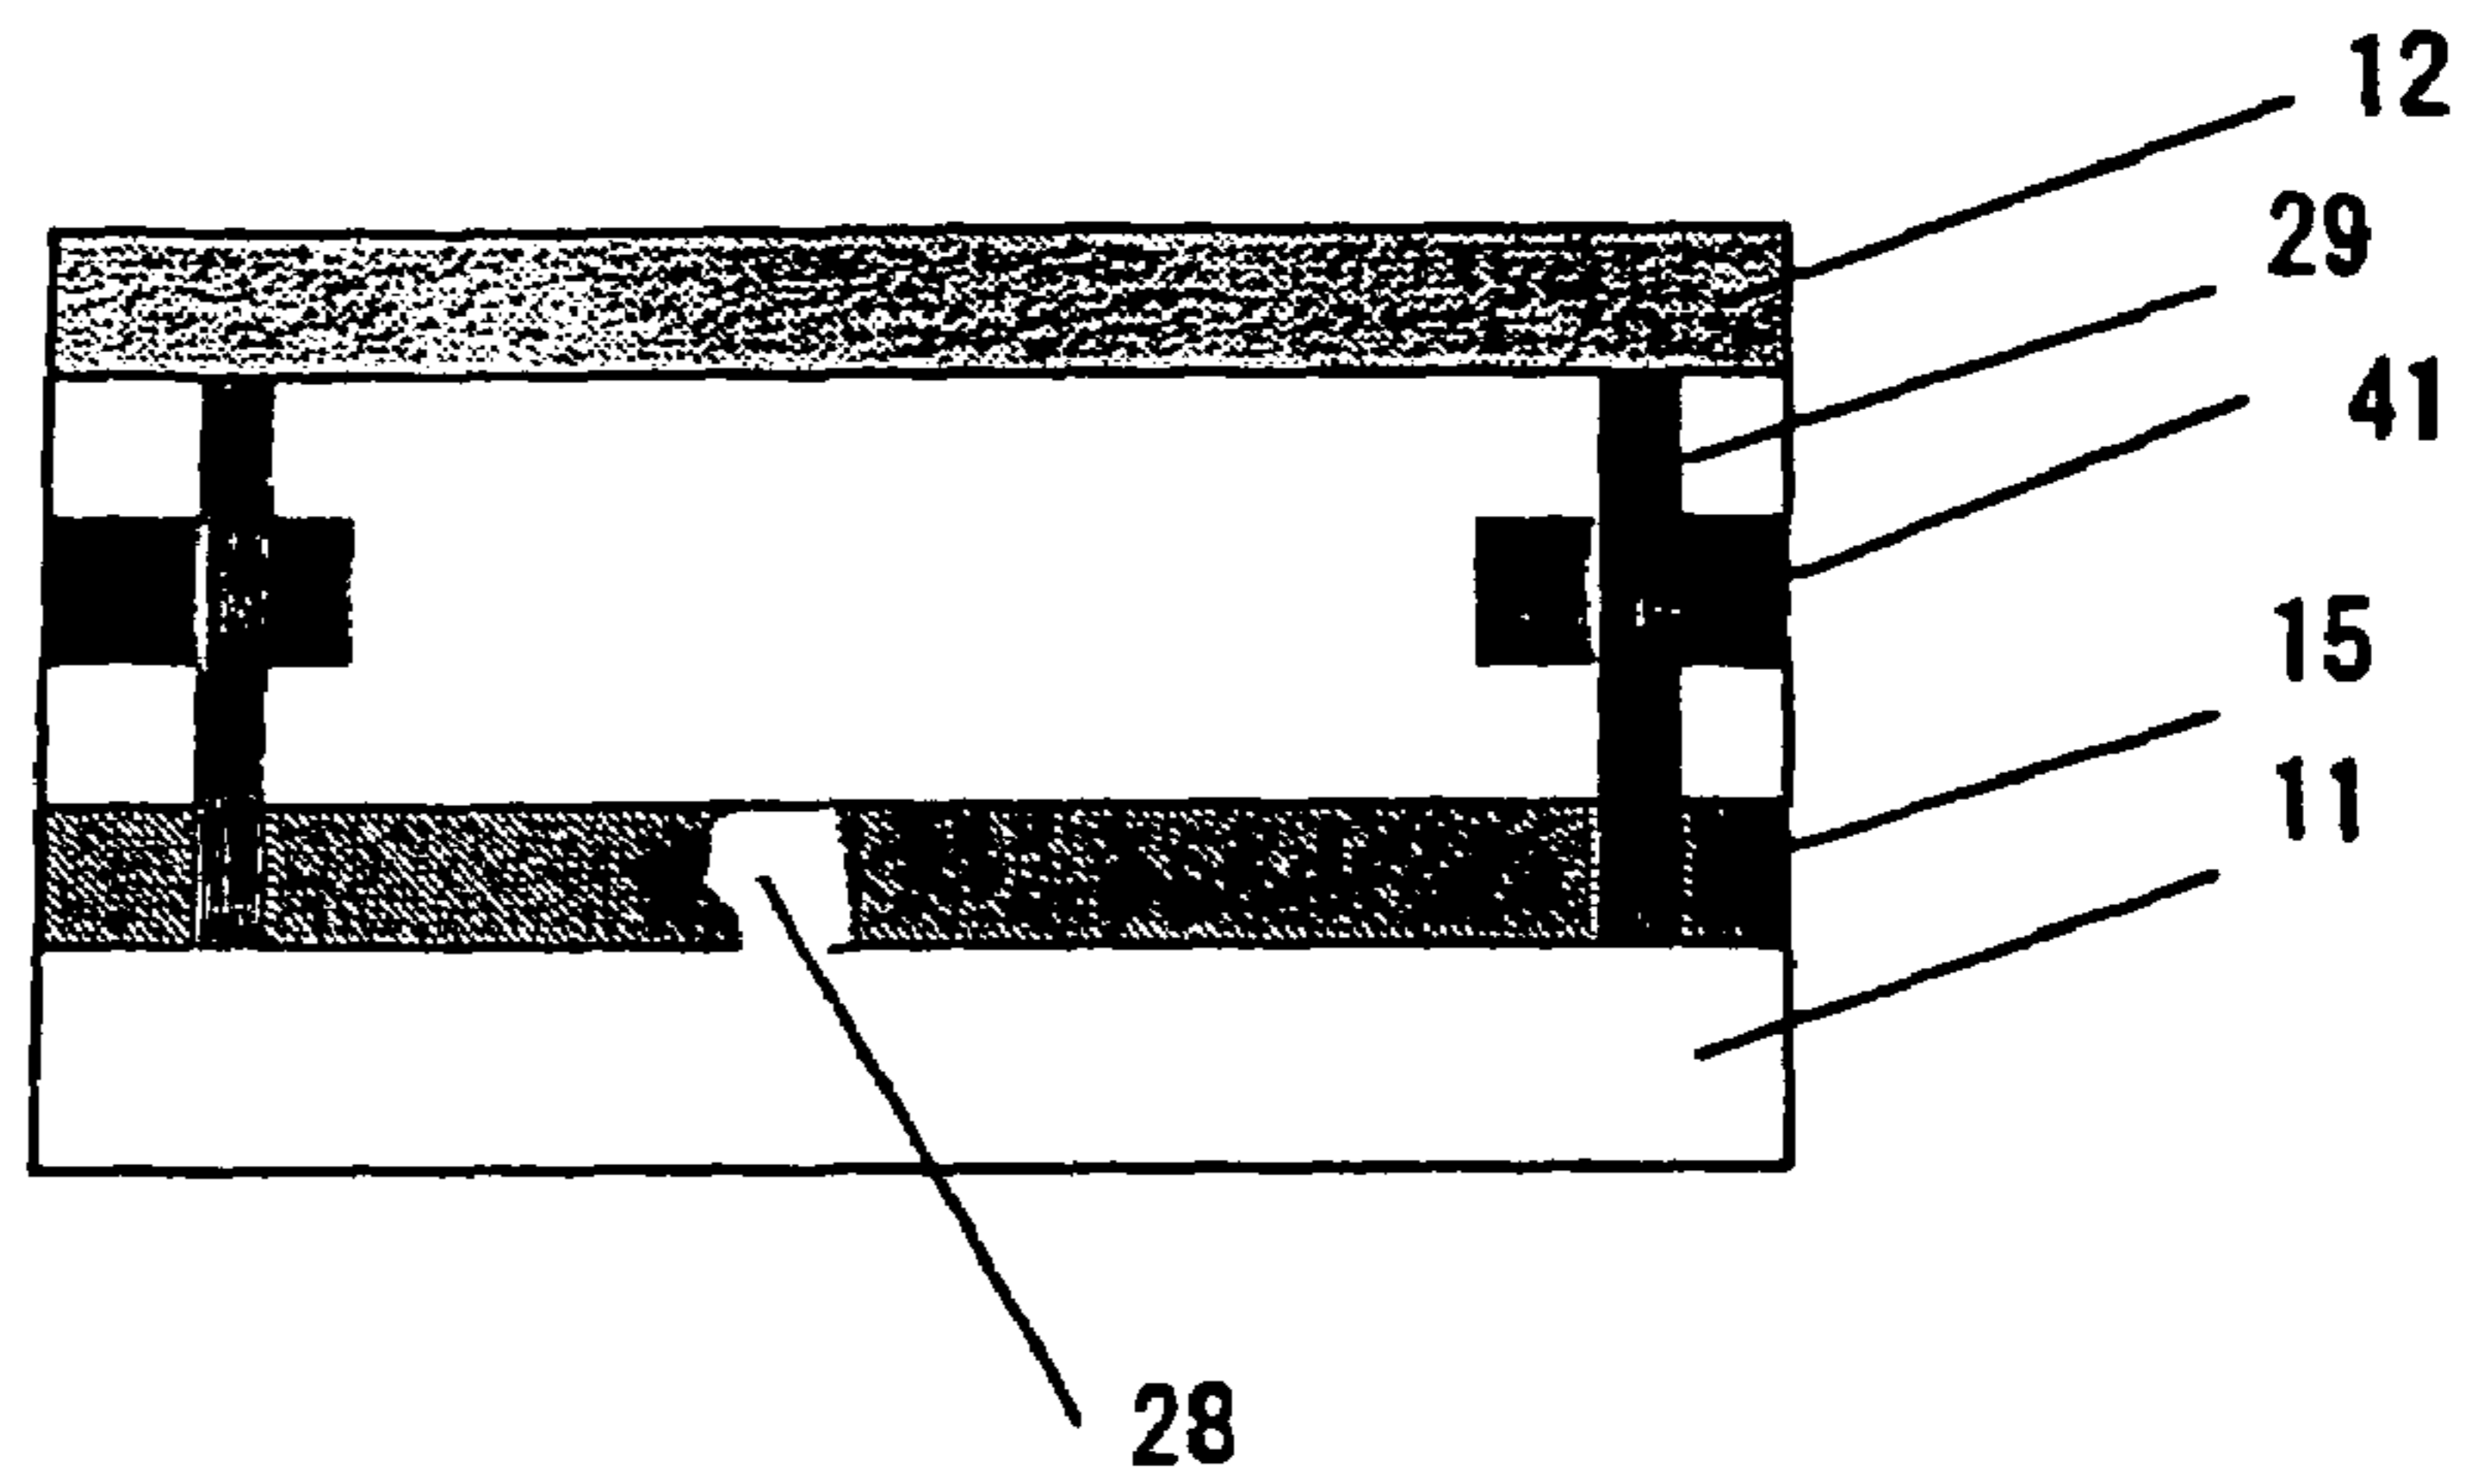
FIG. 6 is a sectional view showing a structure of a disconnected portion of a gate line in the liquid crystal display device according to the second embodiment of the present invention.

FIG. **6** shows a sectional view of the disconnected portion **28** of the gate line in the active matrix liquid crystal display device. The repair of the gate line **15** will be explained hereinbelow. Application of a laser to the conductive layer **41** from the pixel electrode **12** side or the insulating substrate **11** side produces the molten metal **29**. It creates a bypass route through the gate line **15**, the molten metal **29**, the conductive layer **41**, the molten metal **29**, the pixel electrode **12**, the molten metal **29**, the conductive layer **41**, the molten metal **29**, and the gate line **15**. Gate signals can thereby avoid the disconnected portion **28** and go through the bypass route. The line disconnection can be thus repaired.

The connection resistance of an aluminum element and ITO used for the pixel electrode **12** is extremely high. The repair of the gate line **15** in the conventional liquid crystal display device results in the cross-section structure shown in FIG. **8B** in which the pixel electrode **12** and the gate line **15** have the direct contact. Therefore, when a laser is applied to

connect them, the connection electrical resistance almost reaches one megohm, which is above the limit of the connection resistance for repairing disconnection. For the above reason, when repairing the disconnection as in FIG. 6, the conductive layer to produce the molten metal 29 is preferably formed by the material other than aluminum, such as chromium. The conductive layer can be formed in the same layer as the drain electrode 14 shown in FIG. 4. In order that the gate line 15 and ITO of the pixel electrode 12 are connected via the material such as chromium, tantalum, titanium, molybdenum to avoid direct contact, the source line 17 is formed by the above material, not aluminum. The connection resistance is thereby kept within 100 KΩ that is substantially the same value as the connection resistance of the drain electrode 14 and the pixel electrode 12 through the contact hole 30. Therefore, disconnection of the gate line 15 formed by aluminum can be also repaired.

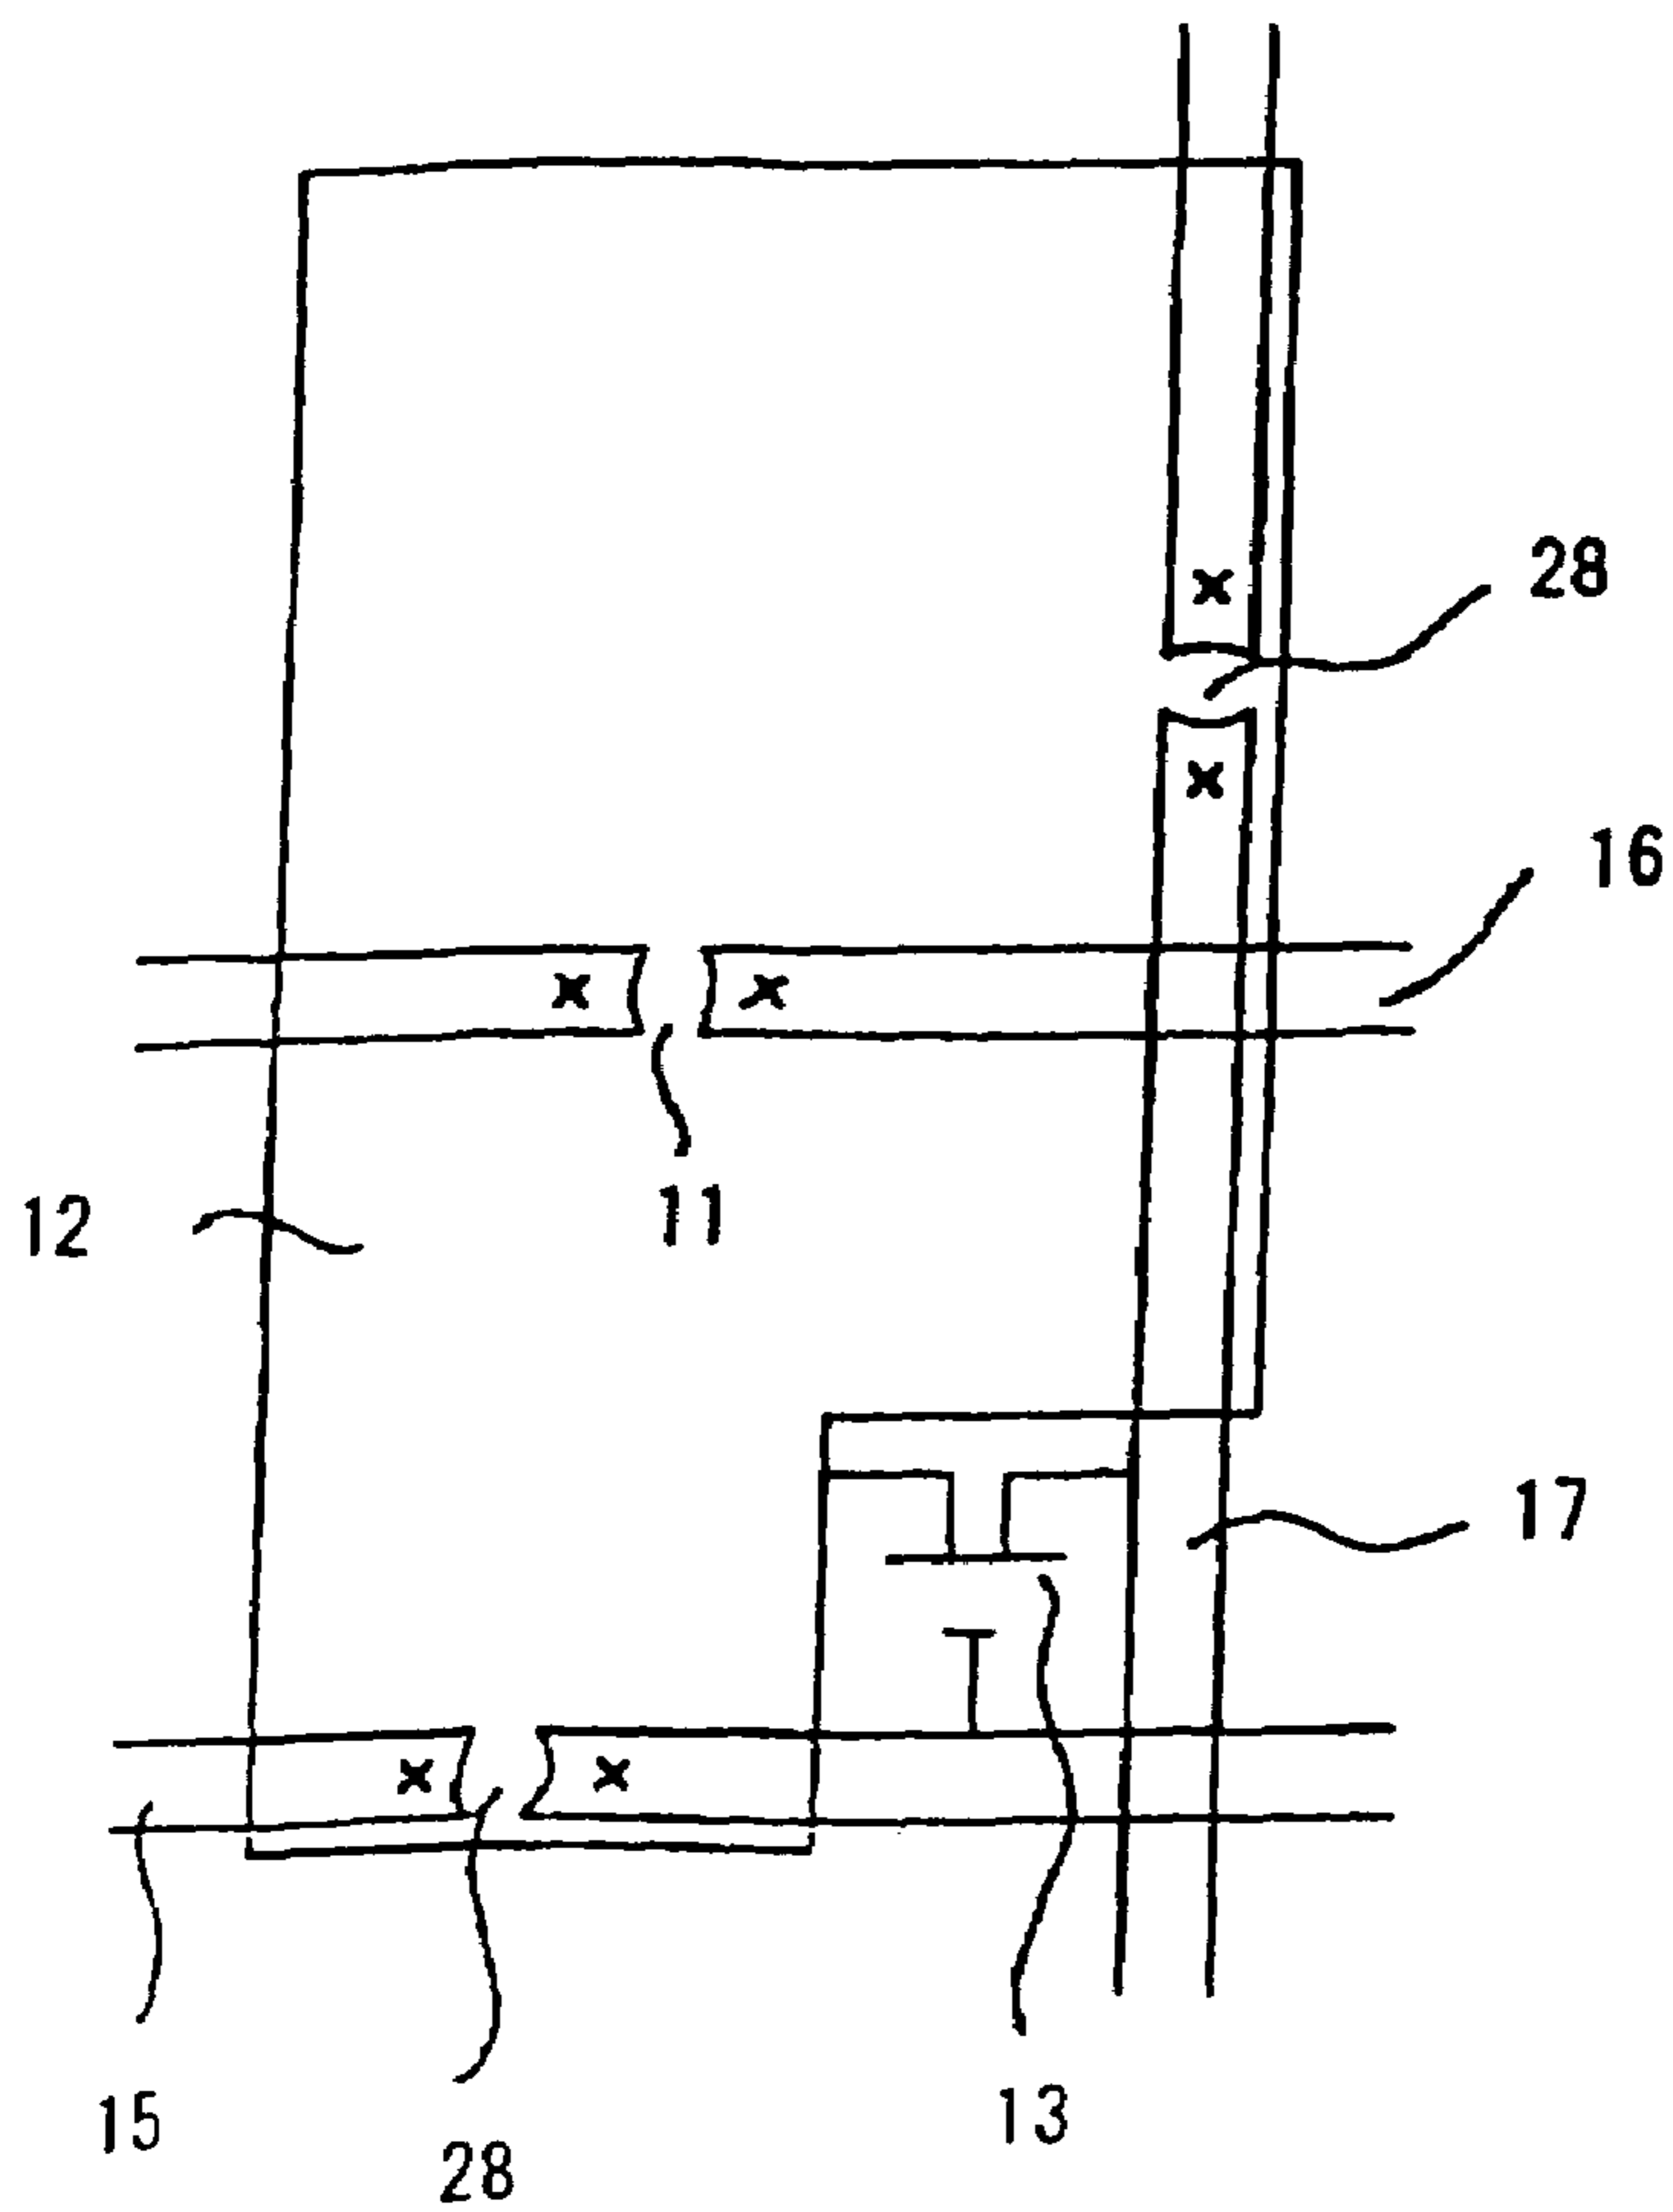
FIG. 7 Background Art

FIG. 7 shows a configuration of a conventional active matrix liquid crystal display device. FIG. 7 is a plan view showing a structure of one pixel area of the liquid crystal display device. Reference numeral 12 designates a pixel electrode, 13 a thin film transistor (TFT), 15 a gate line, 16 a storage capacitor line, 17 a source line, and 28 a disconnected portion.

The active matrix liquid crystal display device shown in FIG. 7 is provided with a matrix of plurality of the pixel electrodes 12, each of which is connected with the TFT 13 that is a switching element. The gate electrode of the TFT 13 is connected with the gate line 15, and gate signals input to the gate electrode control and drive the TFT 13. The source electrode of the TFT 13 is connected with the source line 17, and data (display) signals are input to the pixel electrode 12 through the TFT 13 when the TFT 13 is selected. The gate line 15 and the source line 17 cross each other at right angles, surrounding the pixel electrode 12. The drain electrode of the TFT 13 is connected with the pixel electrode 12.

FIG. 7 is a plan view showing a structure of one pixel area of a conventional liquid crystal display device.

As shown in FIG. 7, the pixel electrode 12 is arranged to partially overlap the gate line 15. They are electrically isolated by the gate insulating film 22 to enlarge the area of the pixel electrode 12, that is, to increase the aperture ratio. Also, an additional capacitor is formed by placing the gate insulation film 22 between the pixel electrode 12 and the gate line 15.

As shown in FIG. 7, there are cross marks on both outsides of the disconnected portion 28 of the gate line 15. A laser is applied to the marks. The gate line 15 or the pixel electrode 12 is molten to produce the molten metal 29 as shown in FIG. 8B. A bypass route through the gate line 15, the molten metal 29, the pixel electrode 12, the molten metal 29, and the gate line 15 is thereby created; therefore, the disconnection is repaired. Disconnection of the source line 17 and the storage capacitor line 16 is also repaired in the same way.
