US007515243B2

(54) **DISPLAY DEVICE AND METHOD FOR REPAIRING LINE DISCONNECTION THEREOF**

(73) Assignee: **Mitsubishi Electric Corporation**, Tokyo (JP)

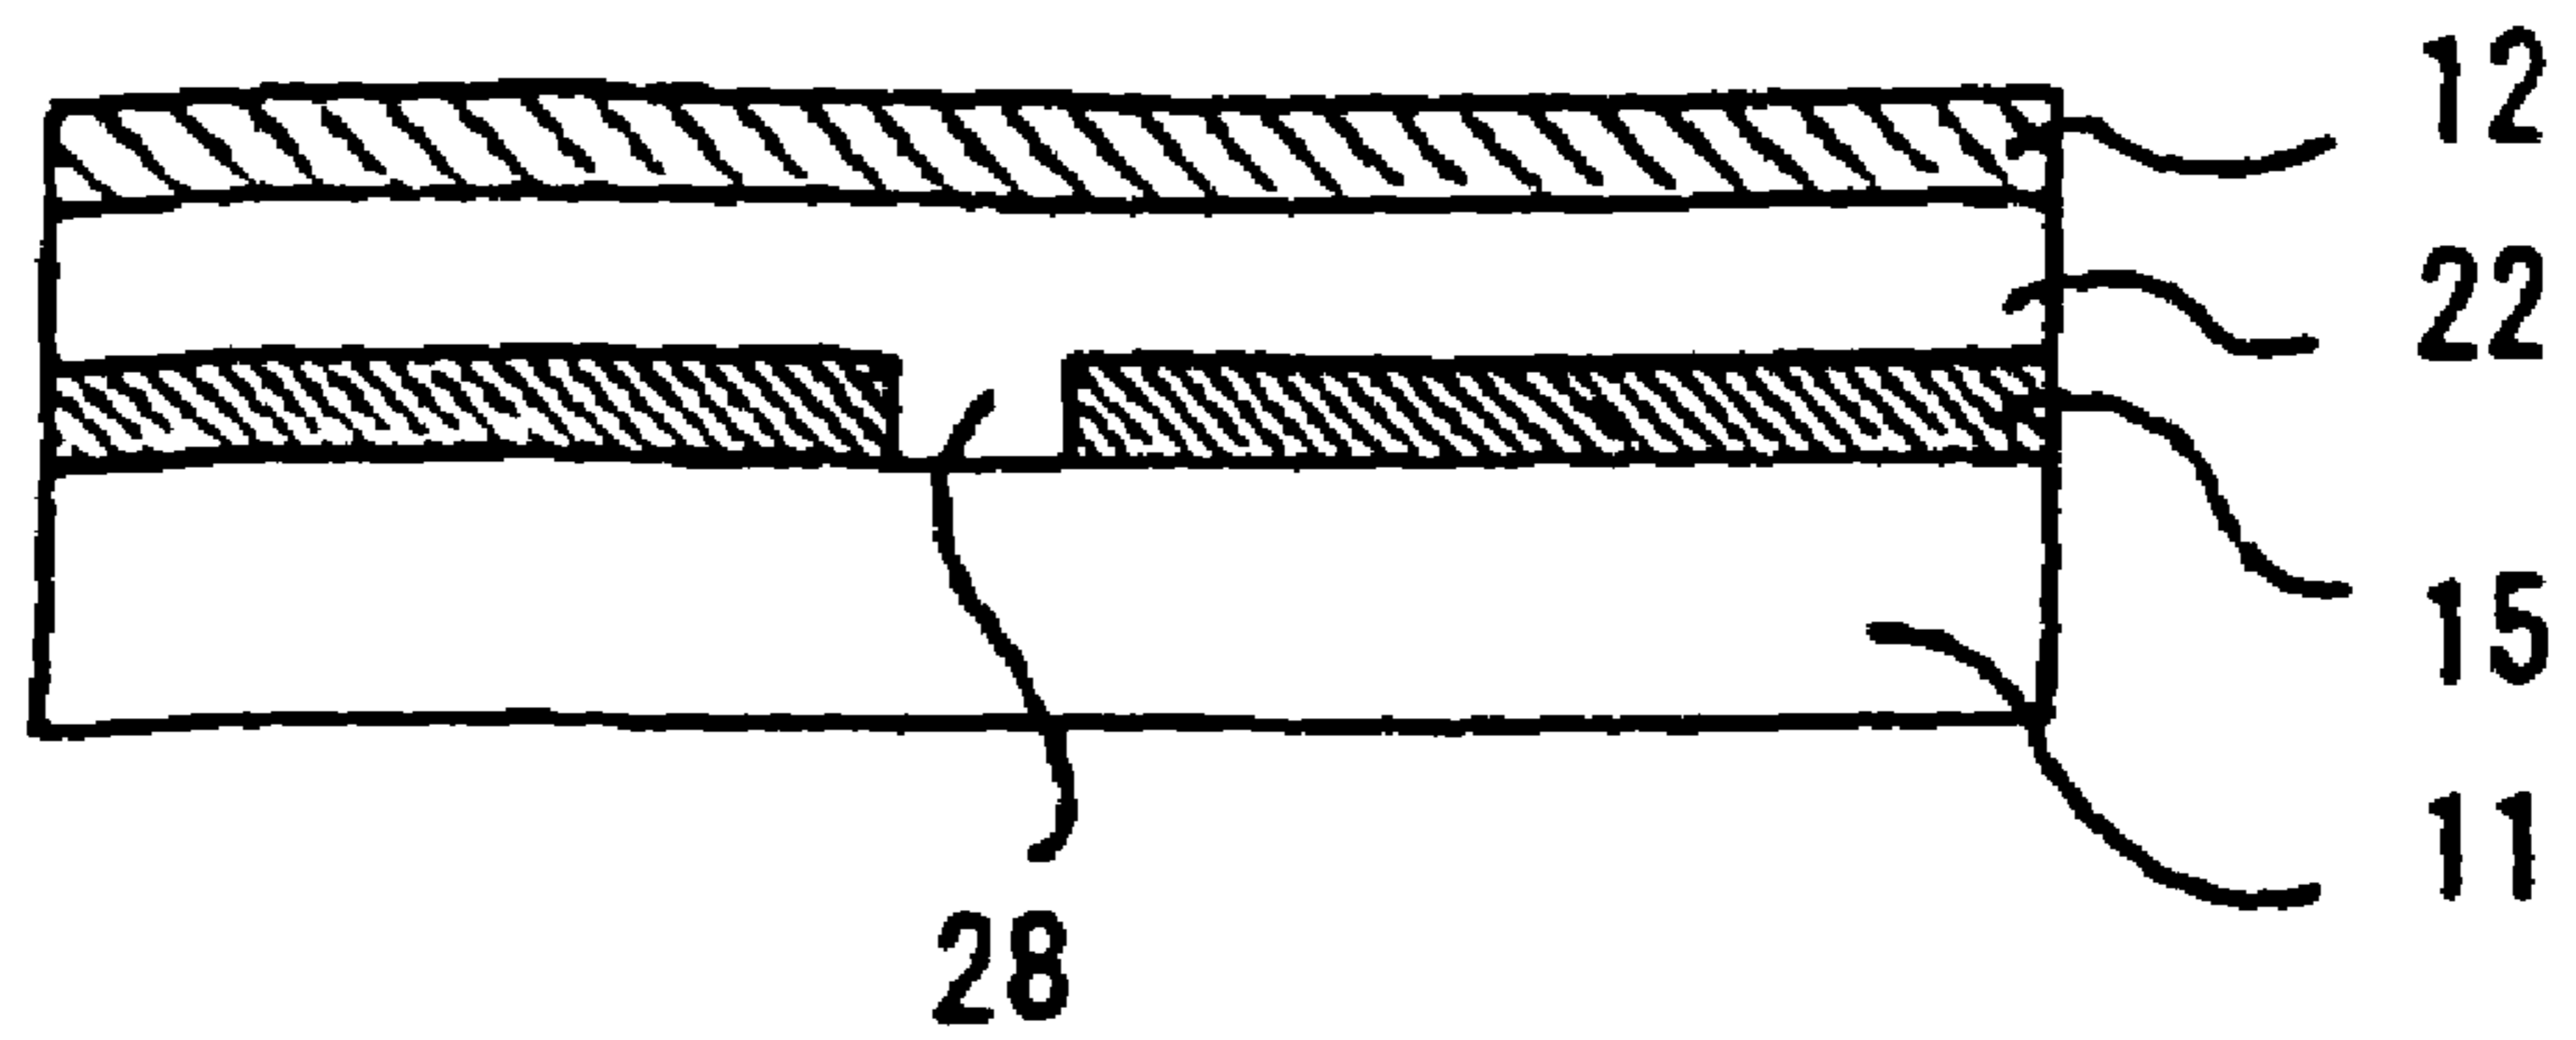
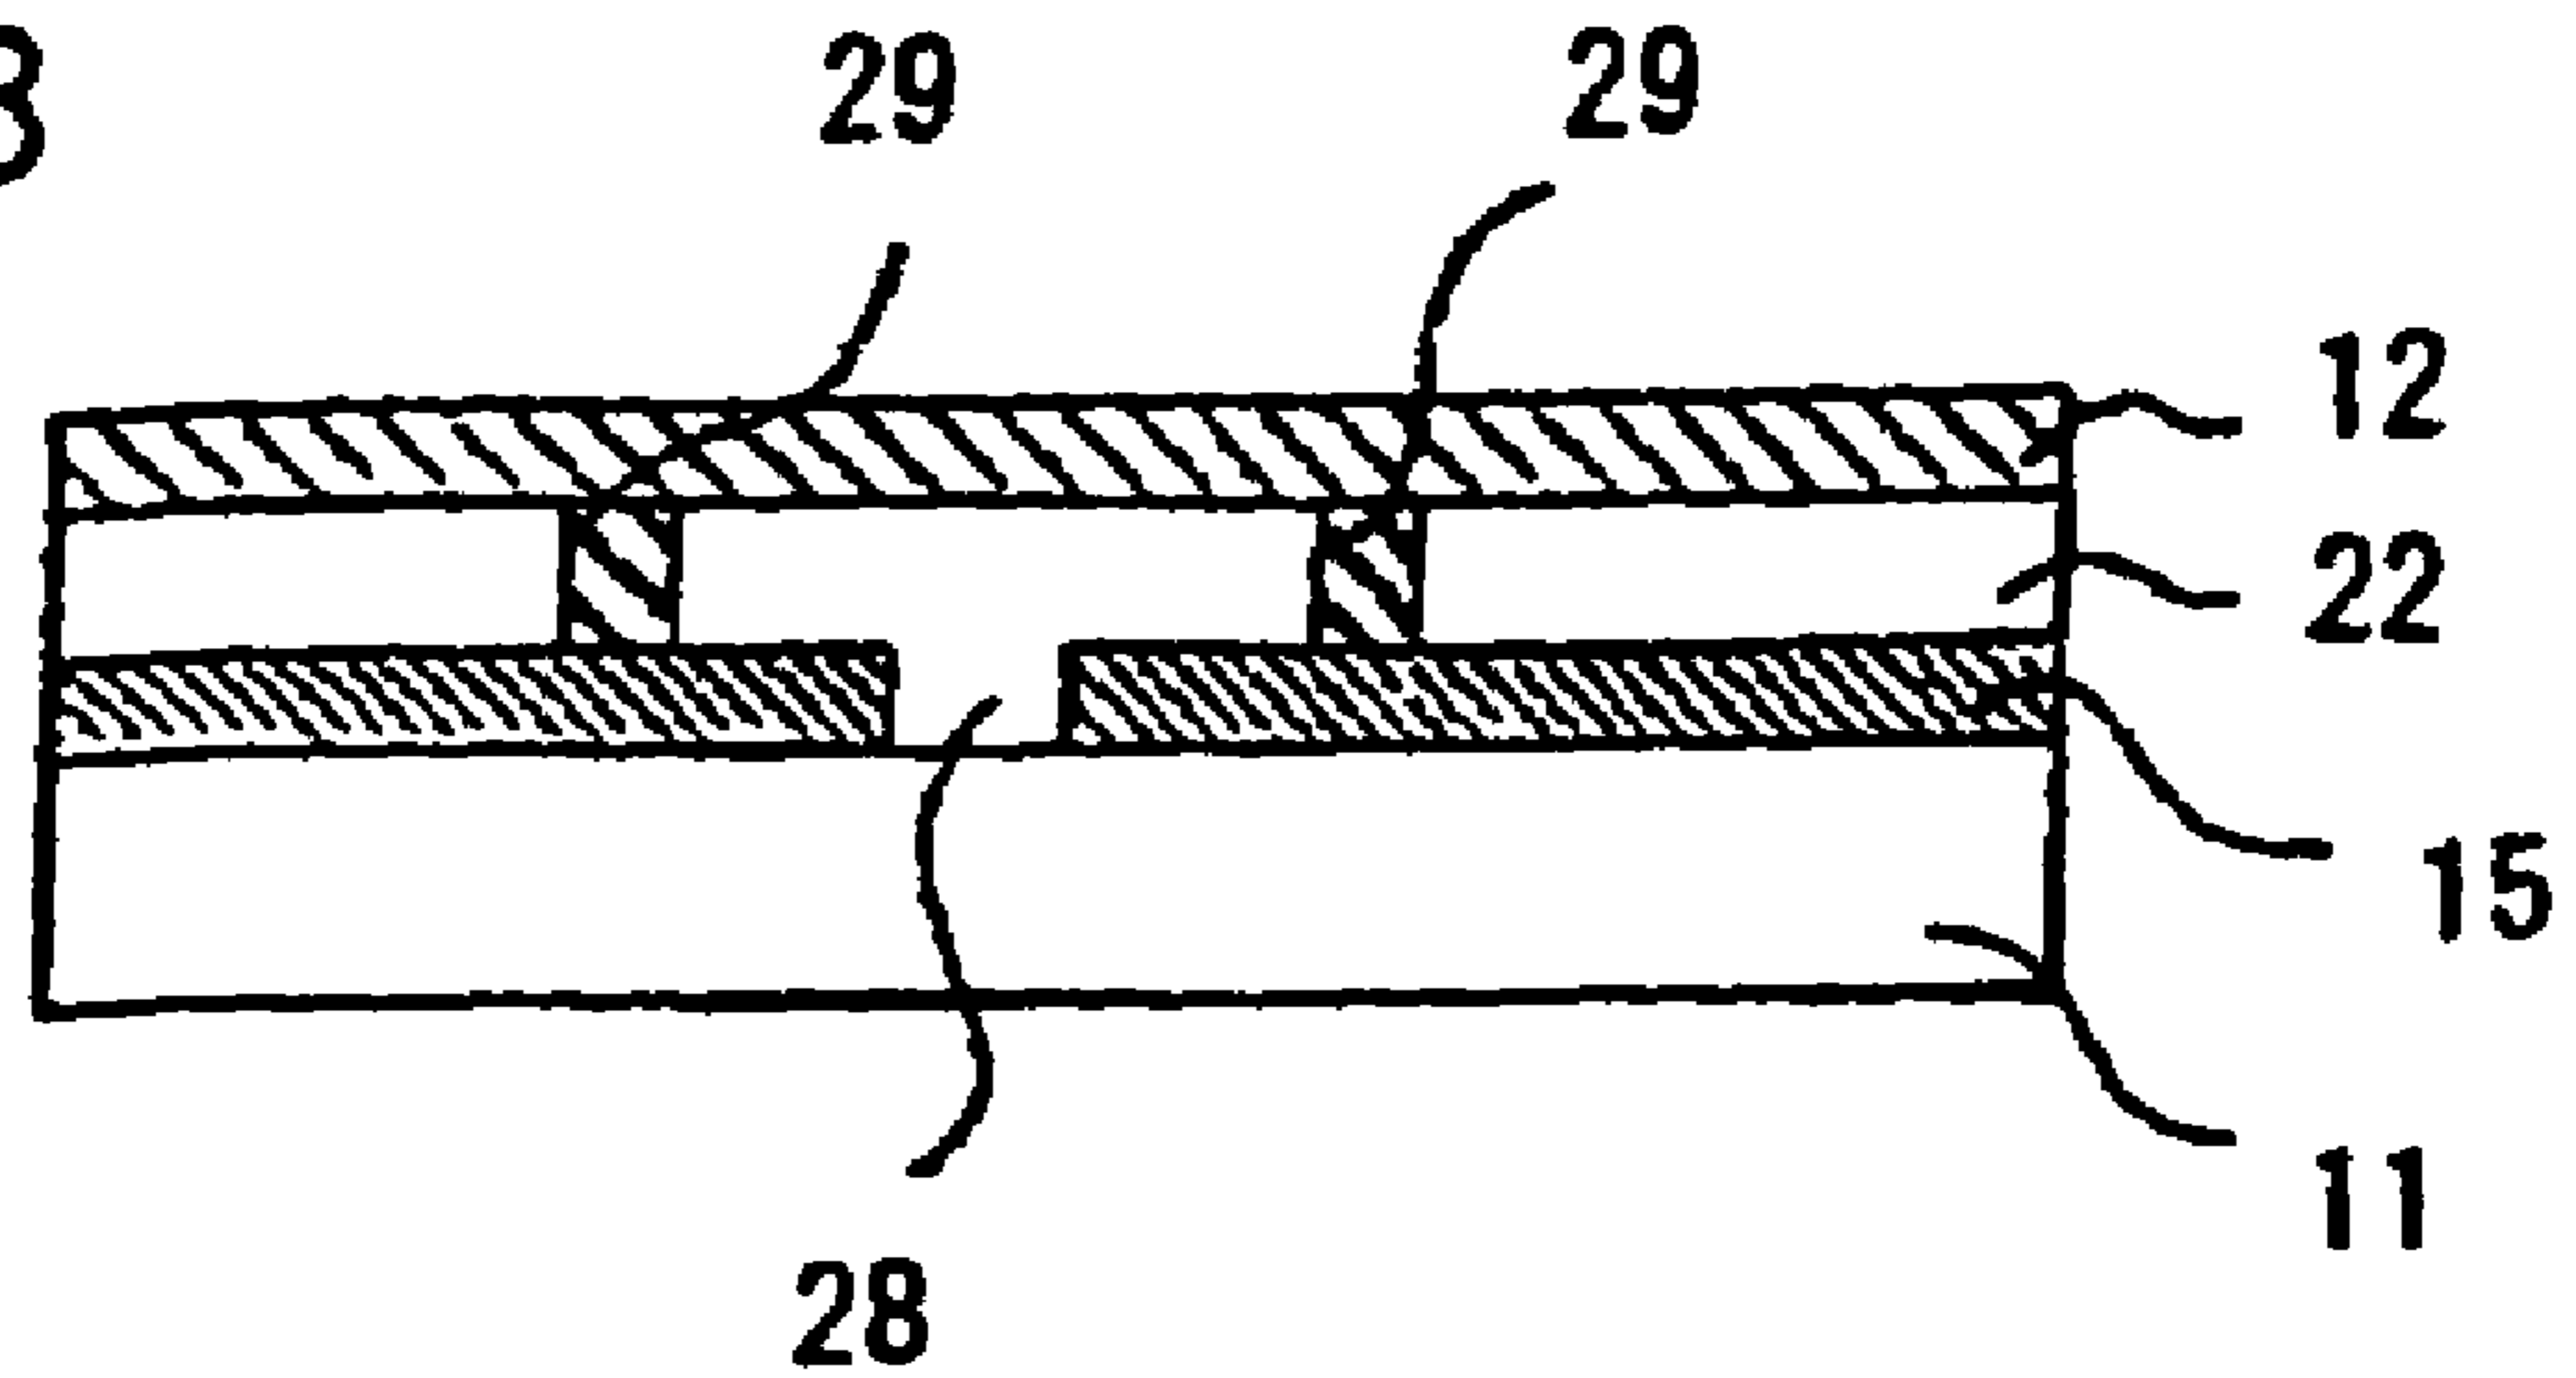
A method for repairing signal line disconnection is described in Japanese Patent Application Laid-Open No. H09-113930, for example. The method according to the first embodiment of the above prior art will be explained hereinbelow. FIG. 8A shows a structure of a cross-section of a disconnected portion of a gate line. The same reference numerals as those in FIG. 7 designate the same elements, and redundant description will be omitted. Reference numeral 11 designates a substrate, 22 a gate insulating film, and 29 a molten metal.

FIGS. 8A and 8B are sectional views showing structures of a disconnected portion of a gate line in the conventional liquid crystal display device.

The above conventional technique, however, has the following problems. In the first embodiment of the invention disclosed in Japanese Patent Application Laid-Open No. H09-113930, the connection resistance of the pixel electrode **12** and the molten metal **29** can be high. The pixel electrode **12** is formed by Indium Tin Oxide (ITO), and the connection resistance with chromium, tantalum, titanium, and molybdenum used for the gate line **15** and the storage capacitor line **16** significantly differs depending on conditions of film deposition and film surface. There is a case where the connection resistance reaches several megohms, which results in decrease in the rate of successful repair. Use of aluminum for the gate line **15** is especially problematic since the connection resistance of an aluminum element and ITO used for the pixel electrode **12** is extremely high. Therefore, when a laser is applied to connect them, the connection electrical resistance almost reaches one megohm, which is above the limit of the connection resistance for repairing disconnection. Besides, the application of a laser to the pixel electrode **12** causes the ITO to be peeled off and a fragment of the ITO is stuck in between a counter electrode and the pixel electrode to trigger unexpected short-circuit.

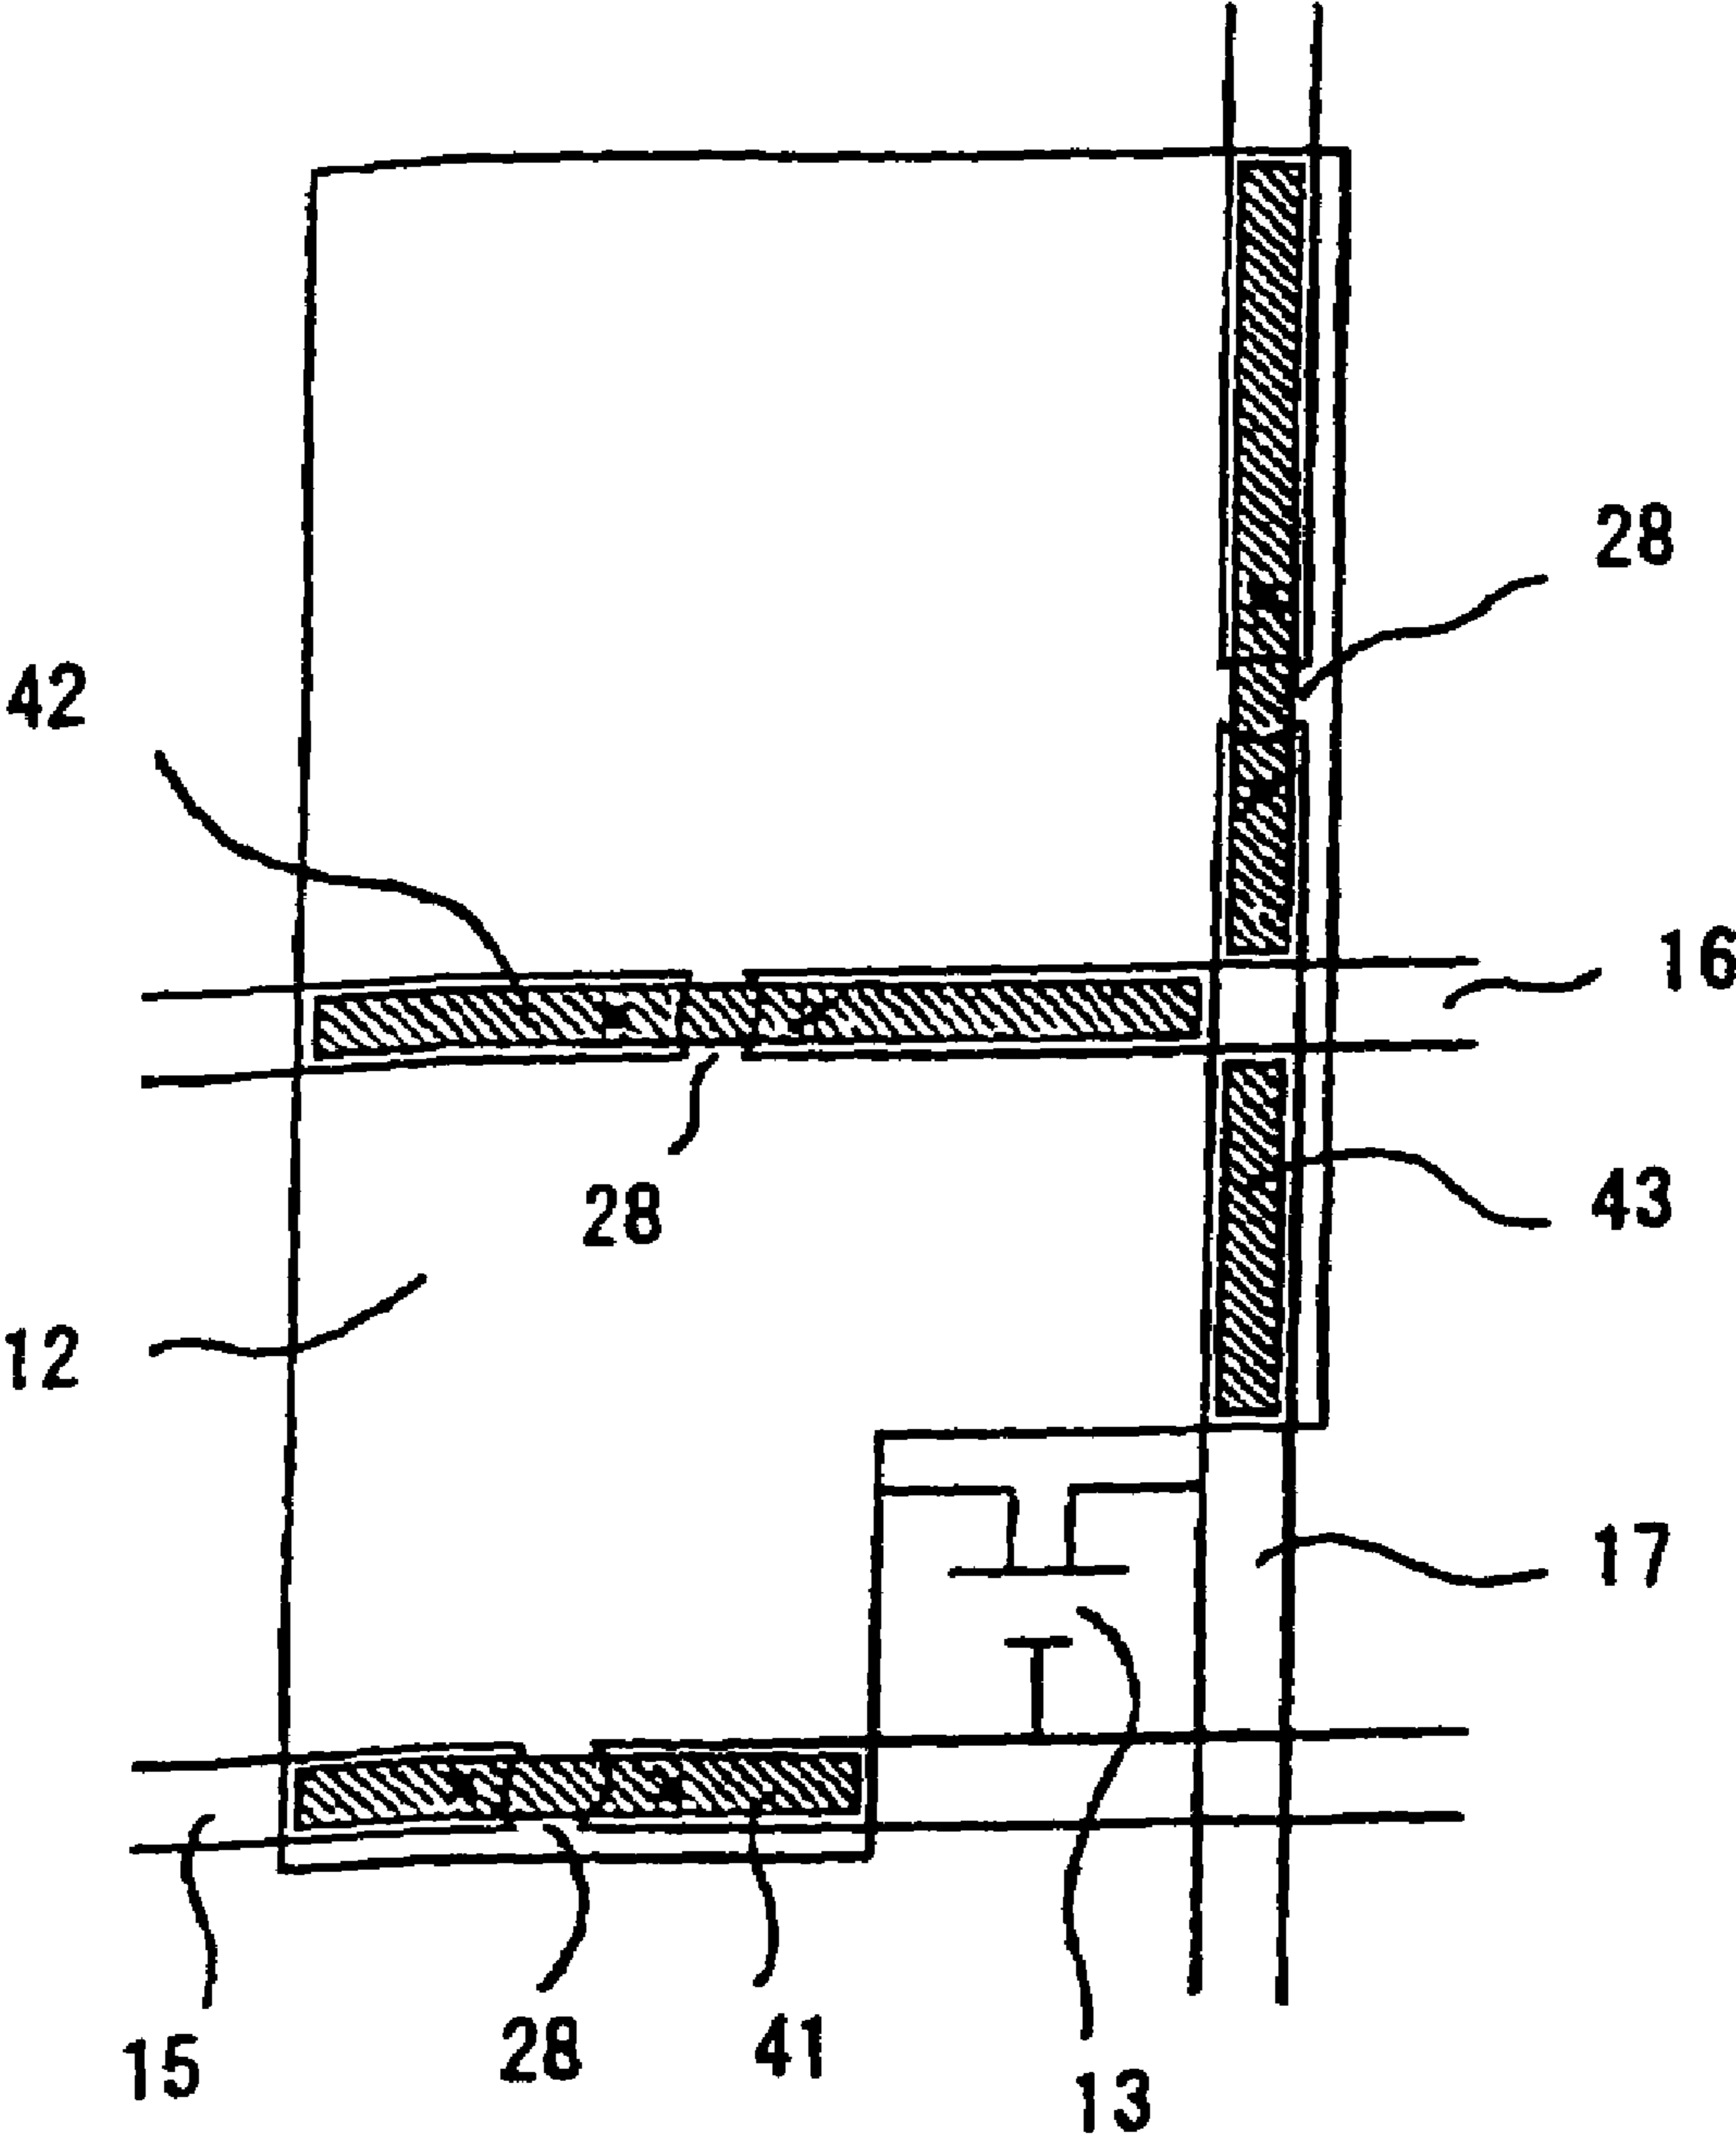
FIGS. 9 and 10 show a structure of one pixel area of the liquid crystal display device where disconnection is repaired according to the second embodiment of the invention disclosed in Japanese Patent Application Laid-Open No. H09-113930. FIG. 9 is a plan view of a structure of one pixel area where disconnection is repaired, and FIG. 10 is a sectional view thereof. The same reference numerals as those in FIGS. 7 and 8 designate the same elements, and redundant description will be omitted. Reference numeral 41 designates a conductive layer for repairing gate line disconnection, 42 a conductive layer for repairing storage capacitor line disconnection, and 43 a conductive layer for repairing source line disconnection.

As shown in FIGS. 9 and 10A, the pixel electrode 12 partially overlaps the gate line 15 with the insulating film interposed therebetween. On the part of the pixel electrode 12 overlapping the gate line 15 is formed a conductive metal layer. The conductive metal layer provided for repairing disconnection of the gate line 15 will be referred to hereinafter as a conductive layer 41. Similarly, conductive metal layers for repairing disconnection of the source line 17 and the storage capacitor line 16 will be referred to as a conductive layer 42 and a conductive layer 43, respectively.

FIG. 9 is a plan view showing a structure of one pixel area of a conventional liquid crystal display device.

In the following, a description will be given on the case where the gate line 15 is disconnected. As shown in FIGS. 9 and 10A, on the insulating substrate 11 are formed the gate line 15 and the storage capacitor line 16. The gate insulating film 22 is formed thereon. Next, the source line 17, the TFT 13, and an insulating layer are formed. Then, the pixel electrode 12 is formed. Further, the conductive layer 41 for repairing gate line disconnection is formed. The conductive layer 41 is provided on the area where the pixel electrode 12 overlaps the gate line 15 with the gate insulating film 22 interposed therebetween. The conductive layer 41 is formed in an island shape above the gate line 15 except the crossing with the source line 17.

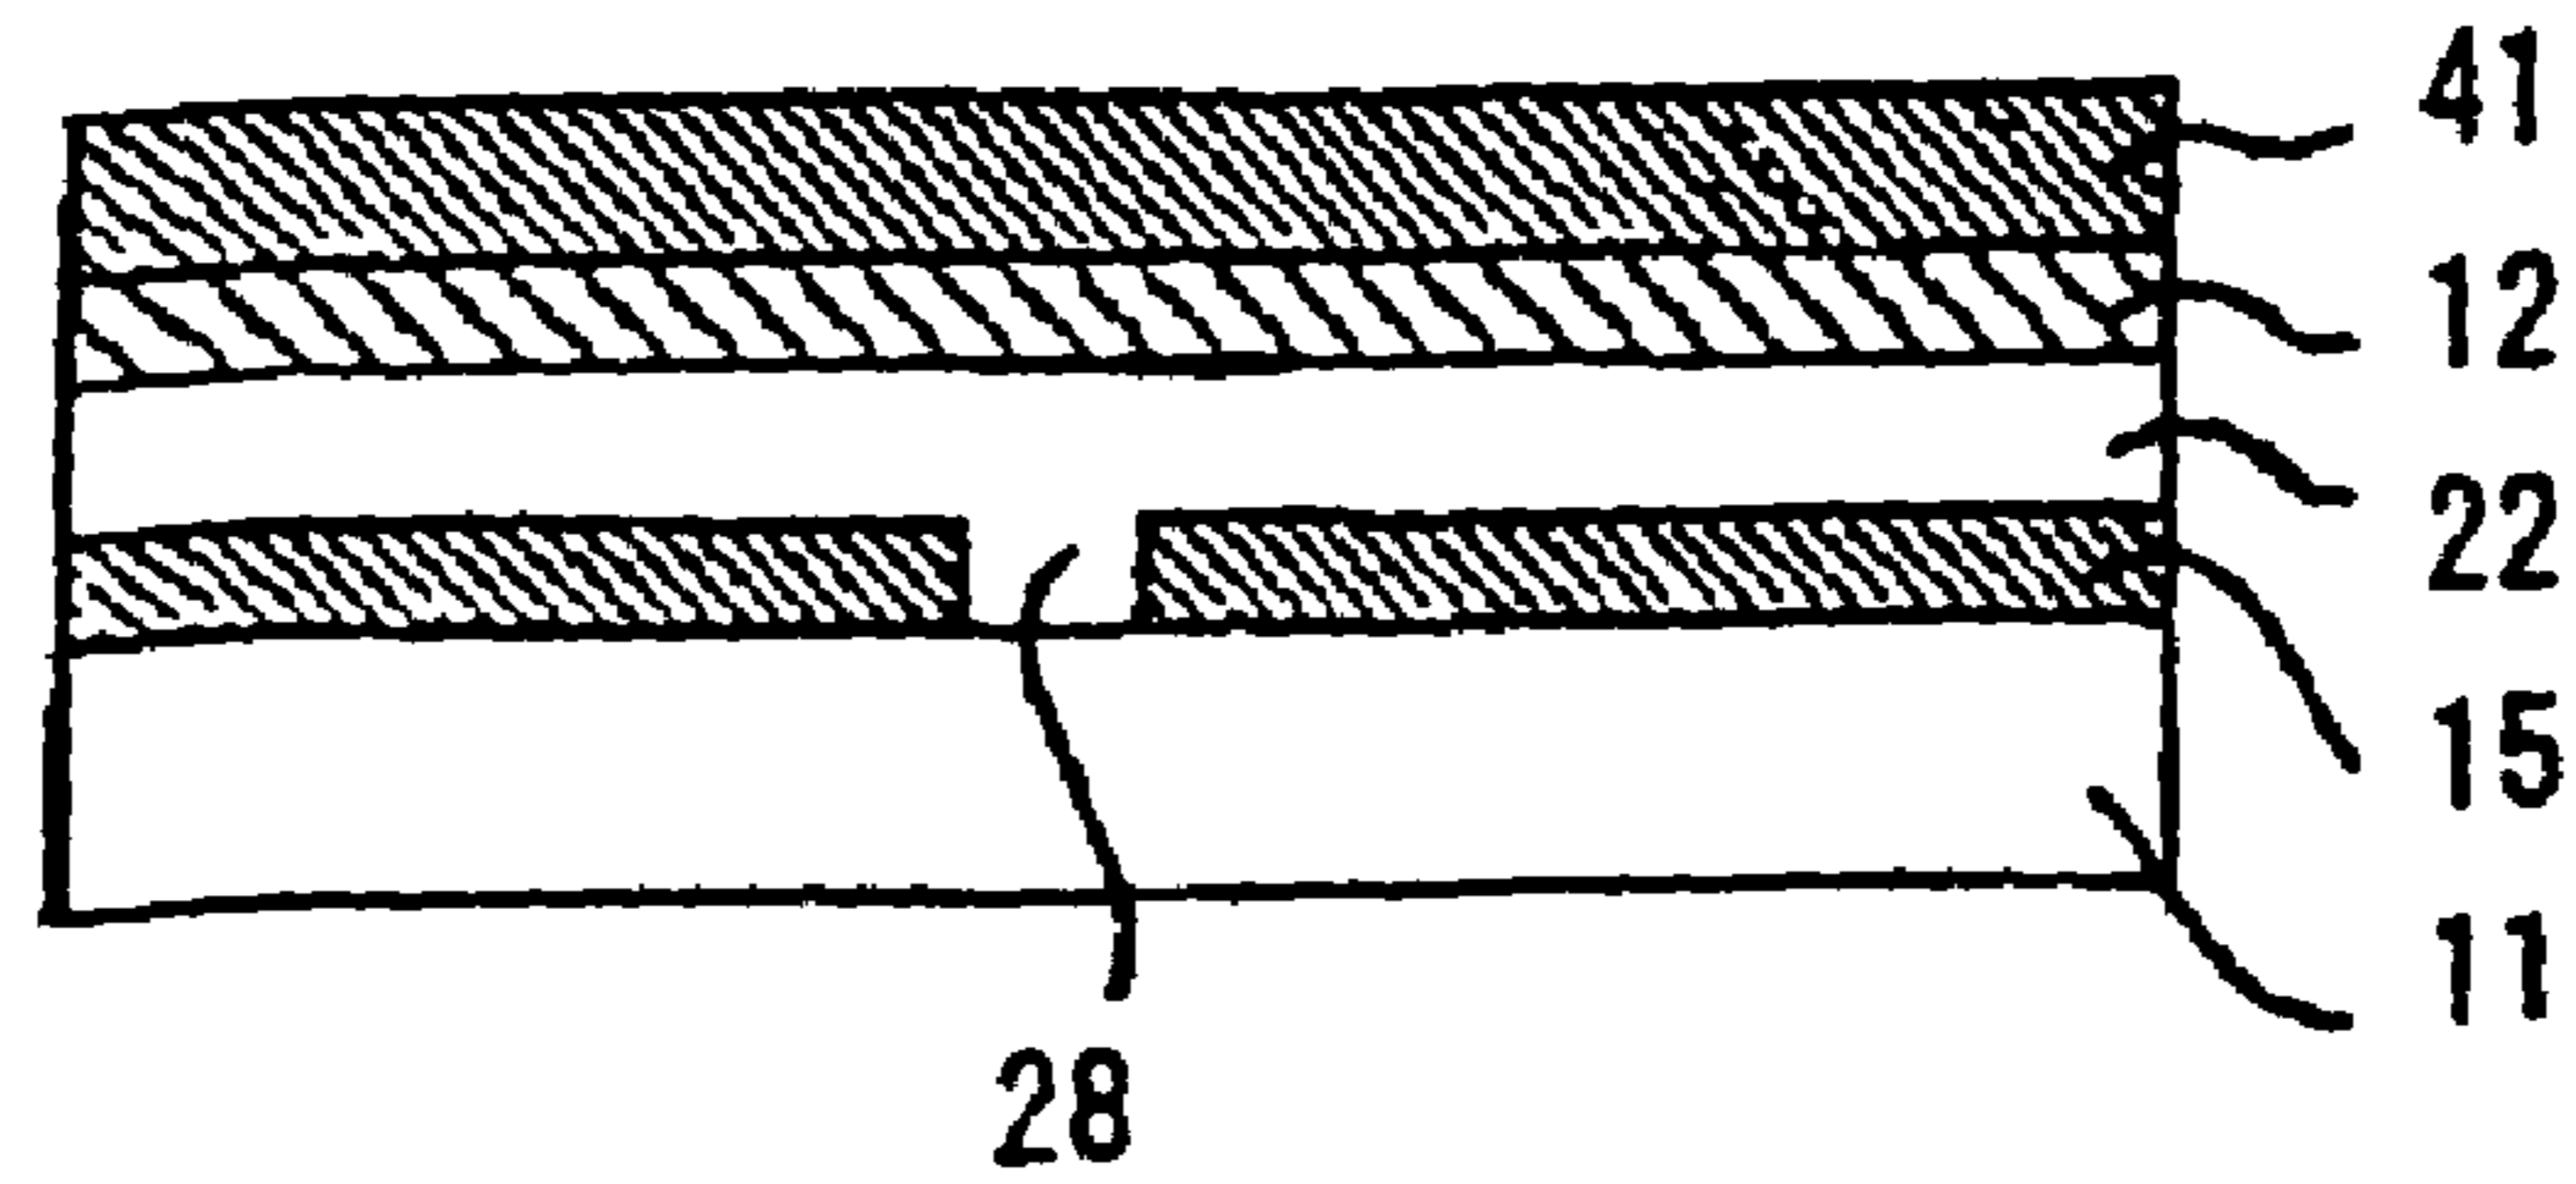
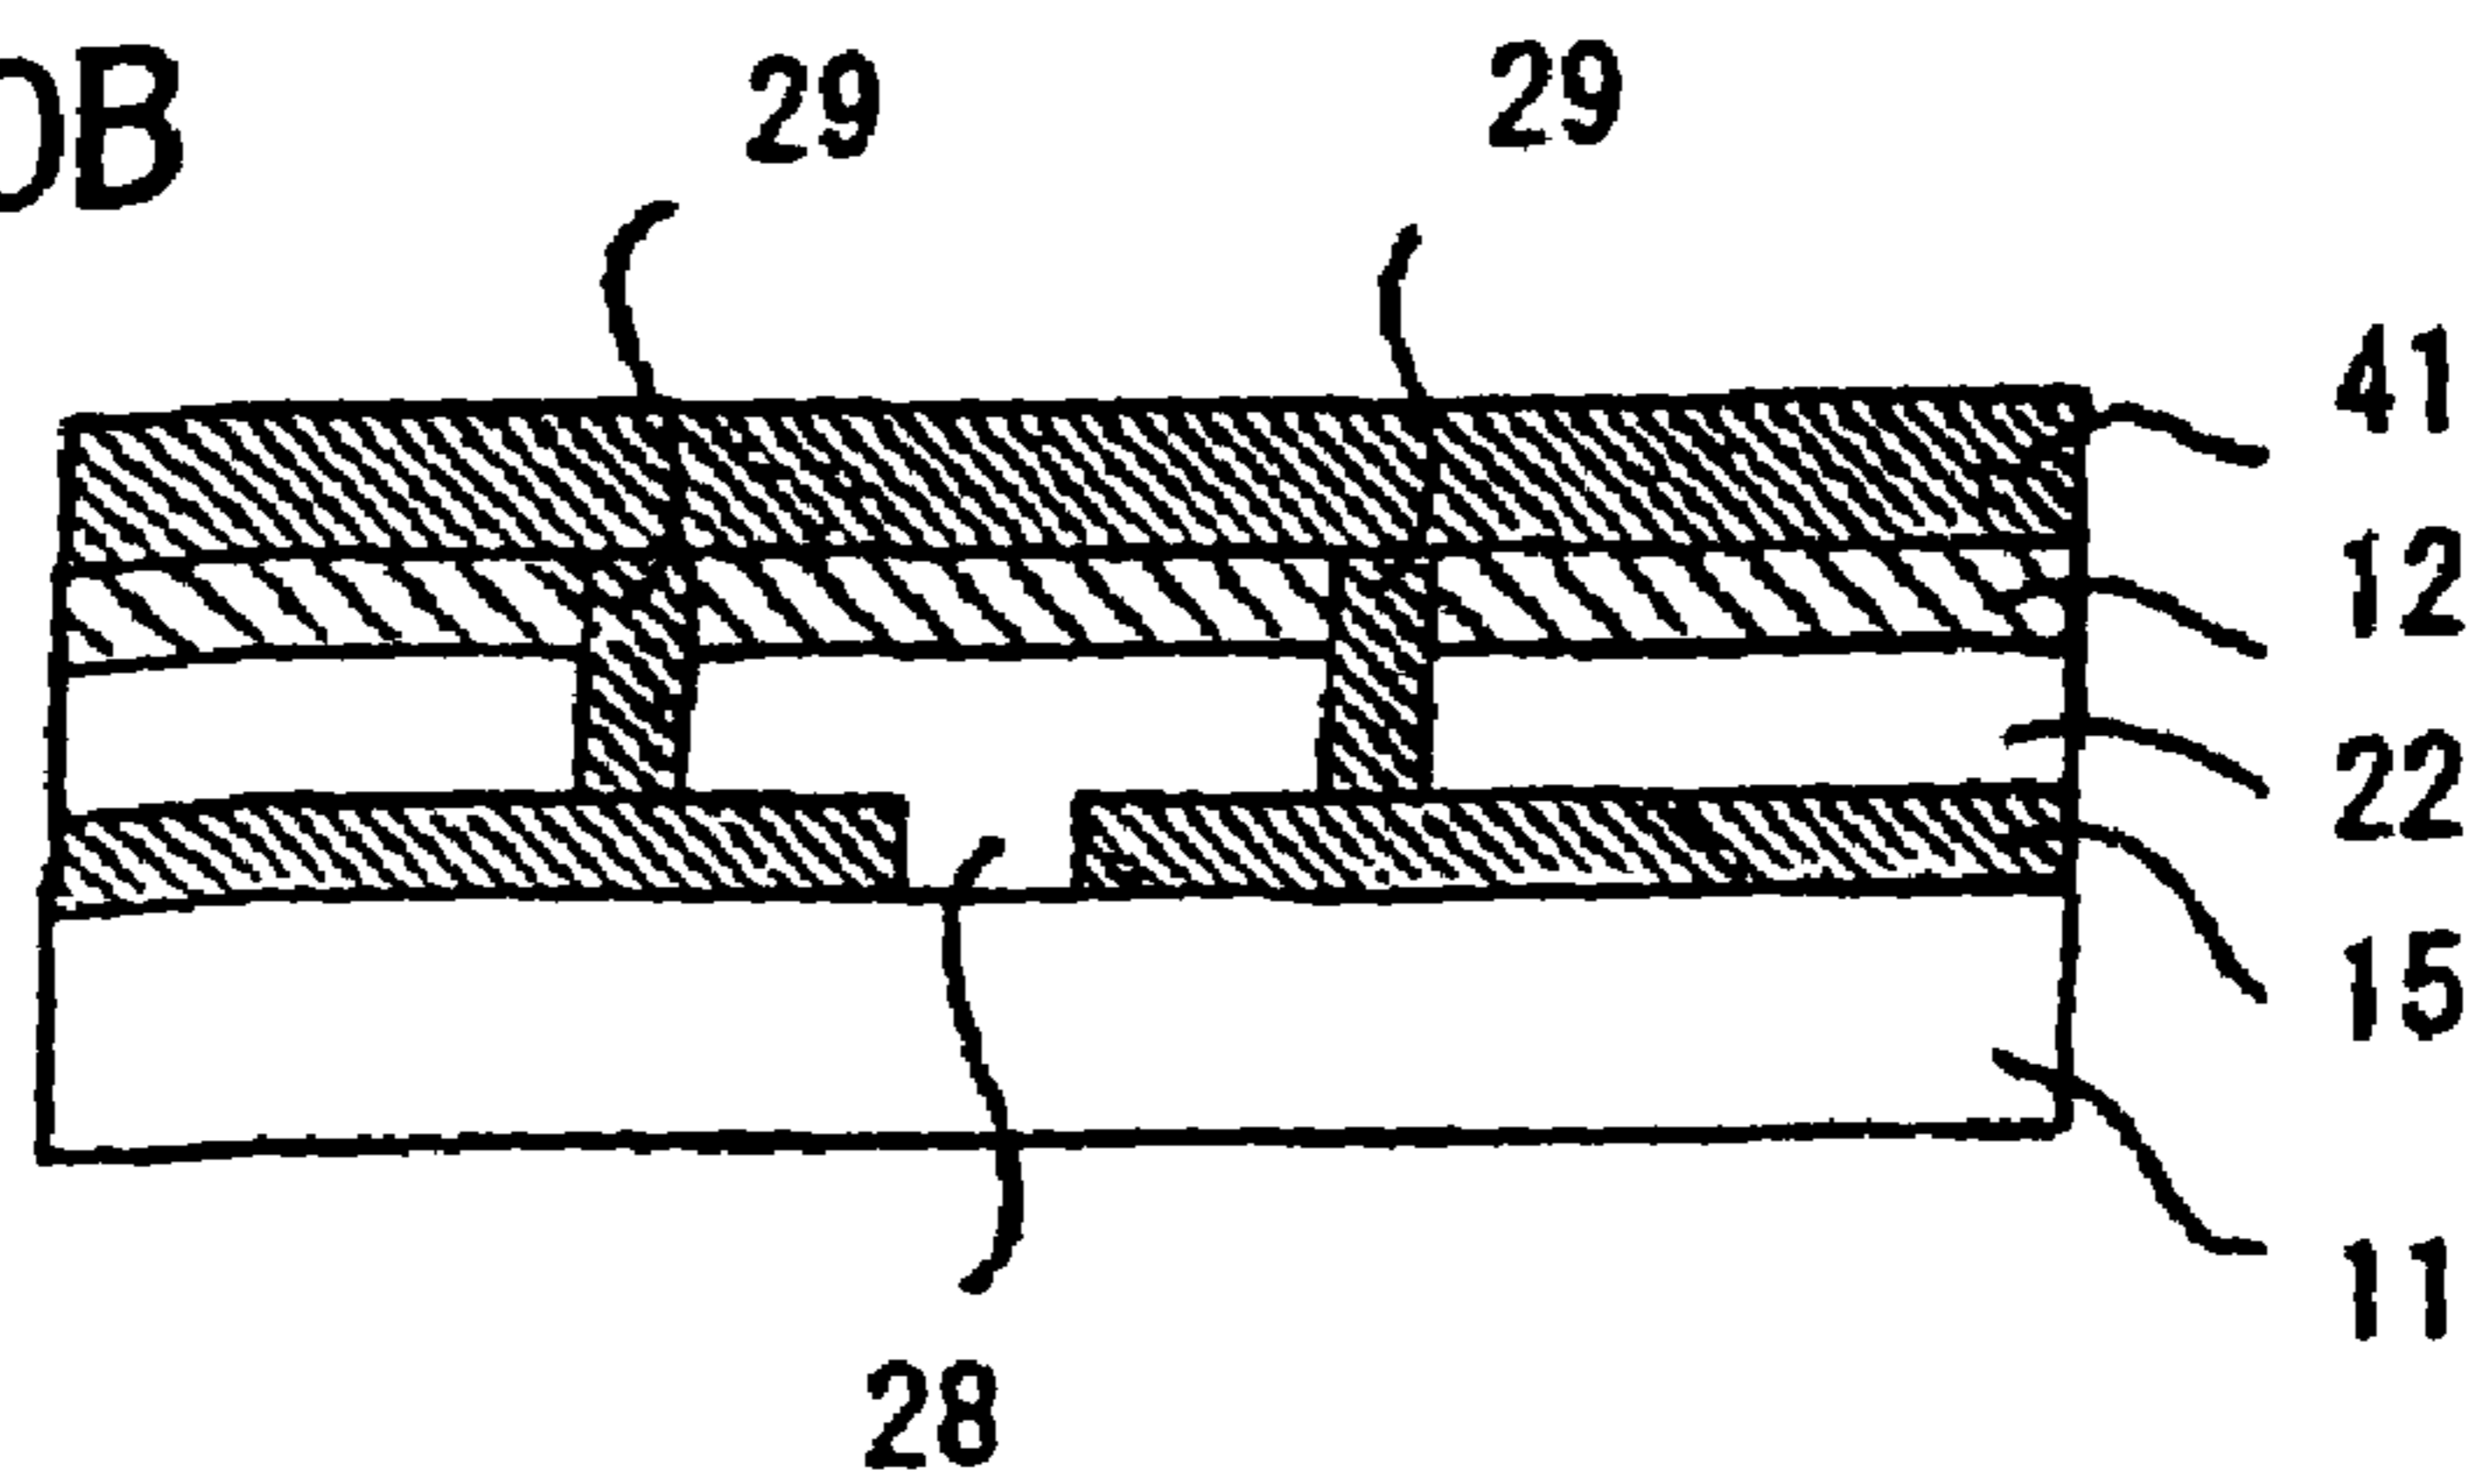
The case where disconnection occurs at the disconnected portion 28 of the gate line 15 of an active matrix liquid crystal display device will be explained hereinbelow. A laser is applied to the positions at both outsides of the disconnected portion 28 (the positions shown by the cross marks in FIG. 9) through the conductive layer 41. The molten metal 29 produced by the laser application electrically connects the conductive layer 41 and the gate line 15. The disconnected gate line 15 regains continuity by a bypass line through the molten metal 29, the conductive layer 41, and the molten metal 29. It

FIGS. 10A and 10B are sectional views showing structures of a disconnected portion of a gate line in the conventional liquid crystal display device.

The repair method described in the second embodiment of the invention disclosed in Japanese Patent Application Laid-Open No. H09-113930 also has problems. According to the method, the conductive layer for repairing line disconnection is additionally provided on the pixel electrode **12**. Therefore, the manufacturing process requires an additional step of forming the conductive layer. Also, the conductive layer is placed on the pixel electrode applying an electric field to liquid crystals. Therefore, after the repair, an electric potential of a source signal, gate signal, or common signal is directly applied to the liquid crystals through the conductive layer. It causes noise to have an adverse effect on operations of the liquid crystals, resulting in poor display quality.

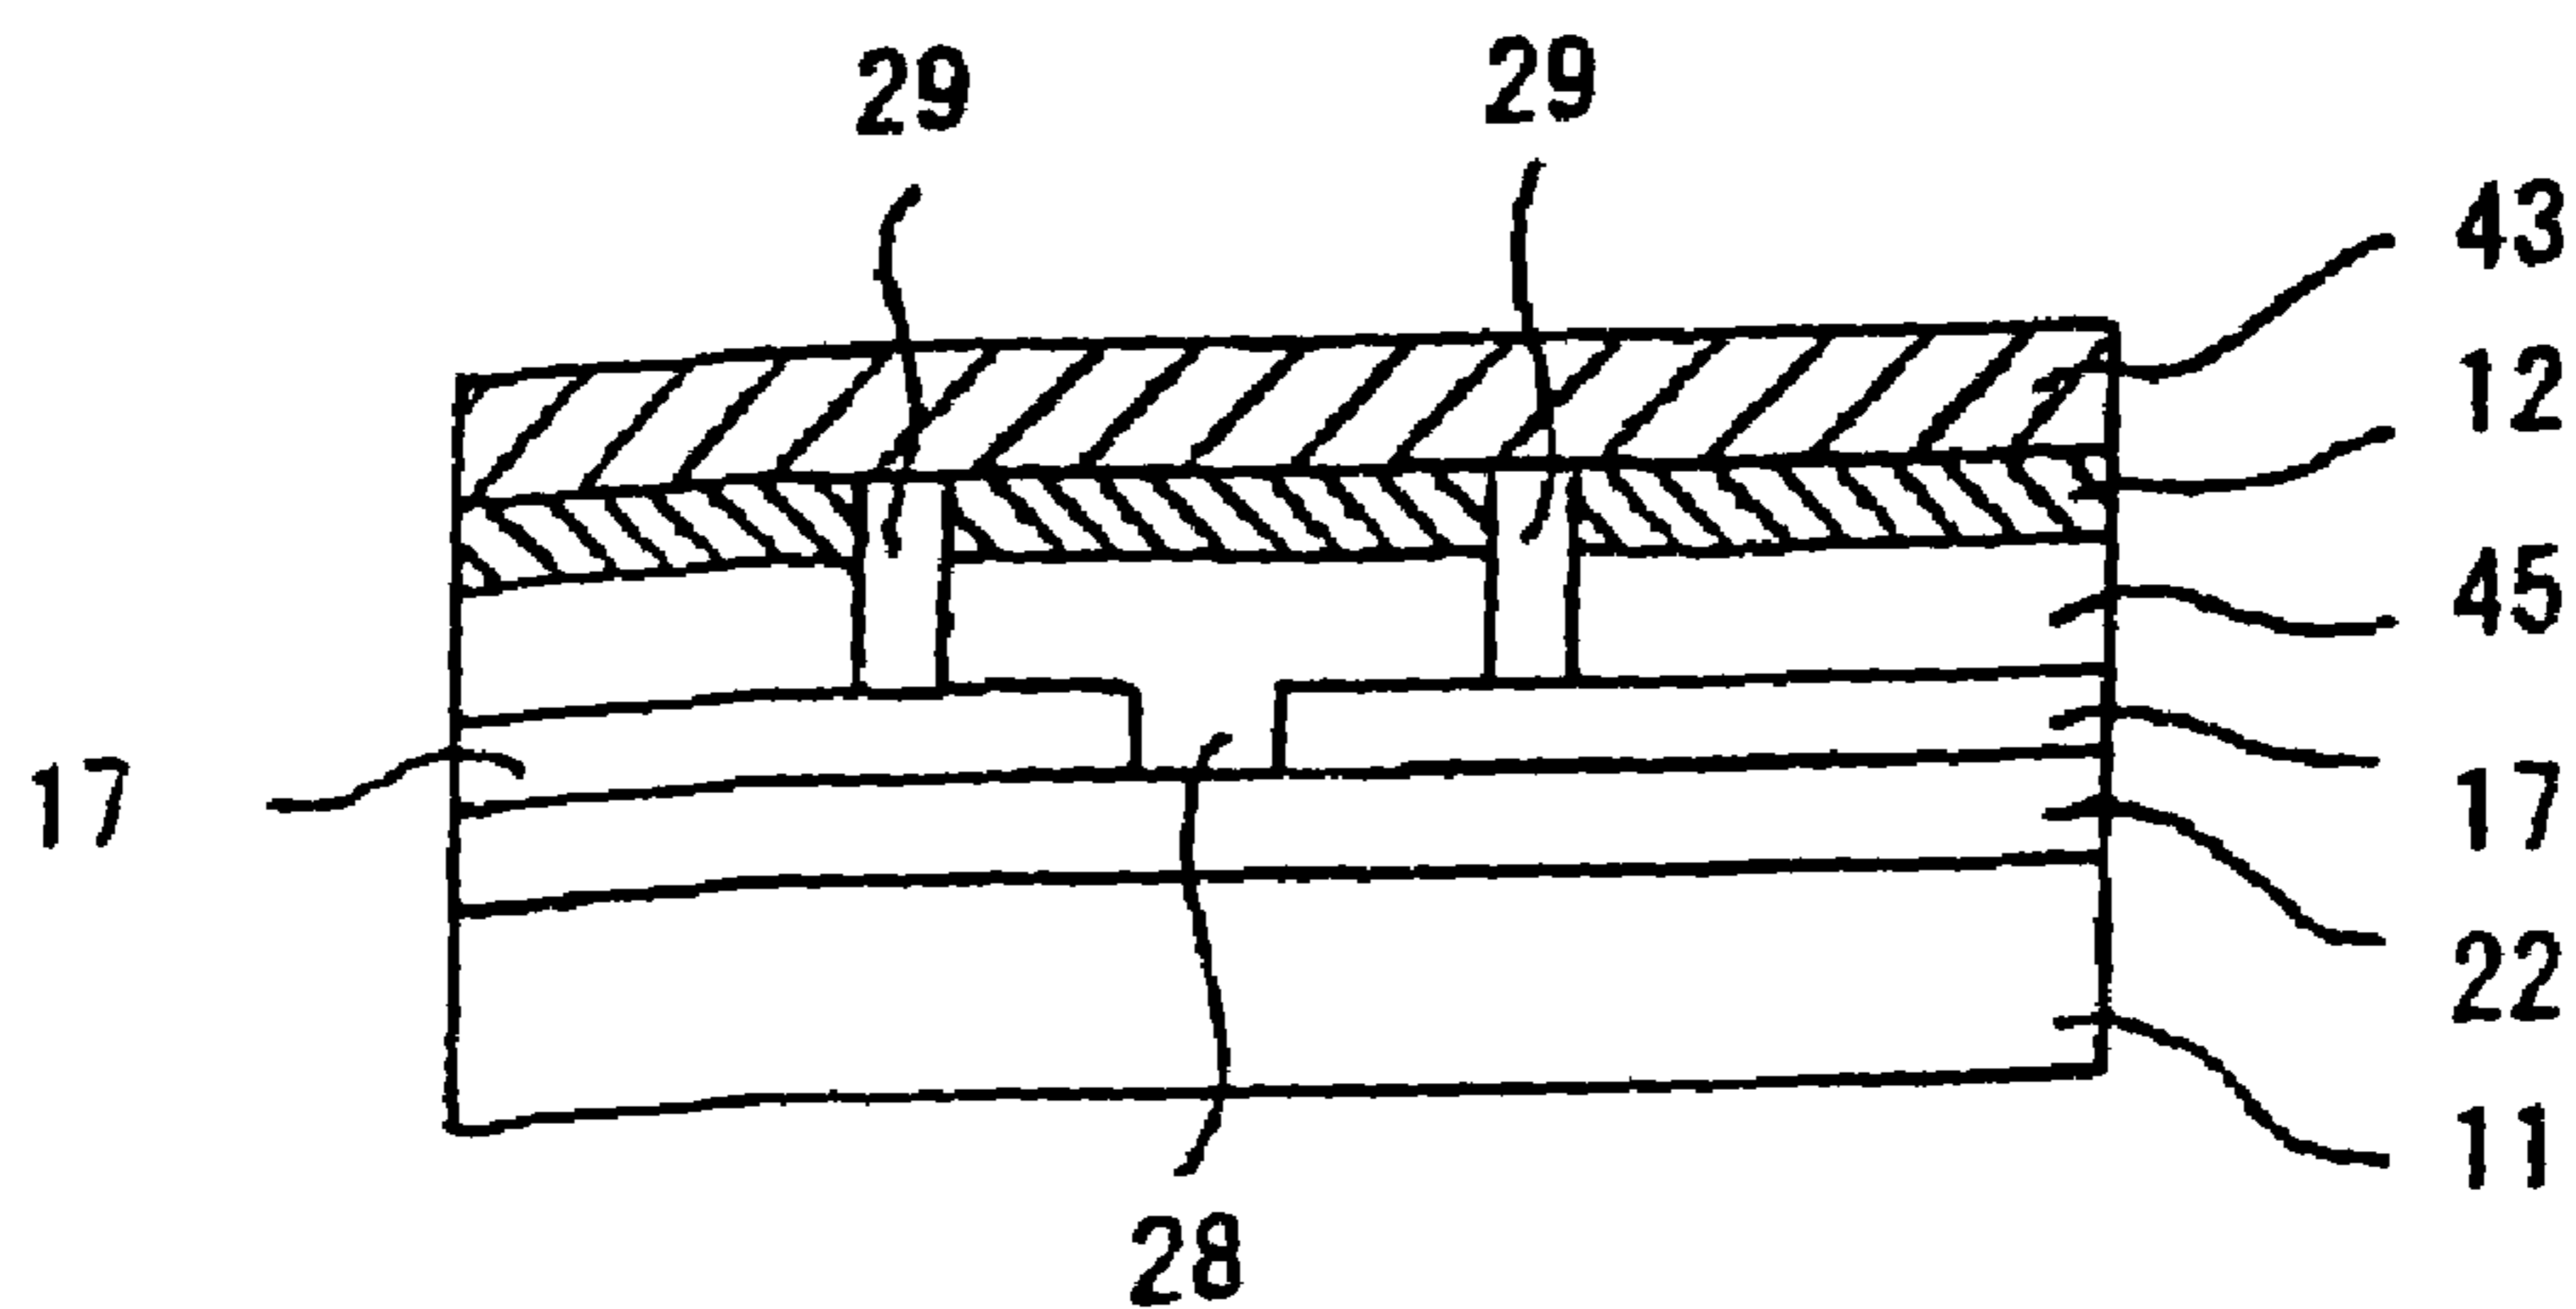
Disconnection of the source line **17** can be also repaired in the same way as shown in FIG. **11**. Further, the storage capacitor line **16** can be repaired in the same manner.

FIG. 11 is a sectional view showing a structure of a disconnected portion of a source line in the conventional liquid crystal display device.
