(10) **Patent No.:** **US 7,568,570 B2**
(45) **Date of Patent:** **Aug. 4, 2009**

(54) **SAFETY MONITORING SYSTEM FOR A PEOPLE CONVEYOR**

(73) Assignee: **Otis Elevator Company**, Farmington, CT (US)

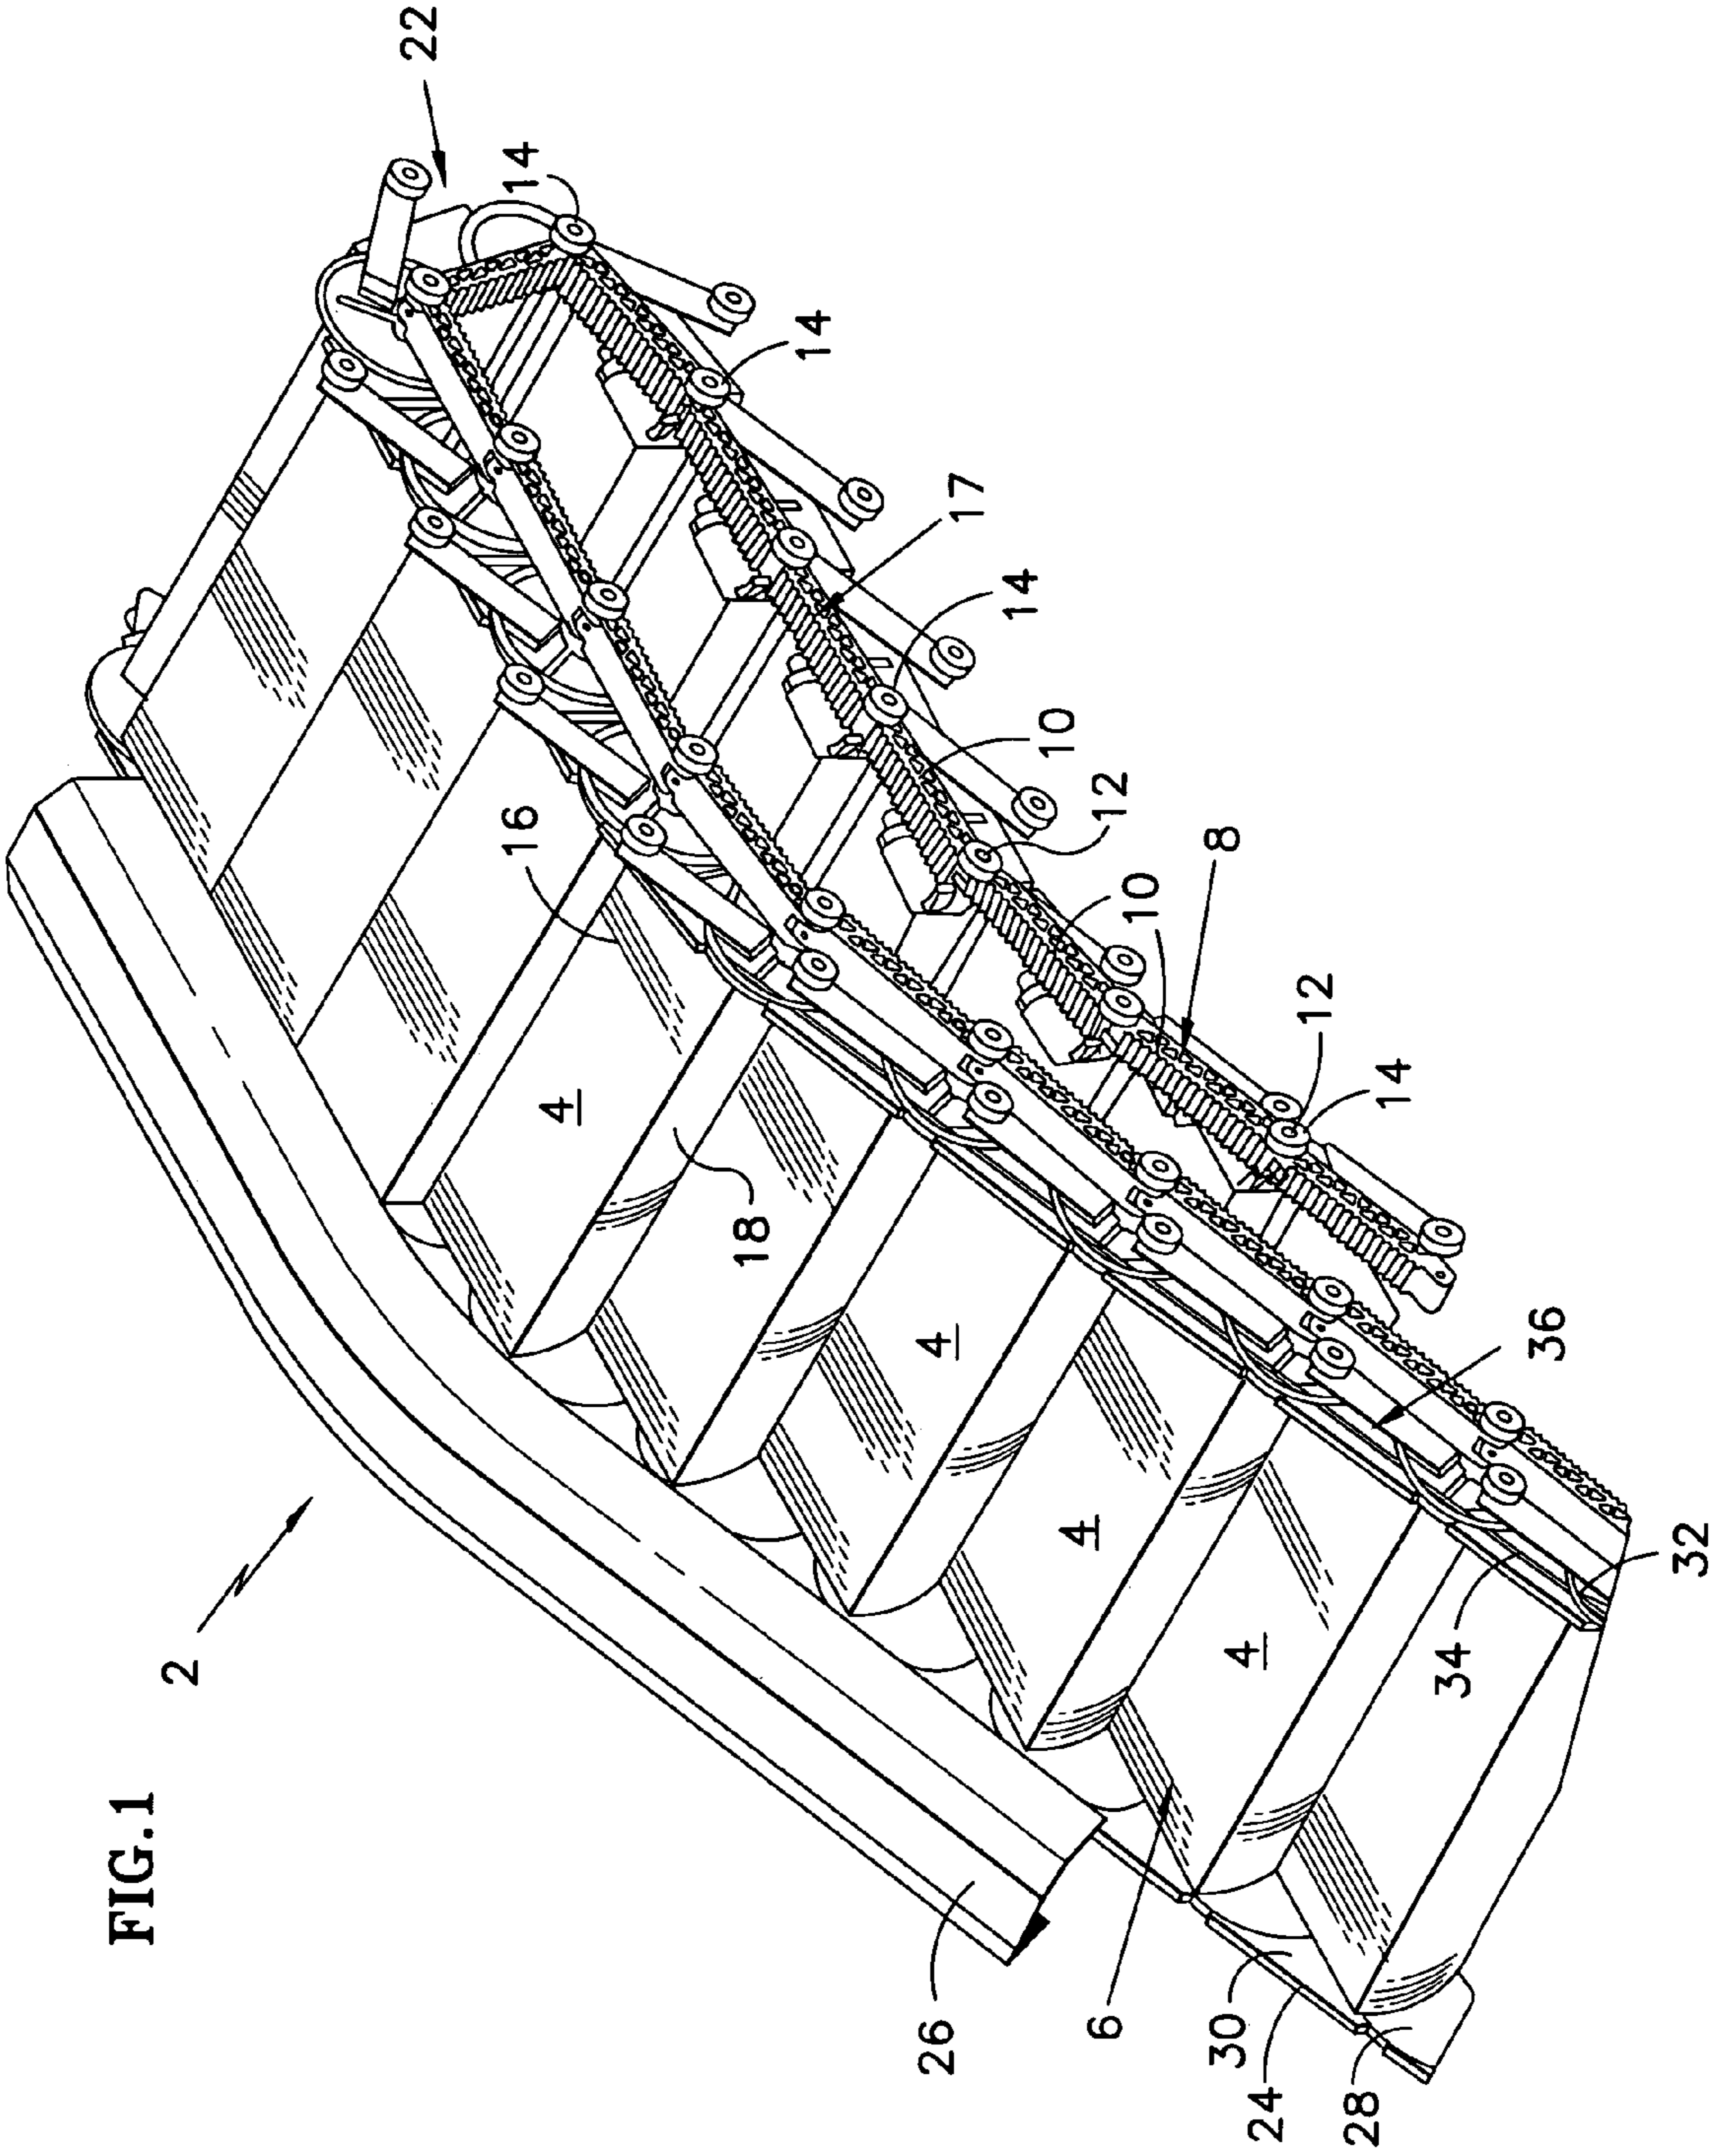
FIG.1

FIG. 1, a part of a people mover according to the invention, in which parts have been broken away for a better representation; and

In FIG. 1, one can recognize a people mover in the form of an escalator 2, comprising an endless step belt 6 formed of several mutually connected tread steps 4. The tread steps 4 are each connected to conveyance chains 8 provided at the sides. Connected "at the sides" is intended to include both embodiments in which the conveyance or step chain[s] 8 are provided laterally alongside the tread steps 4 as seen in a plan view and those in which the step chains 8 are provided laterally underneath the tread surface 16 of a tread step 4 as seen in the plan view. The conveyance chains 8 are formed from a plurality of chain links 10. The chain links 10 are connected together at turning points 12. Also provided at these turning points 12 are step chain rollers 14, which guide the step chains 8 in step chain guides (not shown) along the closed circulation path.

In FIG. 1, it is also recognizable that a tread element 4 has a tread surface or "tread step" 16 as well as a front surface or "riser" 18. One also recognizes that an area of constant inclination is present, in which riser 18 essentially always has the same height. One also recognizes a transition area, in which riser 18 has an increasingly smaller height, until it is finally no longer present just before a reversal point 22, i.e., the individual tread elements or tread steps 4 are arranged in one plane.

One also recognizes in FIG. 1 a concurrently moved side skirt 24, as well as balustrade trim 26, which covers concurrently moved side skirt 24 at the top and continues upwards from there. On top of trim 26, a balustrade made, for example, of glass can be placed, in which a handrest (not shown) circulates essentially synchronously with step belt 6.

Concurrently moved side skirt 24 comprises flange elements 28 having essentially a semicircular shape that are mounted on tread elements 4. Between each two flange elements 28 there is provided a bridge element 30 to fill out the space between them and to enable a movement of concurrently moved side skirt 24 from the constantly inclined area through the transition area into the landing area and from there via the reversal point to the return area. Flange elements 28 and bridge elements 30 can be constructed to engage with one another in a type of tongue and groove joint, thus permit-

Step chain 2 is powered by a linear drive (not shown), which is constructed in the manner of a linear drive formed by an endless revolving toothed drive belt. The toothing of the toothed drive belt engages with toothing 17 of chain links 10. The linear drive is preferably arranged in the constantly inclined area of escalator 2. As an alternative to the linear drive, it is also possible to provide conveyance chain 8 with a conventional drive unit in, for instance, upper or lower reversal point 22.

Flange elements 28 are preferably formed integrally with tread elements 4, typically from an aluminum material, with manufacture from pressure-cast aluminum being particularly favored. Bridge elements 30 are also preferably formed from such a material. Ribs 32 and marking elements 34 in the form, for example, of spring steel clips 34 on flange elements 28 and bridge elements 30 are shown only very schematically in FIG. 1. It is recognizable that these ribs and markers are arranged essentially along a straight line in the constantly inclined area of people mover 2 and form a continuous series 36 of ribs there.

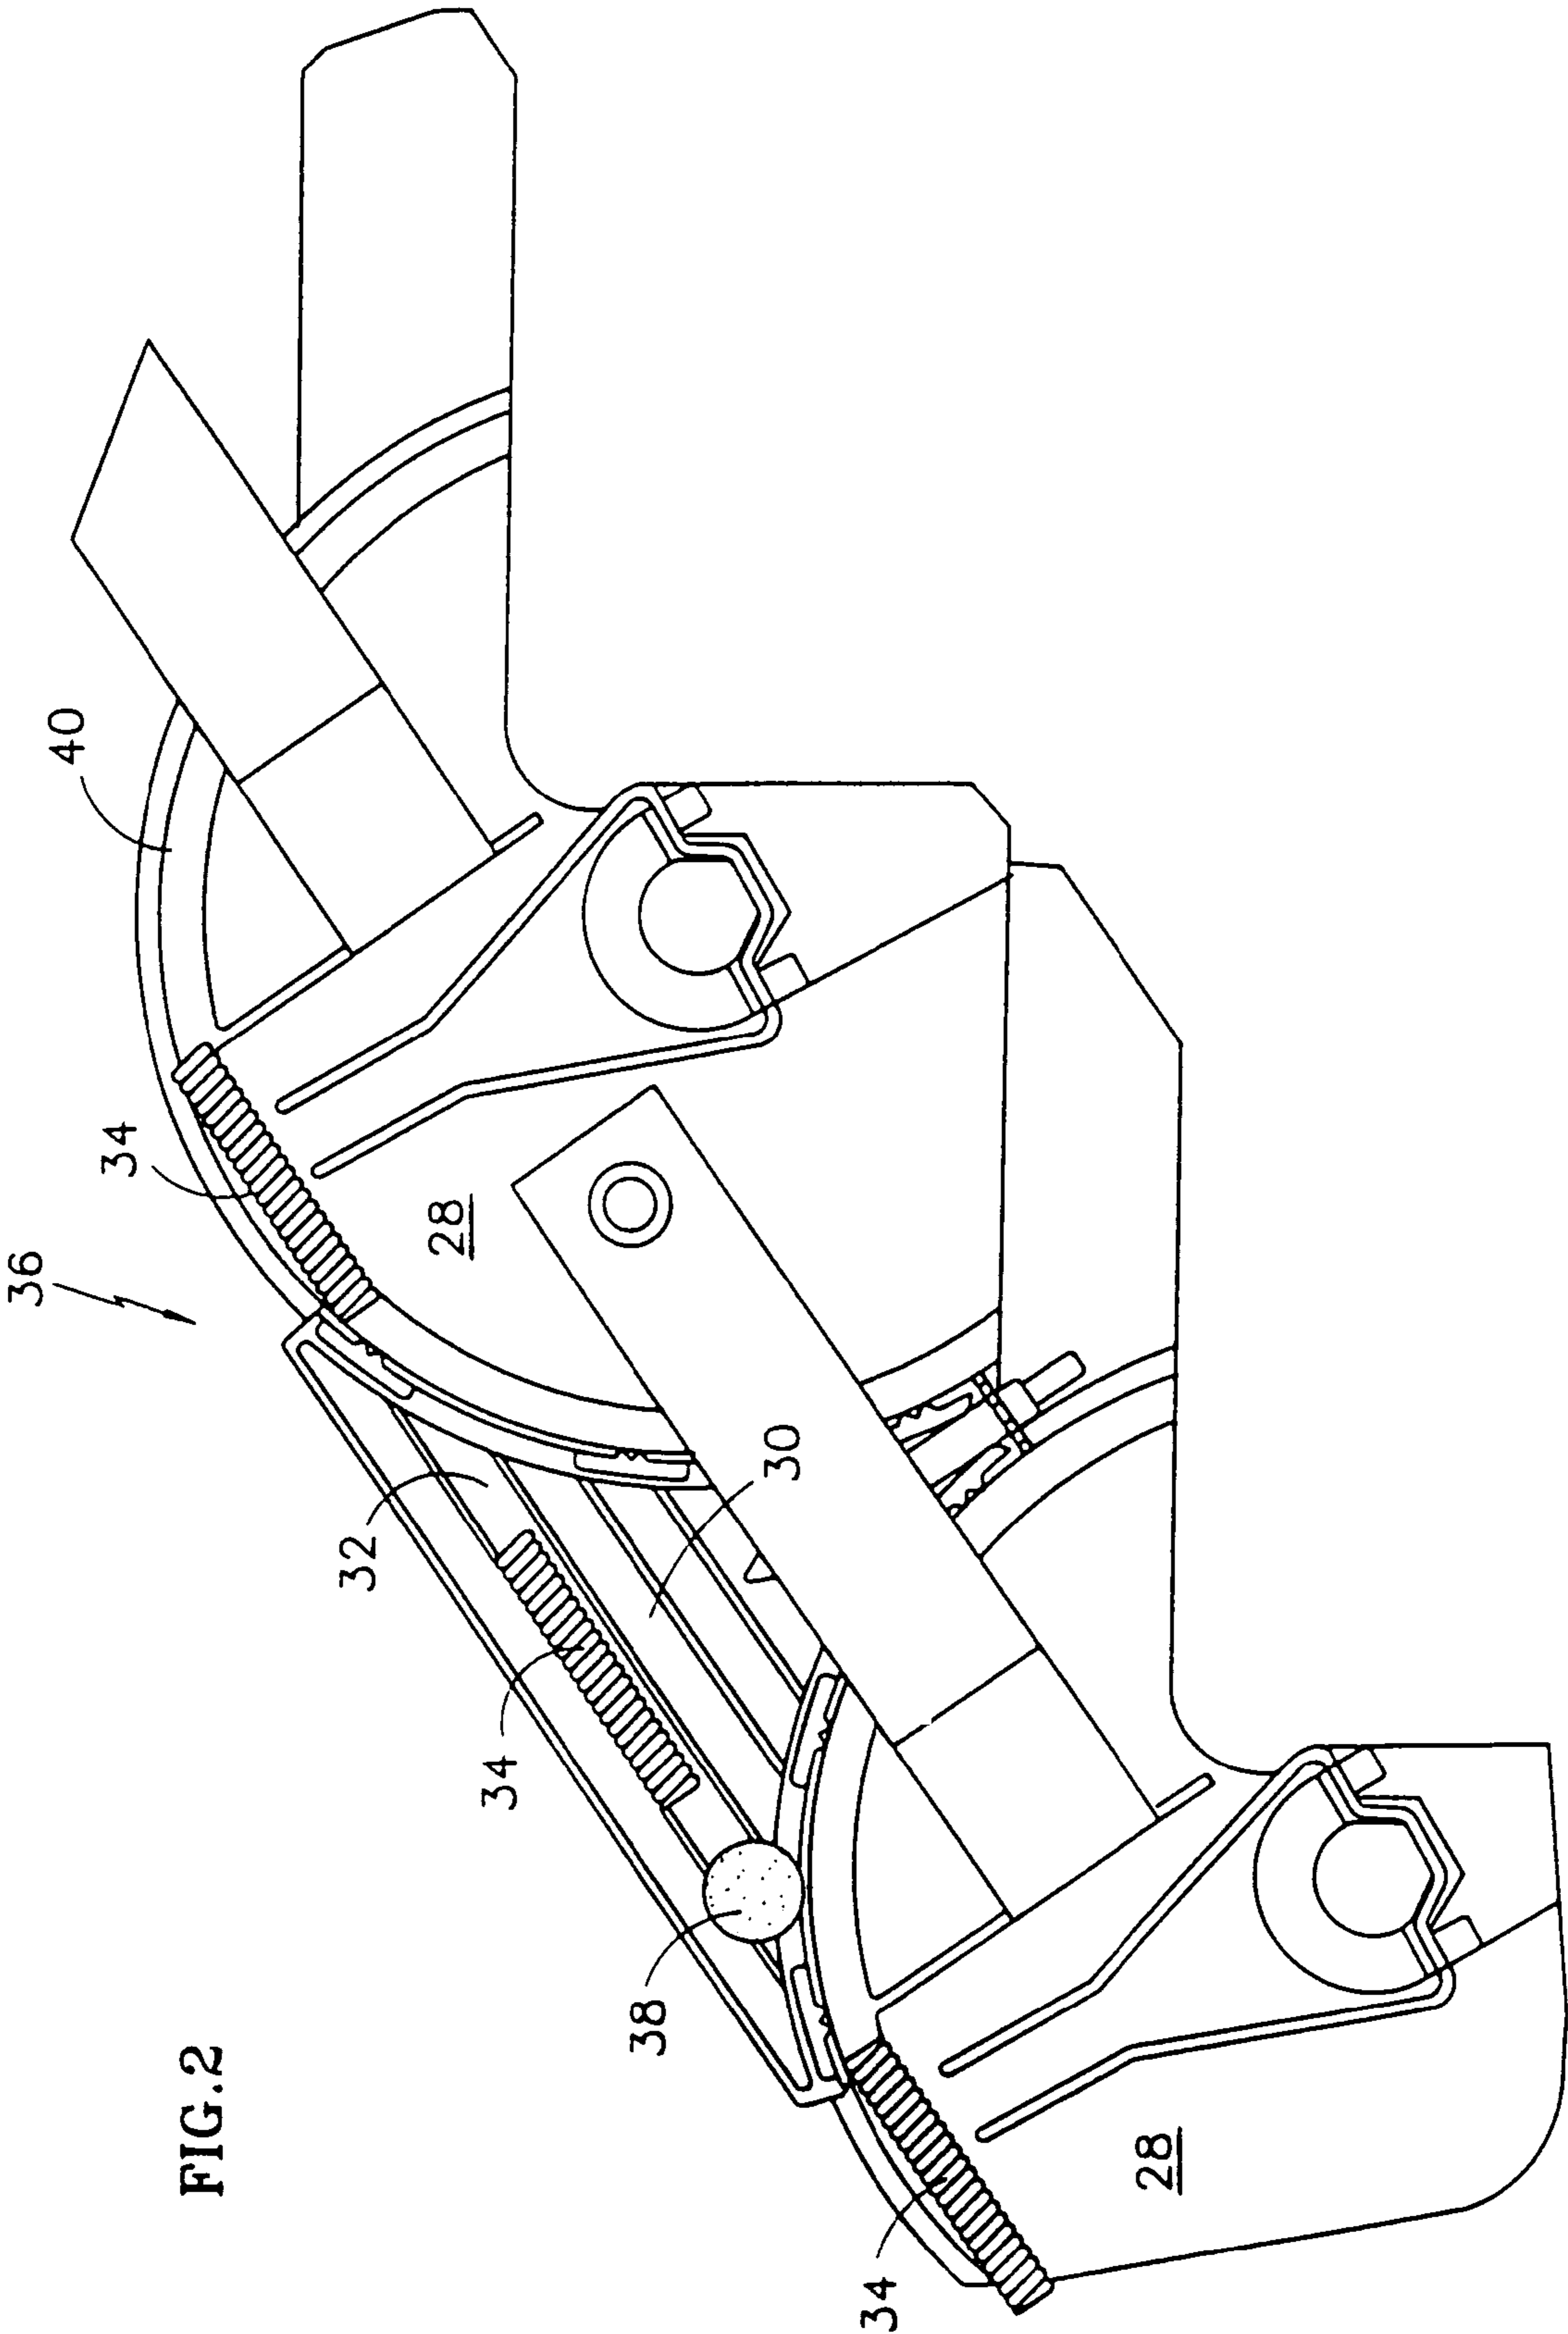
FIG.2

FIG. 2, a detail view of an escalator according to the invention.

In the enlarged detail view of FIG. 2, rib series 36 comprising ribs 32 and spring steel clips 34 is more clearly recognizable. One can also recognize a schematically shown sensor 38, which is located between two spring clips 34 in the position shown. One recognizes in particular that rib 32 on flange elements 28 is a section of peripheral rib 40 of flange elements 28 that has been formed in a straight line. This is preferred for reasons of manufacturing technology.

Spring steel clips 34 preferably consist of a magnetic spring steel. It is also possible to glue essentially flat elements of magnetic material to, for example, the rib or the inner side of flange elements 28 or bridge elements 30. The attachment of clamping elements is particularly simple for reasons of operating and manufacturing technology, however, and is therefore preferred. For other than magnetic sensors 38, other suitable marking materials can be provided. The marking materials can also be provided in the ribs by, for instance, being cast in. Alternatively, the ribs themselves can be constructed such that they represent appropriate marking elements. Measuring quite roughly, the marking elements or spring steel clips have roughly half the length of the associated flange elements 28 or bridge elements 30 at the corresponding positions. Putting it in other terms, the signals generated by a sensor 38 are preferably, roughly square-wave signals with equal duration of the pauses and the individual signals. The marking elements should have a predetermined minimum length to guarantee assured detection and thus an assured signal. That is particularly the case if two sensors 38 are arranged at the same height on different sides of tread belt 6 in order to compensate for possible tolerances in the arrangement of the sensors and the marking elements.

Spring steel clips 34 are preferably formed in essentially a U shape, so that they can be fastened to rib 32 with the legs of the U gripping laterally across rib 32. Barbs are preferably provided to prevent detachment of spring steel clips 34 from rib 32.
