(10) **Patent No.:** **US 7,646,446 B2**
(45) **Date of Patent:** **Jan. 12, 2010**

(54) **REPAIRING METHOD OF A THIN FILM TRANSISTOR ARRAY SUBSTRATE**

(73) Assignee: **Au Optronics Corporation**, Hsinchu (TW)

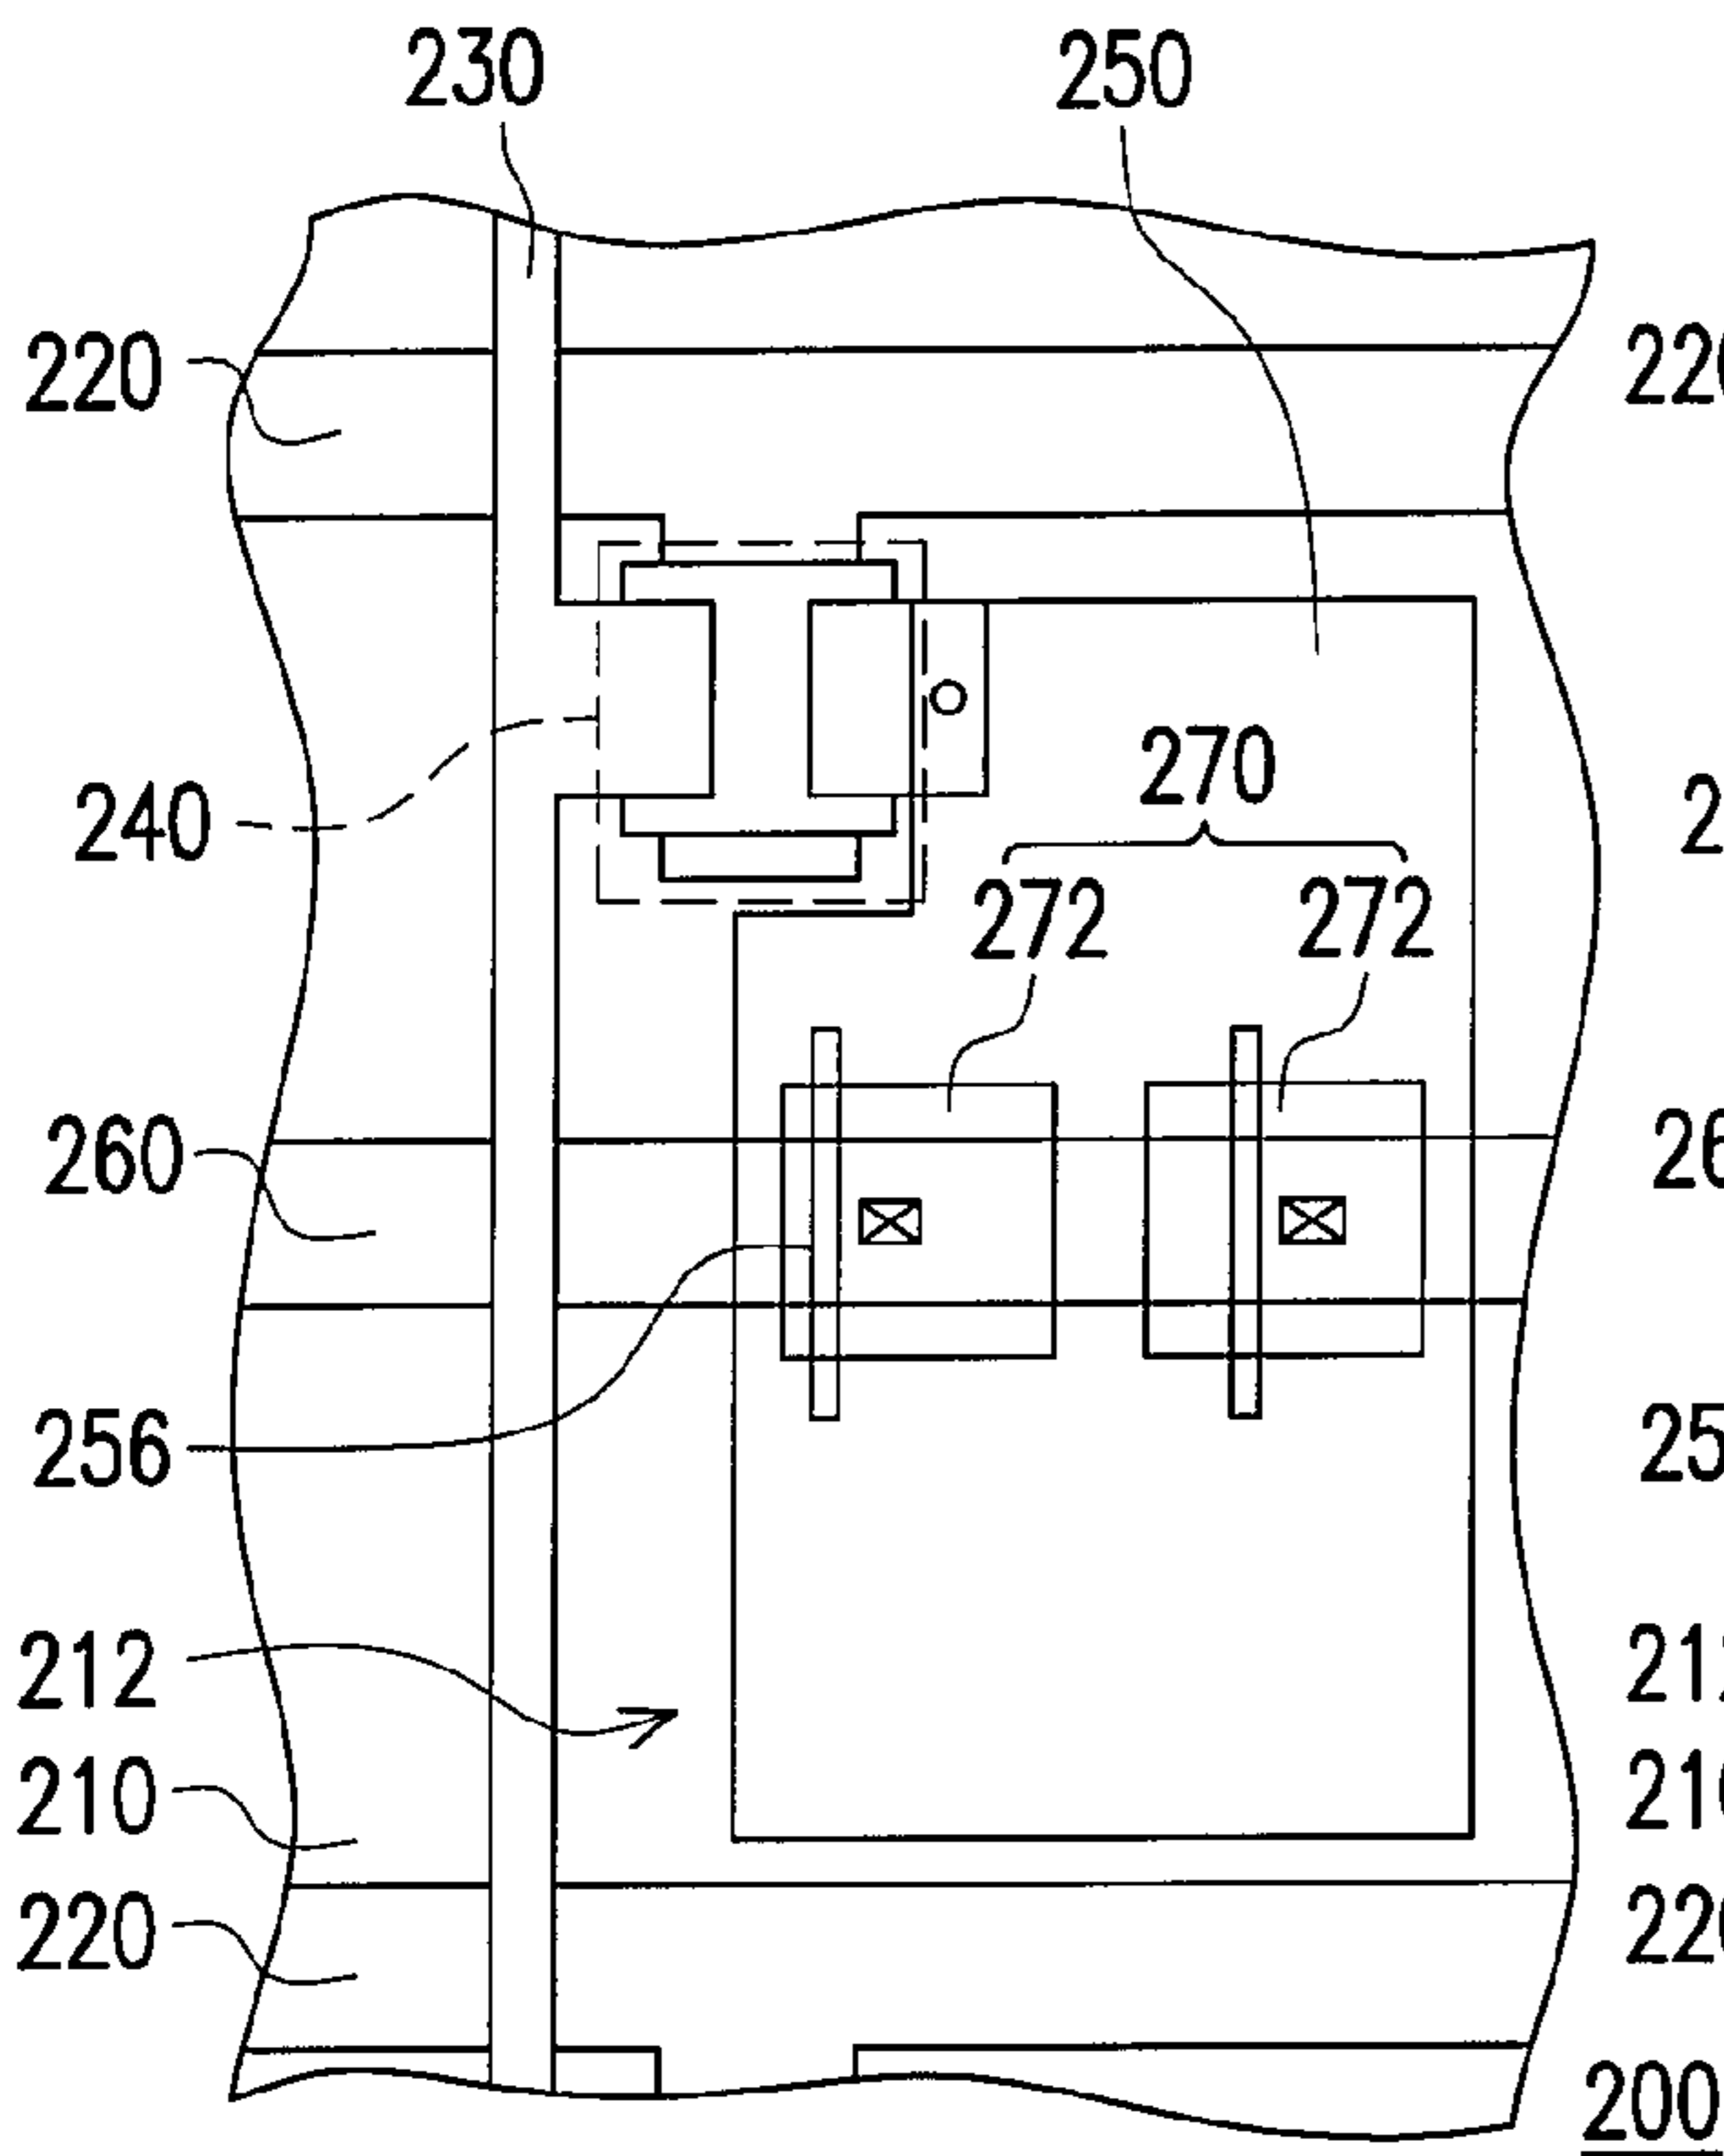
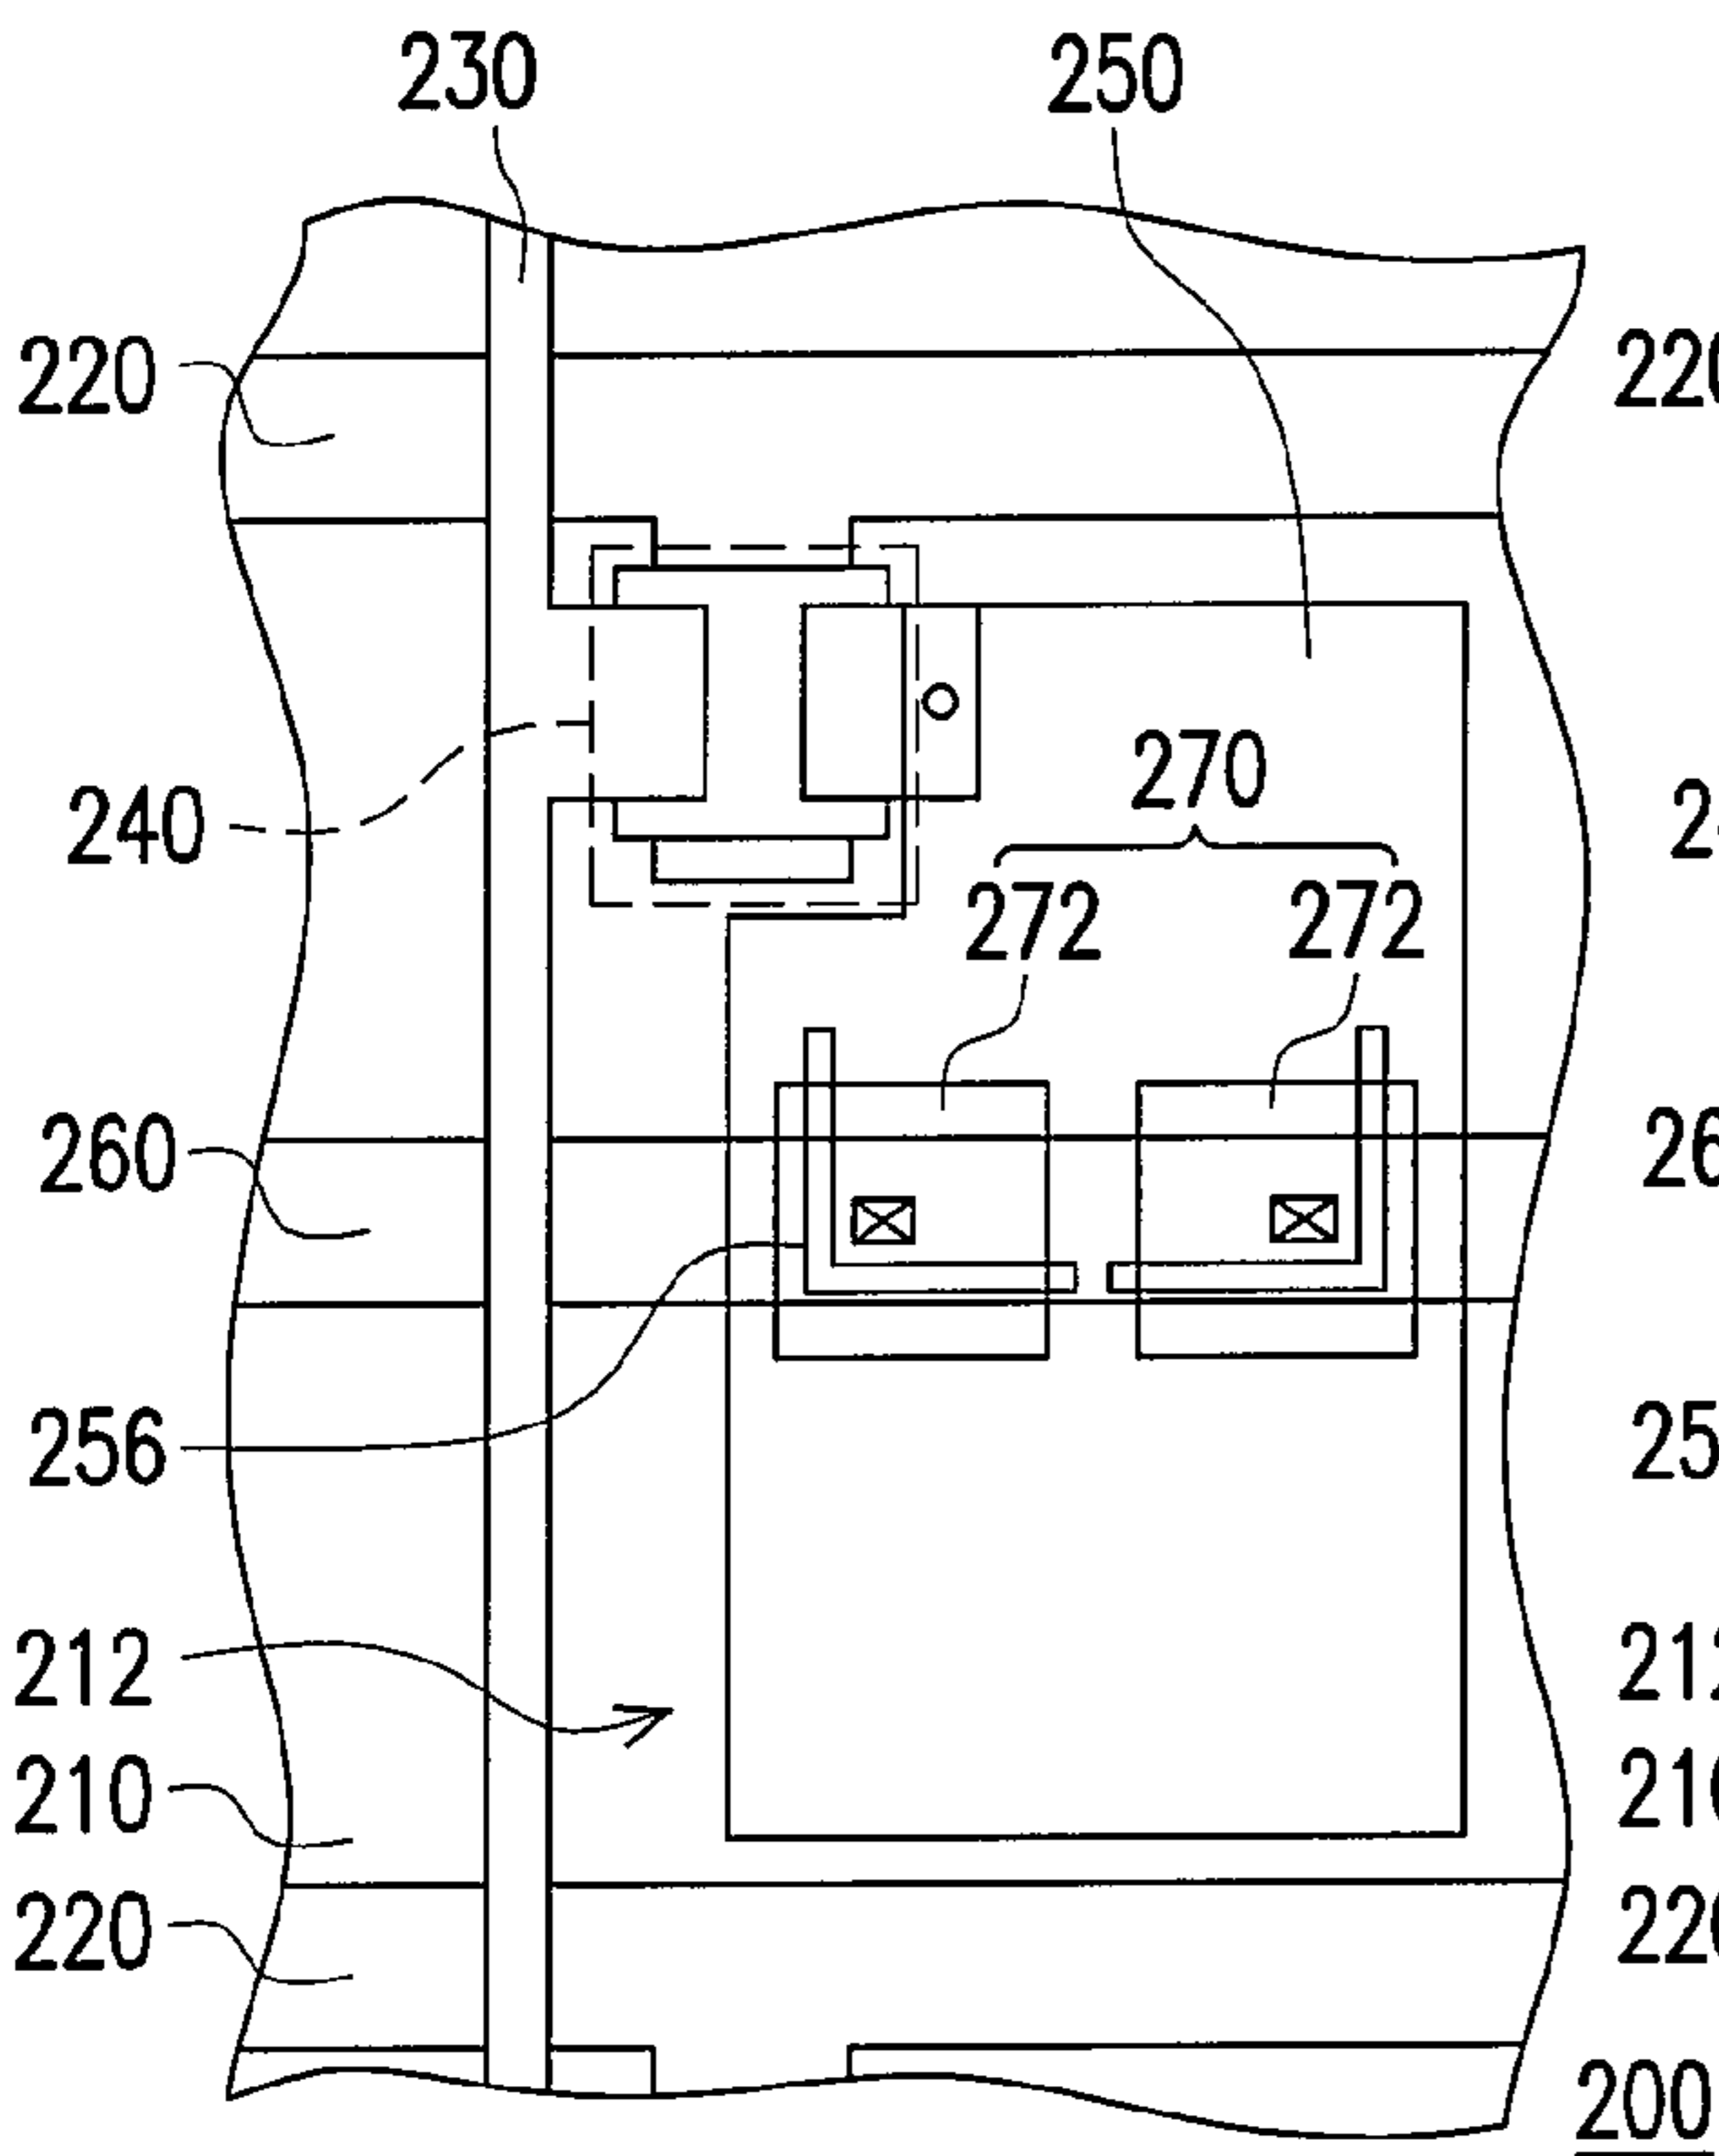
FIGS. 9A through 9D are top views showing different types of thin film transistor array substrates according to another preferred embodiment of the present invention.

FIGS. **9A** through **9D** are top views showing different types of thin film transistor array substrates according to another preferred embodiment of the present invention. The thin film transistor array substrate of the present embodiment is mostly identical to the one shown in FIG. **3**. One major difference is that one or more openings **256** are formed in each pixel electrode **250** when the pixel electrodes **250** are formed. The openings **256** are disposed around the contact region between each sub contact pad **272** and one of the pixel electrodes **250**. For example, a straight line opening **256** (shown in FIG. **9A**), two straight line openings **256** (shown in FIG. **9B**), an L-shaped opening (shown in FIG. **9C**) or a U-shaped opening **256** (shown in FIG. **9D**) is formed over the pixel electrode **250** corresponding to each sub contact pad **272**. With an opening **256** formed over the every pixel electrode **250**, a portion of any one pixel electrode **250** can be readily removed to connect the ends of the opening **256**. Hence, an opening similar to the opening **252** that encircles the contact **292** as shown in FIG. **5** can be produced when there is a particle (or defect) between a sub-upper electrode **272** and one of the common lines **260**. In the present embodiment, the method of removing a portion of the pixel electrode **250** includes performing a laser ablation process.

As shown in FIGS. **9A** through **9D**, a portion of the opening **256** is disposed above the area occupied by the sub-upper electrode **272** while the remaining portion of the opening **256** is disposed outside the area occupied by the sub-upper electrode **272**. In other words, the openings **256** also cover a region outside the upper electrode **272** to simplify and speed the repairing operation. In addition, anyone familiar with the

After removing a portion of the pixel electrode corresponding to the sub-upper electrode of the defective capacitor, the sub-upper electrode of the defective capacitor and one of the scan lines can be electrically connected by performing a laser welding process. Similarly, if a particle (or defect) is found between the pixel electrode and one of the scan lines, the pixel electrode above the particle (or defect) can be removed using a laser removing method. In addition, the process of fabricating the pixel electrode may include forming one or more openings similar to the ones described in FIGS. **9A** through **9D** to facilitate a laser repair operation.

FIGS. **16A** through **16D** show the types of openings formed on the pixel electrode of a conventional thin film transistor array substrate. To simplify and speed up the repairing process, one or more openings **154** are also formed over the thin film transistor array substrate in the process of fabricating the pixel electrode **150**. For example, a straight line opening **154** (as shown in FIG. **16A**), a pair of straight line openings **154** (as shown in FIG. **16B**), an L-shaped opening **154** (as shown in FIG. **16C**) or a U-shaped opening **154** (as shown in FIG. **16D**) are formed over the pixel electrode **150**. Since the openings **154** are similar to the openings disclosed in FIGS. **9A** through **9D**, detailed description is omitted.

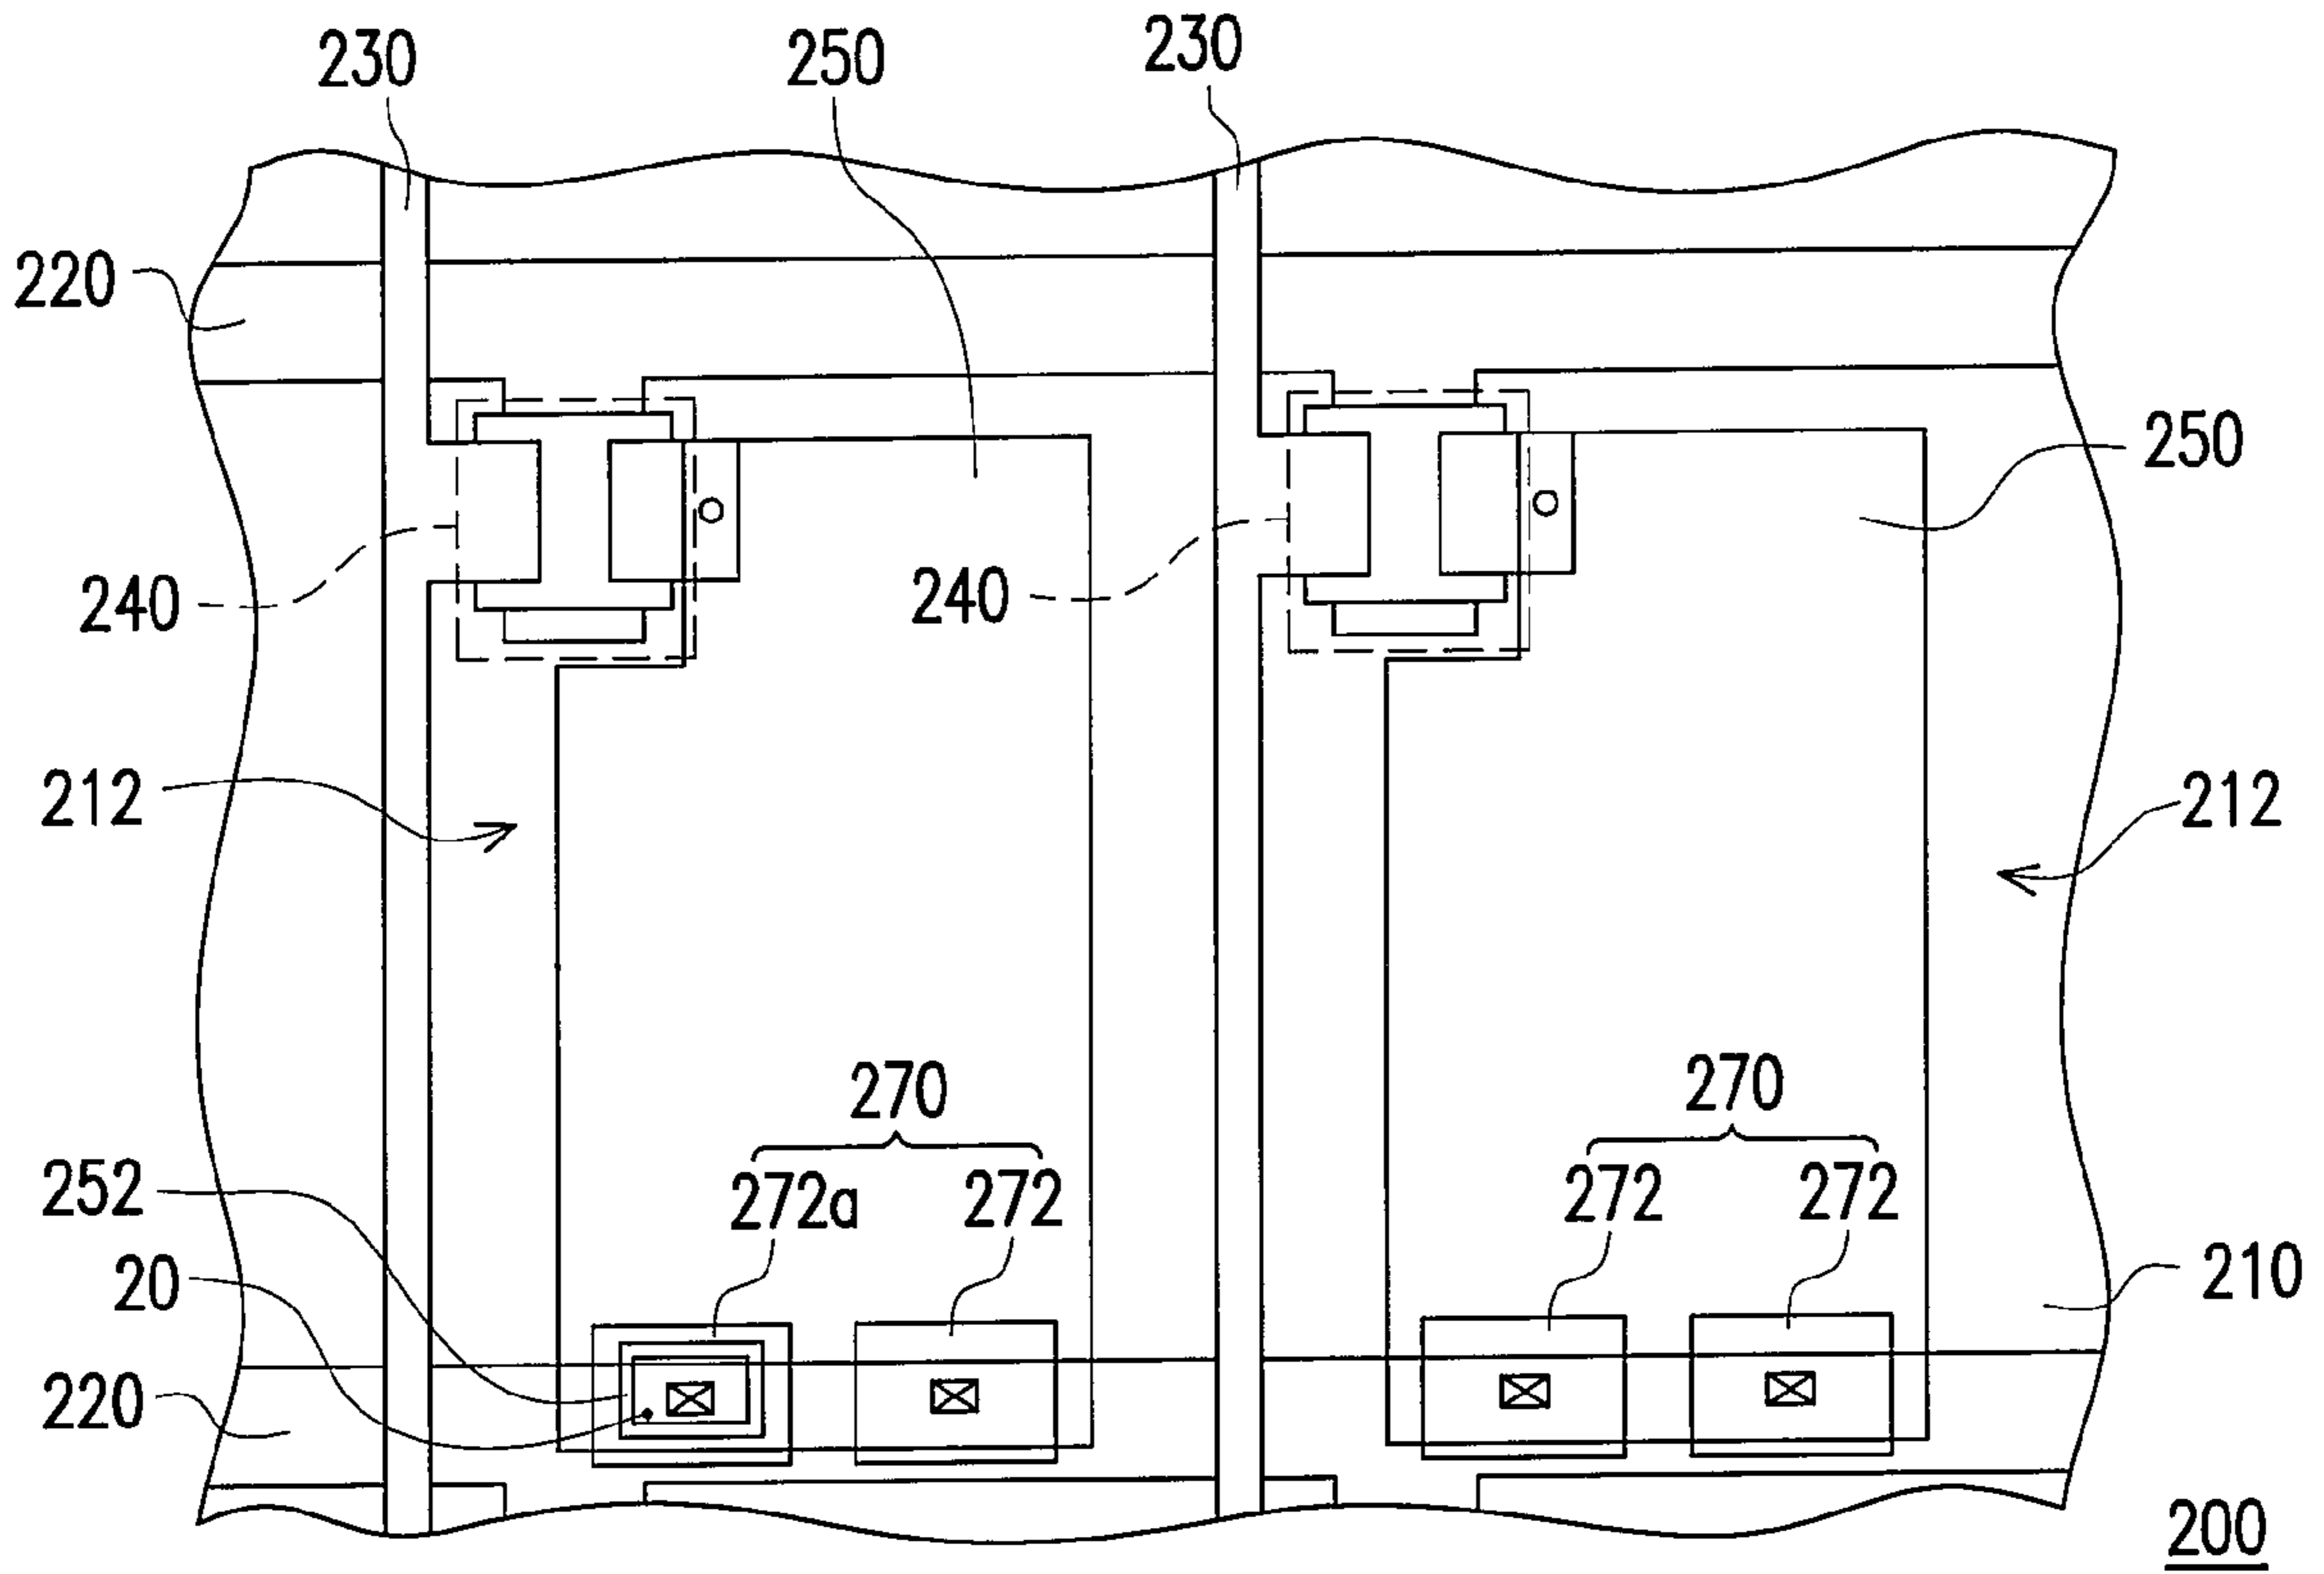
FIG. 12

FIGS. 12 and 13 are top views showing the method of repairing the scan line structure of the storage capacitor inside a thin film transistor array substrate according to the present invention.

FIGS. **12** and **13** are top views showing the method of repairing the scan line structure of the storage capacitor inside a thin film transistor array substrate according to the present invention. As shown in FIGS. **12** and **13**, the thin film transistor array substrate has a capacitor on scan line structure (Cst on gate) similar to one shown in FIG. **5**.

As shown in FIG. **12**, a portion of each pixel electrode **250** extends into the area above one of the scan lines **220**. The patterned upper electrode **270** is disposed between the pixel electrode **250** and the corresponding scan line **220**. The patterned upper electrode **270** comprises a plurality of sub-upper electrodes **272**. The sub-upper electrode **272** and its underlying scan line **220** together form a storage capacitor inside each pixel.

As shown in FIG. **12**, a portion of the pixel electrode **250** above the sub-upper electrode **272a** of the corresponding defective capacitor is removed to form an opening **252**. By forming the opening **252** in the pixel electrode **250**, the sub-upper electrode **272a** and the corresponding pixel electrode **250** of the defective capacitor are electrically isolated. The method of removing a portion of the pixel electrode **250** includes laser ablation, for example.

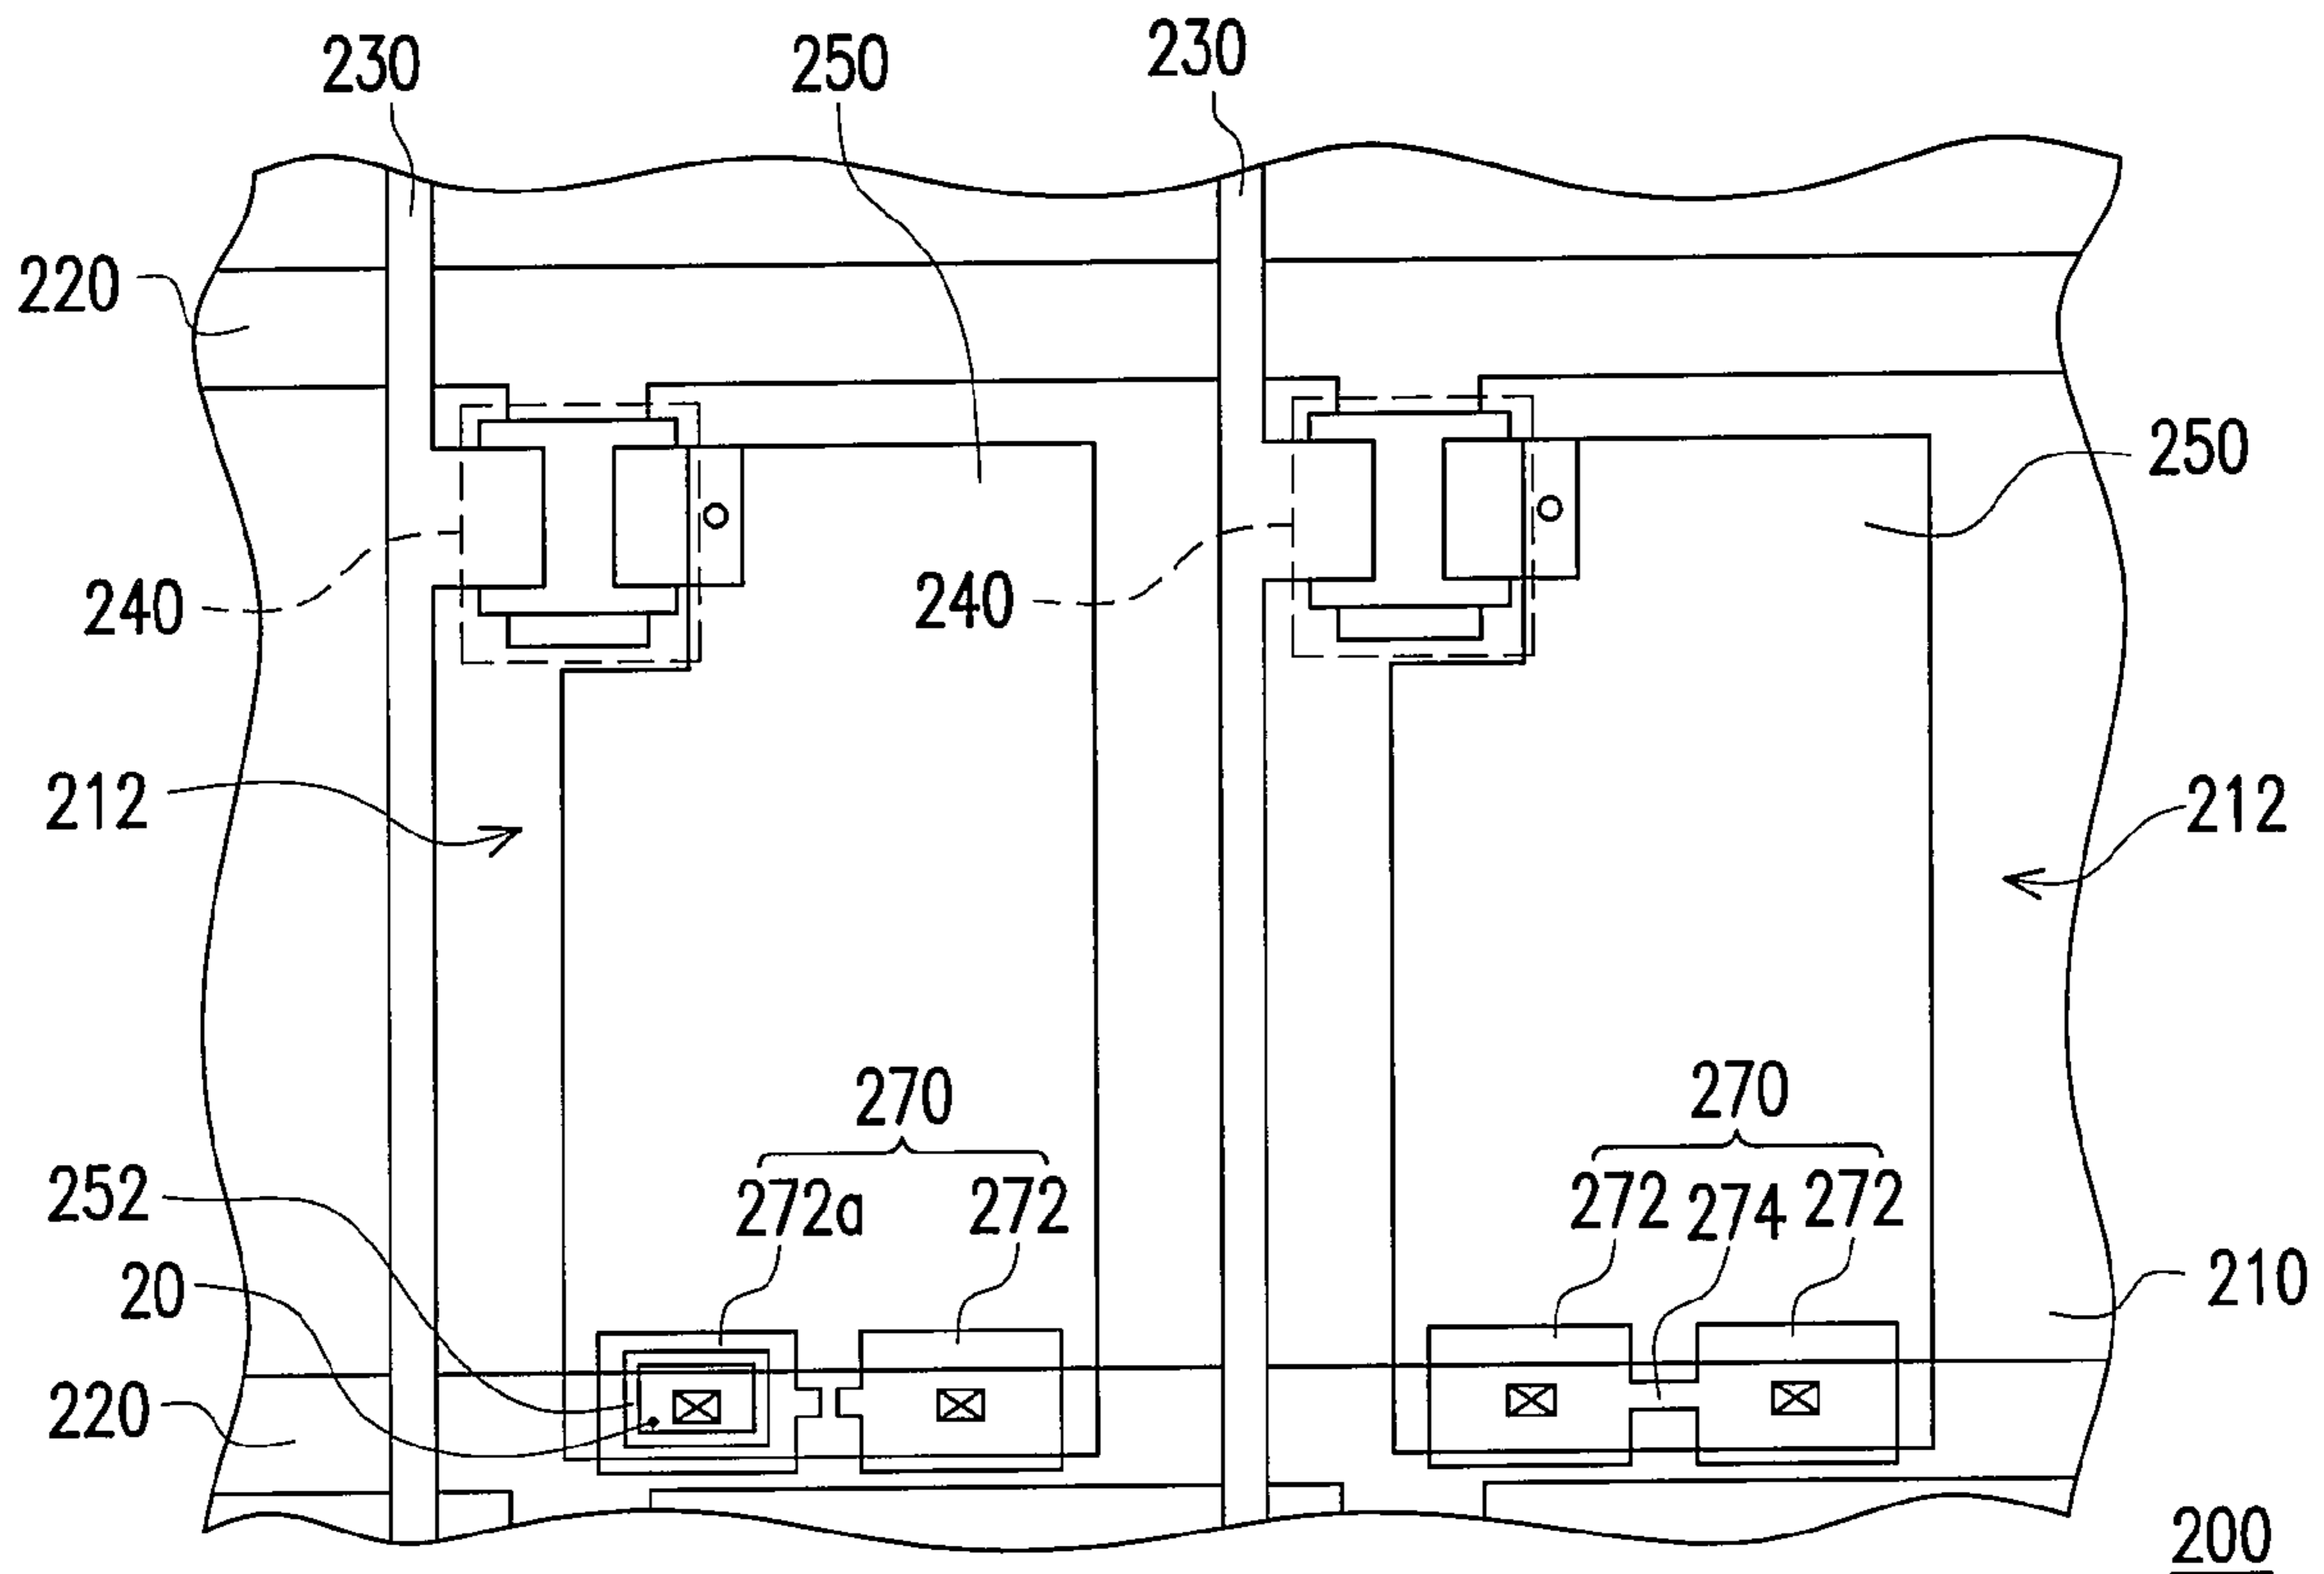
FIG. 13

As shown in FIG. **13**, the patterned upper electrode **270** is disposed between each pixel electrode **250** and one of the scan lines **220**. The patterned upper electrode **270** comprises a plurality of sub-upper electrodes **272**. Furthermore, each sub-upper electrode **272** underneath the pixel electrode **250** has a neck portion **274** connecting with each other. The neck portion **274** serves as a cutting area in a repairing operation.

As shown in FIG. **13**, the repairing method includes removing a portion of the pixel electrode corresponding to the sub-upper electrode **272a** of the defective capacitor to form an opening **252**. Furthermore, the neck portion **274** connecting with the sub-upper electrode **272a** of the defective capacitor is cut so that the sub-upper electrode **272a** of the defective capacitor and the corresponding pixel electrode **250** are electrically isolated. The method of removing a portion of the pixel electrode **250** includes a laser ablation process and the method of cutting the neck portion **274** includes a laser cutting operation.
