(10) **Patent No.:** **US 7,646,446 B2**
(45) **Date of Patent:** **Jan. 12, 2010**

(54) **REPAIRING METHOD OF A THIN FILM TRANSISTOR ARRAY SUBSTRATE**

(73) Assignee: **Au Optronics Corporation**, Hsinchu (TW)

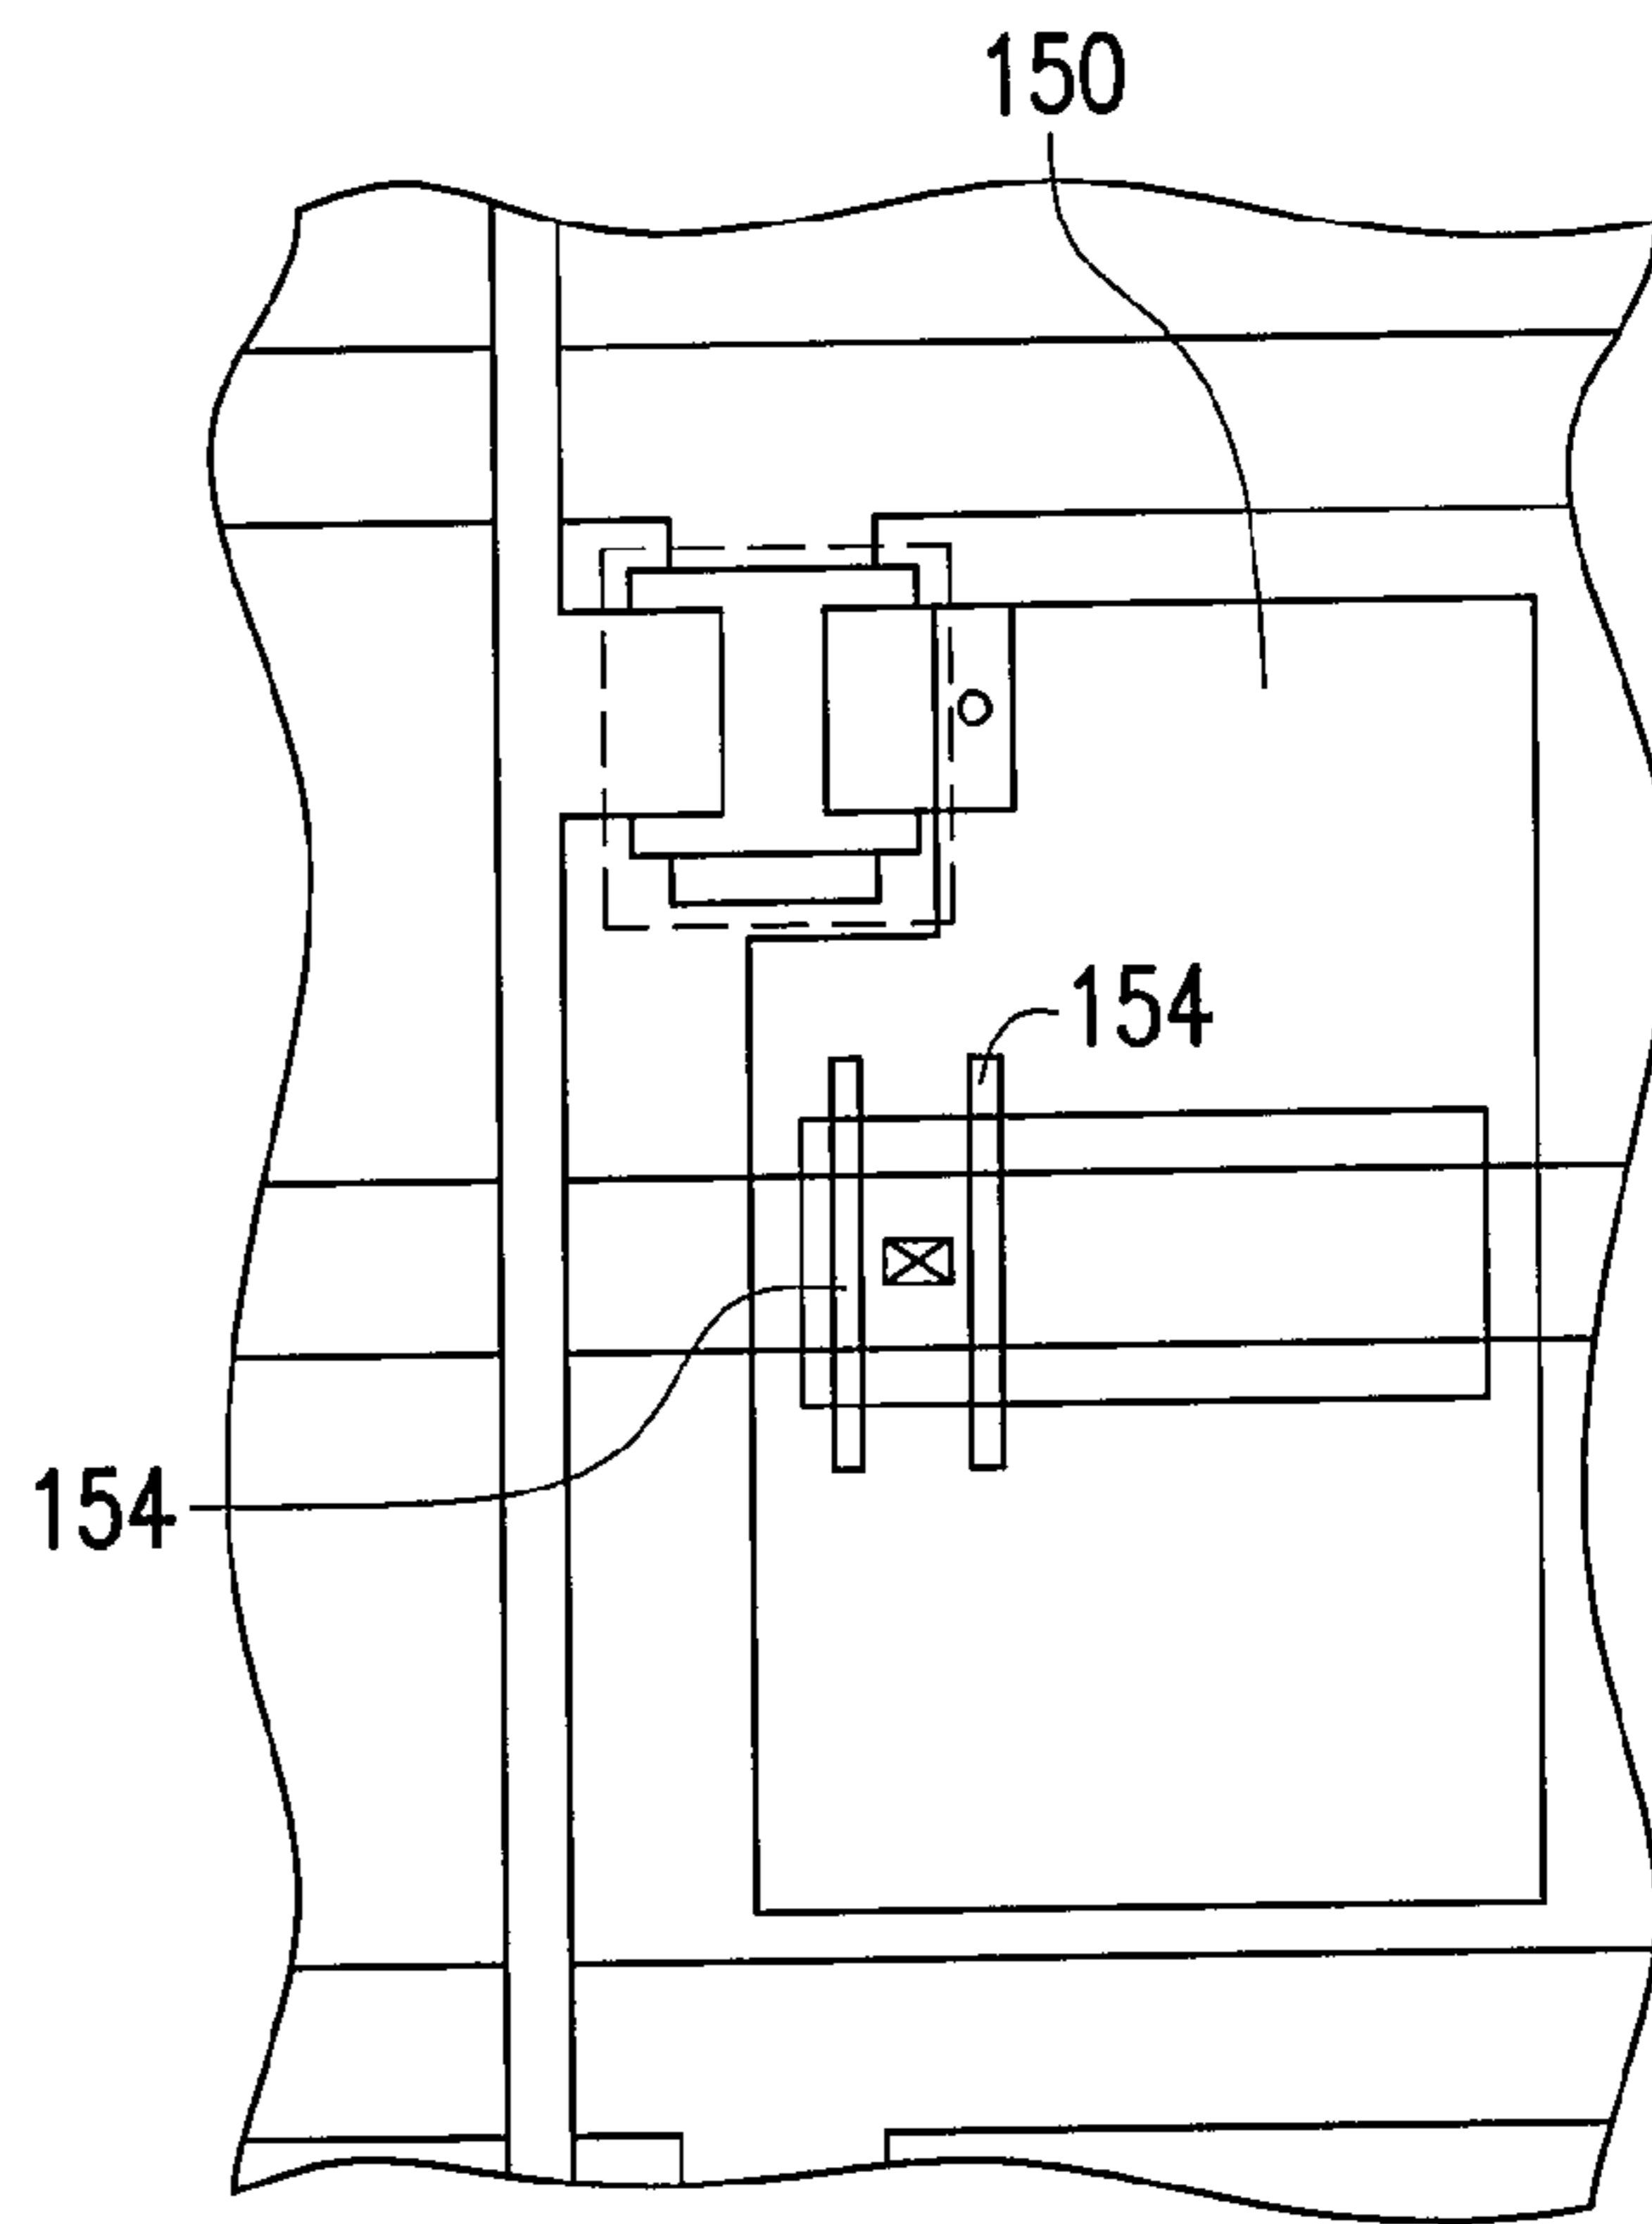
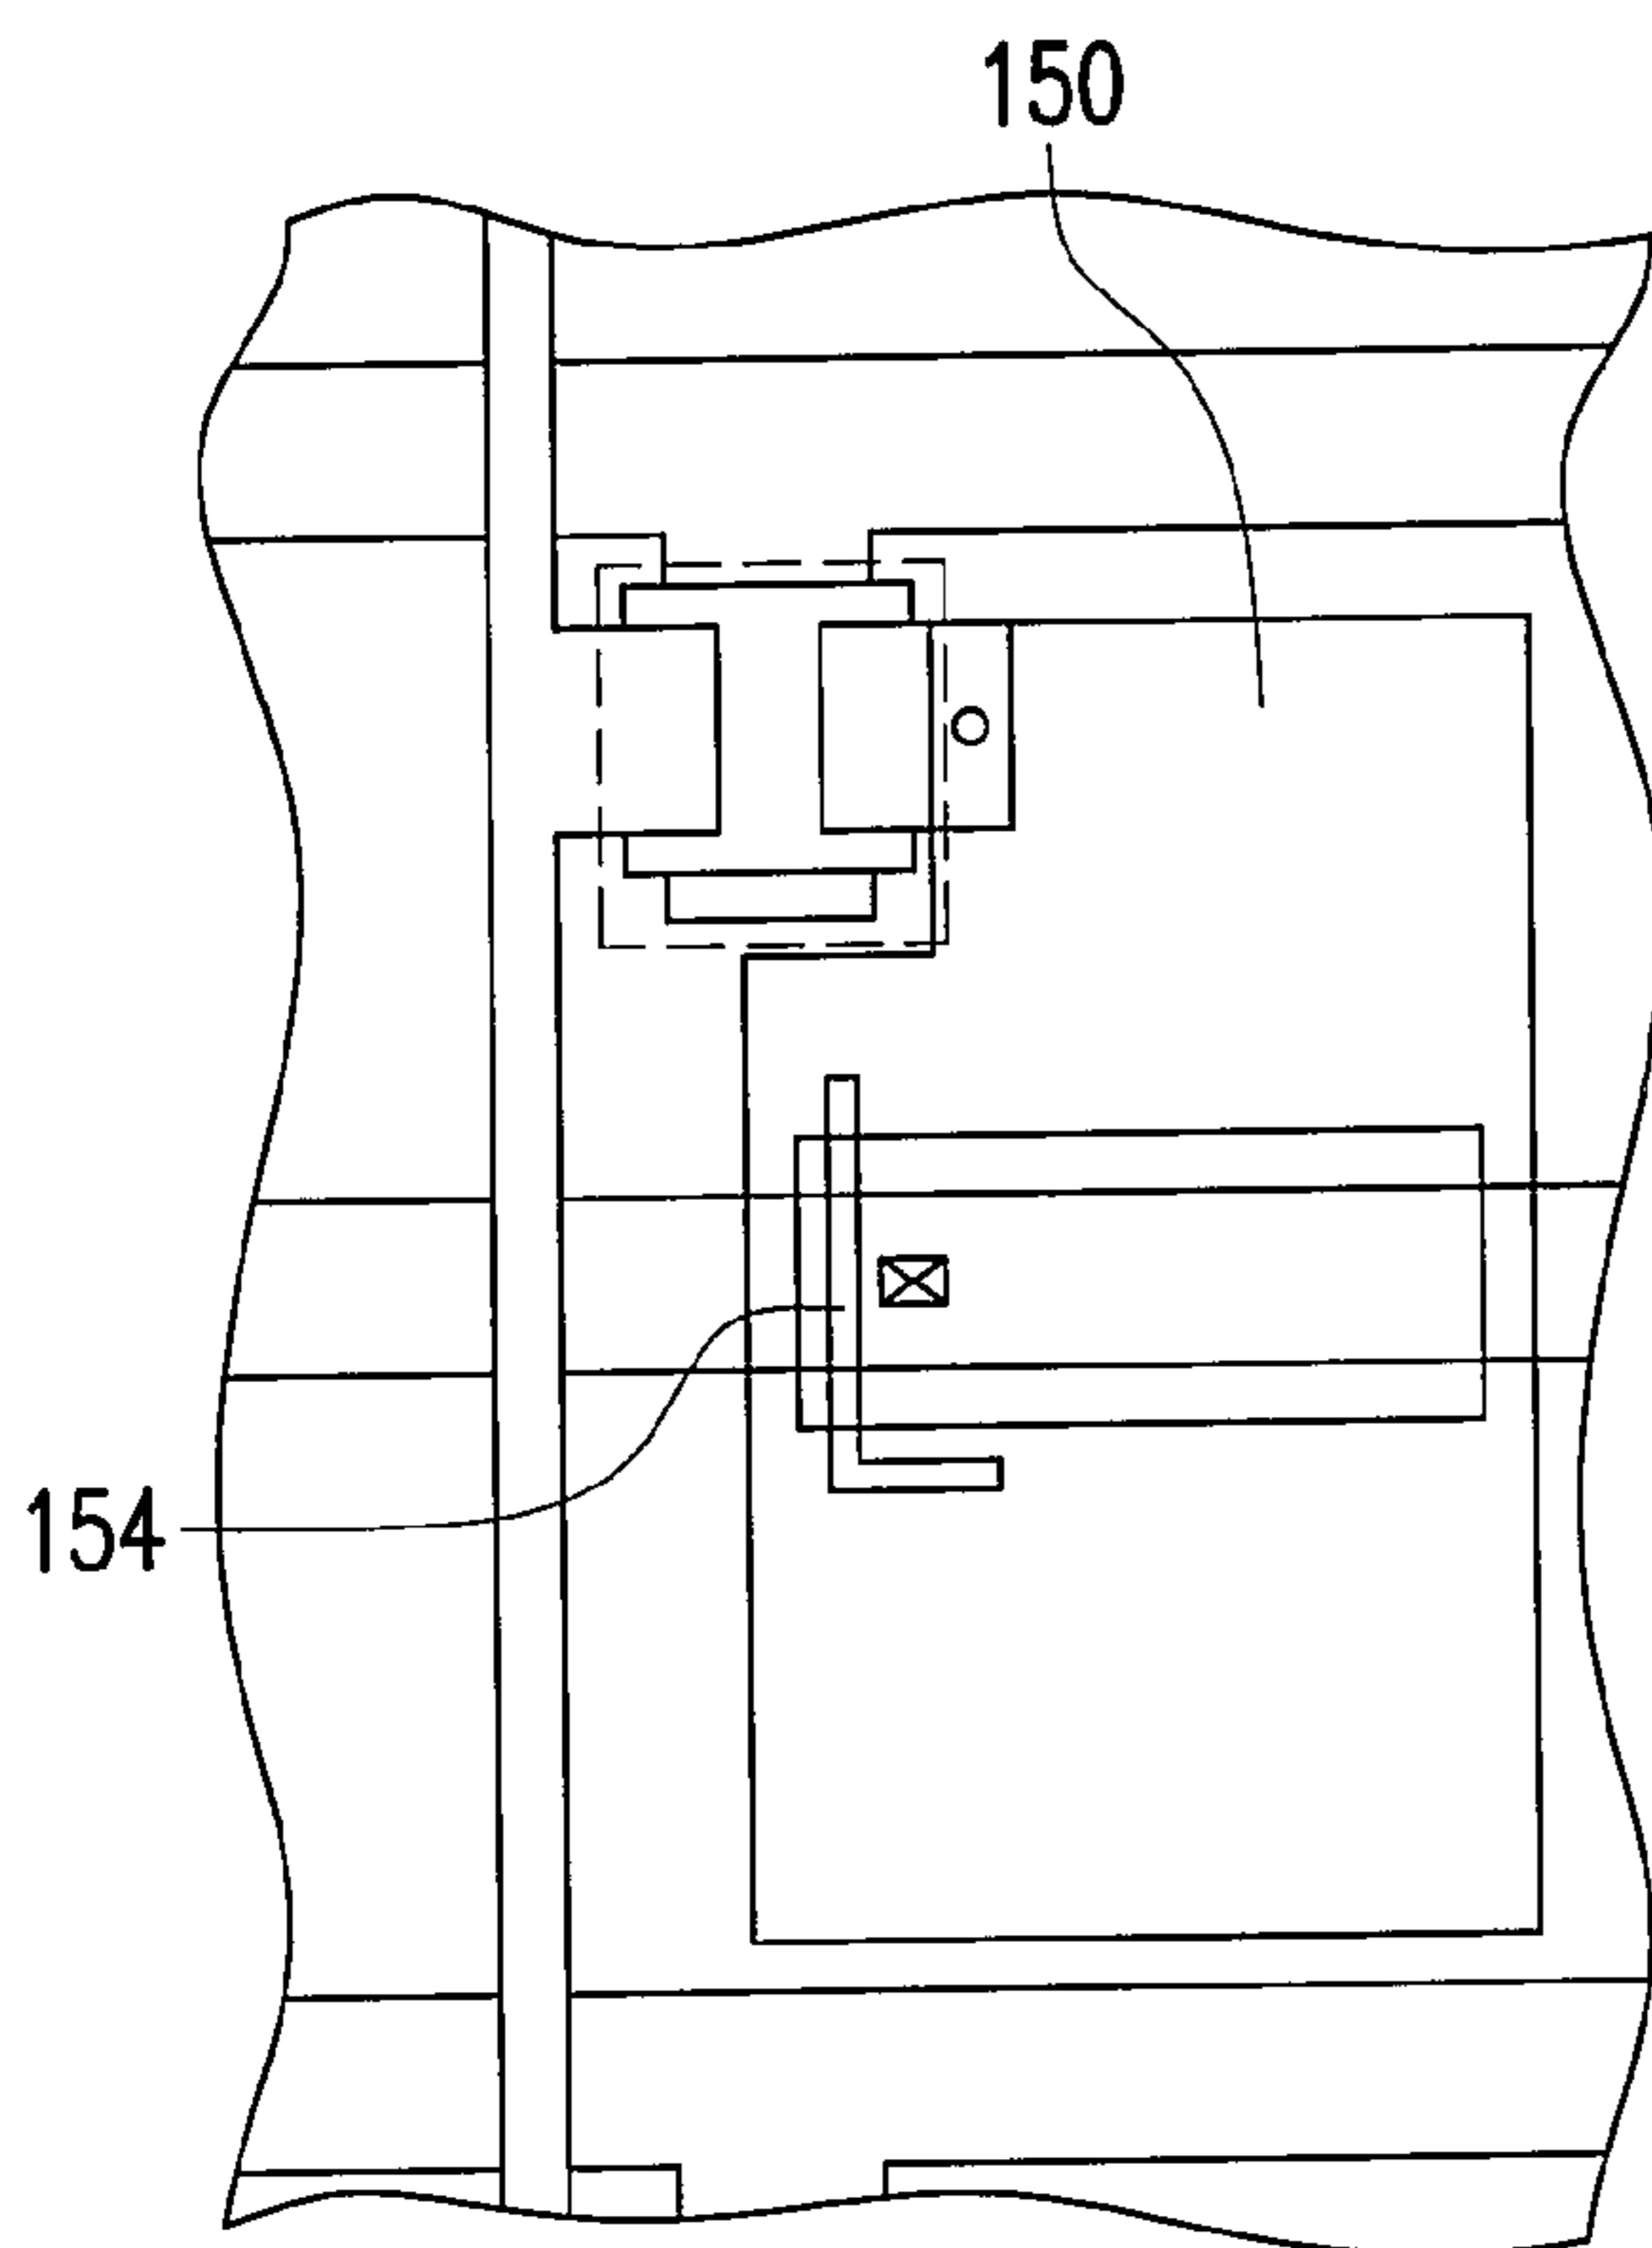
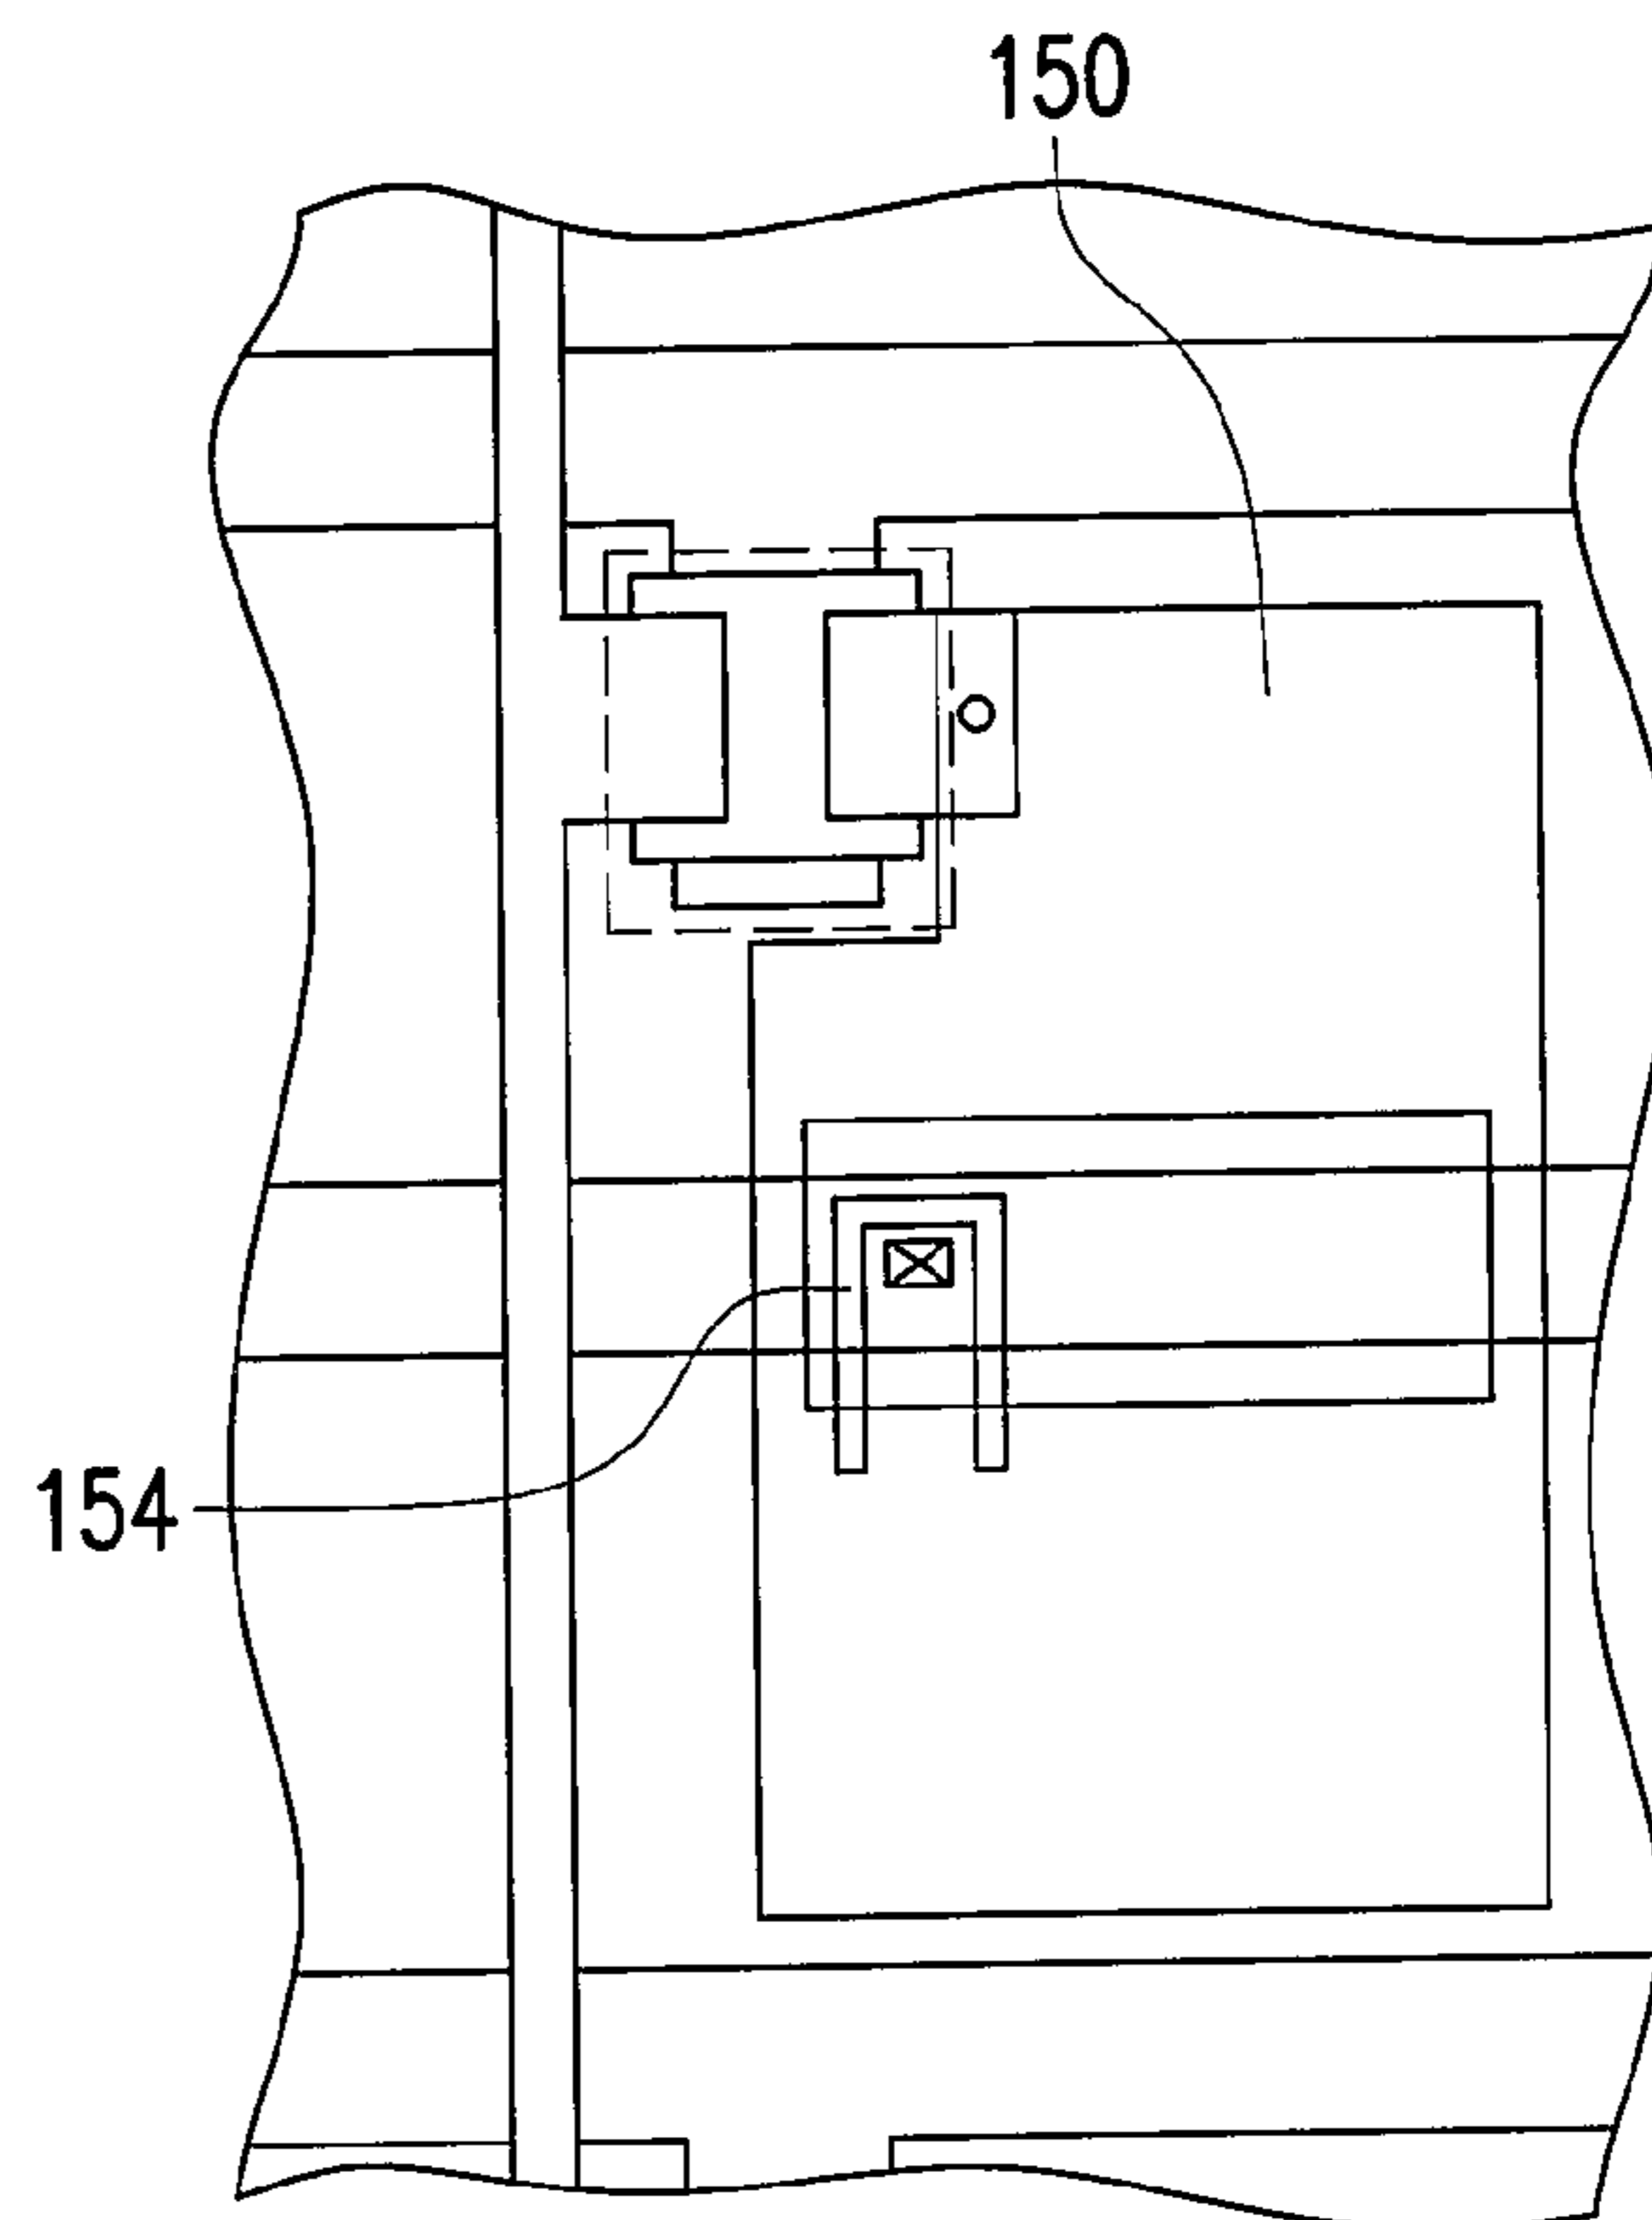
FIGS. 16A through 16D show the types of openings formed on the pixel electrode of a conventional thin film transistor array substrate.

FIGS. **16A** through **16D** show the types of openings formed on the pixel electrode of a conventional thin film transistor array substrate. To simplify and speed up the repairing process, one or more openings **154** are also formed over the thin film transistor array substrate in the process of fabricating the pixel electrode **150**. For example, a straight line opening **154** (as shown in FIG. **16A**), a pair of straight line openings **154** (as shown in FIG. **16B**), an L-shaped opening **154** (as shown in FIG. **16C**) or a U-shaped opening **154** (as shown in FIG. **16D**) are formed over the pixel electrode **150**. Since the openings **154** are similar to the openings disclosed in FIGS. **9A** through **9D**, detailed description is omitted.
