(10) **Patent No.:** **US 7,646,446 B2**
(45) **Date of Patent:** **Jan. 12, 2010**

(54) **REPAIRING METHOD OF A THIN FILM TRANSISTOR ARRAY SUBSTRATE**

(73) Assignee: **Au Optronics Corporation**, Hsinchu (TW)

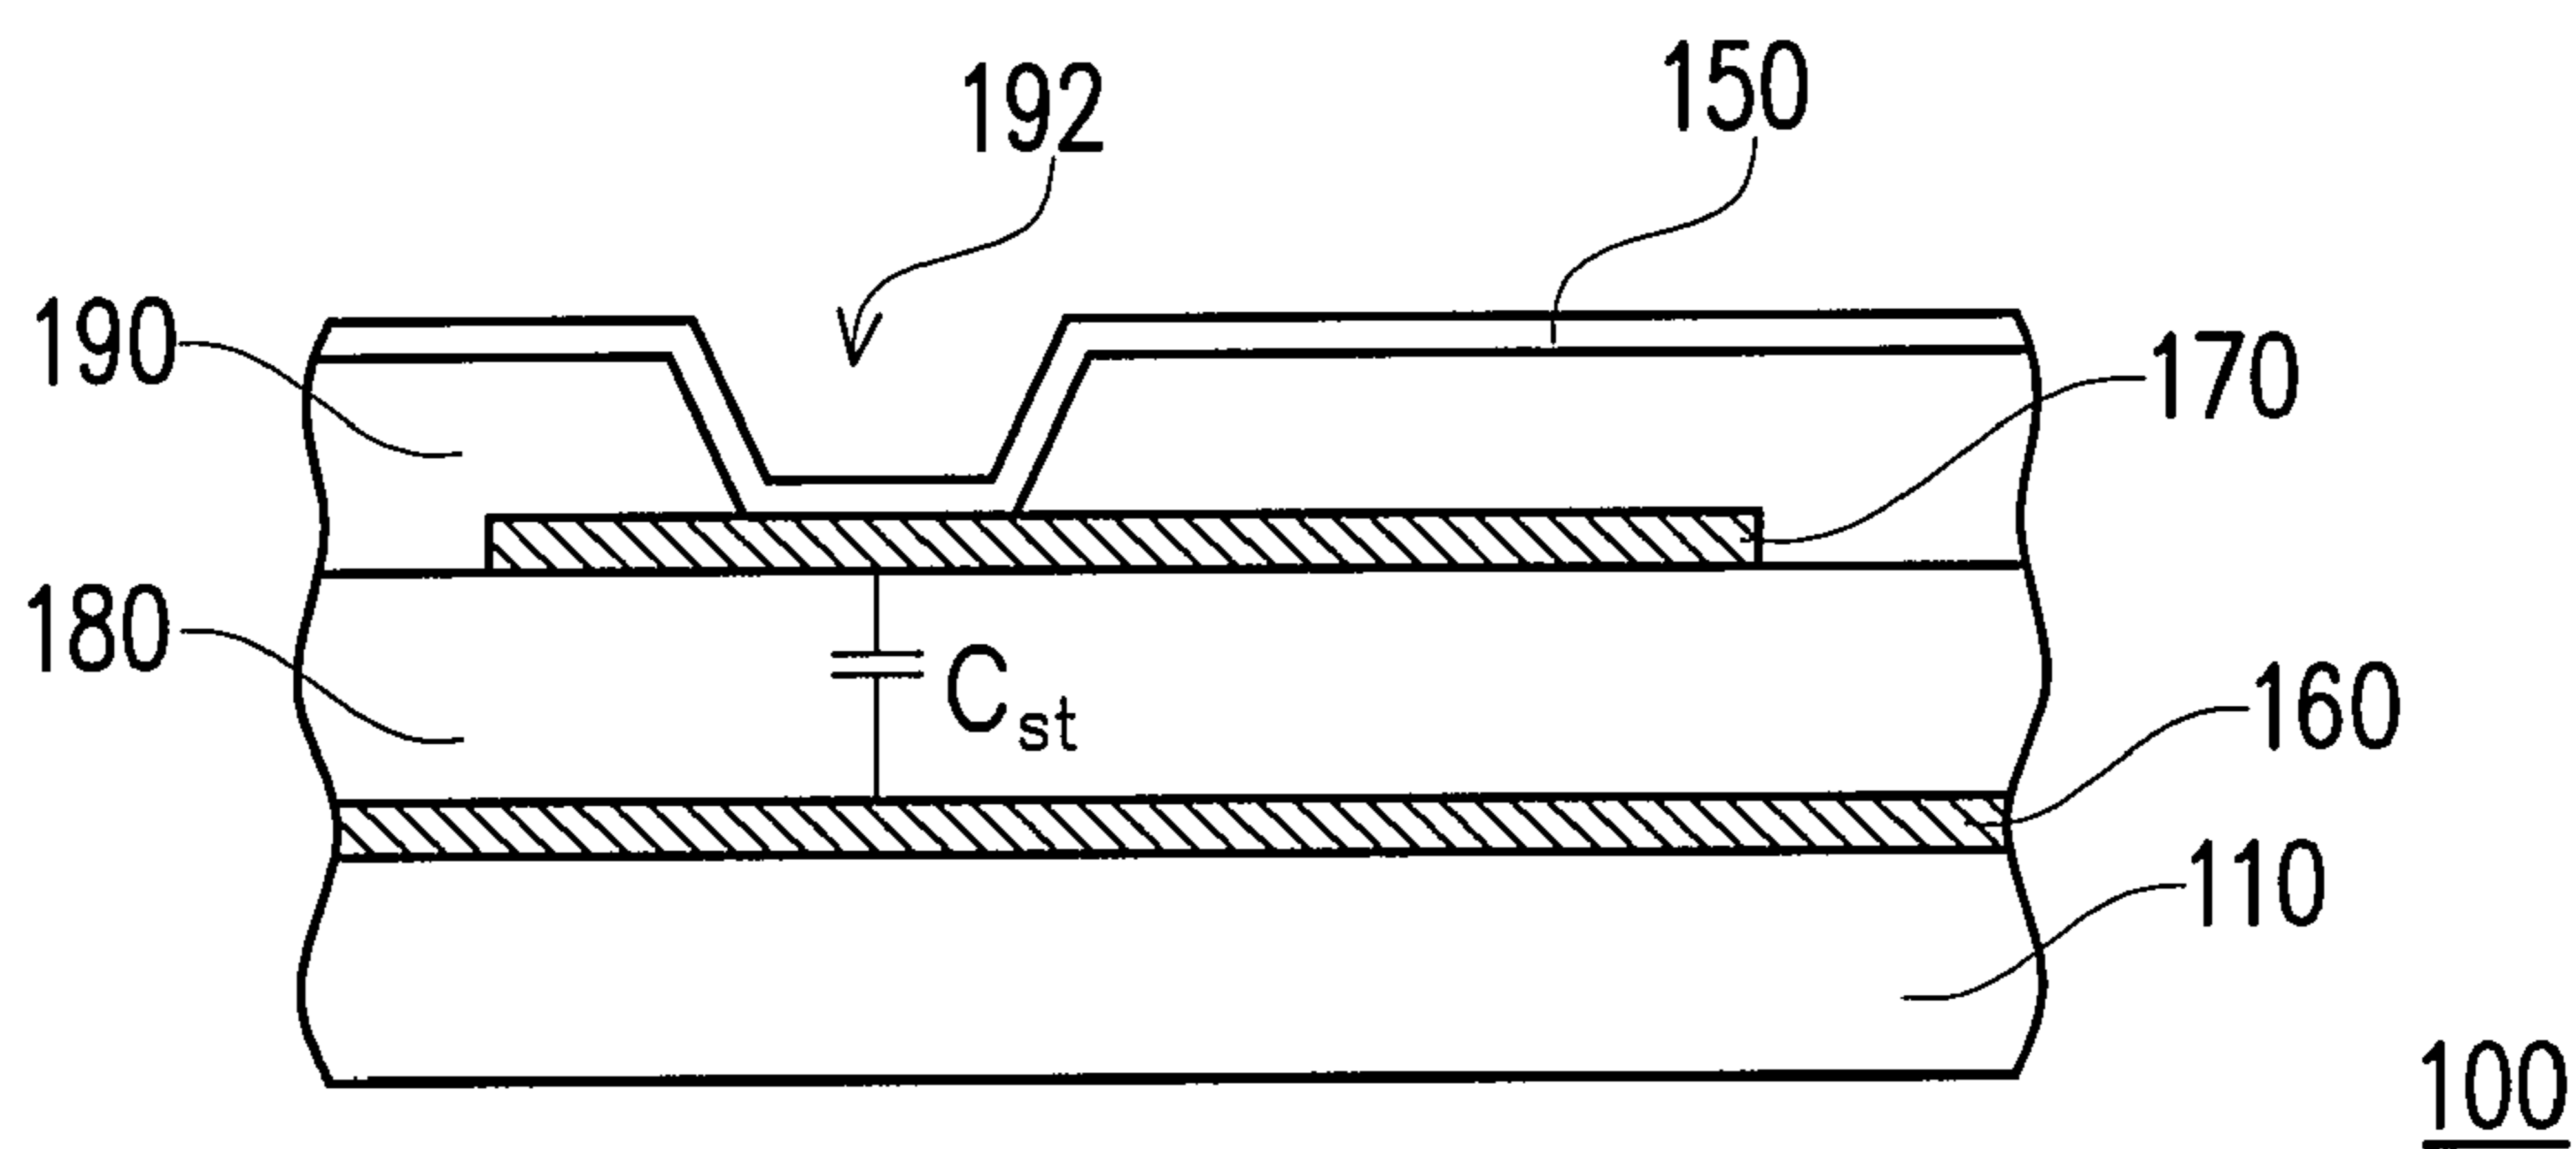
FIG. 2 (PRIOR ART)

As shown in FIG. 2, the upper electrode 170 and the corresponding common line 160 together form a storage capacitor (Cst) that smooth out the normal operation of various pixels within the thin film transistor liquid crystal display. However, any processing defect or other factors may lead to some particles falling into the dielectric layer 180 or trapped in the defects within the dielectric layer 180 and produce a leaky capacitor. Ultimately, the display quality of the pixel will be compromised.

FIG. 2 is a schematic cross-sectional view along line A-A' of the thin film transistor array substrate in FIG. 1.

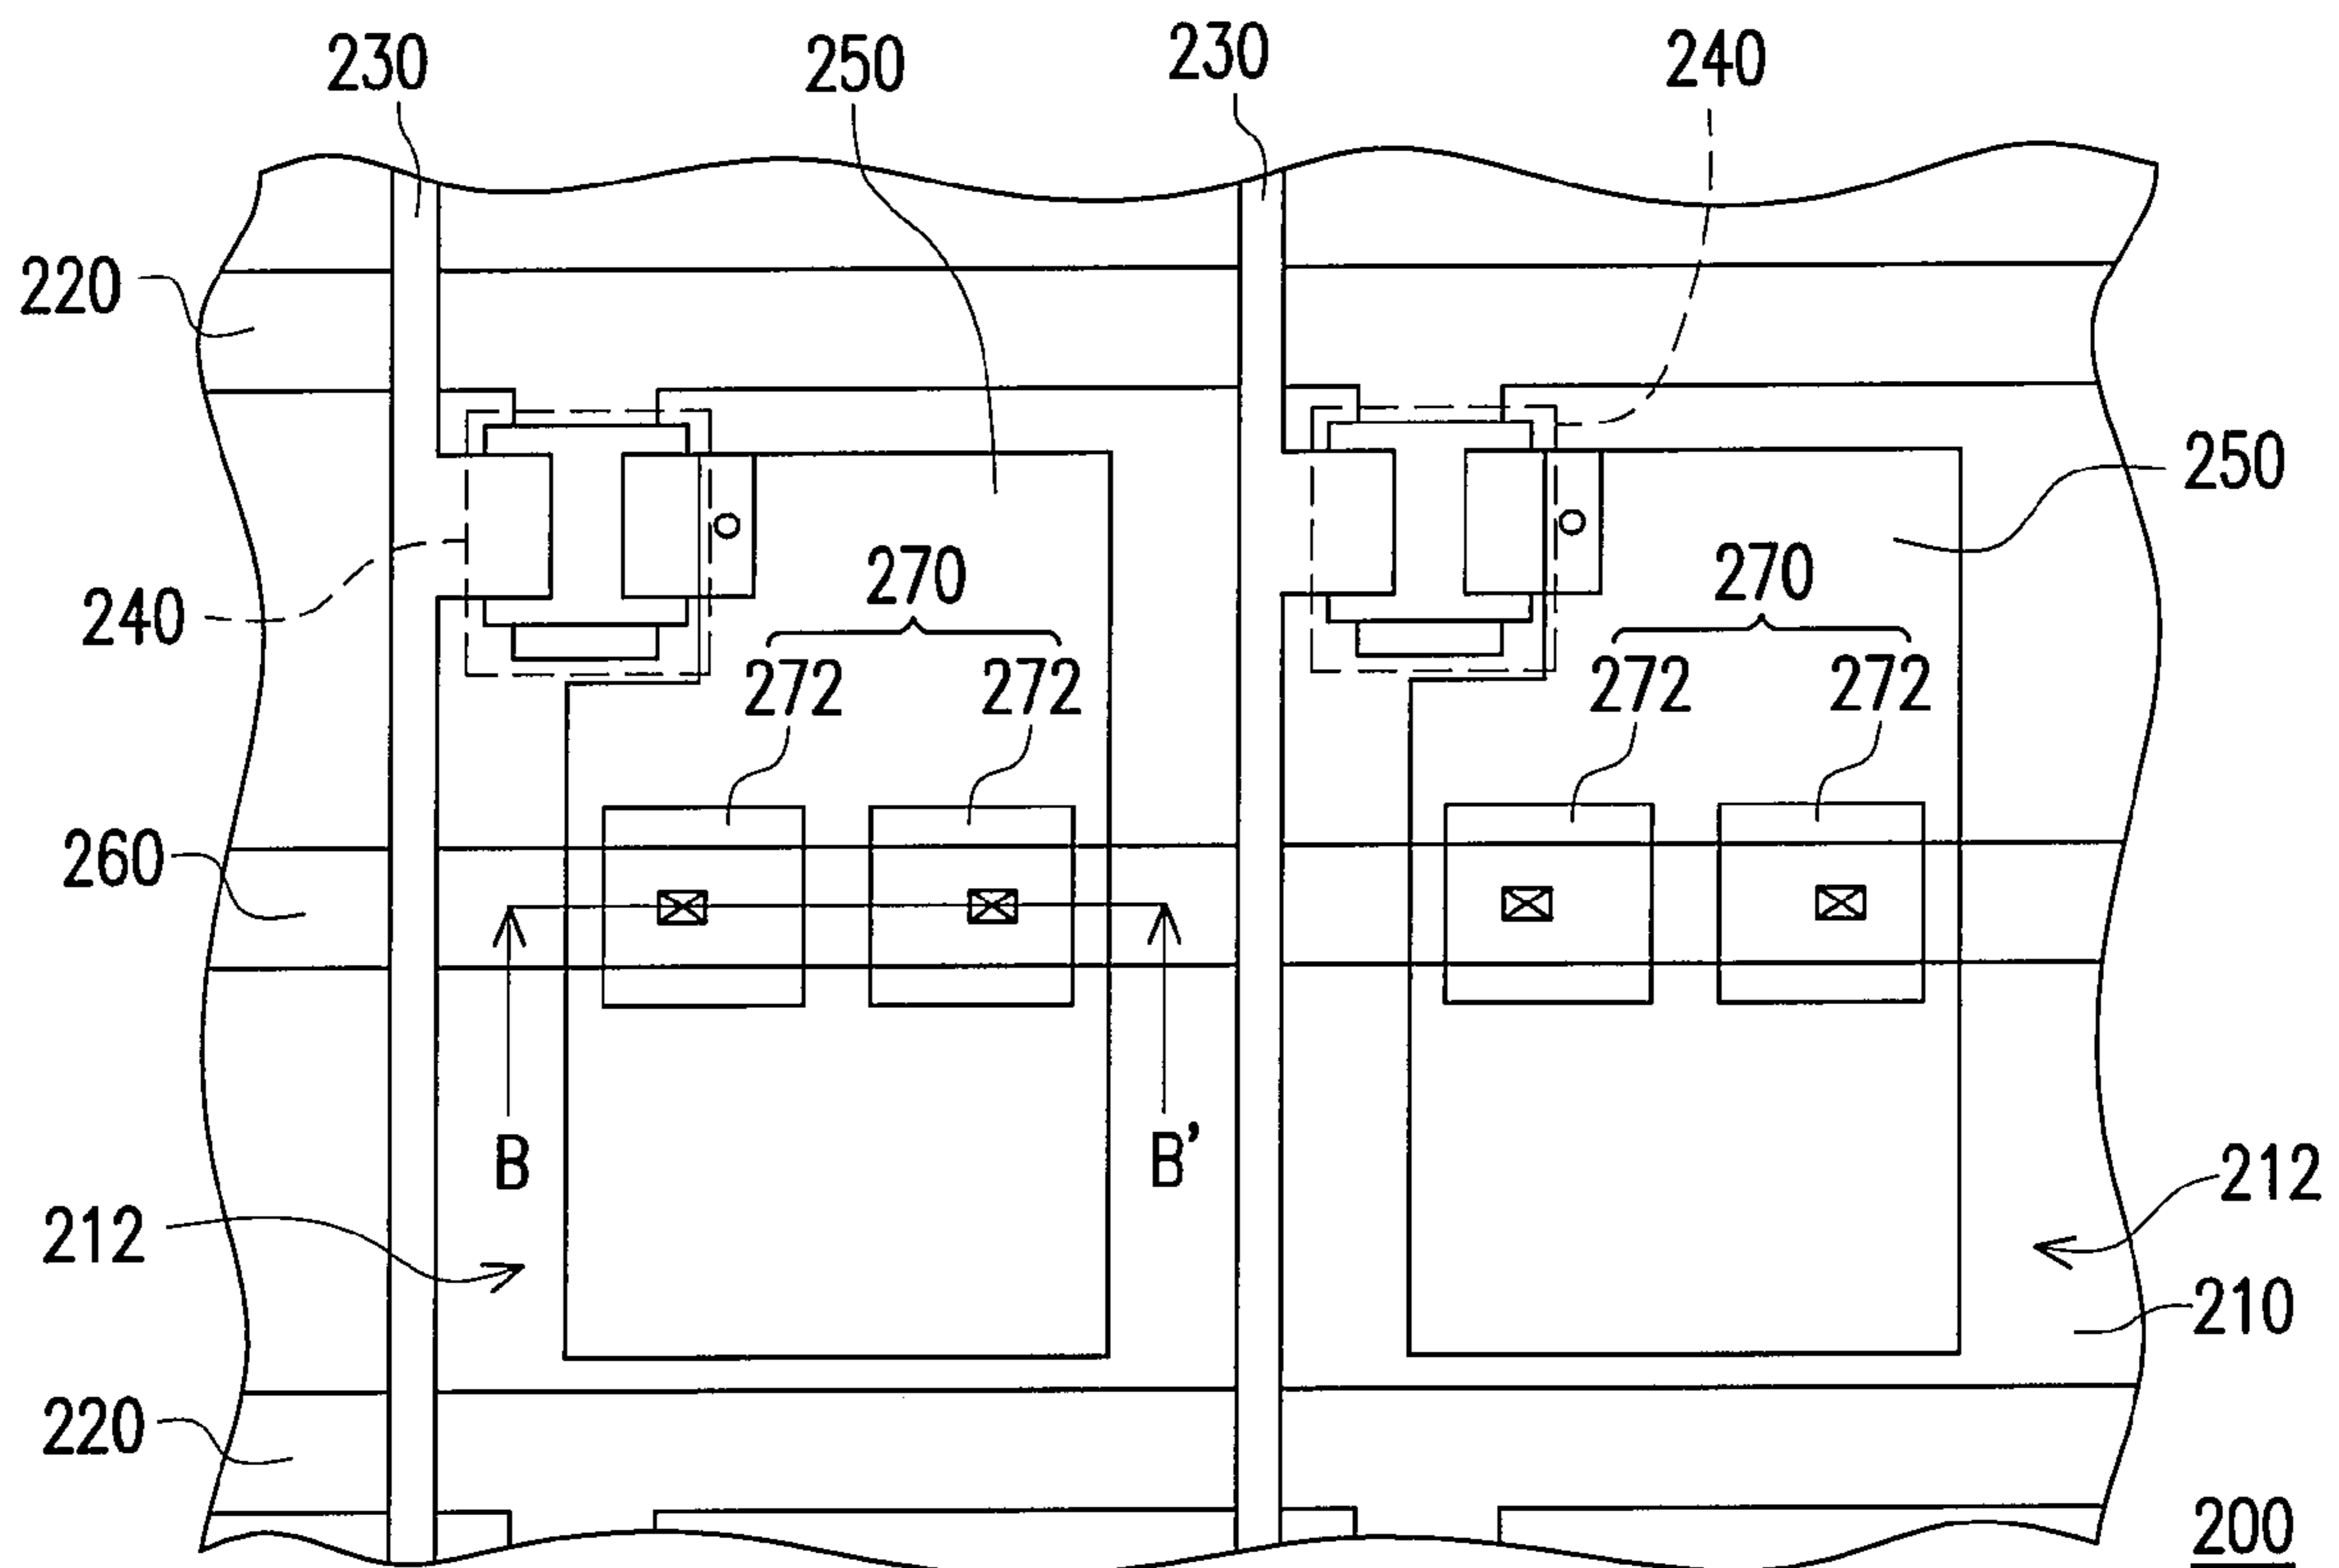
FIG. 3 is a top view of a thin film transistor array substrate according to one preferred embodiment of the present invention. FIG. 4 is a schematic cross-sectional view along line B-B' of the thin film transistor array substrate in FIG. 3. As shown in FIGS. 3 and 4, the thin film transistor array substrate 200 mainly comprises a substrate 210, a plurality of scan lines 220, a plurality of data lines 230, a plurality of thin film transistor 240, a plurality of pixel electrodes 250, a plurality of common lines 260 (only one is shown) and a patterned upper electrode 270.

The scan lines 220 and the data lines 230 are disposed over the substrate 210 to define a plurality of pixel areas 212. Each thin film transistors 240 is disposed inside one of the pixel areas 212 and driven by one of the scan lines 220 and one of the data lines 230. Each pixel electrode 250 is disposed inside one of the pixel areas 212 and electrically connected to one of the thin film transistors 240. The common line 260 is disposed over the substrate 210 such that a portion of each pixel electrode 250 is above one of the common lines 260.

The patterned upper electrode 270 is disposed between each pixel electrode 250 and the corresponding common line 260. A dielectric layer 280 is disposed between the patterned upper electrode 270 and the common line 260. Another dielectric layer 290 is disposed between the patterned upper electrode 270 and the pixel electrode 250. It should be noted that the patterned upper electrode 270 comprises a plurality of sub-upper electrodes 272 (only two of them are shown). A portion of each sub-upper electrode 272 is electrically connected to one of the pixel electrodes 250. For example, a contact 292 is formed in the dielectric layer 290 above each sub-upper electrode 272 so that each sub-upper electrode 272 is electrically connected to one of the pixel electrodes 250. Hence, the sub-upper electrode 272 and one of the common lines 260 together form a storage capacitor (Cst).

FIG. 3 is a top view of a thin film transistor array substrate according to one preferred embodiment of the present invention.

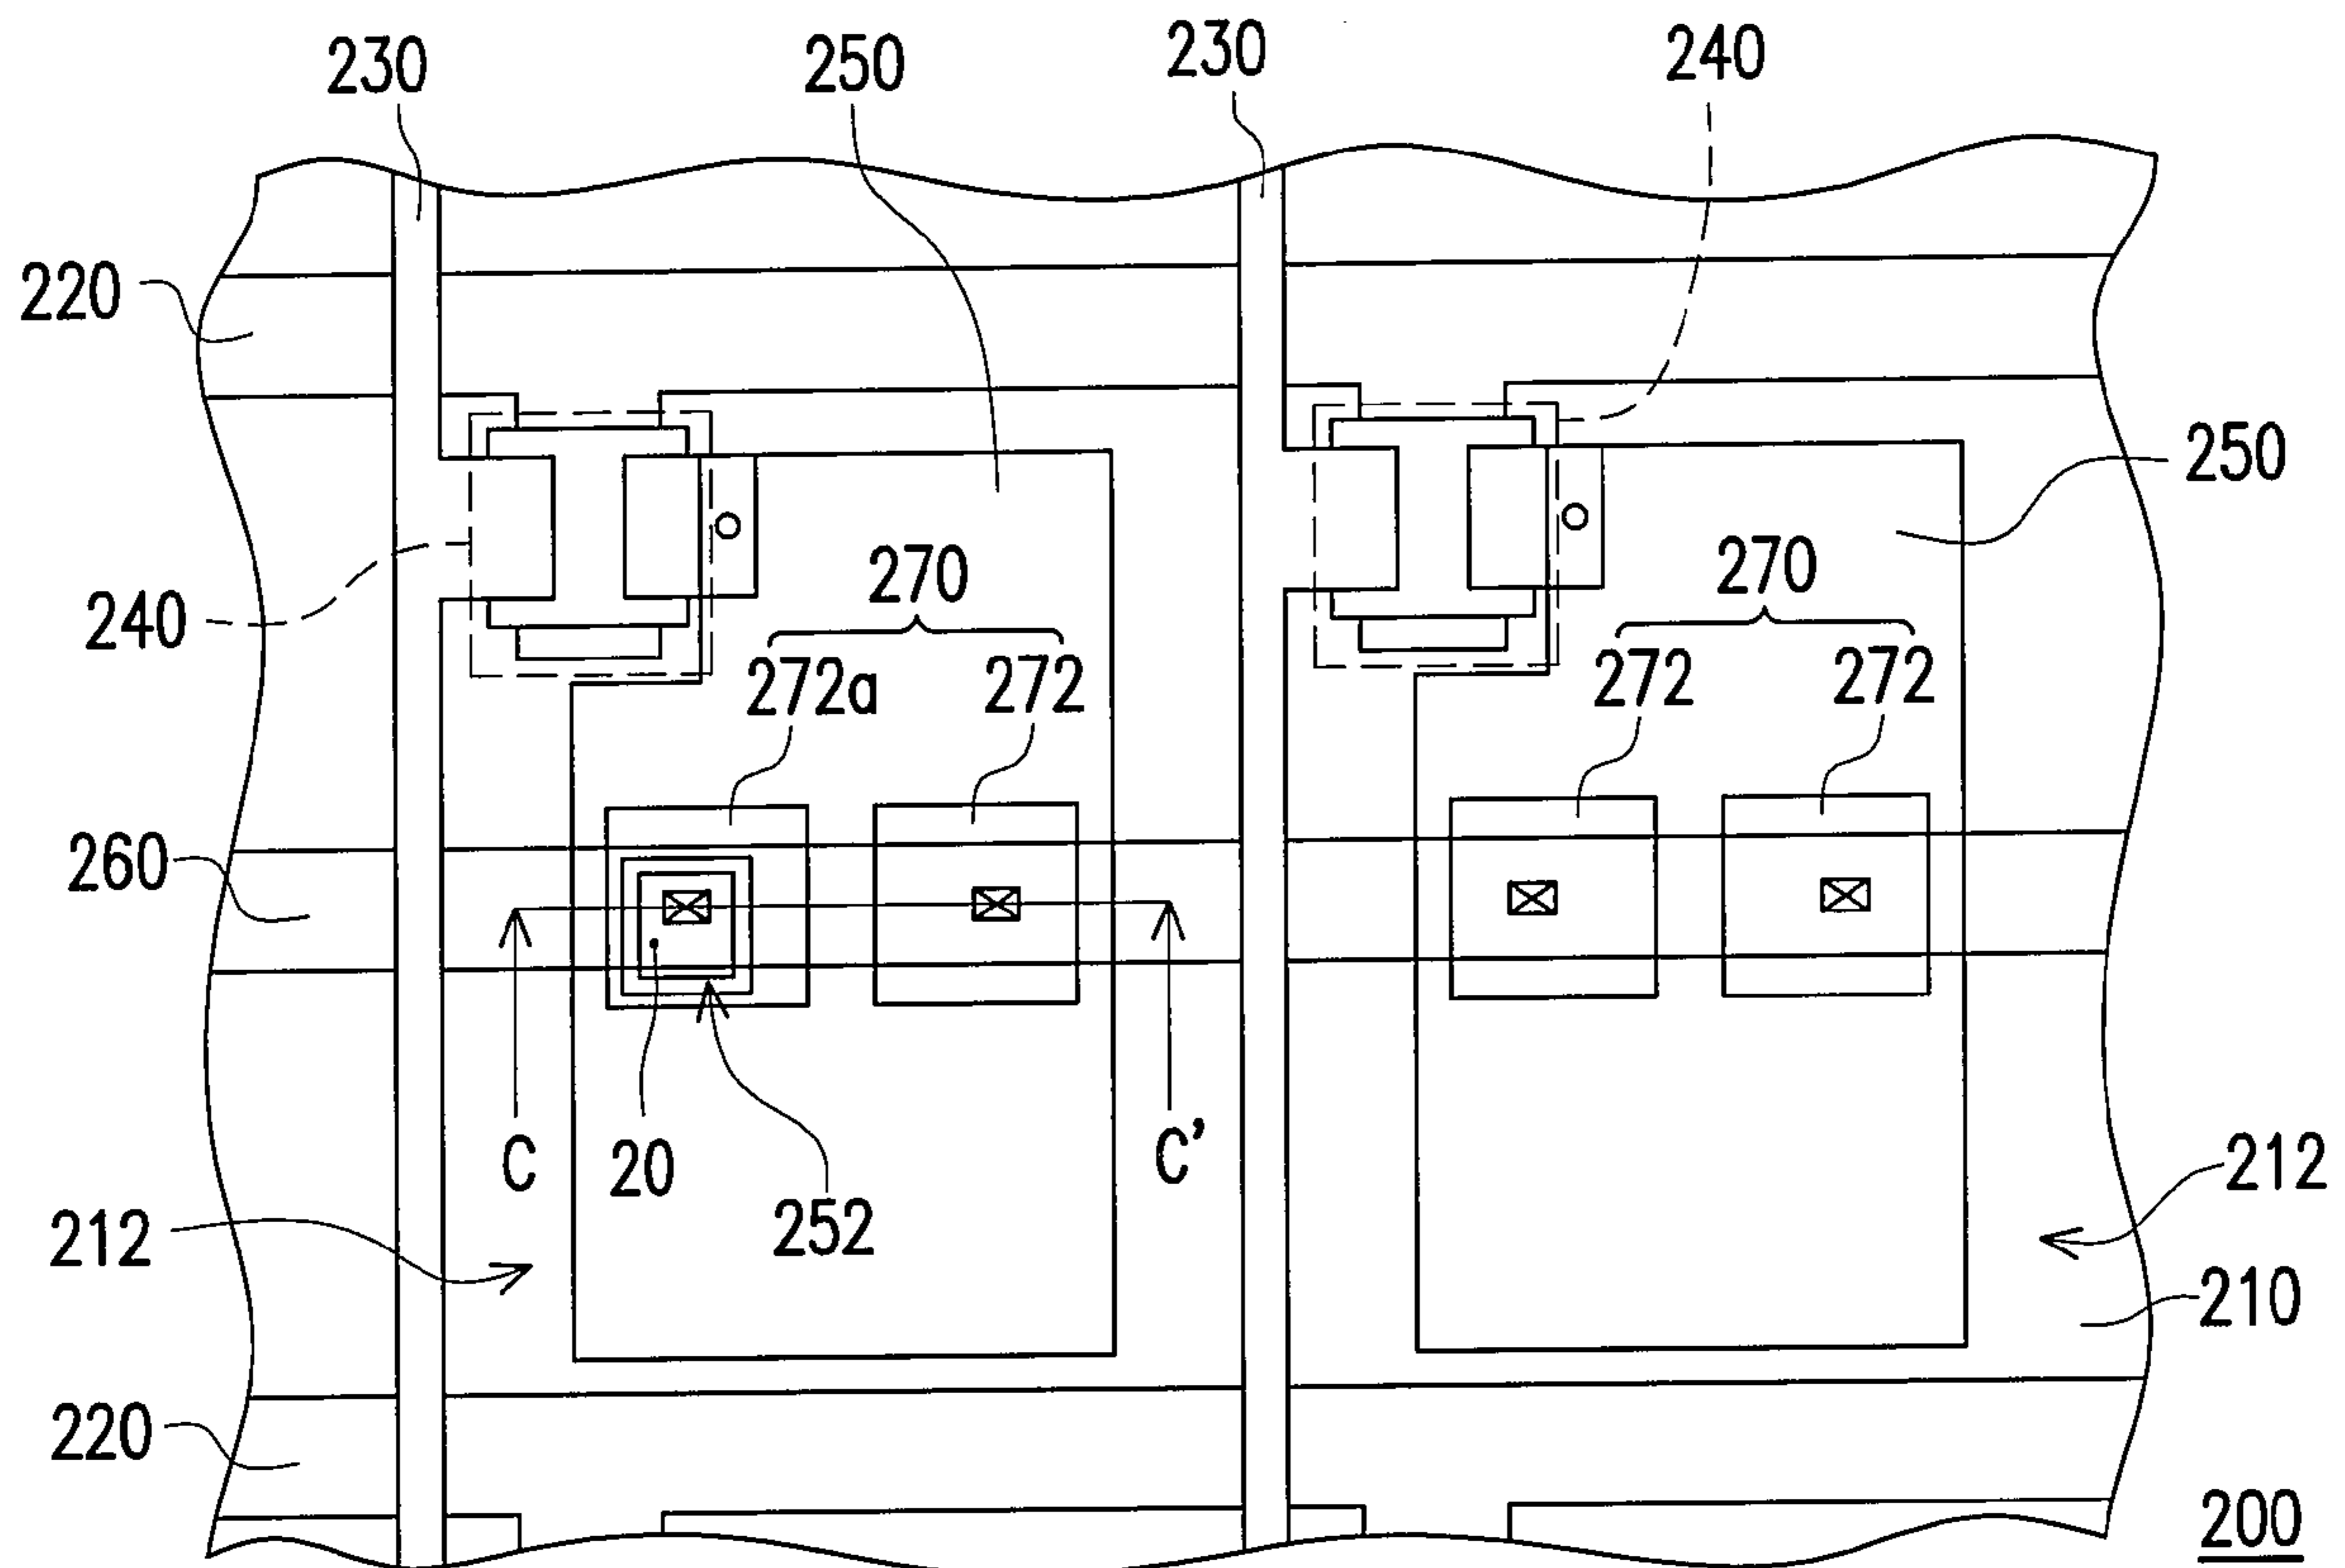
FIG. 5 is a top view of the thin film transistor array substrate in FIG. 3 after performing a laser repairing operation. FIG. 6 is a schematic cross-sectional view along C-C' of the thin film transistor array substrate shown in FIG. 5. As shown in FIGS. 5 and 6, if there is a particle (or defect) in the material between one of the sub-upper electrodes 272 and one of the common lines 260, leakage between the sub-upper electrode 272a and the common line 260 may occur. Thus, the pixel may display abnormally and need a repair. The method of repairing the pixel includes removing a portion of the pixel electrode 250 corresponding to the sub-upper electrode 272a of the defective capacitor so that the sub-upper electrode 272a and the corresponding pixel electrode 250 of the defective capacitor are electrically isolated.

In the present embodiment, a portion of the pixel electrode 250 above the sub-upper electrode 272a of the corresponding defective capacitor is removed to form an opening 252. The method of removing a portion of the pixel electrode 250 includes laser ablation, for example. The opening 252 is located around the contact area between the sub-upper electrode 272a and the corresponding pixel electrode 250 of the defective capacitor (that is, around the contact 292). By forming the opening 252, the sub-upper electrode 272a and the corresponding pixel electrode 250 of the defective capacitor

are electrically isolated. Since the repair causes no disruption to other sub-upper electrodes, the repaired pixel electrode **250** can function properly.

FIG. 5 is a top view of the thin film transistor array substrate in FIG. 3 after performing a laser repairing operation.

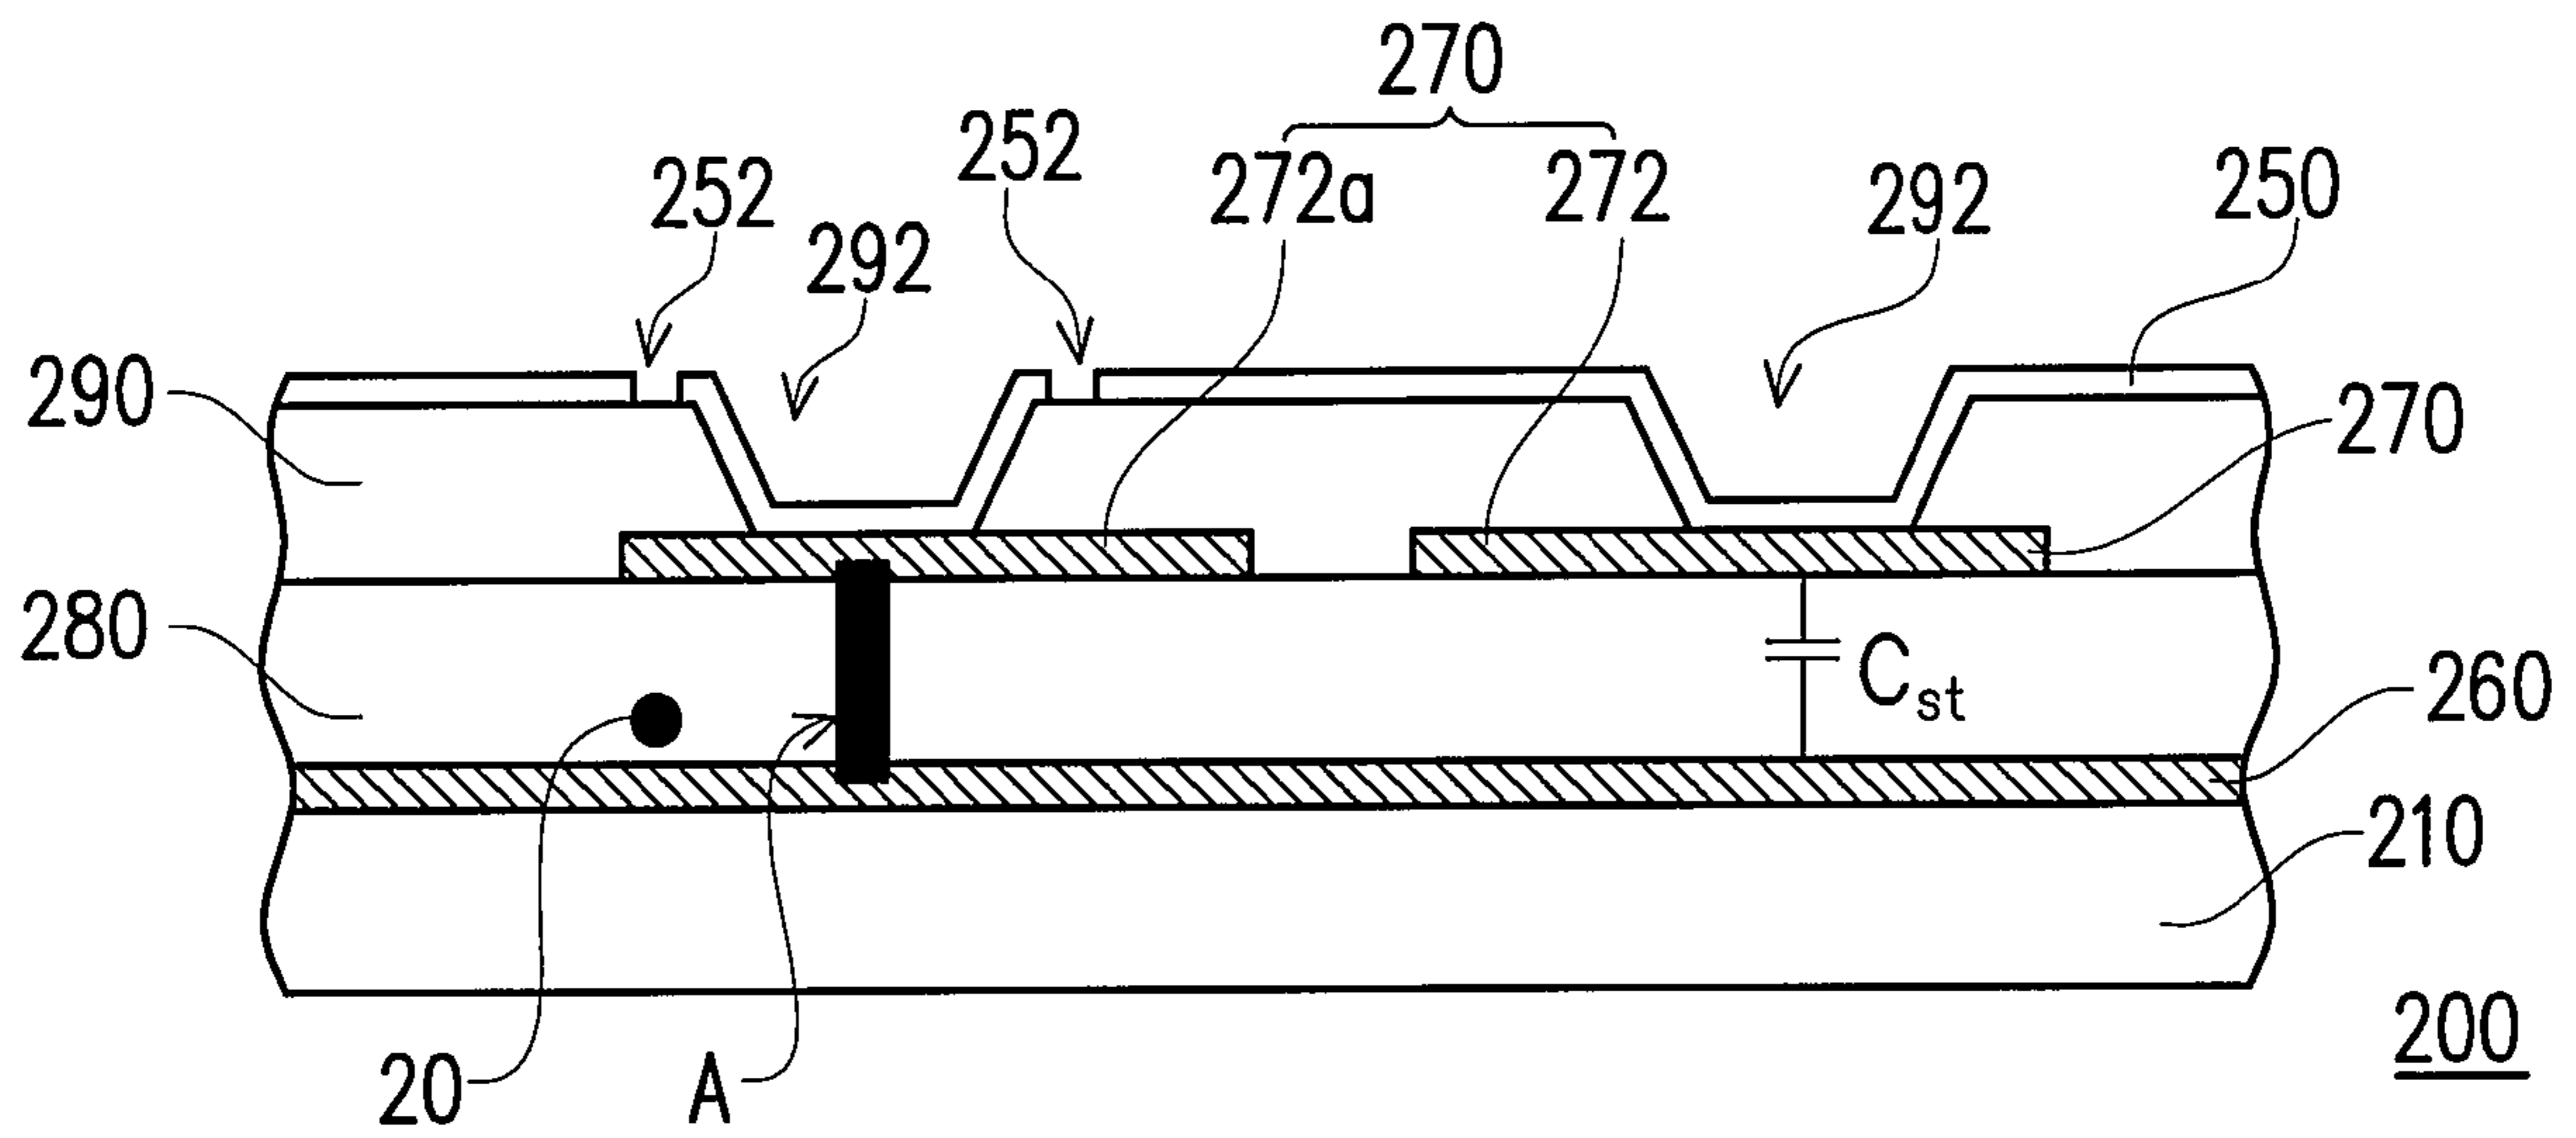
FIG. **7** is a schematic cross-sectional view showing the electrical connection between the common line and the sub-upper electrode in a defective capacitor for repairing a thin film transistor array substrate according to one preferred embodiment of the present invention. After removing a portion of the pixel electrode **250** corresponding to the sub-upper electrode **272a** of the defective capacitor to isolate the sub-upper electrode **272a** and the pixel electrode **250** electrically, the sub-upper electrode **272a** and the corresponding common line **260** are welded together (labeled A). Hence, the sub-upper electrode **272a** and the common line **260** of the defective capacitor are configured at the same potential to prevent any leakage via the particles (or defects). The sub-upper electrode **272a** and the corresponding common line **260** are welded together by performing a laser welding process, for example.

In the present invention, the location at which the sub-upper electrode **272a** and the corresponding common line **260** of the defective capacitor weld together is underneath the contact **292**. However, anyone familiar with the technologies may choose other suitable locations convenient for welding the sub-upper electrode **272a** and the corresponding common line **260** of the defective capacitor together.

FIG. 7 is a schematic cross-sectional view showing the electrical connection between the common line and the sub-upper electrode in a defective capacitor for repairing a thin film transistor array substrate according to one preferred embodiment of the present invention.
