(10) **Patent No.:** **US 7,646,446 B2**
(45) **Date of Patent:** **Jan. 12, 2010**

(54) **REPAIRING METHOD OF A THIN FILM TRANSISTOR ARRAY SUBSTRATE**

(73) Assignee: **Au Optronics Corporation**, Hsinchu (TW)

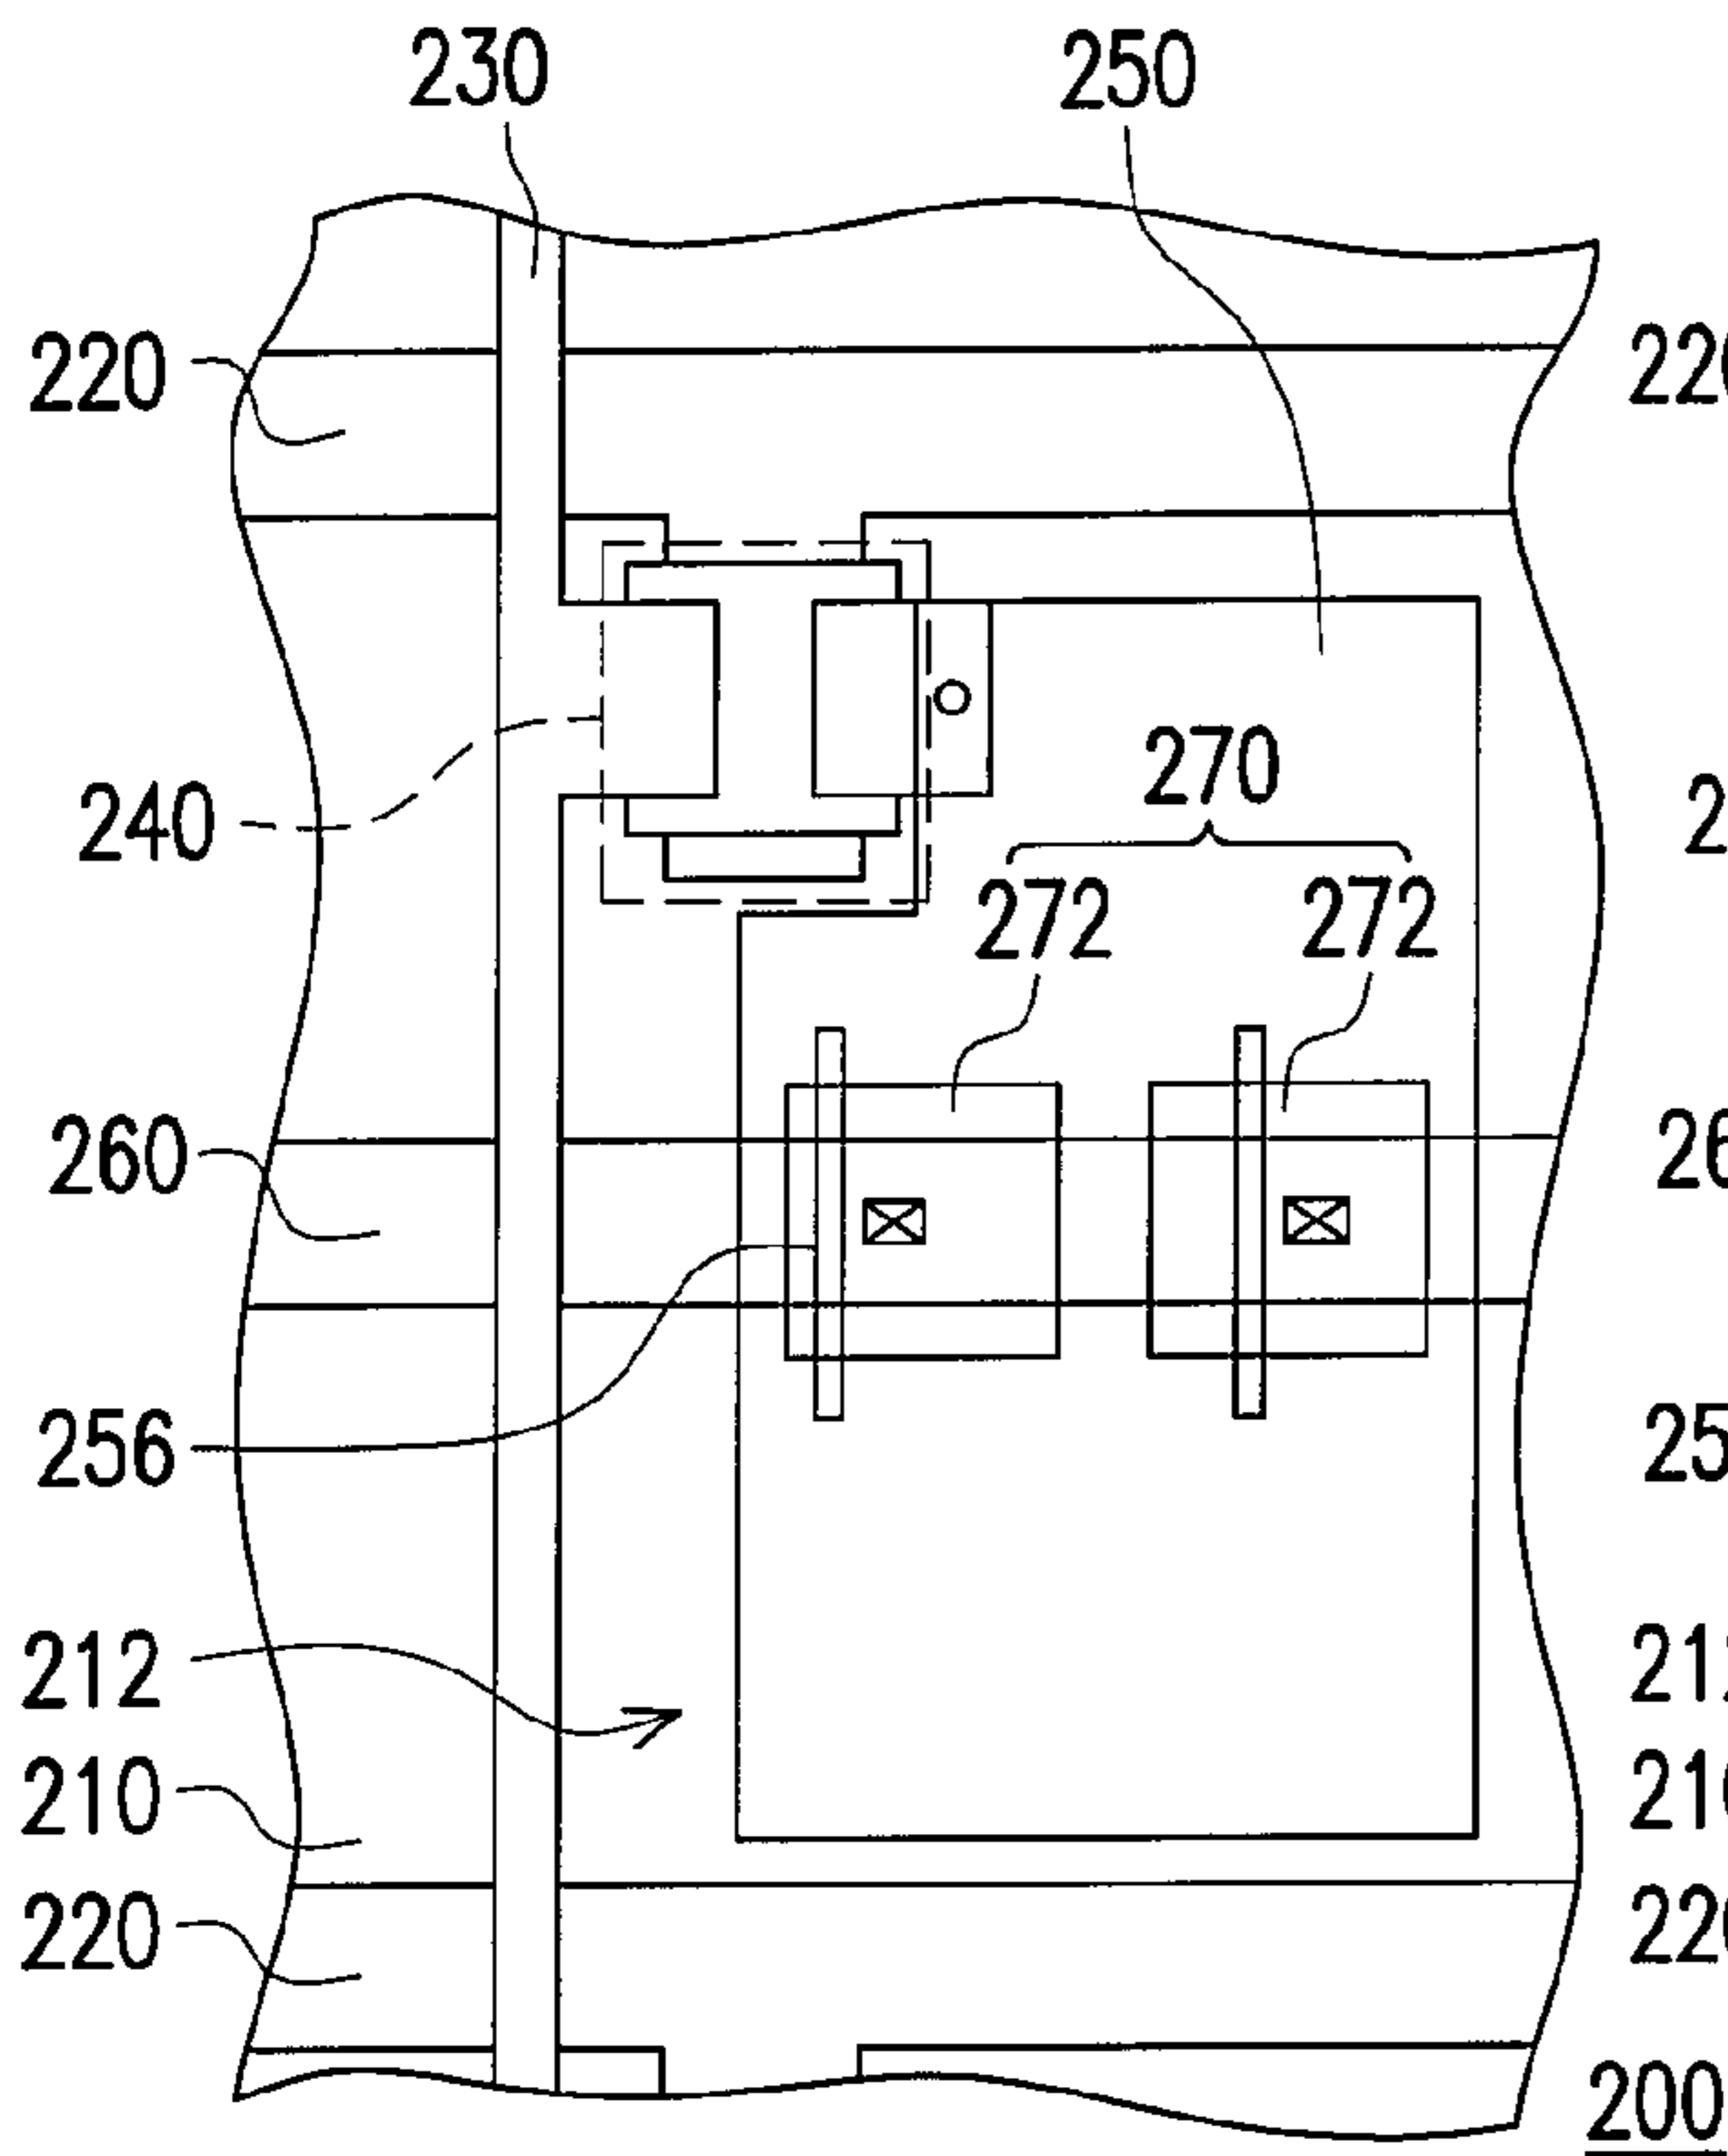
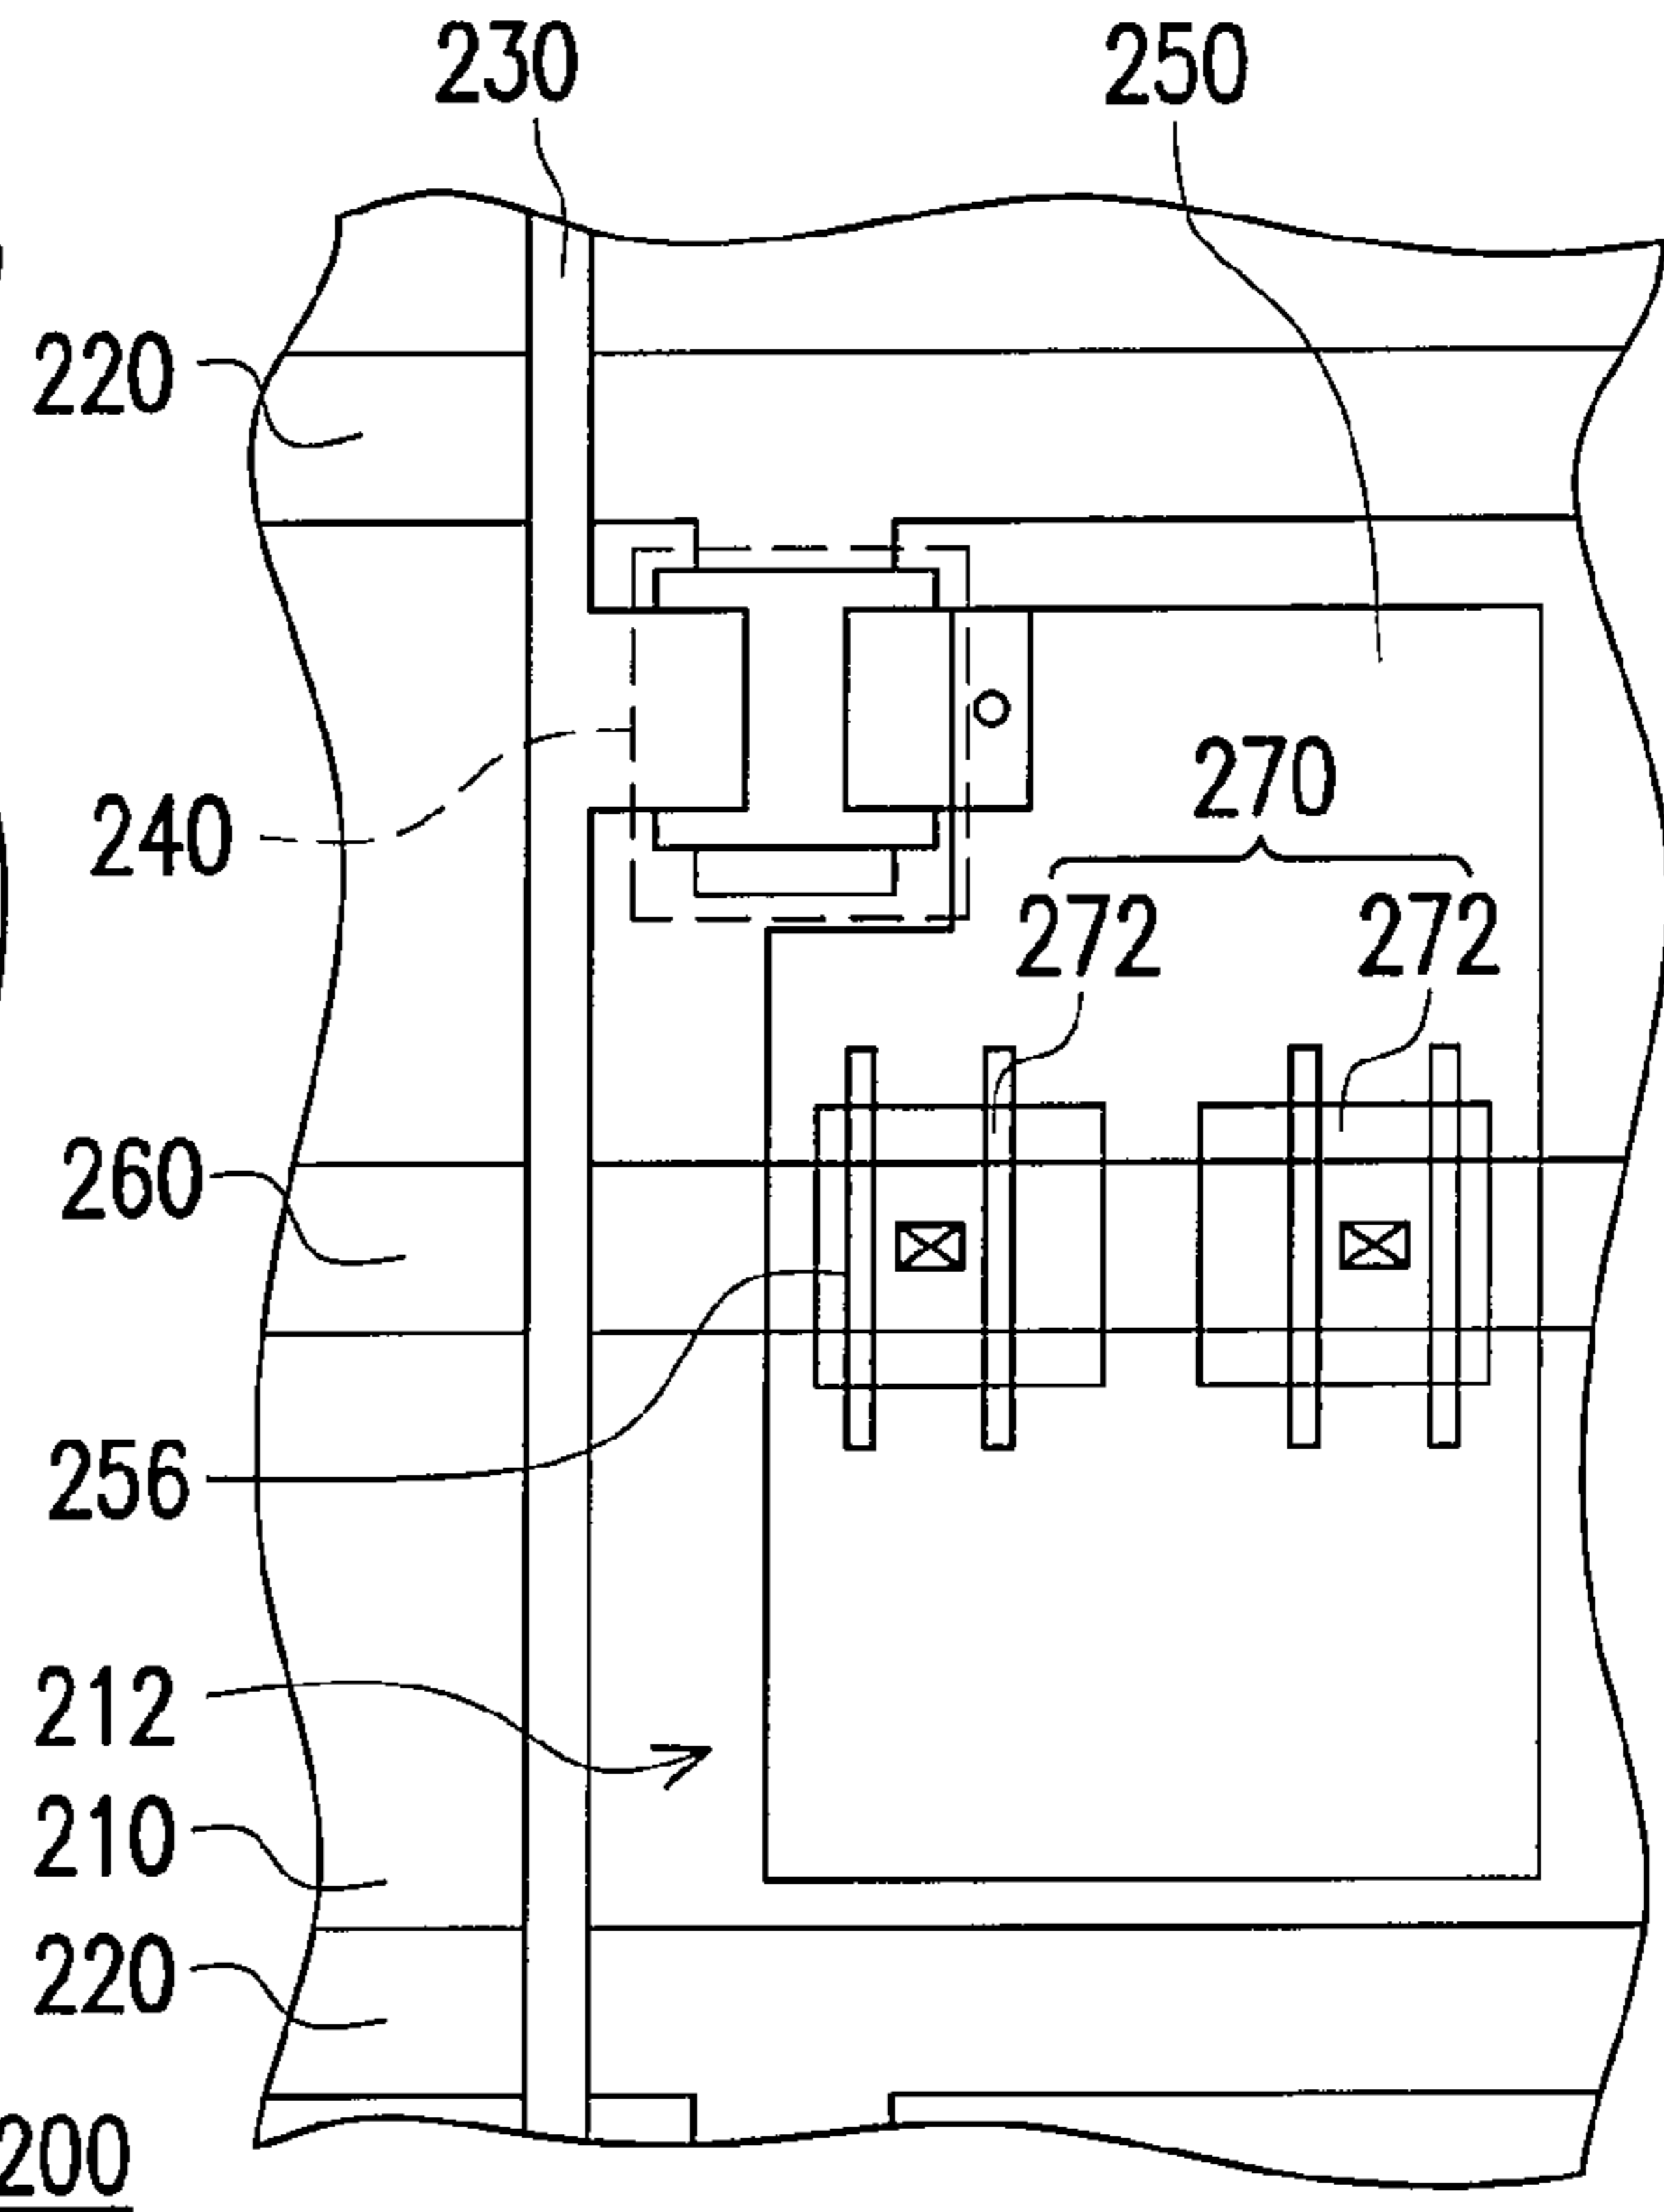
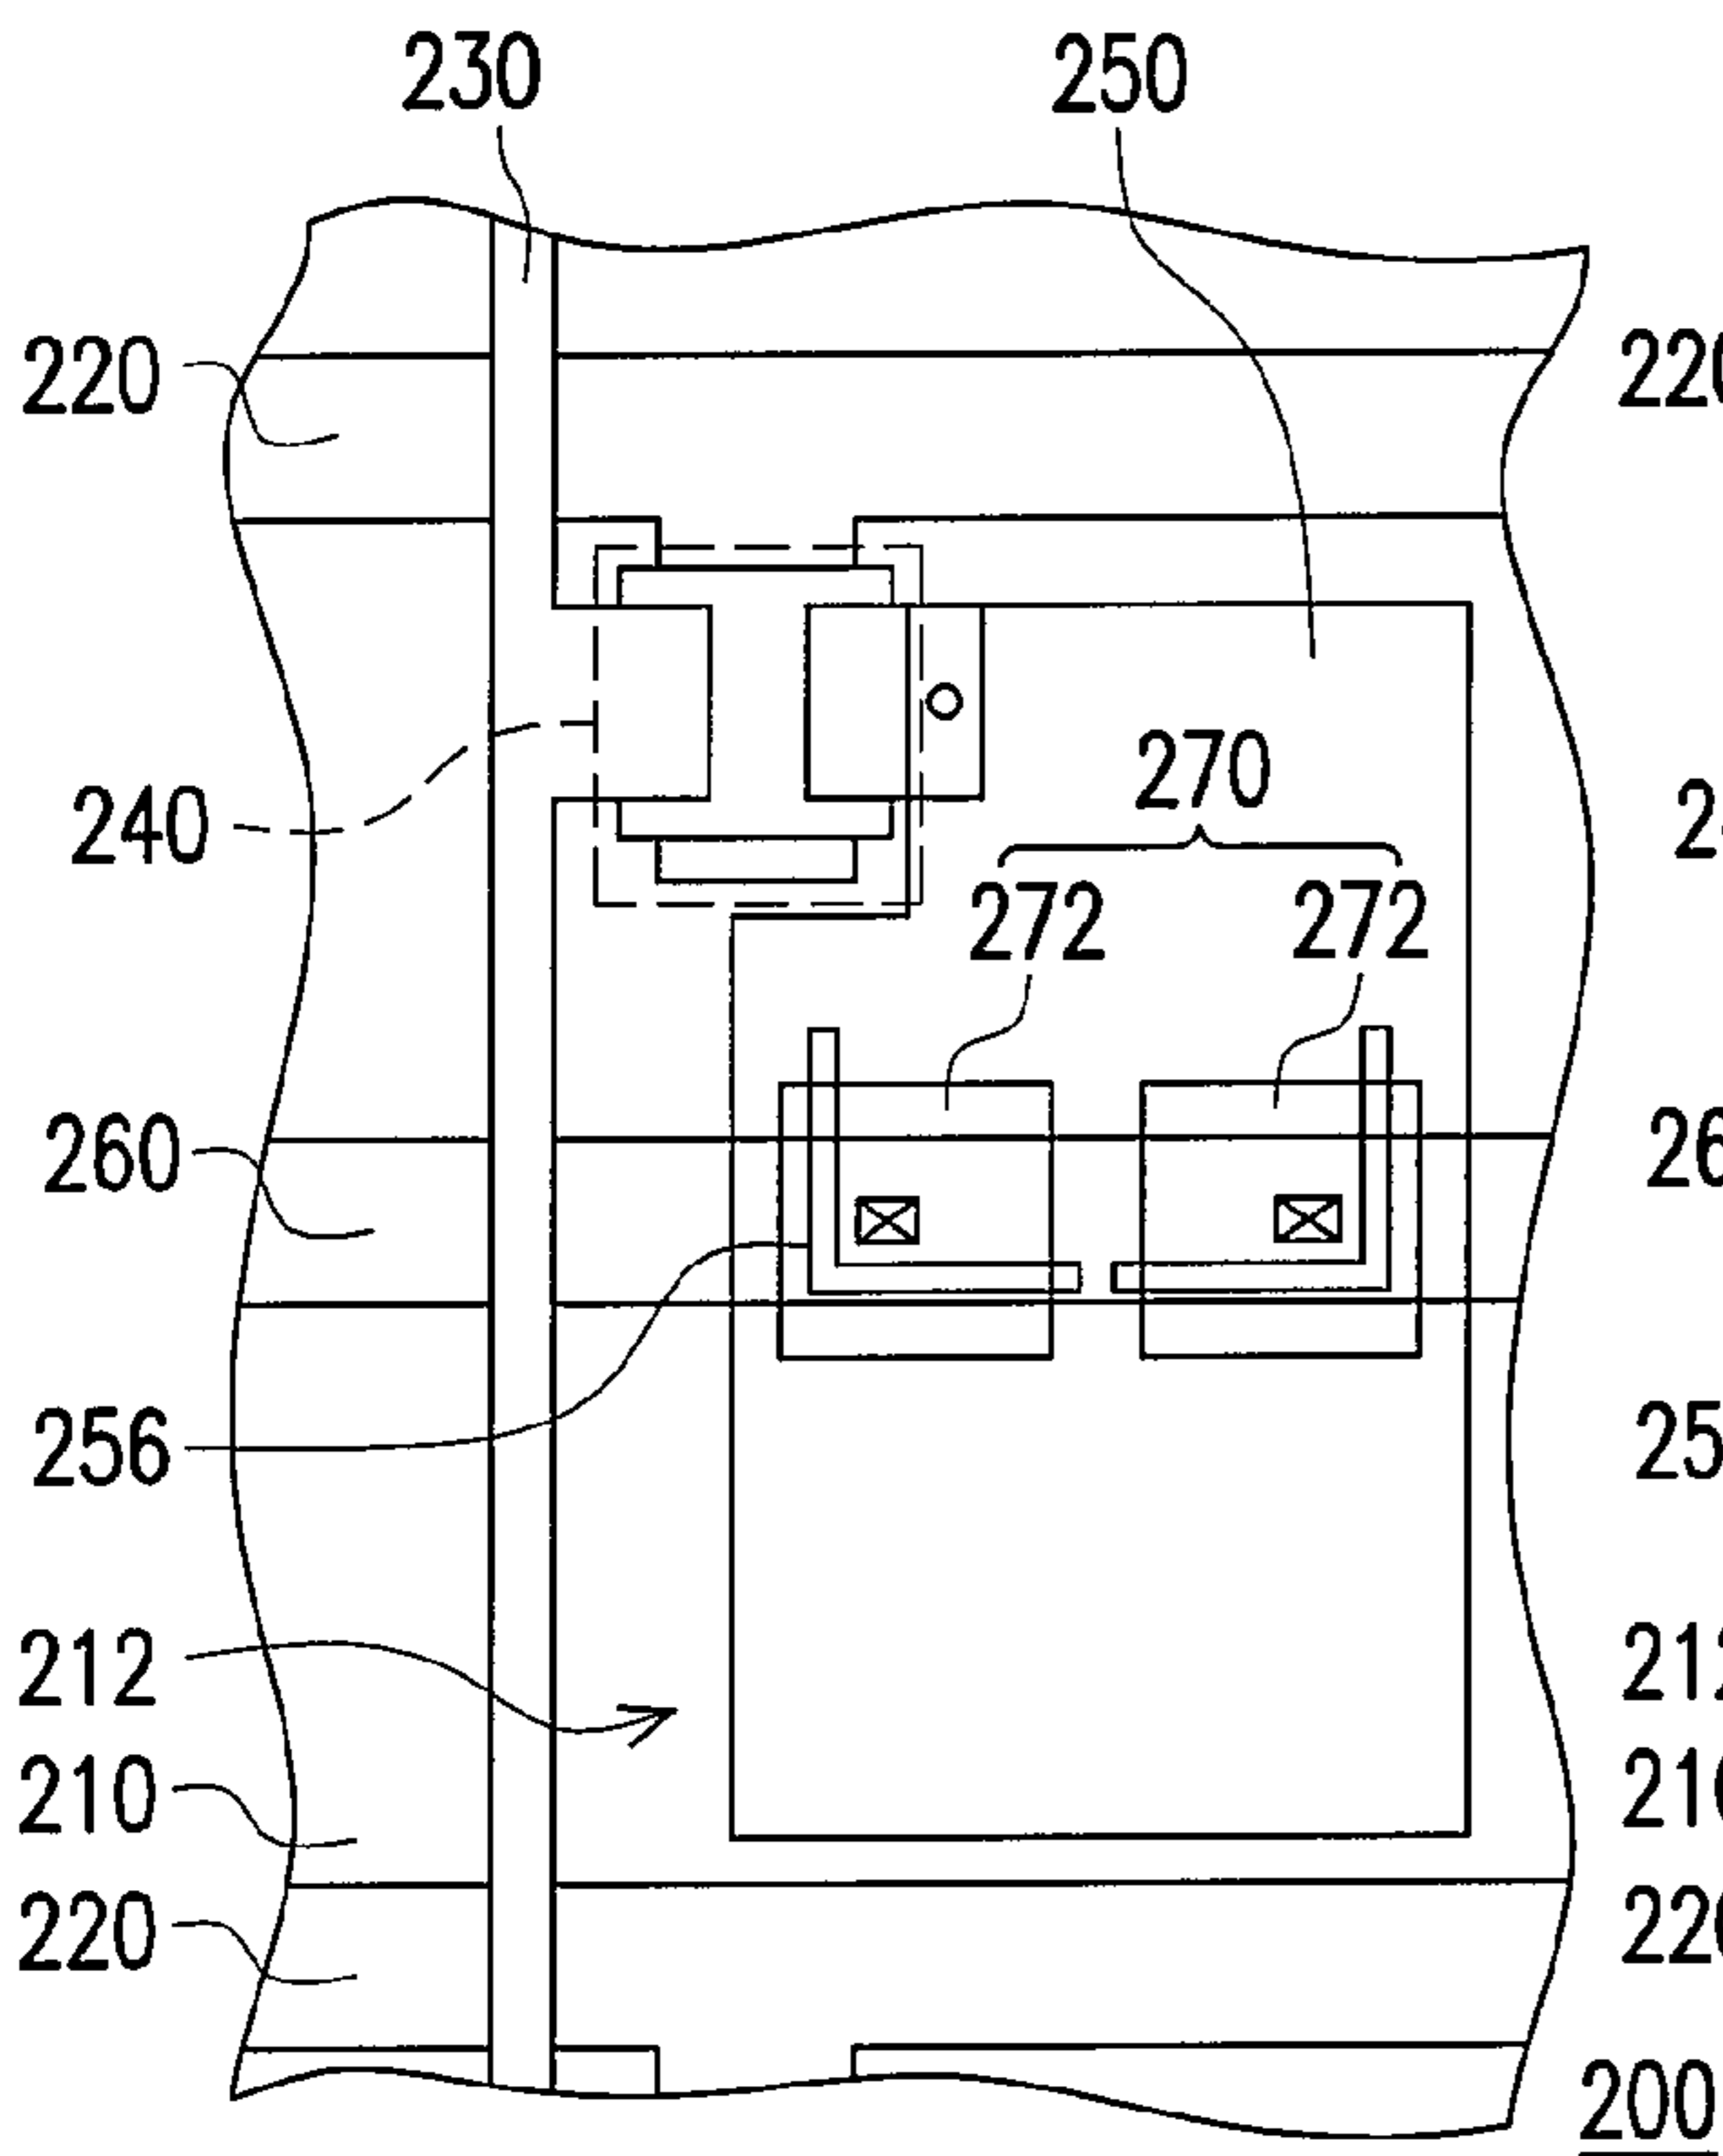
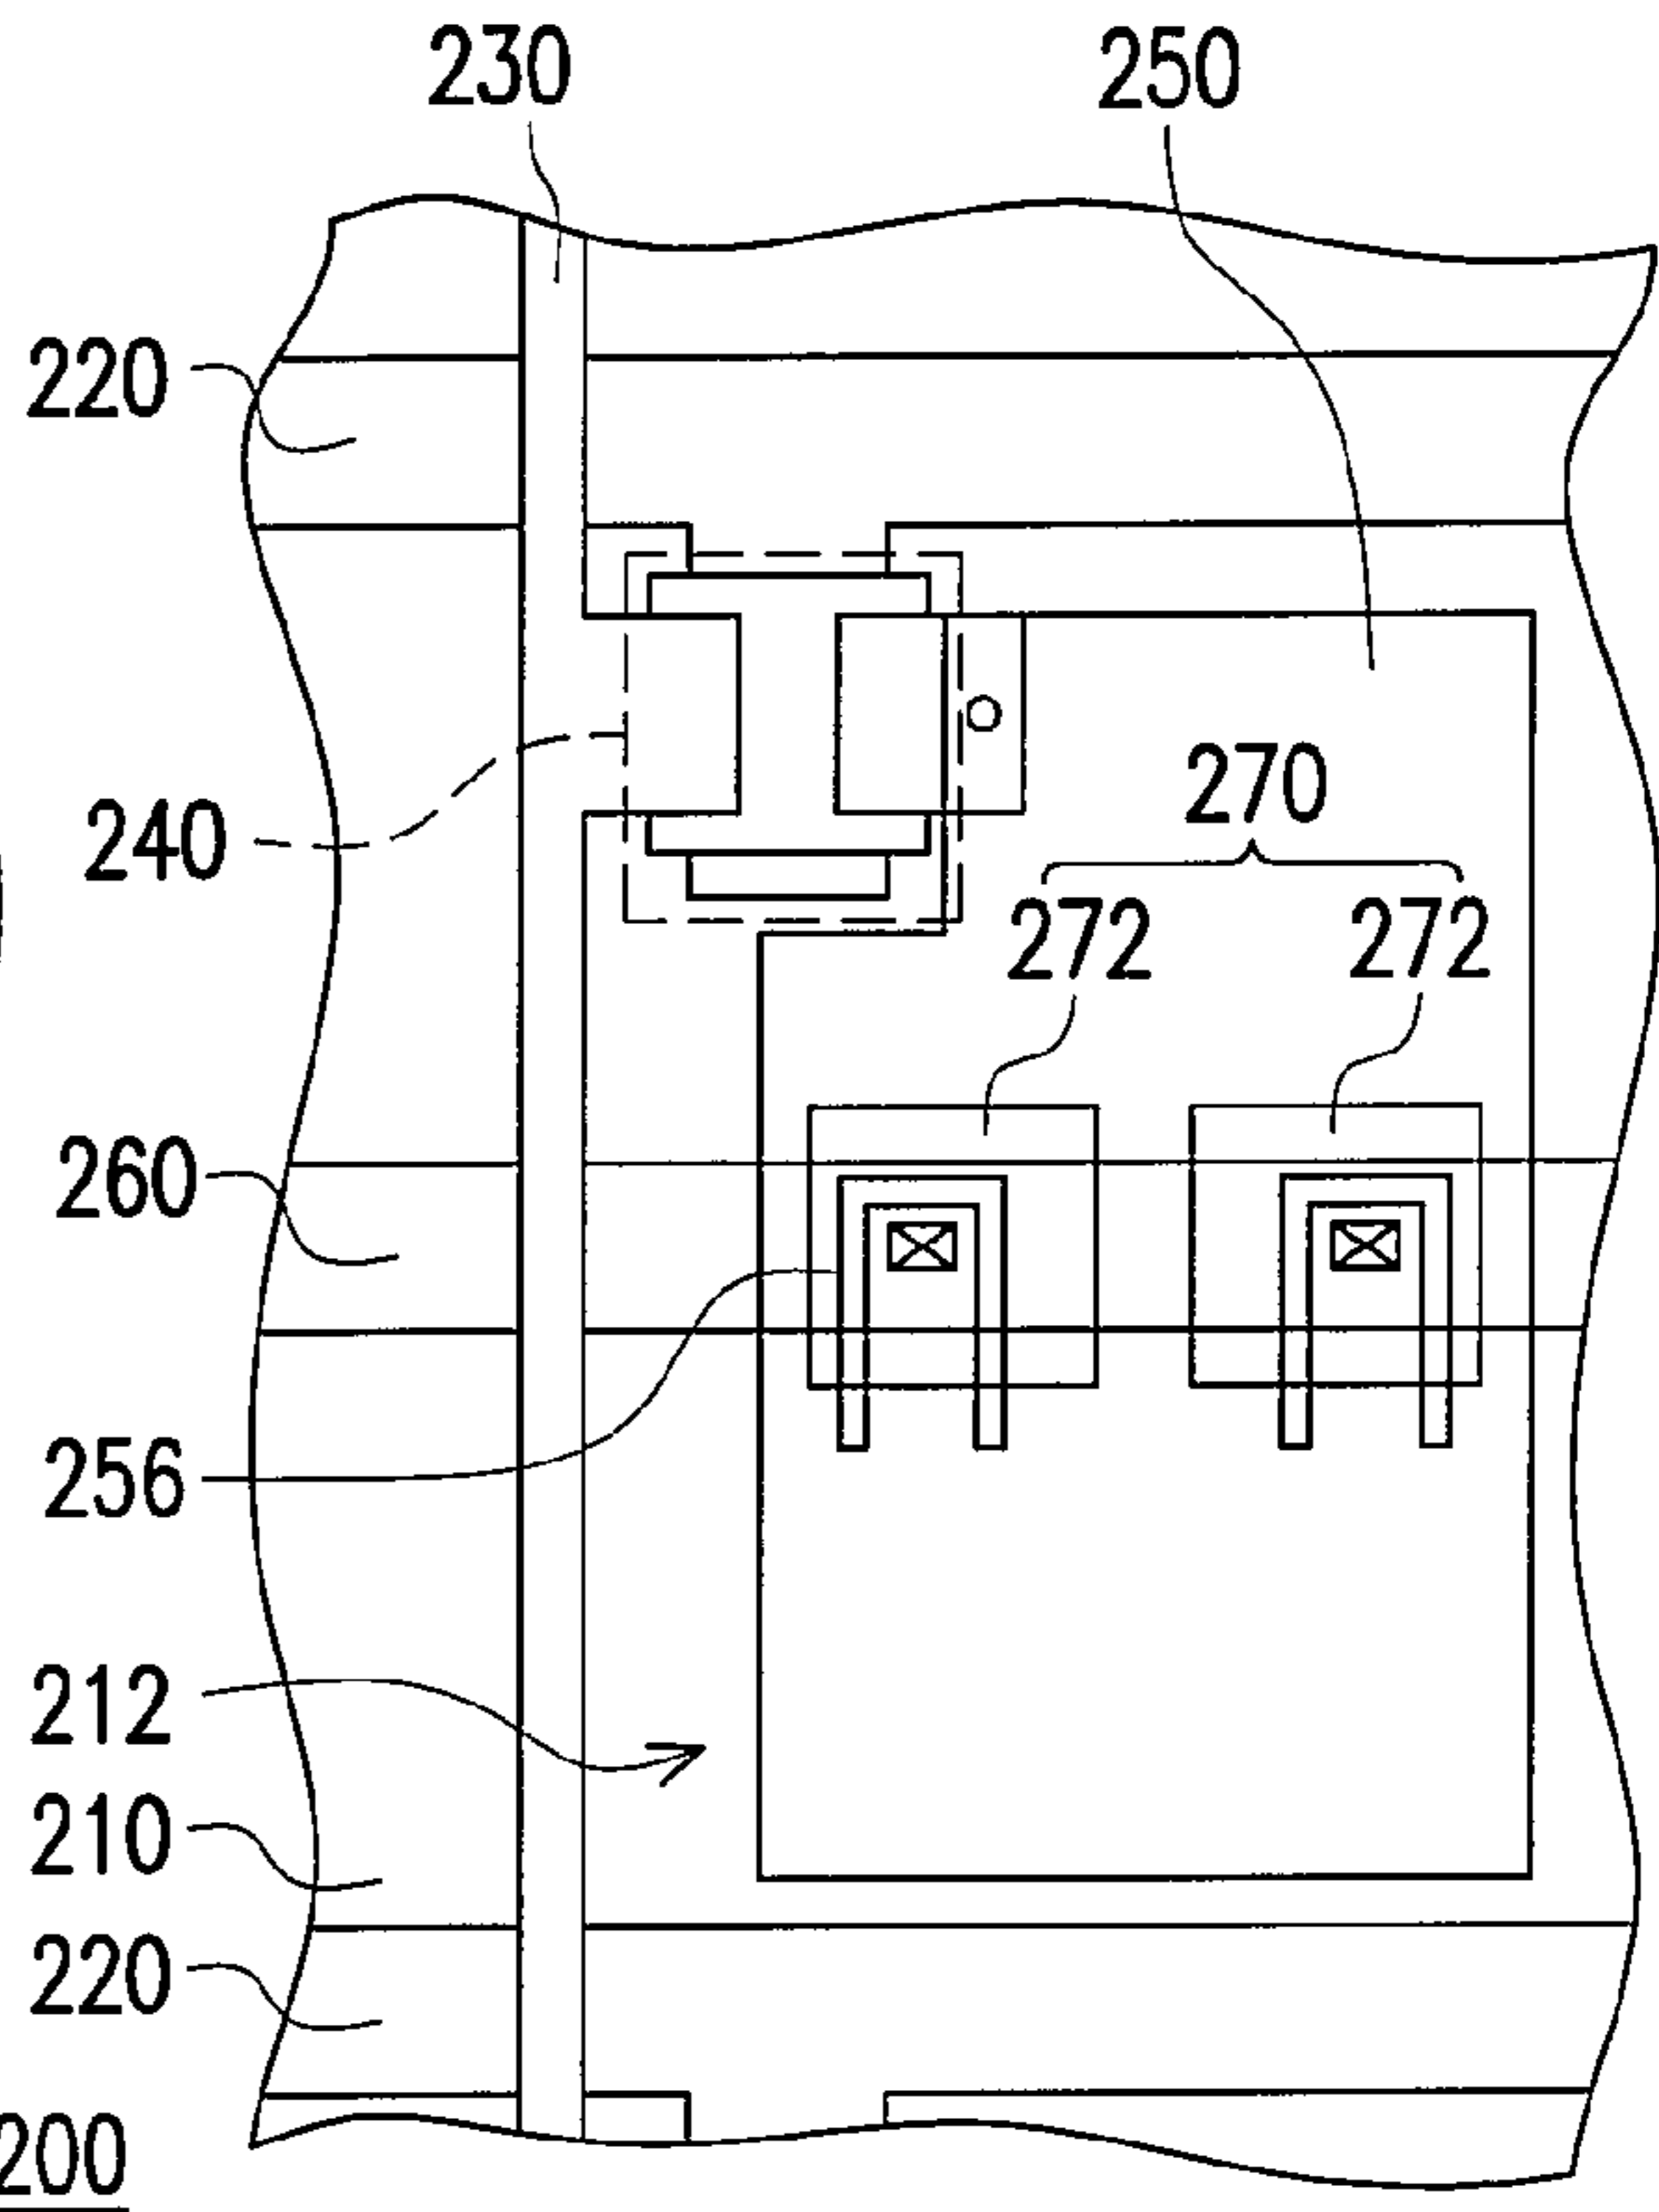
FIGS. **9A** through **9D** are top views showing different types of thin film transistor array substrates according to another preferred embodiment of the present invention. The thin film transistor array substrate of the present embodiment is mostly identical to the one shown in FIG. **3**. One major difference is that one or more openings **256** are formed in each pixel electrode **250** when the pixel electrodes **250** are formed. The openings **256** are disposed around the contact region between each sub contact pad **272** and one of the pixel electrodes **250**. For example, a straight line opening **256** (shown in FIG. **9A**), two straight line openings **256** (shown in FIG. **9B**), an L-shaped opening (shown in FIG. **9C**) or a U-shaped opening **256** (shown in FIG. **9D**) is formed over the pixel electrode **250** corresponding to each sub contact pad **272**. With an opening **256** formed over the every pixel electrode **250**, a portion of any one pixel electrode **250** can be readily removed to connect the ends of the opening **256**. Hence, an opening similar to the opening **252** that encircles the contact **292** as shown in FIG. **5** can be produced when there is a particle (or defect) between a sub-upper electrode **272** and one of the common lines **260**. In the present embodiment, the method of removing a portion of the pixel electrode **250** includes performing a laser ablation process.

As shown in FIGS. **9A** through **9D**, a portion of the opening **256** is disposed above the area occupied by the sub-upper electrode **272** while the remaining portion of the opening **256** is disposed outside the area occupied by the sub-upper electrode **272**. In other words, the openings **256** also cover a region outside the upper electrode **272** to simplify and speed the repairing operation. In addition, anyone familiar with the

technology may notice that there is no particular restriction on the dimension of each opening **256**.

FIGS. 9A through 9D are top views showing different types of thin film transistor array substrates according to another preferred embodiment of the present invention.

After removing a portion of the pixel electrode corresponding to the sub-upper electrode of the defective capacitor, the sub-upper electrode of the defective capacitor and one of the scan lines can be electrically connected by performing a laser welding process. Similarly, if a particle (or defect) is found between the pixel electrode and one of the scan lines, the pixel electrode above the particle (or defect) can be removed using a laser removing method. In addition, the process of fabricating the pixel electrode may include forming one or more openings similar to the ones described in FIGS. **9A** through **9D** to facilitate a laser repair operation.

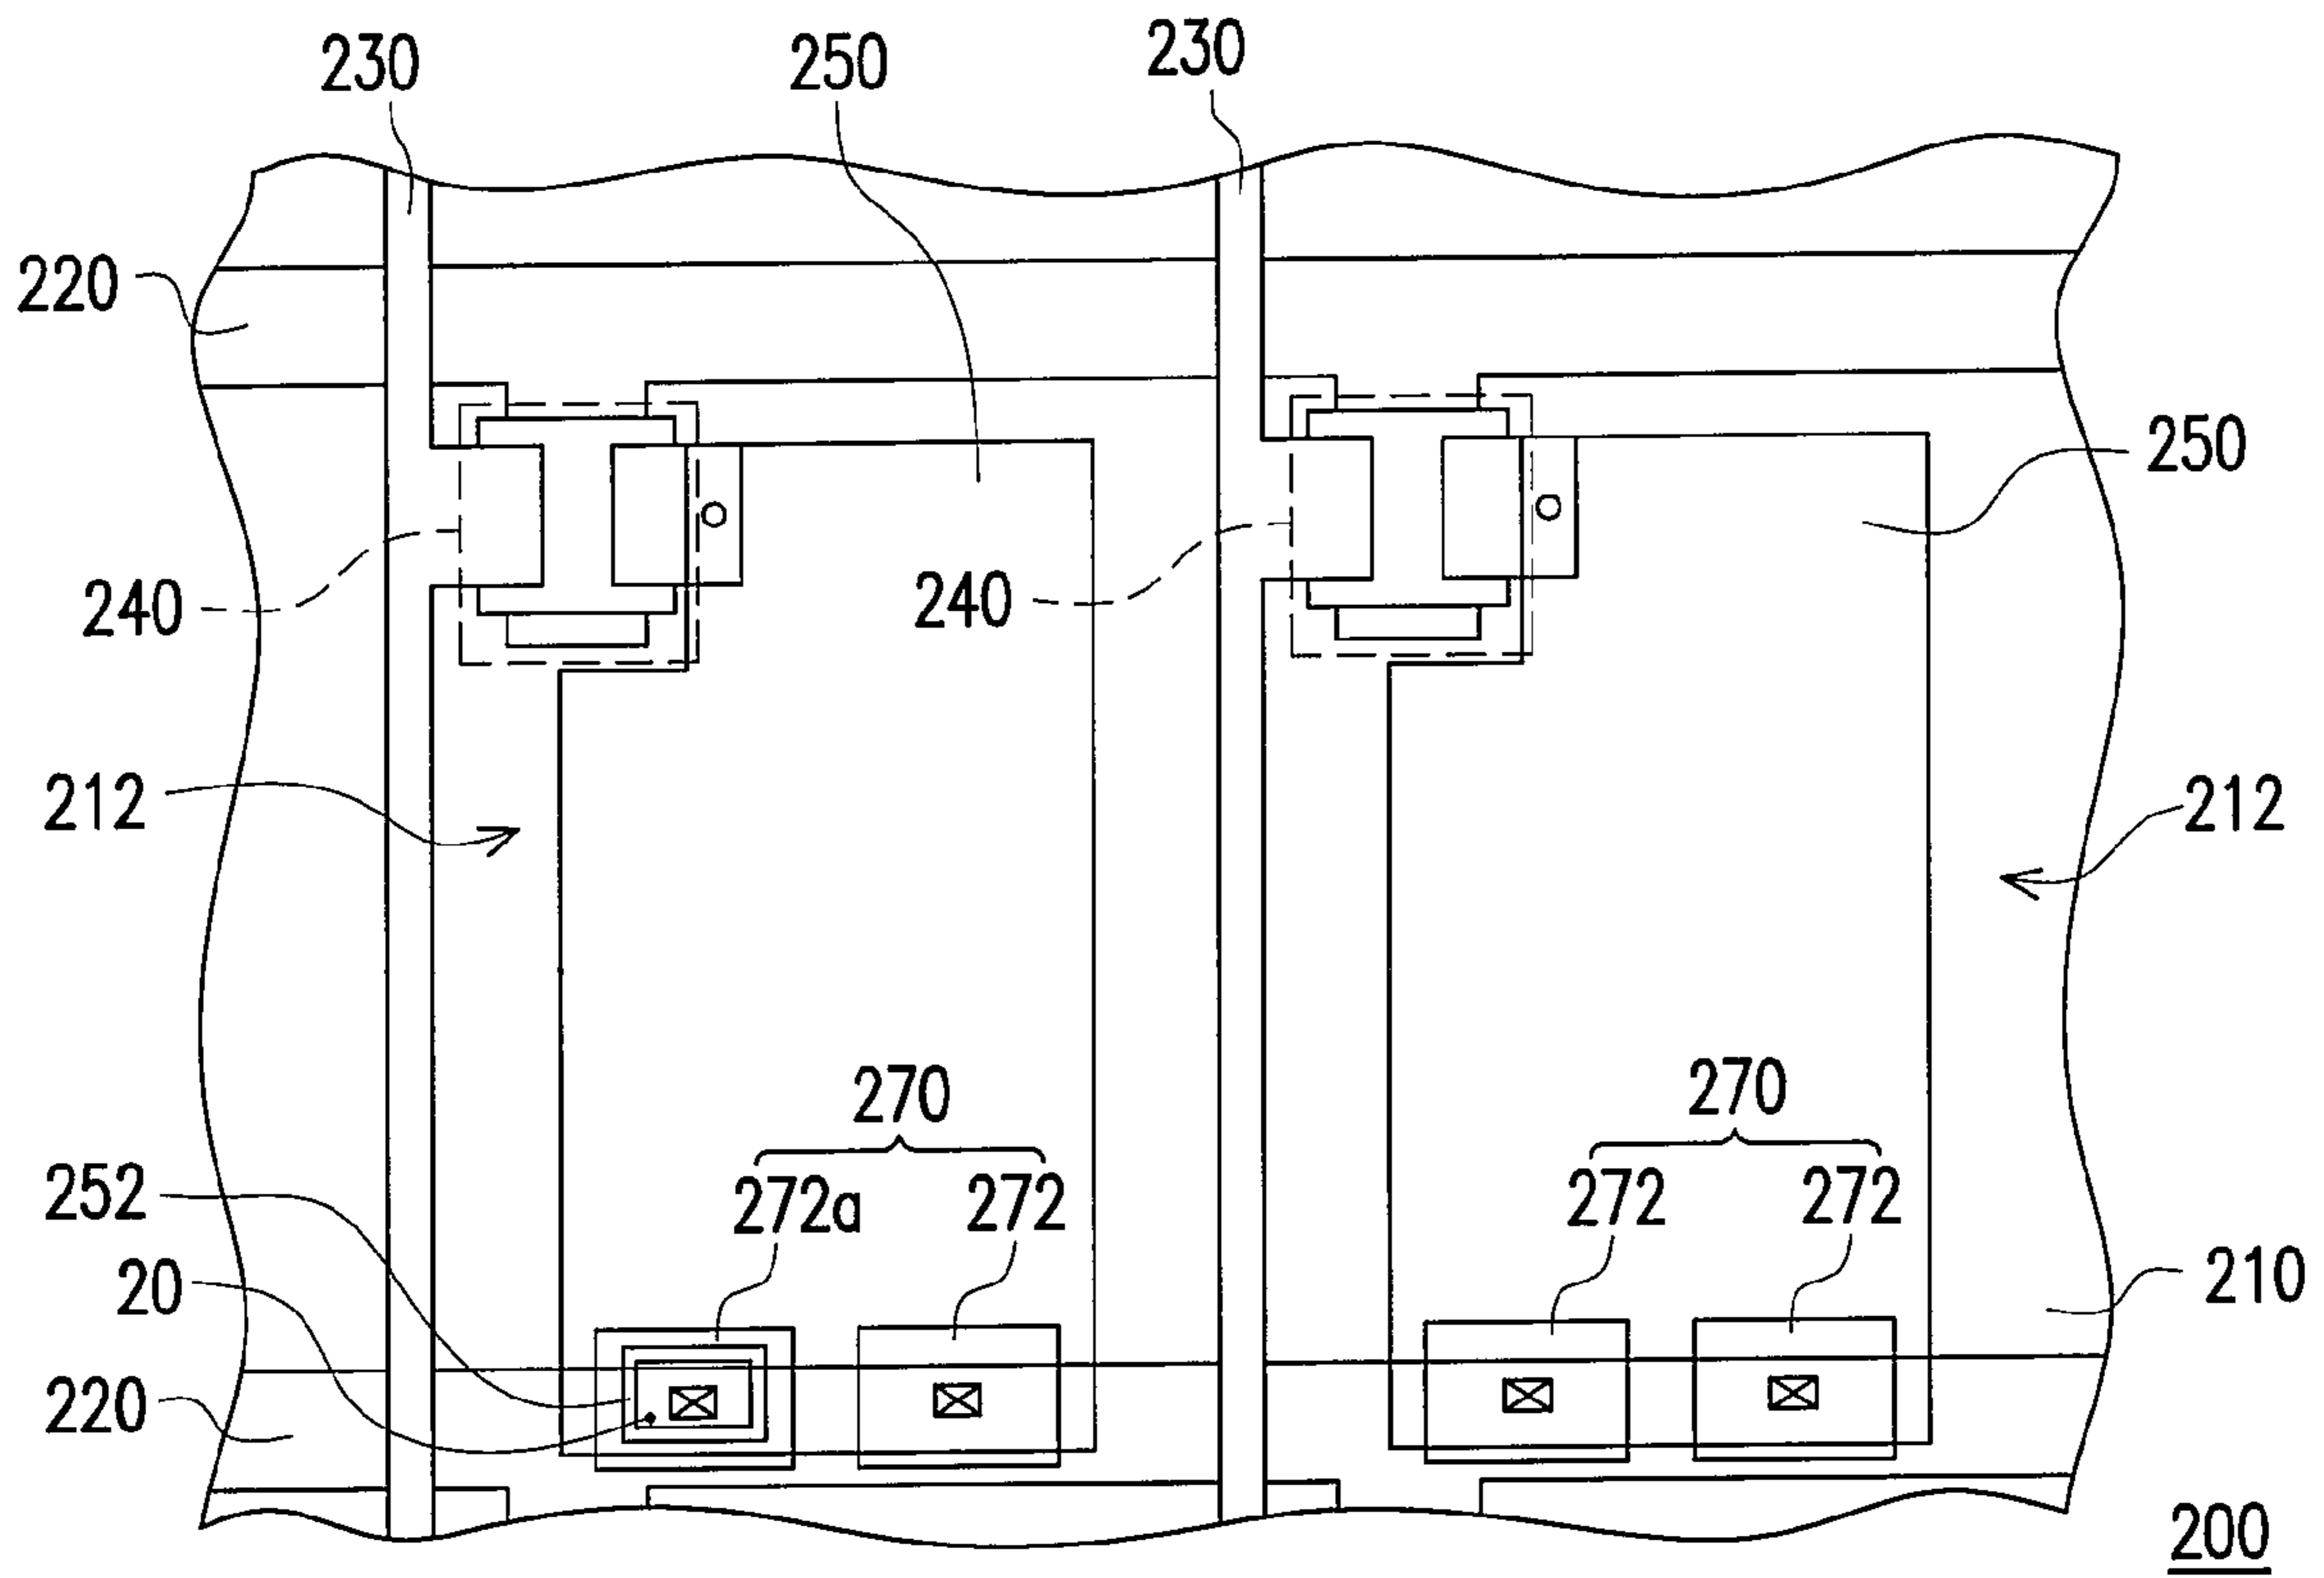
FIG. 12

FIGS. **12** and **13** are top views showing the method of repairing the scan line structure of the storage capacitor inside a thin film transistor array substrate according to the present invention. As shown in FIGS. **12** and **13**, the thin film transistor array substrate has a capacitor on scan line structure (Cst on gate) similar to one shown in FIG. **5**.

As shown in FIG. **12**, a portion of each pixel electrode **250** extends into the area above one of the scan lines **220**. The patterned upper electrode **270** is disposed between the pixel electrode **250** and the corresponding scan line **220**. The patterned upper electrode **270** comprises a plurality of sub-upper electrodes **272**. The sub-upper electrode **272** and its underlying scan line **220** together form a storage capacitor inside each pixel.

As shown in FIG. **12**, a portion of the pixel electrode **250** above the sub-upper electrode **272a** of the corresponding defective capacitor is removed to form an opening **252**. By forming the opening **252** in the pixel electrode **250**, the sub-upper electrode **272a** and the corresponding pixel electrode **250** of the defective capacitor are electrically isolated. The method of removing a portion of the pixel electrode **250** includes laser ablation, for example.

FIGS. 12 and 13 are top views showing the method of repairing the scan line structure of the storage capacitor inside a thin film transistor array substrate according to the present invention.
