(10) **Patent No.:** **US 7,646,446 B2**
(45) **Date of Patent:** **Jan. 12, 2010**

(54) **REPAIRING METHOD OF A THIN FILM TRANSISTOR ARRAY SUBSTRATE**

(73) Assignee: **Au Optronics Corporation**, Hsinchu (TW)

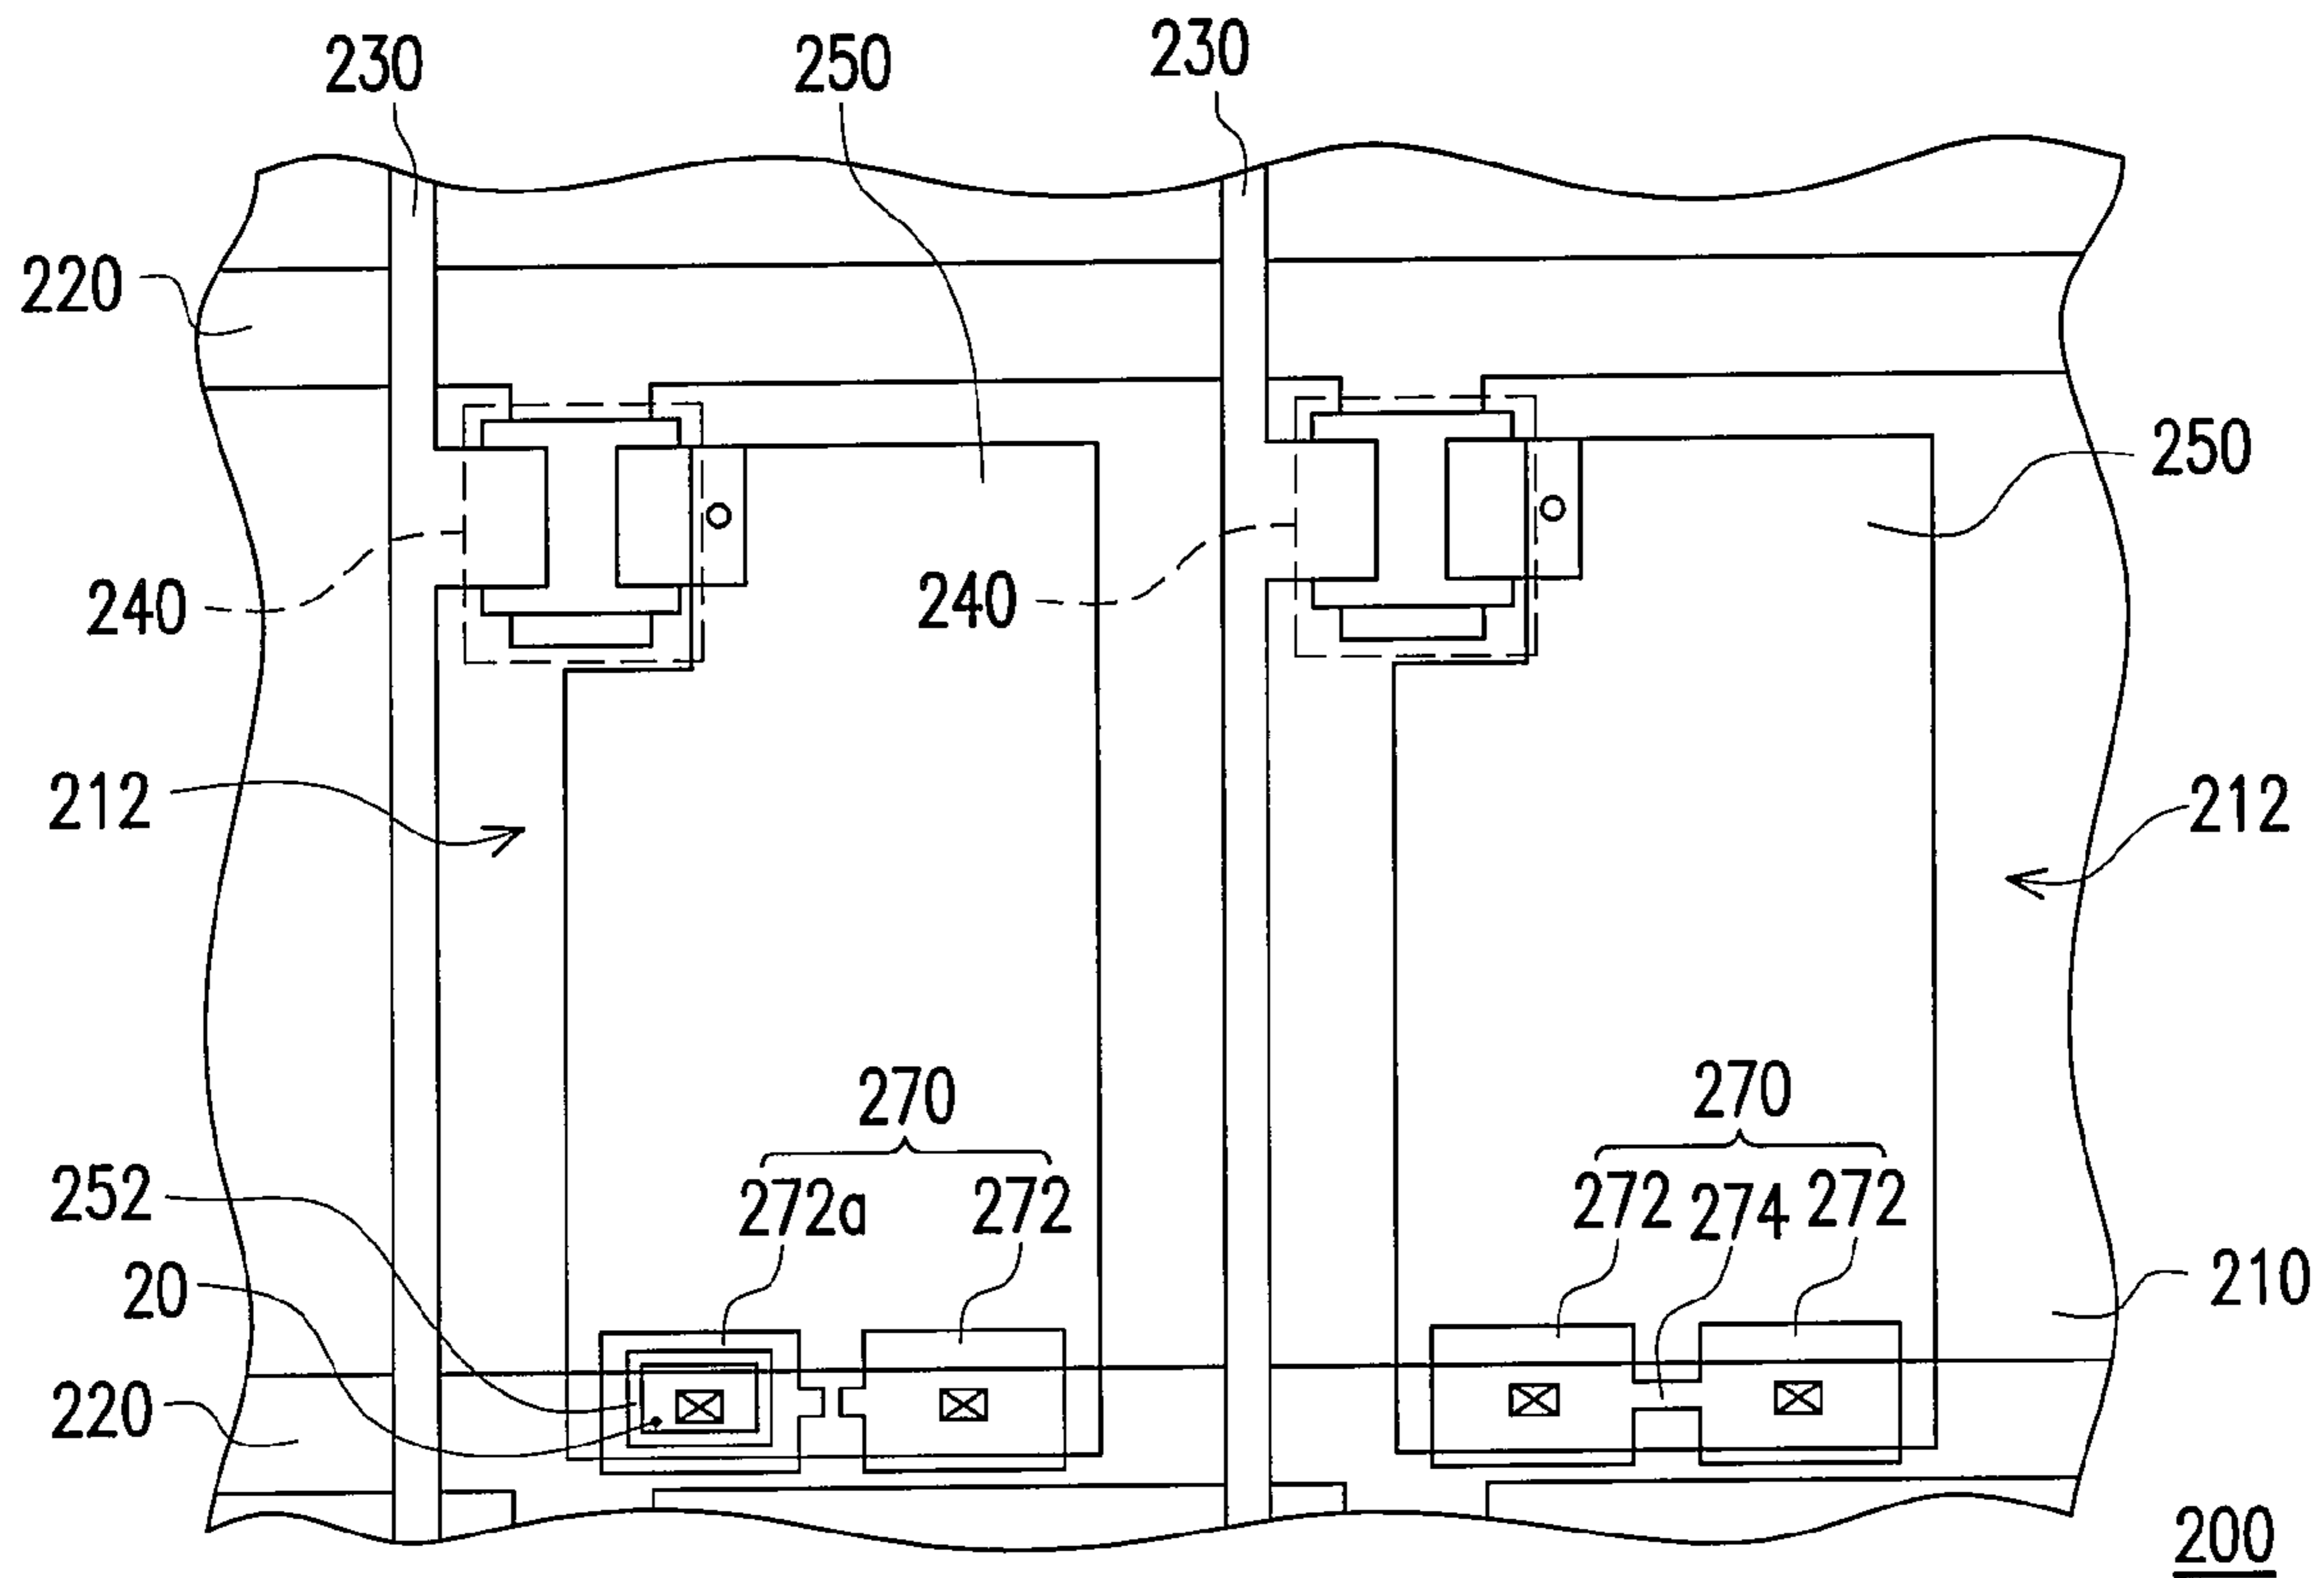
FIG. 13

FIGS. **12** and **13** are top views showing the method of repairing the scan line structure of the storage capacitor inside a thin film transistor array substrate according to the present invention. As shown in FIGS. **12** and **13**, the thin film transistor array substrate has a capacitor on scan line structure (Cst on gate) similar to one shown in FIG. **5**.

As shown in FIG. **13**, the patterned upper electrode **270** is disposed between each pixel electrode **250** and one of the scan lines **220**. The patterned upper electrode **270** comprises a plurality of sub-upper electrodes **272**. Furthermore, each sub-upper electrode **272** underneath the pixel electrode **250** has a neck portion **274** connecting with each other. The neck portion **274** serves as a cutting area in a repairing operation.

As shown in FIG. **13**, the repairing method includes removing a portion of the pixel electrode corresponding to the sub-upper electrode **272a** of the defective capacitor to form an opening **252**. Furthermore, the neck portion **274** connecting with the sub-upper electrode **272a** of the defective capacitor is cut so that the sub-upper electrode **272a** of the defective capacitor and the corresponding pixel electrode **250** are electrically isolated. The method of removing a portion of the pixel electrode **250** includes a laser ablation process and the method of cutting the neck portion **274** includes a laser cutting operation.

FIGS. 12 and 13 are top views showing the method of repairing the scan line structure of the storage capacitor inside a thin film transistor array substrate according to the present invention.

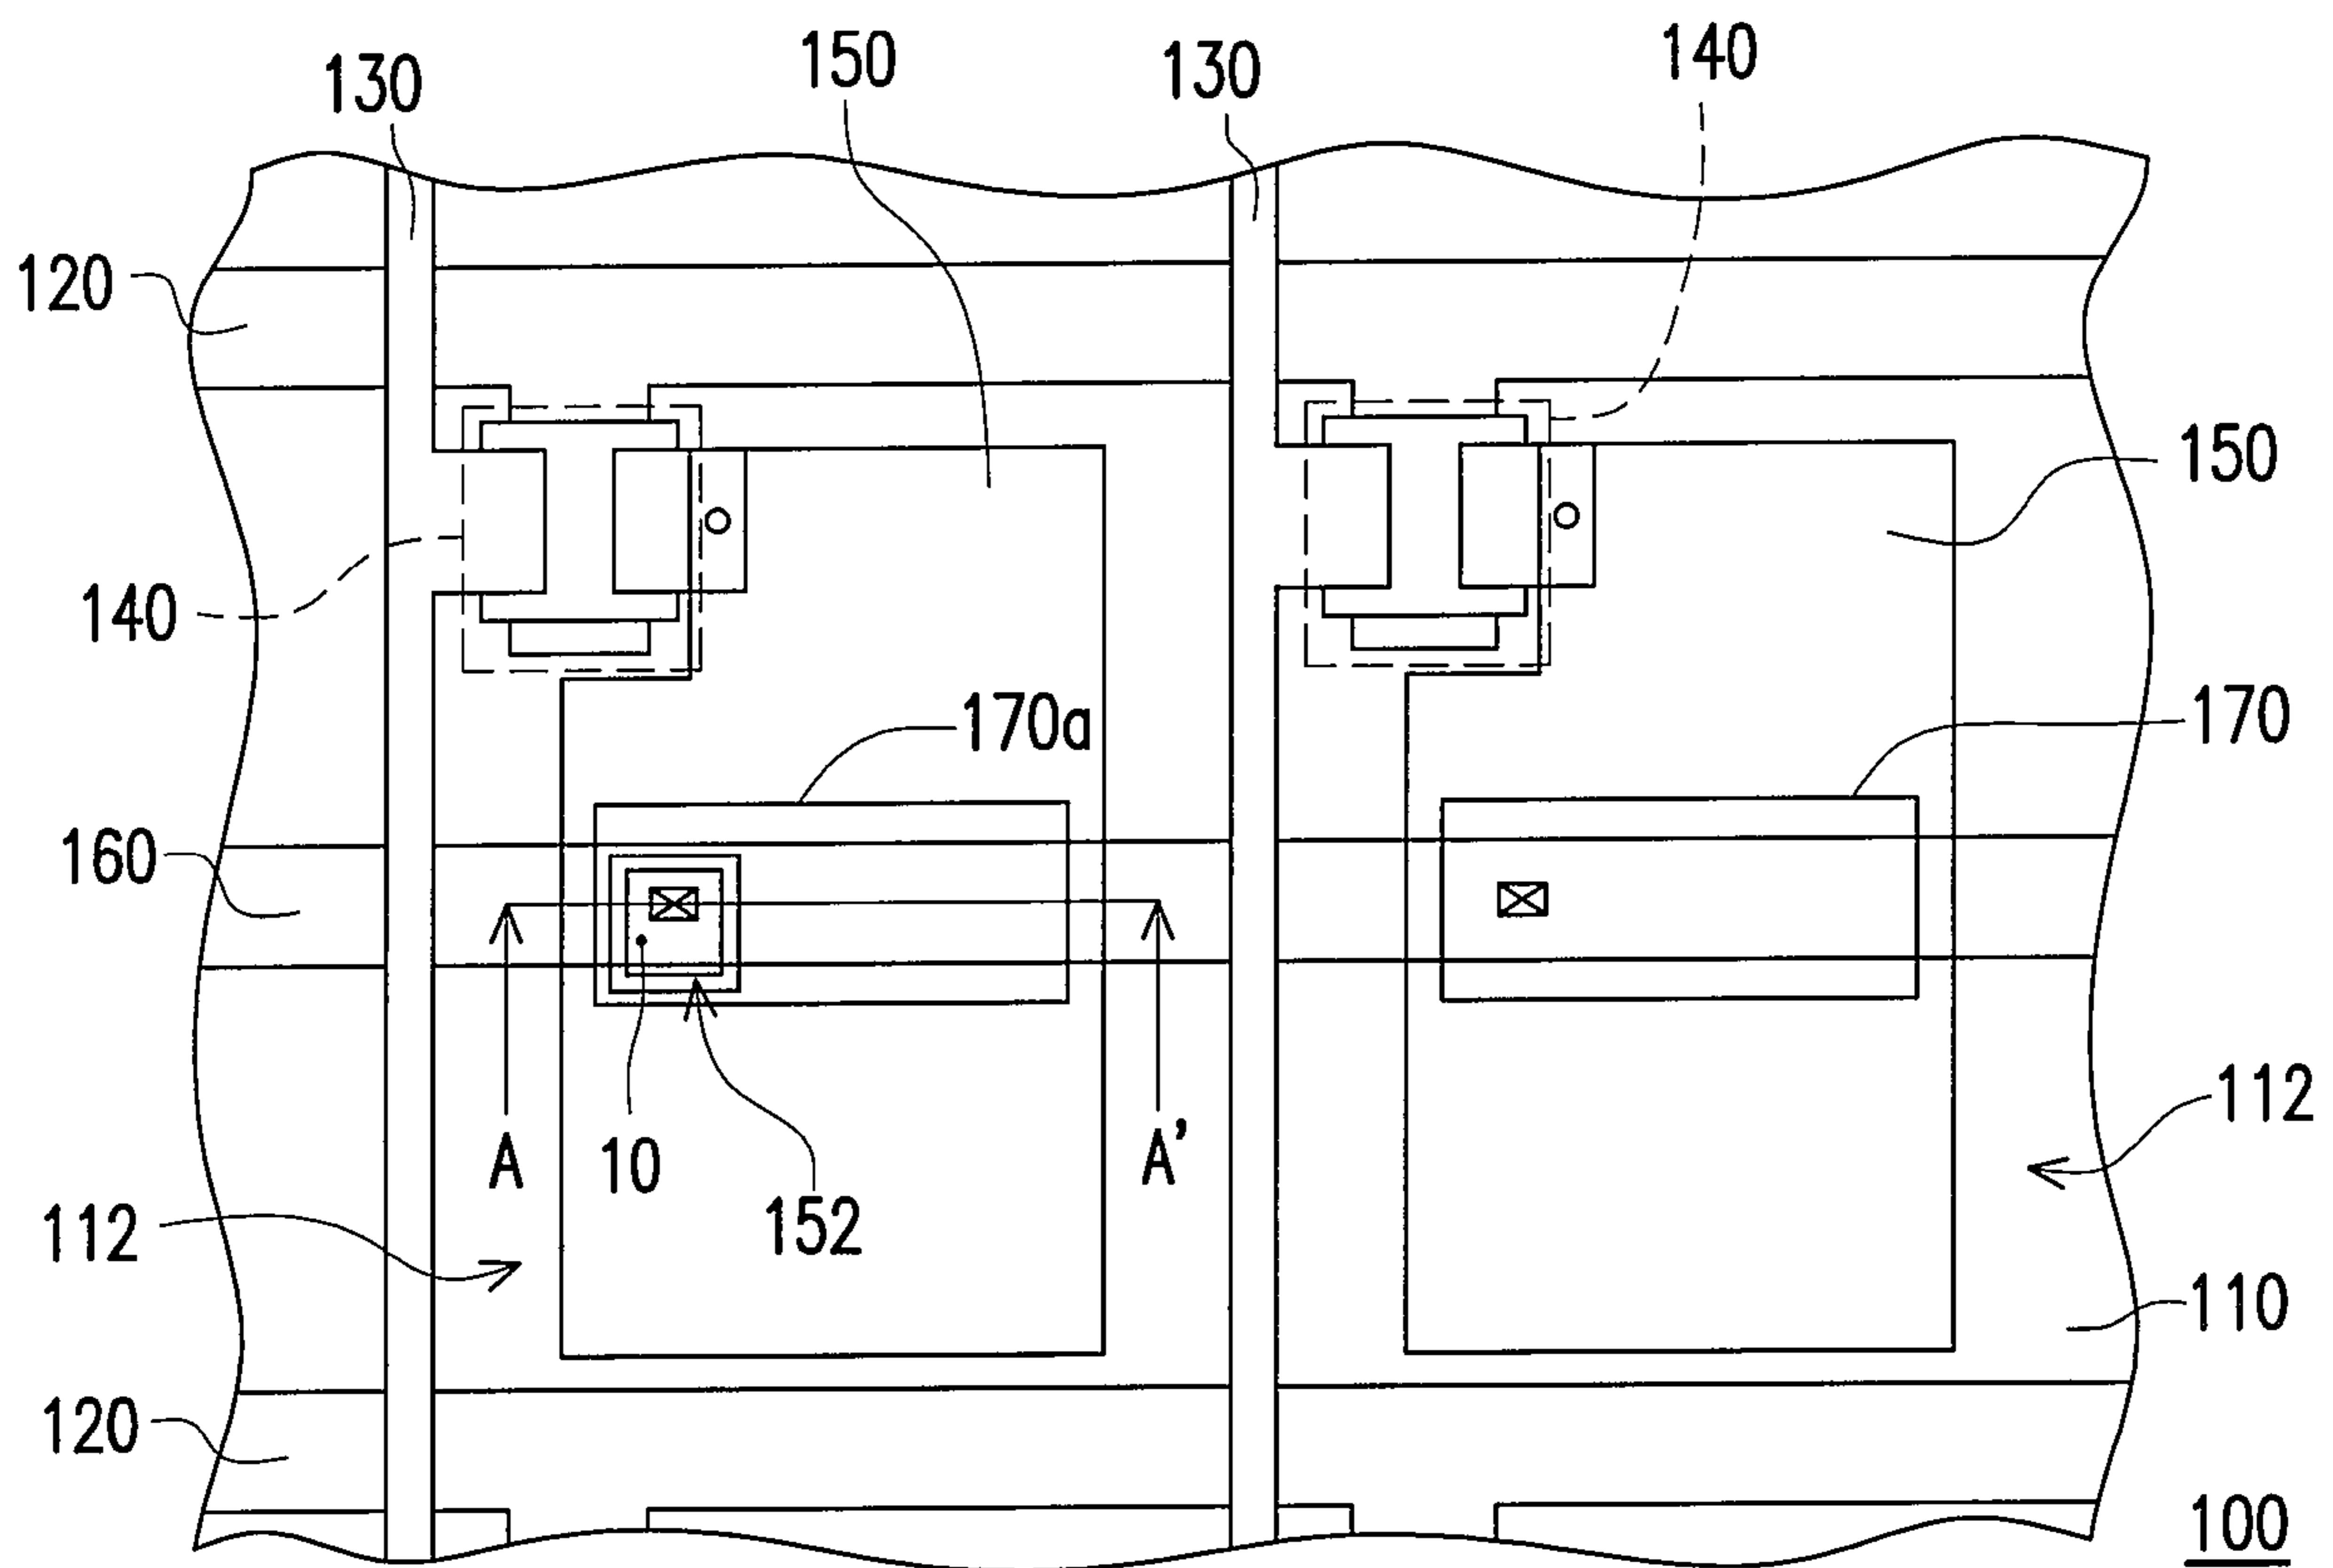
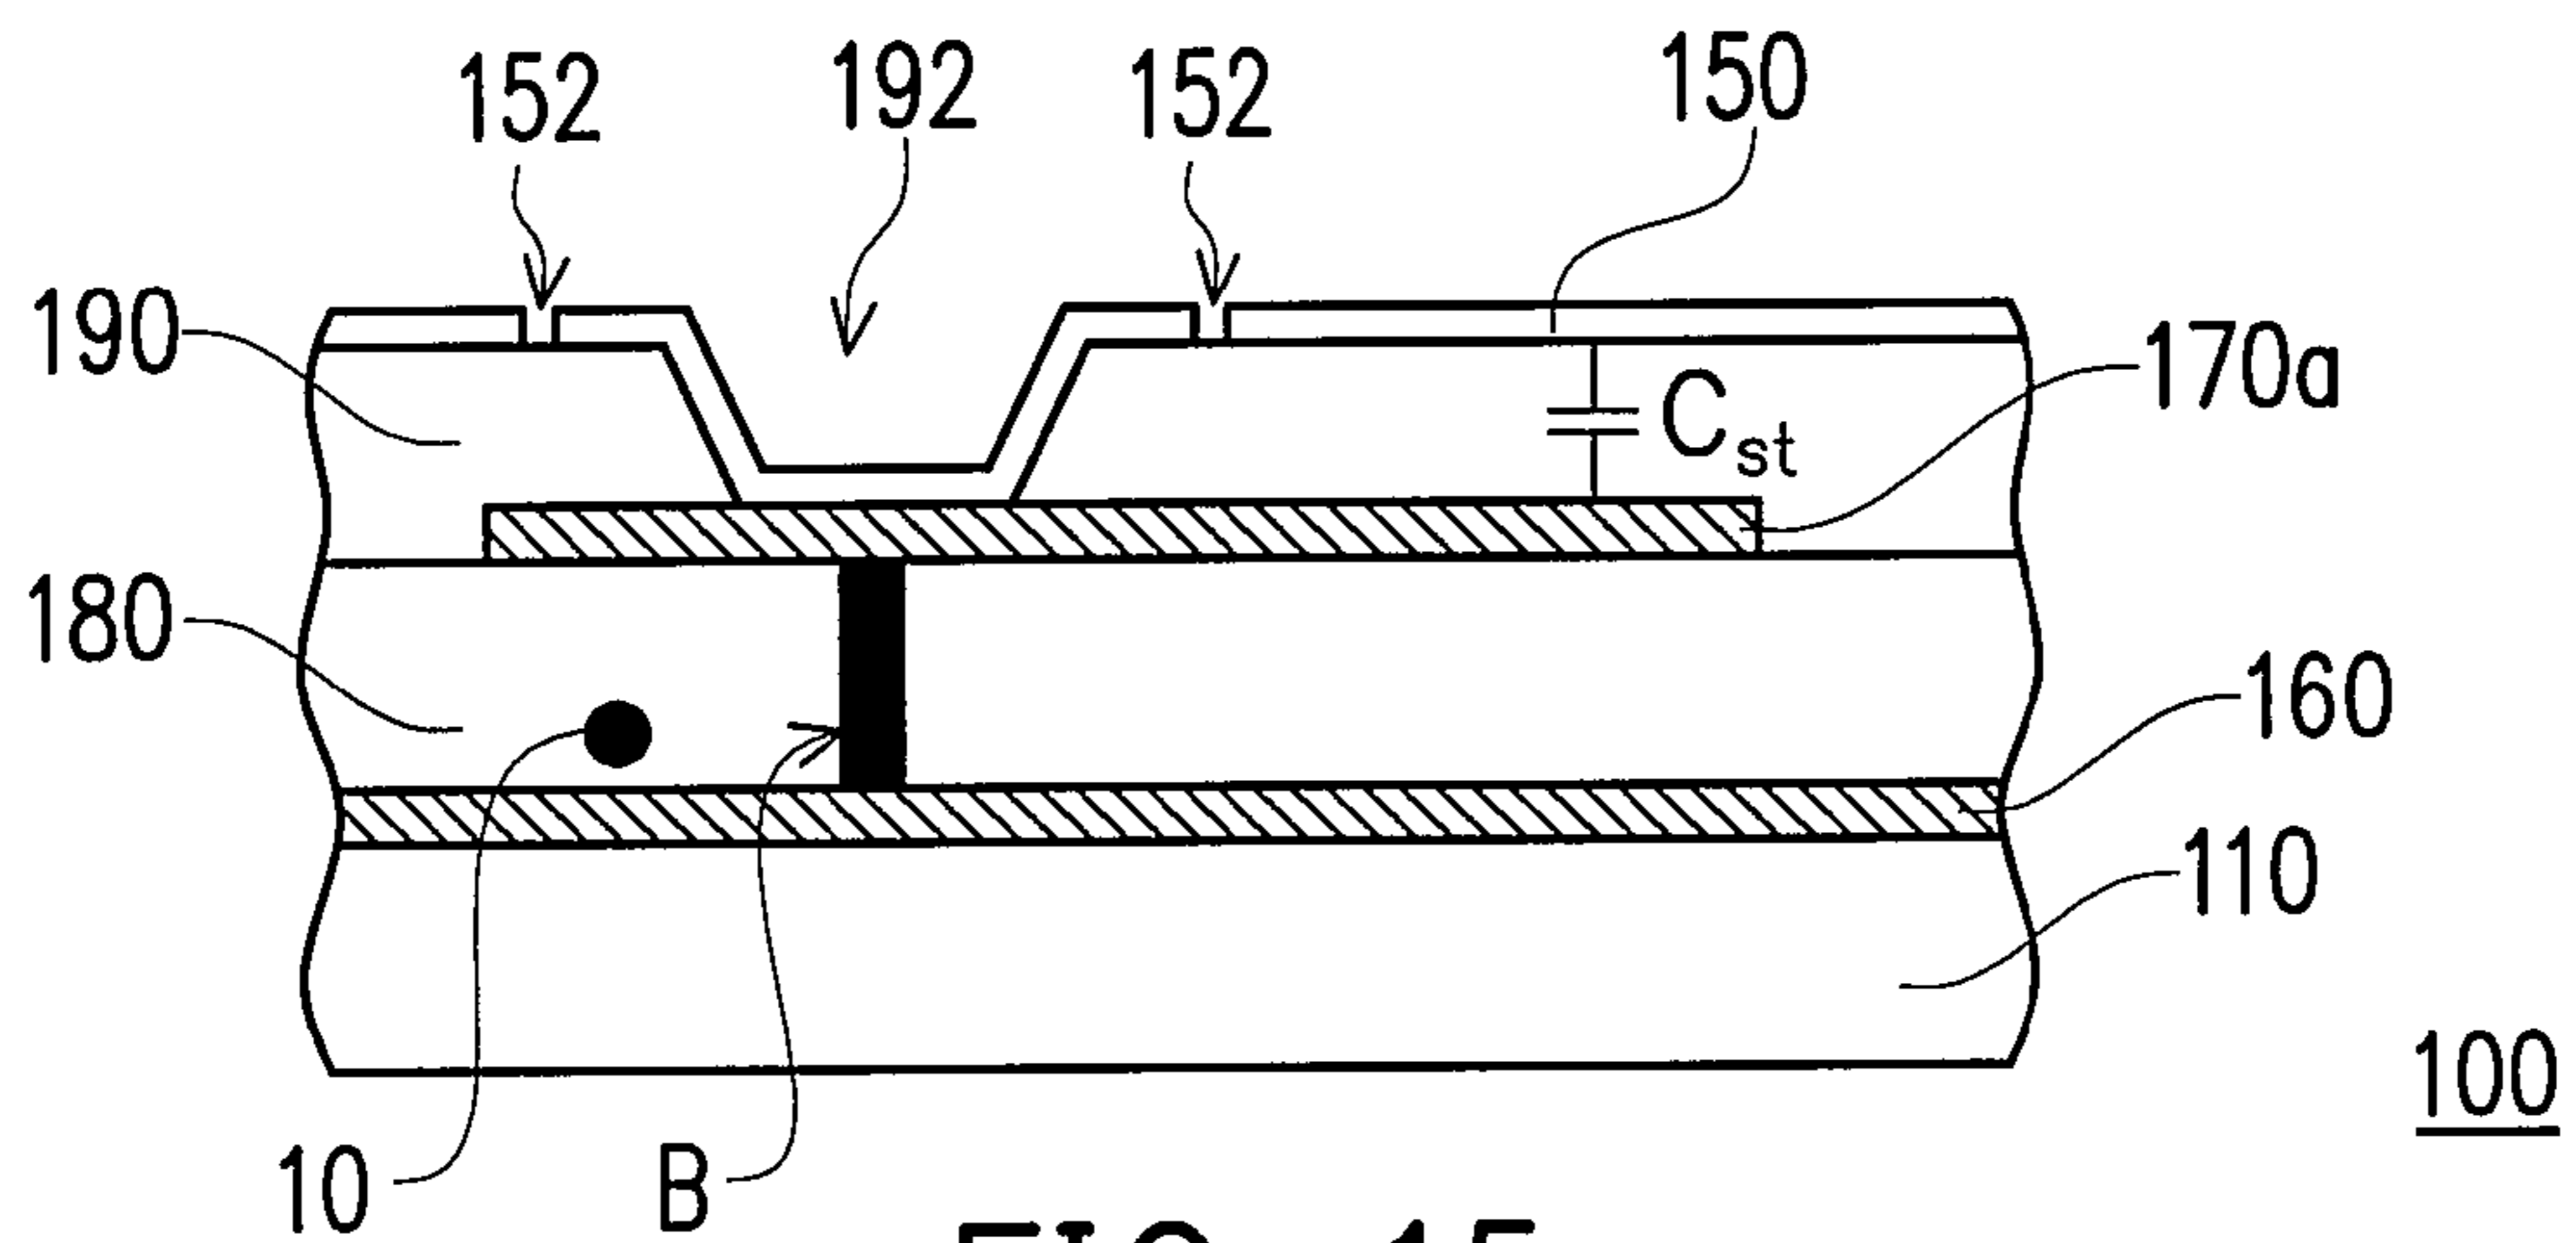
FIGS. **14** and **15** are top view and cross-sectional view showing the configuration after applying the method of the present invention to repair a conventional thin film transistor array substrate. As shown in FIGS. **14** and **15**, a conventional thin film transistor array substrate **100** has an upper electrode **170** between every pixel electrode **150** and corresponding common line **160**. In the presence of a particle (or defect) **10** between any upper electrode **170** and the corresponding common line **160**, the repairing method of the present invention can be used to rectify the problem. The repairing method of the present embodiment includes removing a portion of the pixel electrode **150** corresponding to the upper electrode **170a** of the defective capacitor so that the upper electrode **170a** and the pixel electrode **150** of the defective capacitor is electrically isolated. Thereafter, the upper electrode **170a** and the corresponding common line **160** are welded together. Obviously, whether to weld the upper electrode **170a** and the common line **160** of the defective capacitor together can be determined by the amount of leakage in the defective capacitor.

In the present embodiment, a portion of the pixel electrode **150** above the upper electrode **170a** of the corresponding defective capacitor is removed to form an opening **152**. The method of removing a portion of the pixel electrode **150** includes laser ablation, for example. The opening **152** is located around the contact area between the upper electrode **170a** and the corresponding pixel electrode **150** of the defective capacitor (that is, around the contact **192**). By forming the

opening **152**, the upper electrode **170a** and the corresponding pixel electrode **150** of the defective capacitor are electrically isolated. Thereafter, the upper electrode **170a** and the corresponding common line **160** are welded together (as shown in label B), for example, by performing a laser welding process, so that the upper electrode **170a** and the common line **160** of the defective capacitor are configured at the same potential.

FIGS. 14 and 15 are top view and cross-sectional view showing the configuration after applying the method of the present invention to repair a conventional thin film transistor array substrate.

It should be noted that the thin film transistor array substrate **100** in FIGS. **14** and **15** has capacitor on common line (Cst on common) storage capacitor thereon. However, anyone familiar with the technology can apply the repairing method of the present invention to a substrate having a capacitor on gate (Cst on gate) storage capacitor thereon.

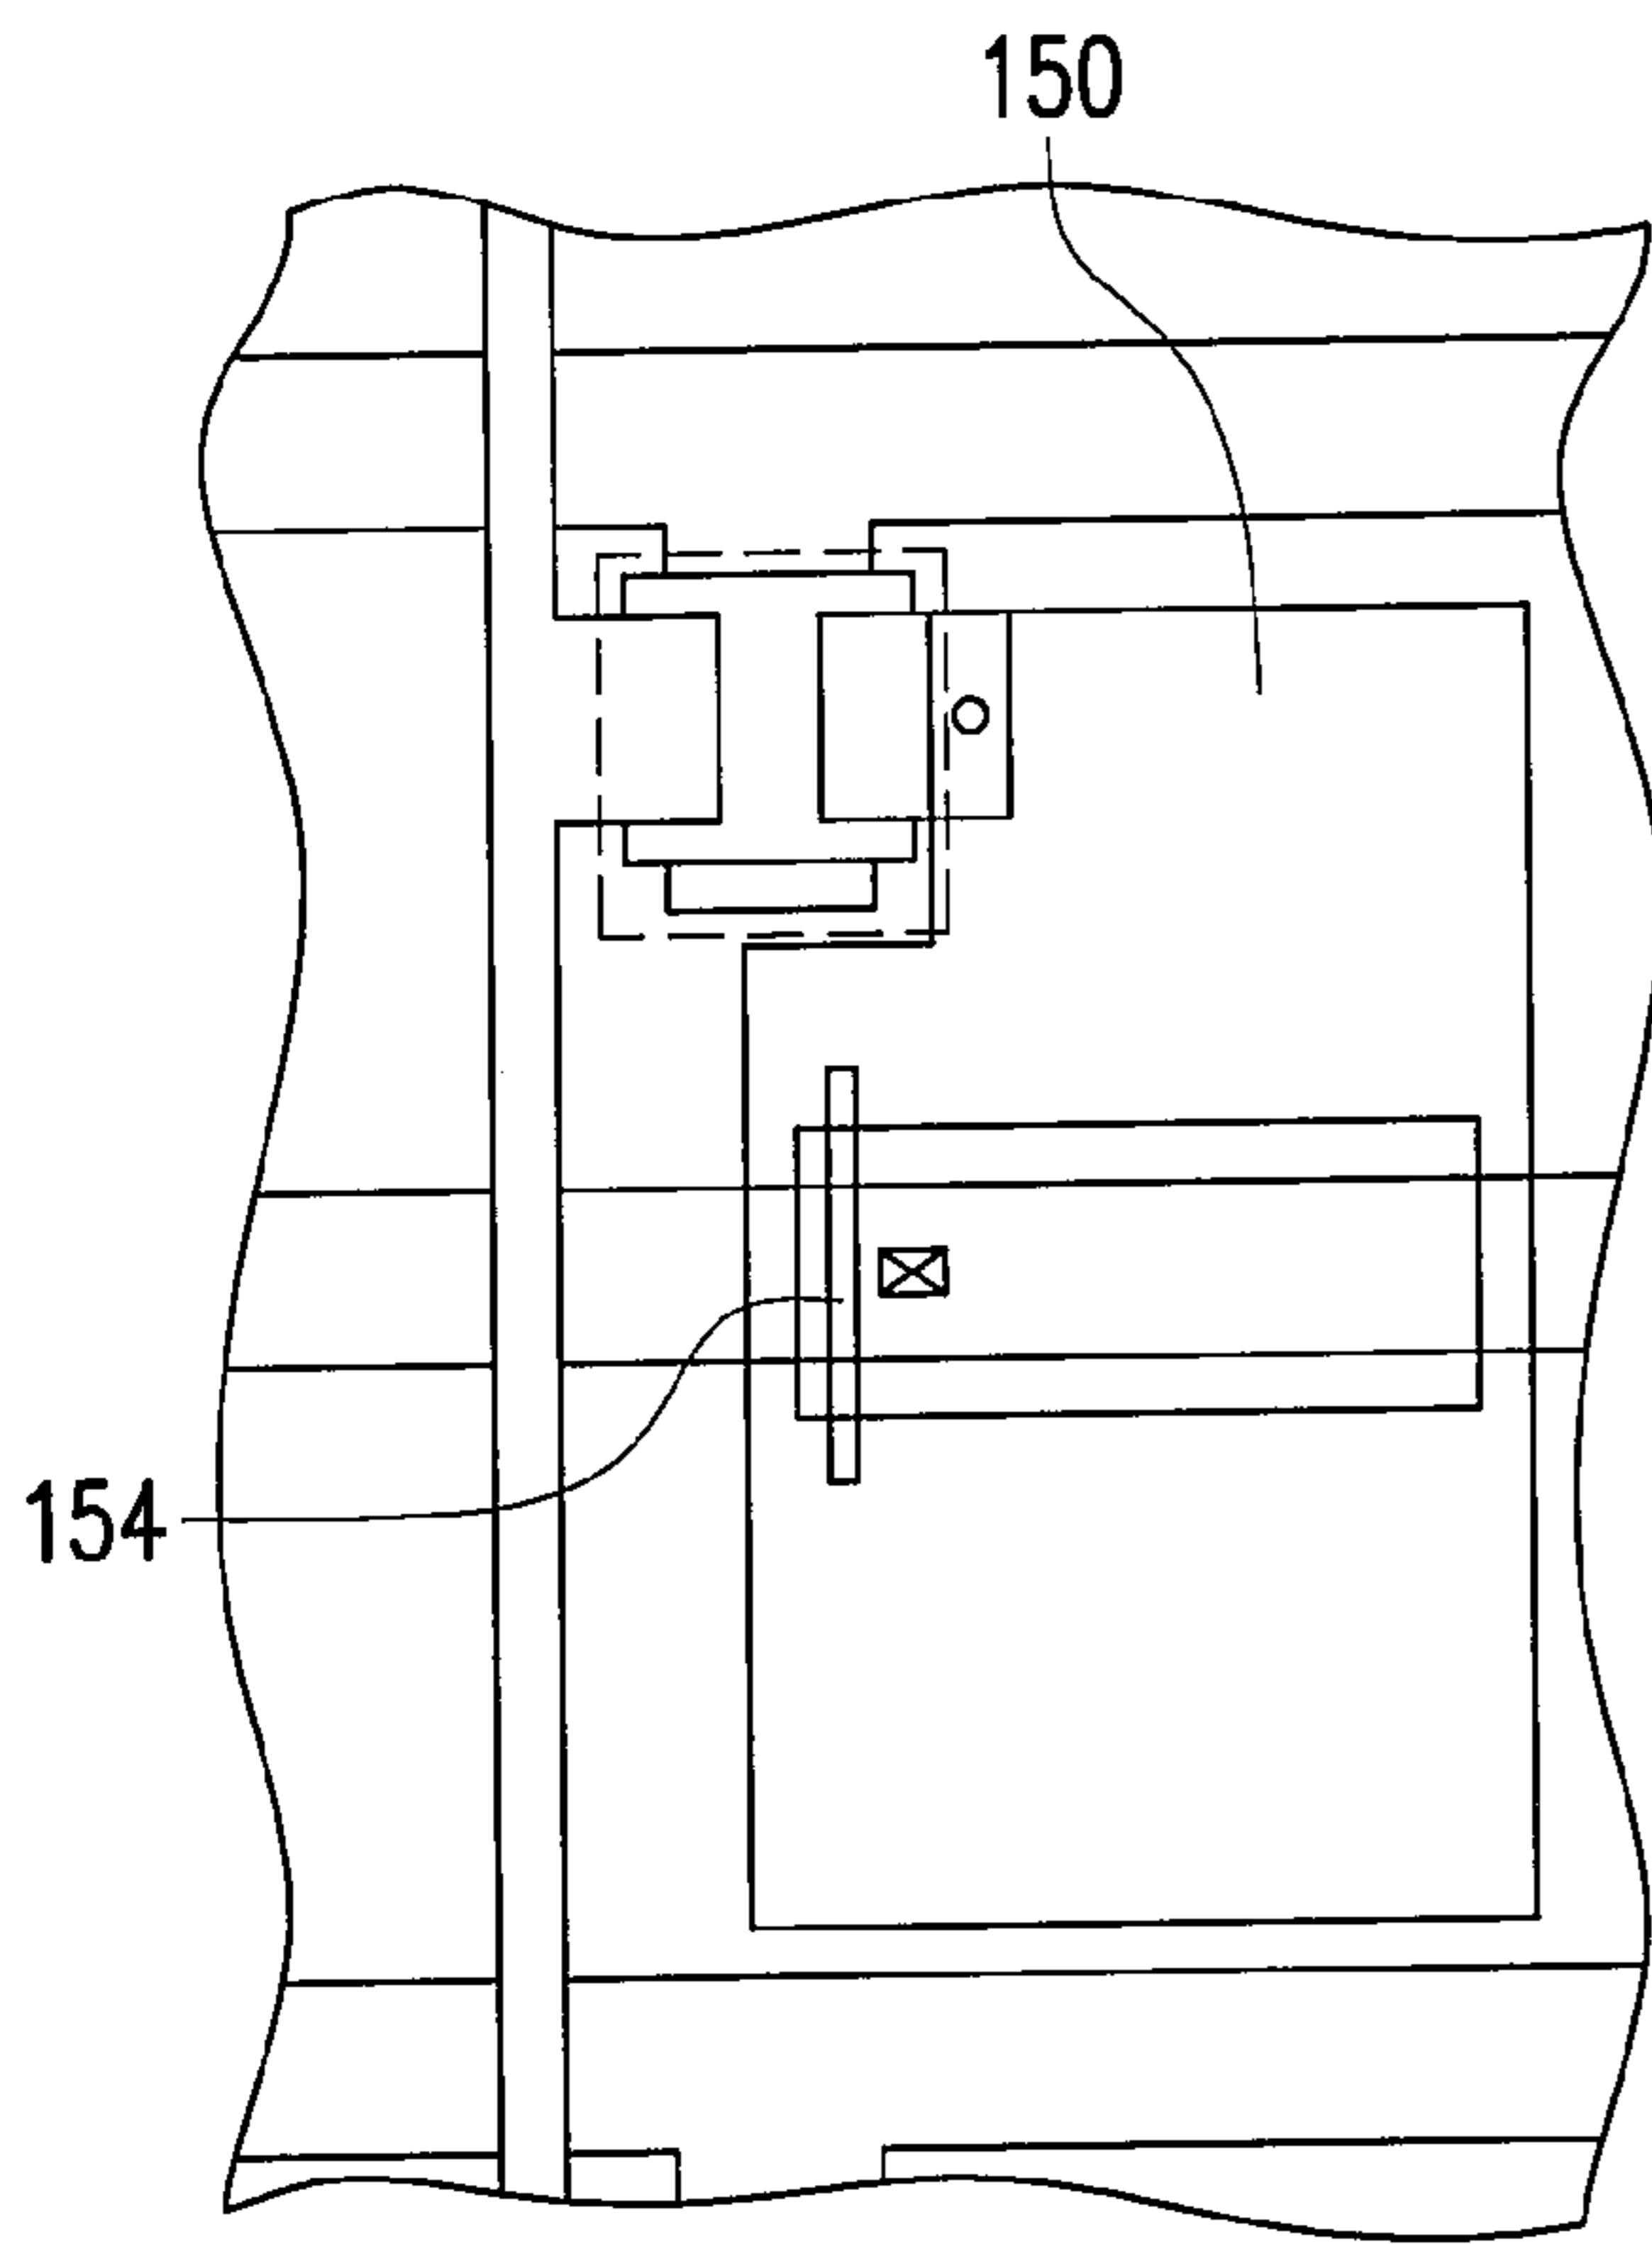
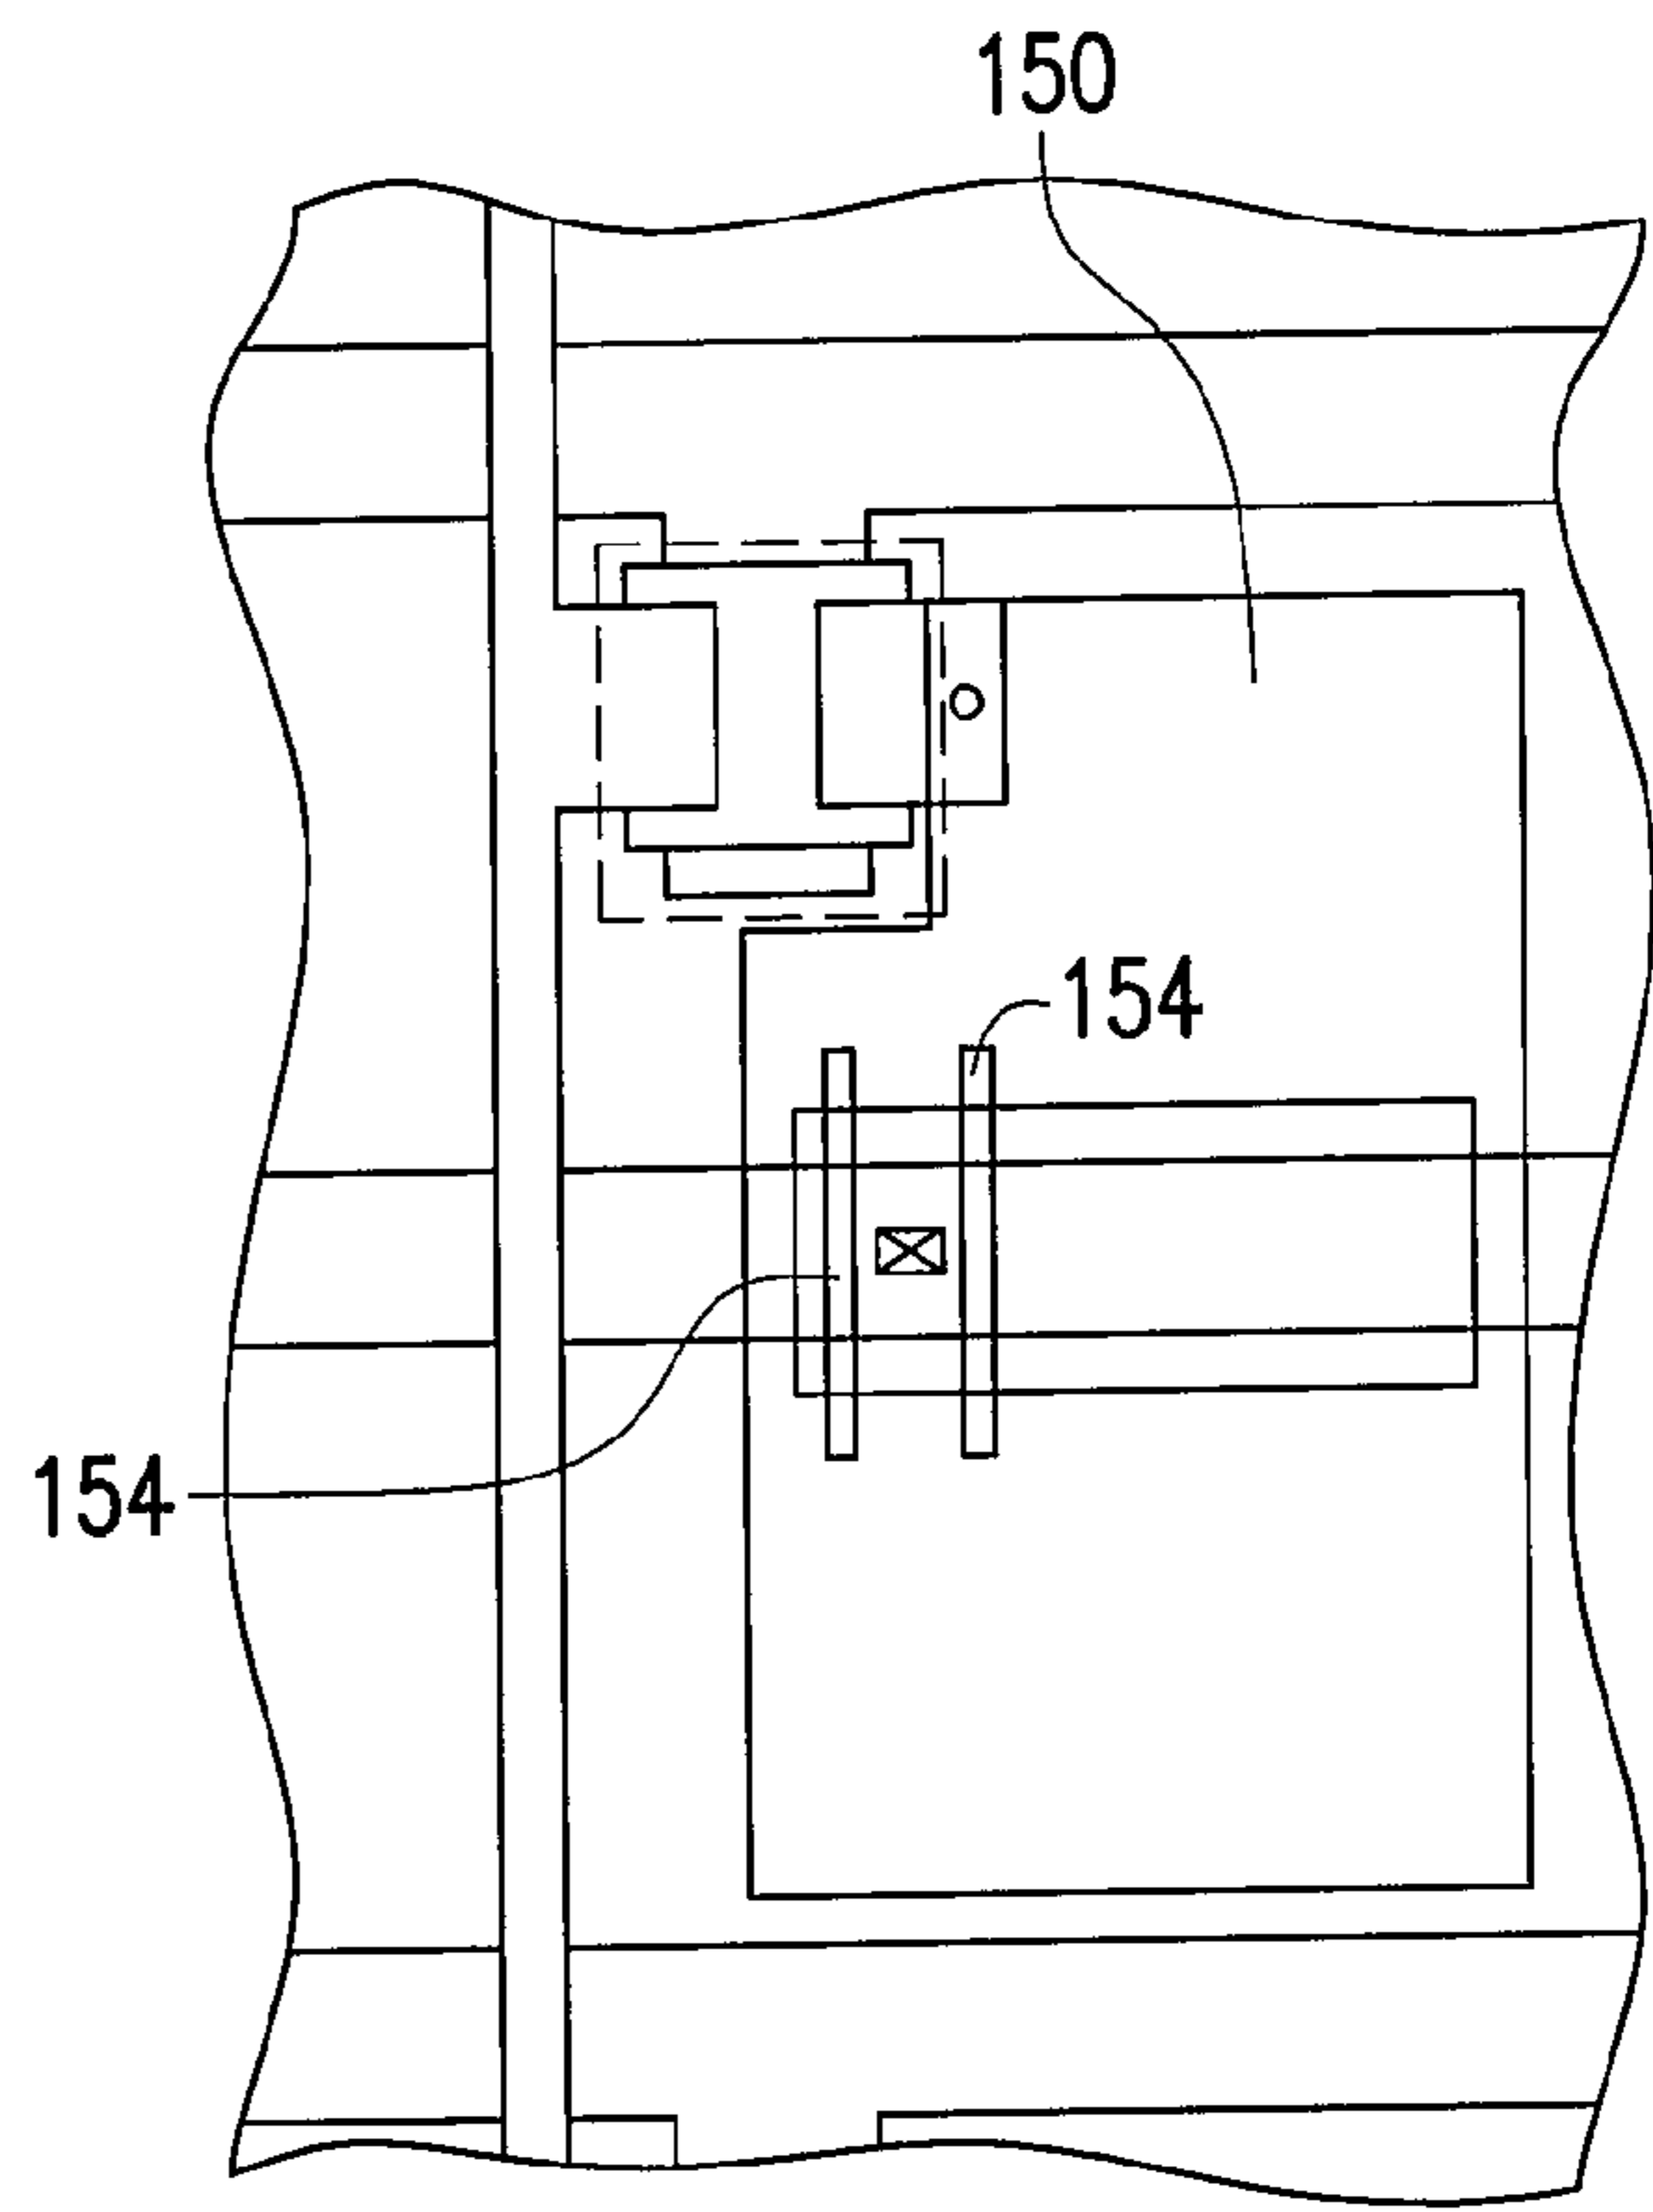
FIGS. **16A** through **16D** show the types of openings formed on the pixel electrode of a conventional thin film transistor array substrate. To simplify and speed up the repairing process, one or more openings **154** are also formed over the thin film transistor array substrate in the process of fabricating the pixel electrode **150**. For example, a straight line opening **154** (as shown in FIG. **16A**), a pair of straight line openings **154** (as shown in FIG. **16B**), an L-shaped opening **154** (as shown in FIG. **16C**) or a U-shaped opening **154** (as shown in FIG. **16D**) are formed over the pixel electrode **150**. Since the openings **154** are similar to the openings disclosed in FIGS. **9A** through **9D**, detailed description is omitted.

FIGS. 16A through 16D show the types of openings formed on the pixel electrode of a conventional thin film transistor array substrate.
