(10) **Patent No.:** **US 7,646,446 B2**
(45) **Date of Patent:** **Jan. 12, 2010**

(54) **REPAIRING METHOD OF A THIN FILM TRANSISTOR ARRAY SUBSTRATE**

(73) Assignee: **Au Optronics Corporation**, Hsinchu (TW)

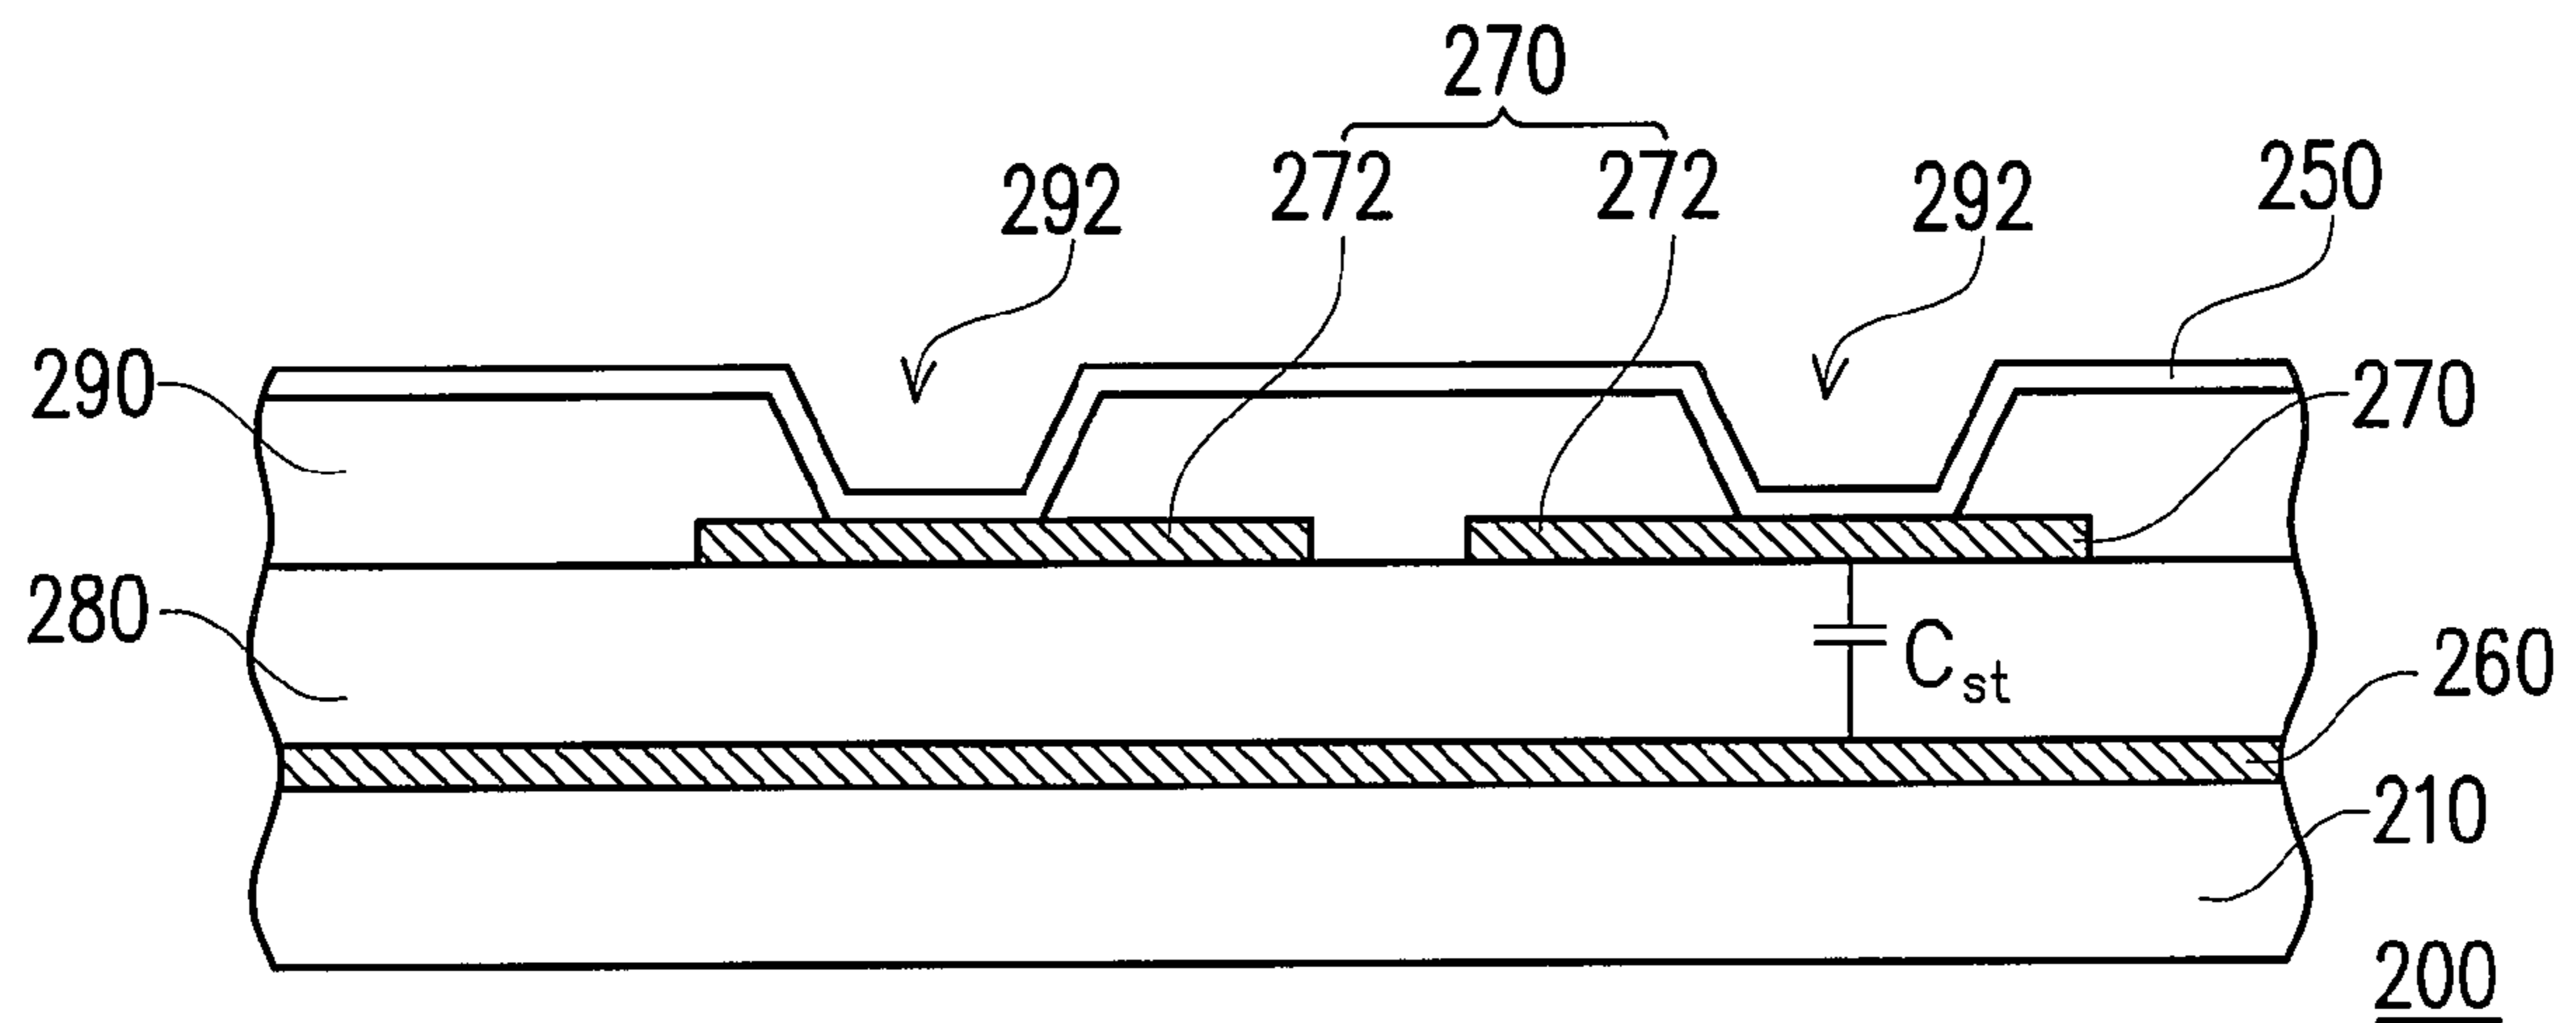
FIG. 4 is a schematic cross-sectional view along line B-B' of the thin film transistor array substrate in FIG. 3.

FIG. 3 is a top view of a thin film transistor array substrate according to one preferred embodiment of the present invention. FIG. 4 is a schematic cross-sectional view along line B-B' of the thin film transistor array substrate in FIG. 3. As shown in FIGS. 3 and 4, the thin film transistor array substrate 200 mainly comprises a substrate 210, a plurality of scan lines 220, a plurality of data lines 230, a plurality of thin film transistor 240, a plurality of pixel electrodes 250, a plurality of common lines 260 (only one is shown) and a patterned upper electrode 270.

The patterned upper electrode 270 is disposed between each pixel electrode 250 and the corresponding common line 260. A dielectric layer 280 is disposed between the patterned upper electrode 270 and the common line 260. Another dielectric layer 290 is disposed between the patterned upper electrode 270 and the pixel electrode 250. It should be noted that the patterned upper electrode 270 comprises a plurality of sub-upper electrodes 272 (only two of them are shown). A portion of each sub-upper electrode 272 is electrically connected to one of the pixel electrodes 250. For example, a contact 292 is formed in the dielectric layer 290 above each sub-upper electrode 272 so that each sub-upper electrode 272 is electrically connected to one of the pixel electrodes 250. Hence, the sub-upper electrode 272 and one of the common lines 260 together form a storage capacitor (Cst).

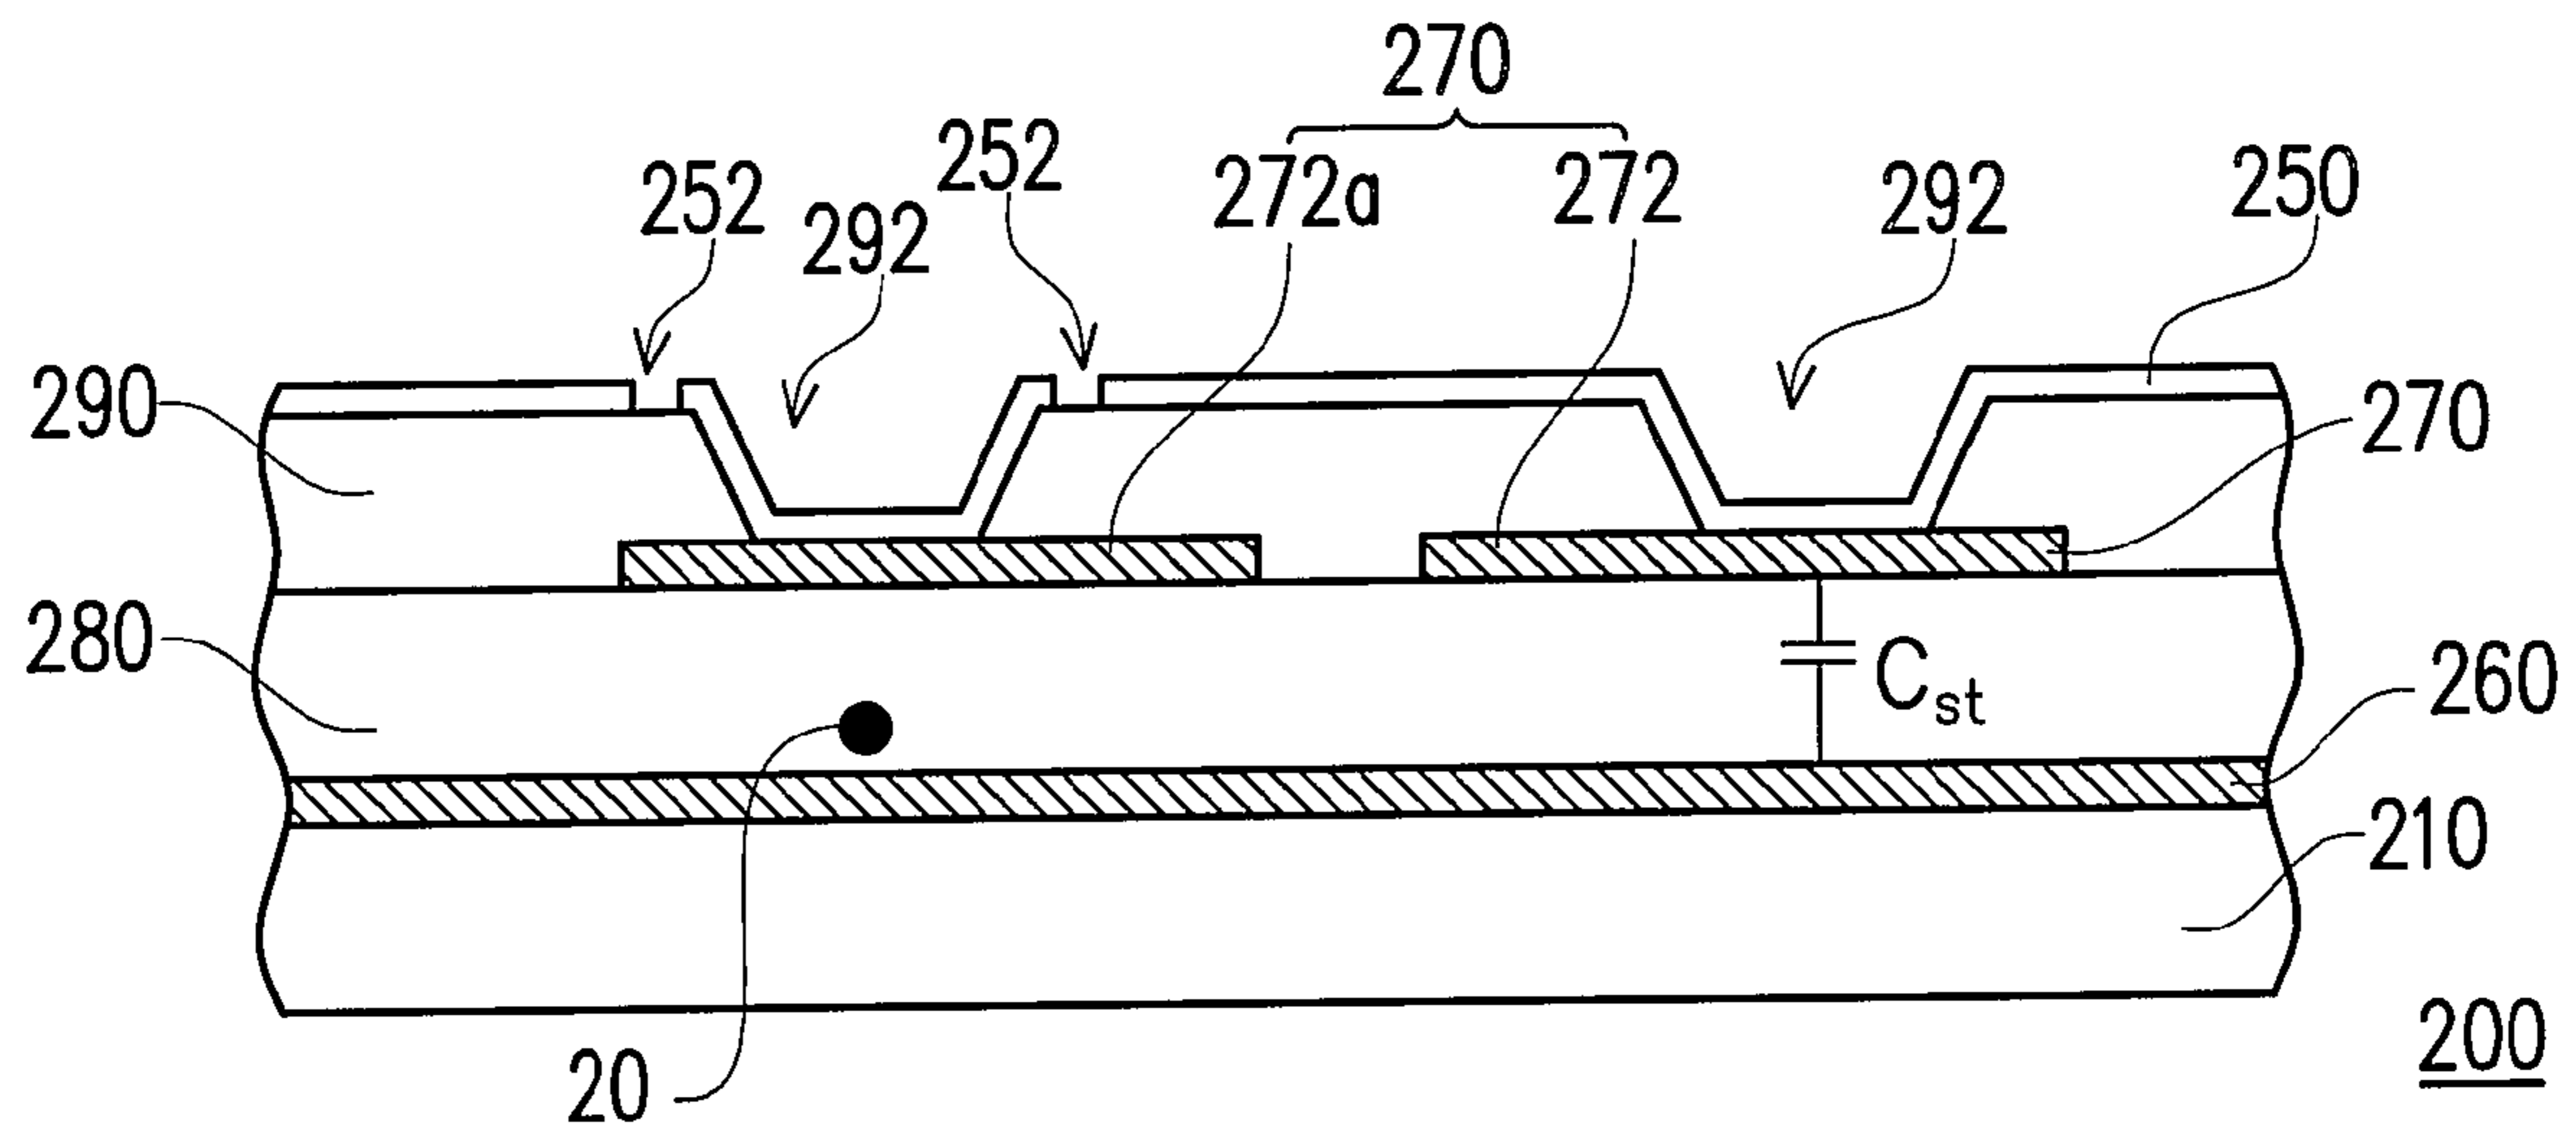
FIG. 6 is a schematic cross-sectional view along C-C' of the thin film transistor array substrate shown in FIG. 5.

FIG. 5 is a top view of the thin film transistor array substrate in FIG. 3 after performing a laser repairing operation. FIG. 6 is a schematic cross-sectional view along C-C' of the thin film transistor array substrate shown in FIG. 5. As shown in FIGS. 5 and 6, if there is a particle (or defect) in the material between one of the sub-upper electrodes 272 and one of the common lines 260, leakage between the sub-upper electrode 272a and the common line 260 may occur. Thus, the pixel may display abnormally and need a repair. The method of repairing the pixel includes removing a portion of the pixel electrode 250 corresponding to the sub-upper electrode 272a of the defective capacitor so that the sub-upper electrode 272a and the corresponding pixel electrode 250 of the defective capacitor are electrically isolated.

In the present embodiment, a portion of the pixel electrode 250 above the sub-upper electrode 272a of the corresponding defective capacitor is removed to form an opening 252. The method of removing a portion of the pixel electrode 250 includes laser ablation, for example. The opening 252 is located around the contact area between the sub-upper electrode 272a and the corresponding pixel electrode 250 of the defective capacitor (that is, around the contact 292). By forming the opening 252, the sub-upper electrode 272a and the corresponding pixel electrode 250 of the defective capacitor

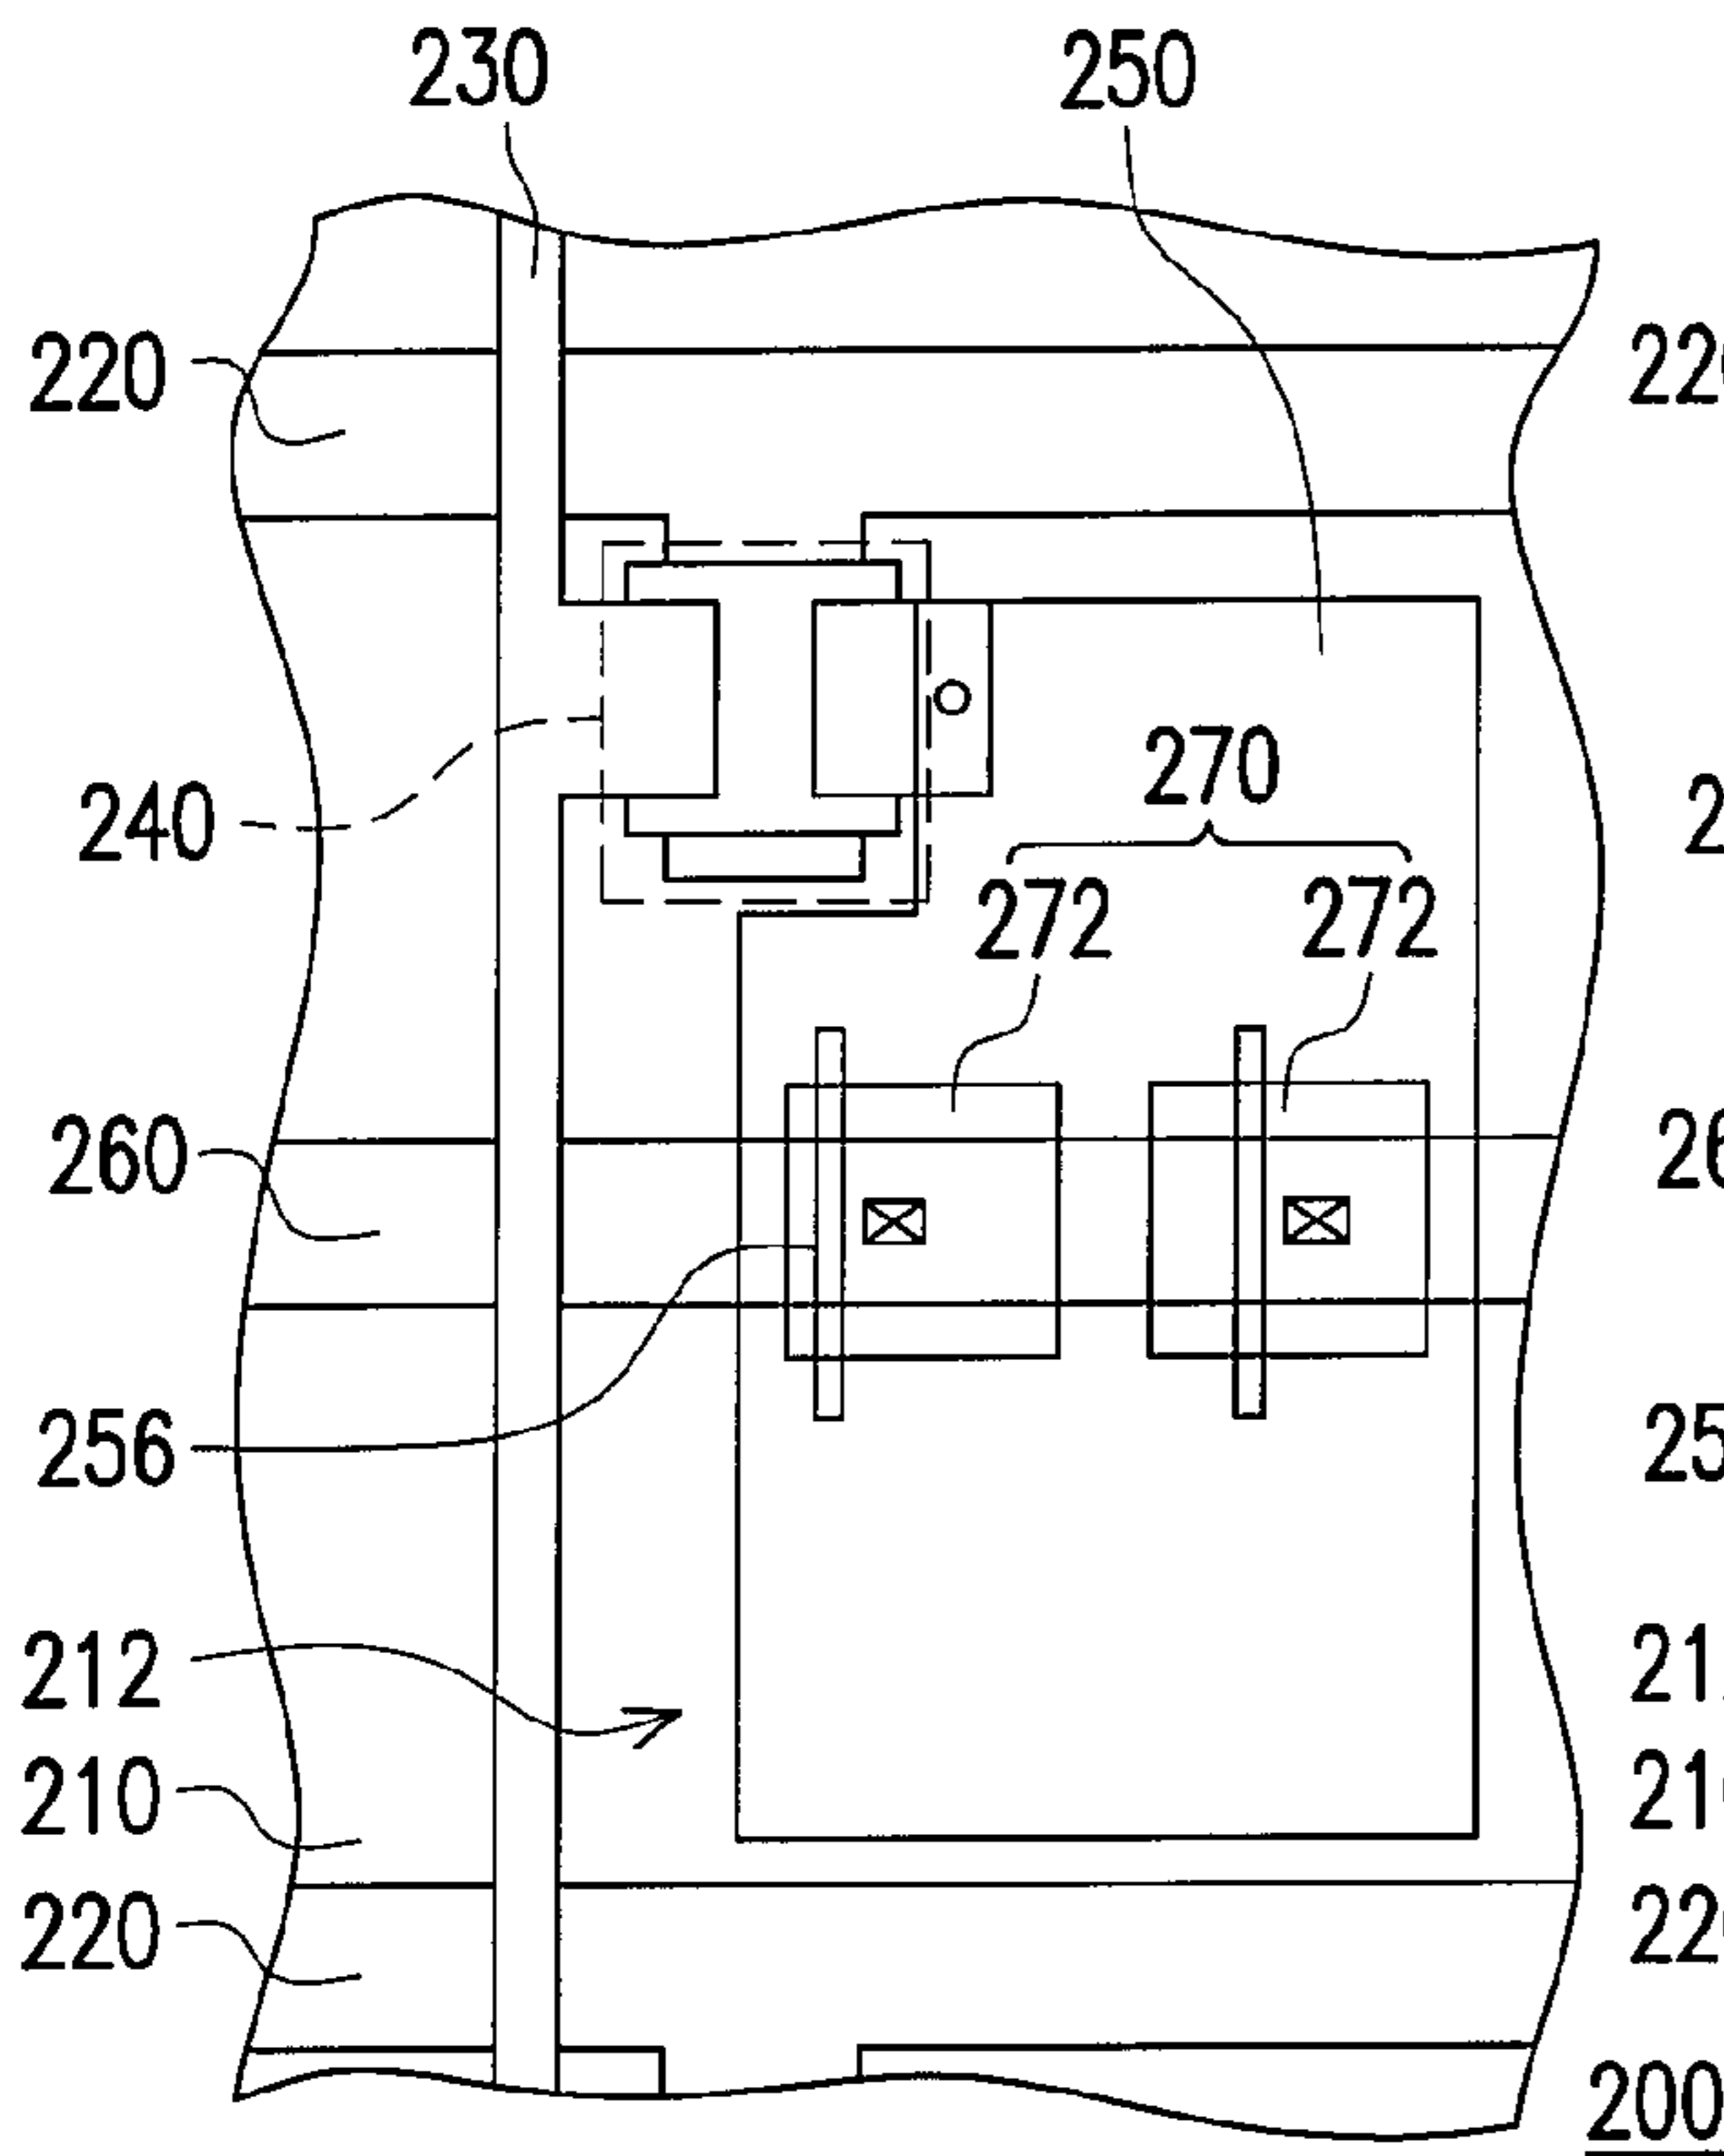
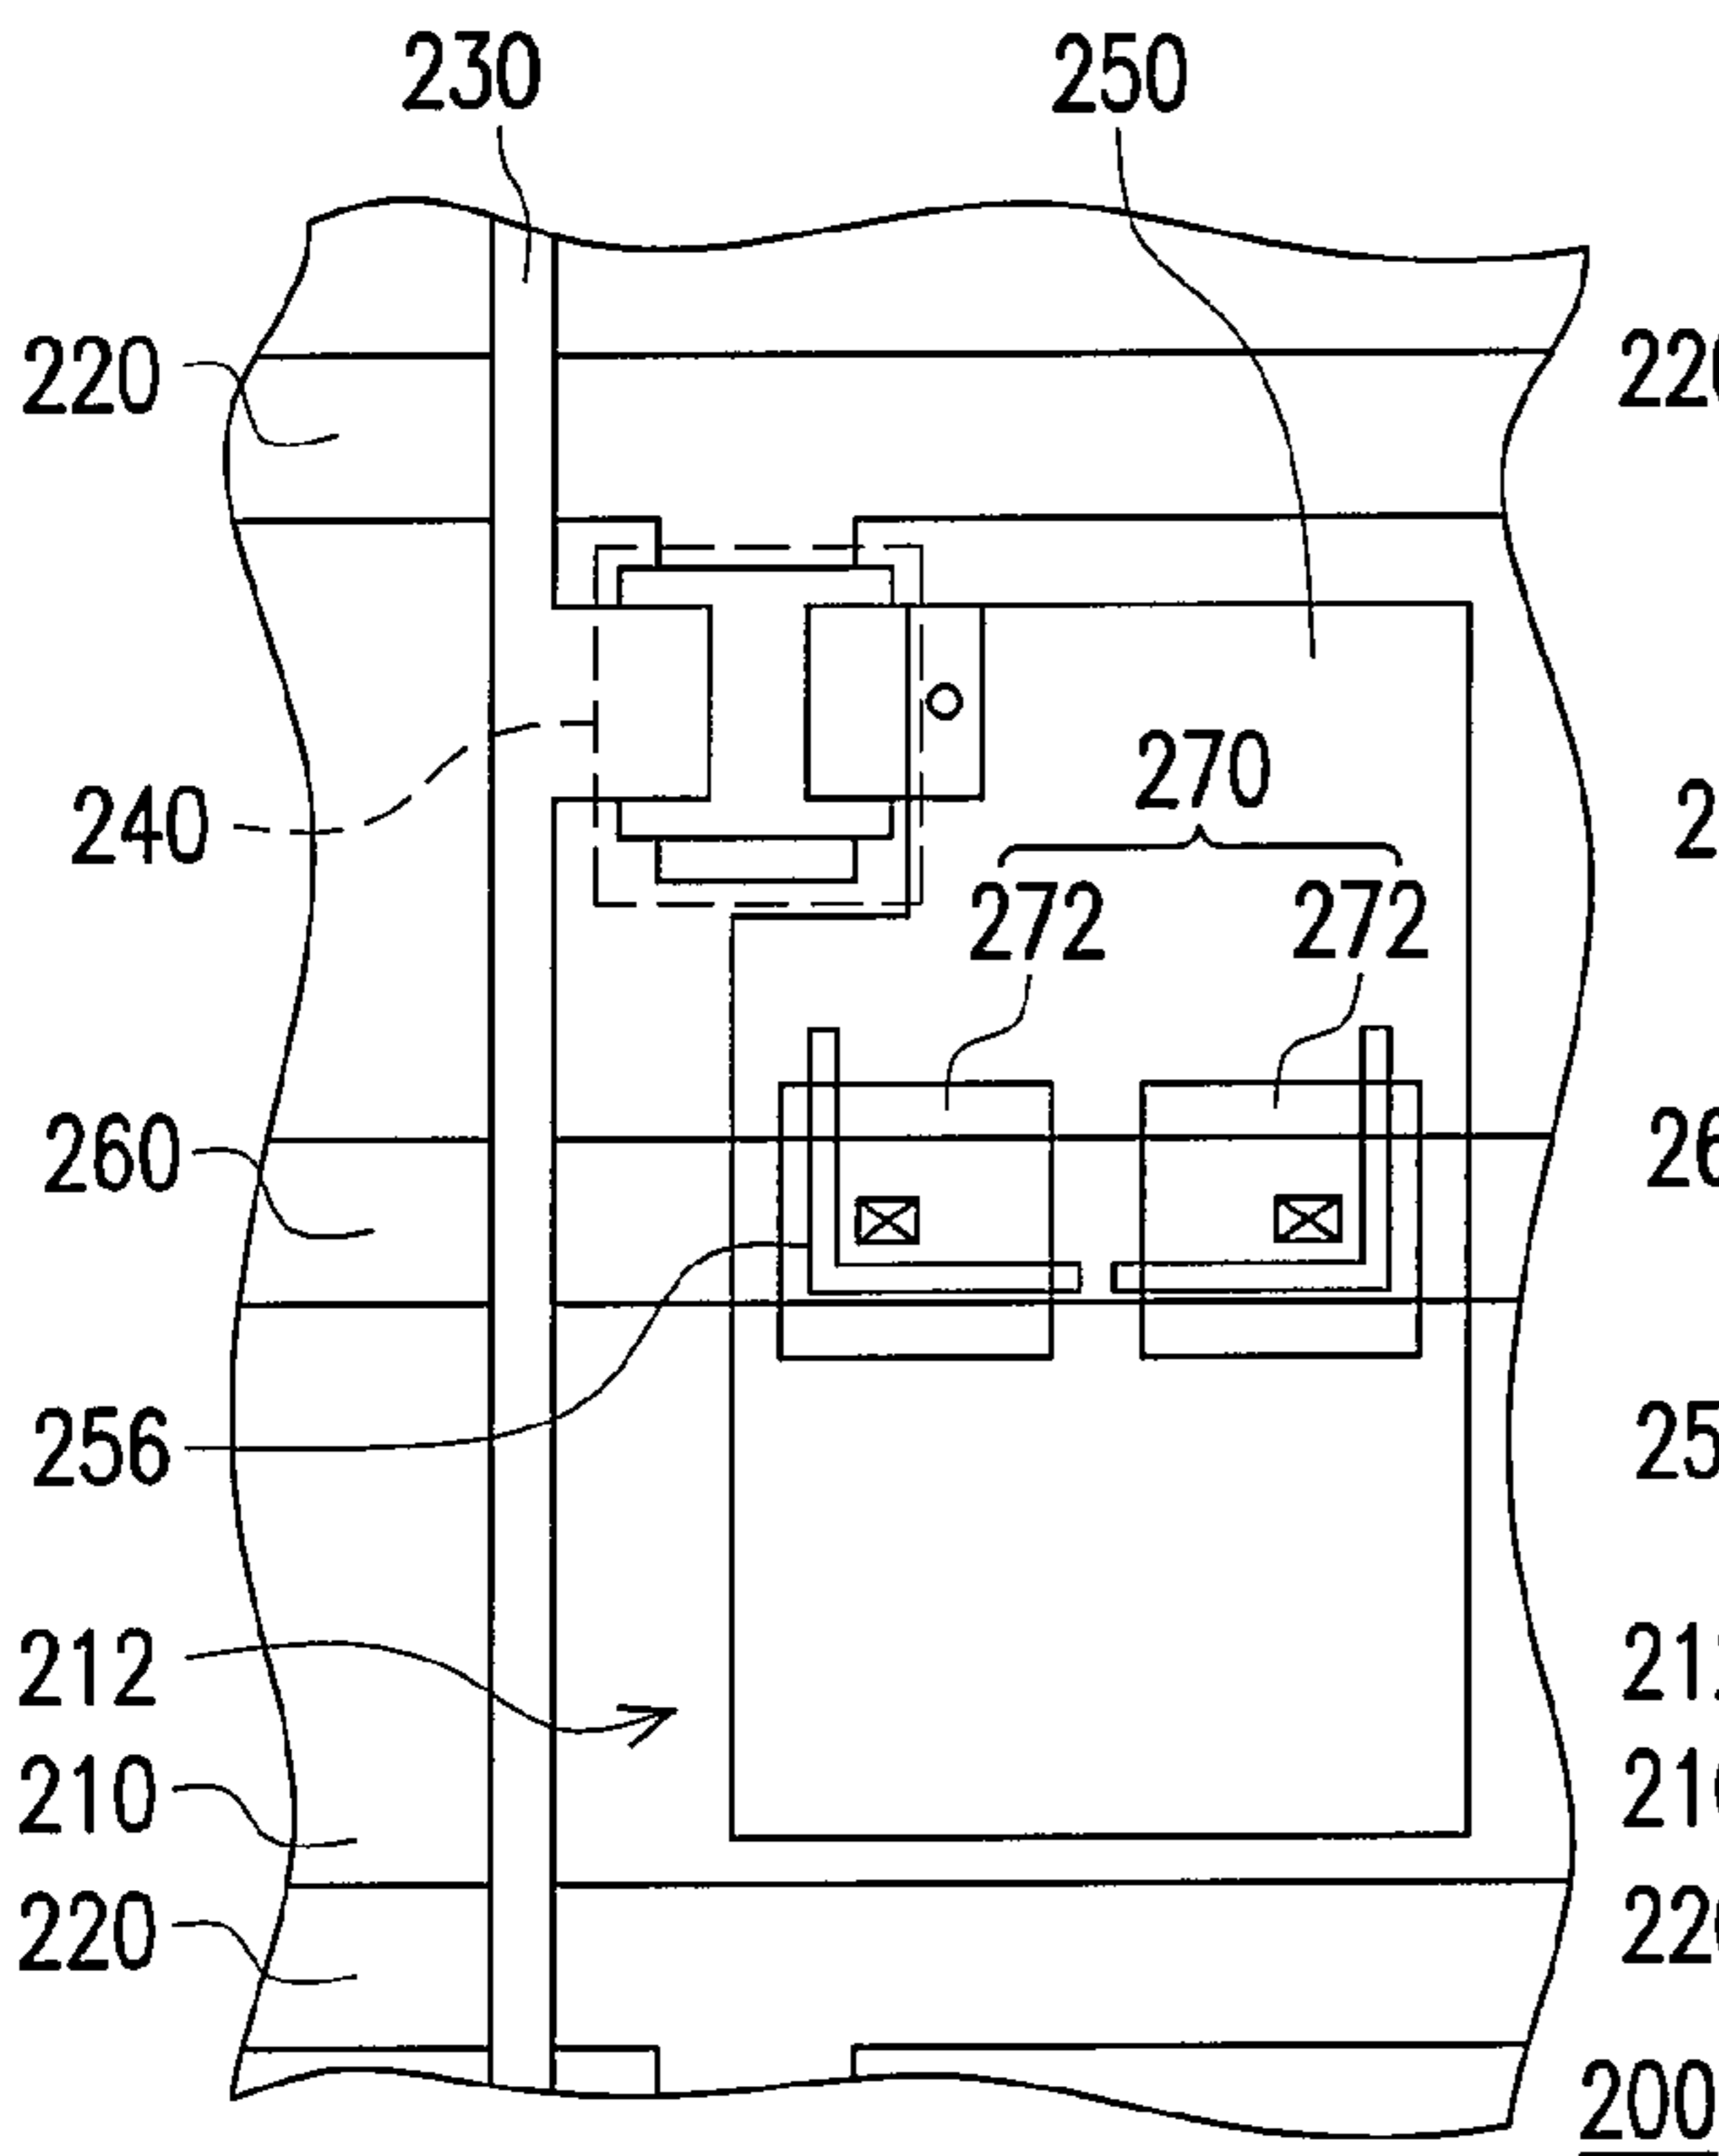
FIGS. 9A through 9D are top views showing different types of thin film transistor array substrates according to another preferred embodiment of the present invention.

FIGS. **9A** through **9D** are top views showing different types of thin film transistor array substrates according to another preferred embodiment of the present invention. The thin film transistor array substrate of the present embodiment is mostly identical to the one shown in FIG. **3**. One major difference is that one or more openings **256** are formed in each pixel electrode **250** when the pixel electrodes **250** are formed. The openings **256** are disposed around the contact region between each sub contact pad **272** and one of the pixel electrodes **250**. For example, a straight line opening **256** (shown in FIG. **9A**), two straight line openings **256** (shown in FIG. **9B**), an L-shaped opening (shown in FIG. **9C**) or a U-shaped opening **256** (shown in FIG. **9D**) is formed over the pixel electrode **250** corresponding to each sub contact pad **272**. With an opening **256** formed over the every pixel electrode **250**, a portion of any one pixel electrode **250** can be readily removed to connect the ends of the opening **256**. Hence, an opening similar to the opening **252** that encircles the contact **292** as shown in FIG. **5** can be produced when there is a particle (or defect) between a sub-upper electrode **272** and one of the common lines **260**. In the present embodiment, the method of removing a portion of the pixel electrode **250** includes performing a laser ablation process.

As shown in FIGS. **9A** through **9D**, a portion of the opening **256** is disposed above the area occupied by the sub-upper electrode **272** while the remaining portion of the opening **256** is disposed outside the area occupied by the sub-upper electrode **272**. In other words, the openings **256** also cover a region outside the upper electrode **272** to simplify and speed the repairing operation. In addition, anyone familiar with the

technology may notice that there is no particular restriction on the dimension of each opening **256**.

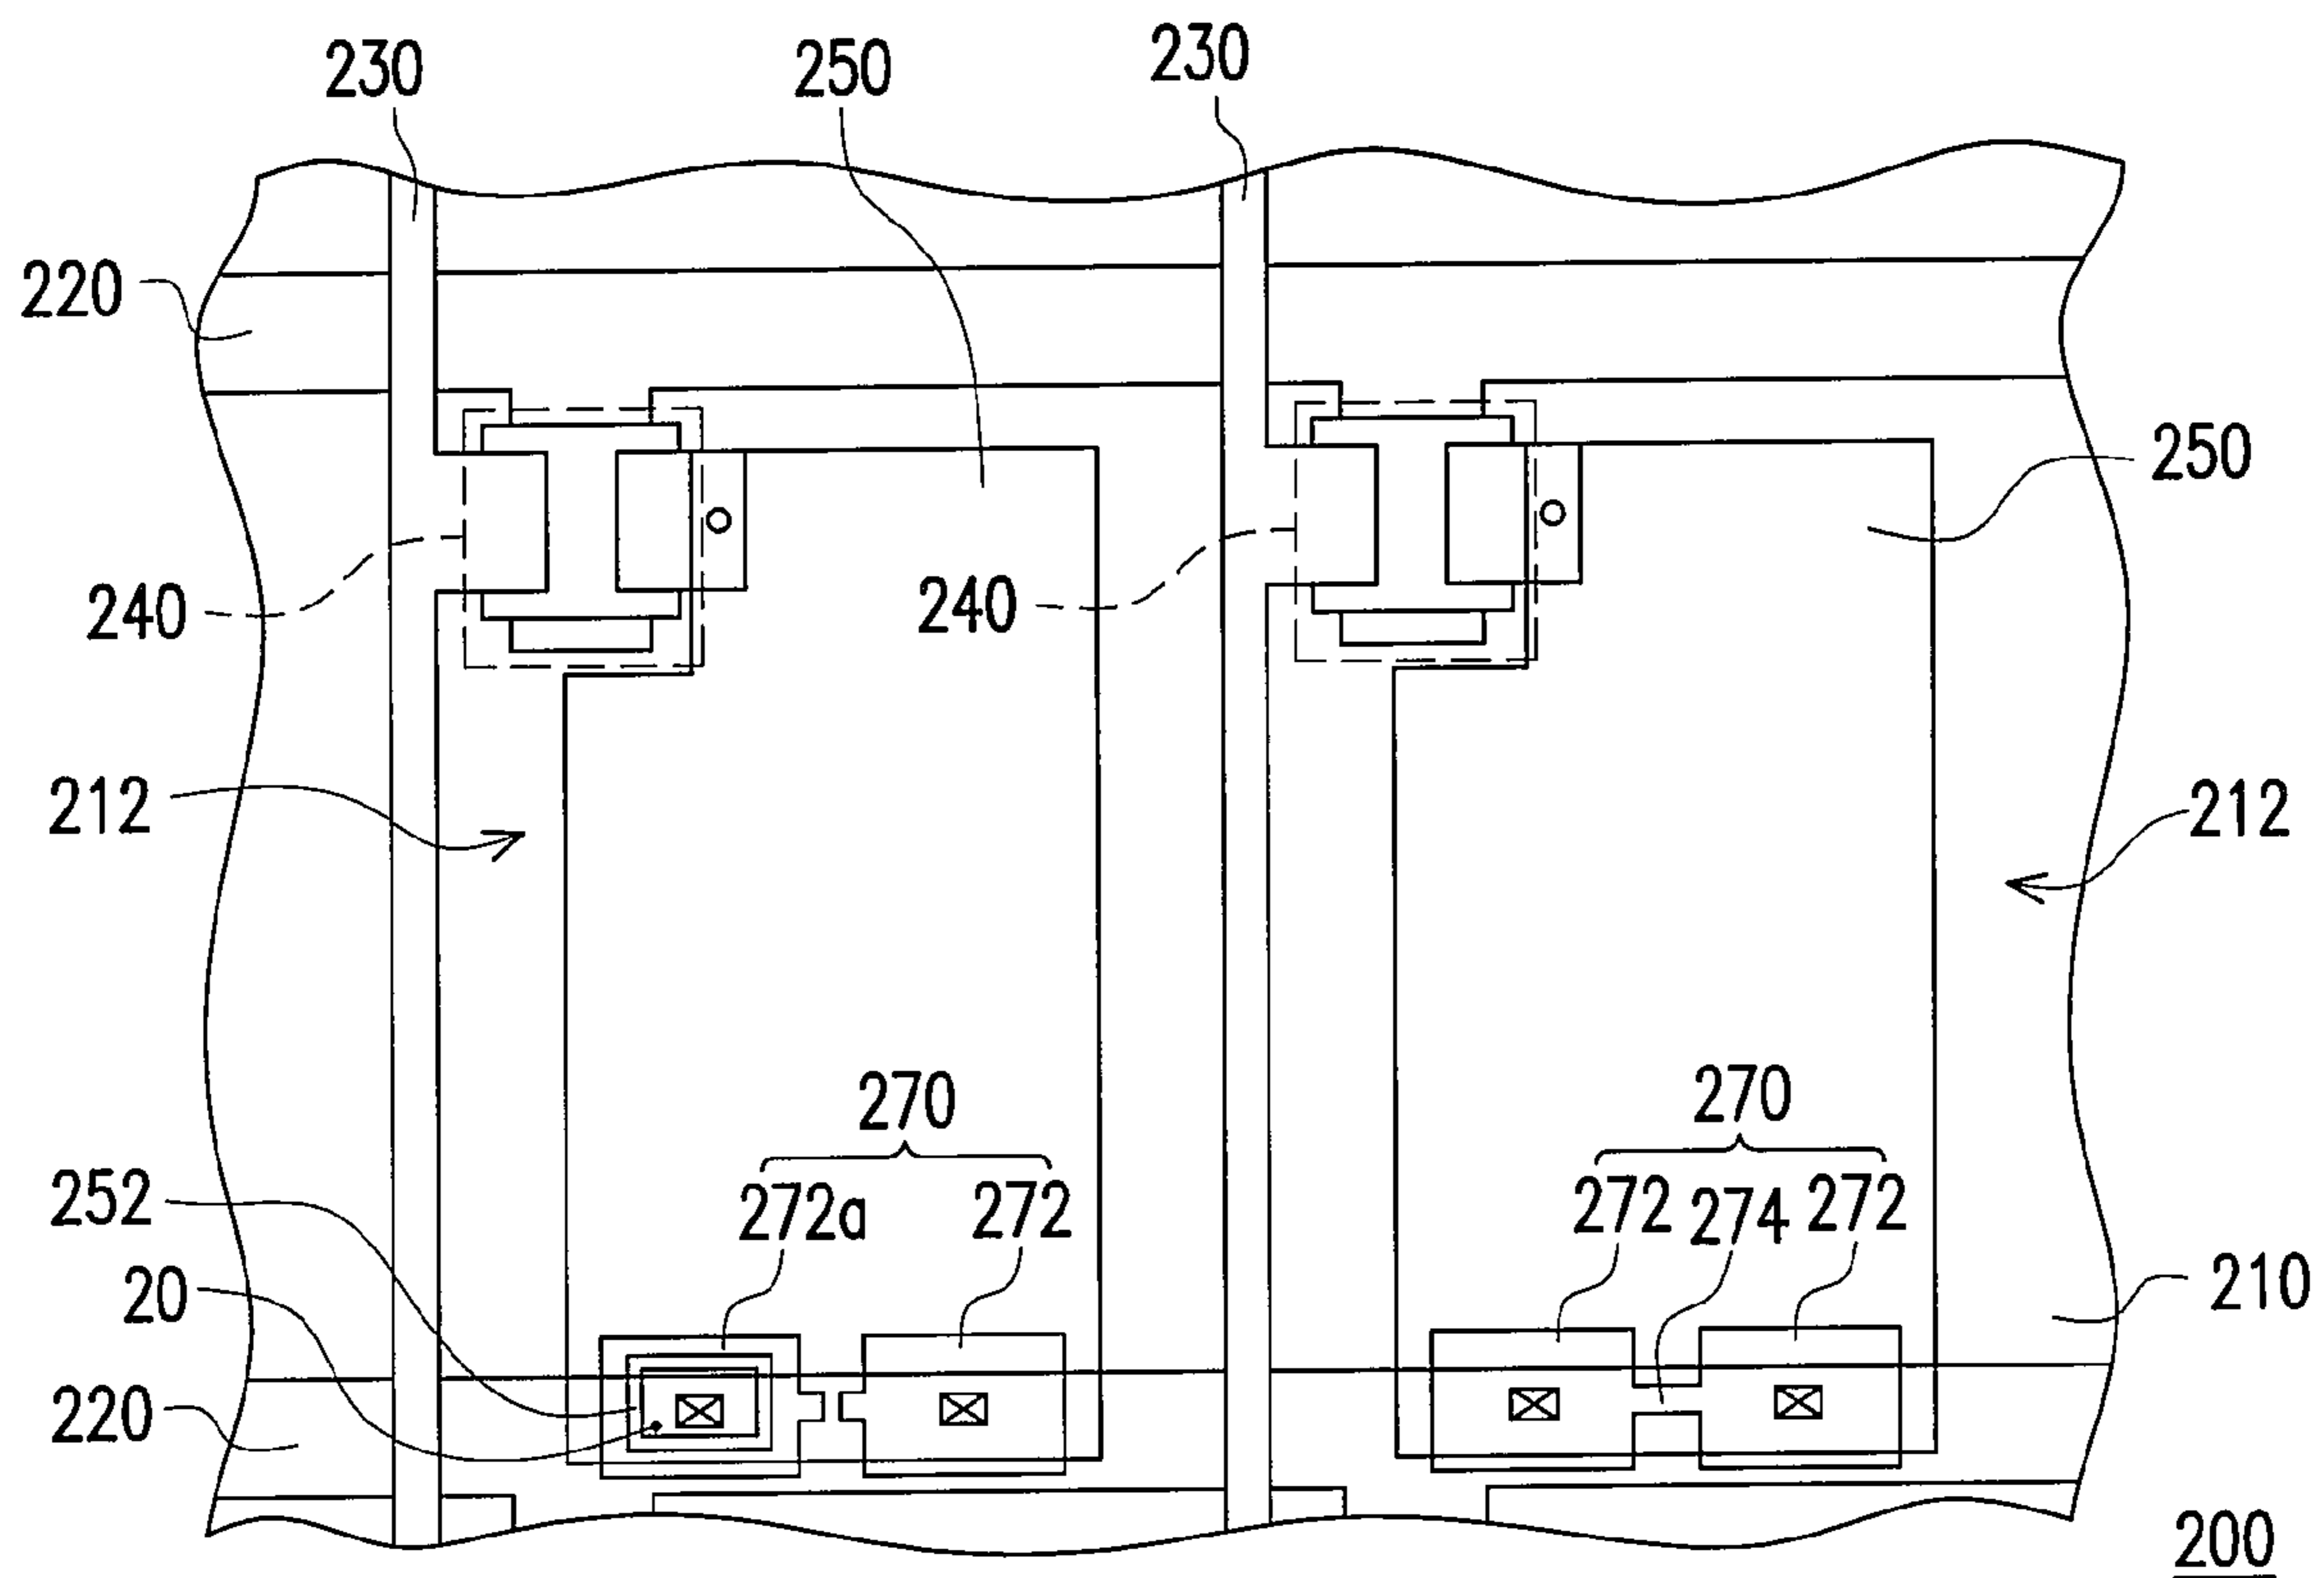
FIG. 13

FIGS. 12 and 13 are top views showing the method of repairing the scan line structure of the storage capacitor inside a thin film transistor array substrate according to the present invention.

As shown in FIG. **13**, the patterned upper electrode **270** is disposed between each pixel electrode **250** and one of the scan lines **220**. The patterned upper electrode **270** comprises a plurality of sub-upper electrodes **272**. Furthermore, each sub-upper electrode **272** underneath the pixel electrode **250** has a neck portion **274** connecting with each other. The neck portion **274** serves as a cutting area in a repairing operation.

As shown in FIG. **13**, the repairing method includes removing a portion of the pixel electrode corresponding to the sub-upper electrode **272a** of the defective capacitor to form an opening **252**. Furthermore, the neck portion **274** connecting with the sub-upper electrode **272a** of the defective capacitor is cut so that the sub-upper electrode **272a** of the defective capacitor and the corresponding pixel electrode **250** are electrically isolated. The method of removing a portion of the pixel electrode **250** includes a laser ablation process and the method of cutting the neck portion **274** includes a laser cutting operation.
