(12) **United States Patent**  
**Lai**

(10) **Patent No.:** **US 7,646,446 B2**  
(45) **Date of Patent:** **Jan. 12, 2010**

(54) **REPAIRING METHOD OF A THIN FILM TRANSISTOR ARRAY SUBSTRATE**

(73) Assignee: **Au Optronics Corporation**, Hsinchu (TW)

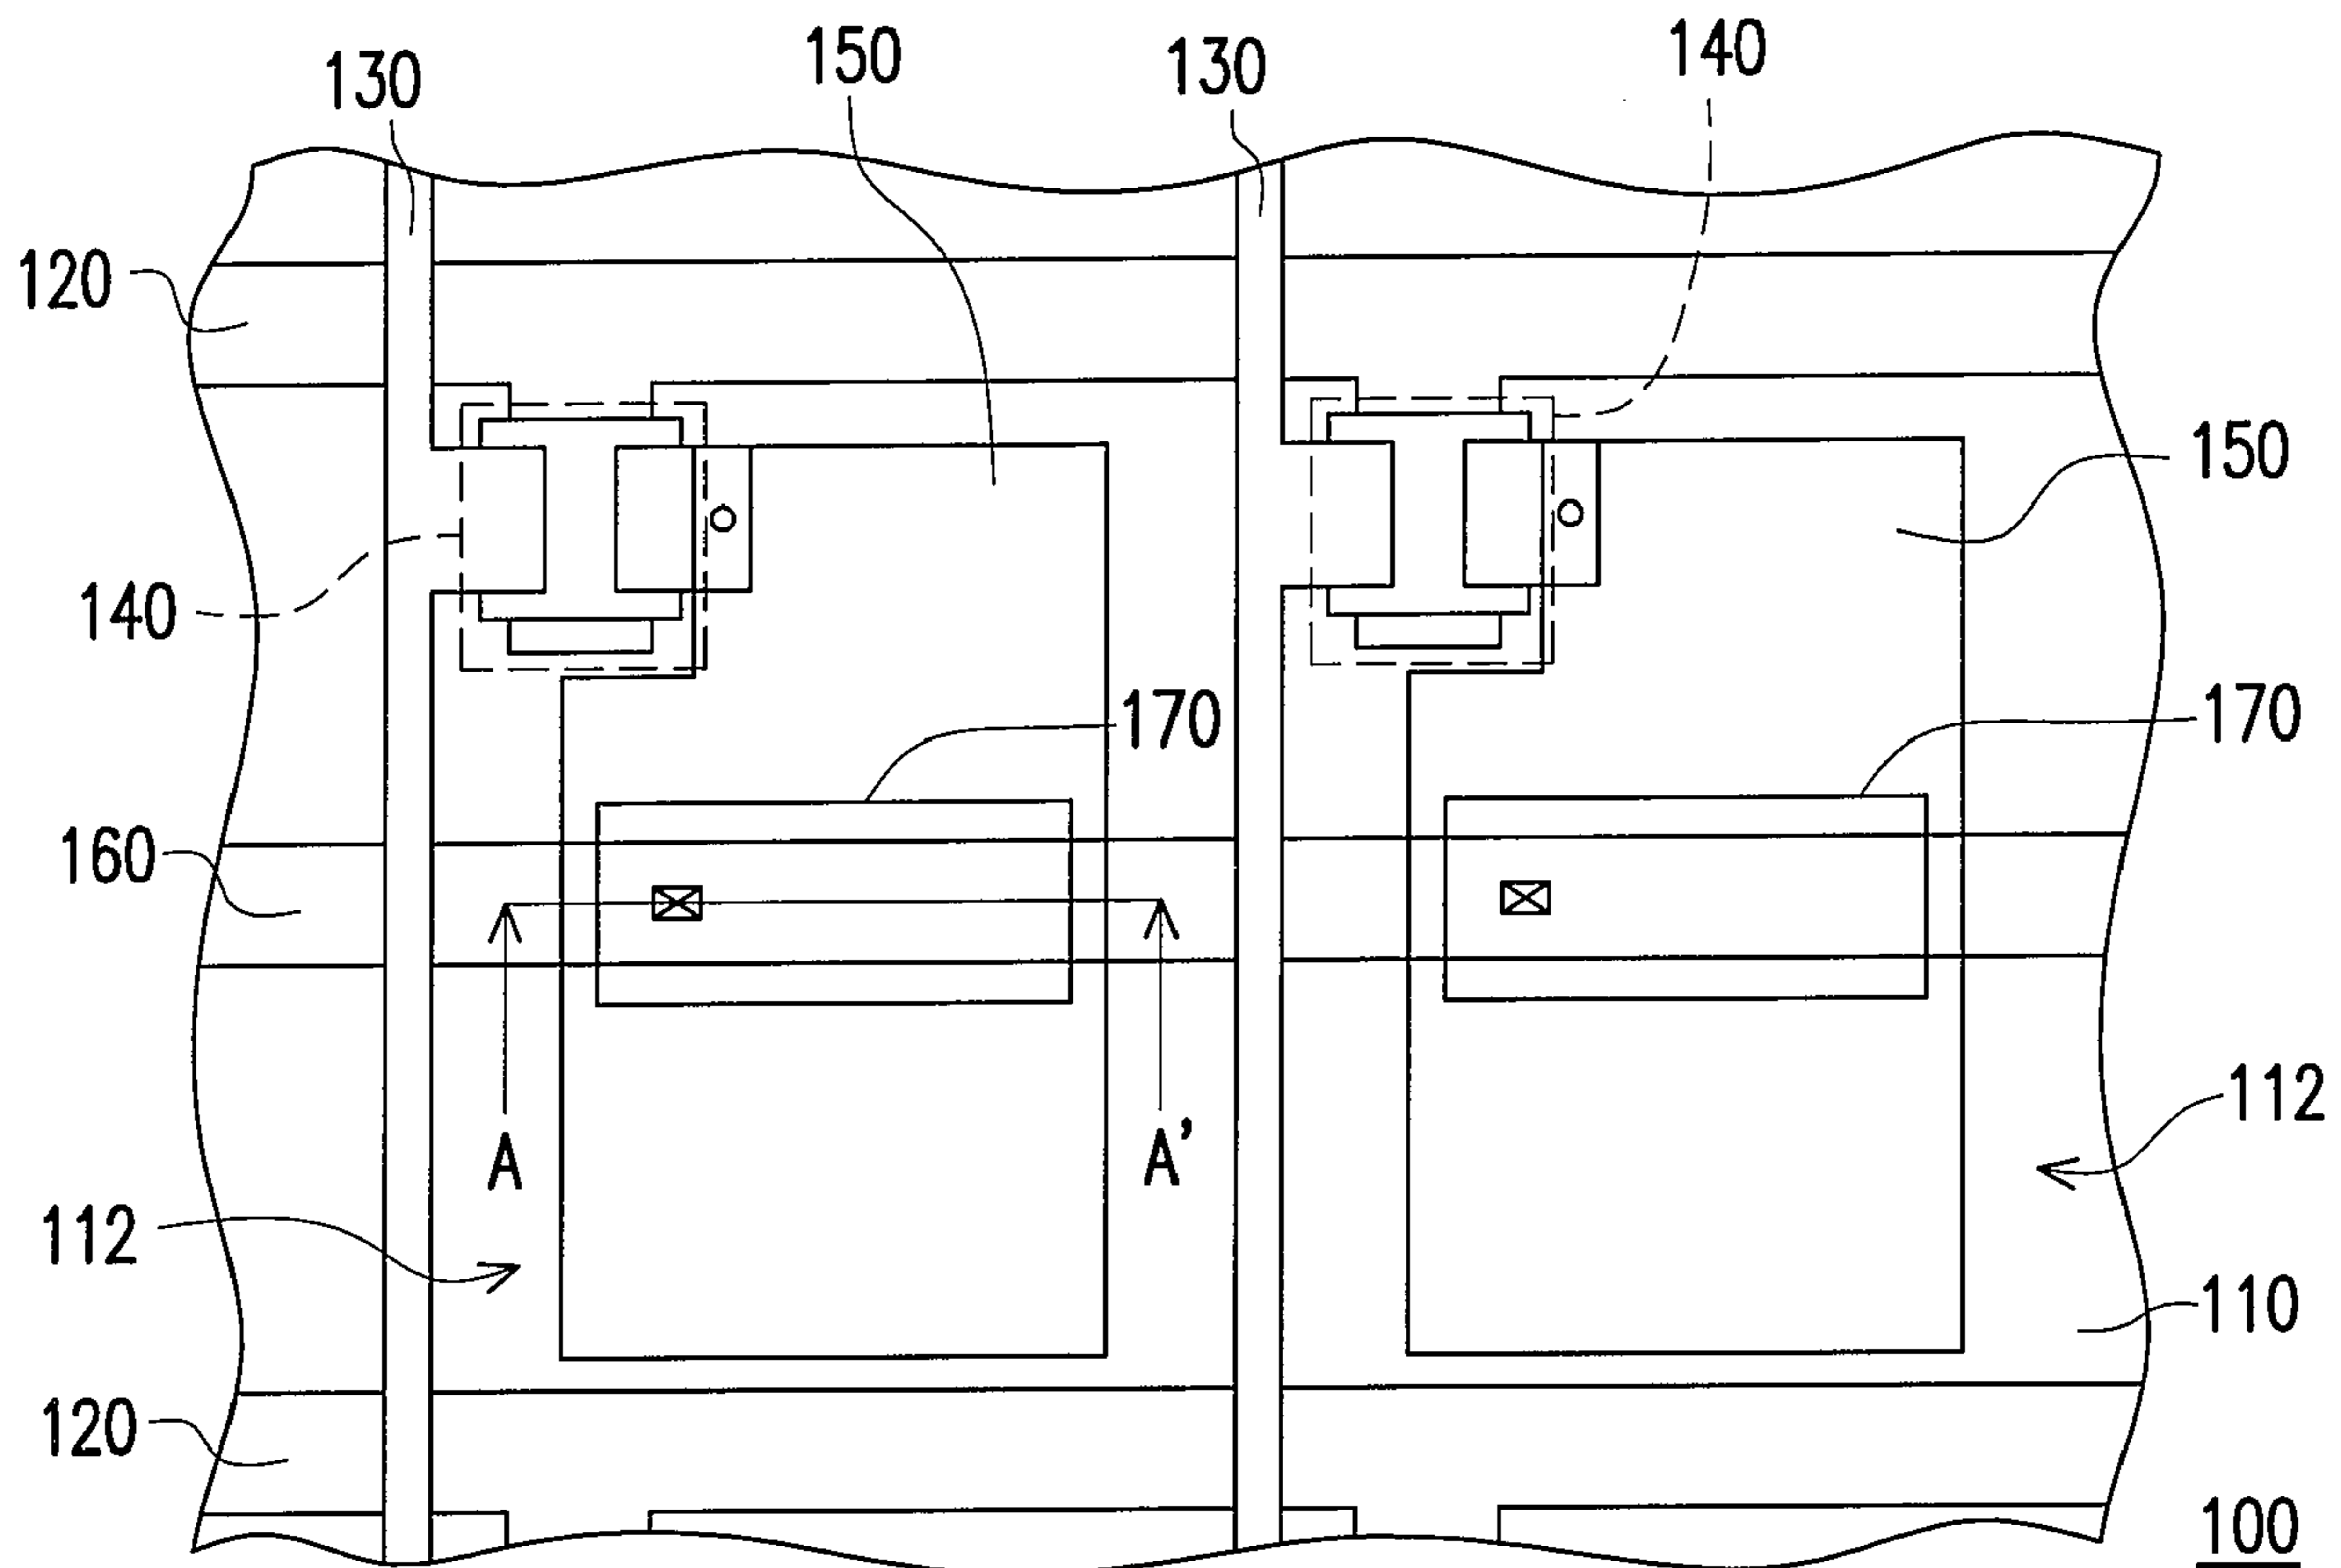
FIG. 1 (PRIOR ART)

FIG. 1 is a top view of a portion of a conventional thin film transistor array substrate. FIG. 2 is a schematic cross-sectional view along line A-A' of the thin film transistor array

substrate in FIG. 1. As shown in FIGS. 1 and 2, a conventional thin film transistor array substrate 100 mainly comprises a substrate 110, a plurality of scan lines 120, a plurality of data lines 130, a plurality of thin film transistors 140, a plurality of pixel electrodes 150, a plurality of common lines 160 (only one is shown) and a plurality of upper electrode 170.

The scan lines 120 and the data lines 130 are disposed over the substrate 110 to define a plurality of pixel areas 112. Each thin film transistor 140 is disposed inside one of the pixel areas 112 and is driven by one of the scan lines 120 and data lines 130. Each pixel electrode 150 is also disposed inside one of the pixel areas 112 and is electrically connected to one of the thin film transistors 140. The common line 160 is disposed over the substrate 110 such that a portion of the pixel electrode 150 is above one of the common lines 160.

In addition, an upper electrode 170 is disposed between each pixel electrode 150 and one of the common lines 160. Furthermore, a dielectric layer 180 is disposed between the upper electrode 170 and the corresponding common line 160 for isolating the upper electrode 170 and the common line 160. Another dielectric layer 190 is also disposed between the upper electrode 170 and one of the pixel electrodes 150. The dielectric layer 190 has a contact 192 for connecting the upper electrode 170 and the corresponding pixel electrode 150 electrically together.

FIG. 1 is a top view of a portion of a conventional thin film transistor array substrate.

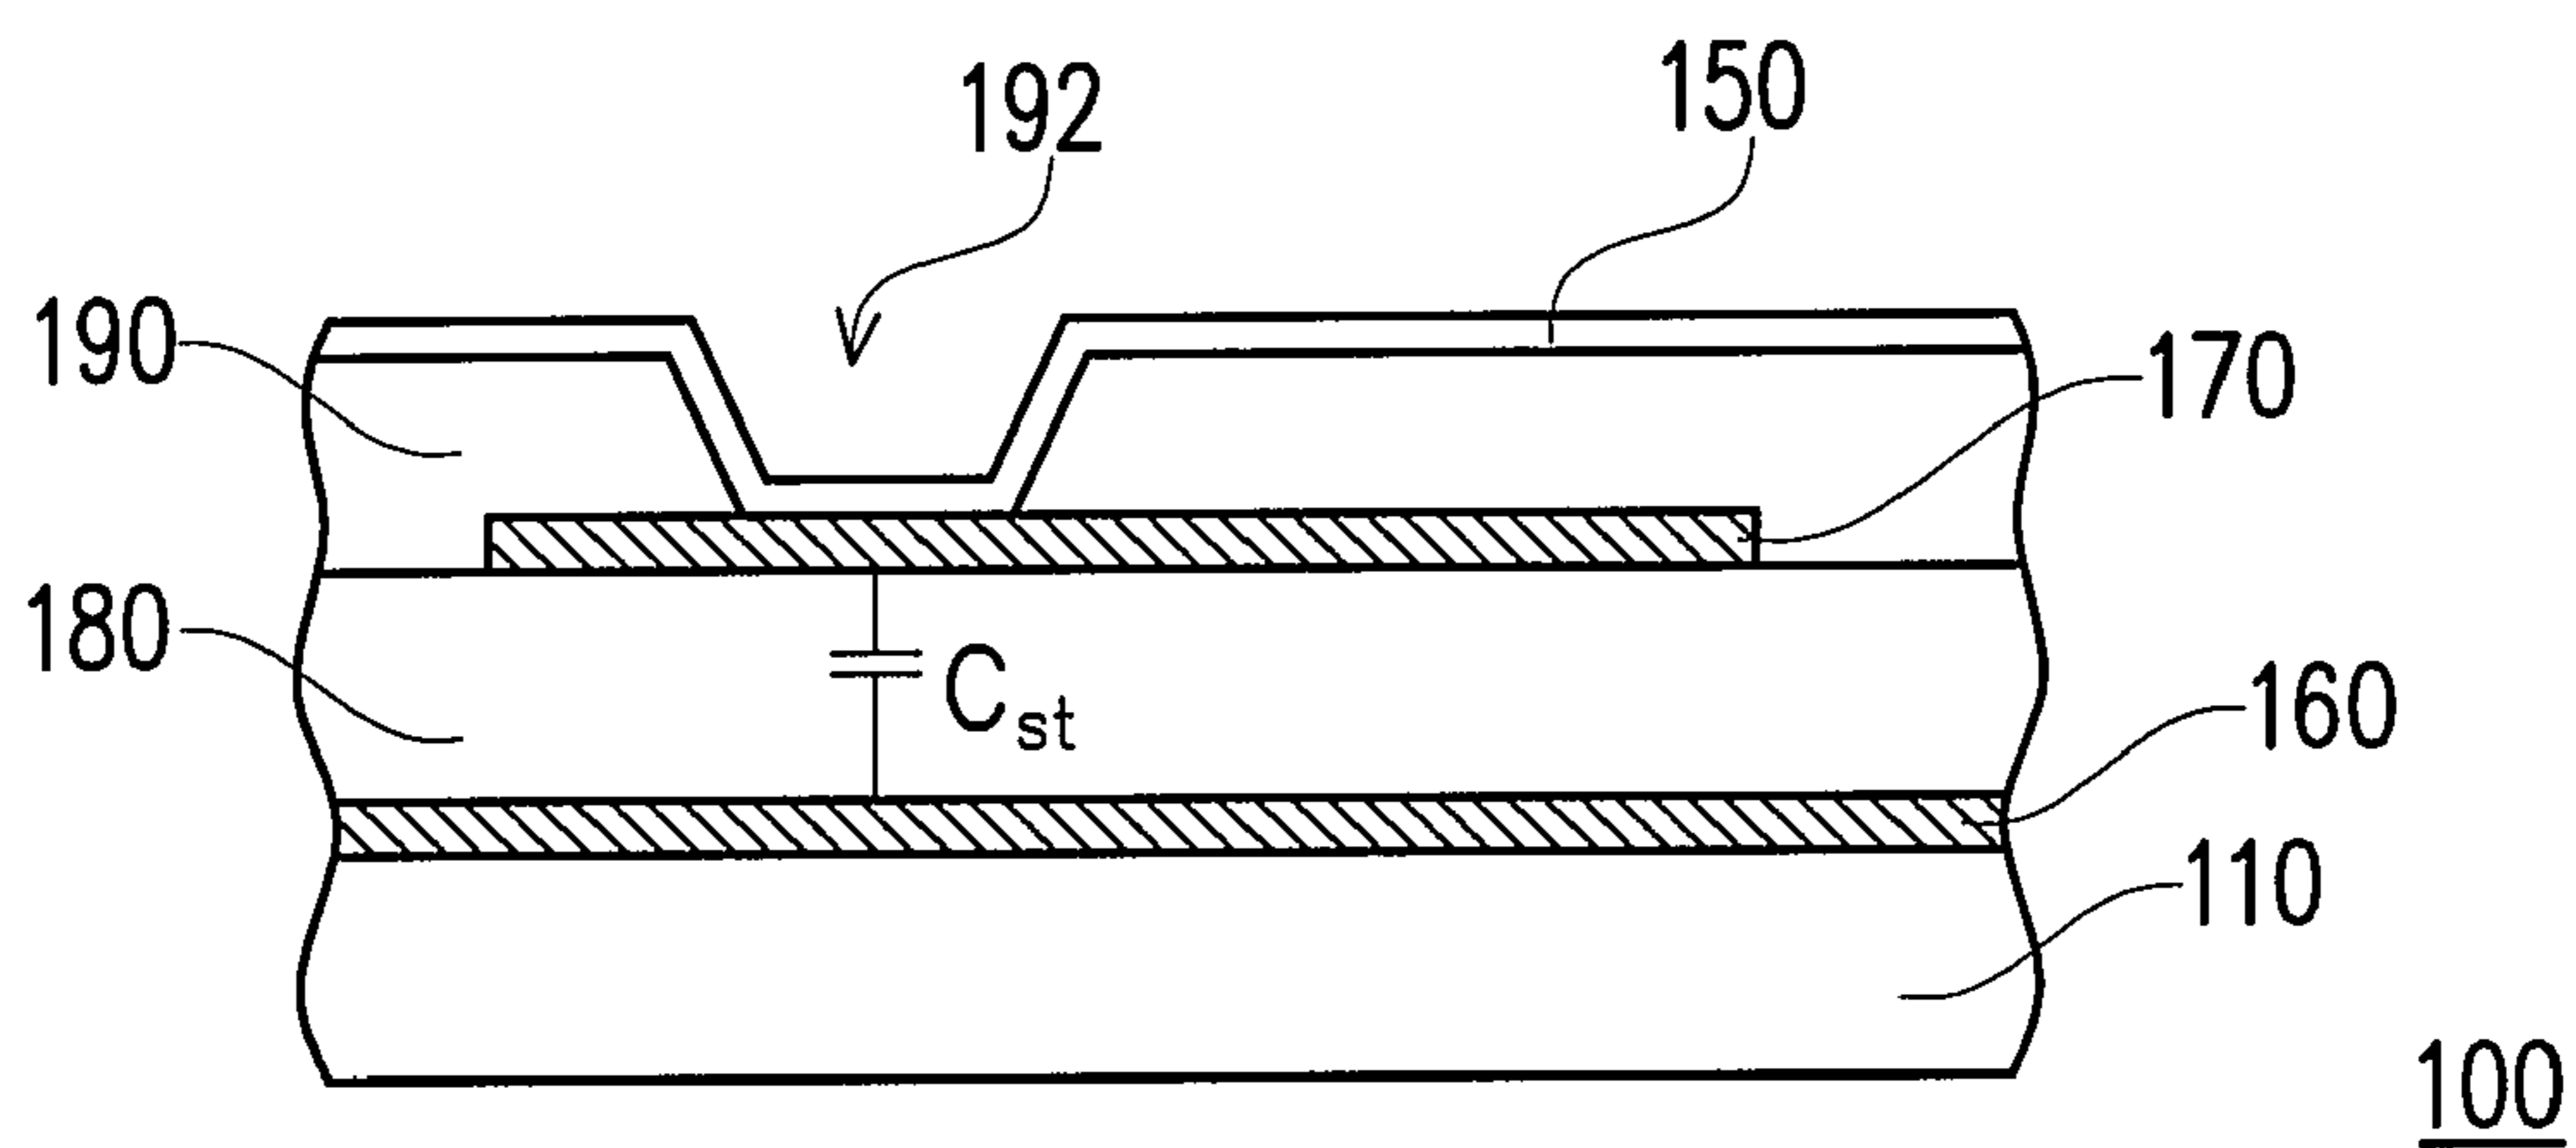
FIG. 2 (PRIOR ART)

As shown in FIG. 2, the upper electrode 170 and the corresponding common line 160 together form a storage capacitor (Cst) that smooth out the normal operation of various pixels within the thin film transistor liquid crystal display. However, any processing defect or other factors may lead to some particles falling into the dielectric layer 180 or trapped in the defects within the dielectric layer 180 and produce a leaky capacitor. Ultimately, the display quality of the pixel will be compromised.

FIG. 2 is a schematic cross-sectional view along line A-A' of the thin film transistor array substrate in FIG. 1.

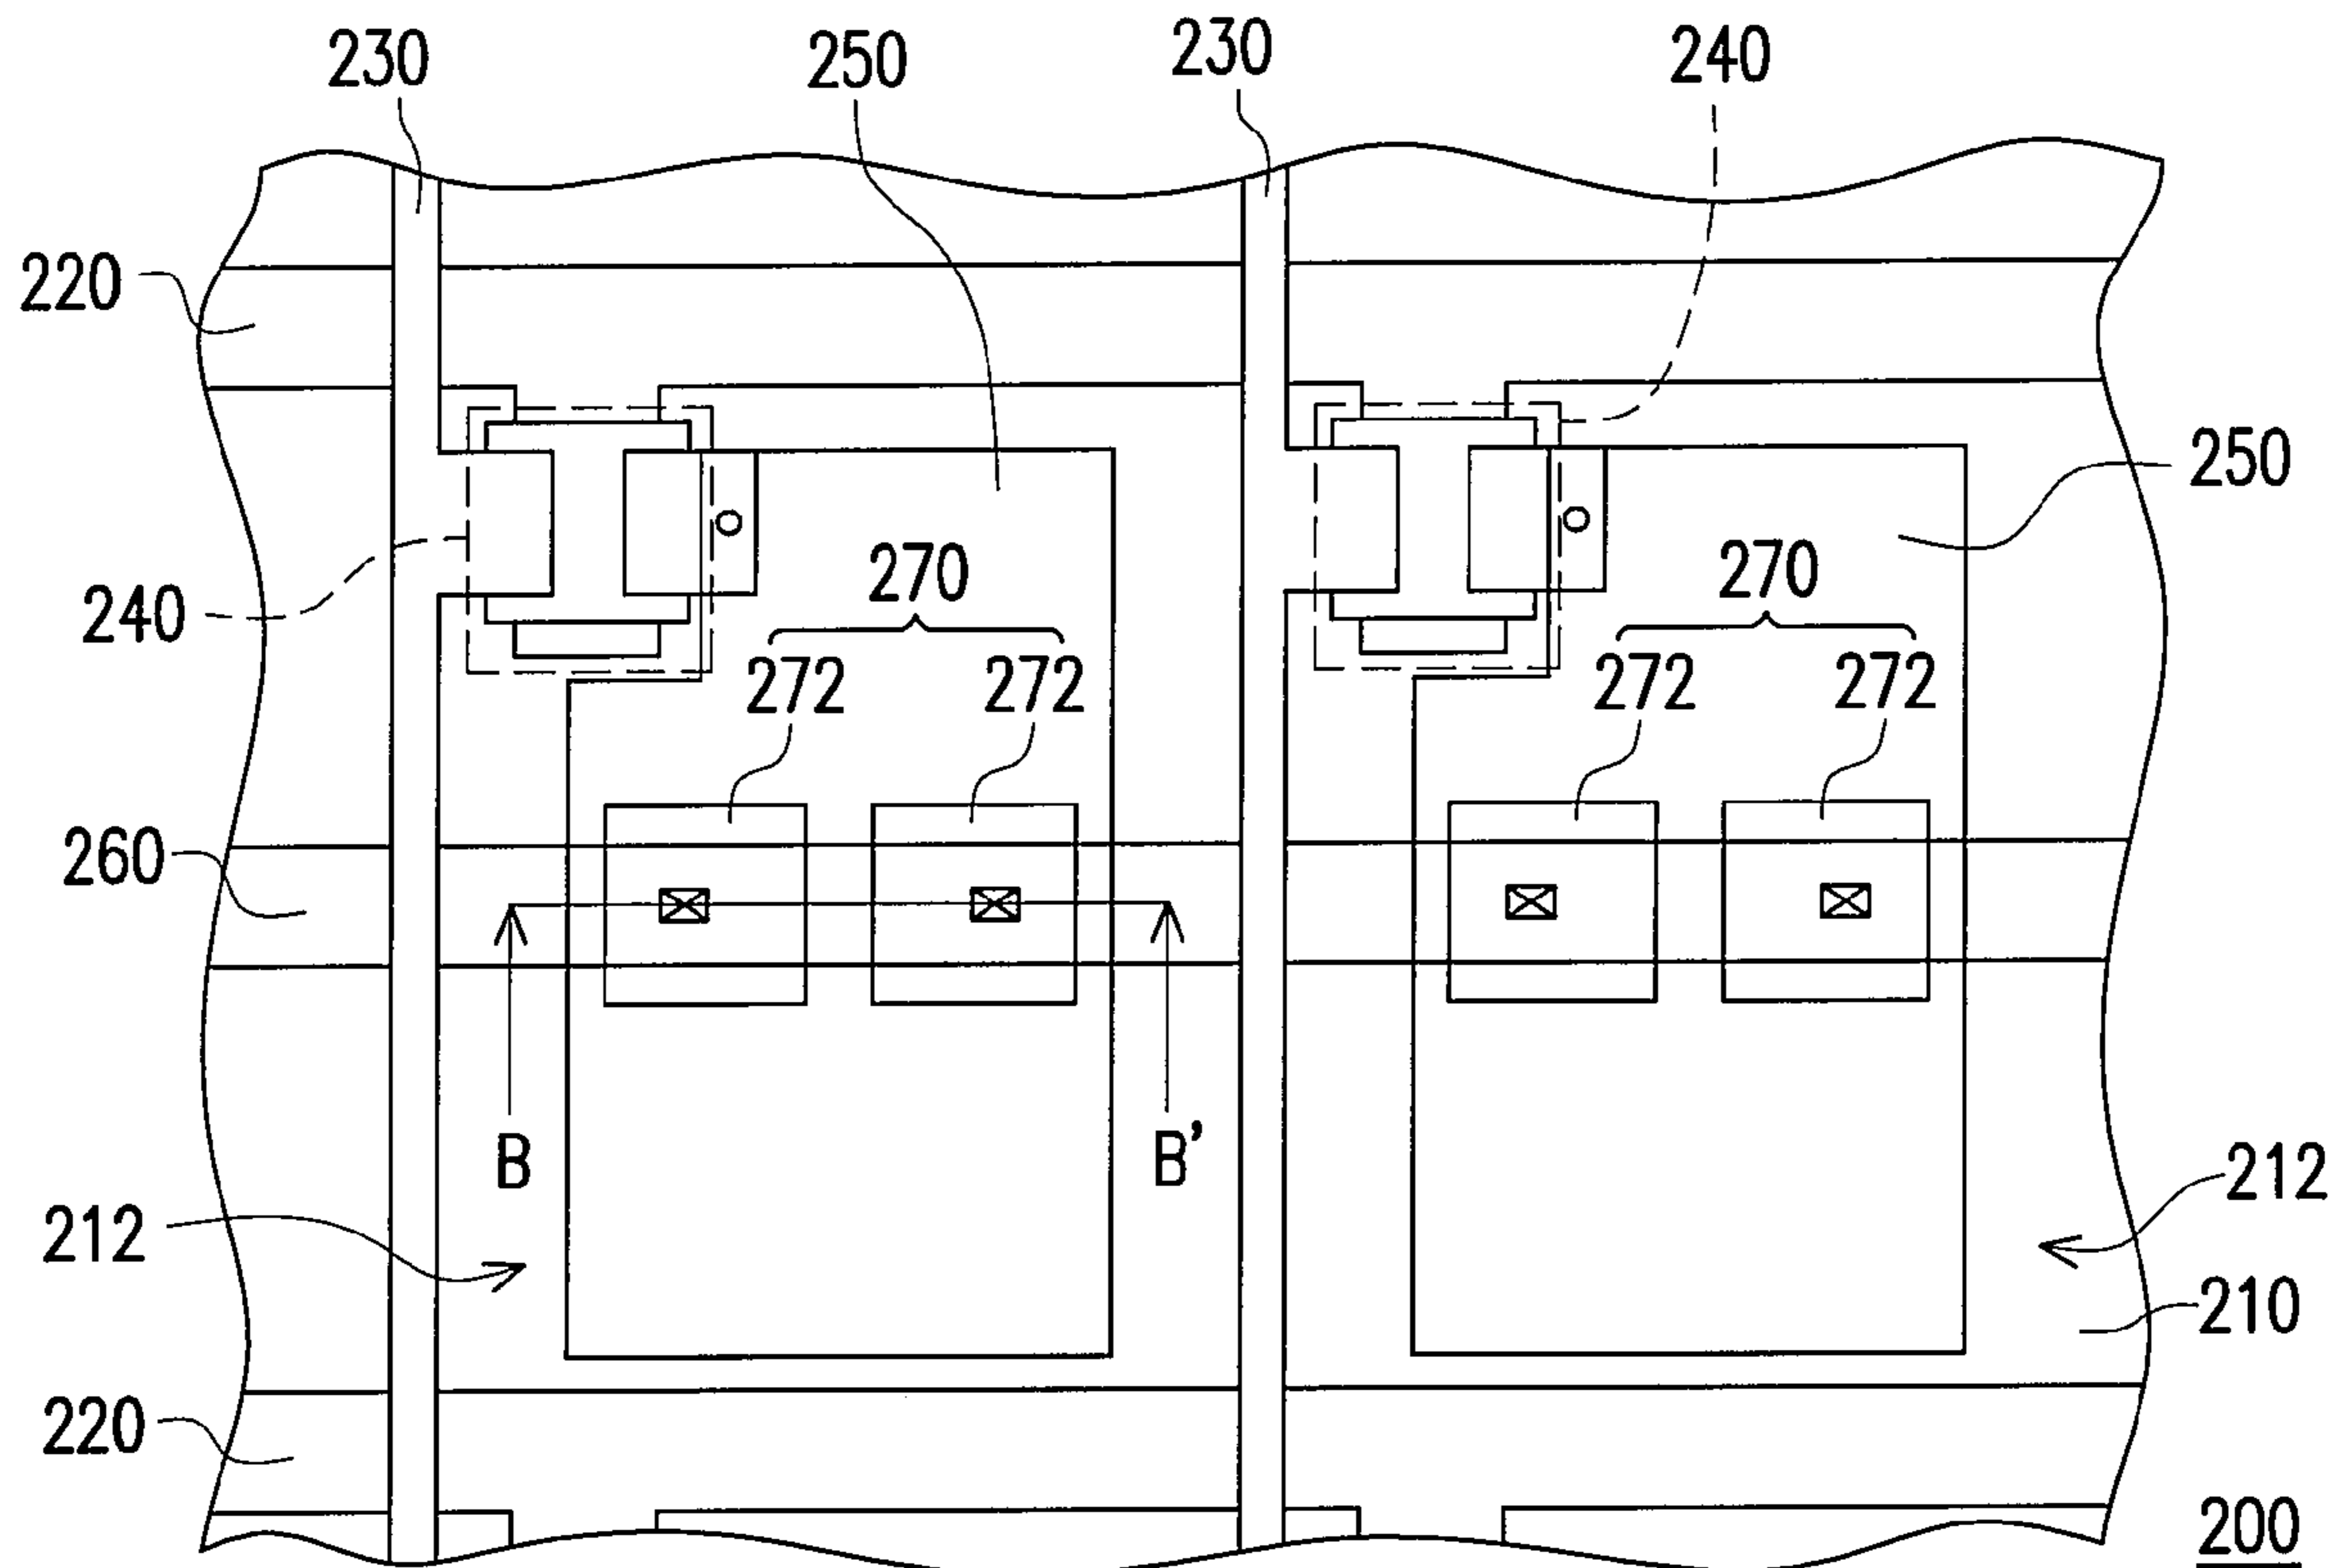
FIG. 3 is a top view of a thin film transistor array substrate according to one preferred embodiment of the present invention.

FIG. 3 is a top view of a thin film transistor array substrate according to one preferred embodiment of the present invention. FIG. 4 is a schematic cross-sectional view along line B-B' of the thin film transistor array substrate in FIG. 3. As shown in FIGS. 3 and 4, the thin film transistor array substrate 200 mainly comprises a substrate 210, a plurality of scan lines 220, a plurality of data lines 230, a plurality of thin film transistor 240, a plurality of pixel electrodes 250, a plurality of common lines 260 (only one is shown) and a patterned upper electrode 270.

The scan lines 220 and the data lines 230 are disposed over the substrate 210 to define a plurality of pixel areas 212. Each thin film transistors 240 is disposed inside one of the pixel areas 212 and driven by one of the scan lines 220 and one of the data lines 230. Each pixel electrode 250 is disposed inside one of the pixel areas 212 and electrically connected to one of the thin film transistors 240. The common line 260 is disposed over the substrate 210 such that a portion of each pixel electrode 250 is above one of the common lines 260.

The patterned upper electrode 270 is disposed between each pixel electrode 250 and the corresponding common line 260. A dielectric layer 280 is disposed between the patterned upper electrode 270 and the common line 260. Another dielectric layer 290 is disposed between the patterned upper electrode 270 and the pixel electrode 250. It should be noted that the patterned upper electrode 270 comprises a plurality of sub-upper electrodes 272 (only two of them are shown). A portion of each sub-upper electrode 272 is electrically connected to one of the pixel electrodes 250. For example, a contact 292 is formed in the dielectric layer 290 above each sub-upper electrode 272 so that each sub-upper electrode 272 is electrically connected to one of the pixel electrodes 250. Hence, the sub-upper electrode 272 and one of the common lines 260 together form a storage capacitor (Cst).

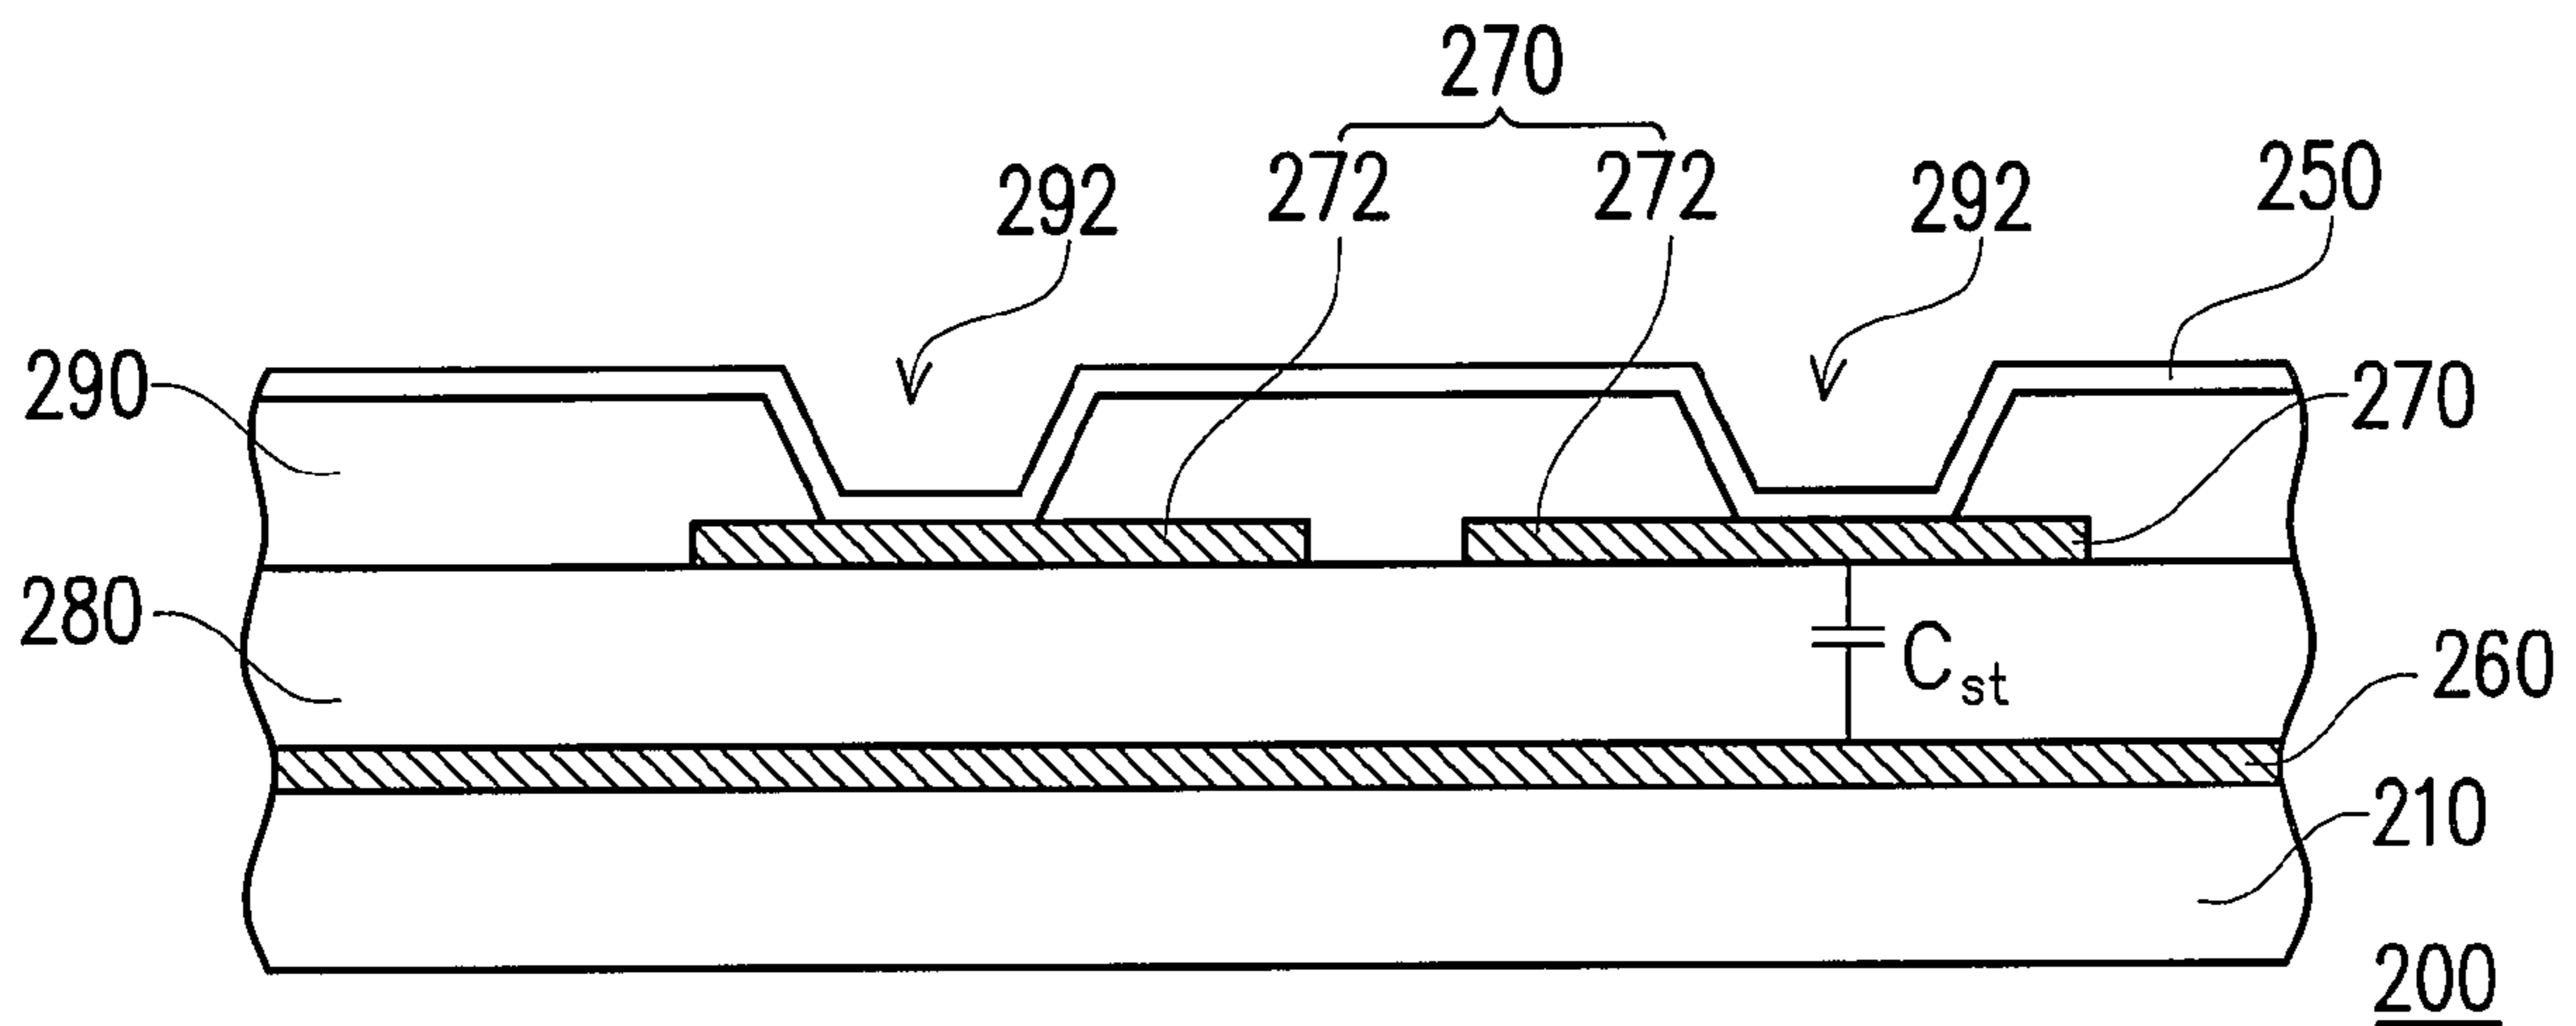
FIG. 4 is a schematic cross-sectional view along line B-B' of the thin film transistor array substrate in FIG. 3.

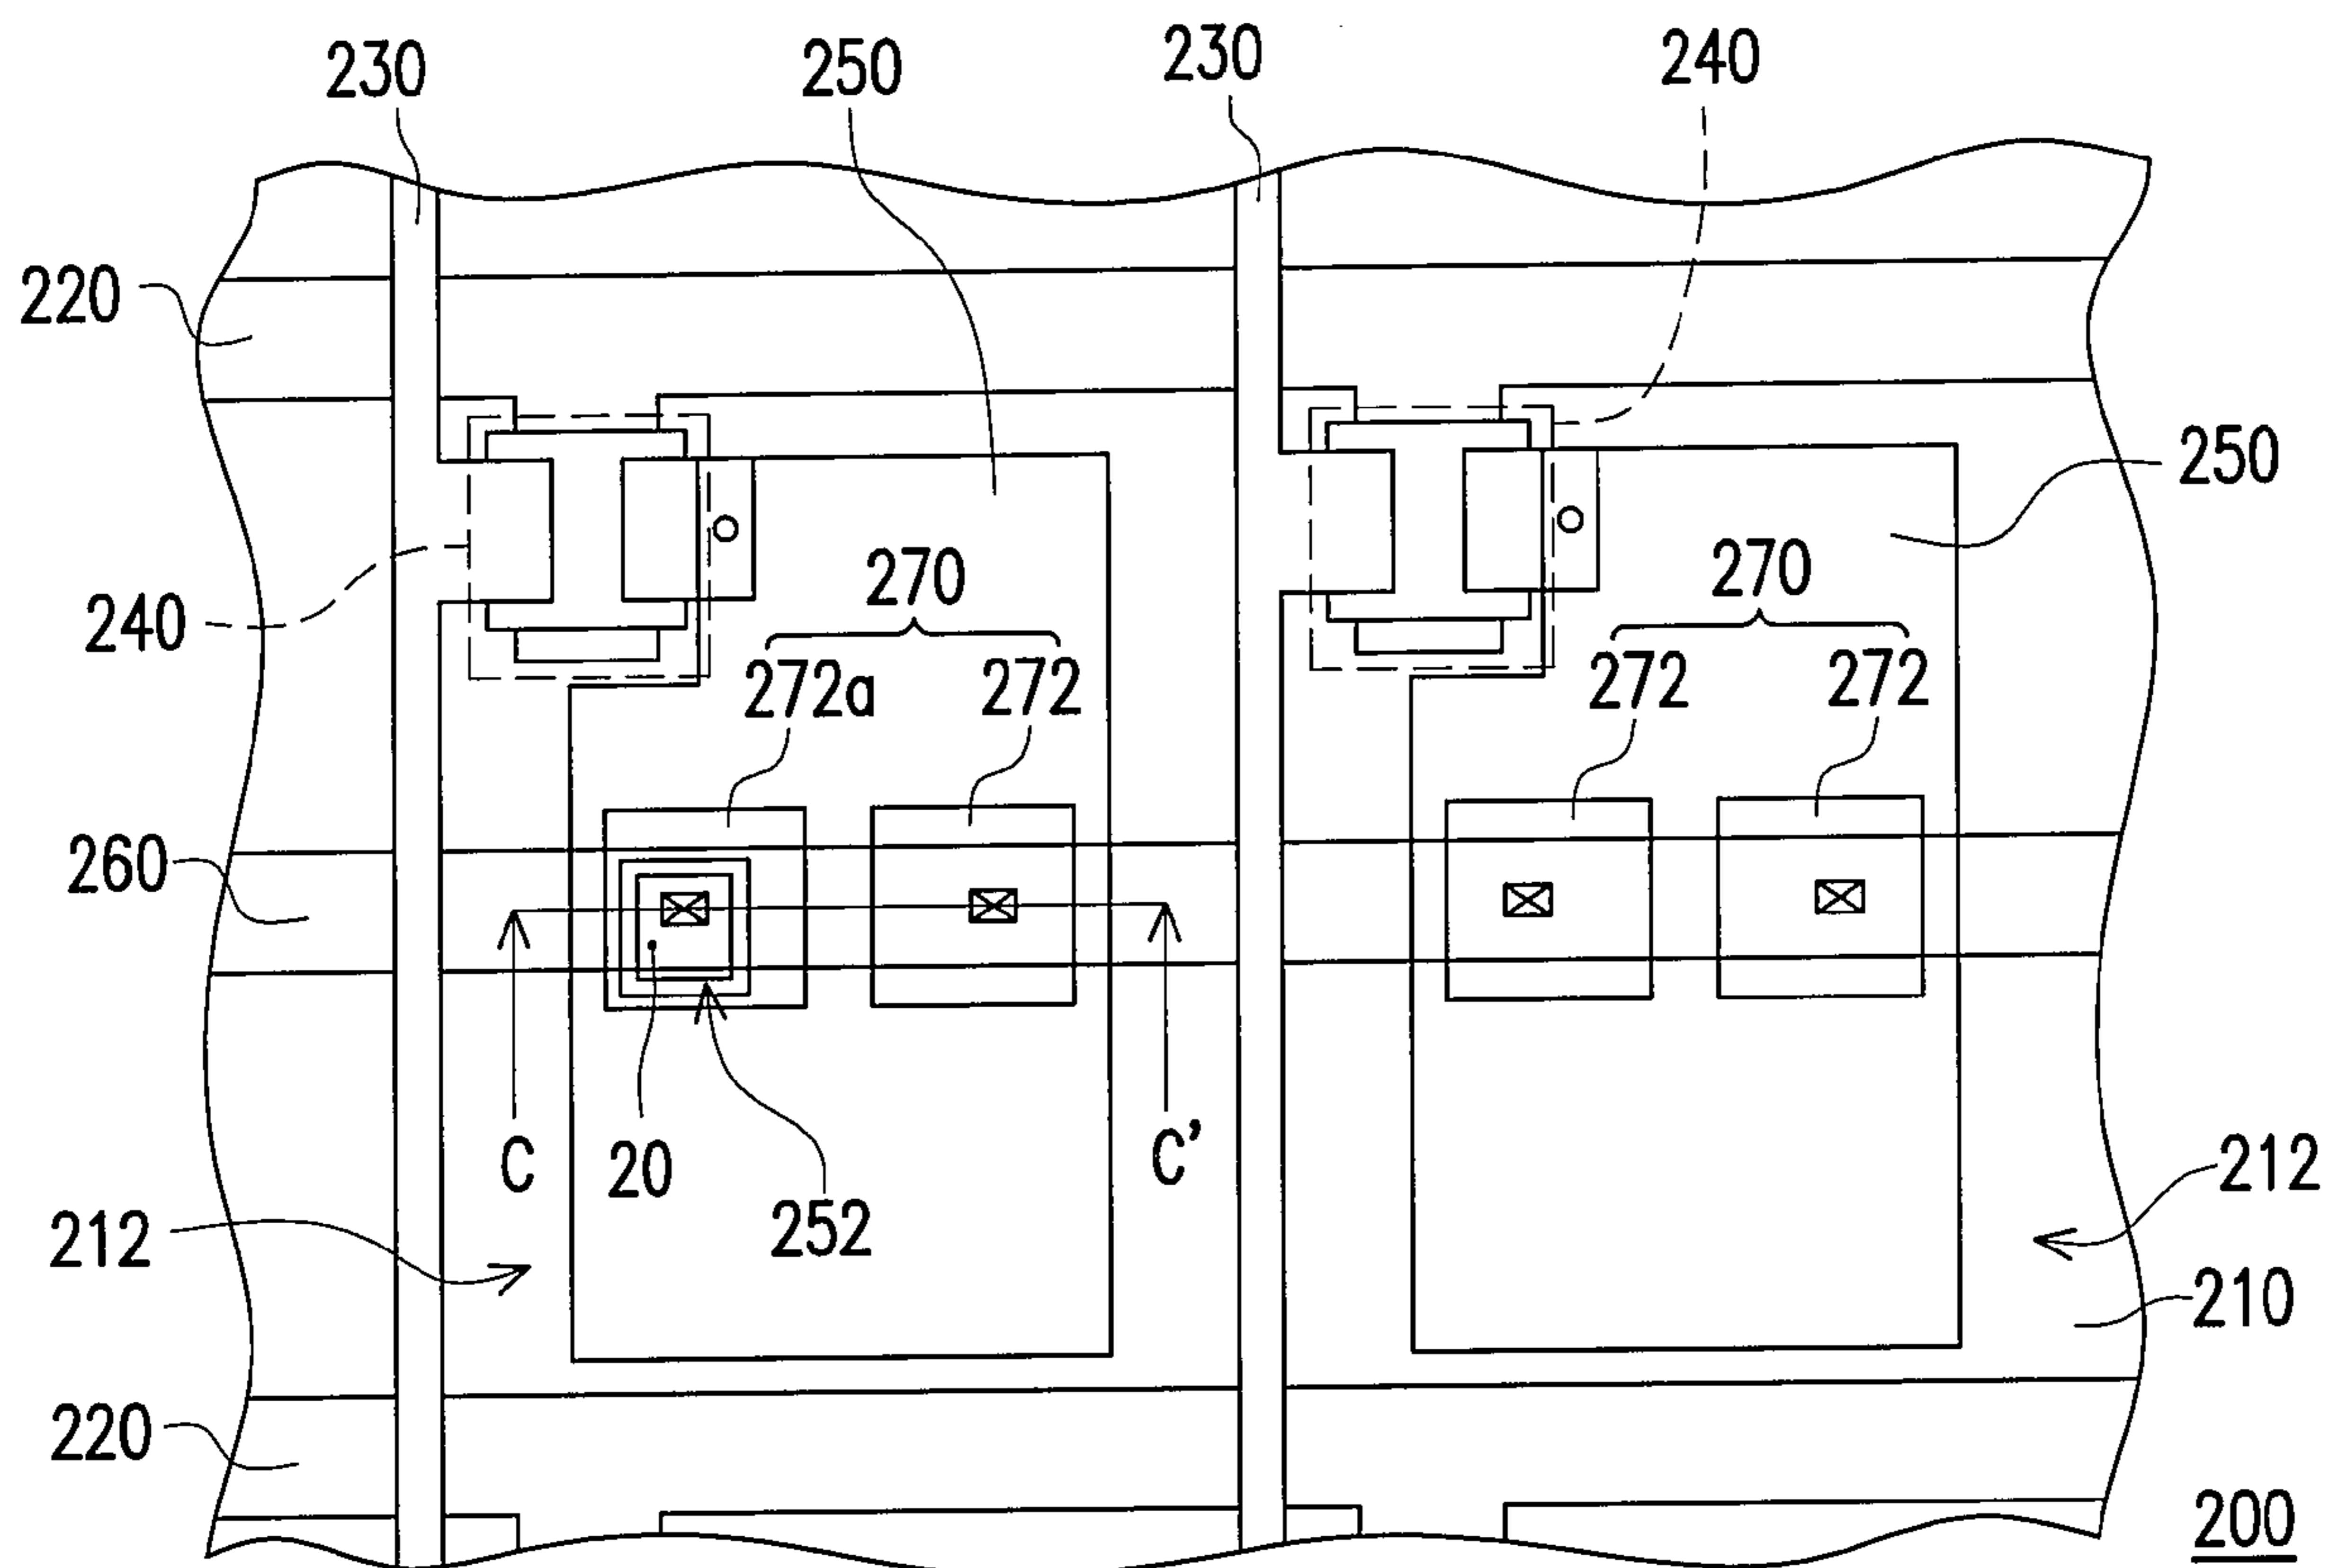
FIG. 5 is a top view of the thin film transistor array substrate in FIG. 3 after performing a laser repairing operation.

FIG. 5 is a top view of the thin film transistor array substrate in FIG. 3 after performing a laser repairing operation. FIG. 6 is a schematic cross-sectional view along C-C' of the thin film transistor array substrate shown in FIG. 5. As shown in FIGS. 5 and 6, if there is a particle (or defect) in the material between one of the sub-upper electrodes 272 and one of the common lines 260, leakage between the sub-upper electrode 272a and the common line 260 may occur. Thus, the pixel may display abnormally and need a repair. The method of repairing the pixel includes removing a portion of the pixel electrode 250 corresponding to the sub-upper electrode 272a of the defective capacitor so that the sub-upper electrode 272a and the corresponding pixel electrode 250 of the defective capacitor are electrically isolated.

In the present embodiment, a portion of the pixel electrode 250 above the sub-upper electrode 272a of the corresponding defective capacitor is removed to form an opening 252. The method of removing a portion of the pixel electrode 250 includes laser ablation, for example. The opening 252 is located around the contact area between the sub-upper electrode 272a and the corresponding pixel electrode 250 of the defective capacitor (that is, around the contact 292). By forming the opening 252, the sub-upper electrode 272a and the corresponding pixel electrode 250 of the defective capacitor

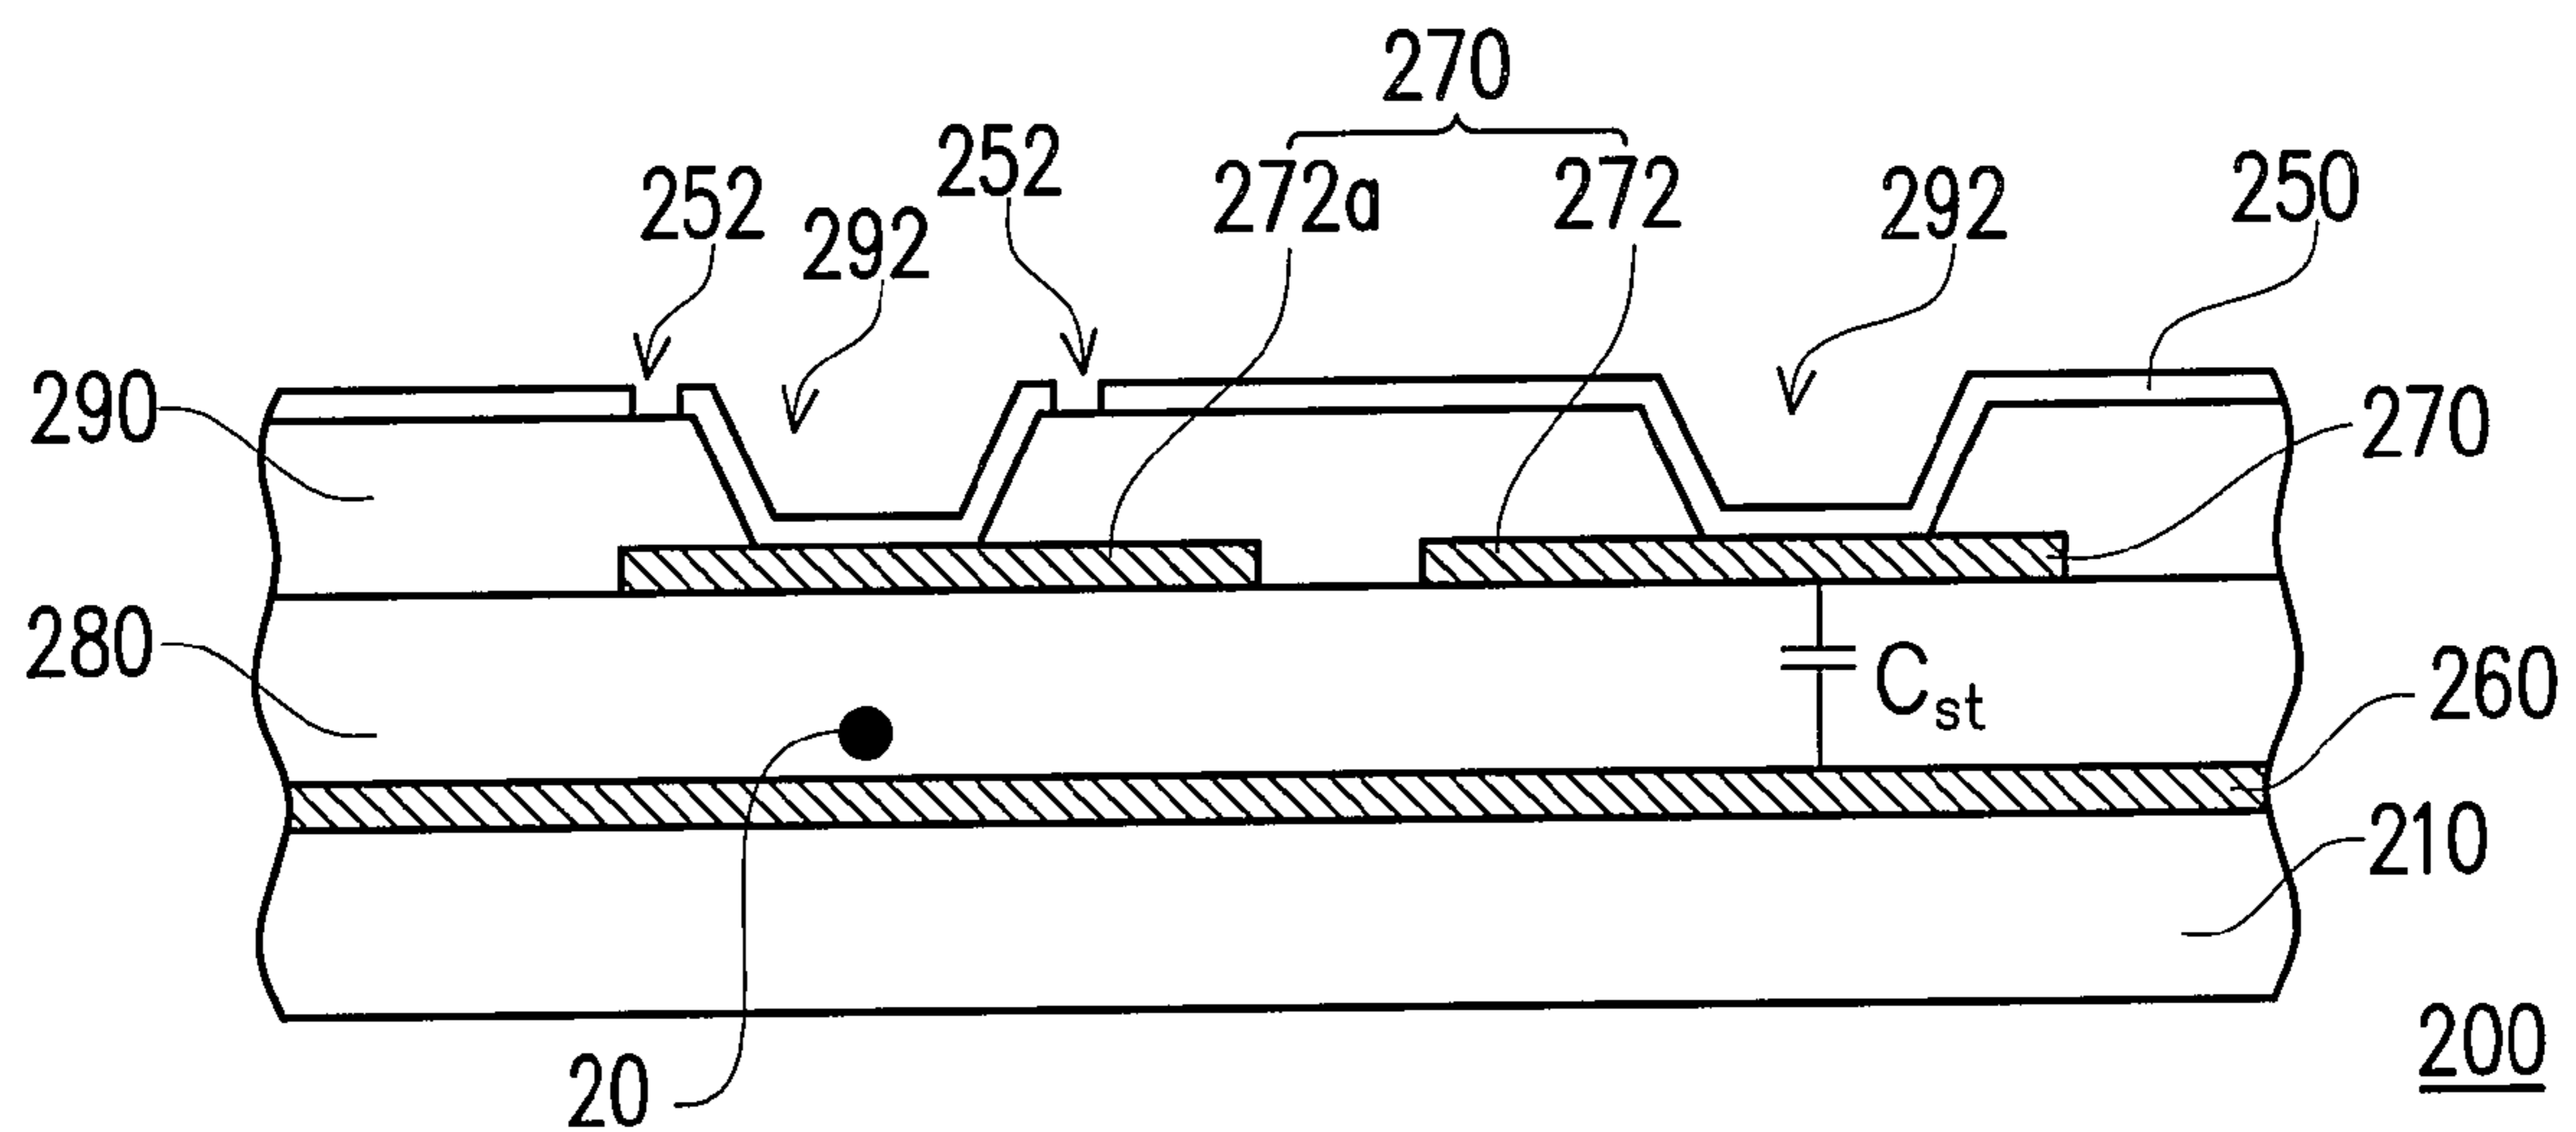
FIG. 6 is a schematic cross-sectional view along C-C' of the thin film transistor array substrate shown in FIG. 5.
