(12) **United States Patent**  
**Lai**

(10) **Patent No.:** **US 7,646,446 B2**  
(45) **Date of Patent:** **Jan. 12, 2010**

(54) **REPAIRING METHOD OF A THIN FILM TRANSISTOR ARRAY SUBSTRATE**

(73) Assignee: **Au Optronics Corporation**, Hsinchu (TW)

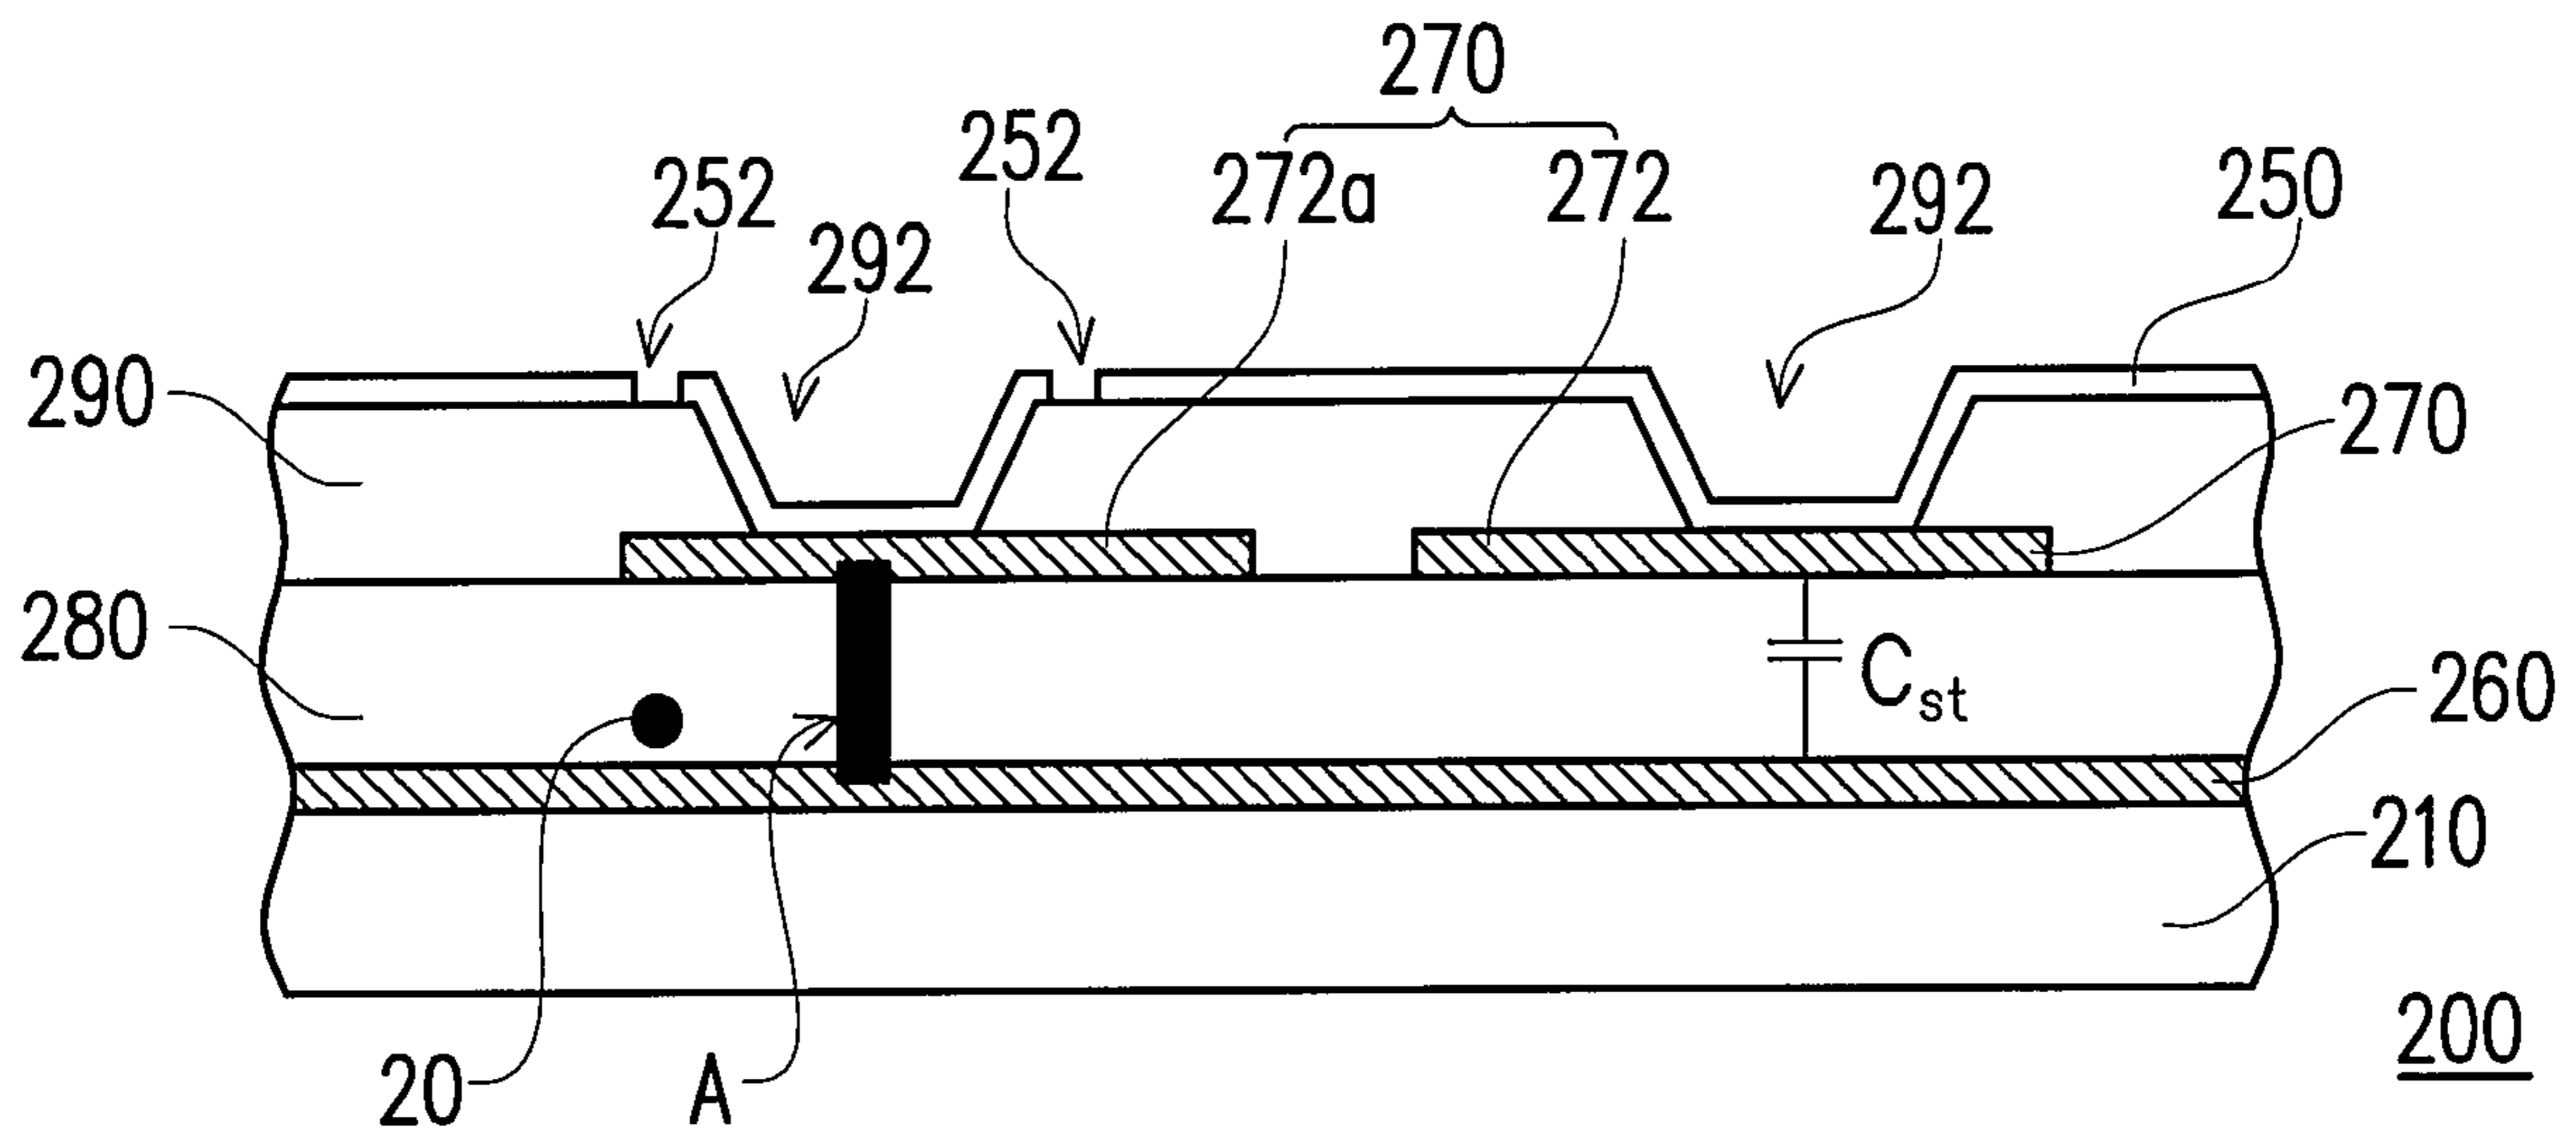
FIG. 7 is a schematic cross-sectional view showing the electrical connection between the common line and the sub-upper electrode in a defective capacitor for repairing a thin film transistor array substrate according to one preferred embodiment of the present invention.

FIG. **7** is a schematic cross-sectional view showing the electrical connection between the common line and the sub-upper electrode in a defective capacitor for repairing a thin film transistor array substrate according to one preferred embodiment of the present invention. After removing a portion of the pixel electrode **250** corresponding to the sub-upper electrode **272a** of the defective capacitor to isolate the sub-upper electrode **272a** and the pixel electrode **250** electrically, the sub-upper electrode **272a** and the corresponding common line **260** are welded together (labeled A). Hence, the sub-upper electrode **272a** and the common line **260** of the defective capacitor are configured at the same potential to prevent any leakage via the particles (or defects). The sub-upper electrode **272a** and the corresponding common line **260** are welded together by performing a laser welding process, for example.

In the present invention, the location at which the sub-upper electrode **272a** and the corresponding common line **260** of the defective capacitor weld together is underneath the contact **292**. However, anyone familiar with the technologies may choose other suitable locations convenient for welding the sub-upper electrode **272a** and the corresponding common line **260** of the defective capacitor together.

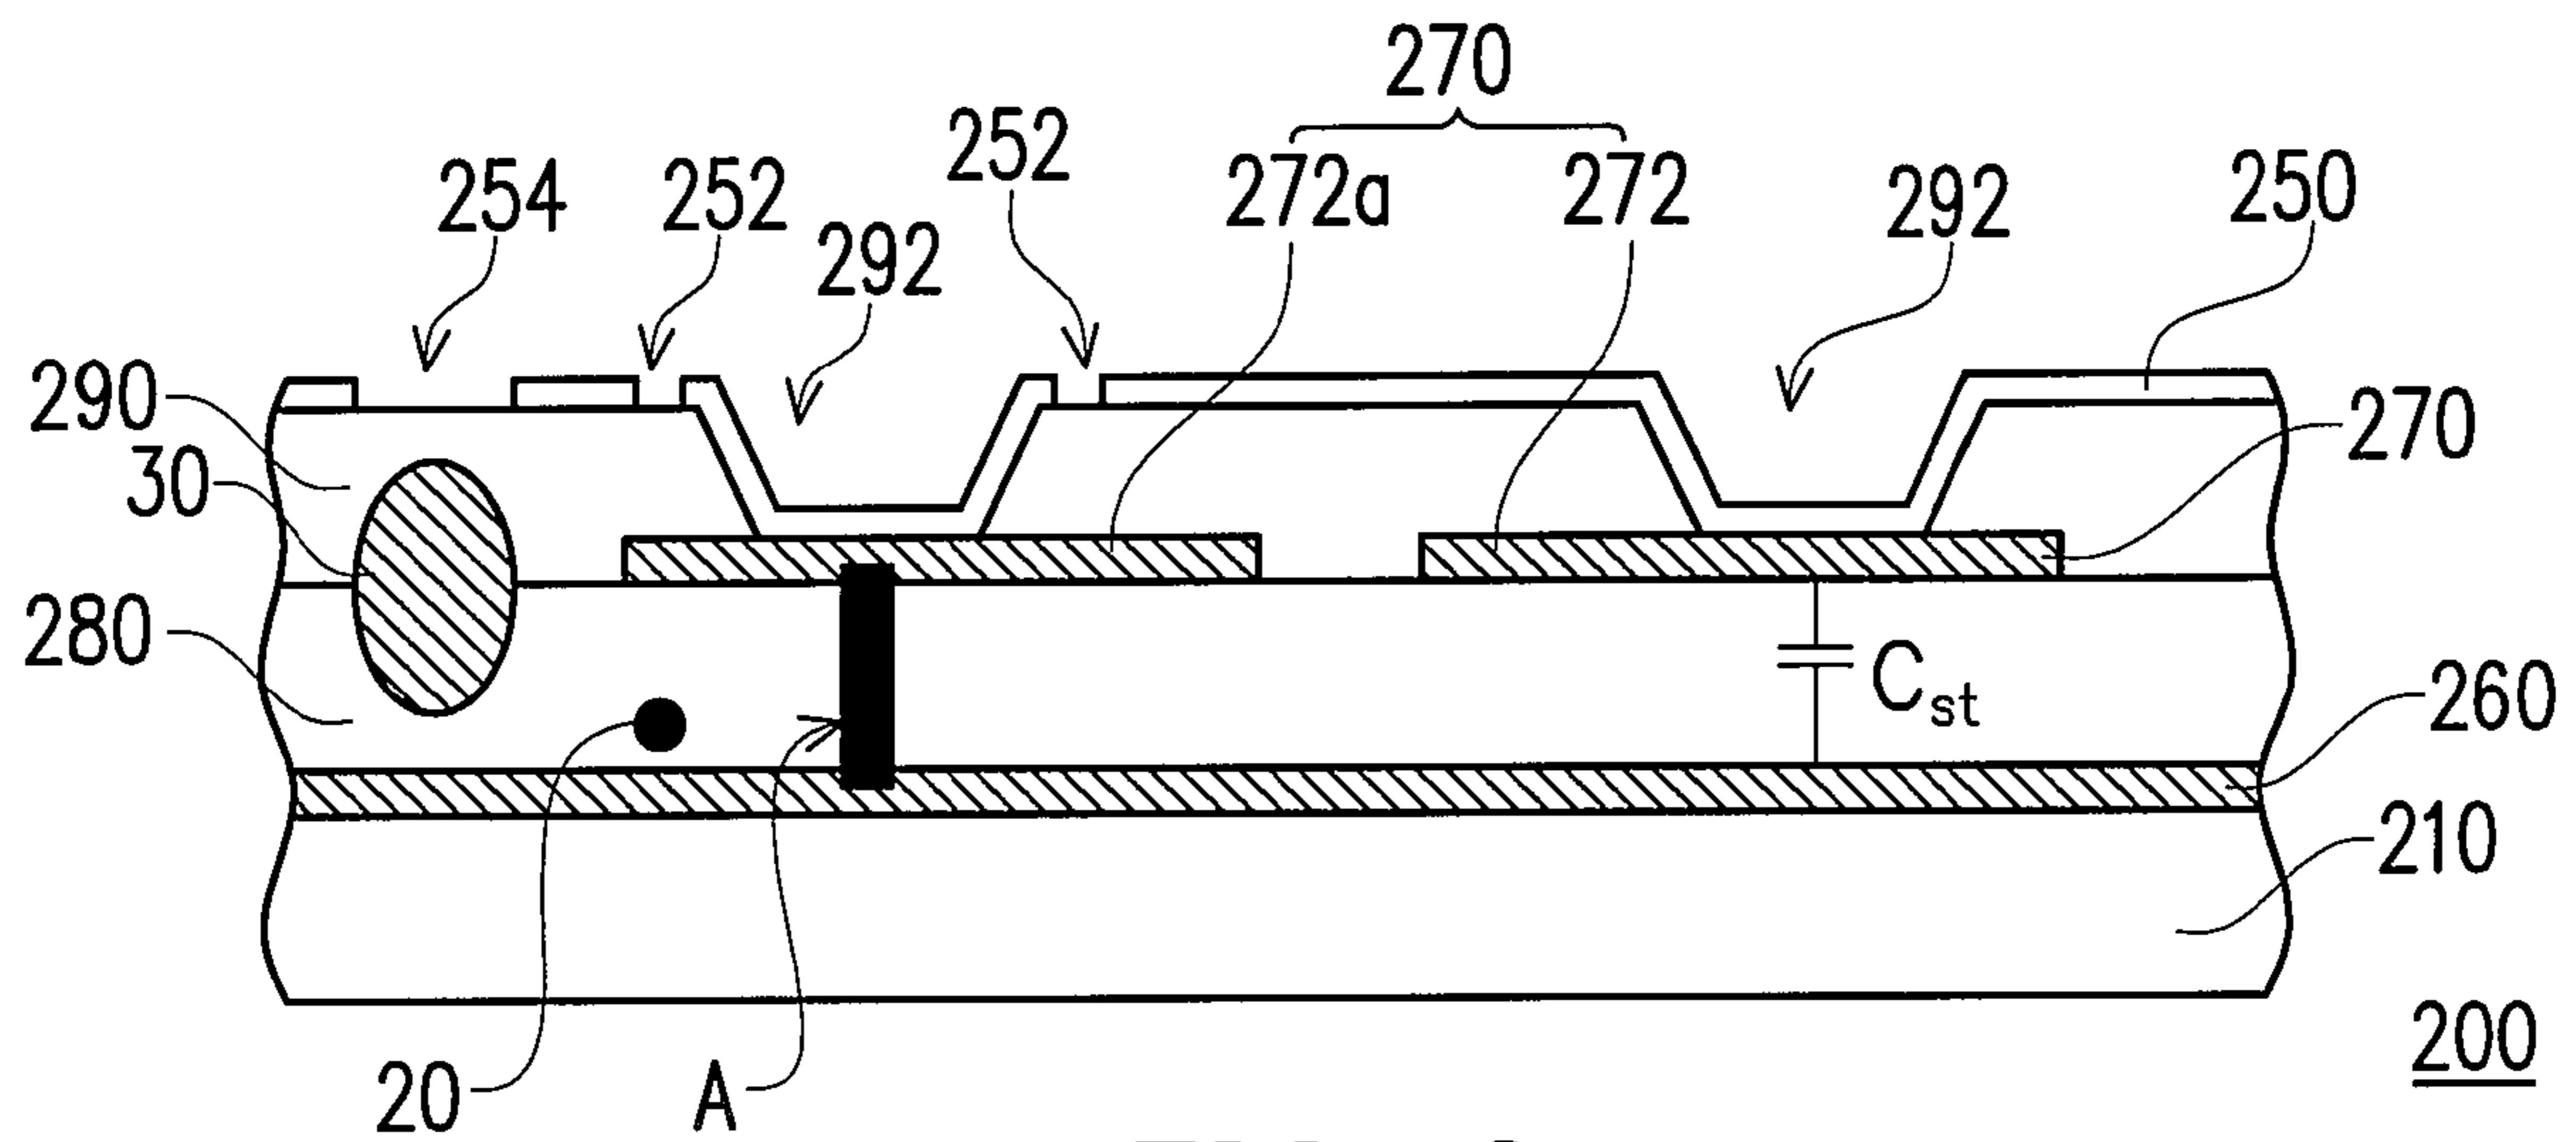
FIG. 8 is a schematic cross-sectional view showing the reparation of a thin film transistor array substrate when a particle is disposed between a pixel electrode and a common line.

FIG. **8** is a schematic cross-sectional view showing the reparation of a thin film transistor array substrate when a particle is disposed between a pixel electrode and a common line. When a particle **30** (or a defect) is formed inside the layers between the pixel electrode and one of the common lines, the repairing method of the present invention also permits the removal of a portion of the pixel electrode **250** above the particle **30** (or defect). For example, a portion of the pixel electrode **250** is removed to form an opening **254** that exposes the particle **30** (or defect) using a laser beam.

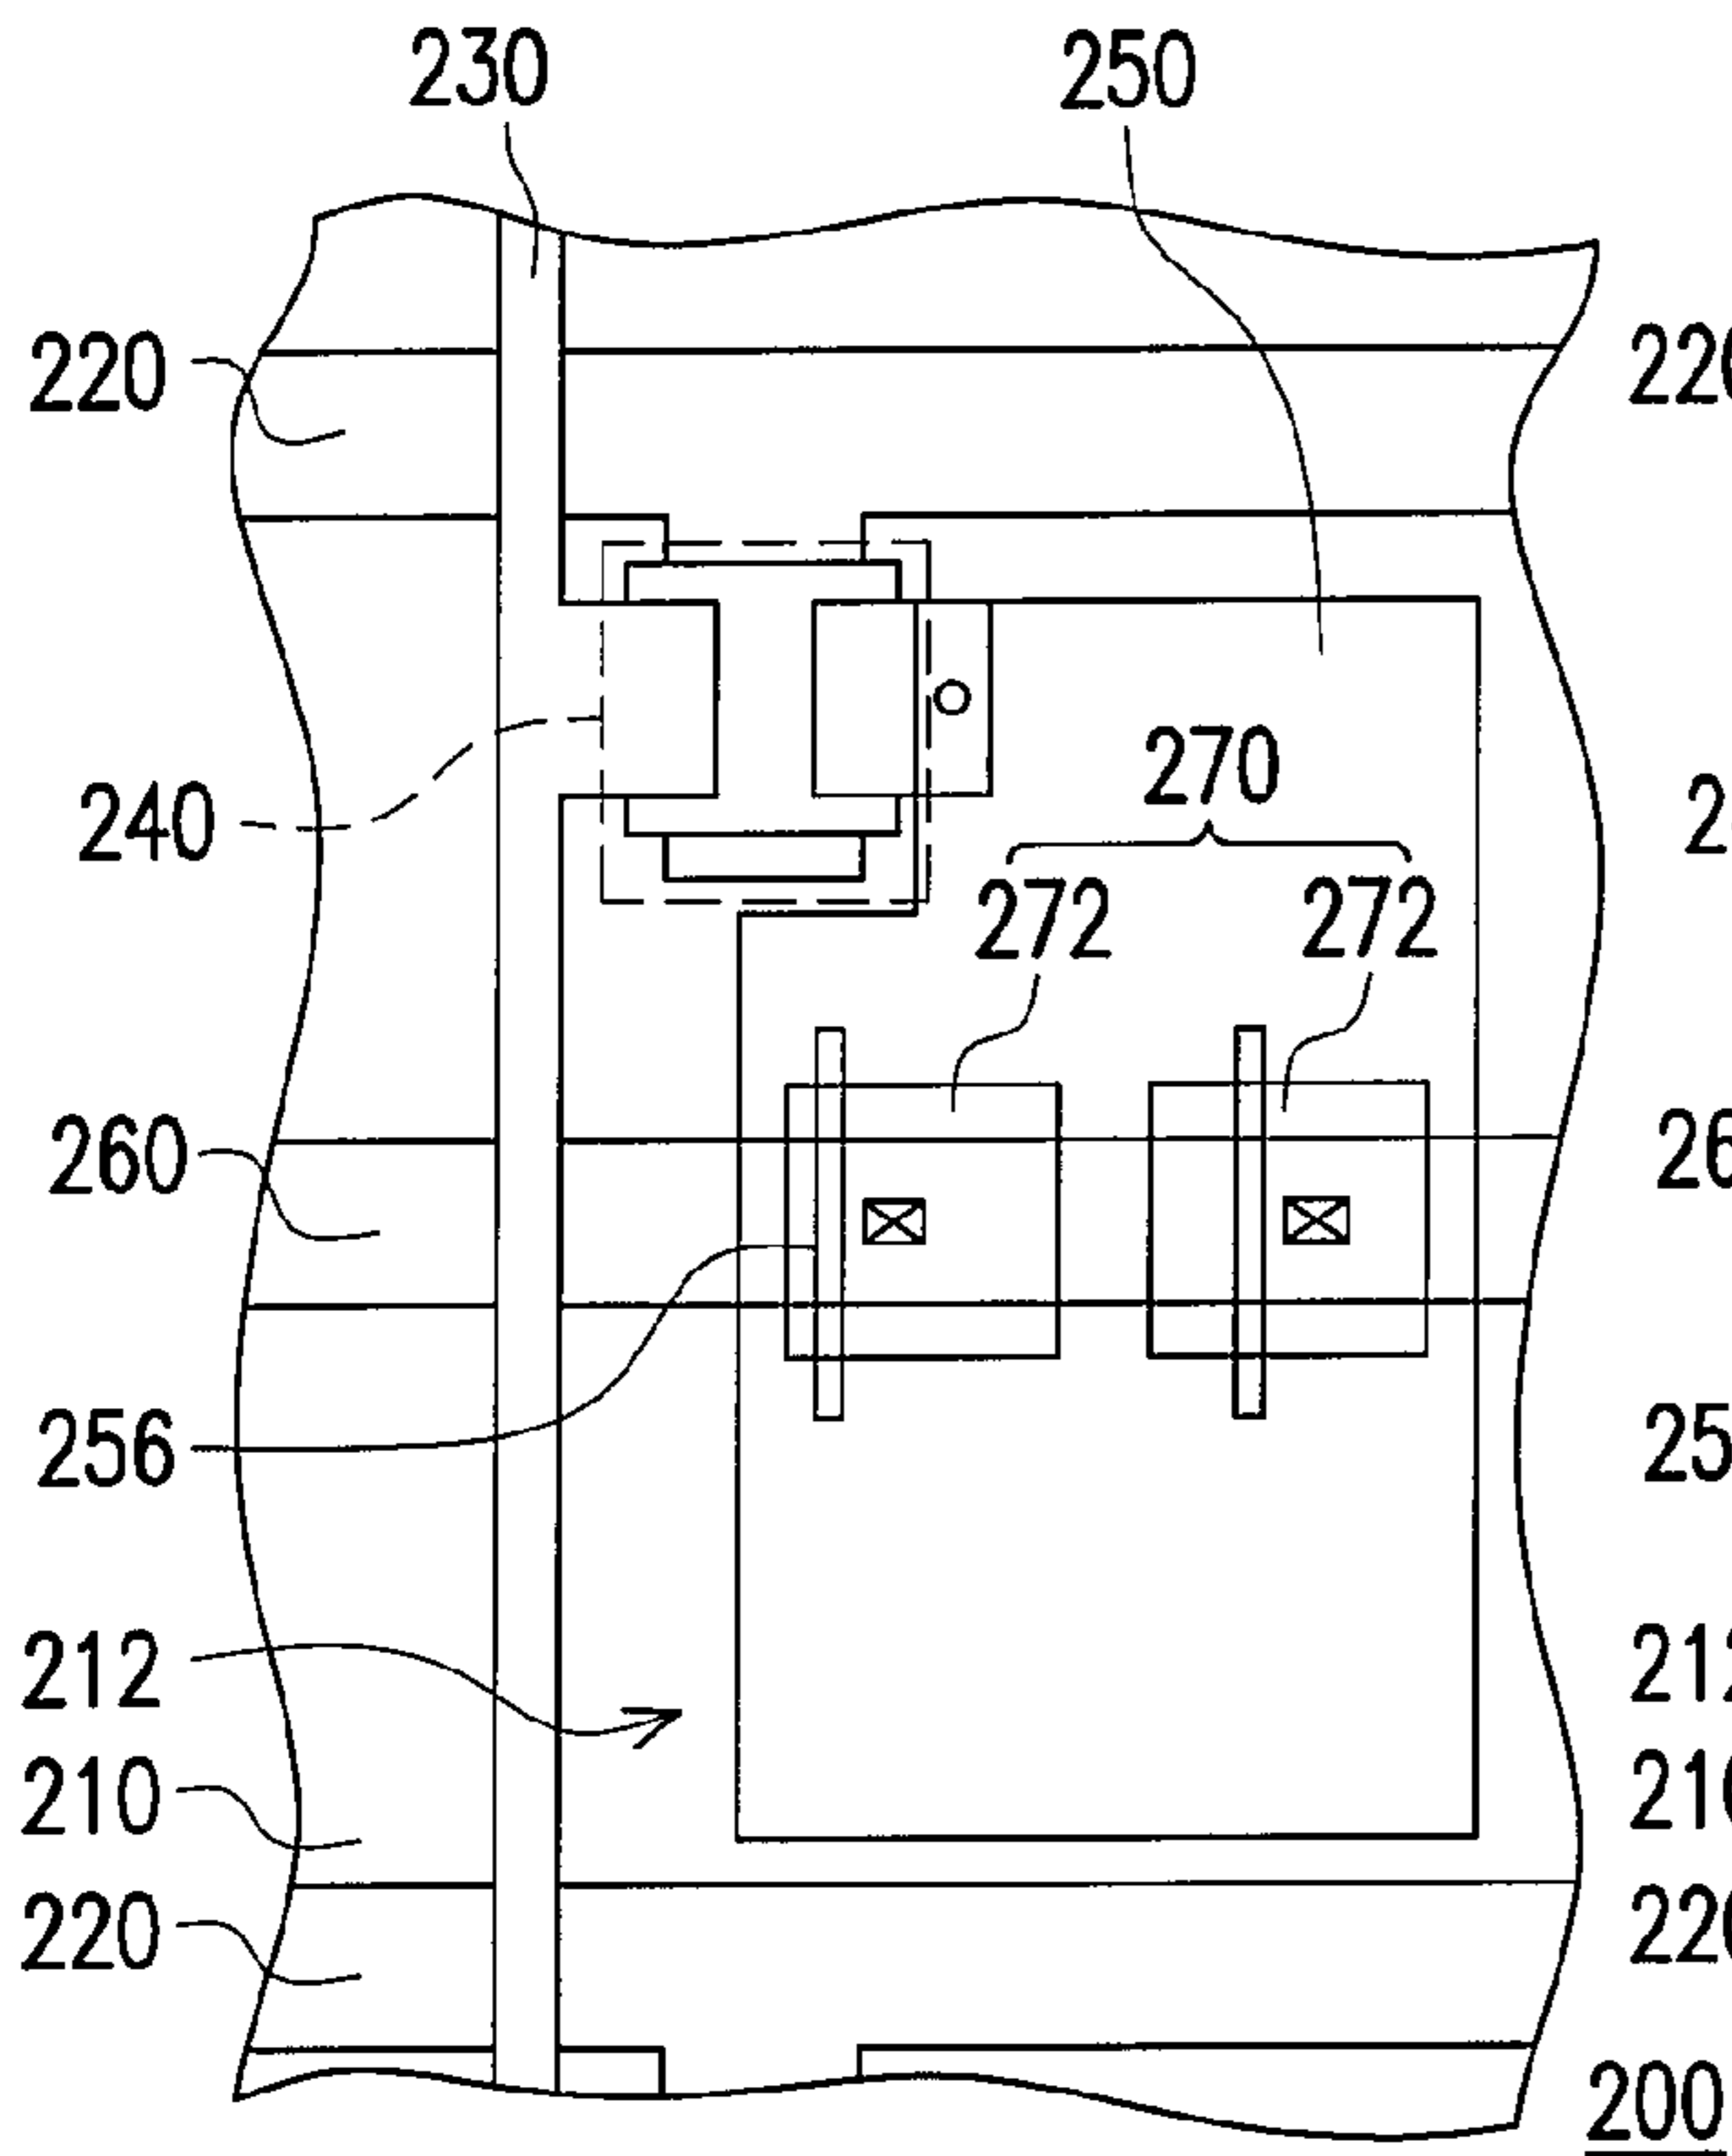
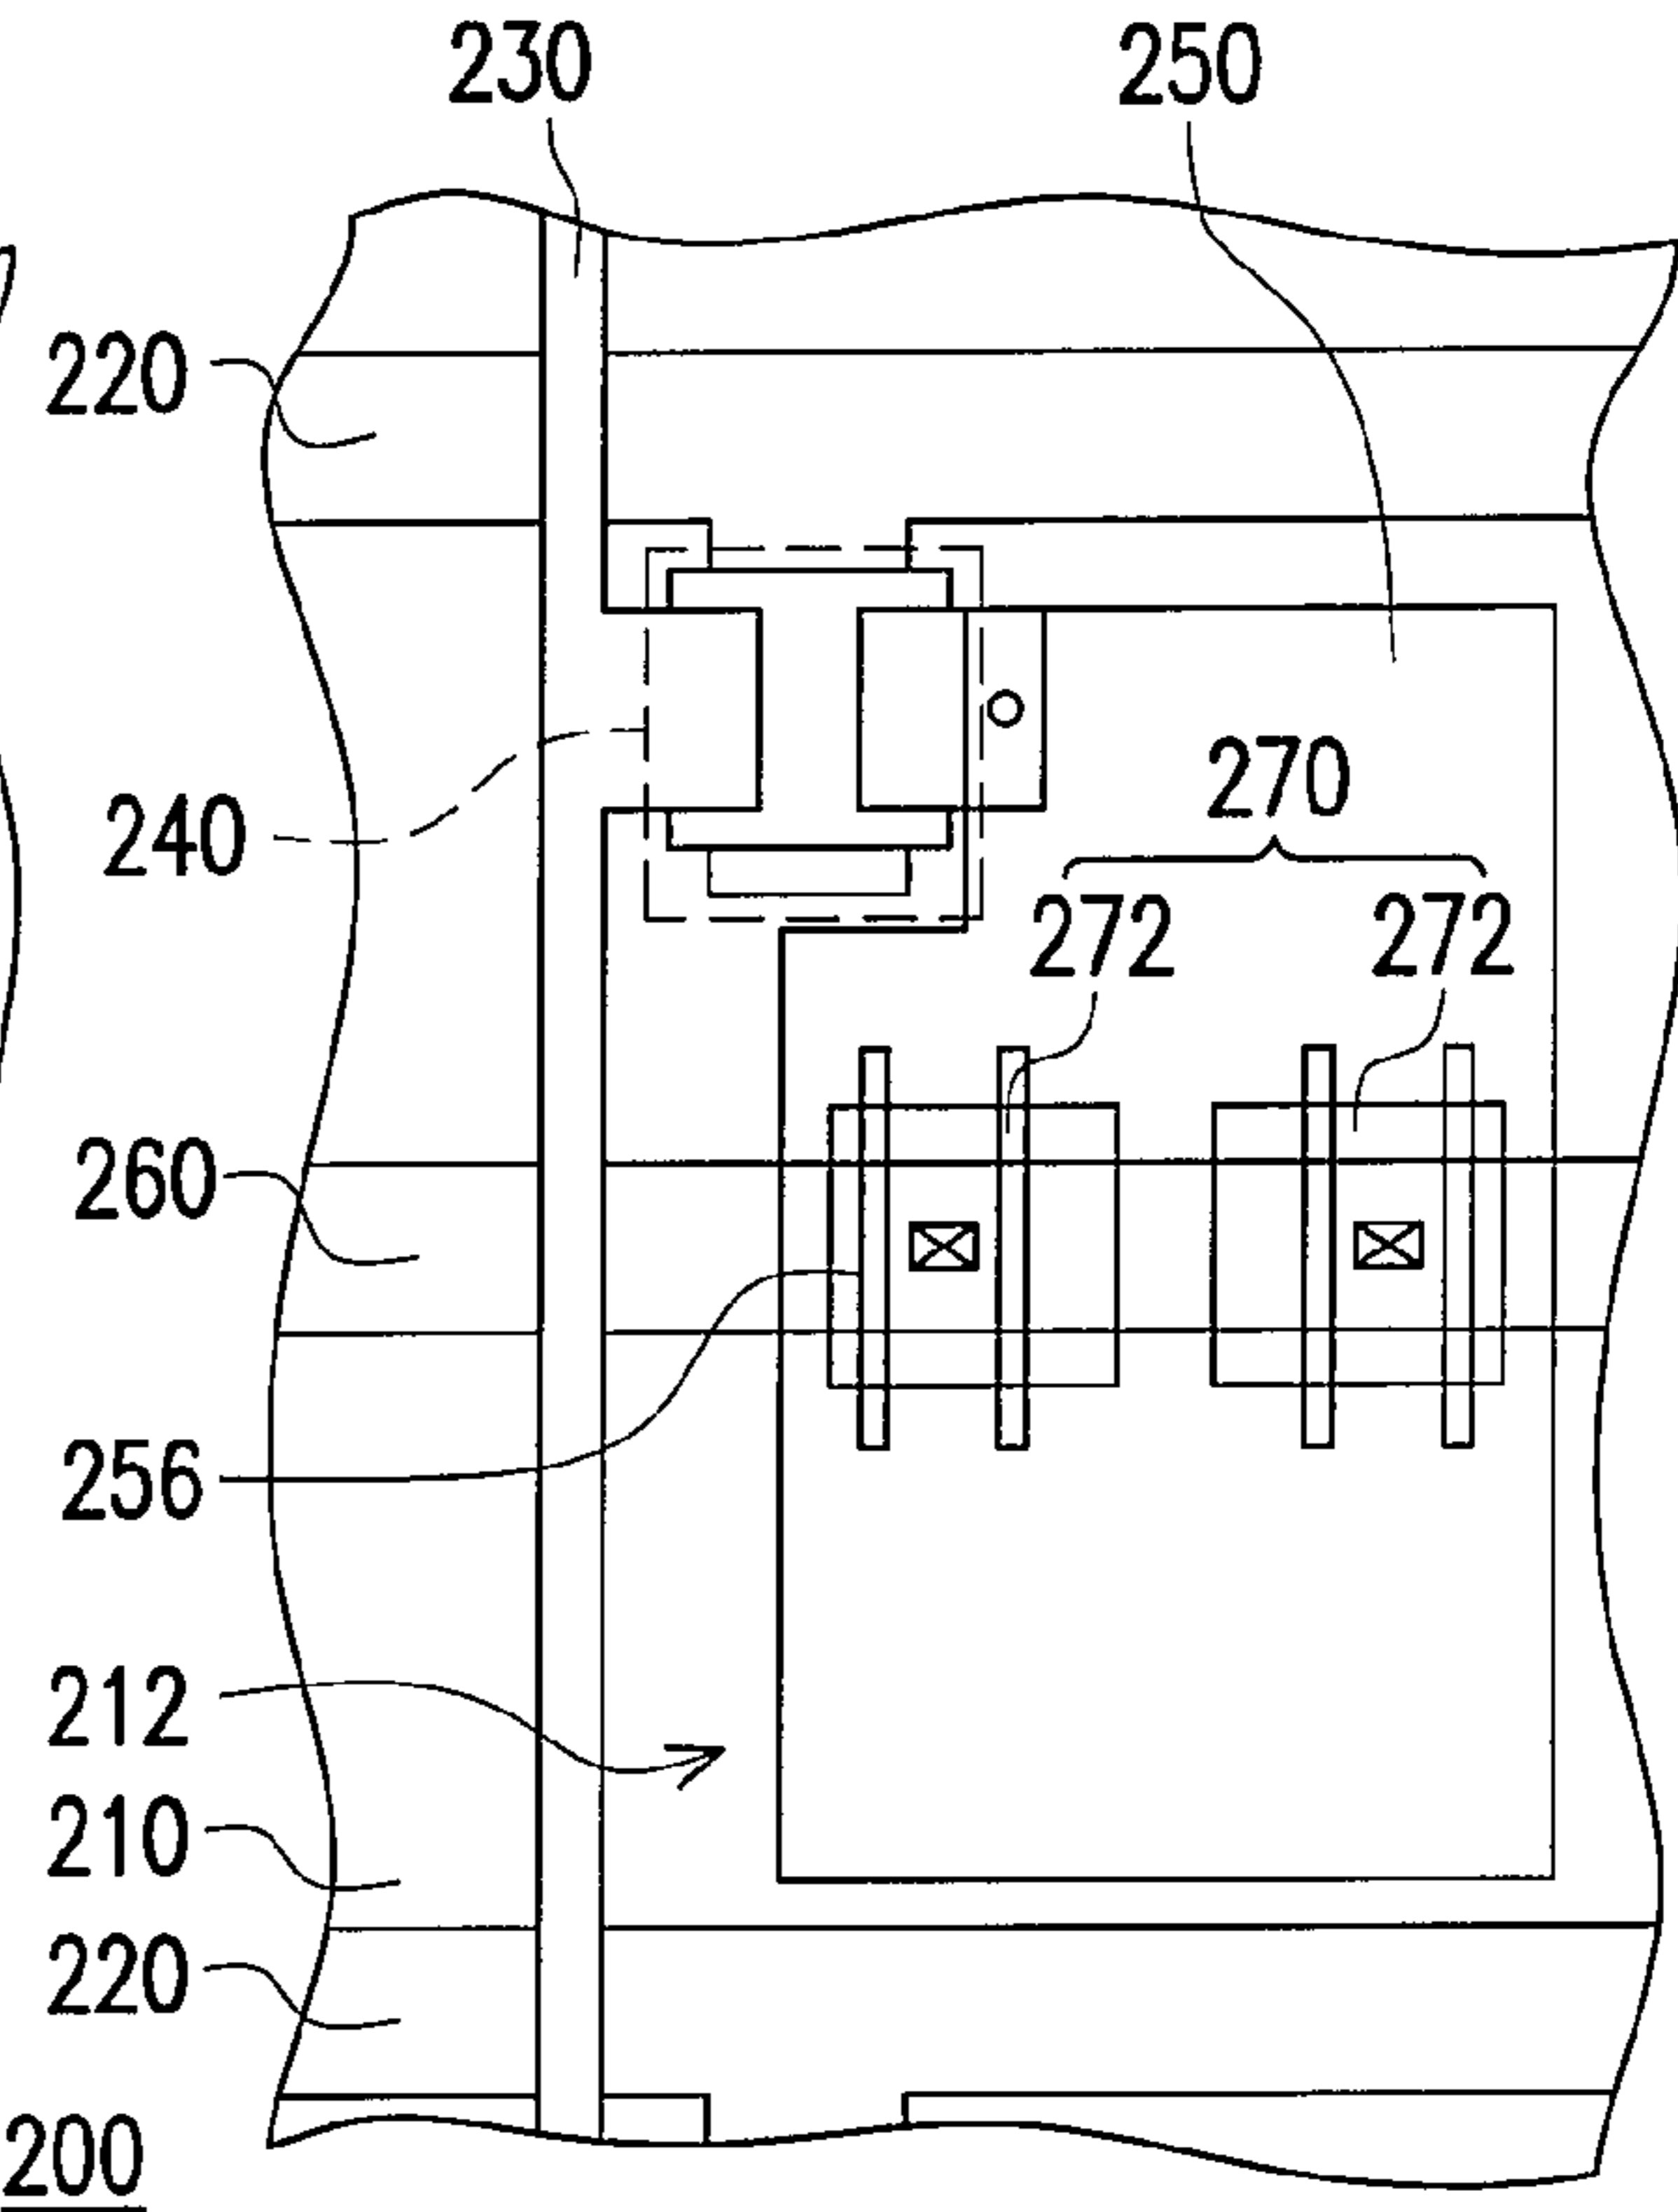
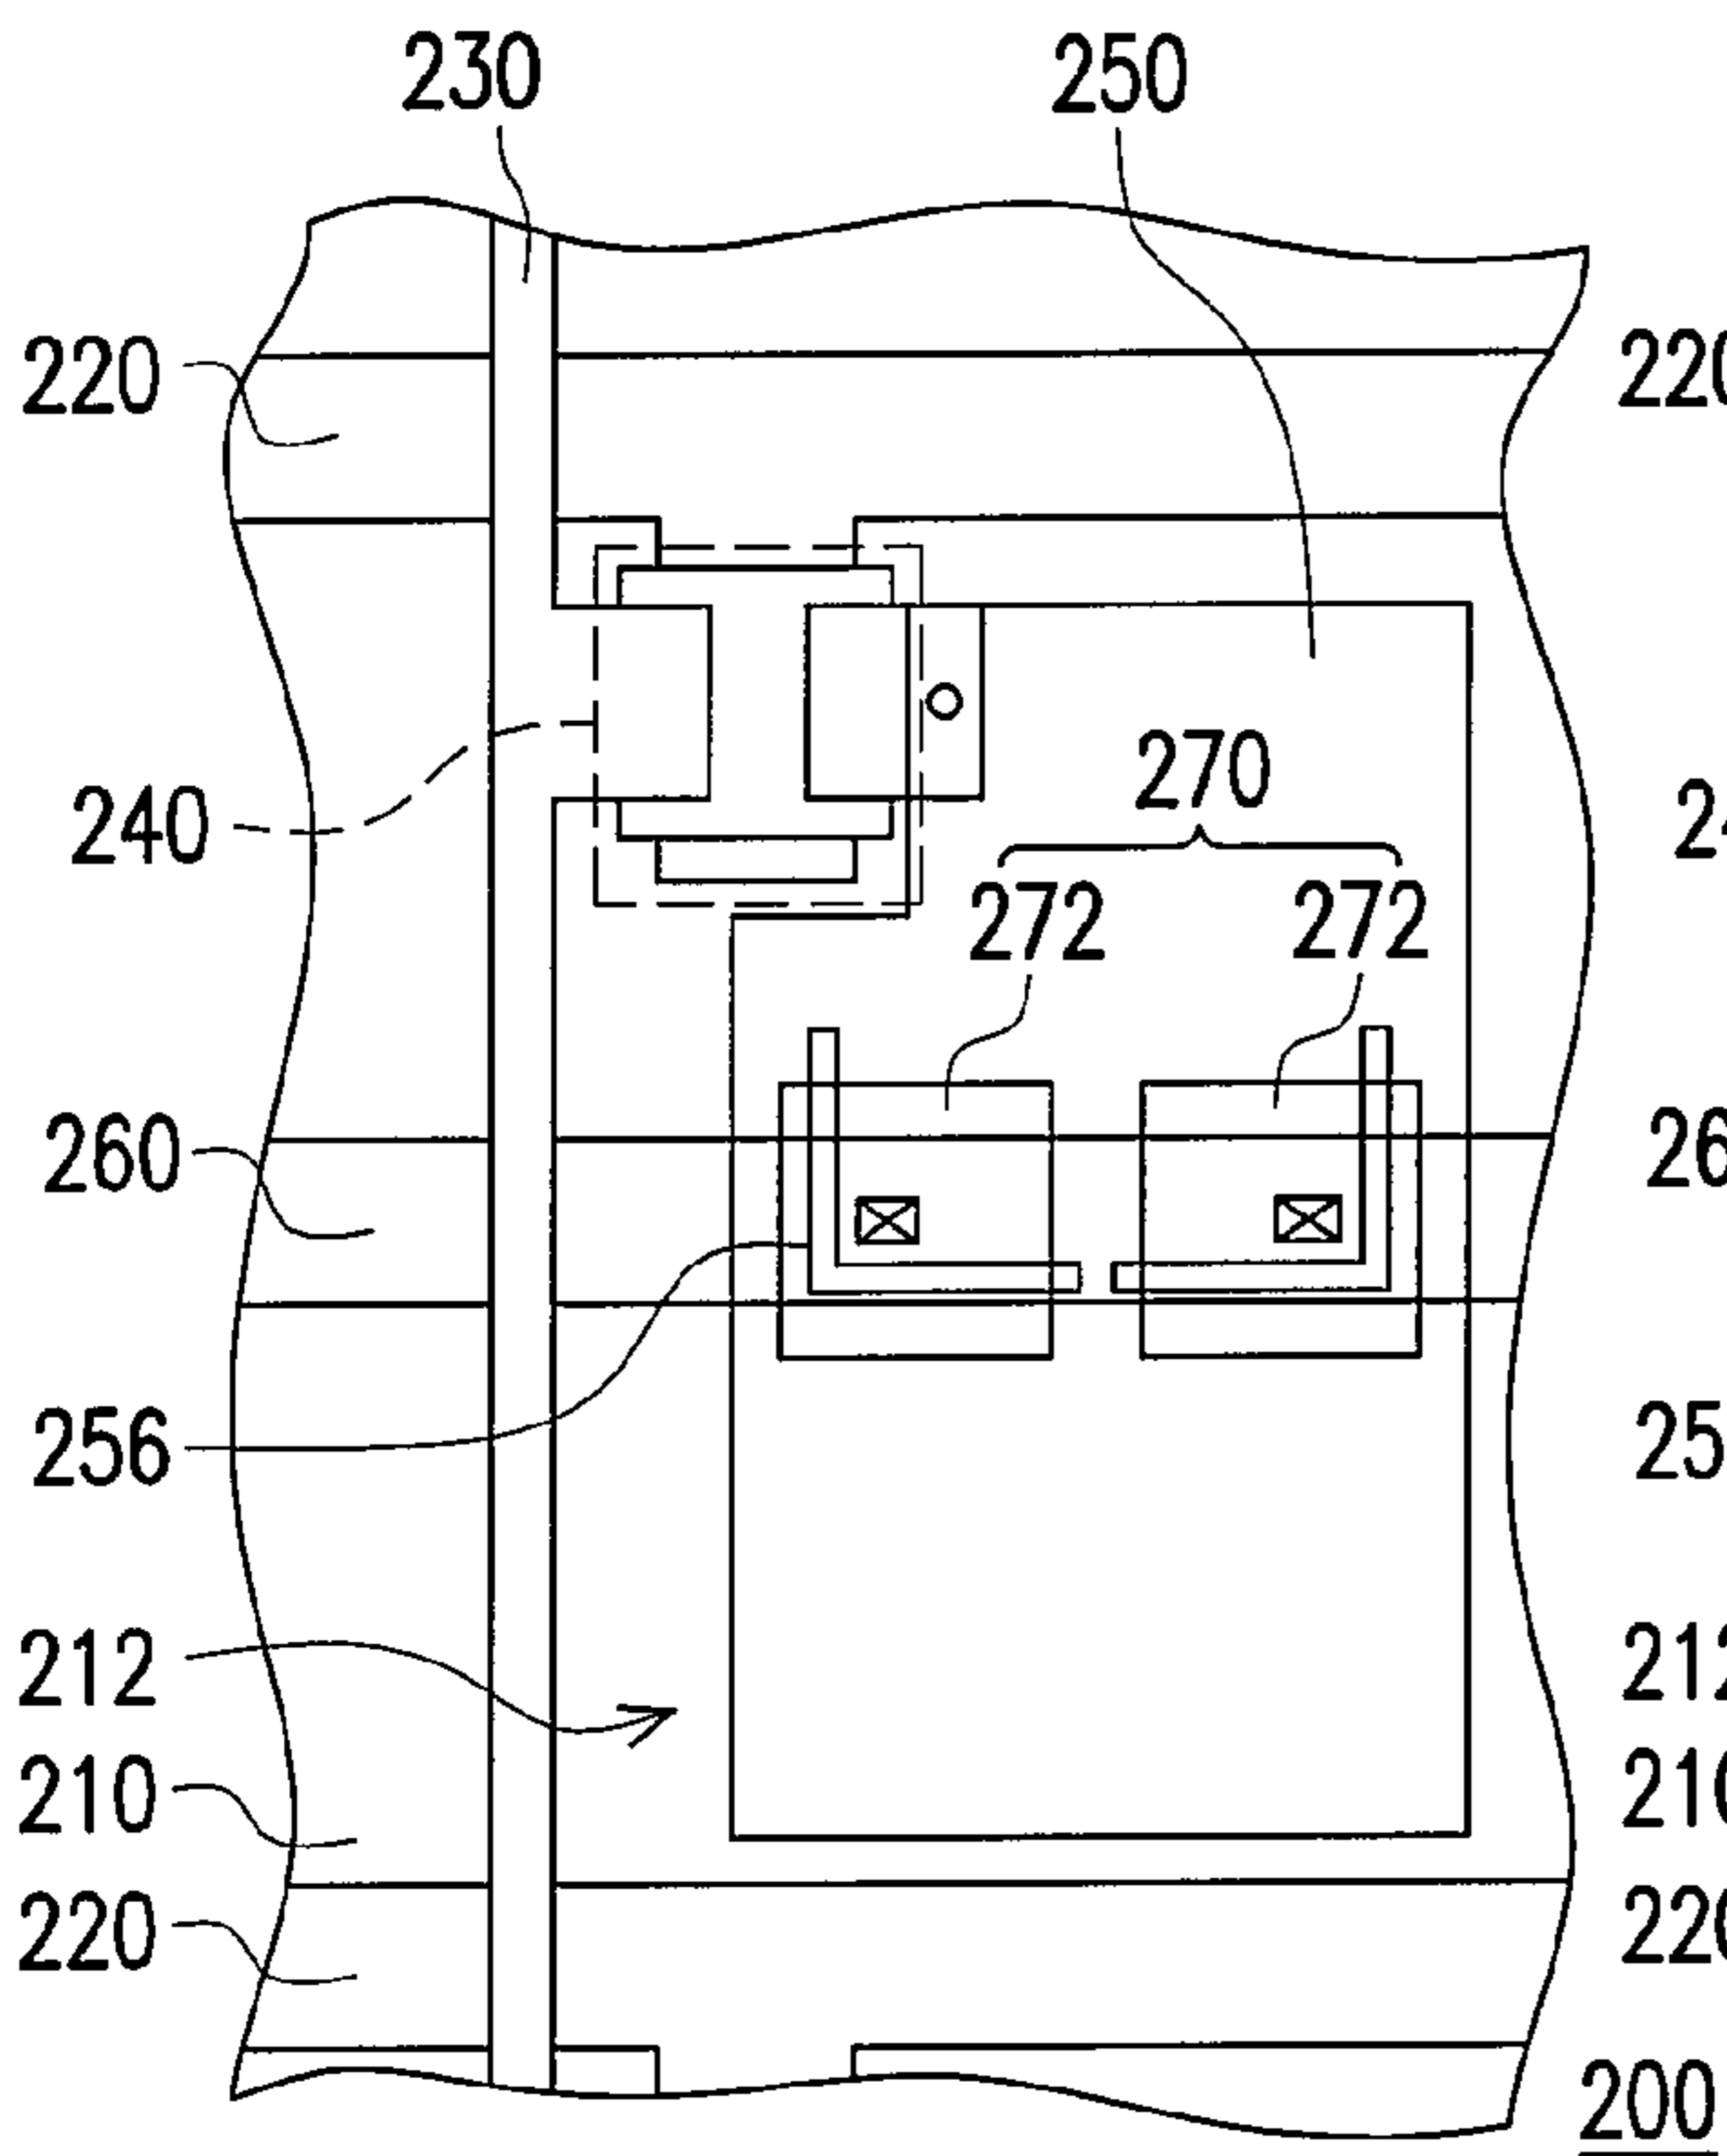
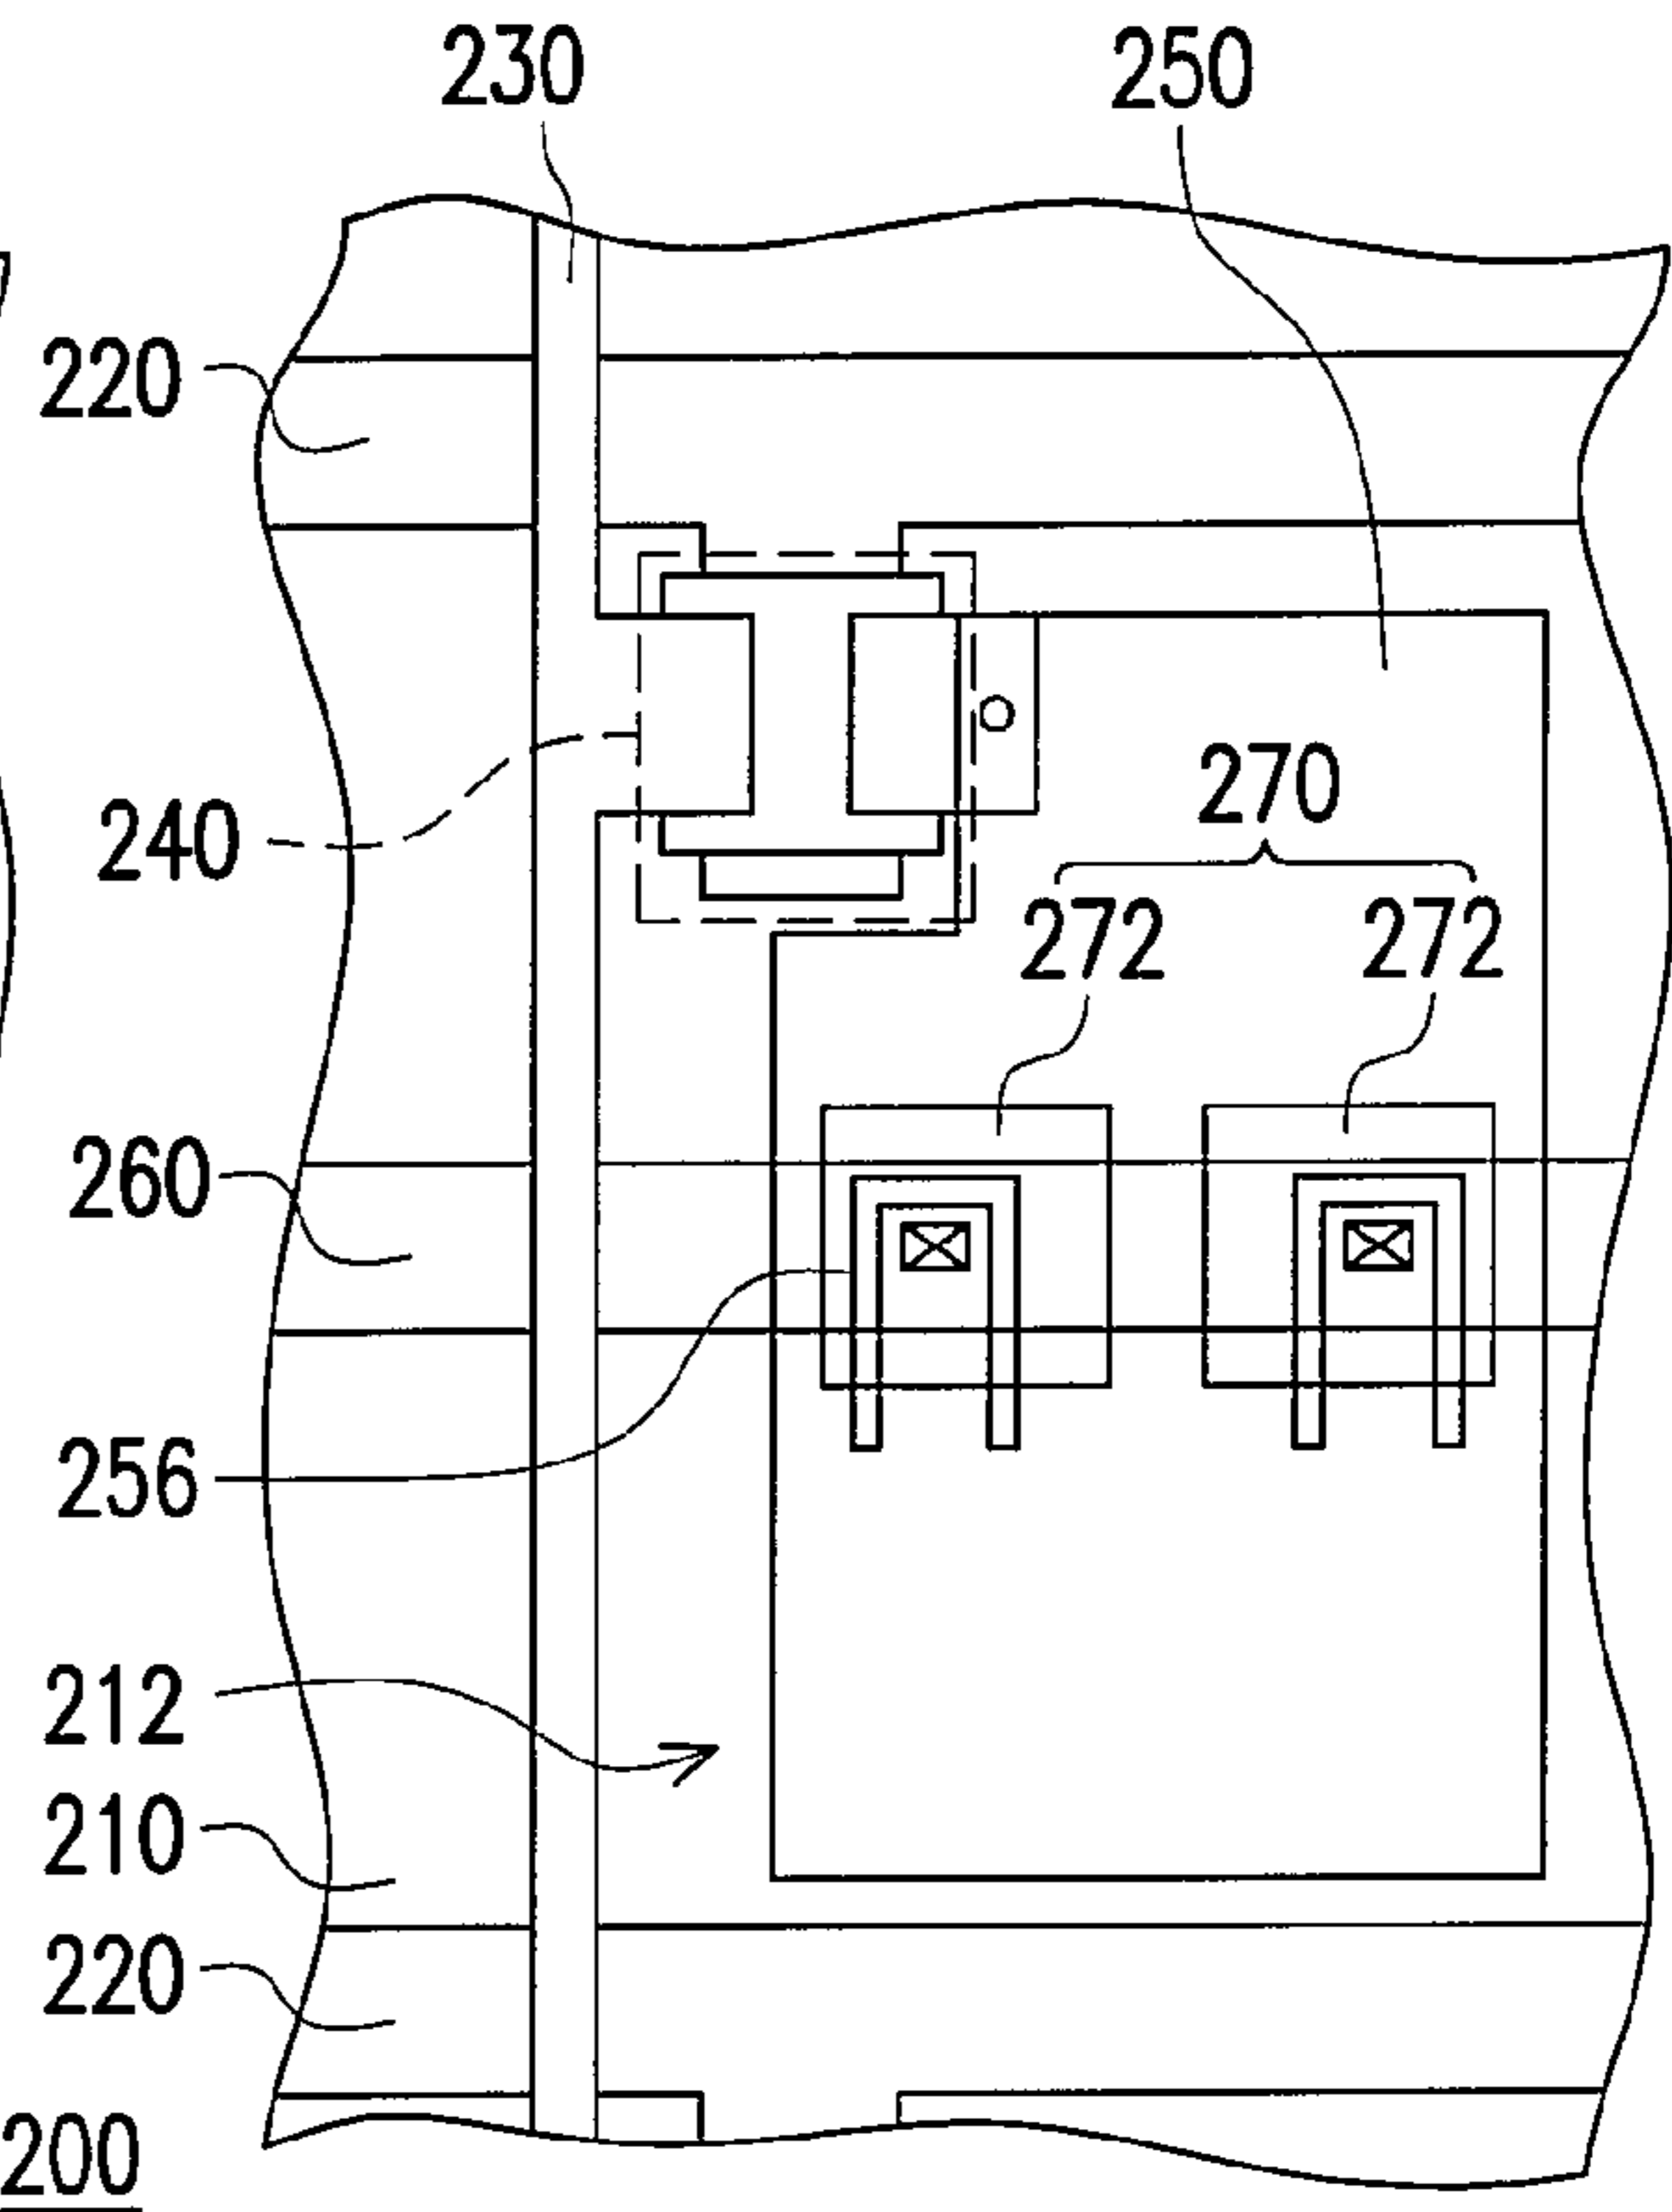
FIGS. 9A through 9D are top views showing different types of thin film transistor array substrates according to another preferred embodiment of the present invention.

FIGS. **9A** through **9D** are top views showing different types of thin film transistor array substrates according to another preferred embodiment of the present invention. The thin film transistor array substrate of the present embodiment is mostly identical to the one shown in FIG. **3**. One major difference is that one or more openings **256** are formed in each pixel electrode **250** when the pixel electrodes **250** are formed. The openings **256** are disposed around the contact region between each sub contact pad **272** and one of the pixel electrodes **250**. For example, a straight line opening **256** (shown in FIG. **9A**), two straight line openings **256** (shown in FIG. **9B**), an L-shaped opening (shown in FIG. **9C**) or a U-shaped opening **256** (shown in FIG. **9D**) is formed over the pixel electrode **250** corresponding to each sub contact pad **272**. With an opening **256** formed over the every pixel electrode **250**, a portion of any one pixel electrode **250** can be readily removed to connect the ends of the opening **256**. Hence, an opening similar to the opening **252** that encircles the contact **292** as shown in FIG. **5** can be produced when there is a particle (or defect) between a sub-upper electrode **272** and one of the common lines **260**. In the present embodiment, the method of removing a portion of the pixel electrode **250** includes performing a laser ablation process.

As shown in FIGS. **9A** through **9D**, a portion of the opening **256** is disposed above the area occupied by the sub-upper electrode **272** while the remaining portion of the opening **256** is disposed outside the area occupied by the sub-upper electrode **272**. In other words, the openings **256** also cover a region outside the upper electrode **272** to simplify and speed the repairing operation. In addition, anyone familiar with the

After removing a portion of the pixel electrode corresponding to the sub-upper electrode of the defective capacitor, the sub-upper electrode of the defective capacitor and one of the scan lines can be electrically connected by performing a laser welding process. Similarly, if a particle (or defect) is found between the pixel electrode and one of the scan lines, the pixel electrode above the particle (or defect) can be removed using a laser removing method. In addition, the process of fabricating the pixel electrode may include forming one or more openings similar to the ones described in FIGS. **9A** through **9D** to facilitate a laser repair operation.
