(12) **United States Patent**  
**Lai**

(10) **Patent No.:** **US 7,646,446 B2**  
(45) **Date of Patent:** **Jan. 12, 2010**

(54) **REPAIRING METHOD OF A THIN FILM TRANSISTOR ARRAY SUBSTRATE**

(73) Assignee: **Au Optronics Corporation**, Hsinchu (TW)

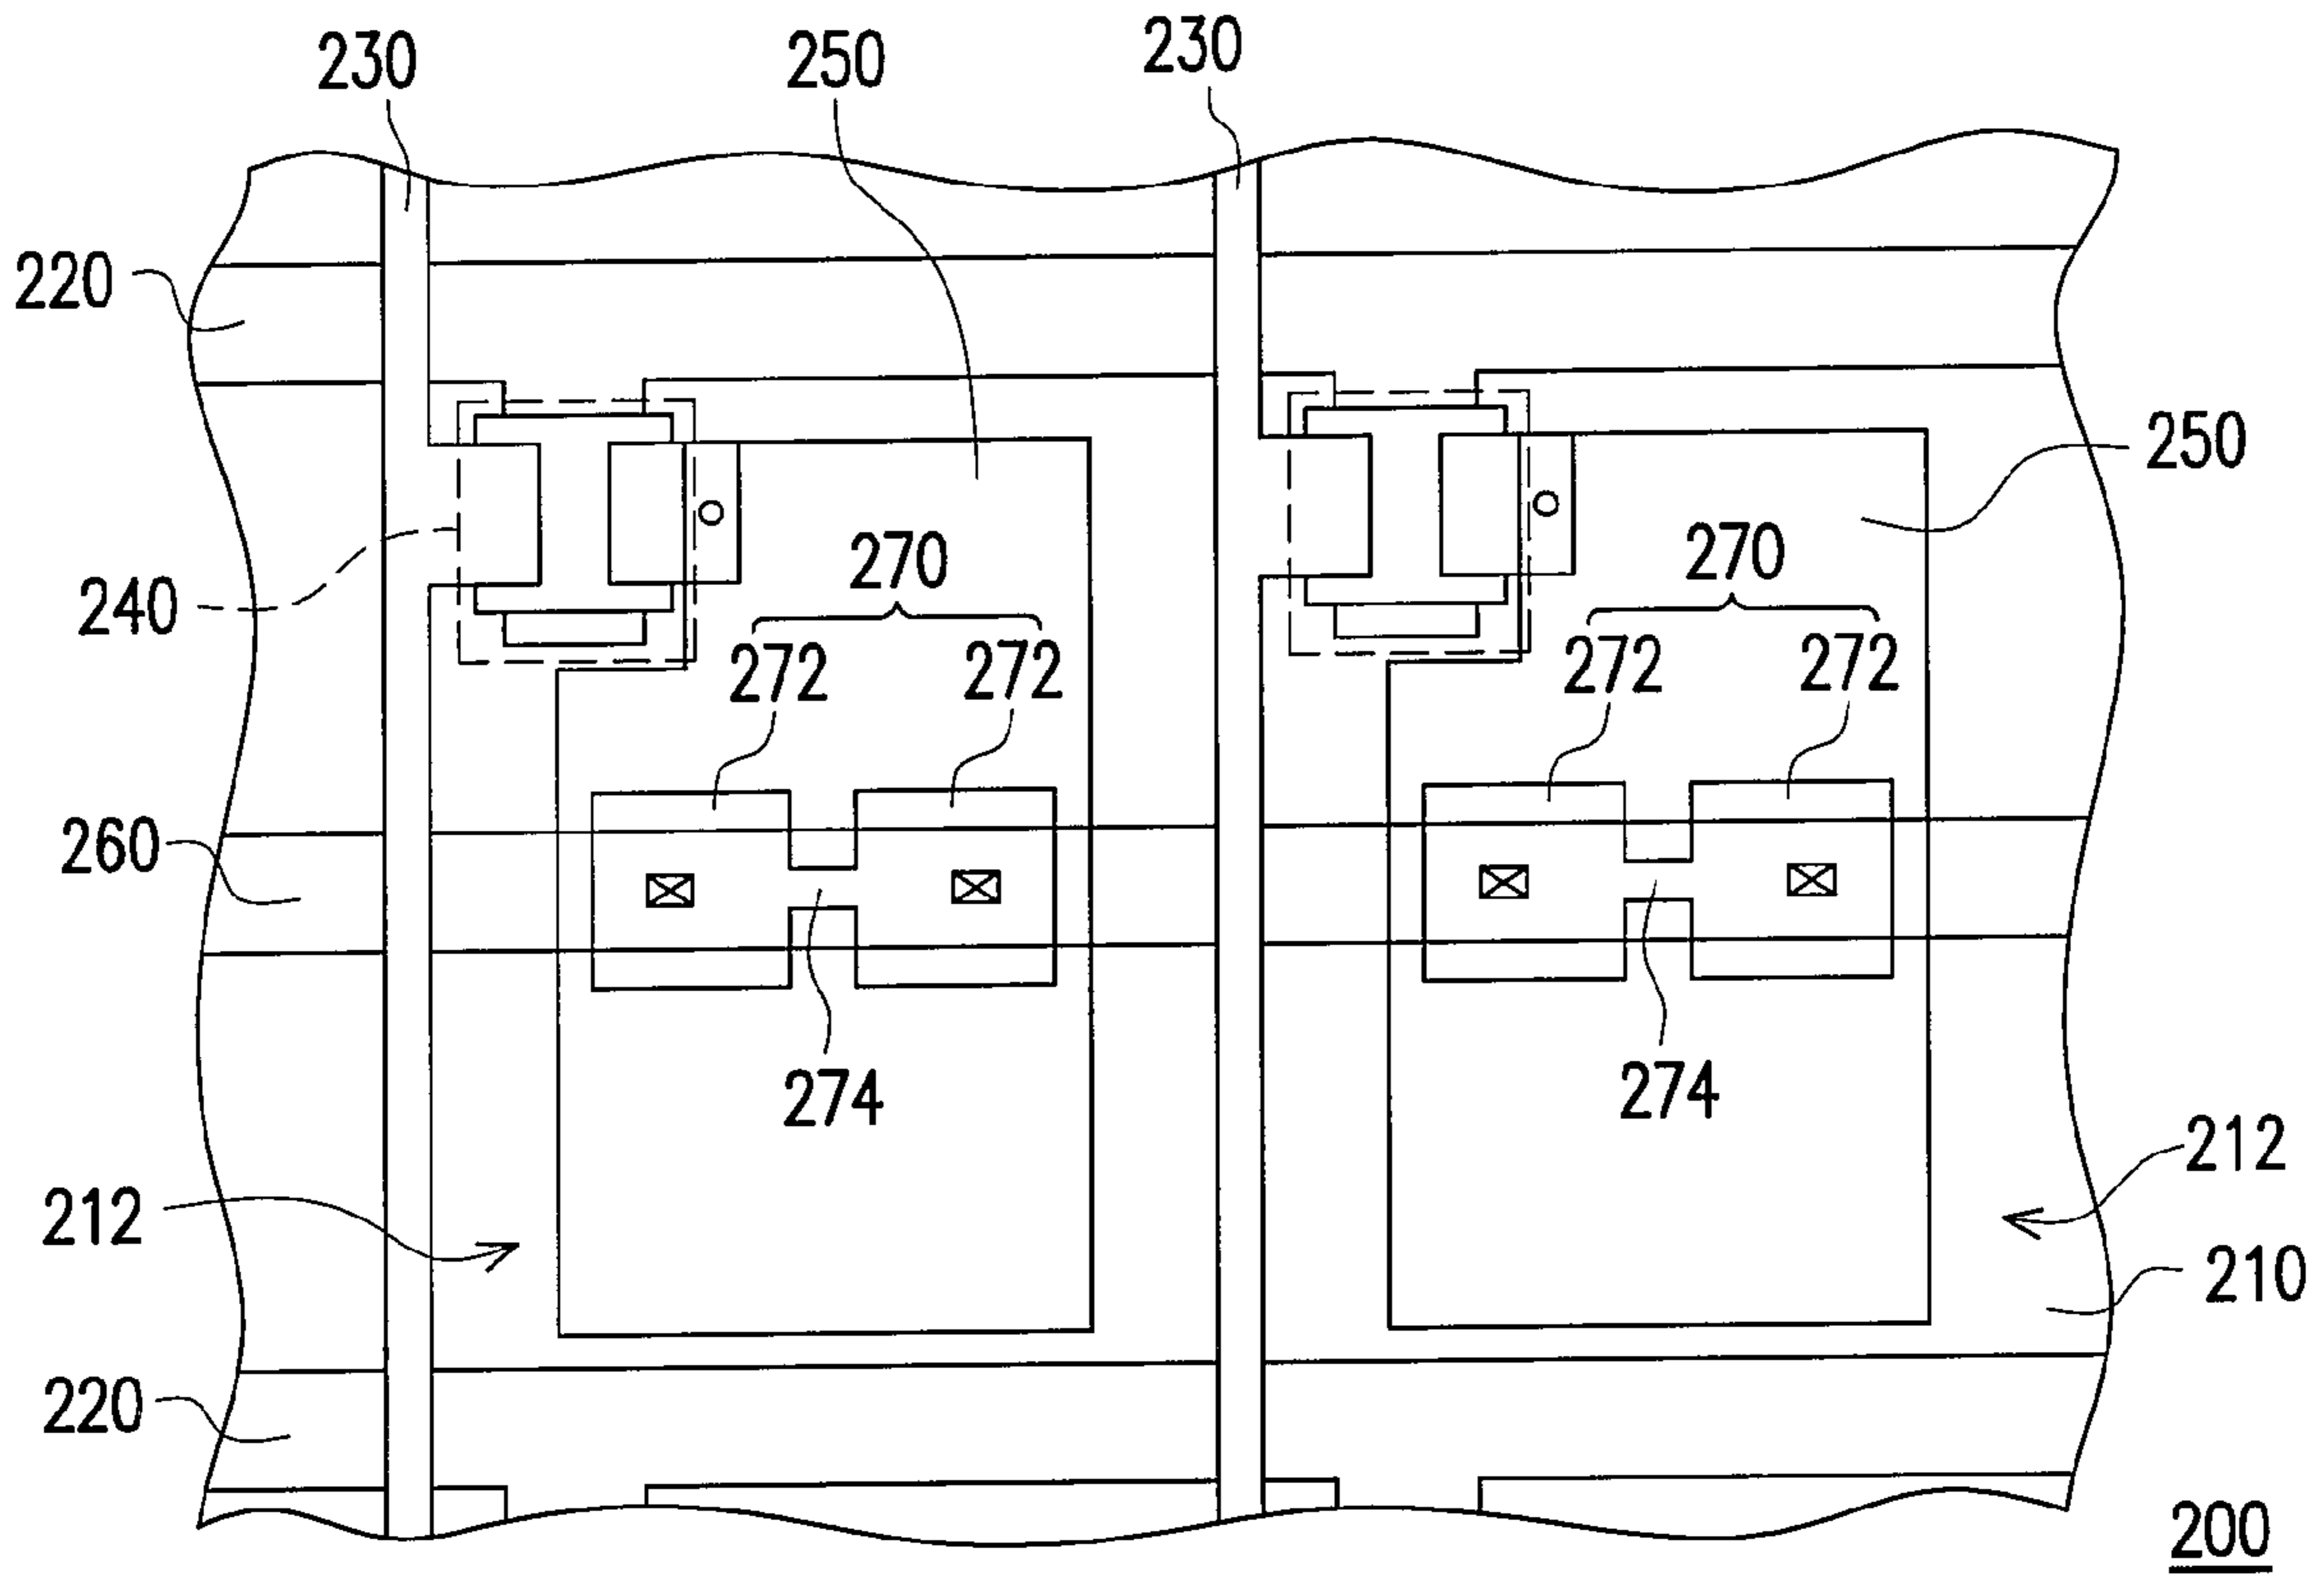
FIG. 10 is a top view of a thin film transistor array substrate according to another preferred embodiment of the present invention.

FIG. **10** is a top view of a thin film transistor array substrate according to another preferred embodiment of the present invention. FIG. **11** is a top view of the thin film transistor array substrate in FIG. **10** after a laser repairing operation. In the present embodiment, the thin film transistor array substrate has a structure mostly similar to the one shown in FIG. **3**. One major difference of the present embodiment is that the sub-upper electrodes **272** underneath each pixel electrode **250** are mutually connected through a neck portion **274** that can be severed in a repair operation.

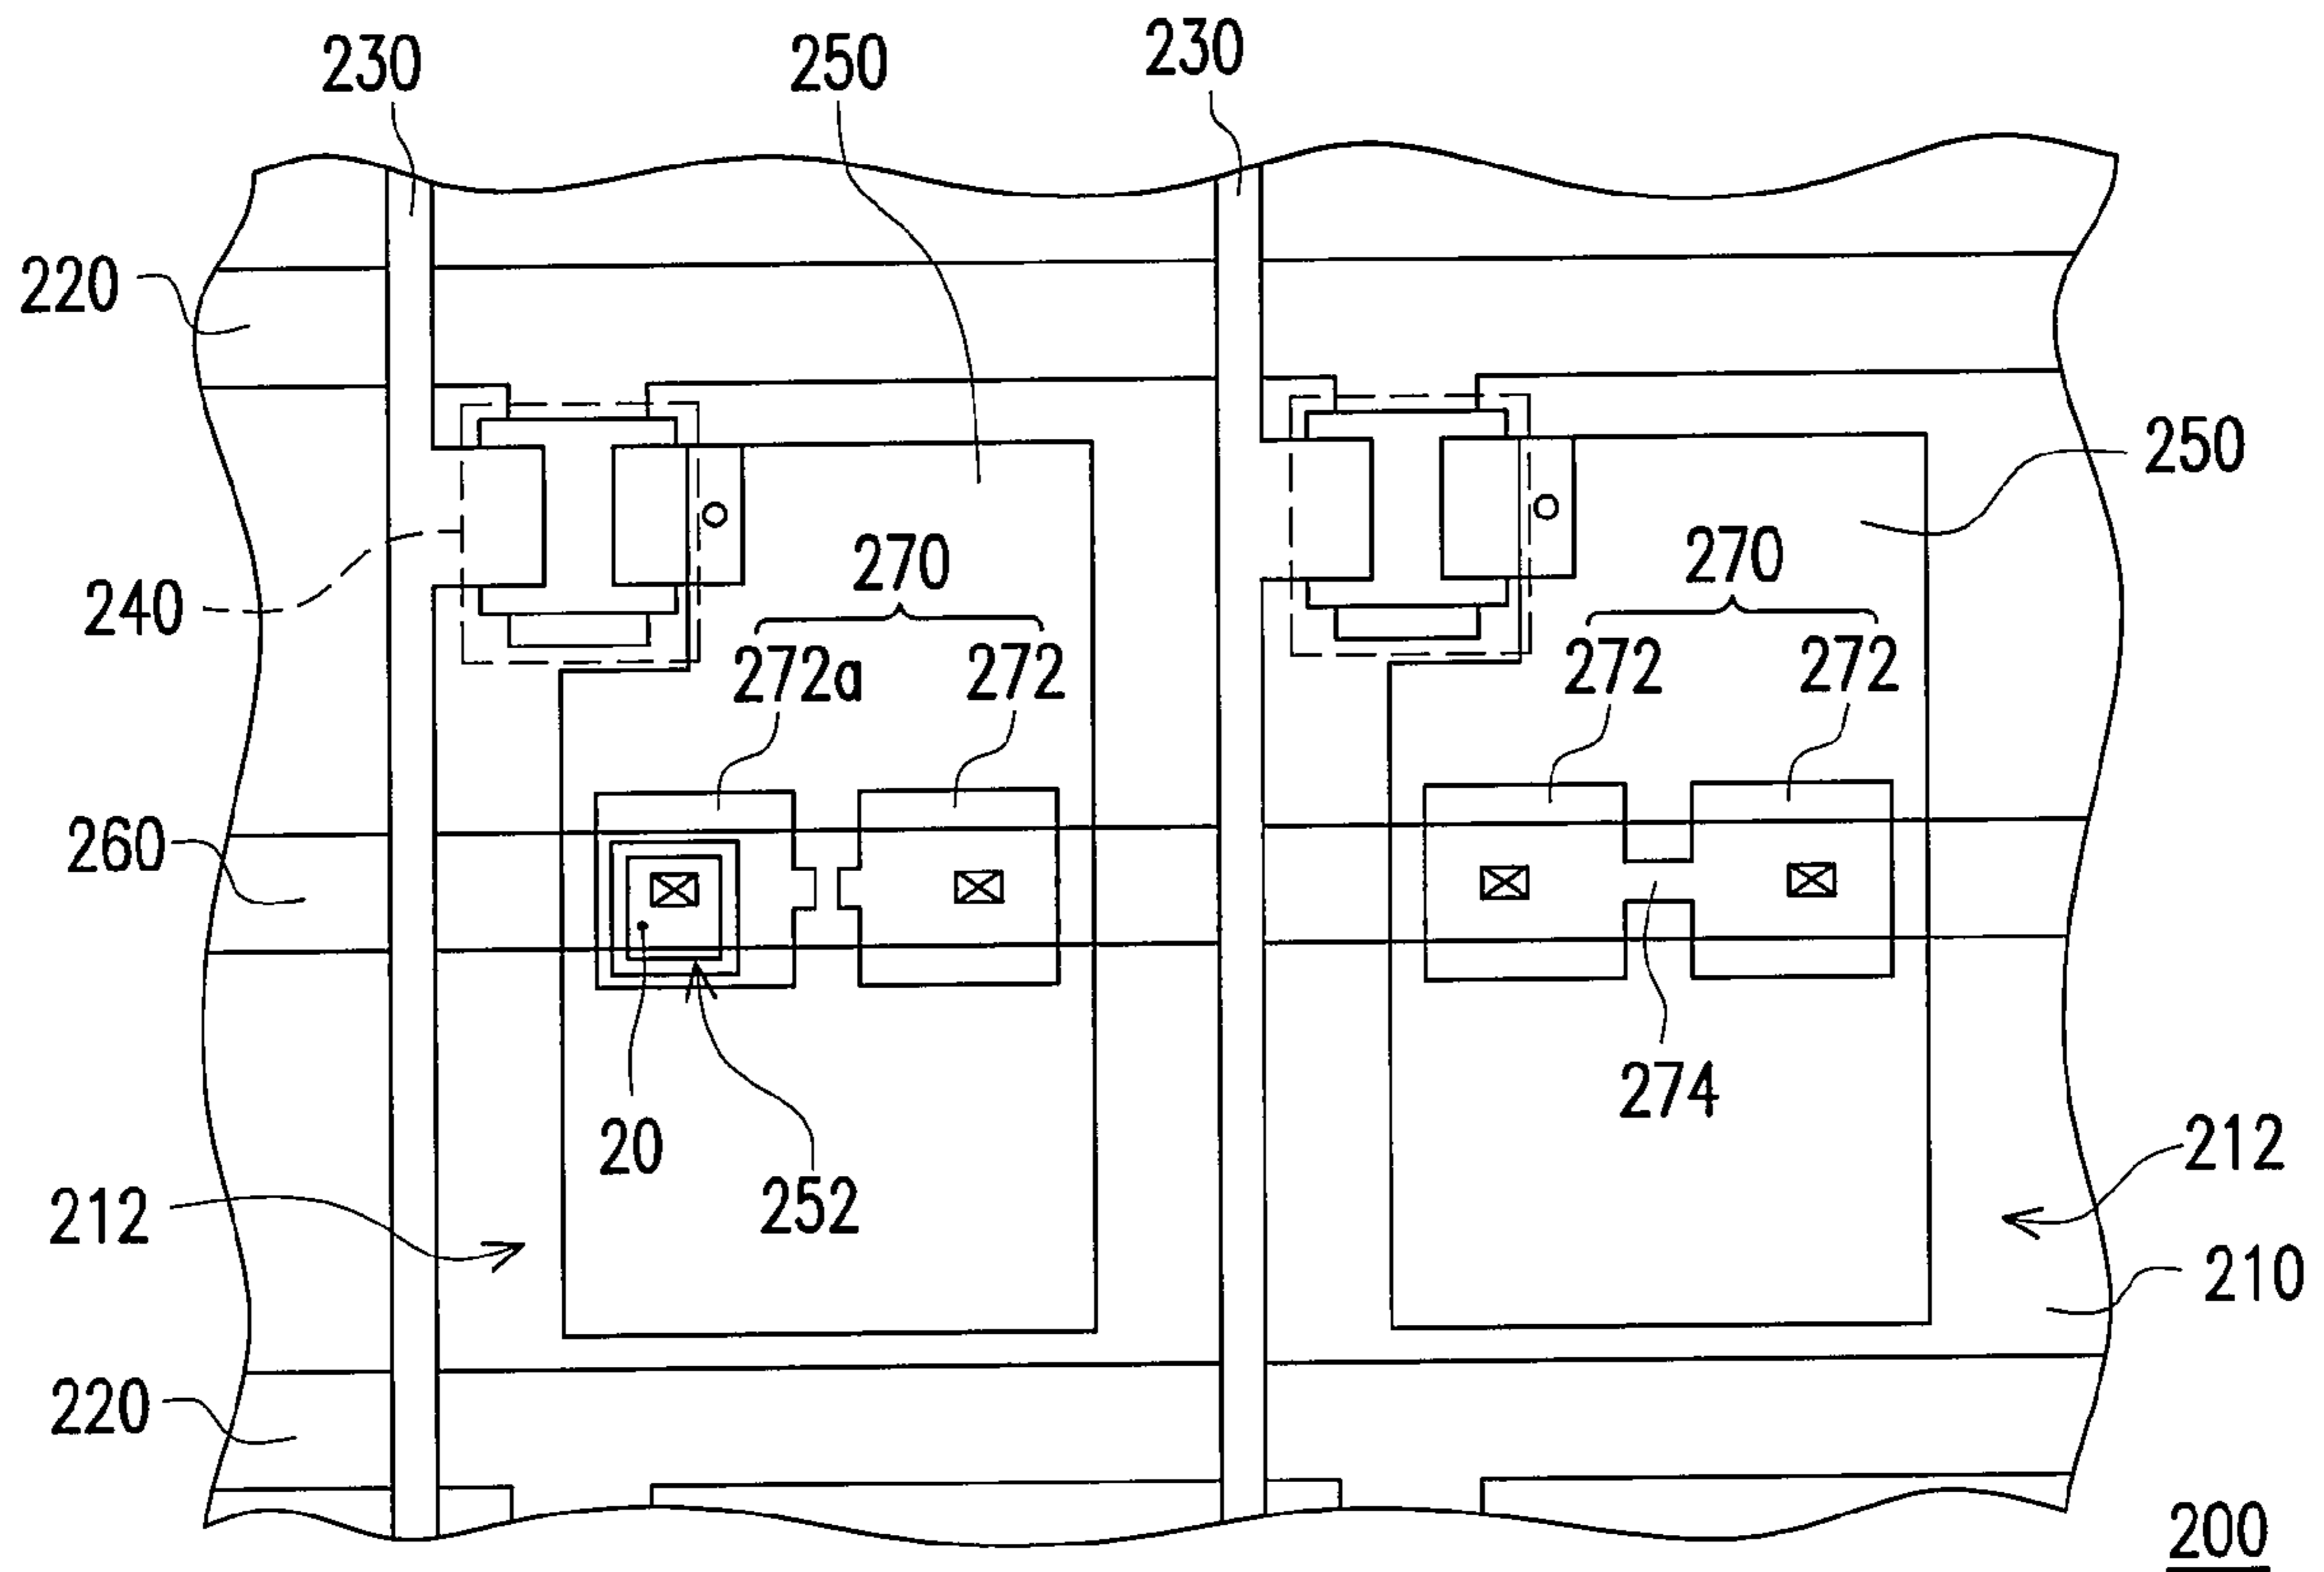
FIG. 11 is a top view of the thin film transistor array substrate in FIG. 10 after a laser repairing operation.

In the presence of a particle **20** (or defect) between one of the sub-upper electrode **270** and one of the common lines **260**, a leakage between the sub-upper electrode **272a** and the common line **260** may occur. To repair such defect, a portion of the pixel electrode **250** corresponding to the sub-upper electrode **272a** of the defective capacitor is removed. Thereafter, the neck portion **274** connecting with the sub-upper electrode **272a** of the defective capacitor **272a** is cut so that the sub-upper electrode **272a** and the corresponding pixel electrode **250** of the defective capacitor are electrically isolated. In the present embodiment, a portion of the pixel electrode **250** is removed to form an opening **252**. The opening **252** is located around the contact area between the sub-upper electrode **272a** and the corresponding pixel electrode of the defective capacitor. Furthermore, the method of removing a portion of the pixel electrode **250** includes performing a laser ablation and the method of cutting the neck portion **274** includes performing a laser cutting operation. After cutting the neck portion **274** connecting the sub-upper electrode **272a** of the defective capacitor, the sub-upper electrode **272a** and the corresponding pixel electrode **250** are electrically isolated to achieve the goal of repairing a thin film transistor array substrate.

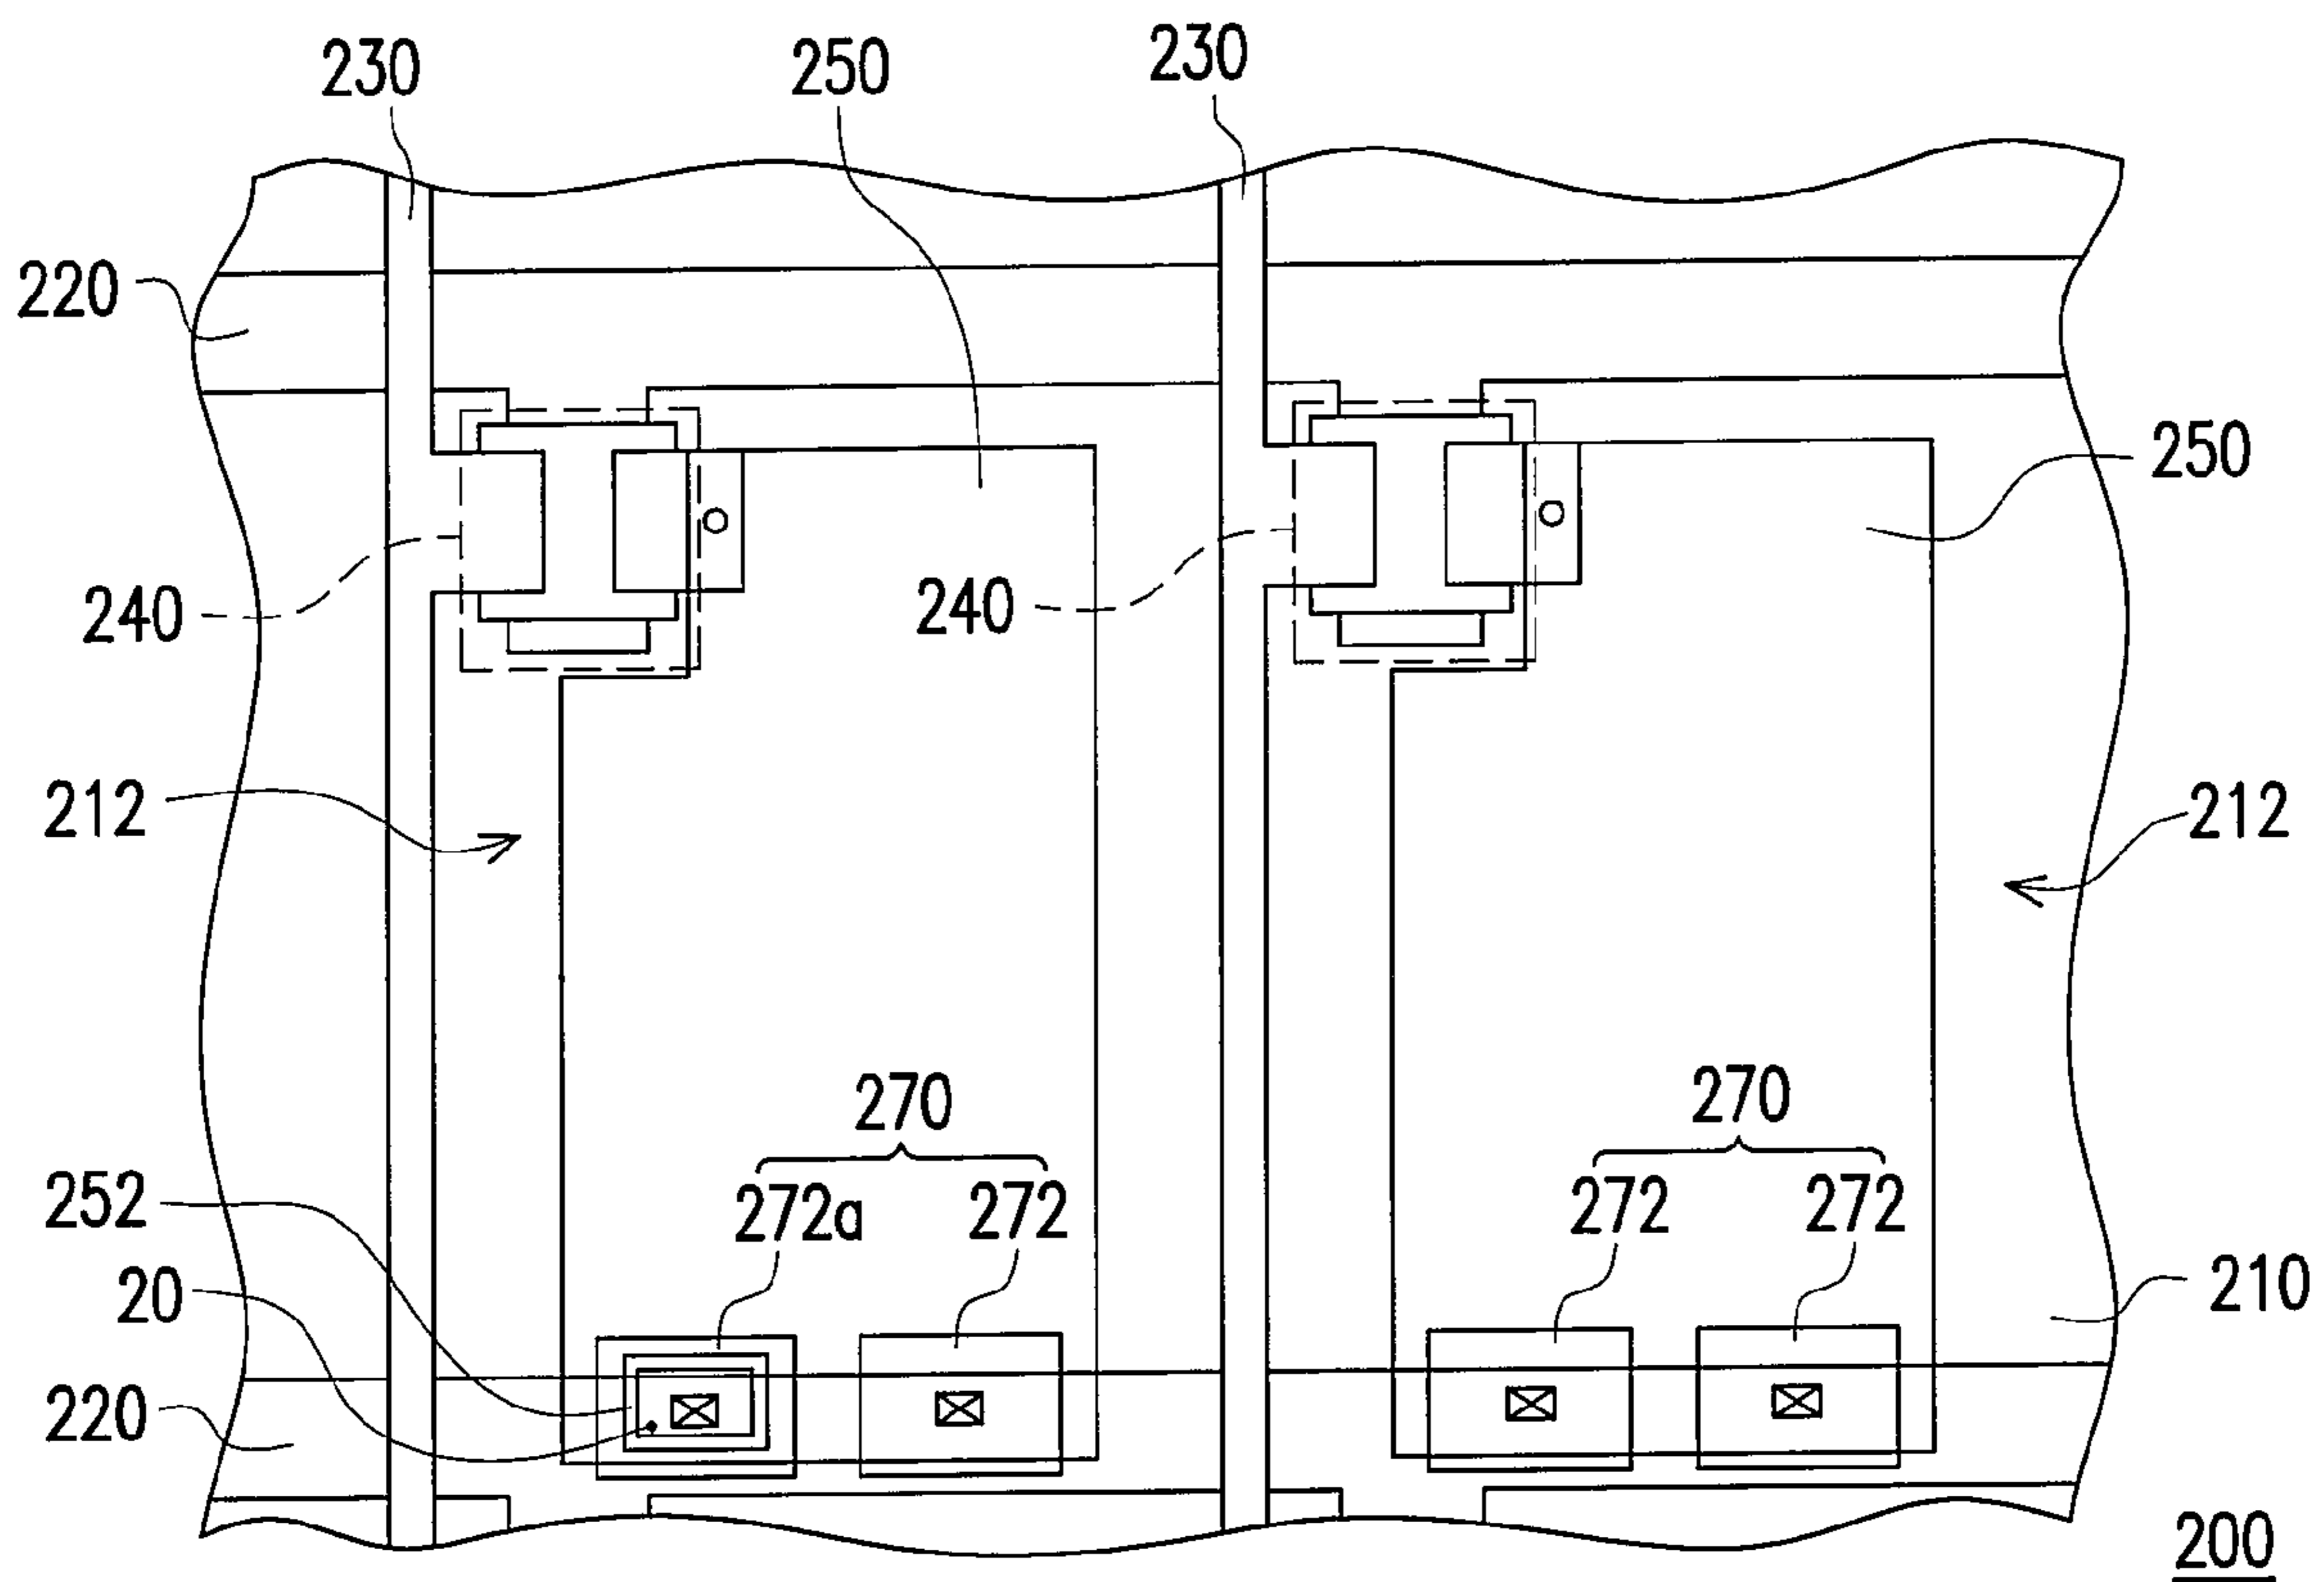
FIG. 12

FIGS. 12 and 13 are top views showing the method of repairing the scan line structure of the storage capacitor inside a thin film transistor array substrate according to the present invention.

FIGS. **12** and **13** are top views showing the method of repairing the scan line structure of the storage capacitor inside a thin film transistor array substrate according to the present invention. As shown in FIGS. **12** and **13**, the thin film transistor array substrate has a capacitor on scan line structure (Cst on gate) similar to one shown in FIG. **5**.

As shown in FIG. **12**, a portion of each pixel electrode **250** extends into the area above one of the scan lines **220**. The patterned upper electrode **270** is disposed between the pixel electrode **250** and the corresponding scan line **220**. The patterned upper electrode **270** comprises a plurality of sub-upper electrodes **272**. The sub-upper electrode **272** and its underlying scan line **220** together form a storage capacitor inside each pixel.

As shown in FIG. **12**, a portion of the pixel electrode **250** above the sub-upper electrode **272a** of the corresponding defective capacitor is removed to form an opening **252**. By forming the opening **252** in the pixel electrode **250**, the sub-upper electrode **272a** and the corresponding pixel electrode **250** of the defective capacitor are electrically isolated. The method of removing a portion of the pixel electrode **250** includes laser ablation, for example.

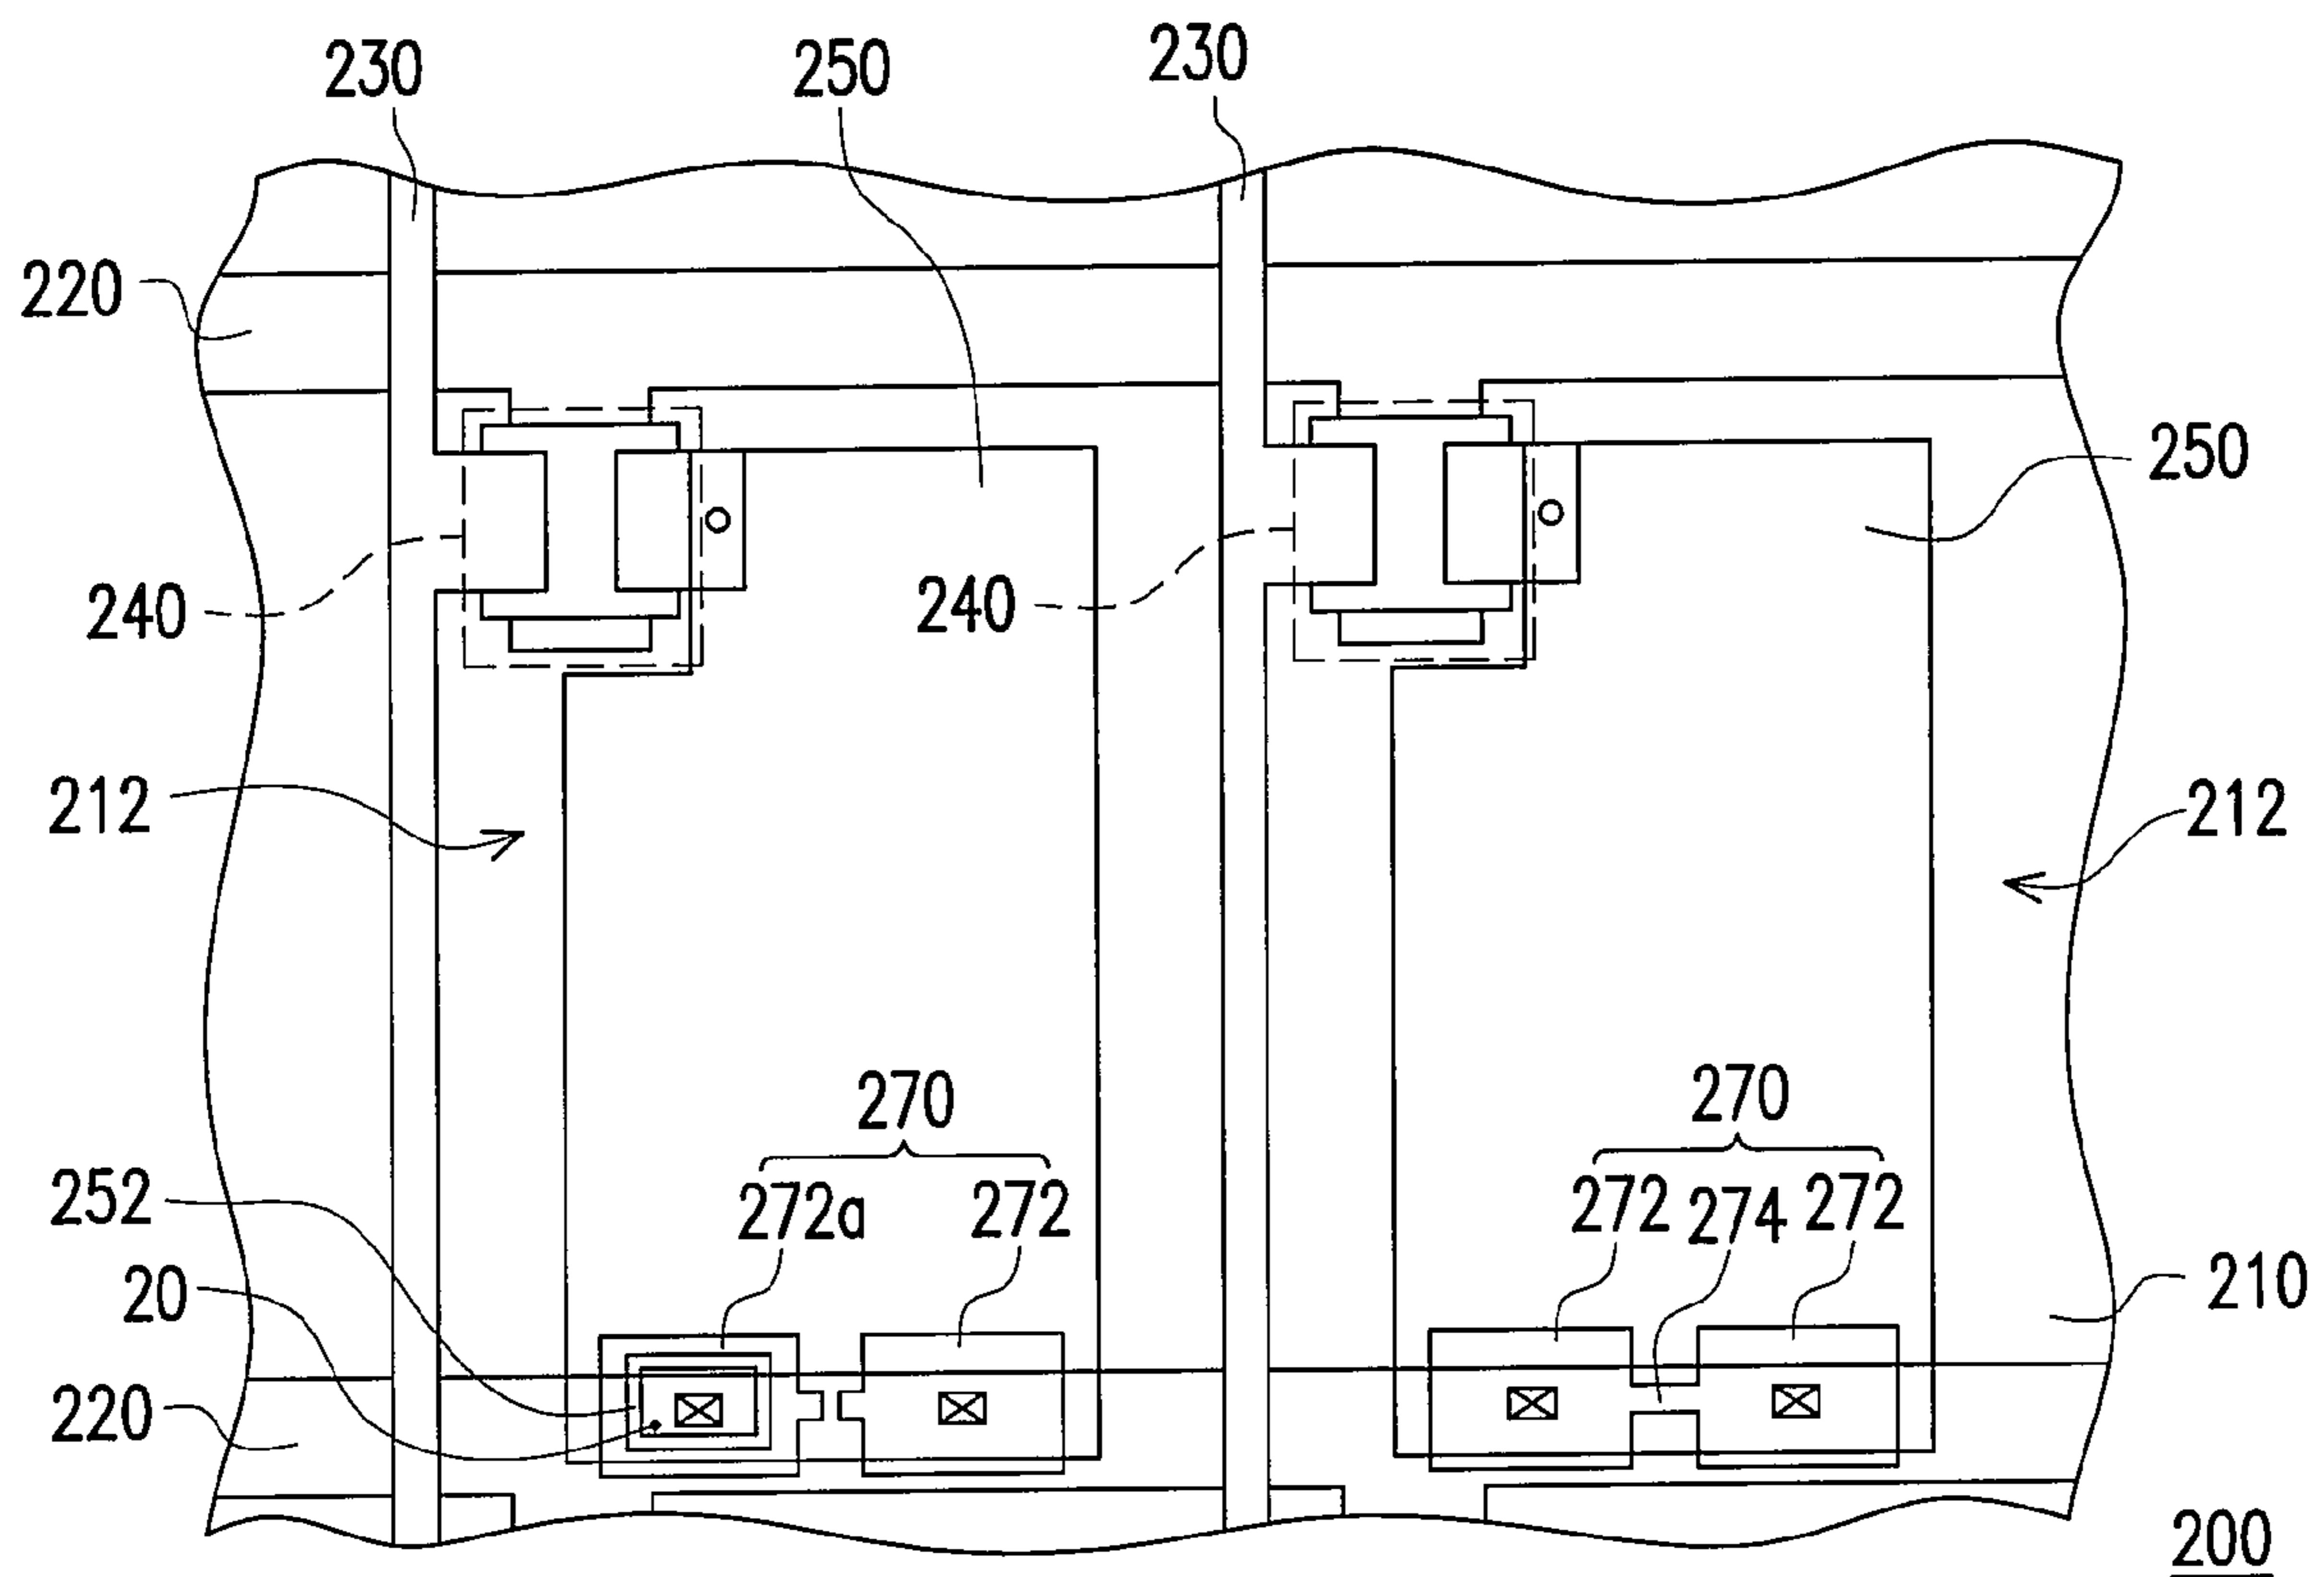
FIG. 13

As shown in FIG. **13**, the patterned upper electrode **270** is disposed between each pixel electrode **250** and one of the scan lines **220**. The patterned upper electrode **270** comprises a plurality of sub-upper electrodes **272**. Furthermore, each sub-upper electrode **272** underneath the pixel electrode **250** has a neck portion **274** connecting with each other. The neck portion **274** serves as a cutting area in a repairing operation.

As shown in FIG. **13**, the repairing method includes removing a portion of the pixel electrode corresponding to the sub-upper electrode **272a** of the defective capacitor to form an opening **252**. Furthermore, the neck portion **274** connecting with the sub-upper electrode **272a** of the defective capacitor is cut so that the sub-upper electrode **272a** of the defective capacitor and the corresponding pixel electrode **250** are electrically isolated. The method of removing a portion of the pixel electrode **250** includes a laser ablation process and the method of cutting the neck portion **274** includes a laser cutting operation.
