(12) **United States Patent**  
**Lai**

(10) **Patent No.:** **US 7,646,446 B2**  
(45) **Date of Patent:** **Jan. 12, 2010**

(54) **REPAIRING METHOD OF A THIN FILM TRANSISTOR ARRAY SUBSTRATE**

(73) Assignee: **Au Optronics Corporation**, Hsinchu (TW)

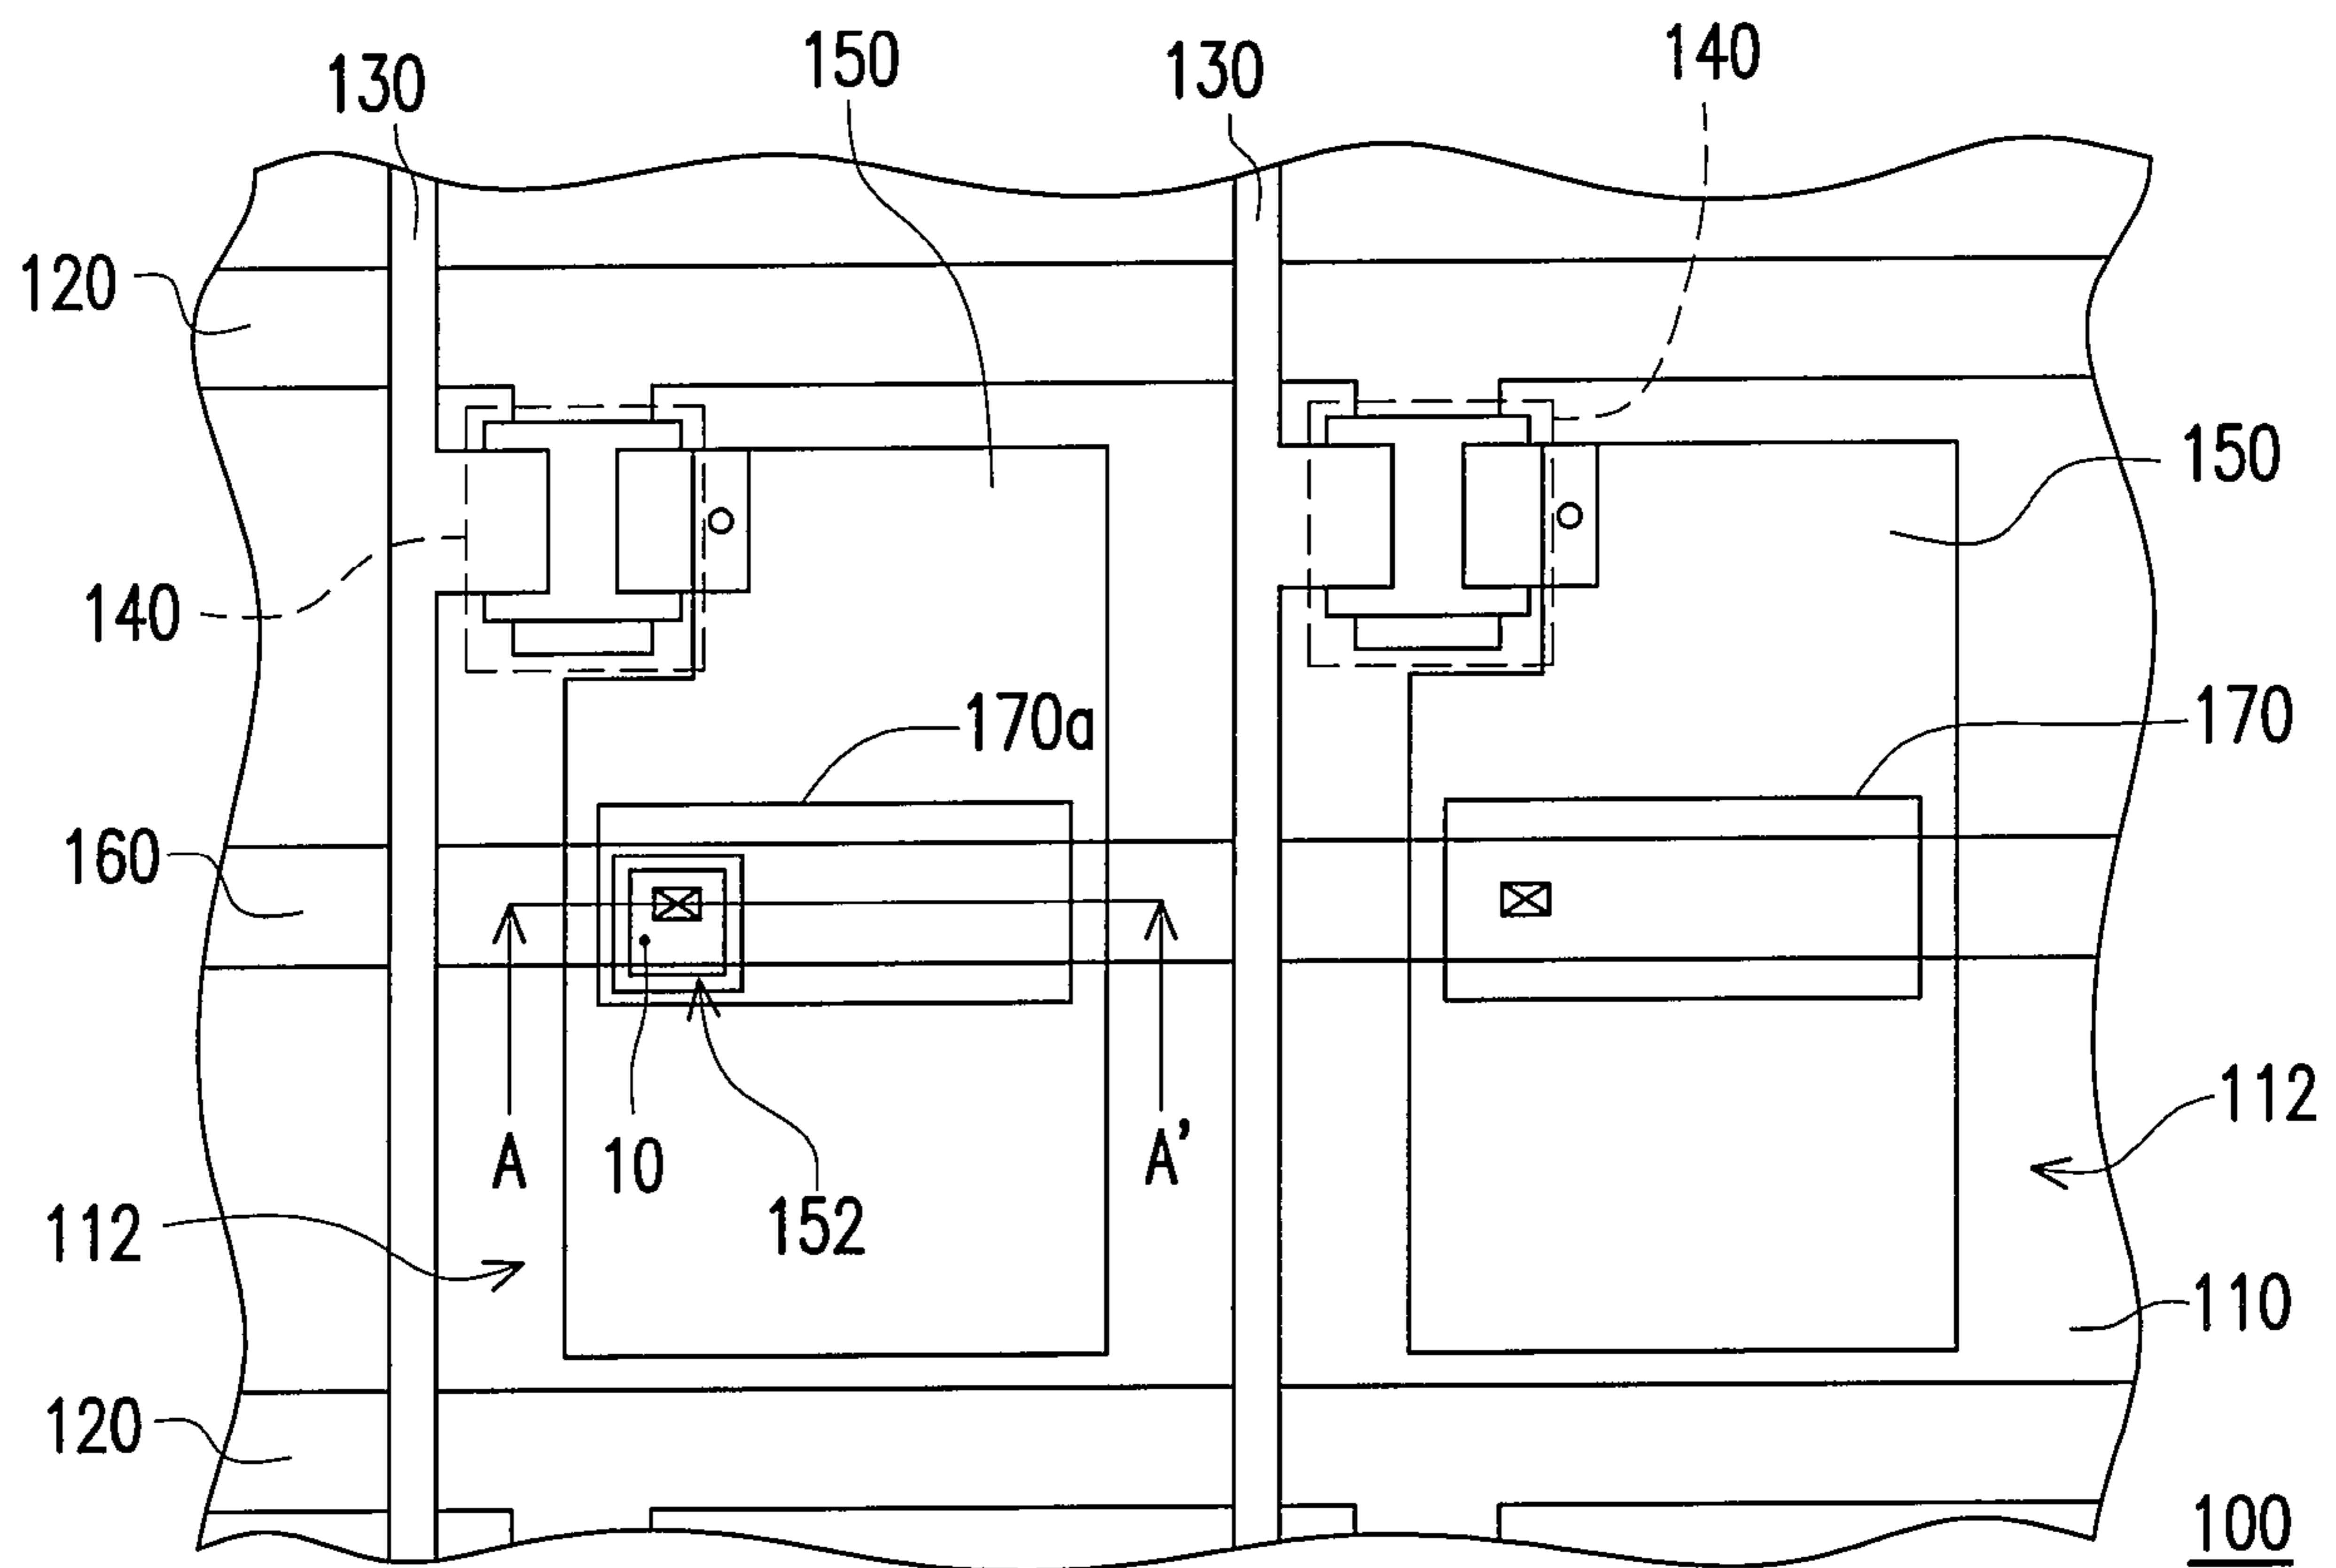
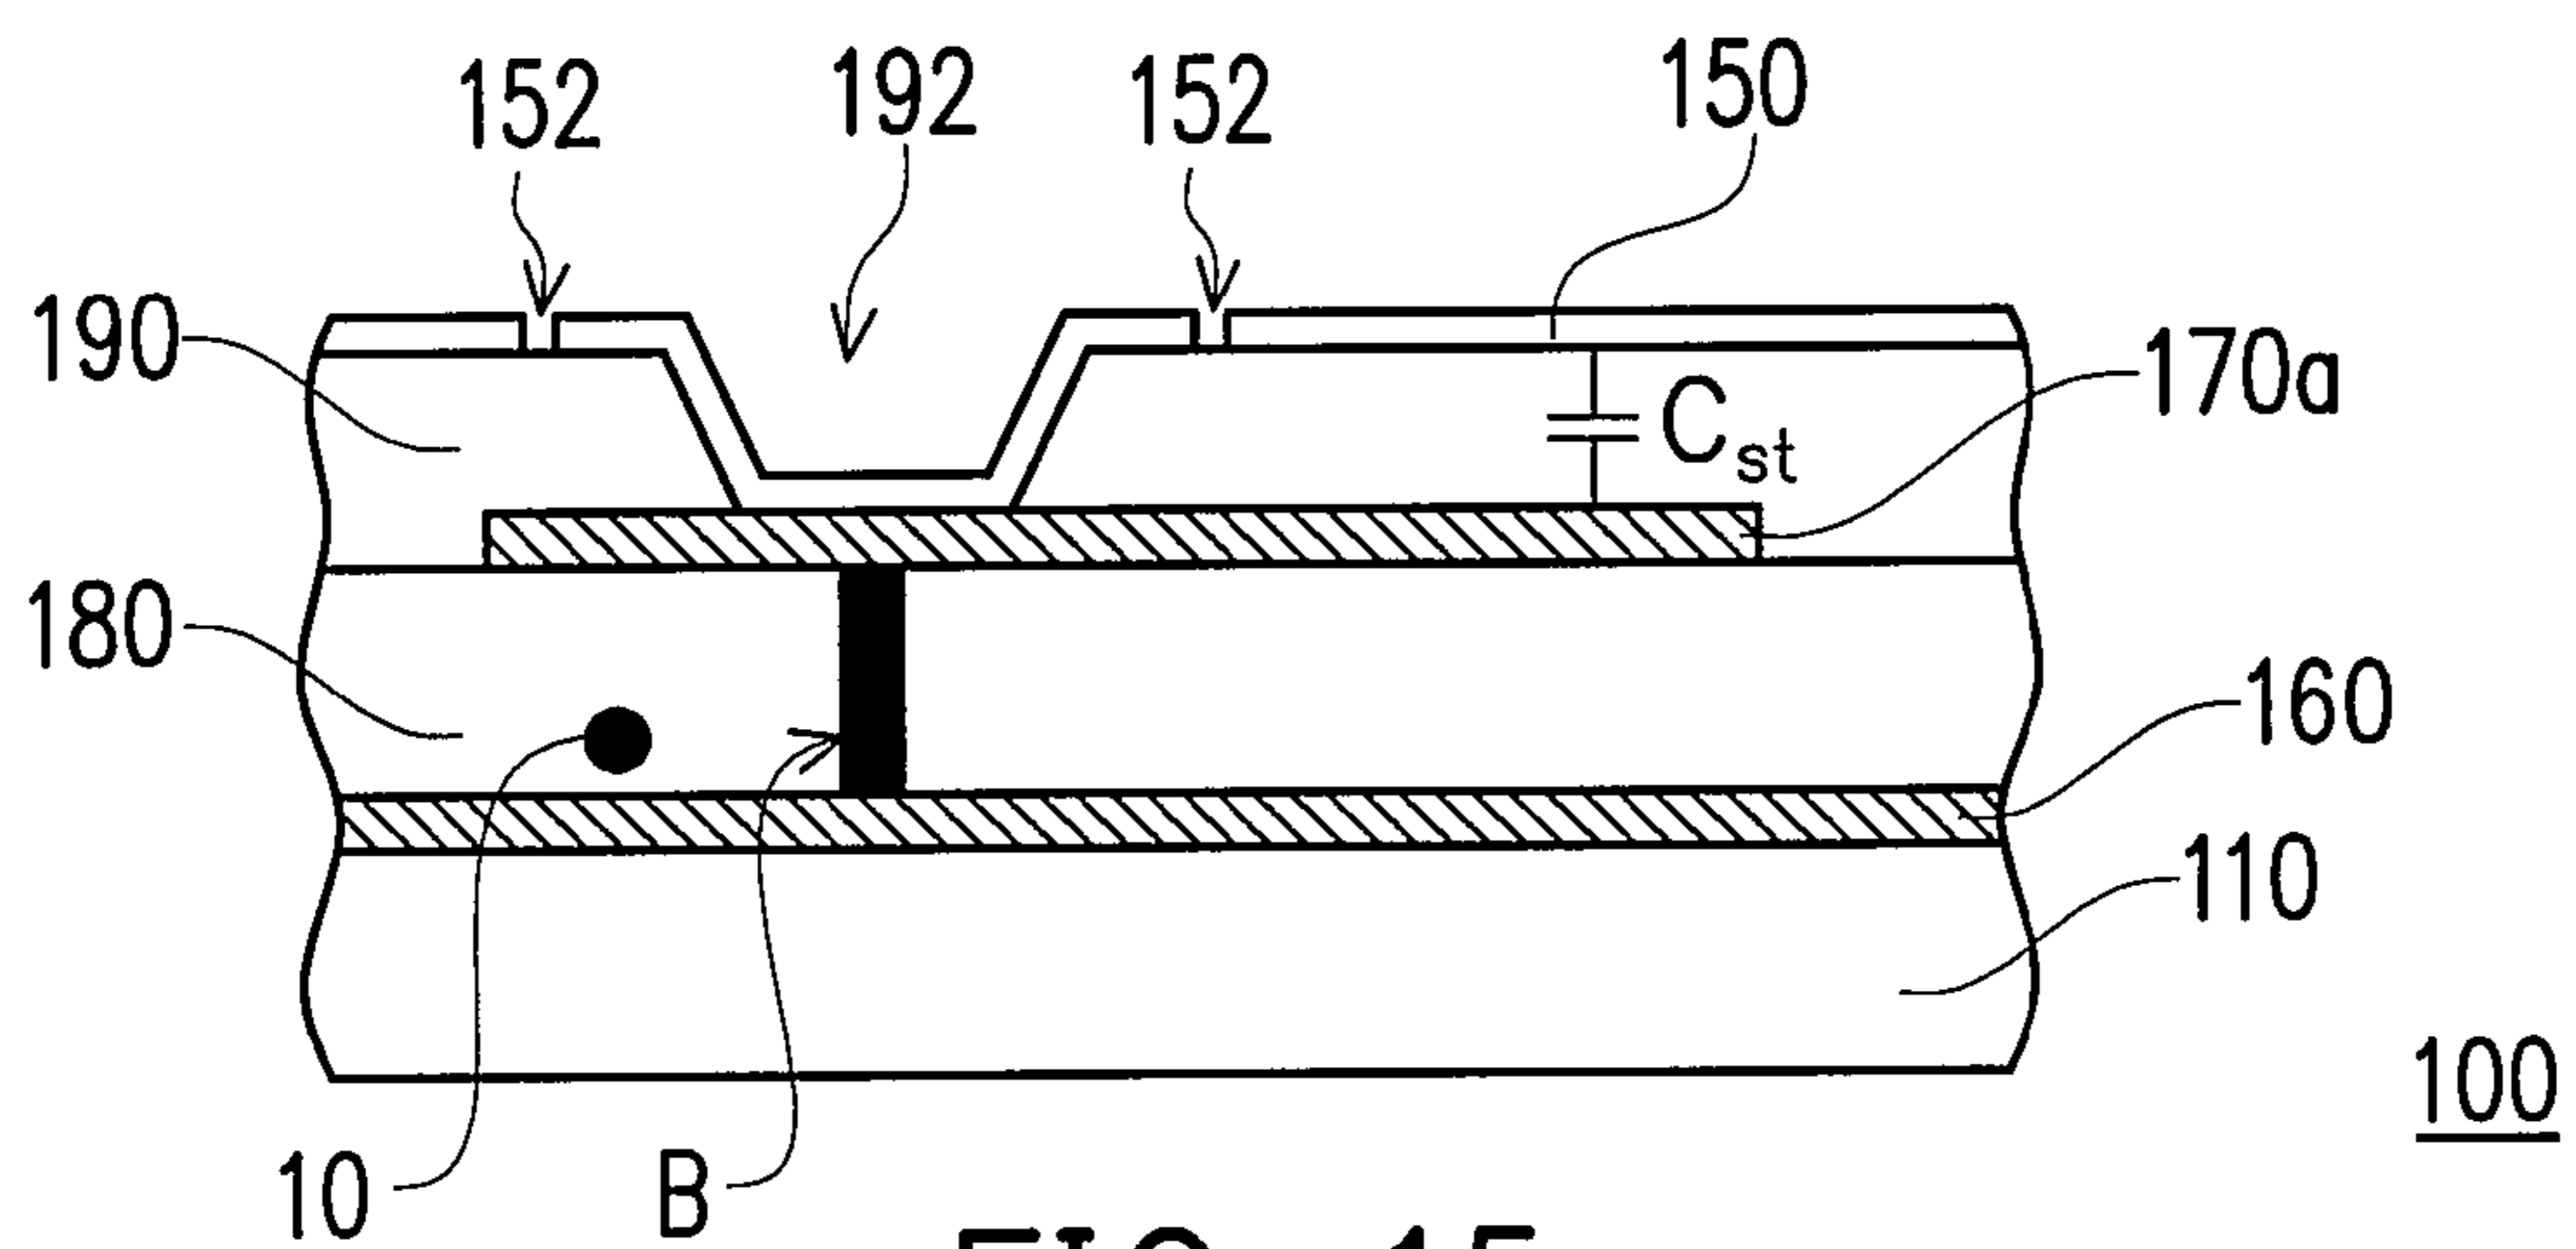
FIGS. 14 and 15 are top view and cross-sectional view showing the configuration after applying the method of the present invention to repair a conventional thin film transistor array substrate.

FIGS. **14** and **15** are top view and cross-sectional view showing the configuration after applying the method of the present invention to repair a conventional thin film transistor array substrate. As shown in FIGS. **14** and **15**, a conventional thin film transistor array substrate **100** has an upper electrode **170** between every pixel electrode **150** and corresponding common line **160**. In the presence of a particle (or defect) **10** between any upper electrode **170** and the corresponding common line **160**, the repairing method of the present invention can be used to rectify the problem. The repairing method of the present embodiment includes removing a portion of the pixel electrode **150** corresponding to the upper electrode **170a** of the defective capacitor so that the upper electrode **170a** and the pixel electrode **150** of the defective capacitor is electrically isolated. Thereafter, the upper electrode **170a** and the corresponding common line **160** are welded together. Obviously, whether to weld the upper electrode **170a** and the common line **160** of the defective capacitor together can be determined by the amount of leakage in the defective capacitor.

In the present embodiment, a portion of the pixel electrode **150** above the upper electrode **170a** of the corresponding defective capacitor is removed to form an opening **152**. The method of removing a portion of the pixel electrode **150** includes laser ablation, for example. The opening **152** is located around the contact area between the upper electrode **170a** and the corresponding pixel electrode **150** of the defective capacitor (that is, around the contact **192**). By forming the

opening **152**, the upper electrode **170a** and the corresponding pixel electrode **150** of the defective capacitor are electrically isolated. Thereafter, the upper electrode **170a** and the corresponding common line **160** are welded together (as shown in label B), for example, by performing a laser welding process, so that the upper electrode **170a** and the common line **160** of the defective capacitor are configured at the same potential.

It should be noted that the thin film transistor array substrate **100** in FIGS. **14** and **15** has capacitor on common line (Cst on common) storage capacitor thereon. However, anyone familiar with the technology can apply the repairing method of the present invention to a substrate having a capacitor on gate (Cst on gate) storage capacitor thereon.

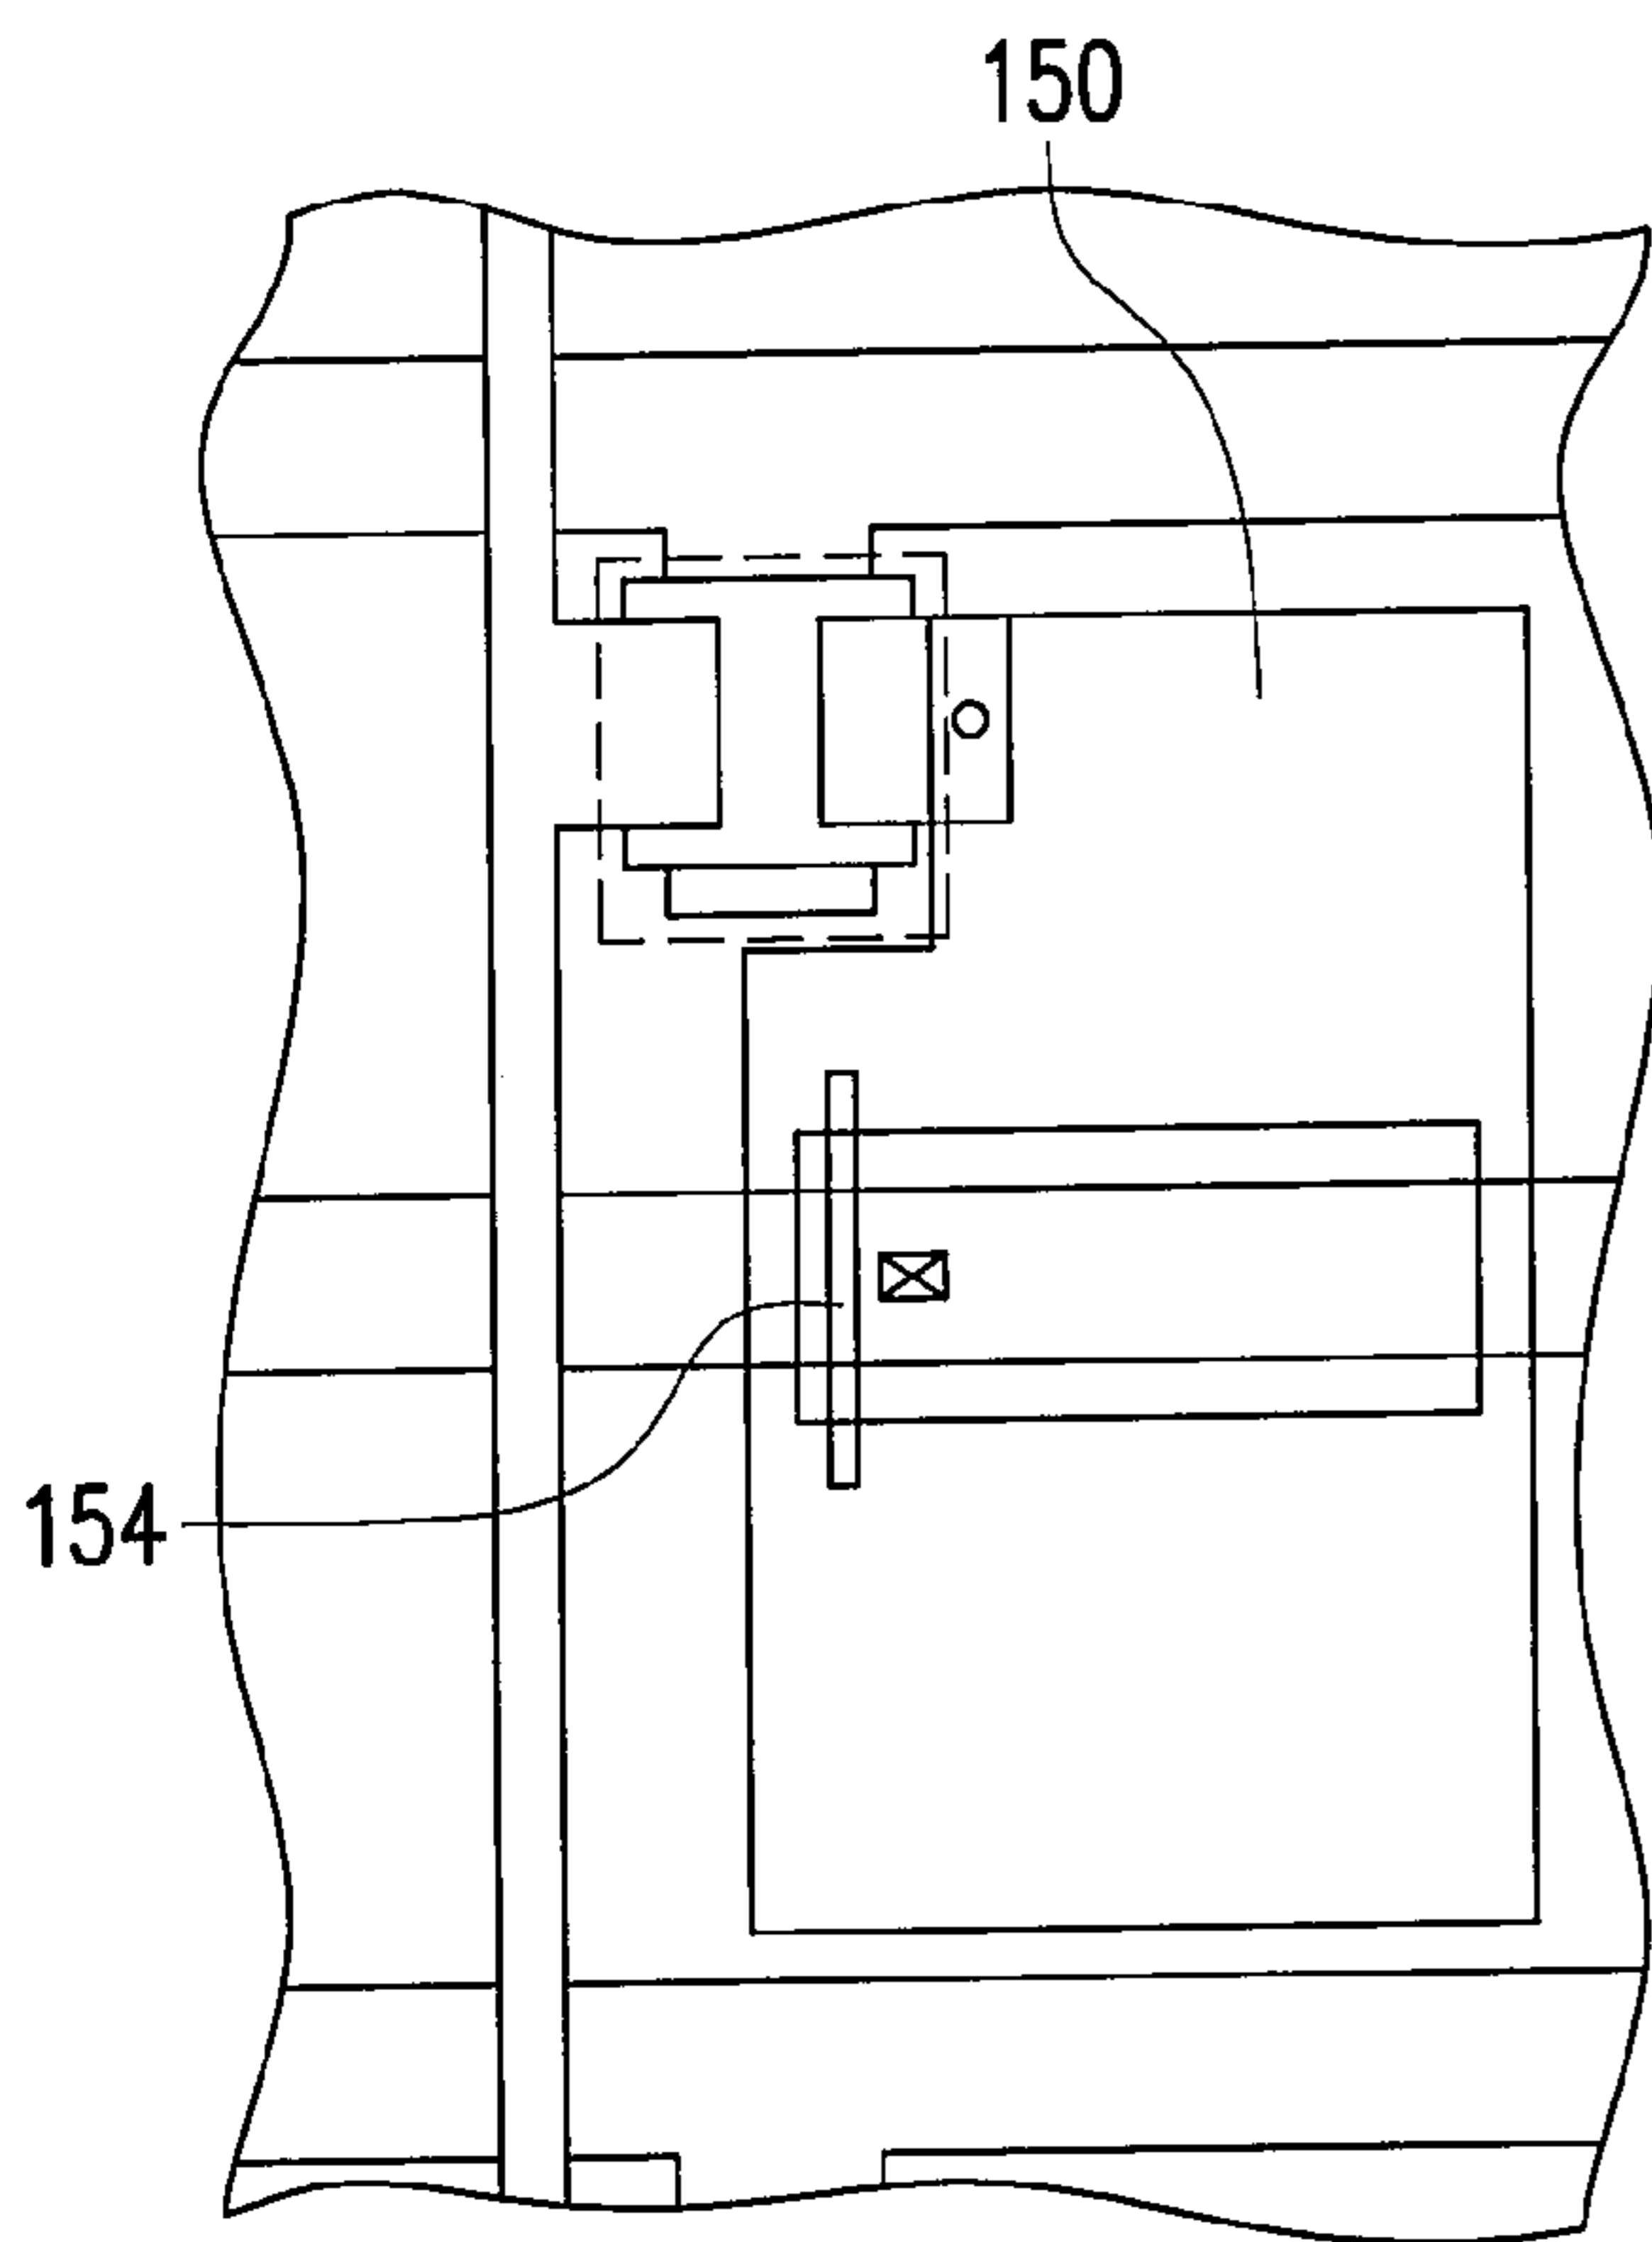
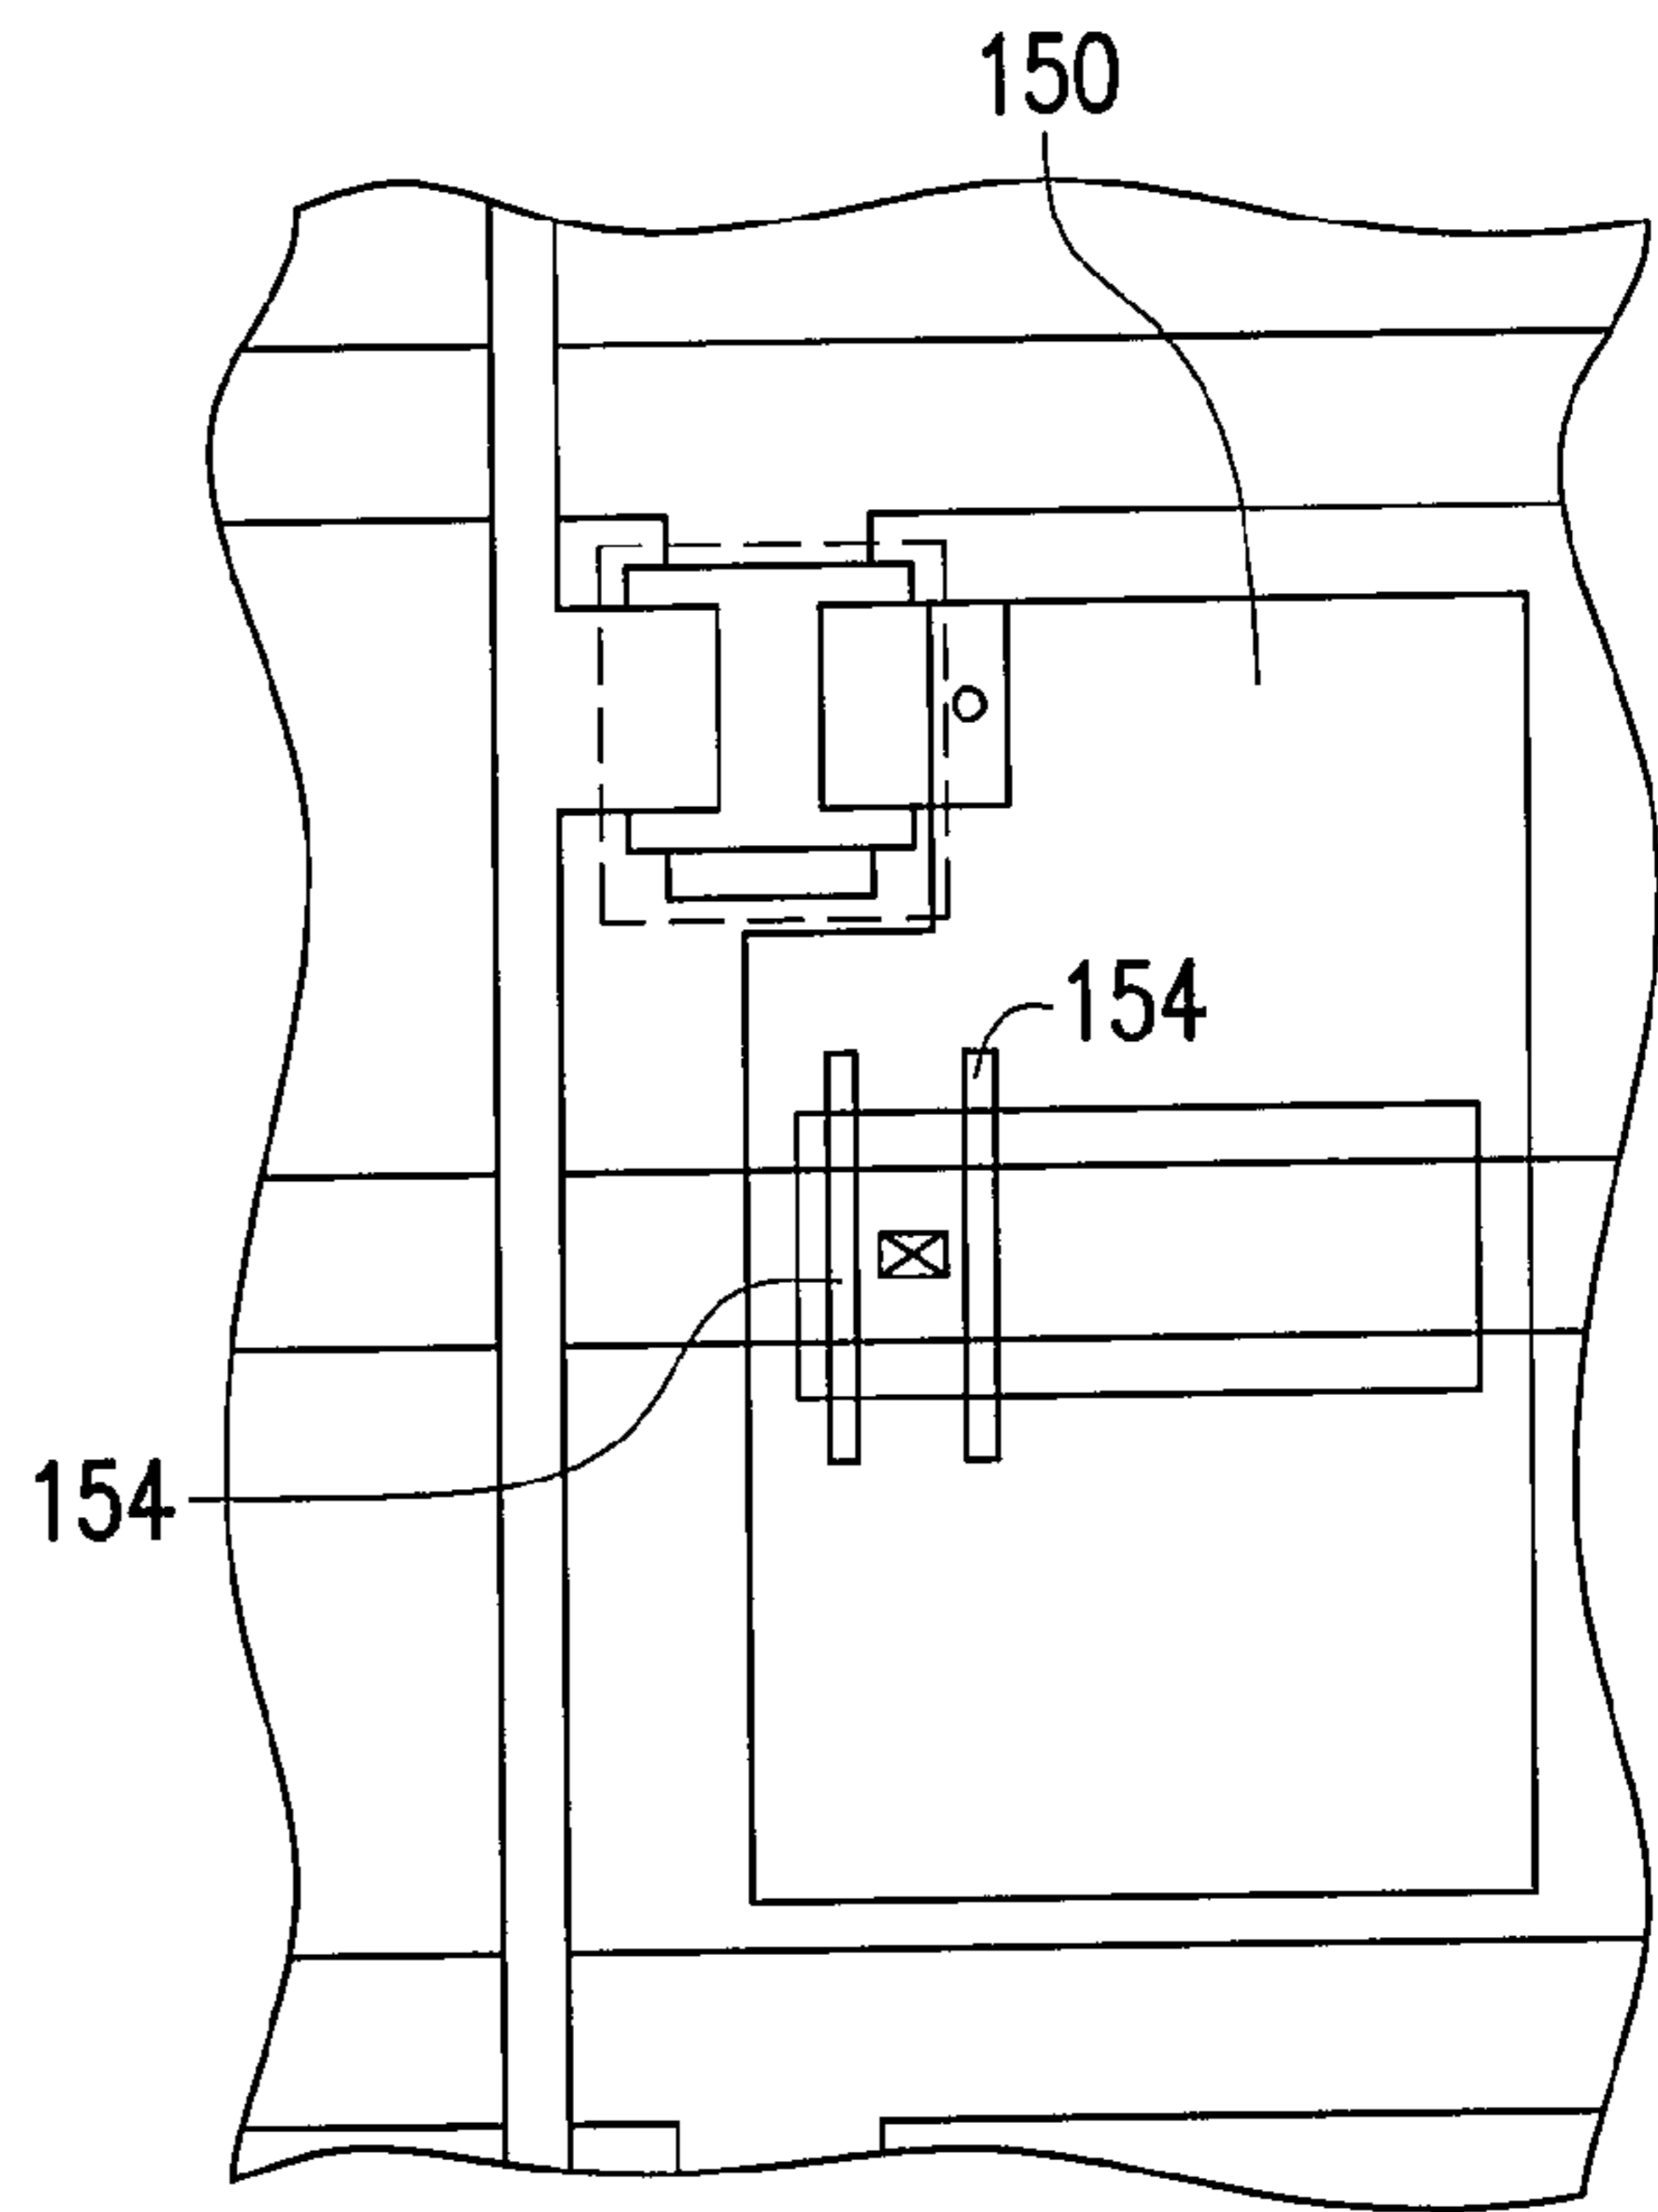
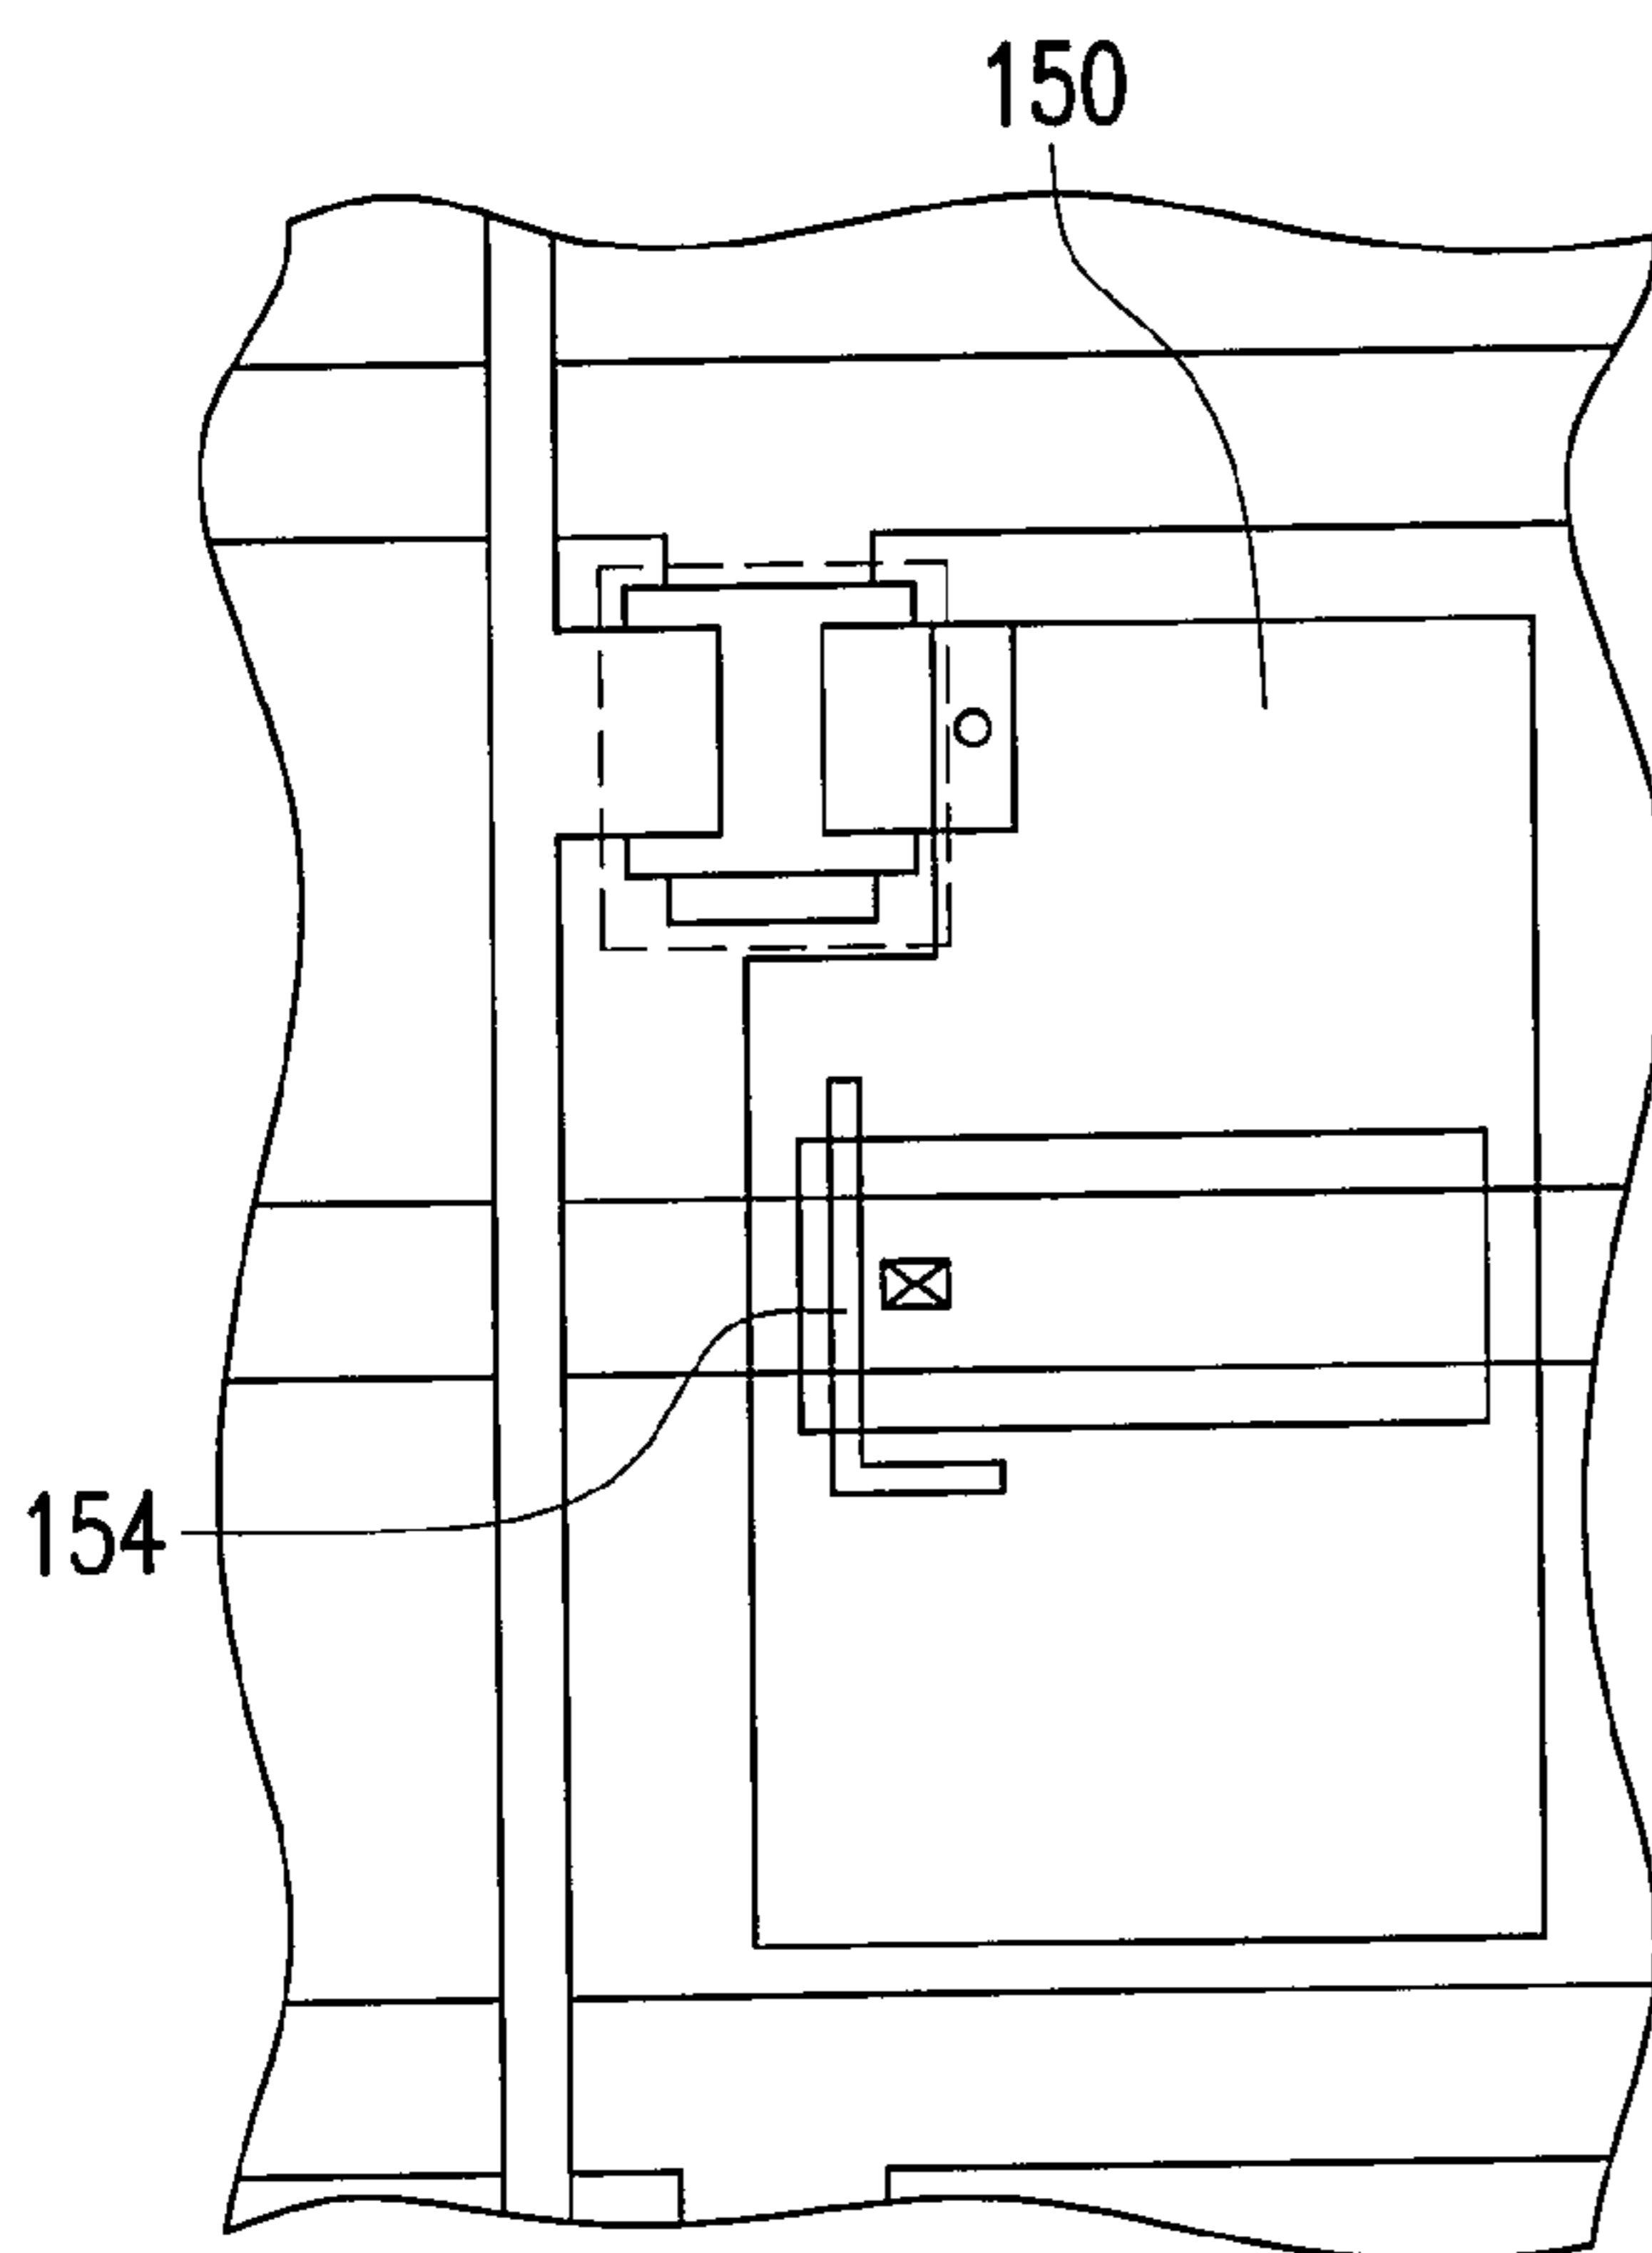
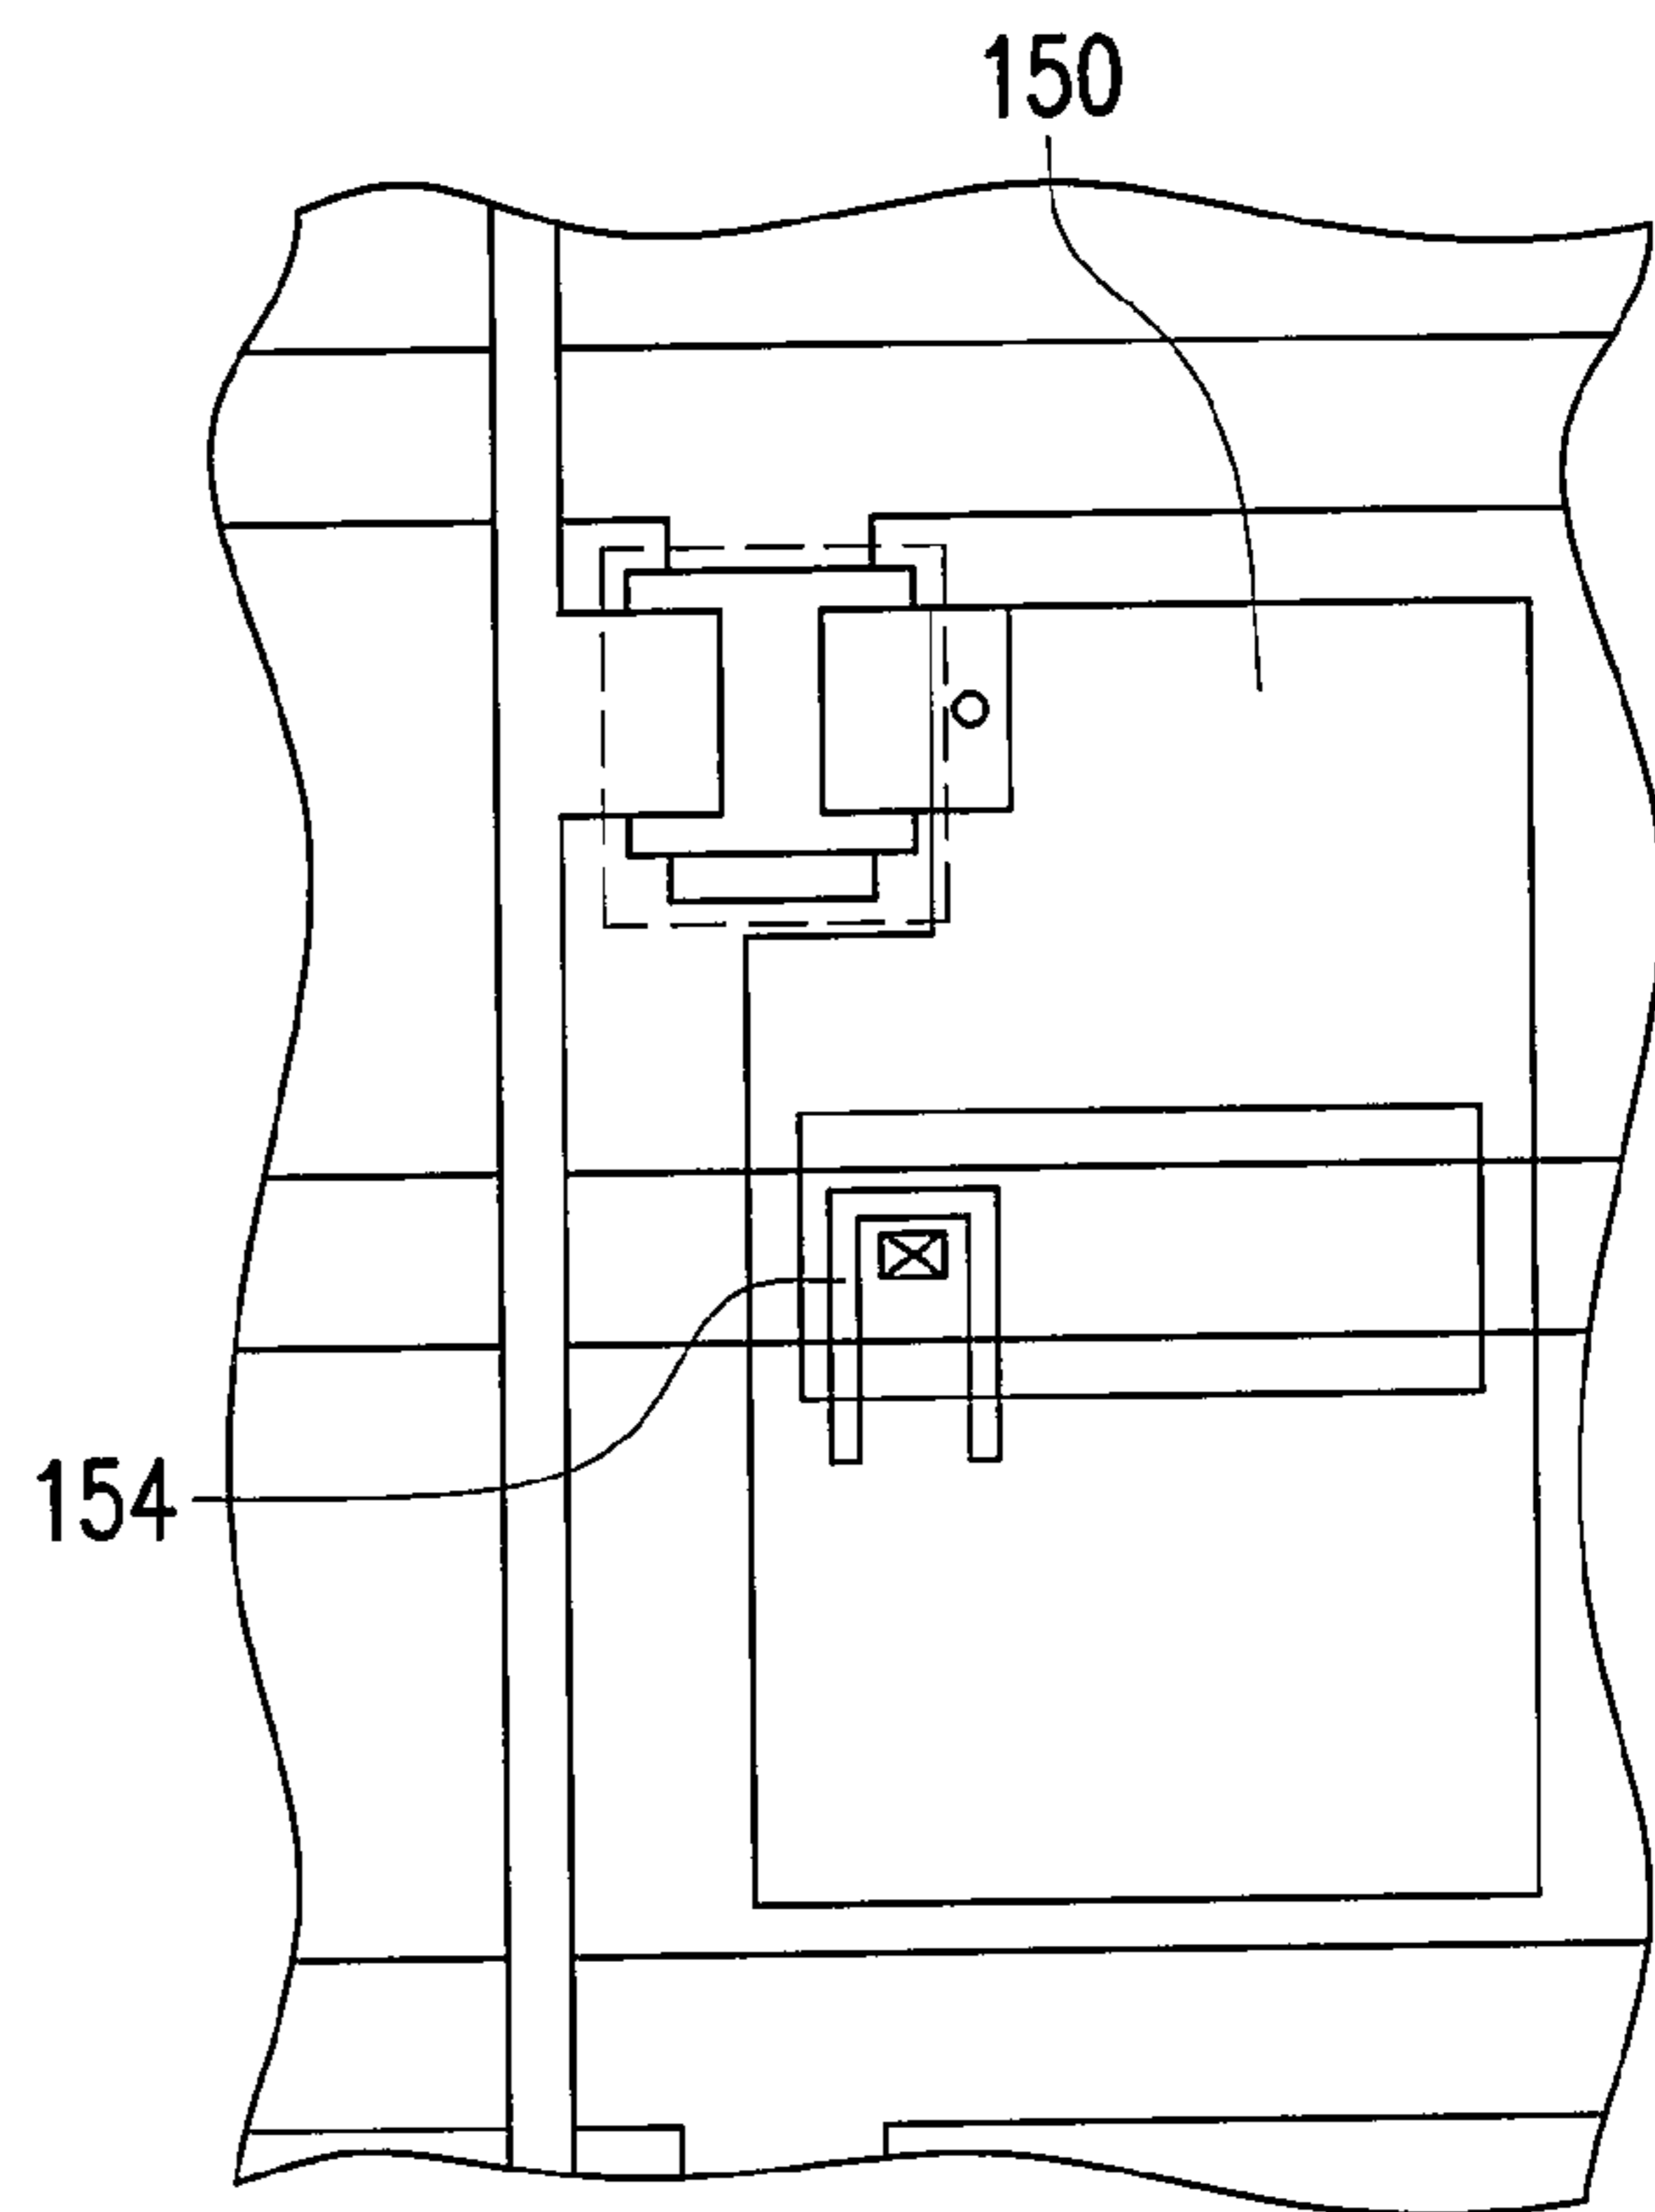
FIGS. 16A through 16D show the types of openings formed on the pixel electrode of a conventional thin film transistor array substrate.

FIGS. **16A** through **16D** show the types of openings formed on the pixel electrode of a conventional thin film transistor array substrate. To simplify and speed up the repairing process, one or more openings **154** are also formed over the thin film transistor array substrate in the process of fabricating the pixel electrode **150**. For example, a straight line opening **154** (as shown in FIG. **16A**), a pair of straight line openings **154** (as shown in FIG. **16B**), an L-shaped opening **154** (as shown in FIG. **16C**) or a U-shaped opening **154** (as shown in FIG. **16D**) are formed over the pixel electrode **150**. Since the openings **154** are similar to the openings disclosed in FIGS. **9A** through **9D**, detailed description is omitted.
