(12) **United States Patent**  
**Lai**

(10) **Patent No.:** **US 7,646,446 B2**  
(45) **Date of Patent:** **Jan. 12, 2010**

(54) **REPAIRING METHOD OF A THIN FILM TRANSISTOR ARRAY SUBSTRATE**

(73) Assignee: **Au Optronics Corporation**, Hsinchu (TW)

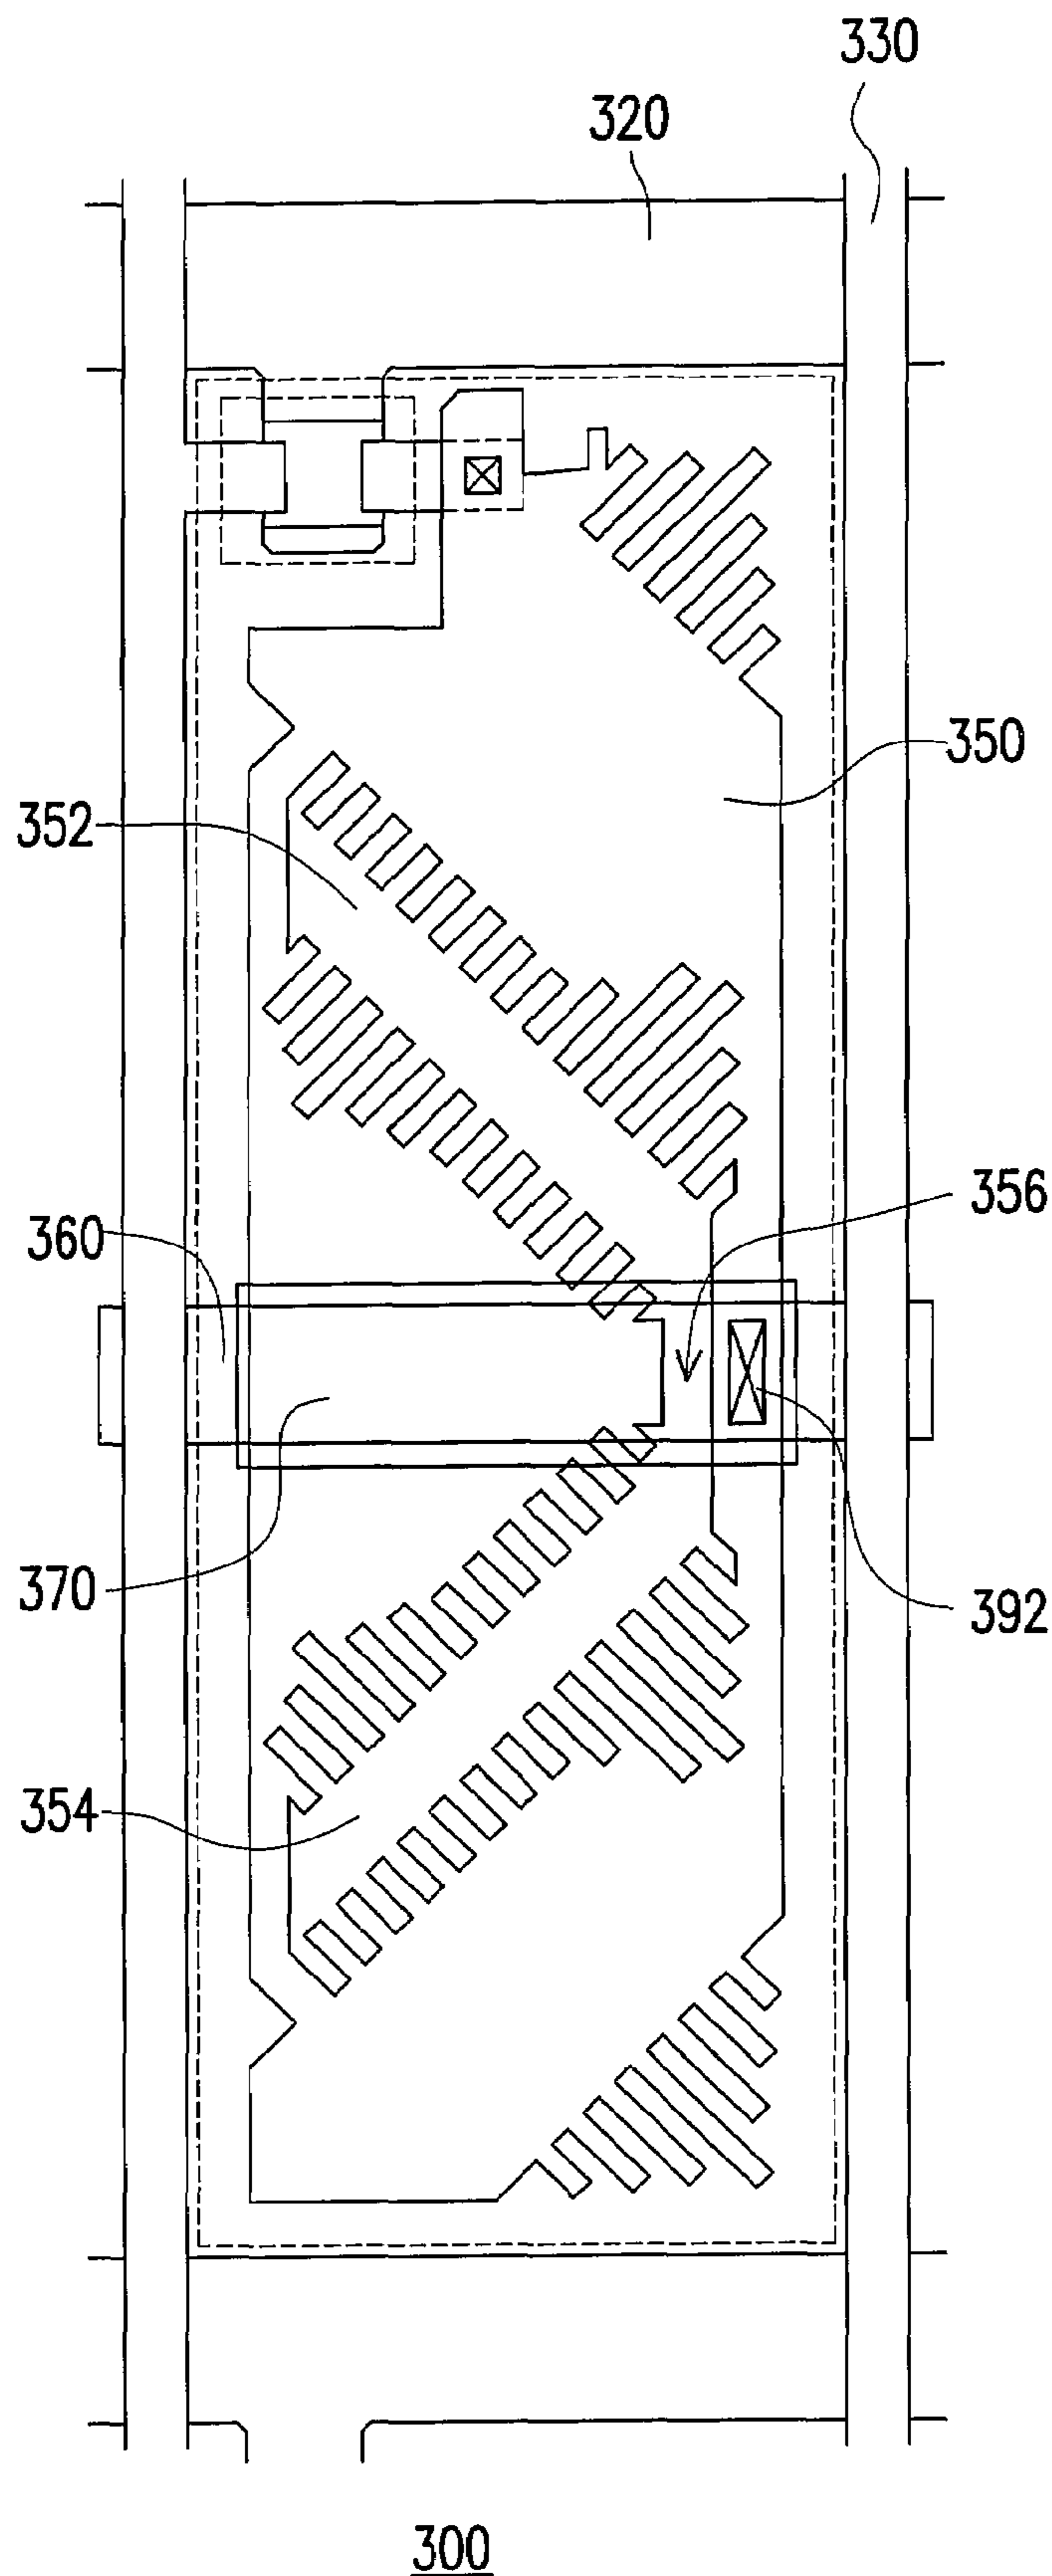
FIG. 17 is a top view showing a thin film transistor array substrate applied to a multi-domain vertical alignment liquid crystal display (MVA-LCD) according to yet another preferred embodiment of the present invention.

FIG. **17** is a top view showing a thin film transistor array substrate applied to a multi-domain vertical alignment liquid crystal display (MVA-LCD) according to yet another preferred embodiment of the present invention. The thin film transistor array substrate **300** in the present embodiment has a structure very similar to the thin film transistor array substrate disclosed in FIG. **1**. Hence, only the dissimilar portions are described in the following.

The thin film transistor array substrate **300** has at least a first slit **352** and at least a second slit **354** disposed over each pixel electrode **350**. The first slit **352** extends in a direction different from the second slit **354** and the direction of exten-

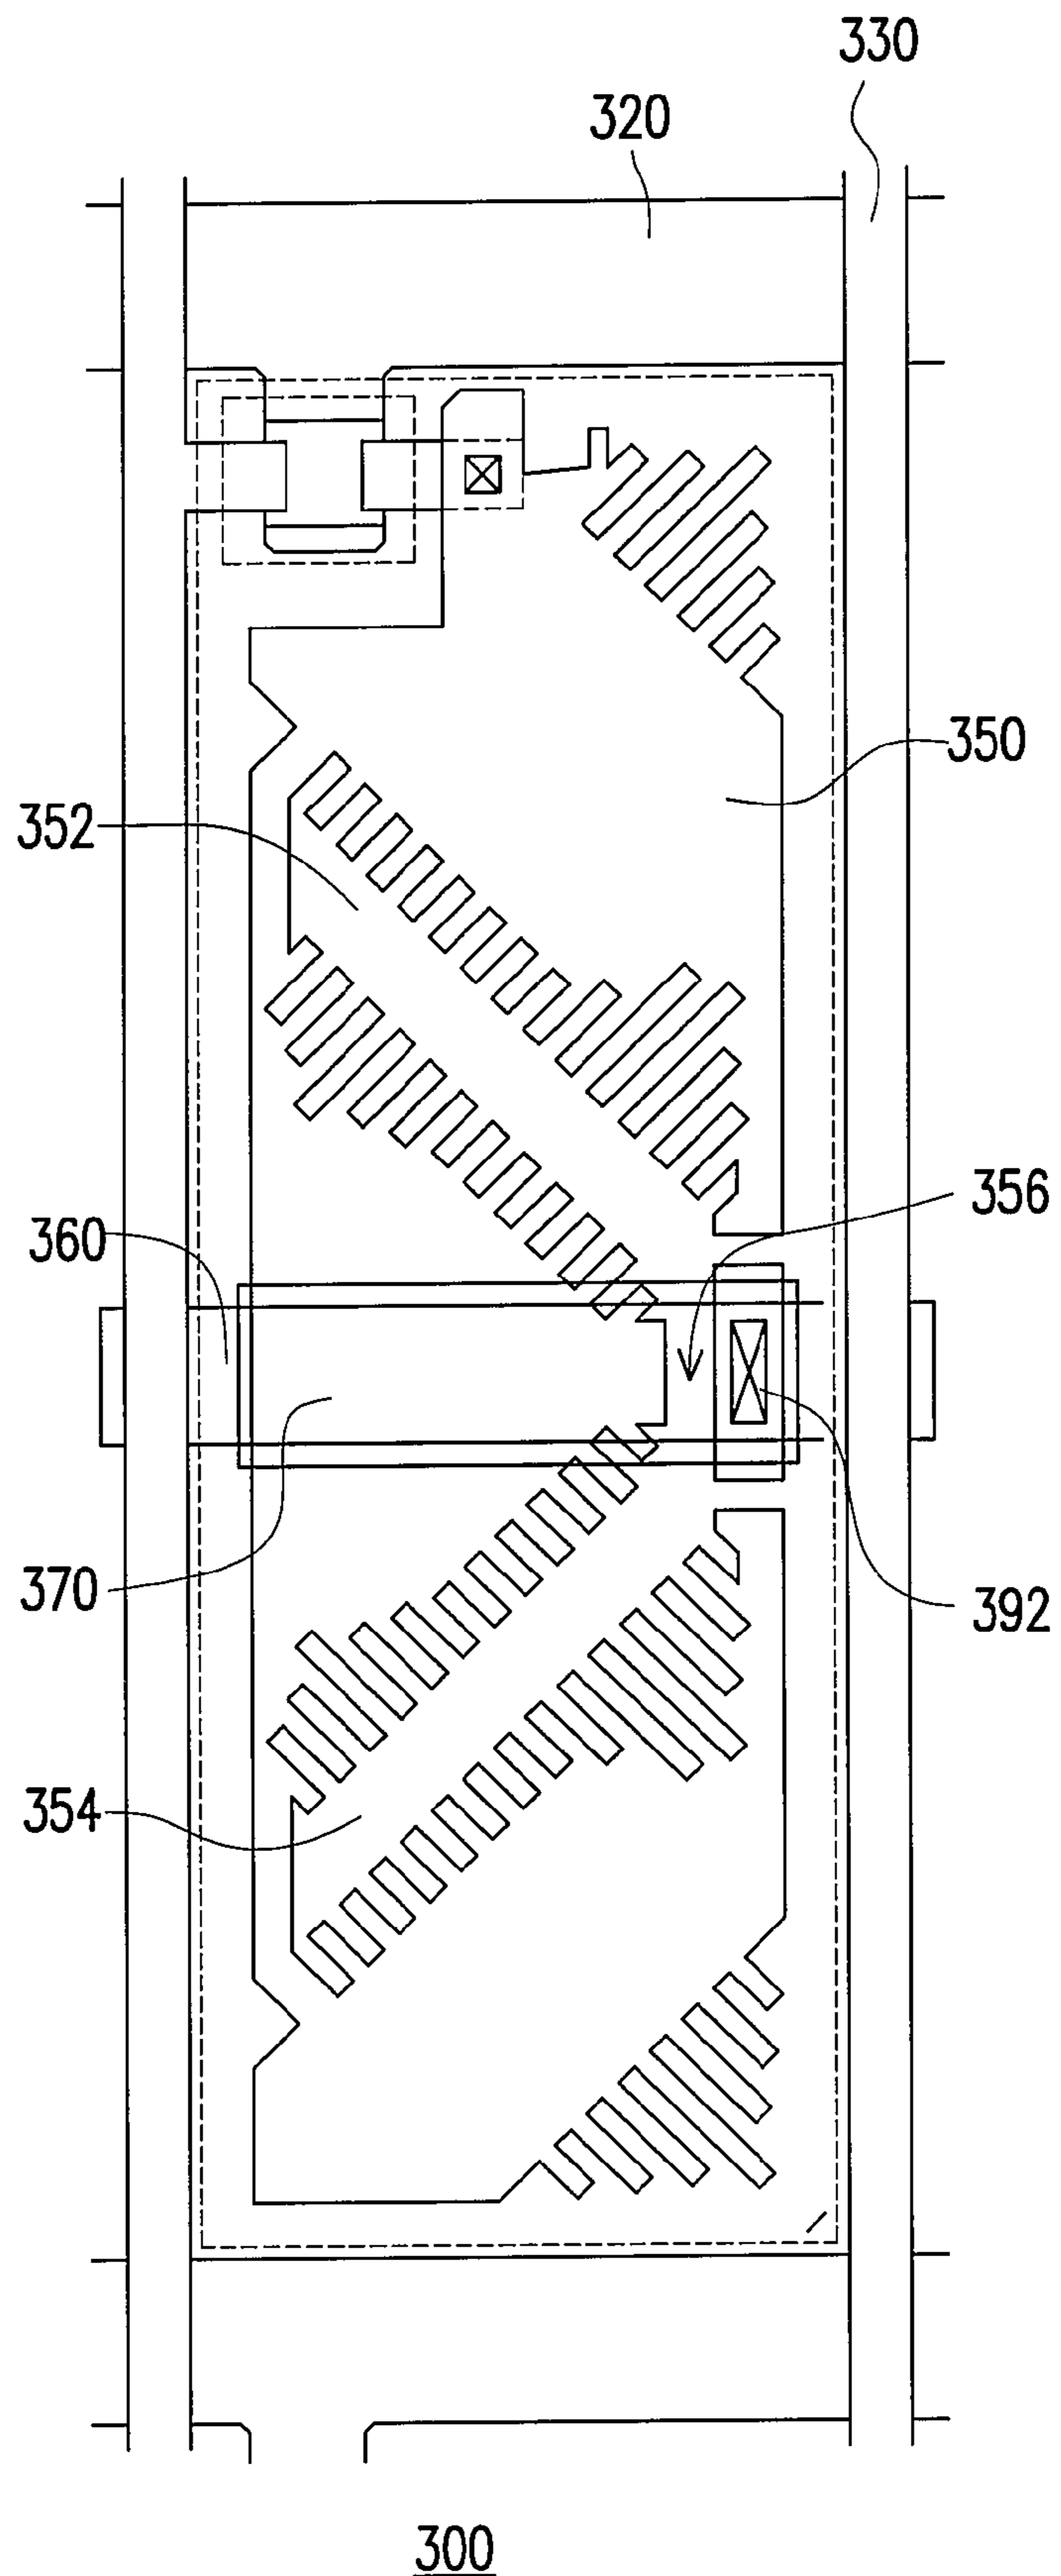
FIG. 18 is a top view of the thin film transistor array substrate of the MVA-LCD in FIG. 17 repaired according to the method of the present invention.

It should be noted a repair is required when a particle or defect is formed between the upper electrode **370** and one of the common lines **360** so that the upper electrode **370** and the common line **360** together form a defective capacitor. FIG. **18** is a top view of the thin film transistor array substrate of the MVA-LCD in FIG. **17** repaired according to the method of the present invention. The repairing method includes removing a portion of the pixel electrode **350** corresponding to the upper electrode of the defective capacitor. In the present embodiment, the portion of the pixel electrode **350** to be removed is the area around the electrical contact (the contact **392**) between the upper electrode **370** and the corresponding pixel electrode **350**. Thus, the upper electrode **370** of the defective capacitor and the corresponding pixel electrode **350** are electrically isolated. In other words, by removing a small portion of the pixel electrode **350** (a small area around contact **392**) covering the upper electrode **370**, the upper electrode **370** and the corresponding pixel electrode **350** of the defective capacitor are electrically isolated. Since only a small portion of the pixel electrode **350** covering the upper electrode **370** is removed in the present embodiment, a large capacitance can be maintained after the repair operation.

Thereafter, the upper electrode **370** and the corresponding common line **360** of the defective capacitor are welded together so that the upper electrode **370** and the corresponding common line **360** of the defective capacitor are at the same potential. Obviously, whether to weld the upper electrode **370** and the common line **360** of the defective capacitor together can be determined by the amount of leakage in the defective capacitor.
