(12) **United States Patent**  
**Addis**

(10) **Patent No.:** **US 7,722,318 B2**  
(45) **Date of Patent:** **May 25, 2010**

(54) **HOLE LINERS FOR REPAIR OF VANE COUNTERBORE HOLES**

(73) Assignee: **United Technologies Corporation**,  
Hartford, CT (US)

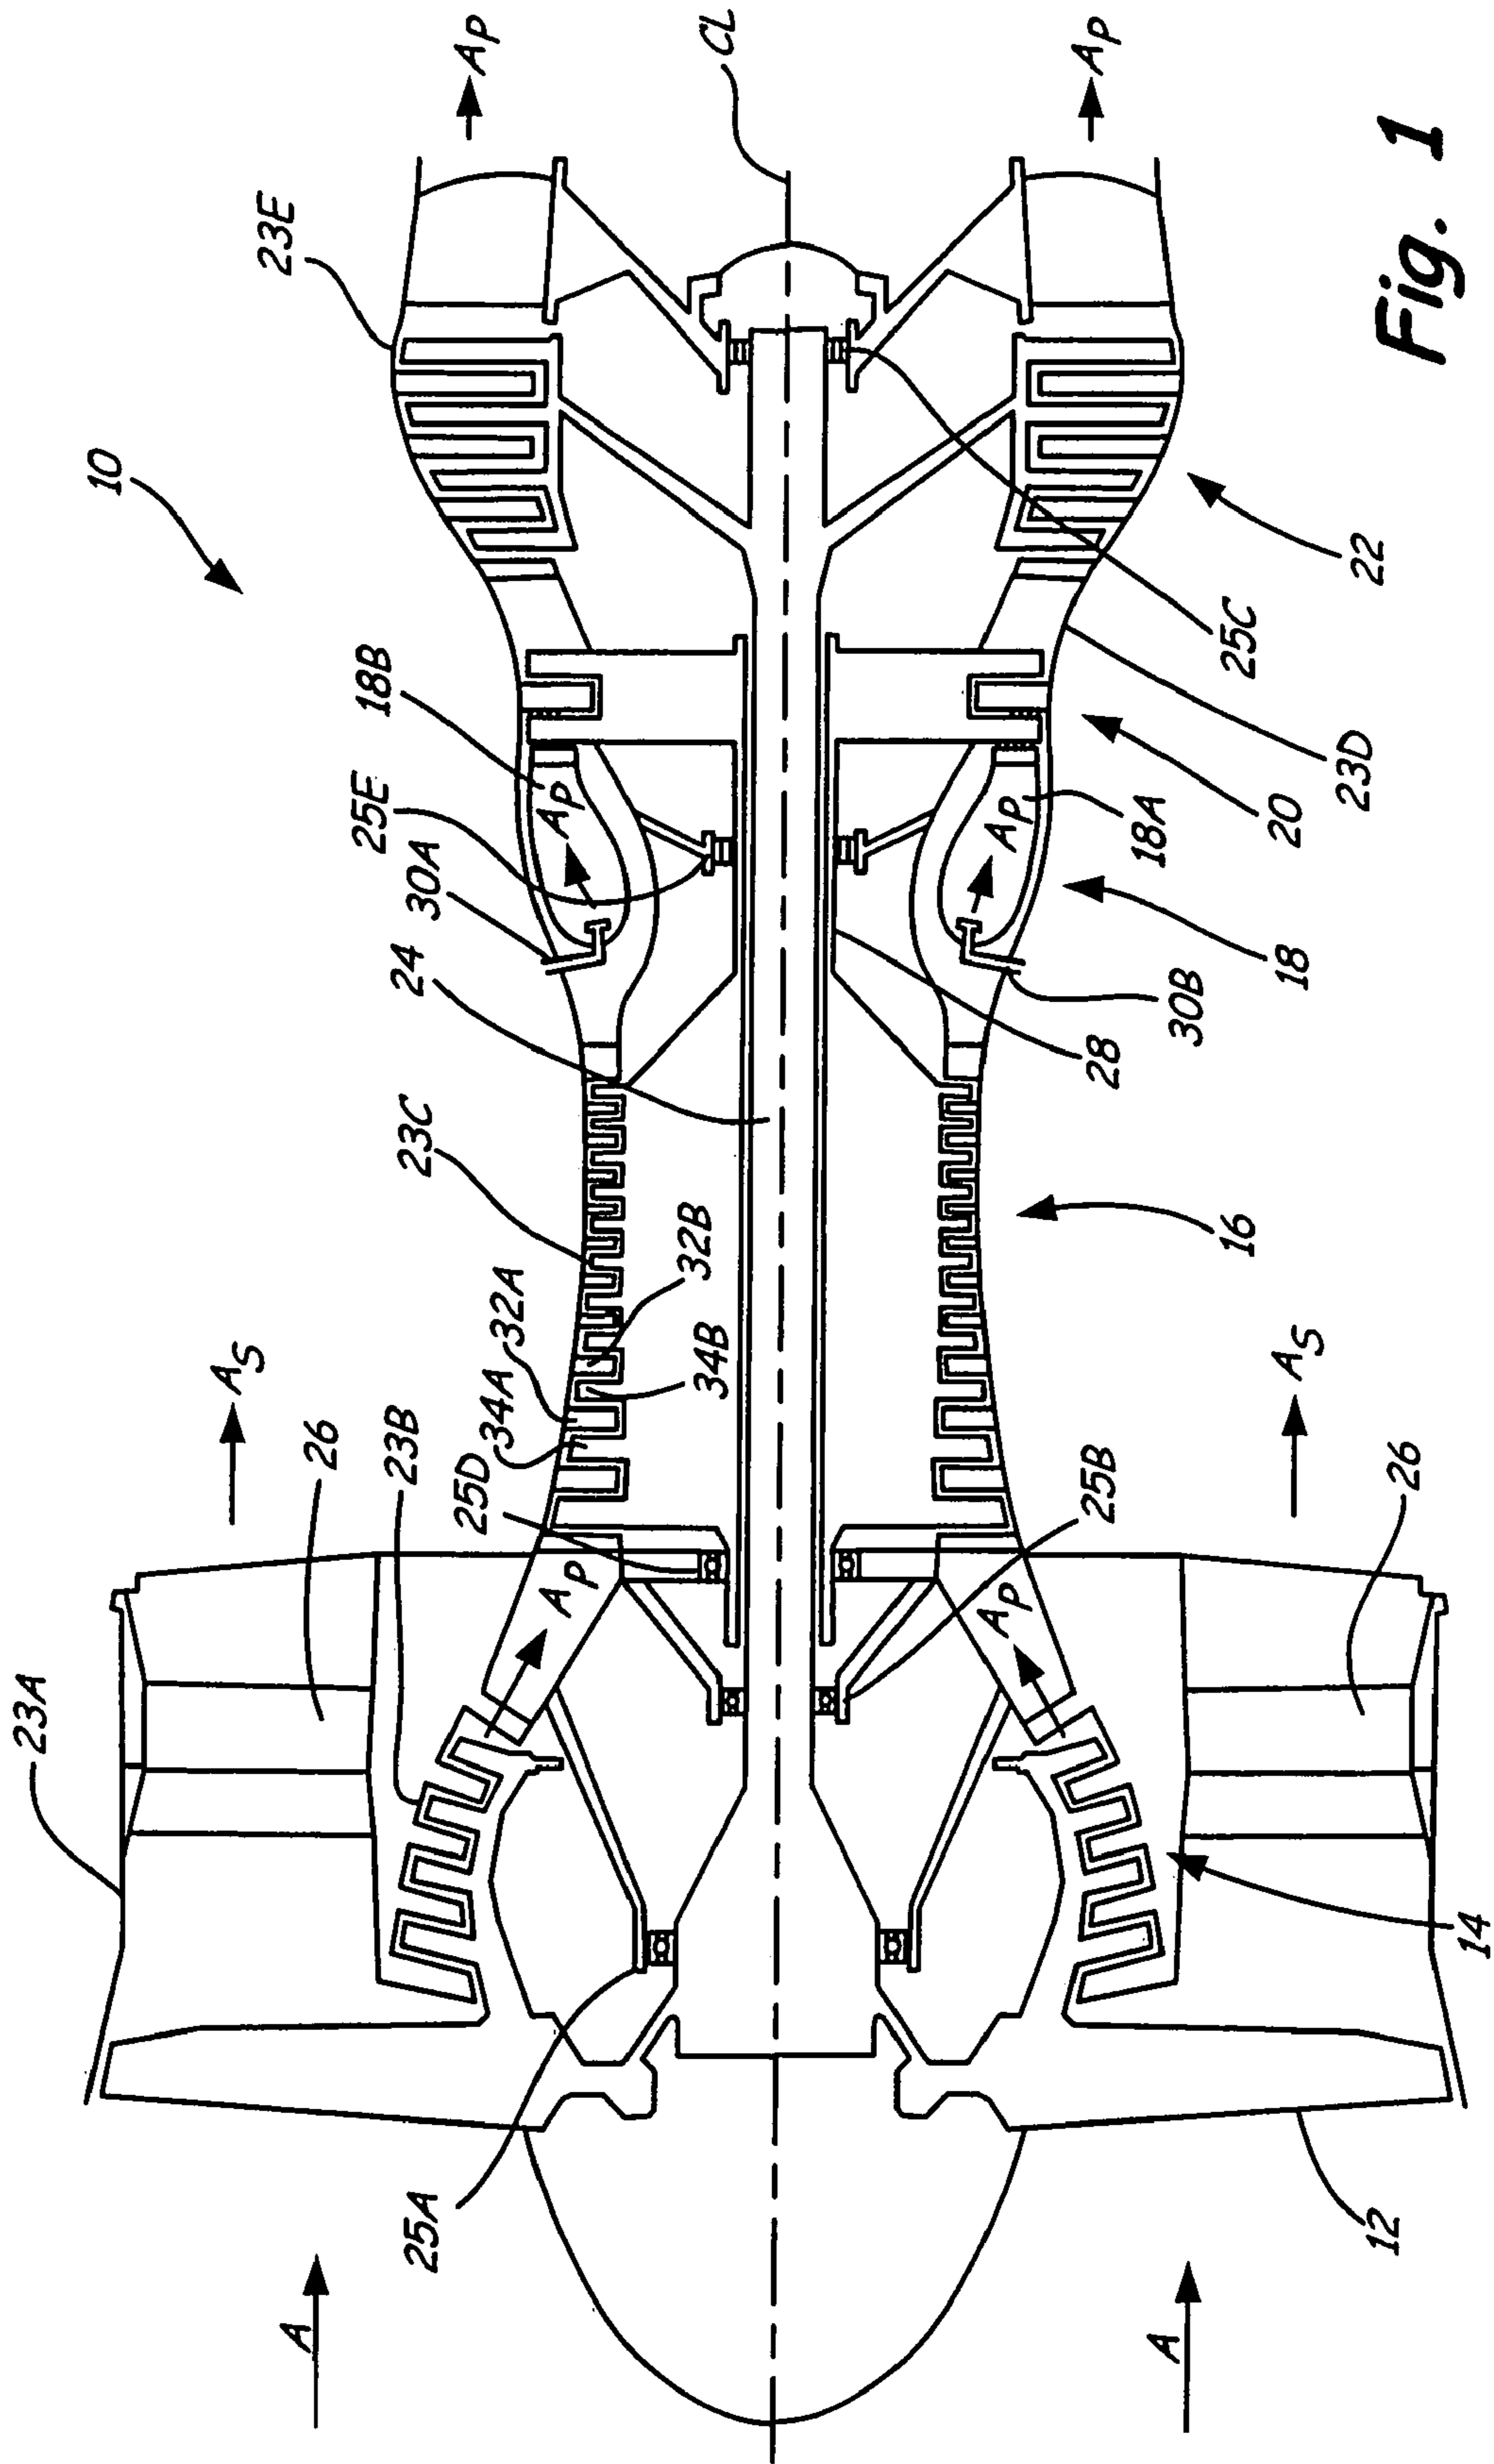
Fig. 1

FIG. 1 shows a schematic of a gas turbine engine in which the variable vane hole liners of the present invention are used.

FIG. 1 shows gas turbine engine 10, in which variable vane hole liners are used. Gas turbine engine 10 comprises a dual-spool turbofan engine having variable stator vanes for which the advantages of the hole liners are particularly well illustrated. Gas turbine engine 10 comprises fan 12, low pressure compressor (LPC) 14, high pressure compressor (HPC) 16, combustor section 18, high pressure turbine (HPT) 20 and low pressure turbine (LPT) 22, which are each concentrically disposed around longitudinal engine centerline CL. Fan 12 is enclosed at its outer diameter within fan case 23A. Likewise, the other engine components are correspondingly enclosed at their outer diameters within various engine casings, including LPC case 23B, HPC case 23C, HPT case 23D and LPT case 23E such that an air flow path is formed around centerline CL.

Inlet air A enters engine 10 and it is divided into streams of primary air  $A_p$  and secondary air  $A_s$  after it passes through fan 12. Fan 12 is rotated by low pressure turbine 22 through shaft 24 to accelerate secondary air  $A_s$  (also known as bypass air) through exit guide vanes 26, thereby producing a major portion of the thrust output of engine 10. Shaft 24 is supported within engine 10 at ball bearing 25A, roller bearing 25B and roller bearing 25C. Primary air  $A_p$  (also known as gas path air) is directed first into low pressure compressor (LPC) 14 and then into high pressure compressor (HPC) 16. LPC 14 and HPC 16 work together to incrementally step up the pressure of primary air  $A_p$ . HPC 16 is rotated by HPT 20 through shaft 28 to provide compressed air to combustor section 18. Shaft 28 is supported within engine 10 at ball bearing 25D and roller bearing 25E. The compressed air is delivered to combustors 18A and 18B, along with fuel through injectors 30A and 30B, such that a combustion process can be carried out to produce the high energy gases necessary to turn turbines 20 and 22. Primary air  $A_p$  continues through gas turbine engine 10 whereby it is typically passed through an exhaust nozzle to further produce thrust.

In order to expand the performance range of engine 10, variable stator vanes are used in high pressure compressor 16. For example, HPC 16 comprises variable vanes 32A and 32B, which are stationary and extend radially inward from fan case 23C. Blades 34A and 34B, which rotate with HPC 16 on shaft 28, are positioned adjacent vanes 32A and 32B. Vanes 32A and 32B form part of an array of vane stages arranged circumferentially around the engine centerline between HPC case 23C and an inner diameter vane shroud. Blades 34A and 34B sequentially push primary air  $A_p$  past vanes 32A and 32B within HPC 16 to increase the pressure of primary air  $A_p$ . Vanes 32A and 32B rotate about their radial axis to adjust the incidence of the air  $A_p$  onto subsequent blades, including blade 34B, during different operation modes, or speeds, of engine 10. In order to ensure optimal operation of engine 10, it is preferable that vanes 32A and 32B are able to rotate freely about their axis within HPC case 23C and the inner diameter vane shroud.

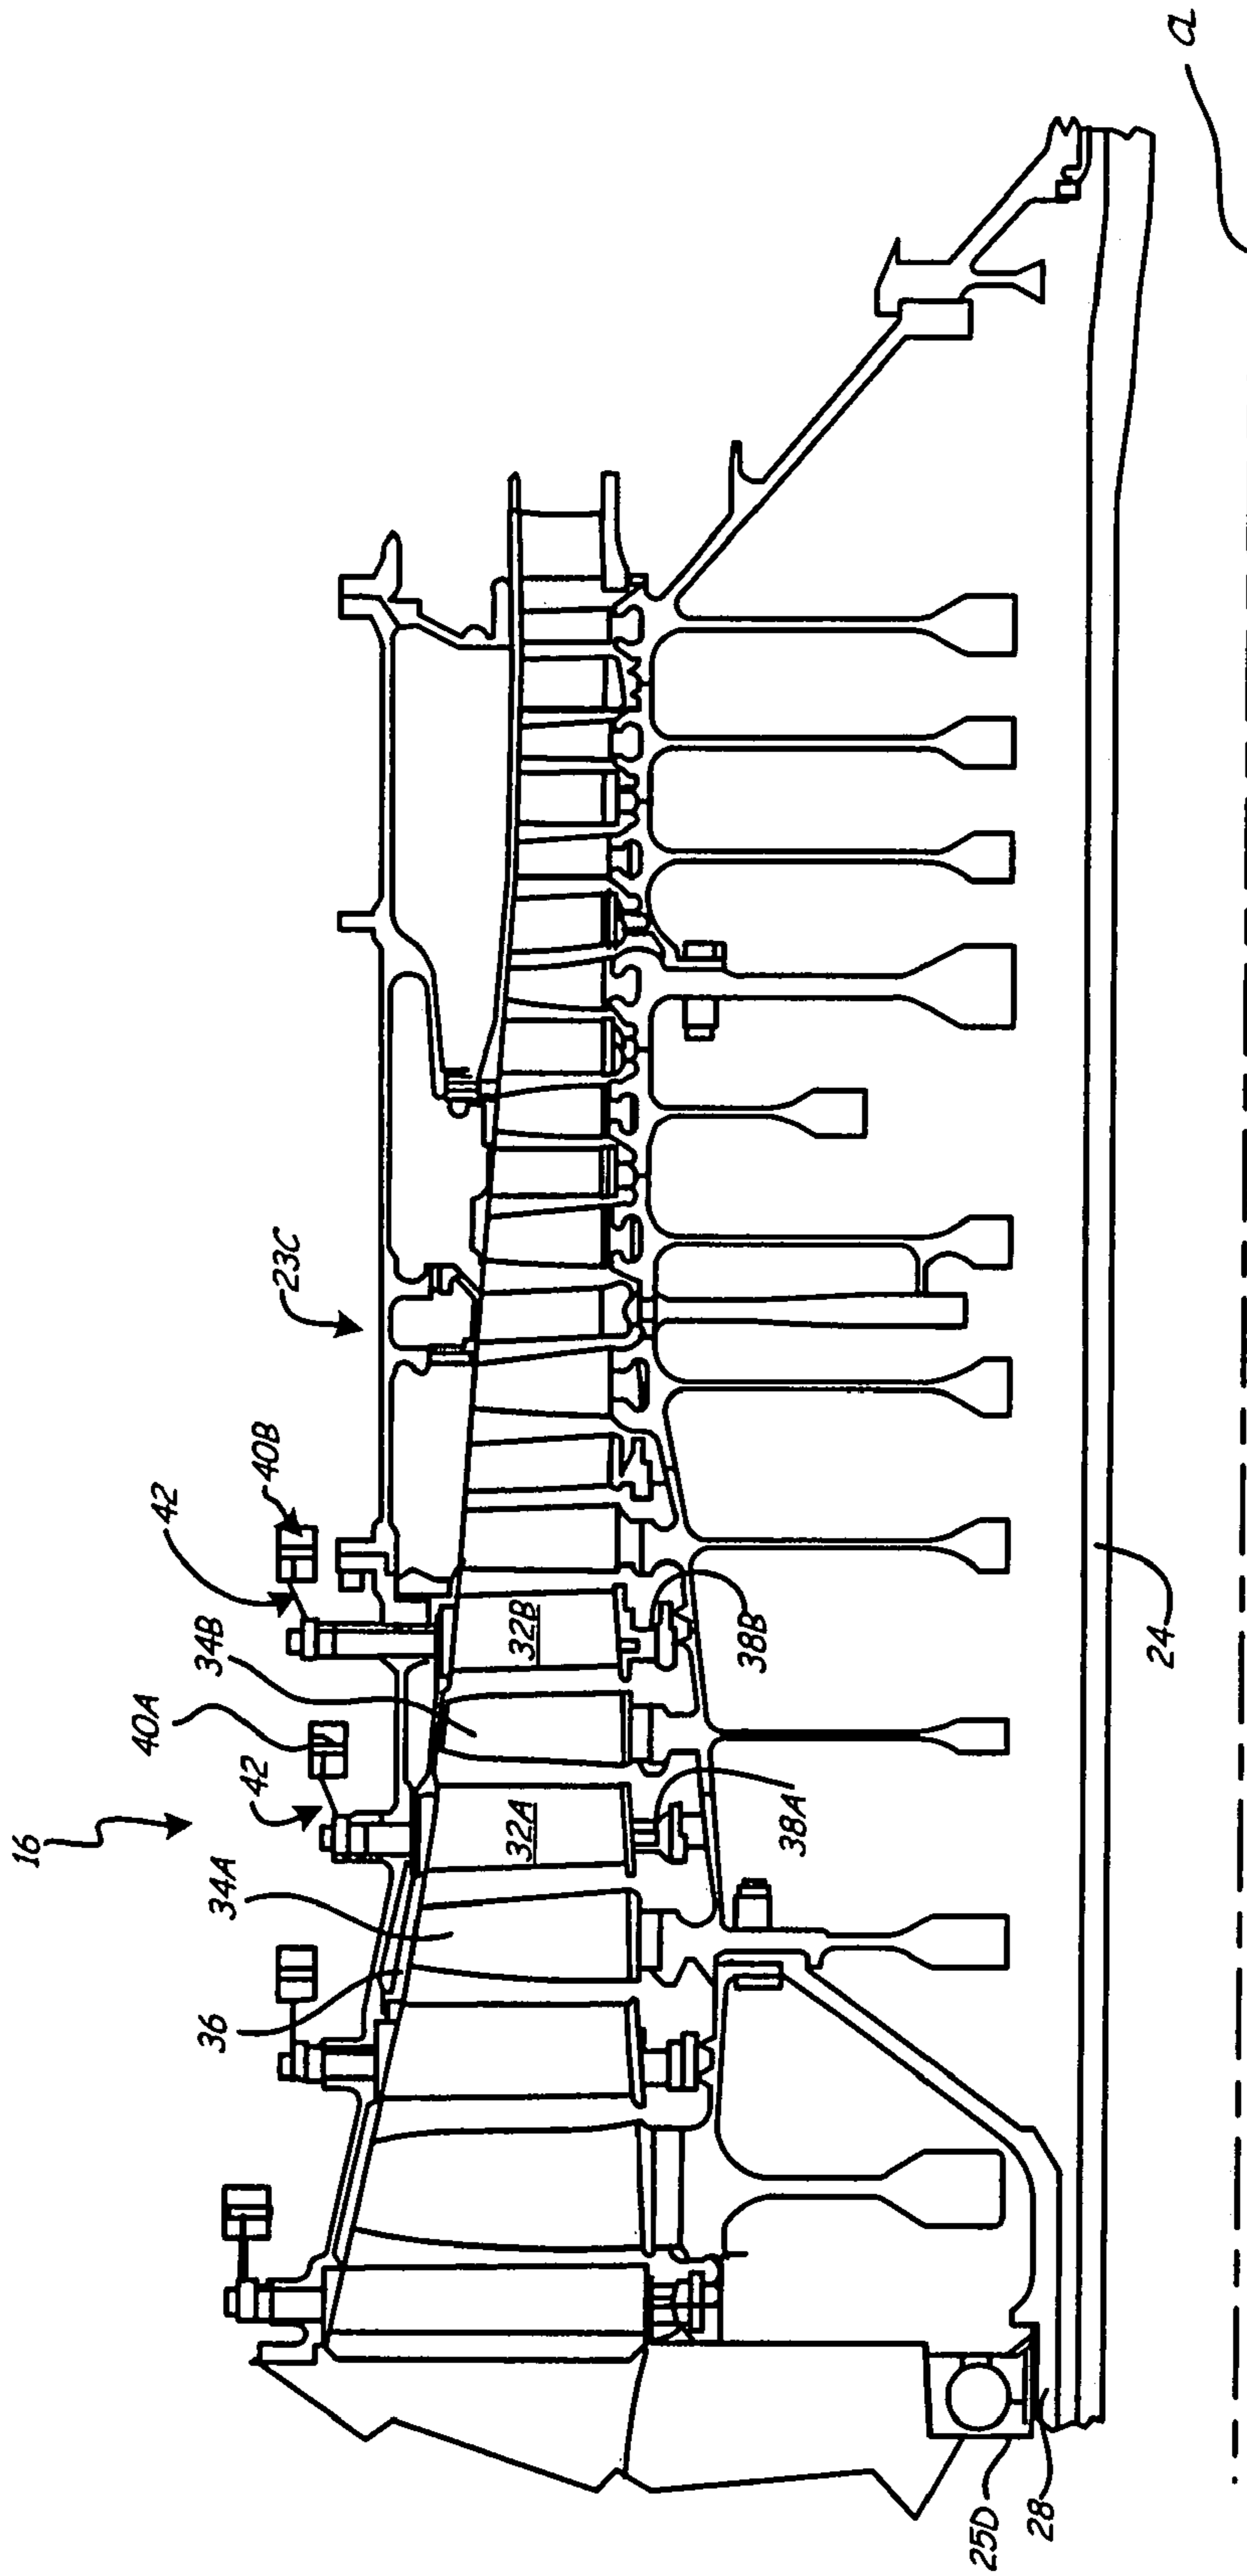
Fig. 2

FIG. 2 shows a high pressure compressor section of the gas turbine engine of FIG. 1 showing the interaction between variable stator vanes and a high pressure compressor (HPC) front case.

FIG. 2 shows the sequential arrangement of the various stages of high pressure compressor 16 about centerline CL of gas turbine engine 10. For the embodiment of engine 10 shown, HPC 16 is divided into stages S5 through S15, with LPC 14 of FIG. 1 comprising stages S1 through S4. Vanes 32A and 32B and blades 34A and 34B comprise stages S6 and S7 of HPC 16, respectively. The variable vanes rotate between HPC case 23C and a plurality of inner diameter vane shrouds. Specifically, vanes 32A and 32B rotate between HPC outer shroud 36, which is a component of case 23C, and HPC inner shrouds 38A and 38B, respectively. In order to rotate vanes 32A and 32B within outer shroud 36, vanes 32A and 32B are connected to sync rings 40A and 40B, respectively, through a plurality of sync arms 42. Sync rings 40A and 40B are connected to, for example, a hydraulic actuator to adjust the pitch of vanes 32A and 32B such that airflow through HPC 16 is optimized for different operating levels of engine 10. In order that vanes 32A and 32B rotate freely within outer shroud 36 and inner shrouds 38A and 38B, vanes 32A and 32B include inner and outer diameter trunnions.

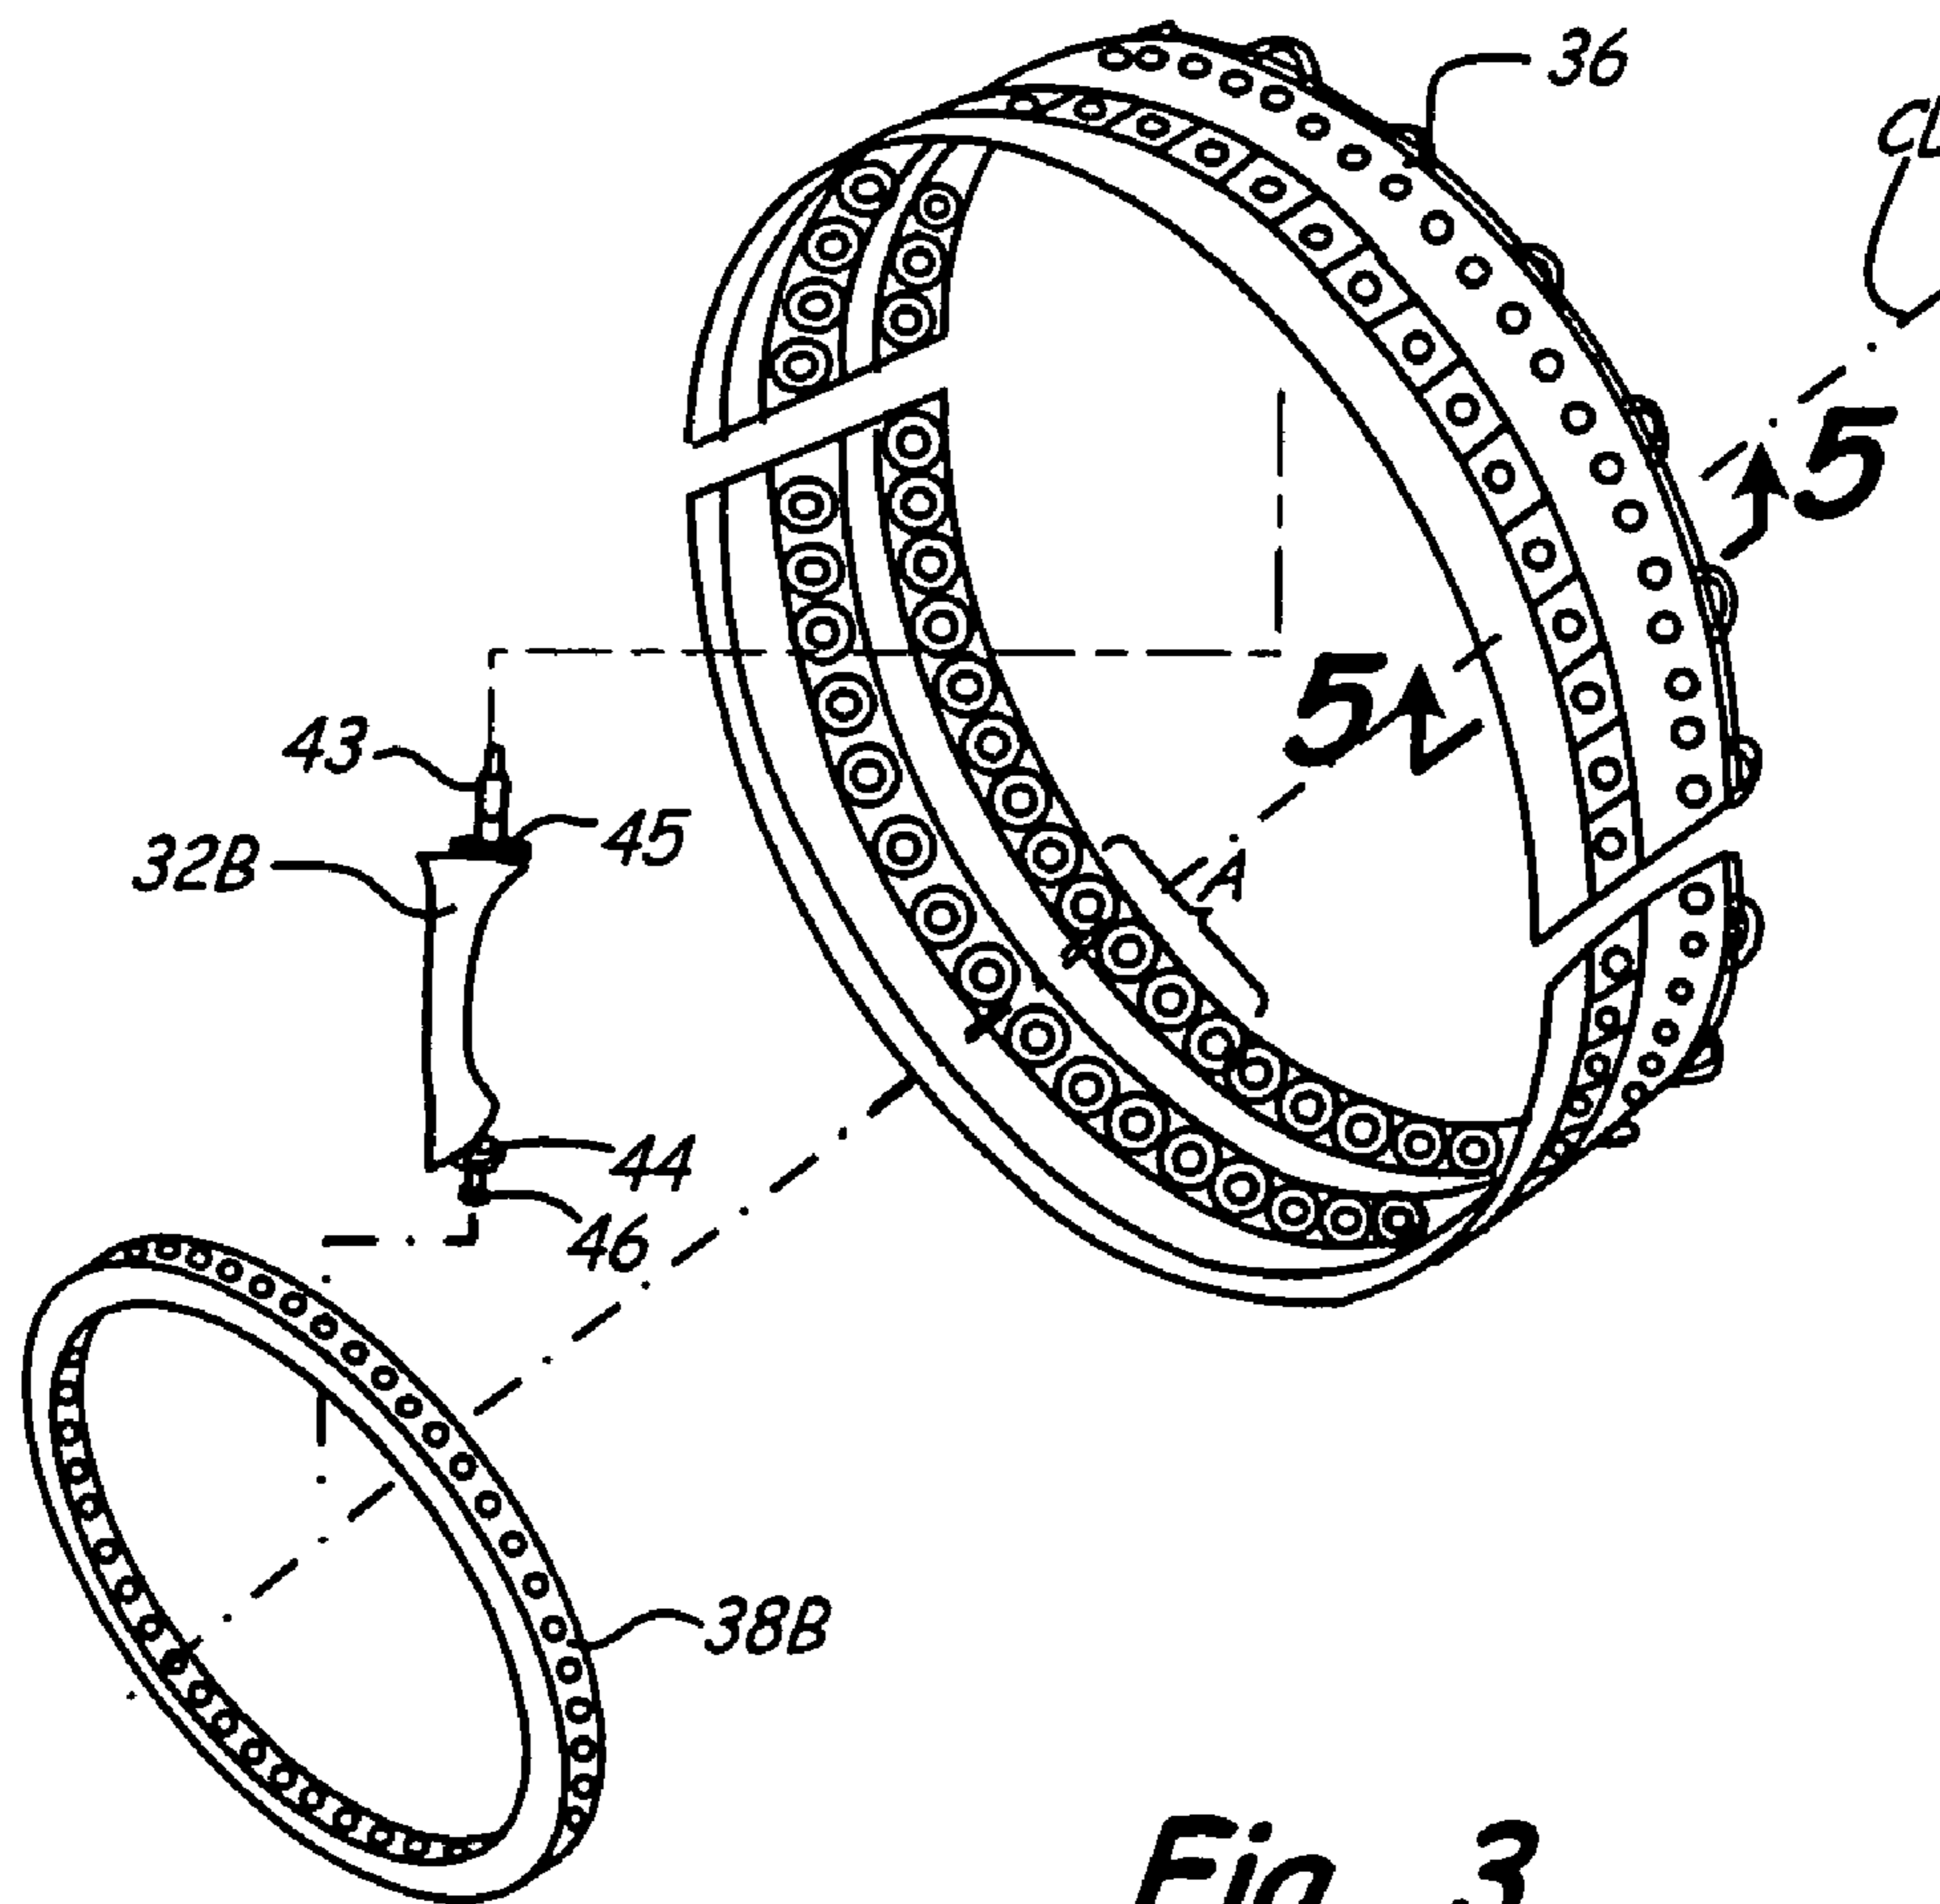
Fig. 3

FIG. 3 shows a perspective view of the HPC front case of FIG. 2.

FIG. 3 shows an exploded view of variable vane 32B positioned between outer vane shroud 36 and inner vane shroud 38B. Outer vane shroud 36 and inner vane shroud 38B are positioned concentrically around engine centerline CL at the inner and outer diameters of vane 32B, respectively. Vane shroud 36 comprises a conically shaped body that surrounds stages S6 and S7 of HPC 16, including vanes 32A and 32B and blades 34A and 34B. Vane shroud 36 typically comprises a split-ring construction wherein it is divided into upper and lower halves.

Vane 32B includes outer trunnion 43 and inner trunnion 44 that rotate within variable vane counterbored holes. Using sync ring 40B and sync arms 42 as shown in FIG. 2, vane 32B is rotatable about trunnions 43 and 44 within the counterbored holes in outer vane shroud 36 and inner vane shroud 38B. Additionally, trunnions may include additional features for assisting in true rotation of the variable vanes. For example, vane 32B includes outer diameter hub 45 and inner diameter hub 46 that rotate within the counterbores surrounding the counterbored trunnion holes and help to keep vanes 32B properly aligned. Vane 32A is configured similarly to vane 32B.

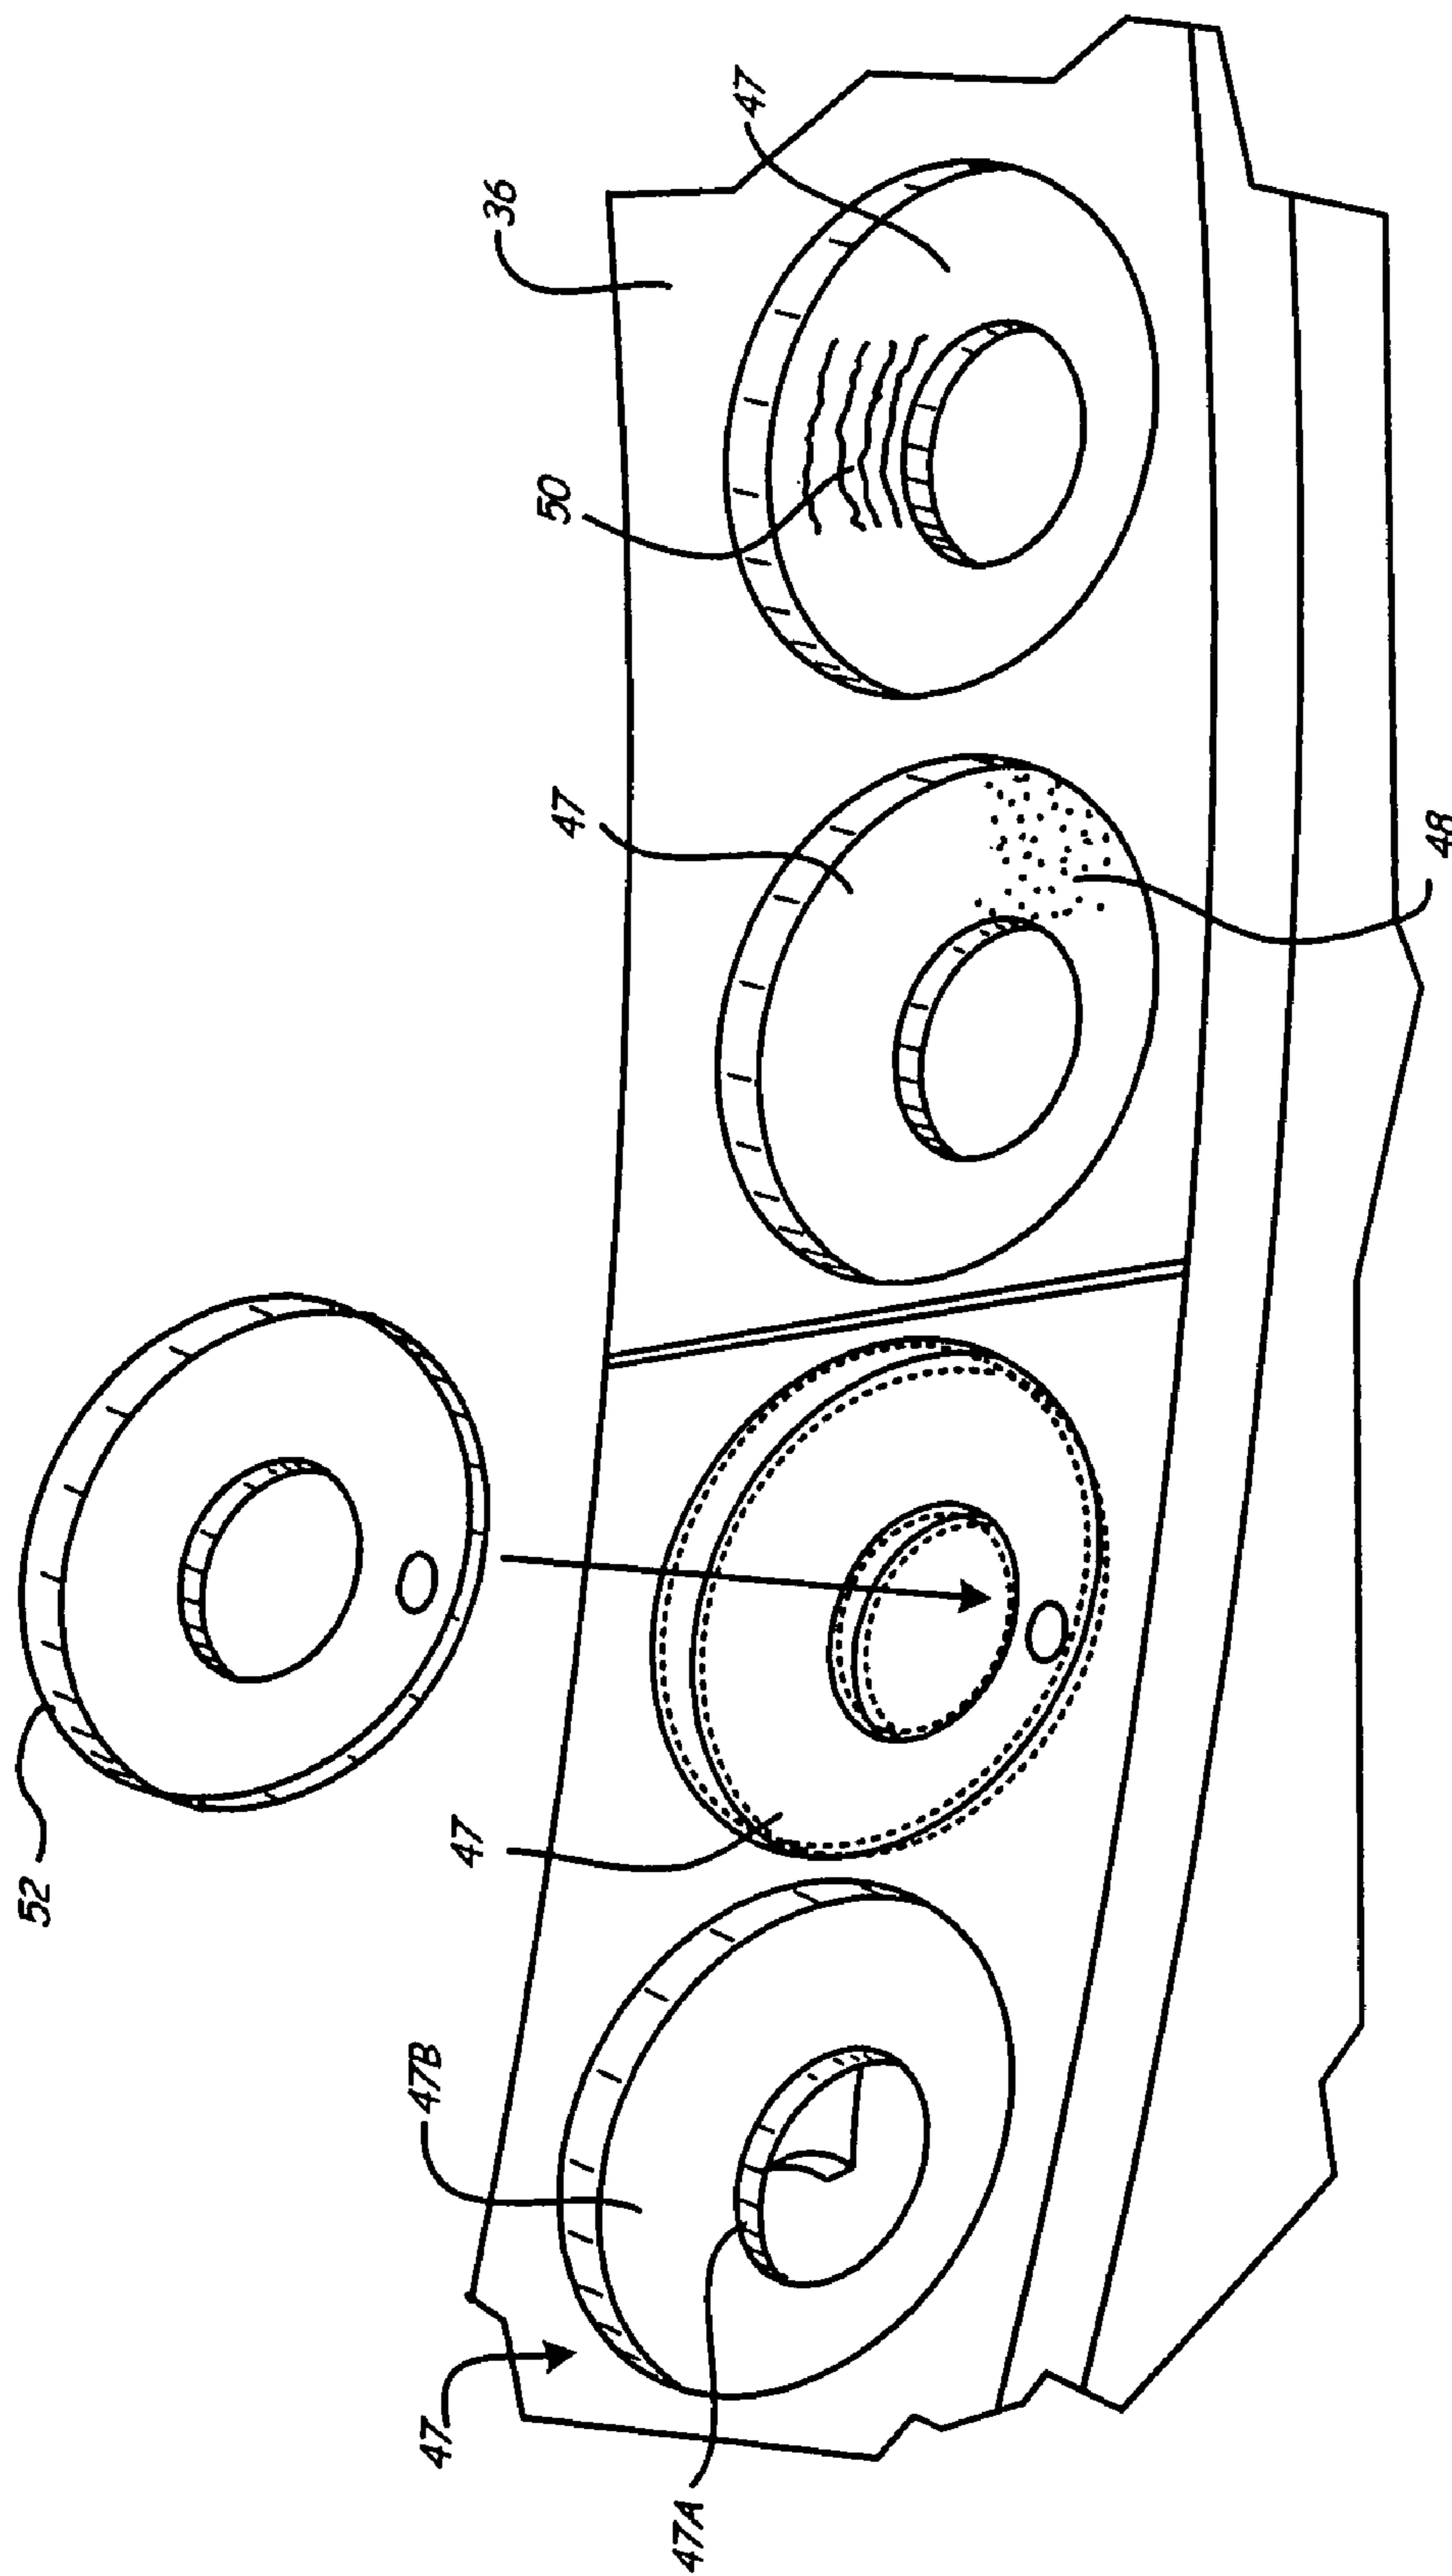
Fig. 4

FIG. 4 shows a perspective view of variable vane counterbores in the HPC front case of FIG. 3.

FIG. 4 shows breakout portion A of FIG. 3, showing a perspective view of vane bottom counterbored holes 47, in outer vane shroud 36. Outer vane shroud 36 includes counterbored holes 47 that each receives an outer diameter trunnion from a variable vane, such as trunnion 43 from vane 32B. Counterbored holes 47 comprise hole 47A, which is surrounded by counterbore 47B. Counterbored holes 47 are machined to original design dimensions, free of any pitting, wear or corrosion. However, due to various sources, vane counterbored holes 47 become damaged such that rotation of hub 45 and trunnion 43 is hampered. For example, counterbored holes 47 develop corrosion 48 that arises from harsh operating conditions of engine 10. Corrosion 48 includes pitting or other structural deficiencies of the base material comprising vane shroud 36, which is typically a steel alloy such as an Austenitic steel or another iron-based alloy that builds up oxide layers leading to corrosion. Corrosion 48 arises from the extreme temperatures at which engine 10 operates and other external factors such as salt-rich operational environments. Counterbored holes 47 also develop scoring 50 that arises from routine rotation of trunnion 43 and hub 45 within counterbored holes 47. Corrosion 48 and scoring 50 prevent free rotation of hub 45 on the surface of the counterbore into which they are inserted. As such counterbored holes 47 are provided with hole liner 52. Counterbored holes 47 are over-bored such that any damage is removed from the base material of shroud 36. Subsequently, liner 52, having dimensions matching that of the removed over-bore, is inserted into counterbored holes 47 to restore shroud 36 to original specifications.

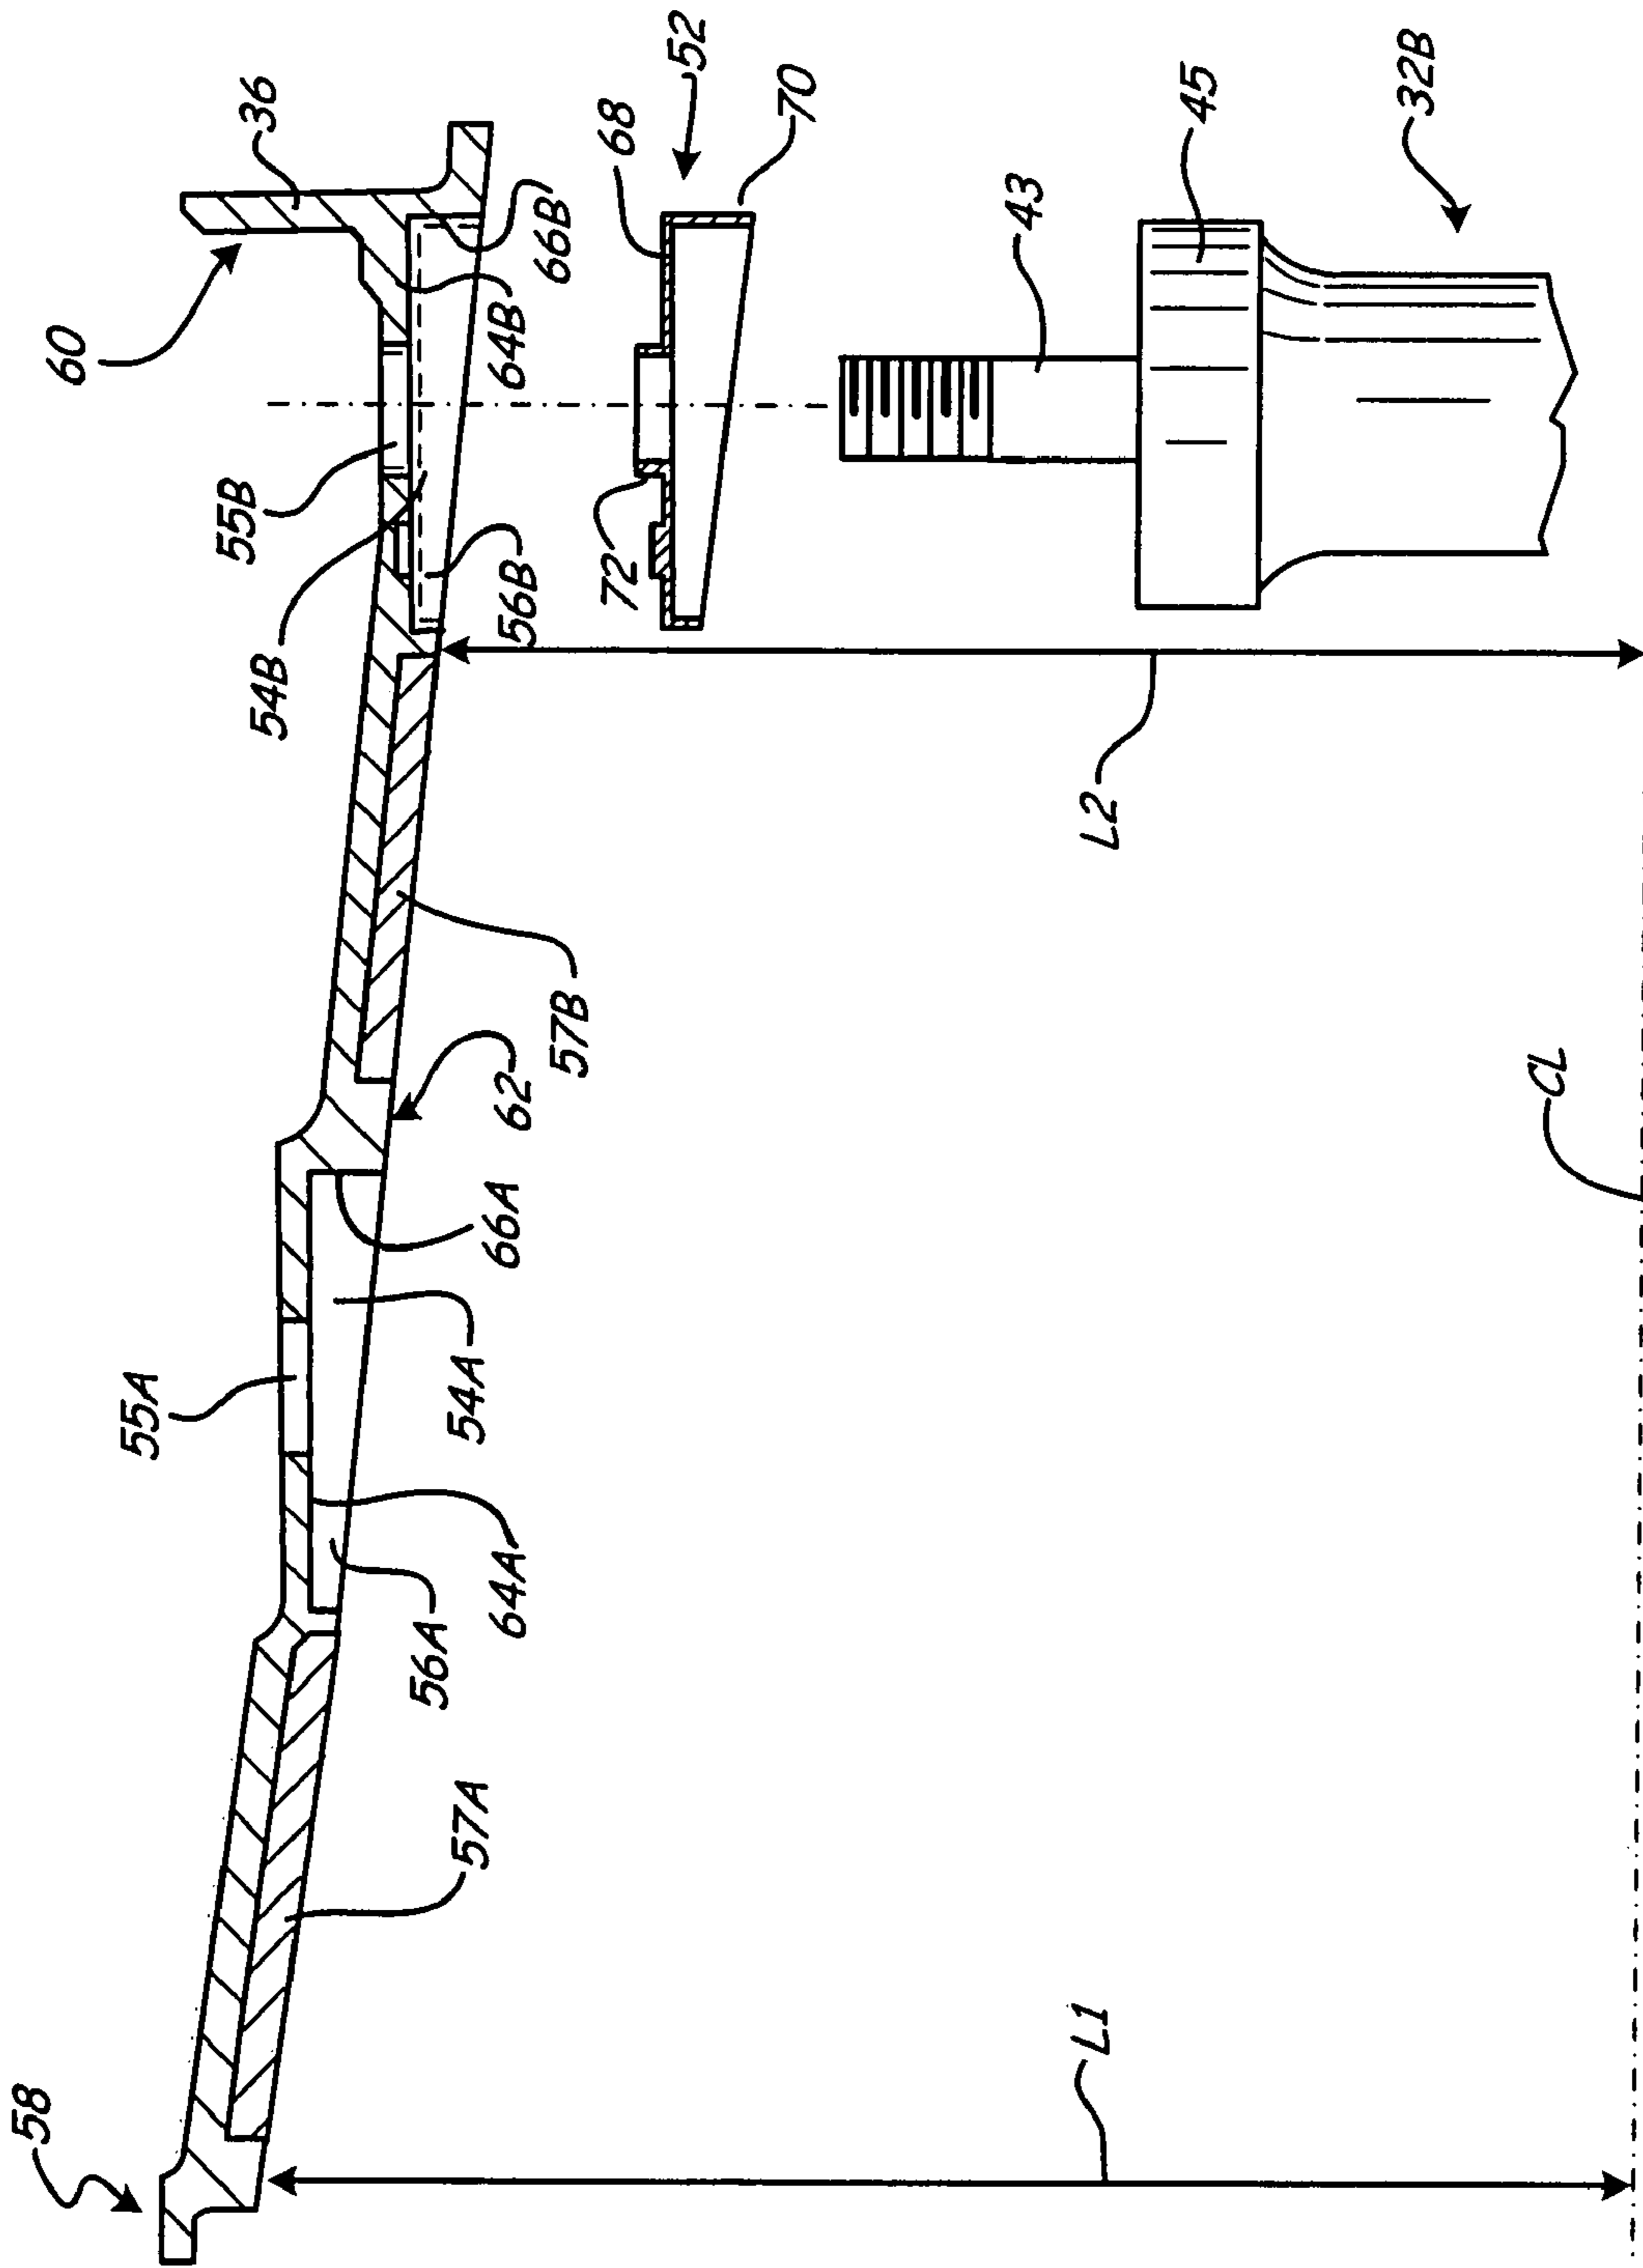
Fig. 5

FIG. 5 shows cross section 5-5 of FIG. 3 showing the insertion of a variable vane hole liner into an HPC front case counterbore.

FIG. 5 shows cross section 5-5 of FIG. 3 showing the insertion of counterbored hole liner 52 into outer diameter shroud 36 of HPC case 23C. Outer diameter shroud 36 includes counterbored holes 54A and 54B for receiving trunnions of variable vanes. Counterbored holes 54A and 54B each comprise a trunnion hole 55A and 55B, respectively, extending through shroud 36 and a corresponding counterbore 56A and 56B, respectively, surrounding trunnion holes 55A and 55B, respectively. Outer diameter shroud 36 also includes trenches 57A and 57B against which the outer diameter ends of blades 34A and 34B engage. In various embodiments of shroud 36, trenches 57A and 57B are filled with a plasma-sprayed abradable material. As shown, counterbored hole 54B receives trunnion 43 and hub 45 of vane 32B. In order to facilitate repair of counterbored hole 54A or 54B, shroud 36 is provided with a variable vane hole liner. For example, liner 52, which is an exemplary embodiment of the hole liners, is used in conjunction with counterbored hole 54B.

Vane shroud **36** is generally a conically shaped cylinder such that it is disposed around engine centerline CL with a sloping orientation. Forward end **58** of shroud **36** is disposed length  $L_1$  away from centerline CL, whereas aft end **60** is disposed length  $L_2$  away from centerline CL. Length  $L_1$  is greater than length  $L_2$  such that radially innermost surface **62** of shroud **36** slopes toward centerline CL as shroud **36** extends from forward end **58** to aft end **60**. However, since vanes **32A** and **32B** need to abut shroud **36** on a surface conducive to rotation, counterbores **56A** and **56B** include flat surfaces **64A** and **64B**, respectively. Thus, counterbores **56A** and **56B** are machined perpendicularly to centerline CL into surface **62**. As such, counterbores **56A** and **56B** include walls **66A** and **66B** that are cylindrically shaped and extend from the generally flat surfaces **64A** and **64B** to the conically shaped surface **62** such that walls **66A** and **66B** follow the contour of surface **62**.

Shroud **36** is typically produced as a single-piece unitary component. Thus, shroud **36** is finished to meet final dimensional tolerances, including the final dimensions of counterbored holes **54A** and **54B**. Counterbored holes **54A** and **54B** are typically finished such that they receive trunnion **43** and hub **45** with fairly tight tolerances such that slop is eliminated from the system, depending on design needs. However, due to damage imparted by corrosion and wear discussed above, the dimensions and tolerances of counterbored holes **54A** and **54B** become altered such that smooth rotation of trunnion **43** and hub **45** is affected. As such, shroud **36** is repaired with hole liner **52**.
