(12) **United States Patent**  
**Addis**

(10) **Patent No.:** **US 7,722,318 B2**  
(45) **Date of Patent:** **May 25, 2010**

(54) **HOLE LINERS FOR REPAIR OF VANE COUNTERBORE HOLES**

(73) Assignee: **United Technologies Corporation**,  
Hartford, CT (US)

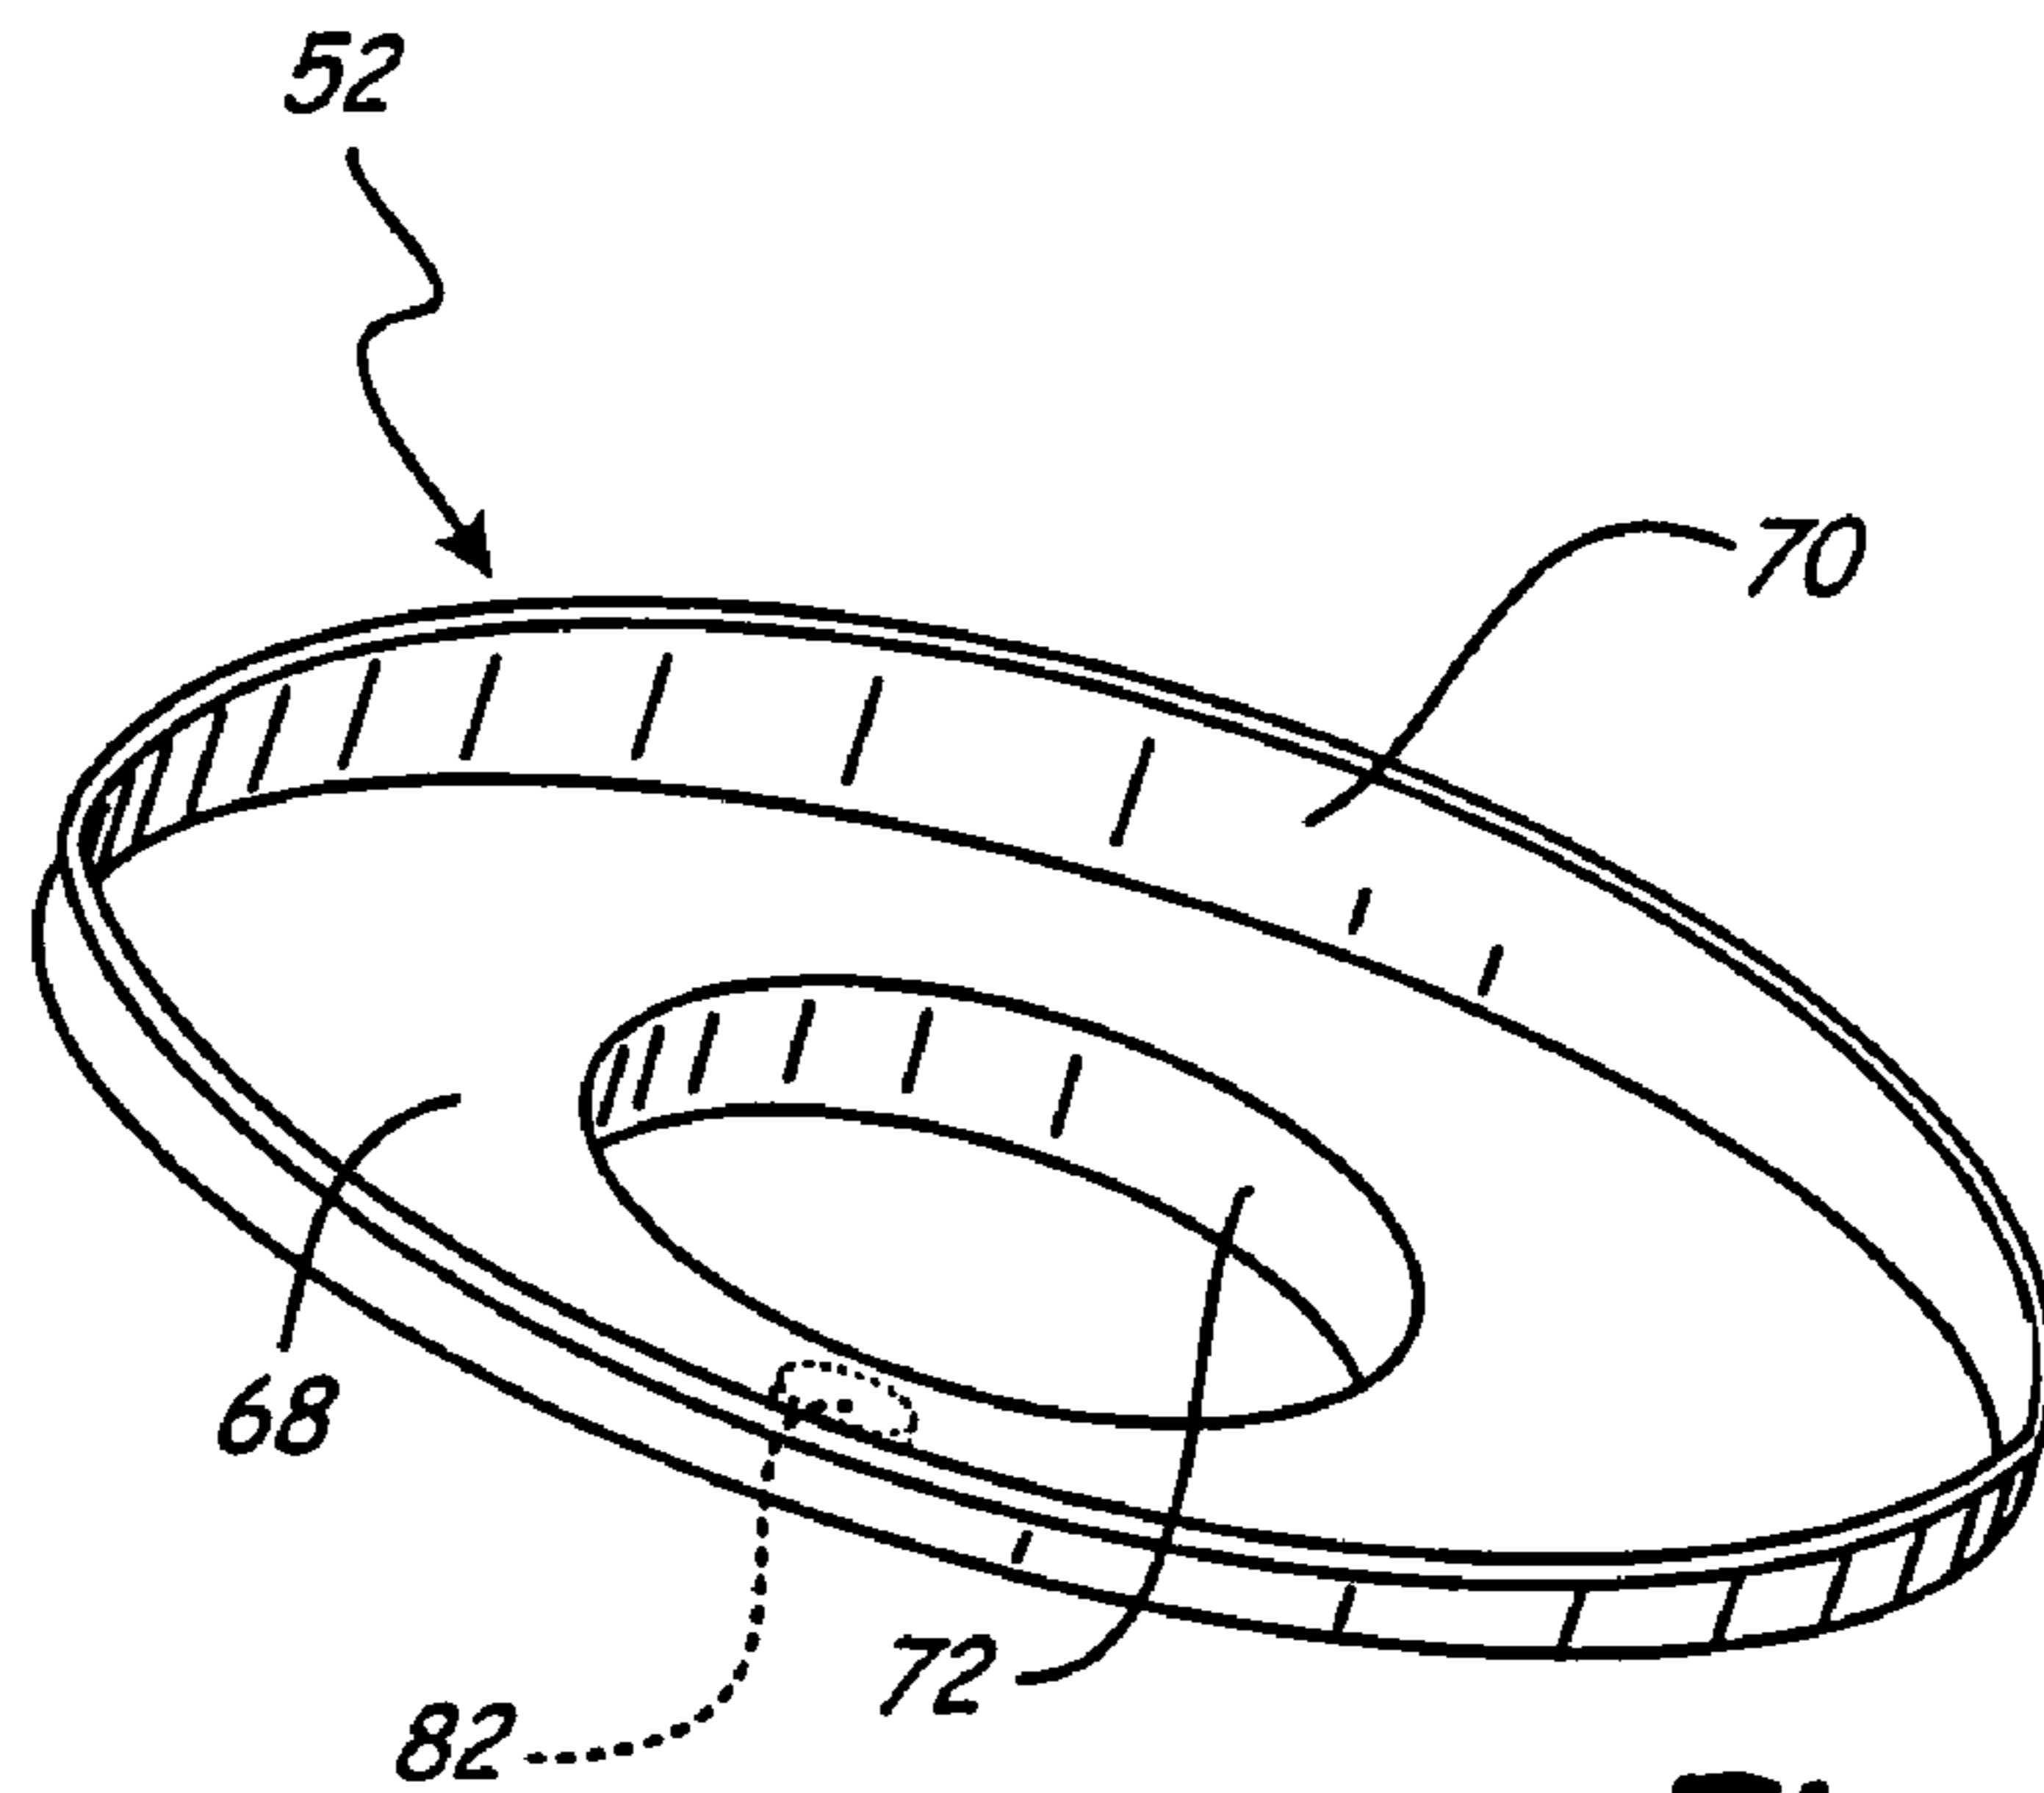
**Fig. 6A**

FIG. 6A shows a top perspective view of a variable vane hole liner.

FIG. **6A** shows a top perspective view of liner **52**, and FIG. **6B** shows a bottom perspective view of liner **52**. Liner **52** is constructed such that counterbored hole **54B** can be milled out, or over-bored, to remove the corrosion or damage to counterbored hole **54B**. Liner **52** includes flat floor **68**, wall **70** and neck **72**. As can be seen, wall **70** has a sloping shape that varies around its edge perimeter to match the contour of surface **62**.

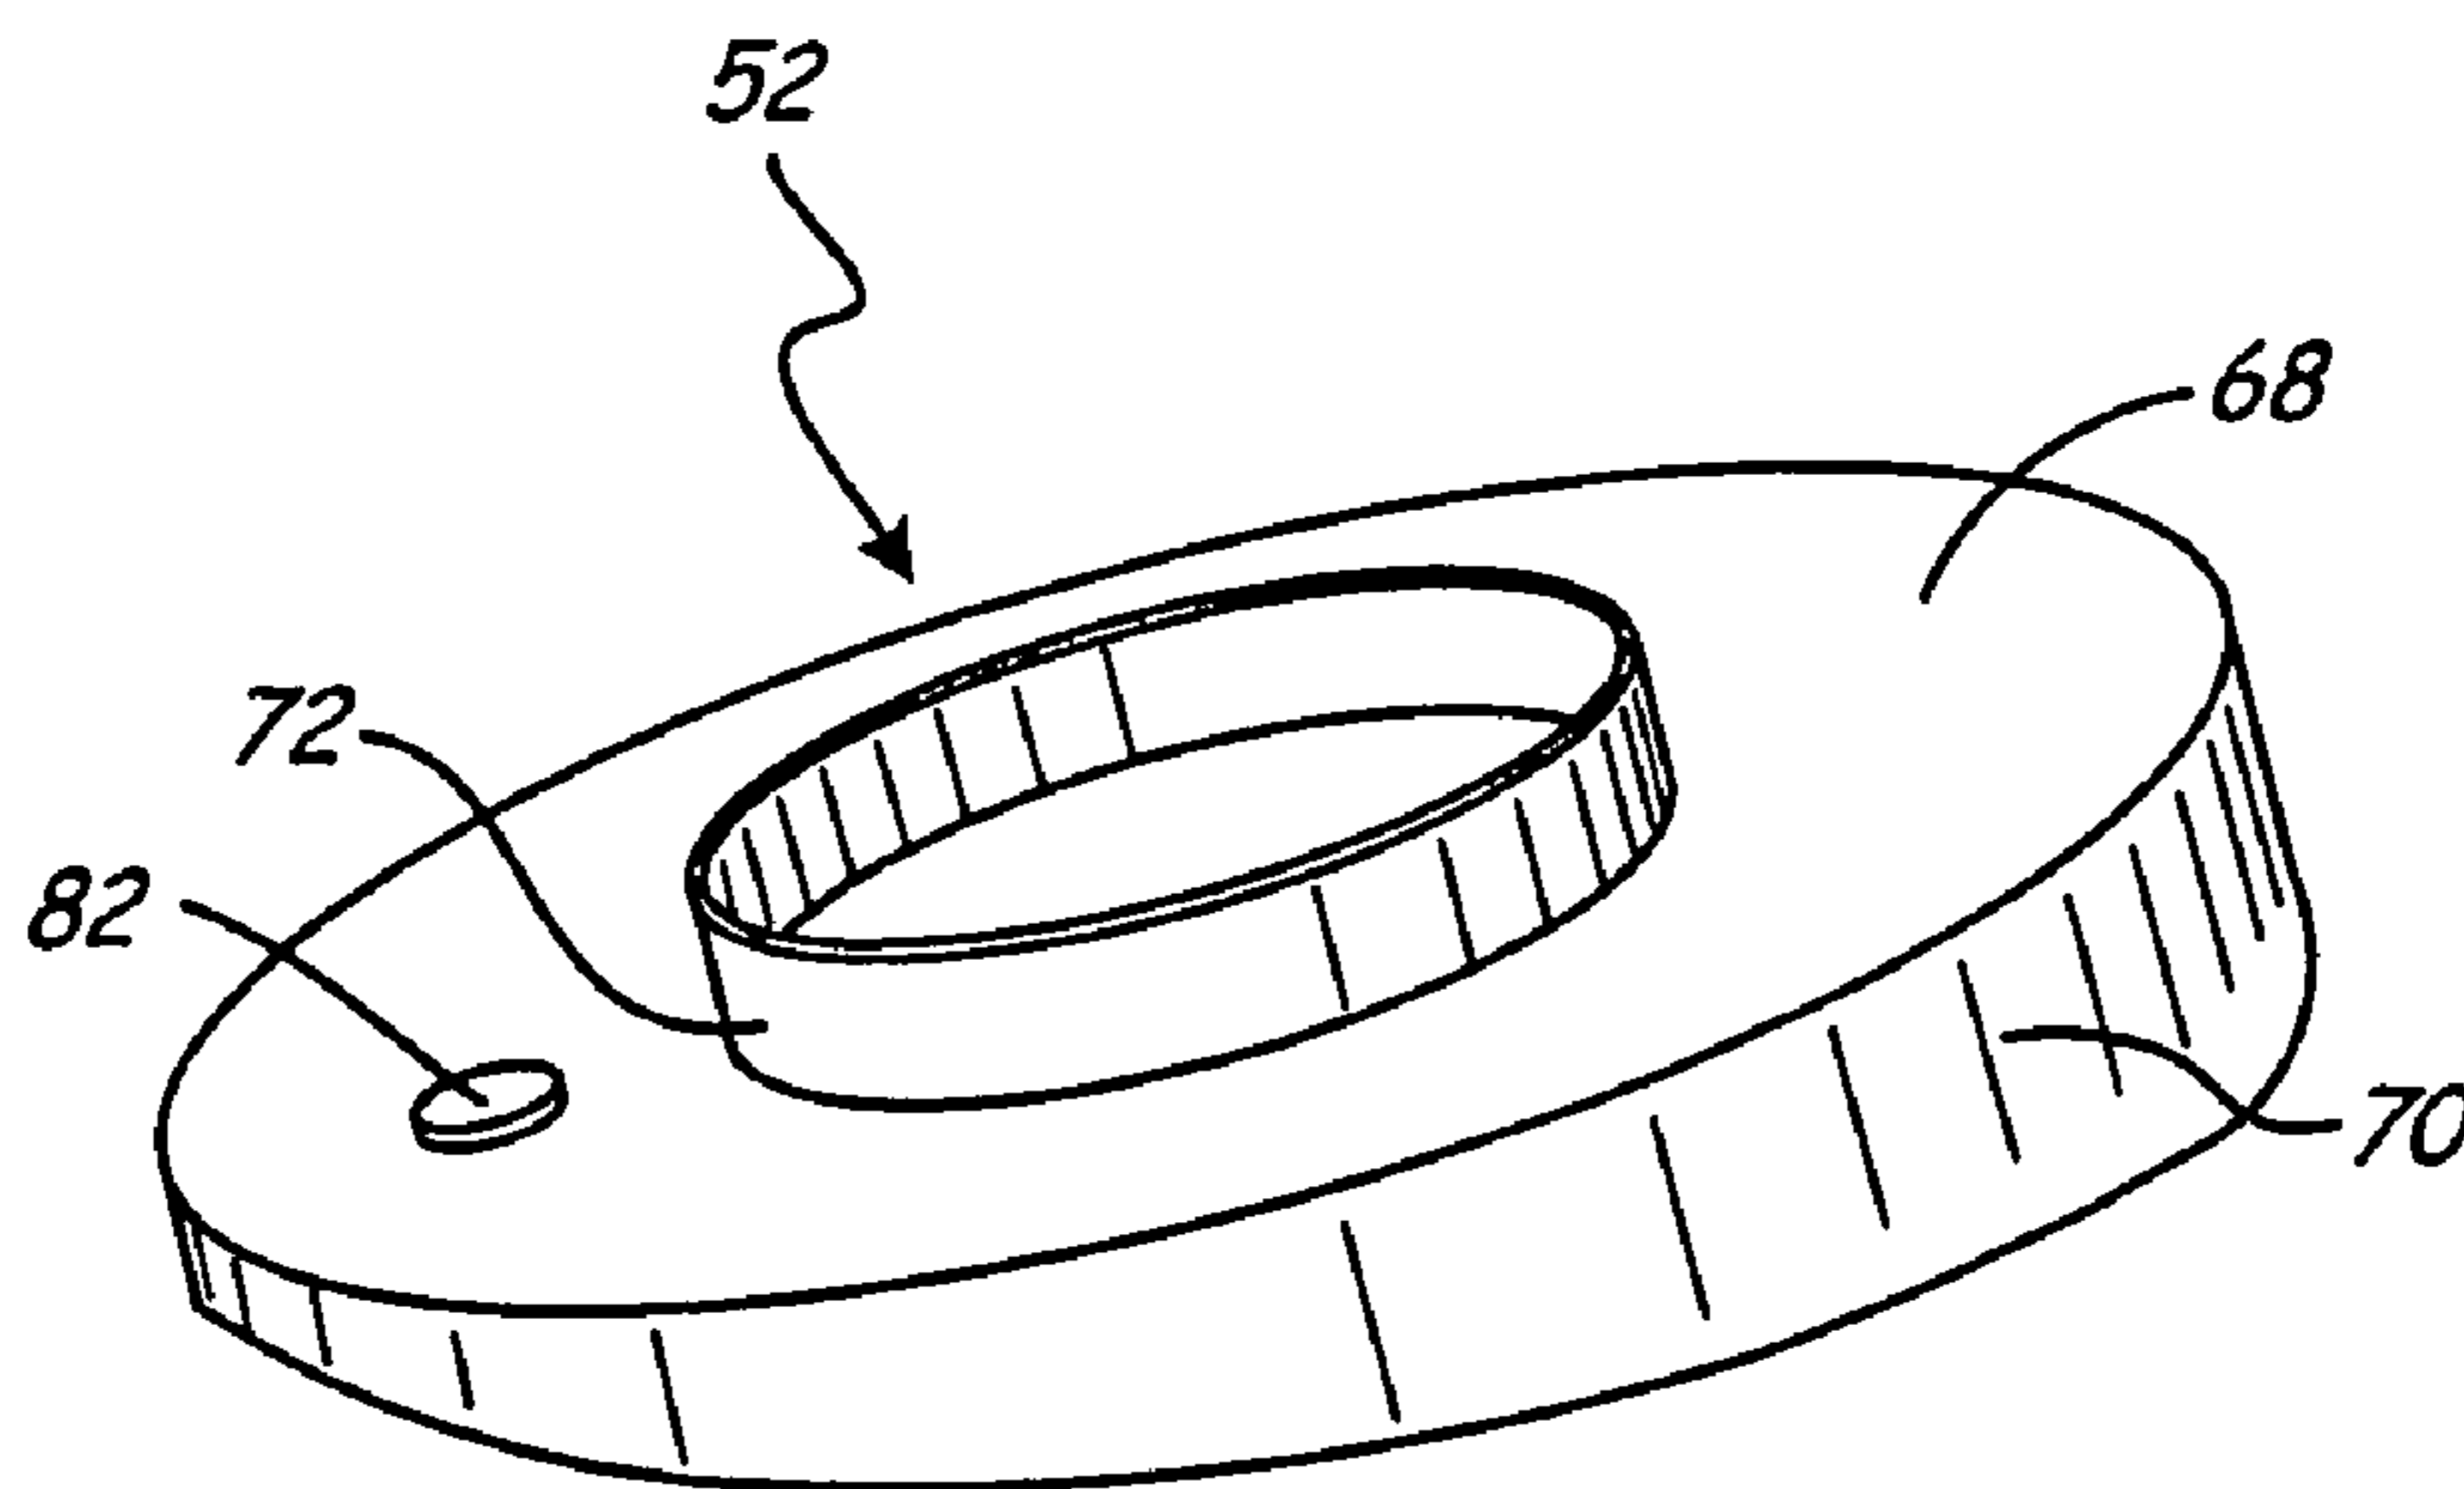
**Fig. 6B**

FIG. 6B shows a bottom perspective view of a variable vane hole liner.

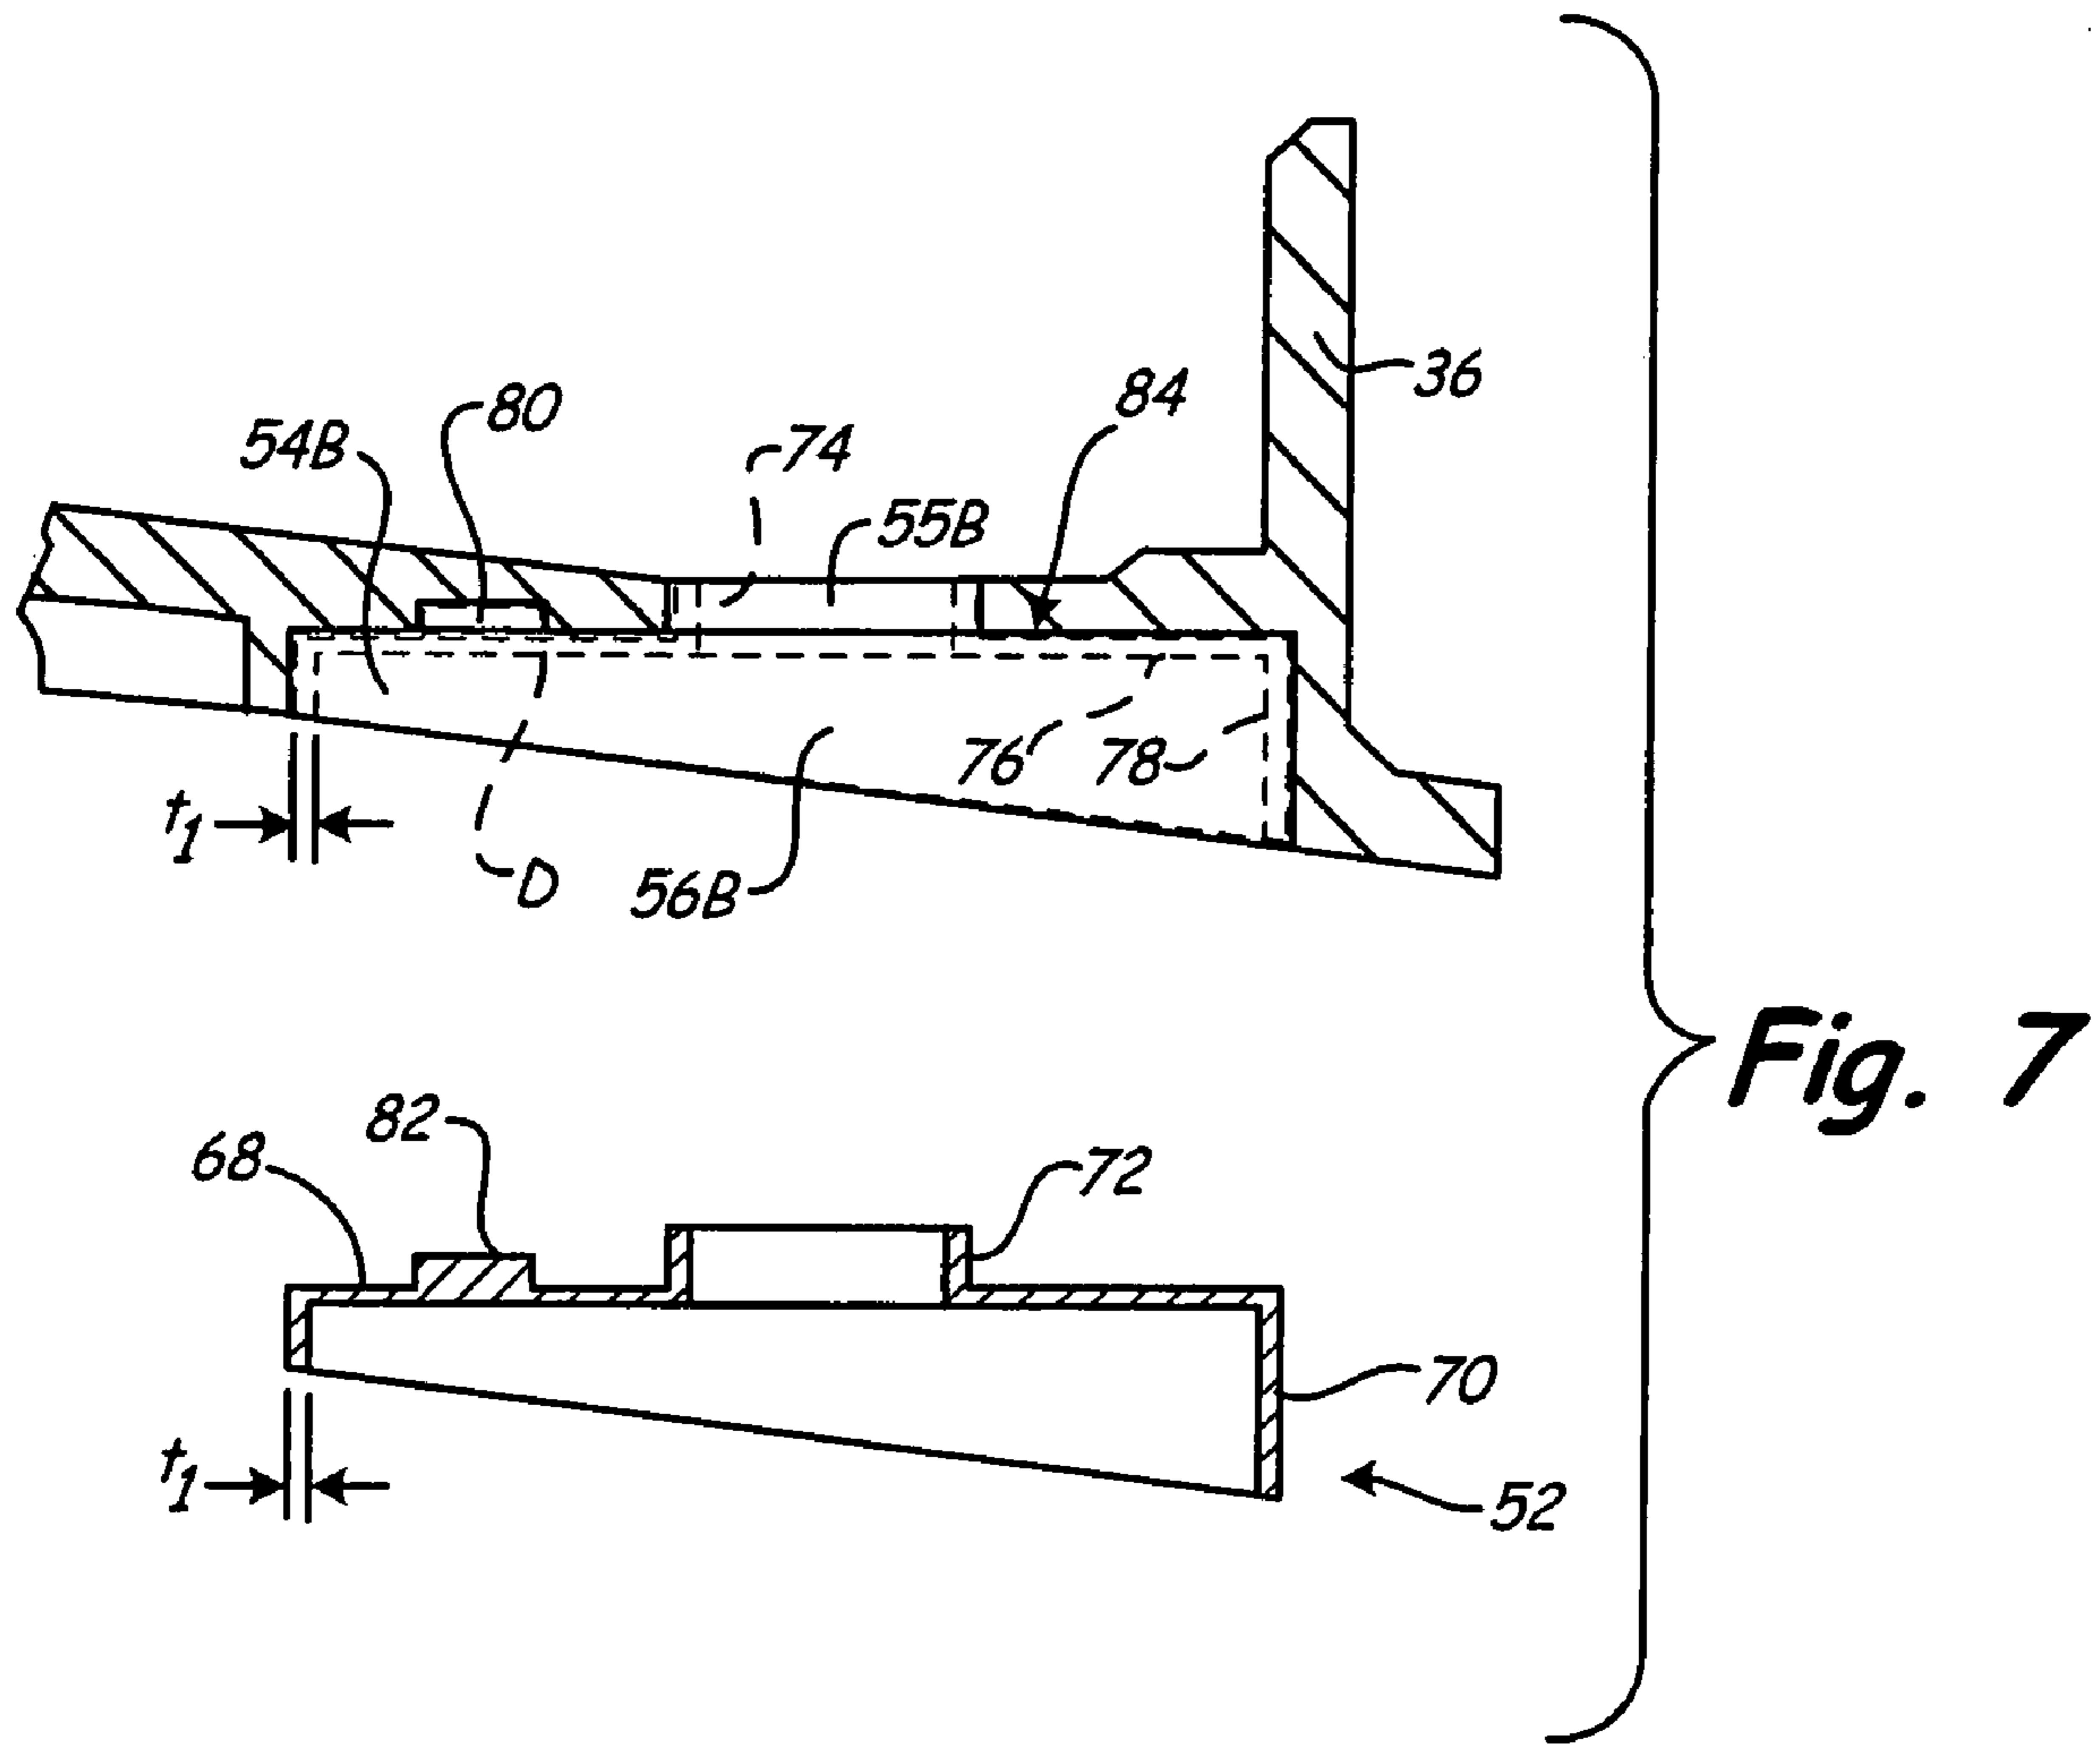
FIG. 7 shows a close-up view of a variable vane hole liner and a variable vane counterbore.

FIG. **7** shows a close-up view of liner **52** for insertion into counterbored hole **54B** of outer diameter vane shroud **36**. Counterbored hole **54B** is machined into shroud **36** such that it is made to specification as is required by design parameters. Counterbored hole **54B** extends into shroud **36** such that it is shown in dotted line D in FIG. **7**. Counterbored hole **54B** includes neck **74**, base **76** and wall **78**. As described above, counterbored hole **54B** undergoes corrosion and wear such that shroud **36** becomes damaged. The damage associated with the corrosion or wear extends into the base material of shroud **36** a particular depth. As such, counterbored hole **54B** is machined out, or over-bored, a particular depth to remove the damaged base material such as shown in solid lines in FIG. **7**. However, it is not enough to simply remove the damaged material, as any material removal of shroud **36** permits slop in the rotation of vane **32B**, which affects the efficiency of IPC **16**. A uniform amount of material is removed from counterbored hole **54B** such that it can be readily replaced to restore shroud **36** to its original design dimensions. Liner **52** is inserted into the over-bored counterbored hole **54B** to restore shroud **36** and counterbored hole **54B** to their original dimensions. Thus, liner **52** is made to dimensions that match the amount of material removed from counterbored hole **54B** in removing the damaged base material.

Wear and corrosion may occur anywhere along counterbored hole **54B**. For example, wall **78** undergoes wear and corrosion such that it becomes damaged to some depth less than or equal to depth  $t_1$ . Thus, material is uniformly removed from the entirety of wall **78** to depth  $t_1$  to ensure all damaged material is removed. Wall **70** of liner **52** is correspondingly manufactured to have a thickness corresponding to depth  $t_1$ . Likewise, material is removed from around neck **74** and floor **76** to a depth necessary to remove any damaged base material at those locations. Correspondingly, liner **52** is fabricated such that neck **72** and floor **68** have thicknesses matching the amount of material removed from neck **74** and floor **76**, which may or may not equal depth  $t_1$ .

Alternatively, material may be uniformly removed from neck **74**, floor **76** and wall **78** to a depth necessary to remove the deepest damage on counterbore **54B**, regardless of the location of the damage. In any event, the least amount of material as is practically possible is removed from shroud **36** such that shroud **36** is not thinned-out too much and its structural integrity is not compromised, as the thickness of shroud **36** is generally on the order of about 0.04 inches (~0.1016 cm). As such, the invention is particularly well suited to shallow damage incurred to counterbored hole **54B**. Thus, when liner **52** is inserted into over-bored counterbored hole **54B**, shroud **36** and counterbore **54B** are restored to their original design dimensions.

In order to facilitate and expedite the assembly of liner **52** with counterbored hole **54B**, floor **76** has additional material removed to form a void or locating recess **80**. Liner **52** is thus fabricated with corresponding button **82** that comprises the negative shape of recess **80** and is positioned on floor **68** on a corresponding location. Locating recess **80** is positioned on floor **76** such that liner **52** can be properly inserted into counterbored hole **54B** in only one way. This is particularly advantageous since wall **70** of liner **52** is of varying height to match the varying height of wall **78**. Liner **52** would be difficult to rotate within counterbored hole **54B** when fully seated due to its thin construction. Thus, in order to prevent misalignment of liner **52**, which would interfere with the free rotation of vane **32B** in counterbored hole **54B**, button **82** prevents liner **52** from becoming fully seated within counterbored hole **54B** unless wall **70** is aligned with the slope of wall **78**. Also,
