(10) **Patent No.:** **US 7,739,974 B1**  
(45) **Date of Patent:** **Jun. 22, 2010**

(54) **SUBMERSIBLE OBJECT WITH  
ANTIFOULING PAINT CONFIGURATION**

(73) Assignee: **Brunswick Corporation**, Lake Forest,  
IL (US)

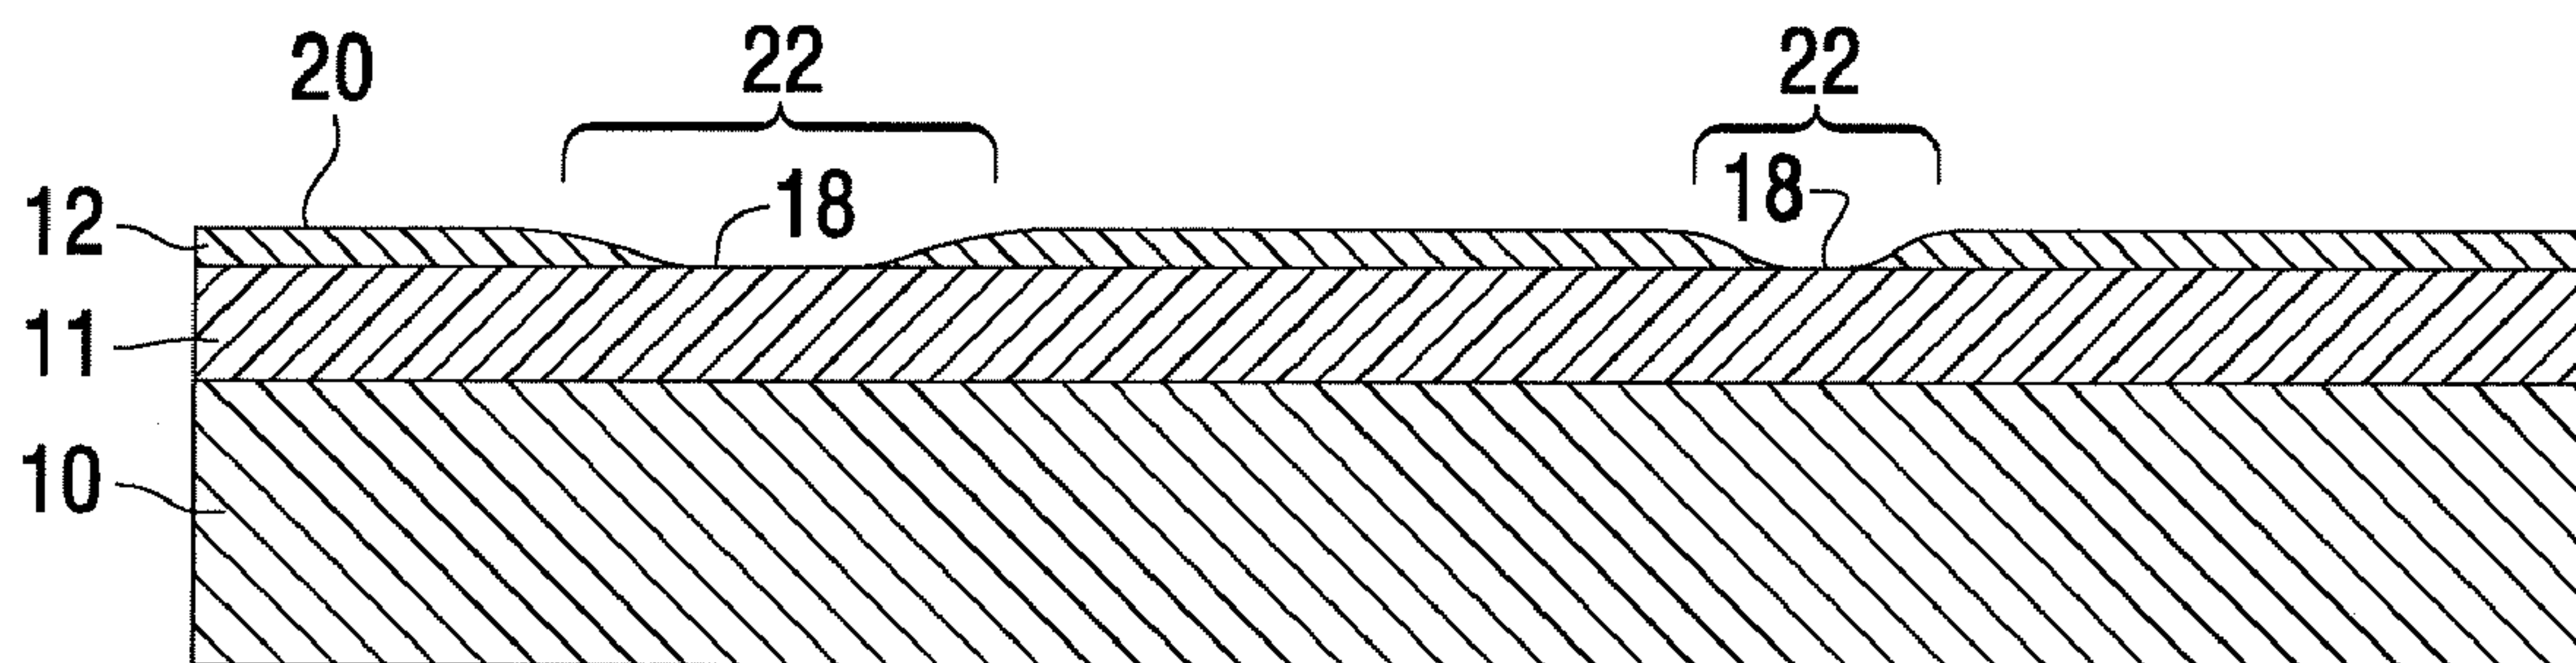
**FIG. 1A**

FIGS. 1A-1D show cross-sections of a submersible object in accordance with a preferred embodiment of the present invention;

FIG. 1A is a simplified schematic view of a section of the submersible object made in accordance with a preferred embodiment of the present invention. It should be understood that FIGS. 1A-1B are enlarged section views drawn without regard to scale so that the various layers, or coatings, of antifouling paint can be more easily identified and clearly described. In FIG. 1A, a substrate 10 is shown with a first layer 11 of a first antifouling material disposed on a surface 14 of the substrate 10. A second layer 12 of a second antifouling material is disposed on the first layer 11. More precisely, the second layer 12 is disposed on an outer surface 18 of the first layer 11. The first and second layers, 11 and 12, are visually distinct from each other. In a particularly preferred embodiment of the present invention, the first layer 11 is a different color than the second layer 12.

The present invention will be described, in conjunction with FIGS. 1A-1B, in terms of two antifouling coatings, 11 and 12, with the first coating 11 being deposited directly on the outer surface 14 of the substrate 10. It should be understood, however, that an additional base coat 30 can be deposited on the outer surface 14 of the substrate 10 prior to the application of the first layer 11 as will be described in greater detail below in conjunction with FIG. 2.

With continued reference to FIG. 1A, the outer surface 20 of the second layer 12 is exposed to water when the submersible object is submerged. FIG. 1B represents the same structure as that shown in FIG. 1A, but after the submersible object has undergone a reduction in the thickness of the second layer 12. That thickness is identified by reference letter T in FIG. 1B. The reduction in thickness T can be caused in several ways. If the second layer 12 is an antifouling material which dissolves over time in the presence of water, the outermost layer 12 will gradually dissolve and reduce the thickness of the second layer 12. This may occur even if no significant erosive conditions exist that would wear away the outer surface 20 and reduce the thickness of the second layer 12. On the other hand, the use of certain antifouling materials on marine vessel hulls or the surfaces of marine drives can result in planned ablation of the second layer 12. If the antifouling material of the second layer 12 is used in conjunction with an electric current that induces the creation of chlorine bubbles on the outer surface 20, oxidation of carbon fibers or other electrically conductive particles in the second layer 12 can result in a thinning of that layer which would reduce dimension T shown in FIG. 1B. Regardless of the precise cause of the thinning of the second layer 12, it should be understood that the second layer can be reduced in thickness through its normal use as an antifouling material.

FIG. 1C shows a more dramatic thinning of the second layer 12 as compared to FIG. 1A or 1B. However, in FIG. 1C, the integrity of the second layer 12 remains intact and the outer surface 18 of the first layer 11 is not exposed. It would be expected that the condition shown in FIG. 1C would occur after a prolonged period of use.

FIG. 1D shows the same structure that is described above in conjunction with FIGS. 1A-1C, but after a longer period of time than represented in FIG. 1C. The second layer 12 shows a greater degree of ablation than FIG. 1C, particularly in the regions identified by reference numerals 21 and 22. In fact, portions of the outer surface 18 of the first layer 11 are exposed as a result of the significant ablation of the second layer 12 in the areas identified by reference numerals 21 and 22. Since the first and second layers, 11 and 12, are visually distinct from each other in a preferred embodiment of the present invention, the exposure of surface 18 in regions 21 and 22 will be visually evident when the submersible object is viewed from a direction above the illustration in FIG. 1D. The different colors of the first and second layers, 11 and 12, will alert the viewer to the presence of wear or ablation in regions 21 and 22 because of the appearance of the color of the first layer 11, at surface 18, through the second layer 12. By the visual presence of the color of the first layer 11, in regions 21 and 22, within the surface 20 of the other color of the second layer 12, it is evident that repair or recoating of the substrate 10 is due.

With continued reference to FIGS. 1A-1D, the first and second layers, 11 and 12, can be made of the same antifouling material, but with a different color or other visually distinct characteristic being provided in order to allow the easy determination of the presence of ablated regions, such as those identified by reference numerals 21 and 22 in FIG. 1D. In a preferred embodiment of the present invention, both the first

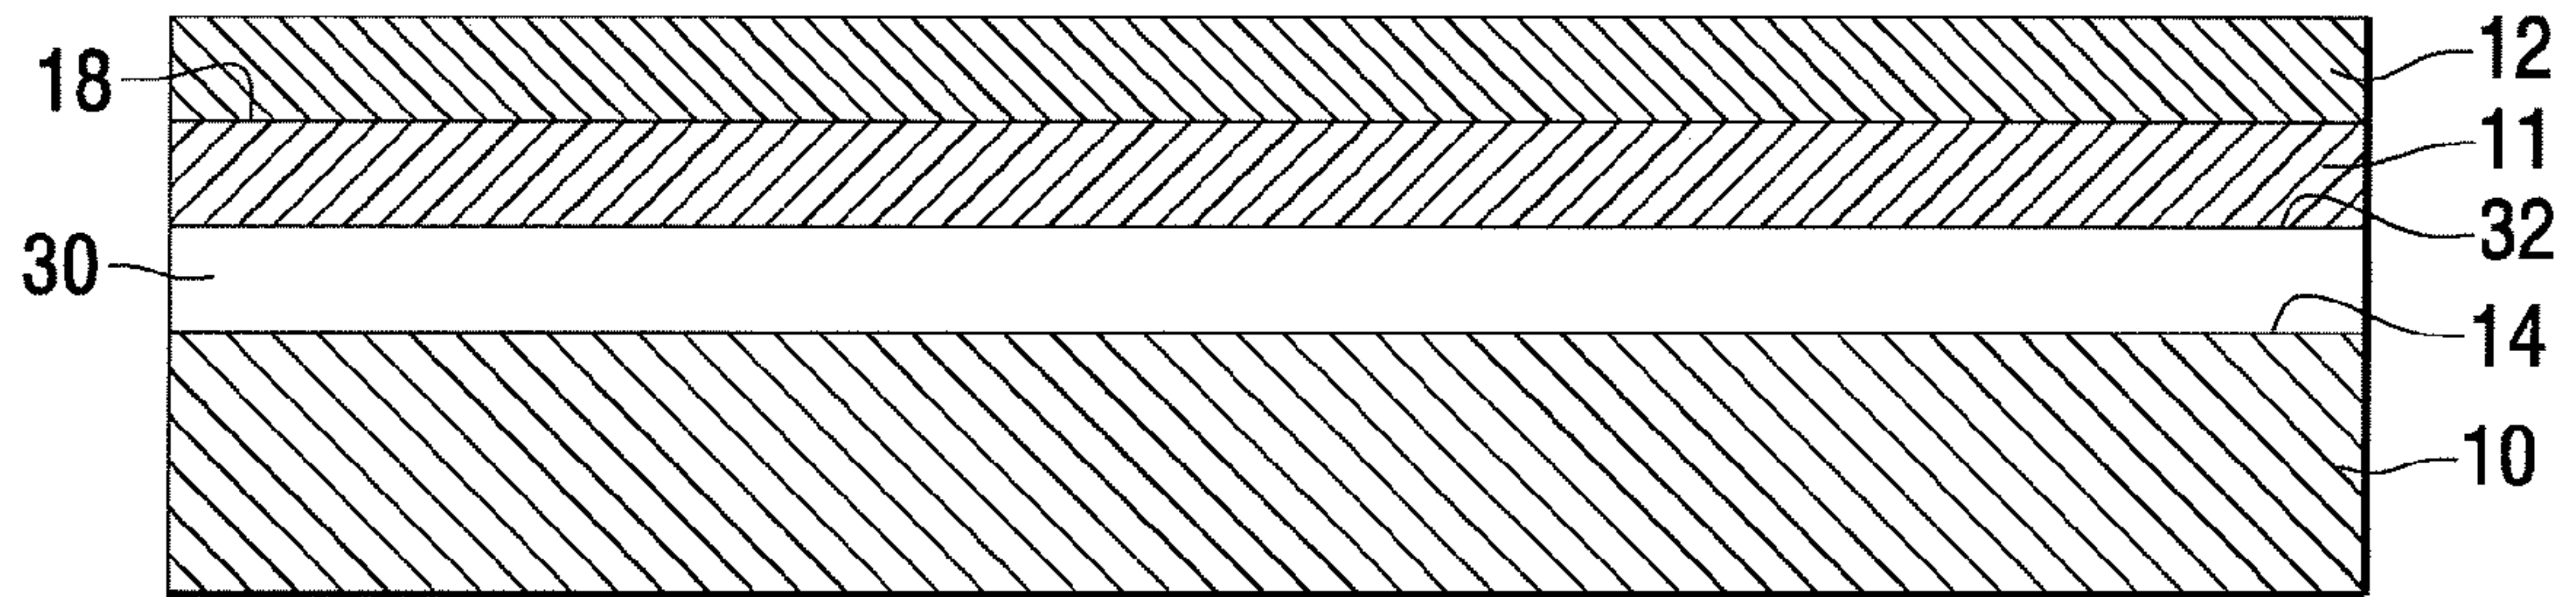
FIG. 2 shows a cross-section of a submersible object made in accordance with an alternative embodiment of the present invention; and

FIG. **2** shows a substrate **10** with first and second layers, **11** and **12**, as in the examples described above in conjunction with FIGS. **1A-1D**. However, a base coat **30** is applied onto the outer surface of the substrate **10** before the application of the first layer **11**. This base coat **30** can comprise a non-antifouling material and can serve the purpose of helping the first layer **11** to adhere to the substrate **10**. It should be understood that the use of a base coat **30** is not required in all embodiments of the present invention. The sequence of application in the configuration shown in FIG. **2** would be the base coat **30**, the first layer **11**, and the second layer **12**.

With continued reference to FIGS. **1A-1D** and **2**, it is also beneficial if the first layer **11** is a different color than the substrate **10**. In embodiments of the present invention that are made with a base coat **30** as described above in conjunction with FIG. **2**, it is also beneficial if the base coat **30** is a different color than the substrate **10** and the first layer **11** is a different color than the base coat **30**. Naturally, the second layer **12** should be a different color than the first layer **11**.

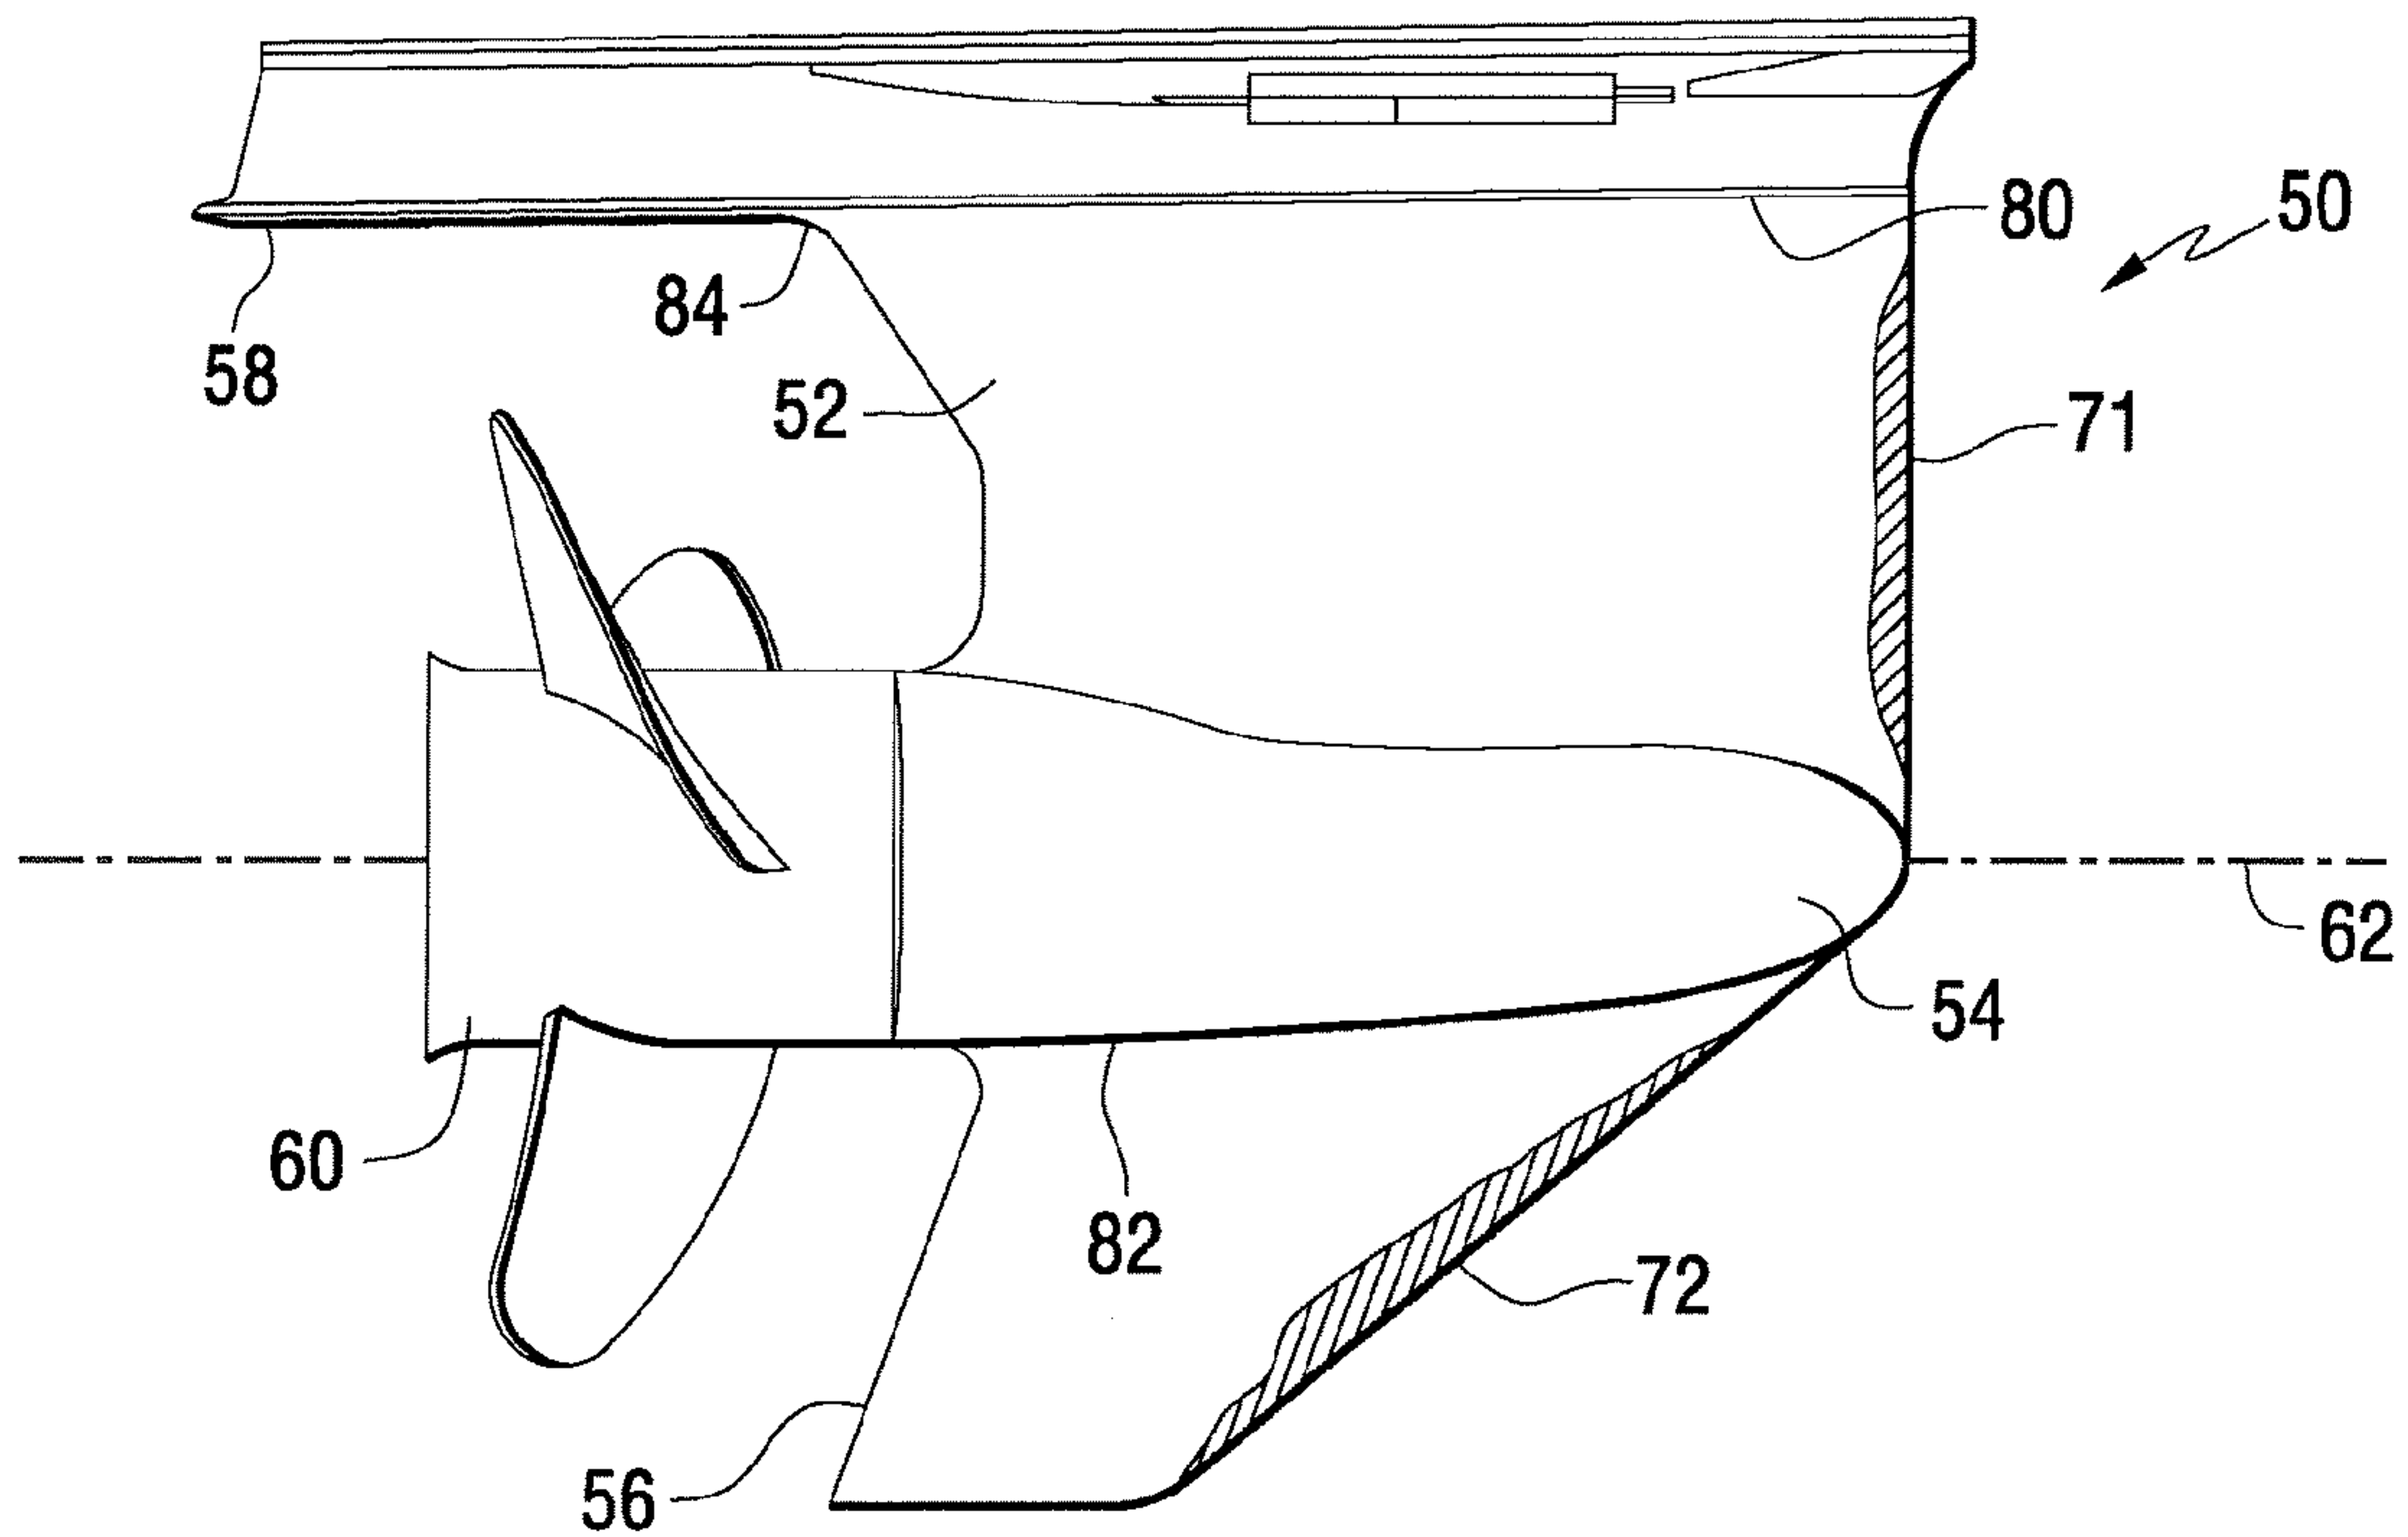
FIG. 3 shows a marine drive unit made in accordance with a preferred embodiment of the present invention.

FIG. **3** is a side view of a marine drive unit **50**. The illustration in FIG. **3** is used as an example of a submersible object with which the present invention can be used. However, it should be understood that the present invention can be used in conjunction with other submersible objects, such as grates and other underwater devices. The marine drive unit **50** shown in FIG. **3** is the driveshaft housing **52** and gear case **54** of a sterndrive unit. It is shown with its skeg **56**, anti-ventilation plate **58** and propeller **60** which is rotatable about a propeller shaft centerline **62**. Two regions, **71** and **72**, are drawn to show hypothetical wear areas on the surface of the

drive unit **50**. As a marine drive moves through the water, the leading edge **71** of the driveshaft housing and leading edge **72** of the skeg **56** are likely to experience a degradation of the second layer **12** described above in conjunction with FIGS. **1A-1D** and **2**, particularly if the second layer is made of an ablative material. If this type of ablation occurs, with the removal of portions of the second layer from the drive unit **50**, the operator of a marine vessel can observe a different coloration in regions **71** and/or **72** compared to the color of the remaining surface of the drive unit. This will serve as a visual indication that the drive unit **50** should be recoated with an outer layer of antifouling paint at the vessel operator's first opportunity to do so. As described above, the use of the present invention also assists the manufacturer during the painting process. Certain regions of the outer surface of the drive unit **50** may present difficulty in assuring that an adequate coat of the second layer has been properly applied. As an example, portions of the region **80** under the anti-ventilation plate, certain portions of the surface of inside bends **84**, and where the torpedo of the gear case **54** meets the generally flat surface of the skeg **56** at location **82**, might present particular difficulty. However, if the second layer is a different color than the first layer, detection of missed regions can more easily be identified and corrected.

With continued reference to FIGS. **1A-1D**, **2** and **3**, it can be seen that a submersible object made in accordance with a preferred embodiment of the present invention comprises a substrate **10**, a first layer **11** of a first antifouling material disposed on a surface of the substrate **10**, and a second layer **12** of a second antifouling material disposed on the first layer **11**, wherein the first and second layers are visually distinct from each other. The first layer **11**, in a preferred embodiment of the present invention, is a different color than the second layer **12**. The second antifouling material can be an ablative material. The first antifouling material is a paint in a preferred embodiment of the present invention. However, it should be understood that the first or second antifouling materials can alternatively be epoxy materials that are applied in ways other than by normal painting processes. These processes could include overmolding. In addition, it should be understood that certain embodiments of the present invention could use paint as both the first and second layers and, in a preferred embodiment of the present invention, both the first and second materials are antifouling materials. In addition, both the first and second antifouling materials can be ablative in nature. The submersible object can be a marine drive unit **50**. The substrate can be aluminum. It should be understood that both the first and second antifouling materials can be made of generally the same material except for their visually distinct characteristic, such as their color. The second antifouling material can contain a chemical which discourages the growth of marine organisms on a wetted surface **20** of the second layer **12**. In addition, the first antifouling material can contain a chemical which discourages the growth of marine organisms on a wetted surface **18** of the first layer, particularly when that surface **18** is exposed in certain regions, **21** and **22**, as a result of the ablation of the second layer **12**. Alternatively, it should be understood that the antifouling characteristic of the first and second layers, **11** and **12**, can result from their use in an electrical process which causes the formation of chlorine gas bubbles on the wetted surfaces.
