(10) **Patent No.:** **US 7,739,974 B1**  
(45) **Date of Patent:** **Jun. 22, 2010**

(54) **SUBMERSIBLE OBJECT WITH  
ANTIFOULING PAINT CONFIGURATION**

(73) Assignee: **Brunswick Corporation**, Lake Forest,  
IL (US)

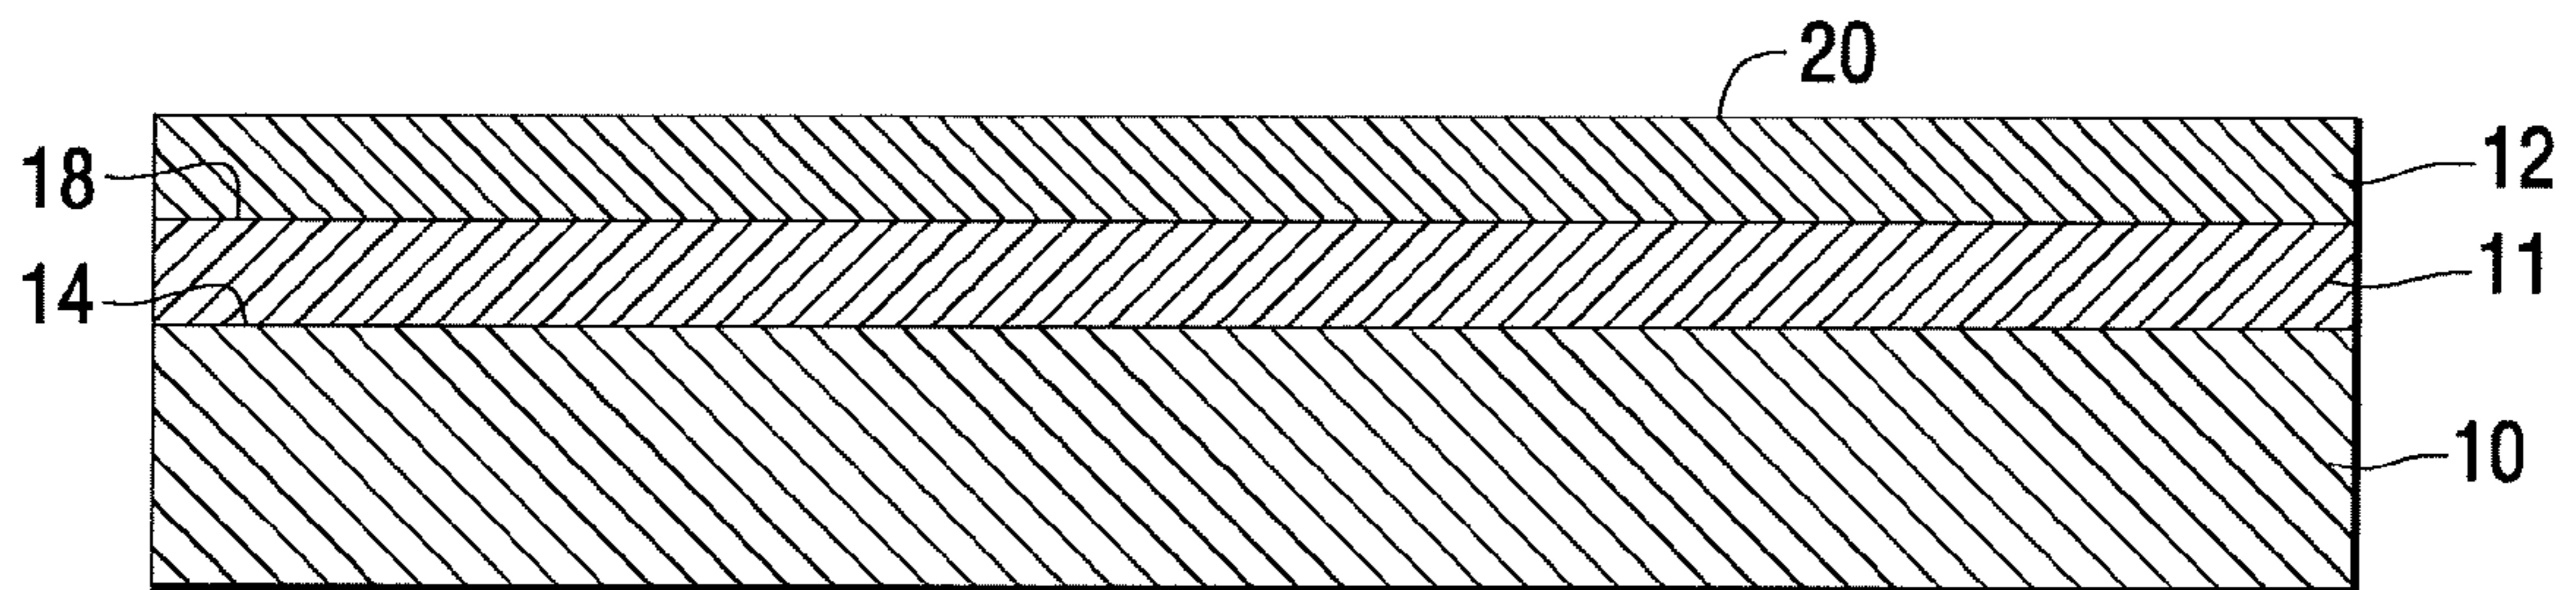
**FIG. 1A**

FIGS. 1A-1D show cross-sections of a submersible object in accordance with a preferred embodiment of the present invention;

FIG. 1A is a simplified schematic view of a section of the submersible object made in accordance with a preferred embodiment of the present invention. It should be understood that FIGS. 1A-1B are enlarged section views drawn without regard to scale so that the various layers, or coatings, of antifouling paint can be more easily identified and clearly described. In FIG. 1A, a substrate 10 is shown with a first layer 11 of a first antifouling material disposed on a surface 14 of the substrate 10. A second layer 12 of a second antifouling material is disposed on the first layer 11. More precisely, the second layer 12 is disposed on an outer surface 18 of the first layer 11. The first and second layers, 11 and 12, are visually distinct from each other. In a particularly preferred embodiment of the present invention, the first layer 11 is a different color than the second layer 12.

The present invention will be described, in conjunction with FIGS. 1A-1B, in terms of two antifouling coatings, 11 and 12, with the first coating 11 being deposited directly on the outer surface 14 of the substrate 10. It should be understood, however, that an additional base coat 30 can be deposited on the outer surface 14 of the substrate 10 prior to the application of the first layer 11 as will be described in greater detail below in conjunction with FIG. 2.

With continued reference to FIG. 1A, the outer surface 20 of the second layer 12 is exposed to water when the submersible object is submerged. FIG. 1B represents the same structure as that shown in FIG. 1A, but after the submersible object has undergone a reduction in the thickness of the second layer 12. That thickness is identified by reference letter T in FIG. 1B. The reduction in thickness T can be caused in several ways. If the second layer 12 is an antifouling material which dissolves over time in the presence of water, the outermost layer 12 will gradually dissolve and reduce the thickness of the second layer 12. This may occur even if no significant erosive conditions exist that would wear away the outer surface 20 and reduce the thickness of the second layer 12. On the other hand, the use of certain antifouling materials on marine vessel hulls or the surfaces of marine drives can result in planned ablation of the second layer 12. If the antifouling material of the second layer 12 is used in conjunction with an electric current that induces the creation of chlorine bubbles on the outer surface 20, oxidation of carbon fibers or other electrically conductive particles in the second layer 12 can result in a thinning of that layer which would reduce dimension T shown in FIG. 1B. Regardless of the precise cause of the thinning of the second layer 12, it should be understood that the second layer can be reduced in thickness through its normal use as an antifouling material.

With continued reference to FIGS. 1A-1D, the first and second layers, 11 and 12, can be made of the same antifouling material, but with a different color or other visually distinct characteristic being provided in order to allow the easy determination of the presence of ablated regions, such as those identified by reference numerals 21 and 22 in FIG. 1D. In a preferred embodiment of the present invention, both the first

With continued reference to FIGS. **1A-1D** and **2**, it is also beneficial if the first layer **11** is a different color than the substrate **10**. In embodiments of the present invention that are made with a base coat **30** as described above in conjunction with FIG. **2**, it is also beneficial if the base coat **30** is a different color than the substrate **10** and the first layer **11** is a different color than the base coat **30**. Naturally, the second layer **12** should be a different color than the first layer **11**.

With continued reference to FIGS. **1A-1D**, **2** and **3**, it can be seen that a submersible object made in accordance with a preferred embodiment of the present invention comprises a substrate **10**, a first layer **11** of a first antifouling material disposed on a surface of the substrate **10**, and a second layer **12** of a second antifouling material disposed on the first layer **11**, wherein the first and second layers are visually distinct from each other. The first layer **11**, in a preferred embodiment of the present invention, is a different color than the second layer **12**. The second antifouling material can be an ablative material. The first antifouling material is a paint in a preferred embodiment of the present invention. However, it should be understood that the first or second antifouling materials can alternatively be epoxy materials that are applied in ways other than by normal painting processes. These processes could include overmolding. In addition, it should be understood that certain embodiments of the present invention could use paint as both the first and second layers and, in a preferred embodiment of the present invention, both the first and second materials are antifouling materials. In addition, both the first and second antifouling materials can be ablative in nature. The submersible object can be a marine drive unit **50**. The substrate can be aluminum. It should be understood that both the first and second antifouling materials can be made of generally the same material except for their visually distinct characteristic, such as their color. The second antifouling material can contain a chemical which discourages the growth of marine organisms on a wetted surface **20** of the second layer **12**. In addition, the first antifouling material can contain a chemical which discourages the growth of marine organisms on a wetted surface **18** of the first layer, particularly when that surface **18** is exposed in certain regions, **21** and **22**, as a result of the ablation of the second layer **12**. Alternatively, it should be understood that the antifouling characteristic of the first and second layers, **11** and **12**, can result from their use in an electrical process which causes the formation of chlorine gas bubbles on the wetted surfaces.

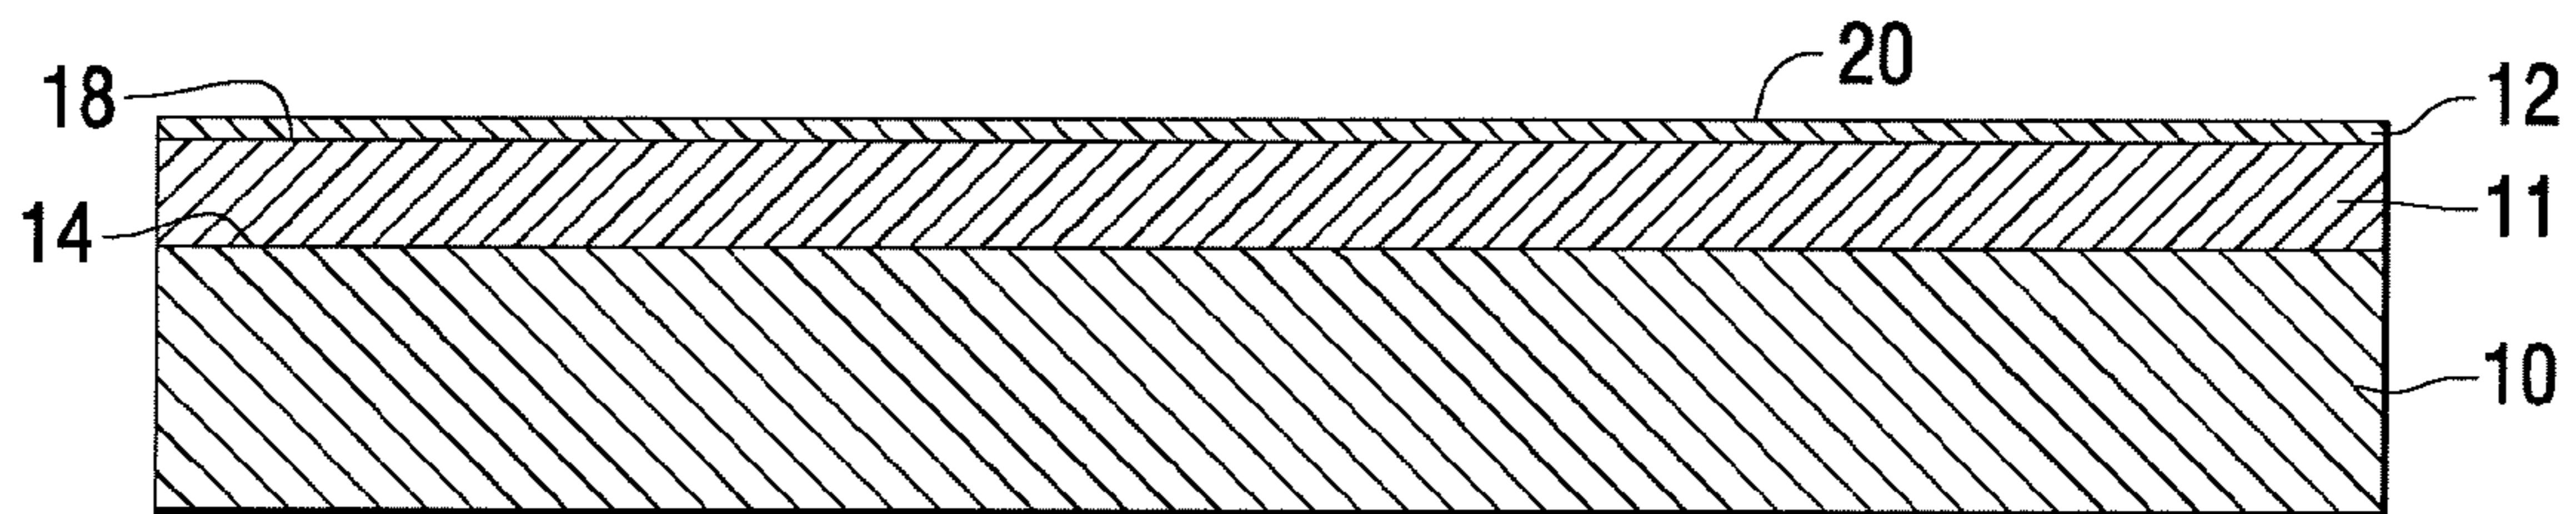
**FIG. 1C**

FIG. 1C shows a more dramatic thinning of the second layer 12 as compared to FIG. 1A or 1B. However, in FIG. 1C, the integrity of the second layer 12 remains intact and the outer surface 18 of the first layer 11 is not exposed. It would be expected that the condition shown in FIG. 1C would occur after a prolonged period of use.

FIG. 1D shows the same structure that is described above in conjunction with FIGS. 1A-1C, but after a longer period of time than represented in FIG. 1C. The second layer 12 shows a greater degree of ablation than FIG. 1C, particularly in the regions identified by reference numerals 21 and 22. In fact, portions of the outer surface 18 of the first layer 11 are exposed as a result of the significant ablation of the second layer 12 in the areas identified by reference numerals 21 and 22. Since the first and second layers, 11 and 12, are visually distinct from each other in a preferred embodiment of the present invention, the exposure of surface 18 in regions 21 and 22 will be visually evident when the submersible object is viewed from a direction above the illustration in FIG. 1D. The different colors of the first and second layers, 11 and 12, will alert the viewer to the presence of wear or ablation in regions 21 and 22 because of the appearance of the color of the first layer 11, at surface 18, through the second layer 12. By the visual presence of the color of the first layer 11, in regions 21 and 22, within the surface 20 of the other color of the second layer 12, it is evident that repair or recoating of the substrate 10 is due.

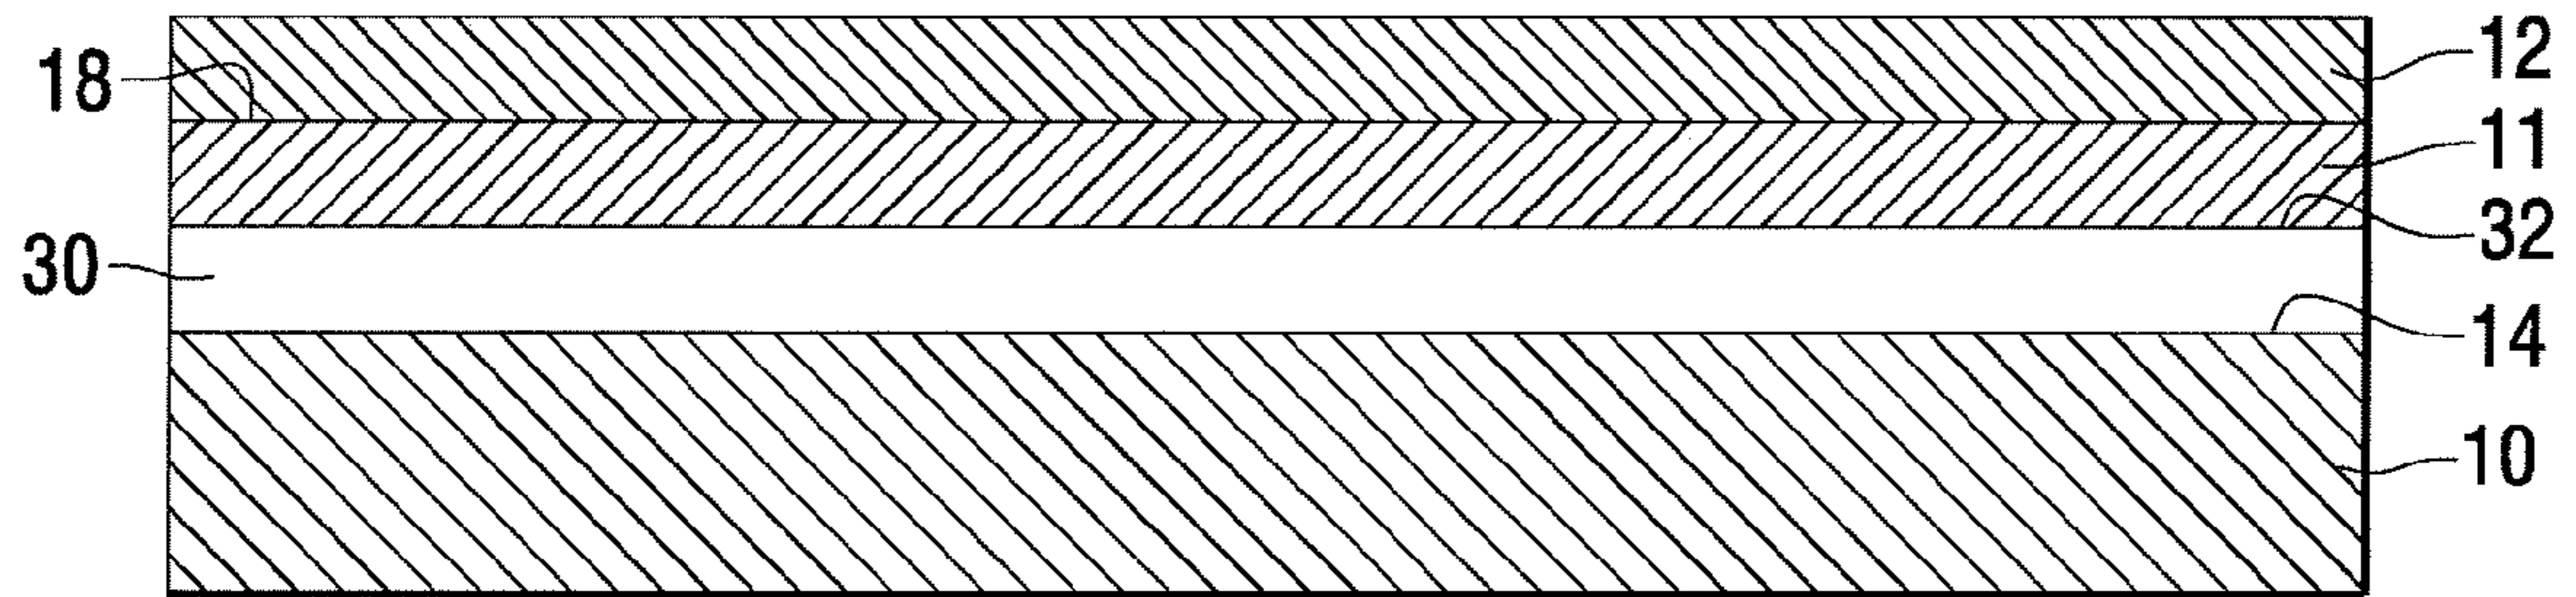
FIG. 2 shows a cross-section of a submersible object made in accordance with an alternative embodiment of the present invention; and

FIG. **2** shows a substrate **10** with first and second layers, **11** and **12**, as in the examples described above in conjunction with FIGS. **1A-1D**. However, a base coat **30** is applied onto the outer surface of the substrate **10** before the application of the first layer **11**. This base coat **30** can comprise a non-antifouling material and can serve the purpose of helping the first layer **11** to adhere to the substrate **10**. It should be understood that the use of a base coat **30** is not required in all embodiments of the present invention. The sequence of application in the configuration shown in FIG. **2** would be the base coat **30**, the first layer **11**, and the second layer **12**.

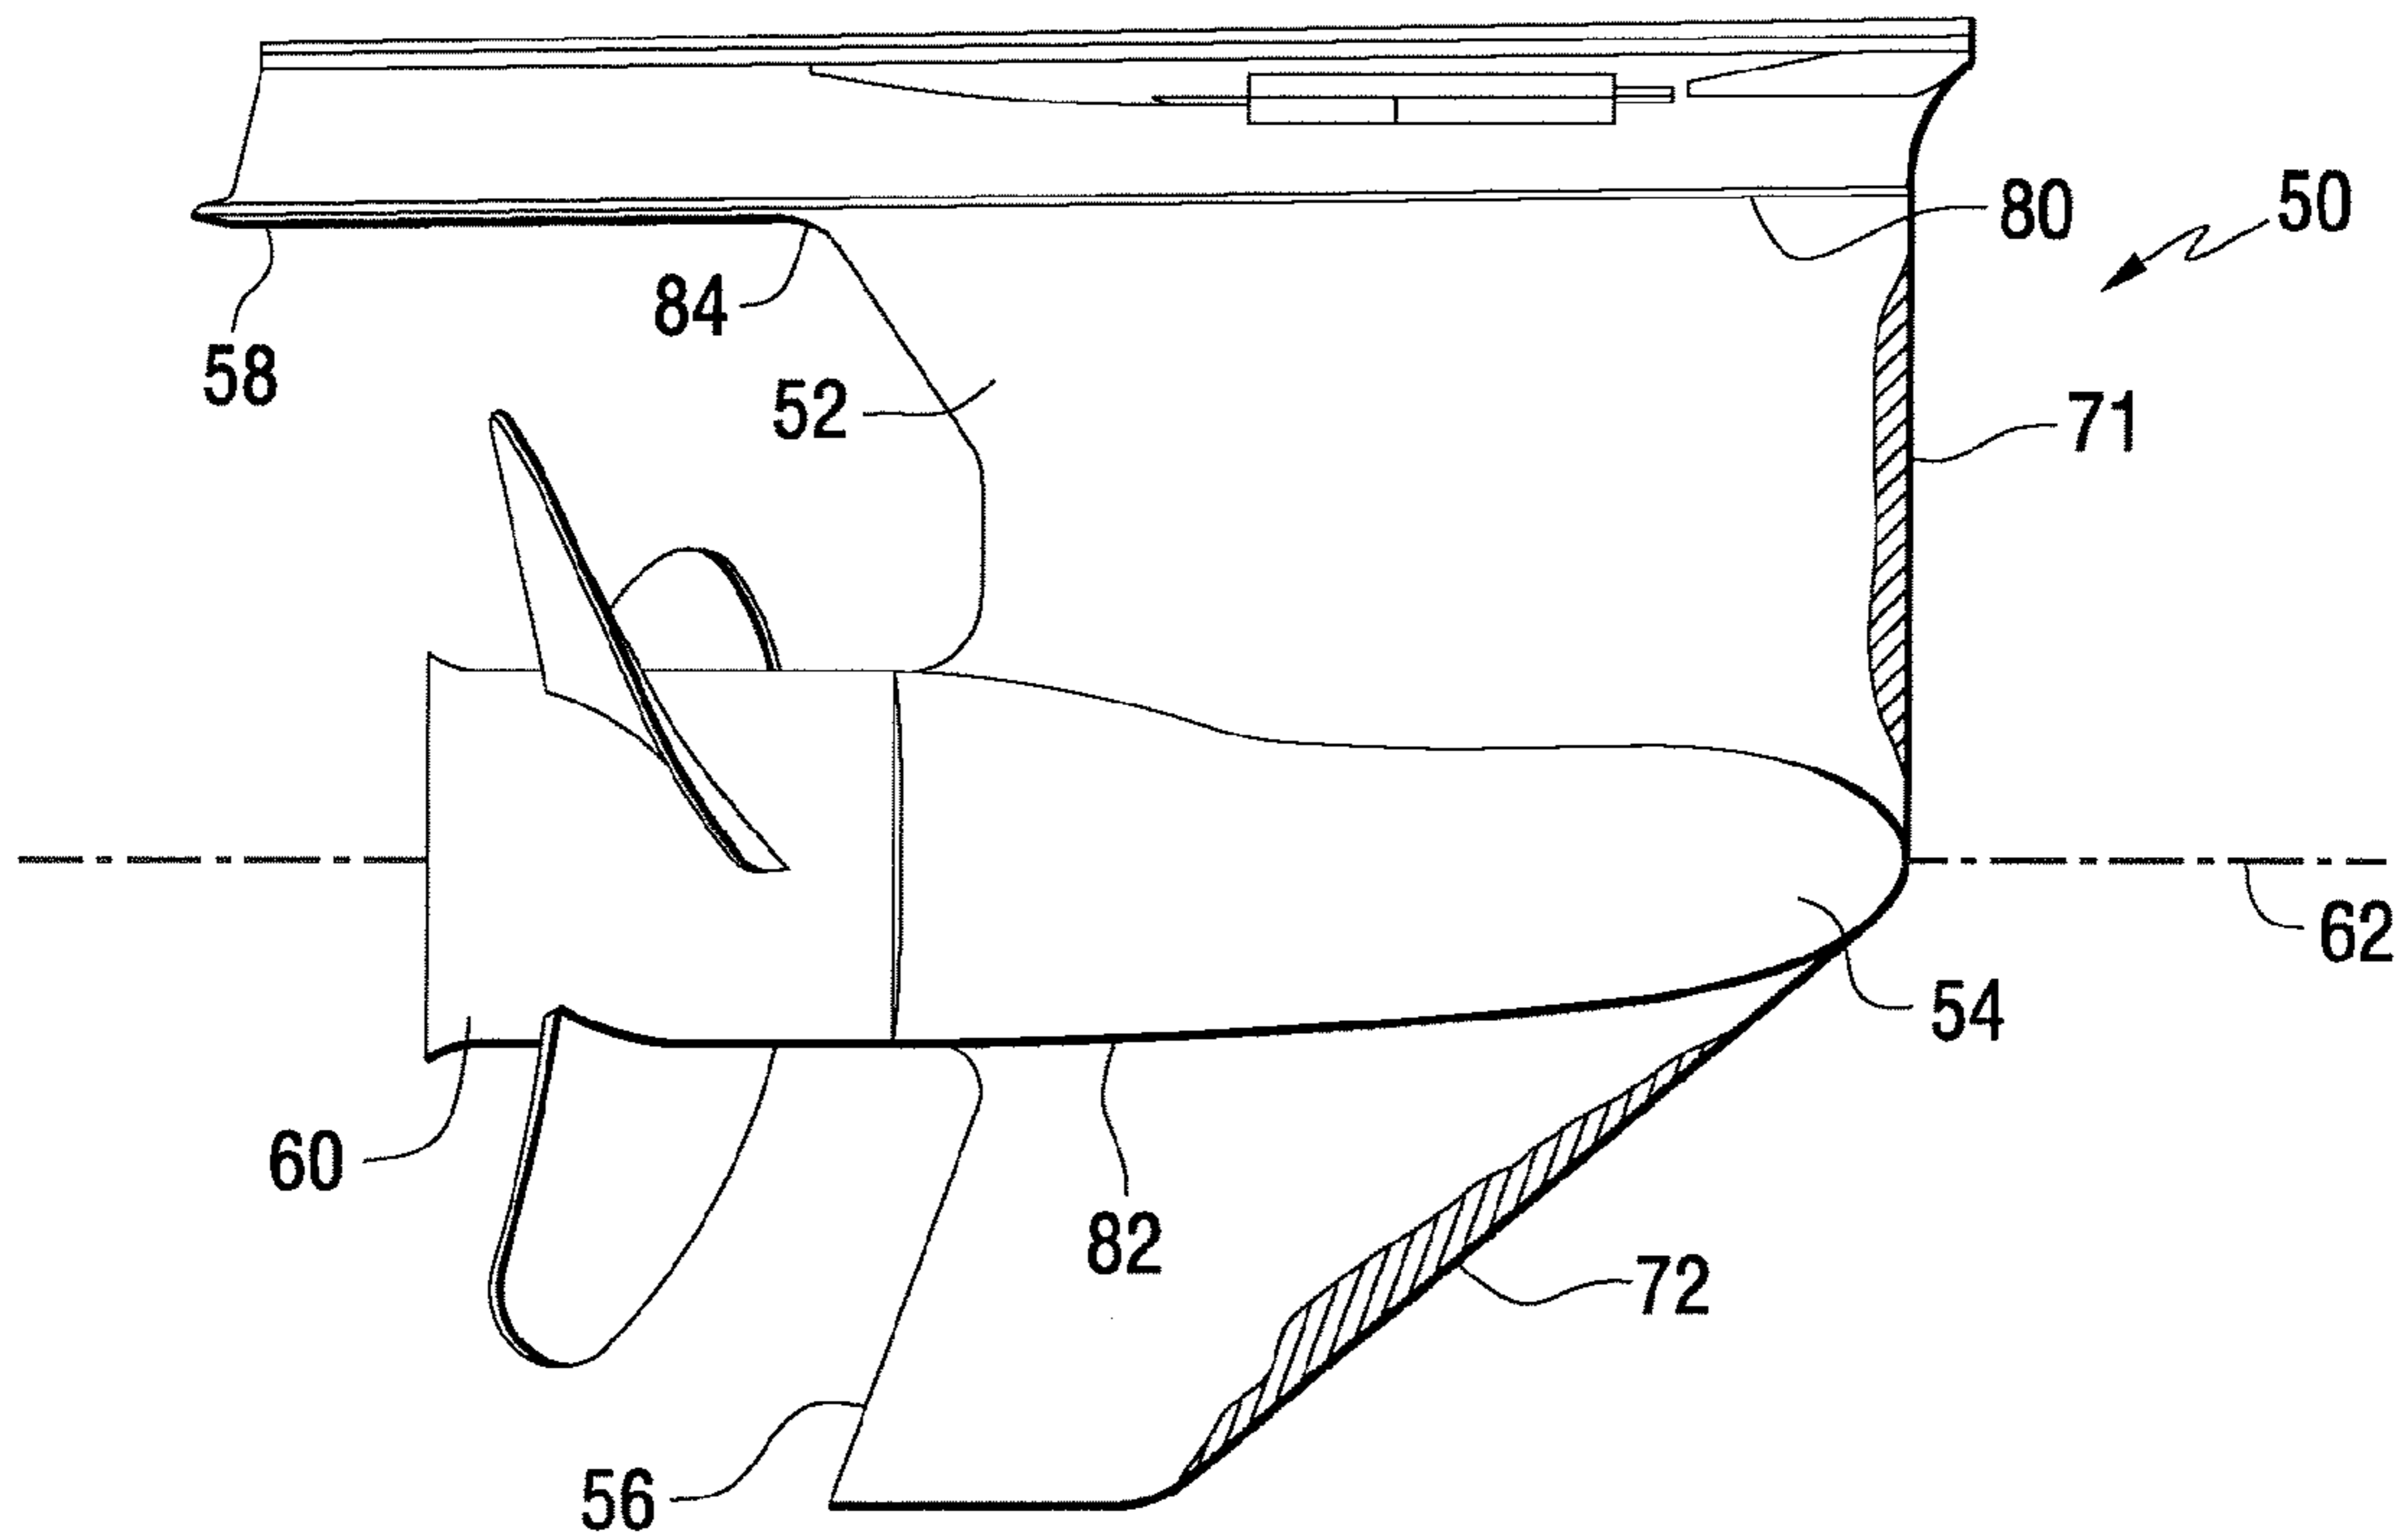
FIG. 3 shows a marine drive unit made in accordance with a preferred embodiment of the present invention.

FIG. **3** is a side view of a marine drive unit **50**. The illustration in FIG. **3** is used as an example of a submersible object with which the present invention can be used. However, it should be understood that the present invention can be used in conjunction with other submersible objects, such as grates and other underwater devices. The marine drive unit **50** shown in FIG. **3** is the driveshaft housing **52** and gear case **54** of a sterndrive unit. It is shown with its skeg **56**, anti-ventilation plate **58** and propeller **60** which is rotatable about a propeller shaft centerline **62**. Two regions, **71** and **72**, are drawn to show hypothetical wear areas on the surface of the

drive unit **50**. As a marine drive moves through the water, the leading edge **71** of the driveshaft housing and leading edge **72** of the skeg **56** are likely to experience a degradation of the second layer **12** described above in conjunction with FIGS. **1A-1D** and **2**, particularly if the second layer is made of an ablative material. If this type of ablation occurs, with the removal of portions of the second layer from the drive unit **50**, the operator of a marine vessel can observe a different coloration in regions **71** and/or **72** compared to the color of the remaining surface of the drive unit. This will serve as a visual indication that the drive unit **50** should be recoated with an outer layer of antifouling paint at the vessel operator's first opportunity to do so. As described above, the use of the present invention also assists the manufacturer during the painting process. Certain regions of the outer surface of the drive unit **50** may present difficulty in assuring that an adequate coat of the second layer has been properly applied. As an example, portions of the region **80** under the anti-ventilation plate, certain portions of the surface of inside bends **84**, and where the torpedo of the gear case **54** meets the generally flat surface of the skeg **56** at location **82**, might present particular difficulty. However, if the second layer is a different color than the first layer, detection of missed regions can more easily be identified and corrected.
