(10) **Patent No.:** **US 7,802,350 B2**
(45) **Date of Patent:** **Sep. 28, 2010**

(54) **FLANGE HOLE REPAIR**

(73) Assignee: **United Technologies Corporation**,
Hartford, CT (US)

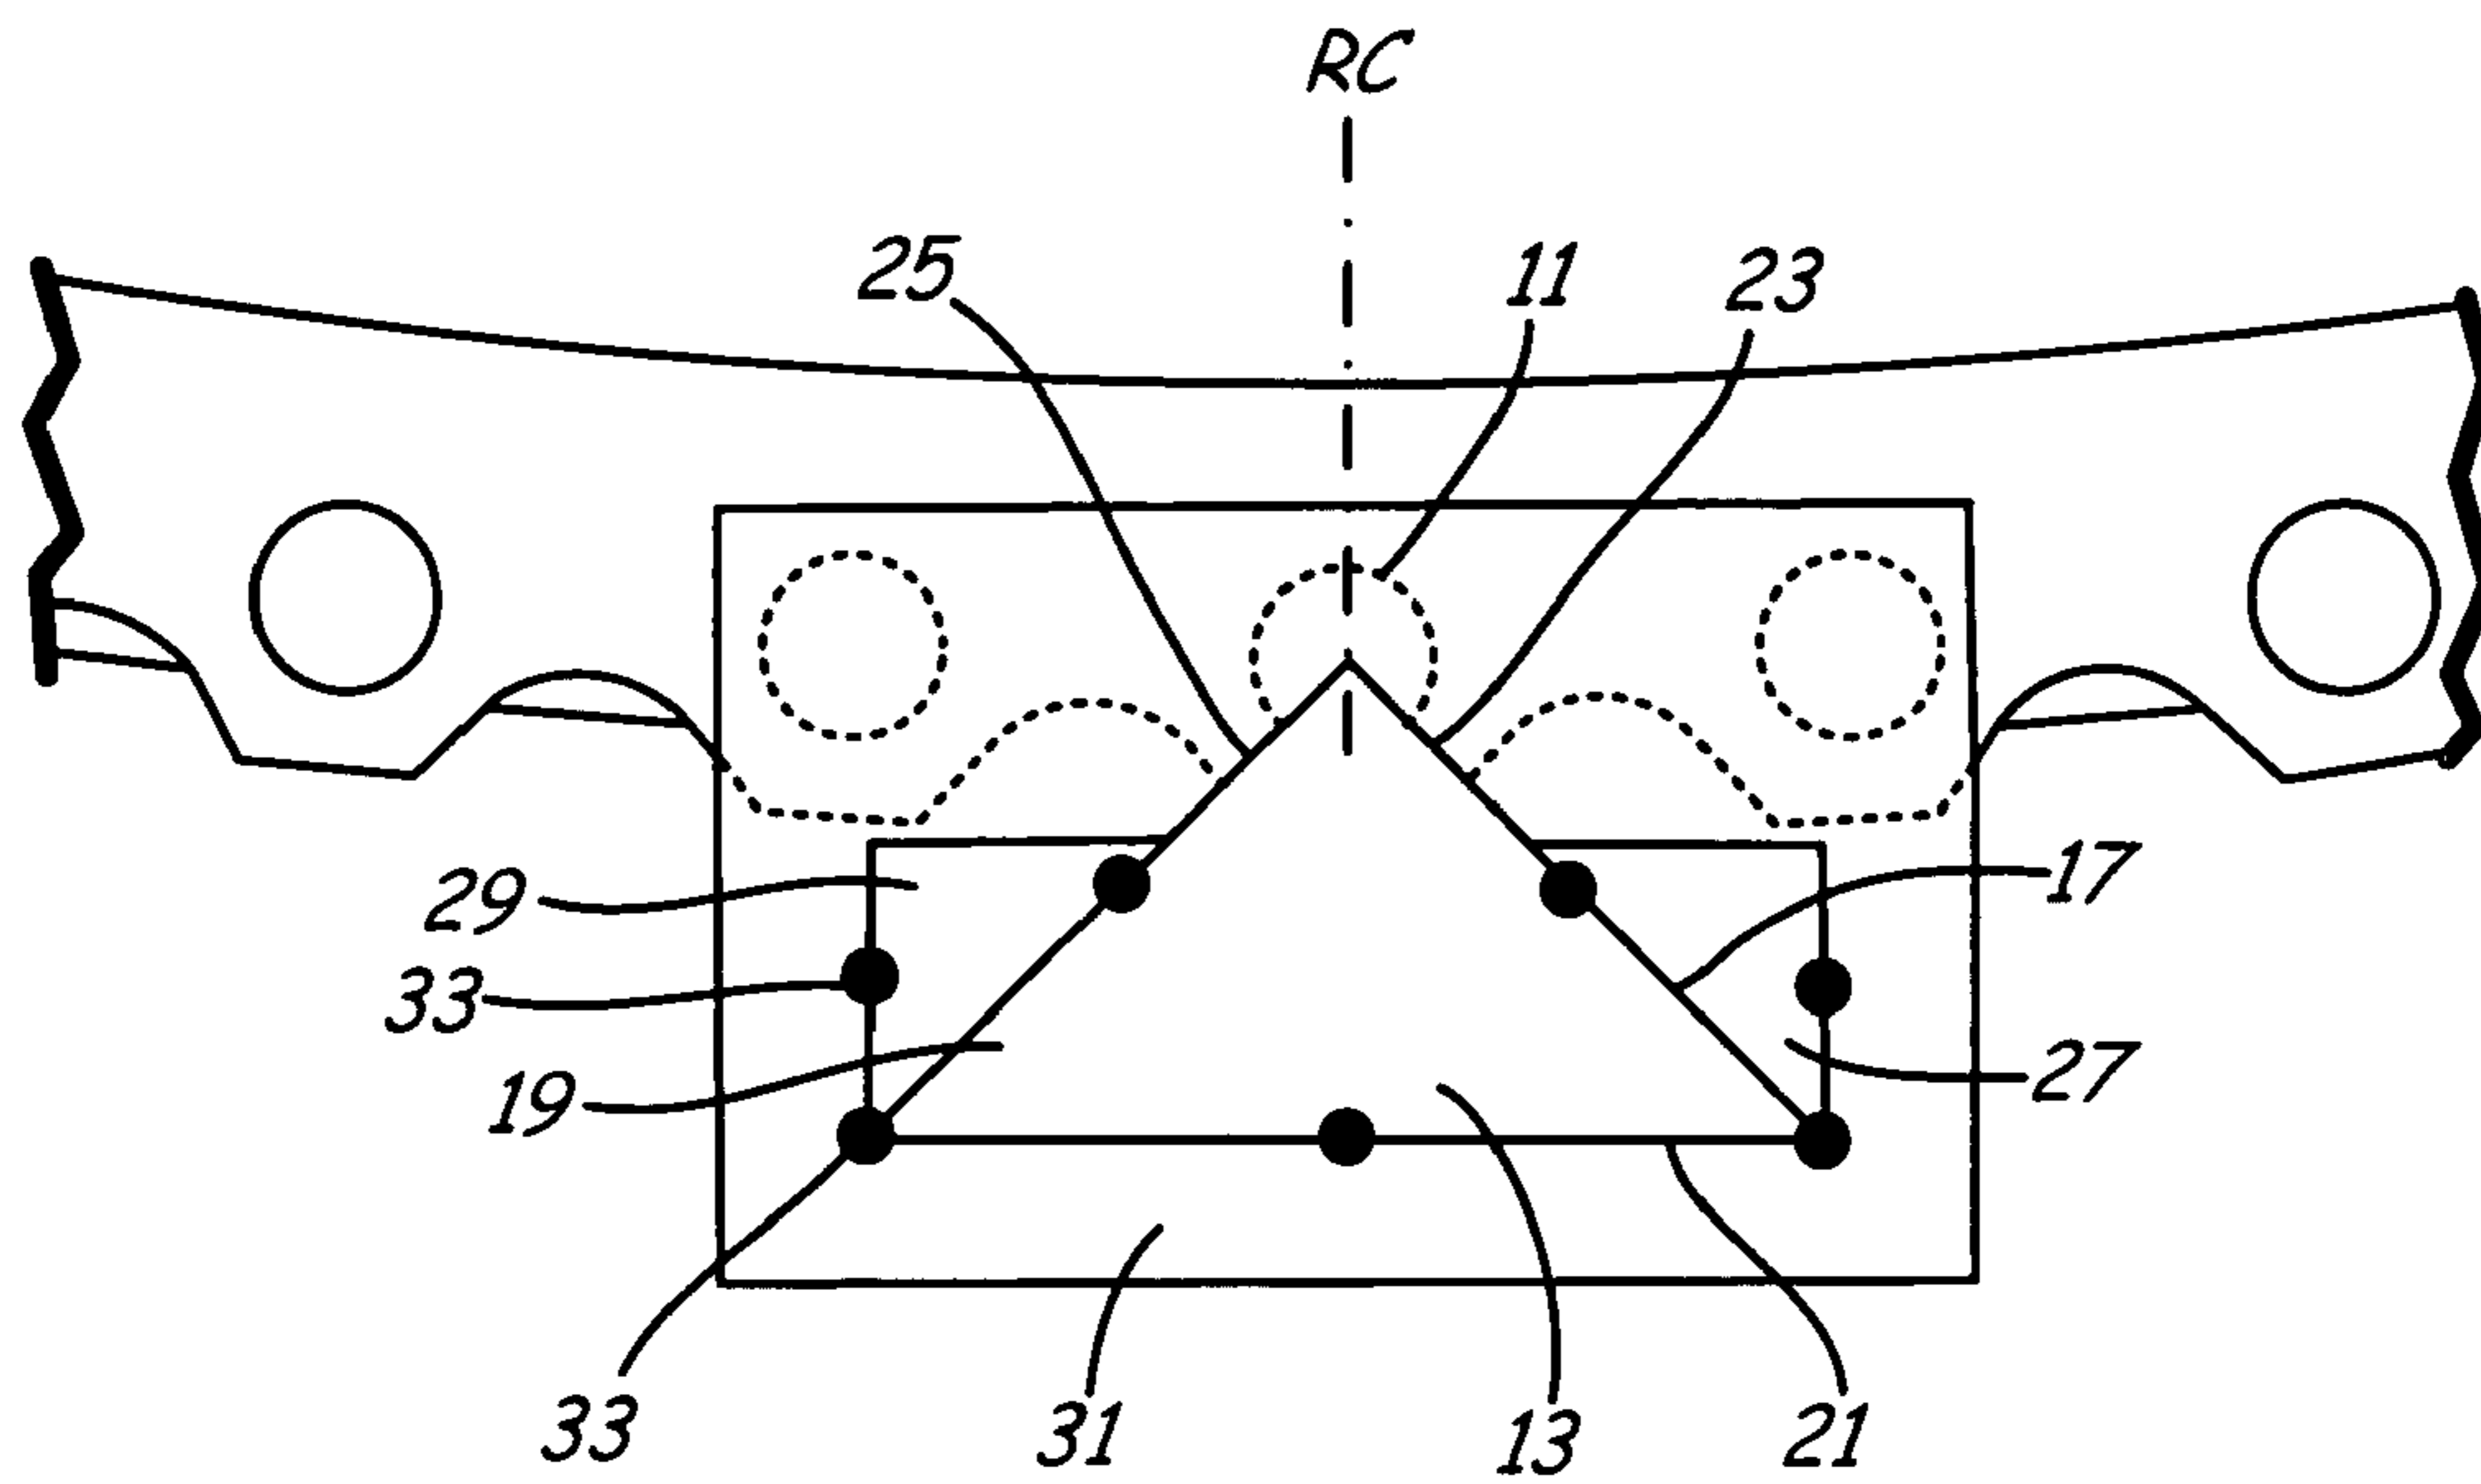
FIG. 1
(PRIOR ART)

There are many techniques known in the art for repairing larger diameter holes, such as bolt holes about 0.30" or greater in diameter. As shown in FIG. 1, in one such prior art repair, an area on a line about 45° on either side of the radial center line RC of hole 11 is removed. This material is then replaced with wedge 13 constructed of a similar material as the base material of the part being repaired. Wedge 13 contains at least two sides 17, 19 that are at approximately 90 degrees to one another. The remaining geometry of the wedge is not critical to the repair, and the remaining side(s) 21, can be of varying shapes and angles. This approximately perpendicular corner is inserted into the area of removed base material, the corner mating with edges 23, 25 of the base material left on the part. Wedge 13 is surrounded by three runoff plates 27, 29, and 31. Additionally, a backing plate may be used in the repair. Thus, five separate pieces are required to initiate the repair. Wedge 13 and run off plates 27, 29, and 31 are attached by tack welds 33 prior to initiating the repair. The multiple run off plates 27, 29, and 31 are small and difficult to assemble about wedge 13.

FIG. 1 is a plan view of a prior art repair for a hole utilizing a wedge and multiple run off plates.

In the prior art repair, wedge 13 is welded into place with welds that are approximately 45 degrees from the original base material. In this configuration, the welds move the weld material (the weld zone with depleted material properties) outboard of the highest stressed areas at the hole location. This allows the raw material of the replacement wedge (with base materials properties) to remain in the highest stressed areas. The highest stressed areas surrounding the hole are located approximately 90 degrees from one another. This repair works well for holes down to about 0.30 inches in diameter, but on smaller holes the wedge becomes so small that the weld used to retain the wedge extends into the highest stressed areas of the flange. Thus, a better repair for smaller diameter holes on flanges is needed.

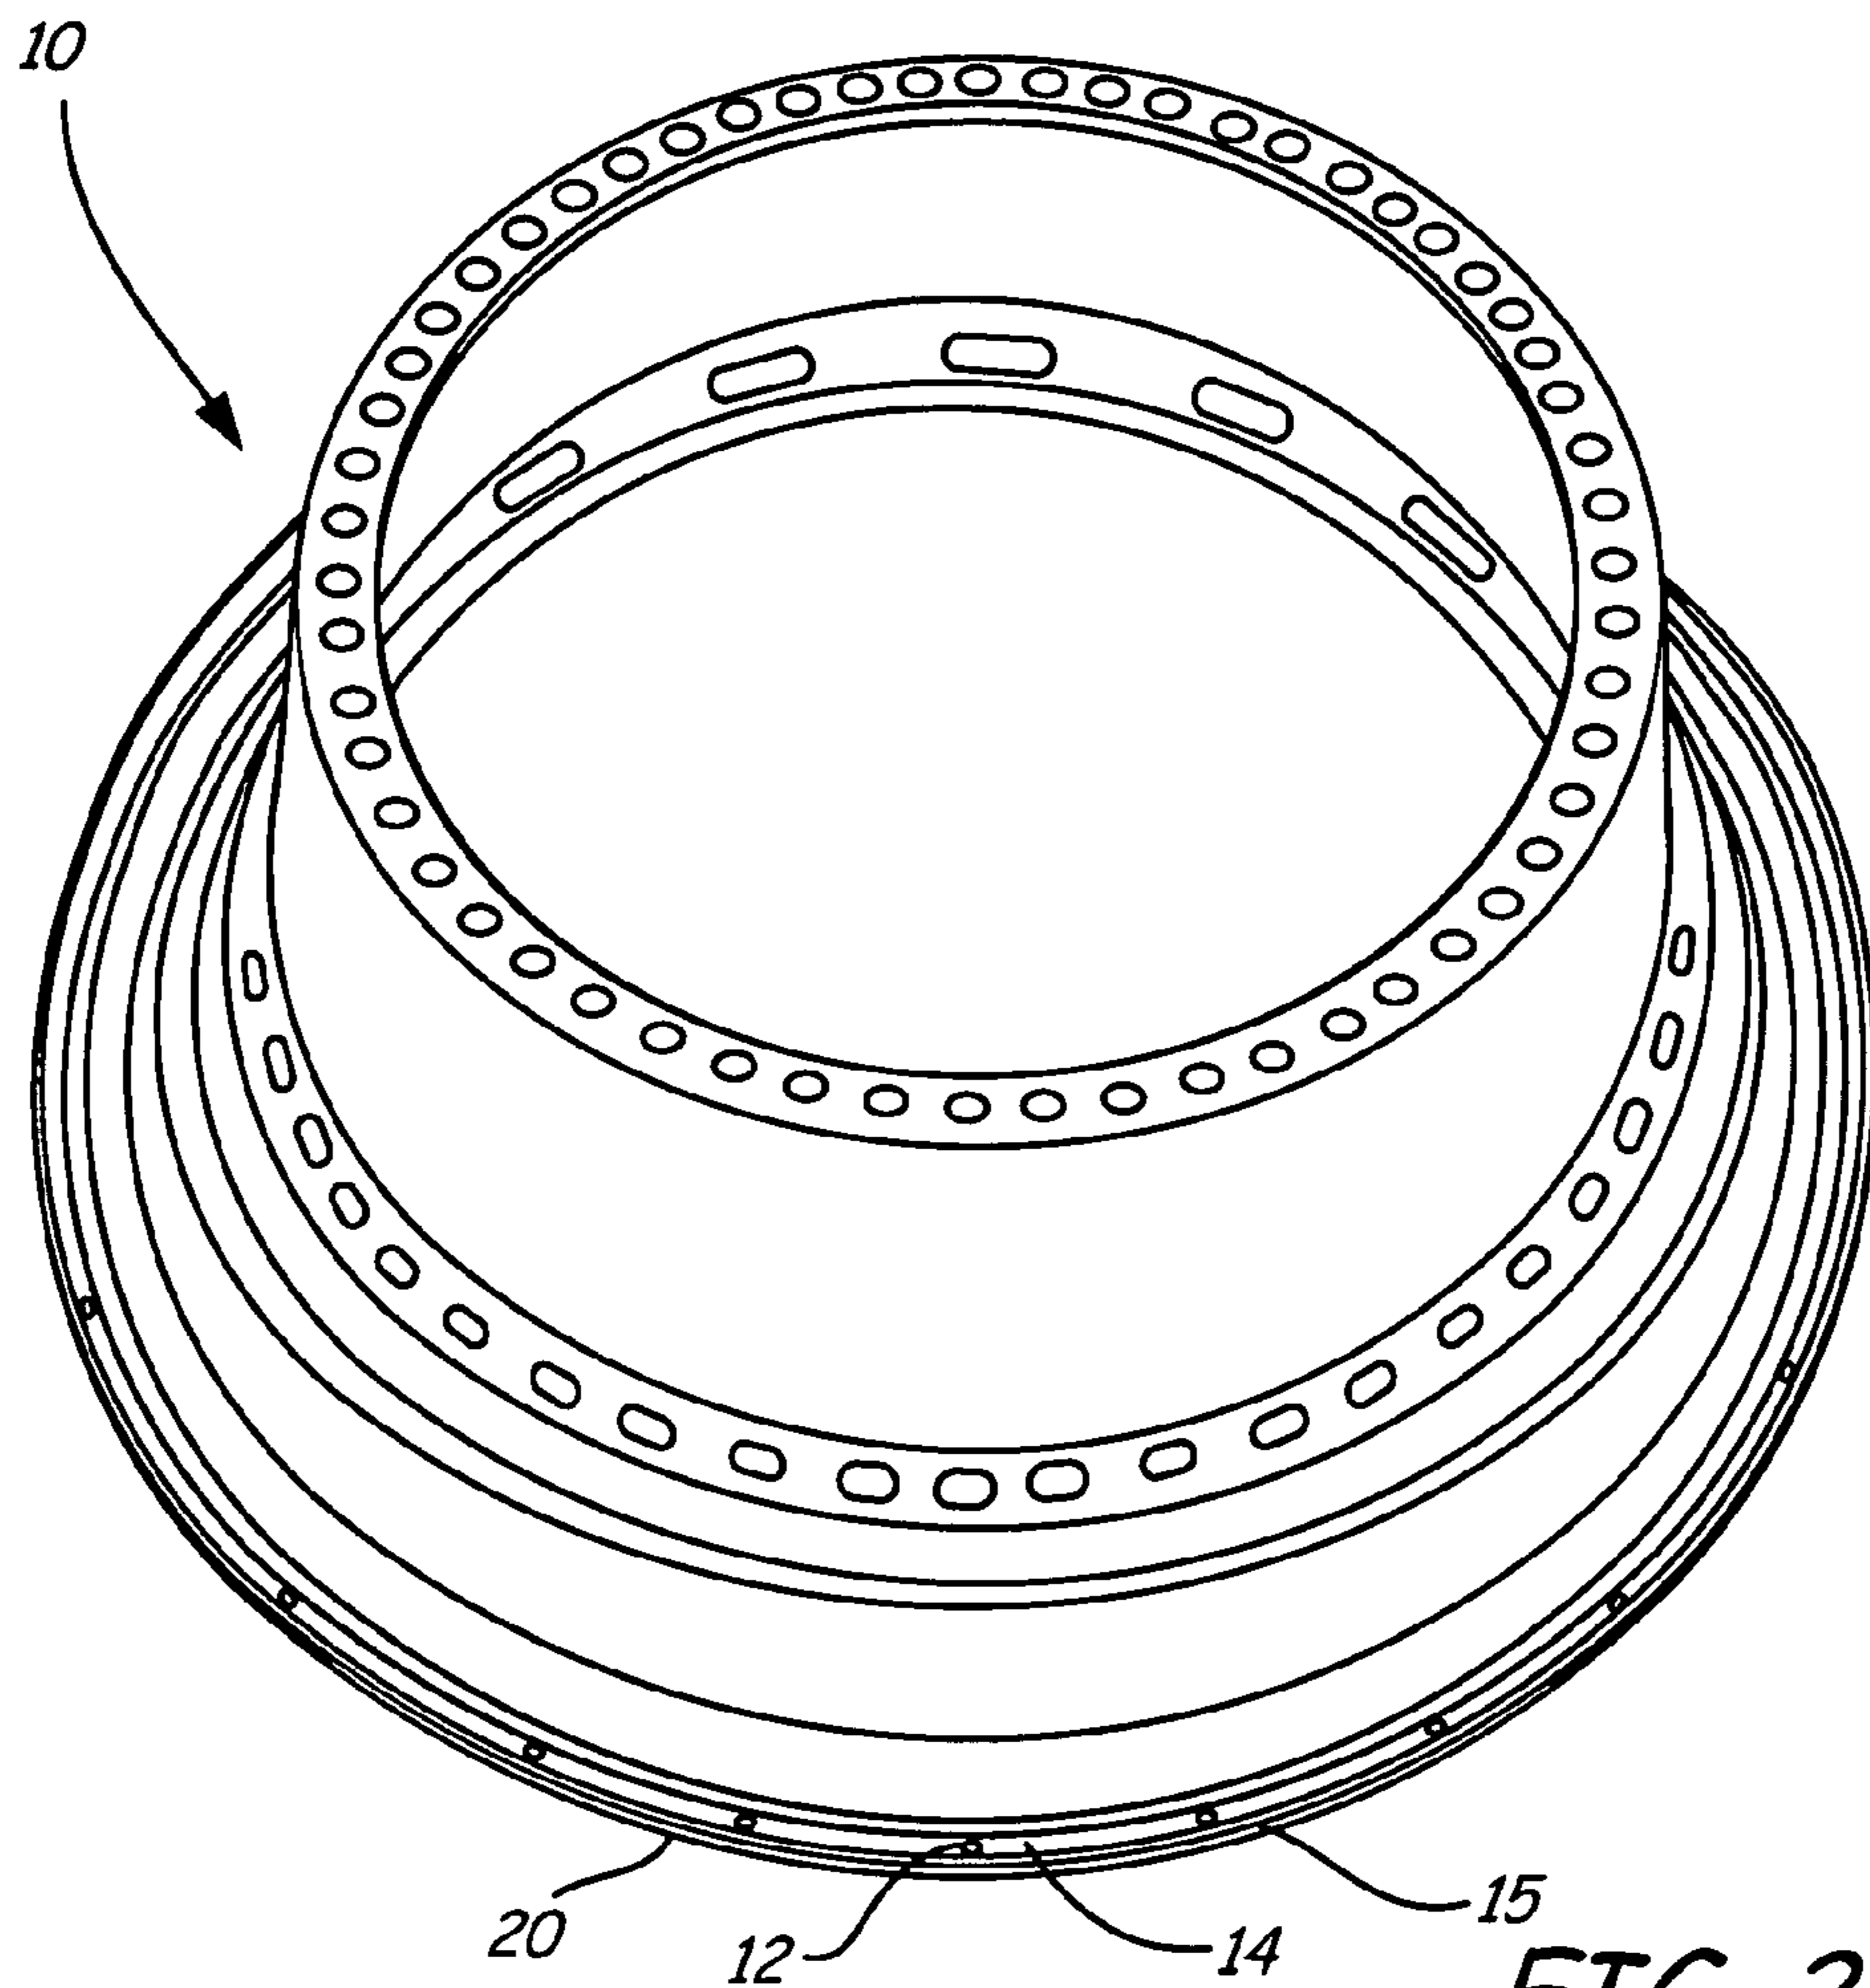
FIG. 2 is a perspective view of a forward inner nozzle support of a dual annular combustor configuration of a high pressure turbine.

FIG. 2 is a perspective view of a forward inner nozzle support 10 of a dual annular combustor (DAC) of a higher pressure turbine. The nozzle support 10 contains a series of small diameter holes 12 circumferentially spaced about an outer diameter flange 14. Holes 12 are apertures used to receive small diameter pins or bolts for additional parts that are mounted to the flange. FIG. 2A is a closeup view of the nozzle support 10 illustrating a crack 16 at one small diameter

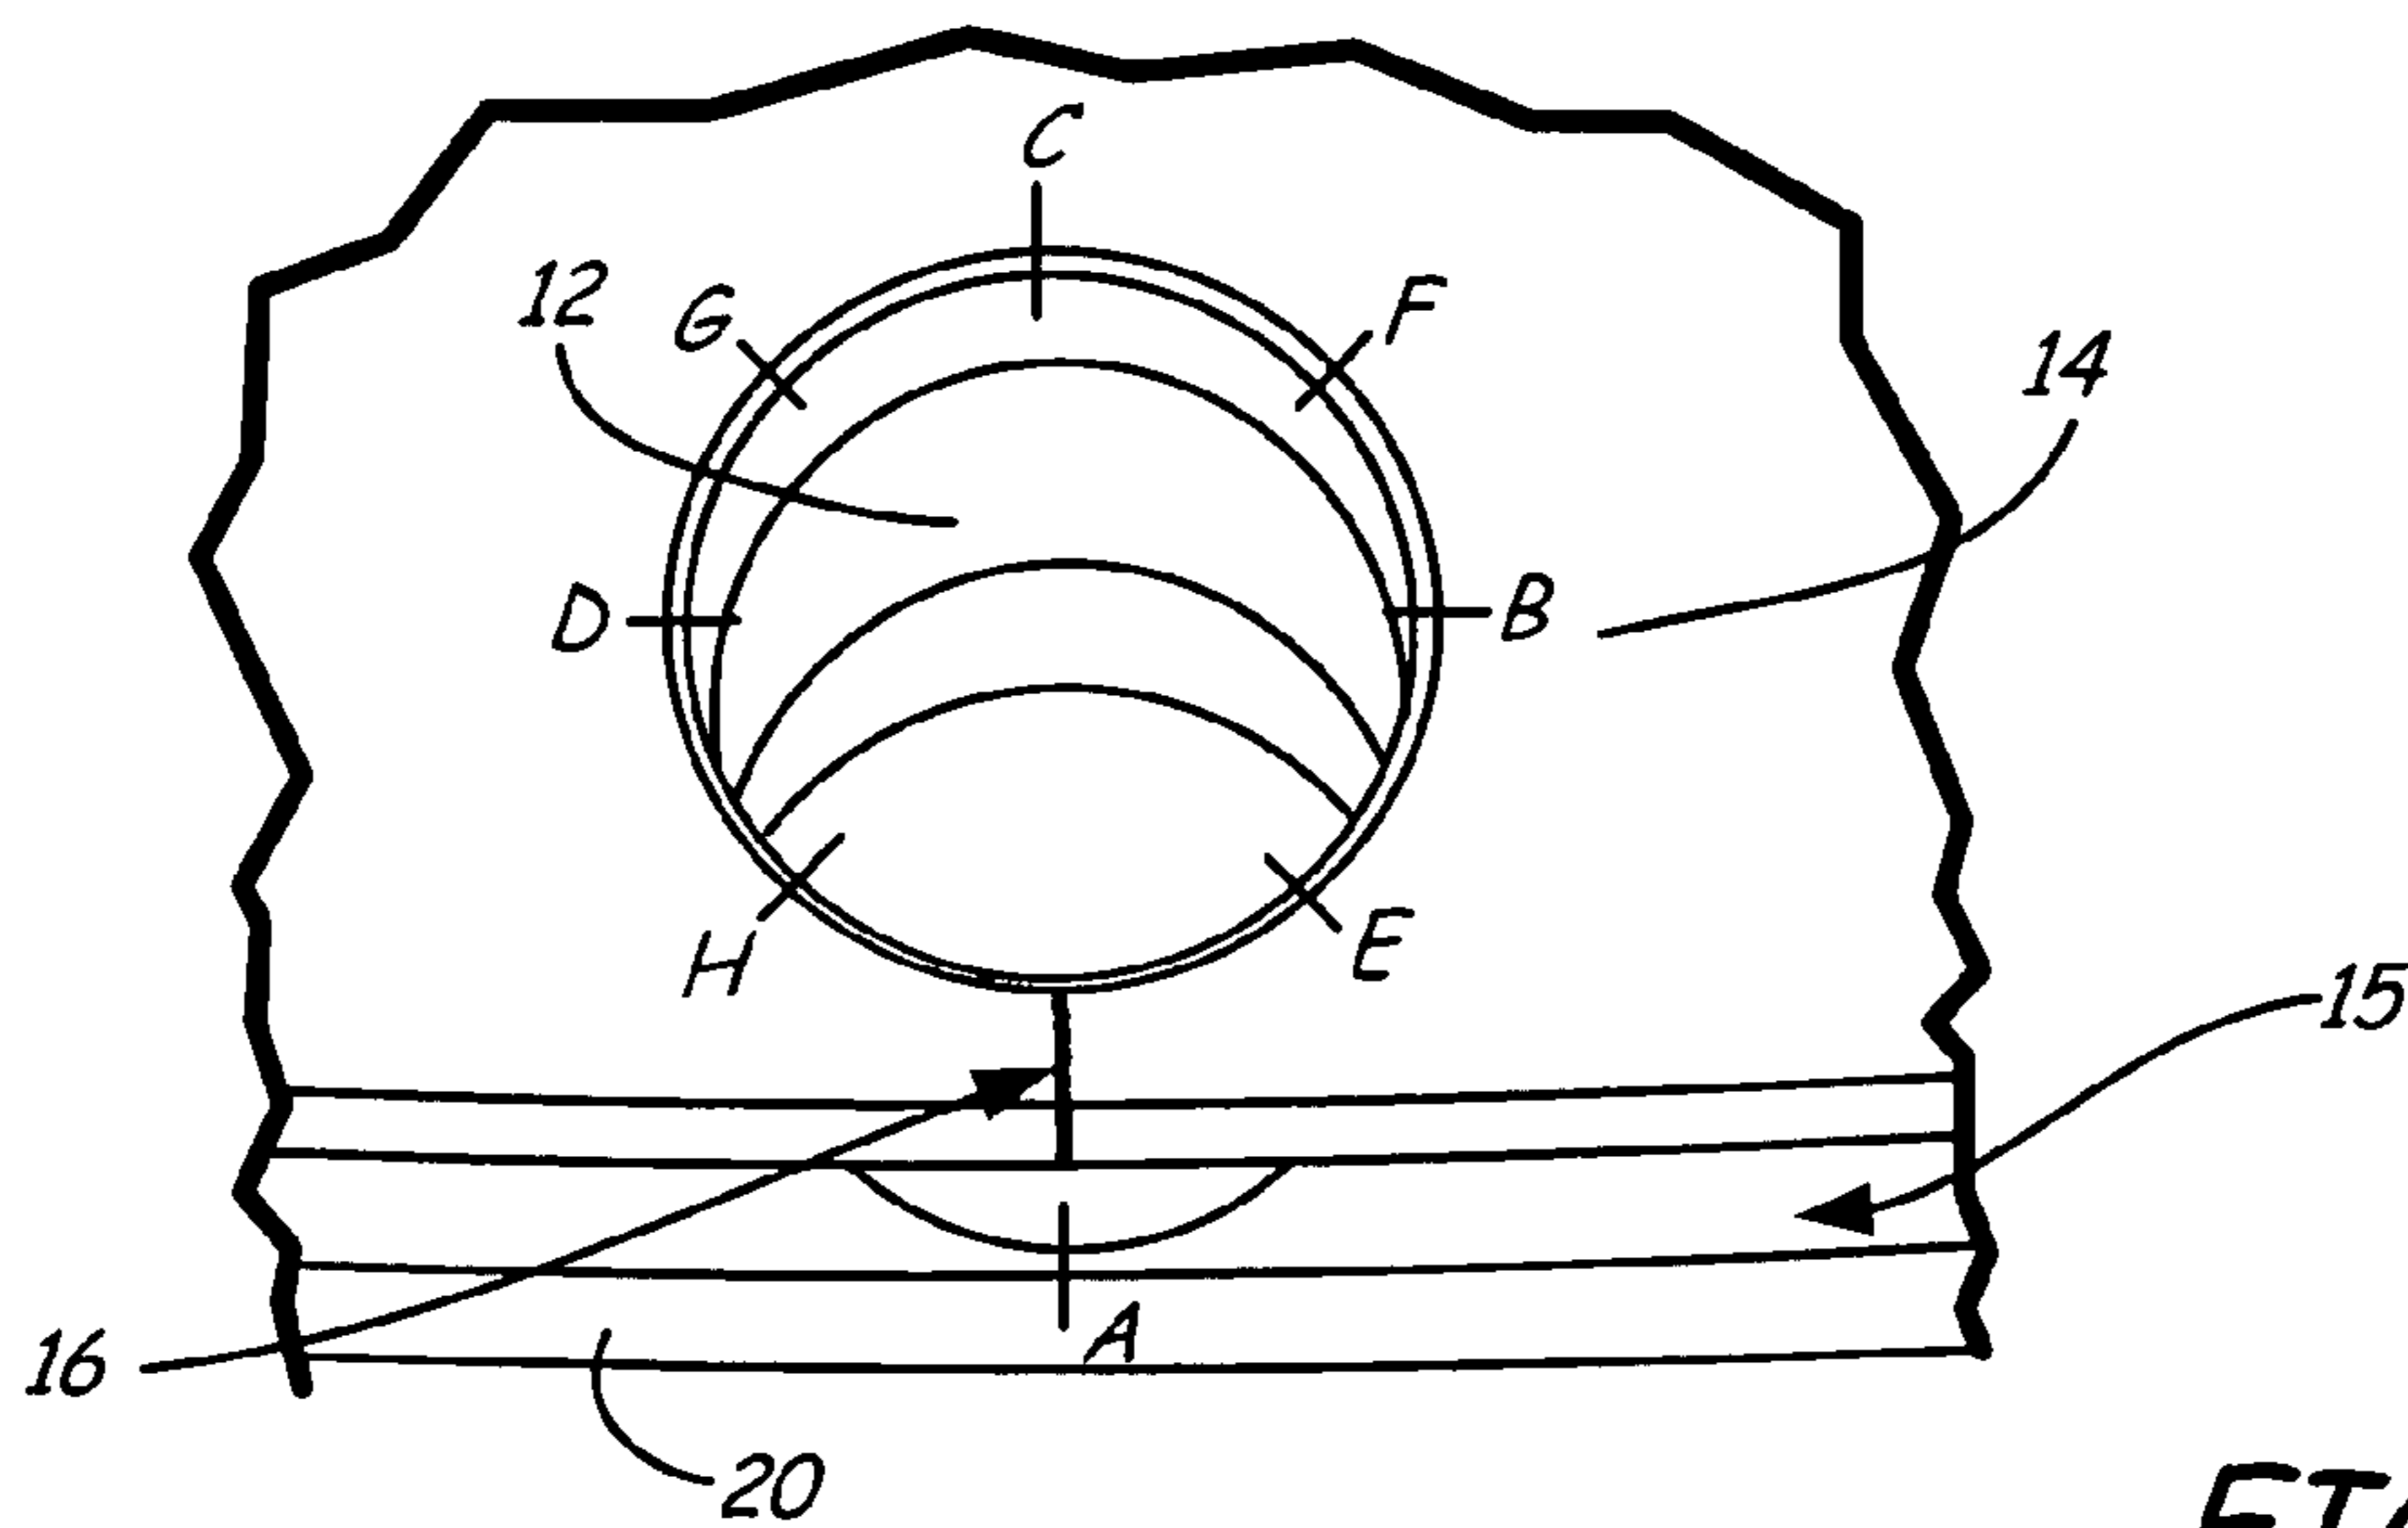
FIG. 2A is a magnification of an area of the perspective view of the nozzle support illustrating a crack at one of the flange bolt holes.

hole 12 on flange 14. Cracks 16 typically emanate from the holes 12 in an outward radial direction. In the past, cracks 16 in small diameter holes 12 of nozzle support 10 were unreparable.

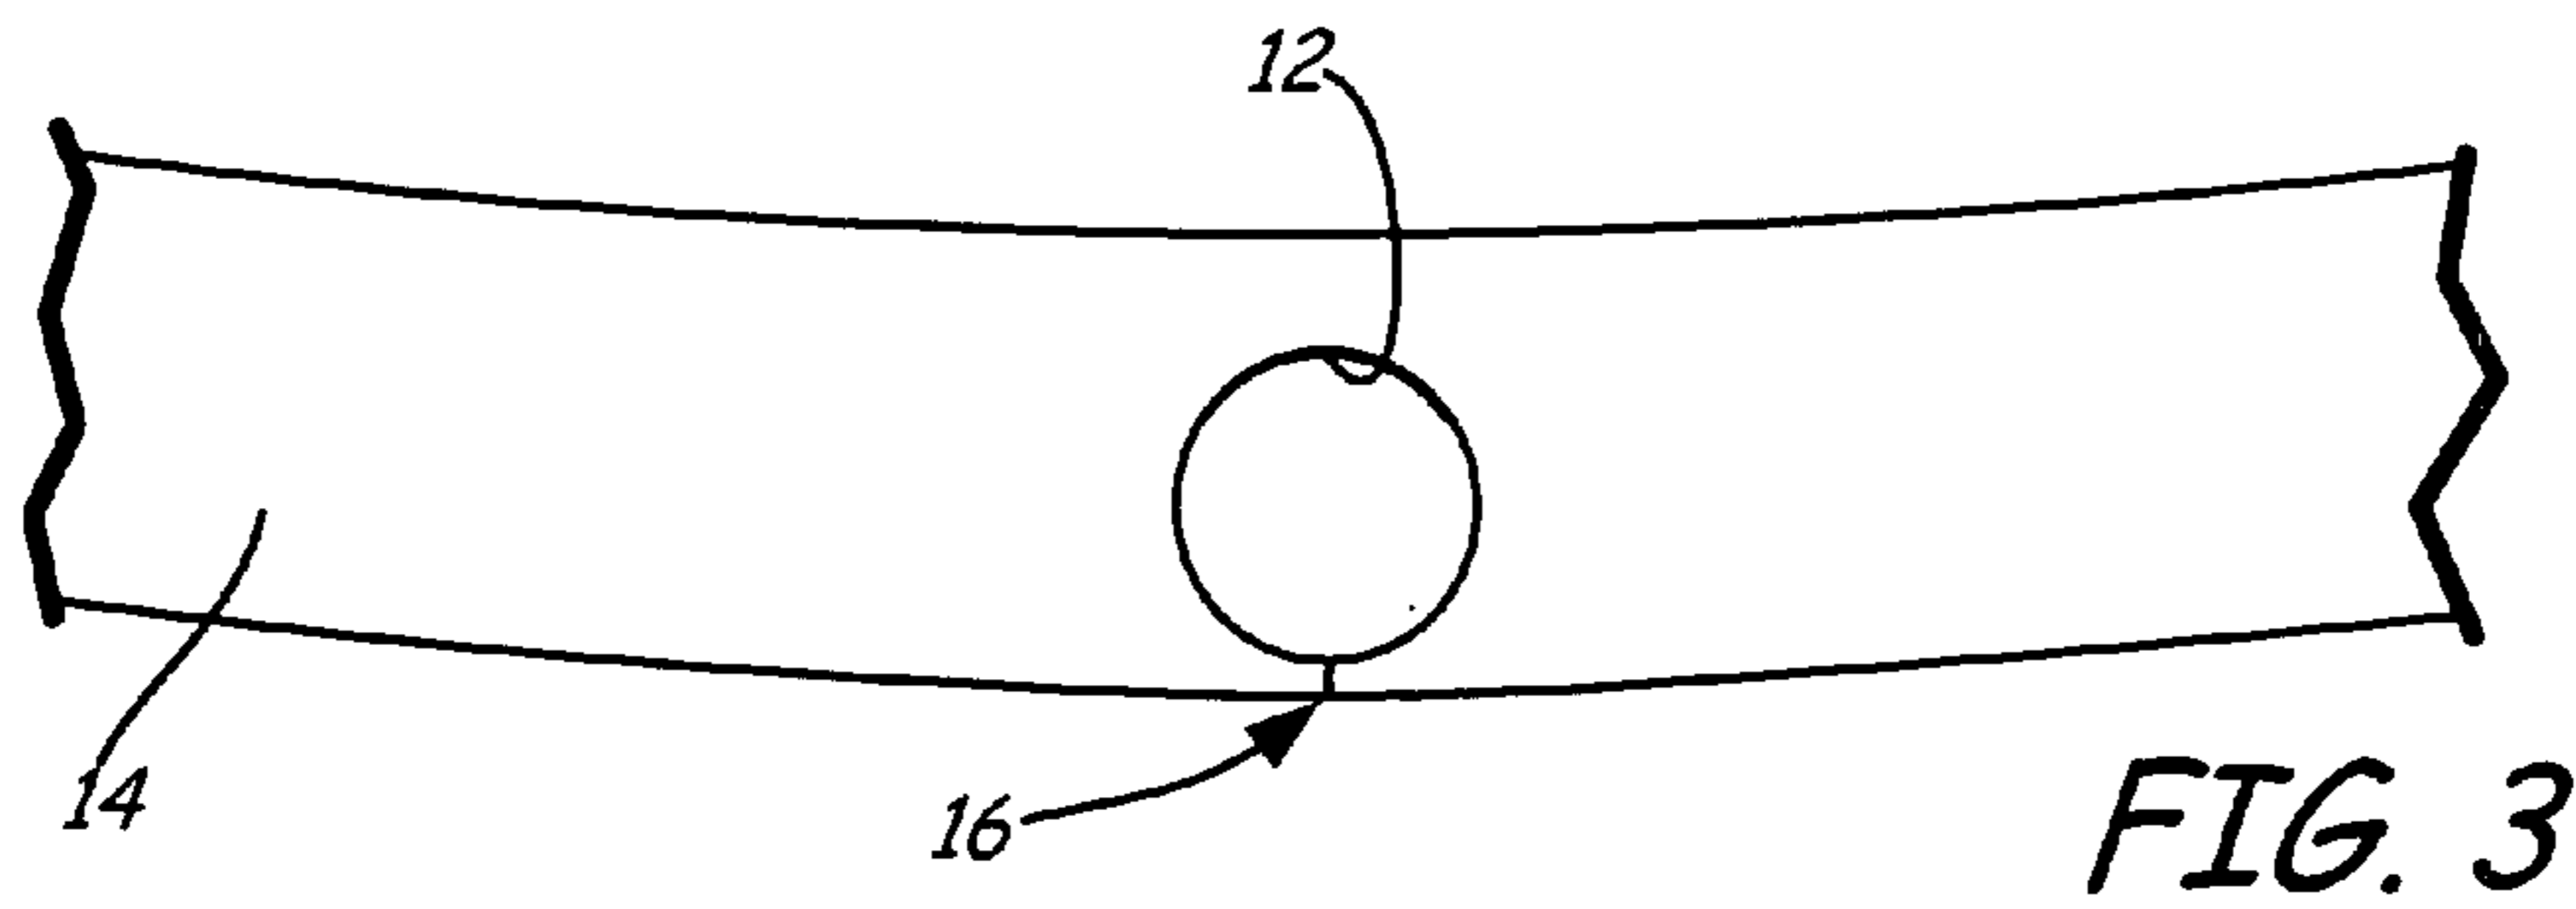
FIG. 3 is a plan view illustrating a defect adjacent an aperture on a flange.

FIG. 3 is a plan view illustrating defect 16 adjacent hole 12 on flange 14. Hole 12 is an aperture through flange 14 which is capable of receiving a pin or bolt to fasten another object to the nozzle support 10. In the embodiment illustrated, hole 12 is circular, although other aperture profiles are envisioned. Hole 12 is a small diameter aperture, less than about 0.30 inches in diameter.

Flange 14 is constructed from a heat resistant base material. The base material is a super alloy, such as a nickel-based or cobalt-based superalloy, or other alloys common in the gas turbine industry. Examples of alloys include Inconel 718 (IN718), IN617, IN625, Ti-6Al-4V and other titanium alloys, Al 6061 and 4043, Waspaloy, Astroloy, Udimet7 500, and HA230. Crack 16 is the result of thermal stress that often emanates from hole 12 to the outer surface of flange 14.

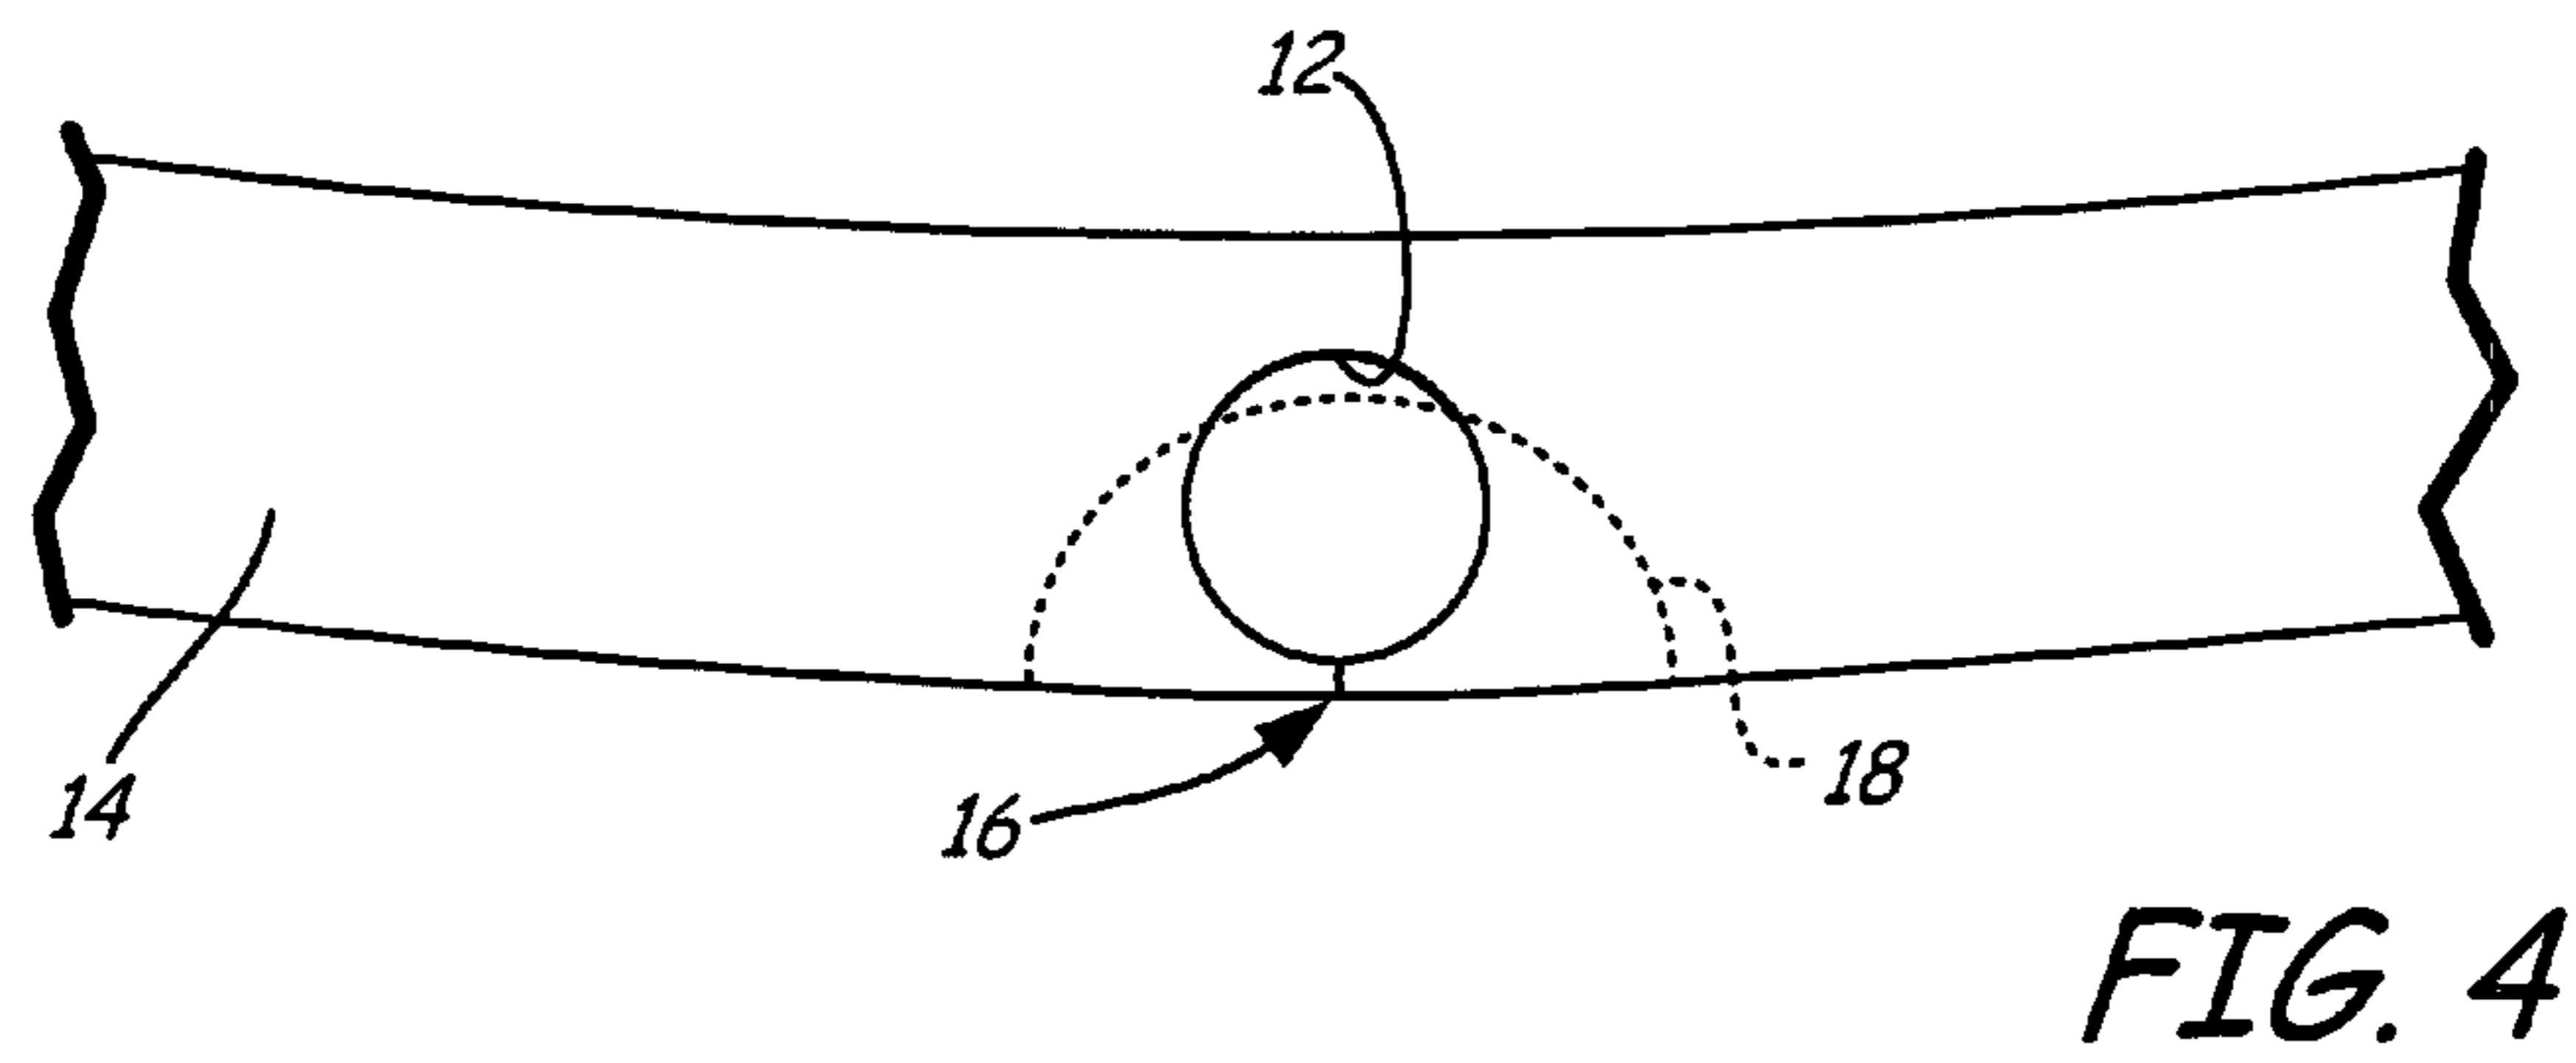
FIG. 4 is a plan view illustrating a portion of the flange to be removed.

FIG. 4 is a plan view illustrating a portion 18 of flange 14 to be removed. Portion 18 of flange 14 is extracted by common techniques known to those of skill in the art for material removal, such as laser cutting or machining. Portion 18 is to be removed in a parabola centered about an axis that runs through the diameter of hole 12, without completely removing the hole 12. The material is removed by cutting perpendicular to the top surface of flange 14. Removing material in the shape of a parabola or similar shape removes the defect and provides an attachment surface outside the high stress zones which are adjacent hole 12. Typically, the position of a hole located nearest the outer edge of the flange, or perpendicular to the outer edge, as well as areas offset 90 degrees, 180 degrees, and 270 degrees therefrom, contain the highest stresses (See A, B, C, and D, respectively, FIG. 2A). Creating a repair where the weld seams fall between these areas (at approximately 45 degrees, 135 degrees, 225 degrees, and 315 degrees) moves the welds out of high stress zones surrounding the hole 12 (See E, F, G, and H, of FIG. 2A). Moving the weld out of the high stress zones surrounding the hole 12 is similar to what occurs when large holes are repaired as described above. This assures good fatigue life for the repaired part.

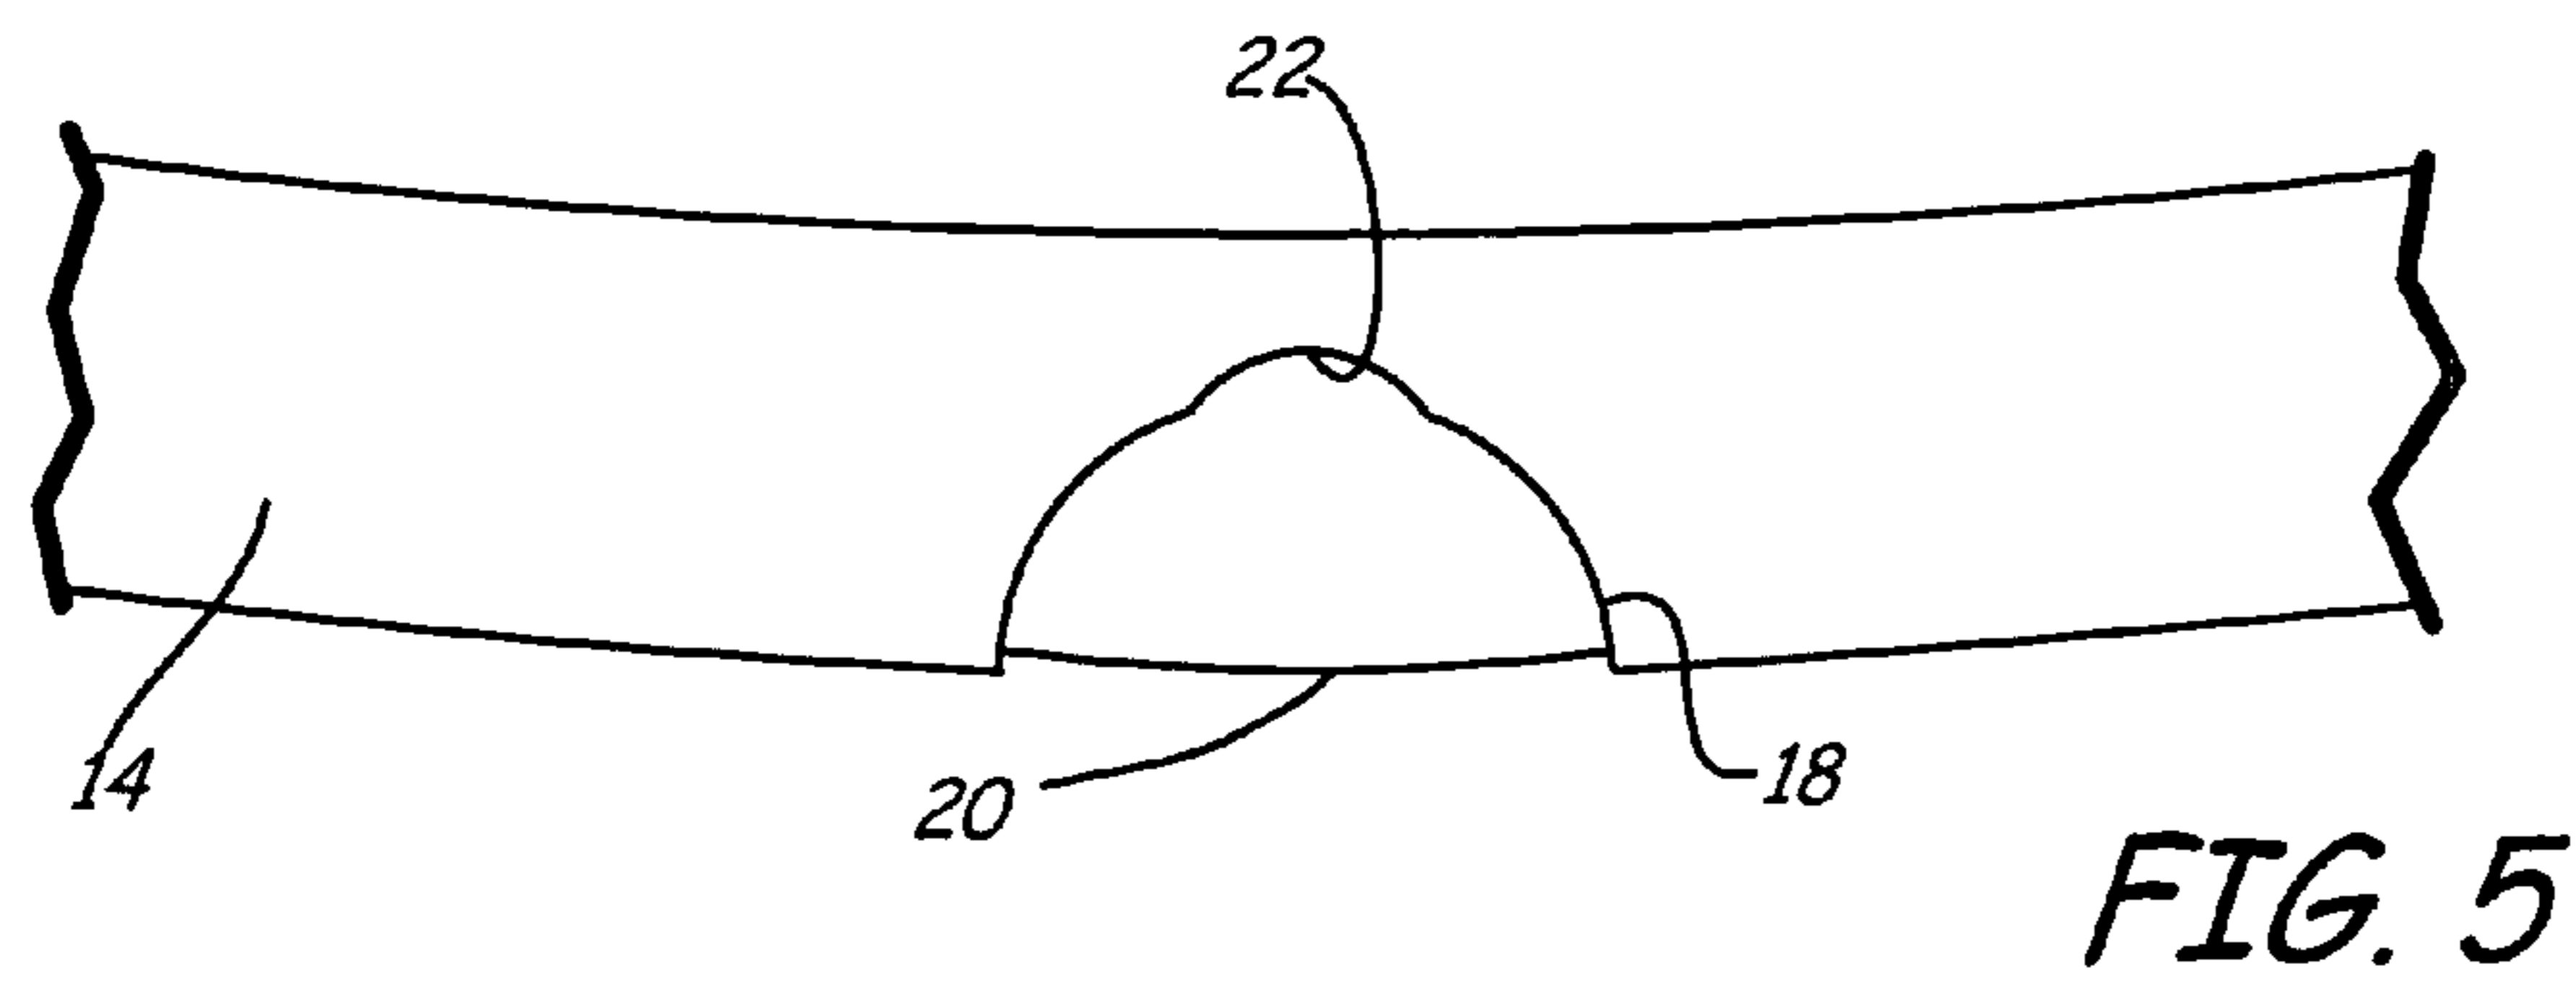
FIG. 5 is a plan view illustrating the portion of the flange removed and a parallel flange.

FIG. 5 is a plan view illustrating portion 18 of flange 14 removed, which reveals lower flange 20. With portion 18 removed, only a small arc 22 of the hole 12 is left. The remaining arc 22 acts as a guide and locator for finishing the repair to assure that the repaired hole is nominally placed in the same position on flange 14 as the original hole 12. Lower flange 20 is a parallel structure to flange 14, and a slot 15 exists between the two flanges 14 and 20, which run circumferentially around the base of the forward inner nozzle support (See FIGS. 2 and 2A).
