(10) **Patent No.:** **US 7,802,350 B2**
(45) **Date of Patent:** **Sep. 28, 2010**

(54) **FLANGE HOLE REPAIR**

(73) Assignee: **United Technologies Corporation**,
Hartford, CT (US)

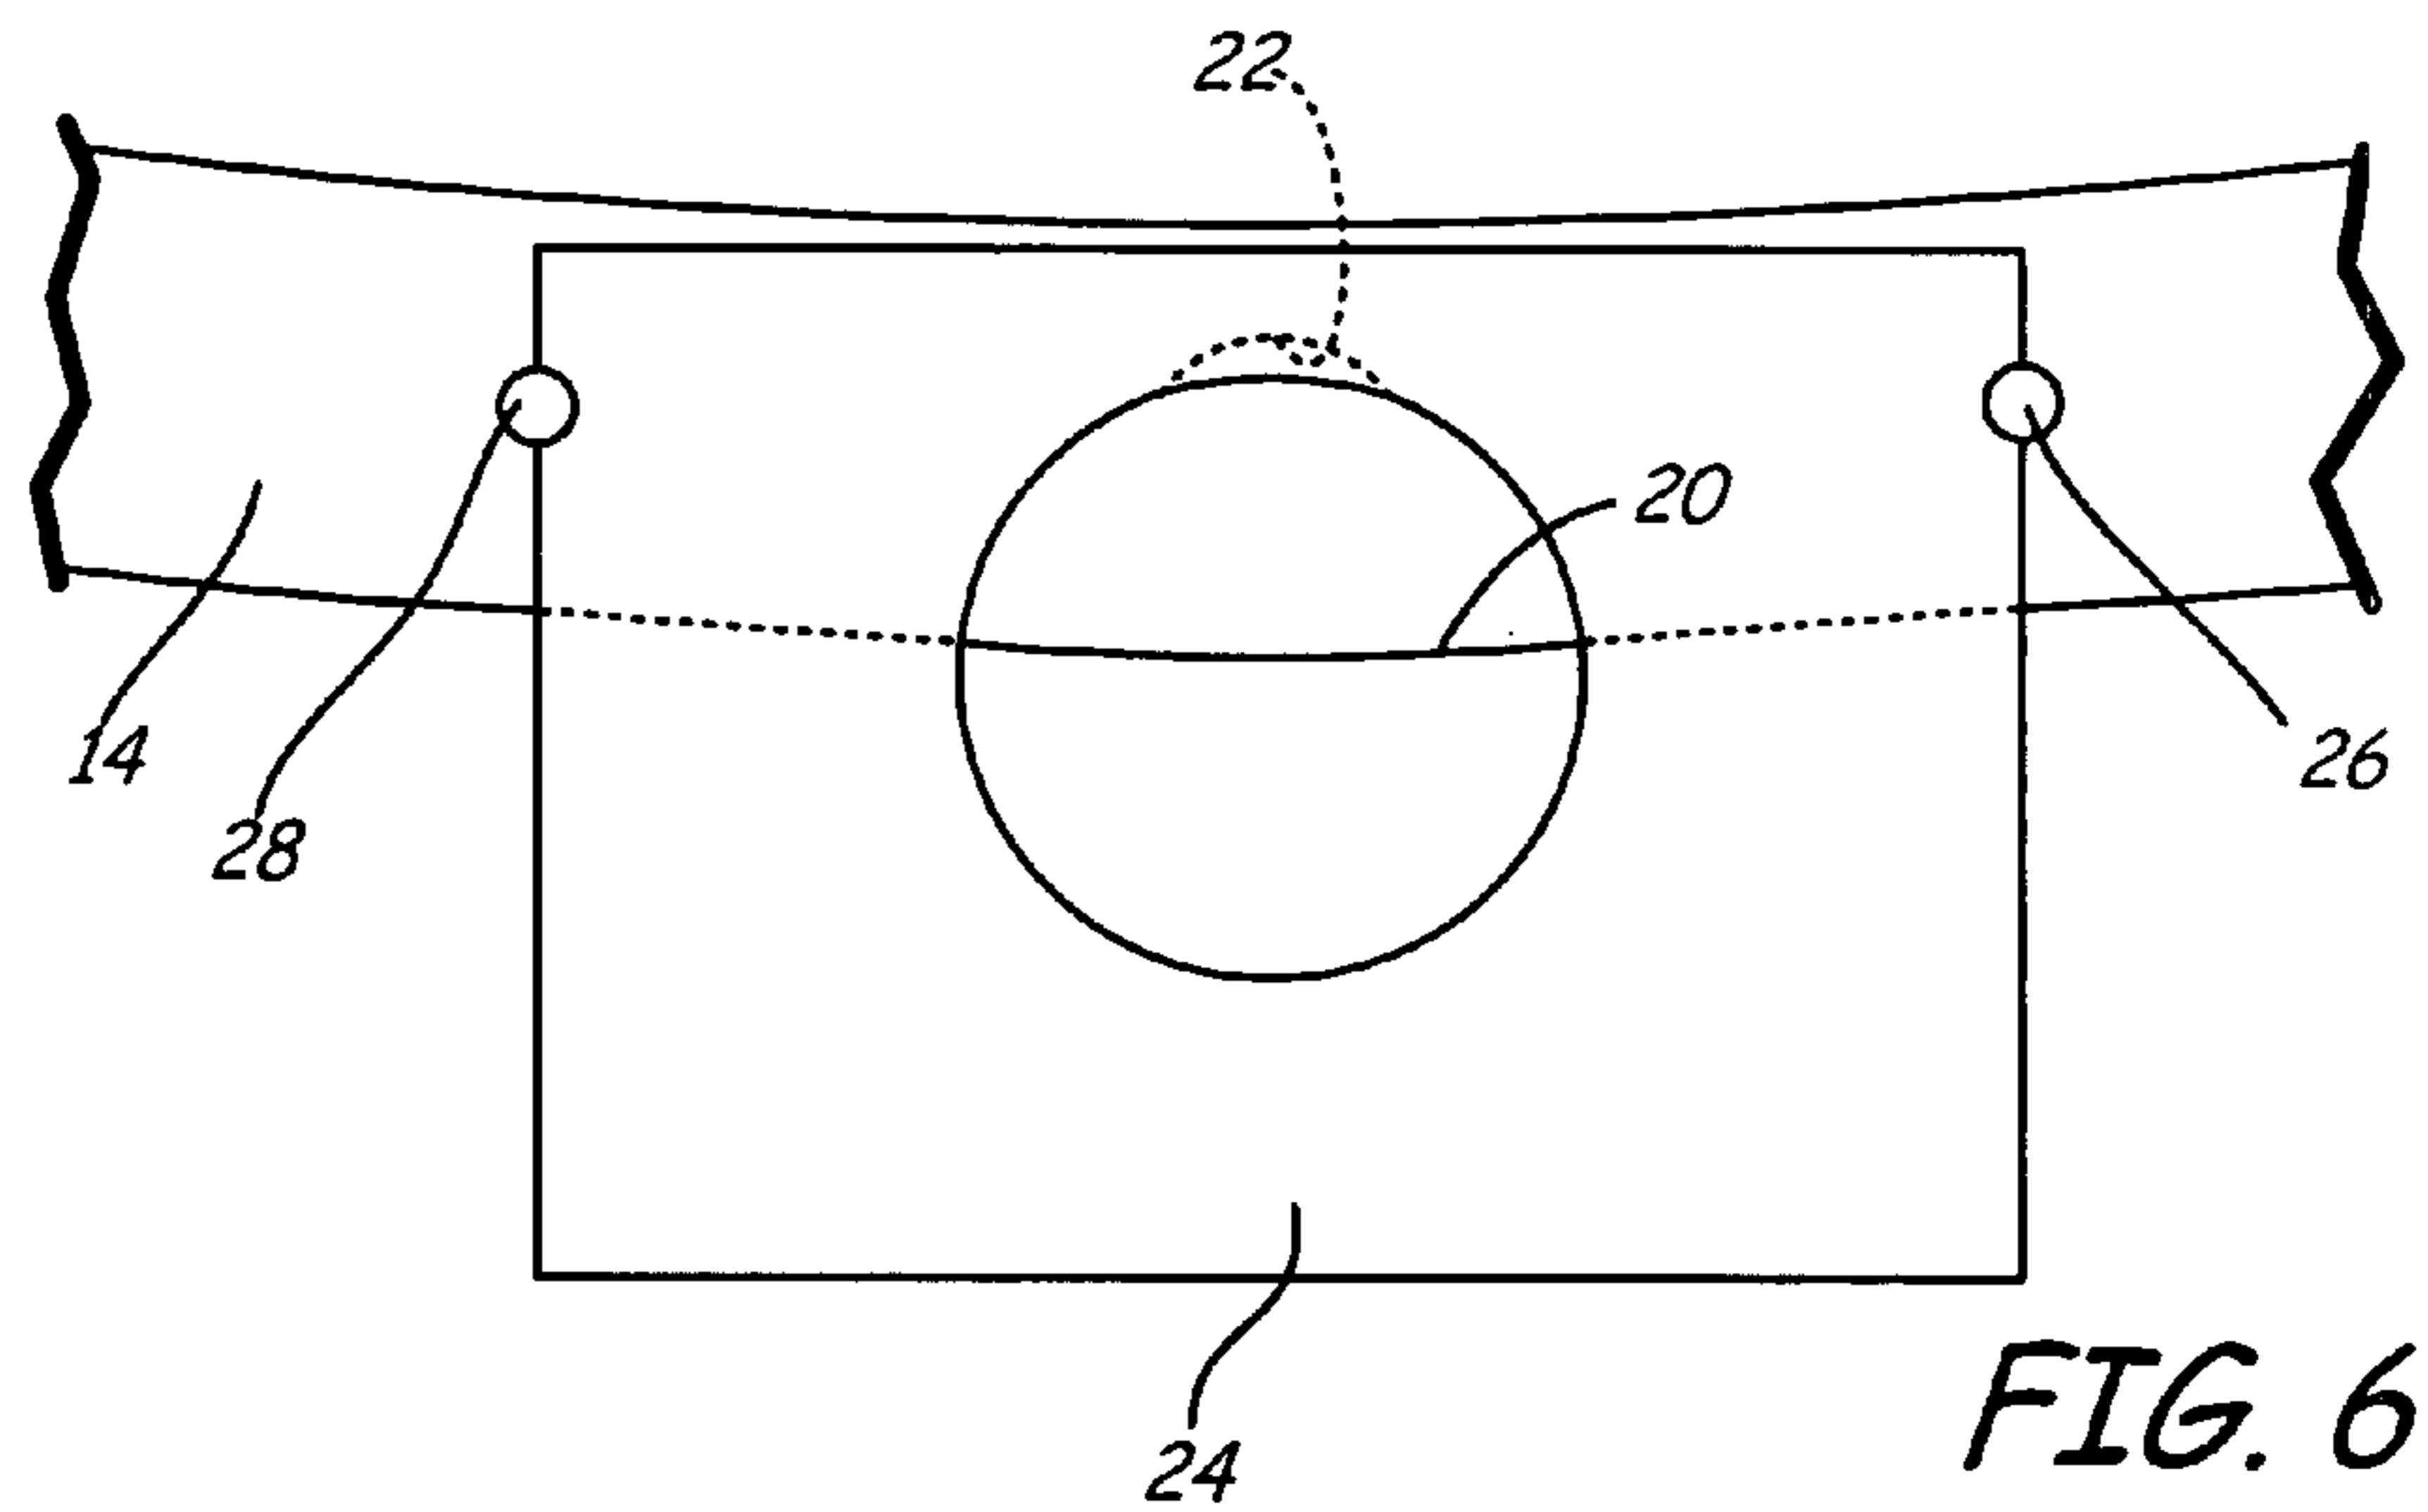
FIG. 6 is a plan view illustrating a combination runoff and top plate tacked to the flange.

FIG. 6 is a plan view illustrating a combination plate 24 (i.e., combination runoff and top plate) attached to flange 14. Combination plate 24 is attached to flange 14 by placing tack welds 26, 28 approximately midway axially of flange 14. Tack welds 26, 28 hold combination plate 24 temporarily in place. Also, tack welds can be easily removed later, without damaging flange 14, to remove combination plate 24. Combination plate 24 may be fabricated from the same material as the base material of flange 14, or a material that has consistent metallurgical properties. In the illustrated embodiments, combination plate 24 has a central portion removed that reveals lower flange 20, and covers arc 22. In alternate embodiments (not illustrated), combination plate 24 does not cover arc 22.

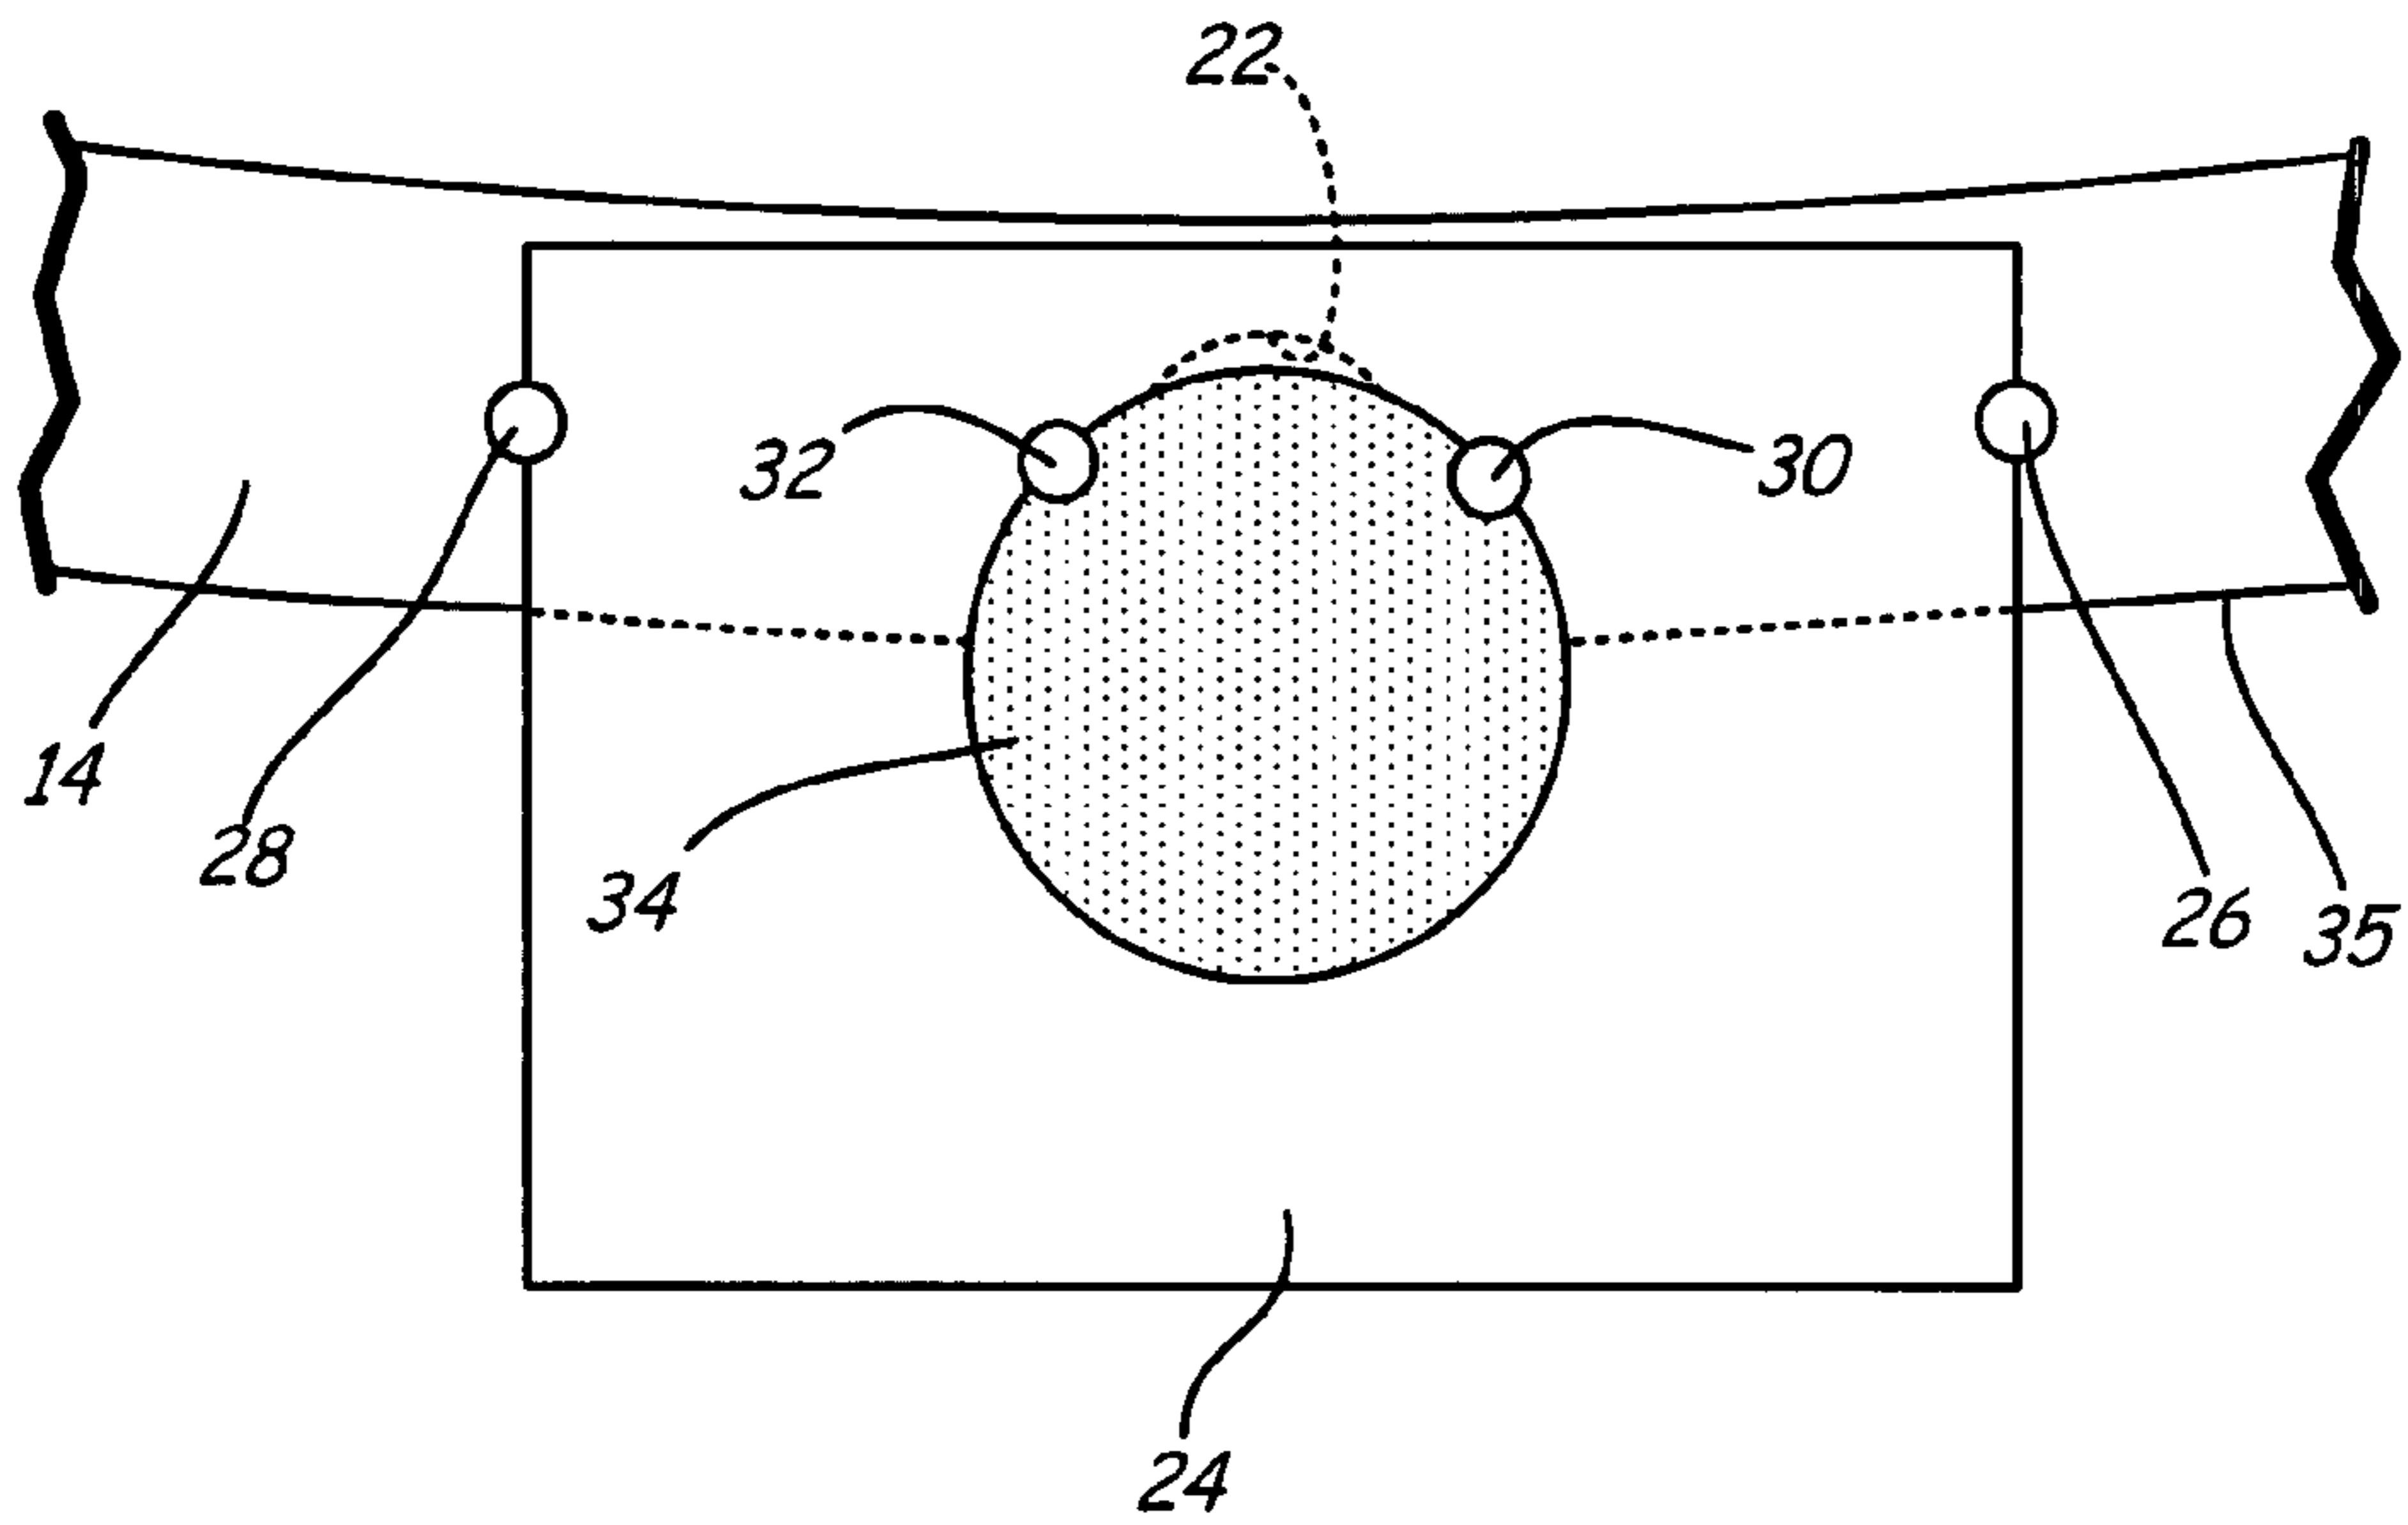
FIG. 7 is a plan view illustrating a biscuit insert tacked to the combination plate.

FIG. 7 is a plan view illustrating insert 34 attached to the combination plate 24 via tack welds 30, 32, which hold the insert 34 in place until the final welding process occurs. Insert 34 is a plug of material that is preferably the same material as, or contains the same metallurgical properties as, that of the base material of flange 14. Insert 34 is sized to be positioned against the edge of portion 18 of flange 14 previously removed (see FIG. 4), as well as mate with the profile of the aperture in combination plate 24. In the embodiment illustrated, insert 34 is circular. Although illustrated as circular, insert 34 may be elliptical, biscuit shaped, or have an arced portion that matches the profile of the removed material 18 of flange 14.

The maximum gap between the outer perimeter of the insert 34 and the parent material that has been weld prepped is preferably about 0.003 inches (0.076 mm). This low tolerance gap yields the best results with this weld repair. Thus, tack welds 30, 32 should be located with the low tolerance gap in mind. The placement of the welds should be about the perimeter of insert 34 in a position between outer edge 35 of flange 14 and the original placement of hole 12, as represented by arc 22. Tack welds 30, 32 are to be placed on opposite sides of where hole 12 previously existed. This position will assure that the correct gap is maintained between insert 34 and combination plate 24 and the remaining portion of flange 14. Tack welds 30, 32 are done using spot welding or a similar process that does not use a filler material. Tack welds 30, 32 should be of depth that does not exceed combination plate 24 thickness. When the weld is complete, tack welds 30, 32 will be incorporated into the final repair weld.

In embodiments, combination plate 24 is larger than the diameter of the hole 12 being repaired. In embodiments, combination plate 24 has a length (measurements of the sides generally parallel to the outer edge of flange 14) of at least two times the diameter of the original hole 12 (FIG. 2), and has a width (measurements of the sides generally perpendicular to the outer edge of flange 14) of at least two times the diameter of hole 12. The aforementioned dimensions of combination plate 24 assure good support for insert 34, and allow for locating tack welds 26, 28 an adequate distance from the repair weld(s) around insert 34.

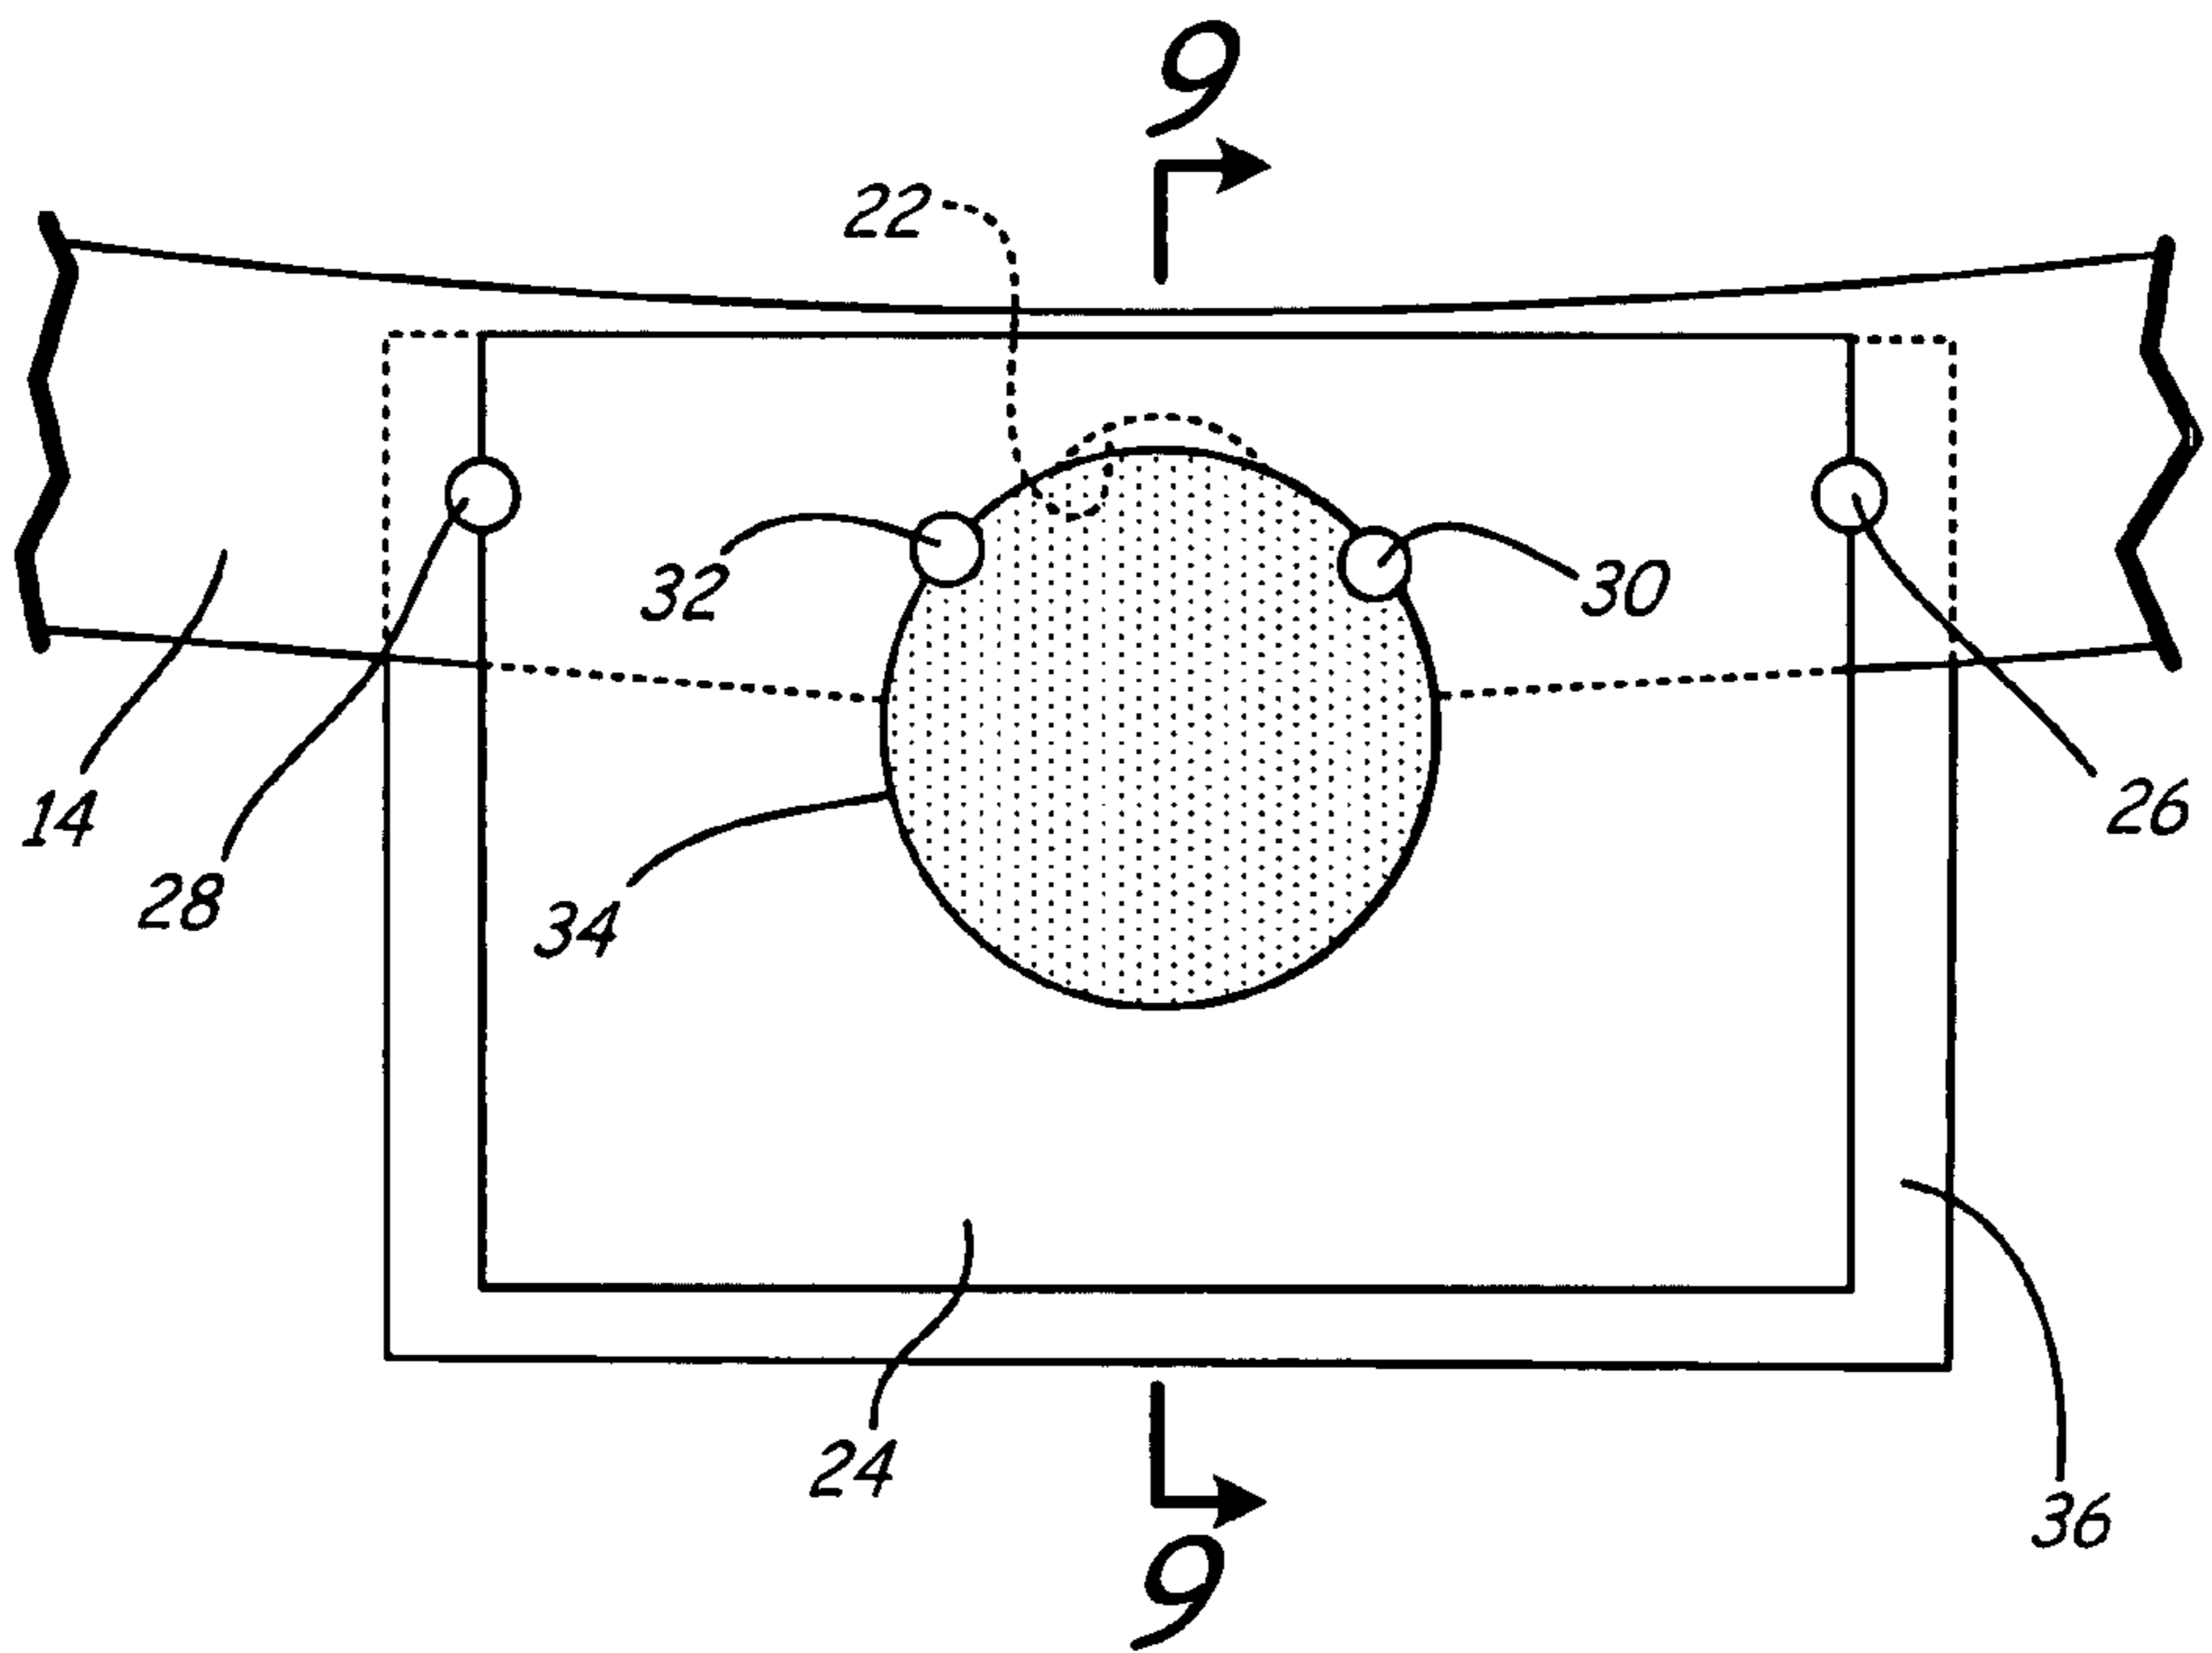
FIG. 8 is a plan view illustrating a backing plate placed below the combination plate and insert.

FIG. 8 is a plan view illustrating backing plate 36 placed below combination plate 24 and insert 34. Backing plate 36 may be fabricated from a similar metal that is used to construct combination plate 24 and insert 34. In alternate embodiments, backing plate 36 is constructed from a different metal, or a heat resistant material such as ceramic. In FIG. 8, backing plate 36 is illustrated as containing larger dimensions than combination plate 24, but backing plate 36 may be smaller in size than combination plate 24 so long as the backing plate 36 covers the area underneath where the repair weld is to be made. When backing plate 36 is larger than combination plate 24, backing plate 36 protects adjacent areas from weld run off or spatter, as well as protects lower flange 20 from penetration of the electron beam or other welding source.

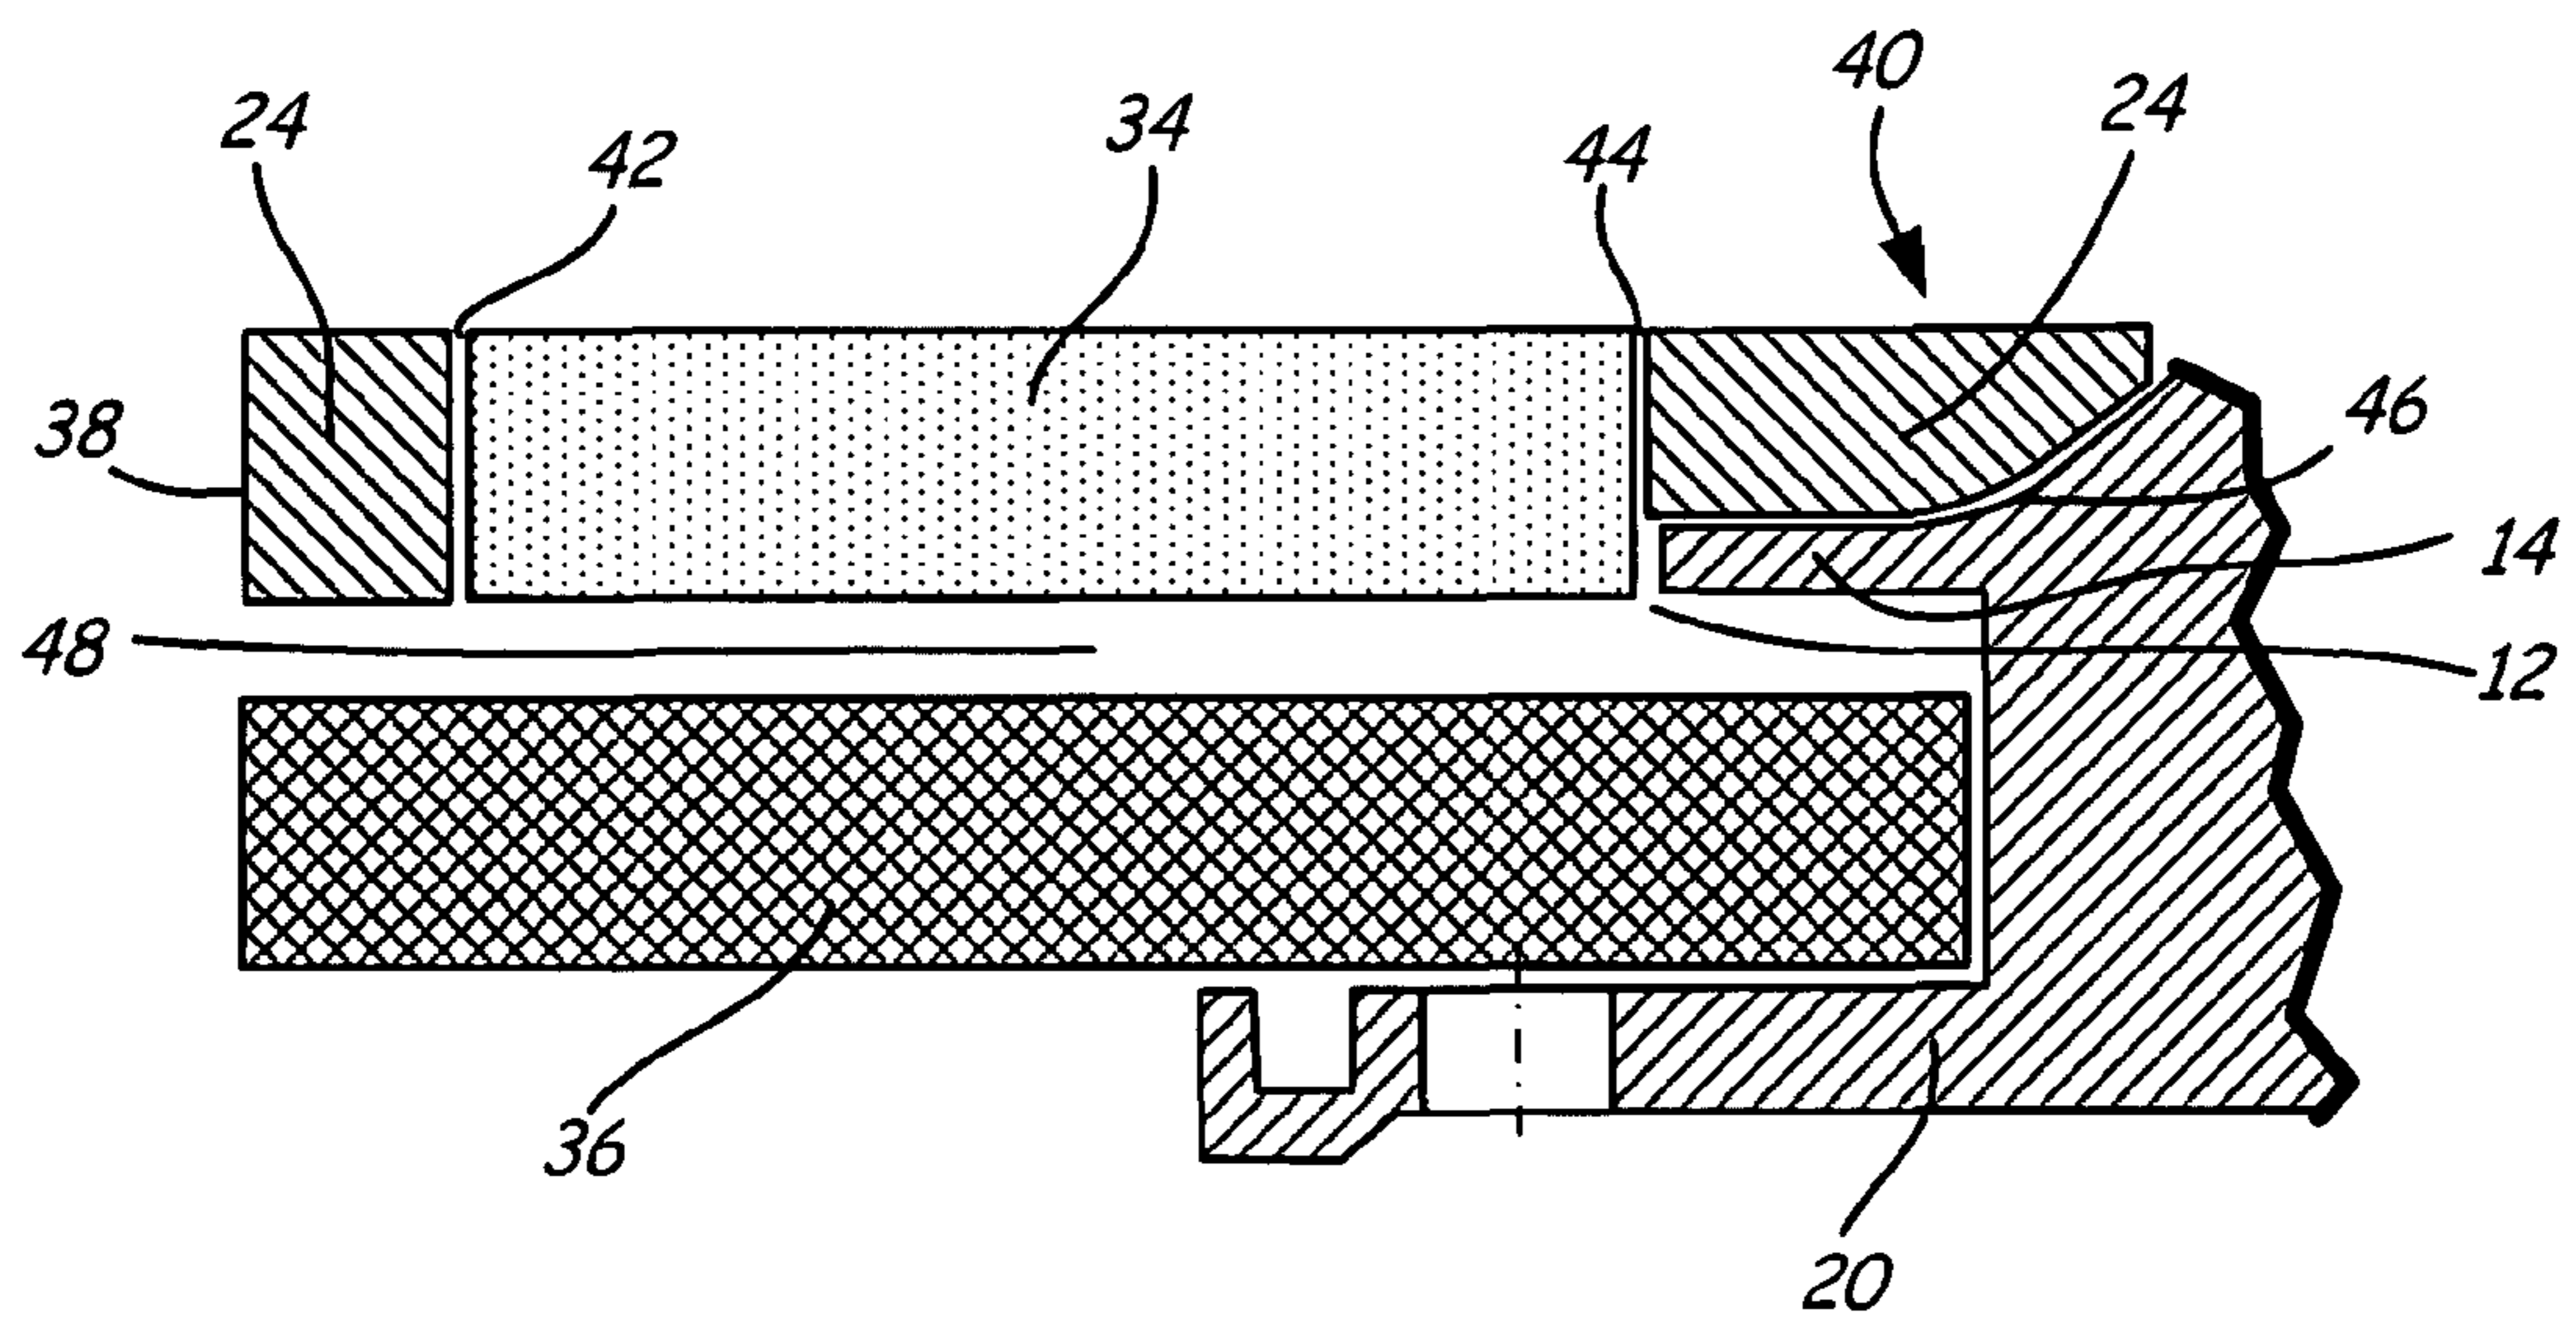
FIG. 9 is a cross-sectional elevation view of the bolt hole repair apparatus for refabrication of the flange of the nozzle support illustrated in FIG. 7.

FIG. 9 is a cross-sectional elevation view of the bolt hole repair apparatus for refabrication of flange 14 illustrated in FIG. 8. In this view, the remaining portion of the base material of flange 14 is visible. Also illustrated are insert 34, combination plate 24, and backing plate 36. Insert 34 is a thickness that is approximately equivalent to the thickness of the rear edge 38 of combination plate 24, which is also approximately equivalent to the thickness of the front end 40 of combination plate 24 added to the thickness of the remnant of hole 12 left on flange 14. Small clearance gaps 42, 44 exist between insert 34 and plate 24. Clearance gaps 42, 44 should be as small as

possible to assure a tight fit between insert **34** and combination plate **24** and flange **14**. The maximum dimension for clearance gap **44** is preferably equal to or less than about 0.003 inches (0.076 mm). The measurement for clearance gap **42** is less critical, but it is preferred to be approximately the same as the measurement for clearance gap **44**. The clearance allows for the insertion of insert **34** into the aperture contained in combination plate **24**. Clearance gaps **42**, **44** will cease to exist as the material from insert **34** and combination plate **24** fuse together during the repair weld.

Front end **40** of combination plate **24** is contoured to mate with remaining surface **46** of flange **14** and hole **12**. Although flange **14** is illustrated in this view as containing a radius at surface **46**, other geometries of the contour are envisioned including bevels, chamfers, rabbets, dados, or stepped notches, the geometry of the contour depending on the geometry of the base material left on flange **14**. Insert **34** and combination plate **24** contain more material than the thickness of the material removed from flange **14** so that insert **34** can be machined to the appropriate size after the weld repair has been completed.

The part illustrated in FIG. **9** is a section of nozzle support **10** of FIG. **2**. Nozzle support **10** contains two flanges, flange **14** which is to be repaired, and a lower flange **20**. Lower flange **20** and flange **14** are spaced close together, and a typical spacing is less than about 0.25 inches. Backing plate **36** is placed between flange **14** and lower flange **20**, and protects the lower flange **20** from any slag, spatter, or similar byproduct resulting from the welding process.

An air gap **48** is left between the top surface of backing plate **36** and the bottom surfaces of insert **34**, combination plate **24**, and the remaining portion of flange **14**. In some embodiments, air gap **48** is about 0.10 inches or less, which assures that the excess energy from the weld beam is adsorbed, but is far enough from the bottom edge of the repair pieces (insert **34**, combination plate **24**, and flange **14**) to assure that backing plate **36** does not become fused to the repair pieces. Utilizing combination plate **24** to provide a good weld, while separating the repair pieces from the backing plate **36** via air gap **48**, assures that a good, structurally sound weld repair can be obtained. Backing plate **36** should be large enough to cover the clearance gaps **42**, **44** between the combination plate **24** and the edges of the insert all the way around the edge of insert **34**. The thickness of backing plate **36** is less than the distance between flange **14** and lower flange **20** so that air gap **48** exists as shown.

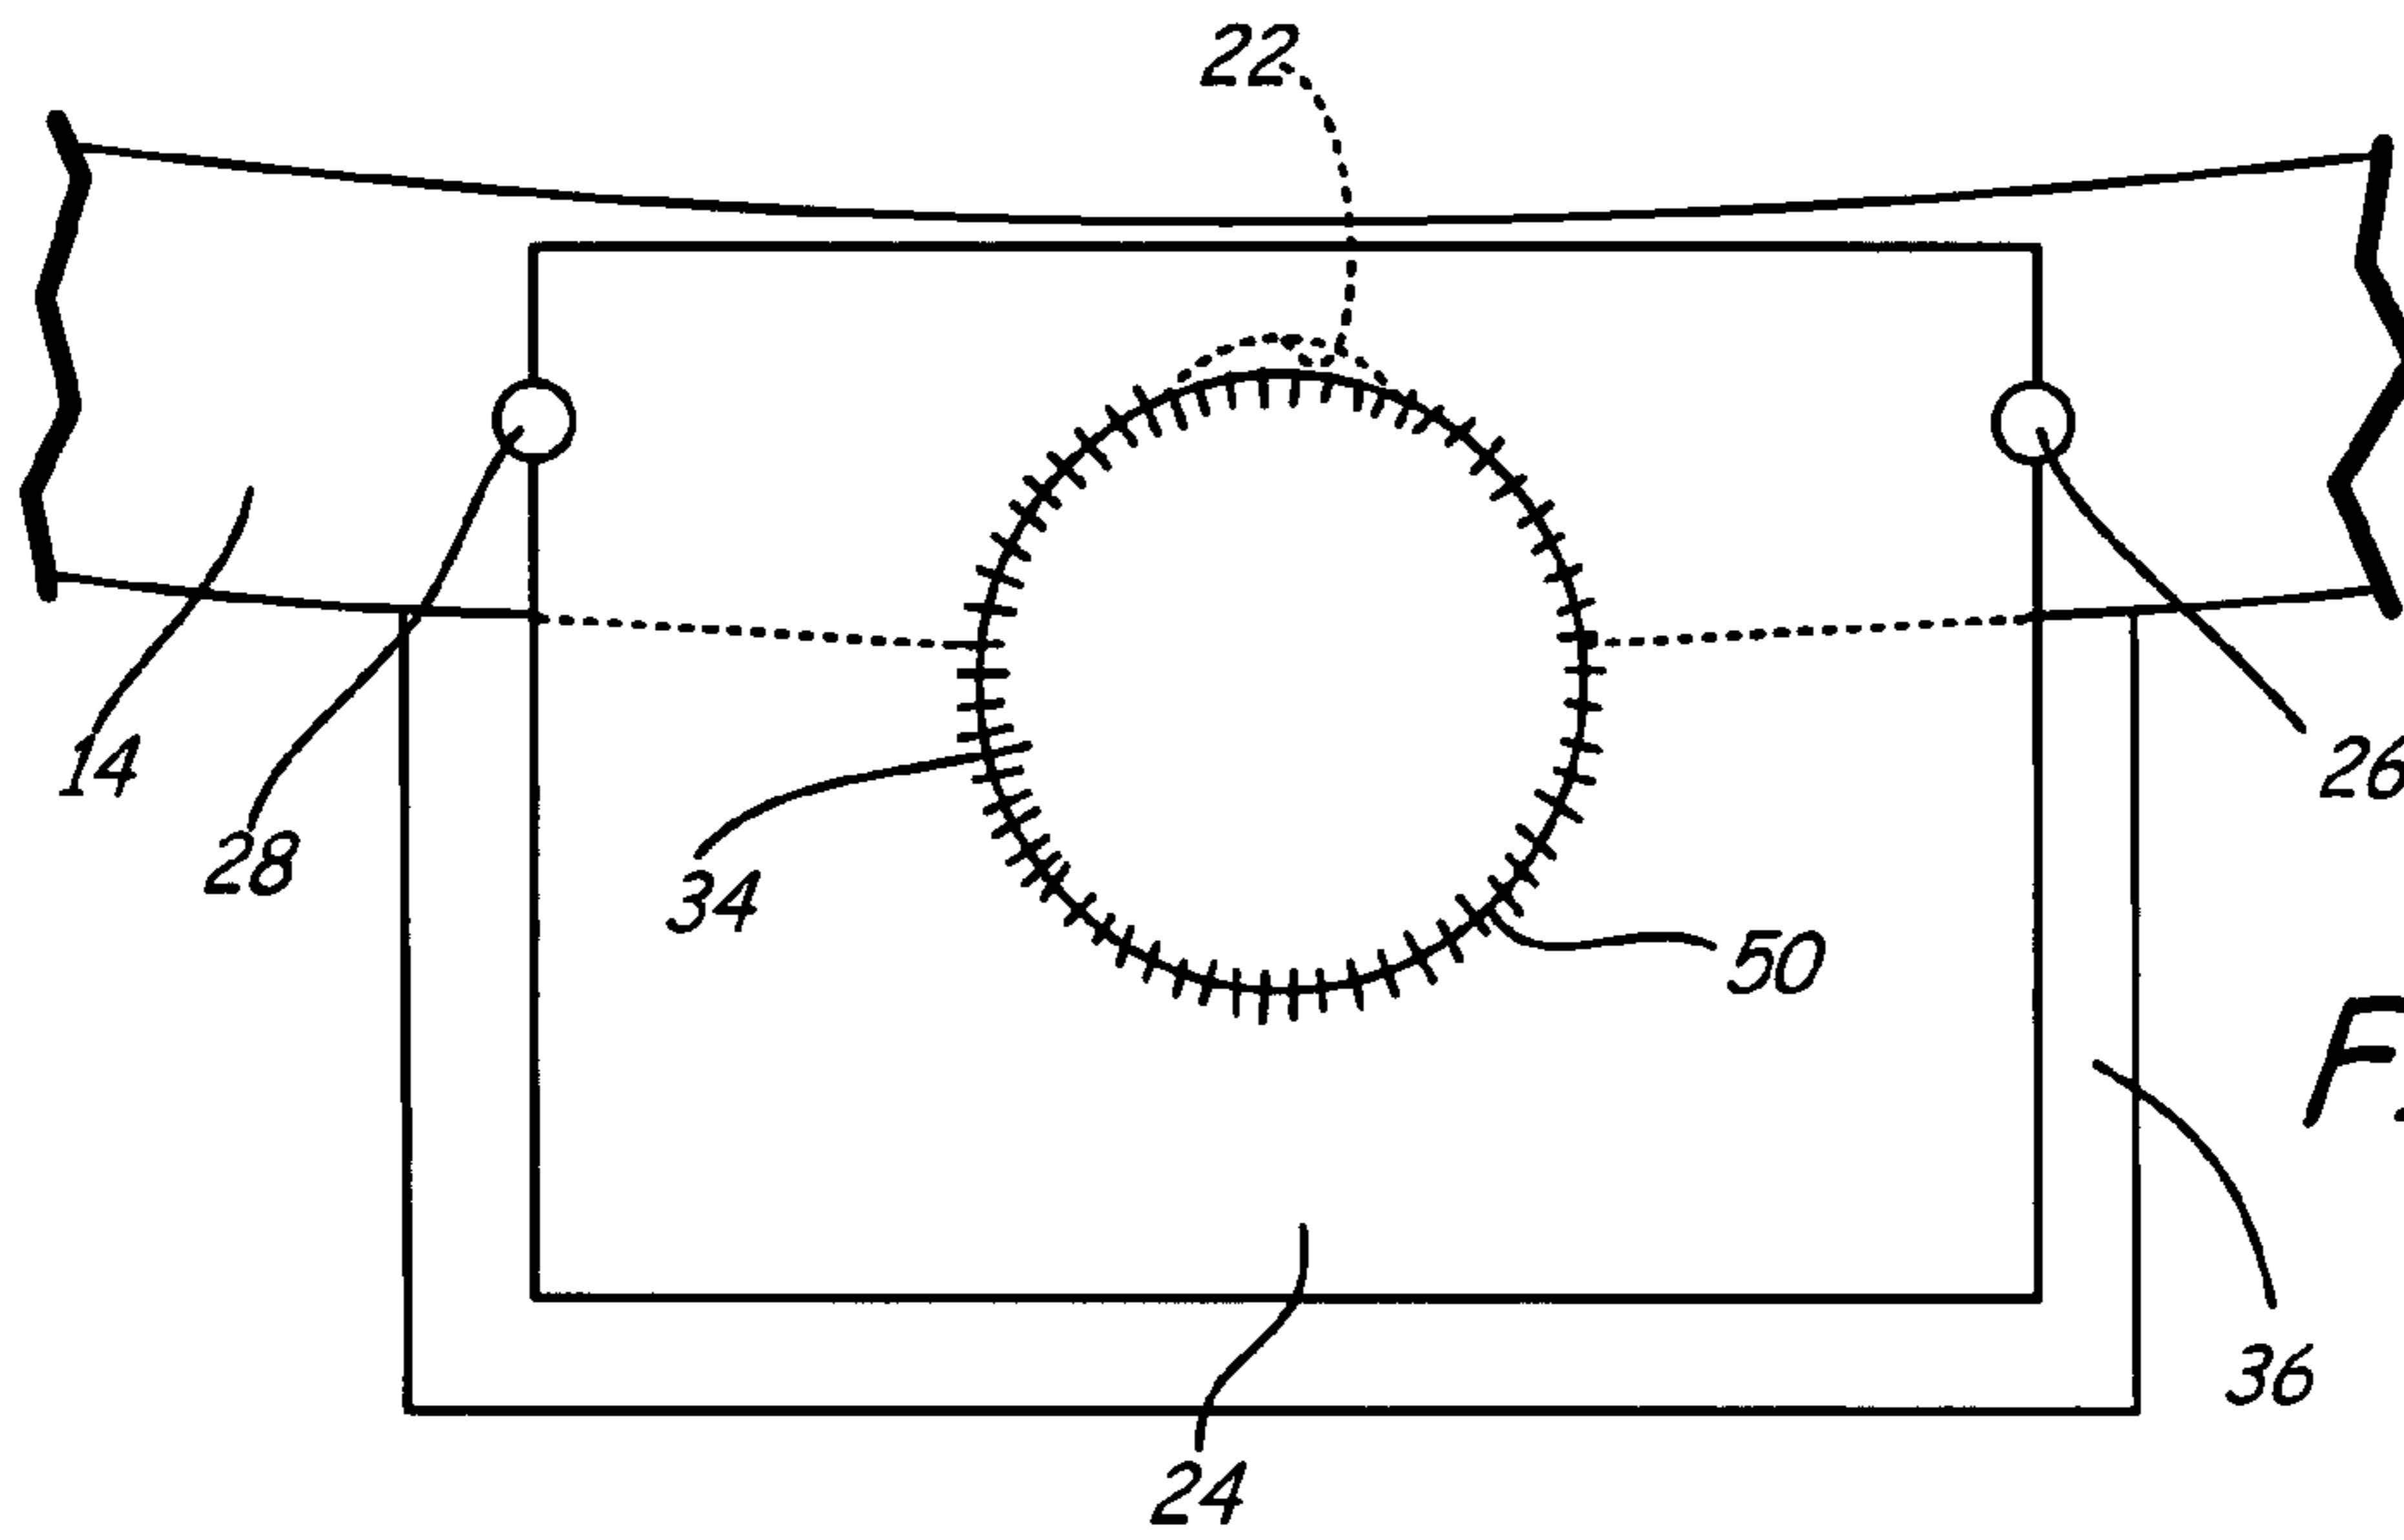
FIG. 10 is a plan view illustrating a completed weld between the insert, combination plate, and flange with the backing plate still in place.

FIG. **10** is a plan view illustrating a completed weld **50** between insert **34** and combination plate **24**. Insert **34** is welded into place by a process such as electronic beam welding. Electronic beam welding (EBW) uses a narrow beam of high velocity, high energy electrons to generate the heat necessary to create a weld in a metal work piece. Special equipment is used to focus the electron beam in a vacuum chamber, and the kinetic energy of the electrons is converted to heat energy as it strikes the metal. The welds created by EBW are characteristically deep and narrow with a very small heat affected zone and low distortion. The current repair moves the weld seams out of the high stress areas surrounding the hole **12**. The weld seams are left in the low stress areas of the flange **14**.

EBW is typically autogenous, that is, does not require a filler material. Thus, a tight fit of insert **34** with the remaining base material and combination plate **24** will occur as the pieces fuse together during the welding process without the addition of a filler material. Weld **50** is a butt weld joining insert **34**, base material of flange **14**, and combination plate **24** together. While weld **50** is done from the top of insert **34**, the

weld extends around the entire perimeter of insert **34** and throughout the entire thickness of insert **34**.

EBW can leave depressions in the parts welded. Thus, ensuring that insert **34** and combination plate **24** are thicker than the original thickness of flange **14** allows for the melting and fusing of material from the respective top sides of insert **34** and combination plate **24** to flow down and fill in the weld against the base material of flange **14**. Thus, when material is removed to finish the repair, none of the base material that has been left will be machined, only the newly welded materials will be removed.
