(10) **Patent No.:** **US 7,802,350 B2**
(45) **Date of Patent:** **Sep. 28, 2010**

(54) **FLANGE HOLE REPAIR**

(73) Assignee: **United Technologies Corporation**,
Hartford, CT (US)

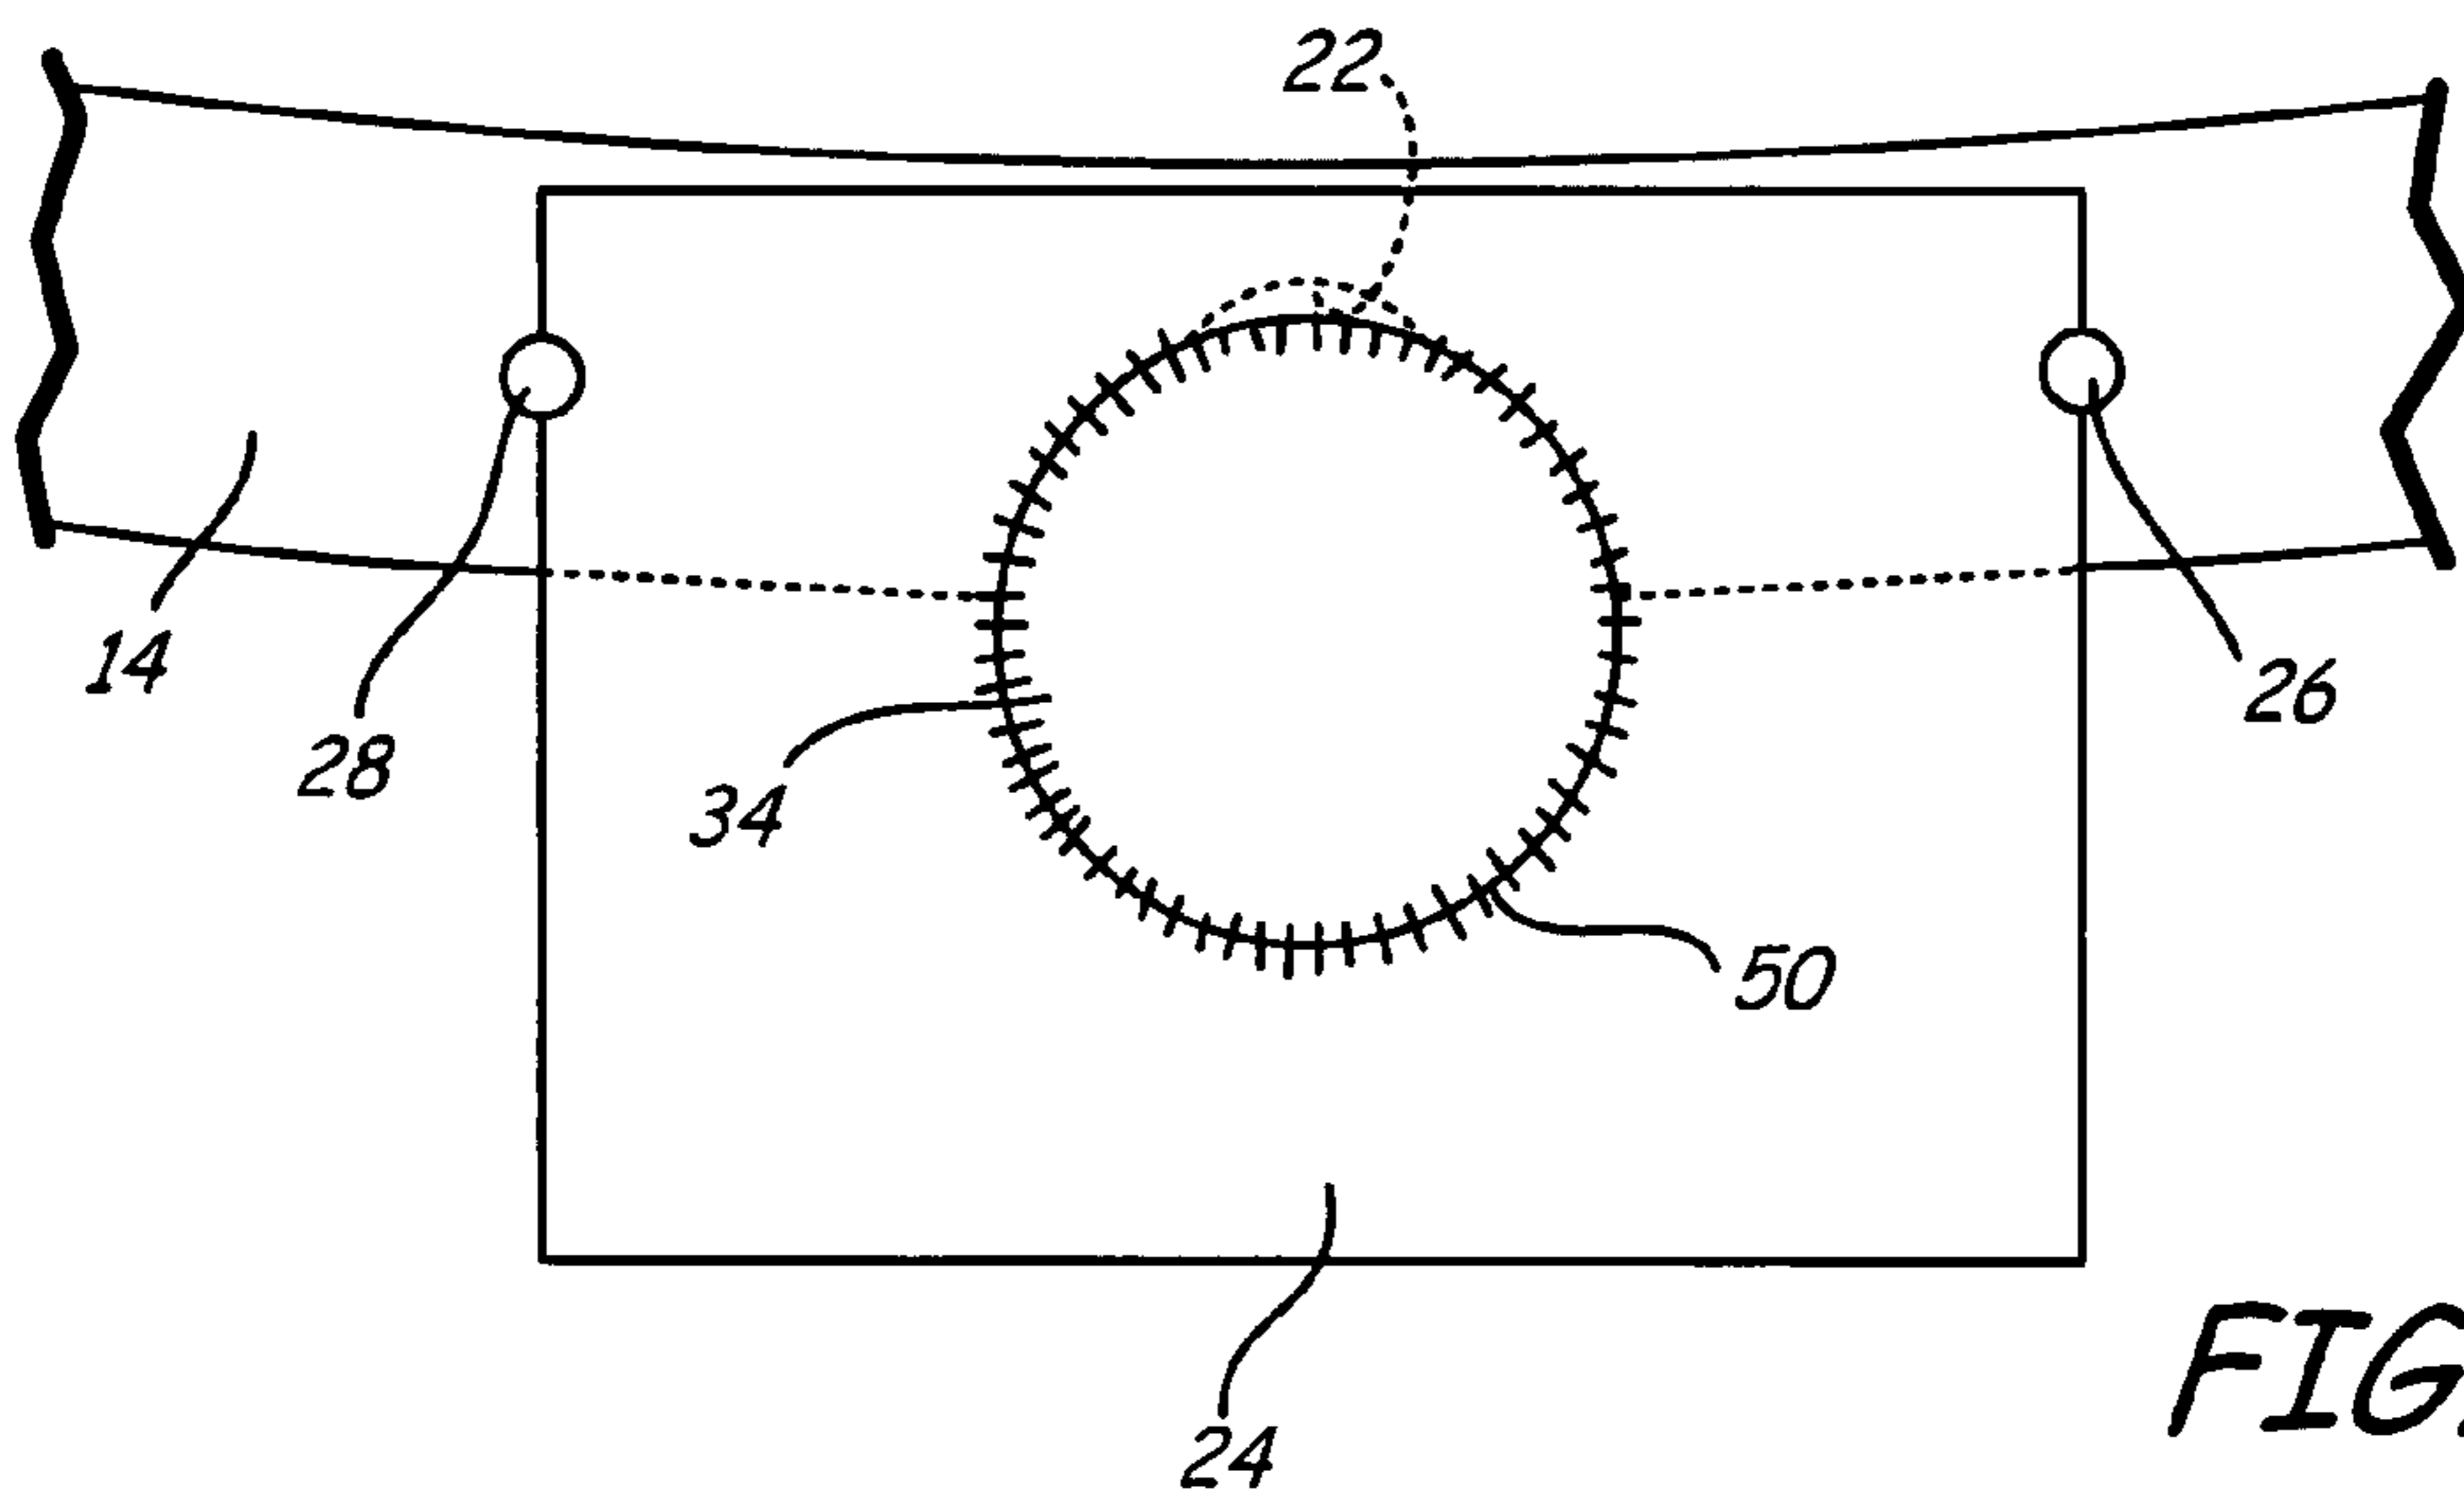
FIG. 11 is a plan view illustrating the completed weld with the backing plate removed.

FIG. **11** is a plan view illustrating completed weld **50** with backing plate **36** removed. Since backing plate **36** does not become fused to the repair pieces (insert **34**, combination plate **24**, and flange **14**), after weld **50** has been completed, backing plate **36** may simply be pulled out from the repaired part. There is no need to use material removal equipment, such as grinders or similar machines to remove backing plate **36**. Backing plate **36** may be reused as there will be minimal damage to the top surface as it will not contain removal scars associated with plates that become fused during the welding process.

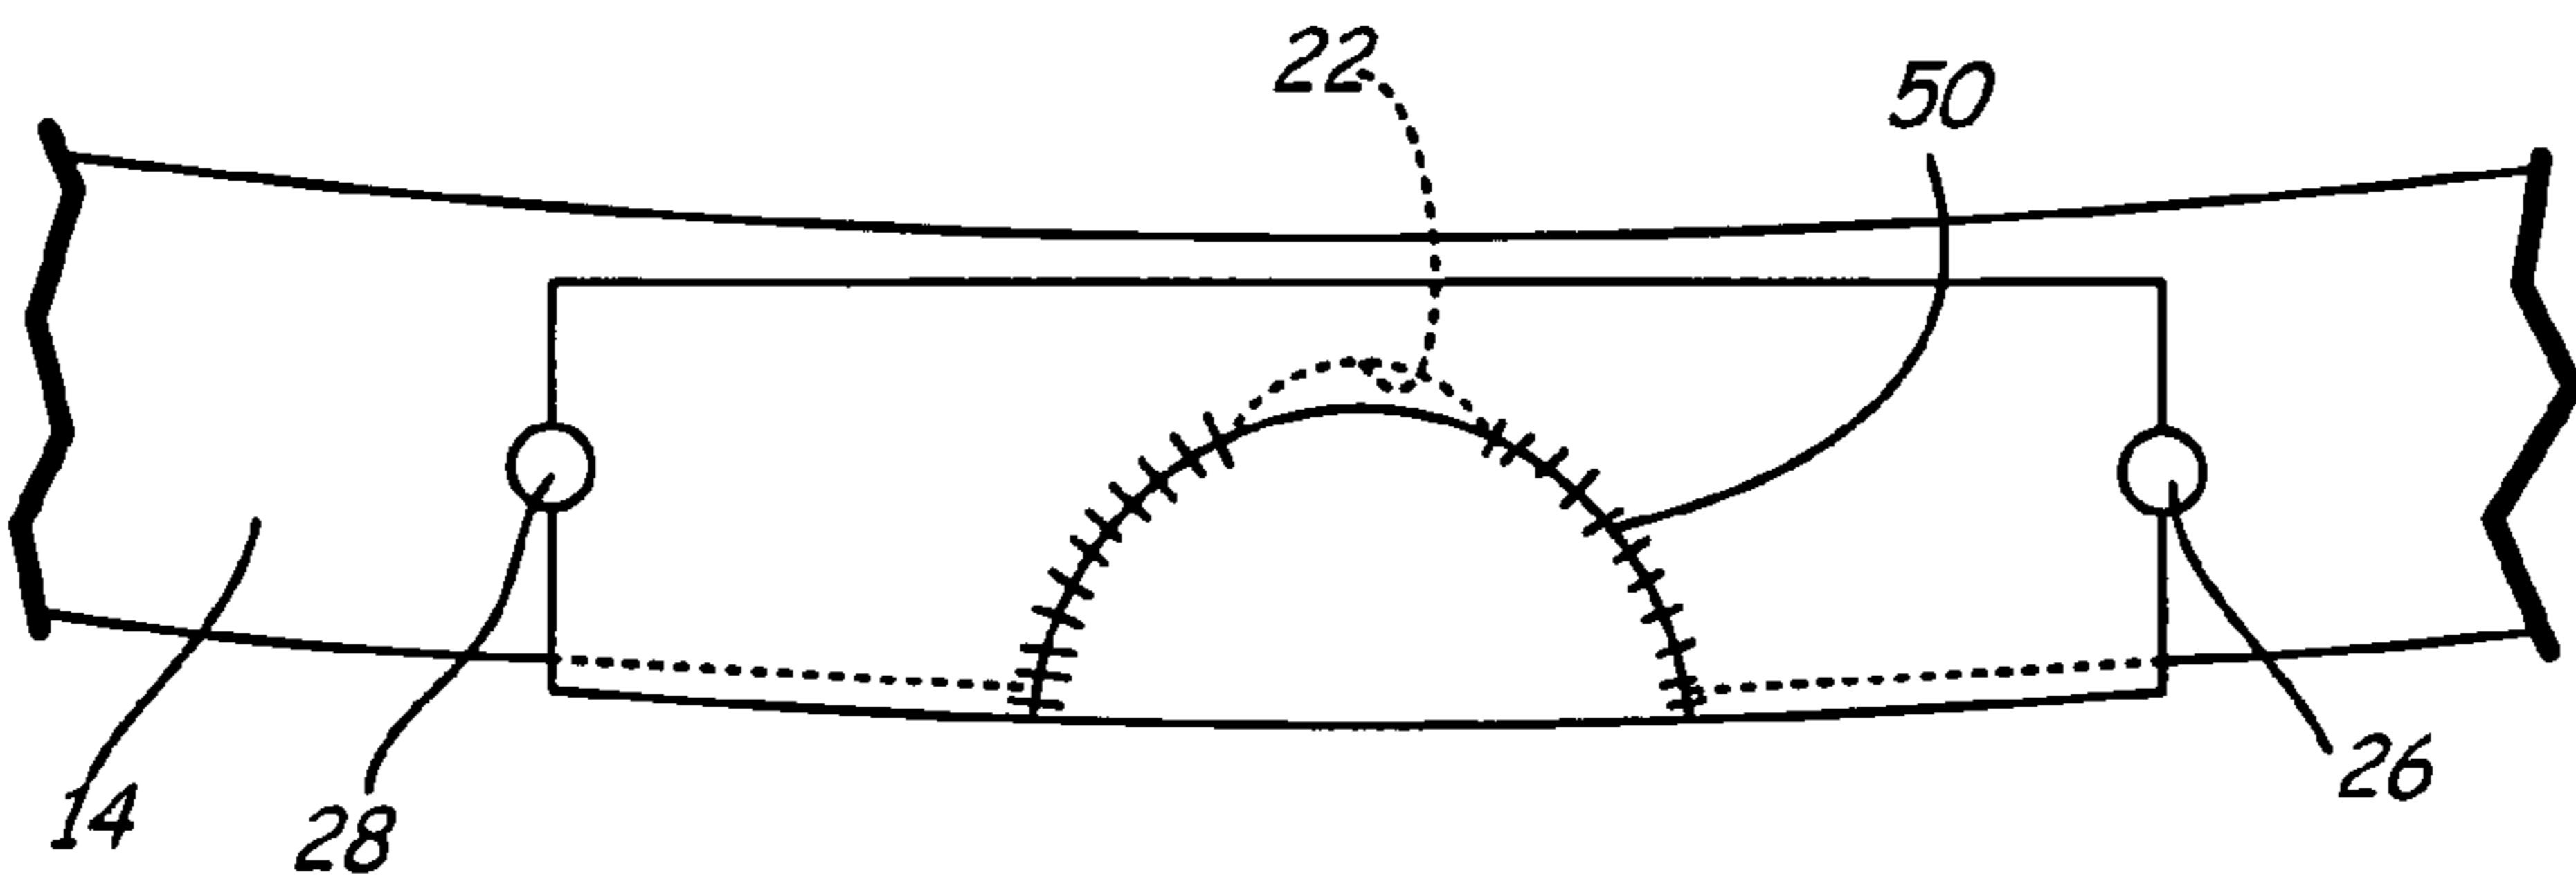
FIG. 12 is a plan view illustrating the completed weld with a portion of the combination plate and insert removed.

FIG. **12** is a plan view illustrating completed weld **50** with portions of combination plate **24** and insert **34** removed. Combination plate **24** and insert **34** are cut along a path that substantially follows the outer profile of flange **14**. A mill, laser, or similar material removal machine is used to cut combination plate **24** and insert **34**. A nominal amount of material of combination plate **24** and insert **34** may remain after an initial cut to ensure that the cutting process does not affect the integrity of the original flange profile.

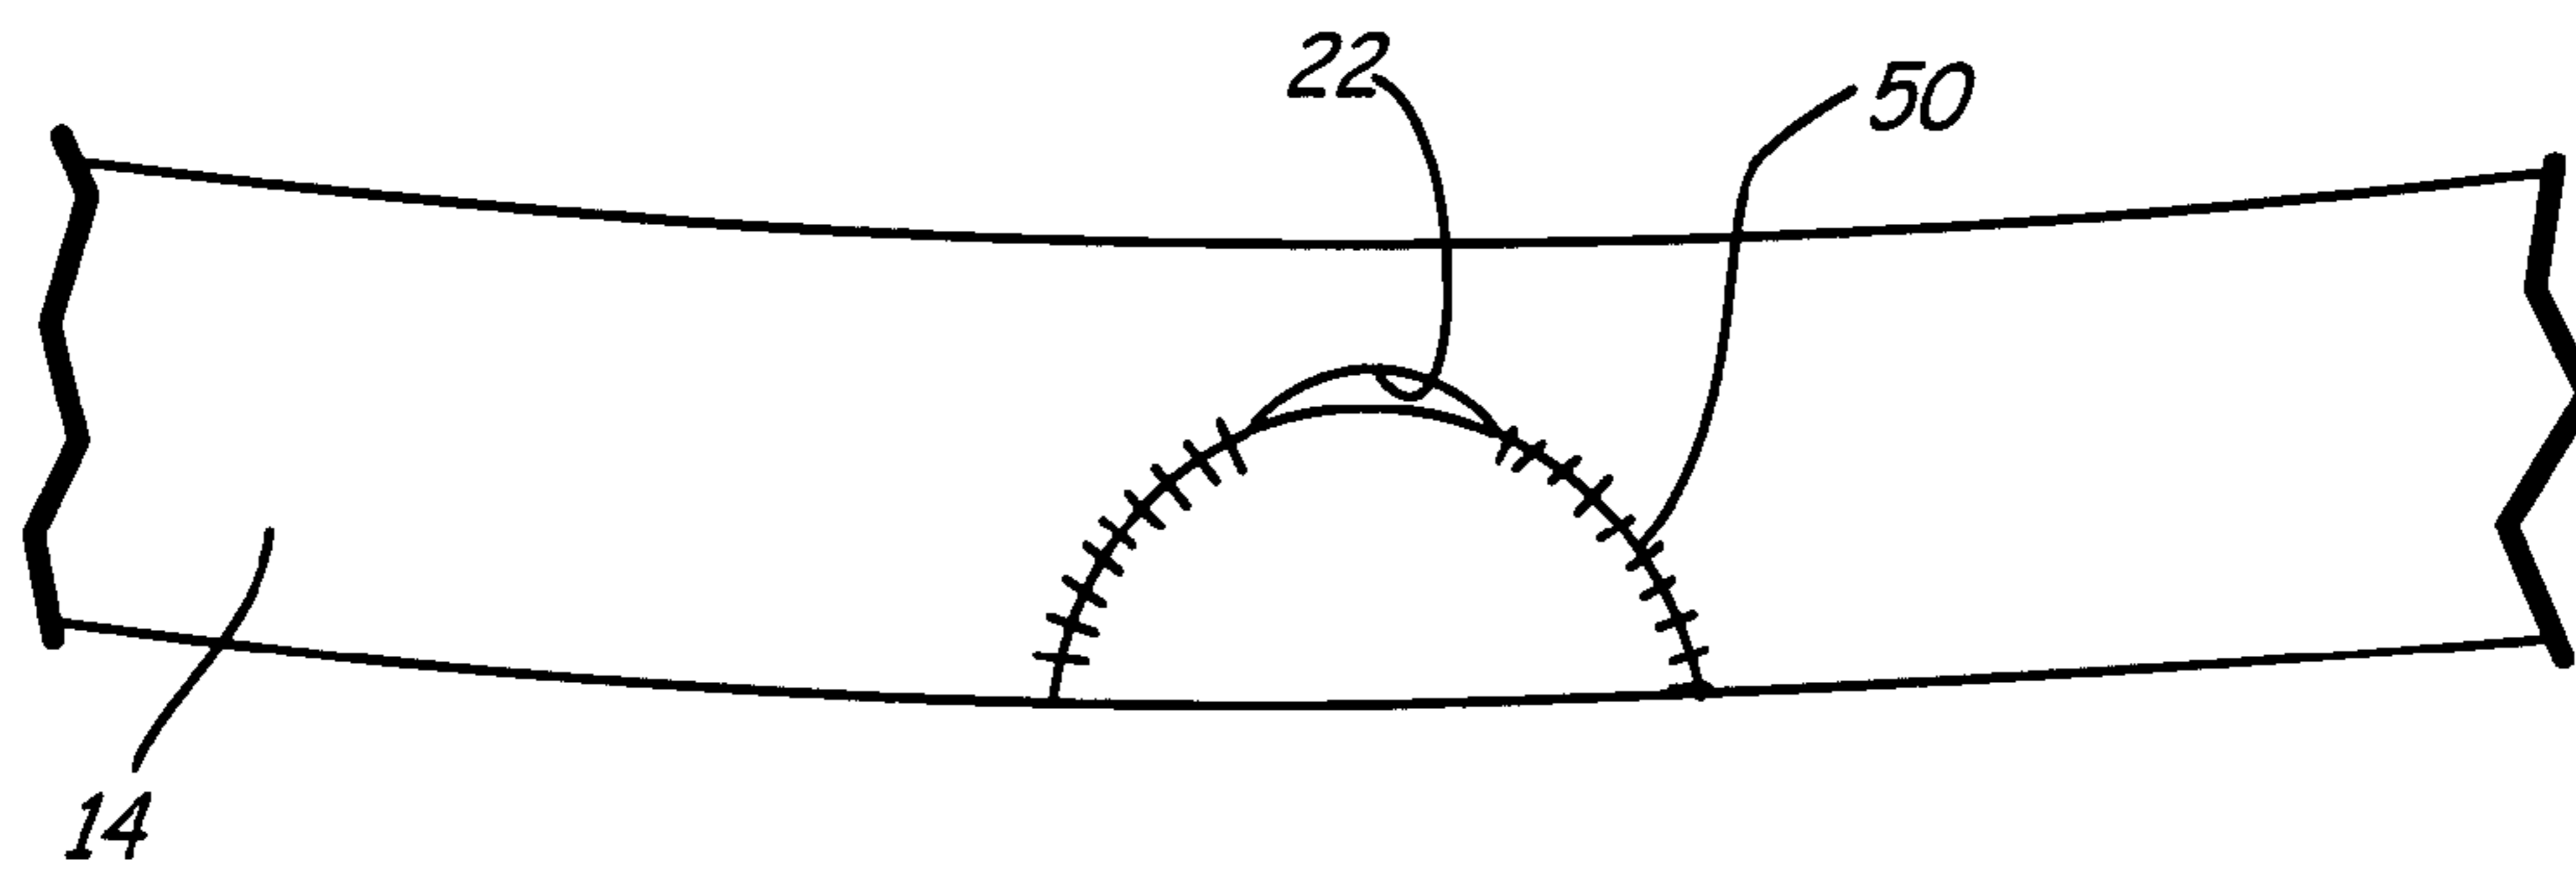
FIG. 13 is a plan view illustrating the combination plate and insert removed to produce the original flange profile.

FIG. **13** is a plan view illustrating combination plate **24** removed to produce the original profile of flange **14**. To remove combination plate **24**, first tack welds **26**, **28** are detached from flange **14**. Next, a mechanized process such as machining is utilized to remove combination plate **24** and excess material from insert **34** until the original profile of the top surface of flange **14** is obtained. After combination plate **24** is removed, arc **22** of the original aperture in flange **14** is again visible. Weld **50** will also be machined on the top and bottom surfaces to obtain nominally the same surfaces of flange **14** as those prior to the repair. Finally, the outer edge of flange **24** is machined to obtain substantially the same profile and outer diameter as the profile prior to the repair.

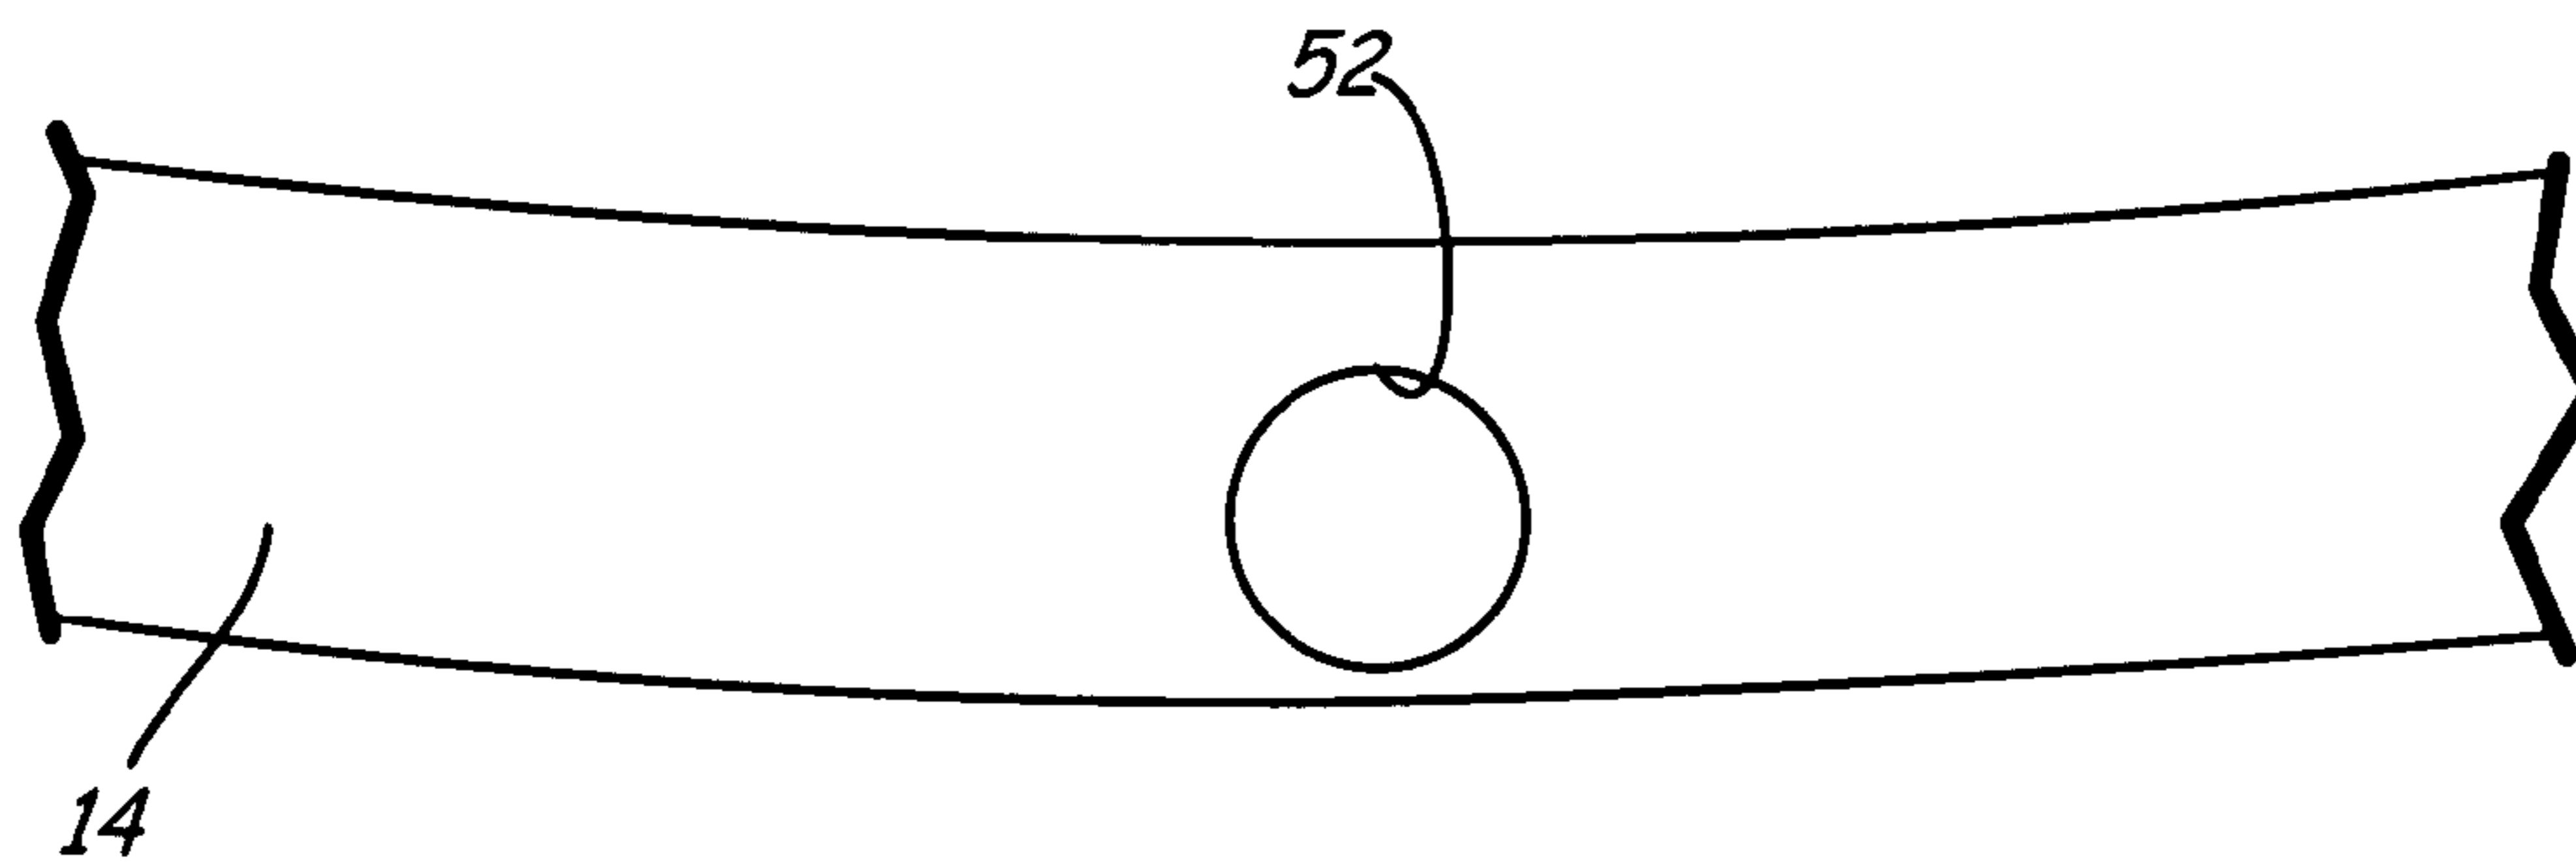
FIG. 14 is a plan view illustrating the complete repair with a new aperture in the flange.

FIG. 14 is a plan view illustrating the complete repair with a new hole 52 in flange 14. After the flange profile has been nominally obtained, an aperture is machined in the flange to create nominally the same hole 12 that existed prior to the repair. Arc 22 is used as a guide to machine hole 52 to assure the location is nominally the same as prior to the repair. In an alternate embodiment, the hole in lower flange 20 (See FIGS. 2A and 9) is used as a guide to create hole 52 in flange 14.
