(12) **United States Patent**
Arcaini et al.

(10) **Patent No.:** **US 7,822,273 B1**
(45) **Date of Patent:** **Oct. 26, 2010**

(54) **METHOD AND APPARATUS FOR
AUTOMATIC CORROSION DETECTION VIA
VIDEO CAPTURE**

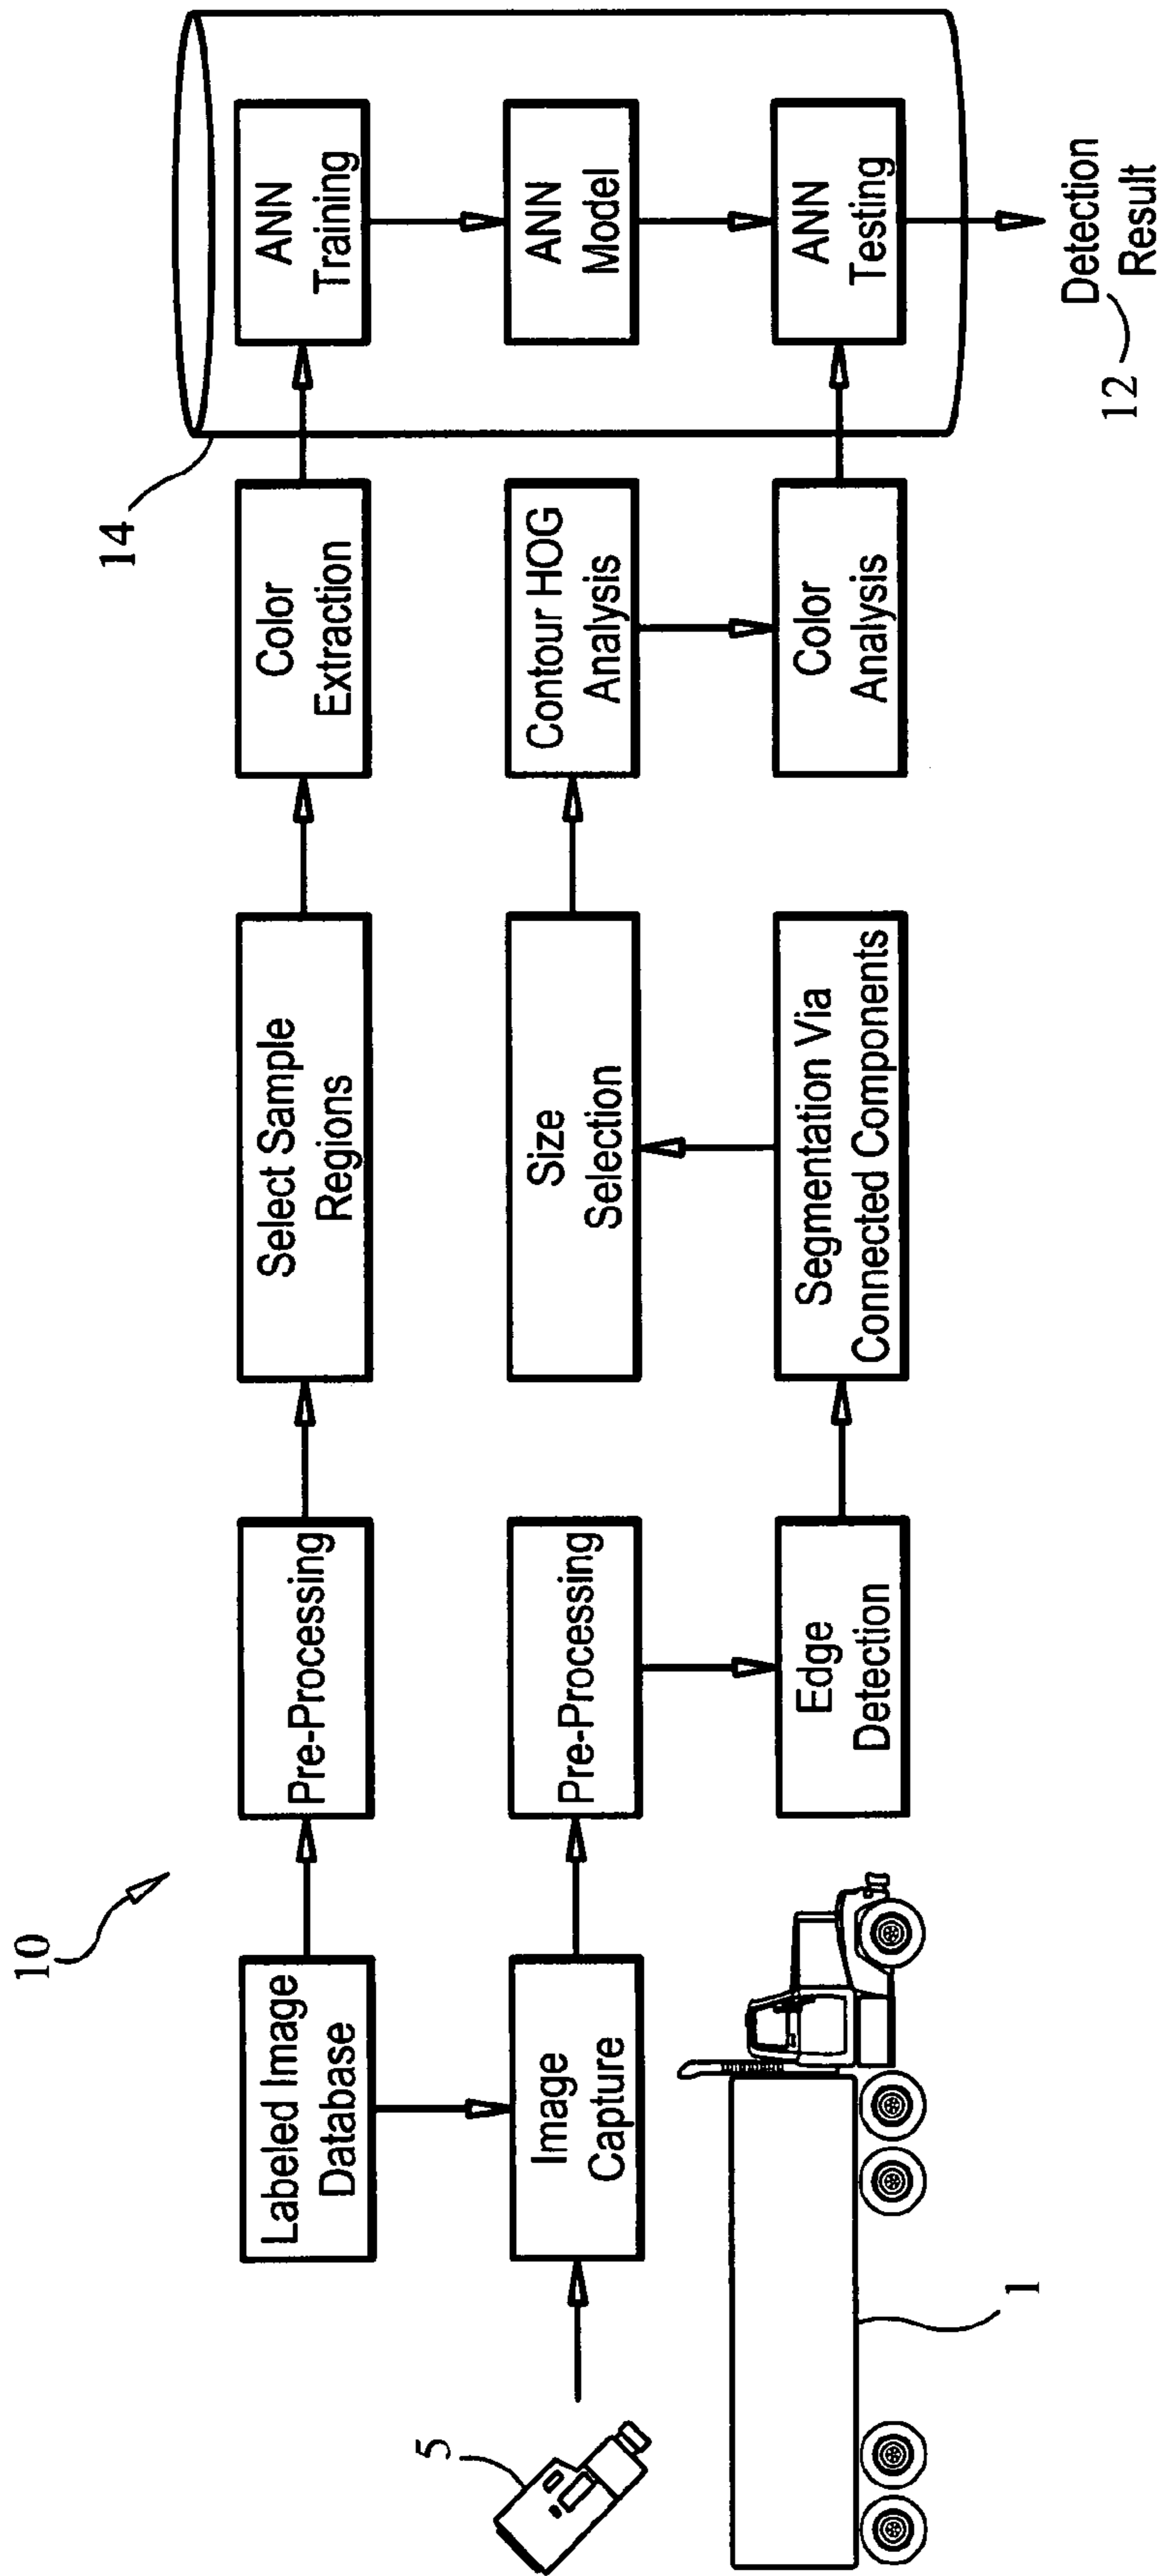
FIG. 1 is a schematic view of the components of the method and apparatus.

This particular method will use a color camera **5**, which will visually inspect the exterior lining of a surface as the tanker **1** moves through a particular portal or point of reference. More than one camera may be used to obtain multiple views of the tank. The camera **5** is likely to be mounted on a truss or frame structure (not depicted) and will be mounted to provide maximum exposure to insure adequate capture of the tank surface as it passes through the portal.

A color image of the tank's surface will be taken, and certain parameters of the surface lining or the surface tank will be viewed and analyzed by software **10**, which has been incorporated into this method. Certain presets are incorporated into the software in order for the software to distinguish between various tank characteristics and areas of possible

concern based on certain parameters. Once the camera image has been analyzed by the software the system will produce a detection result **12**. This detection result **12** will be incorporated into a histogram, which is a graphical display of tabulated frequencies.

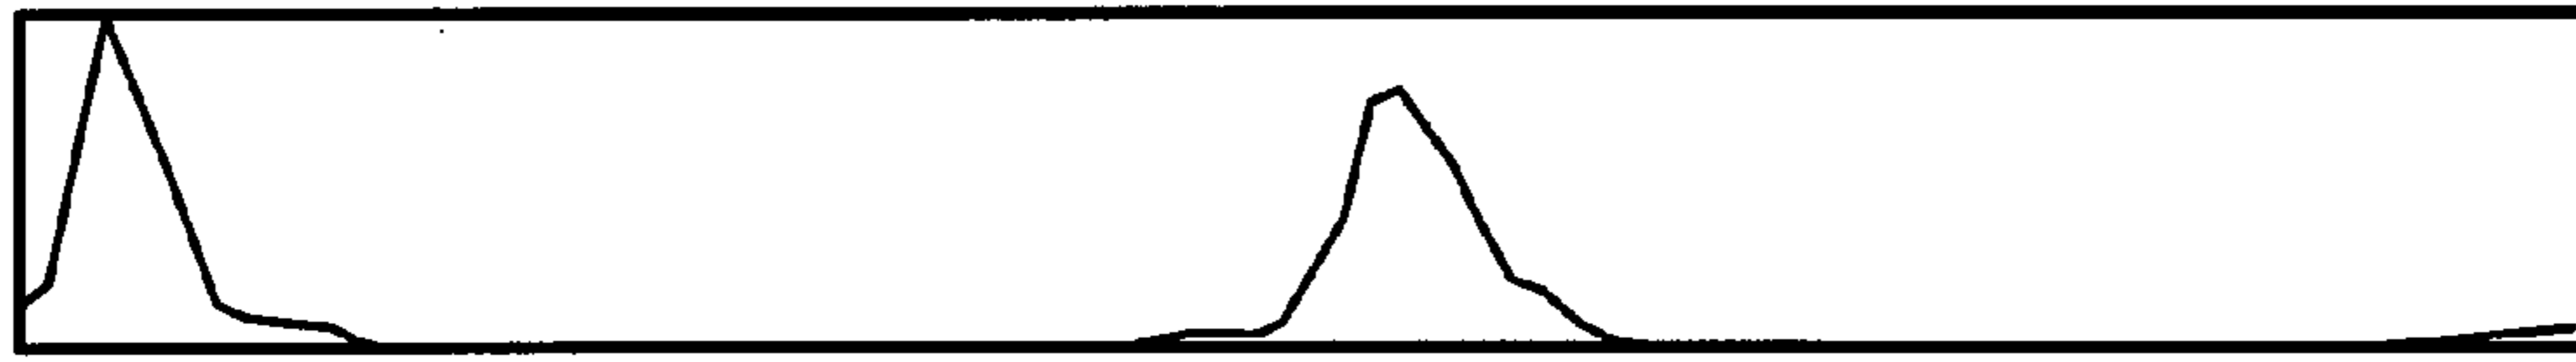
FIG. 2A is a sample histogram of oriented gradient (HOG) depicting the area of a healthy tank liner surface.

FIGS. **2A** and **2B** are representative histograms which depict relatively normal tank surfaces. The spikes that are found on FIGS. **2A** and **2B** are likely to be airborne contaminants such as dust or normal structural edges to the tank. Conversely the multiple areas of spikes that are found on FIGS. **2C** and **2D** are indicative of possible areas of corrosion and should alert personnel to take corrective action.

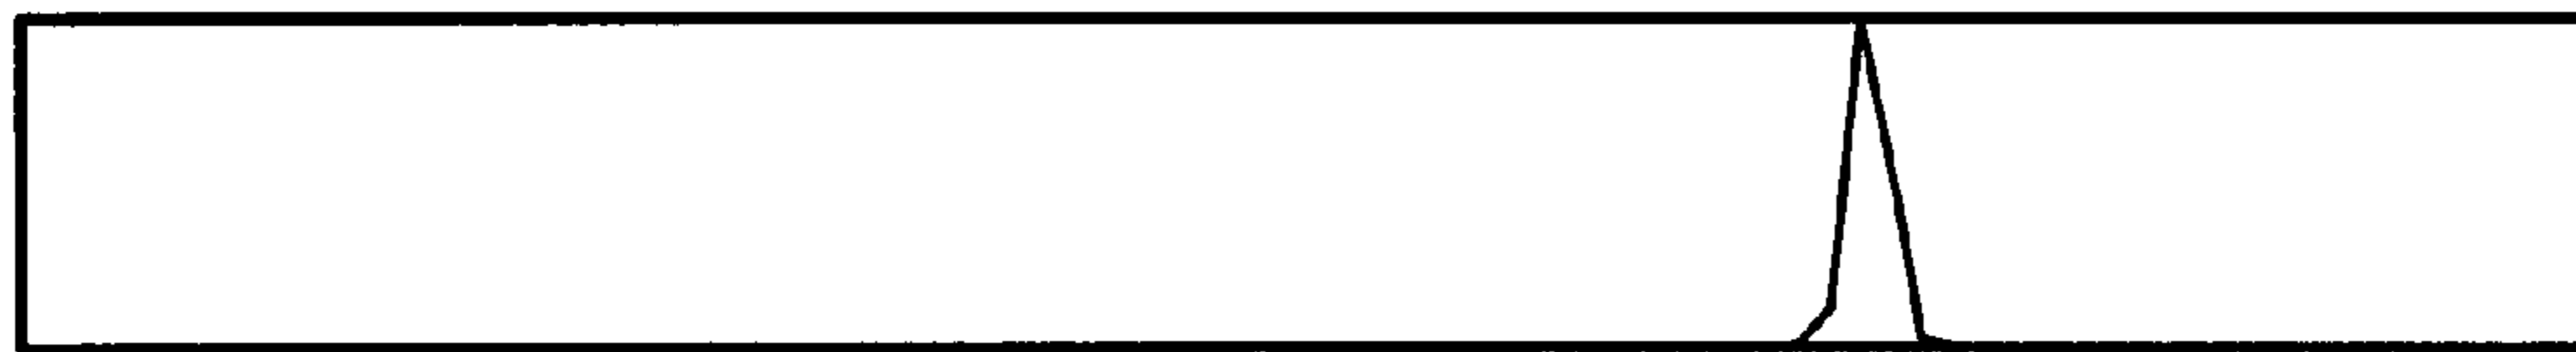
FIG. 2B is a sample histogram of oriented gradient (HOG) depicting the area of a healthy tank liner surface.

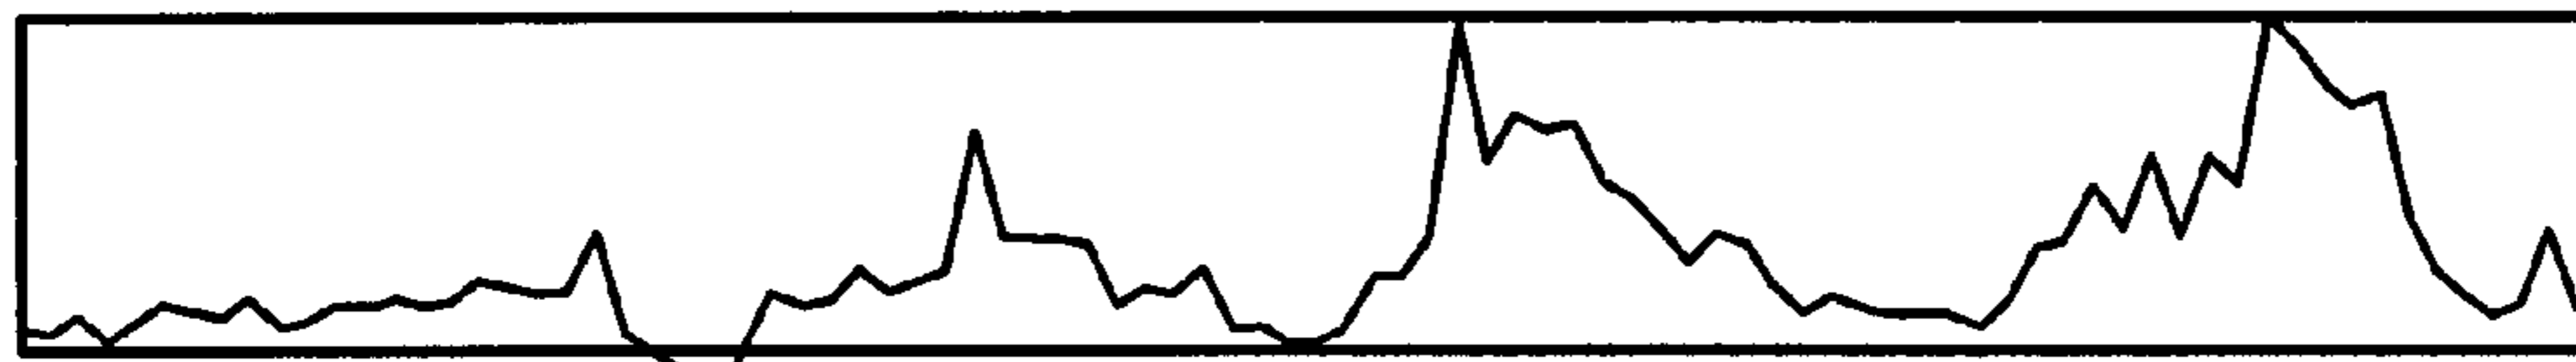
FIG. 2C is a sample histogram of oriented gradient (HOG) depicting the area of a possible corroded tank liner surface.

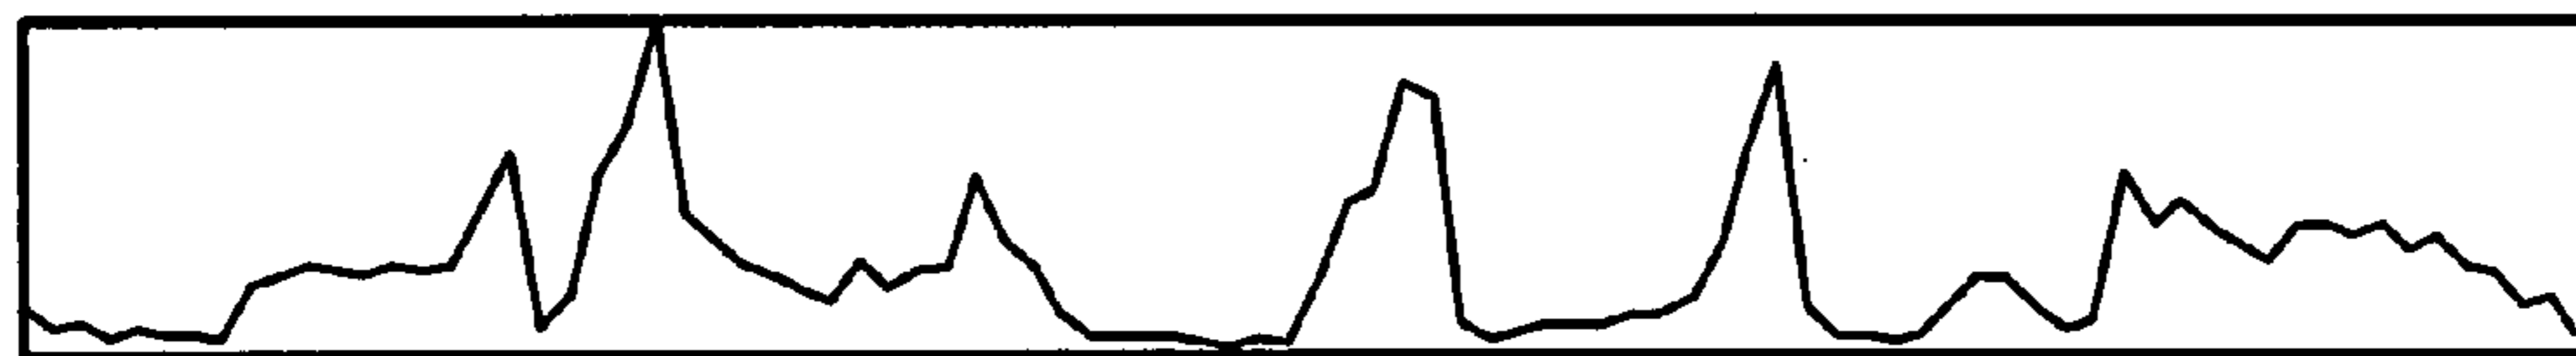
FIG. 2D is a sample histogram of oriented gradient (HOG) depicting the area of a possible corroded tank liner surface.

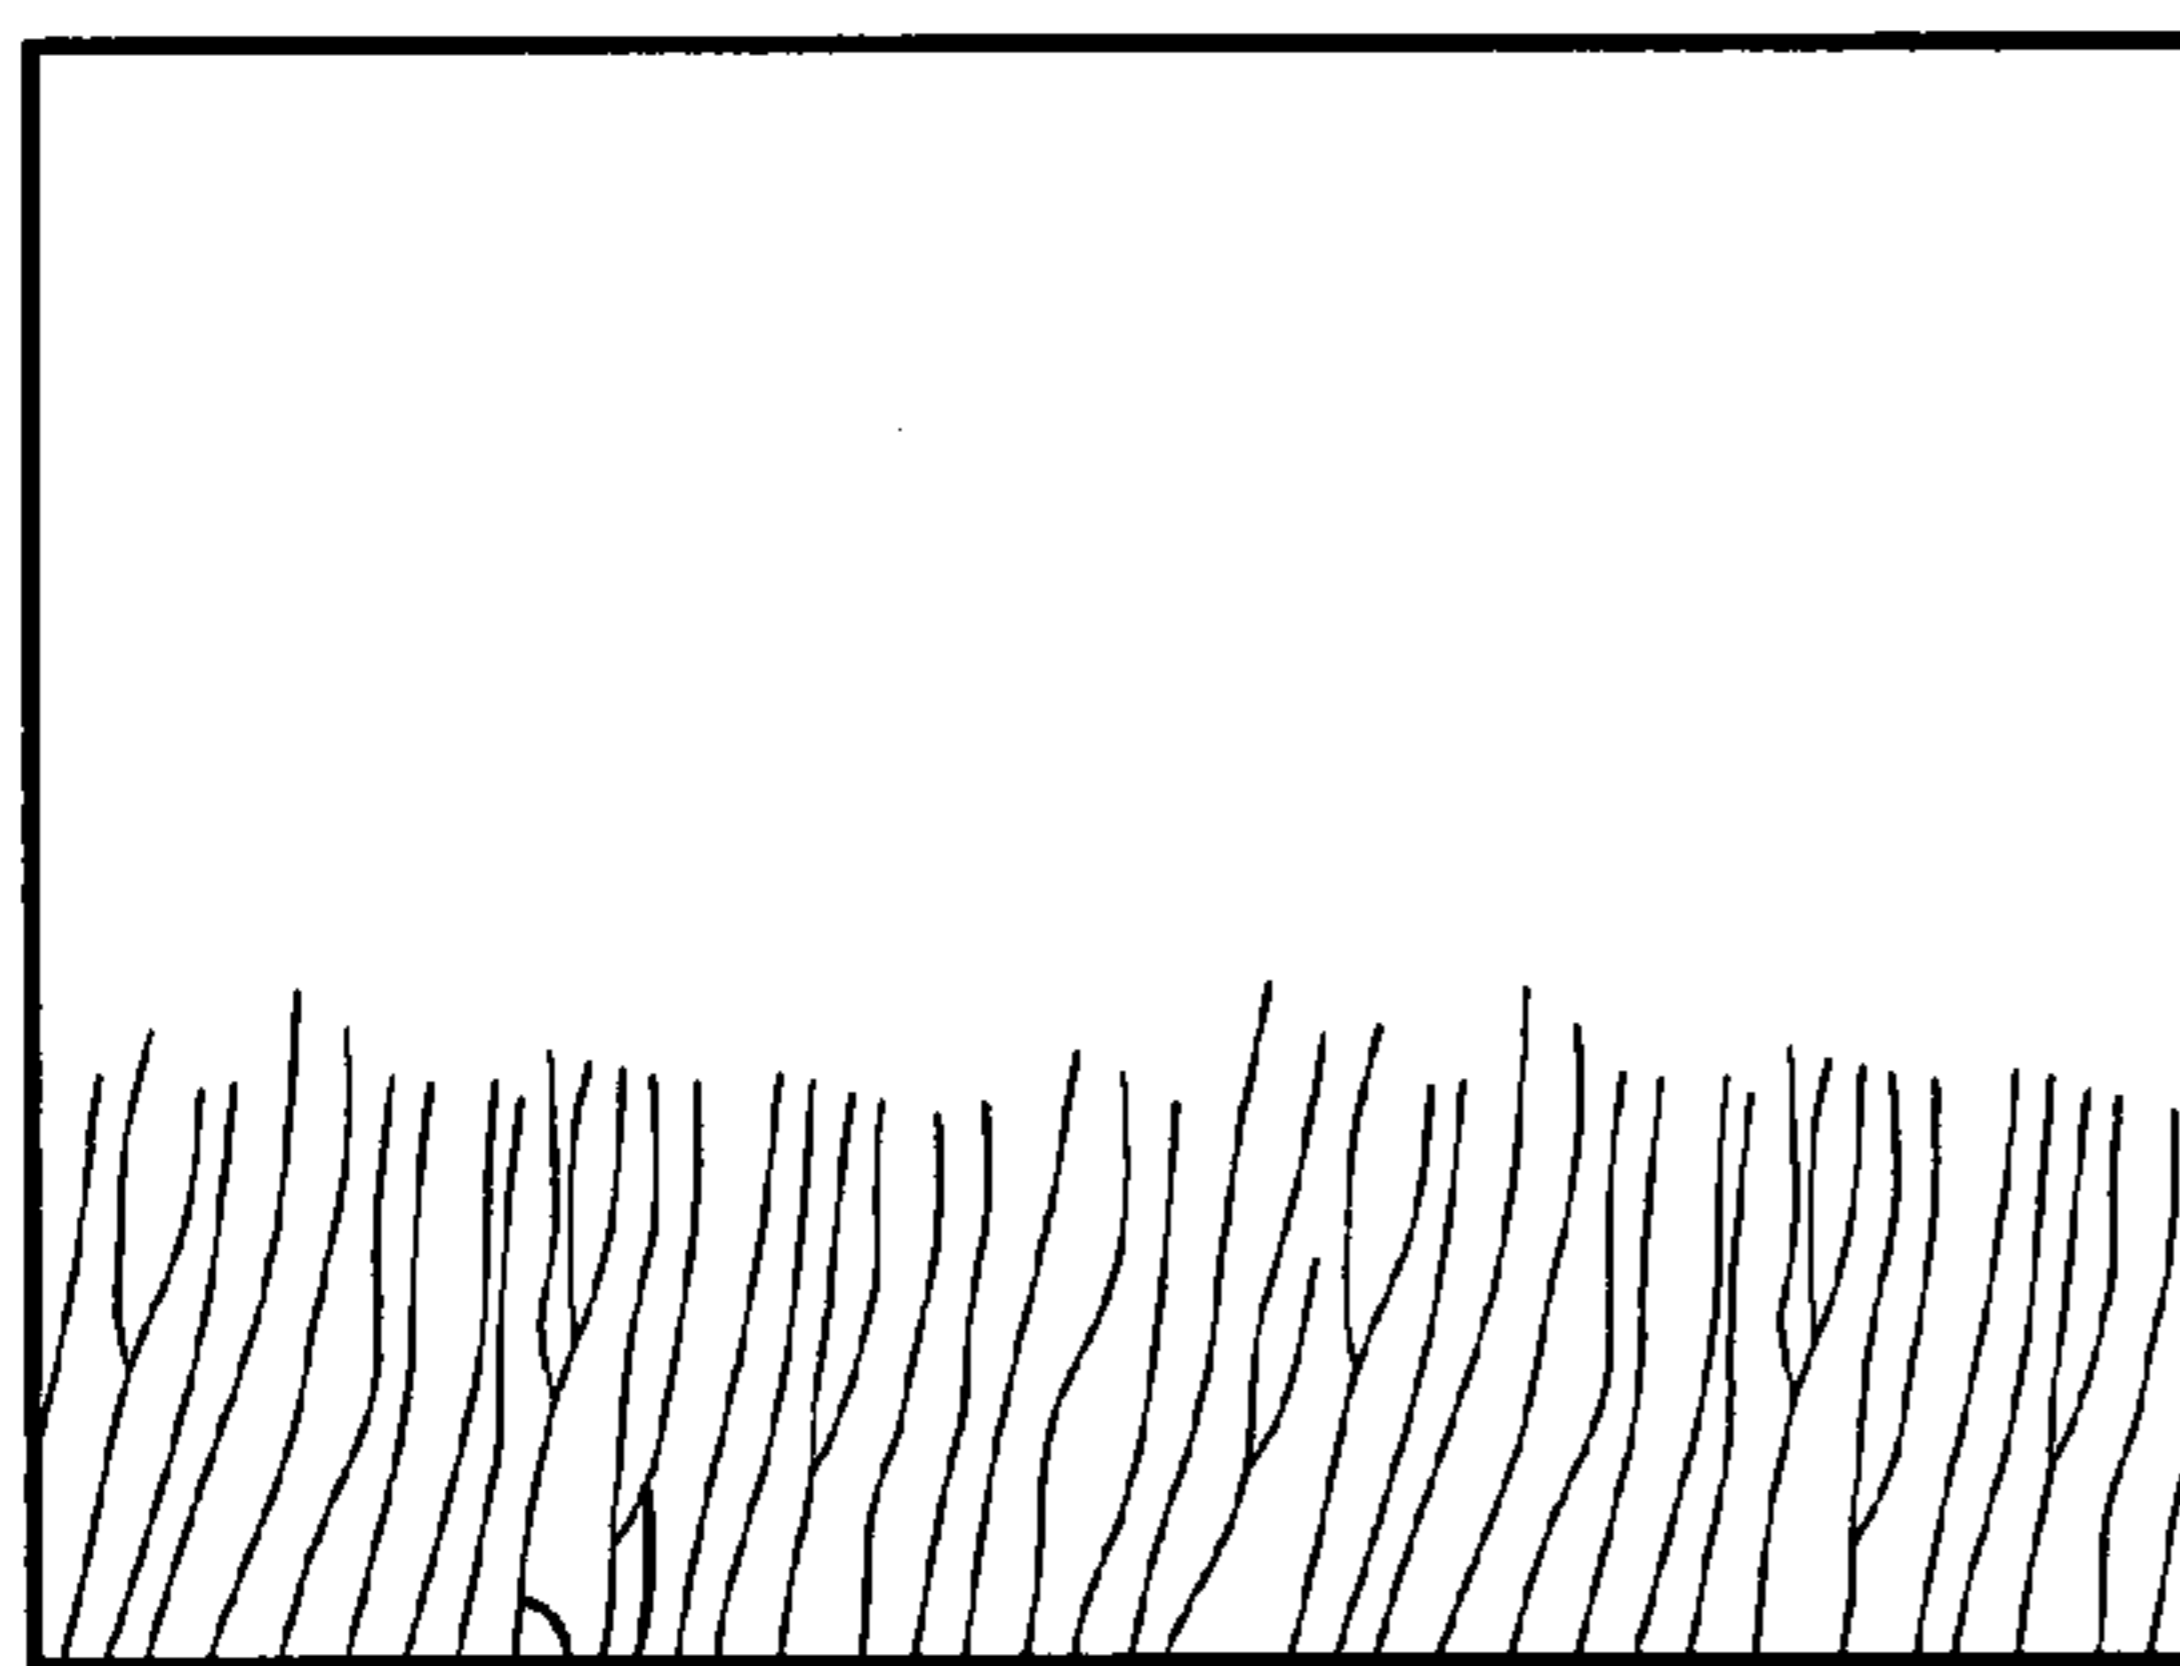
25 FIG. 4A

FIG. 4A is a representation of a healthy tank liner.

Areas of corrosion **20** typically are jagged and may be widespread or spotted throughout the tank lining, which would indicate the possible presence of corrosion such as depicted in FIG. **4B**. The software is able to discriminate between a healthy tank lining such as depicted in FIG. **4A** and areas of corrosion based on surface irregularity such as depicted in FIG. **4B**. These grid locations such as represented by FIGS. **4A** and **4B** can be viewed remotely.

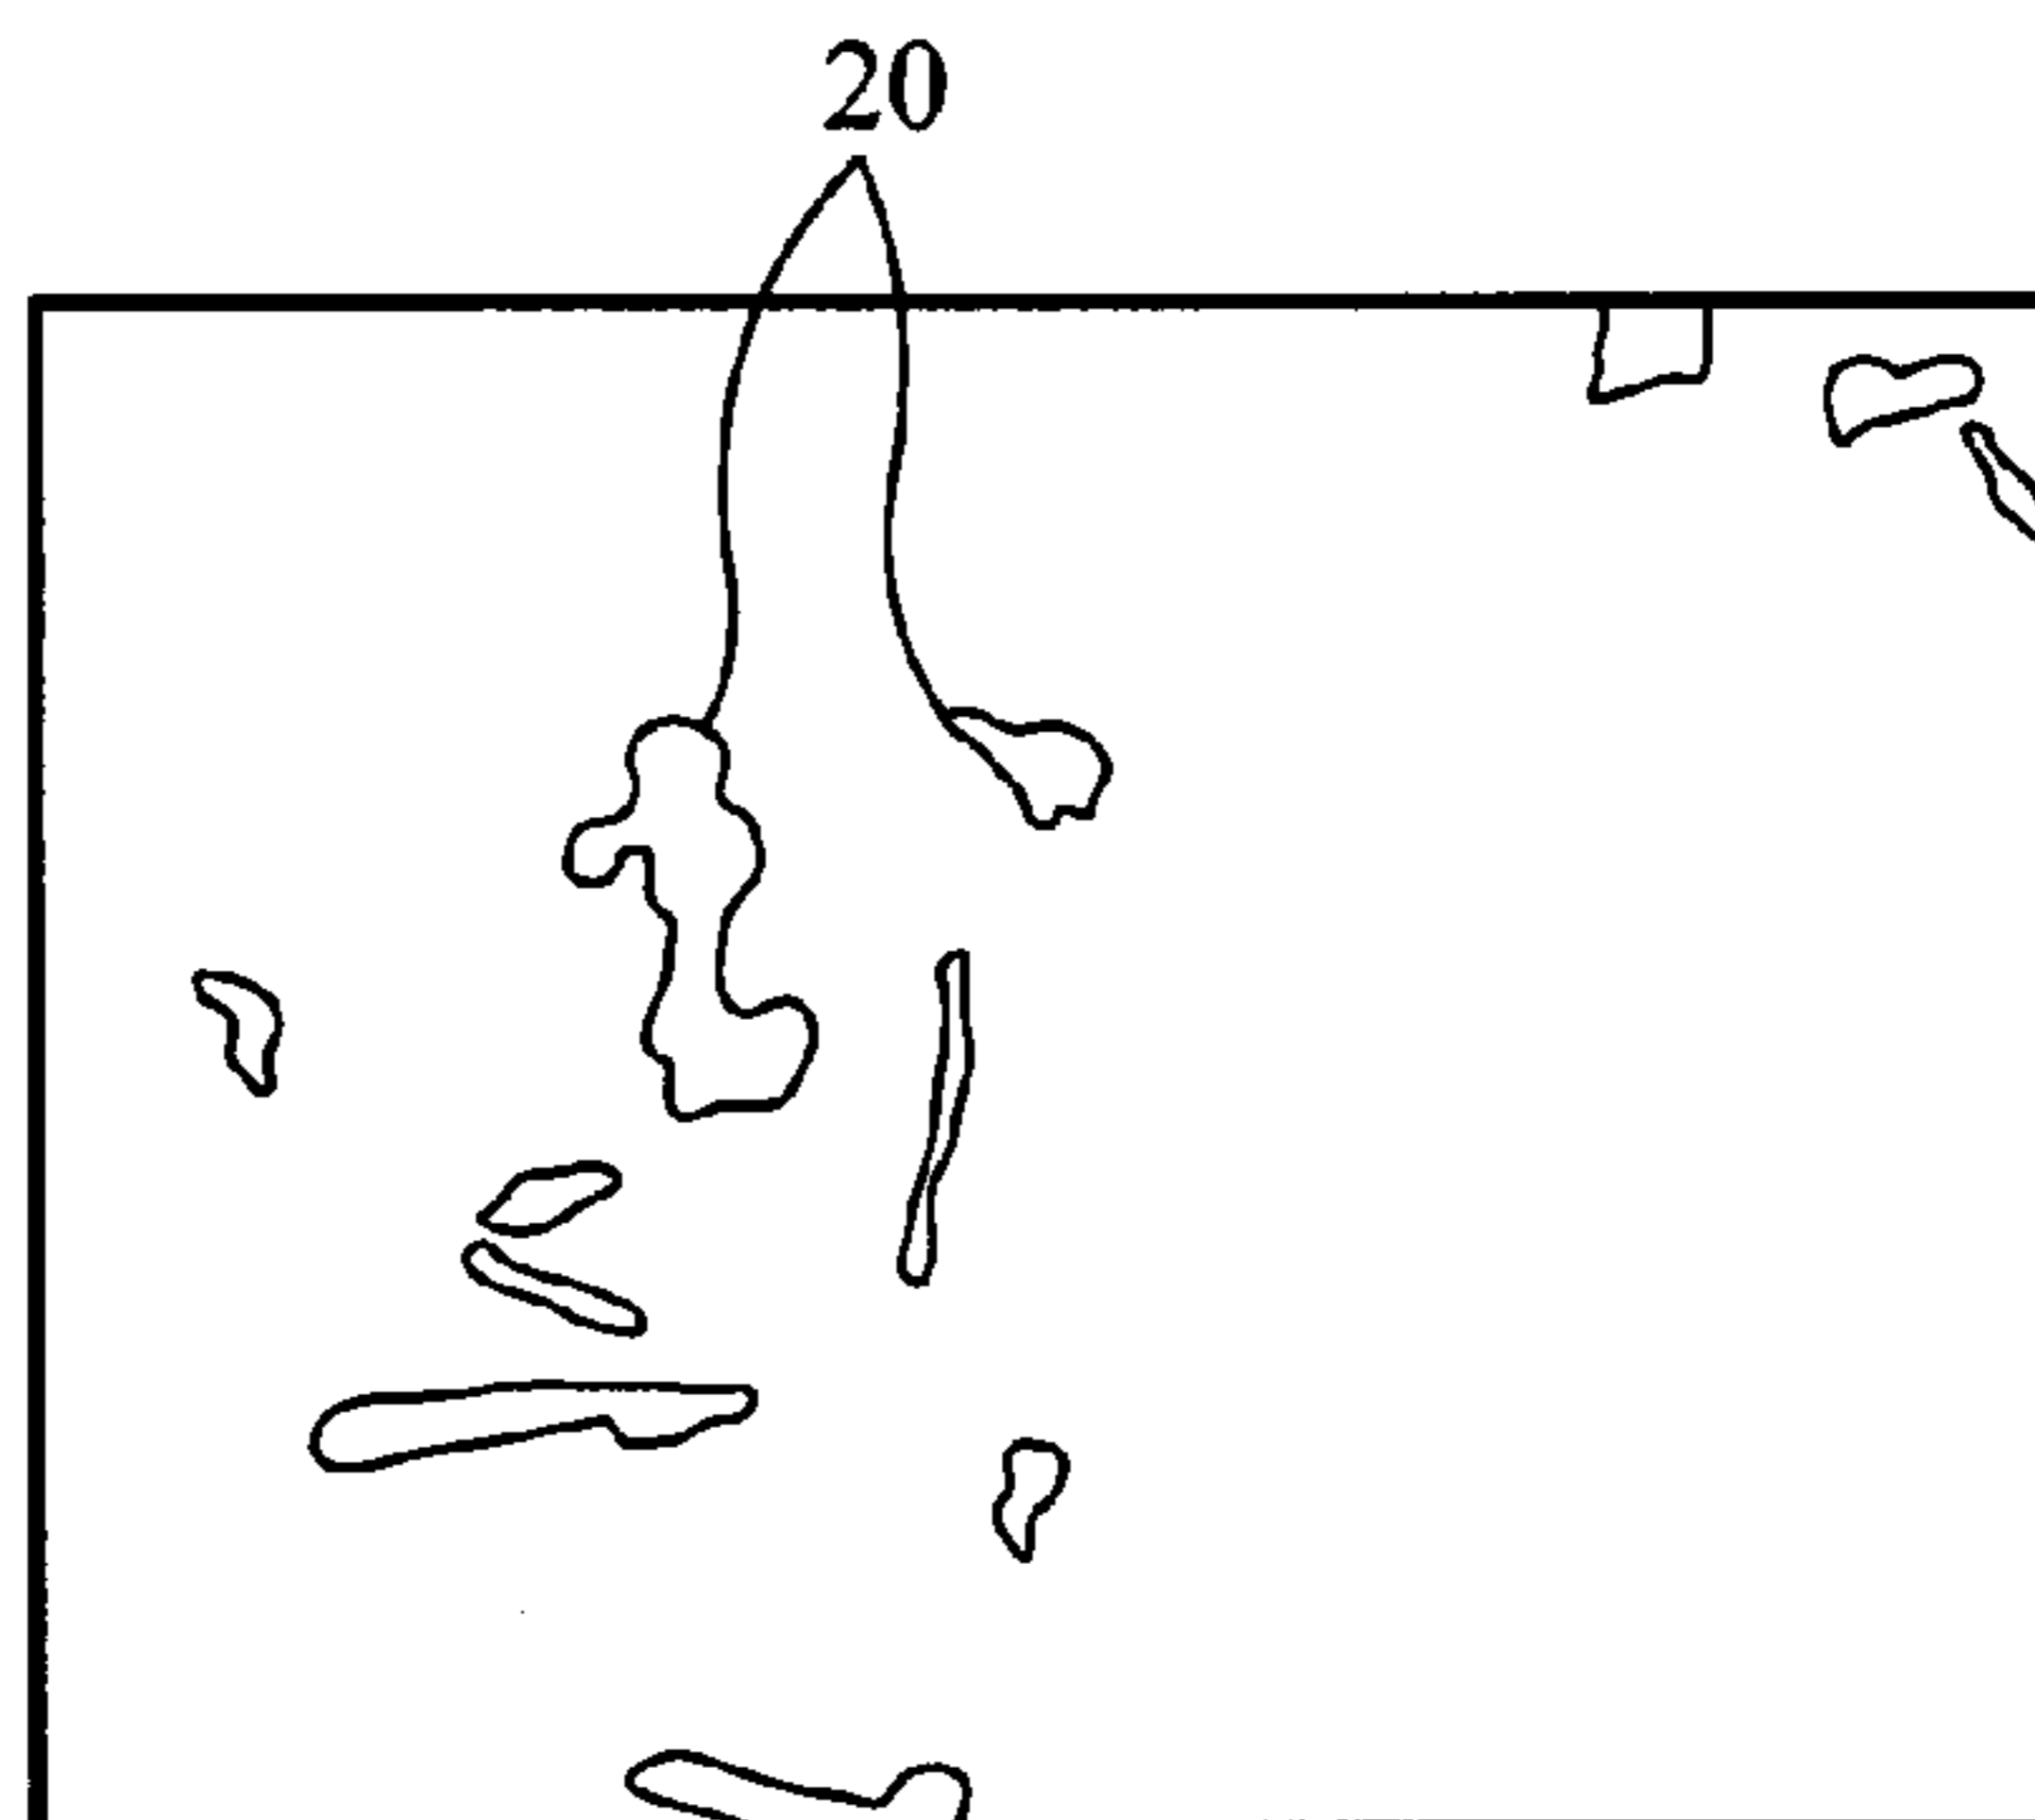
FIG. 4B is a representation of areas of corrosion on a tank liner.

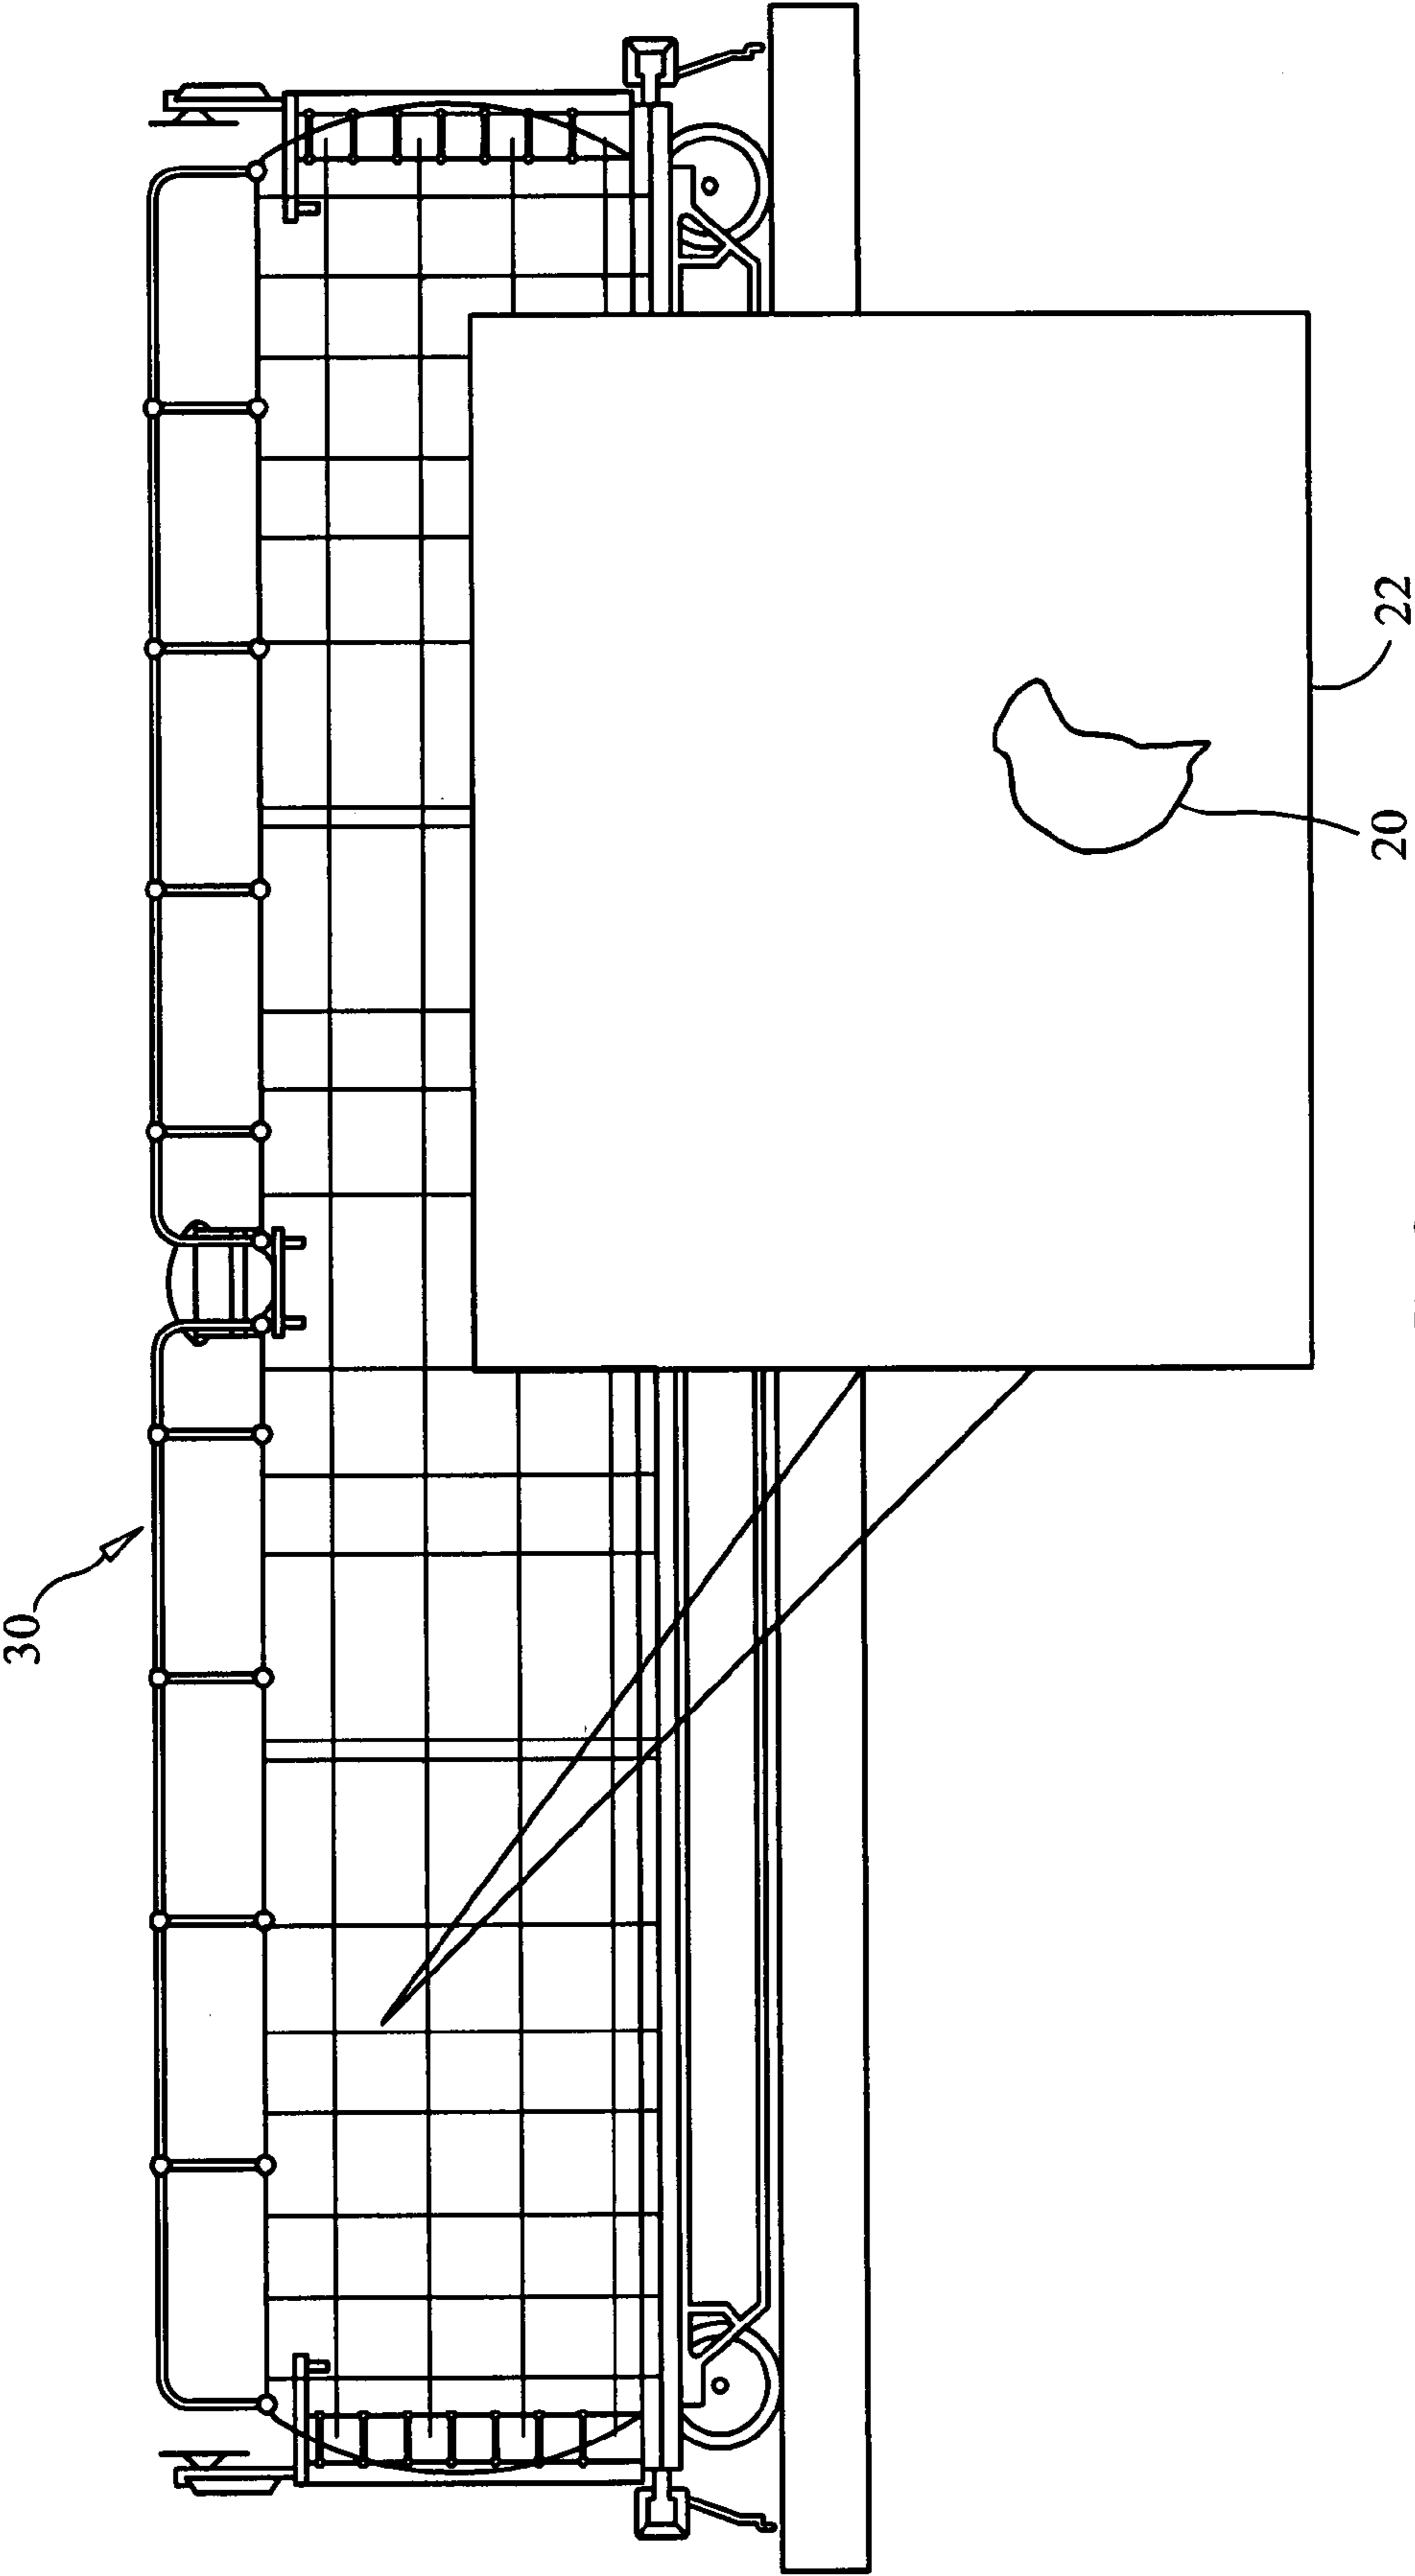
FIG. 3 is a view of the grid overlay on the tanker and a sample section of an area of possible corrosion.

The camera that is used in this system is a color camera. The camera will produce an image superimposed on a grid overlay **30** such as depicted in FIG. **3**. Individual grid locations are also represented by FIGS. **4A** and **4B**. The use of a grid overlay **30** allows the operator to pinpoint the specific location on a specific area **22** on a tank where possible areas of corrosion **20** exist. The grid overlay **30** and individual grid sections **22** can be viewed remotely.
