(12) **United States Patent**
Arcaini et al.

(10) **Patent No.:** **US 7,822,273 B1**
(45) **Date of Patent:** **Oct. 26, 2010**

(54) **METHOD AND APPARATUS FOR
AUTOMATIC CORROSION DETECTION VIA
VIDEO CAPTURE**

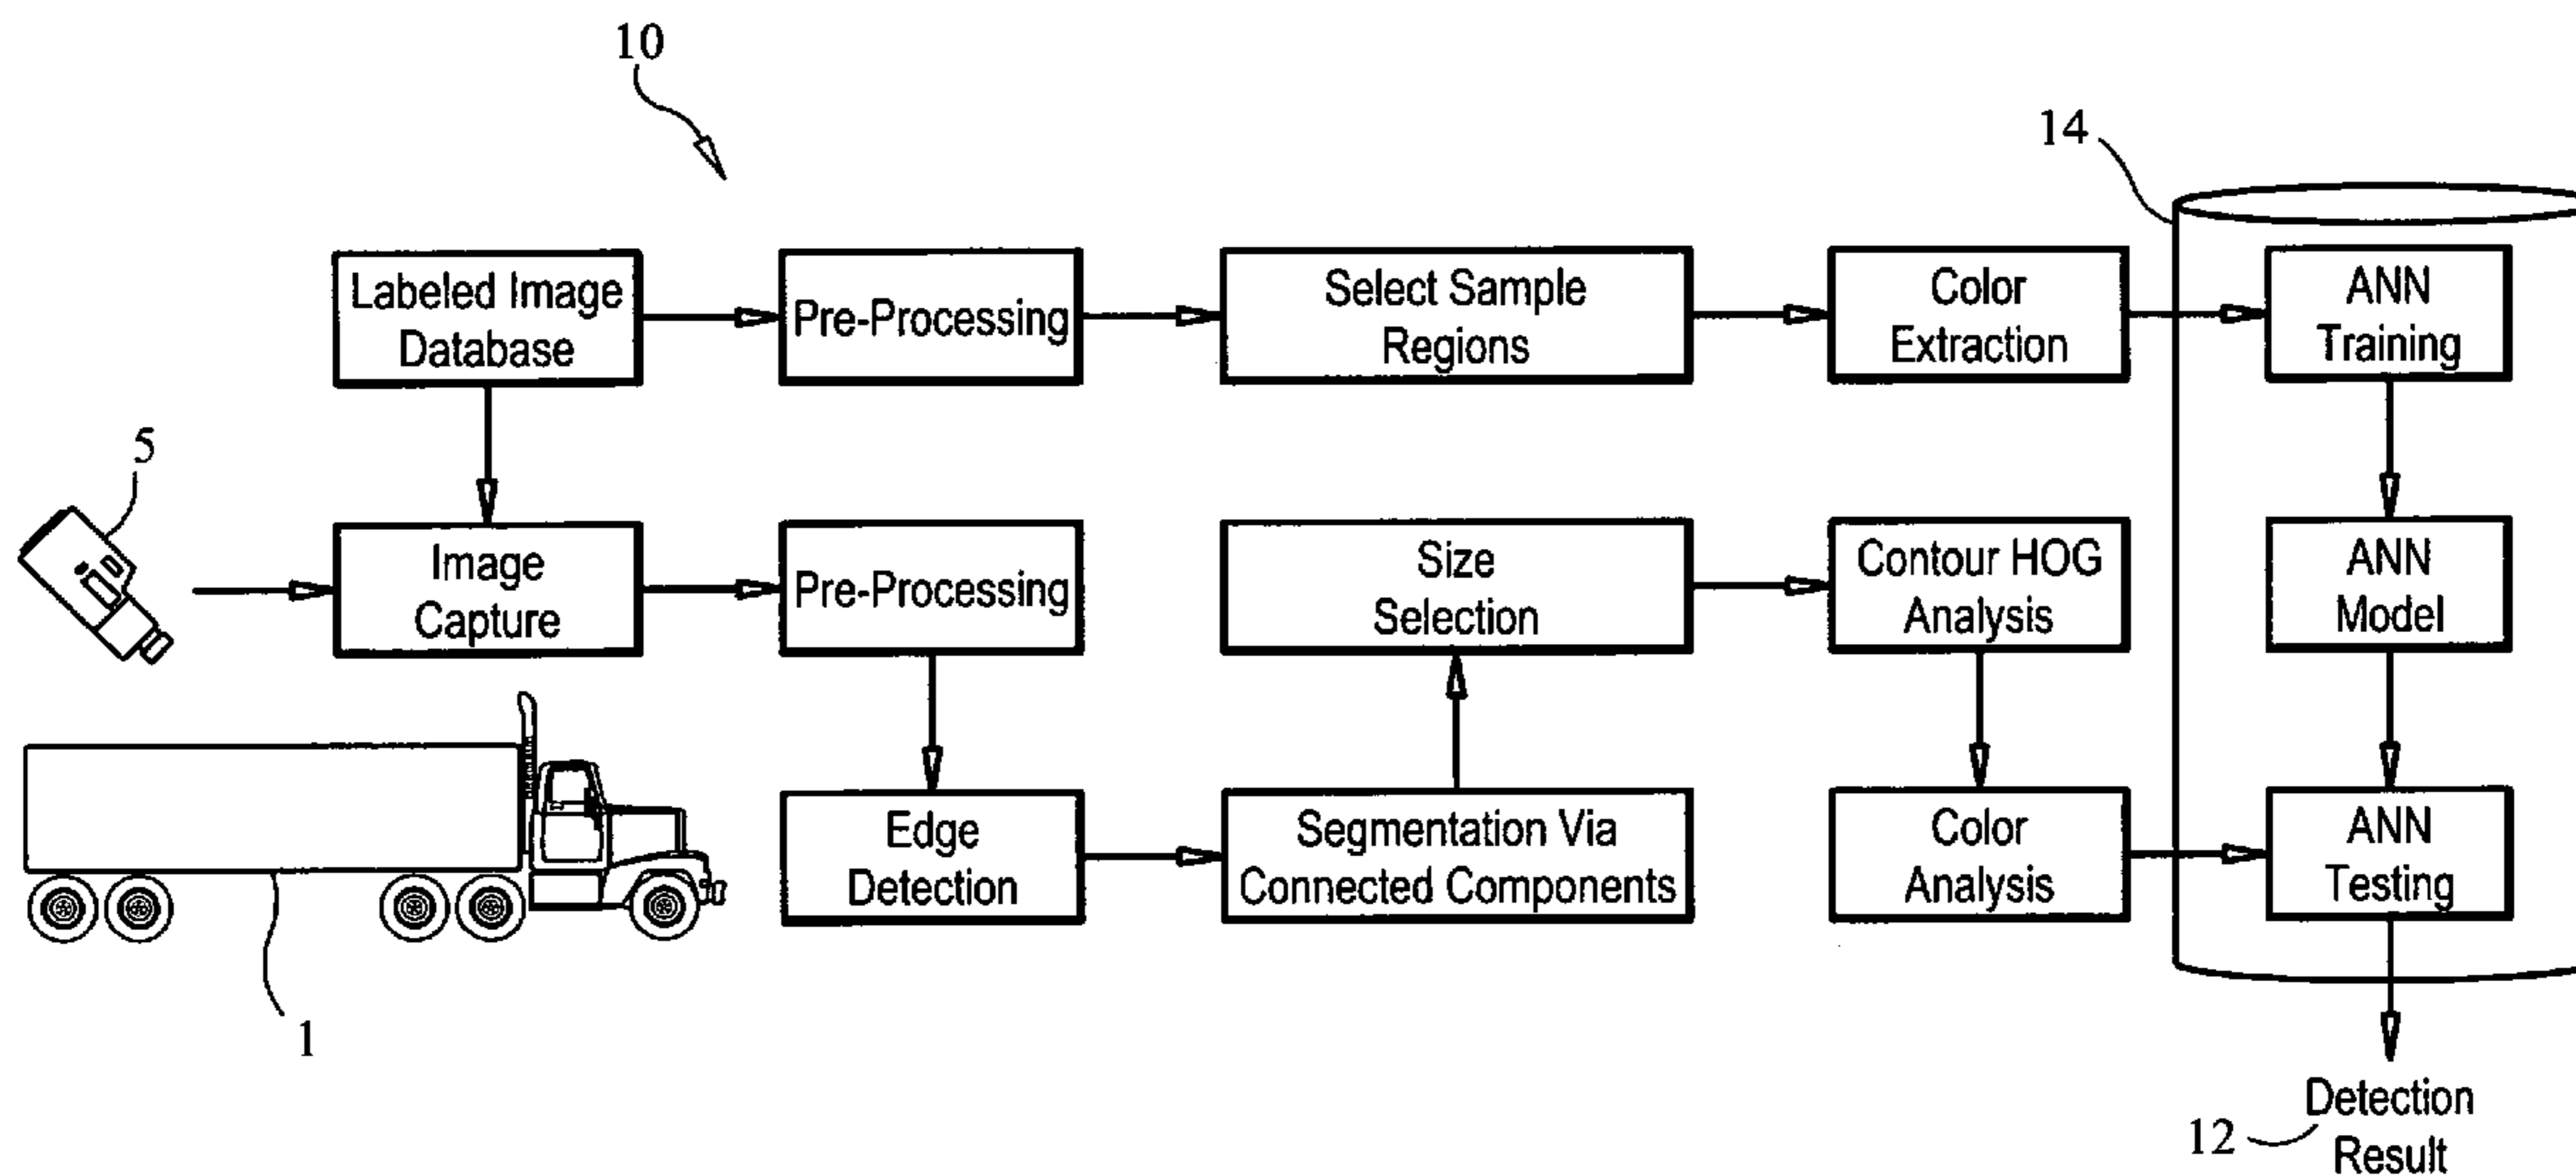
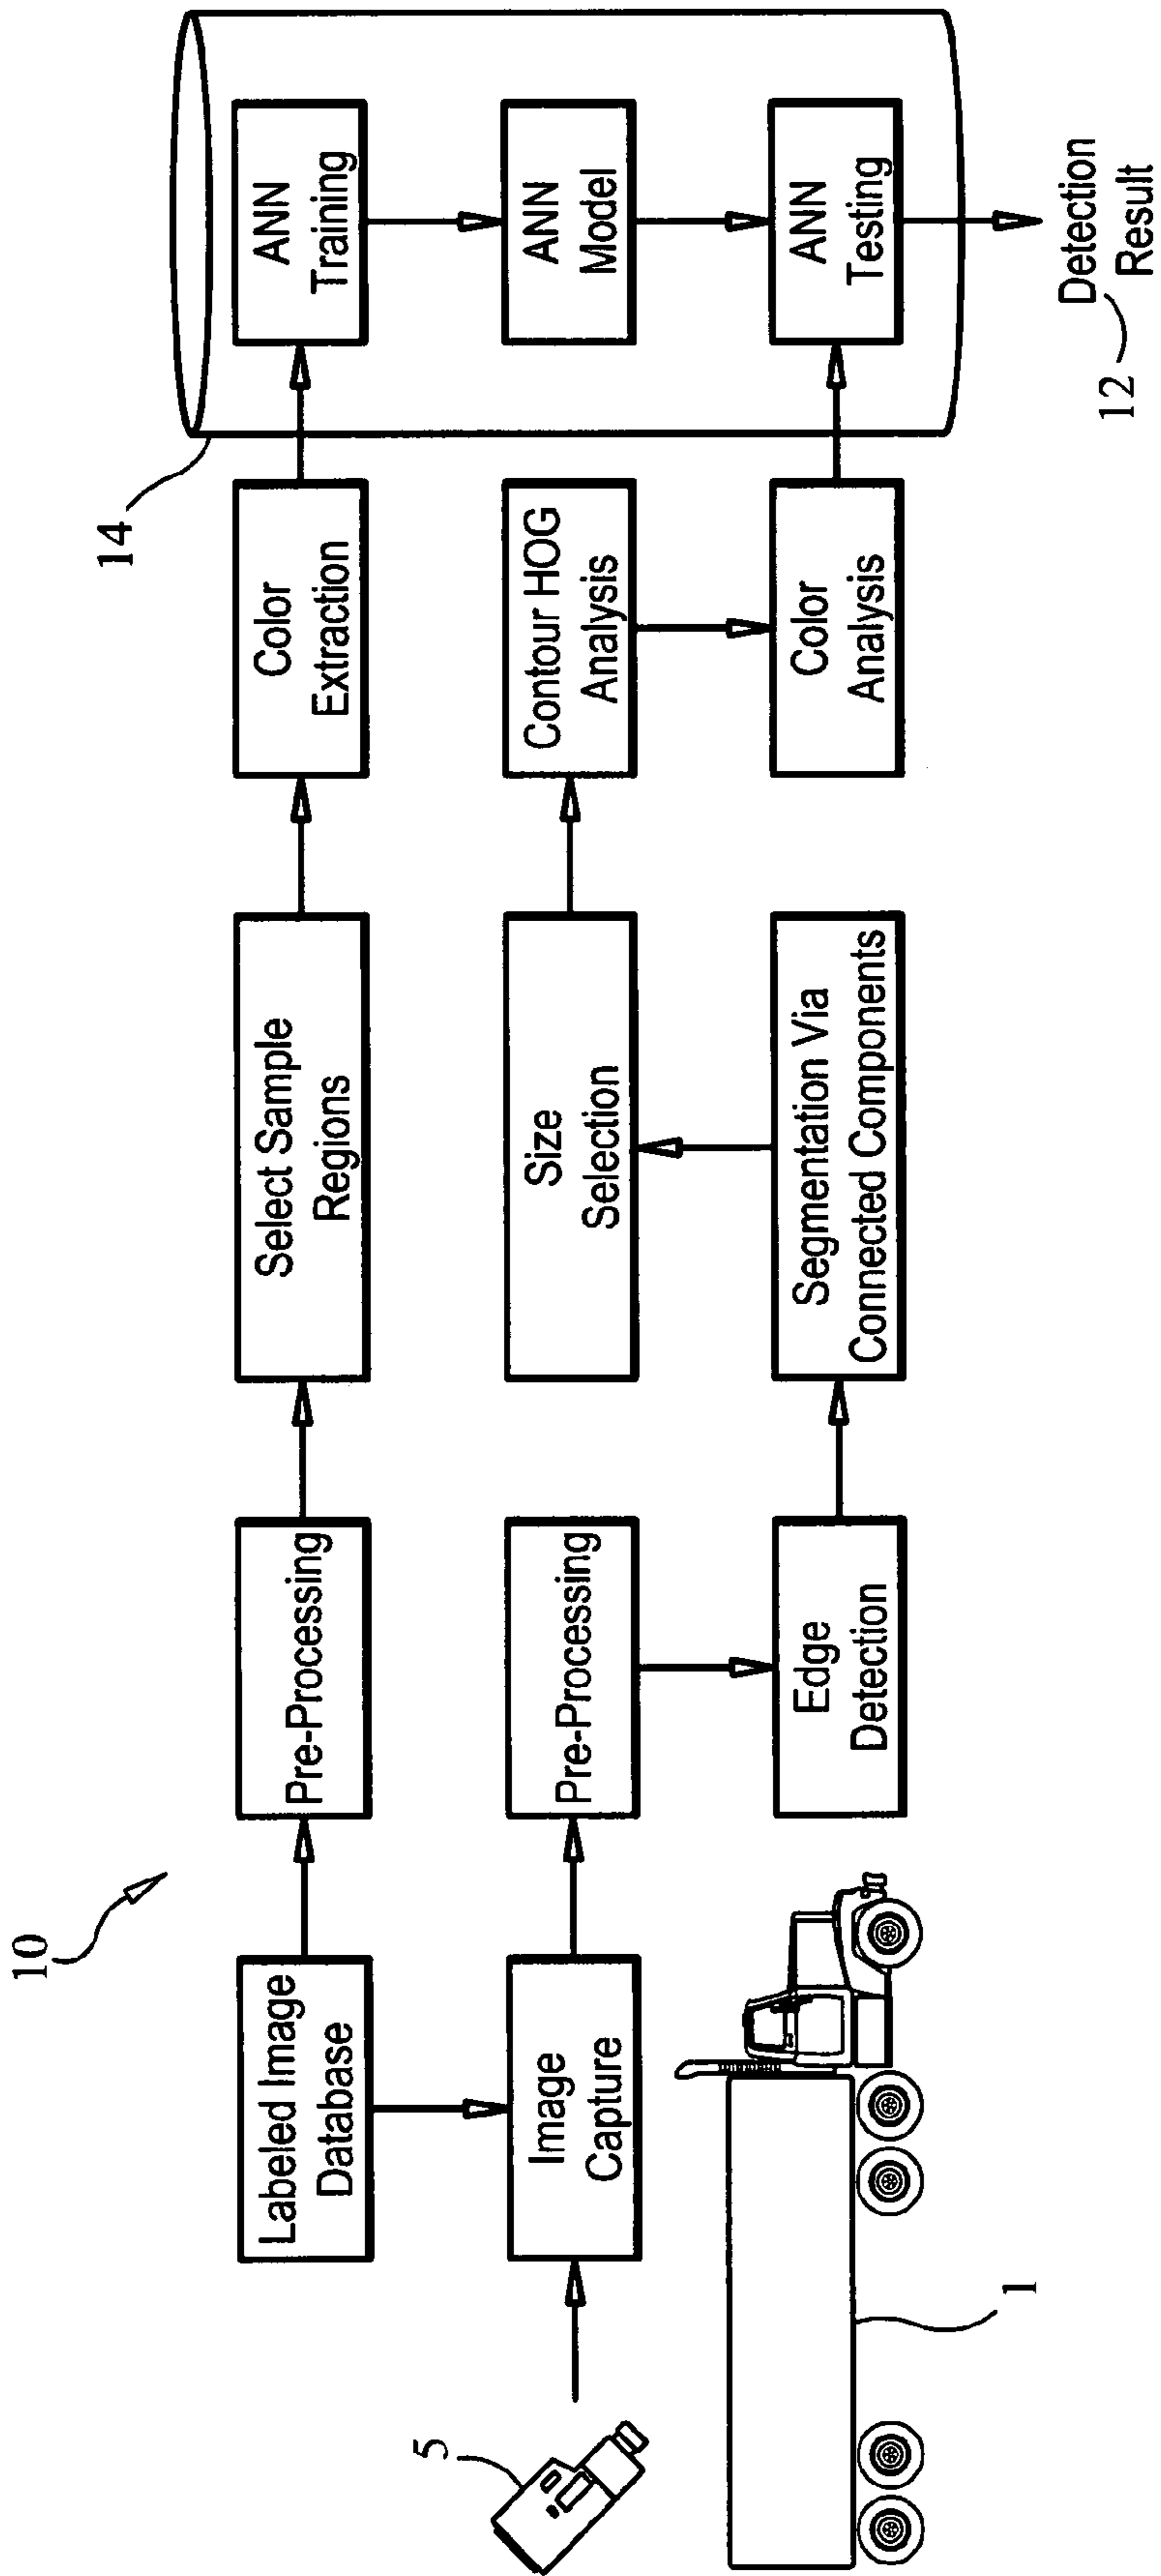
FIG. 1 is a schematic view of the components of the method and apparatus.

This particular method will use a color camera **5**, which will visually inspect the exterior lining of a surface as the tanker **1** moves through a particular portal or point of reference. More than one camera may be used to obtain multiple views of the tank. The camera **5** is likely to be mounted on a truss or frame structure (not depicted) and will be mounted to provide maximum exposure to insure adequate capture of the tank surface as it passes through the portal.

A color image of the tank's surface will be taken, and certain parameters of the surface lining or the surface tank will be viewed and analyzed by software **10**, which has been incorporated into this method. Certain presets are incorporated into the software in order for the software to distinguish between various tank characteristics and areas of possible

concern based on certain parameters. Once the camera image has been analyzed by the software the system will produce a detection result **12**. This detection result **12** will be incorporated into a histogram, which is a graphical display of tabulated frequencies.

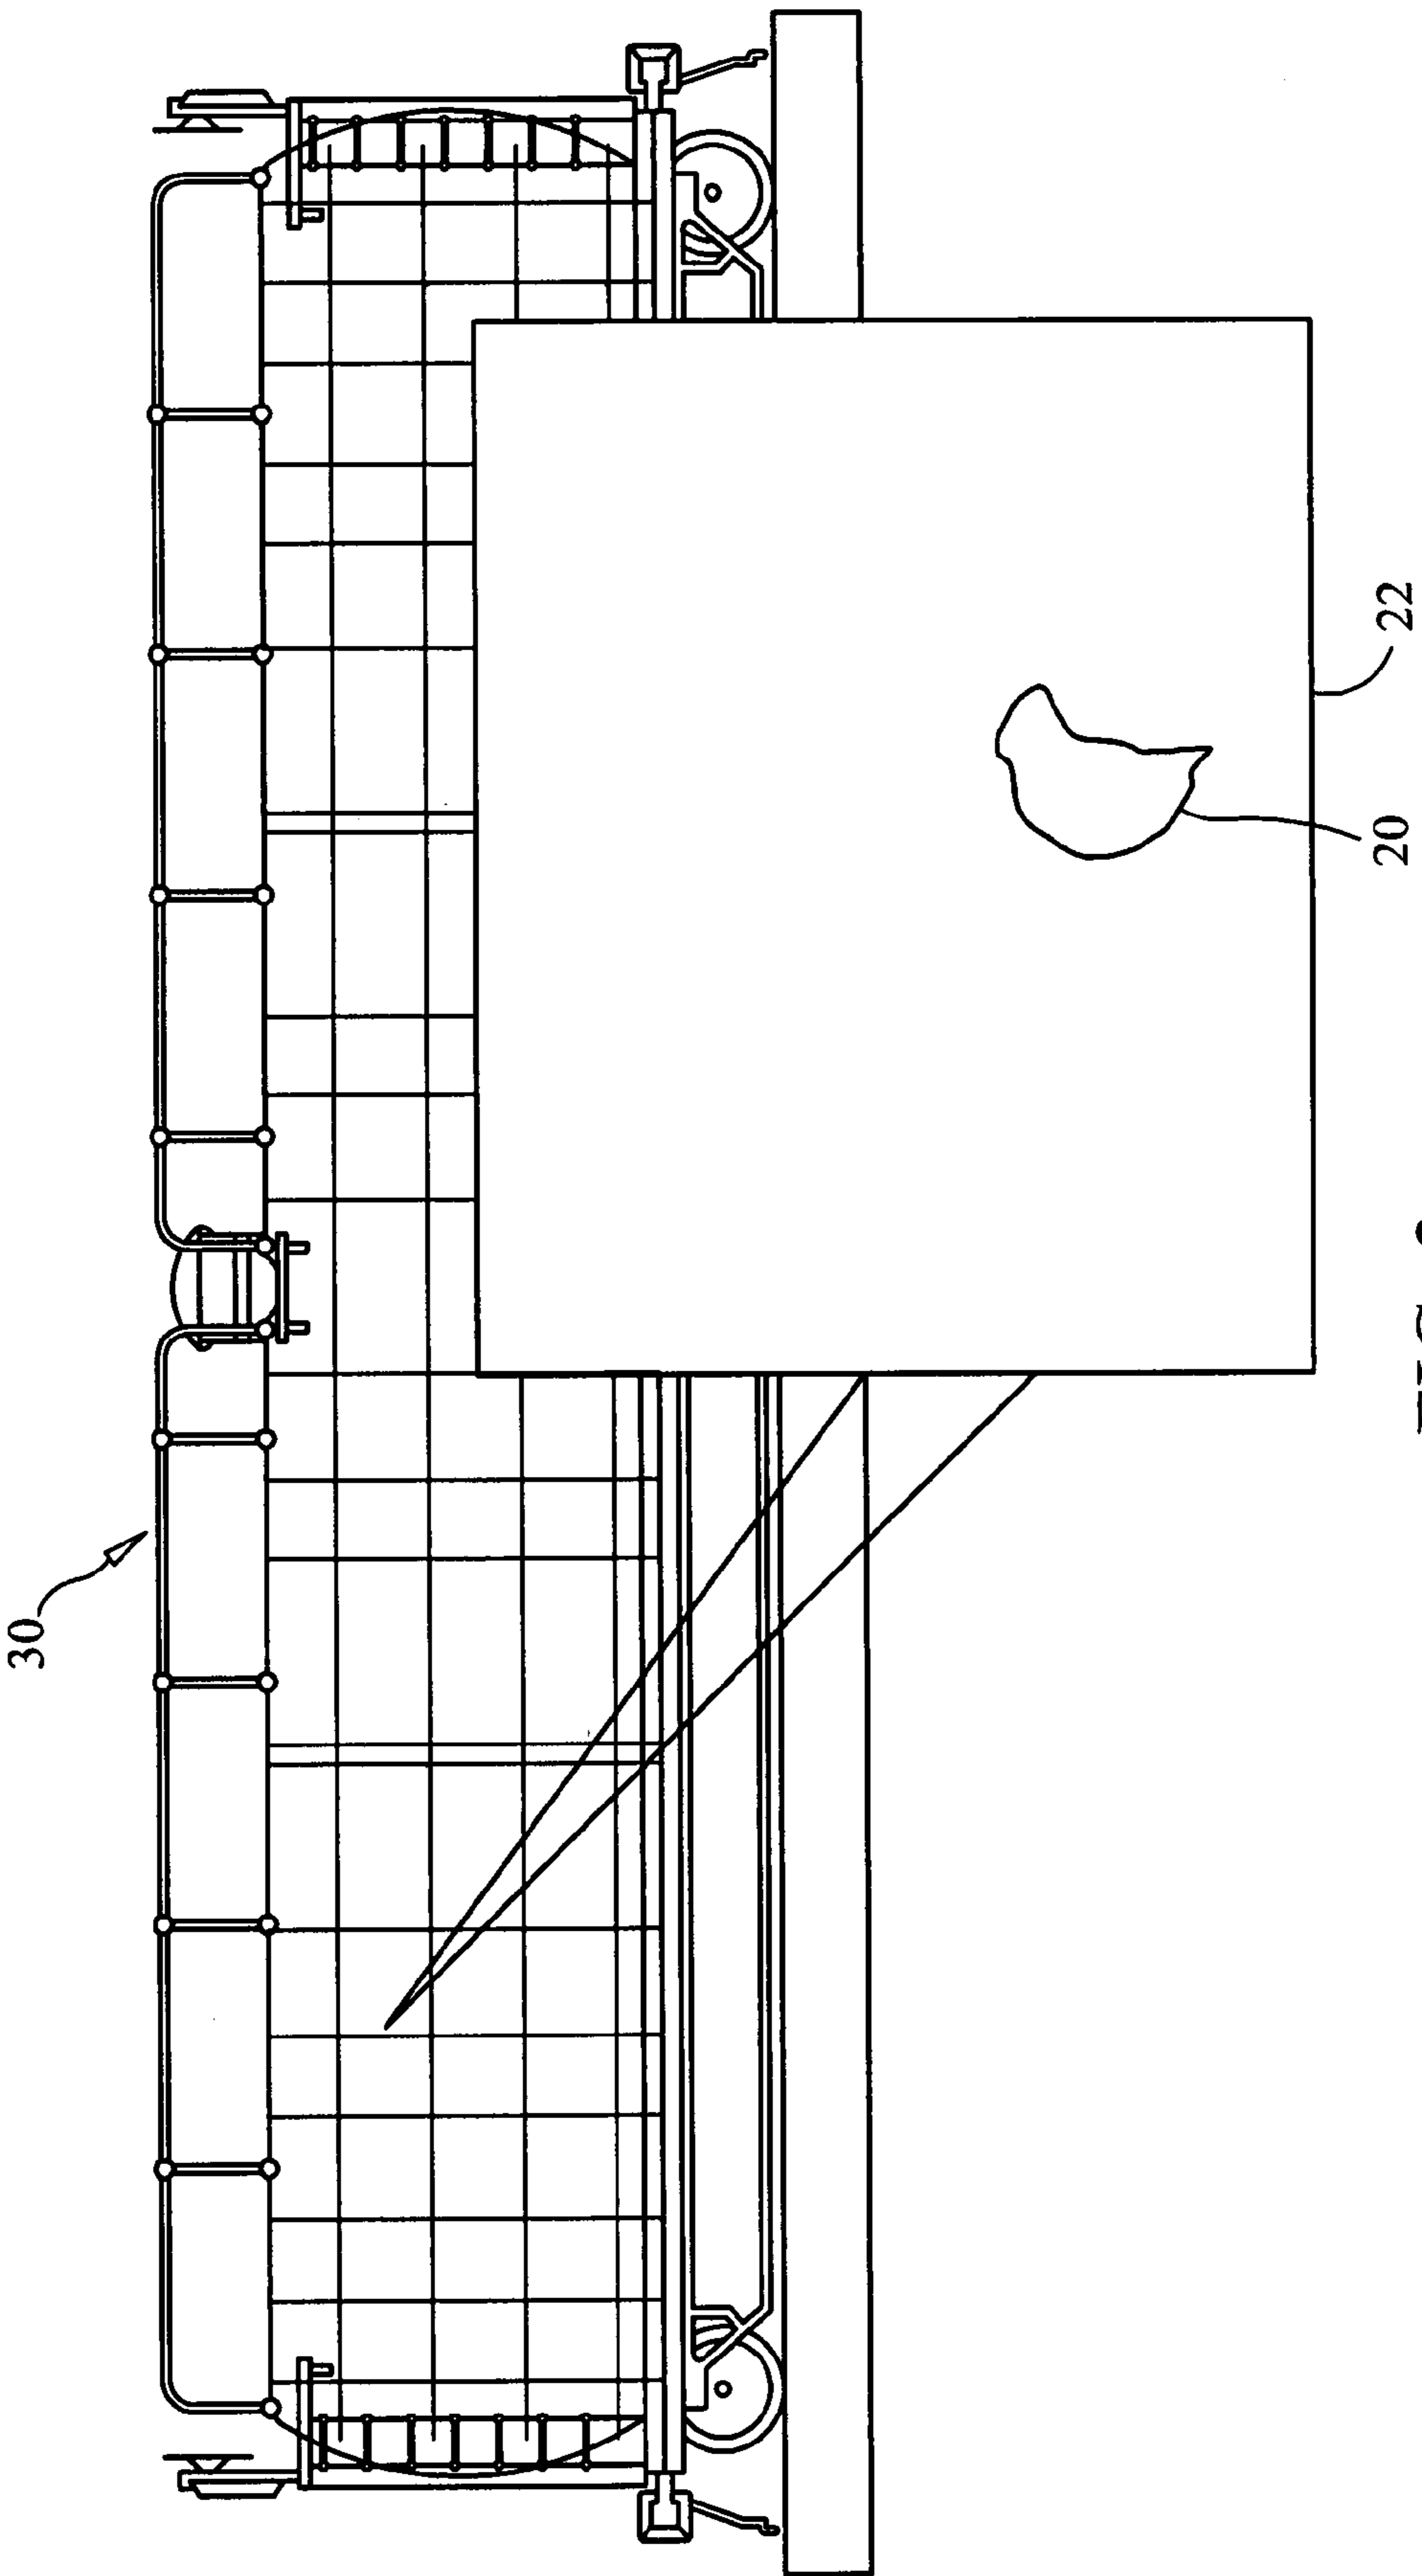
FIG. 3 is a view of the grid overlay on the tanker and a sample section of an area of possible corrosion.

The camera that is used in this system is a color camera. The camera will produce an image superimposed on a grid overlay **30** such as depicted in FIG. **3**. Individual grid locations are also represented by FIGS. **4A** and **4B**. The use of a grid overlay **30** allows the operator to pinpoint the specific location on a specific area **22** on a tank where possible areas of corrosion **20** exist. The grid overlay **30** and individual grid sections **22** can be viewed remotely.
