(10) **Patent No.:** **US 7,858,897 B2**
(45) **Date of Patent:** **Dec. 28, 2010**

(54) **INSERT WELD REPAIR**

(73) Assignee: **United Technologies Corporation**,
Hartford, CT (US)

The present invention relates to the repair of turbine engine components, and in particular to the repair of small diameter holes located on the flange of a part such as the forward inner nozzle support.

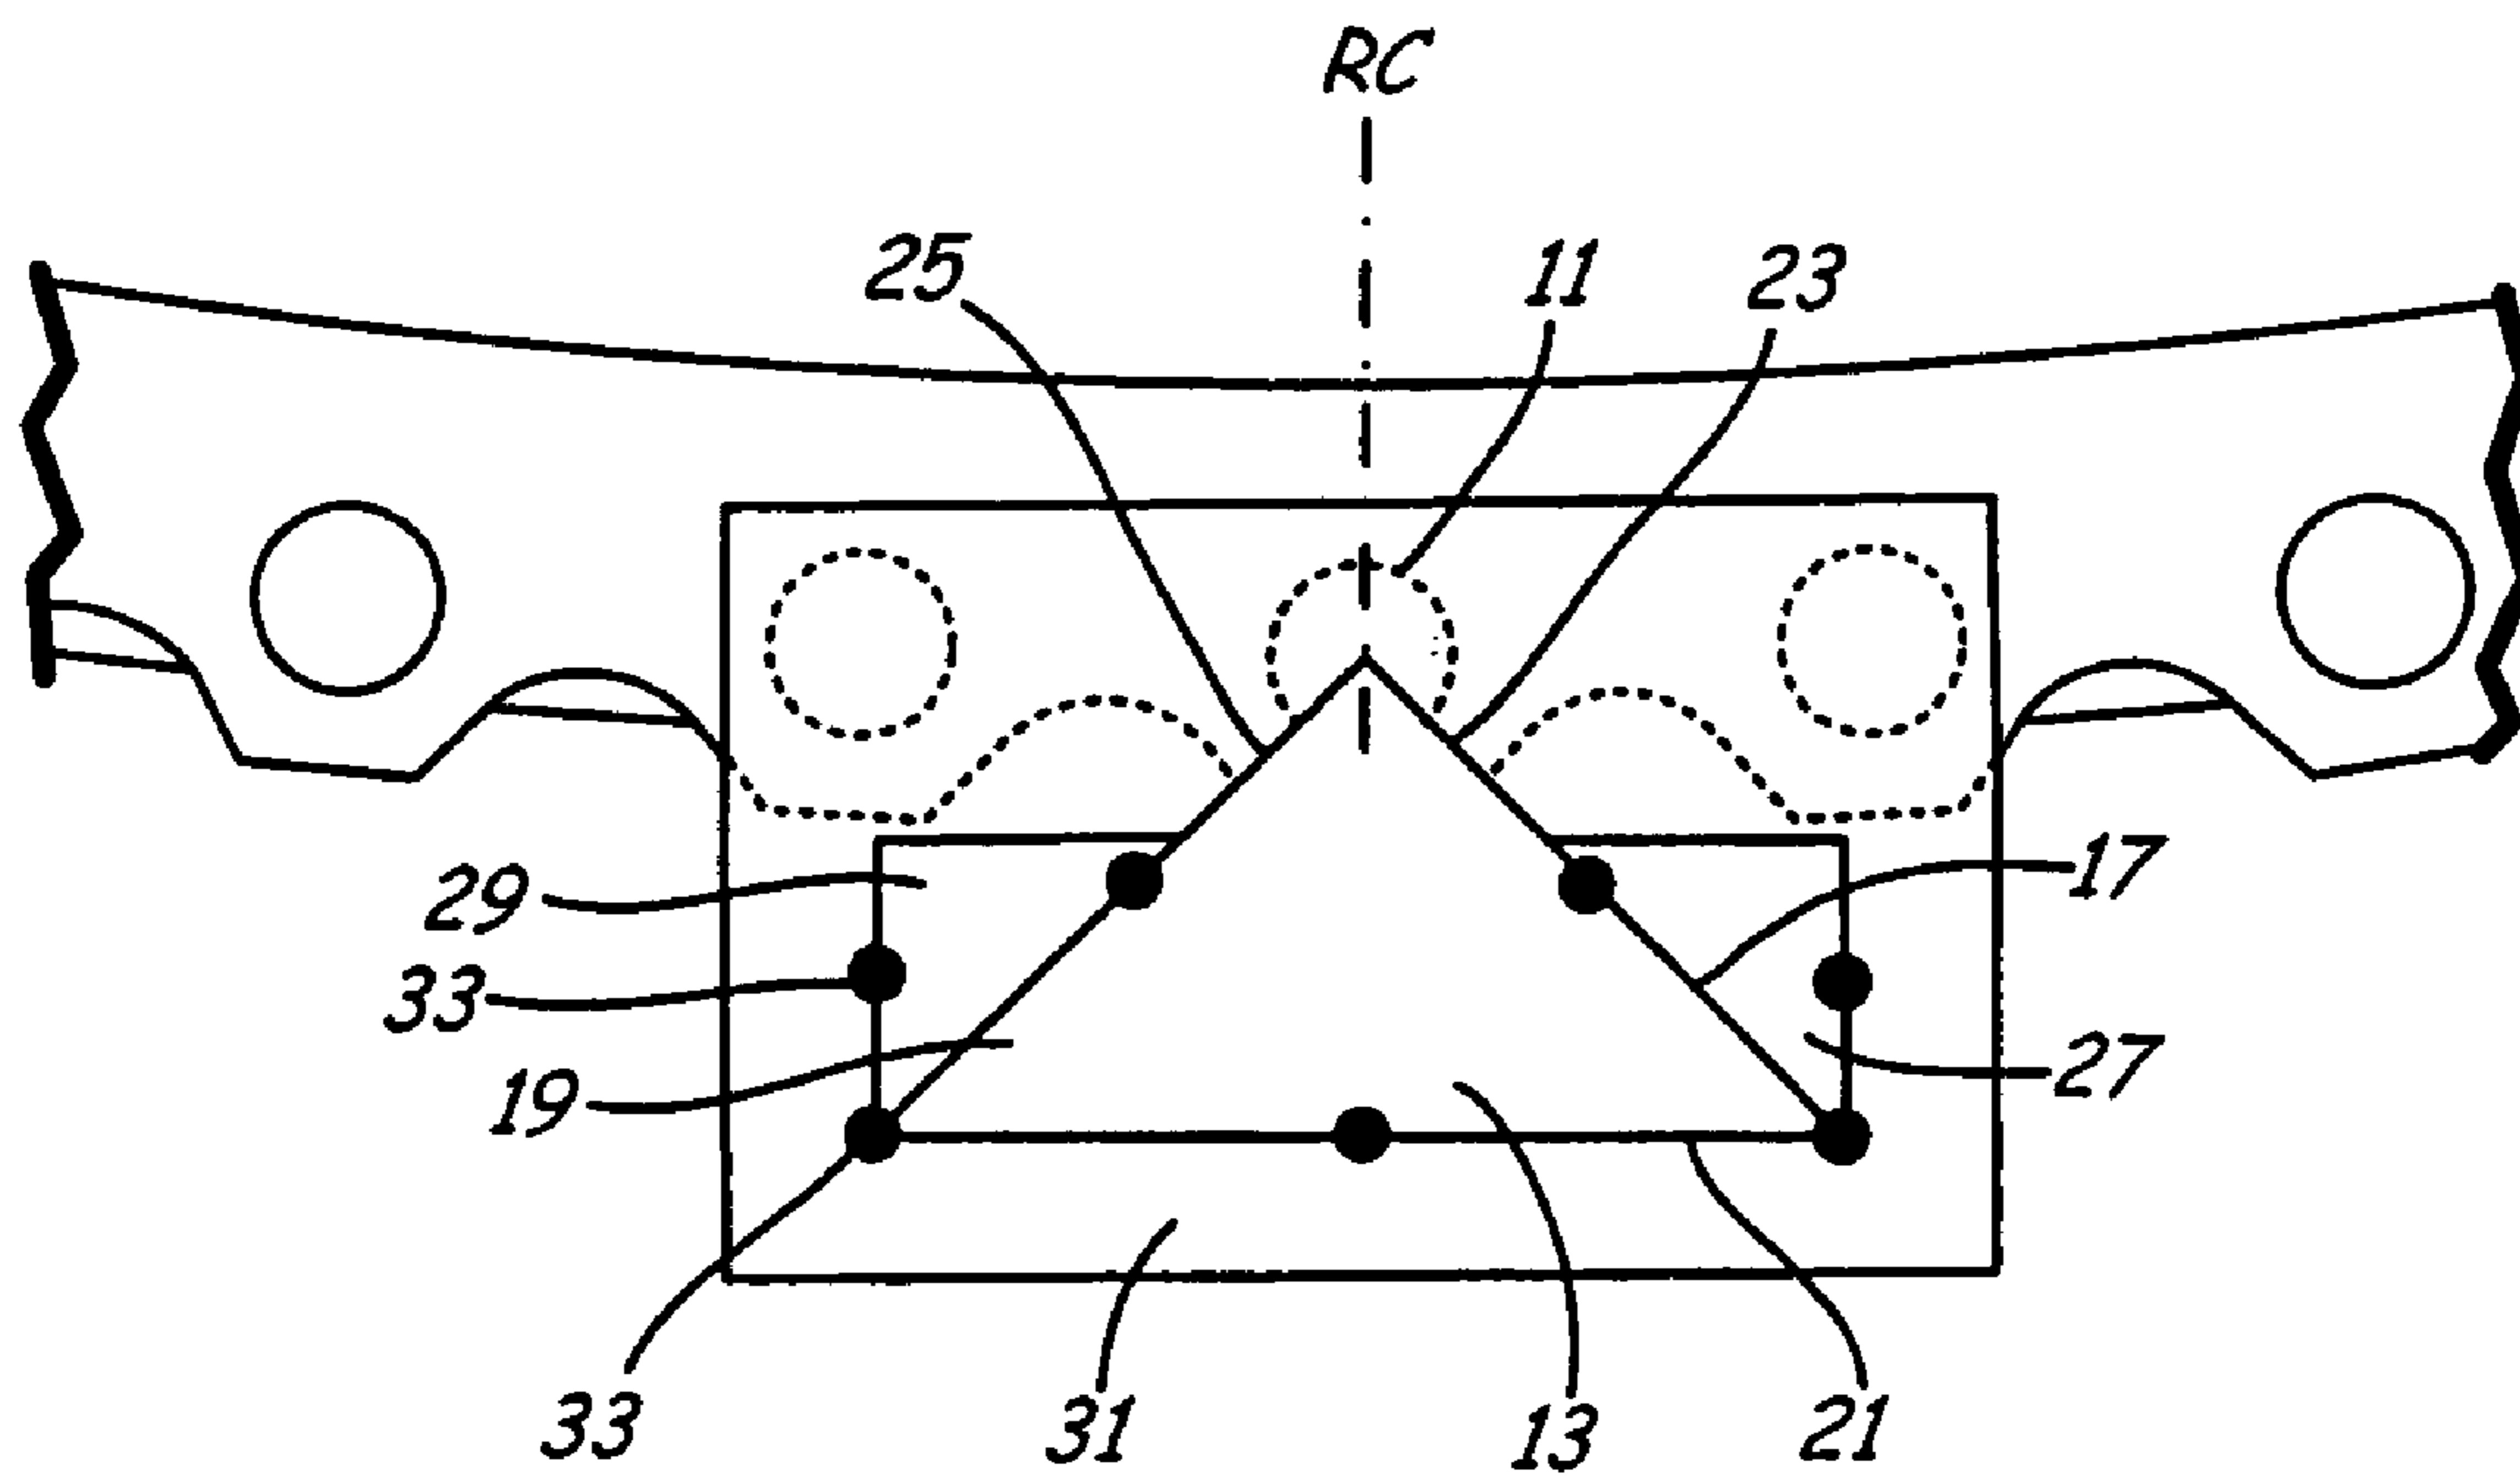
FIG. 1
(PRIOR ART)

There are many techniques known in the art for repairing larger diameter holes, such as bolt holes about 0.30" or greater in diameter. As shown in FIG. 1, in one such prior art repair, an area on a line about 45° on either side of the radial center line RC of hole 11 is removed. This material is then replaced with wedge 13 constructed of a similar material as the base material of the part being repaired. Wedge 13 contains at least two sides 17, 19 that are at approximately 90 degrees to one another. The remaining geometry of the wedge is not critical to the repair, and the remaining side(s) 21, can be of varying shapes and angles. This approximately perpendicular corner is inserted into the area of removed base material, the corner mating with edges 23, 25 of the base material left on the part. Wedge 13 is surrounded by three runoff plates 27, 29, and 31. Additionally, a backing plate may be used in the repair. Thus, five separate pieces are required to initiate the repair. Wedge 13 and run off plates 27, 29, and 31 are attached by tack welds 33 prior to initiating the repair. The multiple run off plates 37, 29, and 31 are small and difficult to assemble about wedge 13.

FIG. 1 is a plan view of a prior art repair for a hole utilizing a wedge and multiple run off plates.

In the prior art repair, wedge 13 is welded into place with welds that are approximately 45 degrees from the original base material. In this configuration, the welds move the weld material (the weld zone with depleted material properties) outboard of the highest stressed areas at the hole location. This allows the raw material of the replacement wedge (with base materials properties) to remain in the highest stressed areas. The highest stressed areas surrounding the hole are located approximately 90 degrees from one another. This repair works well for holes down to about 0.30 inches in diameter, but on smaller holes the wedge becomes so small that the weld used to retain the wedge extends into the highest stressed areas of the flange. Prior to this invention, repairs to smaller diameter holes (i.e., holes having a diameter of about 0.30" or less) on flanges were viewed as being unrepairable. Thus, a repair for smaller holes was needed.

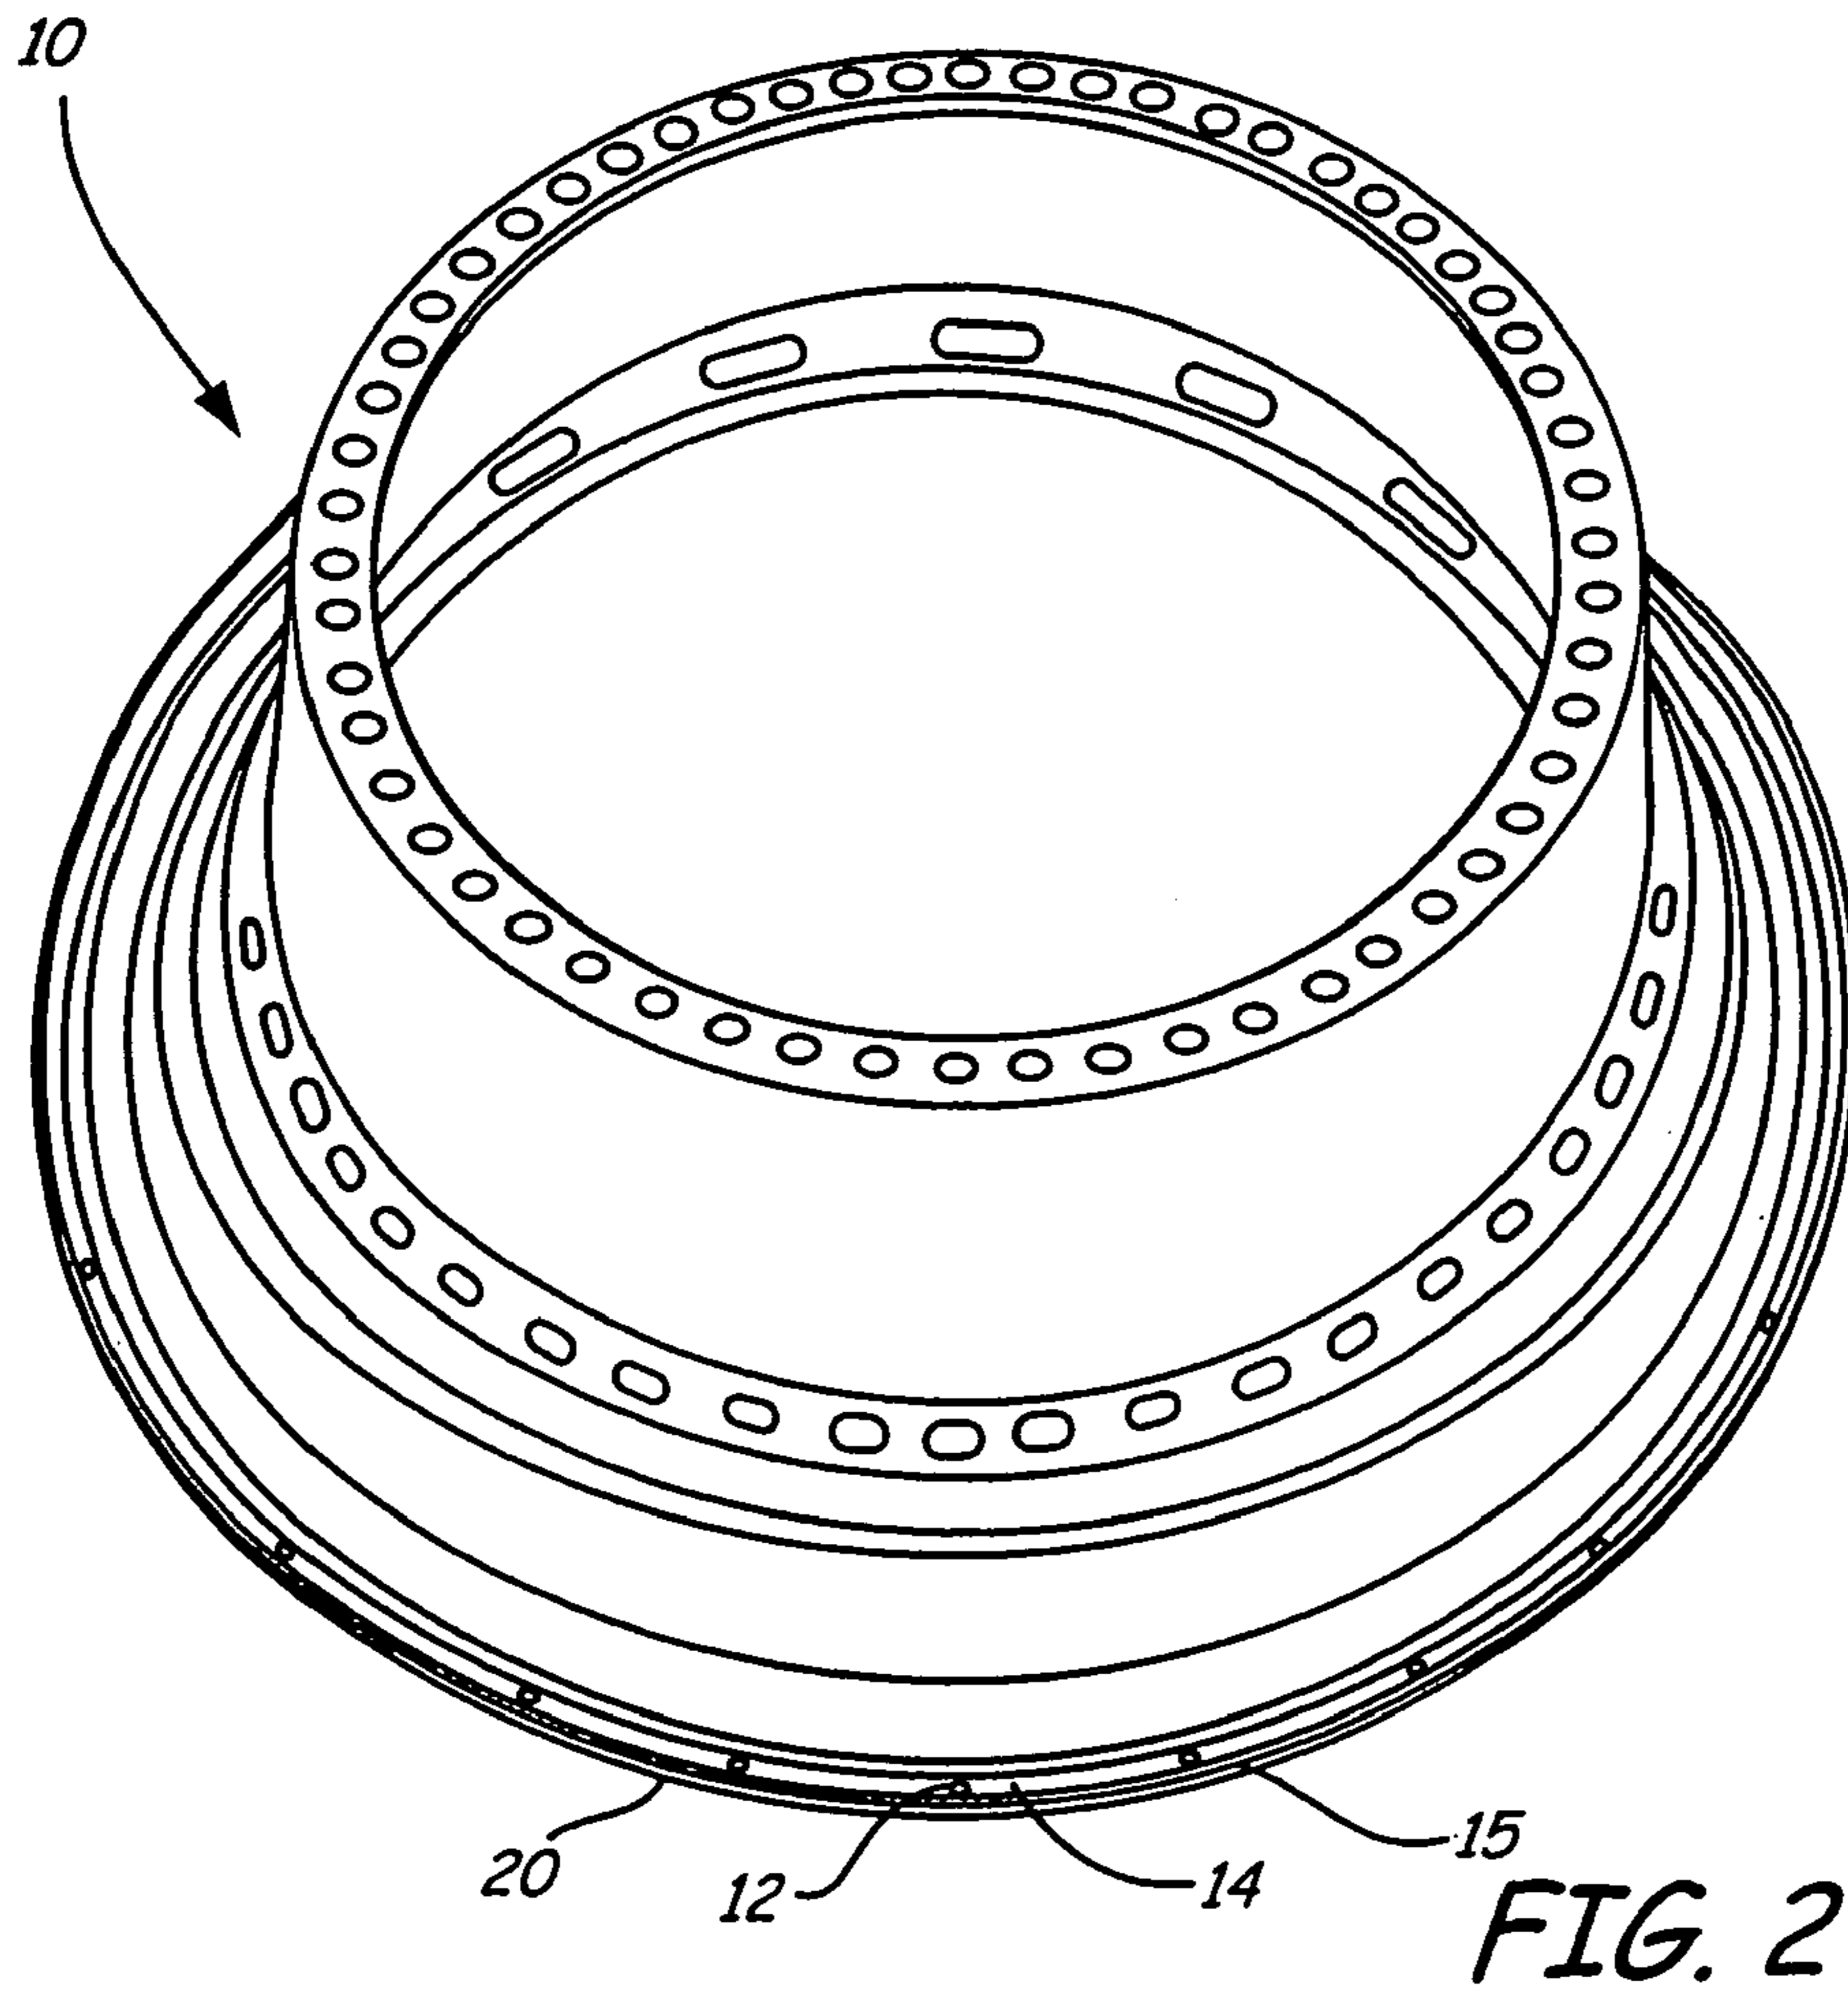
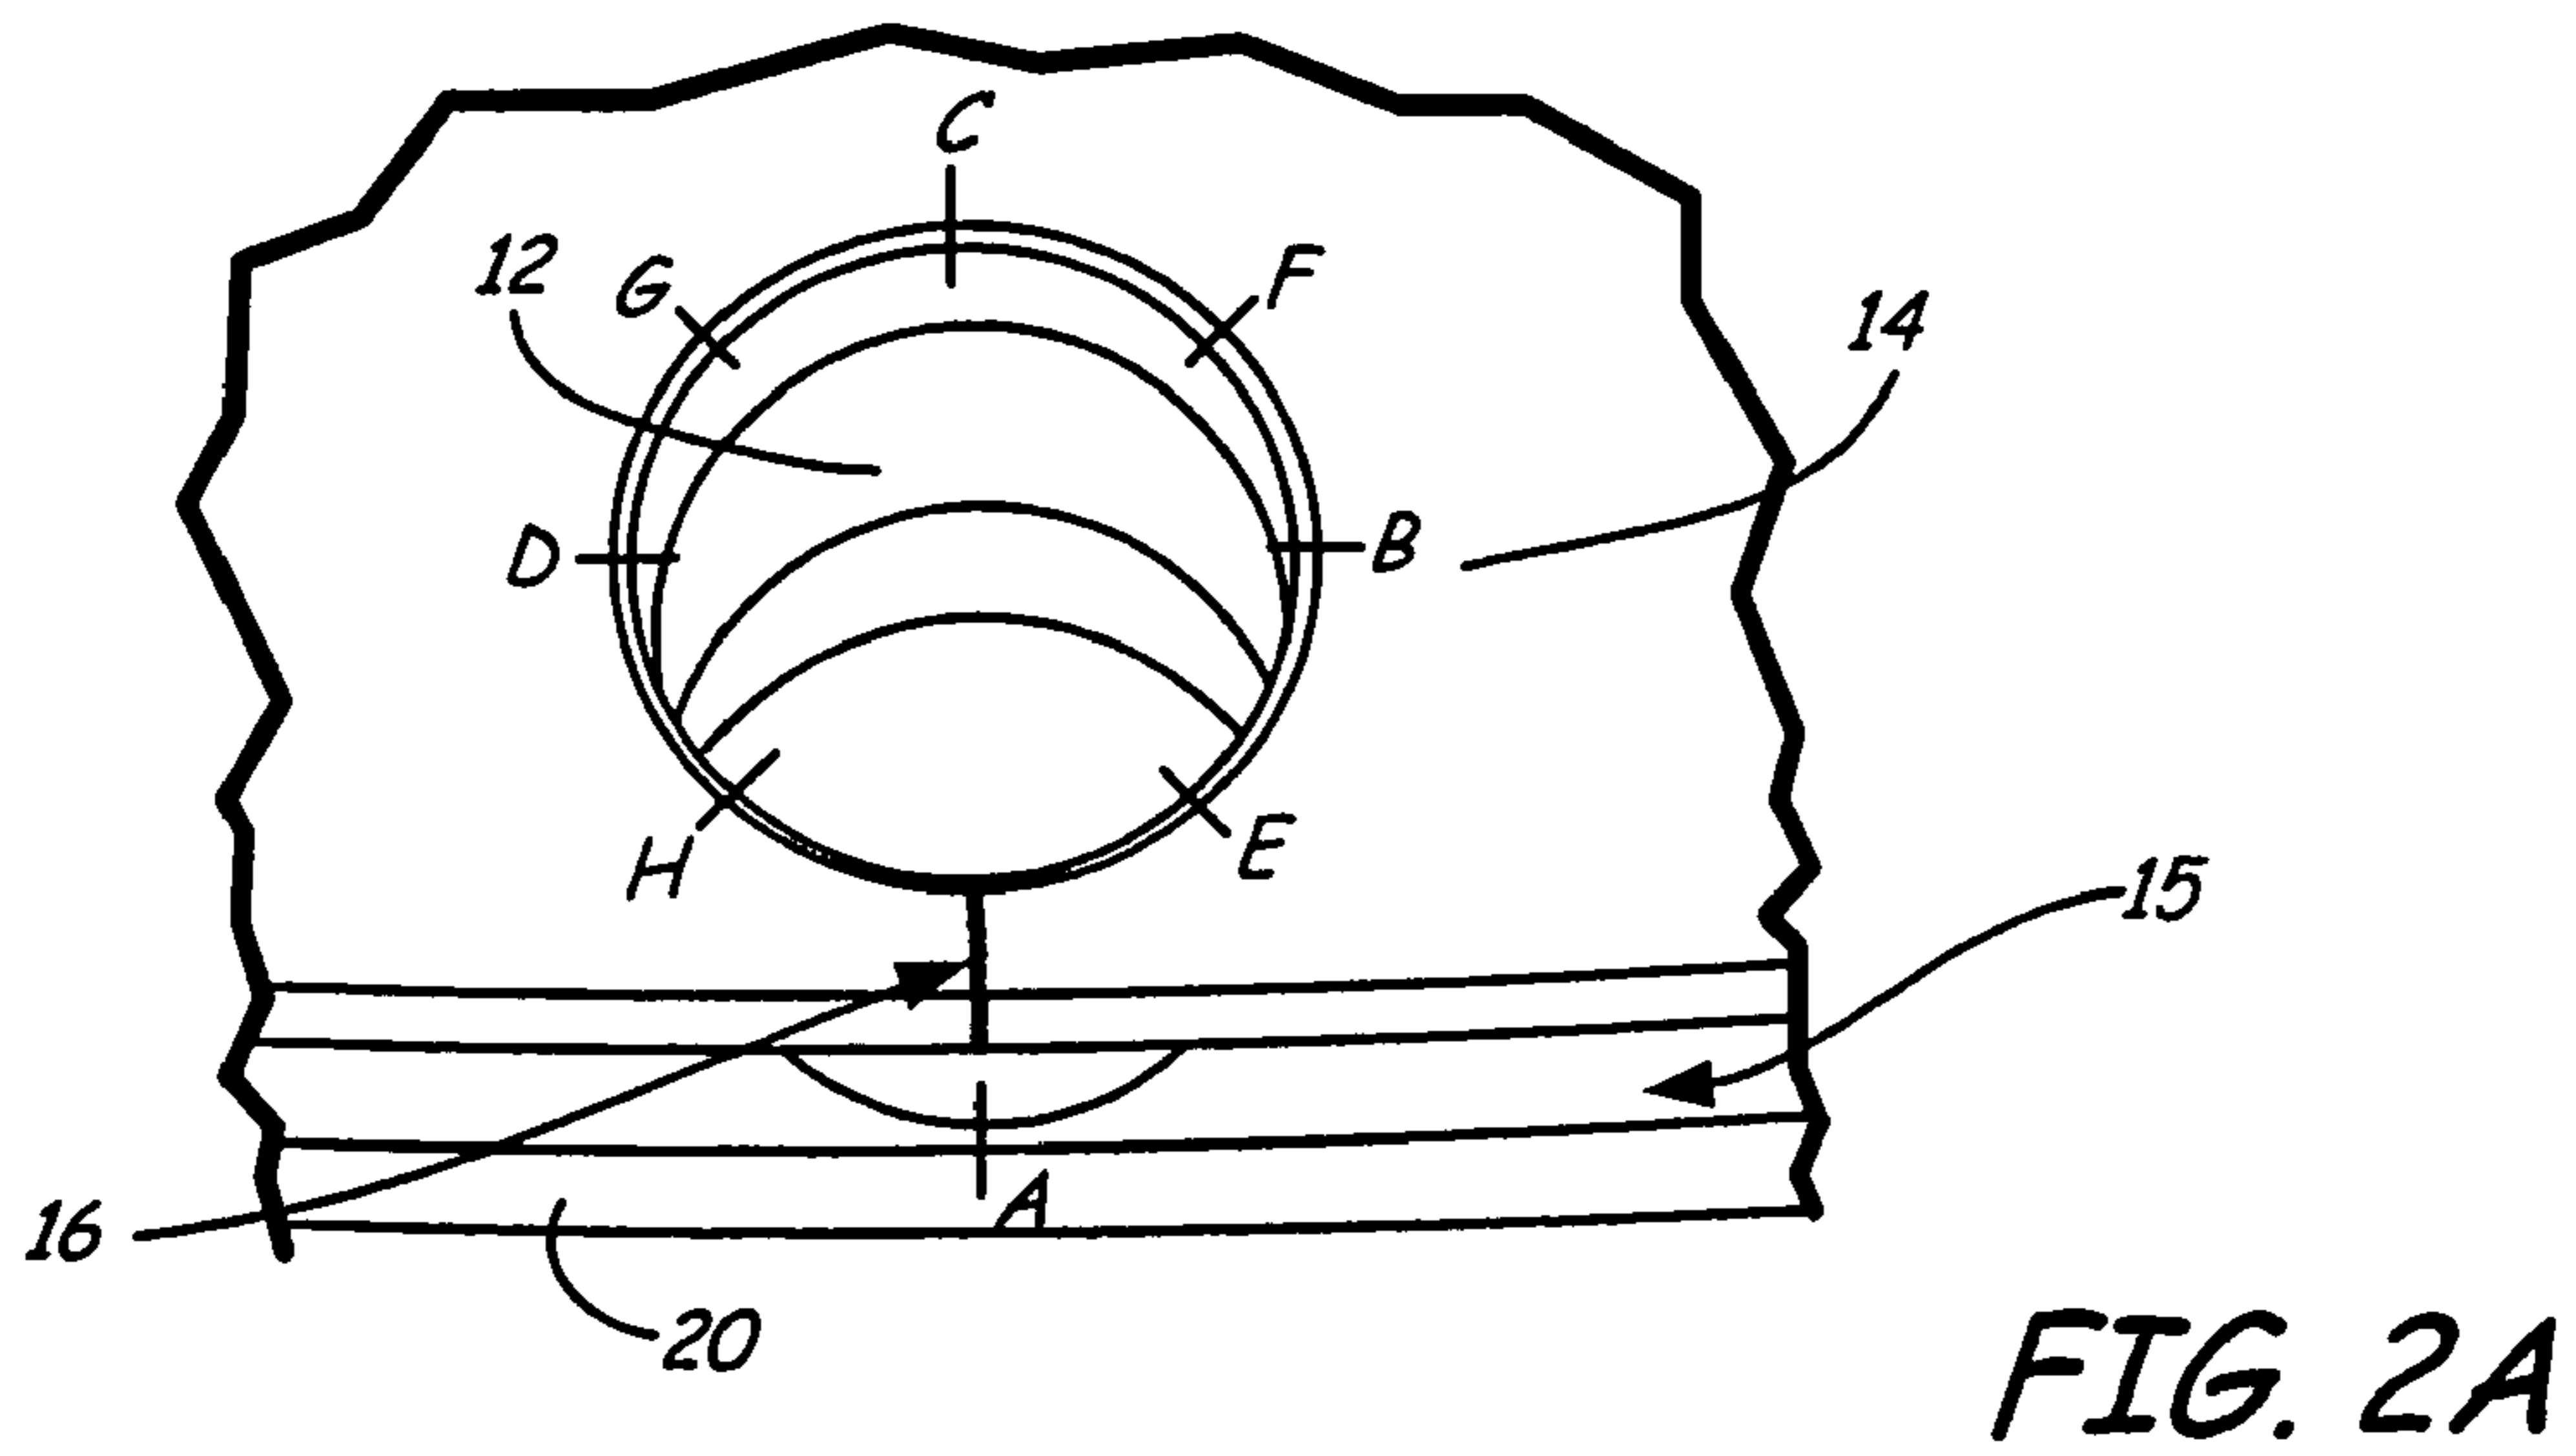
FIG. 2 is a perspective view of a forward inner nozzle support of a dual annular combustor configuration of a high pressure turbine.

FIG. 2A is a magnification of an area of the perspective view of the nozzle support illustrating a crack at one of the flange bolt holes.

FIG. 2 is a perspective view of a forward inner nozzle support 10 of a dual annular combustor (DAC) of a higher pressure turbine. The nozzle support 10 contains a series of small diameter holes 12 circumferentially spaced about an outer diameter flange 14. Holes 12 are apertures used to receive small diameter pins or bolts for additional parts that are mounted to the flange. FIG. 2A is a closeup view of the nozzle support 10 illustrating a crack 16 at one small diameter hole 12 on flange 14. Cracks 16 typically emanate from the holes 12 in an outward radial direction. In the past, cracks 16 in small diameter holes 12 of nozzle support 10 were unrepairable.

On a part that contains holes next to a flange, such as the forward inner nozzle support illustrated in FIG. **2**, defects often appear after extended use. Typically, the defect is a

crack that initiates from one of the apertures in the flange and propagates towards the outer diameter of the flange. The crack is likely created by a thermal cycle hoop stress and the load on the pin through the flange on the attached vane. The stress around the hole is highest adjacent the outer diameter of the flange. Utilizing an insert (i.e., a biscuit or generally circular shape or other suitable shape) to create the repair results in a weld that is similar to that achieved with the known wedge repair for larger holes. The resultant weld is approximately at 45° on either side of the radial centerline of the hole. This moves the weld out of the highest stress areas surrounding the hole to the lower stress areas of the base material, which results in improved fatigue life for the repaired hole. At the same time, the weld is accomplished with a continuous movement of the part in an arced path under the electron beam rather than requiring separate line welds such as associated with the prior art wedge repair processes. With such a small area in the current repair, an abrupt change in the weld path would result in an uneven weld where the weld beam must pause to change direction.
