(10) **Patent No.:** **US 7,858,897 B2**
(45) **Date of Patent:** **Dec. 28, 2010**

(54) **INSERT WELD REPAIR**

(73) Assignee: **United Technologies Corporation**,
Hartford, CT (US)

The present invention relates to the repair of turbine engine components, and in particular to the repair of small diameter holes located on the flange of a part such as the forward inner nozzle support.

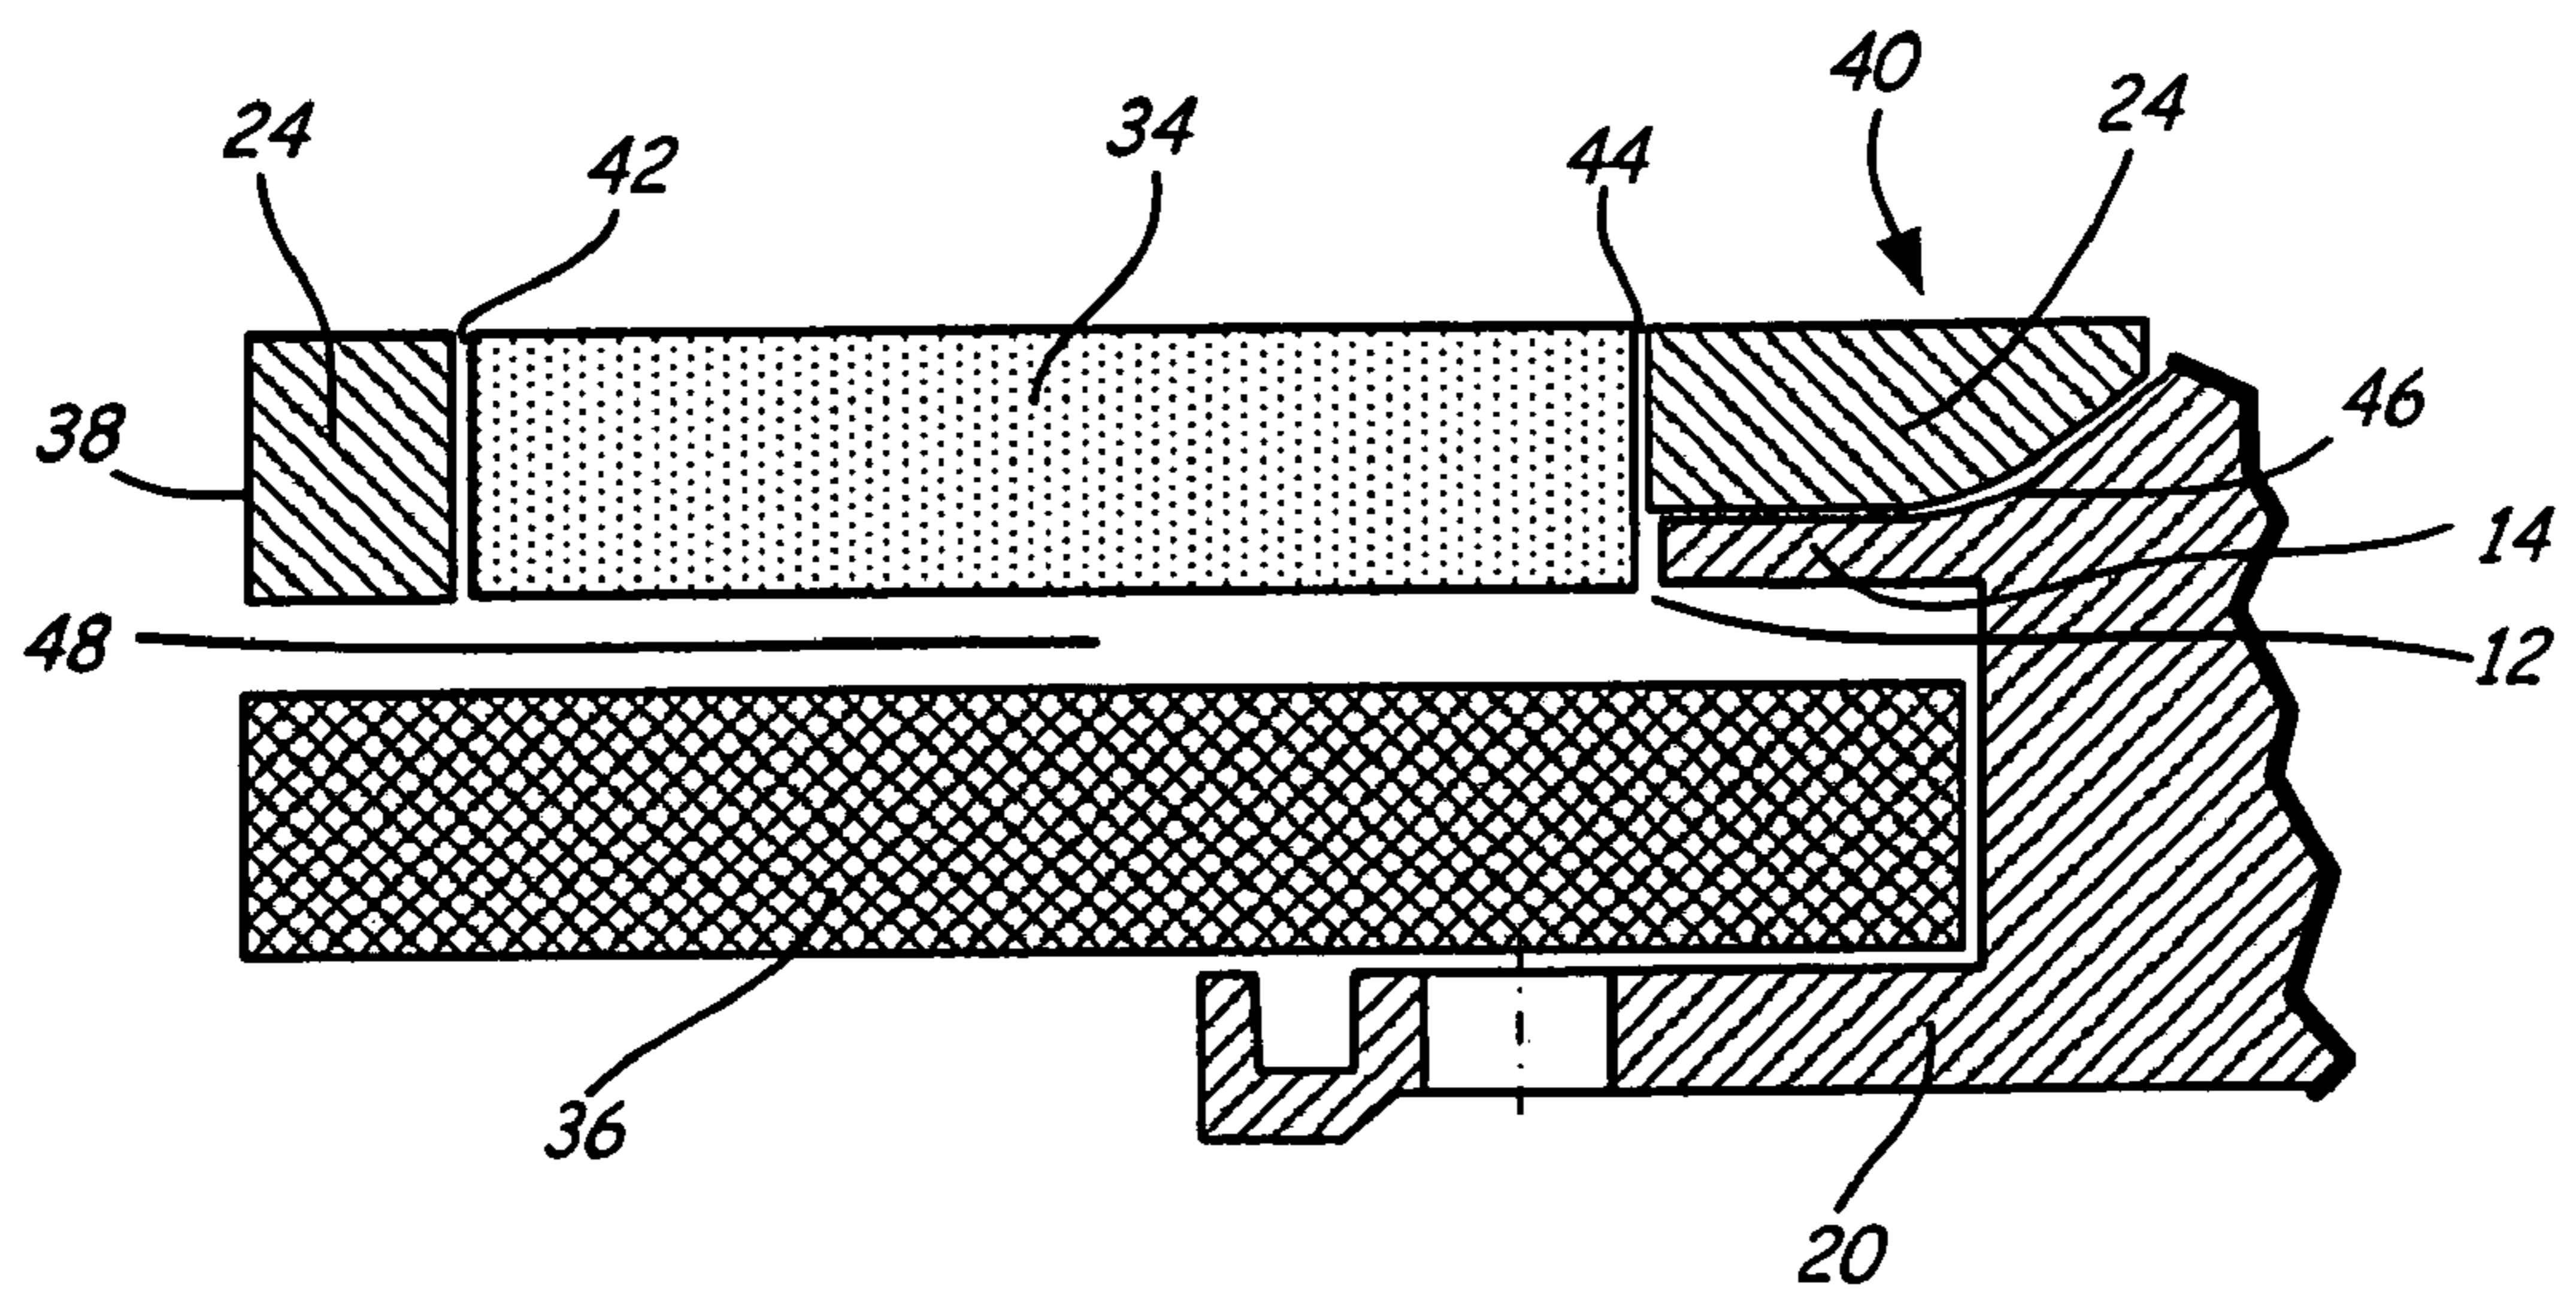
FIG. 9 is a cross-sectional elevation view of the bolt hole repair apparatus for refabrication of the flange of the nozzle support illustrated in FIG. 7.

FIG. 9 is a cross-sectional elevation view of the bolt hole repair apparatus for refabrication of flange 14 illustrated in FIG. 8. In this view, the remaining portion of the base material of flange 14 is visible. Also illustrated are insert 34, combination plate 24, and backing plate 36. Insert 34 is a thickness that is approximately equivalent to the thickness of the rear edge 38 of combination plate 24, which is also approximately equivalent to the thickness of the front end 40 of combination plate 24 added to thickness of the remnant of hole 12 left on flange 14. Small clearance gaps 42, 44 exist between insert 34 and plate 24. The clearance allows for the easy insertion of insert 34 into the aperture contained in combination plate 24. Clearance gaps 42, 44 will cease to exist as the material from insert 34 and combination plate 24 fuse together during the repair weld.

Front end 40 of combination plate 24 is contoured to mate with remaining surface 46 of flange 14 and hole 12. Although flange 14 is illustrated in this view as containing a radius, other geometries of the contour are envisioned including bevels, chamfers, rabbets, dados, or stepped notches, the geometry of the contour depending on the geometry of the base material left on flange 14. Insert 34 and combination plate 24 contain more material than the thickness of the material removed from flange 14 so that insert 34 can be machined to the appropriate size after the weld repair has been completed.

The part illustrated in FIG. 9 is a section of nozzle support 10 of FIG. 2. Nozzle support 10 contains two flanges, flange 14 which is to be repaired, and a lower flange 20. Lower flange 20 and flange 14 are spaced close together, and a typical spacing is less than about 0.25 inches. Backing plate 36 is placed between flange 14 and lower flange 20, and protects the lower flange 20 from any slag, spatter, or similar byproduct resulting from the welding process.

In a typical prior art welding repair utilizing a backing plate, the weld must penetrate through the repair portions to assure a good weld. In such repairs, the backing plate is placed directly behind the weld to adsorb the residual energy from the weld, which allows the backing plate to fuse to the repair. Then, after the repair, the backing plate must be removed. The relatively small distance between flange 14 and lower flange 20 makes such a removal difficult.

Thus, in this invention, an air gap 48 is left between the top surface of backing plate 36 and the bottom surfaces of insert 34, combination plate 24, and the remaining portion of flange 14. In embodiments, air gap 48 is about 0.10 inches or less, which assures that the excess energy from the weld beam is adsorbed, but is far enough from the bottom edge of the repair pieces (insert 34, combination plate 24, and flange 14) to assure that backing plate 36 does not become fused to the repair pieces. Utilizing combination plate 24 to provide a good weld, while separating the repair pieces from the backing plate 36 via air gap 48, assures that a good, structurally sound weld repair can be obtained. Backing plate 36 should be large enough to cover the clearance gaps 42, 44 between the combination plate 24 and the edges of the insert all the way around the edge of insert 34. The thickness of backing plate 36 is less than the distance between flange 14 and lower flange 20 so that air gap 48 exists as shown.

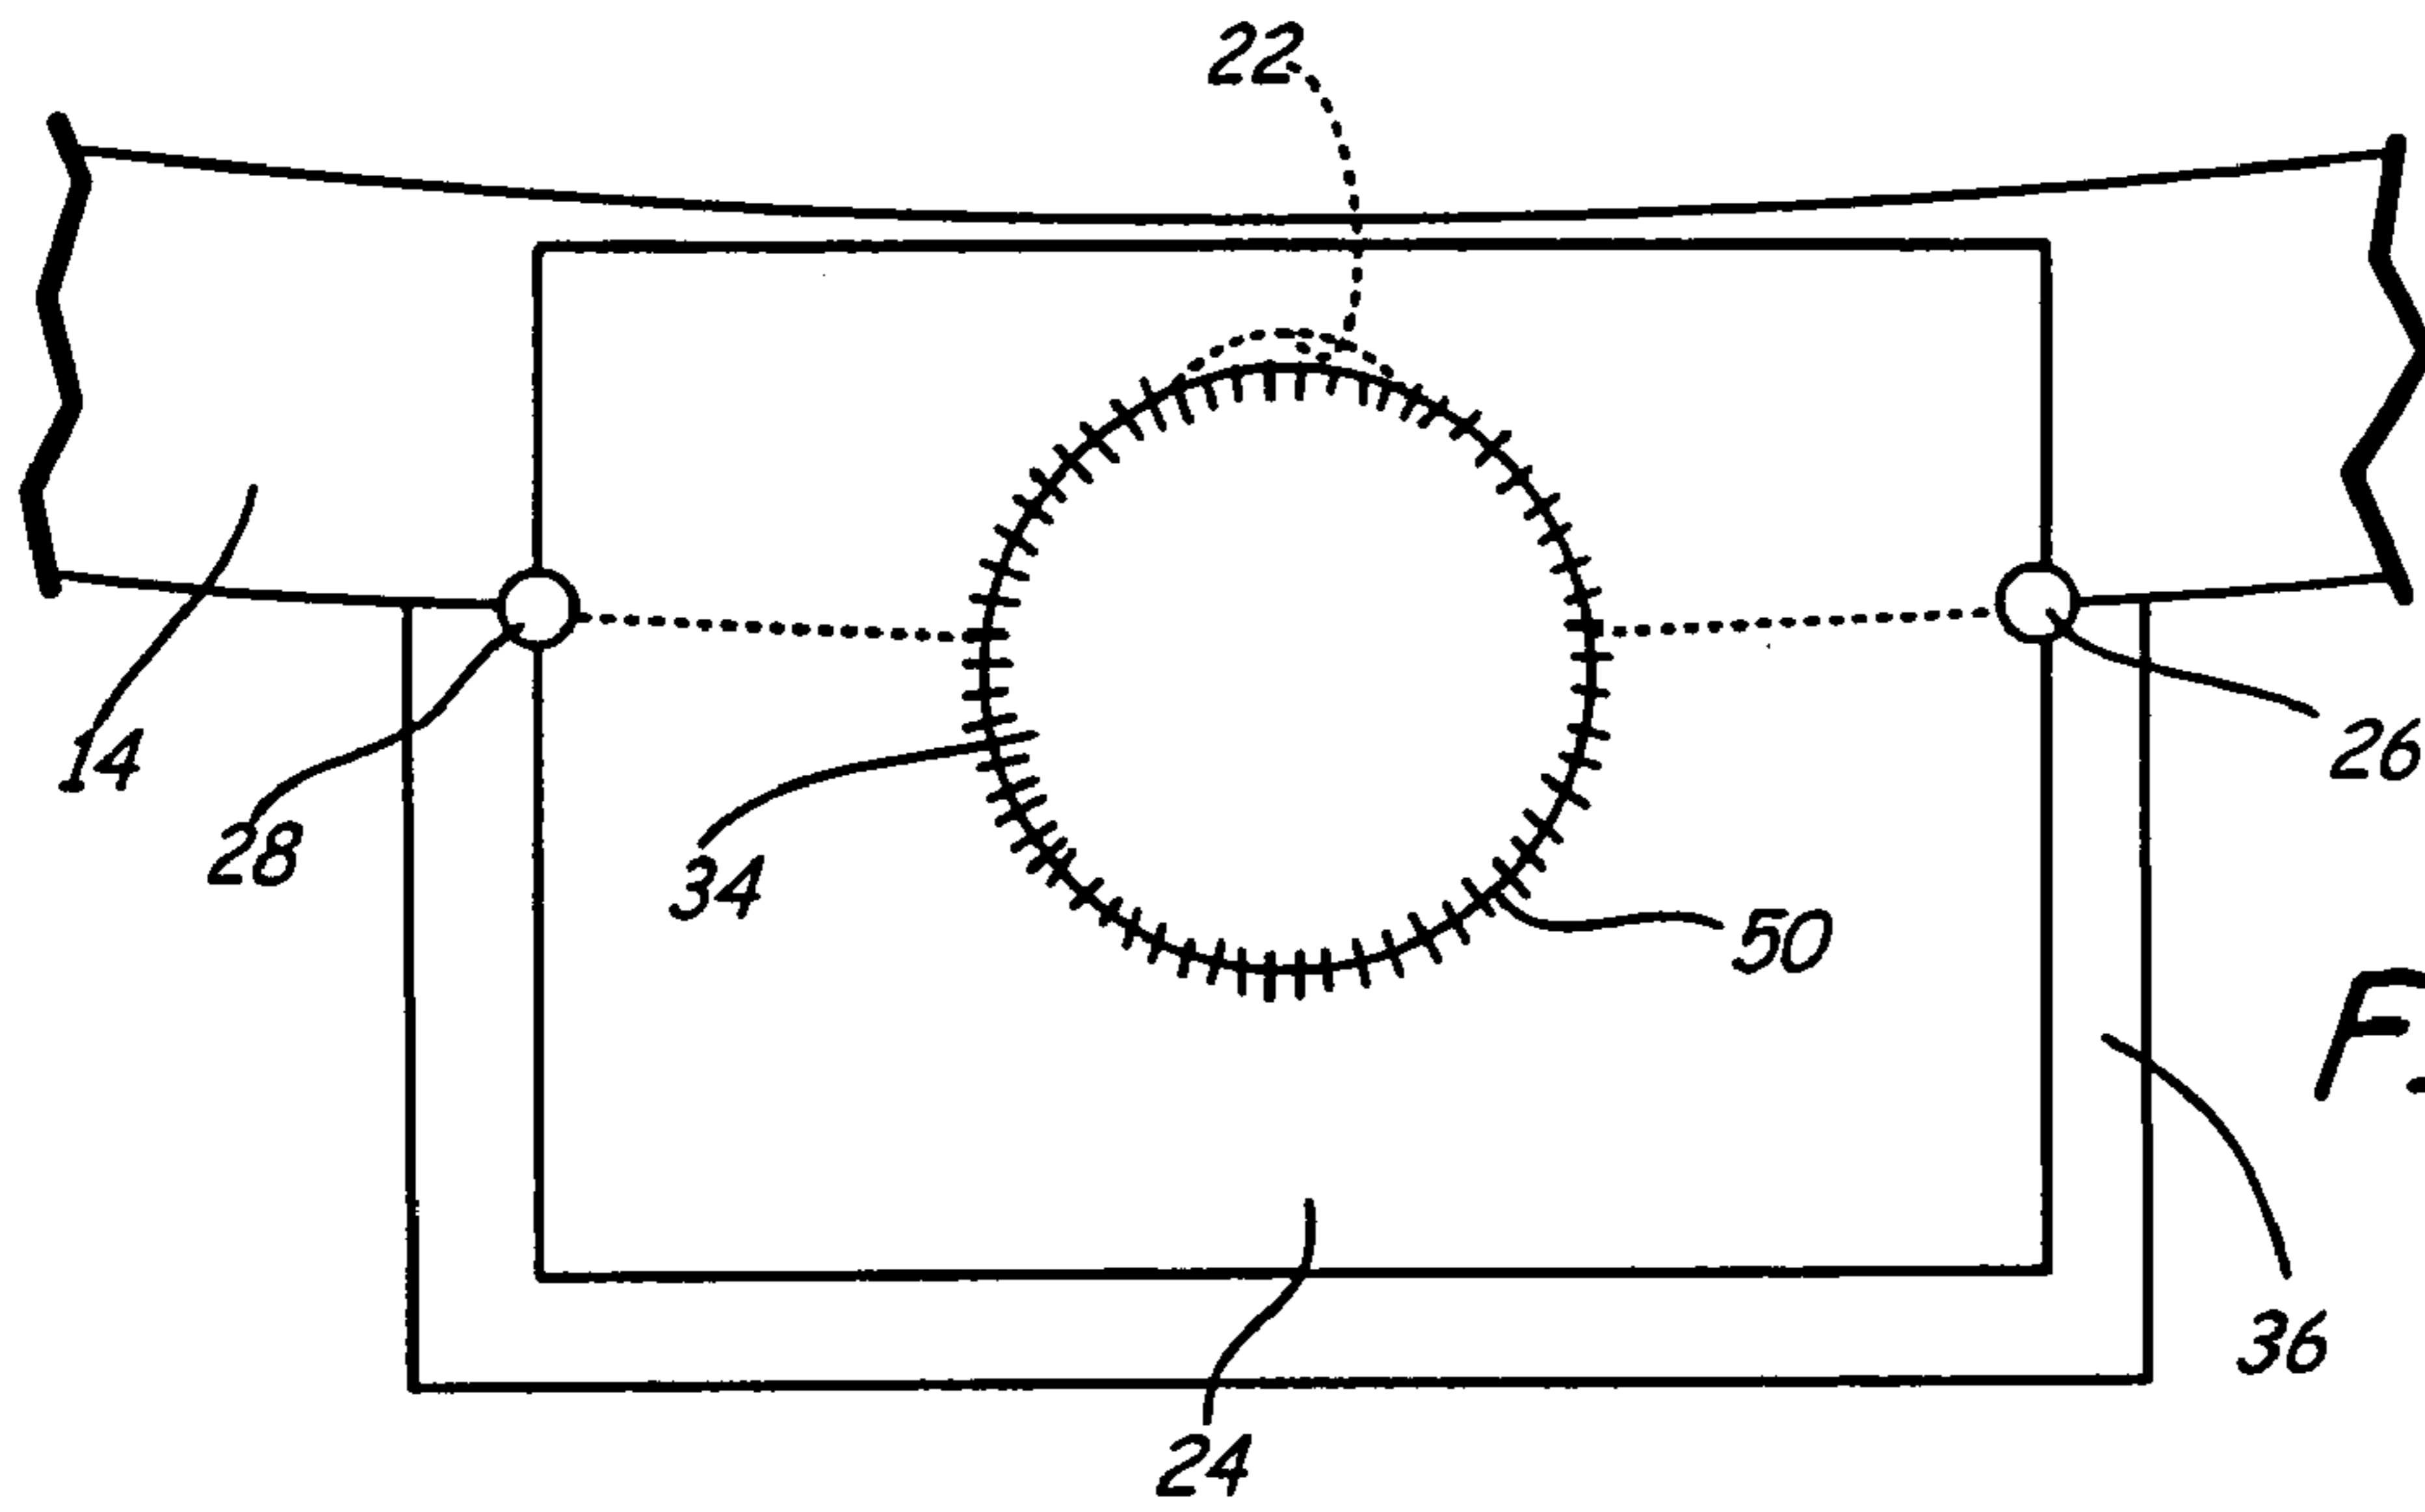
FIG. 10 is a plan view illustrating a completed weld between the insert, combination plate, and flange with the backing plate still in place.

FIG. 10 is a plan view illustrating a completed weld 50 between insert 34 and combination plate 24. Insert 34 is welded into place by a process such as electronic beam welding. Electronic beam welding (EBW) uses a narrow beam of high velocity, high energy electrons to generate the heat necessary to create a weld in a metal work piece. Special equip-

ment is used to focus the electron beam in a vacuum chamber, and the kinetic energy of the electrons is converted to heat energy as it strikes the metal. The welds created by EBW are characteristically deep and narrow with a very small heat affected zone and low distortion. The current repair moves the weld seams out of the high stress areas surrounding the hole 12. The weld seams are left in the low stress areas of the flange 14.

EBW is typically autogenous, that is, does not require a filler material. Thus, a tight fit of insert 34 with the remaining base material and combination plate 24 will occur as the pieces fuse together during the welding process without the addition of a filler material. Weld 50 is a butt weld joining insert 34, base material of flange 14, and combination plate 24 together. While weld 50 is done from the top of insert 34, the weld extends around the entire perimeter of insert 34 and throughout the entire thickness of insert 34.

EBW can leave depressions in the parts welded. Thus, ensuring that insert 34 and combination plate 24 are thicker than the original thickness of flange 14 allows for the melting and fusing of material from the respective top sides of insert 34 and combination plate 24 to flow down and fill in the weld against the base material of flange 14. Thus, when material is removed to finish the repair, none of the base material that has been left will be machined, only the newly welded materials will be removed.

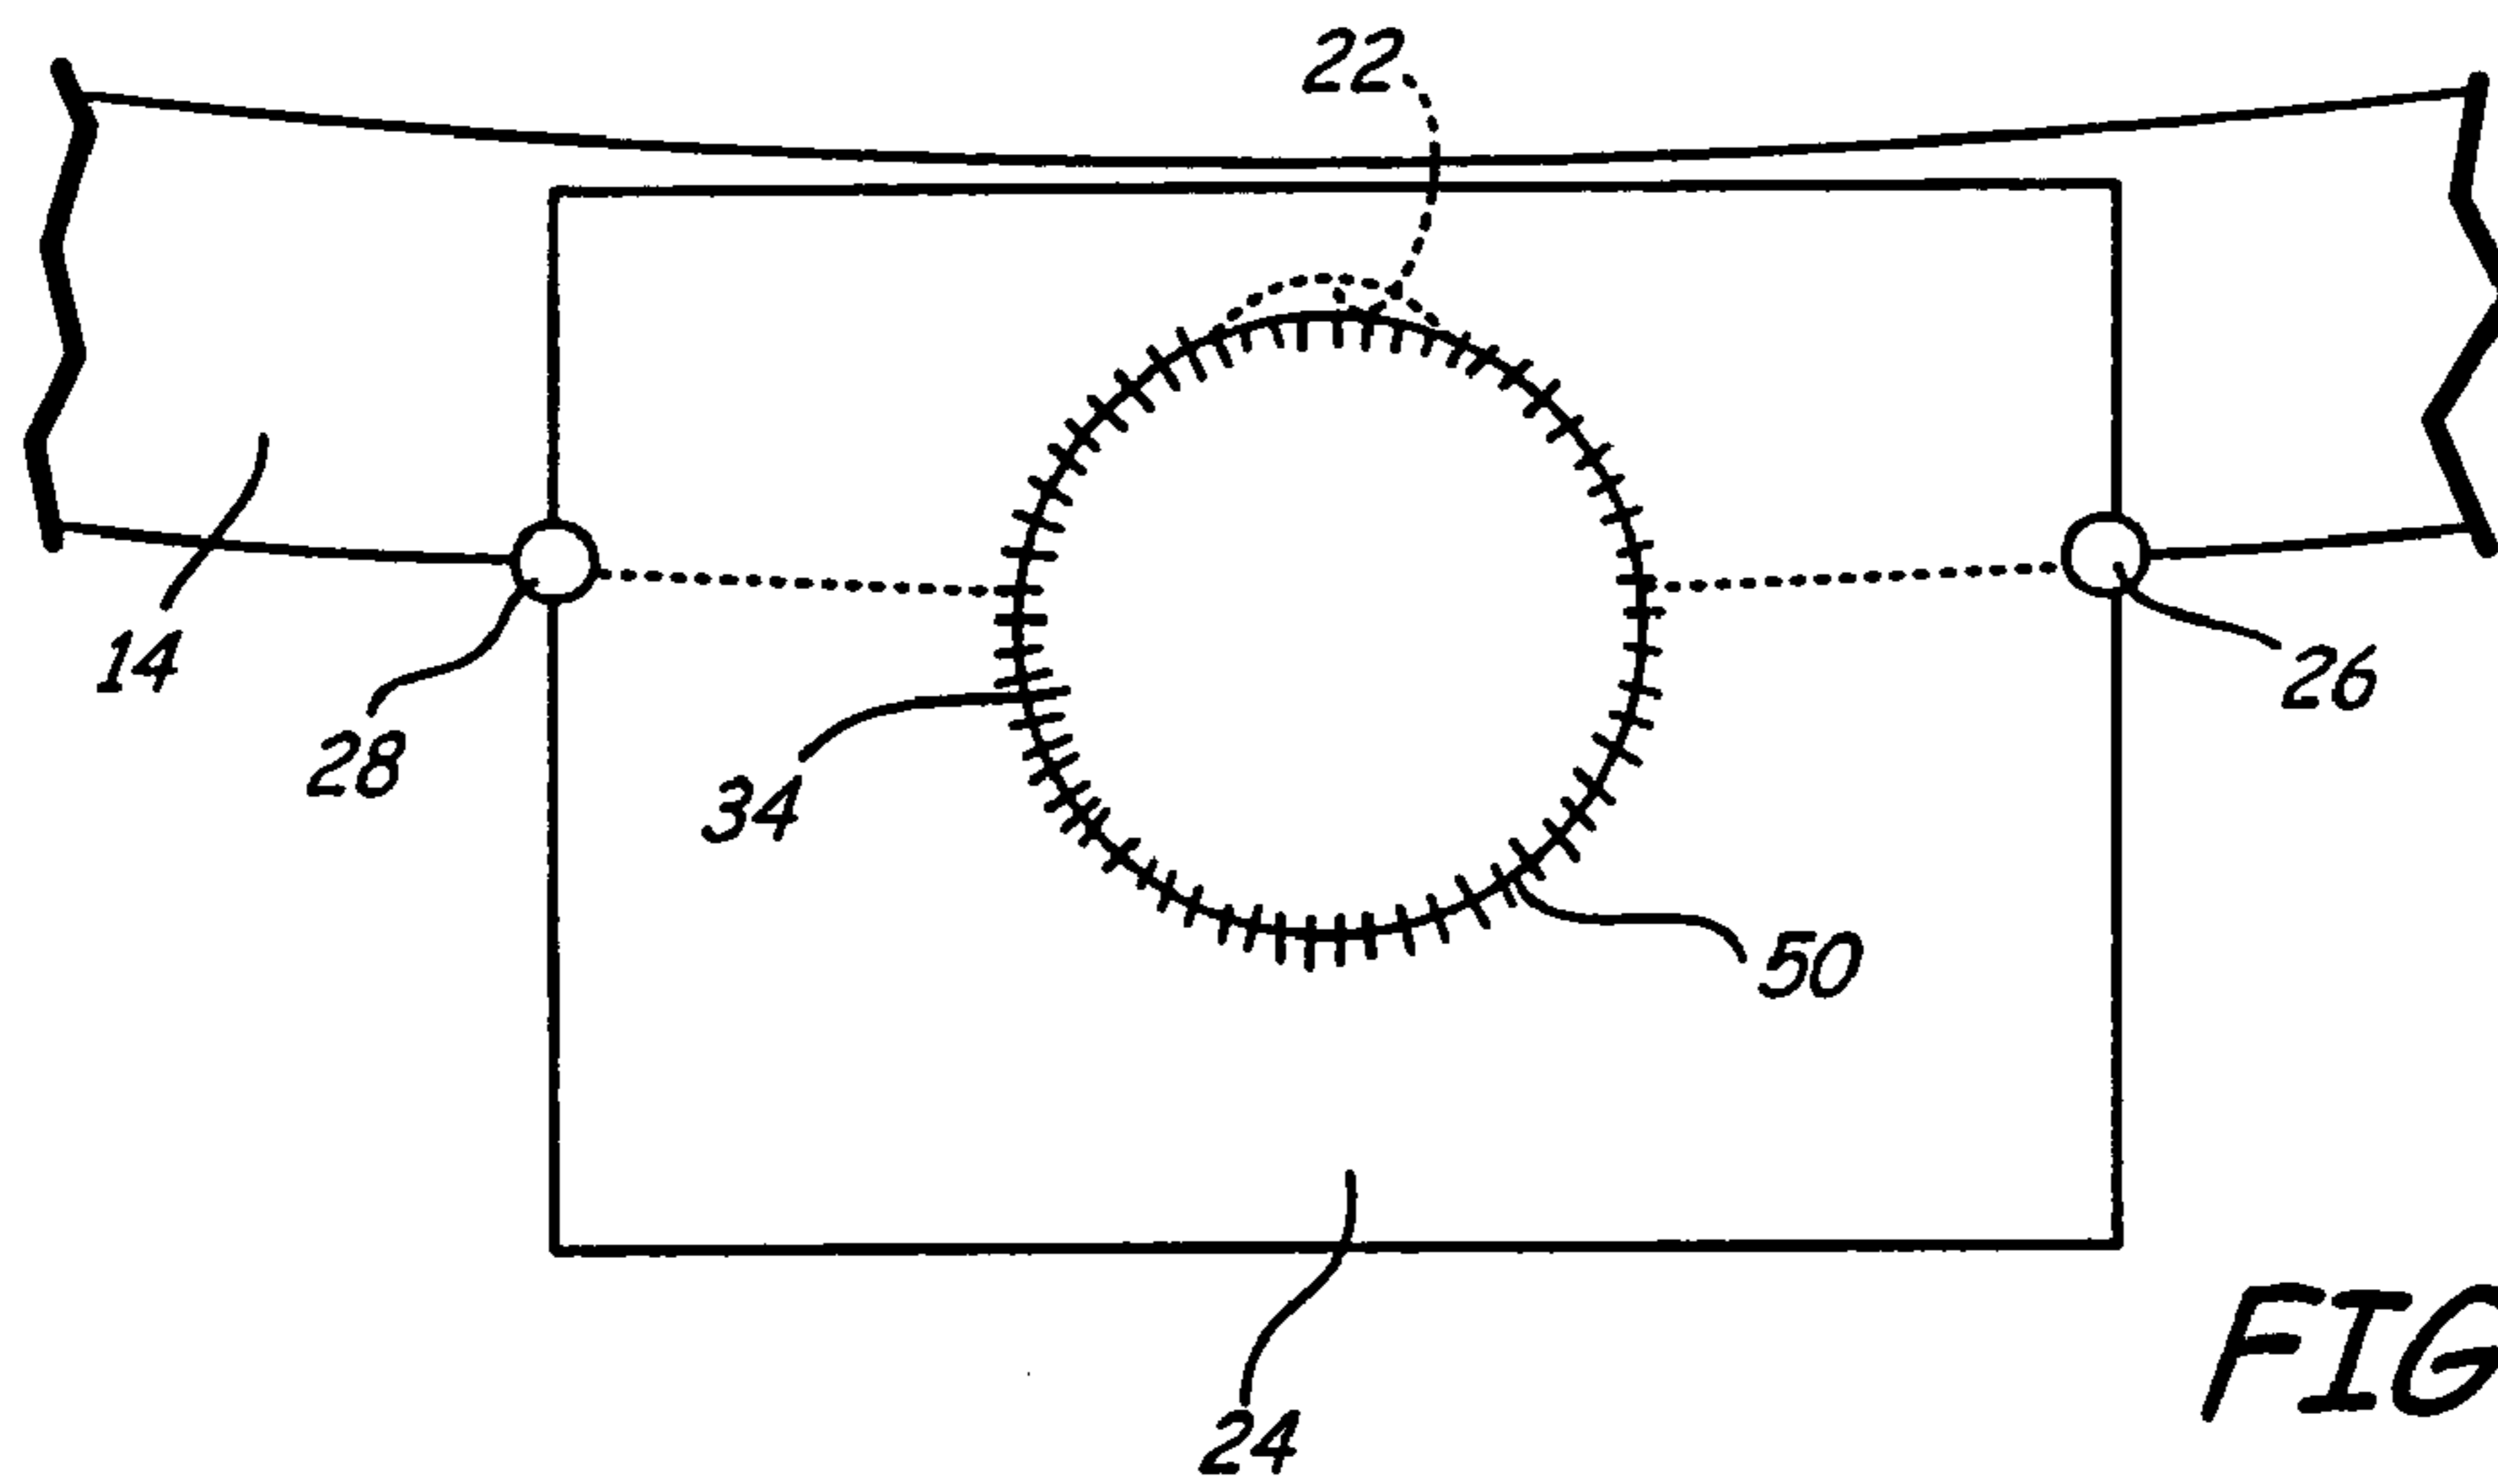
FIG. 11 is a plan view illustrating the completed weld with the backing plate removed.

FIG. 11 is a plan view illustrating completed weld 50 with backing plate 36 removed. Since backing plate 36 does not become fused to the repair pieces (insert 34, combination plate 24, and flange 14), after weld 50 has been completed, backing plate 36 may simply be pulled out from the repaired part. There is no need to use material removal equipment, such as grinders or similar machines to remove backing plate 36. Backing plate 36 may be reused as there will be minimal damage to the top surface as it will not contain removal scars associated with plates that become fused during the welding process.

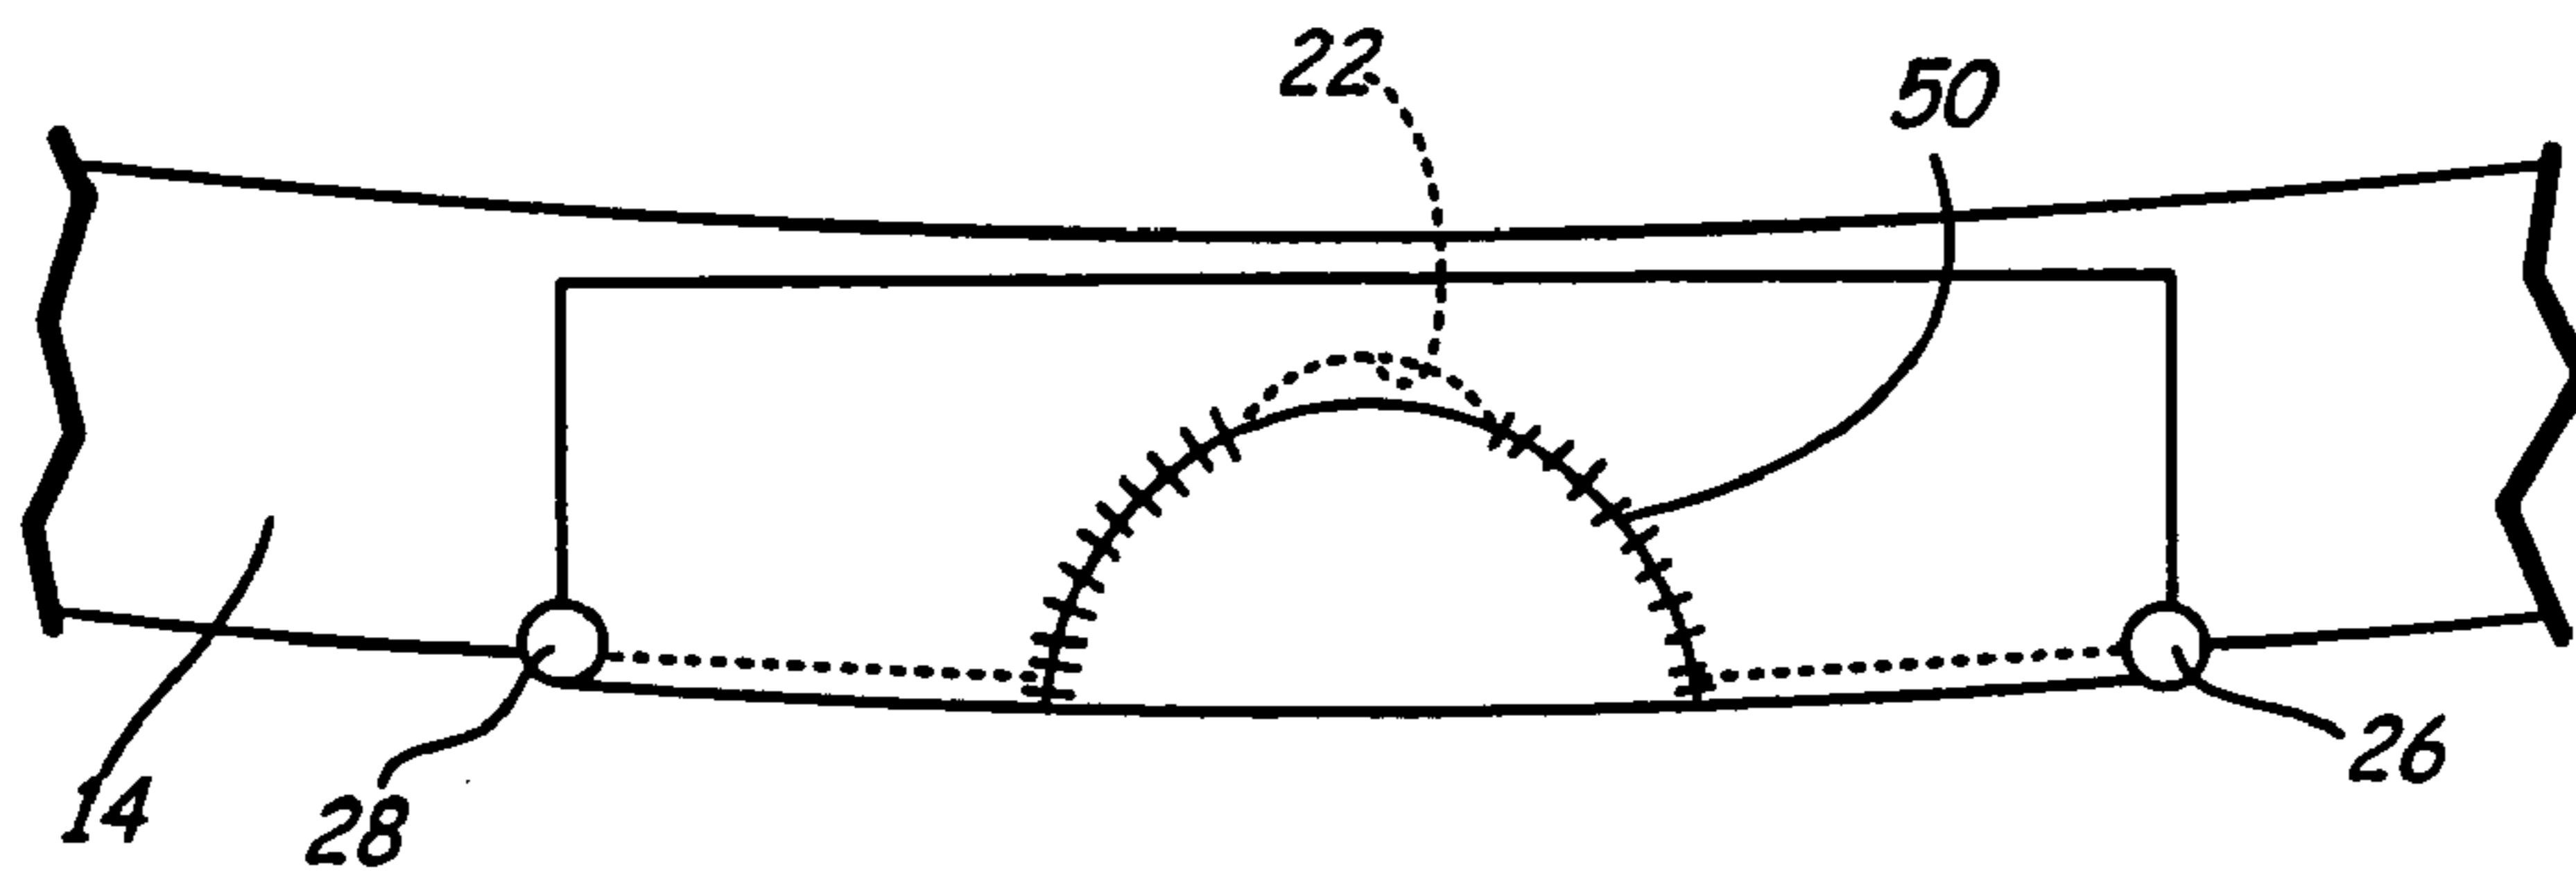
FIG. 12 is a plan view illustrating the completed weld with a portion of the combination plate and insert removed.

FIG. 12 is a plan view illustrating completed weld 50 with portions of combination plate 24 and insert 34 removed.

Combination plate **24** and insert **34** are cut along a path that substantially follows the outer profile of flange **14**. A mill, laser, or similar material removal machine is used to cut combination plate **24** and insert **34**. A nominal amount of material of combination plate **24** and insert **34** may remain after an initial cut to ensure that the cutting process does not affect the integrity of the original flange profile.

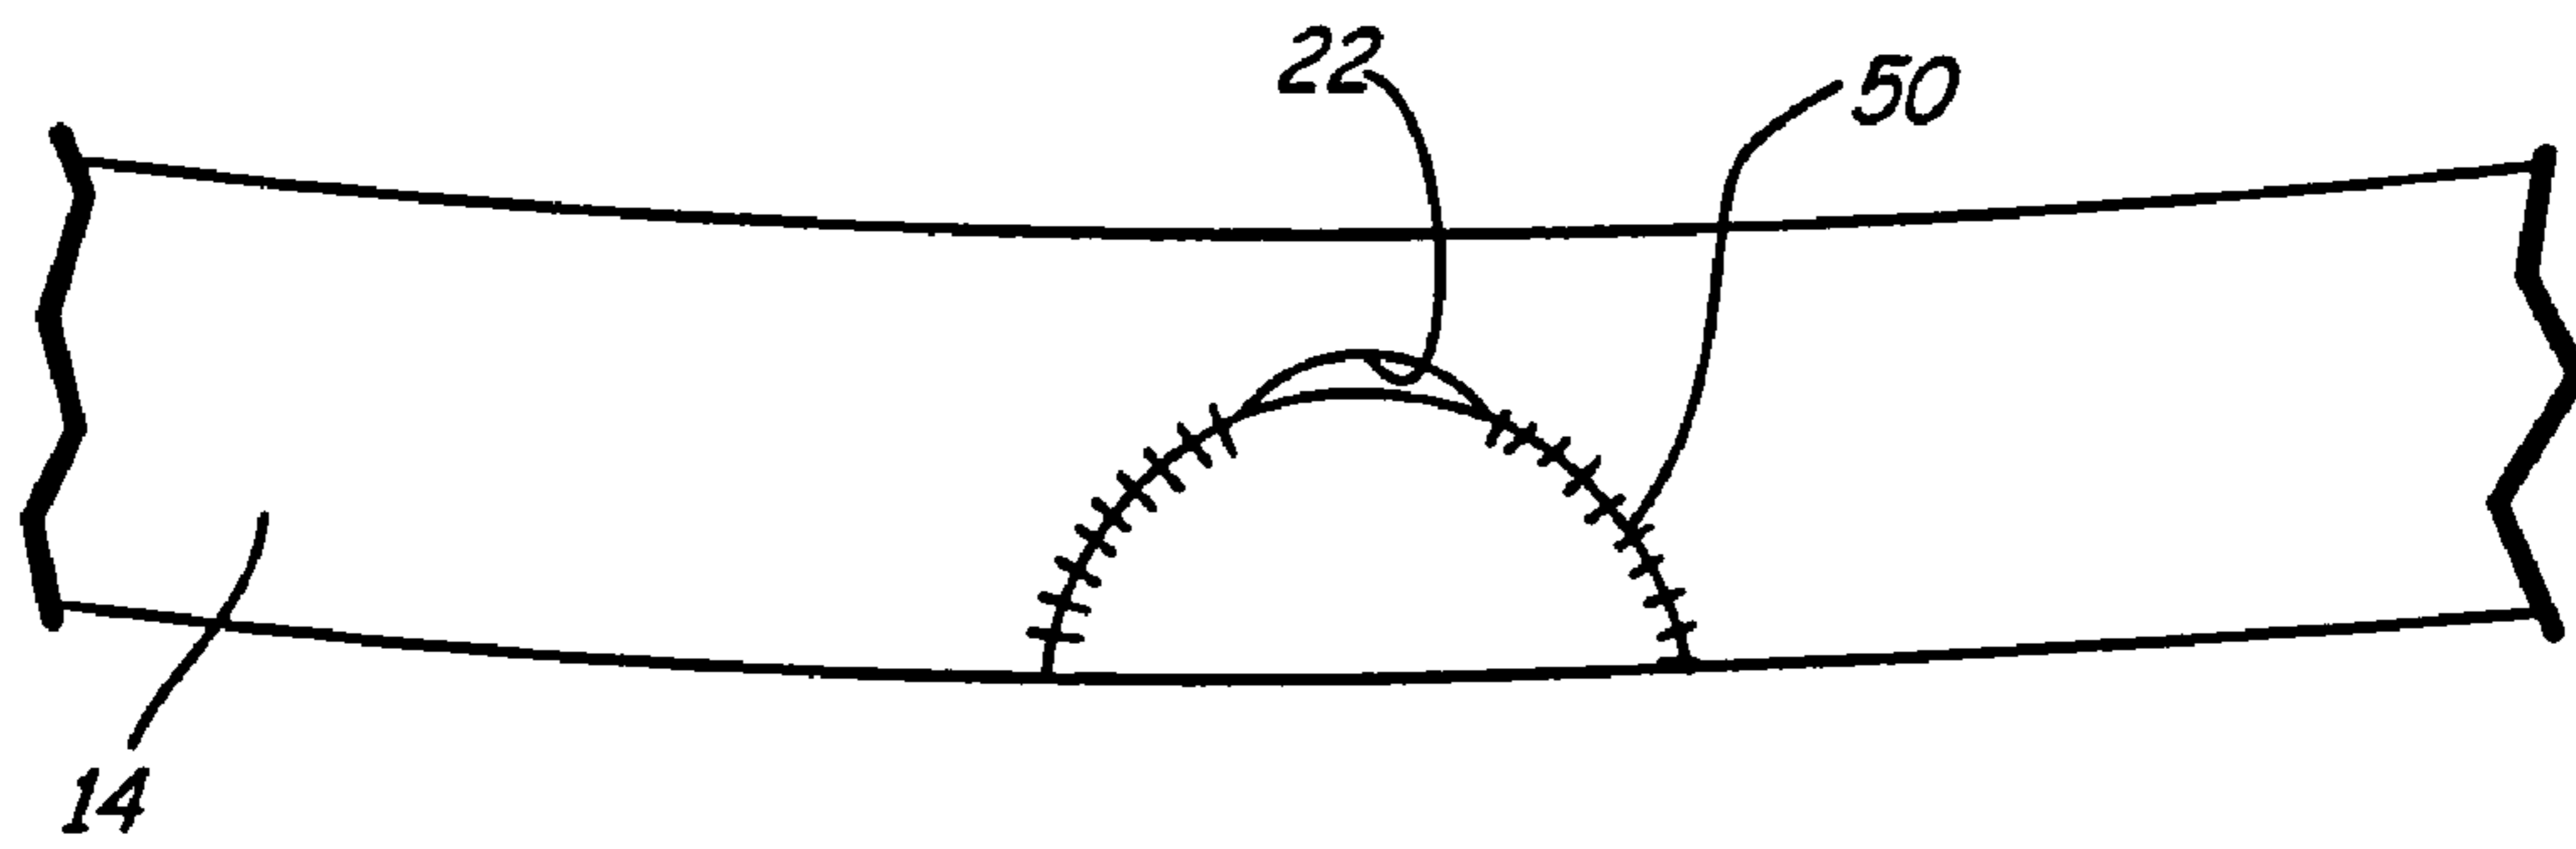
FIG. 13 is a plan view illustrating the combination plate and insert removed to produce the original flange profile.

FIG. **13** is a plan view illustrating combination plate **24** removed to produce the original profile of flange **14**. To remove combination plate **24**, first tack welds **26**, **28** are detached from flange **14**. Next, a mechanized process such as machining is utilized to remove combination plate **24** and excess material from insert **34** until the original profile of the top surface of flange **14** is obtained. After combination plate **24** is removed, arc **22** of the original aperture in flange **14** is again visible. Weld **50** will also be machined on the top and bottom surfaces to obtain nominally the same surfaces of flange **14** as those prior to the repair. Finally, the outer edge of flange **24** is machined to obtain substantially the same profile and outer diameter as the profile prior to the repair.

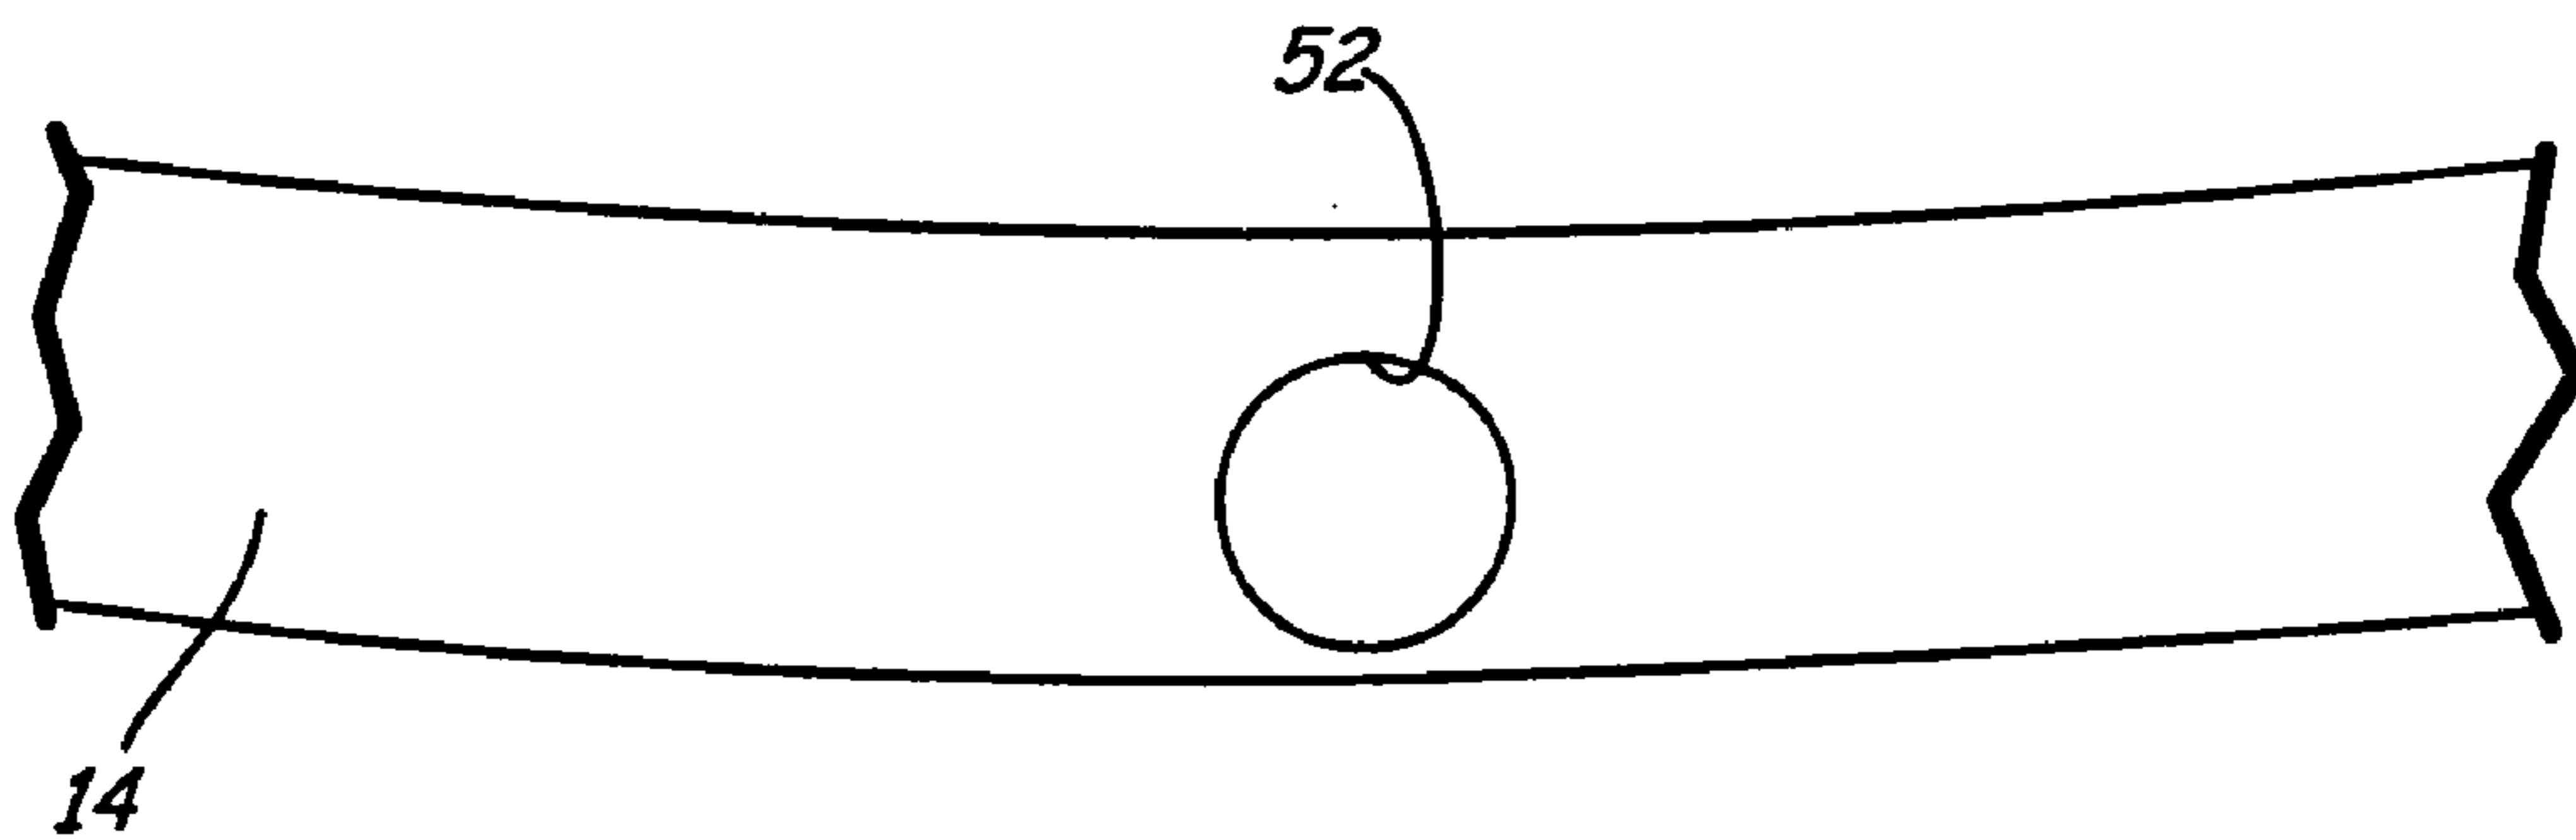
FIG. 14 is a plan view illustrating the complete repair with a new aperture in the flange.

FIG. **14** is a plan view illustrating the complete repair with a new hole **52** in flange **14**. After the flange profile has been nominally obtained, an aperture is machined in the flange to create nominally the same hole **12** that existed prior to the repair. Arc **22** is used as a guide to machine hole **52** to assure the location is nominally the same as prior to the repair. In an alternate embodiment, the hole in lower flange **20** (See FIGS. **2A** and **9**) is used as a guide to create hole **52** in flange **14**.
