(10) **Patent No.:** **US 7,858,897 B2**
(45) **Date of Patent:** **Dec. 28, 2010**

(54) **INSERT WELD REPAIR**

(73) Assignee: **United Technologies Corporation**,
Hartford, CT (US)

The present invention relates to the repair of turbine engine components, and in particular to the repair of small diameter holes located on the flange of a part such as the forward inner nozzle support.

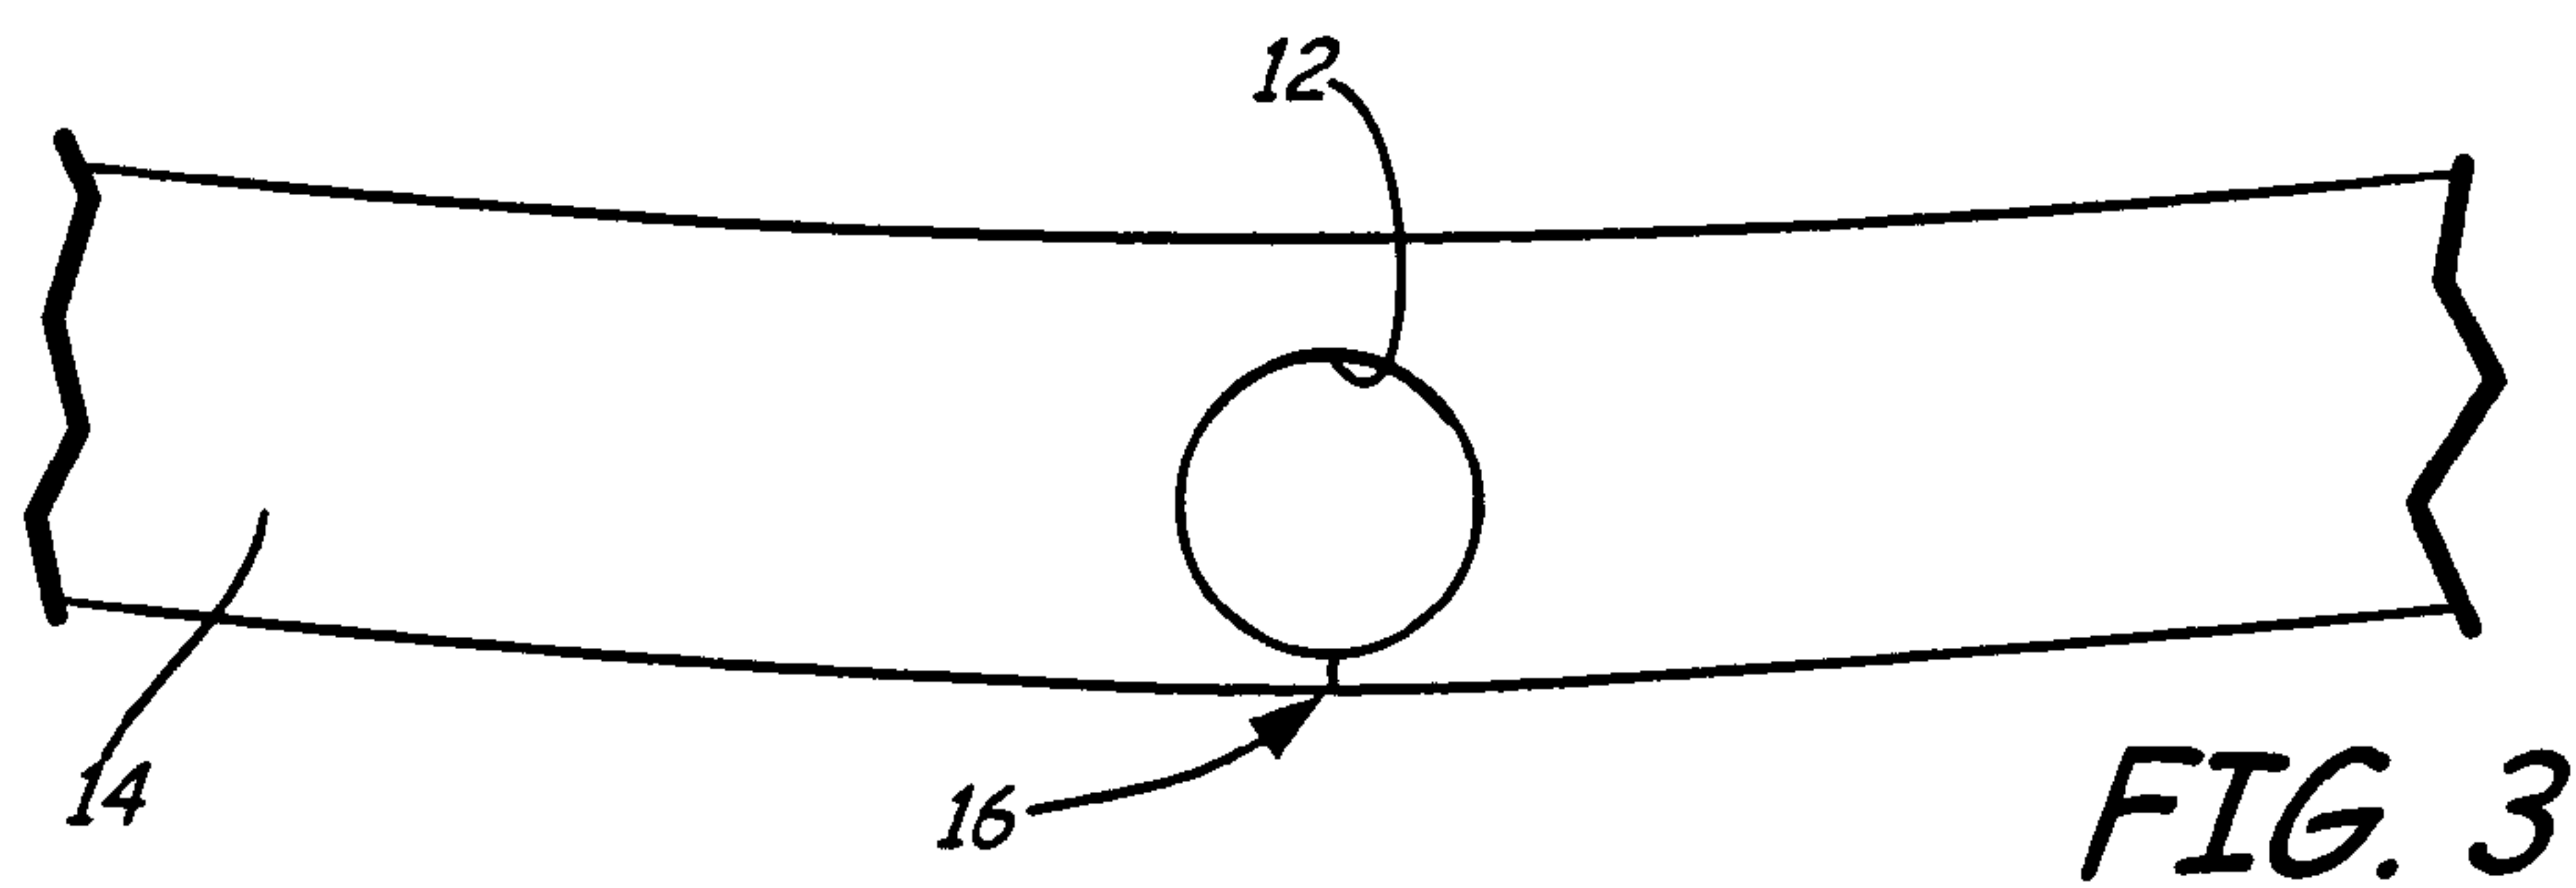
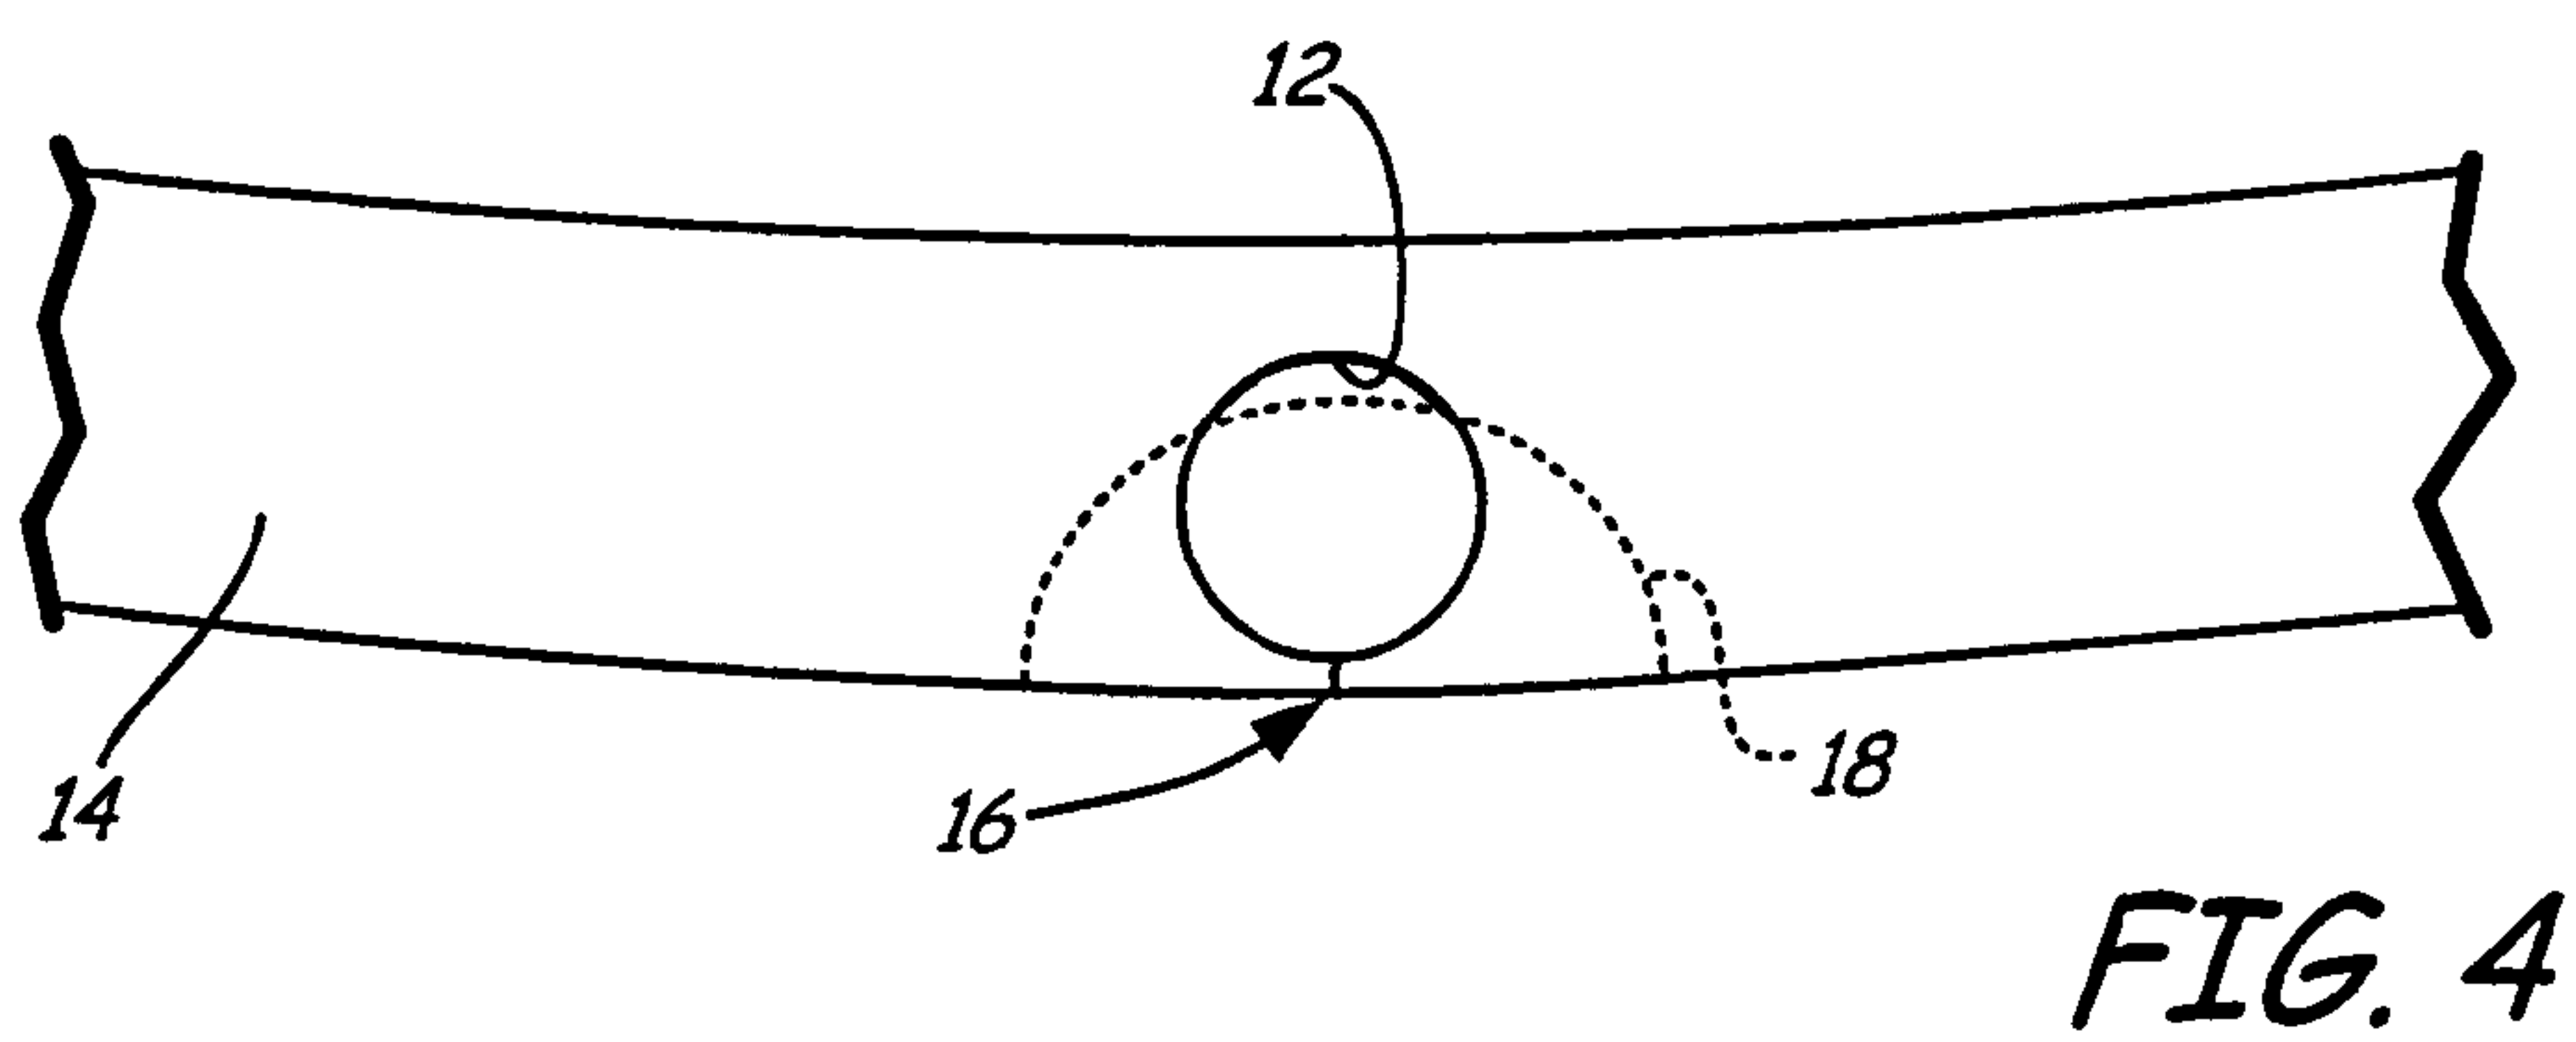
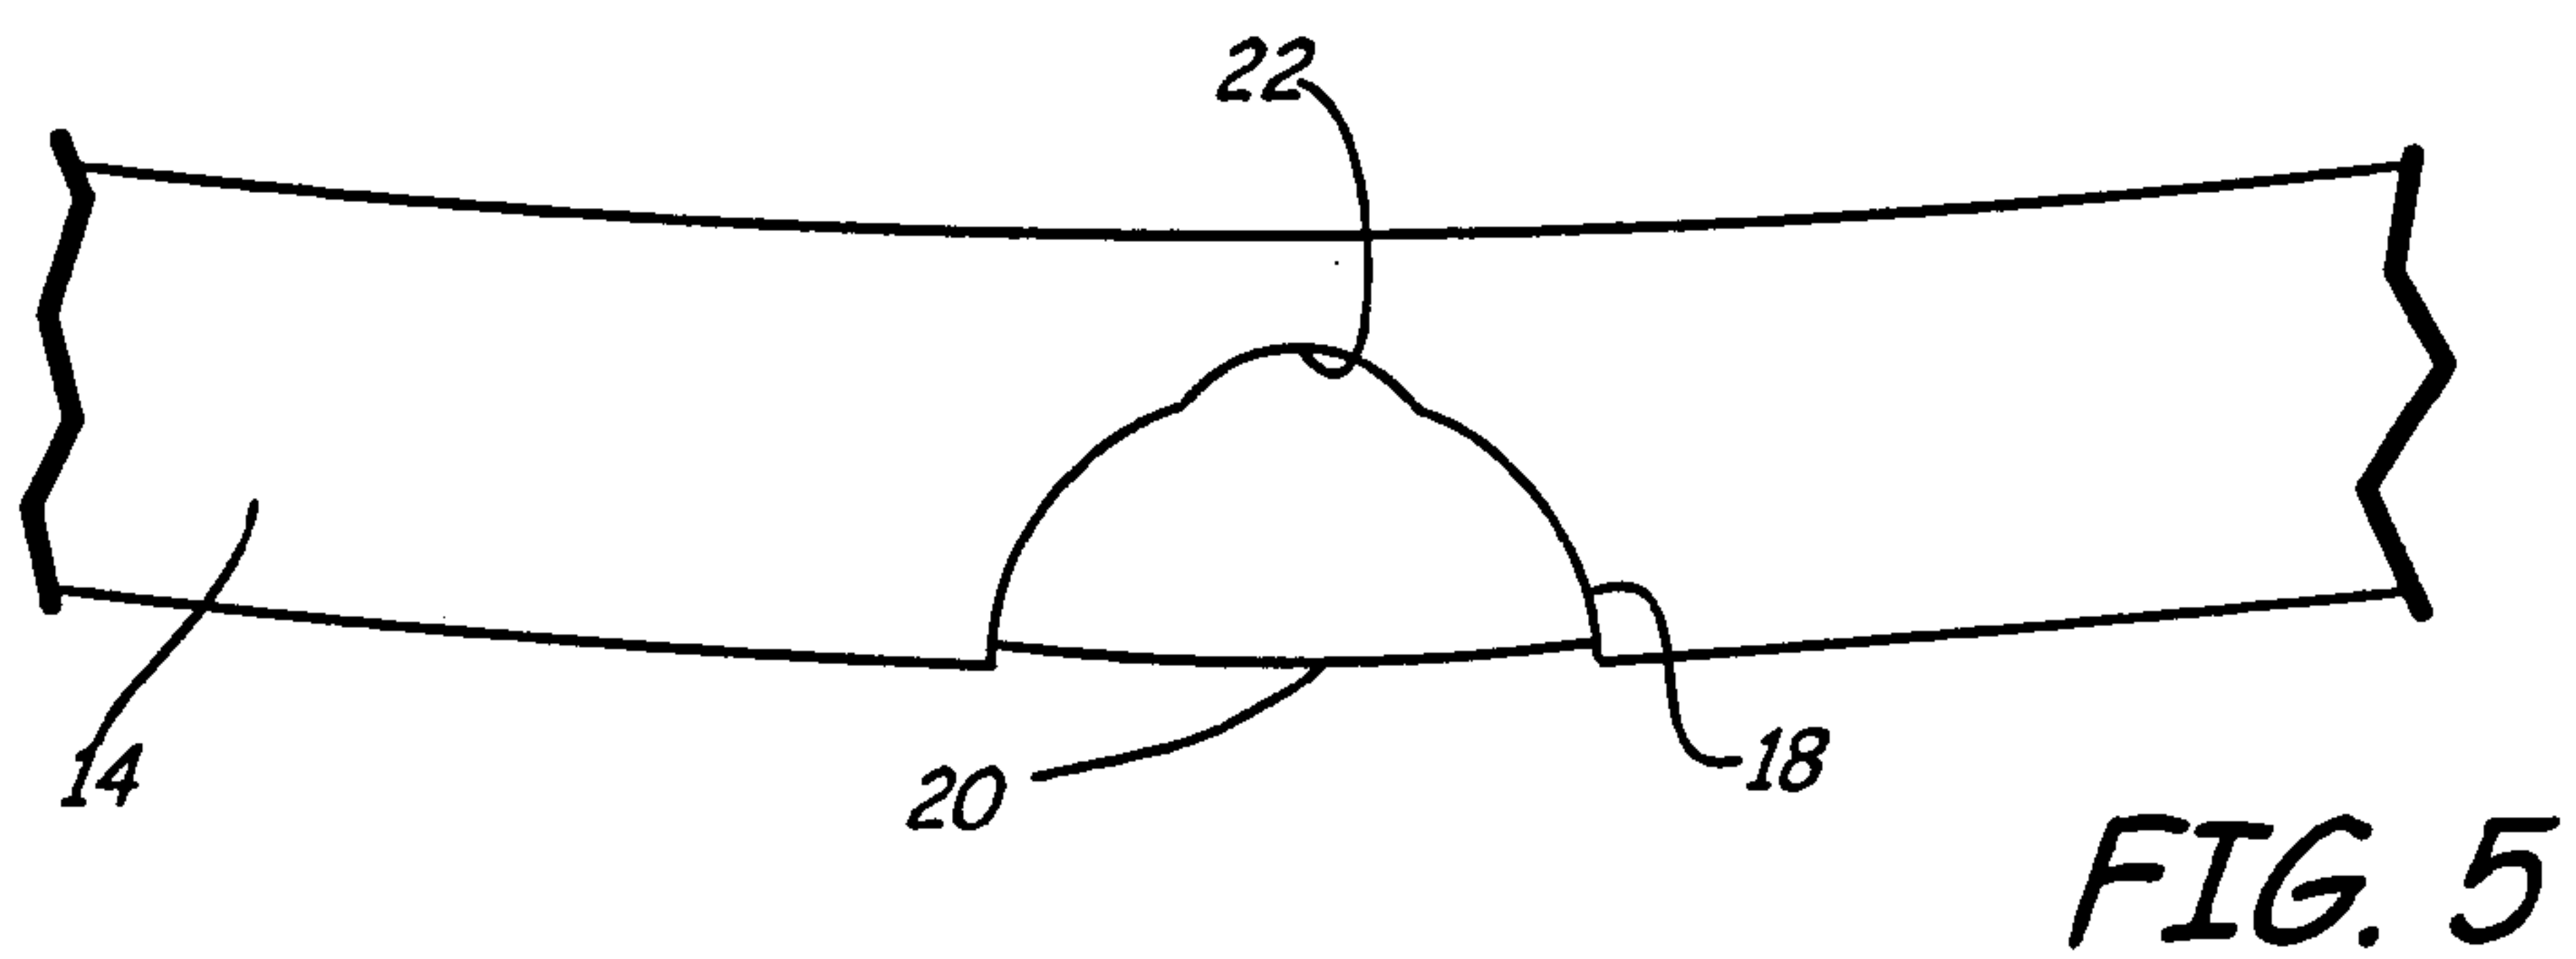
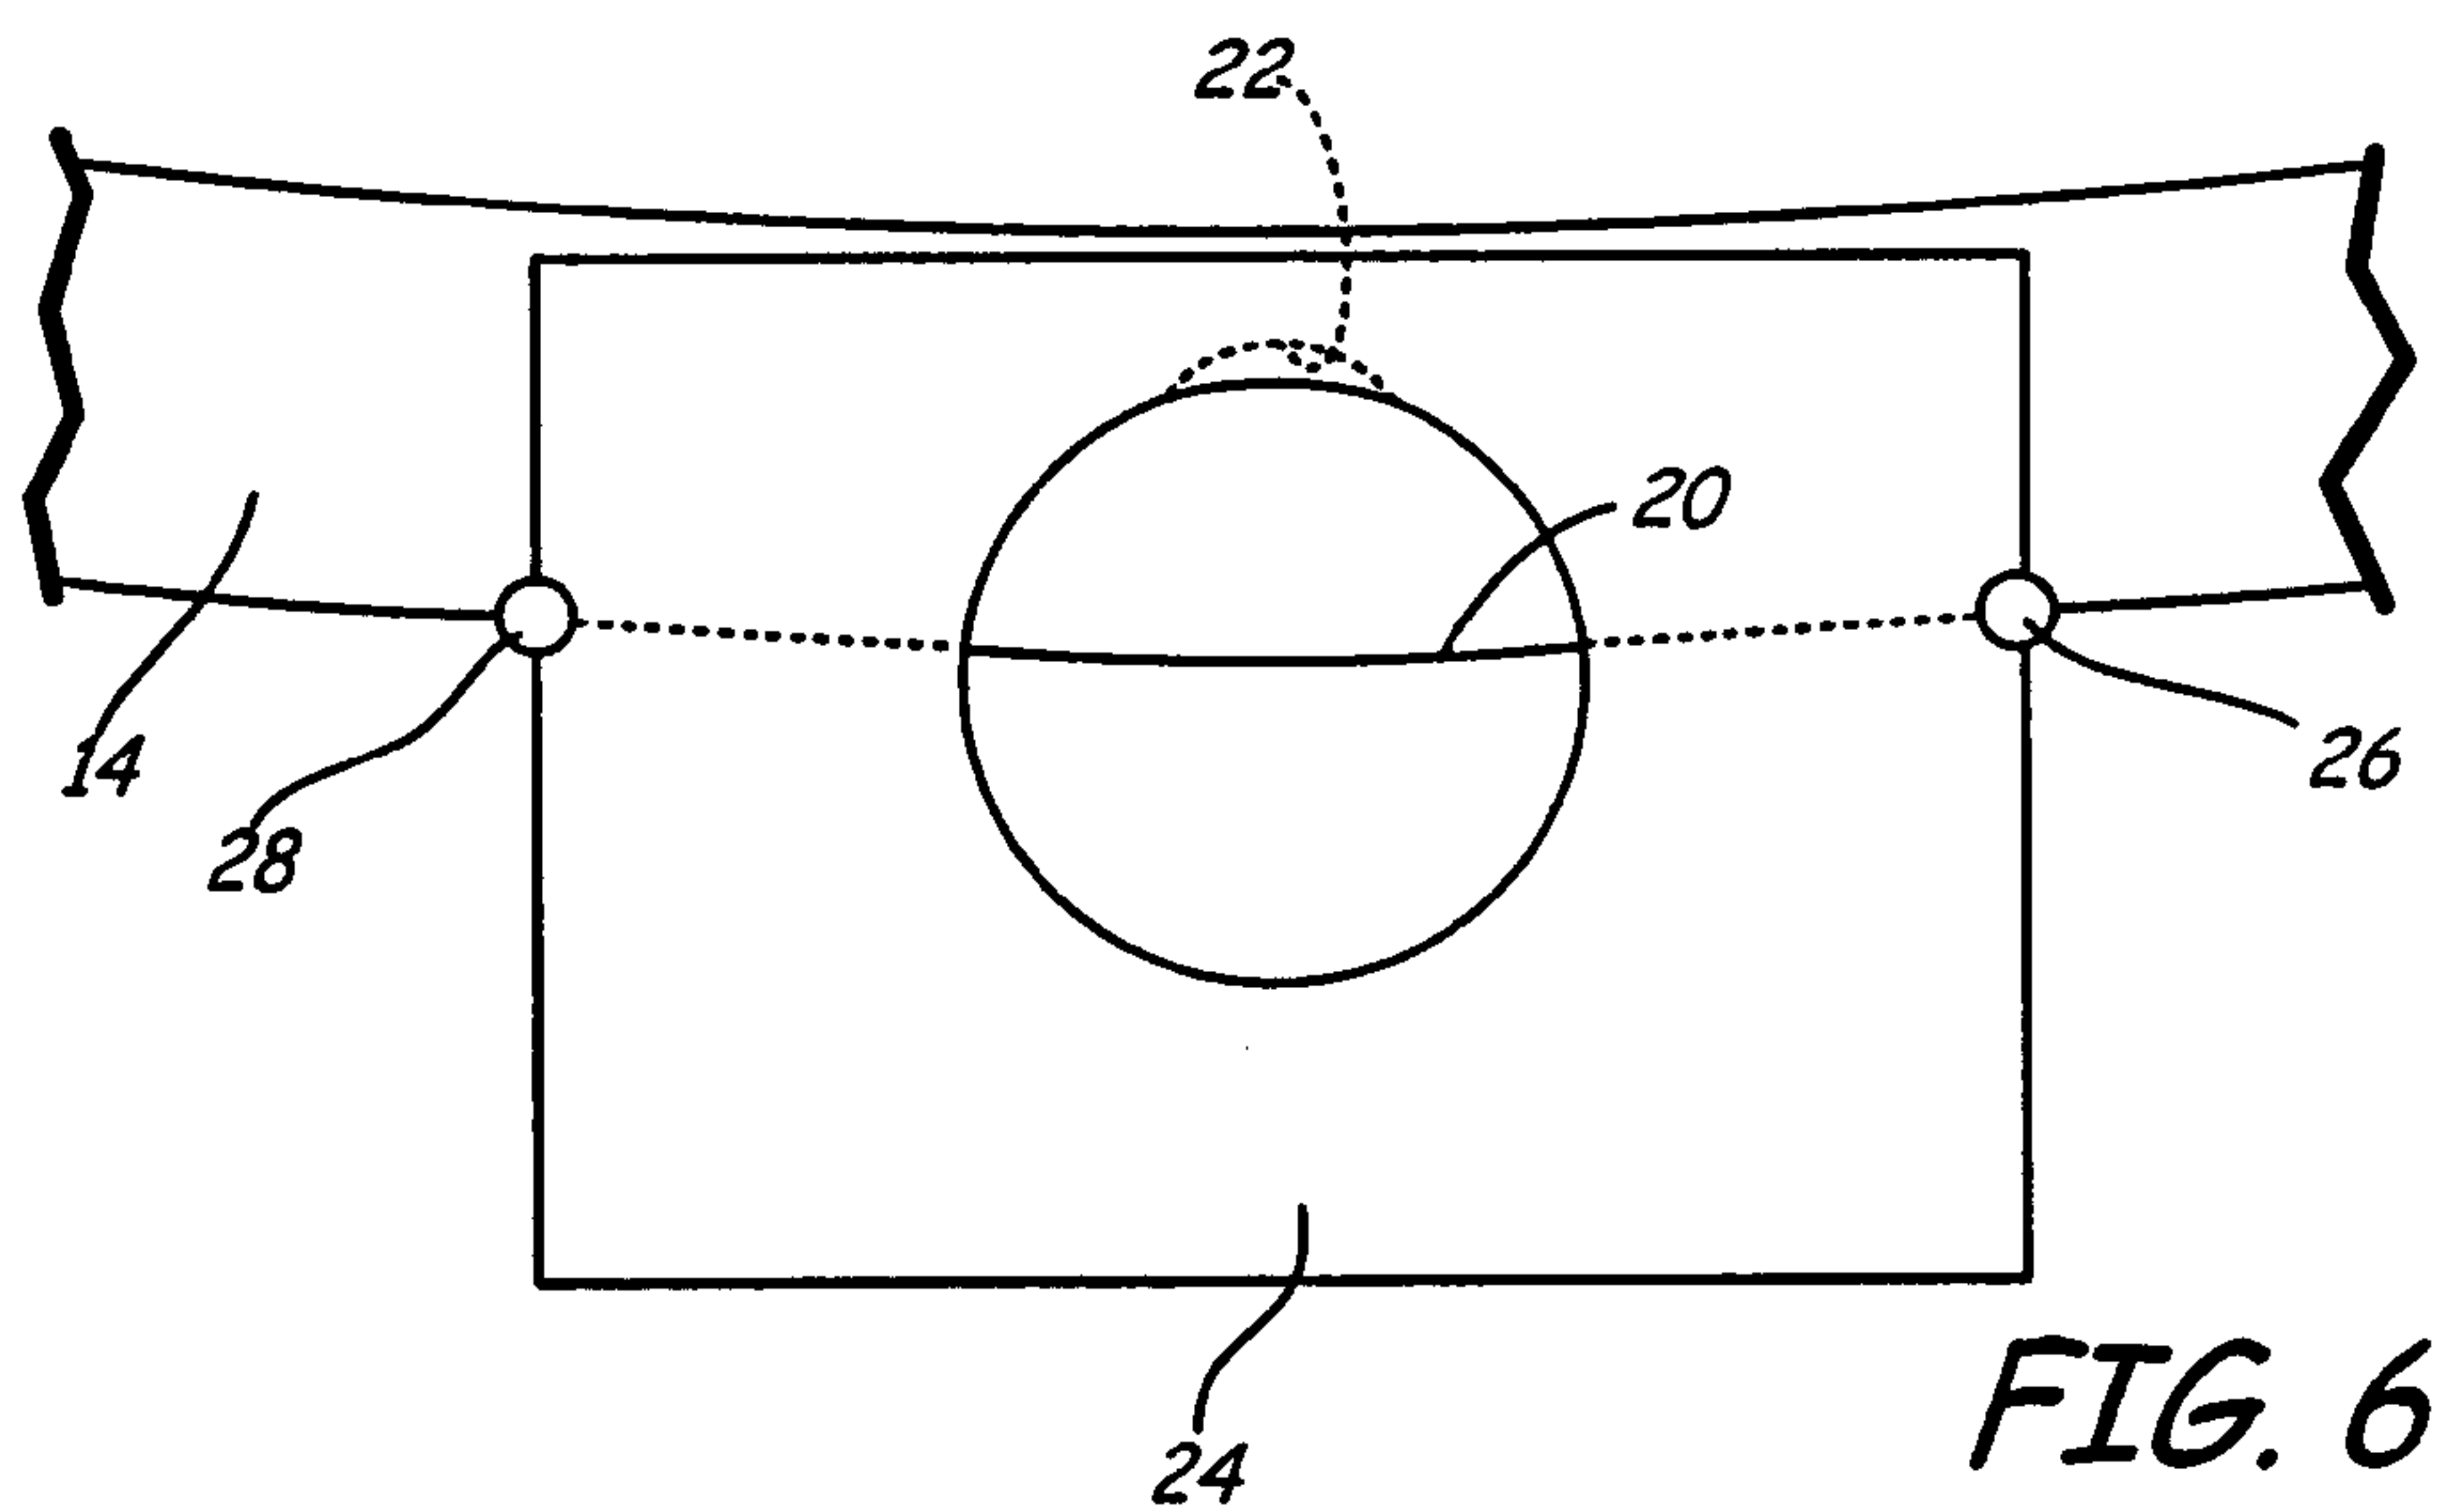
FIG. 3 is a plan view illustrating a defect adjacent an aperture on a flange.

FIG. 4 is a plan view illustrating a portion of the flange to be removed.

FIG. 5 is a plan view illustrating the portion of the flange removed and a parallel flange.

FIG. 6 is a plan view illustrating a combination runoff and top plate tacked to the flange.

FIG. 3 is a plan view illustrating defect 16 adjacent hole 12 on flange 14. Hole 12 is an aperture through flange 14 which is capable of receiving a pin or bolt to fasten another object to the nozzle support 10. In the embodiment illustrated, hole 12 is circular, although other aperture profiles are envisioned. Hole 12 is a small diameter aperture, less than about 0.30 inches in diameter, which was previously unrepairable when a defect was detected adjacent the aperture.

FIG. 4 is a plan view illustrating a portion 18 of flange 14 to be removed. Portion 18 of flange 14 is extracted by common techniques known to those of skill in the art for material removal, such as laser cutting or machining. Portion 18 is to be removed in a parabola centered about an axis that runs through the diameter of hole 12, without completely removing the hole 12. The material is removed by cutting perpendicular to the top surface of flange 14. Removing material in the shape of a parabola or similar shape removes the defect and provides an attachment surface outside the high stress zones which are adjacent hole 12. Typically, the position of a hole located nearest the outer edge of the flange, or perpendicular to the outer edge, as well as areas offset 90 degrees, 180 degrees, and 270 degrees therefrom, contain the highest stresses (See A, B, C, and D, respectively, FIG. 2A). Creating a repair where the weld seams fall between these areas (at approximately 45 degrees, 135 degrees, 225 degrees, and 315 degrees) moves the welds out of high stress zones surround-

FIG. 5 is a plan view illustrating portion 18 of flange 14 removed, which reveals lower flange 20. With portion 18 removed, only a small arc 22 of the hole 12 is left. The remaining arc 22 acts as a guide and locator for finishing the repair to assure that the repaired hole is nominally placed in the same position on flange 14 as the original hole 12. Lower flange 20 is a parallel structure to flange 14, and a slot 15 exists between the two flanges 14 and 20, which run circumferentially around the base of the forward inner nozzle support (See FIGS. 2 and 2A).

FIG. 6 is a plan view illustrating a combination plate 24 (i.e., combination runoff and top plate) attached to flange 14. Combination plate 24 is attached to flange 14 by placing tack welds 26, 28 where the edges of combination plate 24 meet the outer edge of flange 14. Tack welds 26, 28 hold combination plate 24 temporarily in place. Also, tack welds can be easily removed later, without damaging flange 14, to remove combination plate 24. Combination plate 24 may be fabricated from the same material as the base material of flange 14, or a material that has consistent metallurgical properties. In embodiments, combination plate 24 has a central portion removed that reveals lower flange 20, and covers arc 22. In alternate embodiments (not illustrated), combination plate 24 does not cover arc 22.

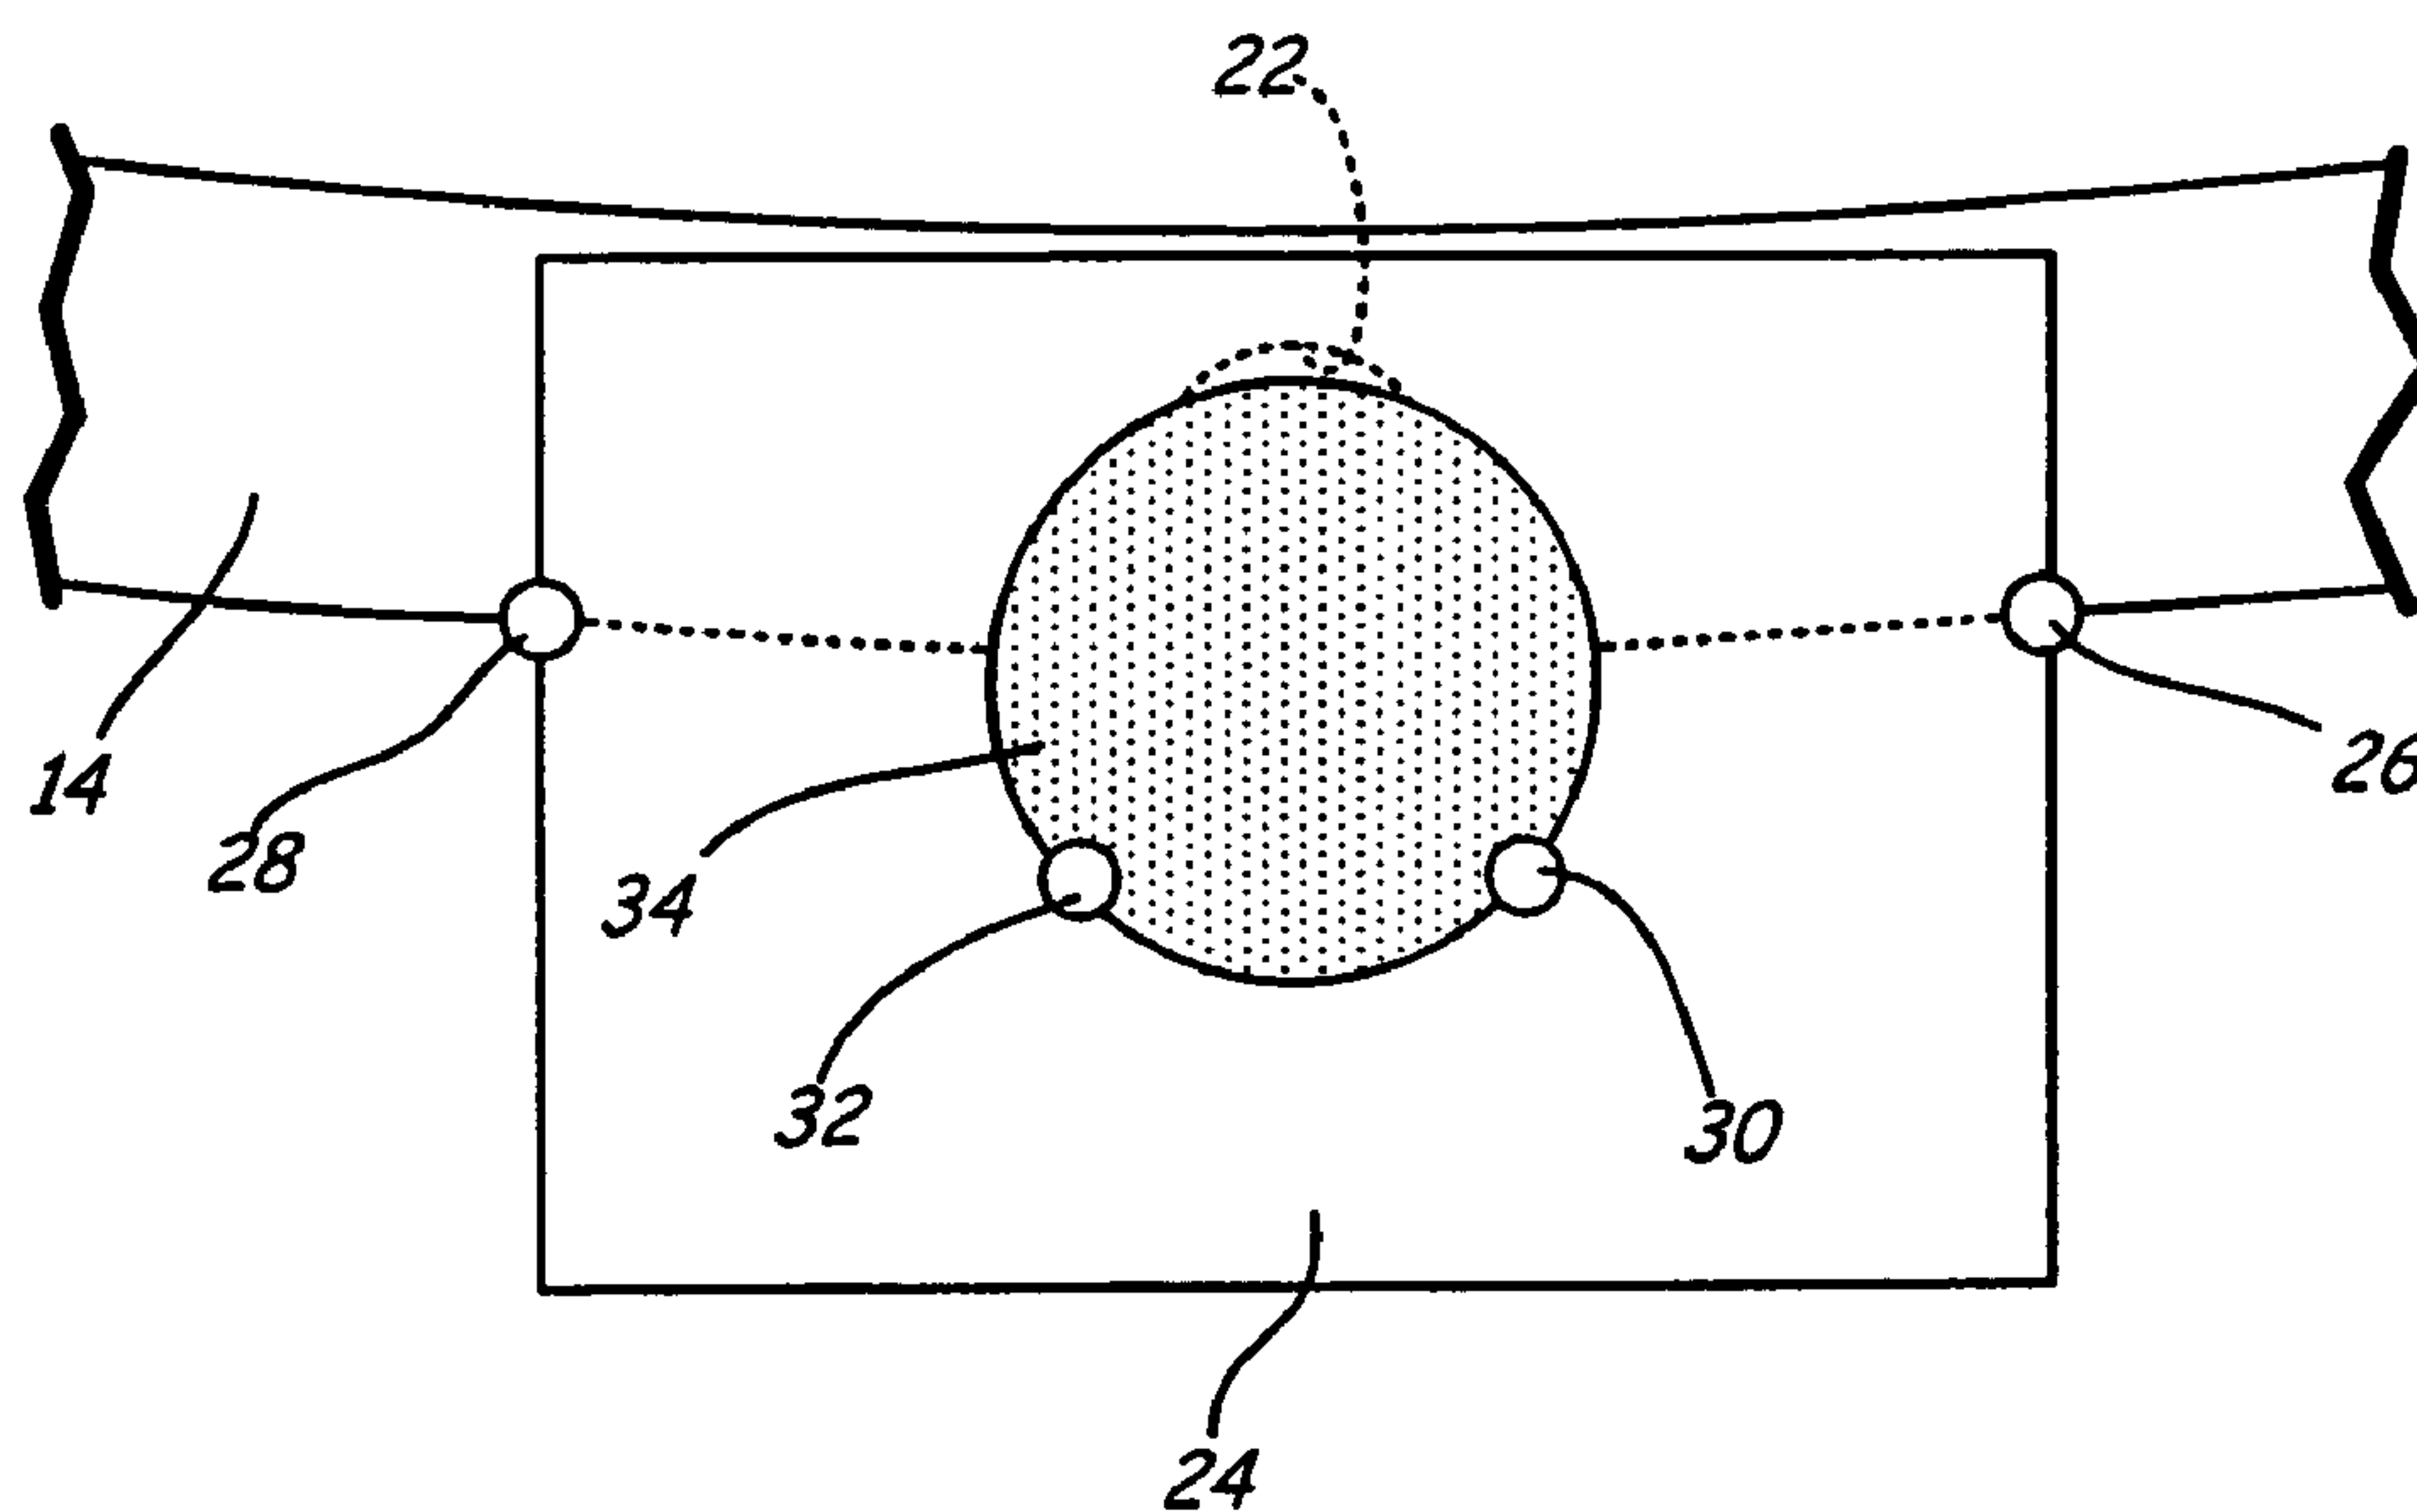
FIG. 7 is a plan view illustrating a biscuit insert tacked to the combination plate.

FIG. 7 is a plan view illustrating insert 34 attached to the combination plate 24 via tack welds 30, 32, which hold the insert 34 in place until the final welding process occurs. Insert 34 is a plug of material that is preferably the same material as, or contains the same metallurgical properties as, that of the base material of flange 14. Insert 34 is sized to be positioned against the edge of portion 18 of flange 14 previously removed (see FIG. 4), as well as mate with the profile of the aperture in combination plate 24. In the embodiment illustrated, insert 34 is circular. Although illustrated as circular, insert 34 may be elliptical, biscuit shaped, or have an arced portion that matches the profile of the removed material 18 of flange 14. When the weld is complete, tack welds 30, 32 will be incorporated into the final repair weld.

In embodiments, combination plate 24 is larger than the diameter of the hole 12 being repaired. In embodiments, combination plate 24 has a length (measurements of the sides generally parallel to the outer edge of flange 14) of at least two times the diameter of the original hole 12 (FIG. 2), and has a width (measurements of the sides generally perpendicular to the outer edge of flange 14) of at least two times the diameter of hole 12. The aforementioned dimensions of combination plate 24 assure good support for insert 34, and allow for locating tack welds 26, 28 an adequate distance from the repair weld(s) around insert 34.

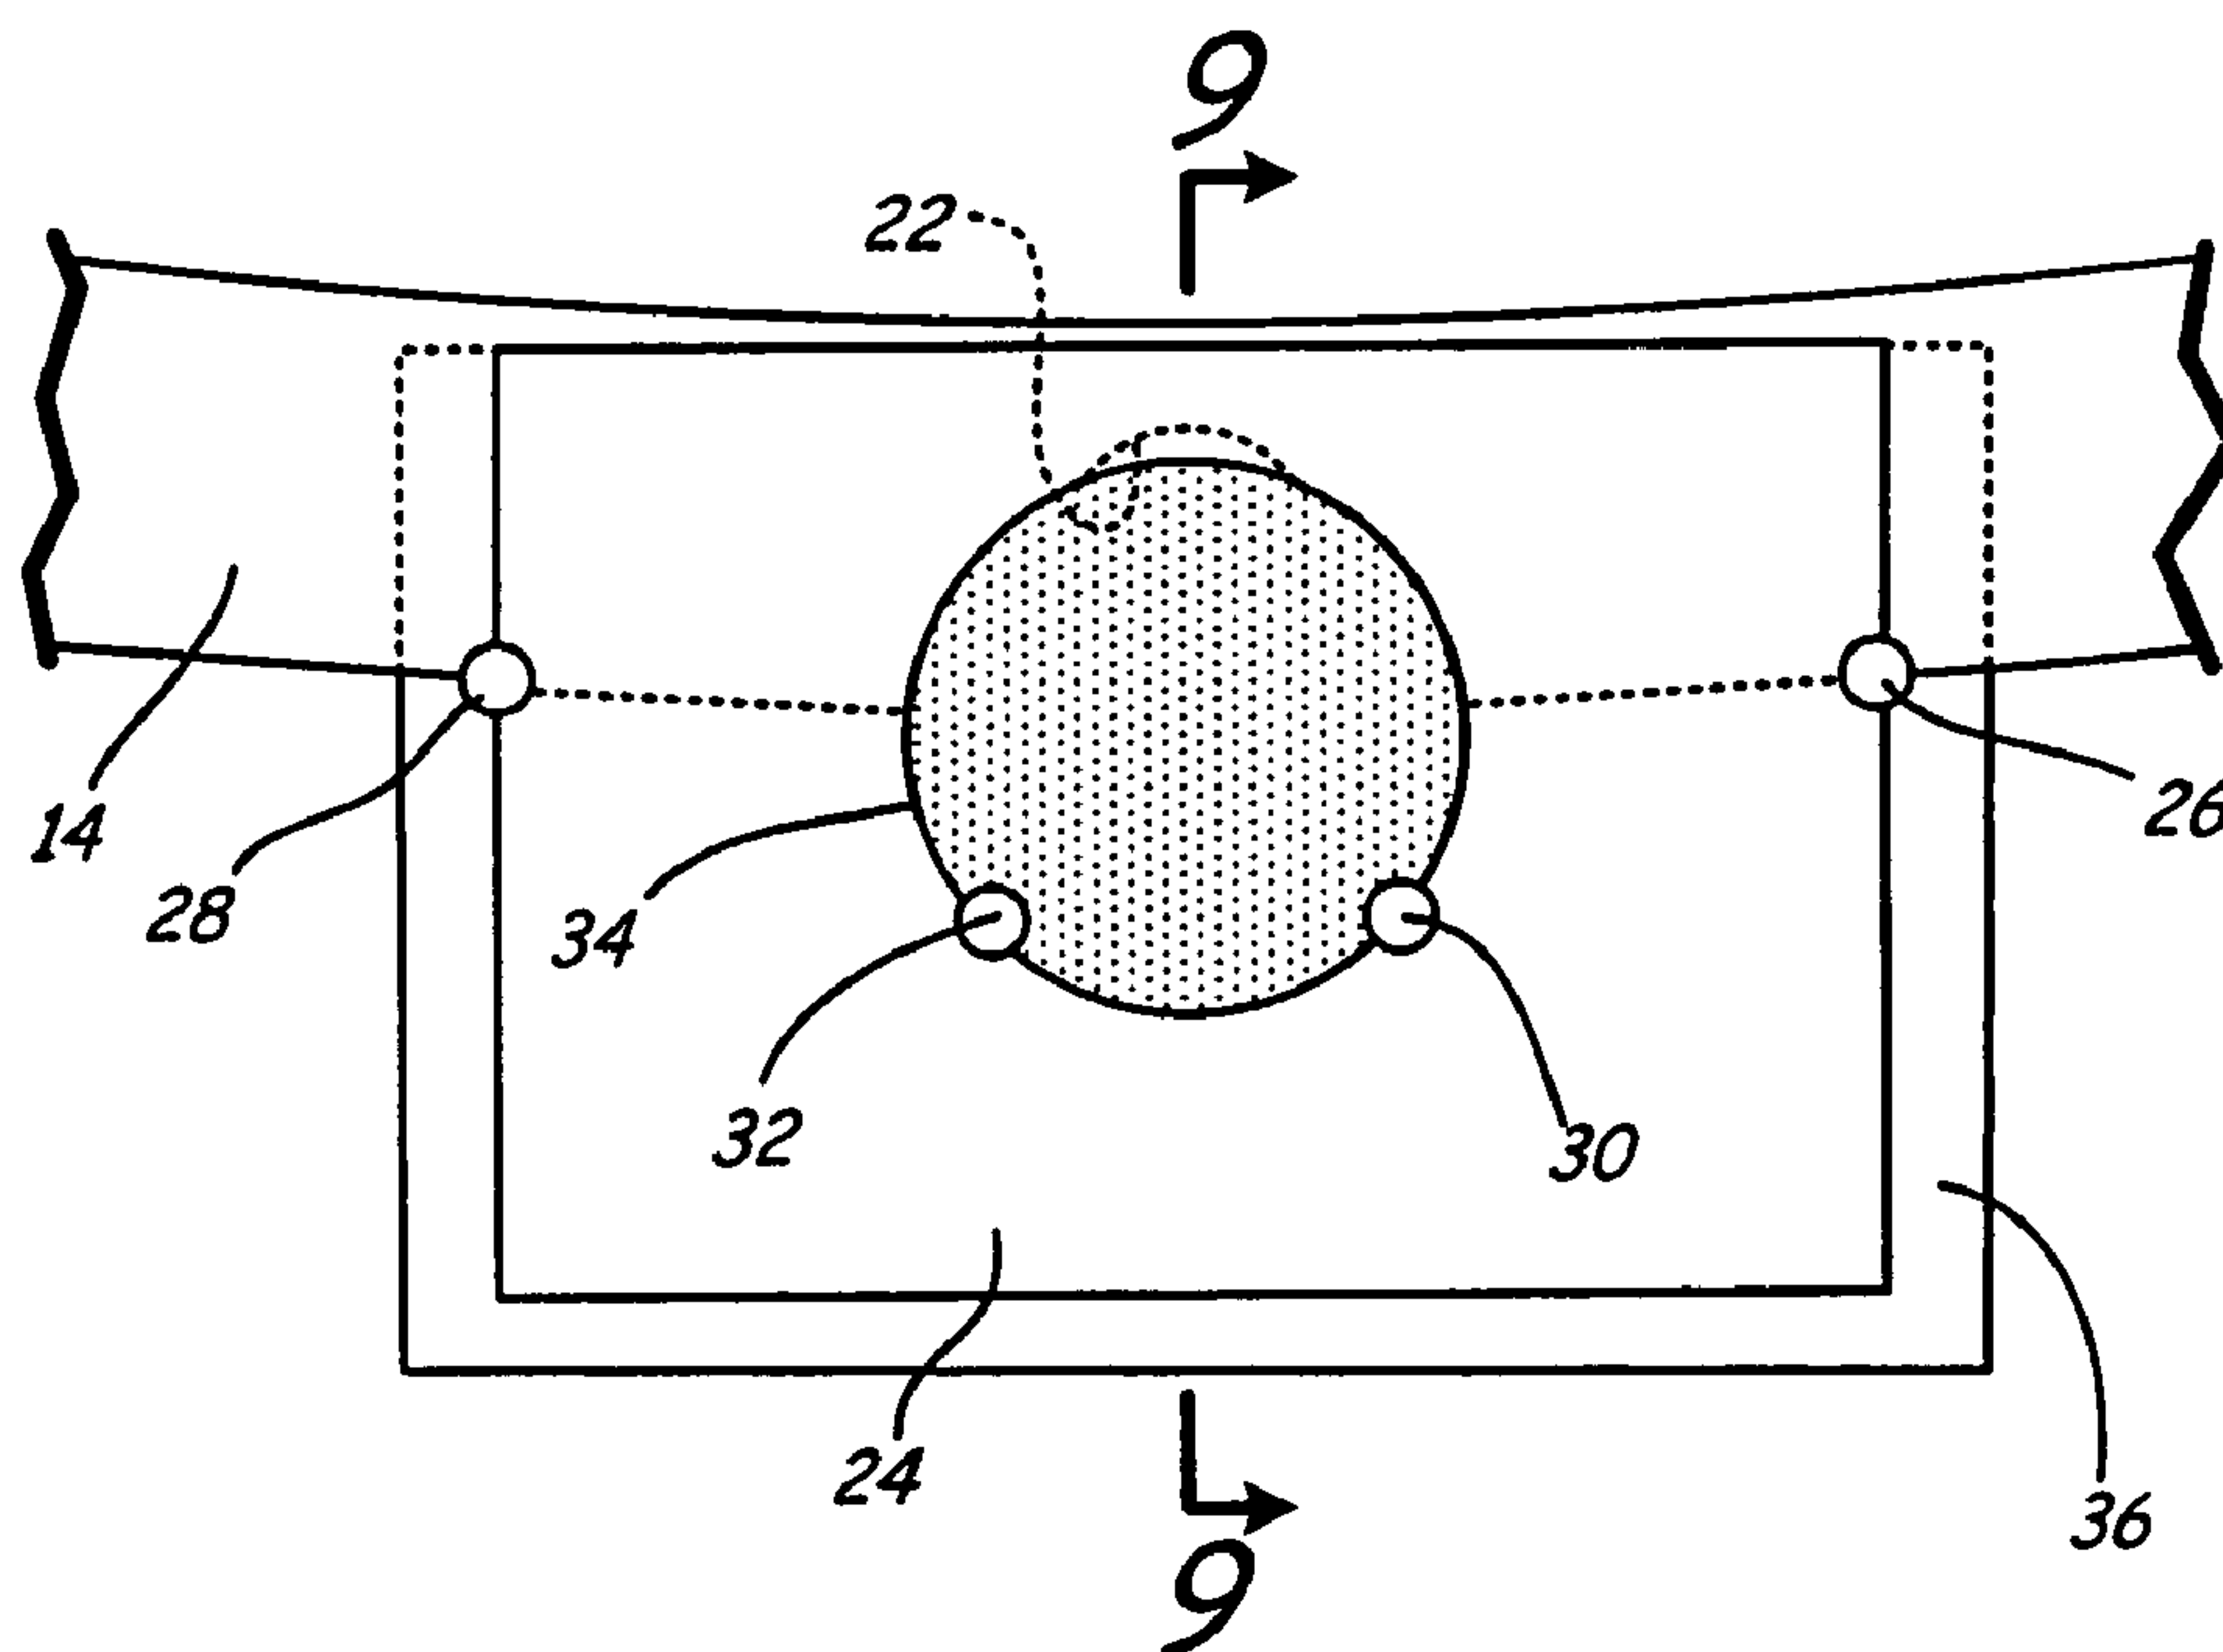
FIG. 8 is a plan view illustrating a backing plate placed below the combination plate and insert.

FIG. 8 is a plan view illustrating backing plate 36 placed below combination plate 24 and insert 34. Backing plate 36 may be fabricated from a similar metal that is used to construct combination plate 24 and insert 34. In alternate embodiments, backing plate 36 is constructed from a different metal, or a heat resistant material such as ceramic. In FIG. 8, backing plate 36 is illustrated as containing larger dimensions than combination plate 24, but backing plate 36 may be smaller in size than combination plate 24 so long as the backing plate 36 covers the area underneath where the repair weld is to be made. When backing plate 36 is larger than combination plate 24, backing plate 36 protects adjacent

areas from weld run off or spatter, as well as protects lower flange 20 from penetration of the electron beam or similar welding source.
