(10) **Patent No.:** **US 7,858,897 B2**
(45) **Date of Patent:** **Dec. 28, 2010**

(54) **INSERT WELD REPAIR**

(73) Assignee: **United Technologies Corporation**,
Hartford, CT (US)

The present invention relates to the repair of turbine engine components, and in particular to the repair of small diameter holes located on the flange of a part such as the forward inner nozzle support.

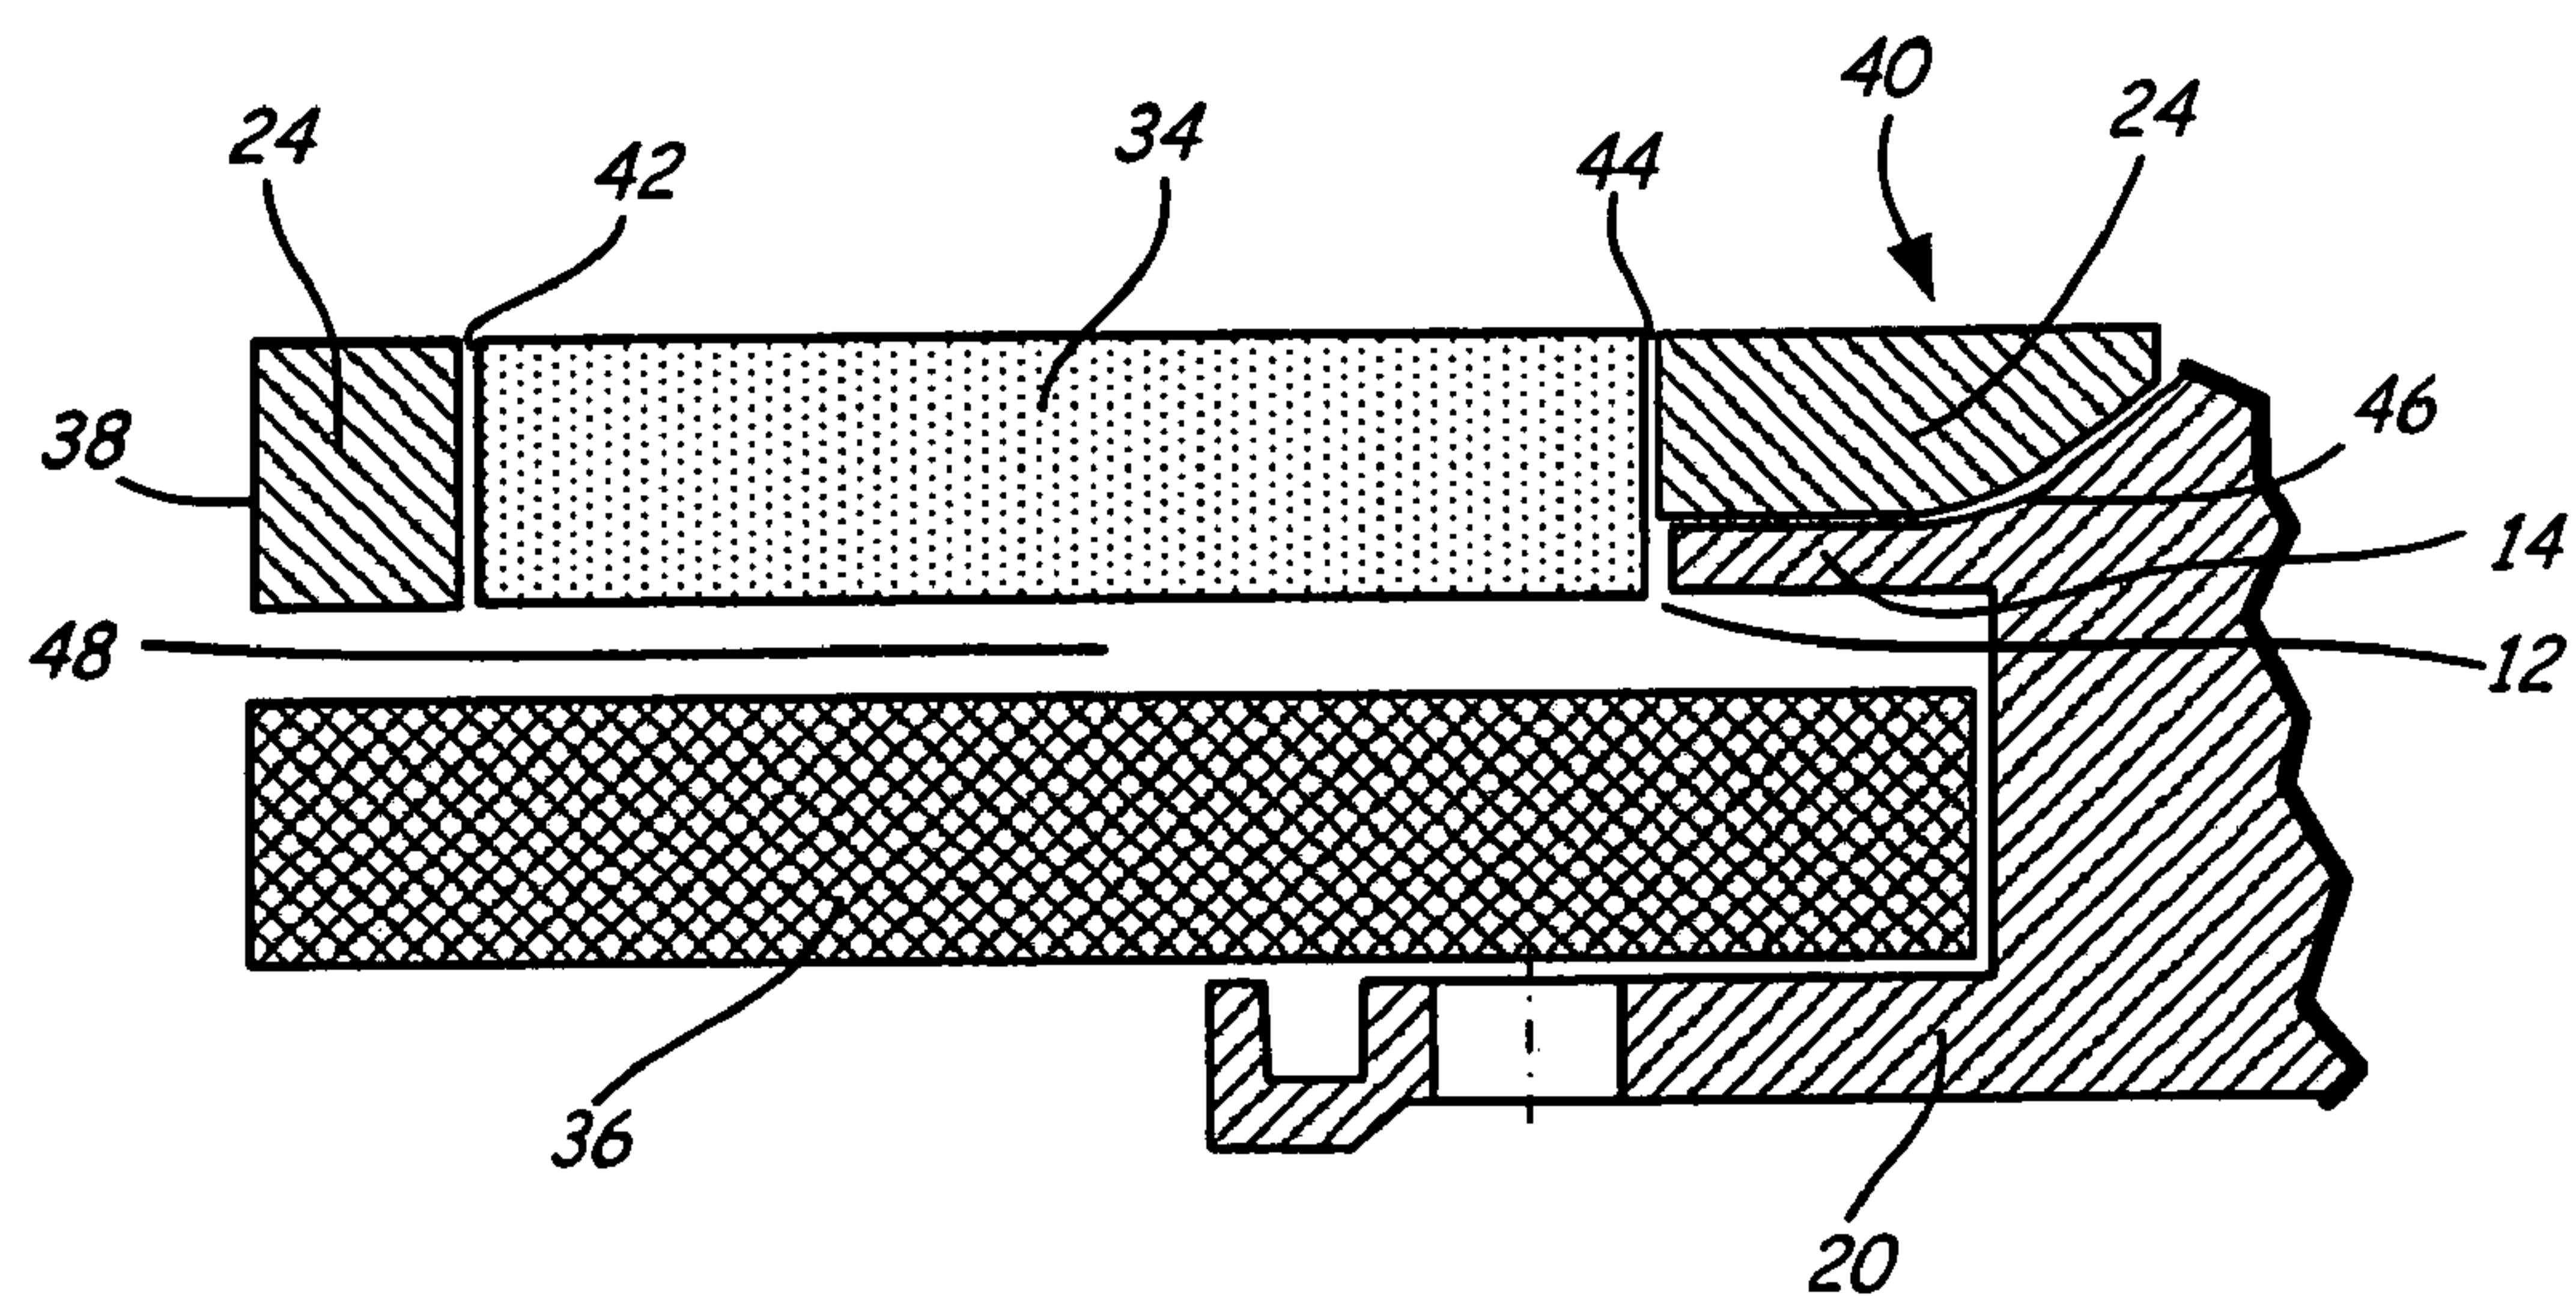
FIG. 9 is a cross-sectional elevation view of the bolt hole repair apparatus for refabrication of the flange of the nozzle support illustrated in FIG. 7.

FIG. 9 is a cross-sectional elevation view of the bolt hole repair apparatus for refabrication of flange 14 illustrated in FIG. 8. In this view, the remaining portion of the base material of flange 14 is visible. Also illustrated are insert 34, combination plate 24, and backing plate 36. Insert 34 is a thickness that is approximately equivalent to the thickness of the rear edge 38 of combination plate 24, which is also approximately equivalent to the thickness of the front end 40 of combination plate 24 added to thickness of the remnant of hole 12 left on flange 14. Small clearance gaps 42, 44 exist between insert 34 and plate 24. The clearance allows for the easy insertion of insert 34 into the aperture contained in combination plate 24. Clearance gaps 42, 44 will cease to exist as the material from insert 34 and combination plate 24 fuse together during the repair weld.

Front end 40 of combination plate 24 is contoured to mate with remaining surface 46 of flange 14 and hole 12. Although flange 14 is illustrated in this view as containing a radius, other geometries of the contour are envisioned including bevels, chamfers, rabbets, dados, or stepped notches, the geometry of the contour depending on the geometry of the base material left on flange 14. Insert 34 and combination plate 24 contain more material than the thickness of the material removed from flange 14 so that insert 34 can be machined to the appropriate size after the weld repair has been completed.

The part illustrated in FIG. 9 is a section of nozzle support 10 of FIG. 2. Nozzle support 10 contains two flanges, flange 14 which is to be repaired, and a lower flange 20. Lower flange 20 and flange 14 are spaced close together, and a typical spacing is less than about 0.25 inches. Backing plate 36 is placed between flange 14 and lower flange 20, and protects the lower flange 20 from any slag, spatter, or similar byproduct resulting from the welding process.

Thus, in this invention, an air gap 48 is left between the top surface of backing plate 36 and the bottom surfaces of insert 34, combination plate 24, and the remaining portion of flange 14. In embodiments, air gap 48 is about 0.10 inches or less, which assures that the excess energy from the weld beam is adsorbed, but is far enough from the bottom edge of the repair pieces (insert 34, combination plate 24, and flange 14) to assure that backing plate 36 does not become fused to the repair pieces. Utilizing combination plate 24 to provide a good weld, while separating the repair pieces from the backing plate 36 via air gap 48, assures that a good, structurally sound weld repair can be obtained. Backing plate 36 should be large enough to cover the clearance gaps 42, 44 between the combination plate 24 and the edges of the insert all the way around the edge of insert 34. The thickness of backing plate 36 is less than the distance between flange 14 and lower flange 20 so that air gap 48 exists as shown.

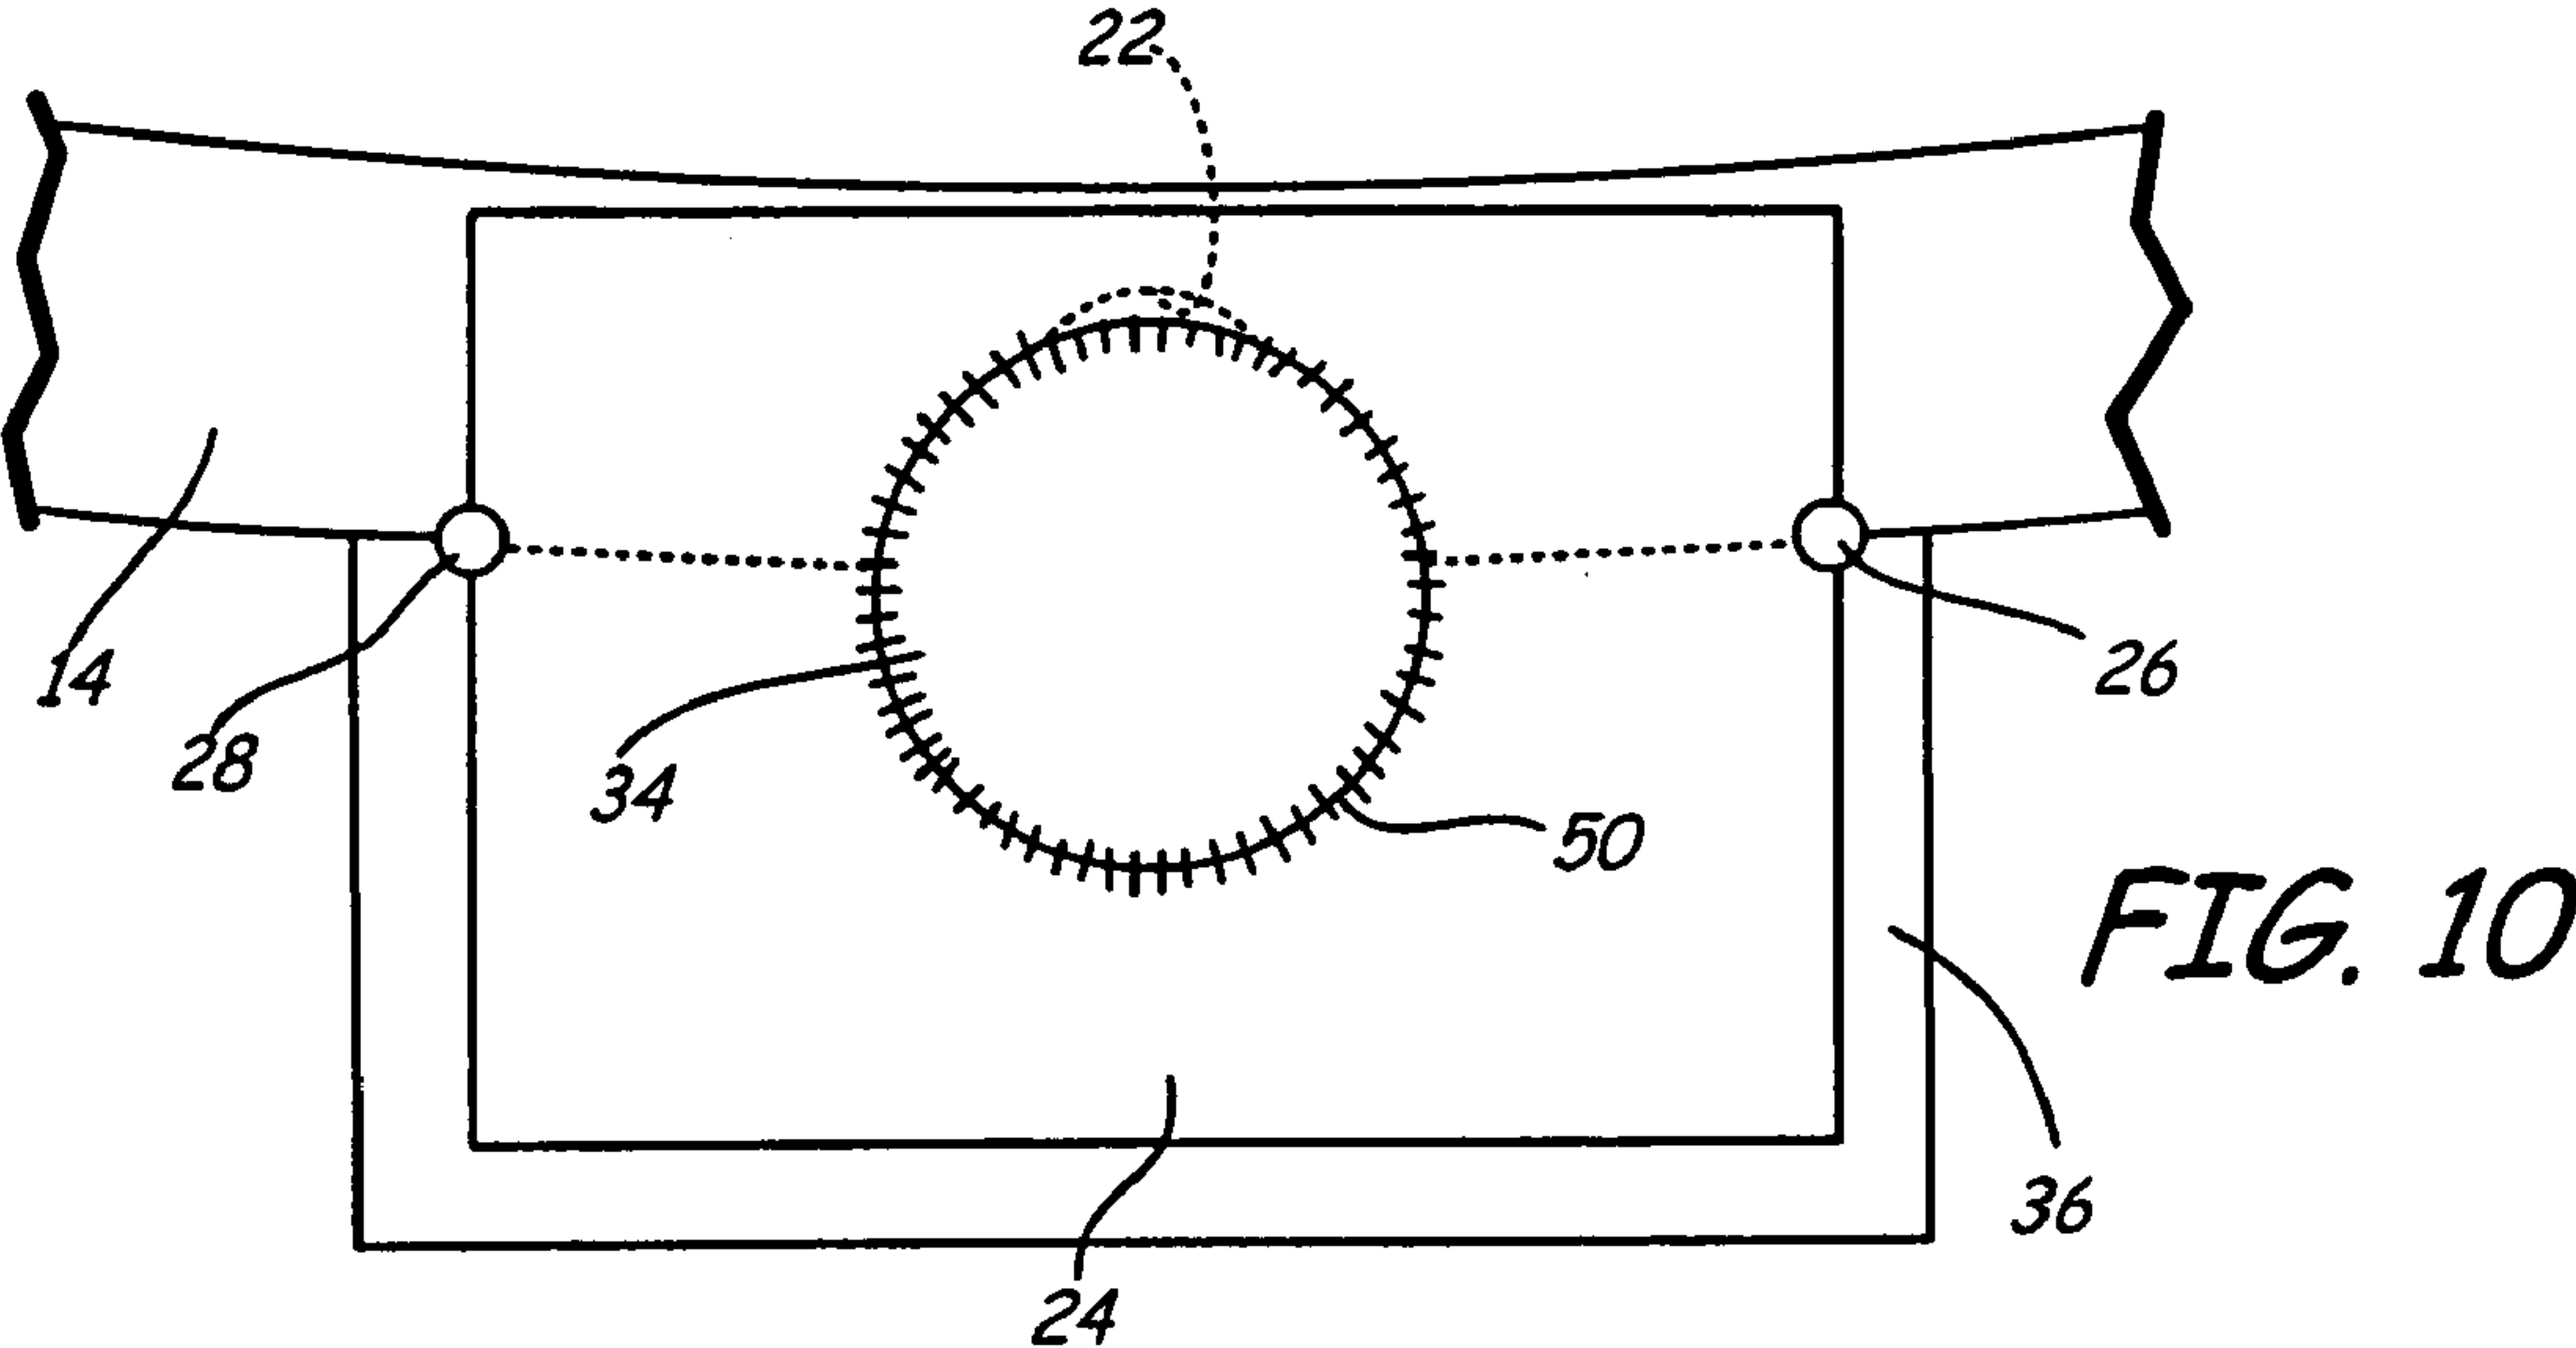
FIG. 10 is a plan view illustrating a completed weld between the insert, combination plate, and flange with the backing plate still in place.

FIG. 10 is a plan view illustrating a completed weld 50 between insert 34 and combination plate 24. Insert 34 is welded into place by a process such as electronic beam welding. Electronic beam welding (EBW) uses a narrow beam of high velocity, high energy electrons to generate the heat necessary to create a weld in a metal work piece. Special equip-

ment is used to focus the electron beam in a vacuum chamber, and the kinetic energy of the electrons is converted to heat energy as it strikes the metal. The welds created by EBW are characteristically deep and narrow with a very small heat affected zone and low distortion. The current repair moves the weld seams out of the high stress areas surrounding the hole 12. The weld seams are left in the low stress areas of the flange 14.

EBW is typically autogenous, that is, does not require a filler material. Thus, a tight fit of insert 34 with the remaining base material and combination plate 24 will occur as the pieces fuse together during the welding process without the addition of a filler material. Weld 50 is a butt weld joining insert 34, base material of flange 14, and combination plate 24 together. While weld 50 is done from the top of insert 34, the weld extends around the entire perimeter of insert 34 and throughout the entire thickness of insert 34.

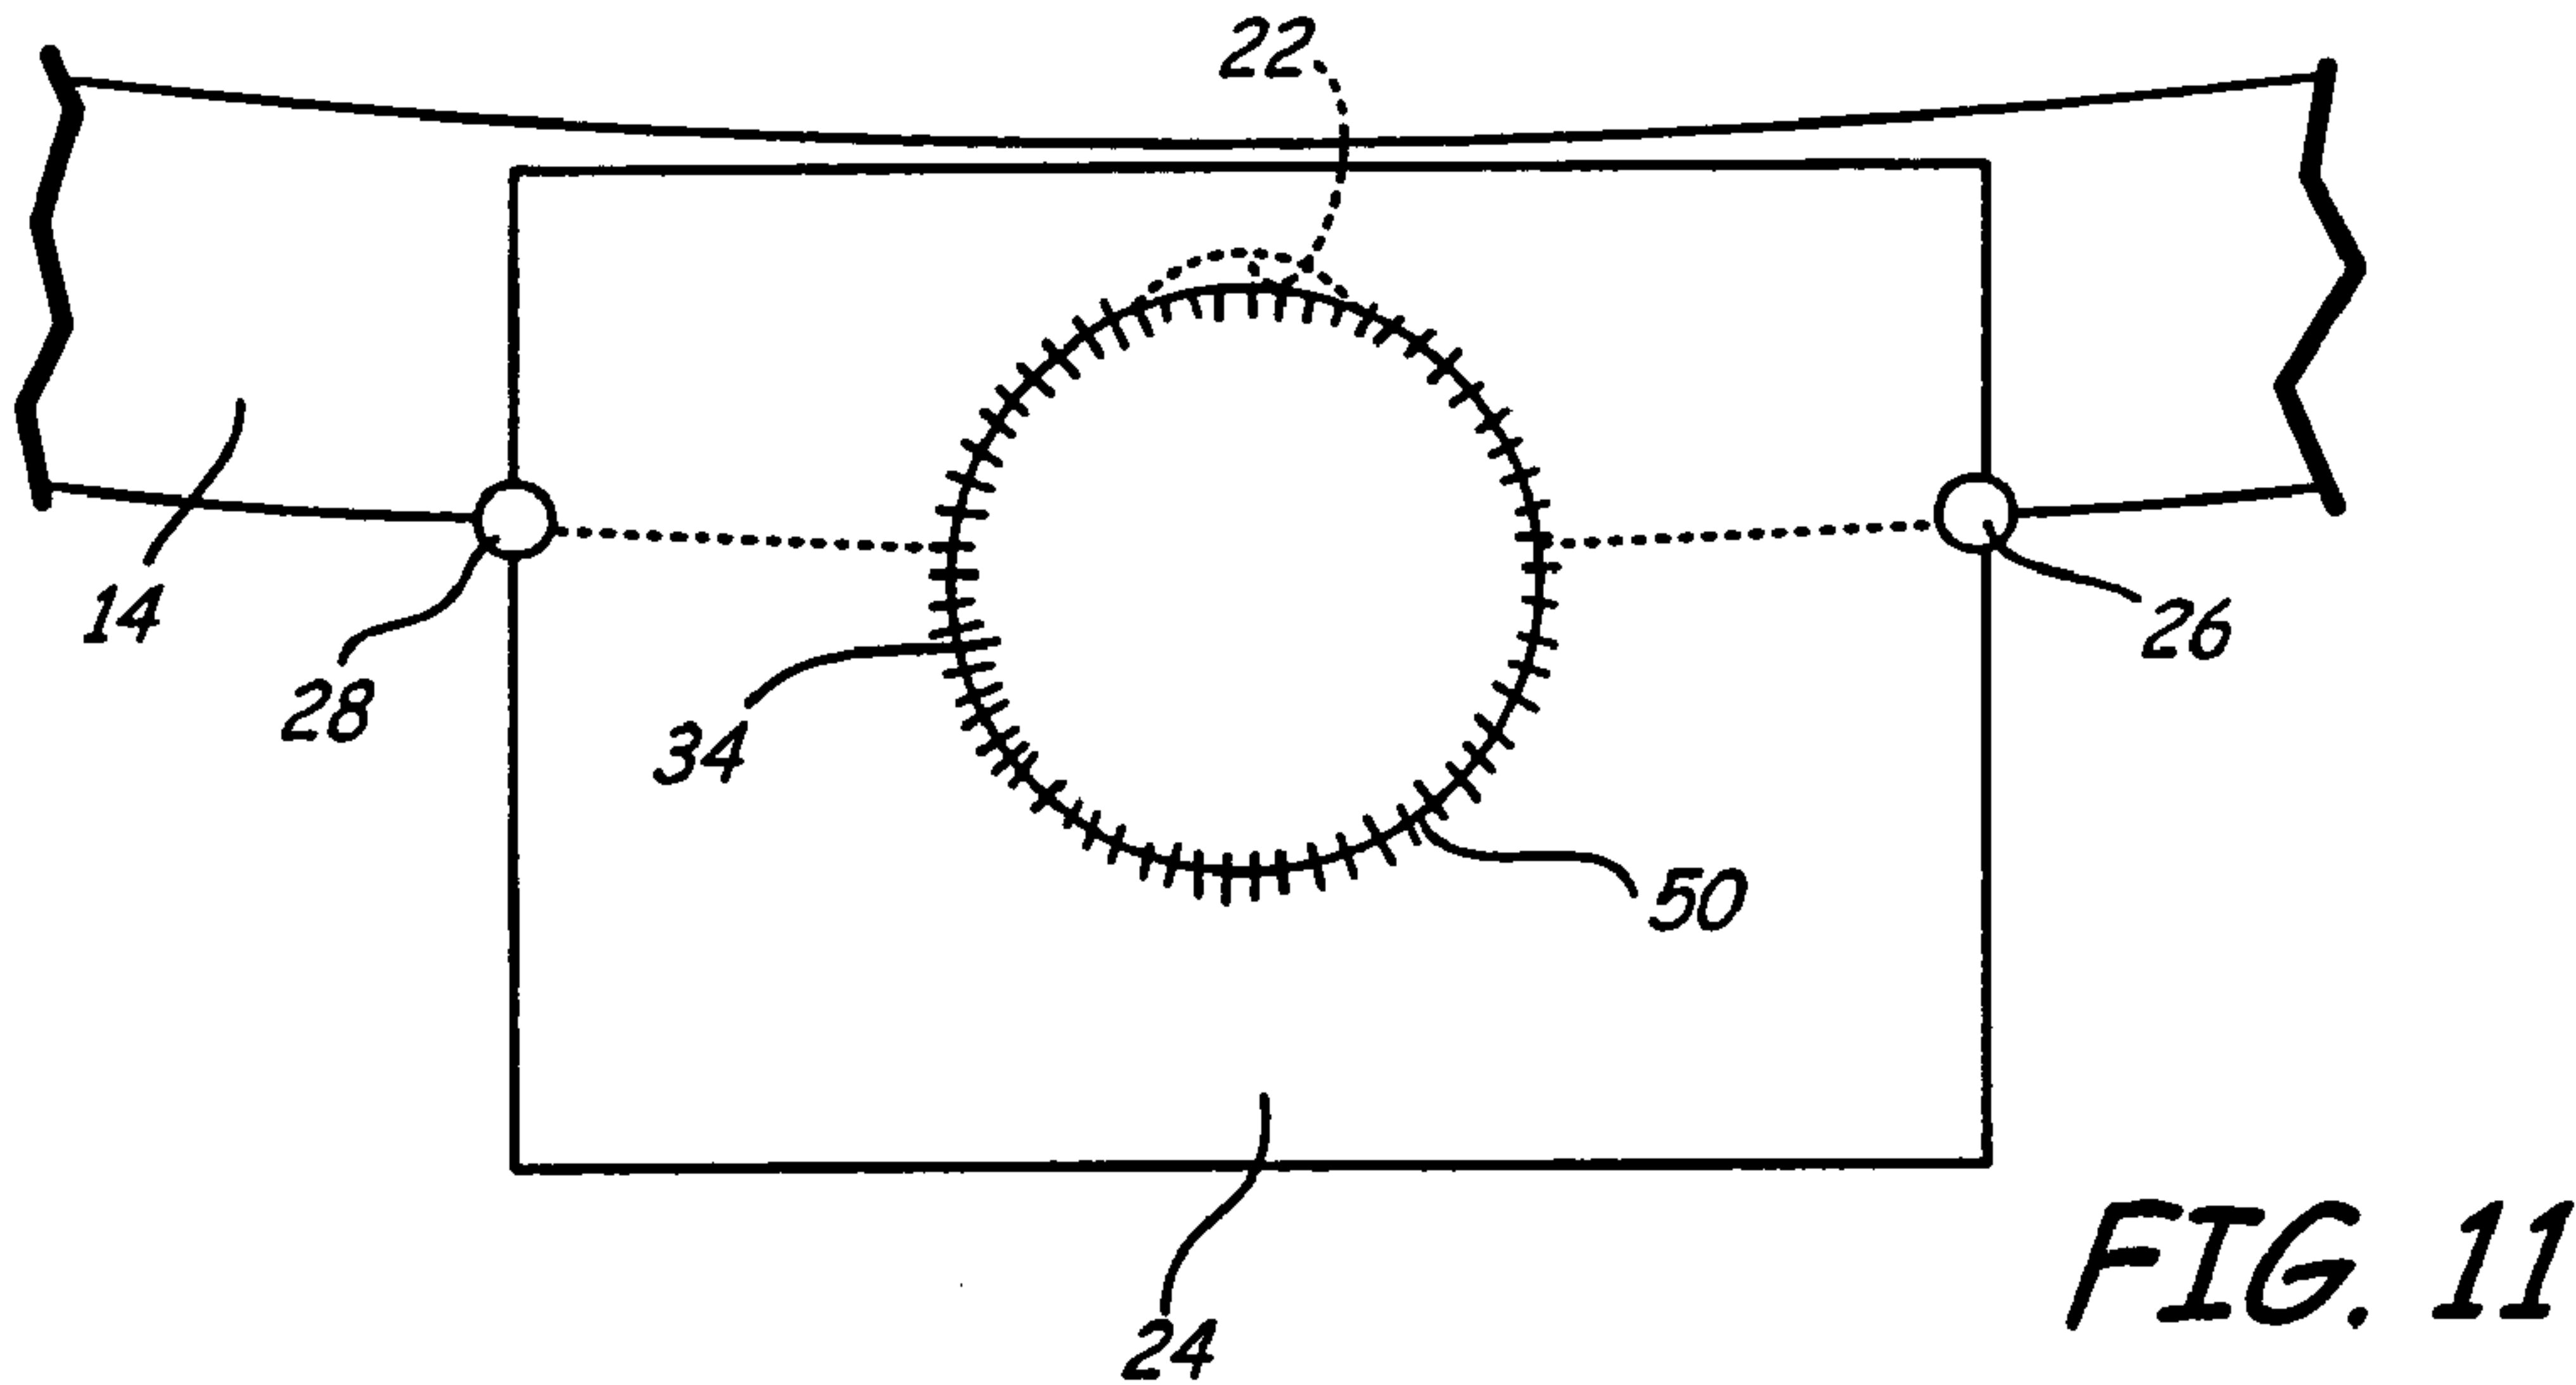
FIG. 11 is a plan view illustrating the completed weld with the backing plate removed.

FIG. 11 is a plan view illustrating completed weld 50 with backing plate 36 removed. Since backing plate 36 does not become fused to the repair pieces (insert 34, combination plate 24, and flange 14), after weld 50 has been completed, backing plate 36 may simply be pulled out from the repaired part. There is no need to use material removal equipment, such as grinders or similar machines to remove backing plate 36. Backing plate 36 may be reused as there will be minimal damage to the top surface as it will not contain removal scars associated with plates that become fused during the welding process.

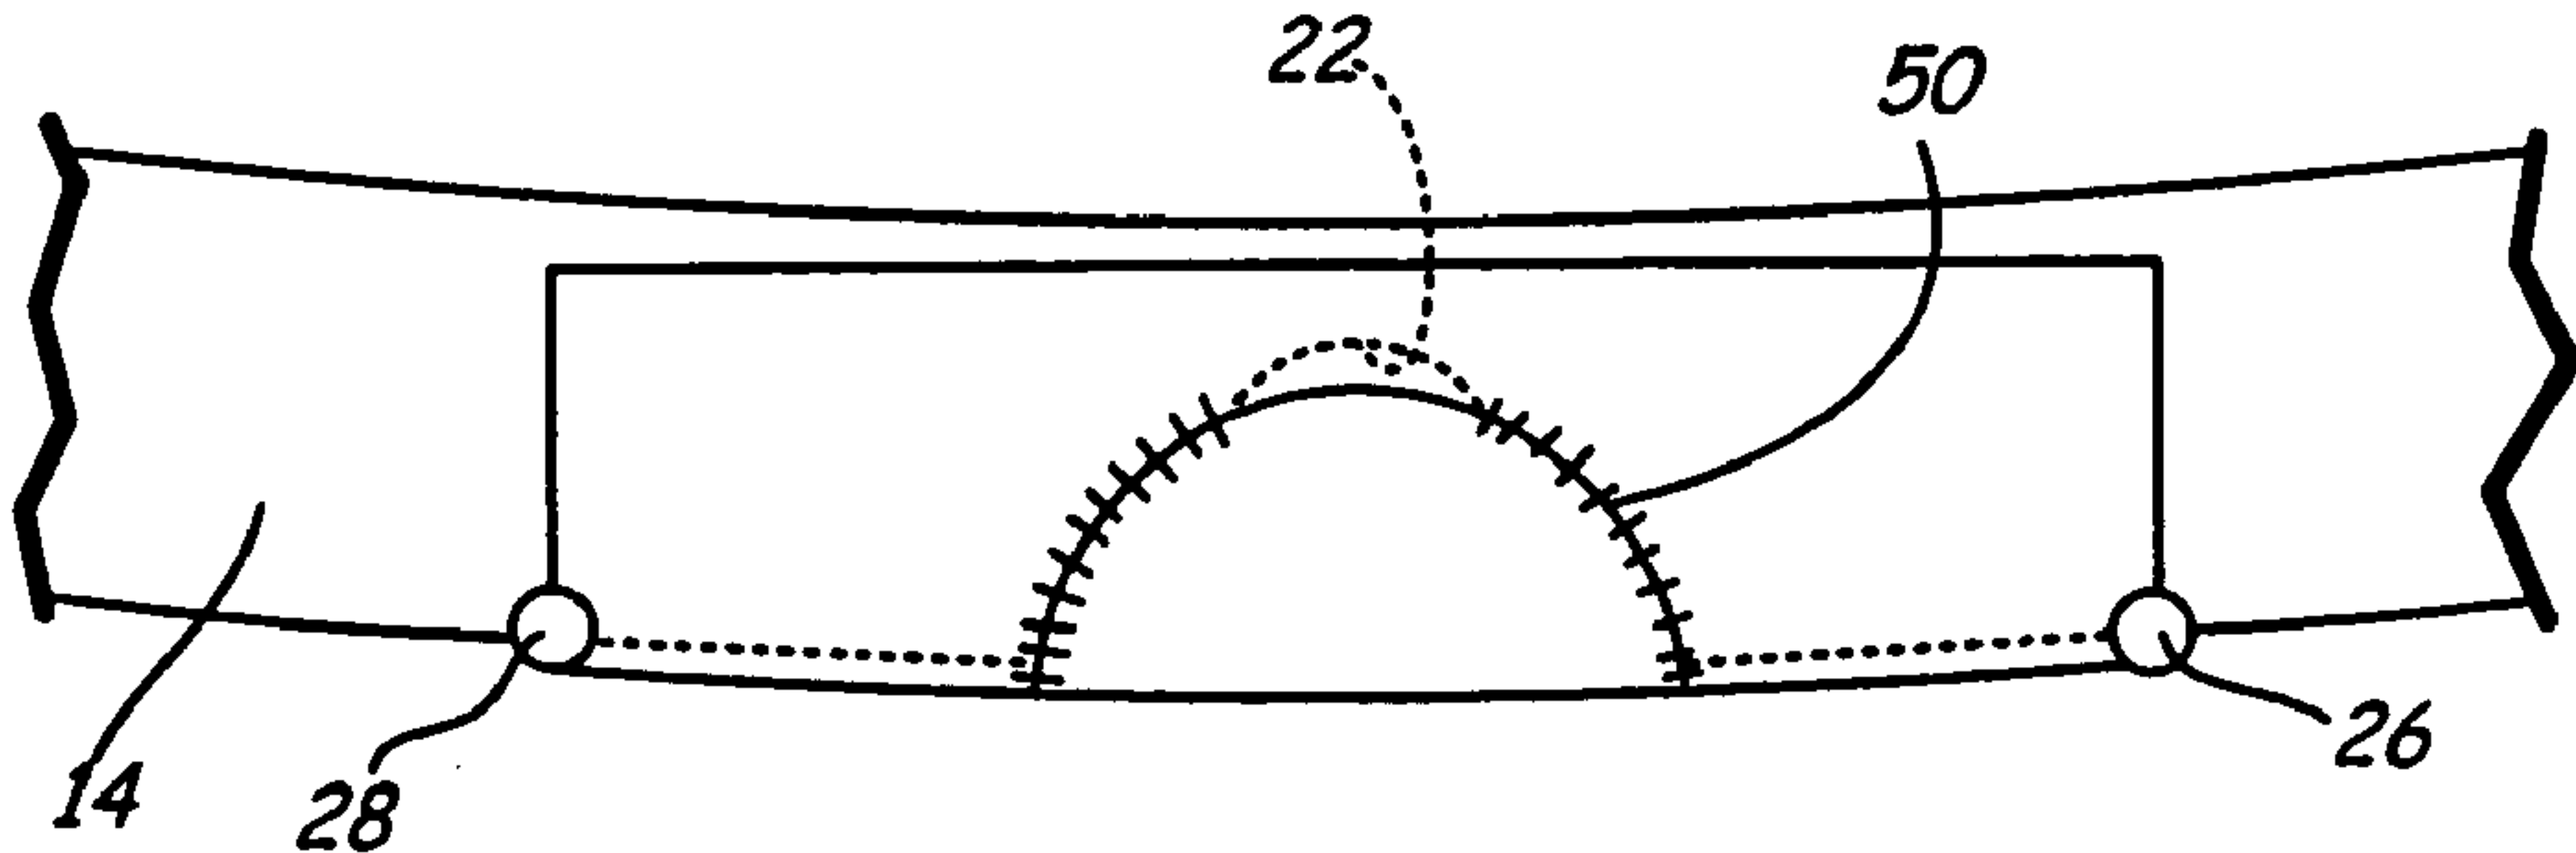
FIG. 12 is a plan view illustrating the completed weld with a portion of the combination plate and insert removed.

FIG. 12 is a plan view illustrating completed weld 50 with portions of combination plate 24 and insert 34 removed.

Combination plate **24** and insert **34** are cut along a path that substantially follows the outer profile of flange **14**. A mill, laser, or similar material removal machine is used to cut combination plate **24** and insert **34**. A nominal amount of material of combination plate **24** and insert **34** may remain after an initial cut to ensure that the cutting process does not affect the integrity of the original flange profile.

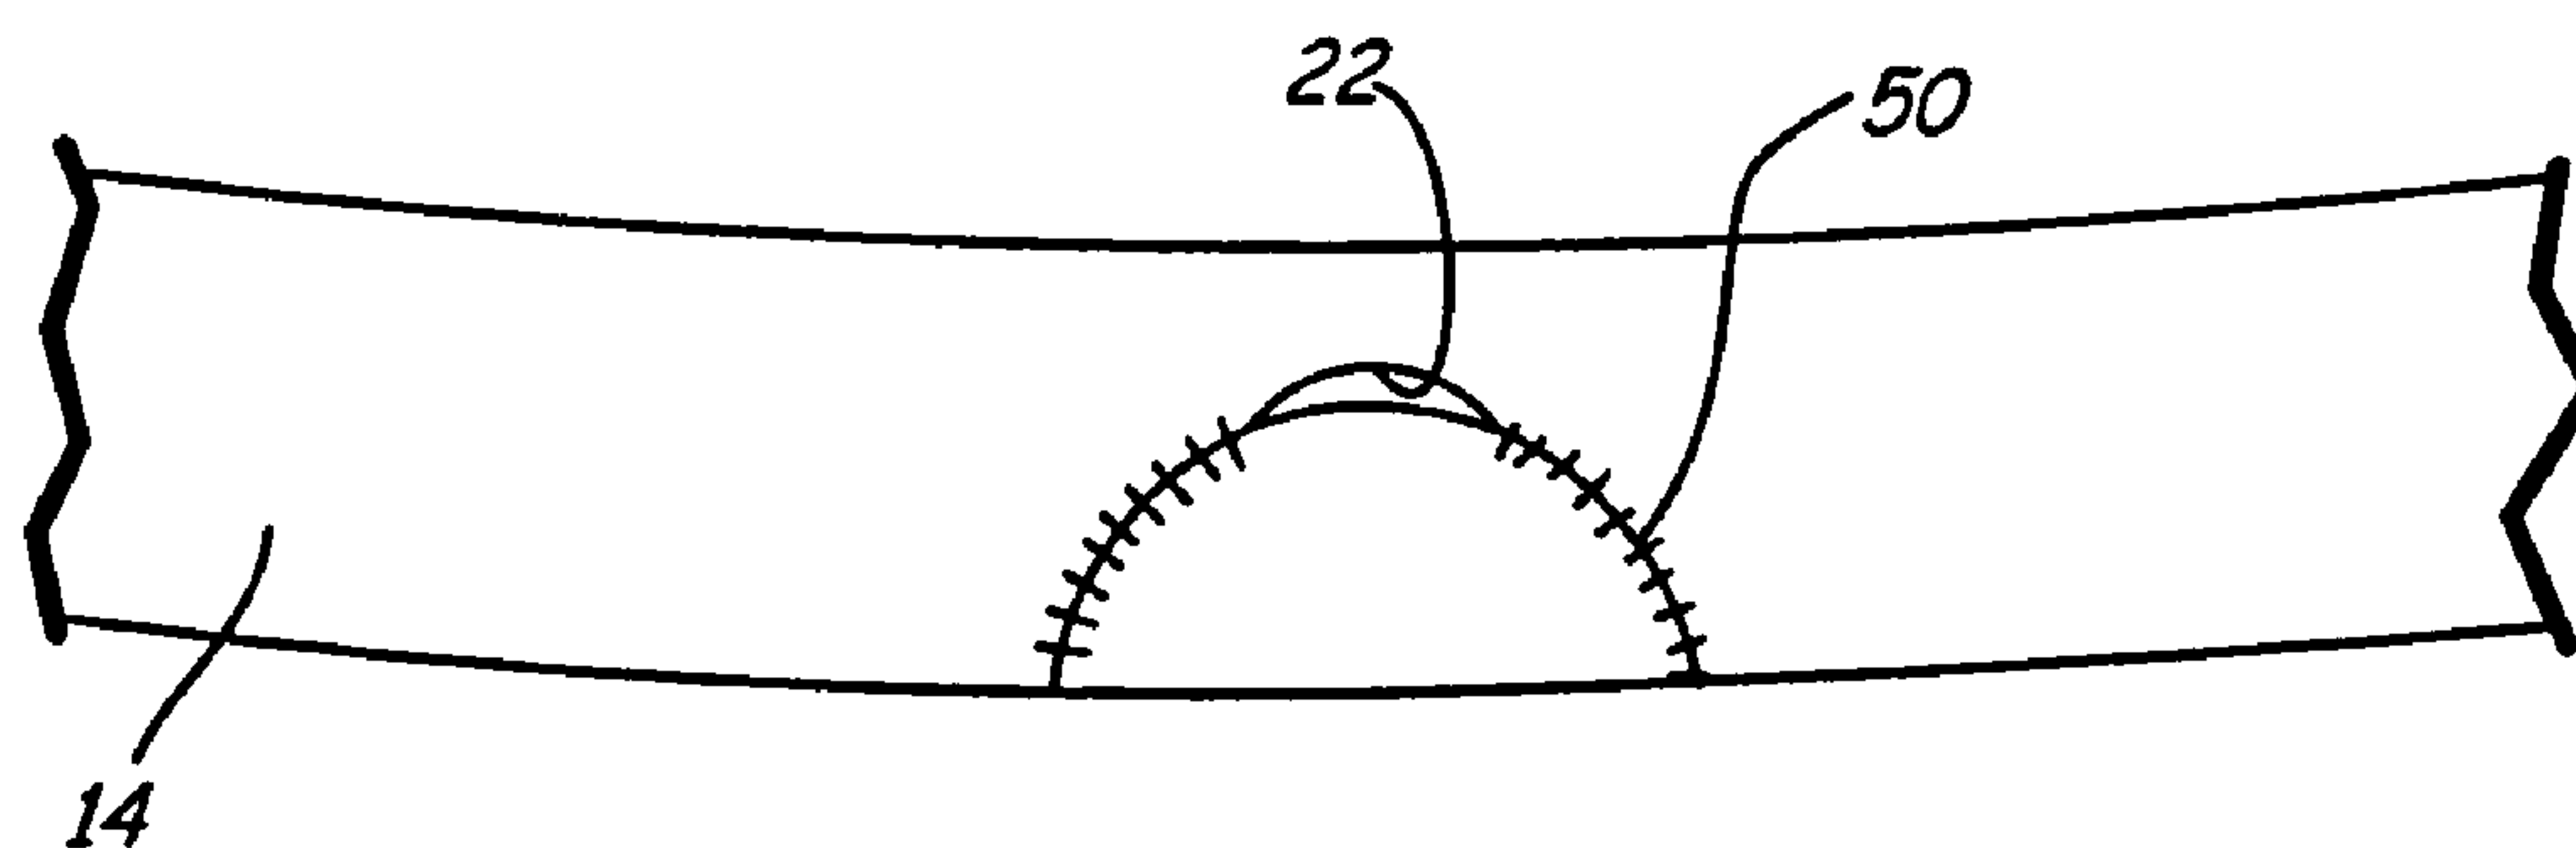
FIG. 13 is a plan view illustrating the combination plate and insert removed to produce the original flange profile.

FIG. **13** is a plan view illustrating combination plate **24** removed to produce the original profile of flange **14**. To remove combination plate **24**, first tack welds **26**, **28** are detached from flange **14**. Next, a mechanized process such as machining is utilized to remove combination plate **24** and excess material from insert **34** until the original profile of the top surface of flange **14** is obtained. After combination plate **24** is removed, arc **22** of the original aperture in flange **14** is again visible. Weld **50** will also be machined on the top and bottom surfaces to obtain nominally the same surfaces of flange **14** as those prior to the repair. Finally, the outer edge of flange **24** is machined to obtain substantially the same profile and outer diameter as the profile prior to the repair.

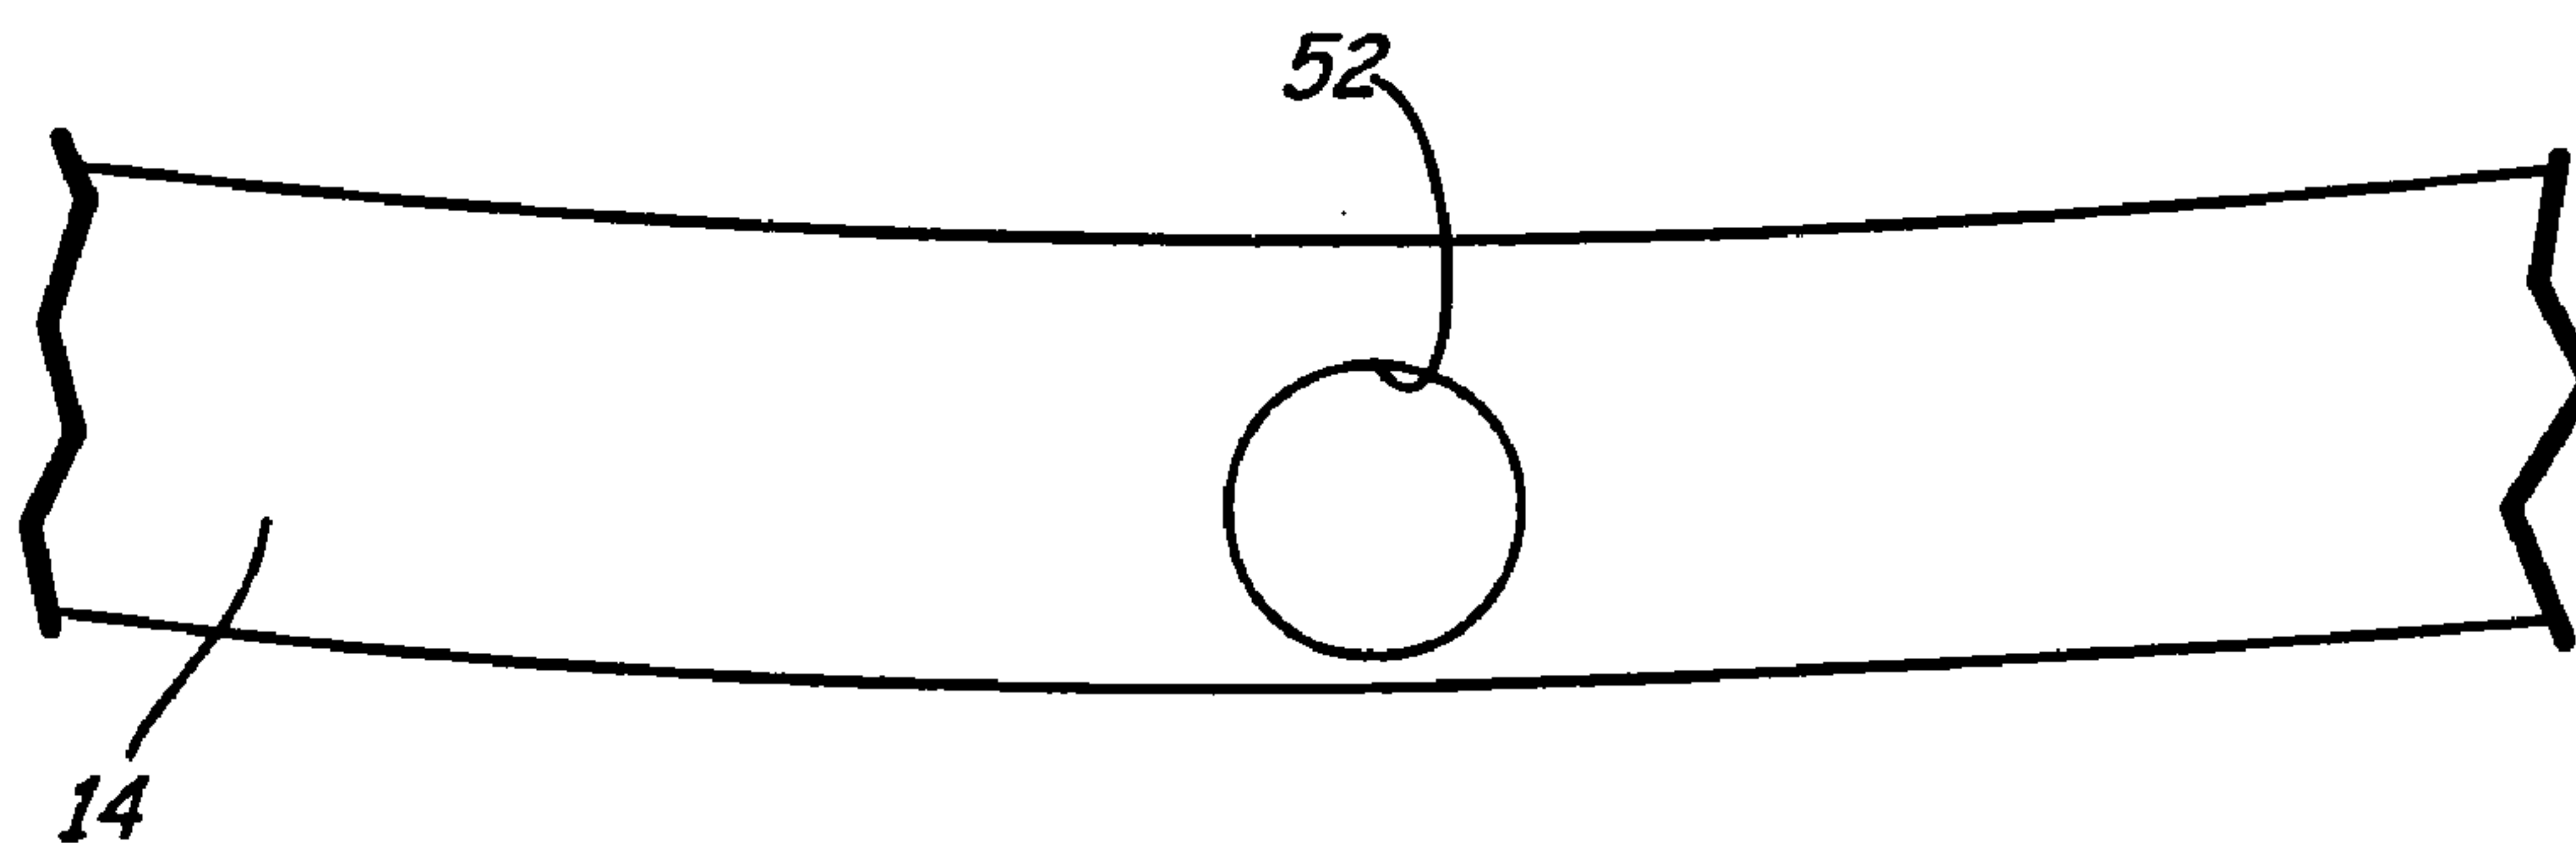
FIG. 14 is a plan view illustrating the complete repair with a new aperture in the flange.

FIG. **14** is a plan view illustrating the complete repair with a new hole **52** in flange **14**. After the flange profile has been nominally obtained, an aperture is machined in the flange to create nominally the same hole **12** that existed prior to the repair. Arc **22** is used as a guide to machine hole **52** to assure the location is nominally the same as prior to the repair. In an alternate embodiment, the hole in lower flange **20** (See FIGS. **2A** and **9**) is used as a guide to create hole **52** in flange **14**.
