(10) **Patent No.:** **US 7,925,454 B1**
(45) **Date of Patent:** **Apr. 12, 2011**

(54) **PROCESS FOR DETERMINING A REMAINING LIFE OF A DETERIORATED TURBINE COMPONENT**

(73) Assignee: **Florida Turbine Technologies, Inc.**, Jupiter, FL (US)

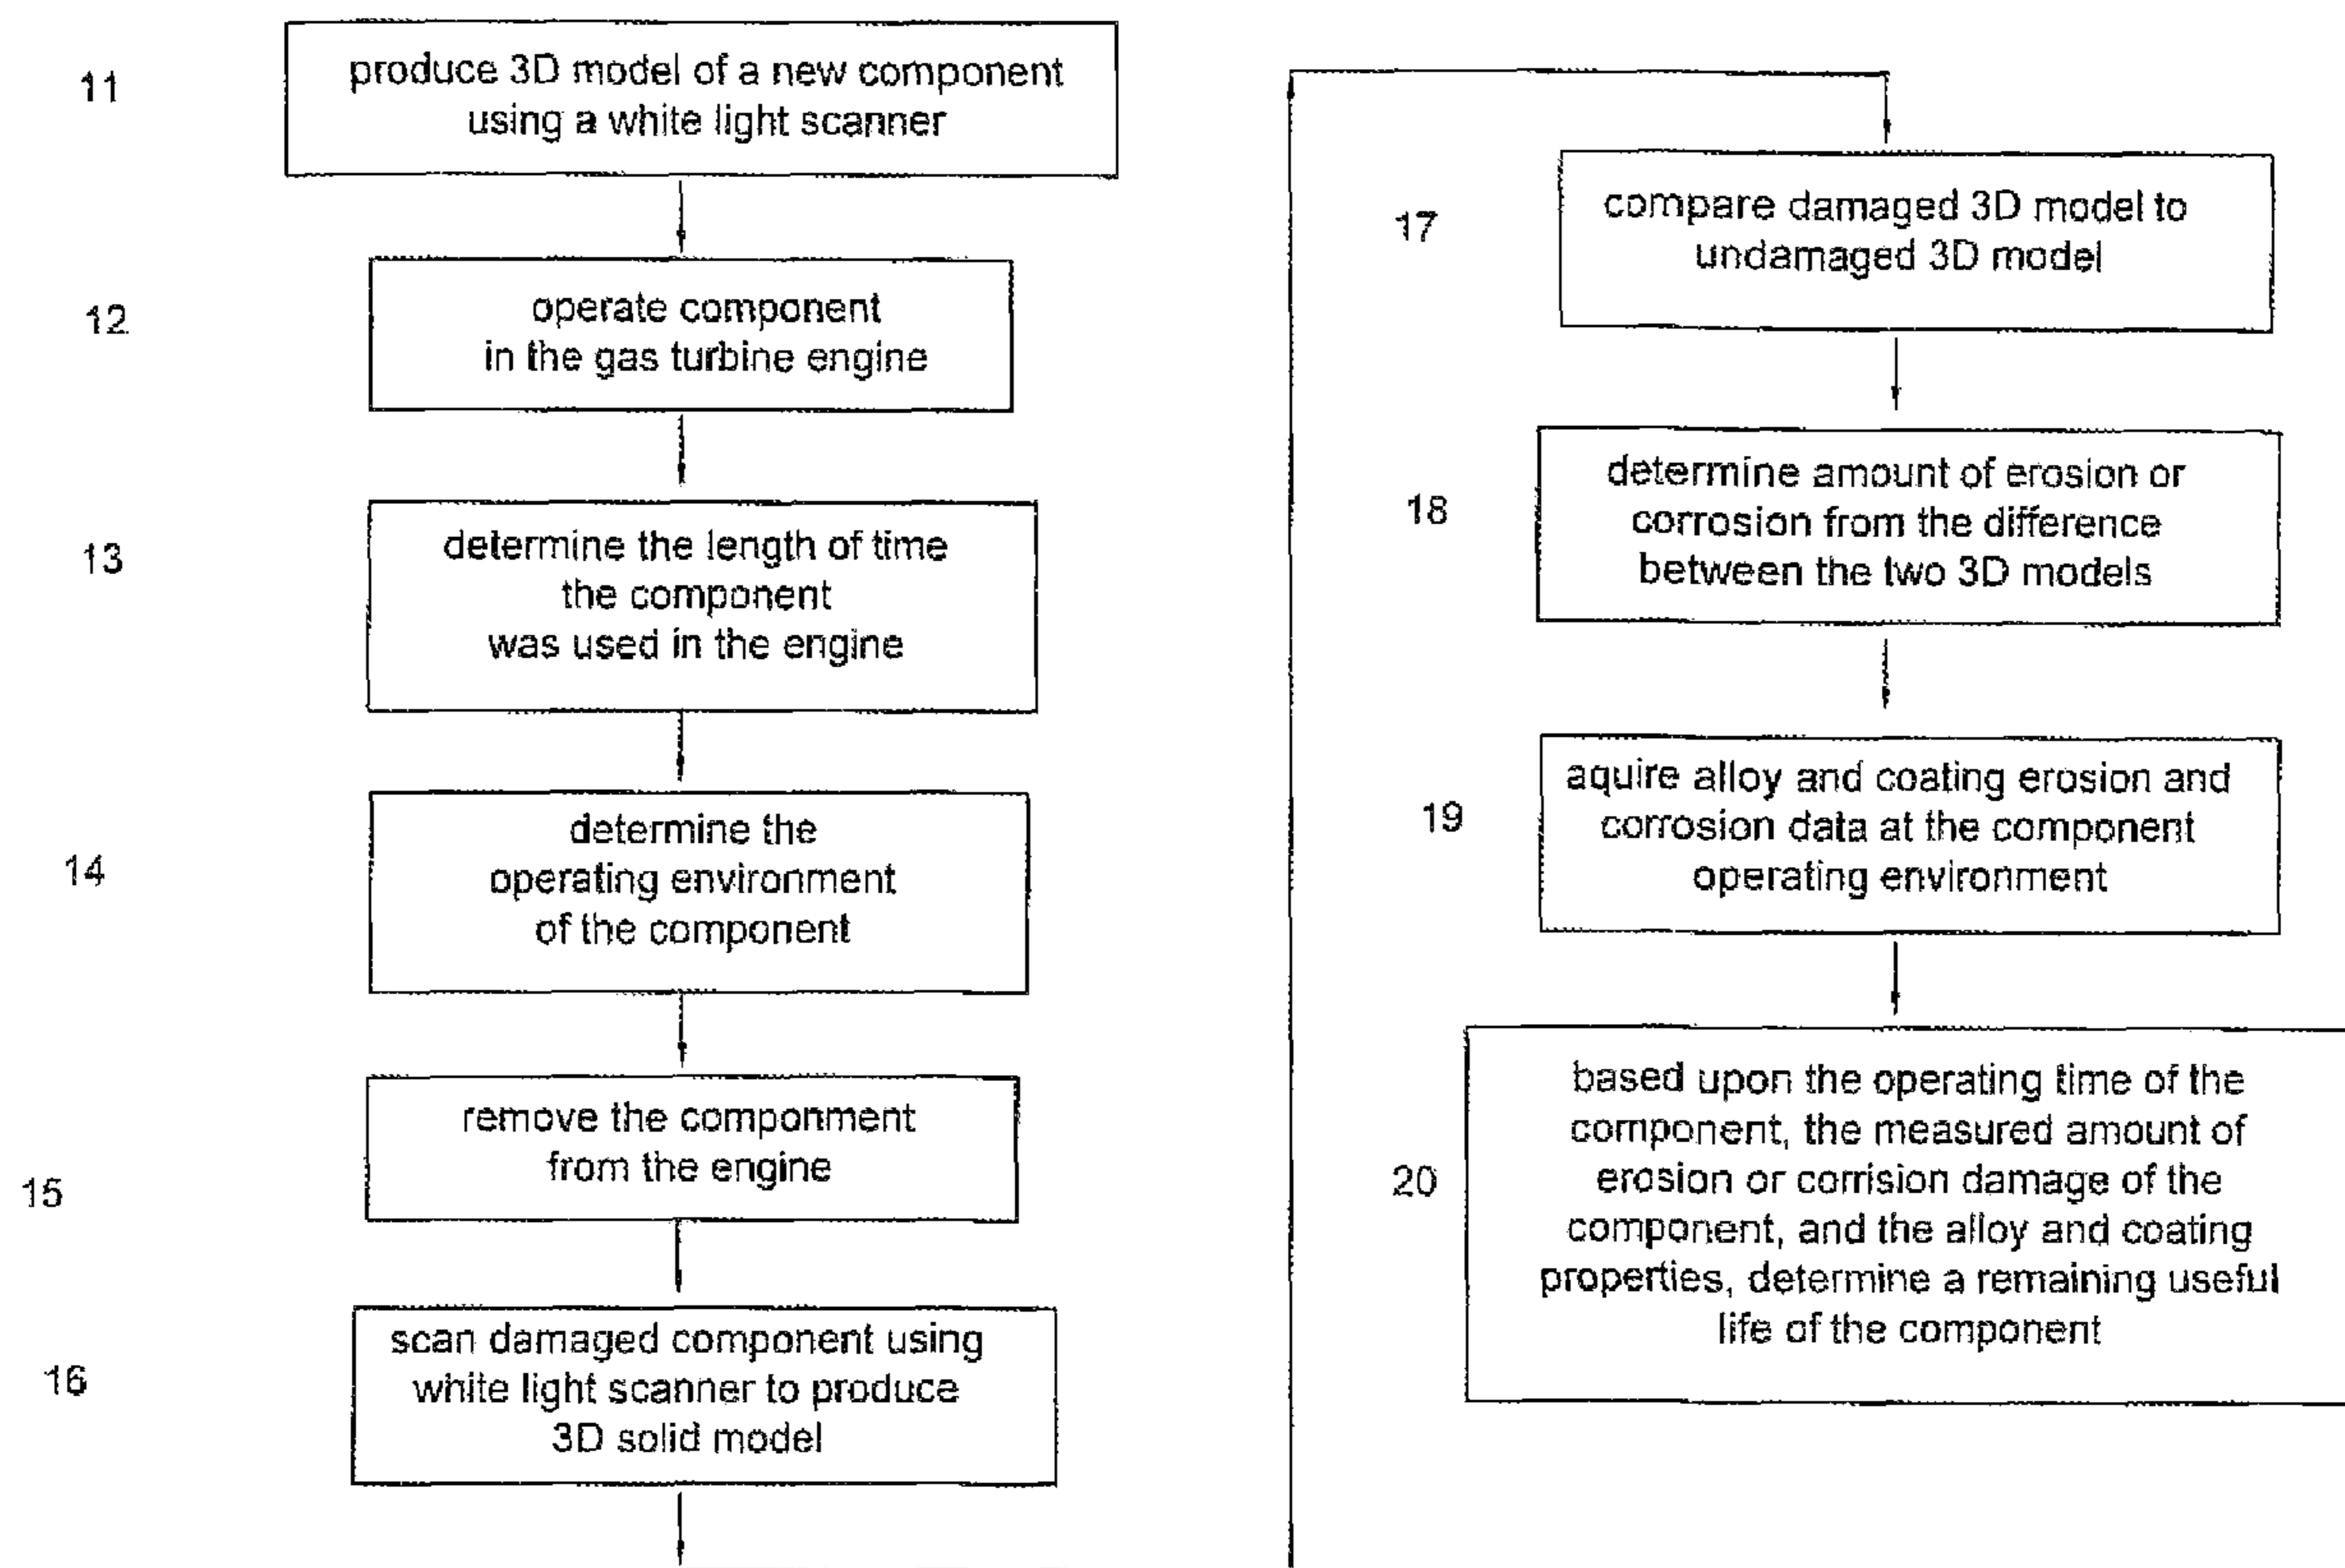
Fig 1

The FIGURE shows a flowchart for the process of determining a remaining useful life for a damaged airfoil.

After the component has undergone exposure in the engine to the high temperature environment that will cause the erosion or corrosion damage, the engine is shut down (step 21) and the component is removed from the engine (step 15) and scanned again to produce a 3D model of the damaged component (step 16). An optical scanner such as a white light scanner is used to produce the 3D model because it can reproduce on the model the amount of erosion or corrosion occurring. A thermal analysis and a structural analysis of the

damaged component 3D model are performed (step 22). From the thermal analysis and a structural analysis of the scanned solid model, the depth of erosion or corrosion can be determined by comparing the original undamaged solid model of the component with the solid model showing the damage (step 17).

When the undamaged solid model is compared to the damaged solid model, the differences can be determined that will represent the amount of damage occurred on the component (step 18). During the component's use—when the damage was done—the length of time (step 13) and the operating conditions of the component (step 14) such as the temperature is noted for use in determining the component's remaining life. For example, the length of time that the component was exposed in the engine is noted. With the length of time that the component was undergoing the erosion or corrosion damage, and the amount of damage done on the component for that length of time, the amount of remaining useful life for that component can then be determined (step 20). Material property tables or previous experiences with the particular material can be used to aid in this determination. If the remaining life of a damaged component is found to be longer than a certain time period, the damaged component is then reused in the engine (step 23). If the time period is less than the certain time period, then the damaged component is discarded and a new component is placed in the engine.
