(12) **United States Patent**
Medynski et al.

(10) **Patent No.:** **US 7,980,813 B2**
(45) **Date of Patent:** **Jul. 19, 2011**

(54) **FAN OUTLET GUIDE VANE SHROUD INSERT REPAIR**

(73) Assignee: **United Technologies Corporation**, Hartford, CT (US)

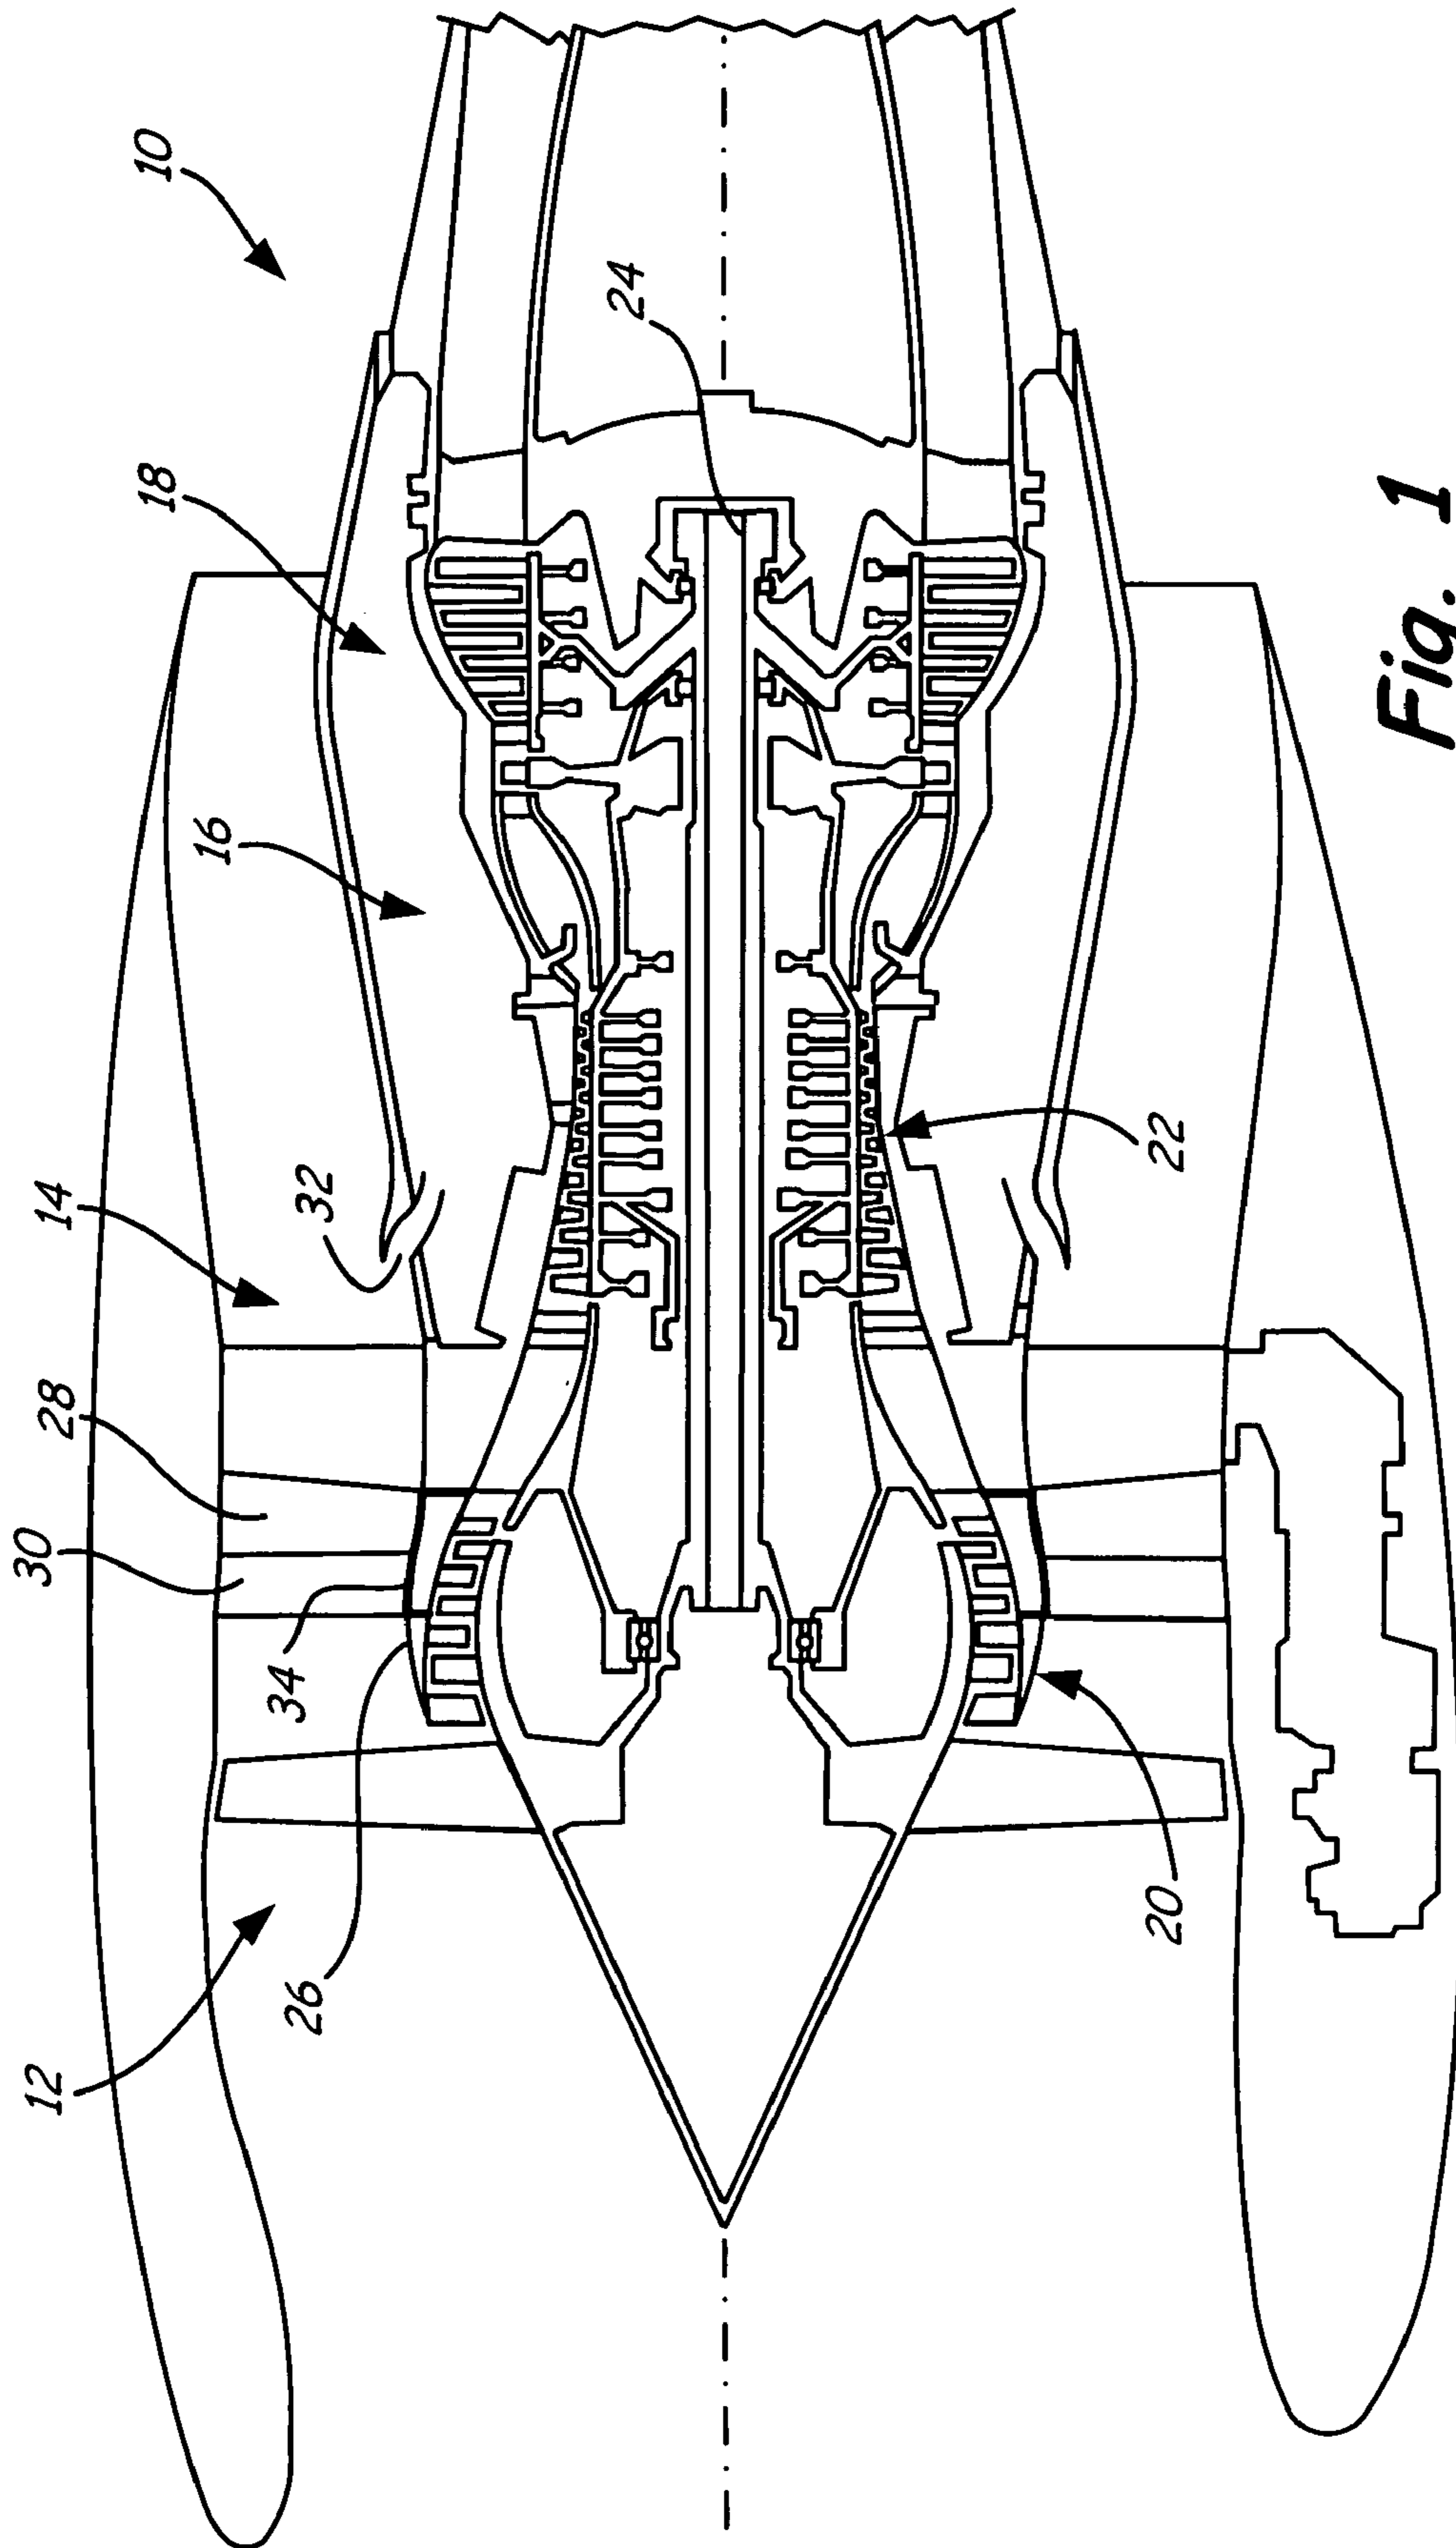
Fig. 1

FIG. 1 is a cross-sectional view of a gas turbine engine.

FIG. 1 is a cross-sectional view of a gas turbine engine 10, which has inlet fan 12, compressor section 14, combustion section 16, and turbine section 18. Compressor section 14 has low pressure compressor 20 and high pressure compressor 22. Air is taken in through fan inlet 12 and a portion is directed to compressor section 14. The air is then compressed by a series of rotating blades and vanes in the compressor section. The compressed air is mixed with fuel, and then ignited in combustion section 16. The combustion exhaust is then directed towards turbine section 18, which is also comprised of blades and vanes. The blades extract kinetic energy from the exhaust to turn shaft 24, which provides power output for the engine.

After air enters fan inlet 12, splitter fairing 26 directs a portion to low pressure compressor 20. The rest of the air flows through bypass duct 28 and is directed by fan guide vanes 30. The air directed to bypass duct 28 will be bled off through opening 32 to be used for cooling the components of high pressure compressor 14, combustion section 16, and turbine section 18. Fan guide vanes 30 are held in place by fan outlet guide vane shroud assembly 34.

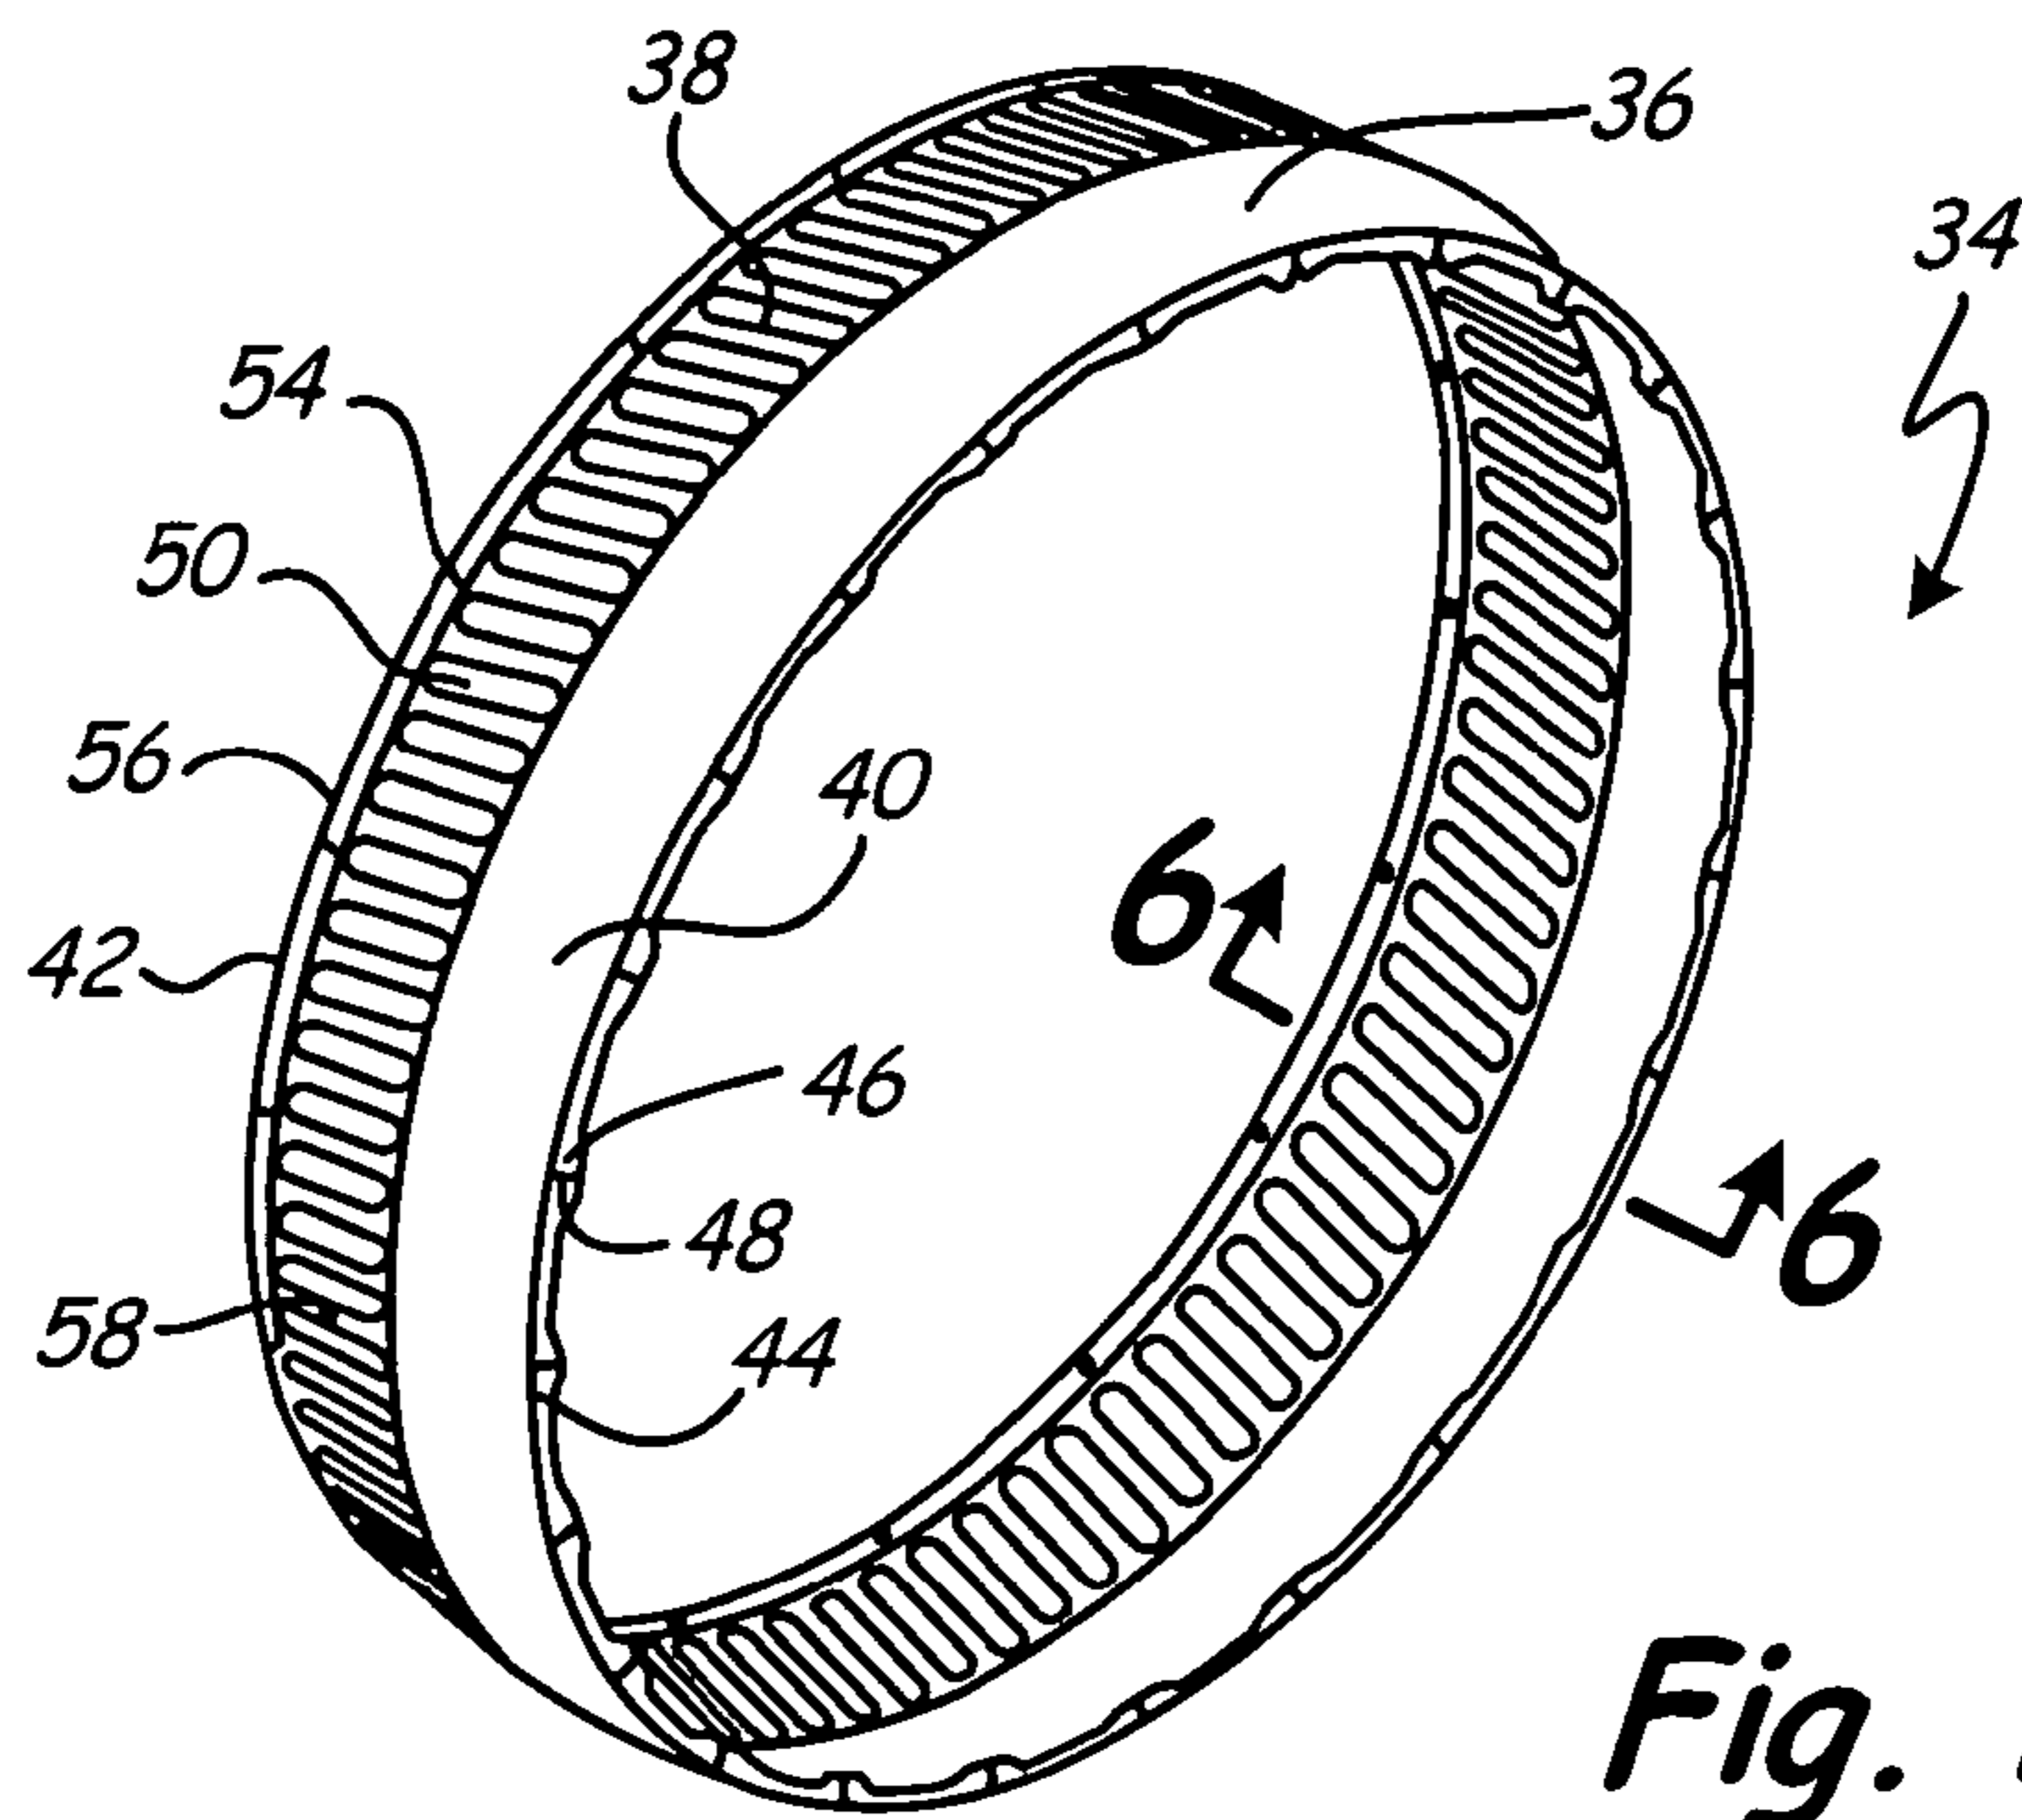
Fig. 2

FIG. 2 is a perspective view of an outlet guide vane shroud assembly.

FIG. 2 is a perspective view of outlet guide vane shroud assembly 34. Outlet guide vane shroud assembly is comprised of shroud ring 36 and liners 38. Shroud ring 34 is generally cylindrical or frustaconical in shape, and has forward side 40 and aft side 42. Shroud ring 34 is fabricated from aluminum, or a similar light weight metal.

Forward side 40 has an inwardly extending flange 44. Flange 44 has several widened areas 46, each containing an aperture 48. Apertures 48 are used as fastener holes for securing outlet guide vane shroud assembly 34 to other engine casing components. Aft side 42 has a series of equally spaced slots 50. Each slot 50 contains liner 38, which is used to secure one fan guide vane 30. Liners 38 are constructed from a polymer, and may held in place with an adhesive. Aft side 42 also contains a series of apertures 54 between slots 50 and aft edge 56. Again, apertures 54 are used for the insertion of fasteners to secure outlet guide vane shroud assembly 34 to other engine casing components. Between two slots 50 is borescope hole 58. Borescope hole 58 is a small aperture for the insertion of a borescope to inspect the various components of the engine.

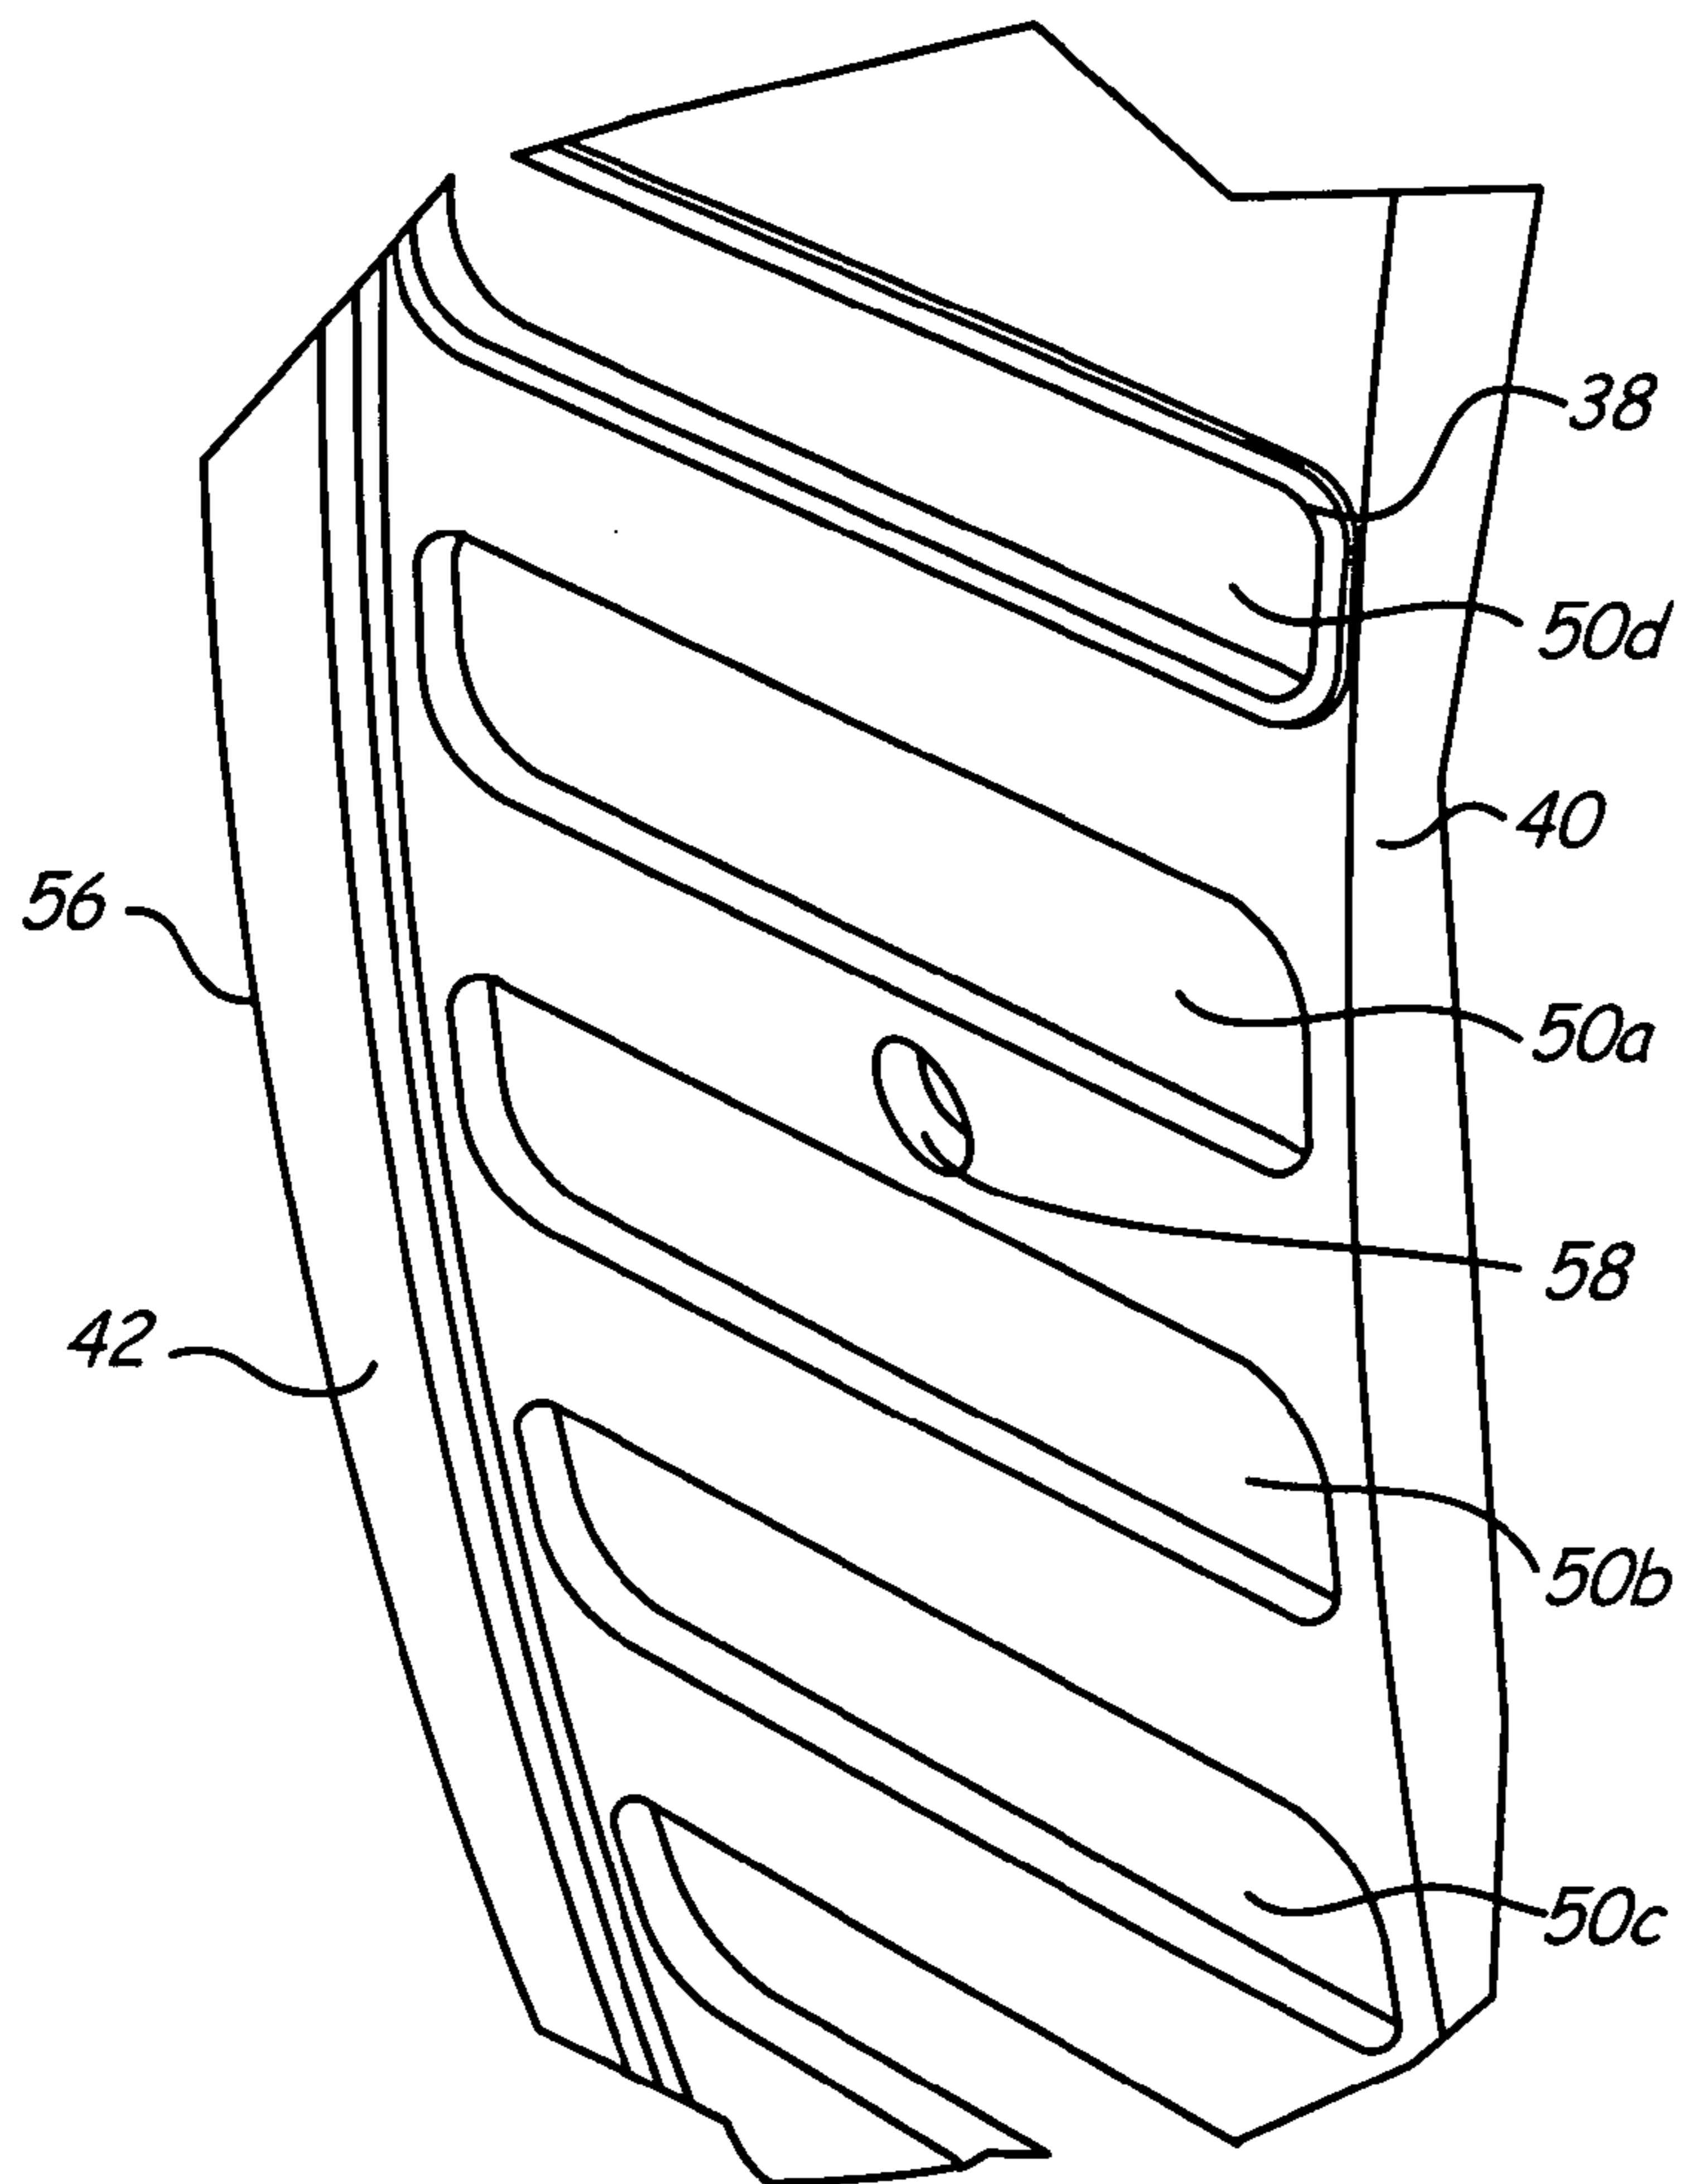
Fig. 3

FIG. 3 is a magnified perspective view of a portion of the outlet guide vane shroud.

FIG. 3 is a magnified view of a portion of outlet guide vane shroud assembly 34. In this view, slot 50d contains liner 38, while the inserts have been removed from slots 50a-50c. Borescope hole 58 is located between slots 50a and 50b. The current repair method is not available for slots 50a and 50b adjacent borescope hole 58, but is available for the remaining slots (including 50c and 50d).

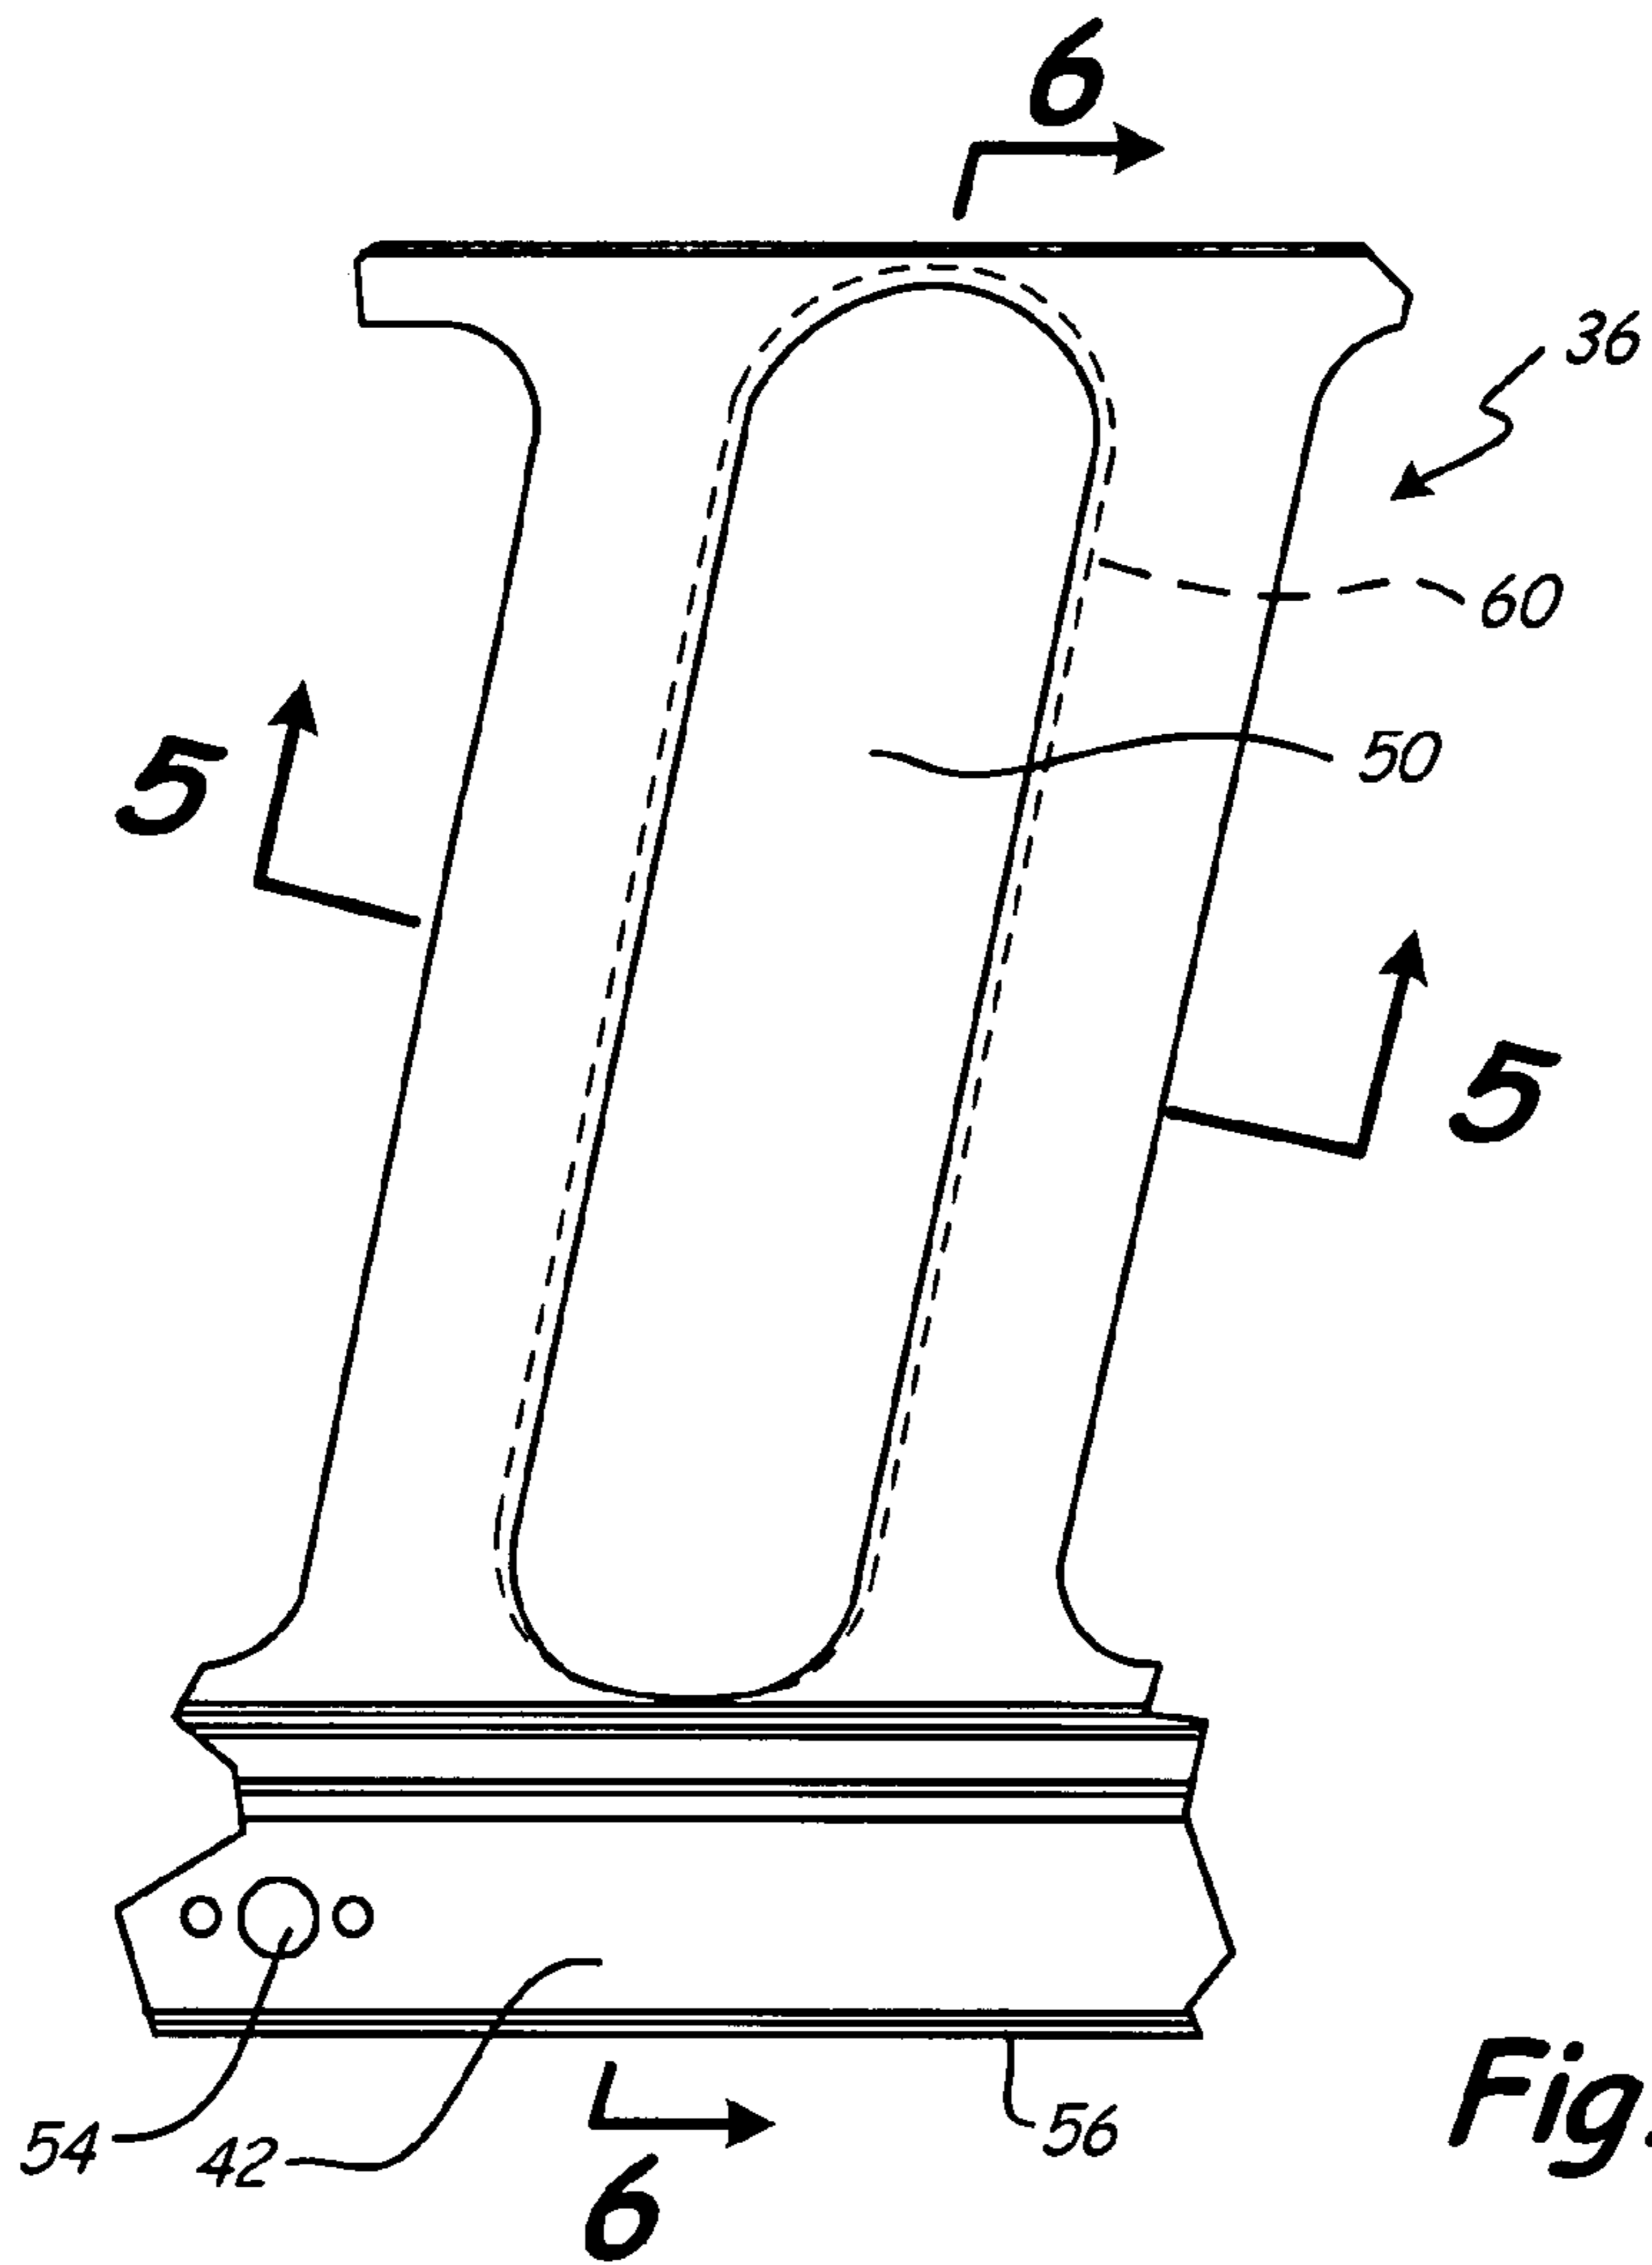
Fig. 4

FIG. 4 is an elevation view of a portion of the outlet guide vane shroud ring.

FIG. 4 is an elevation view of a portion of the outlet guide vane shroud ring. Illustrated are slot 50, as well as aperture 54 adjacent aft edge 56 of aft side 42 of shroud ring 36. Liner 38 has been removed. To initiate the repair, the material of shroud ring 36 is removed adjacent slot 50 along line 60. The removal is accomplished through common material removal techniques, such as machining. In the embodiment illustrated, more material is removed opposite aft side 42 along line 60. In operation, the angular velocity and acceleration direct fan guide vanes 30 away from aft side 42 of shroud ring 30. Thus, it is more common to identify defects in this area, which results in the non-uniform removal of material along line 60 to remove any defects.

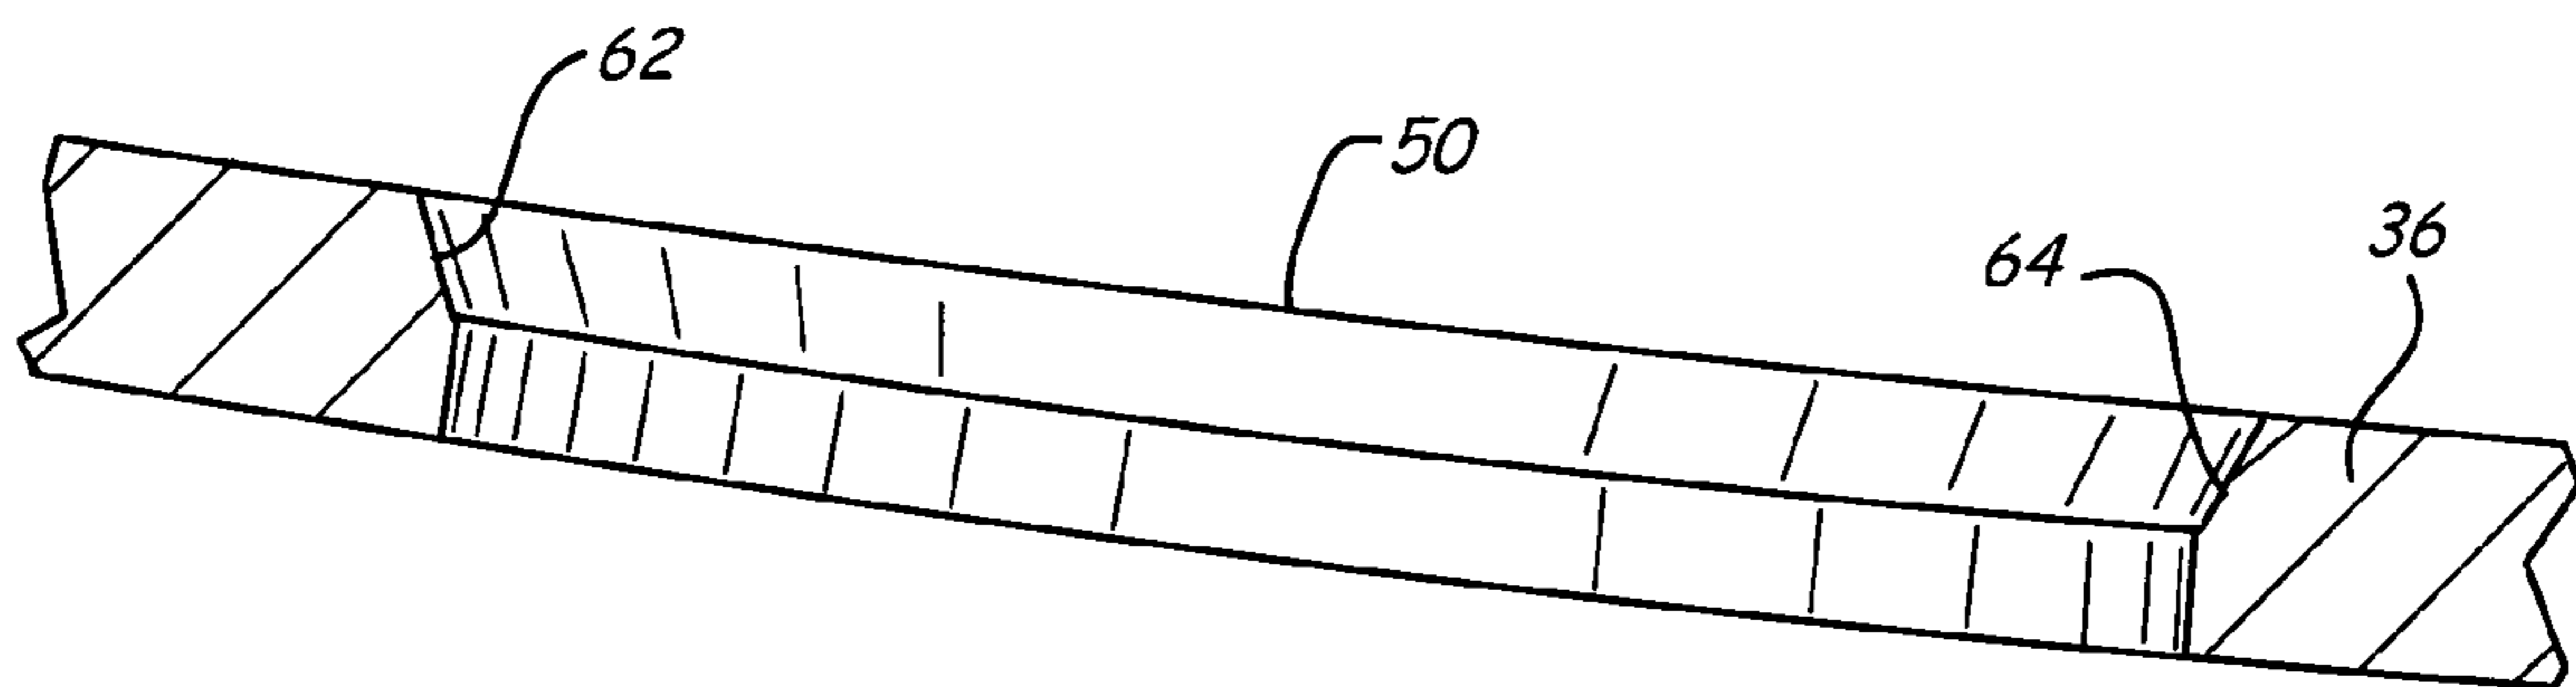
Fig. 5

FIG. 5 is a cross-sectional view of the outlet guide vane shroud ring taken along line 5-5 illustrated in FIG. 4.

FIG. 5 is a cross-sectional view of shroud ring 36 taken along line 5-5 illustrated in FIG. 4. FIG. 6 is a cross-sectional view of shroud ring 36 taken along line 6-6 in FIGS. 2 and 4. In FIG. 5, parent material has been removed from shroud ring 36 adjacent slot 50. In this embodiment, the parent material is removed to leave beveled surfaces 62 and 64 on each side of slot 50. Parent material is material of shroud ring 36 that has previously been in service, and includes original as well as subsequent material added during prior repairs.

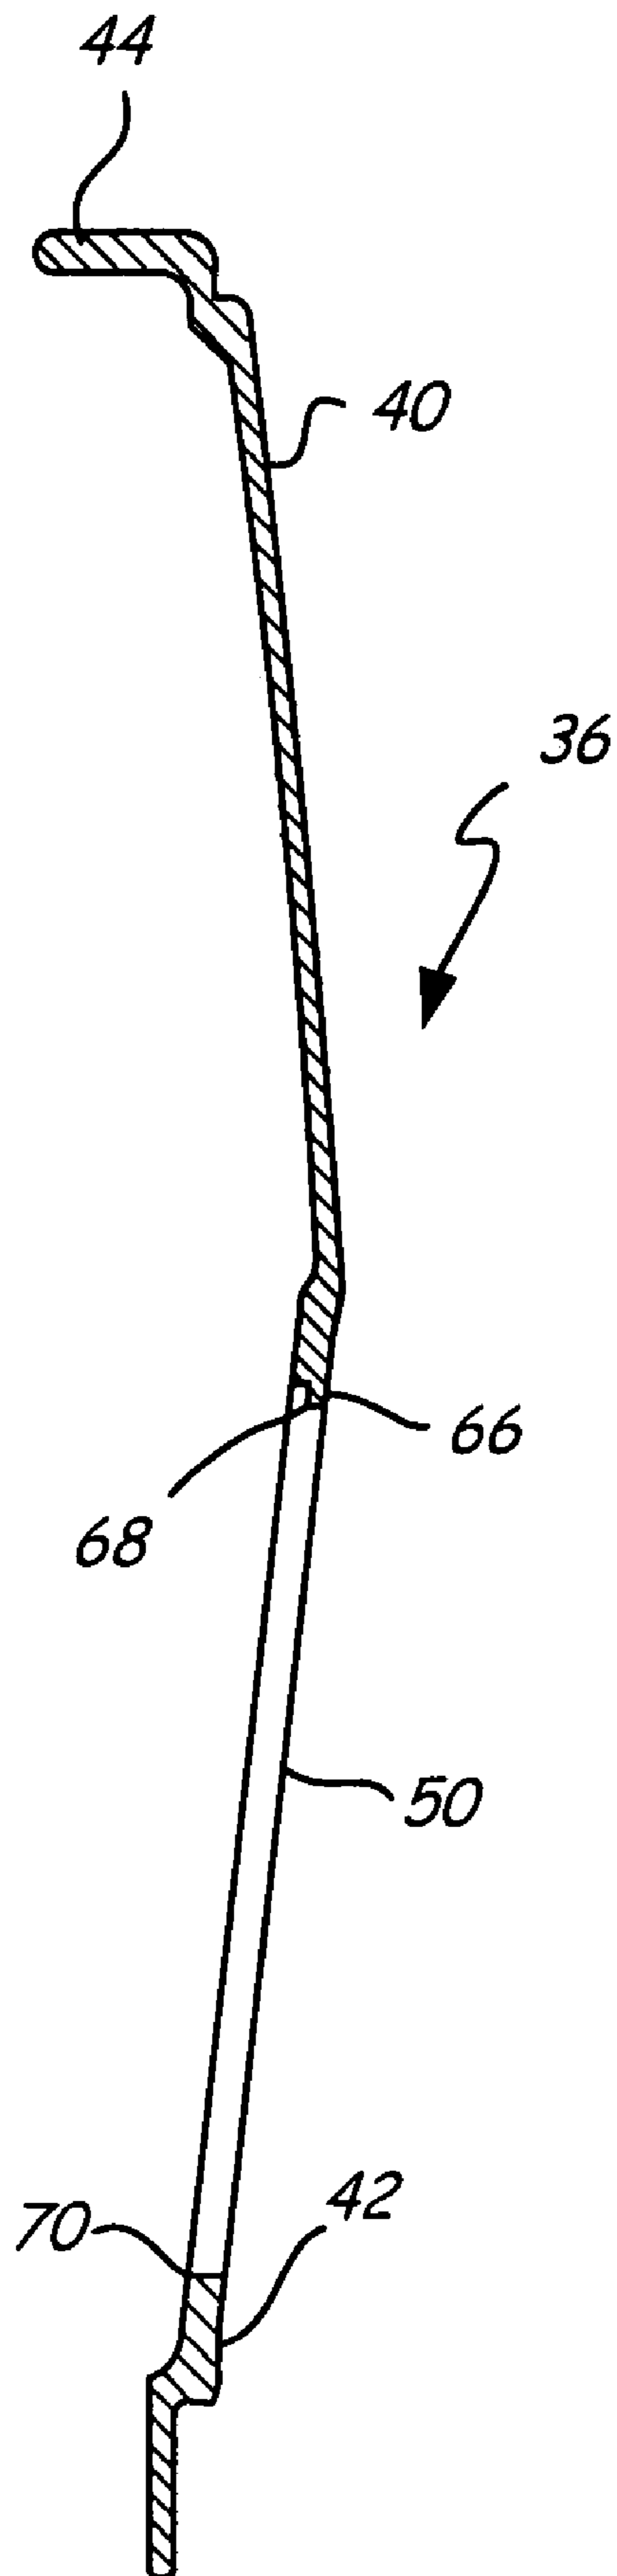
Fig. 6

FIG. 6 is a cross-sectional view of the outlet guide vane shroud ring taken along line 6-6 in FIG. 4.

In FIG. 6, parent material has been removed also. The parent material has been removed and left step 66 on forward edge 68. Aft edge 70 is machined to contain a surface substantially parallel to the original surface of slot 50. The difference in material removal between forward edge 68 and aft edge 70 can be adjusted as required to assure removal of defects caused during normal engine operation.

Insert 72 is illustrated as containing a generally uniform cross-section on first end 74, and has a stepped cross-section at second end 76. This configuration allows for a mating of insert 72 into refurbished slot 50 as illustrated in FIG. 6. Although illustrated as containing a graduated step from first end 74 to second end 76, insert 72 may contain other geometries for the edges including bevels (to mate with the embodiment shown in FIG. 5), chamfers, tapers, radii, or similar shapes that may be either graduated or of a constant cross-sectional area throughout the profile of insert 72.
