(12) **United States Patent**
Medynski et al.

(10) **Patent No.:** **US 7,980,813 B2**
(45) **Date of Patent:** **Jul. 19, 2011**

(54) **FAN OUTLET GUIDE VANE SHROUD INSERT REPAIR**

(73) Assignee: **United Technologies Corporation**, Hartford, CT (US)

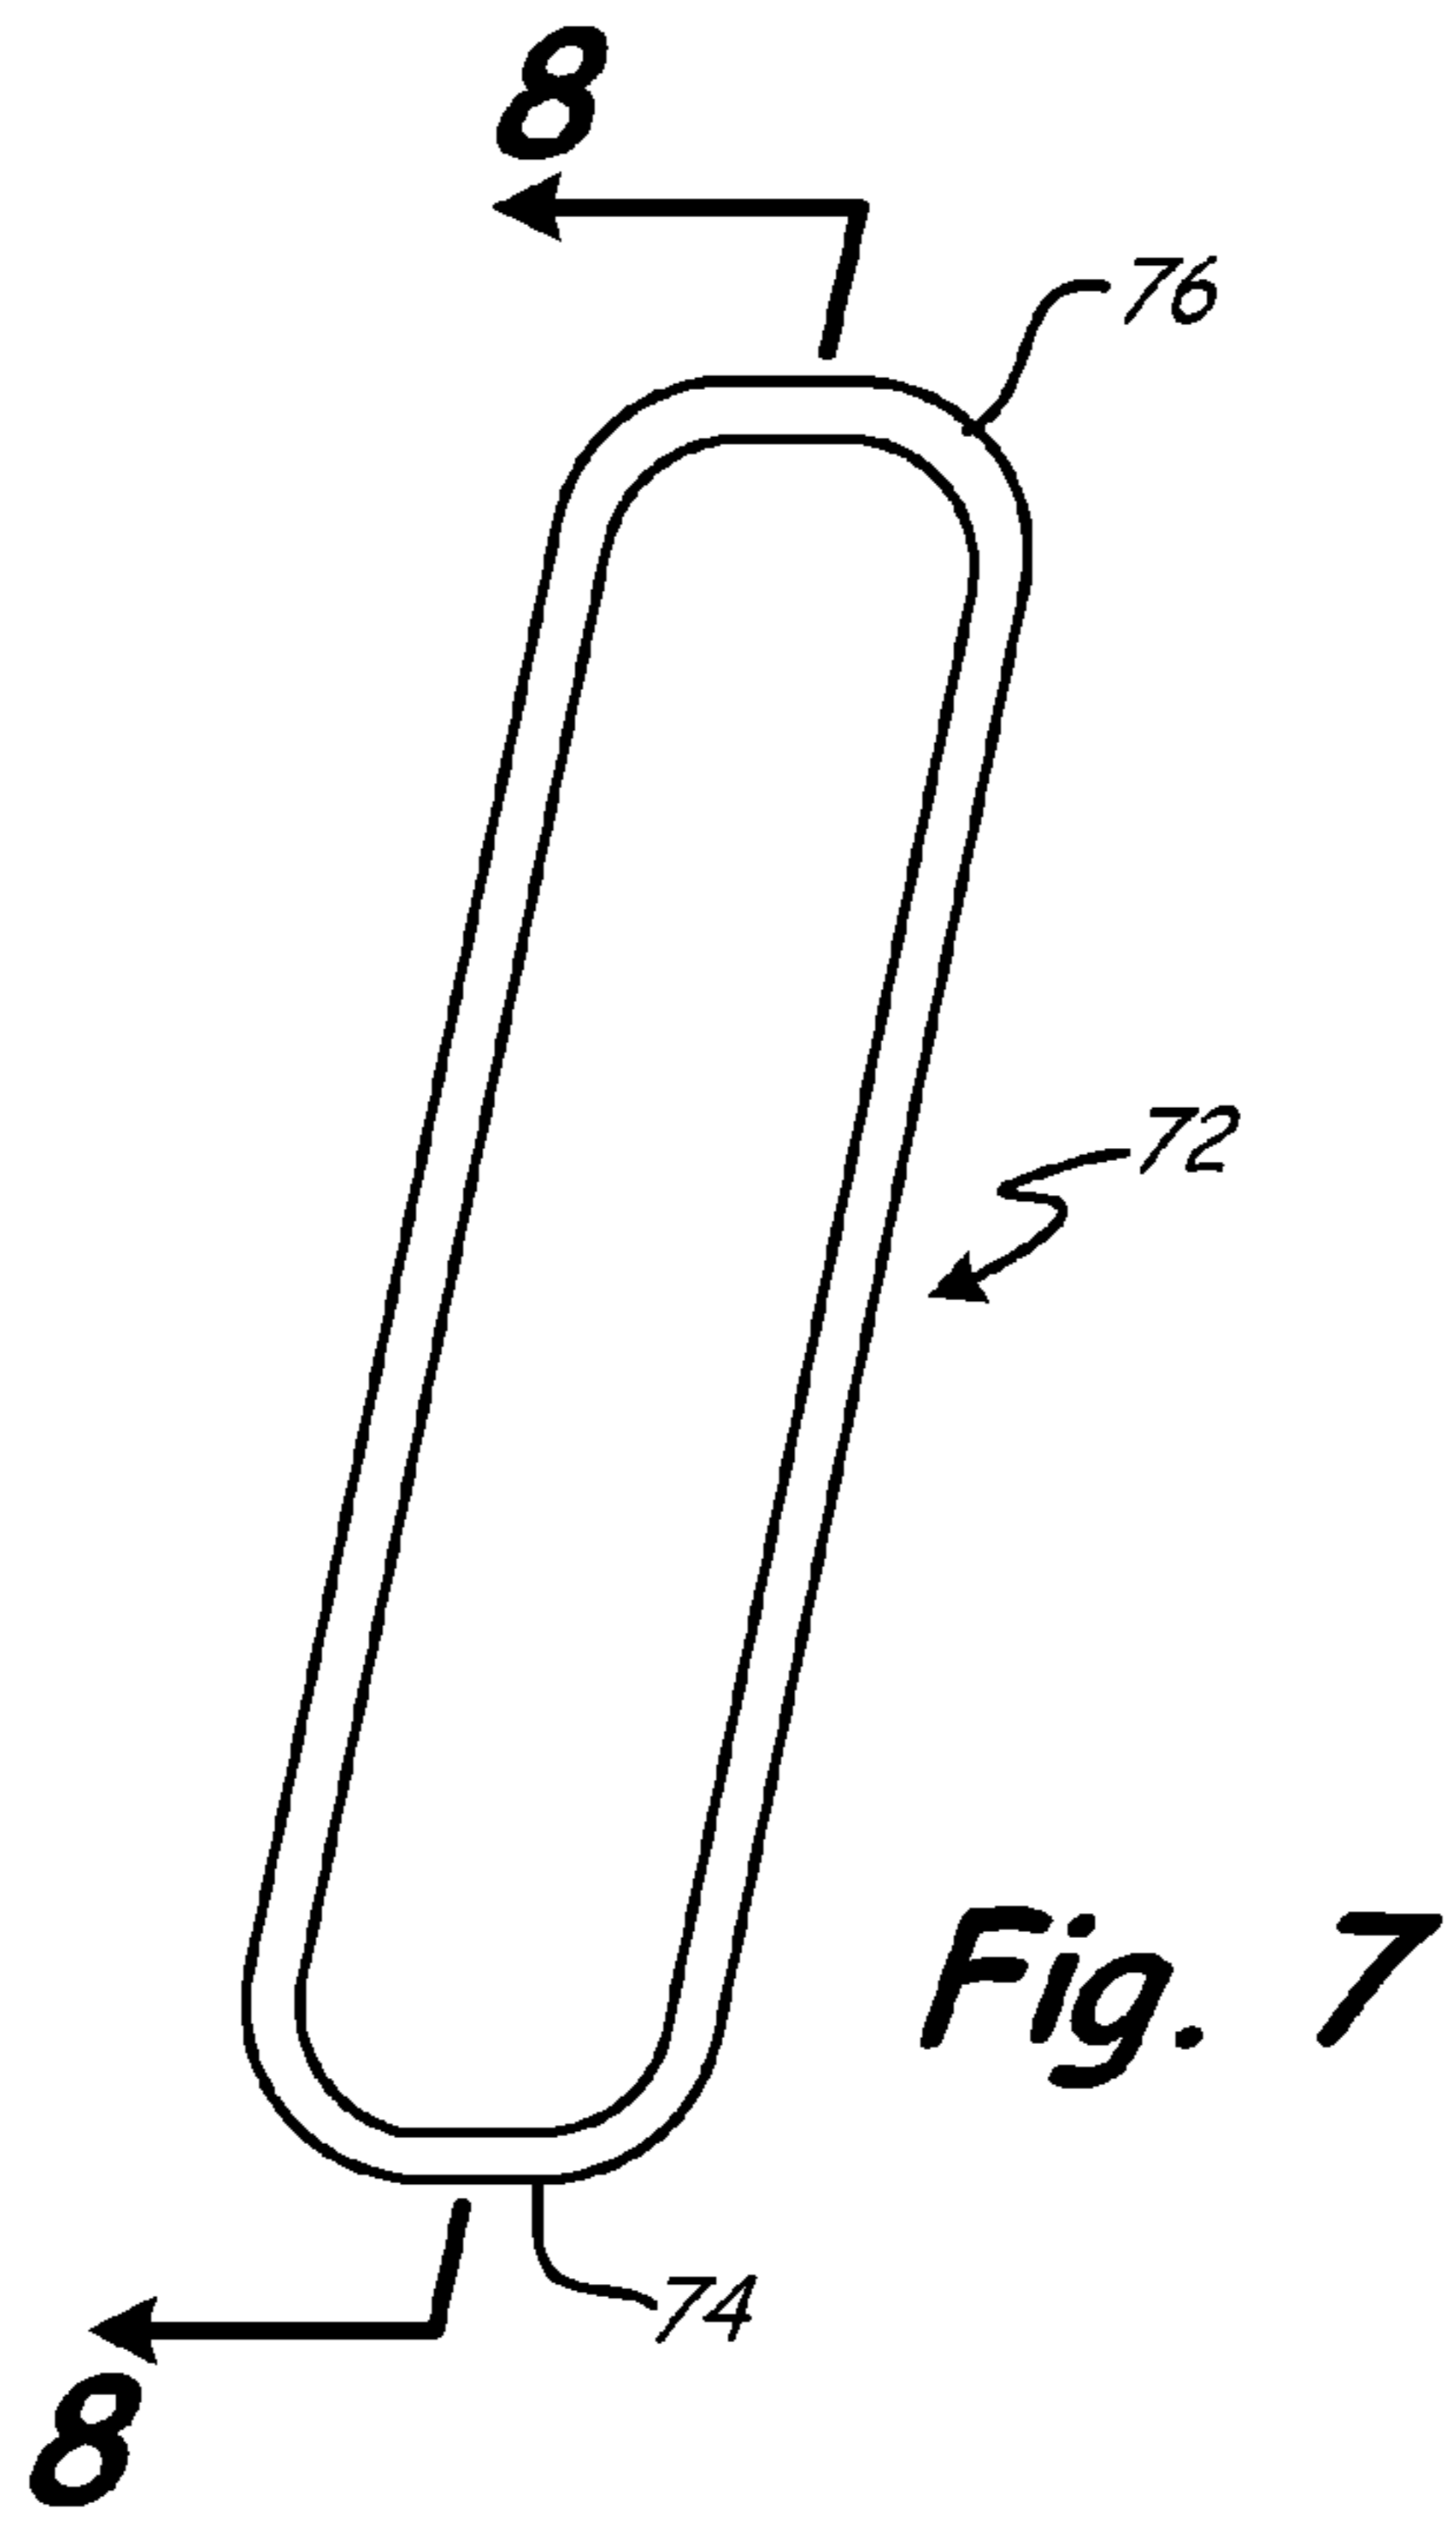
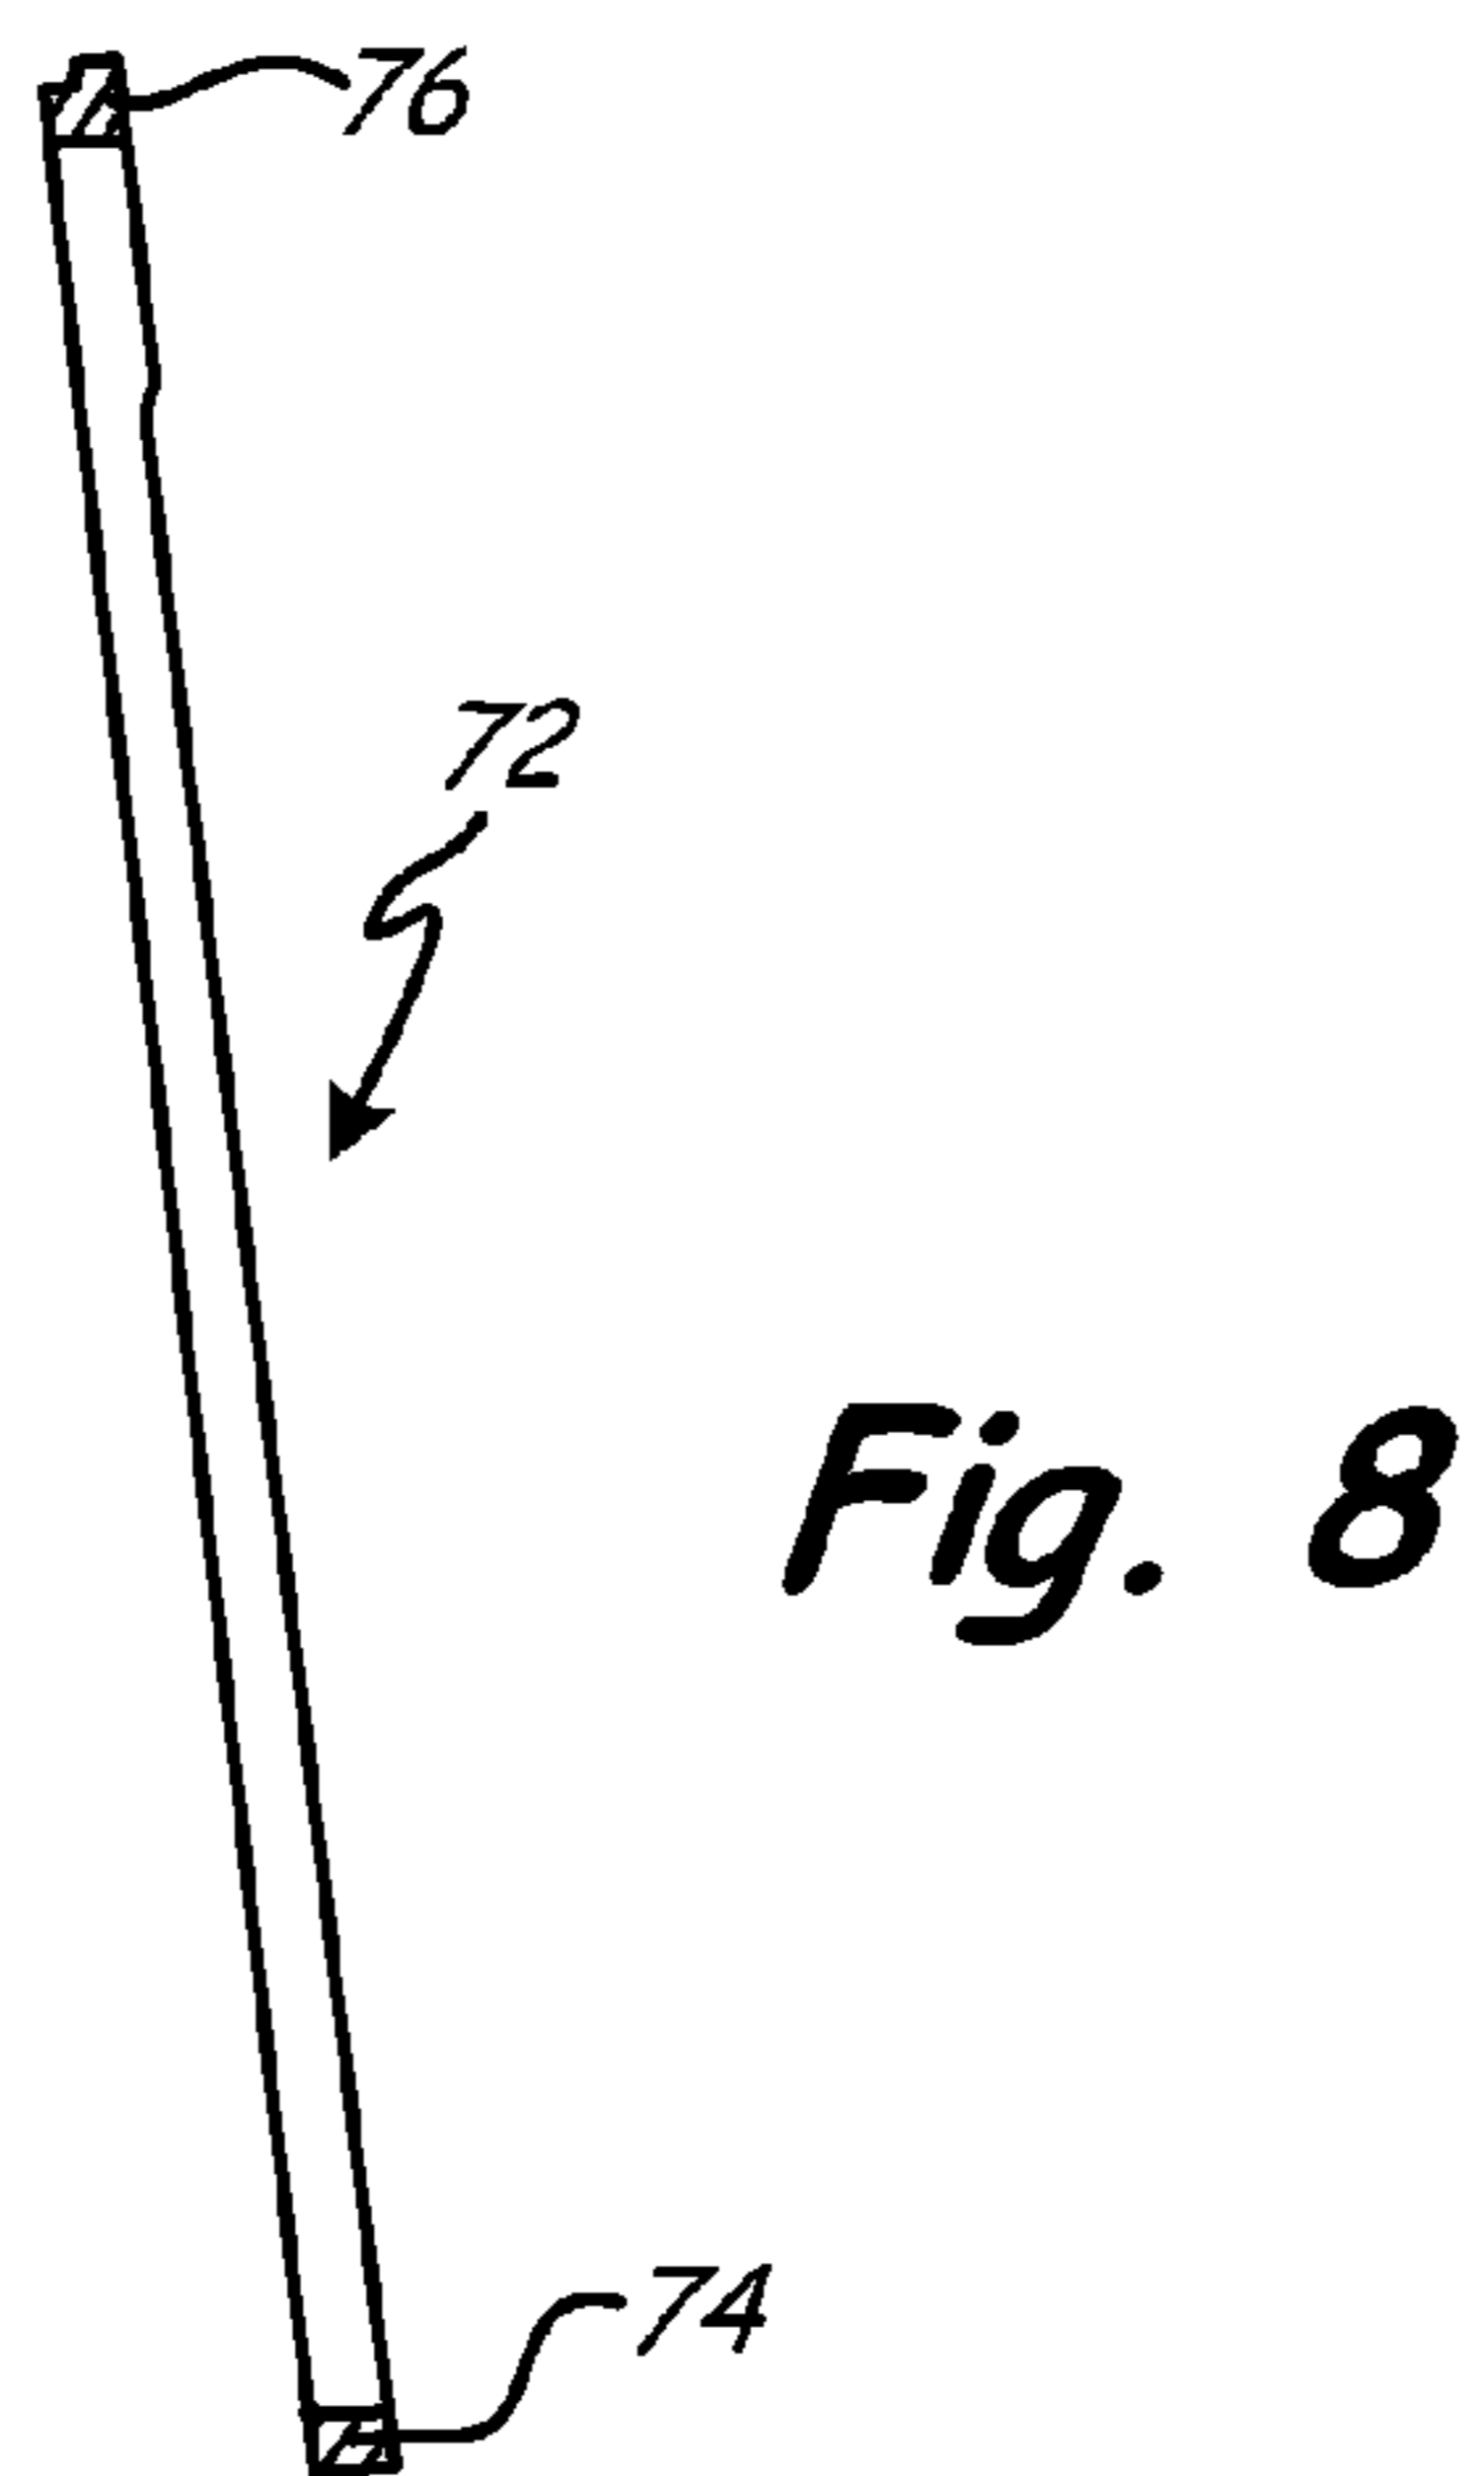
FIG. 7 is a plan view of a replacement insert for the outlet guide vane shroud assembly.

FIG. 8 is a cross-sectional view of the insert taken along line 8-8 in FIG. 7.

FIG. 7 is a plan view of replacement insert 72 for insertion into shroud ring 36. FIG. 8 is a cross-sectional view of the insert taken along line 8-8 in FIG. 7. Replacement insert 72 is manufactured from the same or similar material as shroud ring 36. In one embodiment, insert 72 contains the same metallurgical properties as shroud ring 36, and is made by casting. In other embodiments, insert 72 is made by forging, or machining a piece of raw material to the specifications for insert 72.

Insert 72 is illustrated as containing a generally uniform cross-section on first end 74, and has a stepped cross-section at second end 76. This configuration allows for a mating of insert 72 into refurbished slot 50 as illustrated in FIG. 6. Although illustrated as containing a graduated step from first end 74 to second end 76, insert 72 may contain other geometries for the edges including bevels (to mate with the embodiment shown in FIG. 5), chamfers, tapers, radii, or similar shapes that may be either graduated or of a constant cross-sectional area throughout the profile of insert 72.

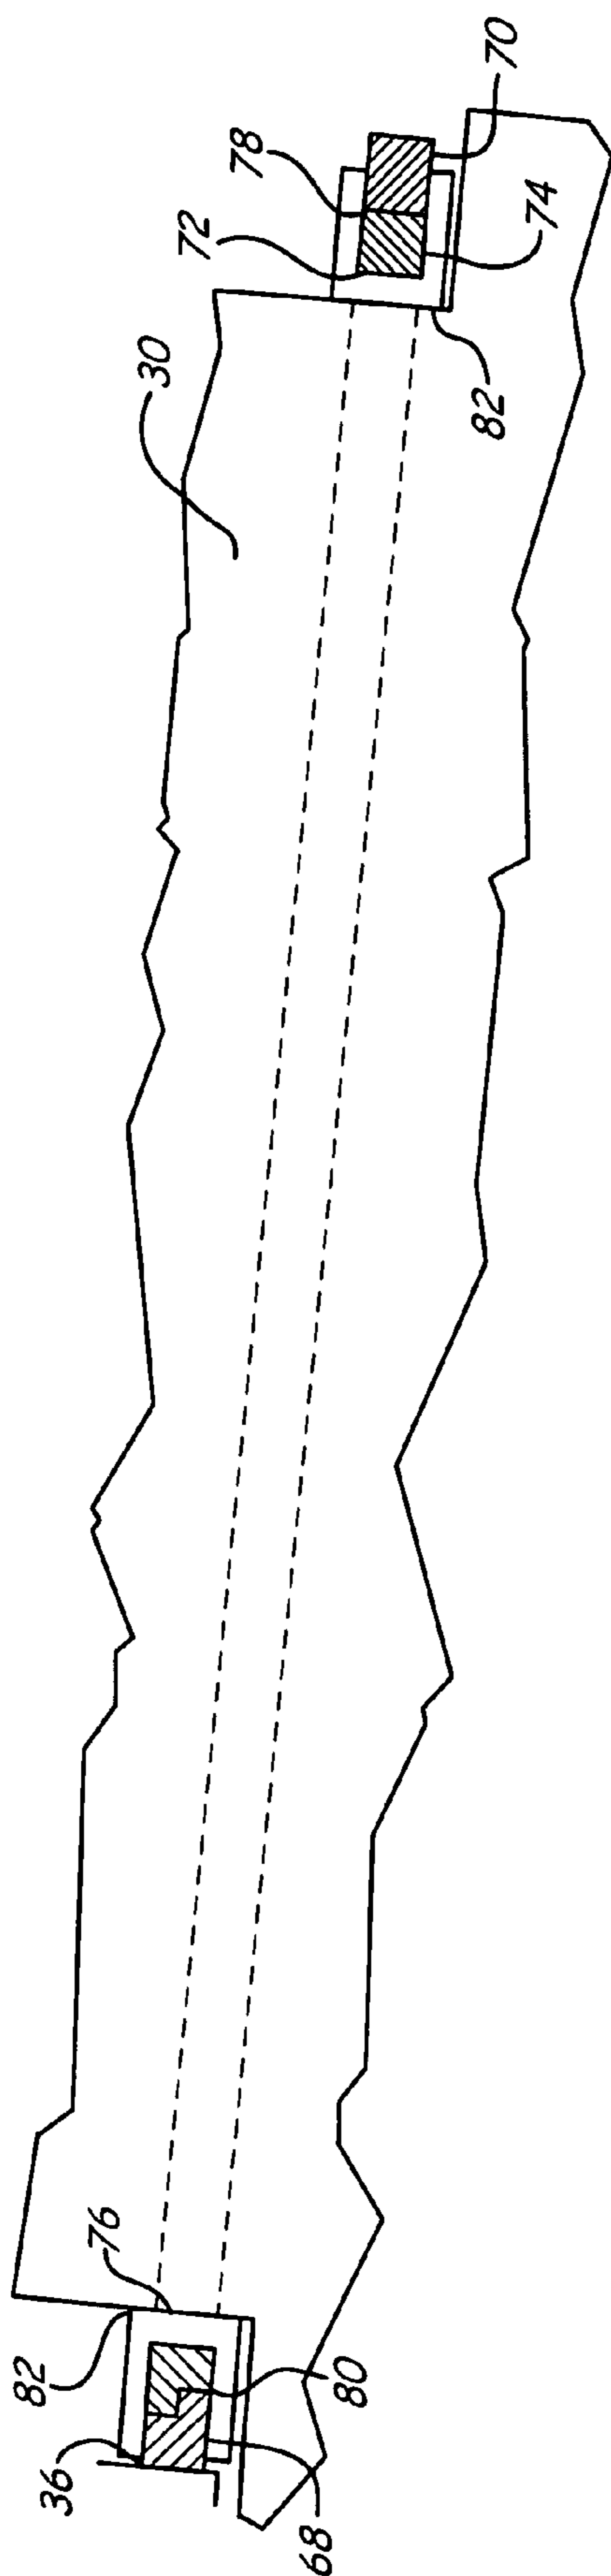
Fig. 9

FIG. 9 is a cross-sectional view of the insert joined to the outlet guide vane shroud.

FIG. 9 is a partial cross-sectional view of insert 72 joined to shroud ring 36 with liner 82 and fan guide vane 30. As illustrated, first end 74 of insert 72 is mated to aft edge 70 of shroud ring 36 at joint 78. Similarly, second end 76 of insert 72 is mated to forward edge 68 of shroud ring 36 at joint 80. Joint 80 is a stepped or rabbet joint, while joint 78 is a butt joint. Insert 72 is secured to shroud ring 36 through any of various methods, including interference fit, adhesives, welding, or similar attachment methods. In an alternate embodiment, insert 72 is secured in place once liner 82 has been installed in fan outlet guide vane shroud assembly 24. Although illustrated with a varying or non-uniform cross section, in alternate embodiments insert 72 contains a uniform or substantially uniform cross sectional area.

Liner 82 is a polymer insert used to position a fan guide vane within slot 50. Liner 82 may be a previously used insert, such as liner 38 illustrated in FIG. 3, or may be a new part. Liner 82 contains a generally uniform cross section. As illus-

trated, liner 38 covers insert 72. In one embodiment, the liner is used to hold the insert in place.

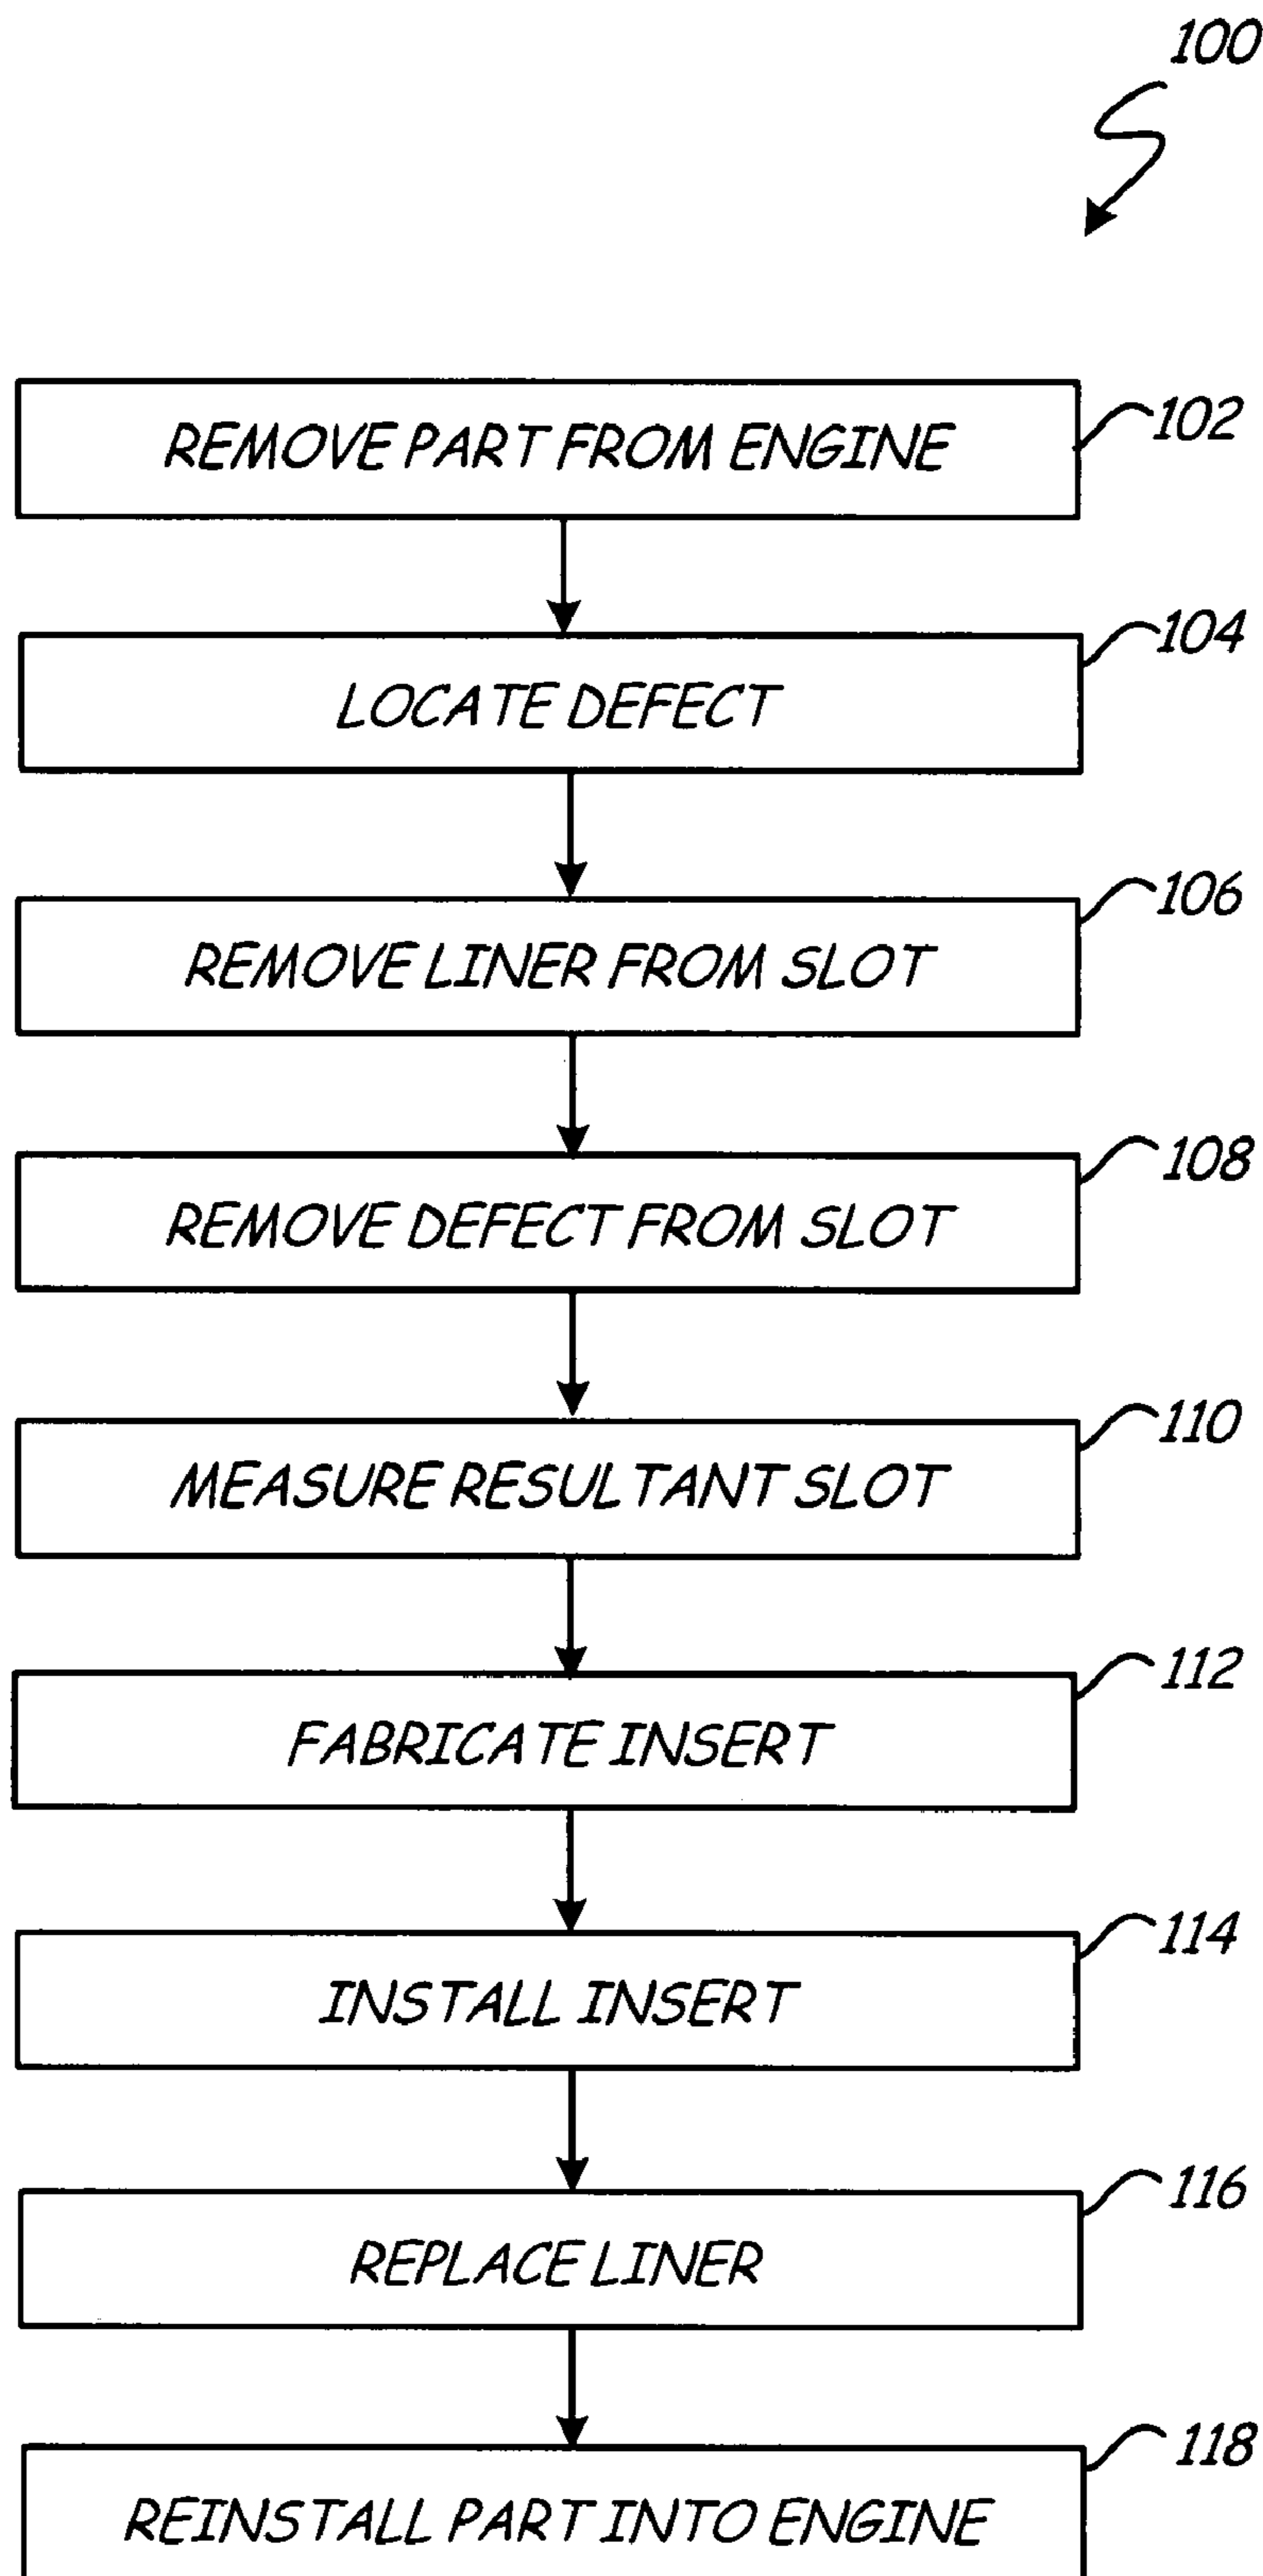
Fig. 10

FIG. 10 is a flow diagram of a repair process for the outlet guide vane shroud assembly.

FIG. 10 is a flow diagram of a repair process 100 for outlet guide vane shroud assembly 34. To initiate the repair process, the fan guide vane shroud assembly 34 is removed from the engine, Box 102. The shroud ring and liners are isolated. As depicted in Box 104, defects are identified. Defects may refer to cracks, chips, or other readily ascertainable deformations of the shroud ring, or a slot that is no longer within recommended dimensional tolerances from ordinary wear due to engine operation. Liner 38 of slot 50 to be repaired is removed from shroud ring 36, Box 106.

A center location of the slot is established. This position is verified by measuring of dimensions of the slot in both the generally axial and generally circumferential directions of the part. The term "axial" and "circumferential" relate to dimensions using the center axis of the engine as the base reference. Measurements are preferably taken from unworn portions of the surface of the slot.

Next, the area adjacent shroud slot 50 is machined to remove defects, Box 108, while at the same time maintaining clearance required for assembly. After machining, the part may be put through a finishing process, such as deburring or breaking edges.

The resultant aperture is measured, i.e. the new slot dimensions are taken, Box 110, and the resultant measurements are used to create an insert. In one embodiment, the insert is locally fabricated from a material that contains similar properties as the base material of the shroud ring, Box 112. As depicted in Box 114, insert 72 is installed. Insert 72, once installed, will return the aperture to acceptable tolerances just as if the part were original. In an alternate embodiment, insert 72 is prefabricated and slot 50 is machined to meet the outer dimensions of the prefabricated insert.

The dimensions from outer surface of the shroud wall to inner surface of the insert are verified prior to final assembly. This allows adjustment of dimensions, if necessary to meet specification requirements. The locally machined area and new locally manufactured insert are inspected to assure no defects are present, or remain from prior to initiating the repair.

Shroud ring 36 is prepared for insert 72 installation by using an adhesive that develops a high strength bond, and permanently keeps insert 72 in a pre-machined shroud slot. In one embodiment, the adhesive is a two component adhesive/sealant. For example, the adhesive may be a polysulfide rubber, which comes in two separate components that are combined just prior to or during application. Polysulfide rubber is typically used as an adhesive or sealant in a temperature range of -55° C. to 85° C. In one embodiment, the adhesive and insert 72 are joined in a clean environment, such as a bonding room. This will assure the proper temperature and humidity for curing the adhesive. The tools used, as well as shroud 36 and insert 72, are cleaned. The clean environment should be free from silicones, oils, dusts, or other contaminants harmful to sound bonds. In order to maintain required strength, fit of insert 72 in shroud slot 50 must be maintained as required per specification, and verified prior to assembly. Shroud ring 36 may be masked to assure the placement of the adhesive only onto the bonding surfaces of shroud ring 36 and insert 72.

After installation of the insert into the shroud ring, the surfaces are treated and finished to create a smooth part. This includes the removal of excess material from the insert and any excess adhesive. The part is then finally inspected to assure the part meets specified dimensions, no excess material or adhesive residue is present on the part, and that there are no defects in the joint.

After shroud ring 36 and insert 72 have been joined, the aperture liner is reinstalled, Box 116. In one embodiment, liner 38 has been previously used in service, while in another embodiment, liner 82 is a new part. Shroud ring 36 is then reinstalled into the engine to complete the repair, Box 118.
