(10) **Patent No.:** **US 8,028,207 B1**
(45) **Date of Patent:** **Sep. 27, 2011**

(54) **EARLY MEMORY TEST**

(73) Assignee: **Google Inc.**, Mountain View, CA (US)

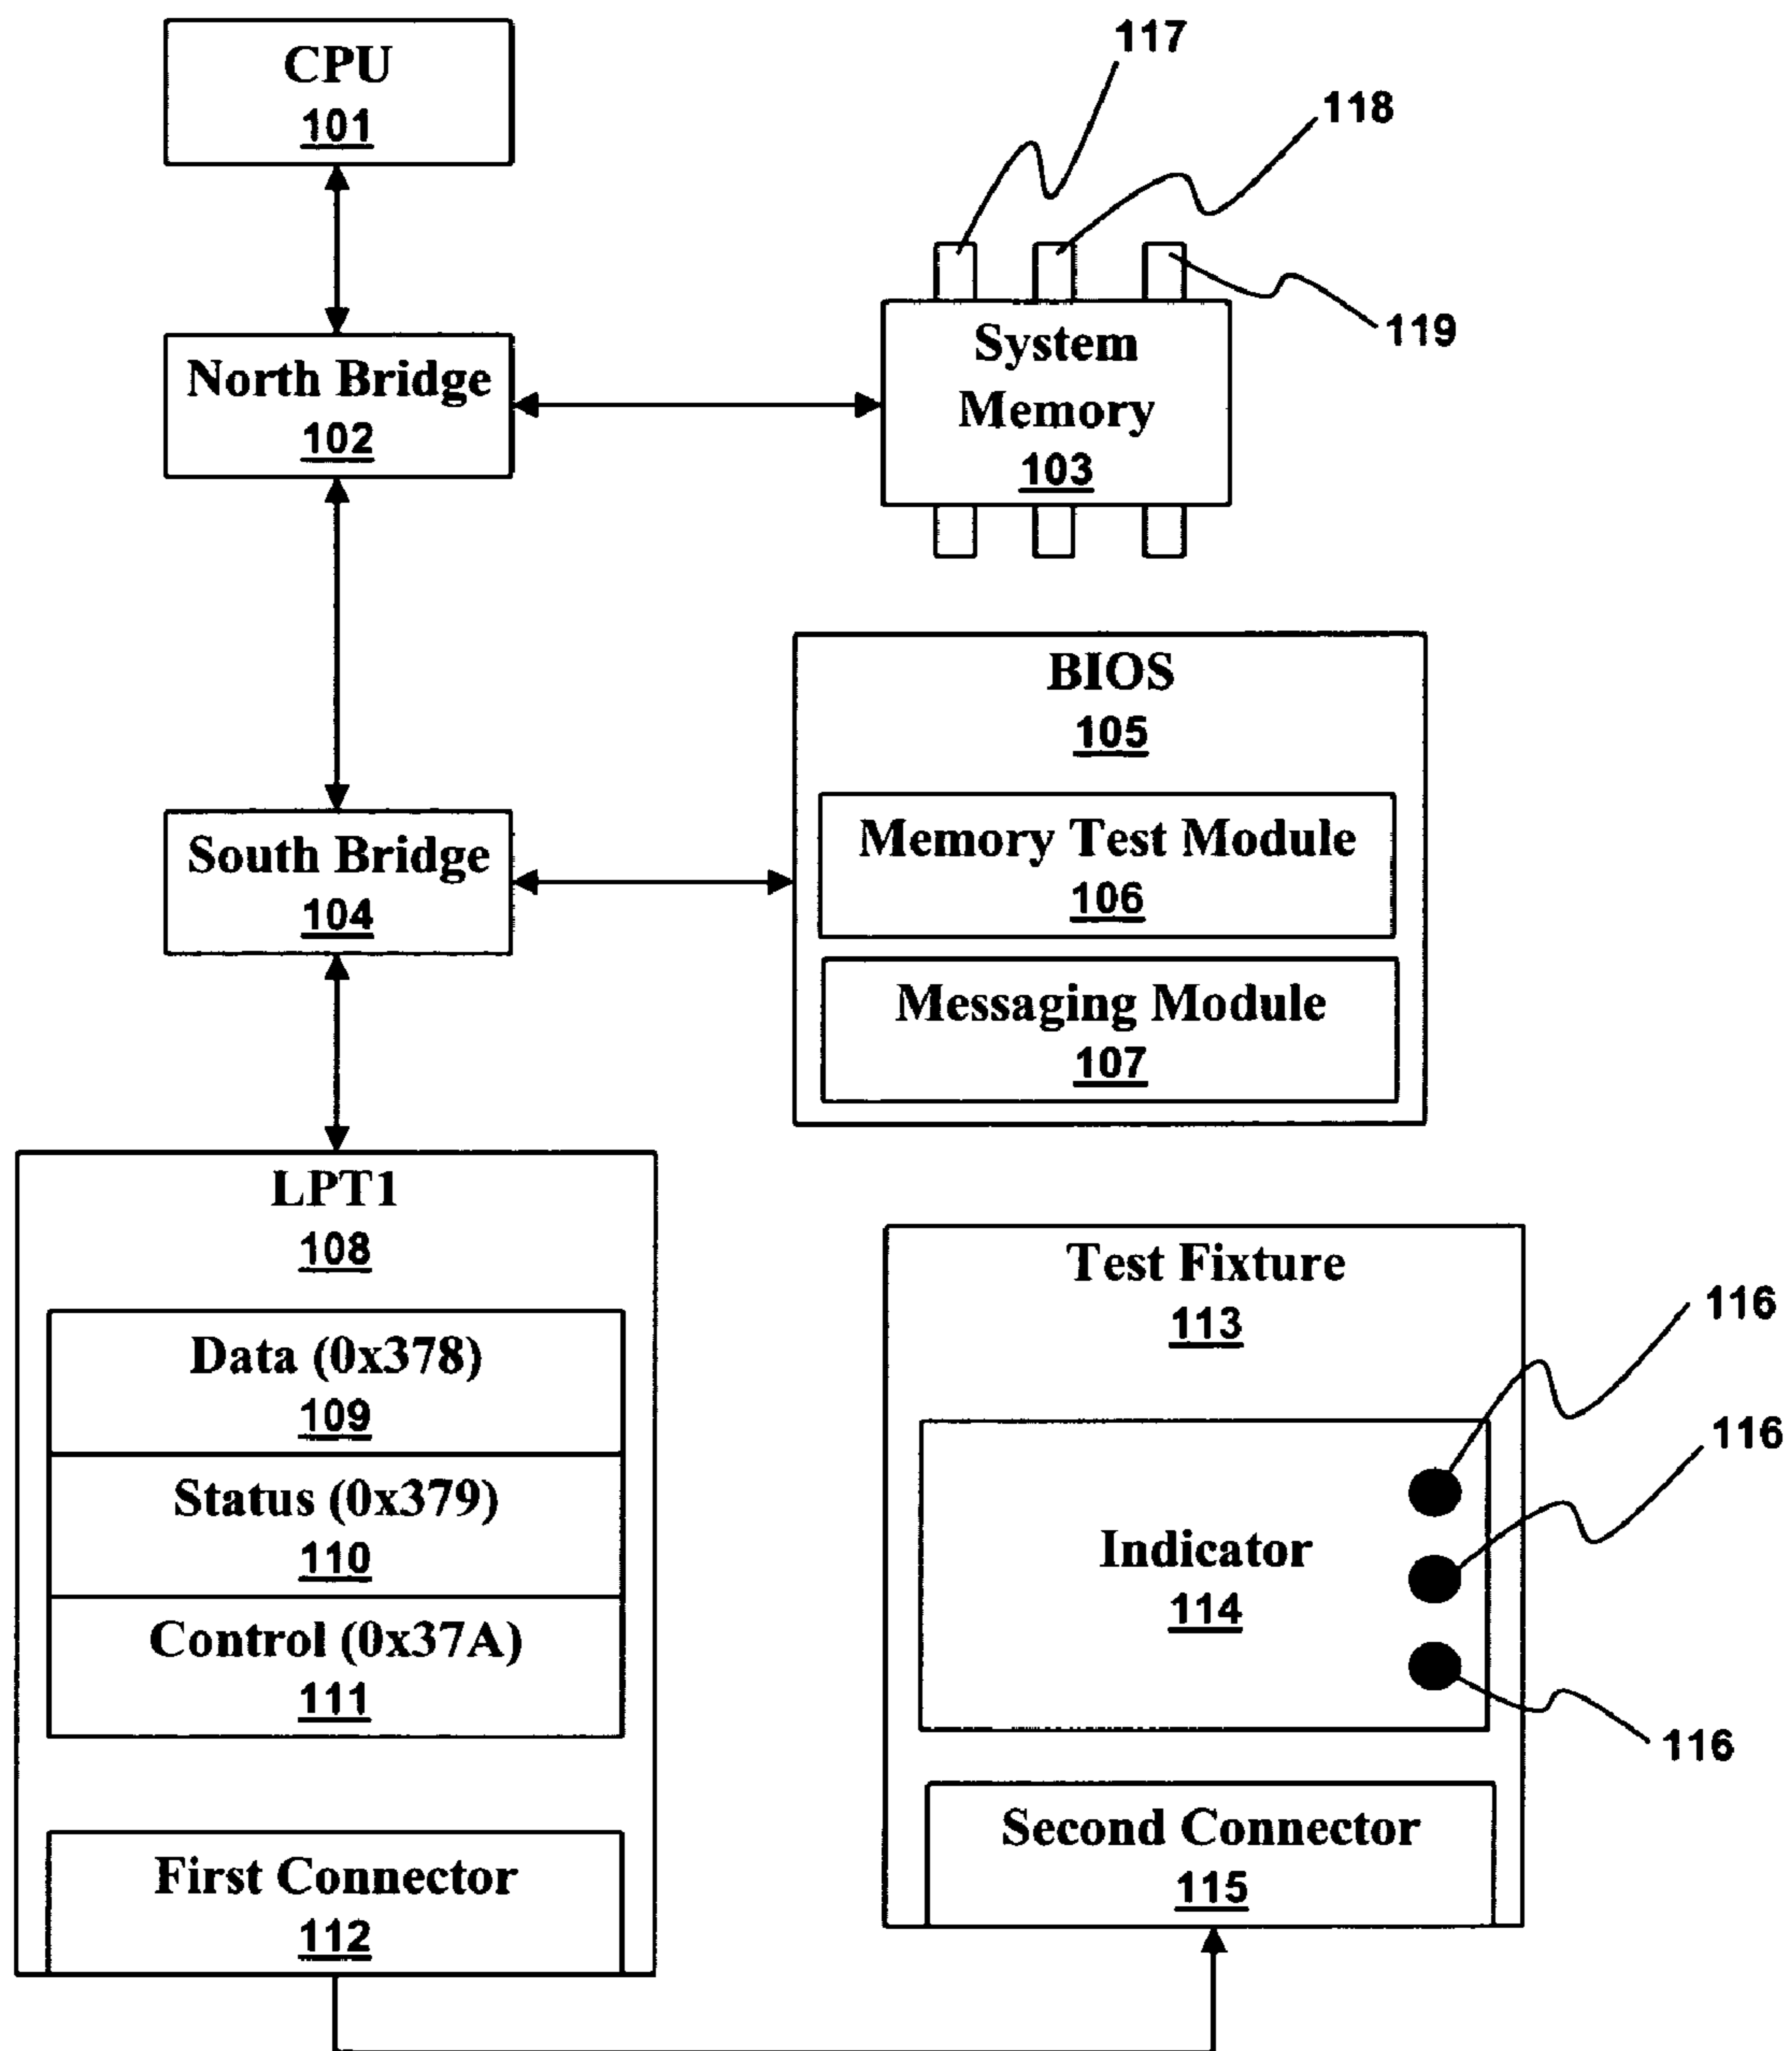
Fig. 1

FIG. 1 illustrates a high level block diagram of a system that can report the memory slot containing a bad memory in accordance with aspects of the embodiments. The CPU 101 accesses the BIOS 105 by way of the north bridge 102 and south bridge 104. The BIOS 105 contains instructions that the CPU 101 can execute, such as the instructions in a memory test module 106 and a messaging module 107. The memory test module 106 contains programs for testing the system memory 103 which is made of memories (not shown) held inside memory slots 117, 118, 119. The system illustrated shows a first memory slot 117, second memory slot 118, and third memory slot 119 whereas other systems based on the PC architecture can contain more or fewer memory slots.

If a bad memory is identified, the memory slot 117, 118, 119 holding it is identified. The messaging module 107 contains instructions telling the CPU how to report the identified memory slot via a communications module. In FIG. 1, a PC standard LPT1 port 108 is shown as the communications module. The PC standard LPT1 port 108 is located at IO address 0x378 with data 109 at location 0x378, status 110 at address 0x379, and control 111 at address 0x37A. A similar port, LPT2, is located at address 0x278 with similar registers at 0x278, 0x279, and 0x27A. Those skilled in the arts of computer design, computer architecture, operating systems, or device drivers are aware of the properties and use of communications ports, registers, and IO addresses. The LPT1 port is shown with a first connector 112.

A test fixture 113 with an indicator 114 and a second connector 115 can be used to supply a visual indication of which memory slot contains a bad memory. The LPT1 is used to report the identified memory slot by placing a pattern of high and low voltages on the first connector 112. The second connector 115 and test fixture 113 ensure that an electrical connection is established between the first connector 112 and the indicator 114. The indicator 114 is shown with three light emitting diodes 116 for indicating which of the three memory slots 117, 118, 119 contains a bad memory.

FIG. 1 illustrates a high level block diagram of a system that can report the memory slot containing a bad memory in accordance with aspects of the embodiments;

The electrical connection between the indicator 114 and the first connector can be hot pluggable. Hot pluggable means that the electrical connection can be established while the pattern of high and low voltages are on the first connector 112. In practice, hot pluggability means that the PC can begin booting, detect a bad memory failure and report it. The indicator 114, however, is required for the report to be received because a technician must use an indicator 114 to observe the report. The technician can plug in the test fixture and immediately observe the report. Hot plugging is known to those practiced in the arts of electrical or electronic equipment operation and maintenance.

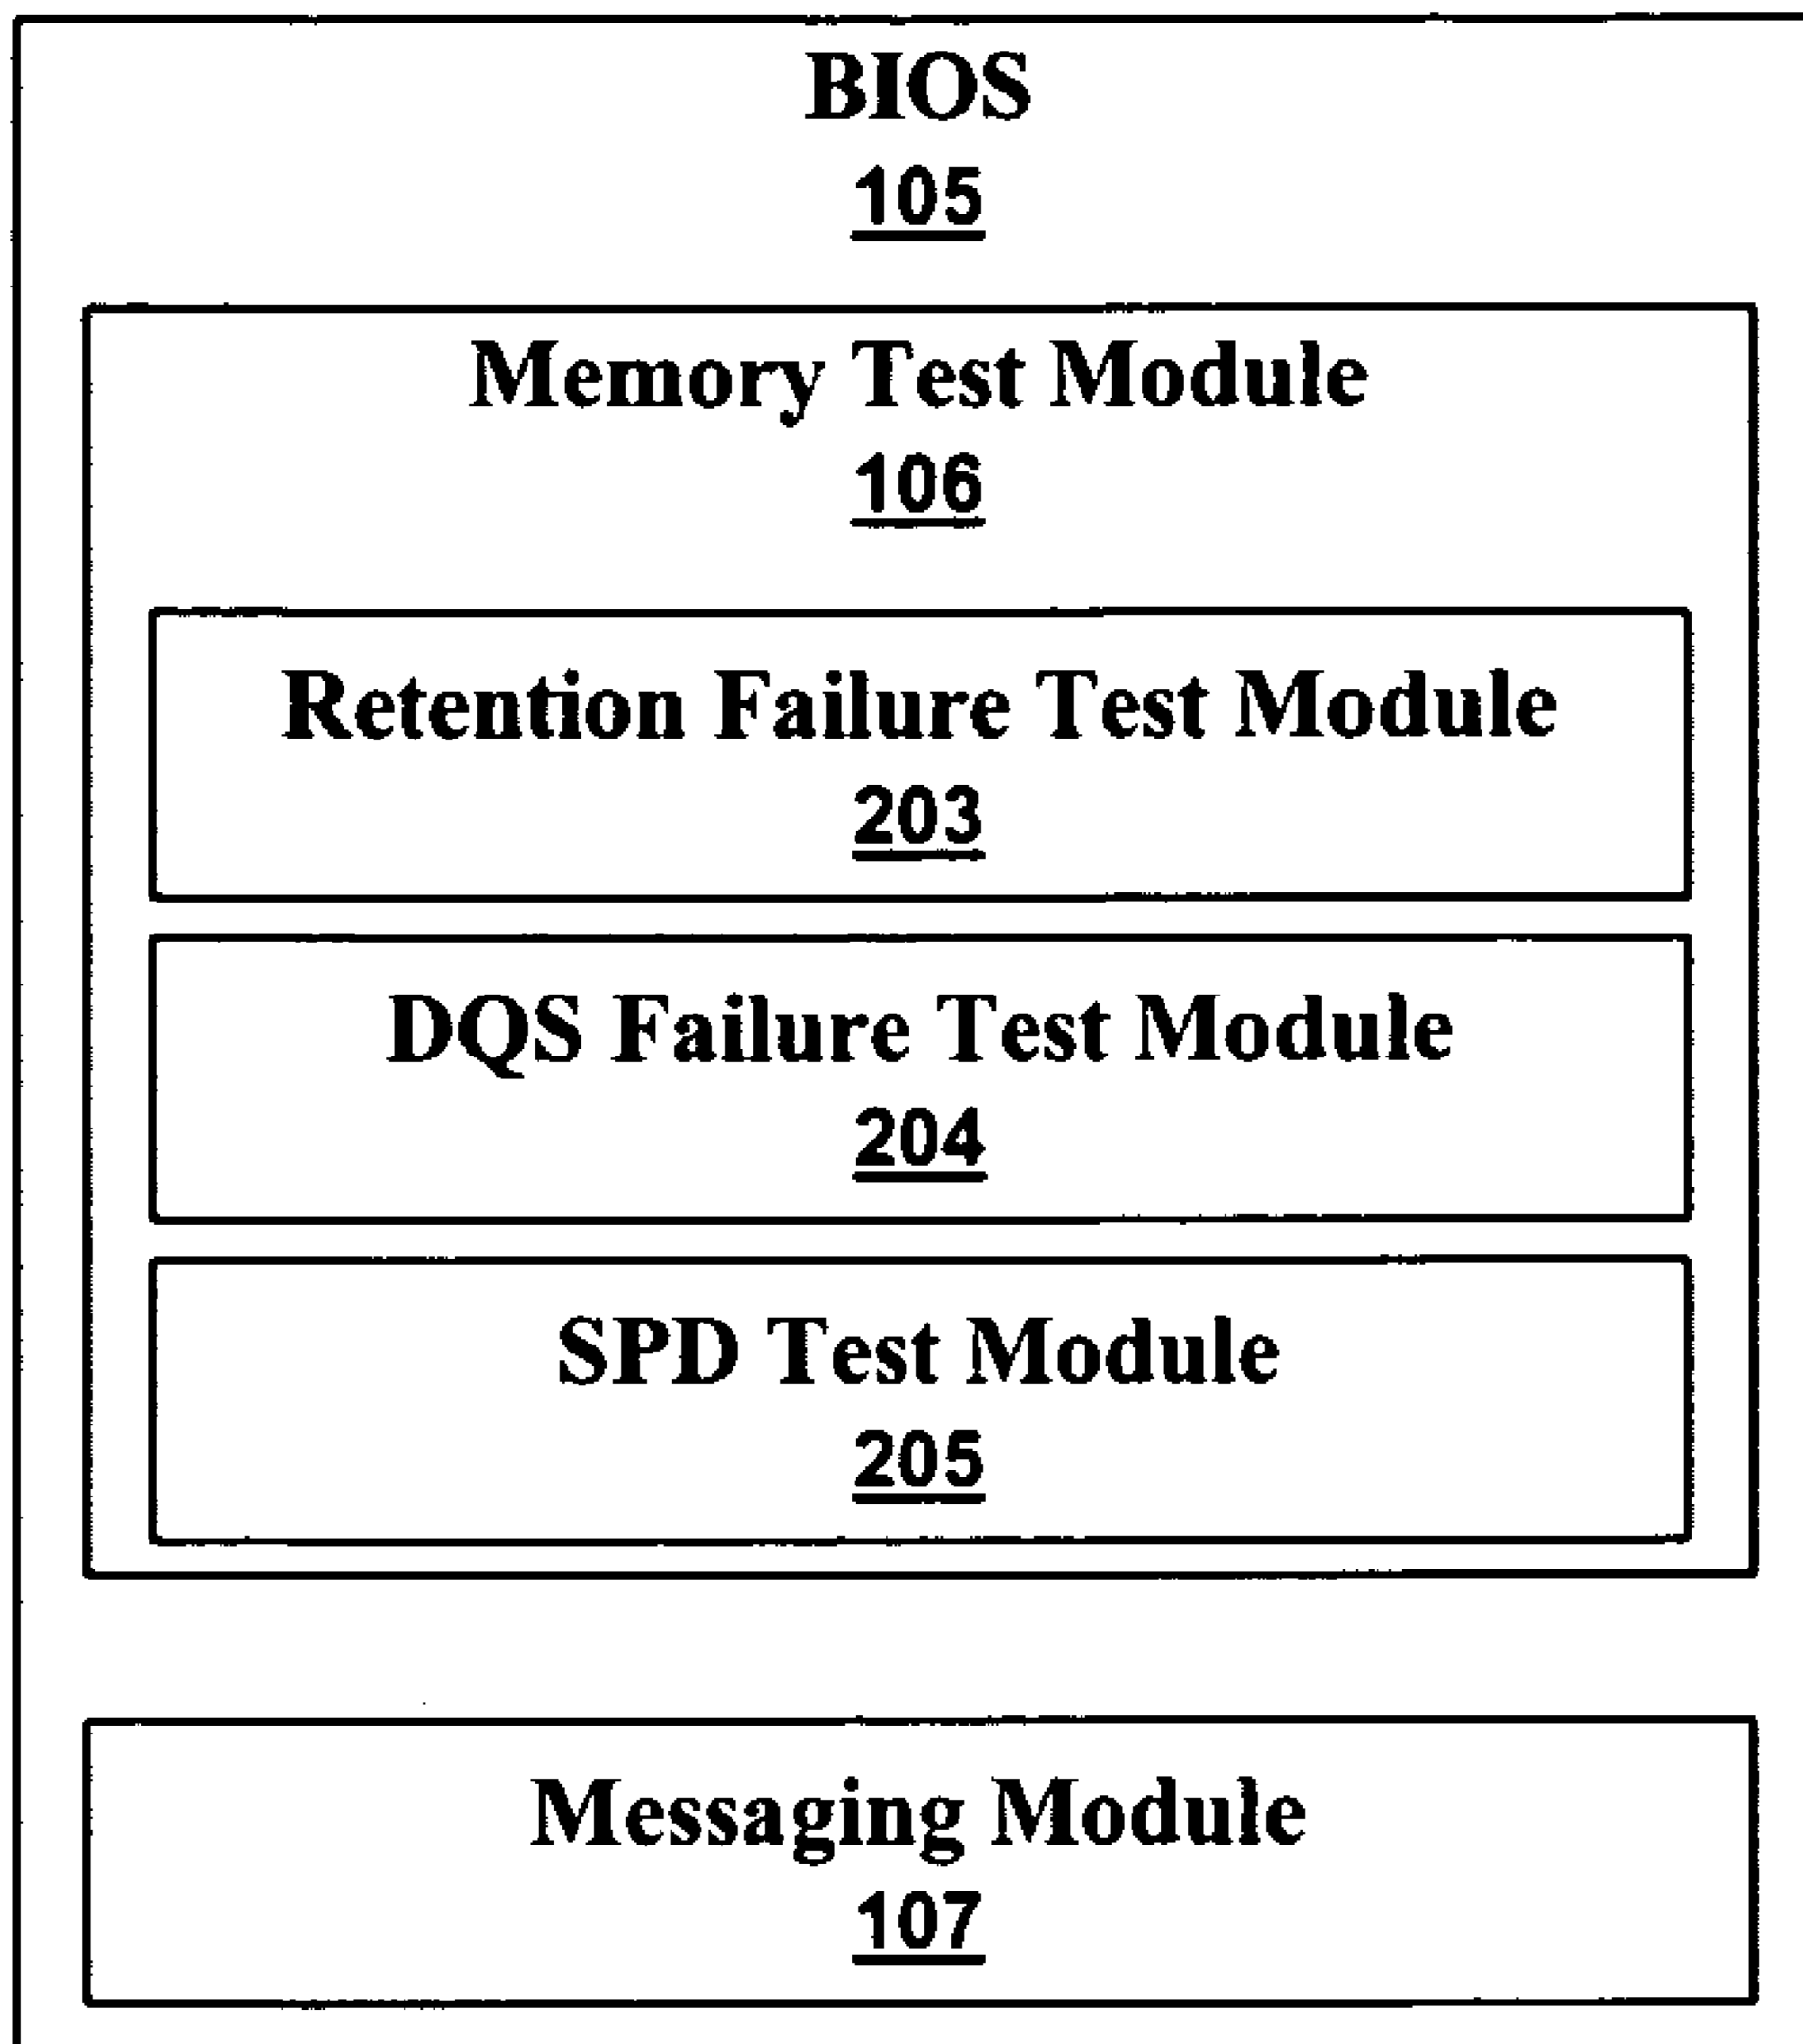
Fig. 2

FIG. 2 illustrates a high level block diagram of a BIOS 105 containing modules in accordance with aspects of the embodiments. As in FIG. 1, the BIOS 105 contains a memory test module 106 and a messaging module 107. Here, however, the memory test module 106 contains other modules that can test for specific memory faults. The three modules are a retention test module 203, DQS failure test module 204, and a SPD test module 205.

FIG. 2 illustrates a high level block diagram of a BIOS containing modules in accordance with aspects of the embodiments;

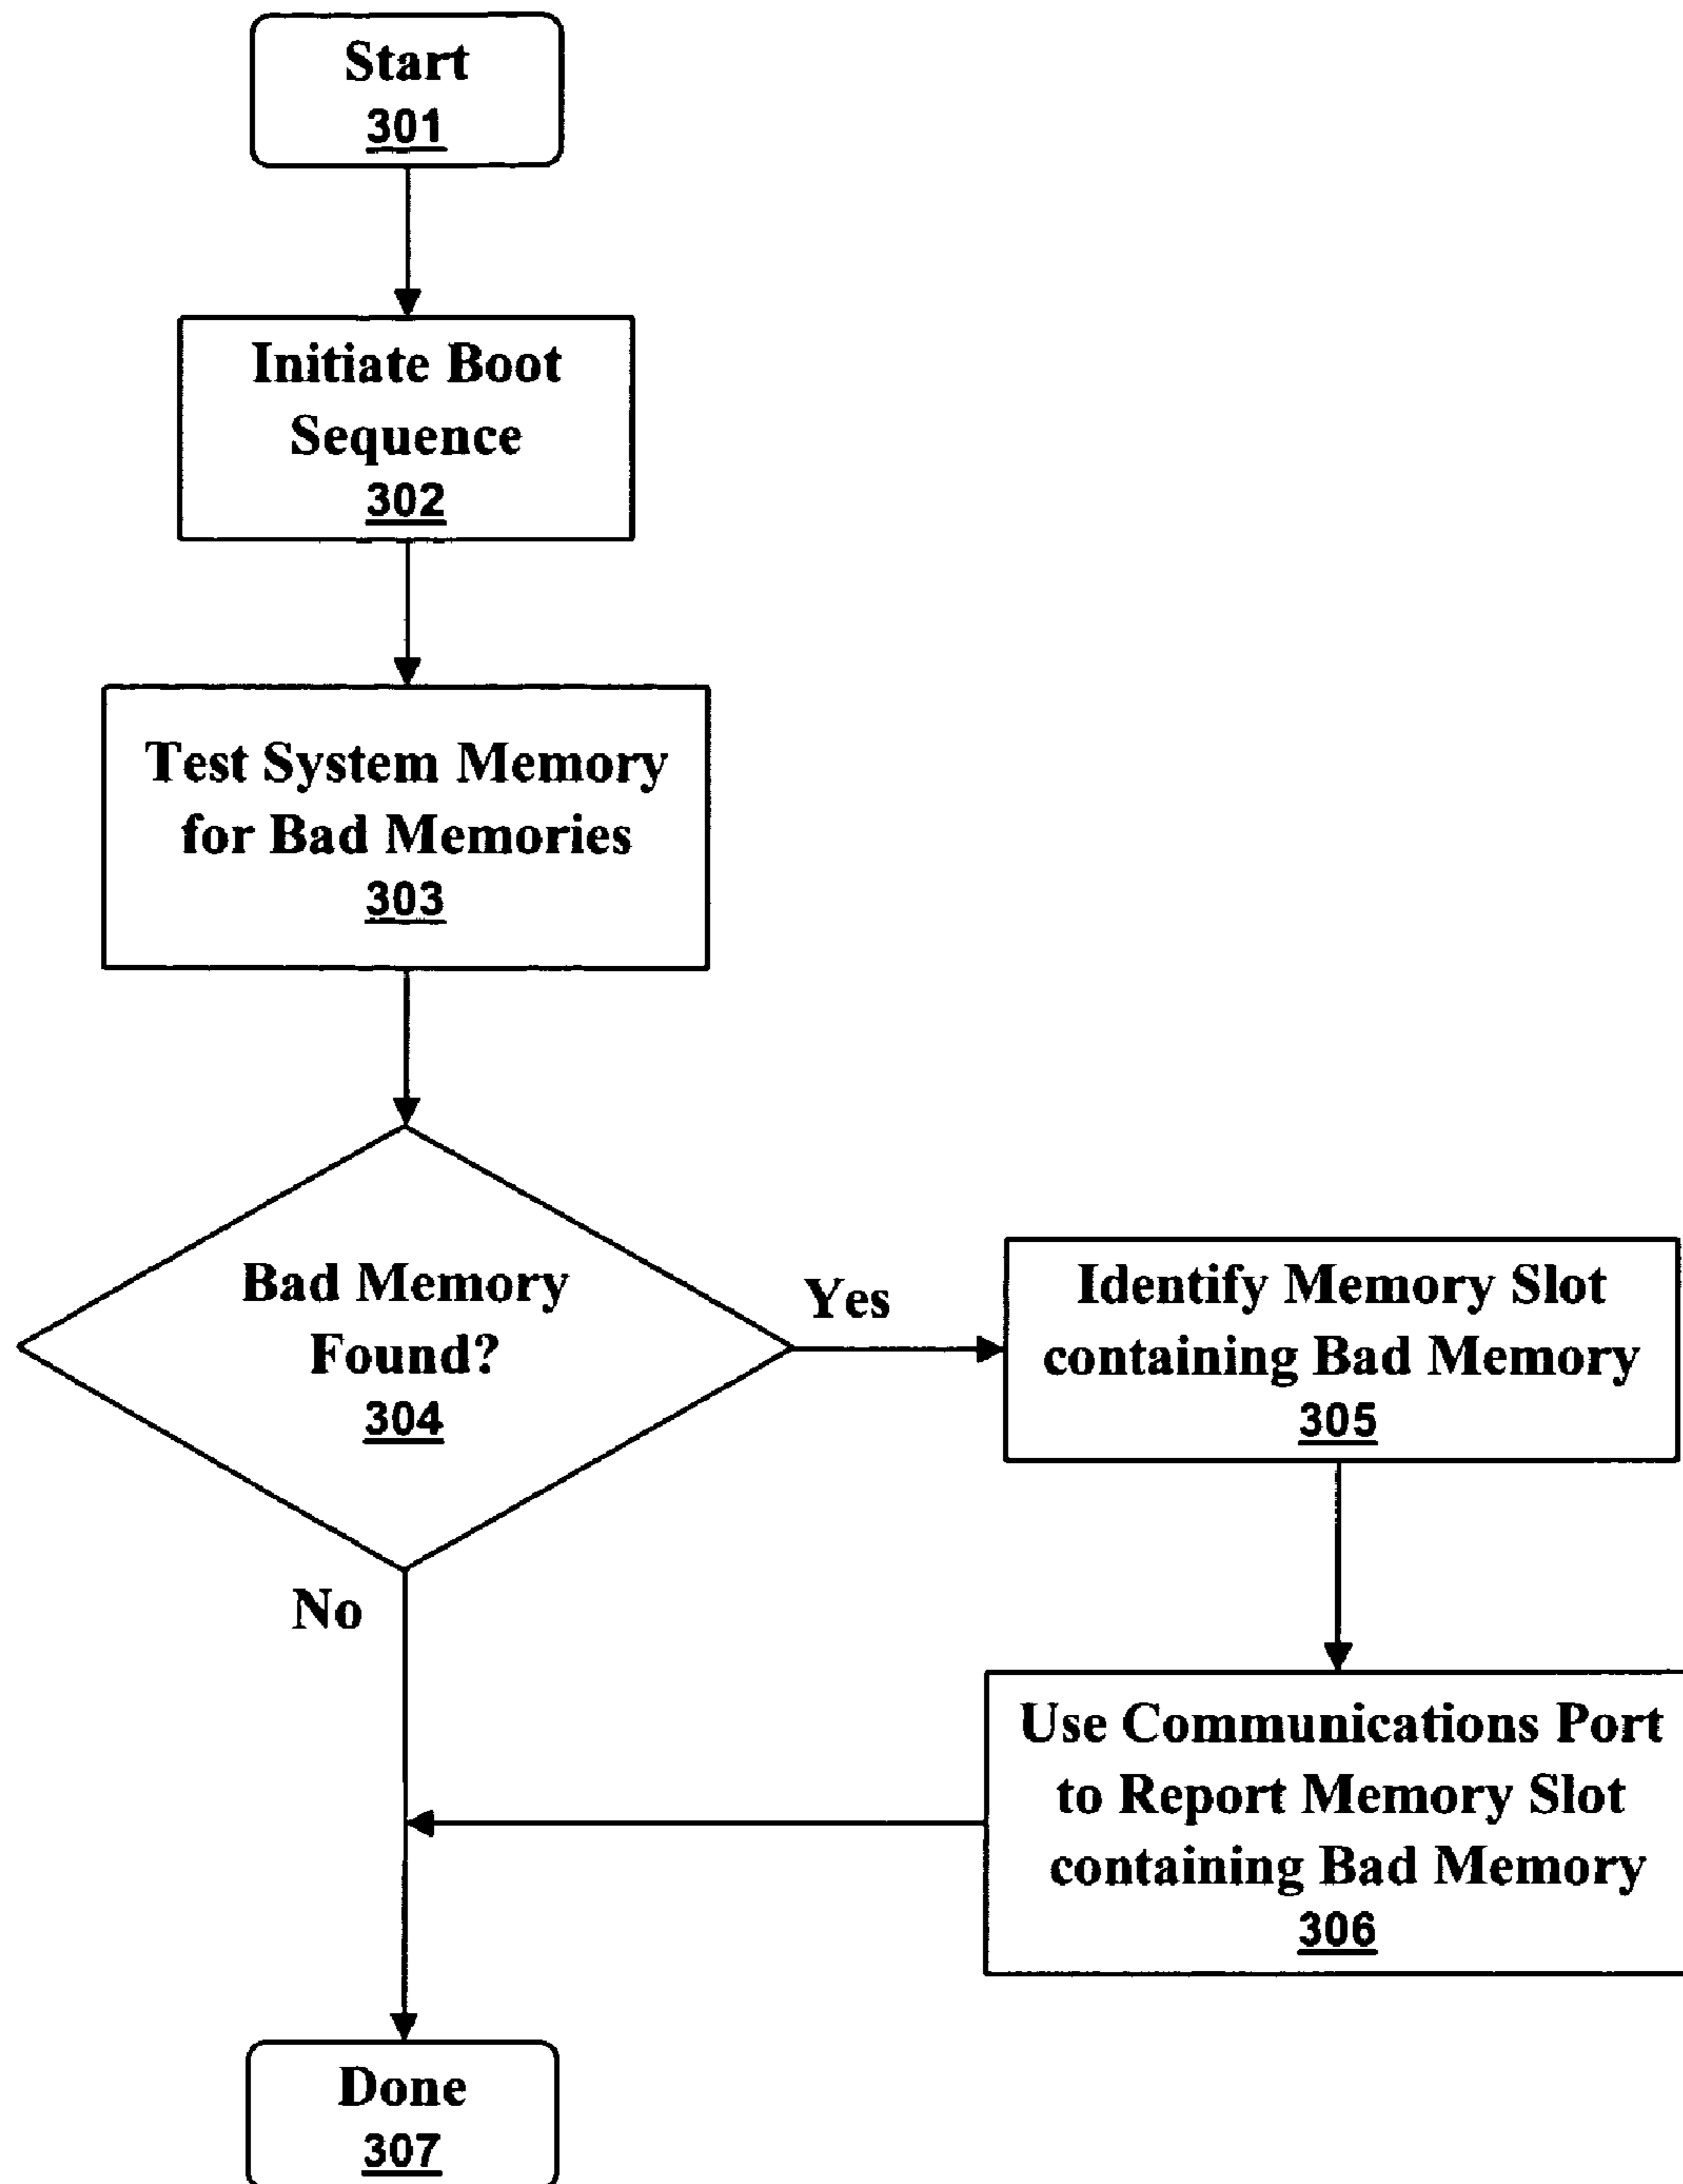
Fig. 3

FIG. 3 illustrates a high level flow diagram of a PC finding and reporting a memory slot containing a bad memory in accordance with aspects of the embodiments. After the start 301, the PC initiates the boot sequence 302. The system memory is tested 303 for bad memories. If none is found 304, the process completes 307. Otherwise, the memory slot containing the bad memory is found 305 and reported 306 via the communications port and then the process completes 307.

FIG. 3 illustrates a high level flow diagram of a PC finding and reporting a memory slot containing a bad memory in accordance with aspects of the embodiments;

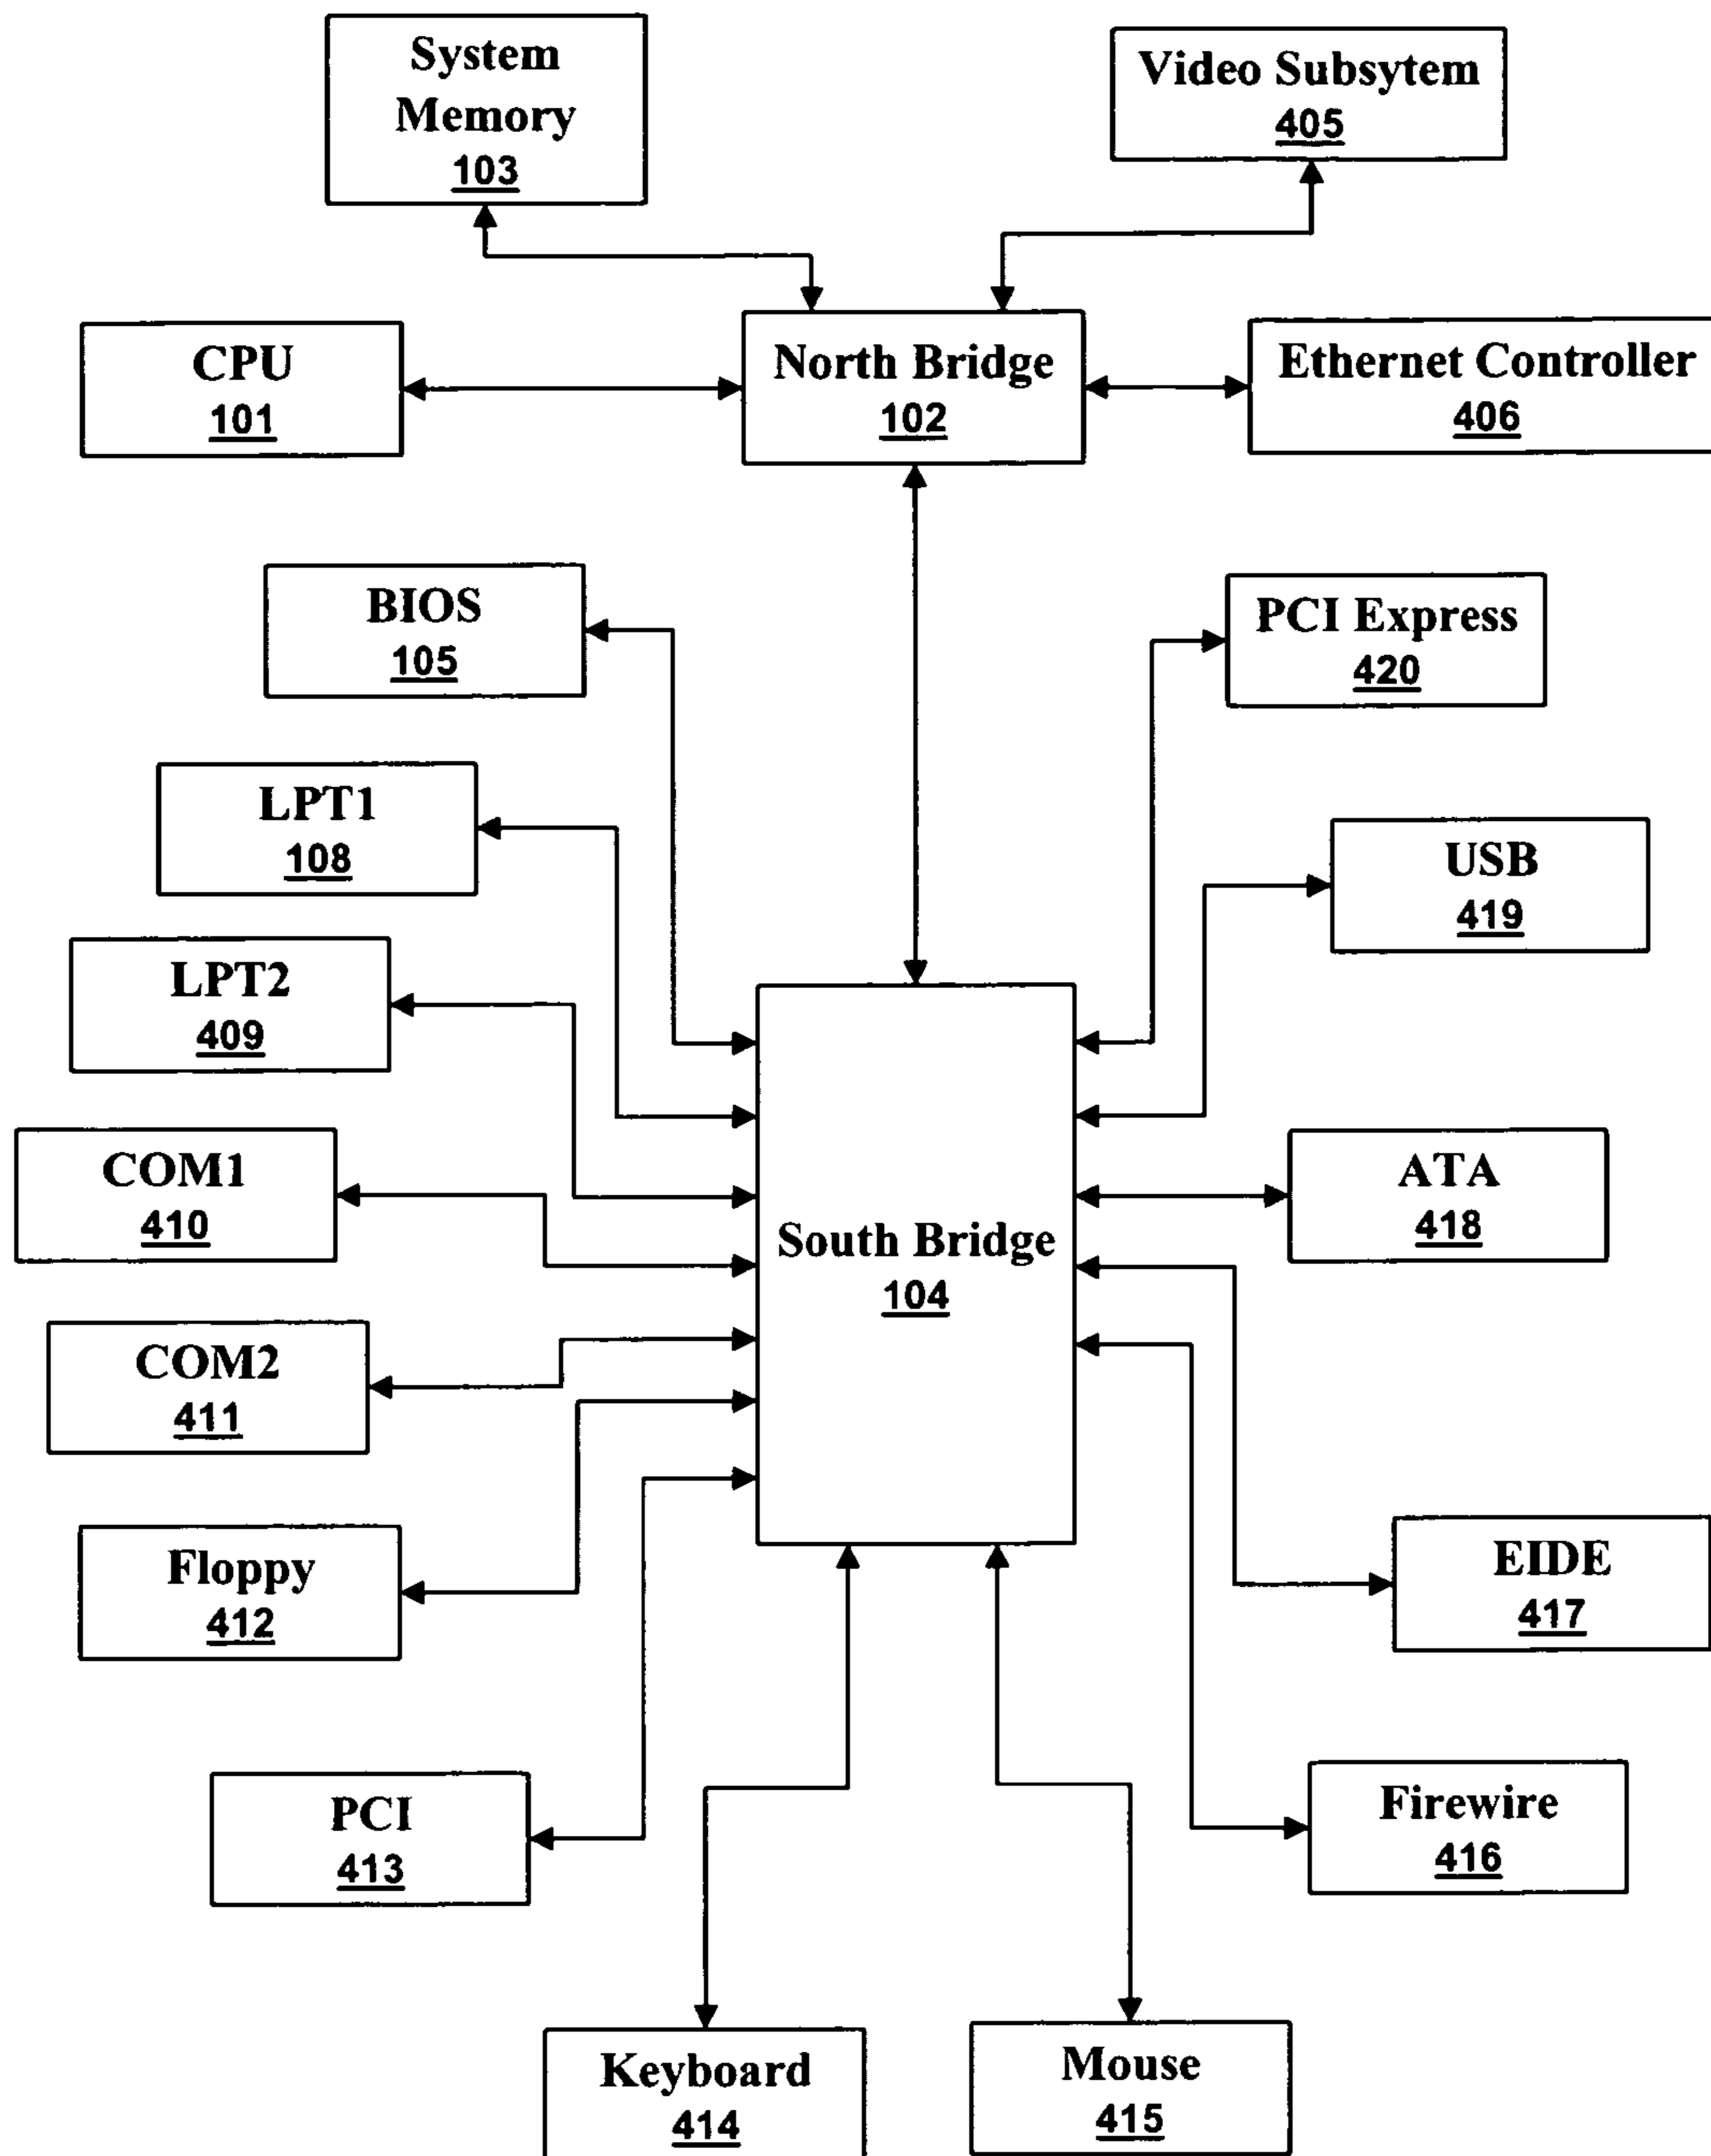
Fig. 4 (prior art)

FIG. 4, labeled as “prior art”, illustrates a high level block diagram of a PC compatible motherboard, meaning it is based on the PC architecture, in accordance with aspects of the embodiments. The components on the motherboard are divided into two groups, those that require high bandwidth communications and those that do not. The north bridge 102 coordinates communications between high bandwidth components such as the CPU 101, the system memory 103, the video subsystem 405, the Ethernet controller 406, and the south bridge 104. The south bridge 104 controls communications between low bandwidth devices and the north bridge 102. Some of the low bandwidth devices are the BIOS 105, LPT1 108, LPT2 409, the first serial port 410, the second serial port 411, the floppy drive 412, the PCI bus 413, the keyboard controller 414, the mouse controller 415, the firewire controller 416, the EIDE controller 417, the ATA controller 418, the USB controller 419, and the PCI express controller 420. Many of the low bandwidth devices are actually contained within the same computer chip as the south bridge 104.

FIG. 4, labeled as “prior art”, illustrates a high level block diagram of a PC compatible motherboard, meaning it is based on the PC architecture, in accordance with aspects of the embodiments; and

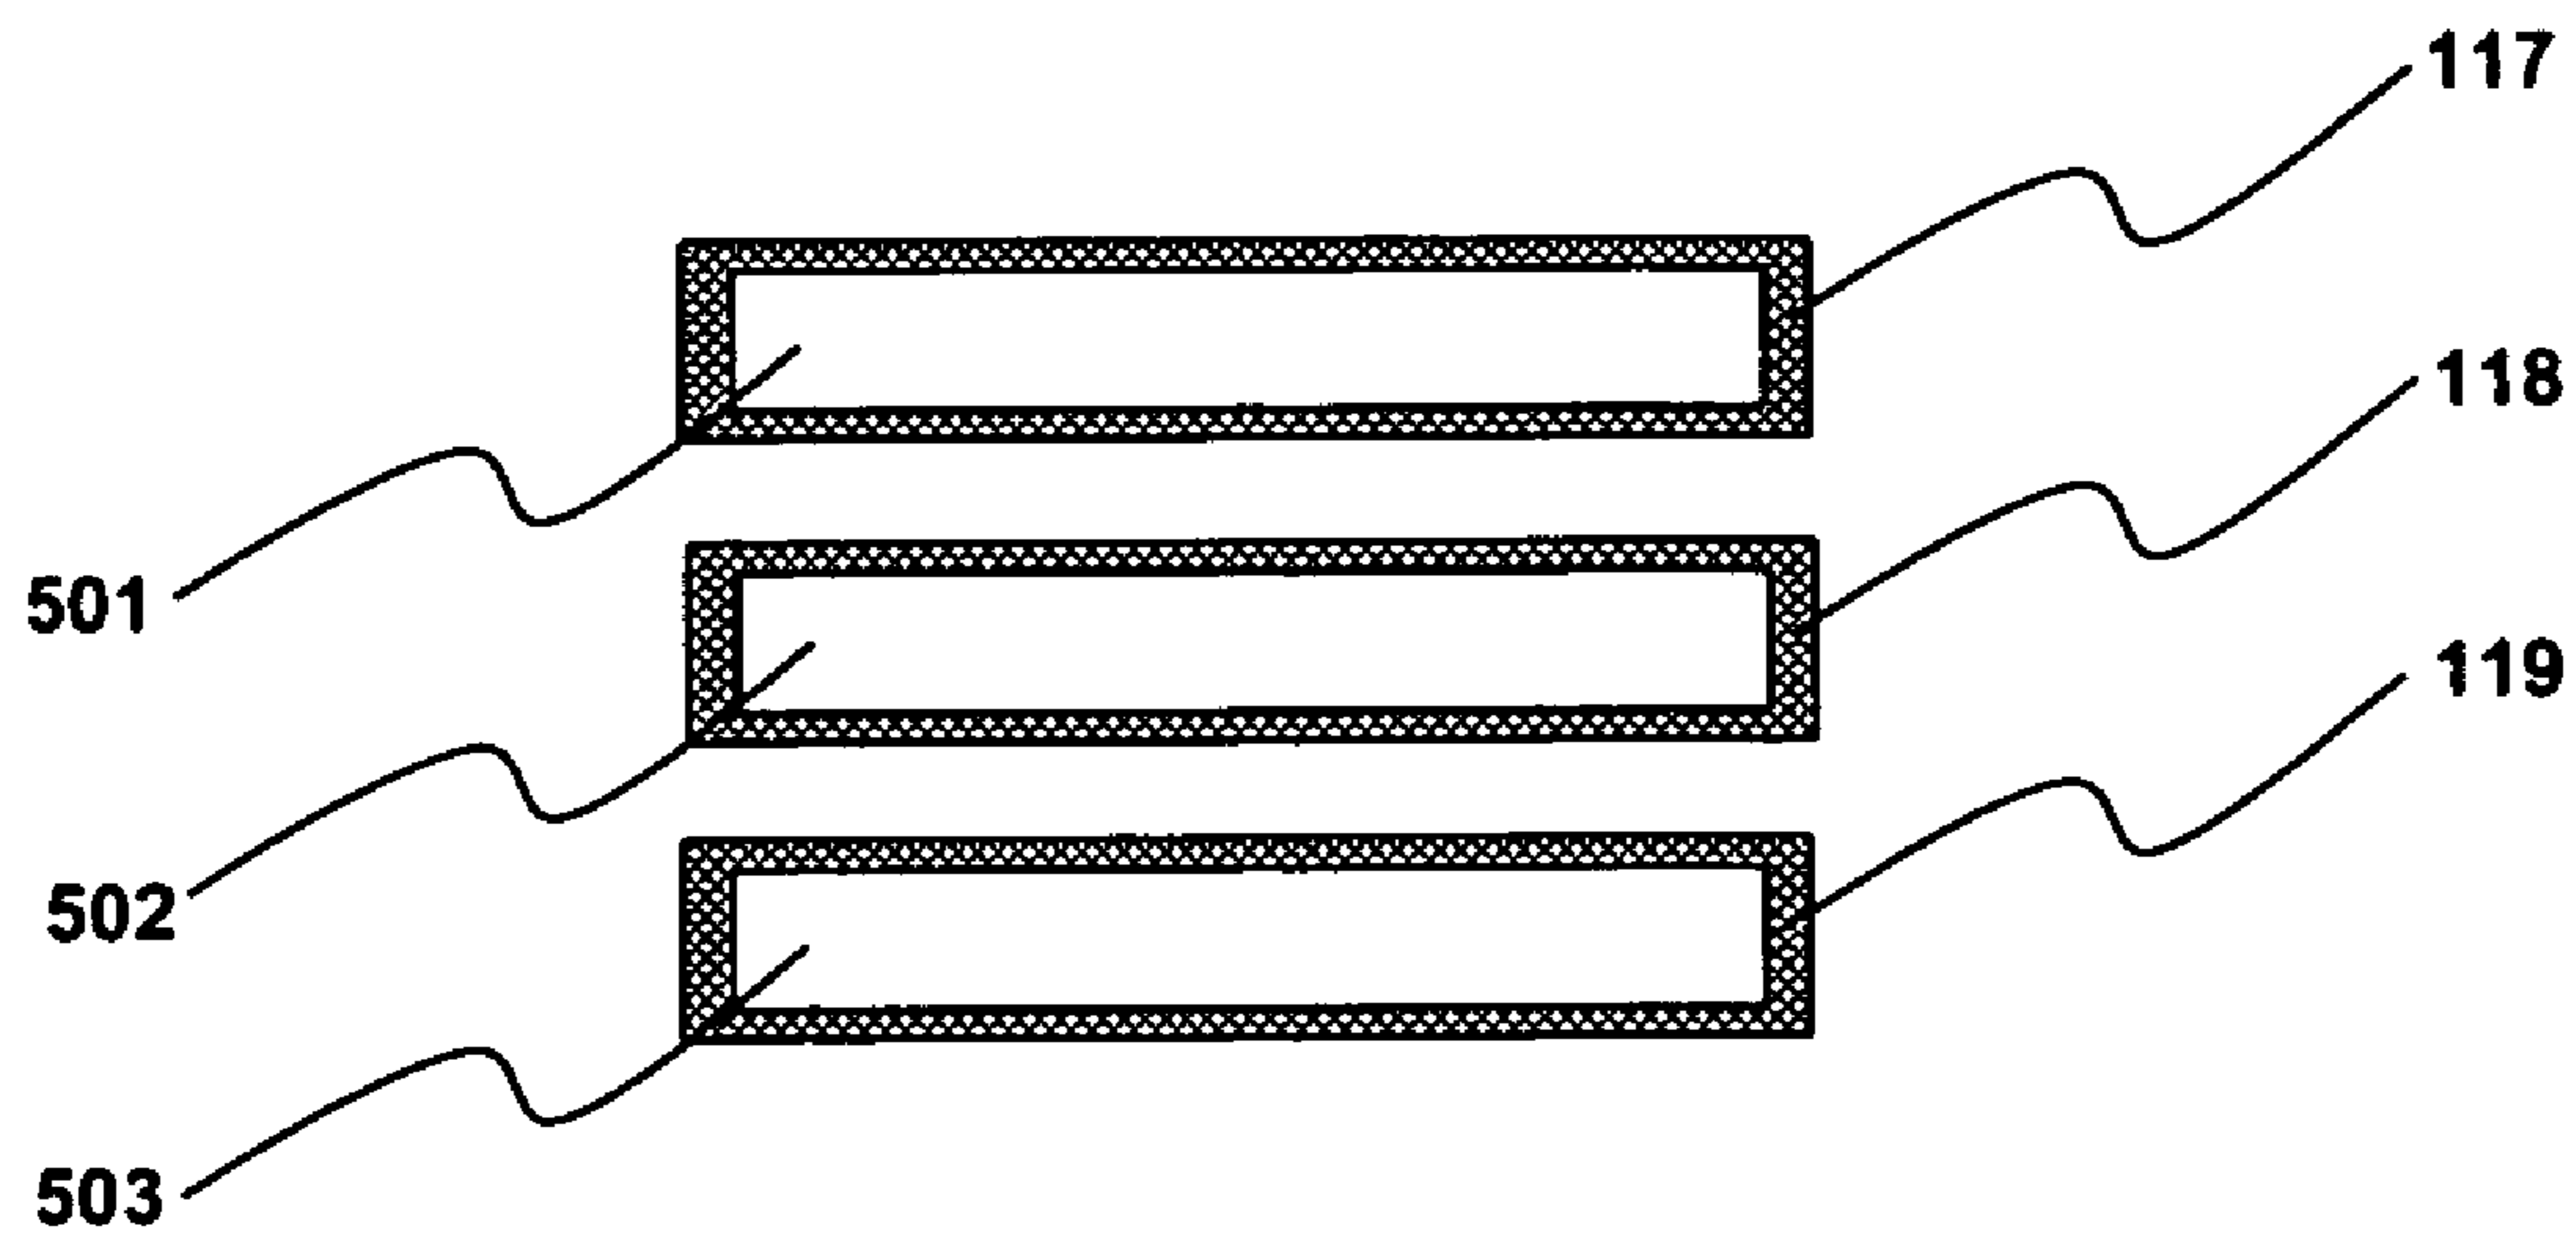
Fig. 5 (prior art)

FIG. 5, labeled as “prior art”, illustrates memory and memory slots in accordance with aspects of the embodiments. A system memory 103 is shown in FIG. 4. The system memory 103 is made of one or more memories. A first memory 501, second memory 502, and third memory 503 are shown in FIG. 5. The first memory 501 is held in a first memory slot 117. The second memory 502 is held in a second memory slot 118. The third memory 503 is held in a third memory slot 119. The three memories 501, 502, 503 combined are the system memory. The three slots 117, 118, 119 are used to hold the memories 501, 502, 503 and to electrically connect them to the motherboard.

is bad. Recalling FIG. 5, any one of the three memories 501, 502, 503 can be bad. A technician can diagnose which memory is bad by pulling out memories, swapping them in and out of the slots 117, 118, 119, and observing the boot up sequence. This can take considerable time and break additional hardware through handling. Handling damage can be aggravated when the technician is working in a cramped and unstable position which often happens because the diagnosis must often be performed in place. Another option is for the technician to simply replace all the memory and send the suspect memory elsewhere for diagnosis and testing. This option also involves unnecessary effort, logistics problems, and arguments if the diagnosis that takes place elsewhere does not match the environment in which the memory failed.

FIG. 5, labeled as “prior art”, illustrates memory and memory slots in accordance with aspects of the embodiments.
