(12) **United States Patent**
Oriet et al.

(10) **Patent No.:** **US 8,056,958 B2**
(45) **Date of Patent:** **Nov. 15, 2011**

(54) **SCHOOL BUS ROLLOVER PROTECTION STRUCTURE**

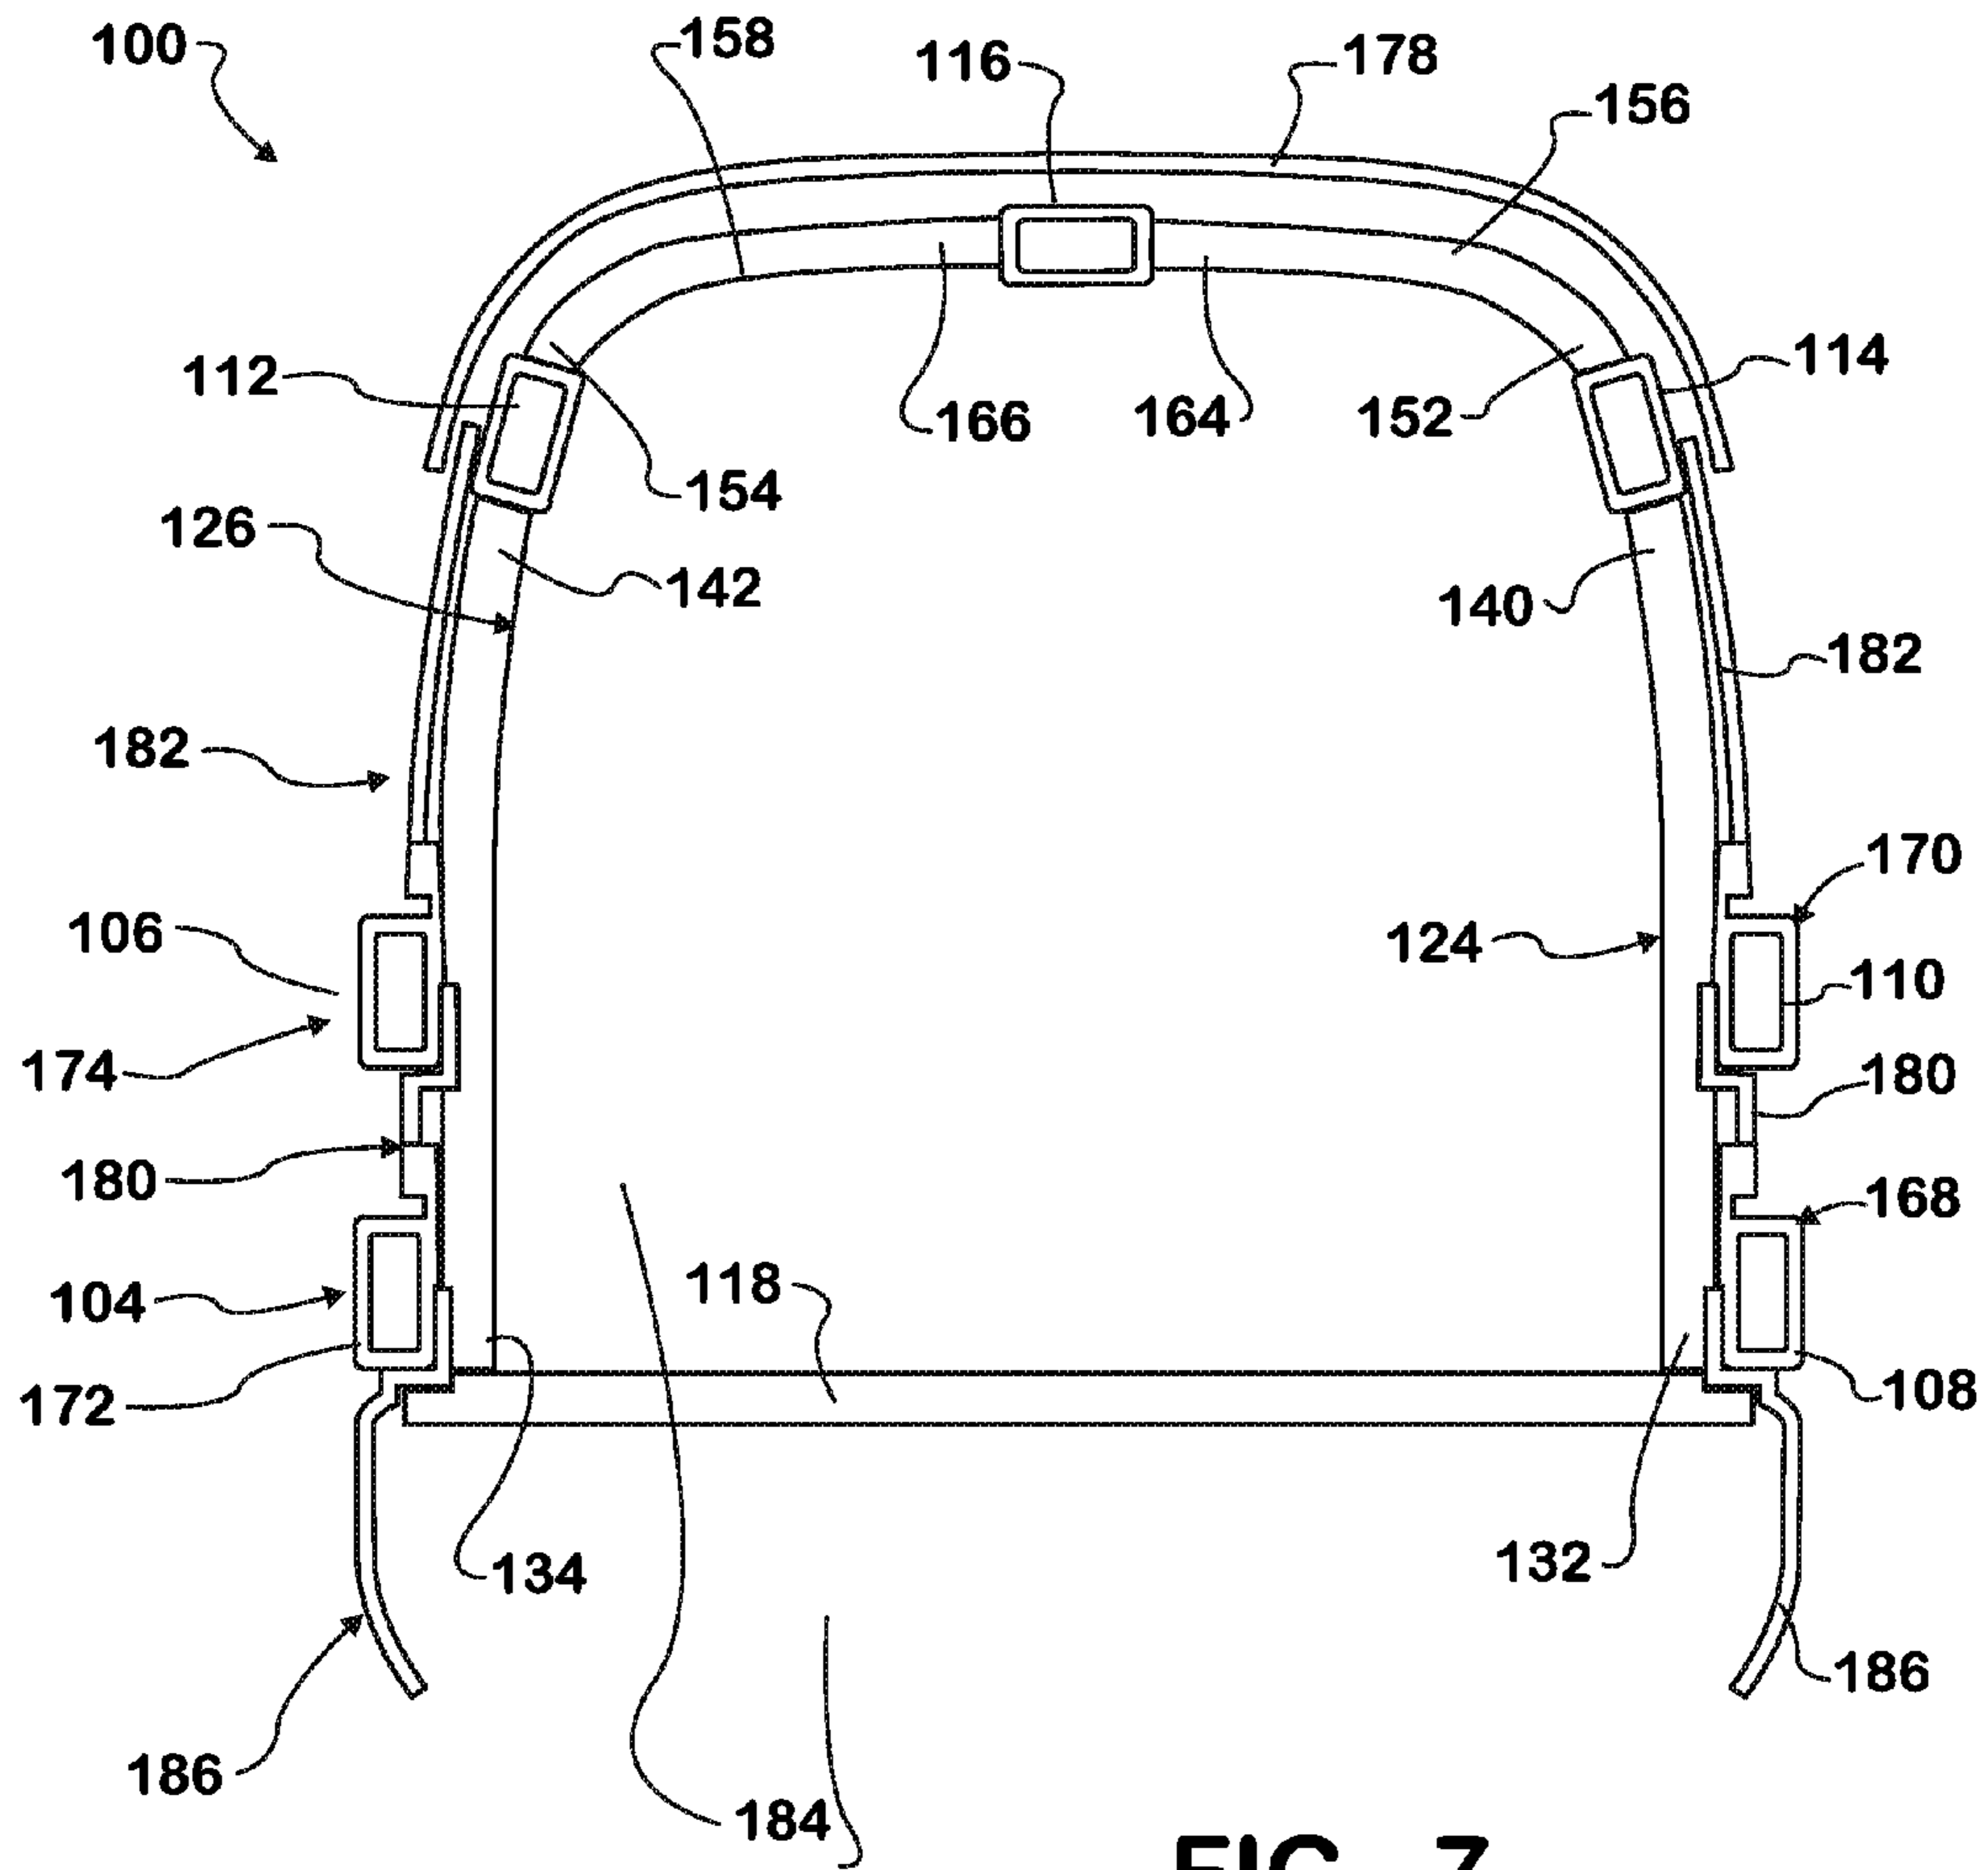
FIG. 7 shows a rear end sectional view of an embodiment of school bus rollover protection structure to which body and glass panels are attached taken along the line VII-VII in FIG. 4; and

A particularly advantageous benefit of the disclosed school bus rollover protection structure **100** includes the ability to attach non-structural roof panels **178**, side panels **180** and glass panels **182** directly to the protection structure **100** to define and enclose an occupant compartment **184**. The roof panels **178**, side panels **180** and glass panels **182** can be attached to the various components of the protection structure **100** so as to overlap one another to form a shingled configuration, as shown in FIGS. **7** and **8**. For example, the corner longitudinally extending tubular beams **112, 114** provides a bonding surface for urethane bonded side glass panels **182**. This structure eliminates the water leak warrantee issues of prior structures. A skirt panel **186** is directly attached to the lower one of the pair of longitudinally extending side beams on each side.

The school bus rollover protection structure **100** of the present disclosure, as shown in FIGS. **3, 5, 6** and **7**, is readily applied to existing vehicle platforms. FIG. **2** shows an outside view of a typical existing school bus that may incorporate the disclosed rollover protection structure. However, other designs are contemplated to which the disclosed rollover protection structure can be applied, as shown in FIGS. **4, 7** and **8**, where the roof, exterior panels and the side glass attached directly to the rollover protection structure, thereby eliminating the need and costs of redundant body structure. These beams completely replace the conventional U-shaped, one-piece rib members spaced at intervals along the length of the body and coupled adjacent to their ends to the bus floor in an inverted position. These beams are located between the interior and exterior panels and all of the panels are joined to the beams as illustrated in FIG. **7**.
