US008059223B2

(54) REPAIR STRUCTURE AND METHOD FOR LIQUID CRYSTAL DISPLAY

A data line repair structure for a liquid crystal display panel is disclosed. The data line repair structure includes a first repair line parallel to the scan line and crossing a first end of the data line; a fourth repair line formed in an oblique line area of the liquid crystal panel, coupled to the first repair line; a second repair line parallel to the data line, coupled to the gate driving chip and the fourth repair line; a third repair line parallel to the scan line, coupled to the second repair line and separated from a second end of the data line; and a floating line connected between the third repair line and the second end of the data line when the data line has a broken point.

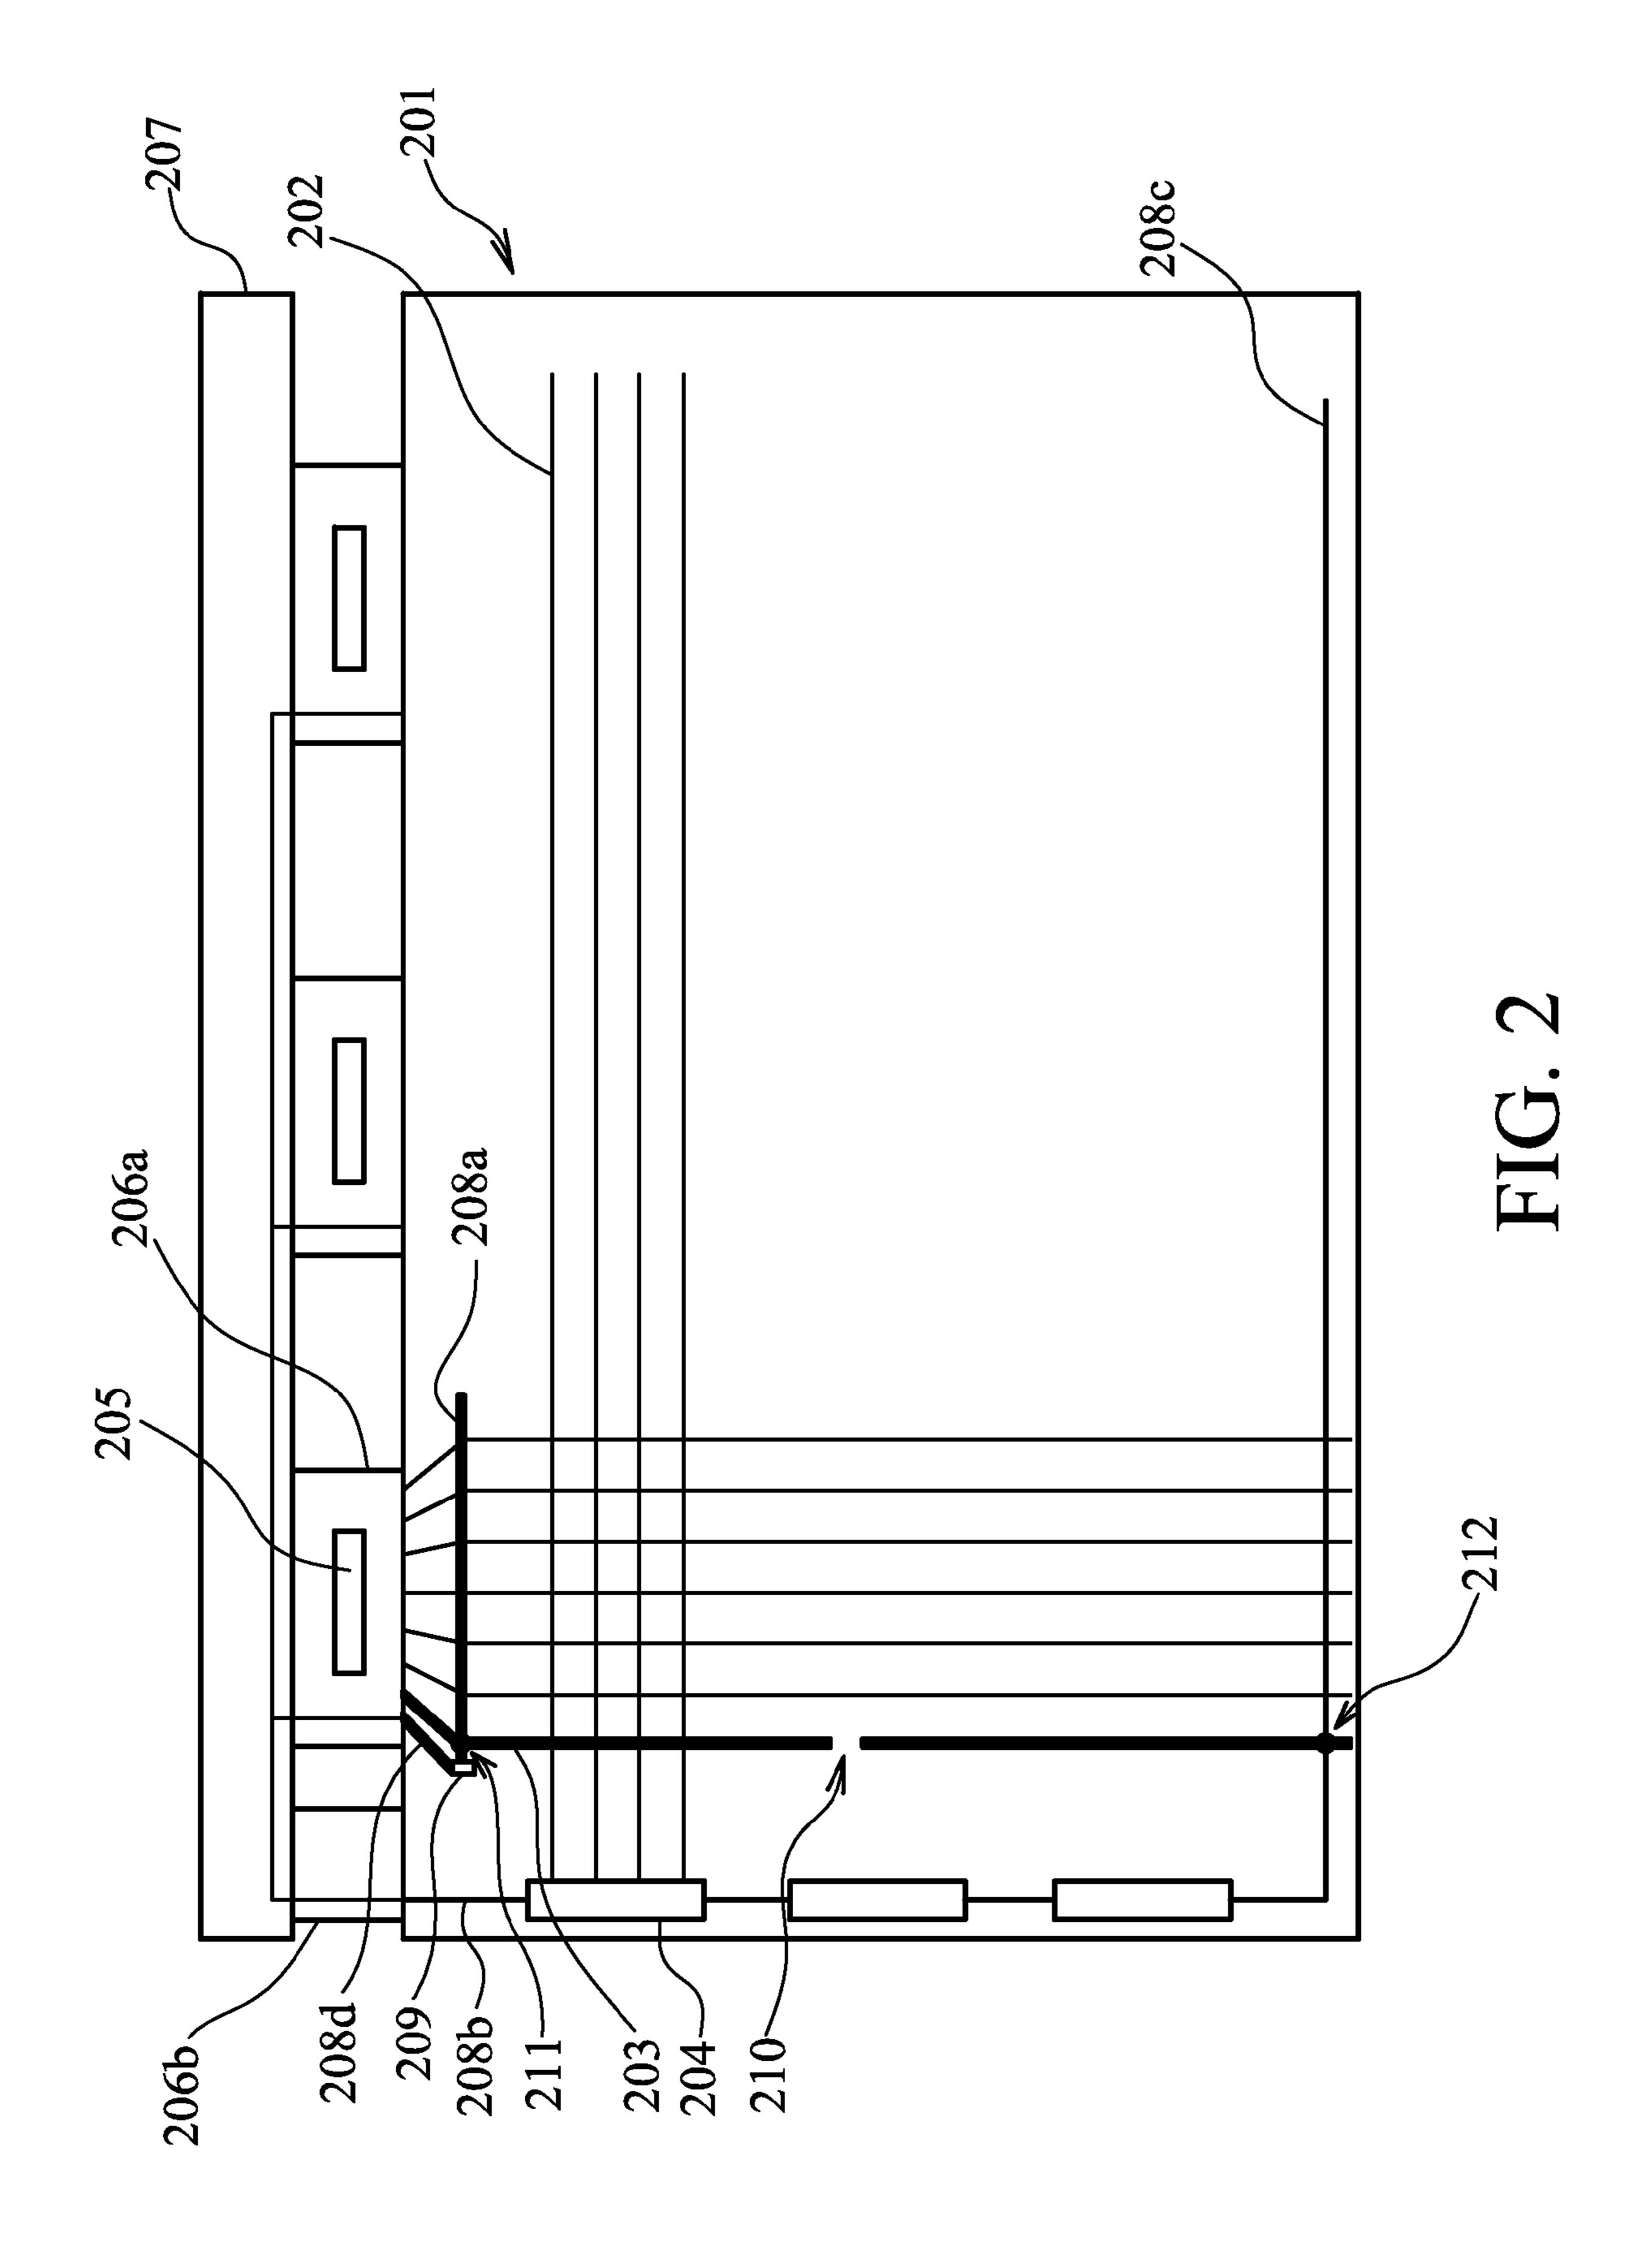
FIG. 2 shows a data line repair structure for a liquid crystal display panel according to a first embodiment of the invention;

FIG. 2 shows a data line repair structure for a liquid crystal display panel according to a first embodiment of the invention. Liquid crystal display panel 201, such as a glass baseboard, comprises scan line 202 and data line 203 crossing

scan line 202. A thin film transistor (not shown in FIG. 2) is formed at an intersection of scan line 202 and data line 203. The thin film transistor comprises a gate coupled to scan line 202, a source coupled to data line 203 and a drain coupled to a pixel electrode (not shown). Gate driving chip 204 is connected by conductive glue to a Y side area of liquid crystal display panel 201, a chip-on-glass (COG) structure, and uses scan line 202 to transmit a gate signal to drive the thin film transistor. Source driving chip 205 is bound to flexible board 206a, a tape carrier package (TCP) structure, and uses data line 203 to transmit a data signal to write to the pixel electrode. One side of flexible board 206a is connected to liquid crystal display panel 201 and another side thereof is connected to printed circuit board 207. In addition, printed circuit board 207 comprises a plurality of power lines and ground lines.

As shown in FIG. 2, the data line repair structure comprises first repair line 208a, second repair line 208b and third repair line 208c. First repair line 208a is parallel to scan line 202 and crosses one end of data line 203 near source driving chip 205. Second repair line 208b is parallel to data line 203 and connected to gate driving chip 204. Second repair line 208b is connected to printed circuit board 207 through flexible board 25 **206***b*. Third repair line **208***c* is parallel to scan line **202** and crosses another end of data line 203 on the opposite side of source driving chip **205**. The data line repair structure further comprises fourth repair line 208d formed in an oblique line area of liquid crystal display panel 201 and connected to first repair line **208***a* and lines of printed circuit board **207** through flexible circuit board 206a. In addition, transparent conductive layer 209 is disposed between fourth repair line 208d and first repair line 208a.

According to the first embodiment of the invention, a laser beam can be implemented to weld first repair line 208a and data line 203 to form connecting point 211, weld third repair line 208c and data line 203 to form connecting point 212 and weld transparent conductive layer 209 to connect first repair line 208a with fourth repair line 208d when data line 203 comprises broken point 210. Thus, a data signal generated by source driving chip 205 is transmitted to data line below broken point 210 through first repair line 208a, fourth repair line 208d, flexible board 206a, lines of printed circuit board 207, flexible board 206b, second repair line 208b, inner circuits of gate driving chip 204 and third repair line 208c, sequentially.

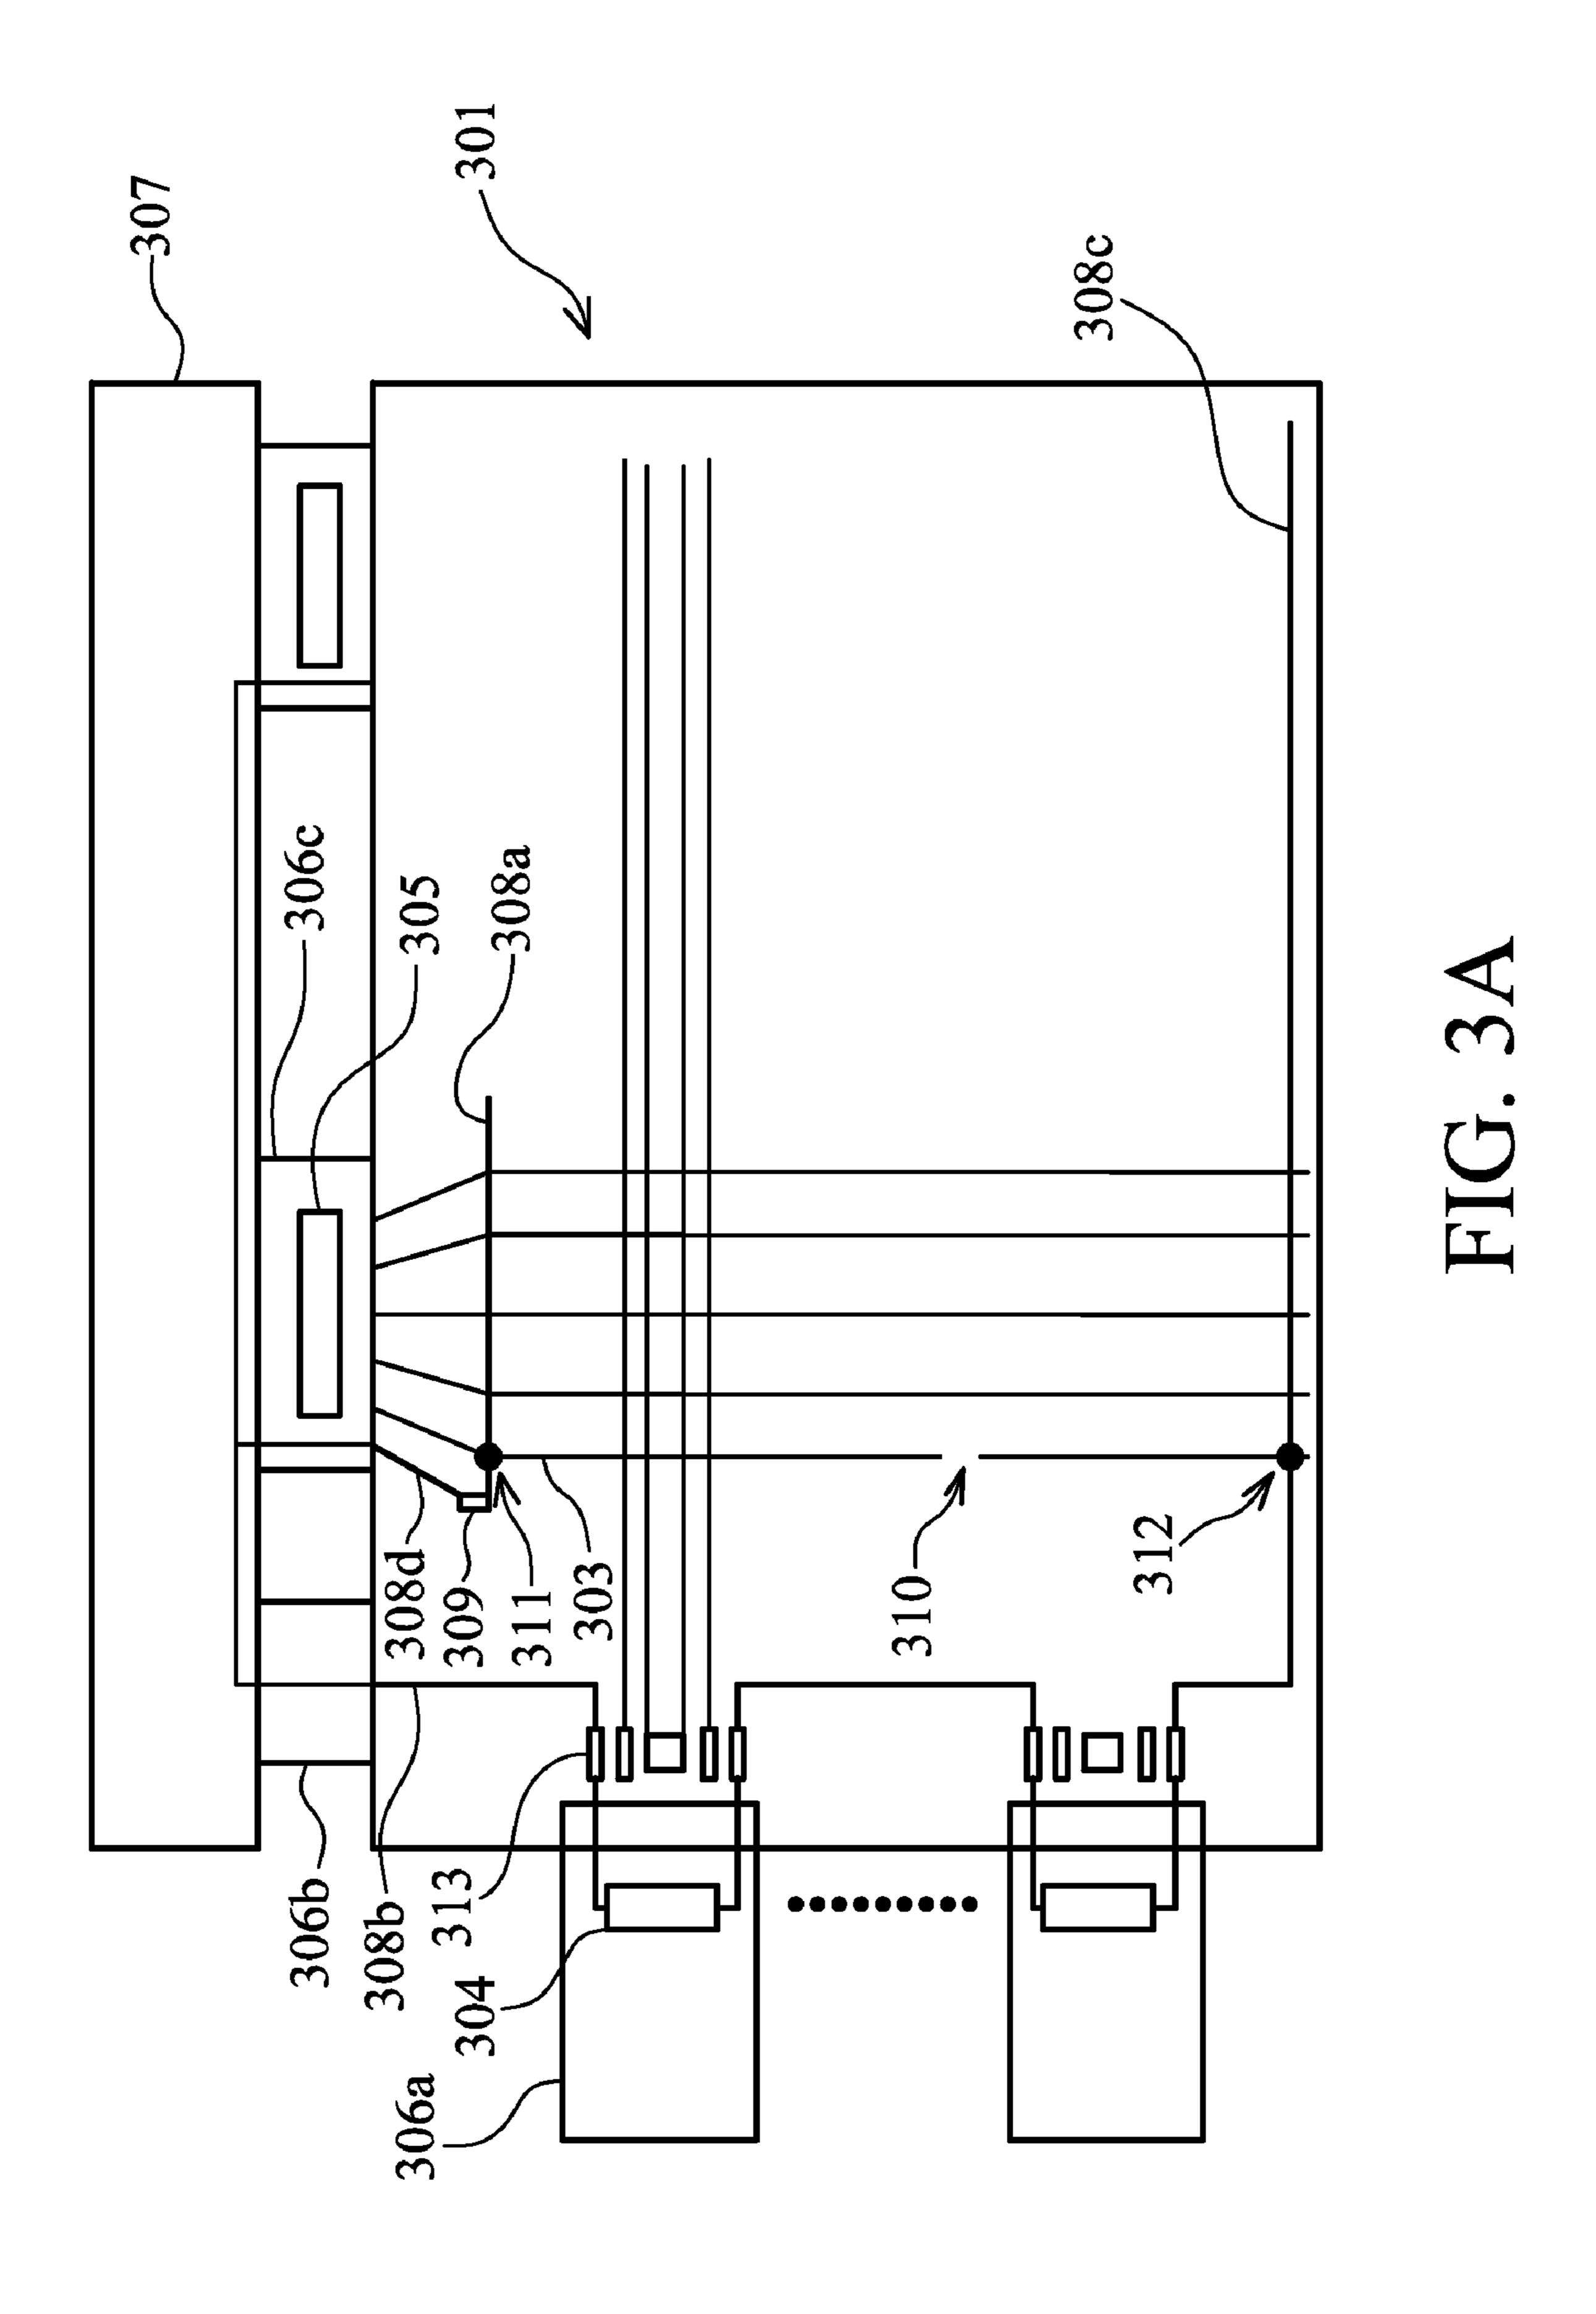
FIG. 3A shows a data line repair structure for a liquid crystal display panel according to a second embodiment of the invention;

FIG. 3A shows a data line repair structure for a liquid crystal display panel according to a second embodiment of the invention. Liquid crystal display panel 301 is similar to the first embodiment of the invention, except that, here, gate driving chip 304 is bound to flexible board 306a, a chip-onfilm (COF) structure. Flexible board 306a is connected to liquid crystal display panel 301. Thus, second repair line 308b is connected to gate driving chip 304 through connecting pad 313 and one line of flexible board 306a. As shown in FIG. 3A, a laser beam can be implemented to weld first repair line 308a and data line 303 to form connecting point 311, weld third repair line 308c and data line 303 to form connecting point 312 and weld transparent conductive layer 309 to connect first repair line 308a with fourth repair line 308d when data line 303 comprises broken point 310. Thus, a data signal generated by source driving chip 305 is transmitted to data line below broken point 310 through first repair line 308a, fourth repair line 308d, flexible board 306c, lines of printed circuit board 307, flexible board 306b, second repair line 308b, flexible board 306a, inner circuits of gate driving chip 304 and third repair line 308c sequentially.

FIG. 3B shows a data line repair structure for a liquid crystal display panel according to a third embodiment of the invention. A data signal generated by source driving chip 305 is transmitted through bypass circuit line 321 not inner circuits of gate driving chip 304. Thus, a data signal generated by source driving chip 305 is transmitted to data line below broken point 310 through first repair line 308a, fourth repair line 308d, flexible board 306c, lines of printed circuit board 307, flexible board 306b, second repair line 308b, flexible board 306a, bypass circuit line circuit line 321 and third 10 repair line 308c, sequentially.
