(10) **Patent No.:** **US 8,091,228 B2**
(45) **Date of Patent:** **Jan. 10, 2012**

(54) **METHOD REPAIR OF TURBINE BLADE TIP**

(73) Assignee: **United Technologies Corporation**,
Hartford, CT (US)

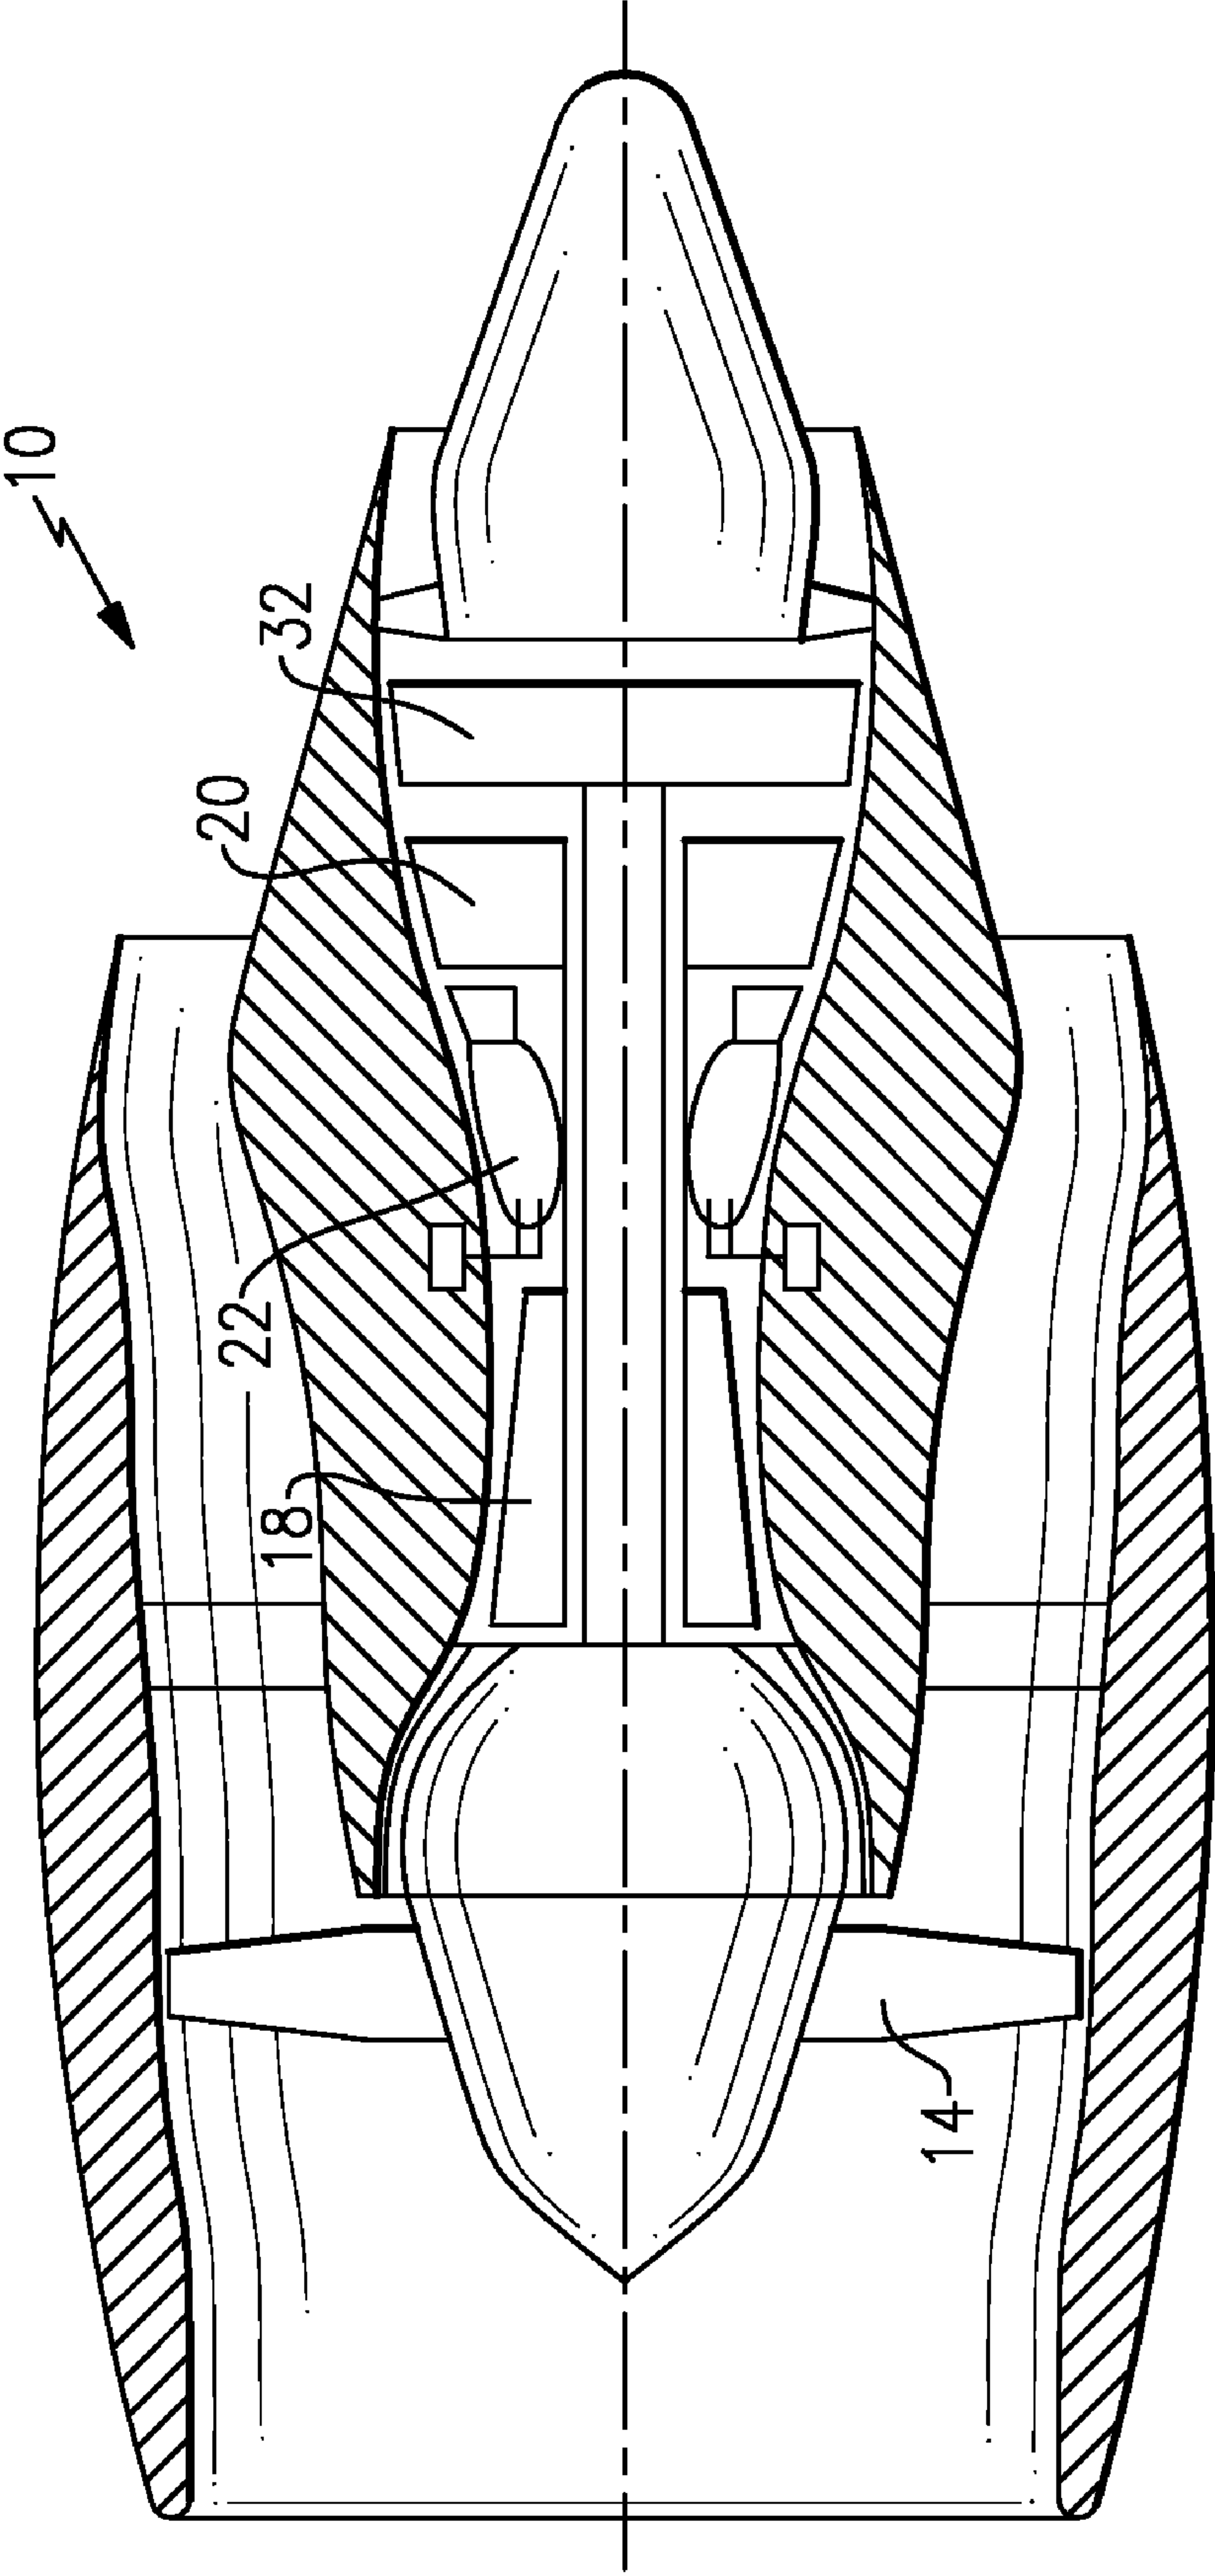
FIG. 1 illustrates a view of a turbine engine known in the art.

FIG. 1 illustrates an example of a gas turbine engine 10, here a turbofan engine, that would benefit from the inventive repair technique. As other types of gas turbine engines will likewise benefit from the inventive technique, the term gas turbine engine is not limited to the disclosed embodiment. As shown, gas turbine engine 10 has fan 14 which propels ambient air into gas turbine engine 10. Multi-stage high and low pressure compressors 18 compress the air. The compressed air is then mixed with fuel and ignited in a combustor 22, where the gas expands. Expanded gas then passes through high pressure turbine section 20 and low pressure turbine section 32 as known and passes out of gas turbine engine 10.

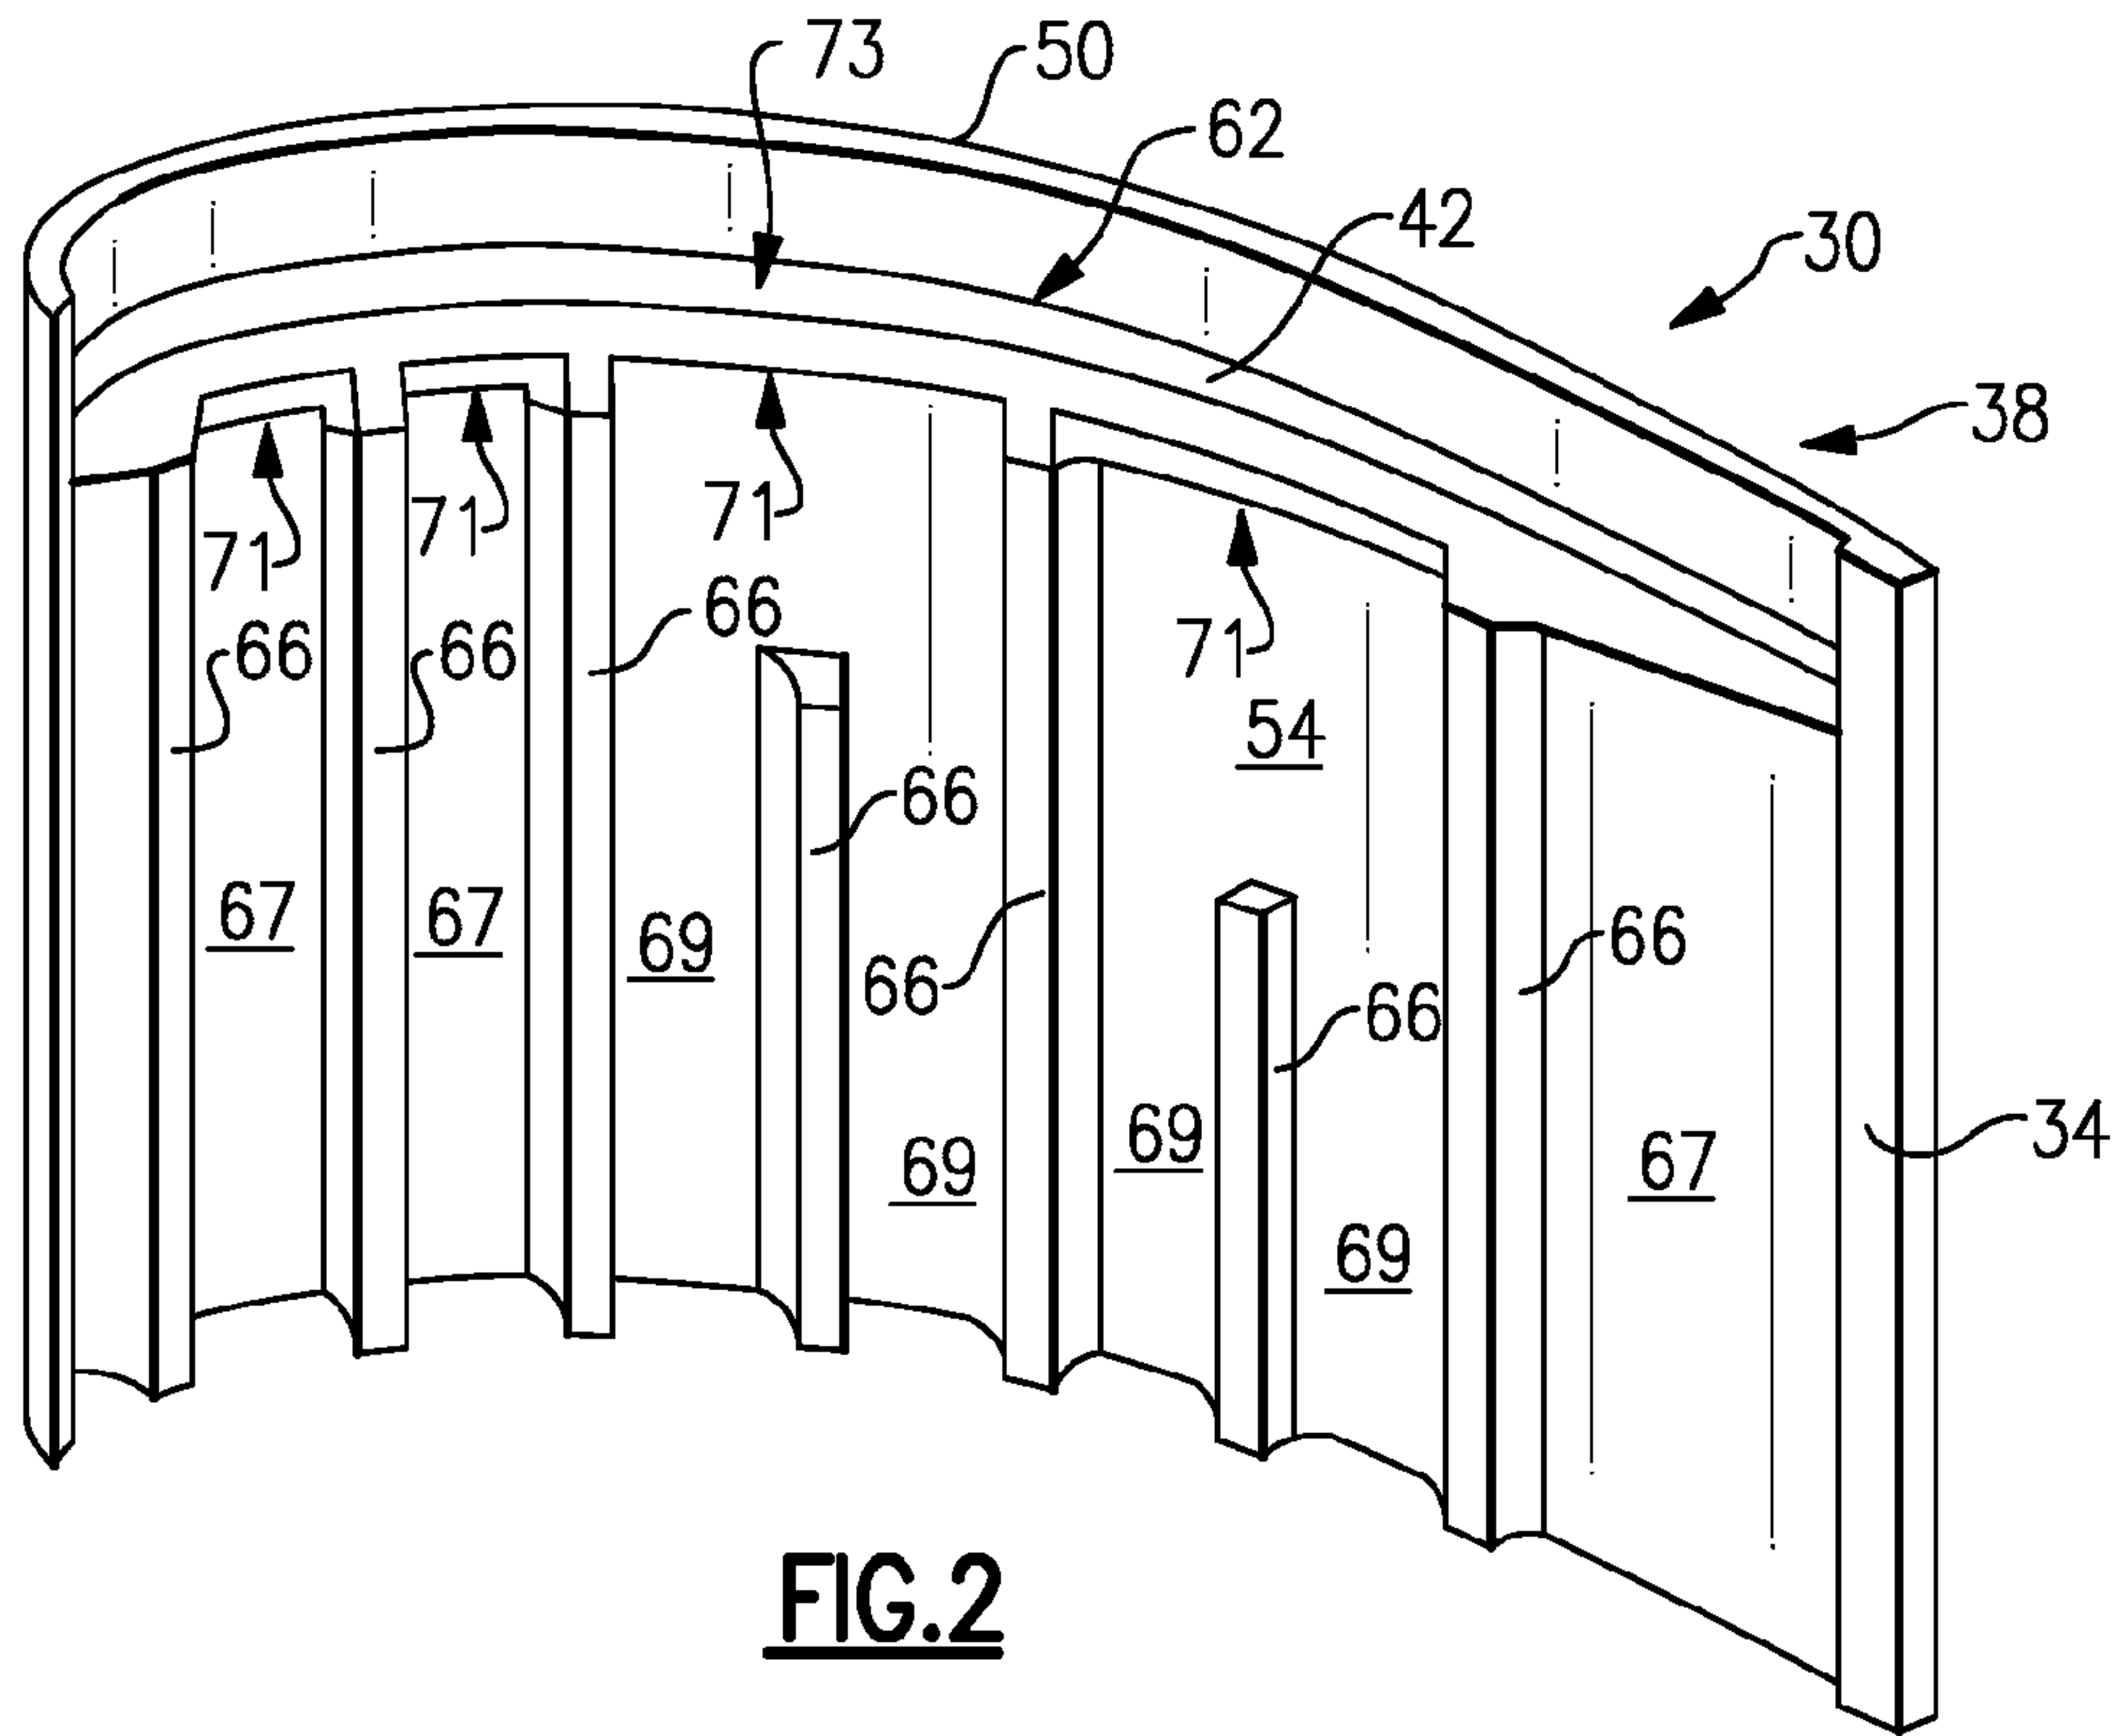
FIG. 2 illustrates a cross-sectional view of a turbine blade of the turbine engine of FIG. 1.

FIG. 2 illustrates a turbine blade 30 as known in the art. Here, turbine blade 30 is shown in cross-section with dashed lines showing the perimeter of turbine blade 30. As shown, turbine blade 30 has blade body 34 and blade tip 38. In addition, blade tip 38 has cap 42 that covers internal cavity 54. Squealer 50, a rail, extends around the perimeter 62. Within blade body 34 is internal cavity 54, which has structural supports 66 extending throughout to support turbine blade 30 as known. Between structural supports 66 are cooling passages 67, 69. These cooling passages 67, 69 permit air to cool blade body 34 as known. Cap 42 has internal cavities 71 that permit air to come close to surface 73 of cap 42 for air to cool so as to relieve heat buildup within blade body 34.

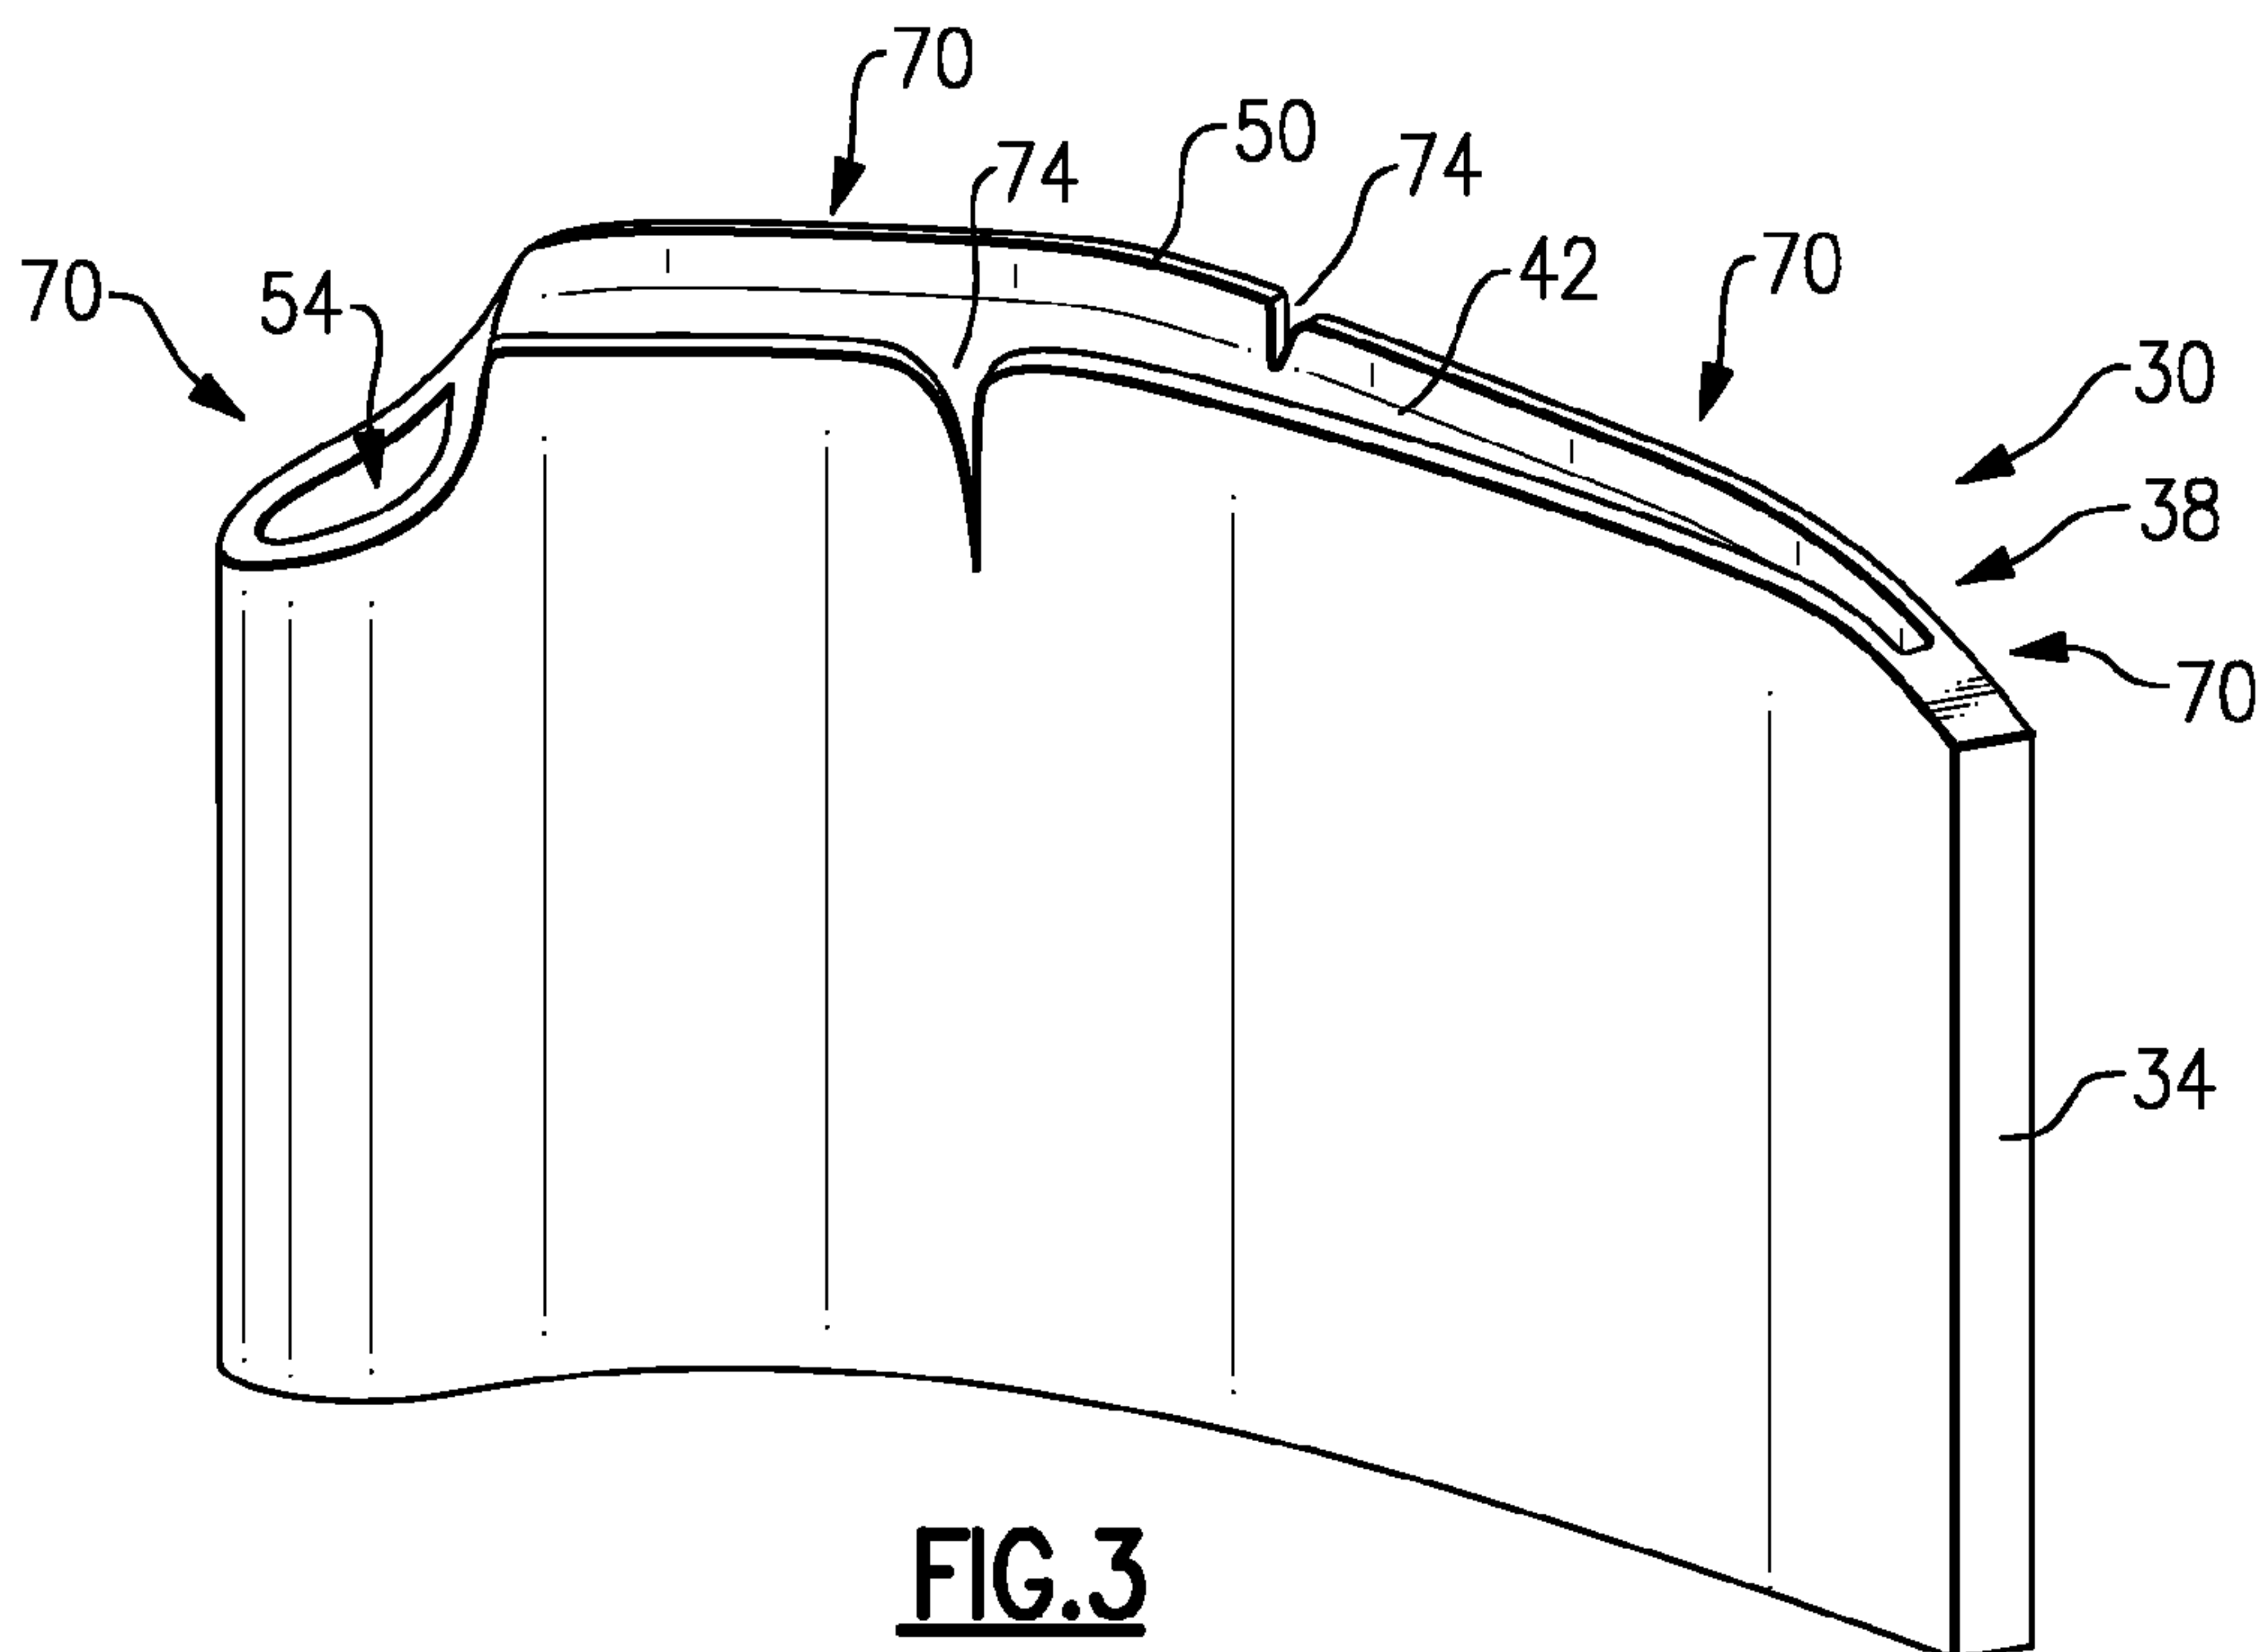
FIG. 3 illustrates an example of a worn turbine blade.

Due to stress and wear, turbine blade 30 may develop areas of wear 70 and cracks 74, as shown in FIG. 3. Indeed, areas of wear may be large enough to expose internal cavity 54 as shown. Because of the high expense of replacing turbine blade 30, it may be desirable to repair it. FIGS. 3-7 illustrate the inventive repair technique.

As shown in FIG. 3, the inventive repair technique involves grinding down squealer 50 of the worn turbine blade 30 shown in FIG. 3 to the level of cap 42 as shown in FIG. 4. Following this step, areas of wear 70 and cracks 74 are built-up by welding with weld wire to the level of cap 42. When this step is complete, cap 42 is removed by electrical discharge machining, leaving blade body 34 with exposed internal cavity 54 as shown in FIG. 5.

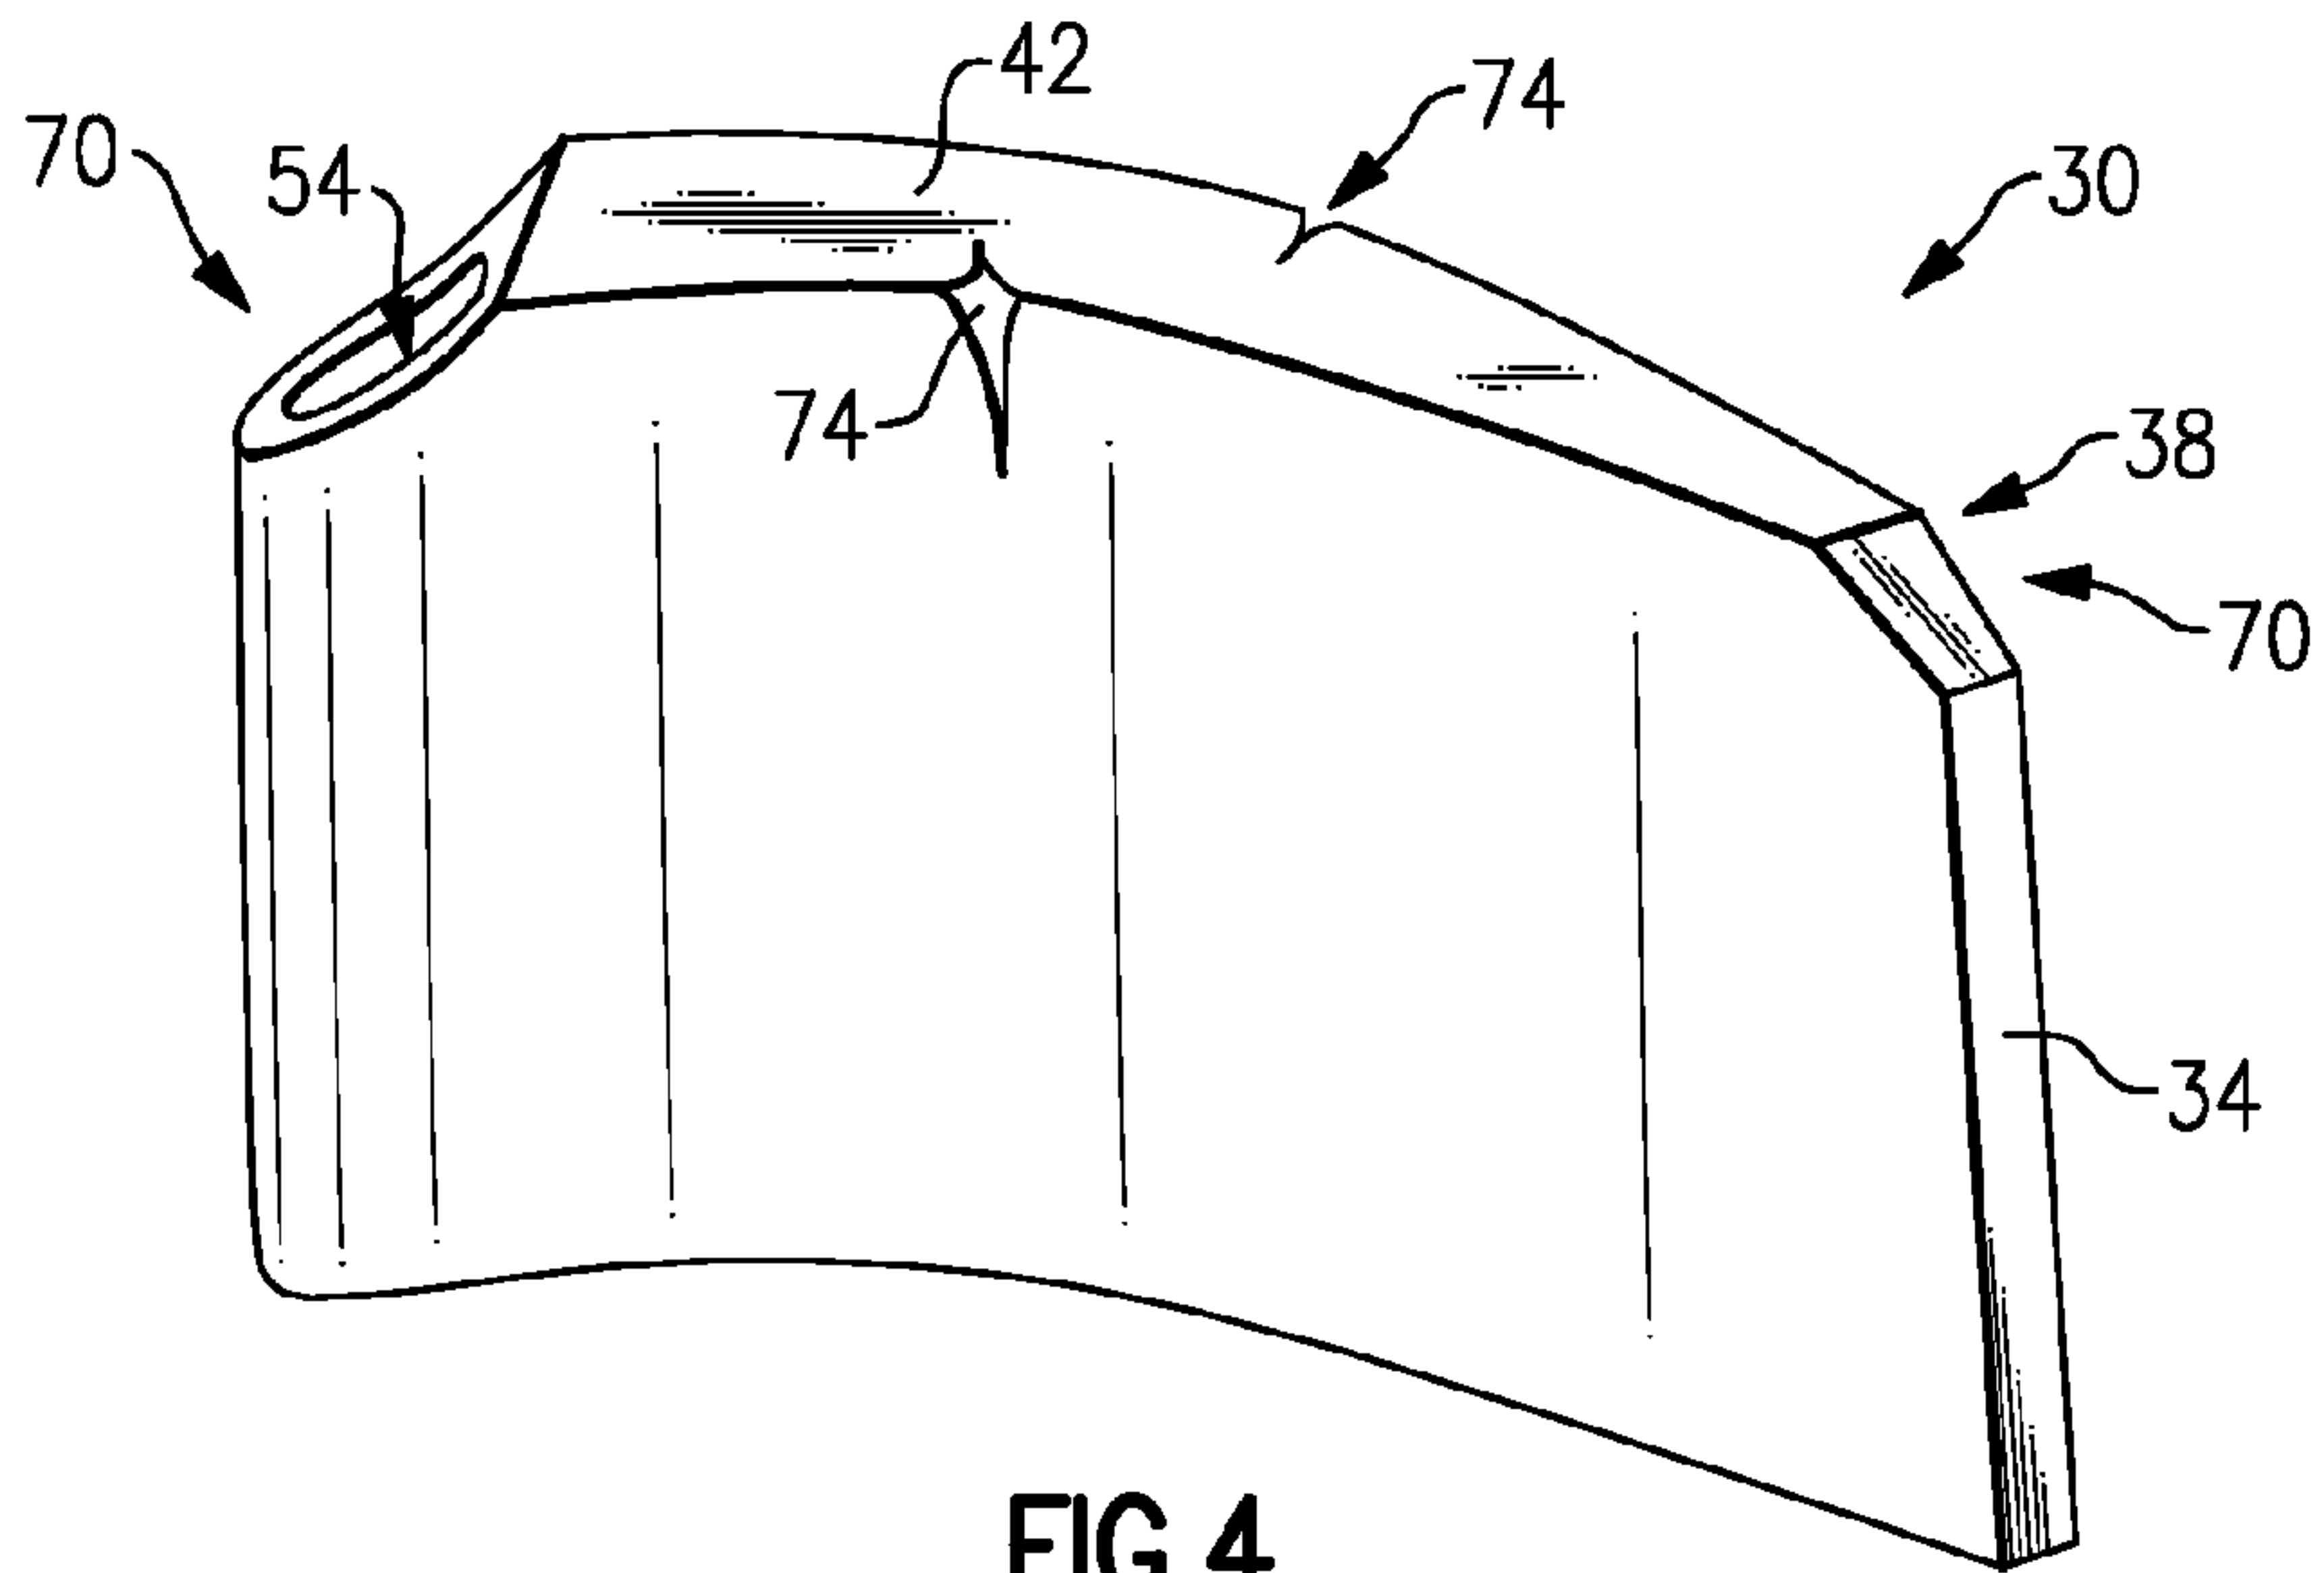
FIG. 4 illustrates an aspect of the inventive technique of repairing a turbine blade.

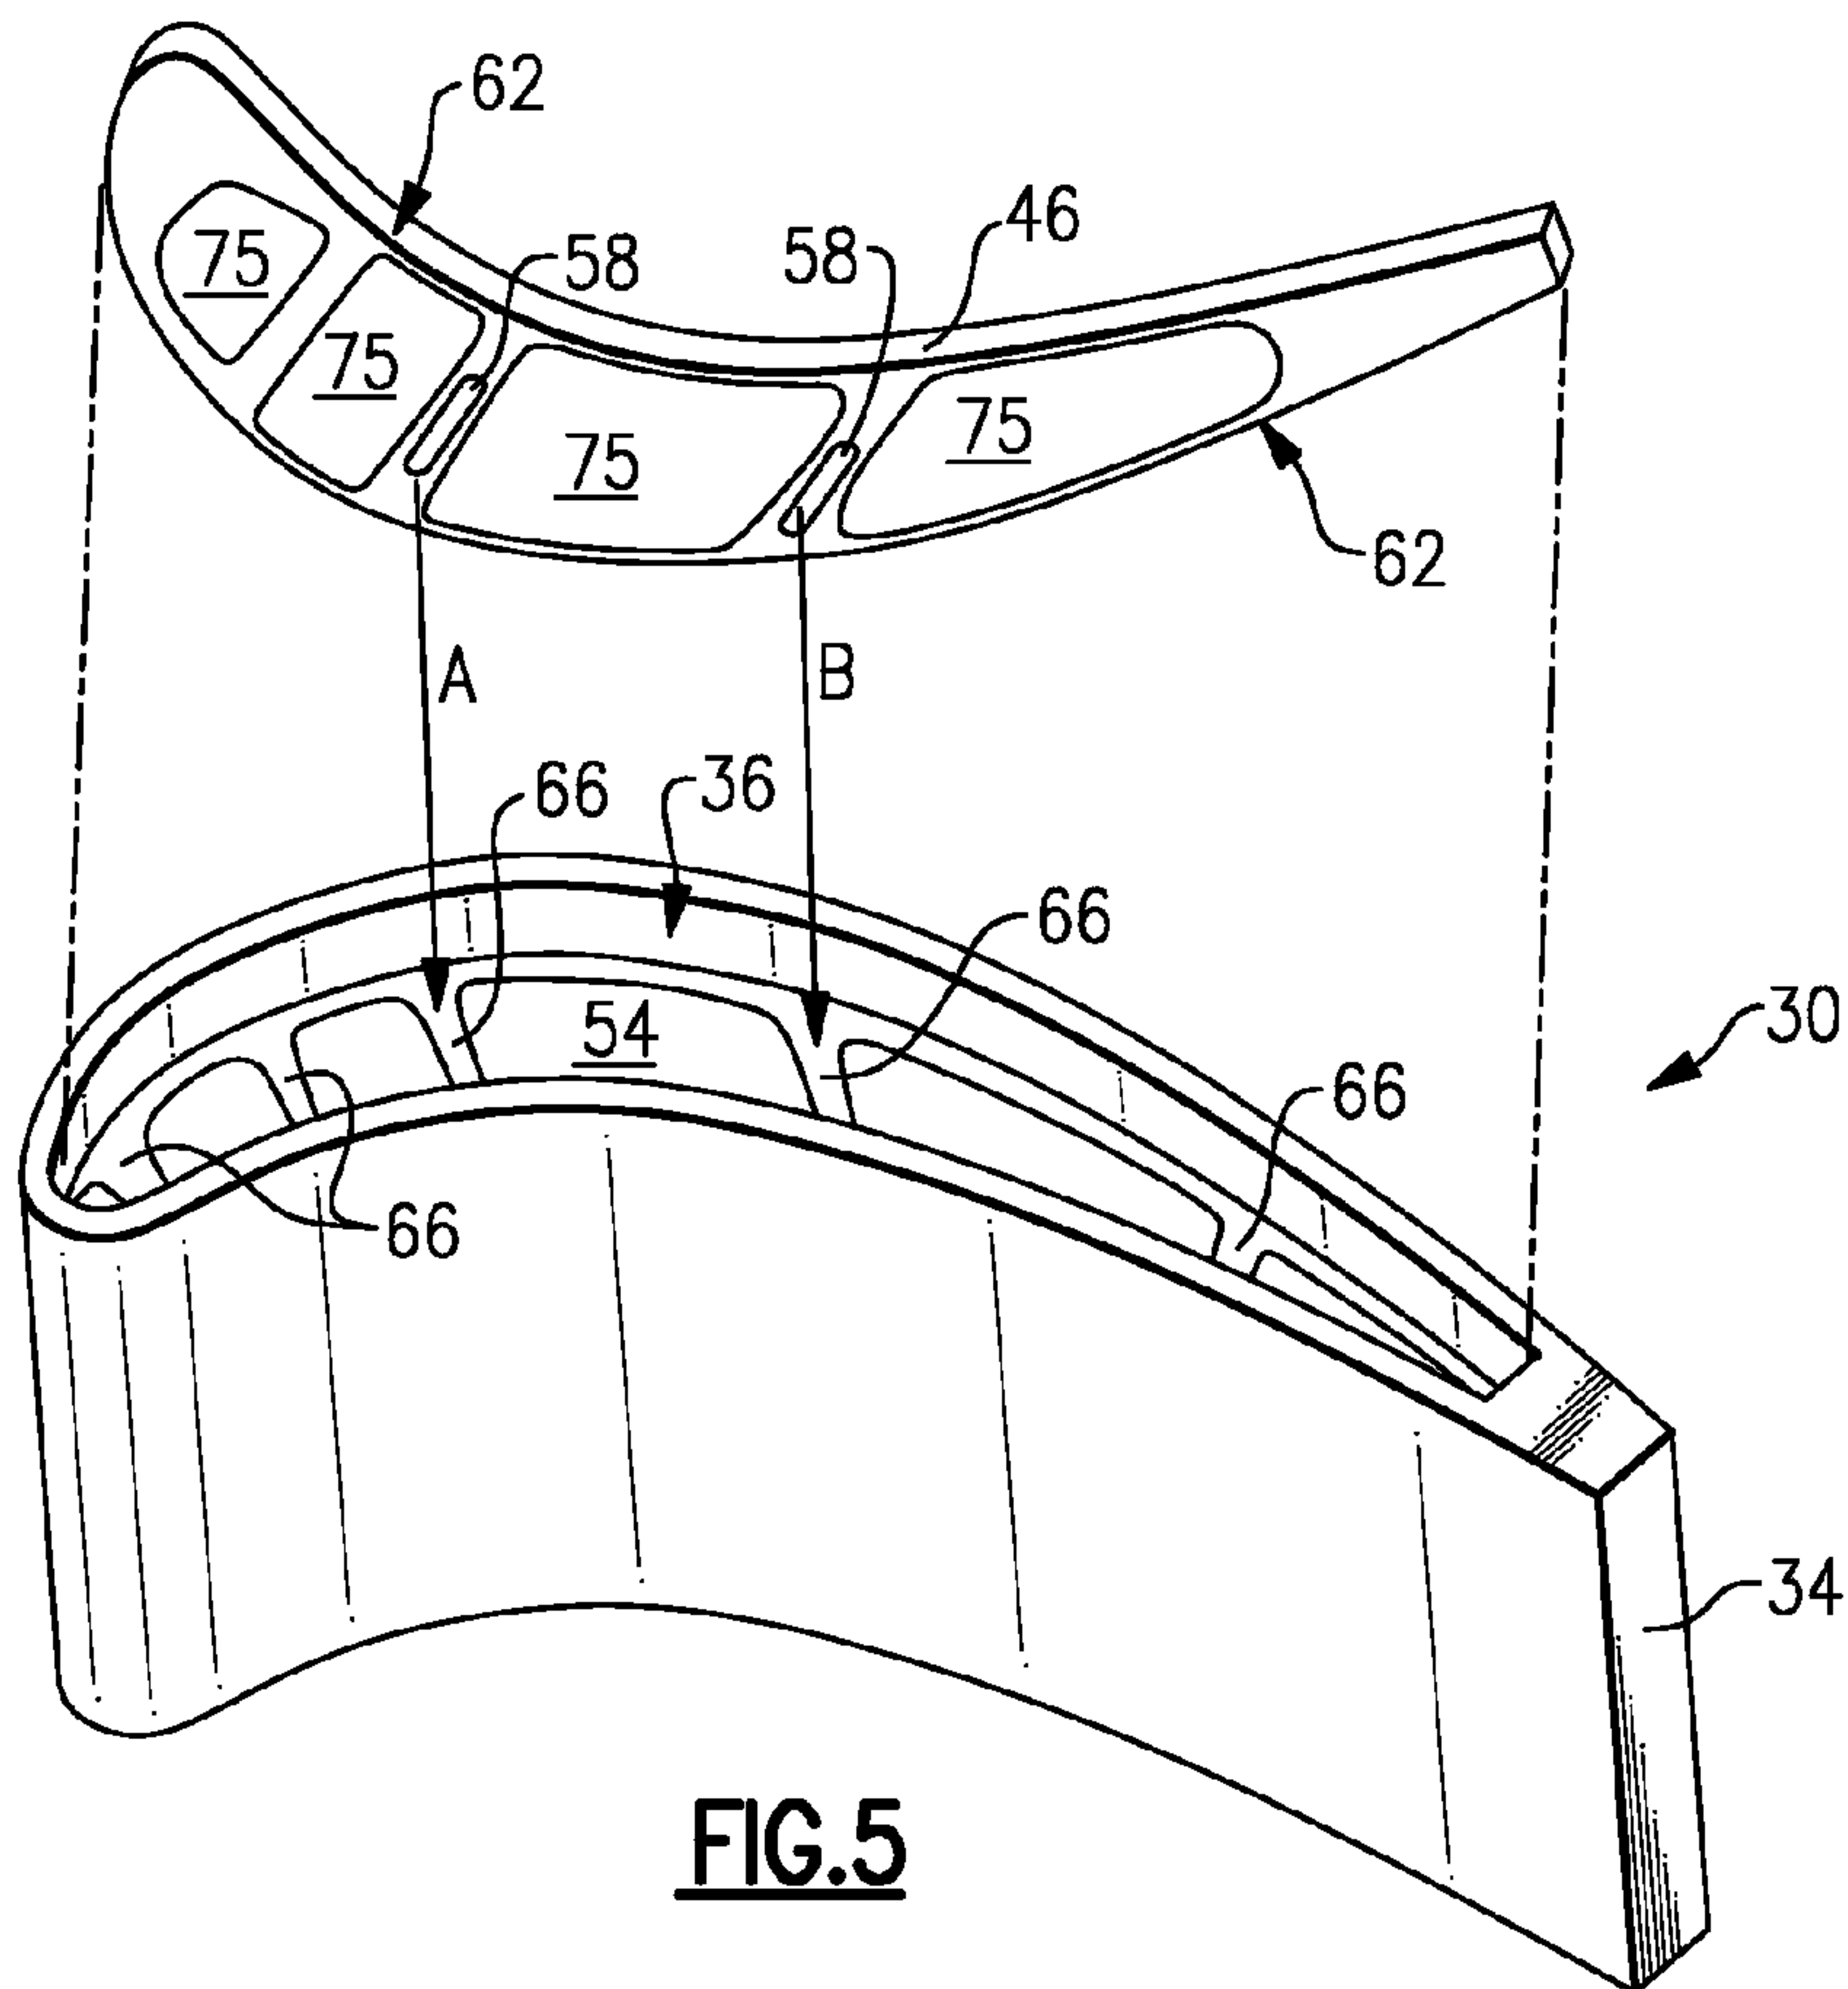
FIG. 5 illustrates another aspect of the inventive technique, highlighting replacement cap with openings permitting access to an internal cavity of the turbine blade.

As shown in FIG. 5, openings 58 are aligned with structural supports 66 disposed within internal cavity 54 so that when replacement cap 46 is seated in blade body 34 within wall 36, openings 58 will provide direct access to structural supports 66 as shown in FIG. 6 in cross-section. Openings 58 are aligned along arrows A and B as shown in FIG. 5. Furthermore, perimeter 62 is sized and shaped so that when replacement cap 46 is disposed in blade body 34 alignment of openings 58 occurs just by seating replacement cap 46 in blade body 34. In addition, internal cavities 75 are positioned within replacement cap 46 to mimic internal cavities 71 of original cap 42.

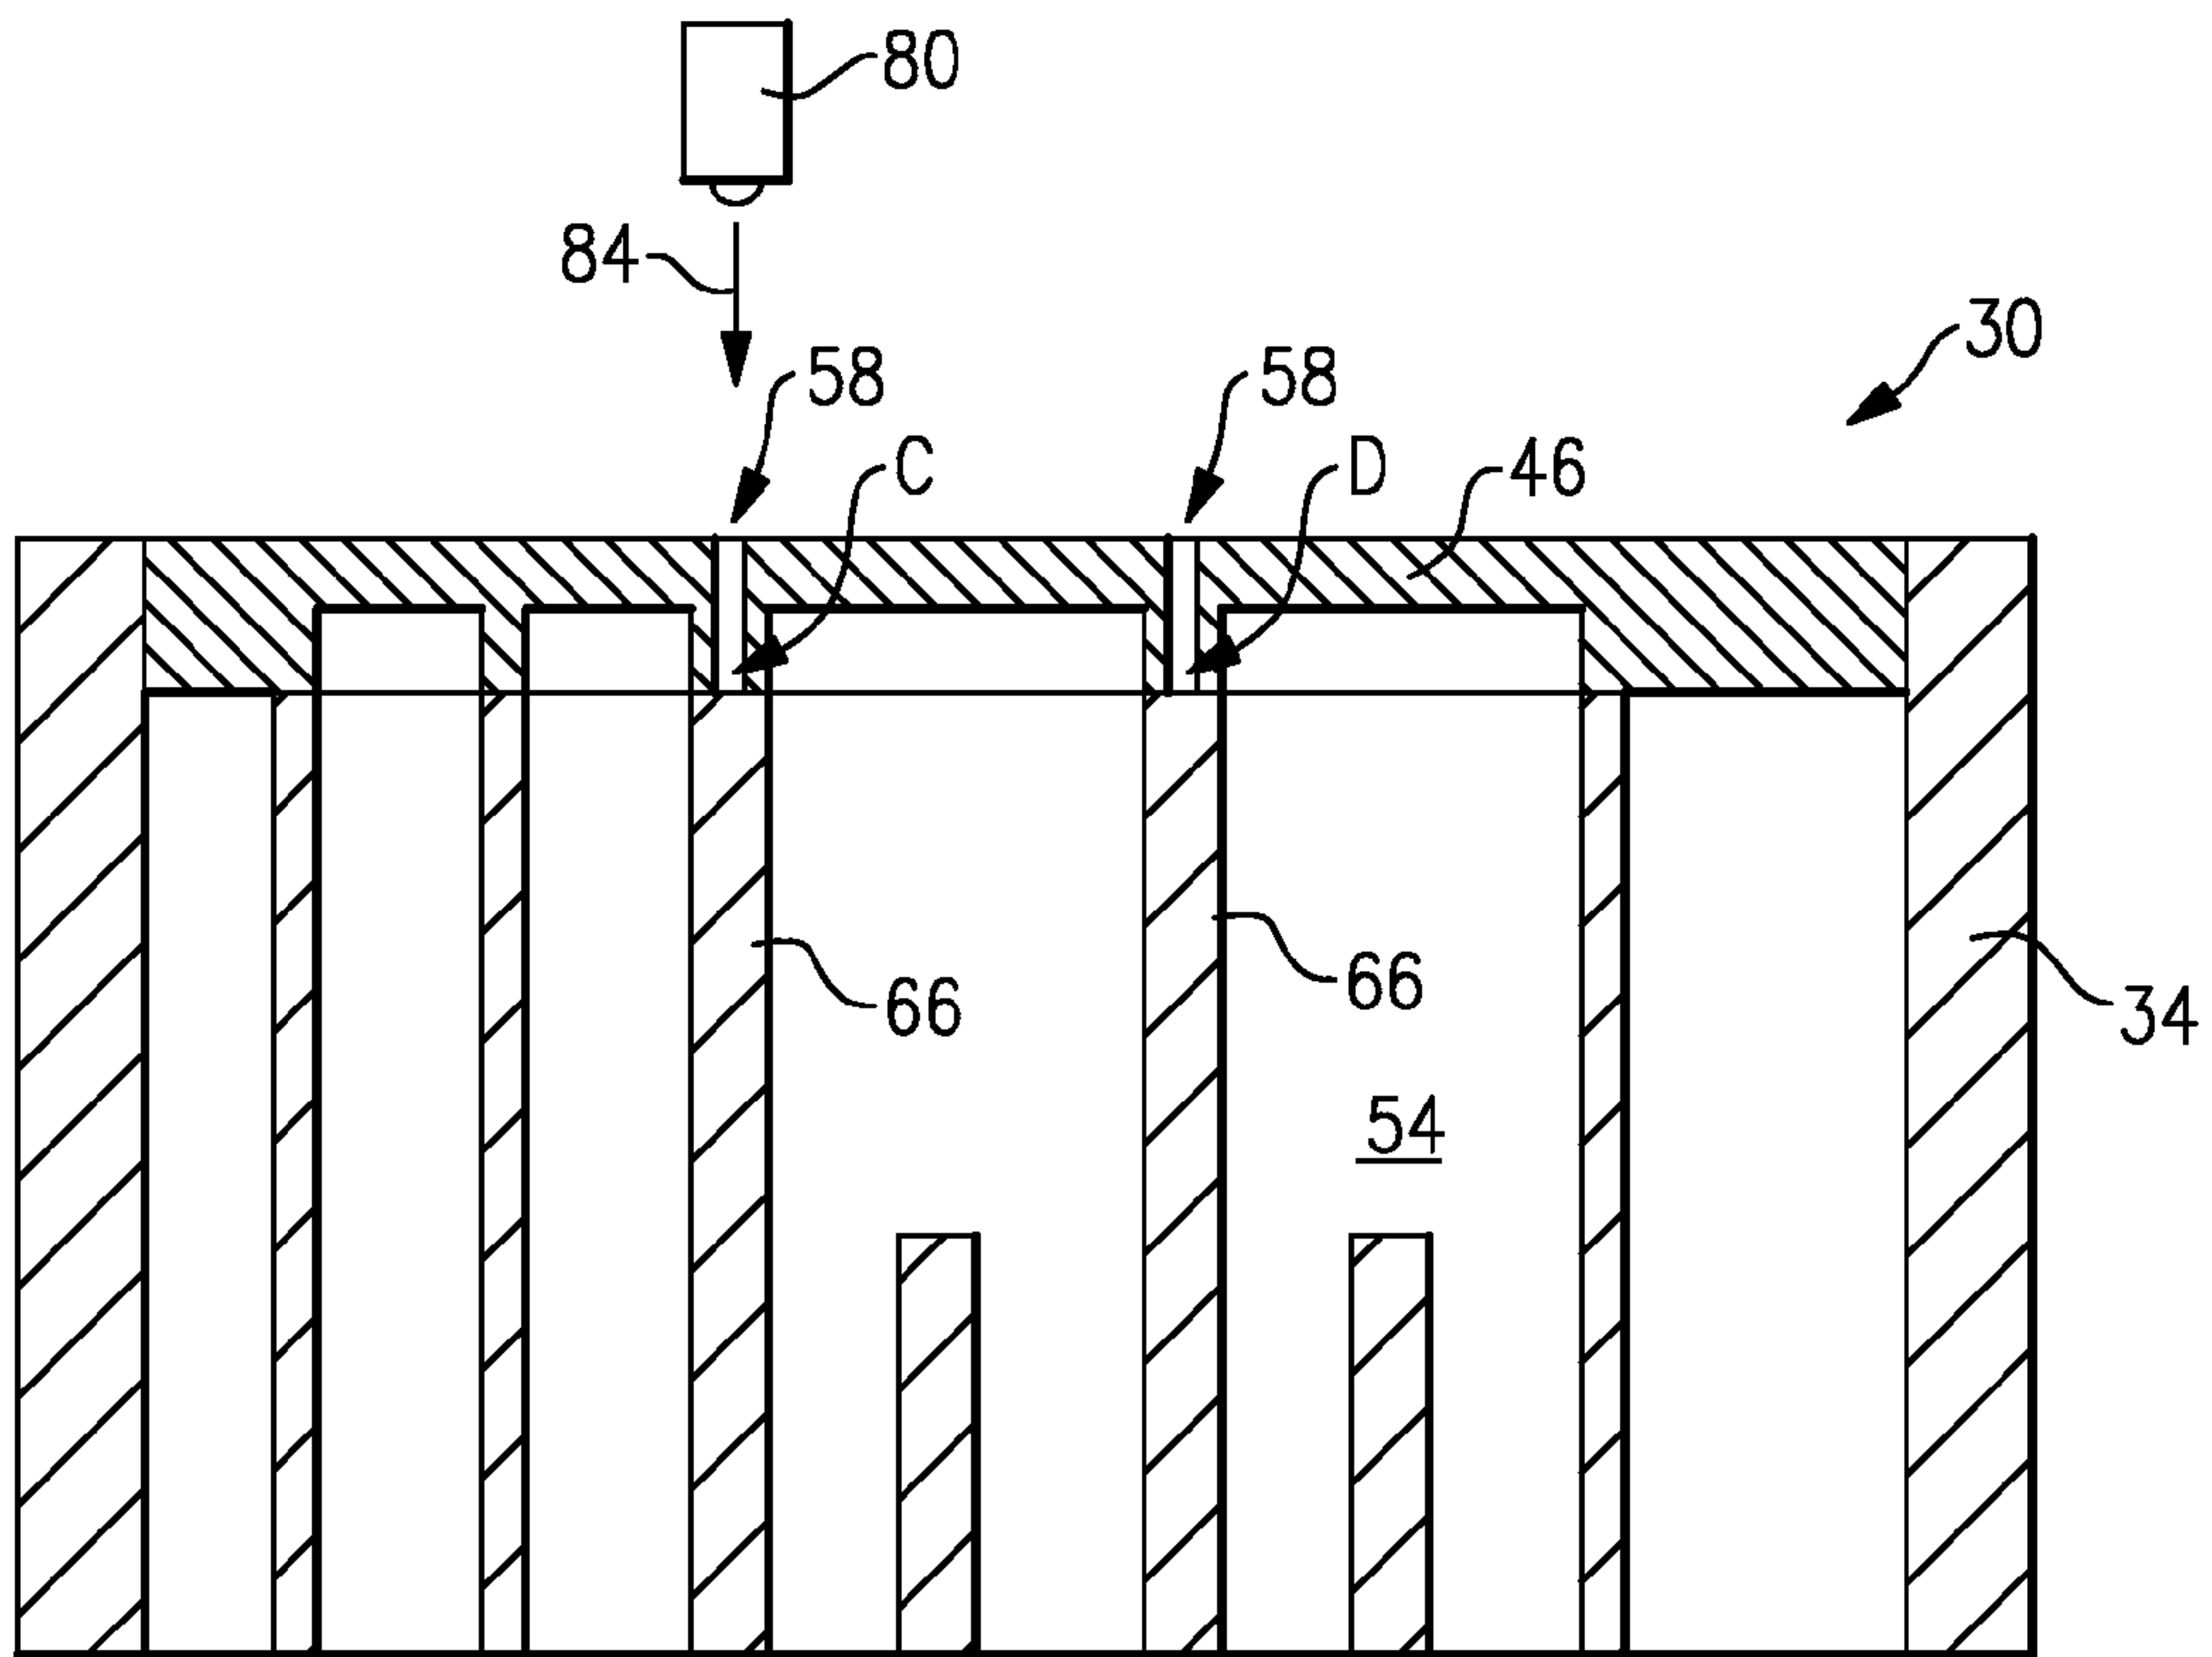
FIG. 6 illustrates a side cross-sectional view of the turbine blade with replacement cap.

As shown in FIG. 6, openings 58 are sized sufficiently large enough to permit welding of replacement cap 46 to structural supports 66 at points C and D by weld source 80 projecting beam 84. Beam 84 may be a laser or other known welding technique. In this way, replacement cap 46 may be directly welded to structural supports 66 located within internal cavity 54. Following this welding operation, openings 58 are then filled with welding wire of the same material as replacement cap 46.
