(10) **Patent No.:** **US 8,091,228 B2**
(45) **Date of Patent:** **Jan. 10, 2012**

(54) **METHOD REPAIR OF TURBINE BLADE TIP**

(73) Assignee: **United Technologies Corporation**,
Hartford, CT (US)

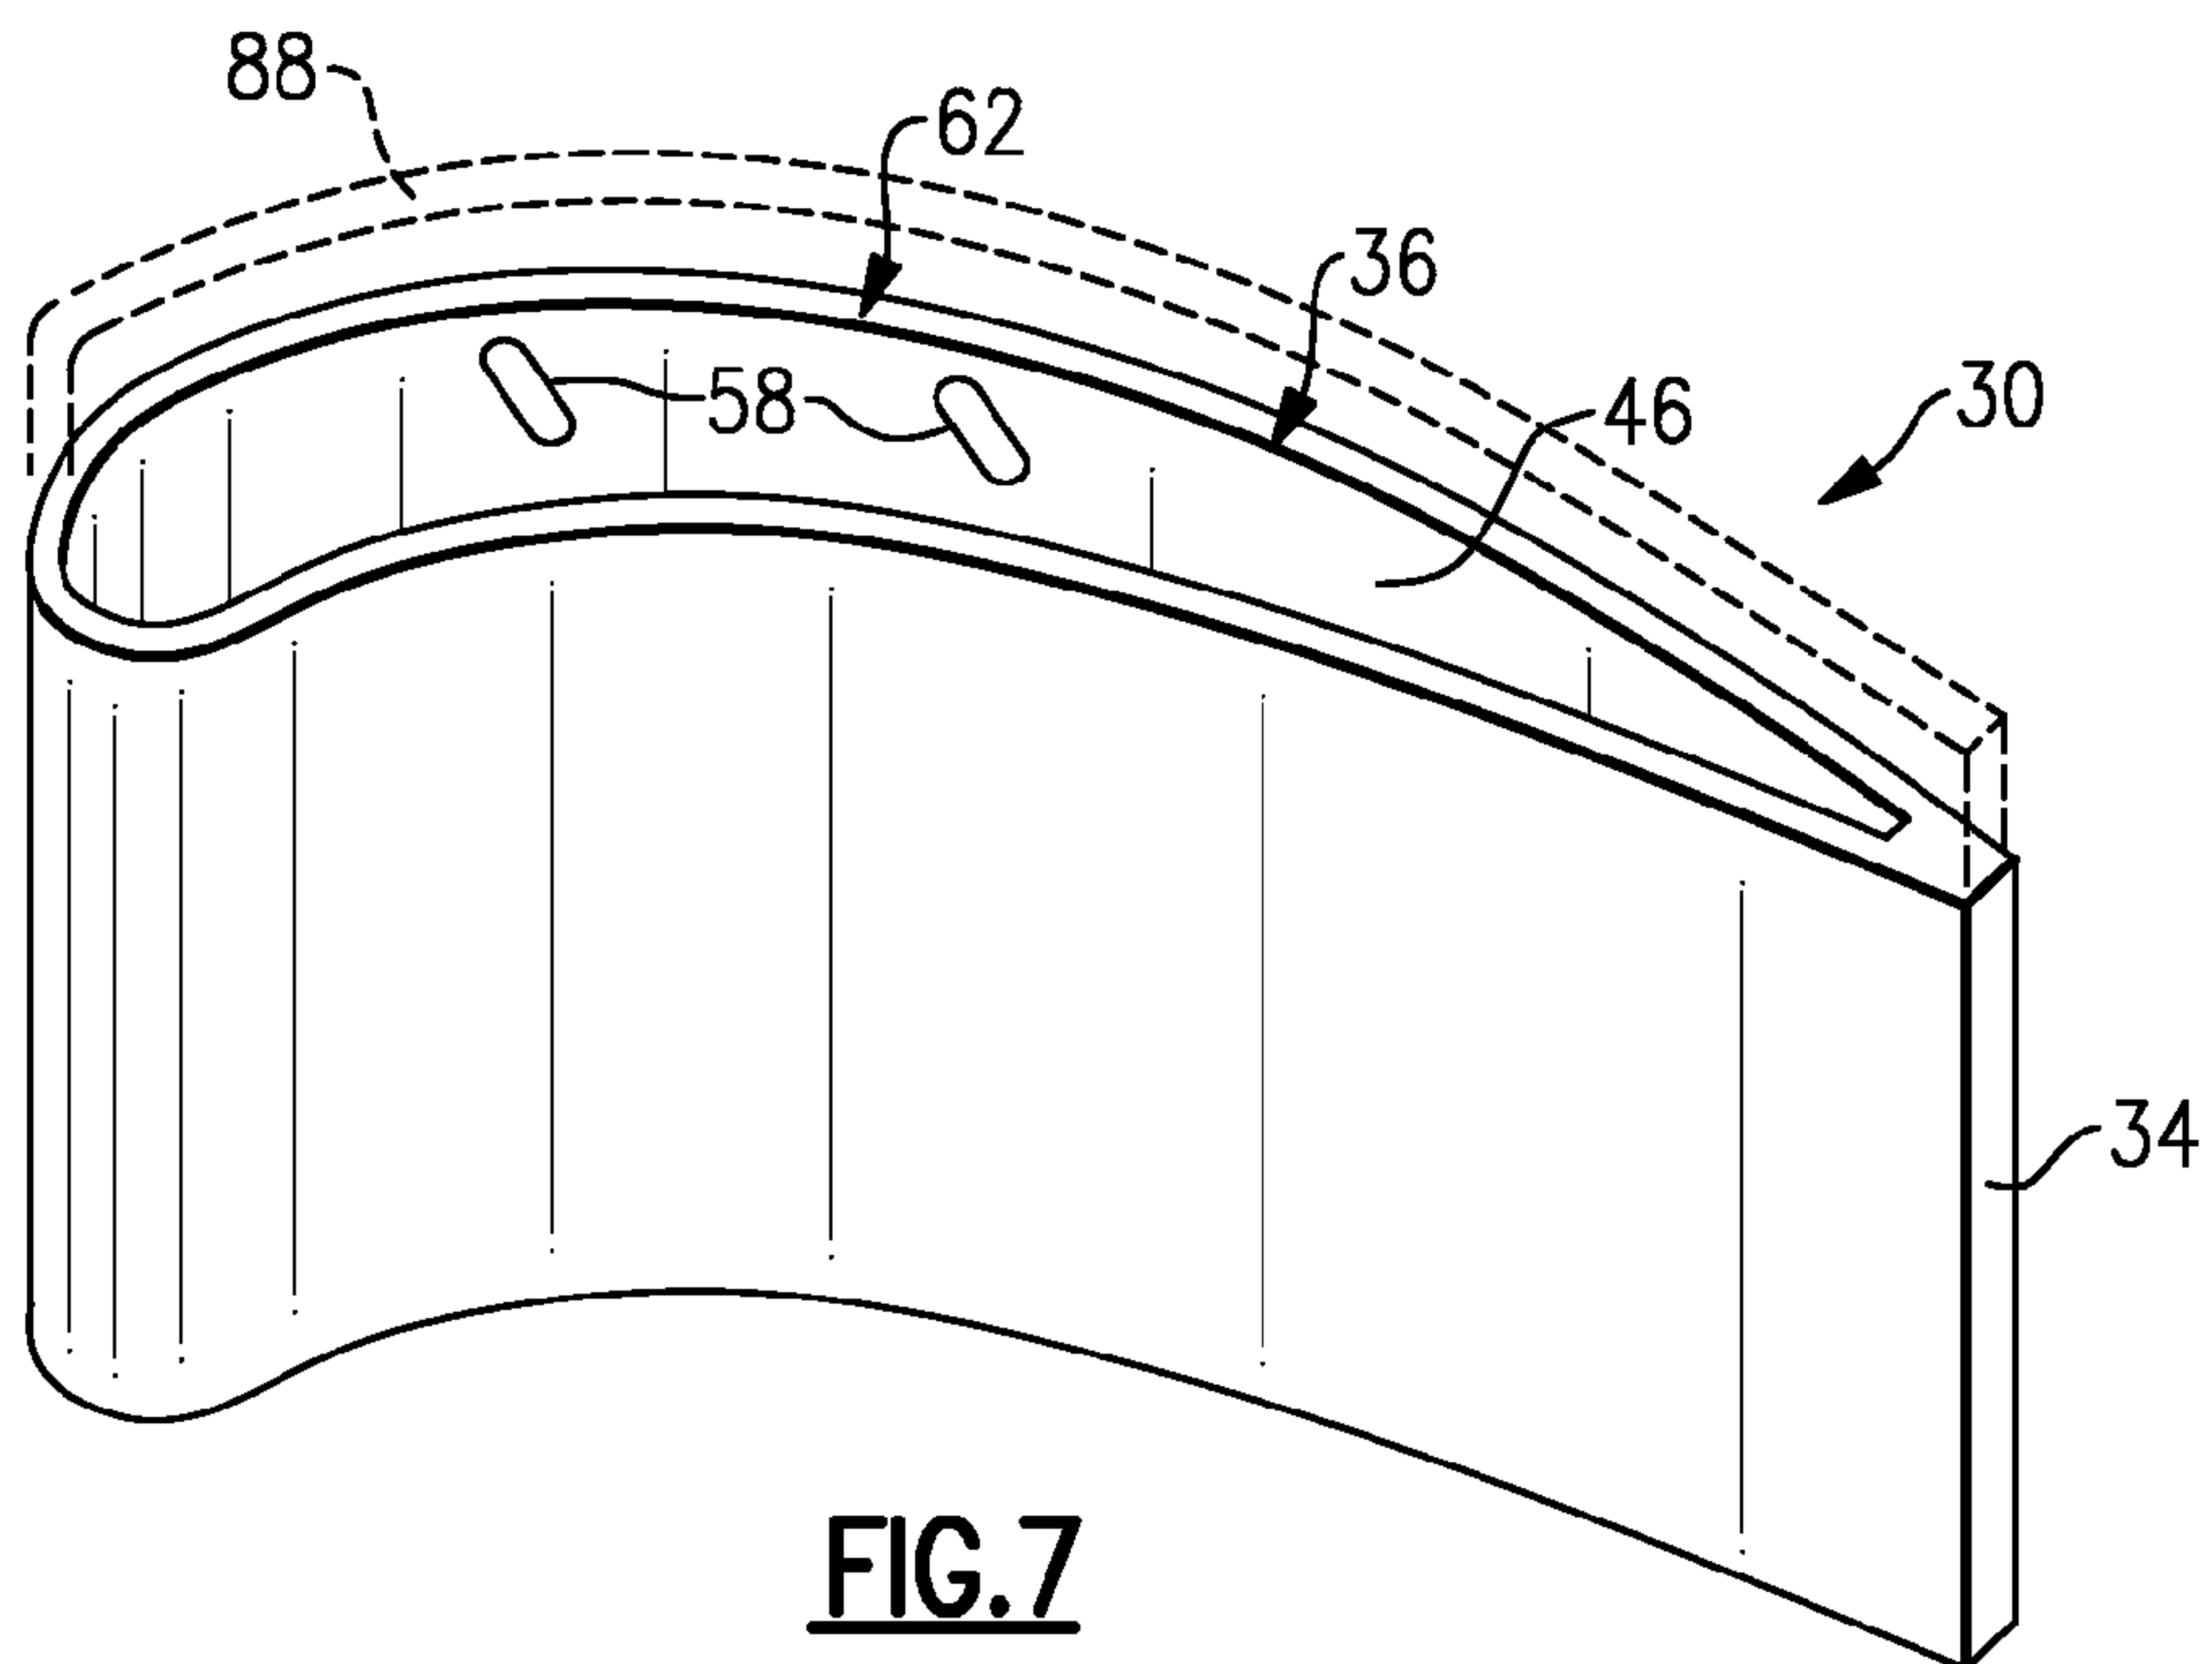
FIG. 7 illustrates a perspective view of the turbine blade with replacement cap.

Following removal of cap 42, replacement cap 46 is disposed over blade body 34. Replacement cap 46 is similar to cap 42 in shape and structure. However, replacement cap 46 has openings 58 that permit access to internal cavity 54 when replacement cap 46 is placed into blade body 34. Replacement cap 46 has perimeter 62 that serves to interface with wall 36 of blade body 34 so that replacement cap 46 may nest flush with wall 36 as shown in FIG. 7.

With reference to FIG. 7, perimeter 62 of replacement cap 46 is also welded along wall 36. Then, with weld wire, squealer 88 is built to the original shape of squealer 50 but to a height higher than the original height of squealer 50 so that squealer 88 may be ground down to the correct height. Following this operation, the outside of turbine blade 30 is ground to remove weld beads. Electrical discharge machining may be used to remove weld beads around perimeter 62 of replacement cap 46.
